<b>Project Name:</b> Anaconda Aluminum Company	<b>Site Location:</b> Columbia Falls Aluminum Company Site, Flathead County, Montana	<b>TDD No:</b> 0004/1305-04
---	---	--------------------------------

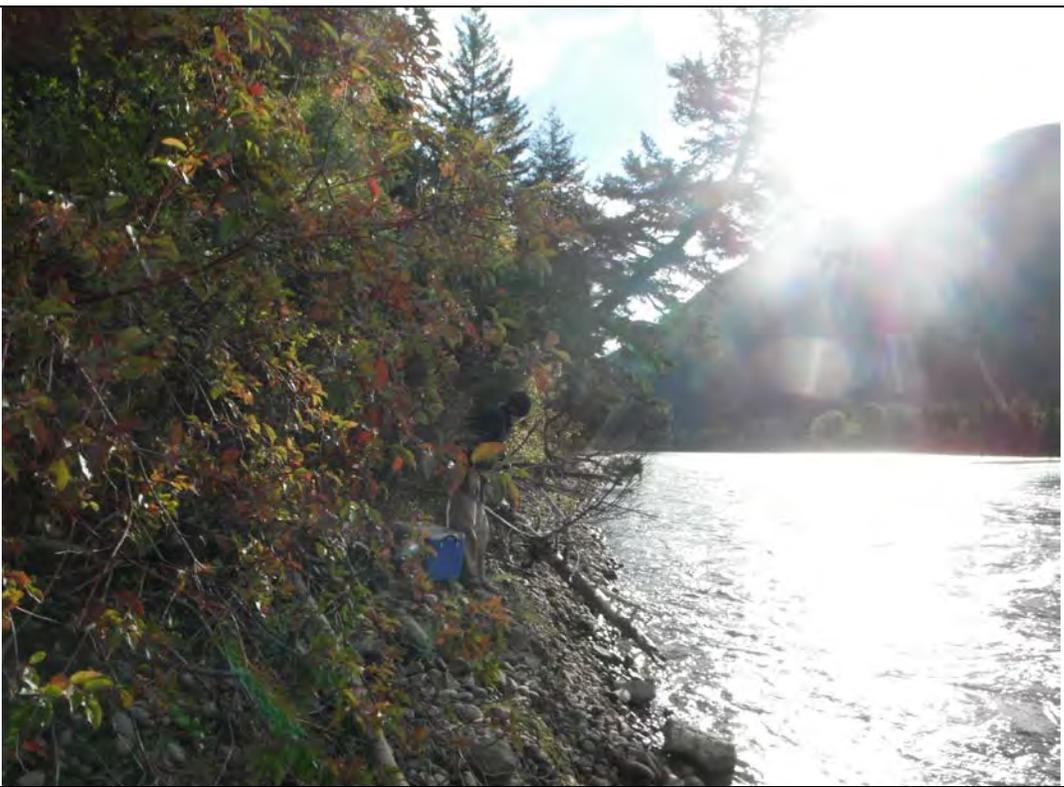
<b>Photo No.</b> <b>28</b>	<b>Date:</b> 9/26/2013
<b>Direction Photo Taken:</b>  E

**Description:**  
Showing impassable river bank to sample location for co-located sediment/surface water samples: CF-SD-10 / CF-SW-10, CF-SD-11 / CF-SW-11, CF-SD-12 / CF-SW-12; Samples not collected.

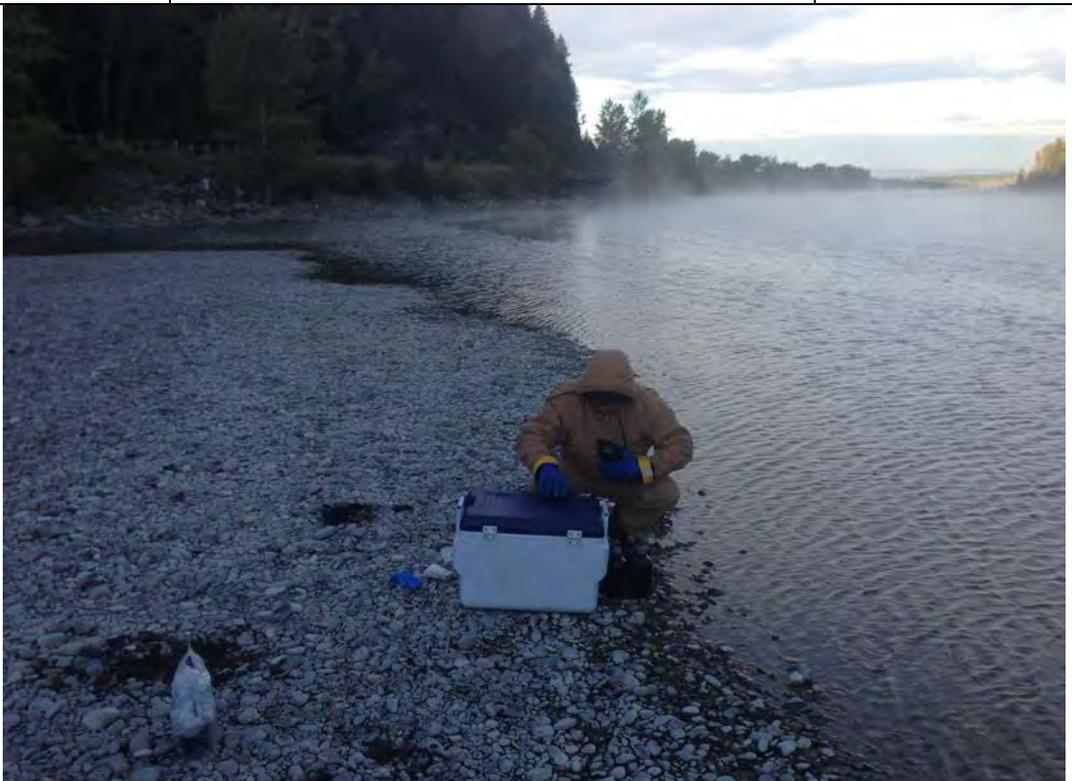
<b>Photo No.</b> <b>29</b>	<b>Date:</b> 9/27/2013
<b>Direction Photo Taken:</b>  SW

Showing location for co-located sediment/surface water samples:  
CF-SD-13 / CF-SW-13.

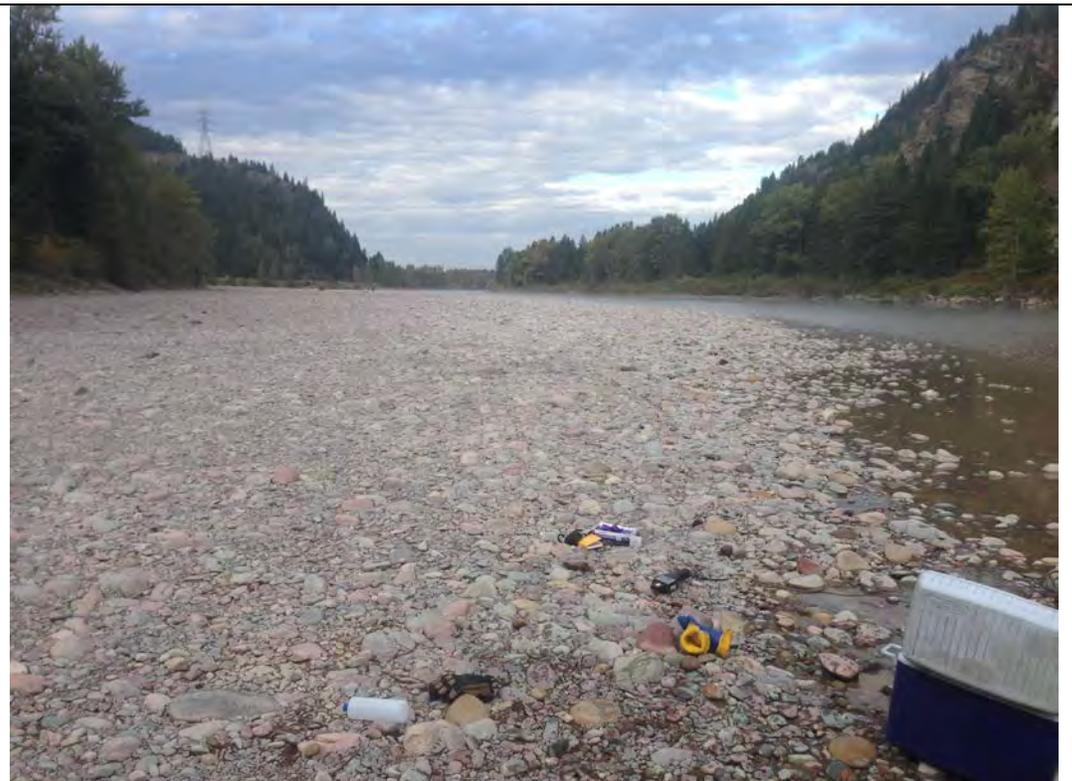
<b>Photo No.</b> <b>30</b>	<b>Date:</b> 9/27/2013
<b>Direction Photo Taken:</b>  SW

Showing location for co-located sediment/surface water samples:  
CF-SD-14 / CF-SW-14.

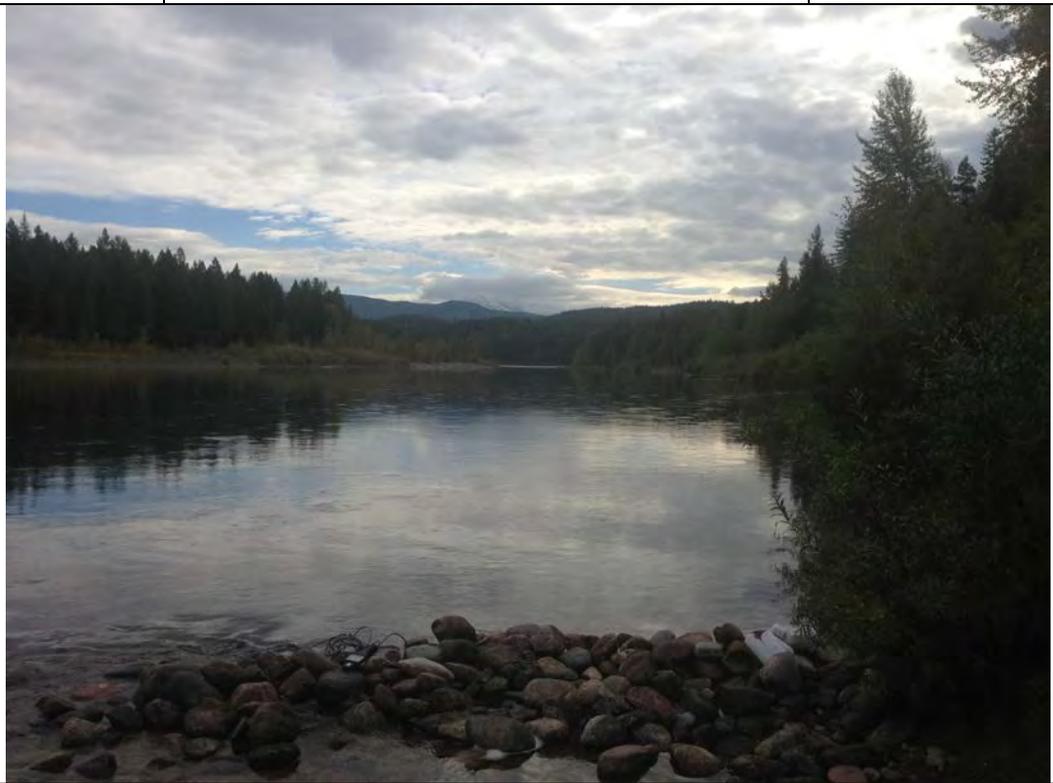
<b>Photo No.</b> <b>31</b>	<b>Date:</b> 9/27/2013
-------------------------------	---------------------------

**Description:**  
Showing location for co-located sediment/surface water samples:  
CF-SD-15 / CF-SW-15.

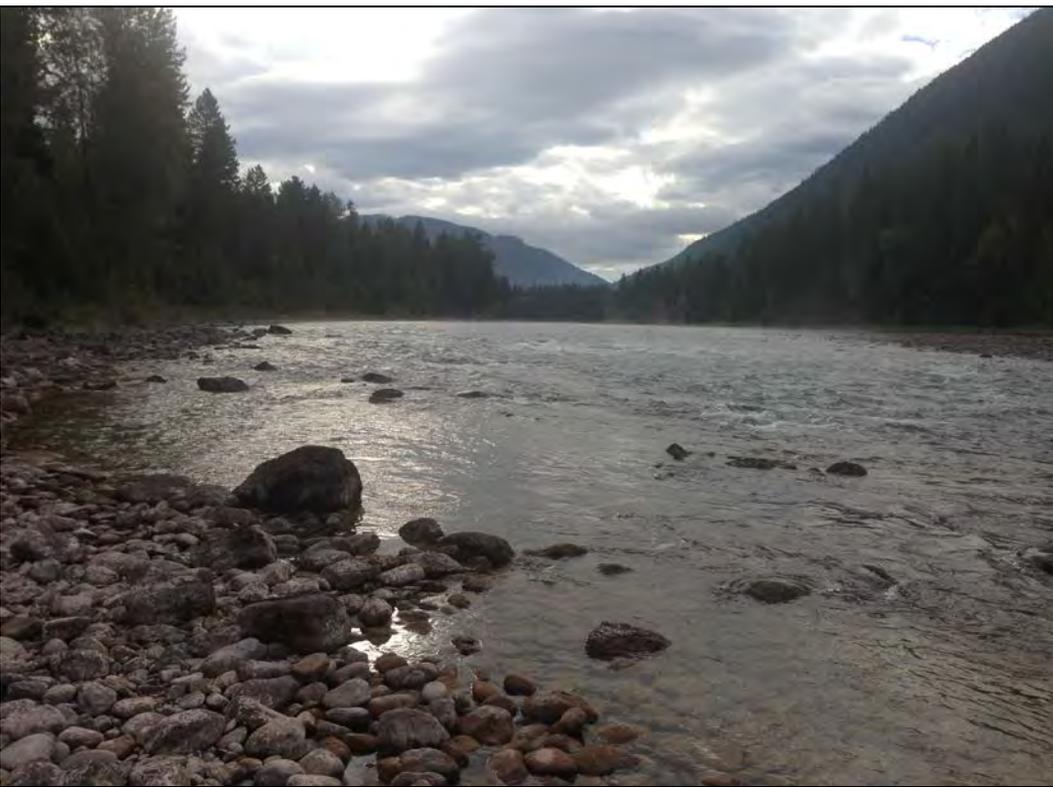
<b>Photo No.</b> <b>32</b>	<b>Date:</b> 9/27/2013
-------------------------------	---------------------------

**Description:**  
Showing location for co-located sediment/surface water samples:  
CF-SD-16 / CF-SW-16.

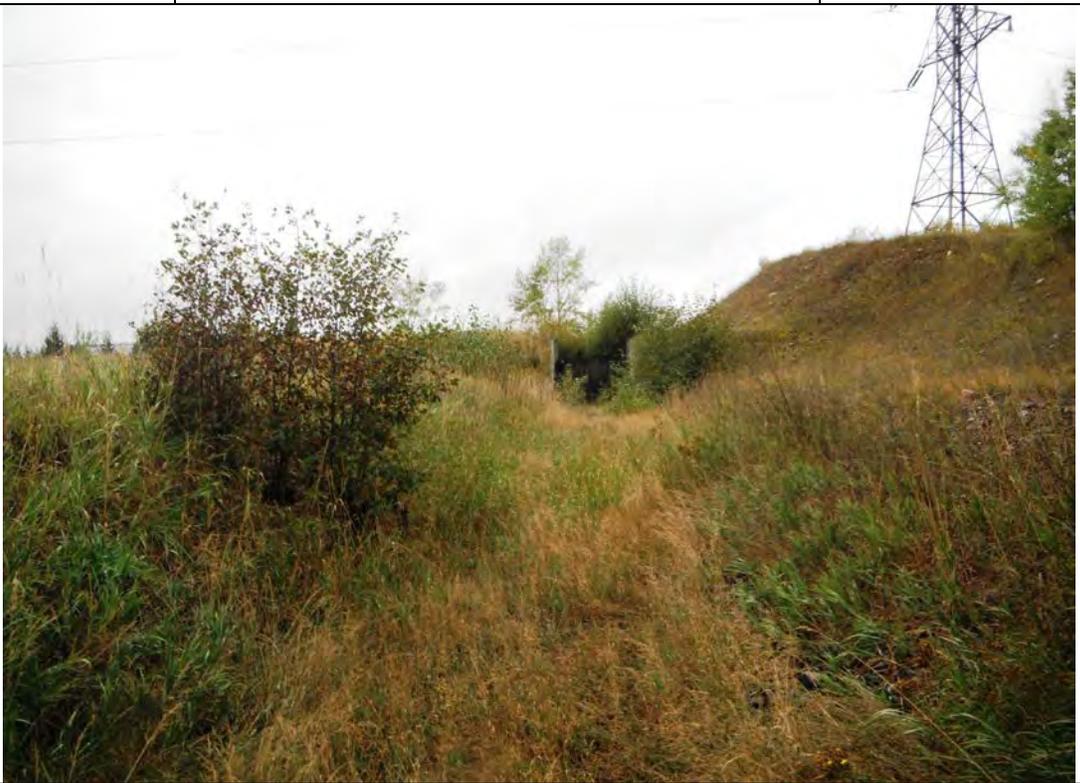
<b>Photo No.</b> <b>33</b>	<b>Date:</b> 9/24/2013
-------------------------------	---------------------------

Showing location for sediment sample: CF-SD-OP-01. Overflow gate in Cedar Creek Overflow Drainage Ditch in background.

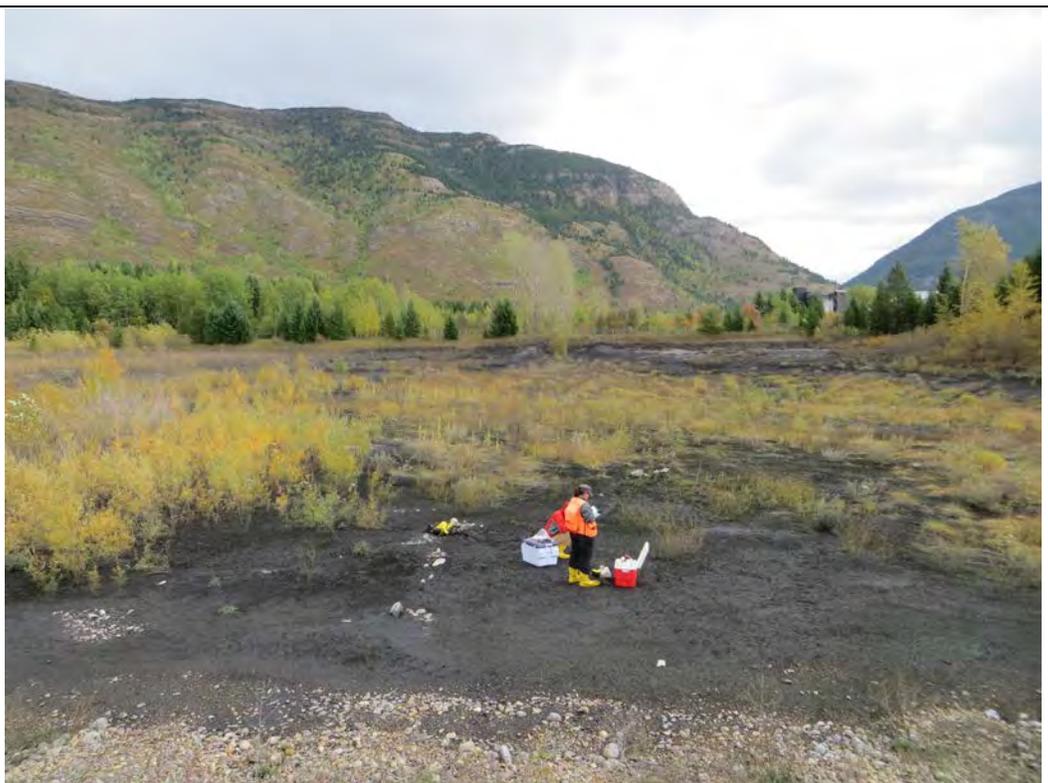
<b>Photo No.</b> <b>34</b>	<b>Date:</b> 9/30/2013
-------------------------------	---------------------------

Showing location for waste source sample: CF-WS-17.

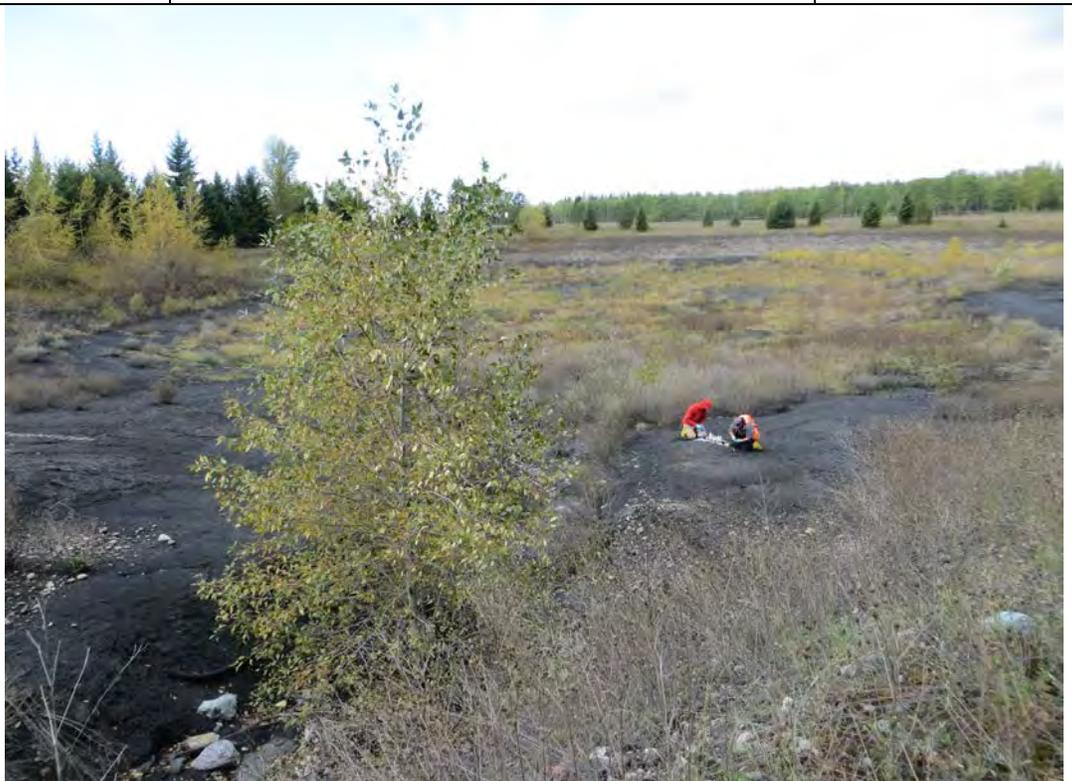
<b>Photo No.</b> <b>35</b>	<b>Date:</b> 9/30/2013
<b>Direction Photo Taken:</b>  W

**Description:**  
Showing location for waste source sample: CF-WS-18.

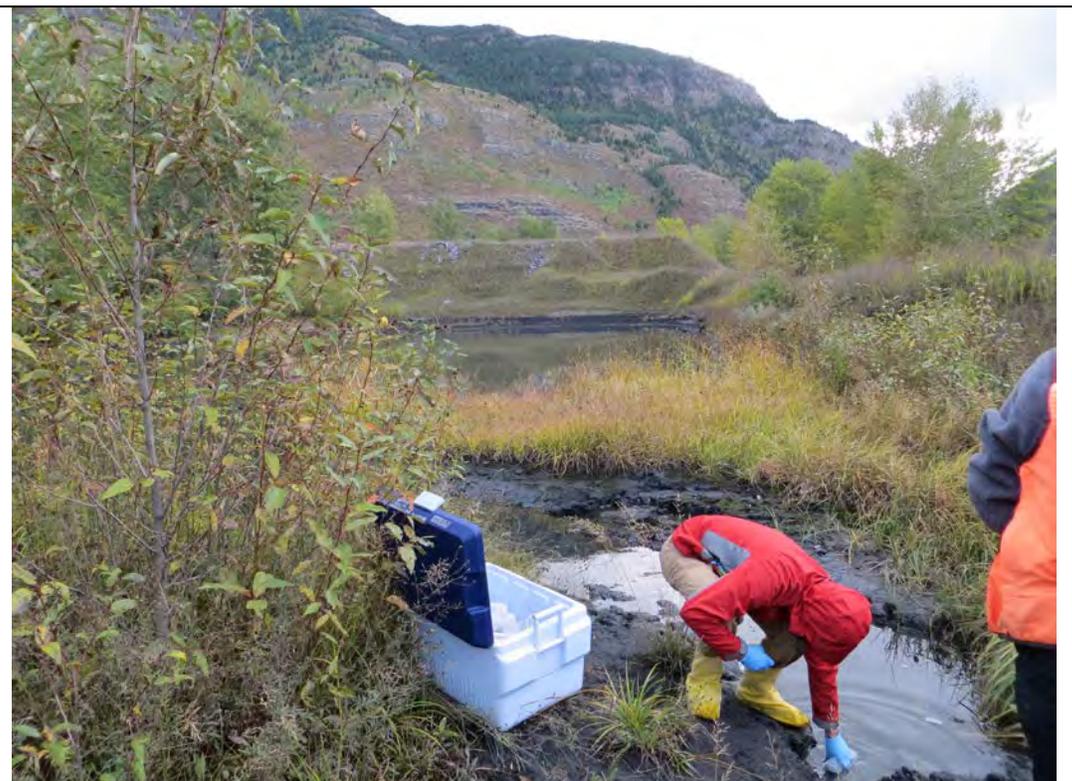
<b>Photo No.</b> <b>36</b>	<b>Date:</b> 9/30/2013
<b>Direction Photo Taken:</b>  E

**Description:**  
Showing location for co-located waste source / surface water sample: CF-WS / SW-19.

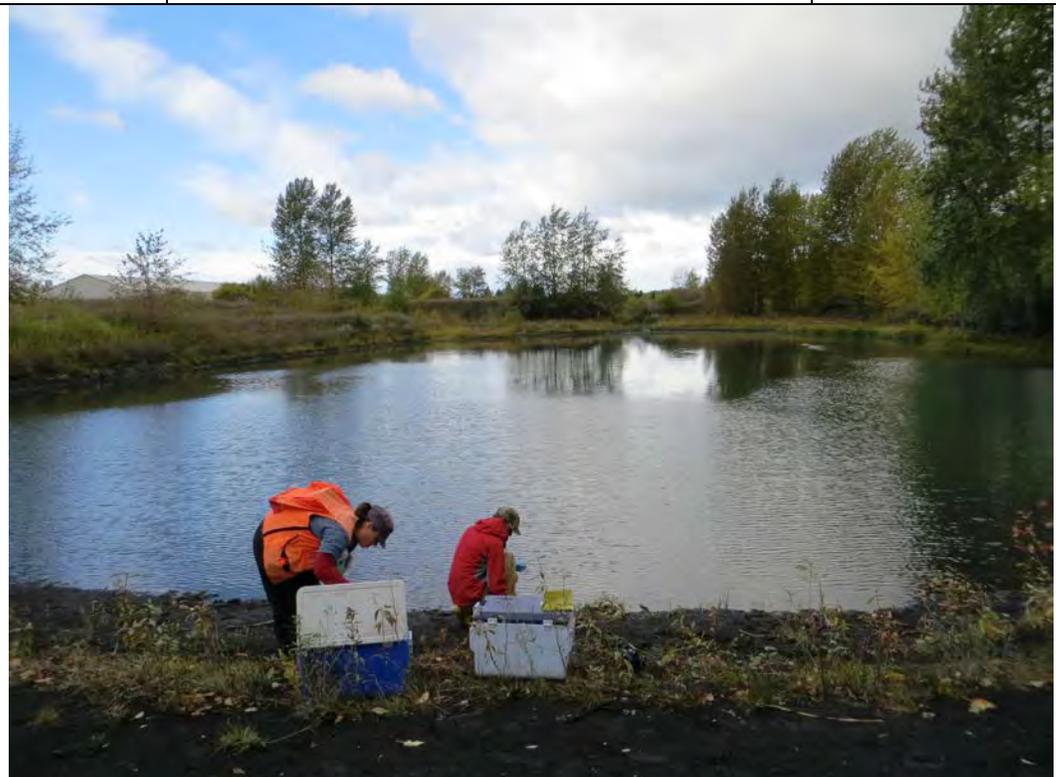
<b>Photo No.</b> <b>37</b>	<b>Date:</b> 9/30/2013
<b>Direction Photo Taken:</b>  W

Showing location for co-located waste source / surface water sample: CF-WS / SW-20.

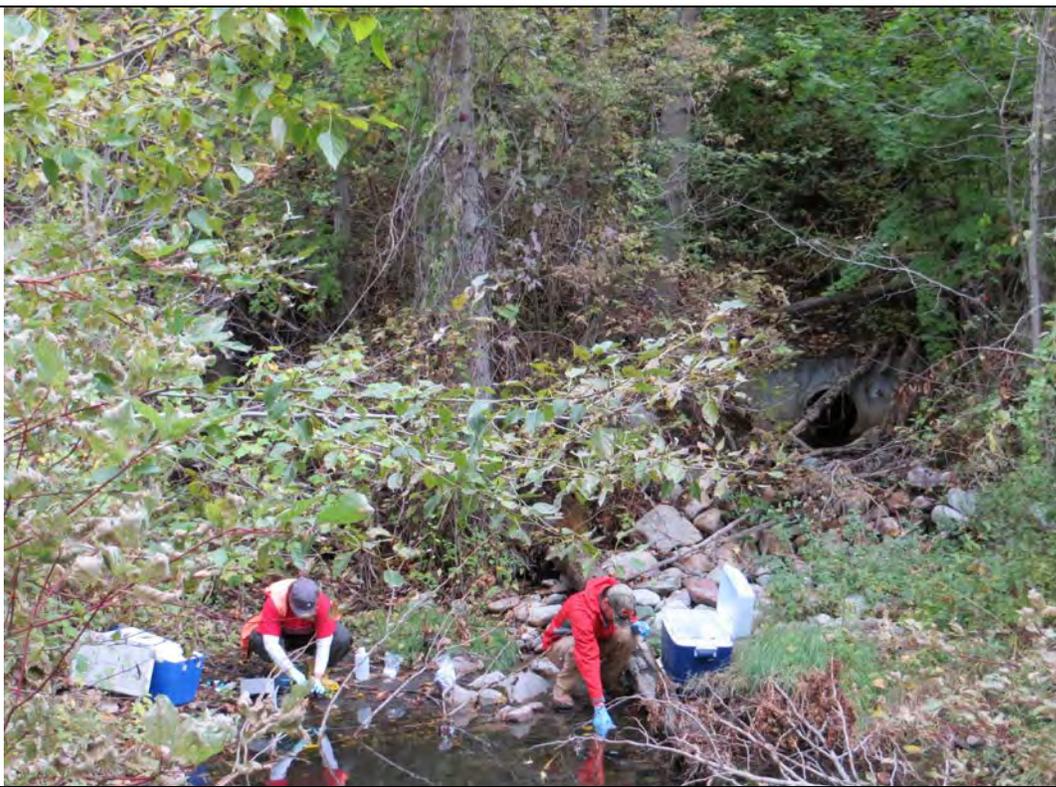
<b>Photo No.</b> <b>38</b>	<b>Date:</b> 10/1/2013
<b>Direction Photo Taken:</b>  N

Showing location for co-located waste source / surface water sample: CF-WS / SW-21. Outfall D005 in background.

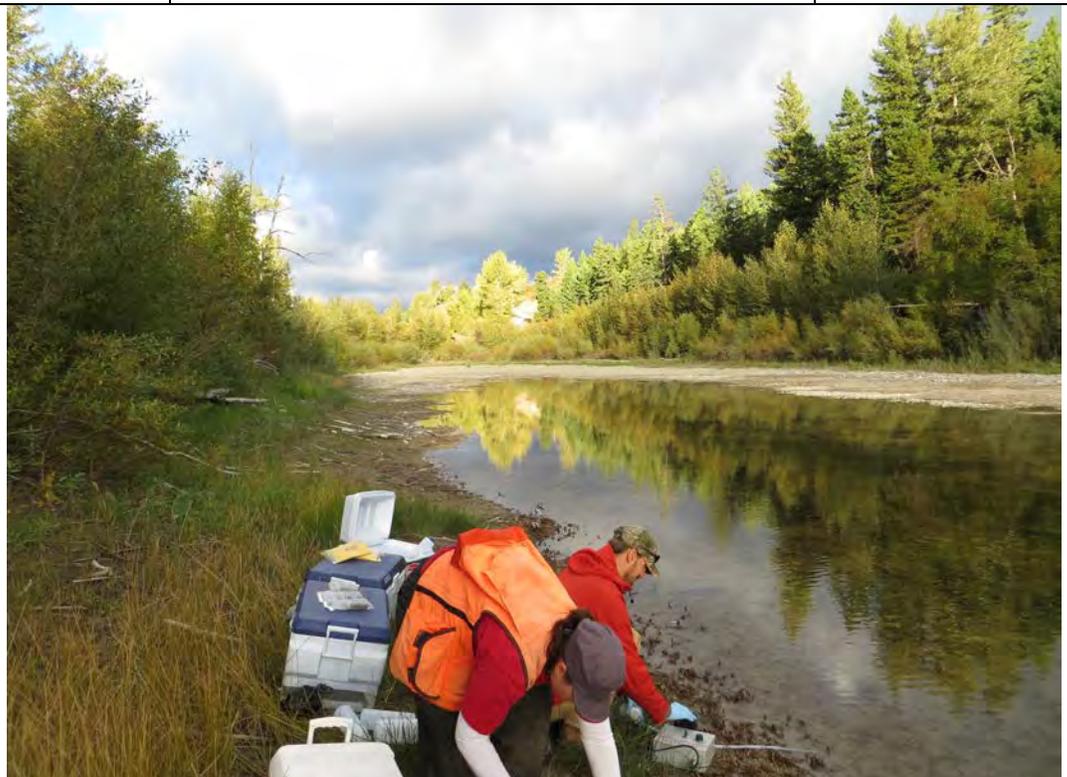
<b>Photo No.</b> <b>39</b>	<b>Date:</b> 10/1/2013
<b>Direction Photo Taken:</b>  W

Showing location for co-located waste source / surface water sample: CF-WS / SW-22.

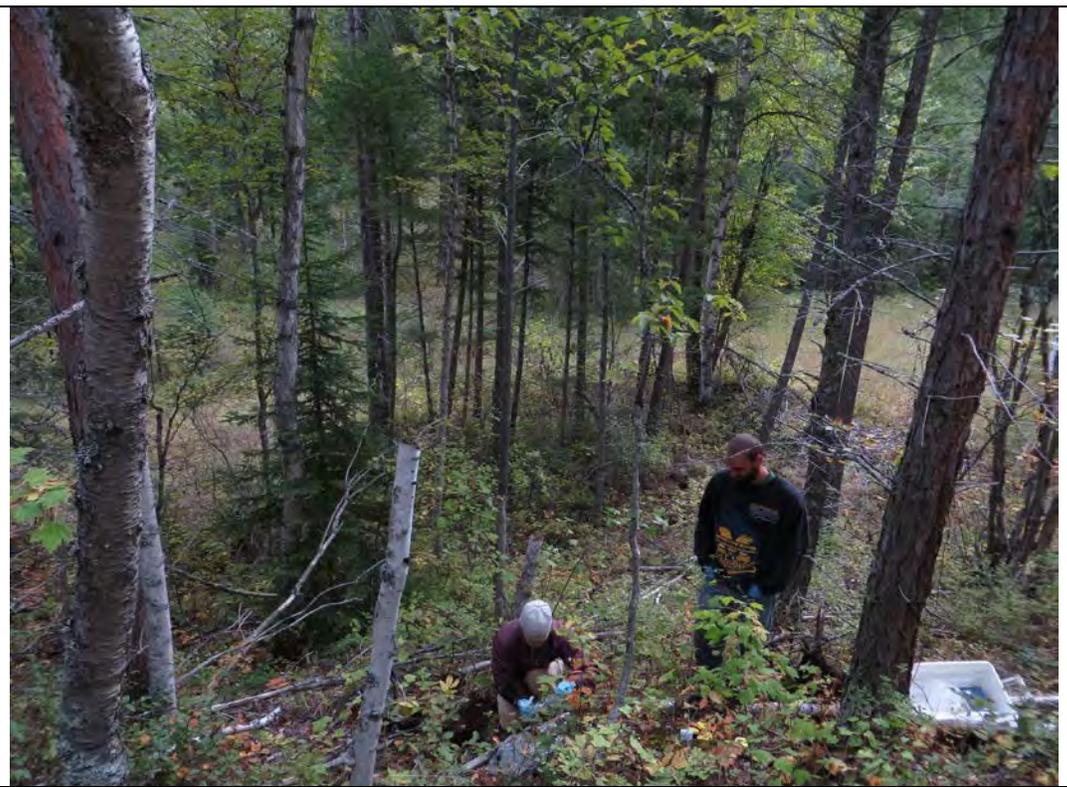
<b>Photo No.</b> <b>40</b>	<b>Date:</b> 9/27/2013
<b>Direction Photo Taken:</b>  E

Showing location for soil sample: CF-SS-01.

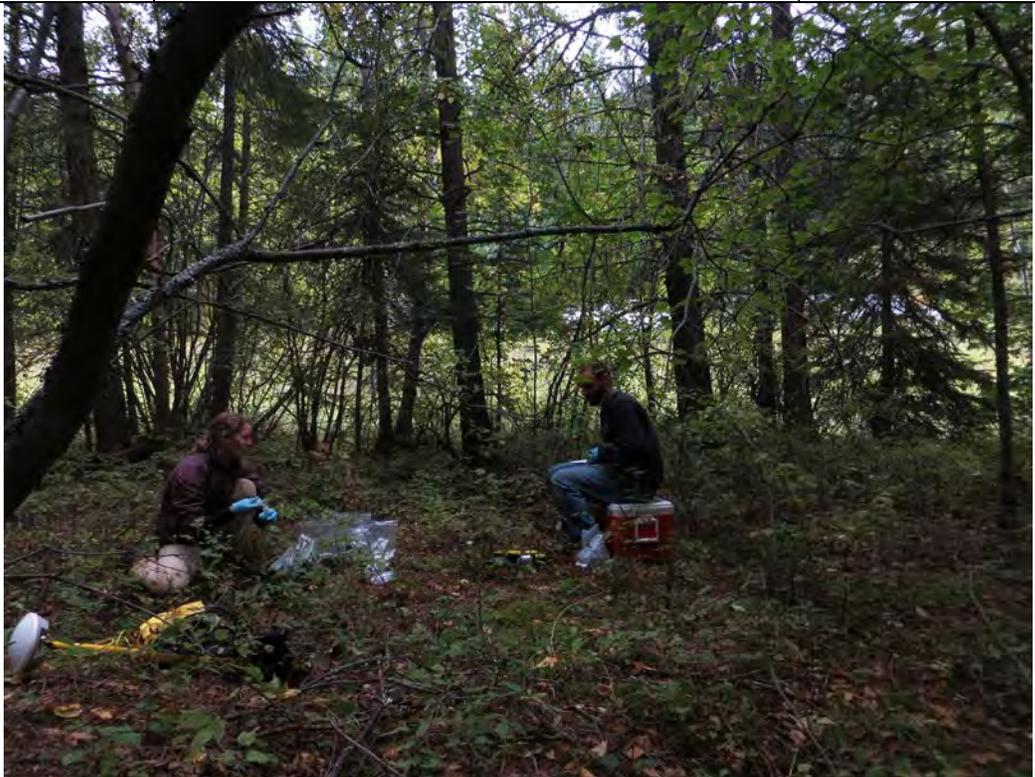
<b>Photo No.</b> <b>41</b>	<b>Date:</b> 9/27/2013
<b>Direction Photo Taken:</b>  E

**Description:**  
Showing location for soil sample: CF-SS-02.

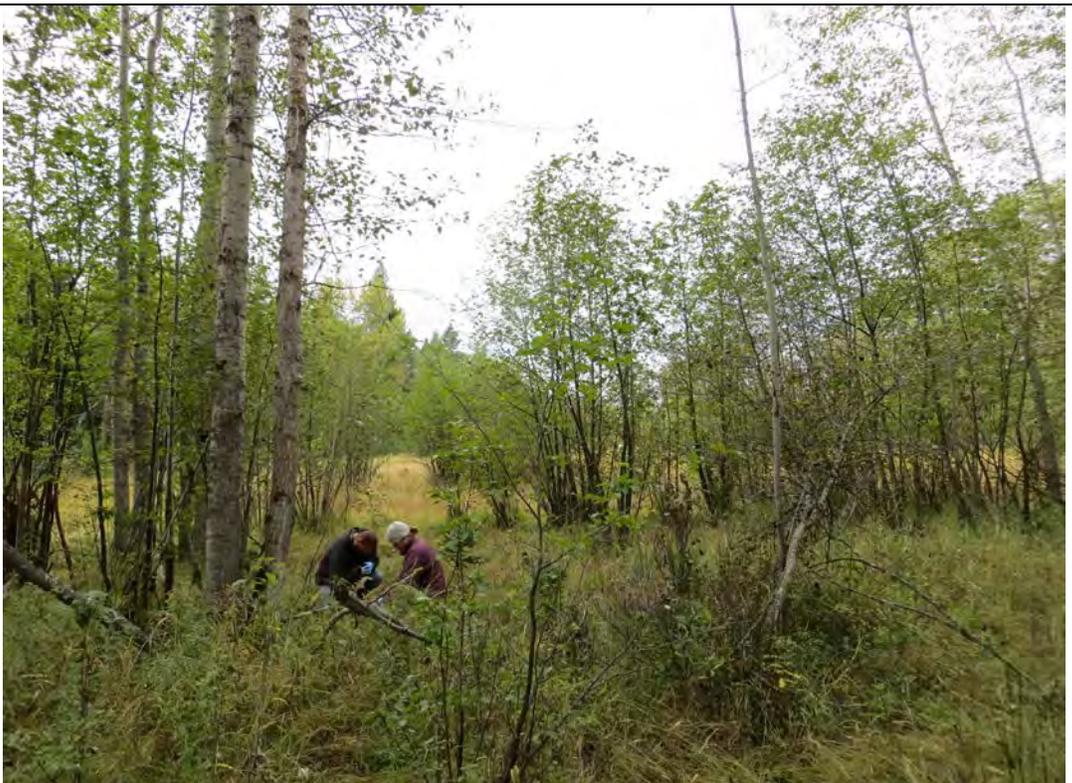
<b>Photo No.</b> <b>42</b>	<b>Date:</b> 9/27/2013
<b>Direction Photo Taken:</b>  SE

**Description:**  
Showing location for soil sample: CF-SS-03.

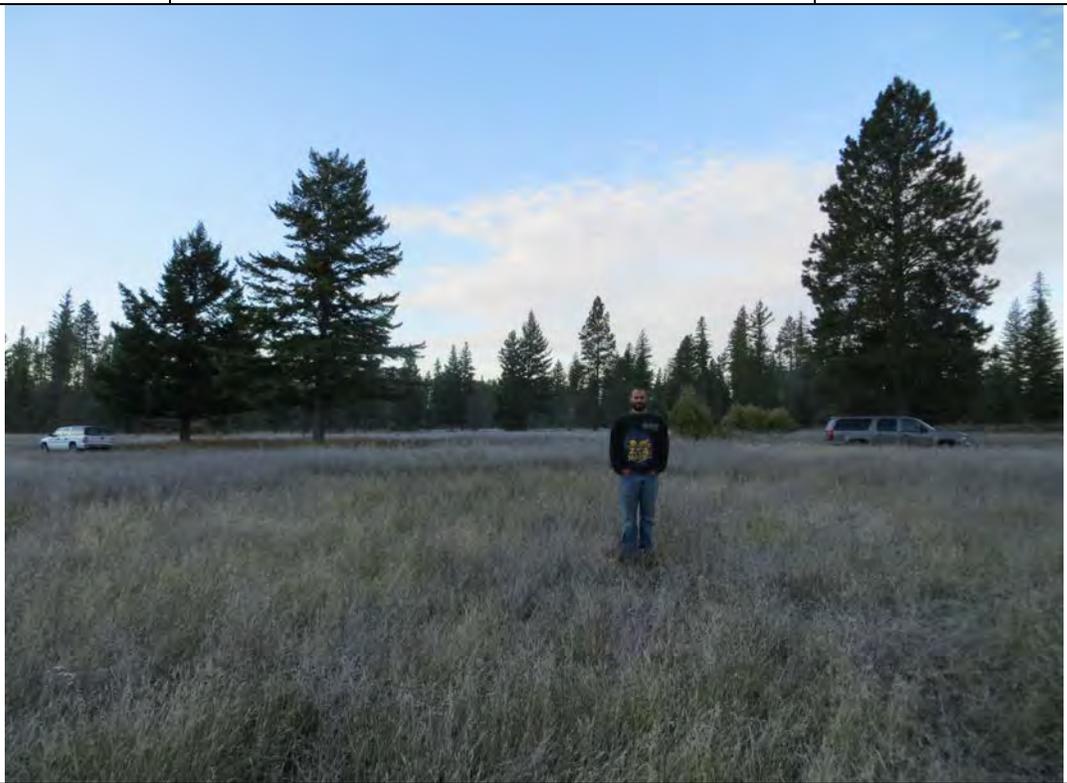
<b>Photo No.</b> <b>43</b>	<b>Date:</b> 9/27/2013
-------------------------------	---------------------------

Showing location for soil sample: CF-SS-04.

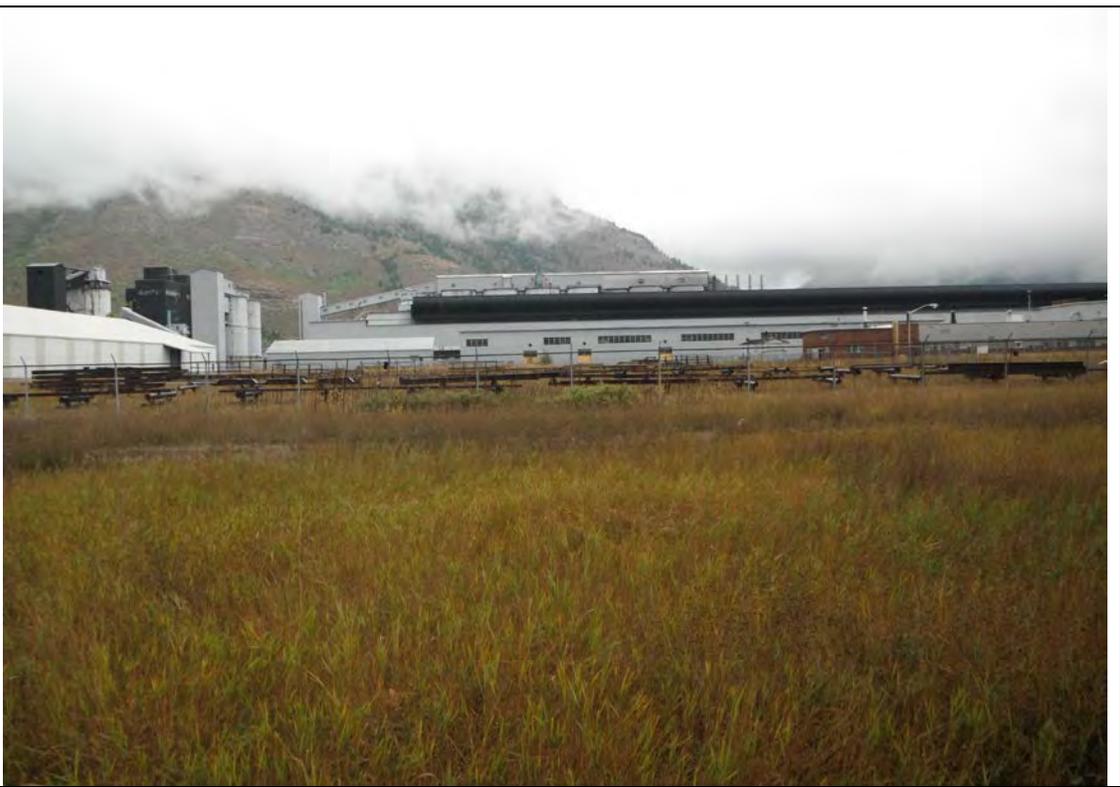
<b>Photo No.</b> <b>44</b>	<b>Date:</b> 9/24/2013
-------------------------------	---------------------------

Showing location for soil sample: CF-SS-05.

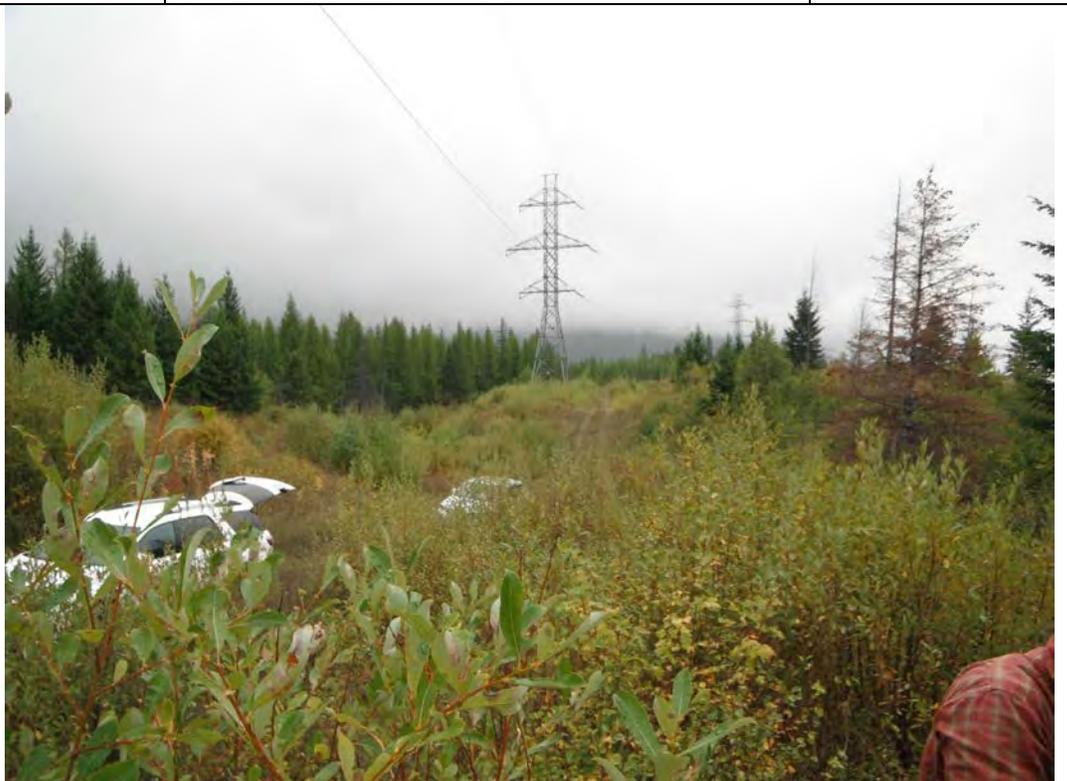
<b>Photo No.</b> <b>45</b>	<b>Date:</b> 9/24/2013
<b>Direction Photo Taken:</b>  S

**Description:**  
Showing location for soil sample: CF-SS-06.

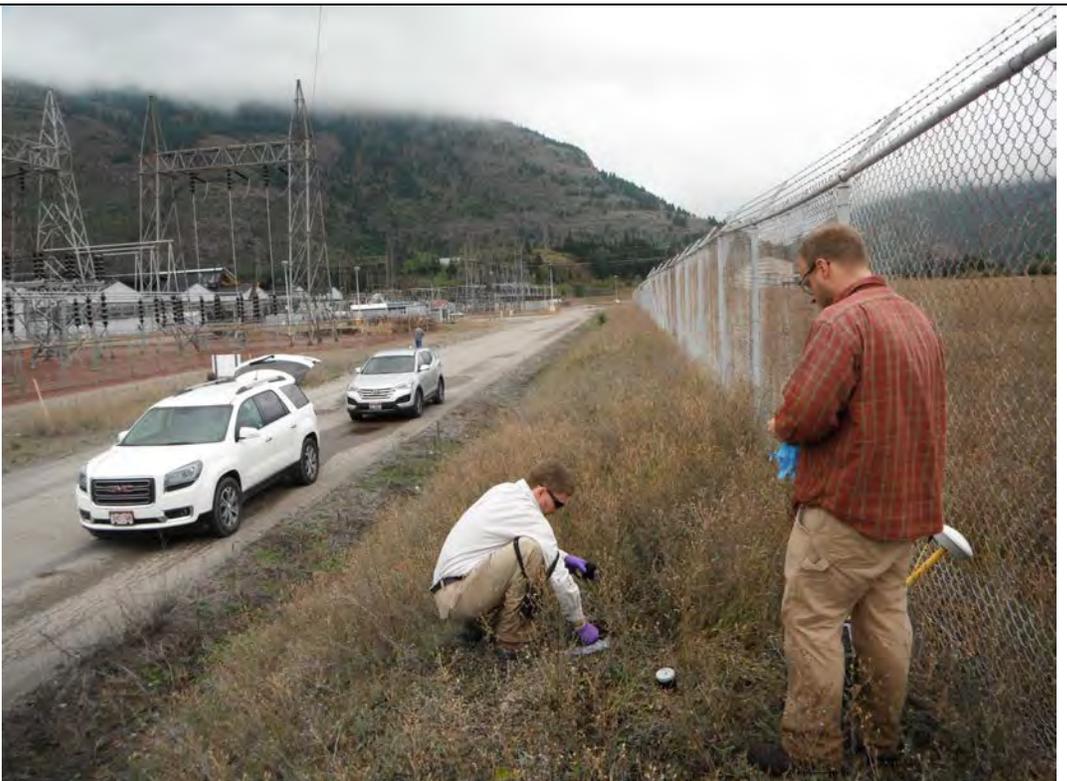
<b>Photo No.</b> <b>46</b>	<b>Date:</b> 9/24/2013
<b>Direction Photo Taken:</b>  E

**Description:**  
Showing location for soil sample: CF-SS-07.

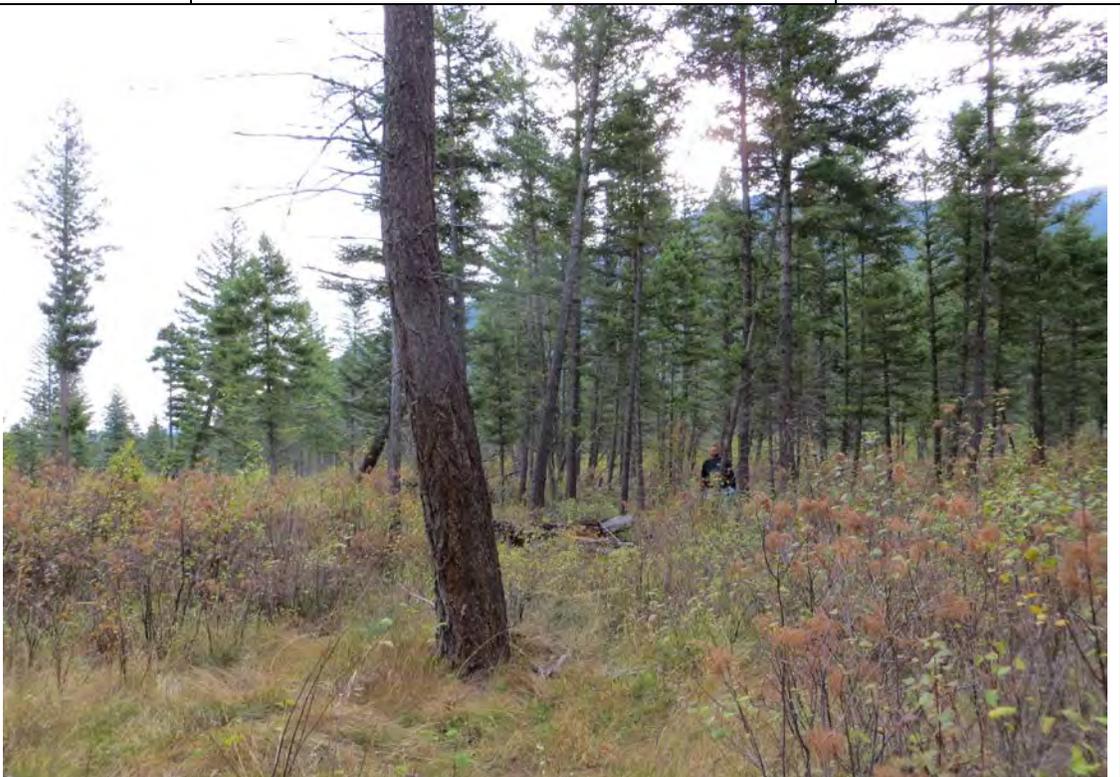
<b>Photo No.</b> <b>47</b>	<b>Date:</b> 9/27/2013
<b>Direction Photo Taken:</b>  SE

Showing location for soil sample: CF-SS-08.

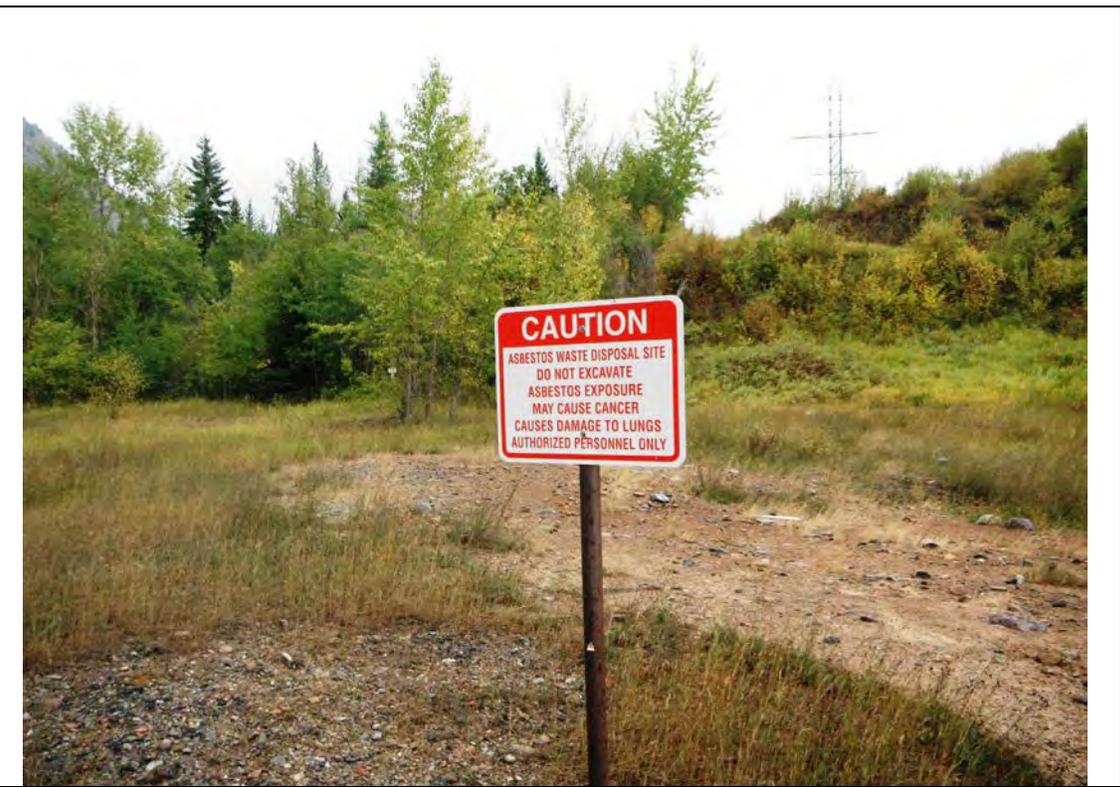
<b>Photo No.</b> <b>48</b>	<b>Date:</b> 9/24/2013
<b>Direction Photo Taken:</b>  S

Showing asbestos waste disposal site located southwest of sediment sample location for CF-SD-OP-01.

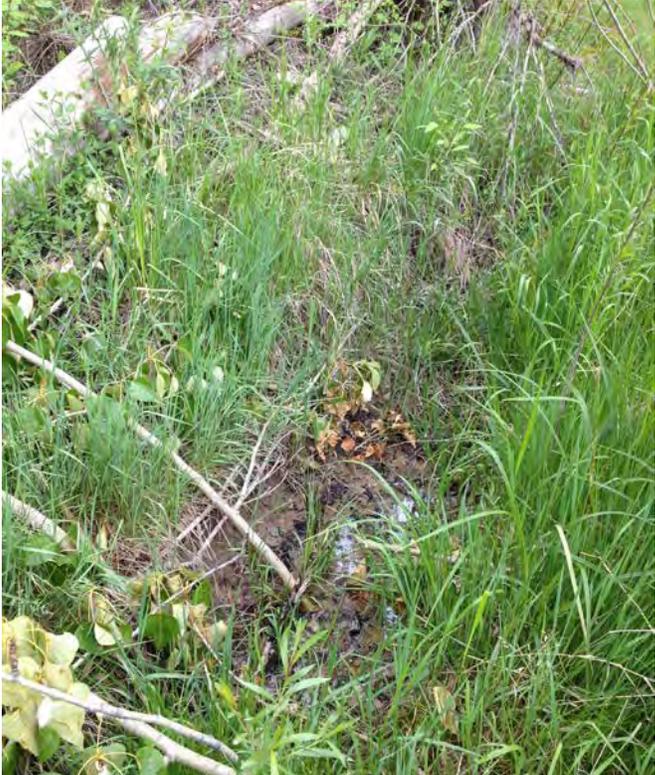
<b>Direction Photo Taken:</b> Down			
<b>Description:</b> Showing seep of Outfall D006 location.
