FOURTH FIVE-YEAR REVIEW REPORT

**SHARON STEEL SUPERFUND SITE
CERCLIS ID: UTD980951388**

**CITY OF MIDVALE
SALT LAKE COUNTY, UTAH**

Utah Department of Environmental Quality
Division of Environmental Response and Remediation

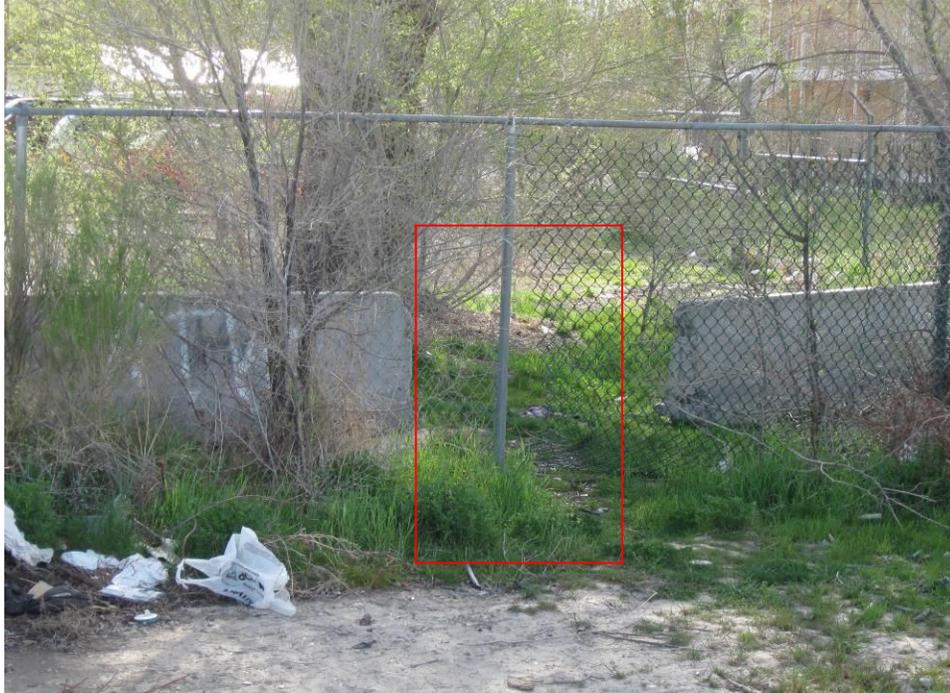
There were no significant issues identified regarding the cap and photos taken during the site inspection are provided in Attachment K. Holes cut in the chain-link fence were observed during the site inspection near the end of Lennox Street and along the Jordan River Parkway Trail. Trees and brush growing on the cap's surface were also observed during the site inspection.

Photo No. 1 – Hole in chain-link fence near the end of Lennox Street at OU1

OU(s): 1	Issue Category: Operations and Maintenance			
	Issue: <i>Holes were observed in the chain-link fence near the end of Lennox Street and along the Jordan River Parkway Trail.</i>			
	Recommendation: <i>Repair fence at these locations.</i>			
Affect Current Protectiveness	Affect Future Protectiveness	Implementing Party	Oversight Party	Milestone Date
No	Yes	Property Owner	Midvale City	11/19/2014

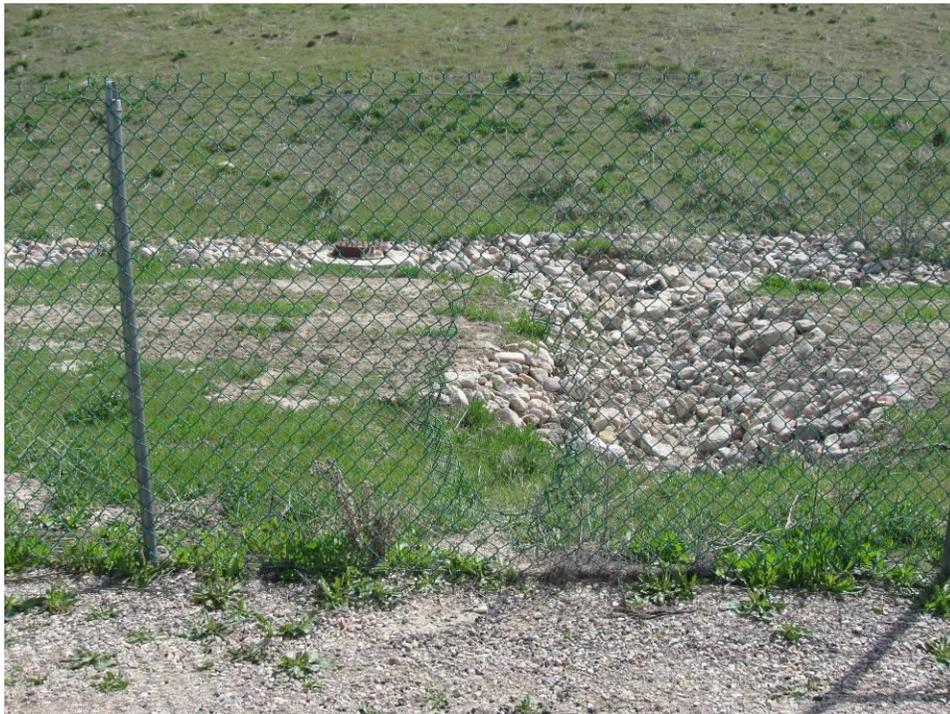
Photo No. 2 – Hole in chain-link fence near the Jordan River Parkway Trail at OU1

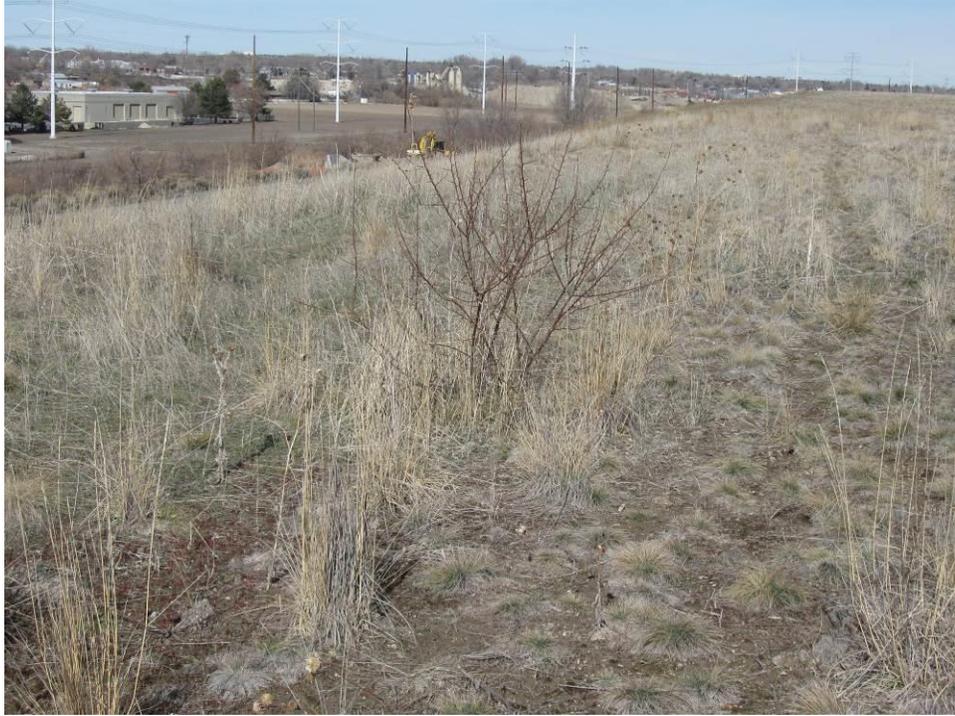
Photo No. 3 – Tree growing on the cap's surface at OU1

OU(s): 1	Issue Category: Operations and Maintenance			
	Issue: <i>Trees and brush are growing on the cap's surface.</i>			
	Recommendation: <i>Remove trees and brush growing on cap's surface.</i>			
Affect Current Protectiveness	Affect Future Protectiveness	Implementing Party	Oversight Party	Milestone Date
No	Yes	Property Owner	Midvale City	11/19/2014

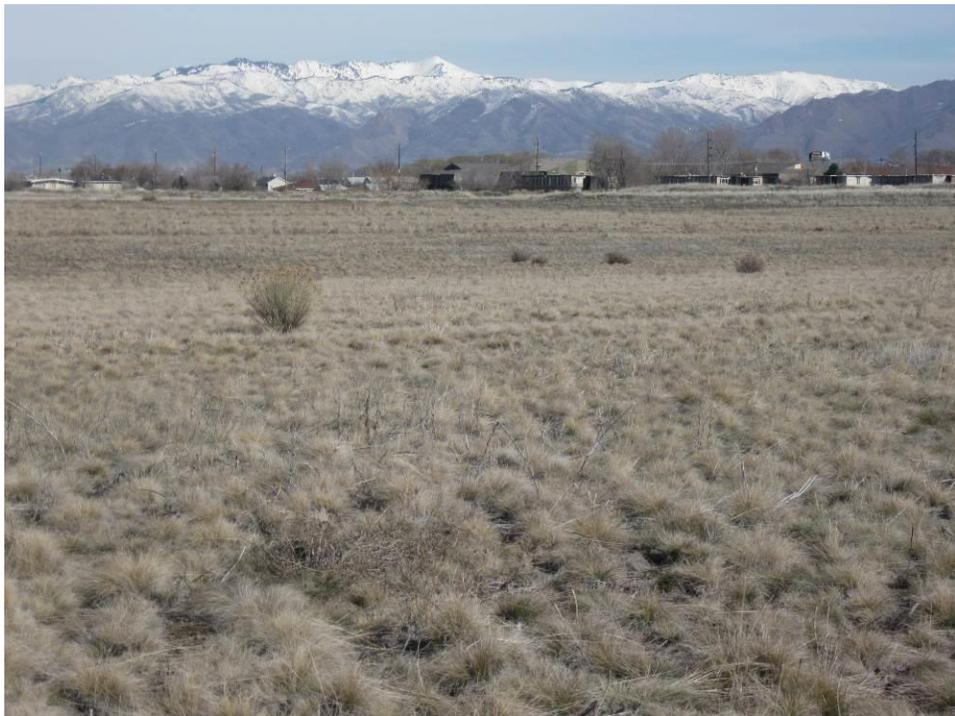
Photo No. 4 – Brush growing on cap's surface at OU1

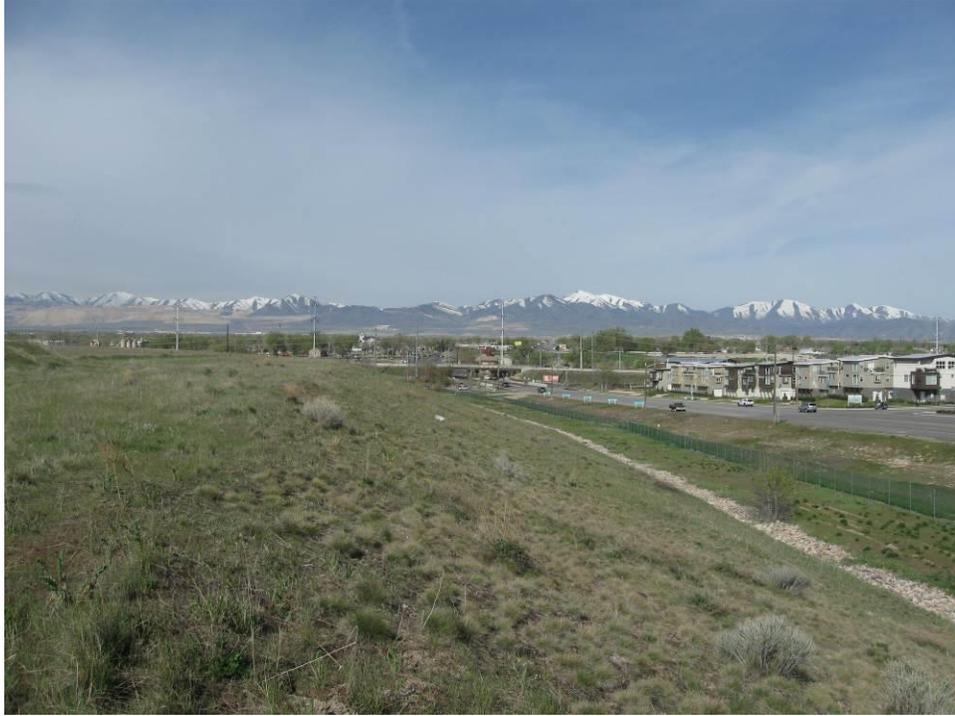
Photo No. 5 – View of cap's north slope parallel to 7800 South at OU1

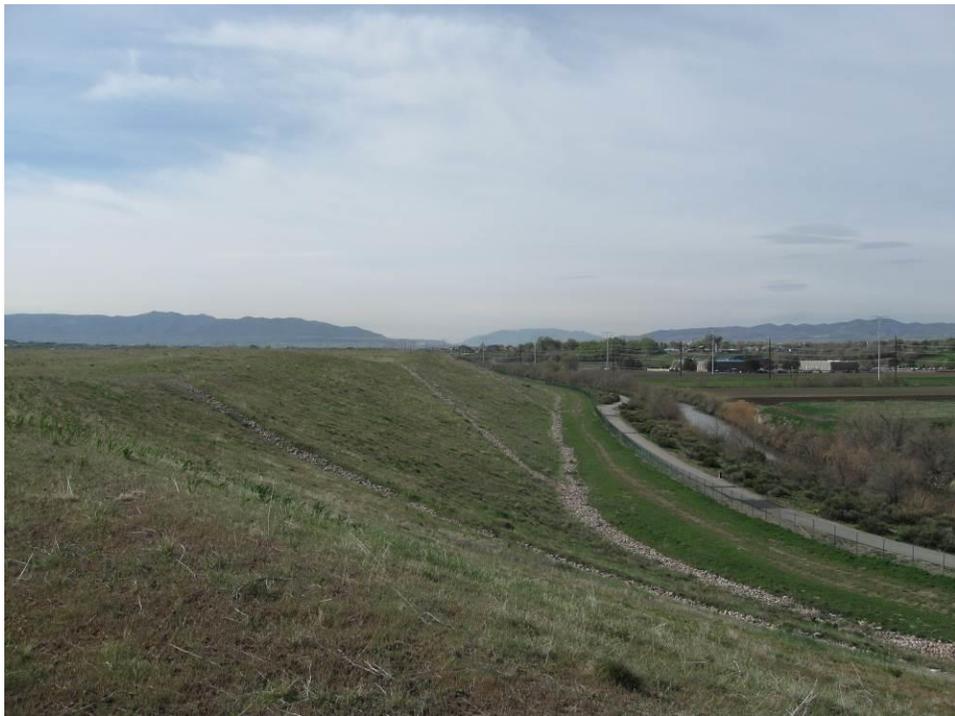
Photo No. 6 – View of cap's west slope parallel to the Jordan River at OU1

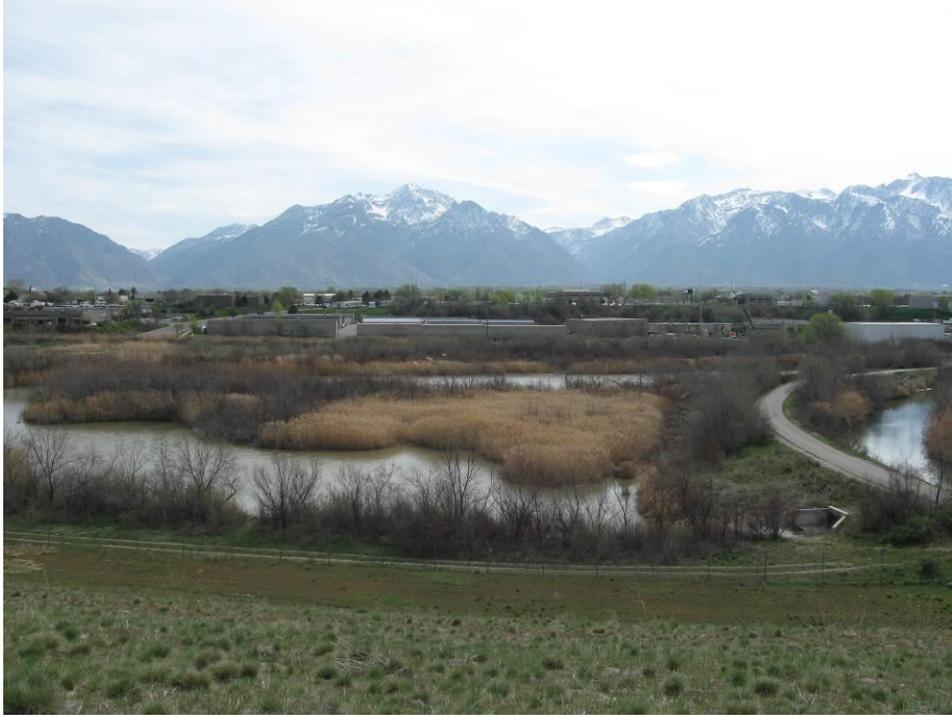
Photo No. - 7 View of wetland area at OU1

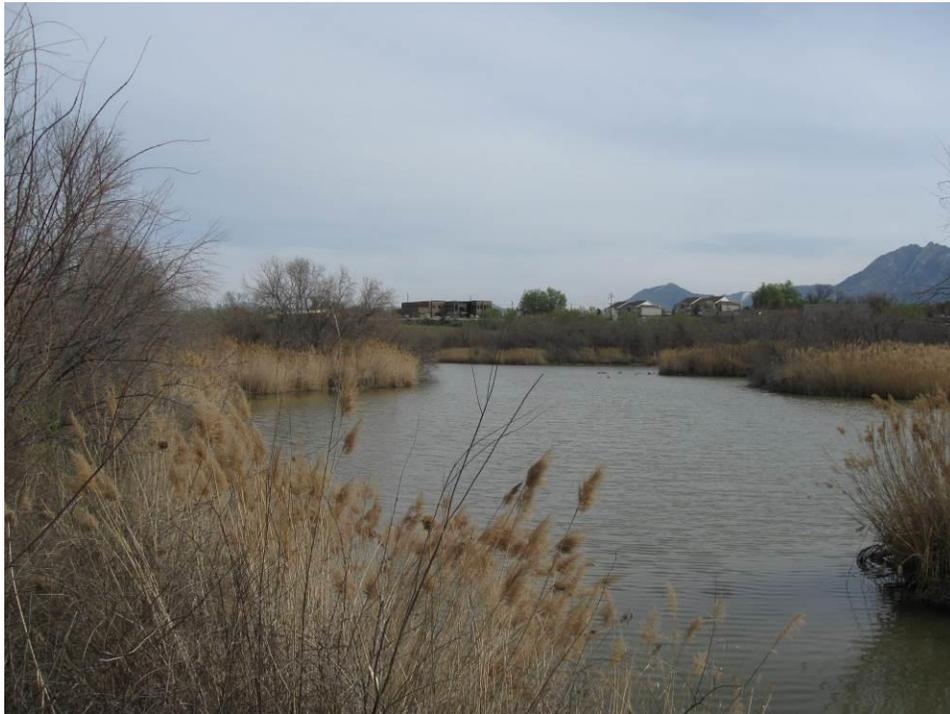
Photo No. 8 – View of wetland pond at OU1
