**DEPARTMENT OF THE ARMY**  
**OFFICE OF THE ASSISTANT SECRETARY OF THE ARMY**  
**INSTALLATIONS, ENERGY AND ENVIRONMENT**  
**110 ARMY PENTAGON**  
**WASHINGTON DC 20310-0110**

18 April 2013

**Department of Army**

**Report**

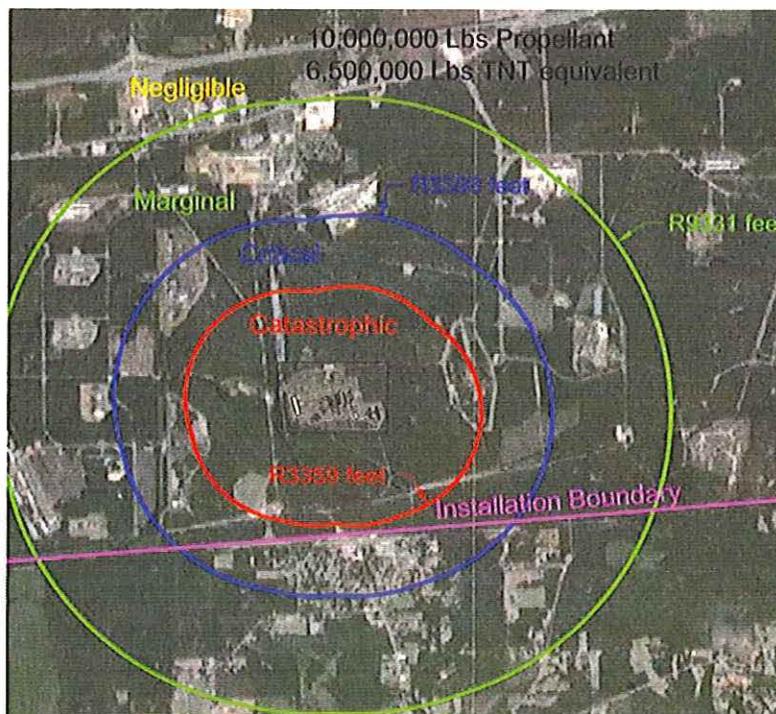
Figure 1 – Original Situation (November 2012)

Figure 1 shows the situation on the S-Line in November 2012. The ESQD situation depicted is for 6.5M lbs of TNT, which is the TNT equivalency of 10M lbs of M6 propellant. The team calculated the TNT equivalency by simply adding all the explosives material present on the S-Line at that time.

In its ESQD analysis of the S-Line's original situation, the team assumed that all 10M lbs of M6 propellant on the line in November 2012 would react with a prompt propagation as a Hazard Division (HD) 1.1 – a reaction of 6.5M lbs net explosives weight (NEW).

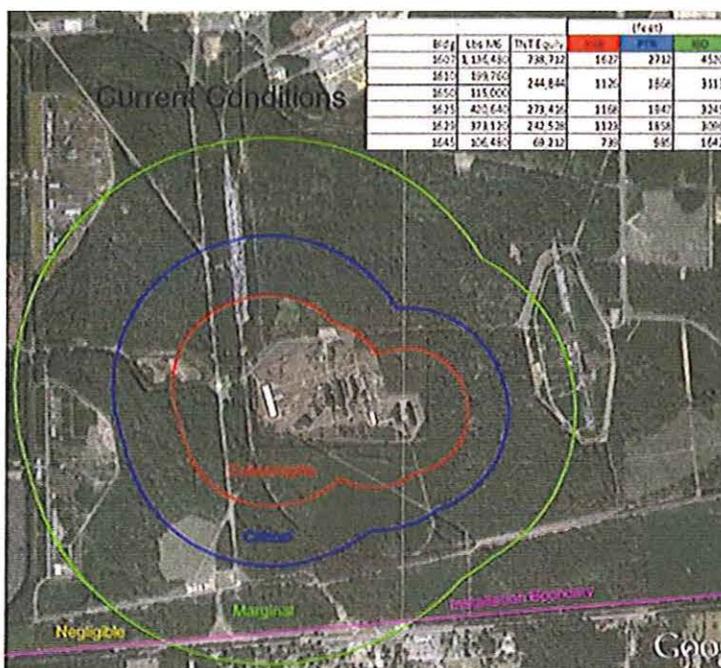
Figure 2 – Current Situation (Apr 13)

- There are three inter-magazine distance (IMD) violations on S-line.
  - The first is from building 1607 to building 1645. Considering both buildings only contain M6 propellant, it is not anticipated that propagation will occur between these buildings. Therefore, the IMD violation will be discounted.

- The second is from building 1607 to building 1610. Considering both buildings only contain M6 propellant, it is not anticipated that propagation will occur between these buildings. Therefore, the IMD violation will be discounted.

- The third is between buildings 1610 and 1650. Therefore, for the "Current Situation" analysis, buildings 1610 and 1650 will be referred to as the "group of 2," with the explosives totaled and treated as one explosives storage location. IMD is maintained between the "group of 2" and all other explosives storage buildings.

- The small wing on building 1607 that extends east towards building 1610 does not contain any explosives materials. Non-explosives materials are allowed.

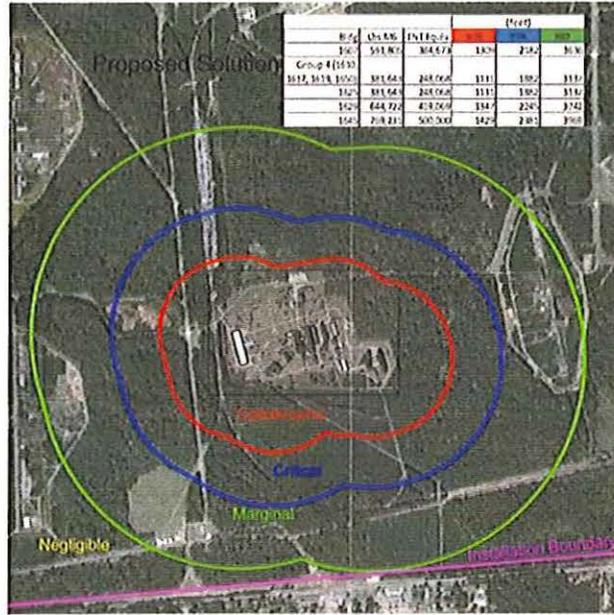
Figure 3 – Proposed Solution

- For the proposed solution, buildings 1610, 1617, 1619, and 1650 will be referred to as the “group of 4,” with the explosives totaled and treated as one explosives storage location. IMD is maintained between the “group of 4” and all other explosives storage facilities. Grouping these four buildings as one explosives location maximizes the allowable explosives storage within S-line.

- The proposed solution meets DoD 6055.09-M’s criteria, with respect to IMD, and provides an acceptable level of protection for the public.

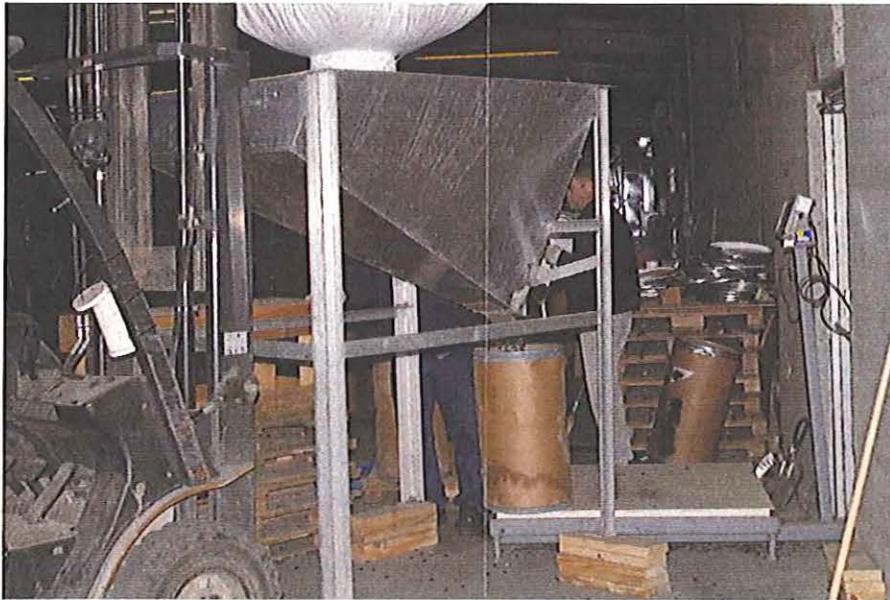
Propellant repackaging operations in building 1607

**Recommendation:** Prohibit Explo from repackaging propellant in building 1607 and move the repackaging operation to another location that complies with DoD 6055.09-M. Limit building 1607's use to storage of M6 propellant.

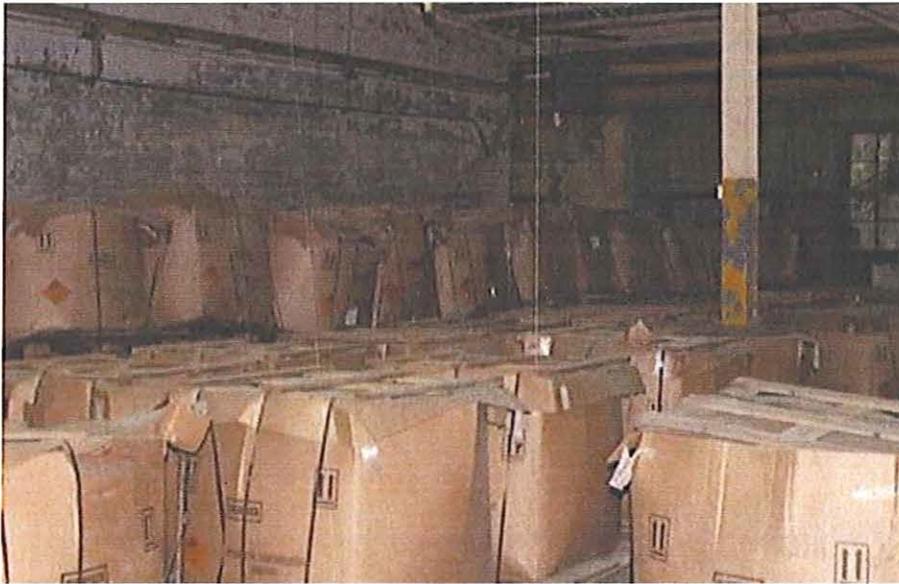
- **Observation:** The amount of propellant in storage in building 1607 creates ESQD violations.

M6 Propellant in 880 lb bulk pack, Bldg 1610 (typical)

**Recommendation:** Reduce the propellant in storage in building 1607 to no more than 591K lbs. Limit building 1607's use to storage of M6 propellant. Prohibit the storage of hazardous materials, other than M6 propellant.

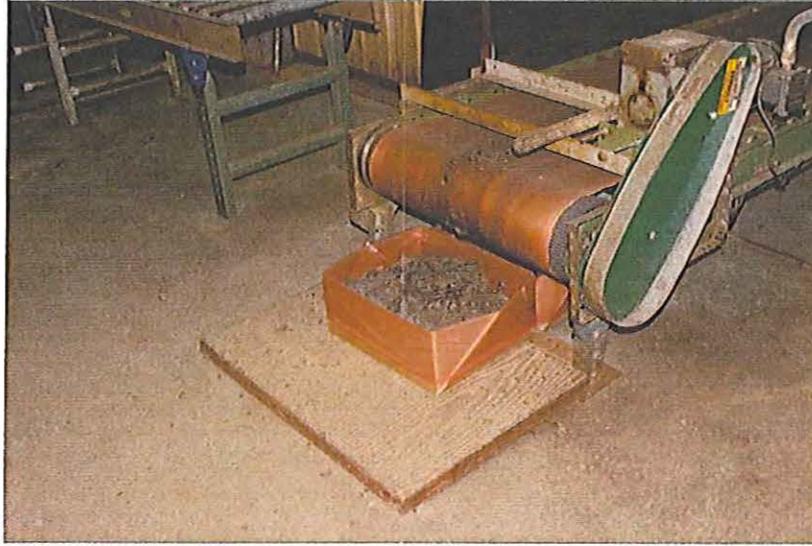
- **Observation:** The explosives in S-Line violate DoD 6055.09-M's explosives safety compatibility rules - if IMD is not met, all explosives must be treated as being at one location. M6 propellant, Tritonal, hazardous waste (pink water) and explosives residue (i.e., tar mixed with TNT) from a previous TNT/Tritonal melt-out operation, and Explosive D (ammonium picrate) are all stored within the S-Line (in buildings 1619 and 1617).

**Tritonal Flaking Belt – Building 1619**

**Recommendation:** Remove, segregate and store explosives per DoD 6055.09-M's explosives safety compatibility and mixing rules. Comply with DoD 6055.09-M's criteria for storage of waste military munitions. Prohibit the storage of hazardous waste with explosives.

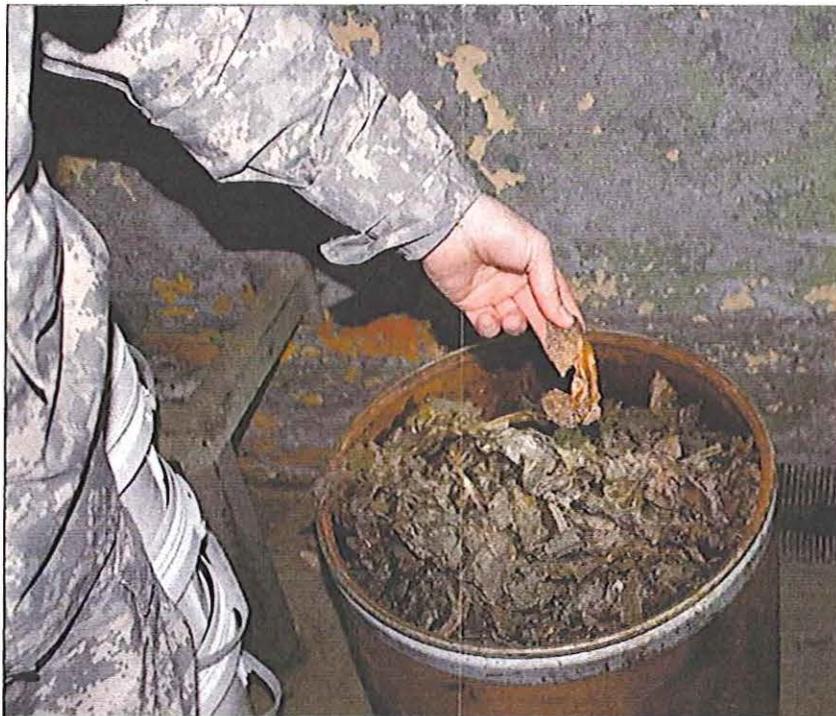
**Tritonal scraps located in Building 1619 generated from Tritonal flaking operation**

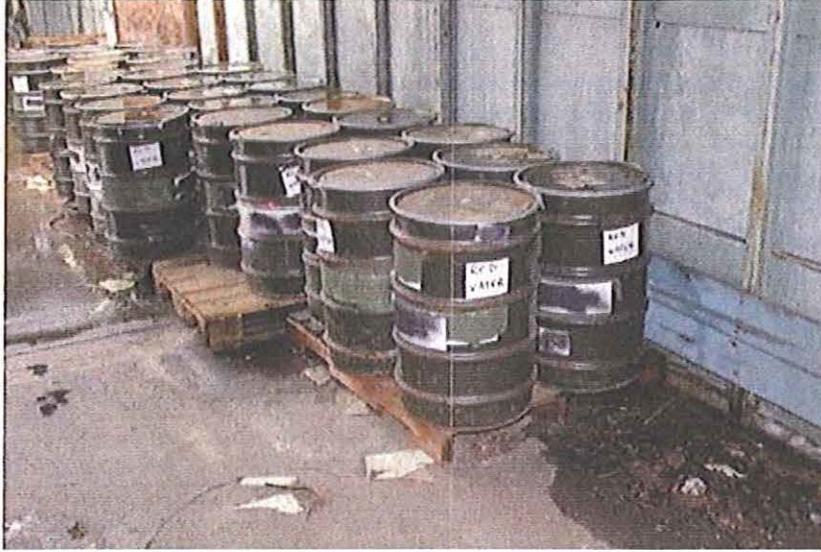
DA Pam 385-64, paragraph 2-7.a.(4) – *At a minimum, hazardous waste material will be removed from AE and other operating facilities and taken to an approved disposal area or temporary collection point at the end of each shift. (b) Hazardous waste material should not be "stored" in the disposal area, but disposed of as soon as possible after arrival.*

TNT Contaminated Water (red water/pink water)
