DRAFT TECHNICAL MEMORANDUM

TO: [REDACTED] EPA Region 8, On-Scene Coordinator
FROM: [REDACTED], Superfund Technical Assessment and Response Team (START)
DATE: August 12, 2015
SUBJECT: Gold King Mine Investigation and Blowout Event

PHOTOGRAPH LOG

| Project Name: Gold King Mine | Site Location: Silverton, San Juan County, Colorado | Project No.: 0001/1408-01 |

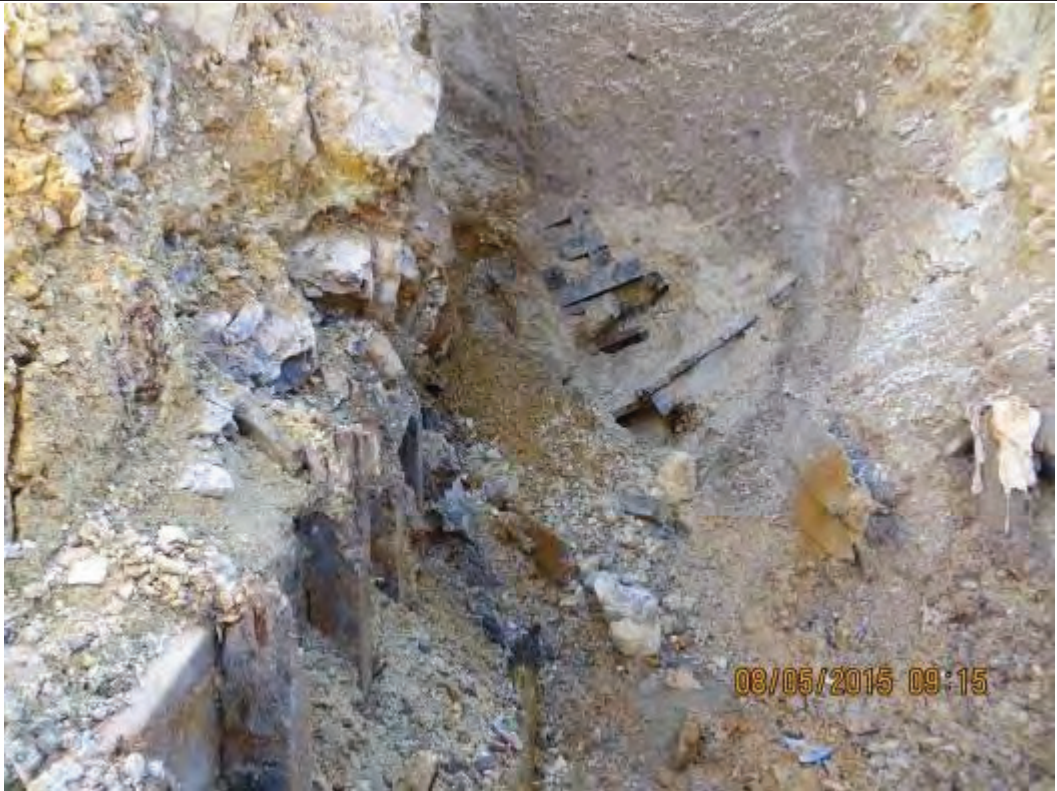
| Photo No.: 13 | Date: 08/05/2015 |

| Description: Adit conditions the morning of 8/5. | |

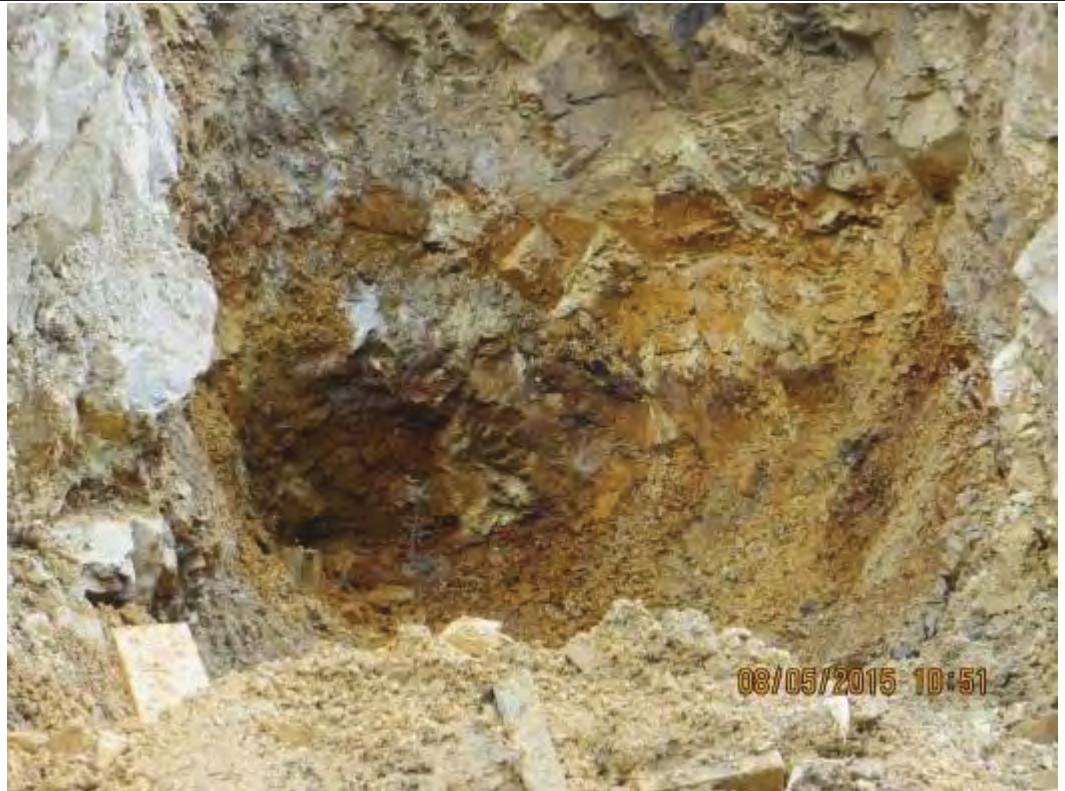
| Photo No. 17 | Date: 08/05/2015 |

| Description: Small leak close up. | |

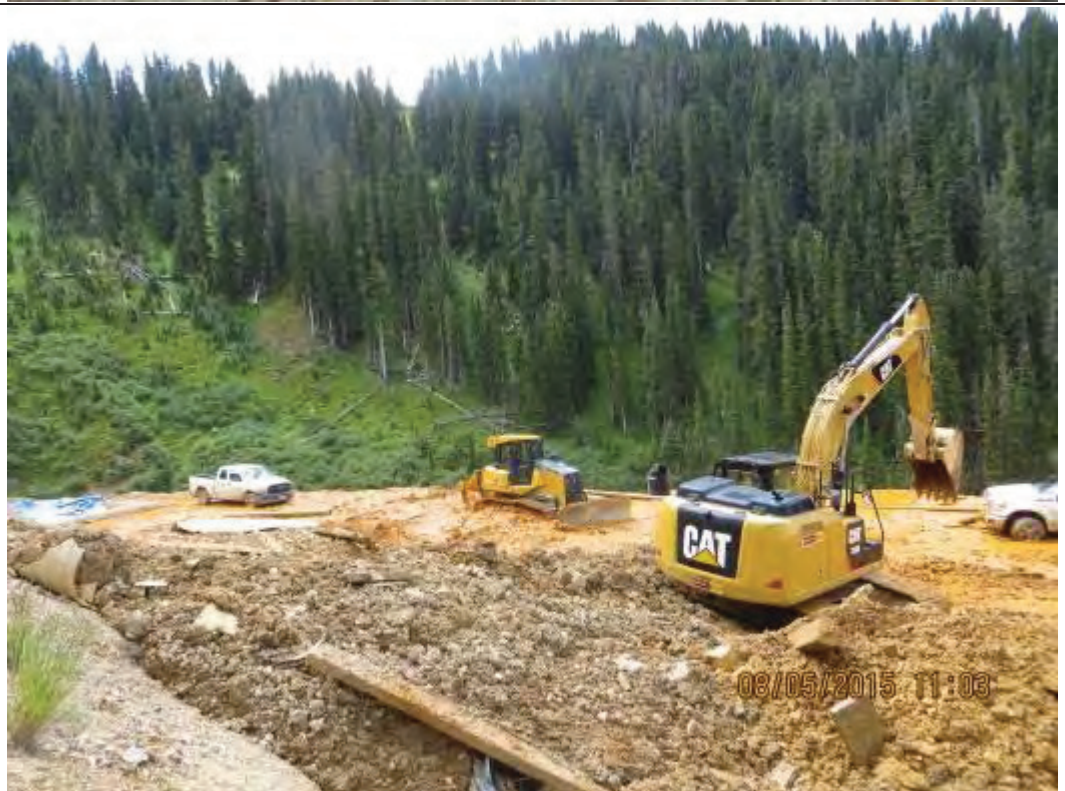
Photo No.
22

Description:
Water flowing over the edge of the waste dump and collapsing the edge.

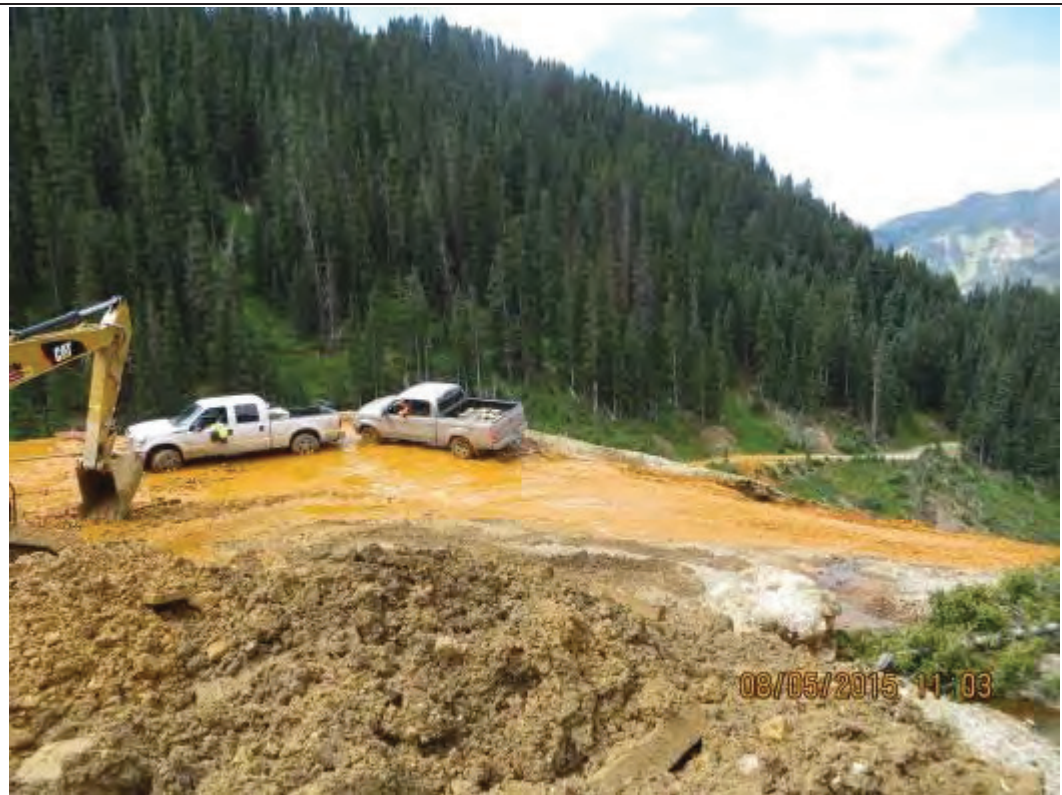
| Photo No. 23 | Date: 08/05/2015 |

| Description: Exit route starting to collapse | |

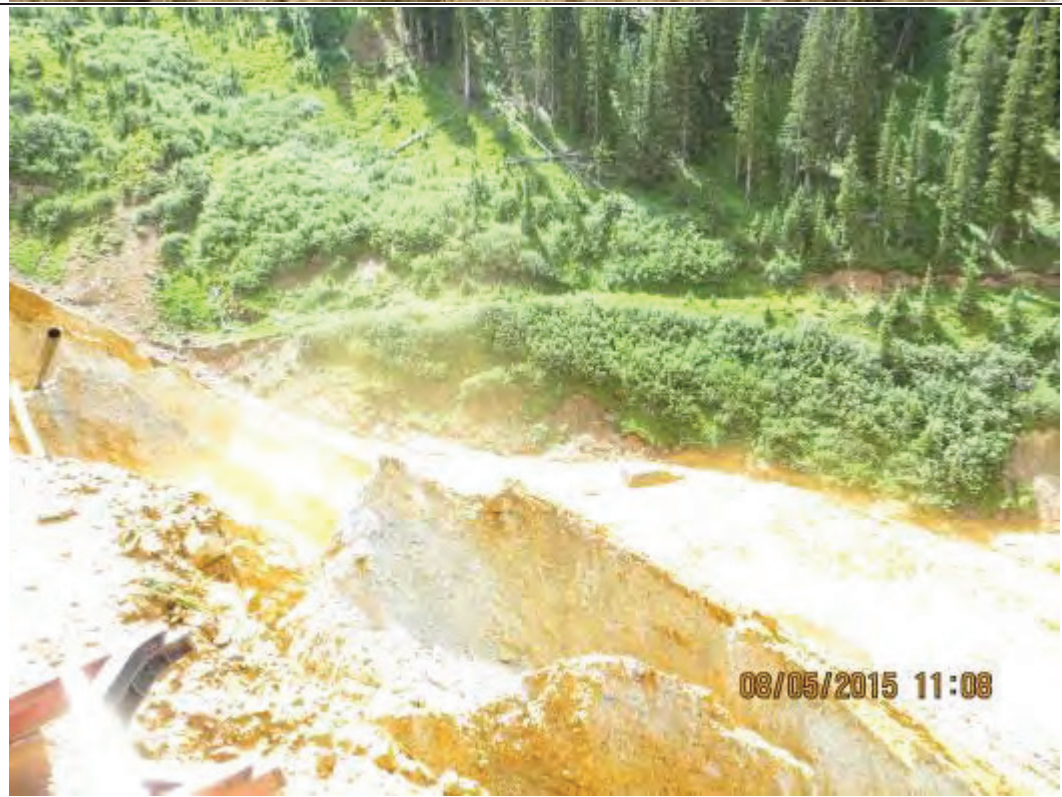
| Photo No. 24 | Date: 08/05/2015 |

discharged water had flowed. The vehicle was later found it to be water damaged, would not start, and was un-drivable.

| Description: Edge of the tailings dump collapsed, suburban trapped and half submerged in center of photo. | |

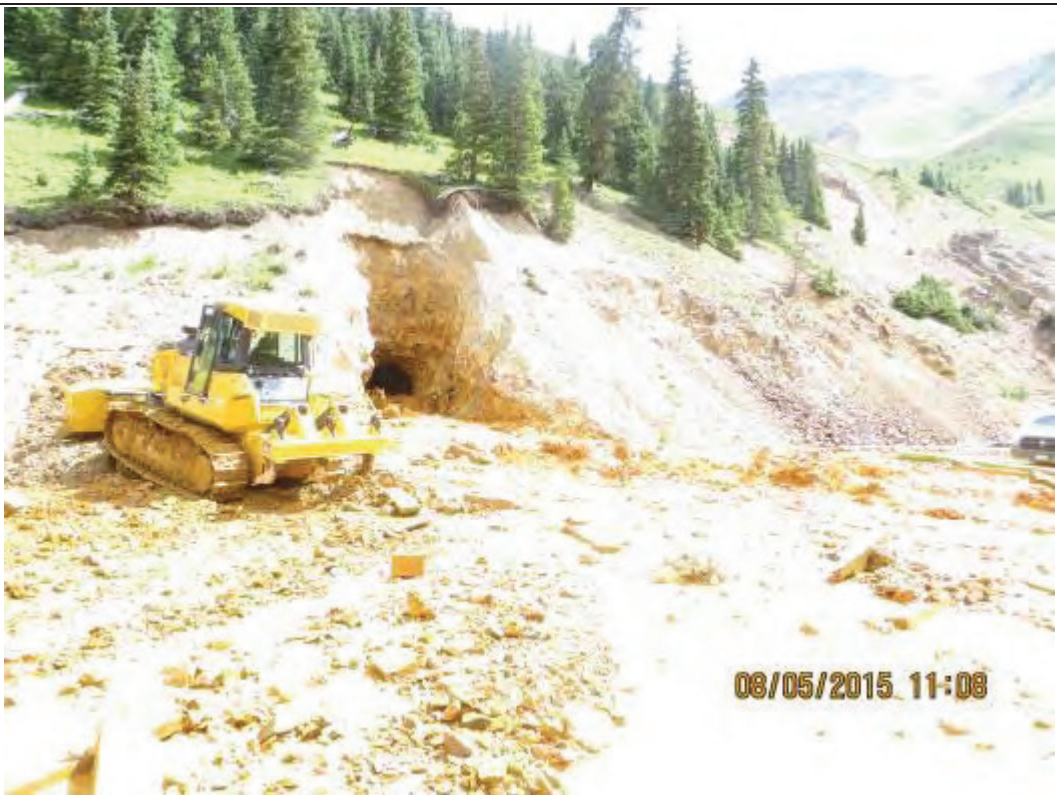
| Photo No.: 25 | Date: 08/05/2015 |

| Description: Gold King adit exposed. | |

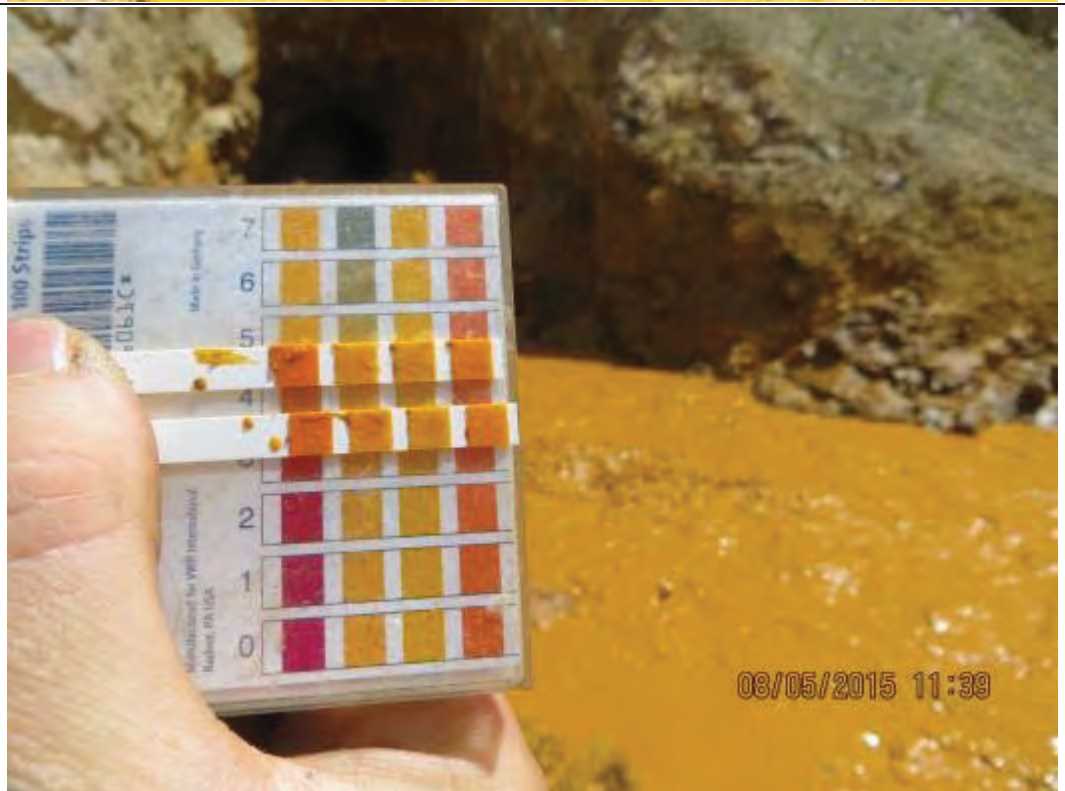
Photo No.
28

11:33 pH testing (using pH indicator paper) of mine discharge water showed a pH of approximately 4.5.

Description:
pH of discharge water is approximately 4 to 4.5.

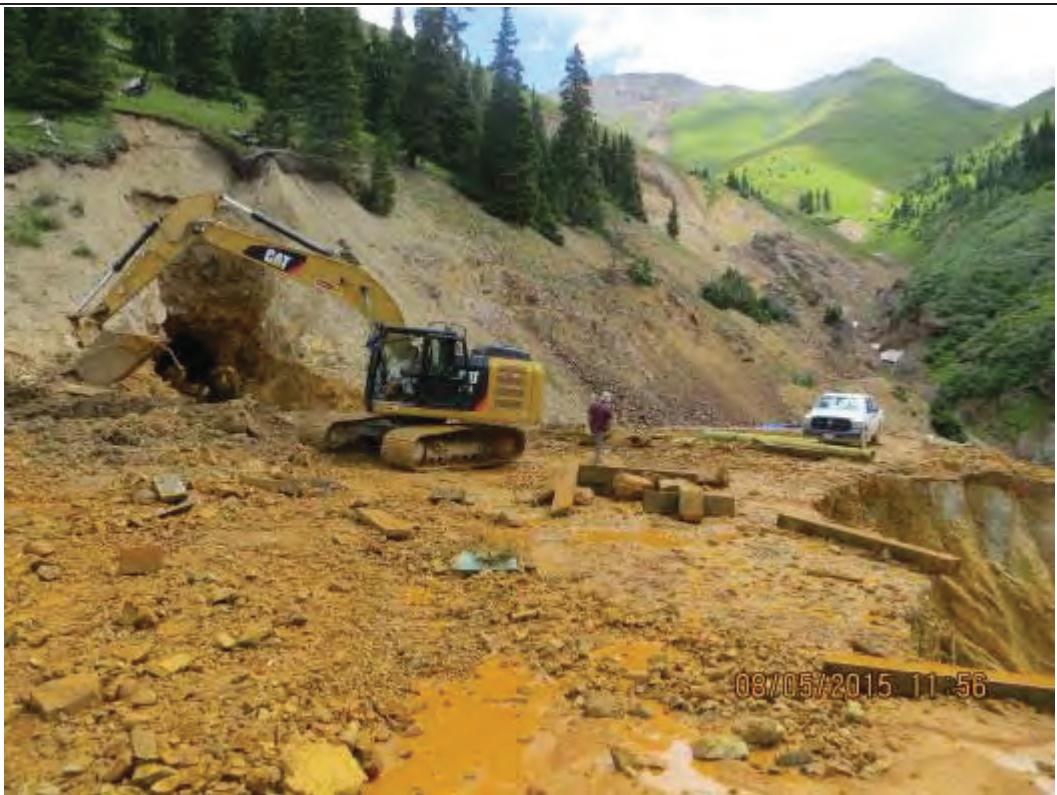
| Photo No. 29 | Date: 08/05/2015 |

| Description: Excavator redirecting water into existing half-pipe channel. | |

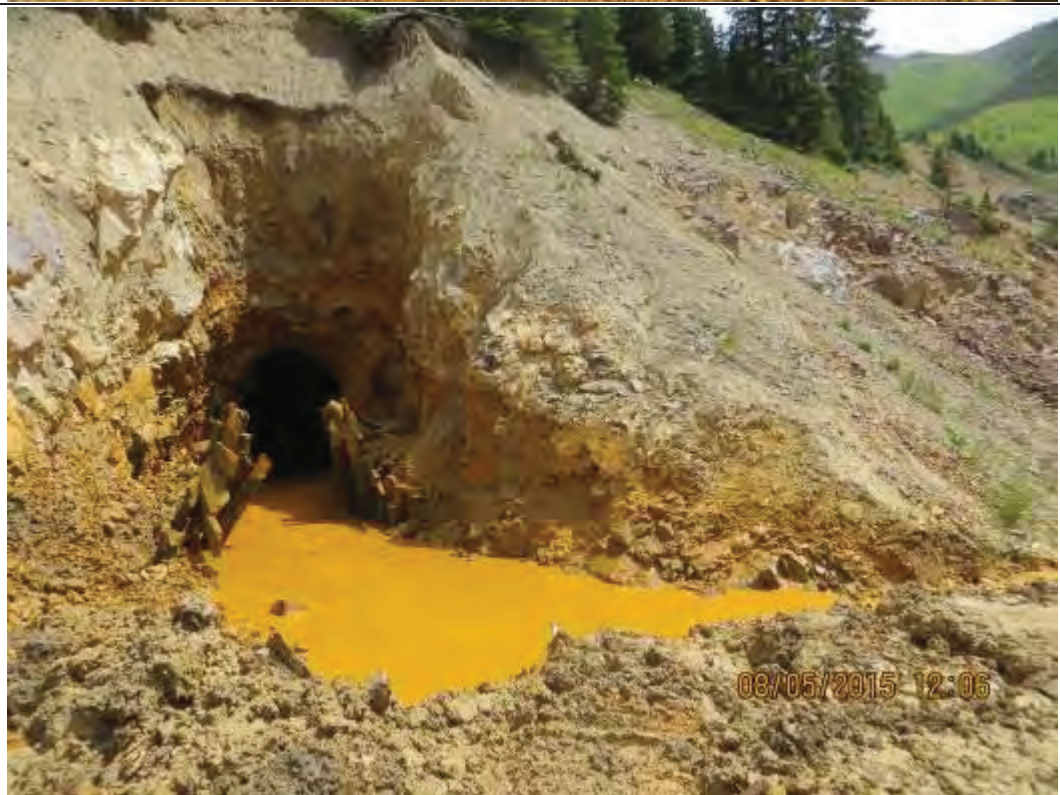
| Photo No.: 32 | Date: 08/05/2015 |

| Description: Exposed adit and redirected flow, flow is beginning to subside. | |

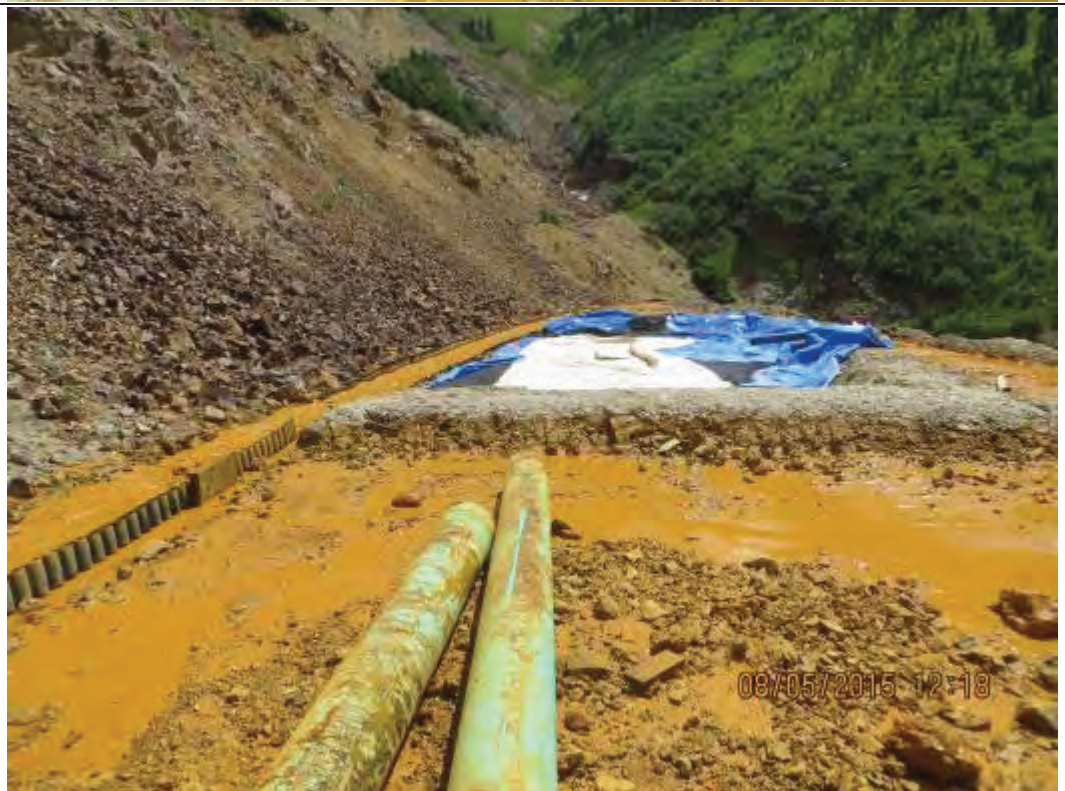
Photo No.
36

Description:
Existing flow channel at maximum capacity.

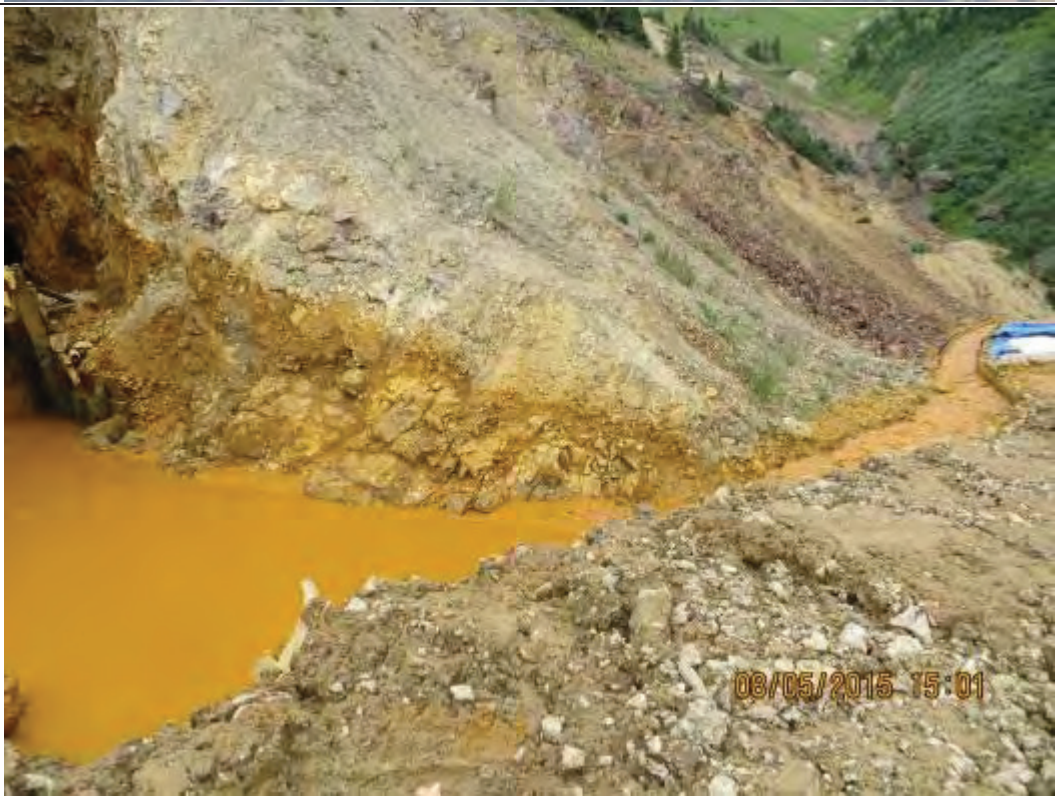
| Photo No. 48 | Date: 08/05/2015 |

14:00 The discharge water flow steadily declined until this point and then appeared to stabilize.

| Description: Flow path from adit, water flow appears to have stabilized around 1400. | |

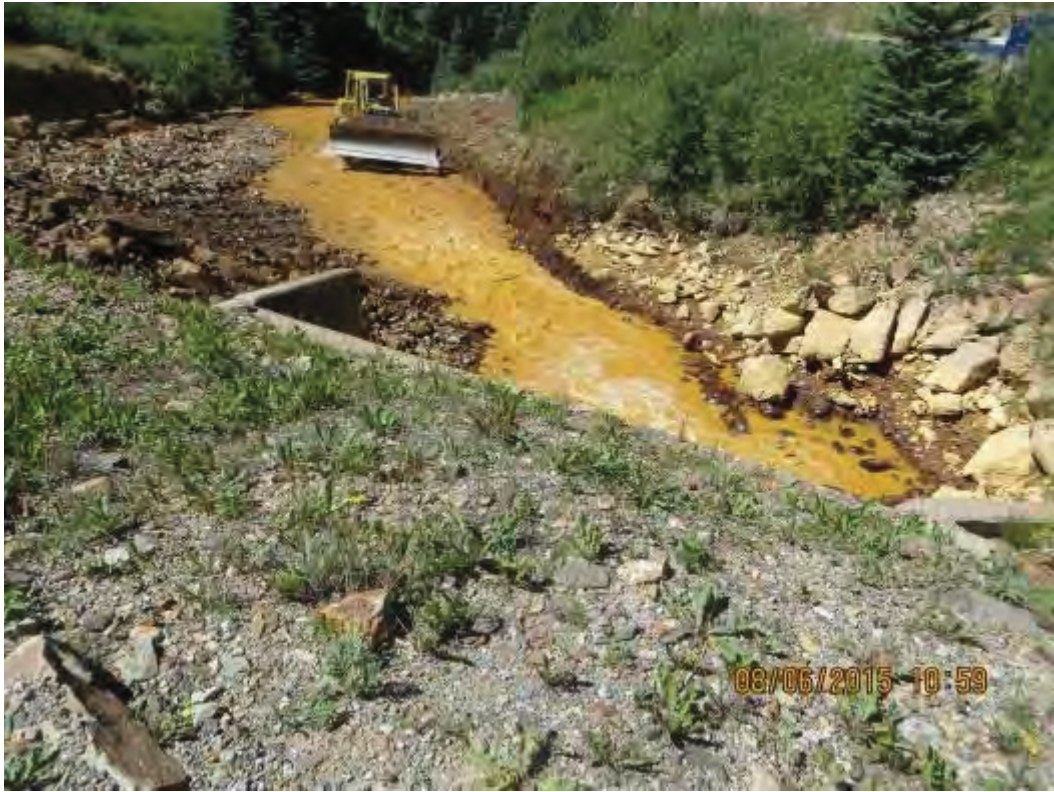
Repairing road damage along County Road 110 between Silverton and Gladstone.

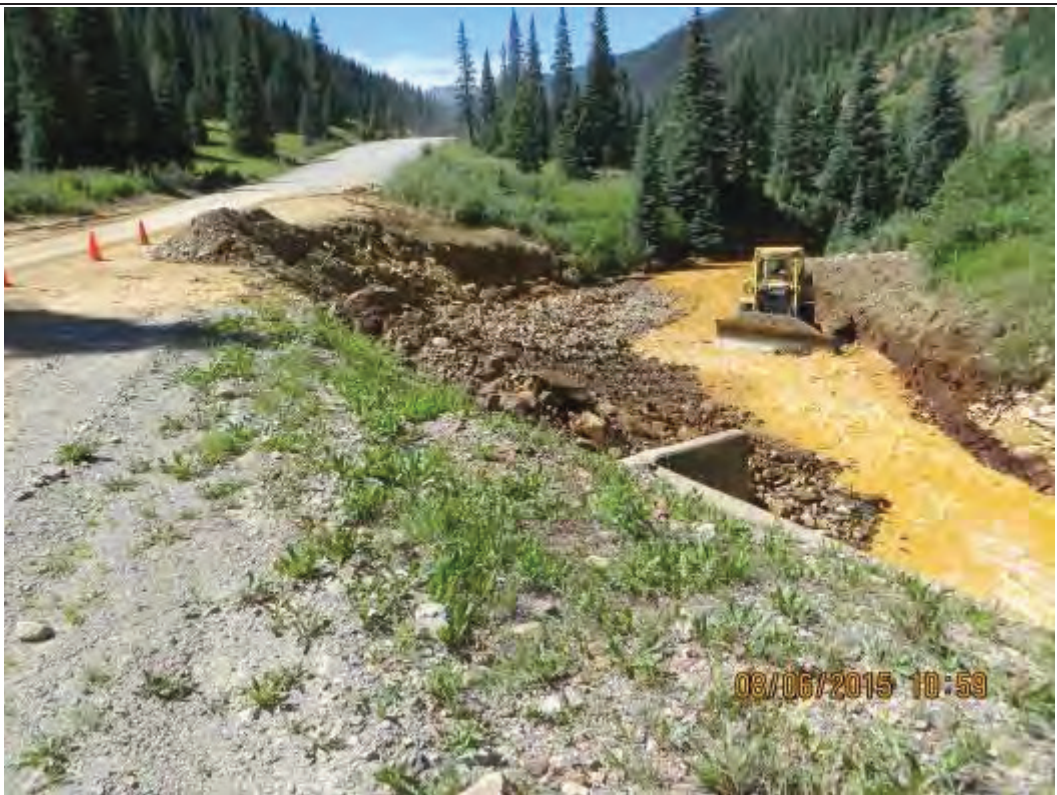
| Photo No. 5 | Date: 08/06/2015 |

| Description: Repairing road damage along County Road 110 between Silverton and Gladstone. | |

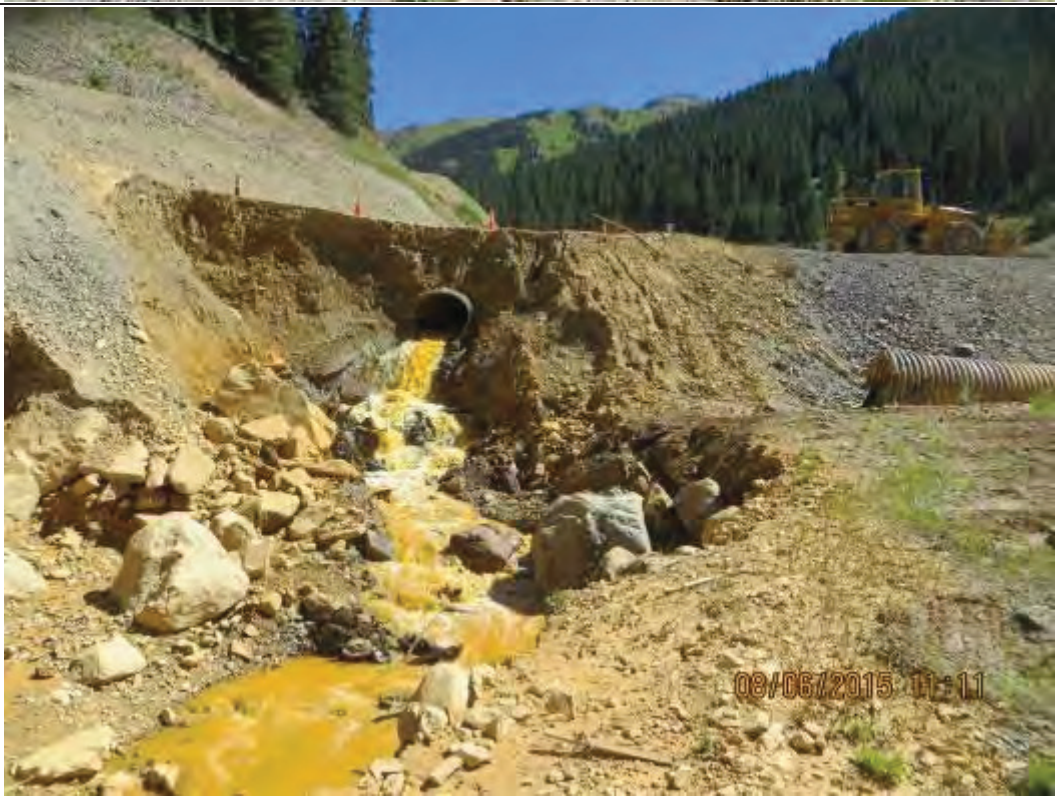
| Photo No. 6 | Date: 08/06/2015 |

| Description: Road crossing over Cement Creek at Gladstone damaged, view from downstream. | |

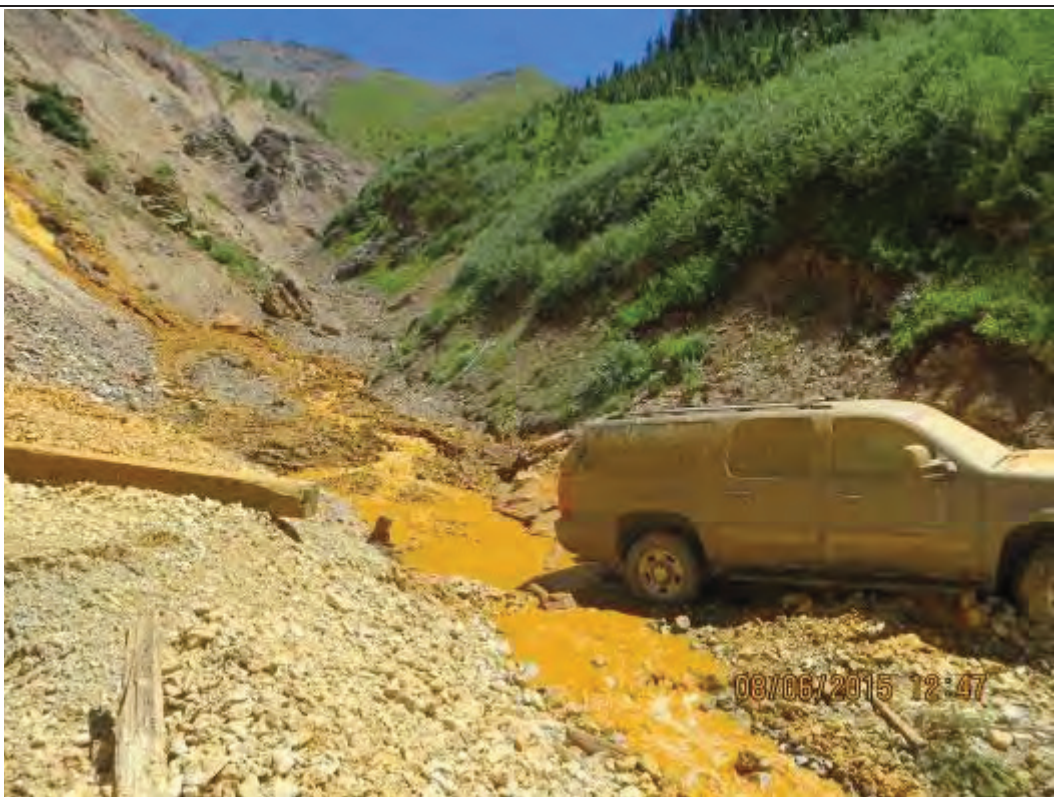
| Photo No. 11 | Date: 08/06/2015 |

| Description: Damaged GSA Suburban at base of Gold King mine dump | |

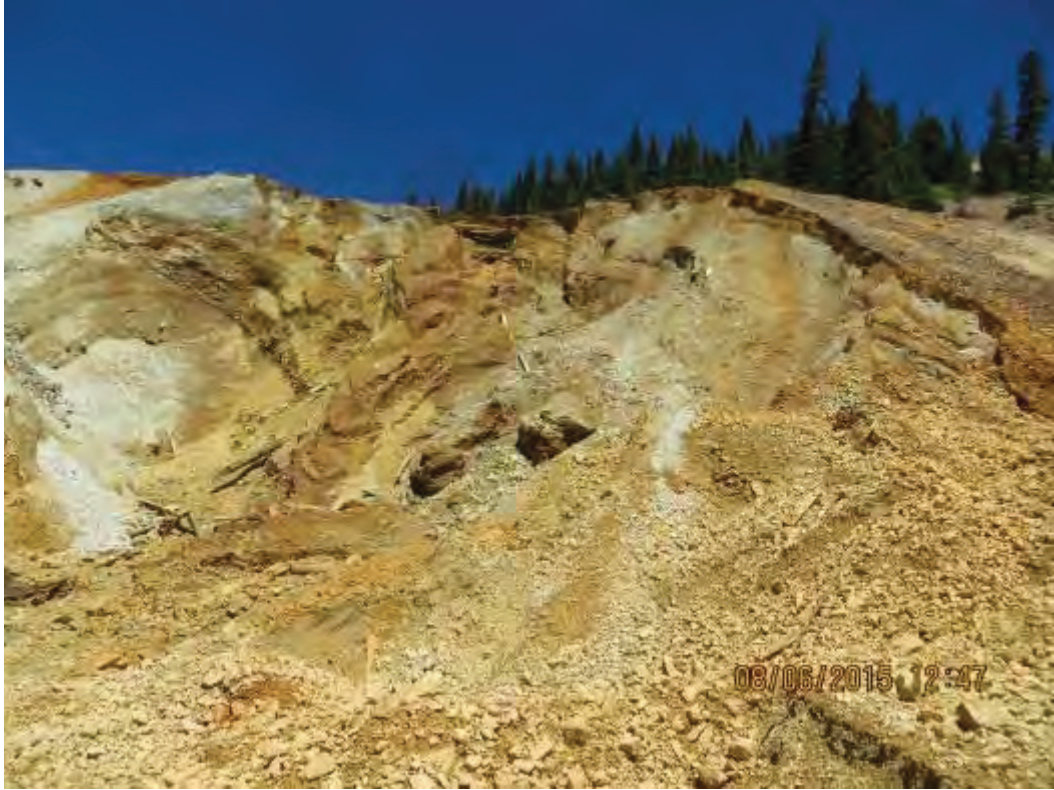
| Photo No. 14 | Date: 08/06/2015 | |

| Description: Gold King mine dump damage. | | |

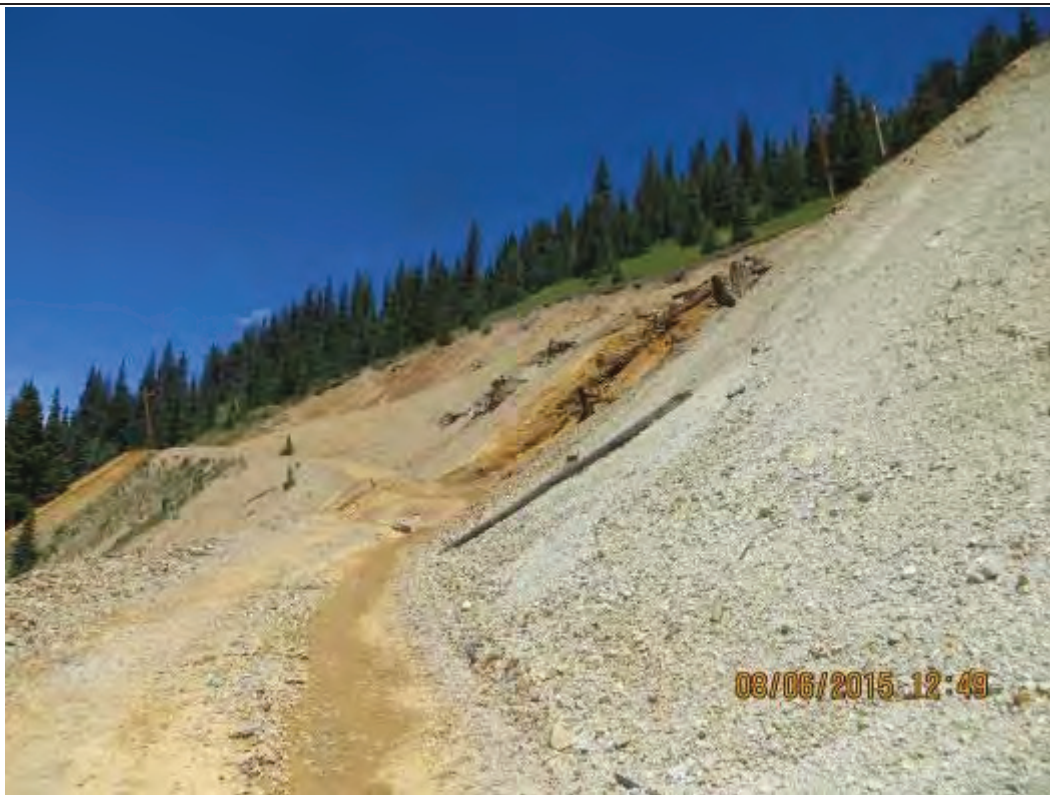
Gold King mine dump damage.

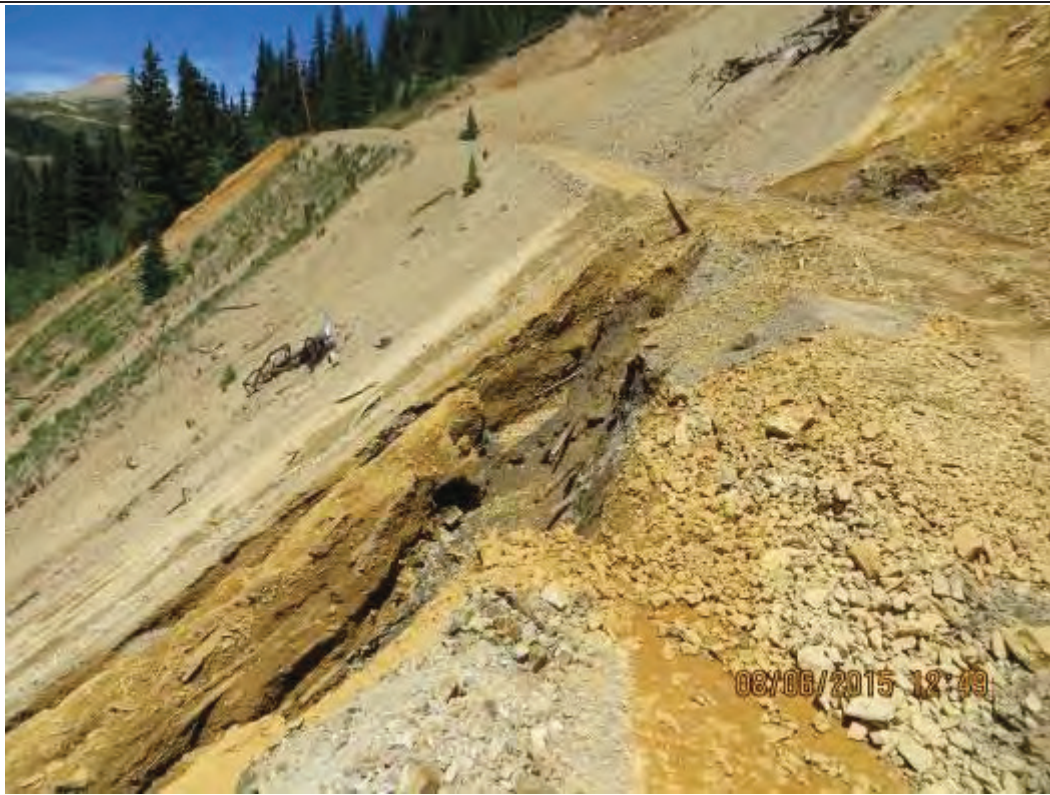
Photo No.
18

Gold King mine dump damage.

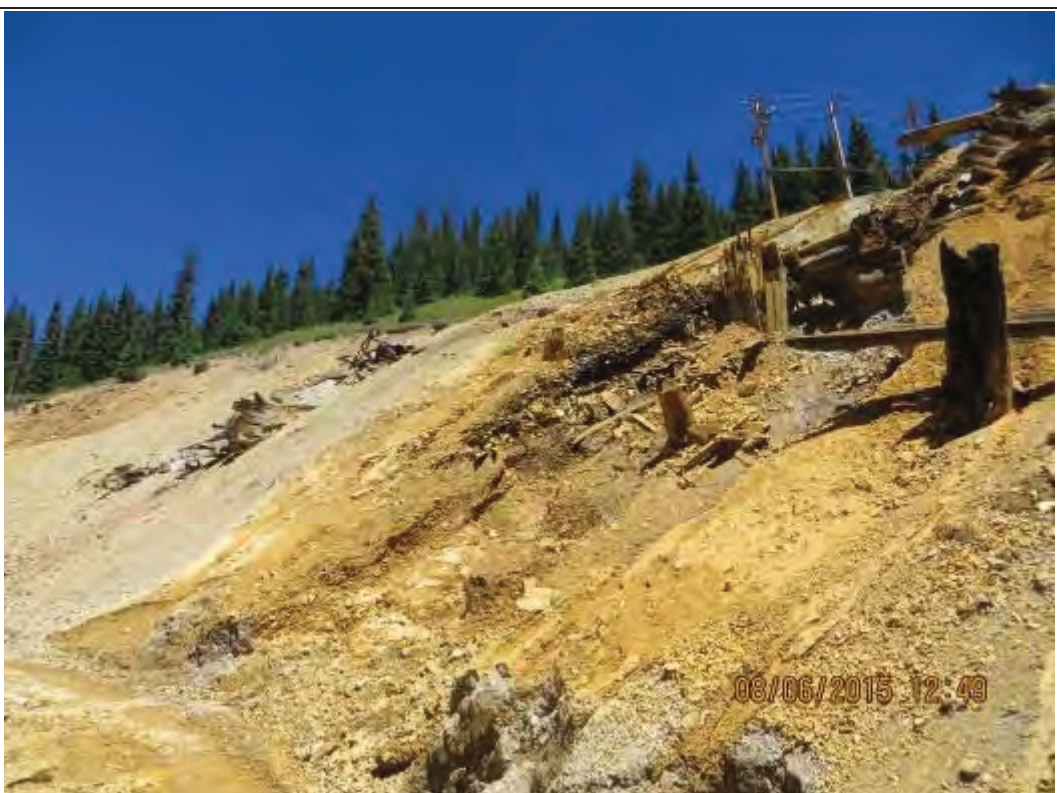
| Photo No. 19 | Date: 08/06/2015 |

| Description: Gold King mine dump damage. | |

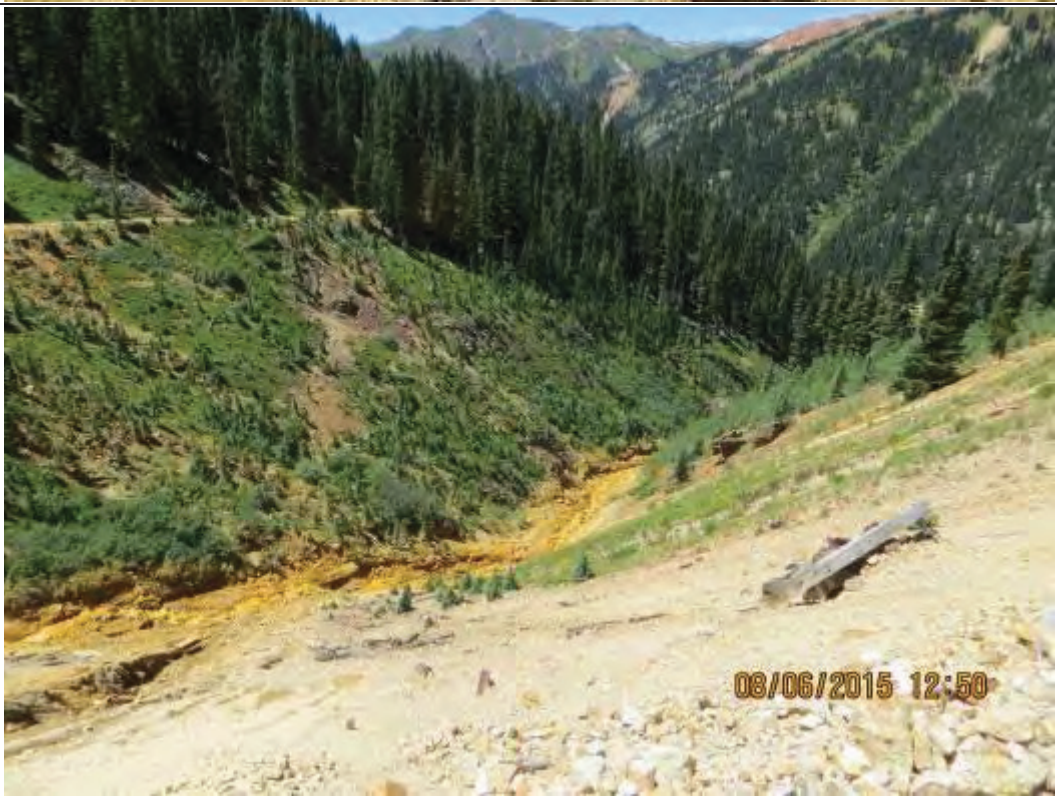
| Photo No. 20 | Date: 08/06/2015 |

| Description: North Fork Cement Creek downstream of Gold King road crossing. North Fork Cement Creek is orange. | |

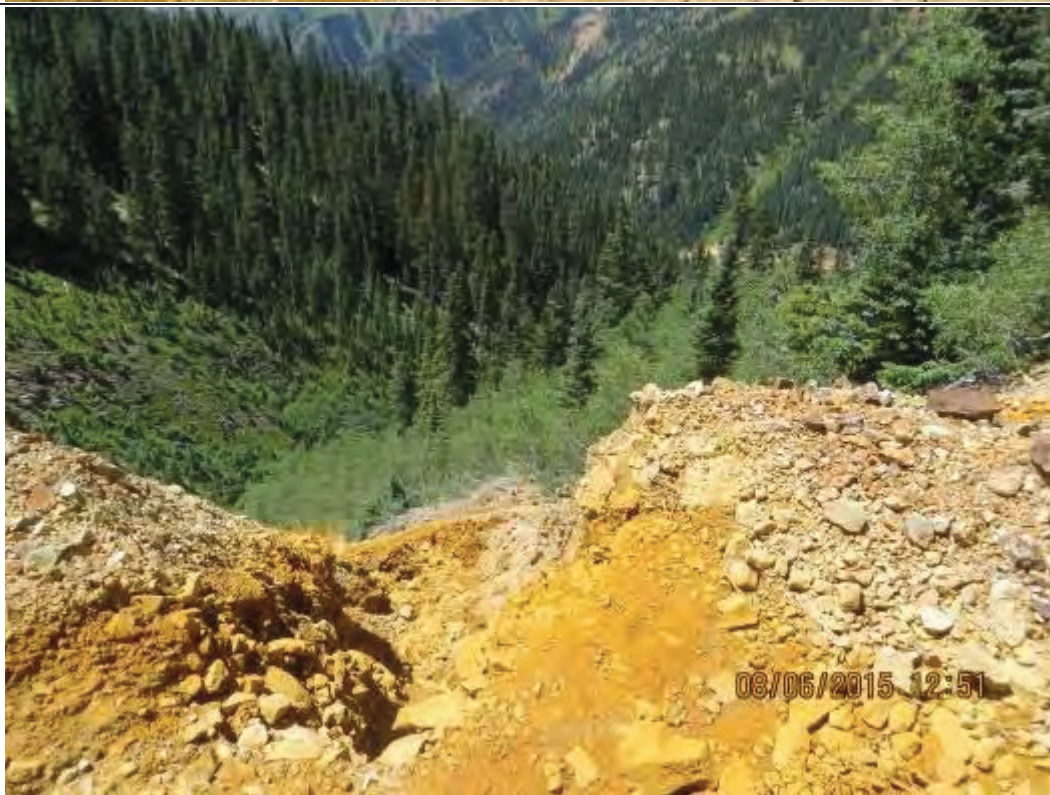
Gold King mine dump road damage.

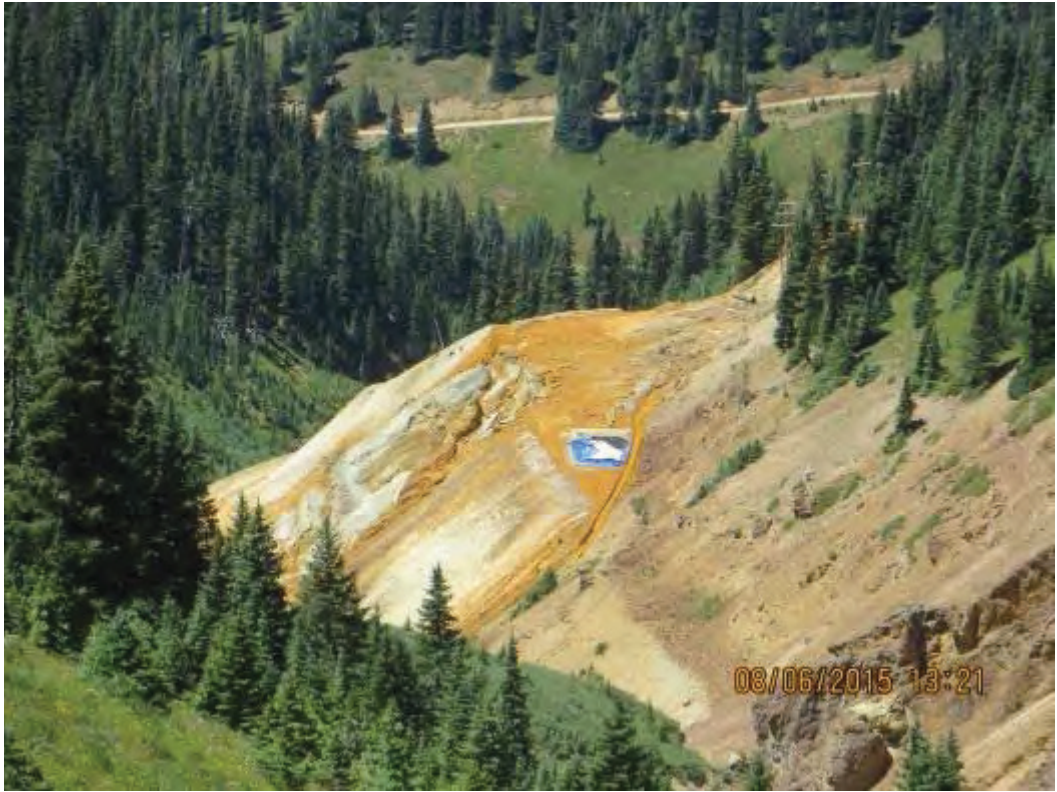
| Description: Overview of the Gold King waste dump pad after mine discharge. Note orange water in half culvert channel and damage to center of pad. | |

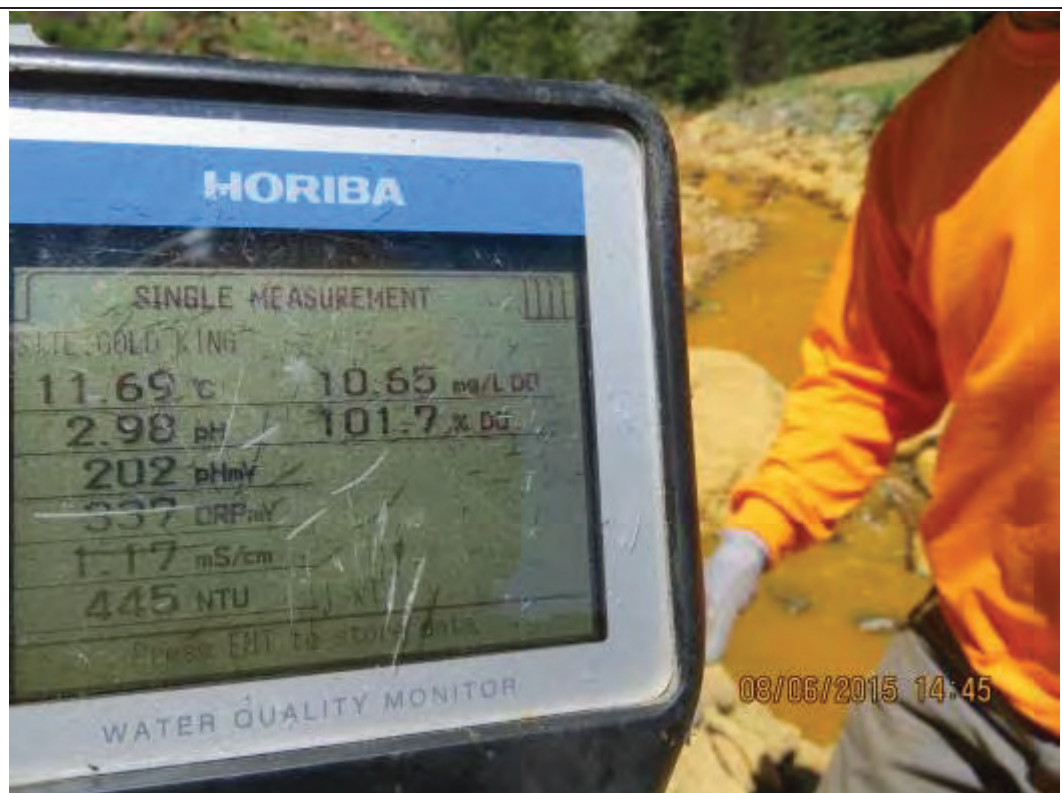
| Description: Stabilized Horiba reading of Cement Creek north of Gladstone culvert. Bad DO reading, pH = 2.98 | |
