Hurricane John / 4007-DR-ST/ 06-01-2006

Anytown Department of Public Works

## **Damage/Cost Report-Elevated Water Tower Damage from Hurricane John**

Draft - 06/30/2006

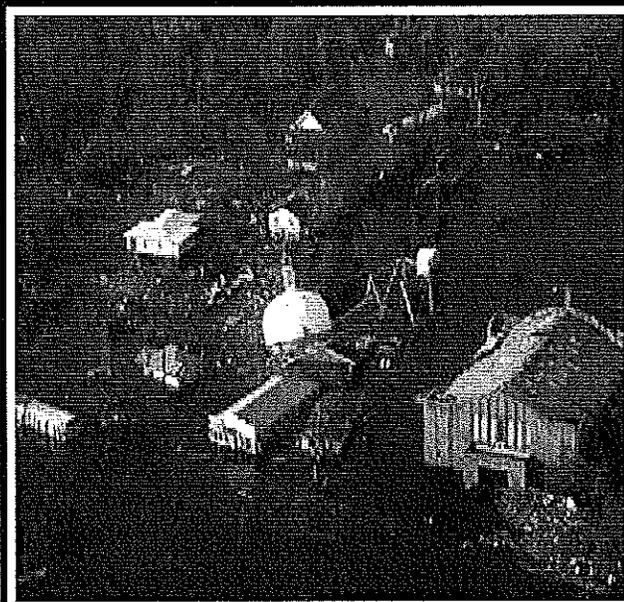
Caption: collapsed water tower, aerial view

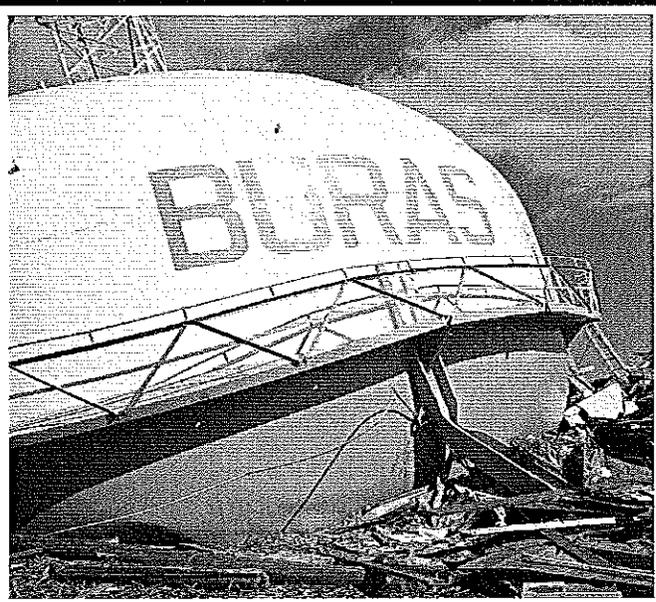
Caption: close up of collapsed water tower

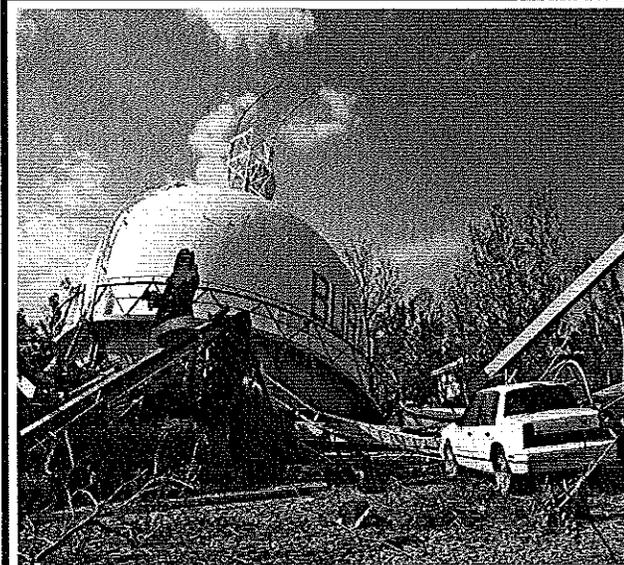
Caption: another view of collapsed water tower
