MEMORANDUM

SUBJECT: ACTION MEMORANDUM: Request for an Emergency and Time Critical Removal Action at the Seerley Road Fire Site, Indianapolis, Marion County, Indiana, (Site ID # C59J)

Site Name: Seerley Road Fire Site
Site ID: C59J
CERCLIS ID: INN000506096
Category: Emergency Removal Action
RCRA ID: Pending

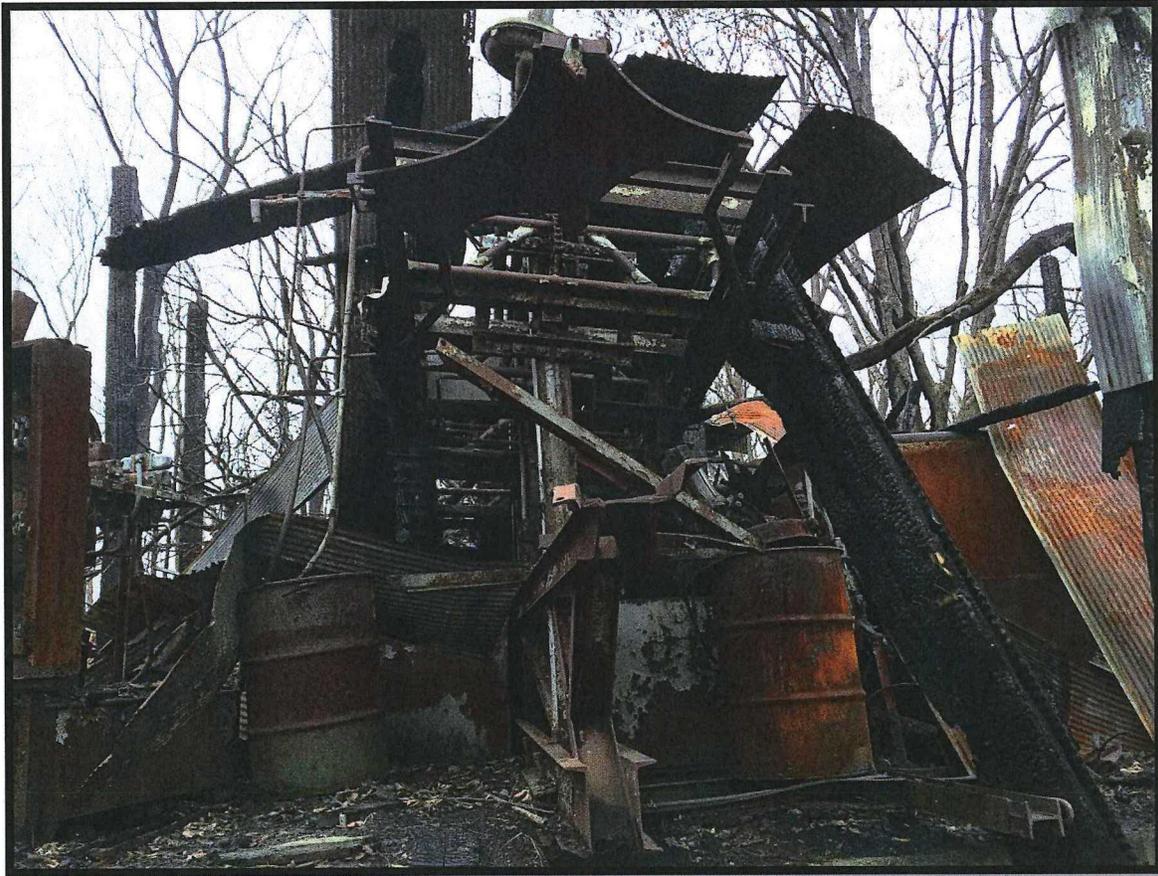
B-1 - Electroplating equipment in Barn 1

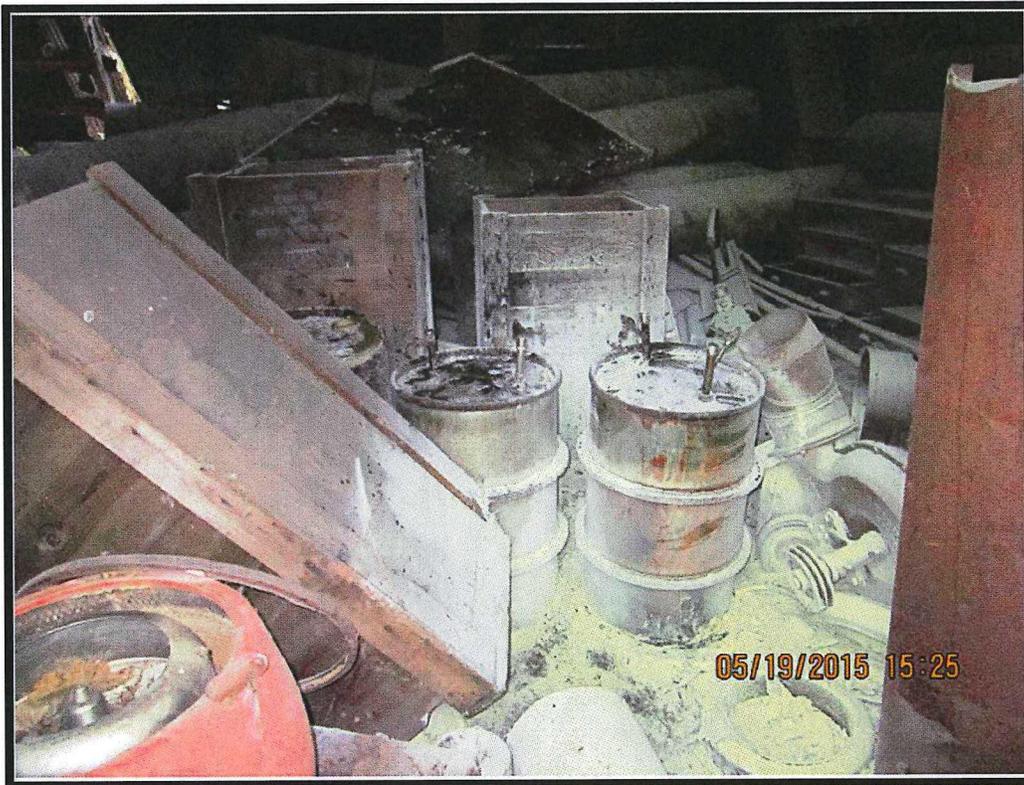
“potassium metal” and “keep water away.” The remaining two drums were not overpacked and were not labeled (Figure B-2).

B-2 – Potassium metal drums in Barn 1

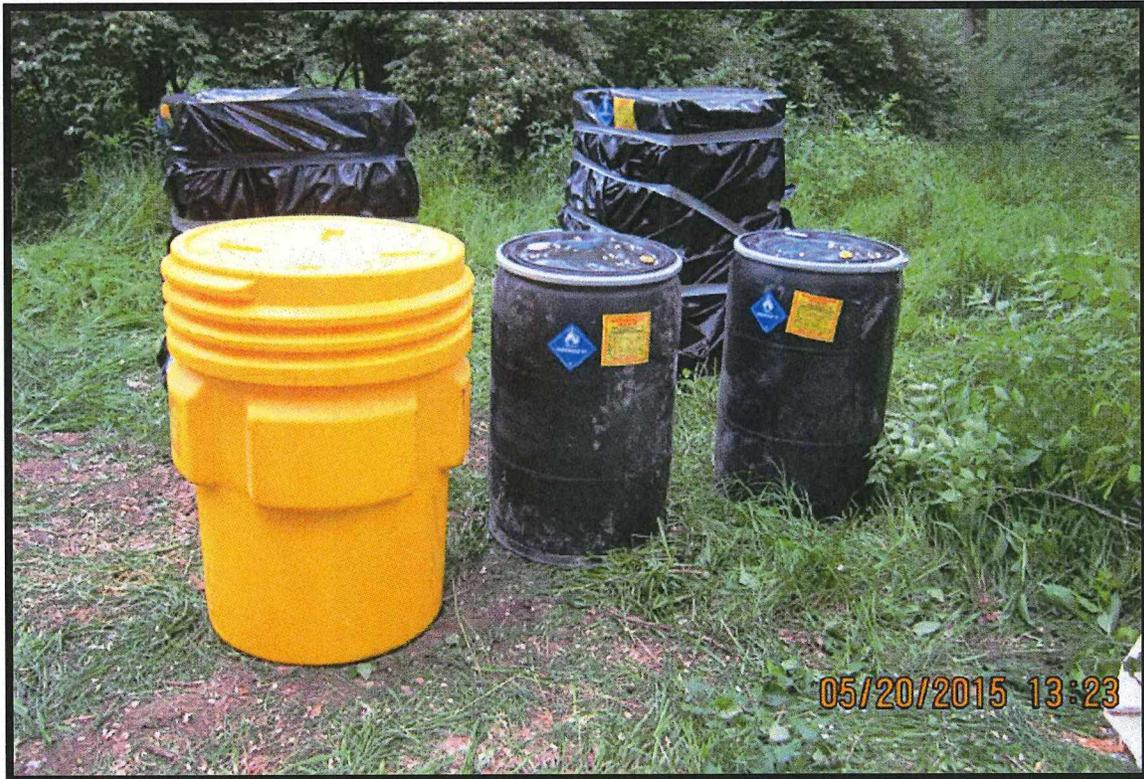
On May 20, 2015, Joel I. Williamson, Jr. hired Summit Contracting (Summit) to overpack the five drums to prevent further contact with water (humidity, precipitation). Summit removed all of the five drums from Barn 1 and staged them outside nearby. While moving the drums, an unknown material dripped from one of the drums and immediately caught fire. Summit overpacked three of the five drums in plastic / poly overpack drums and wrapped the two remaining drums in plastic within their original wood crates (Figure B-3) (AR Document No. 19).

B-3 – Summit Contracting overpacked water reactive drums May 19, 2015

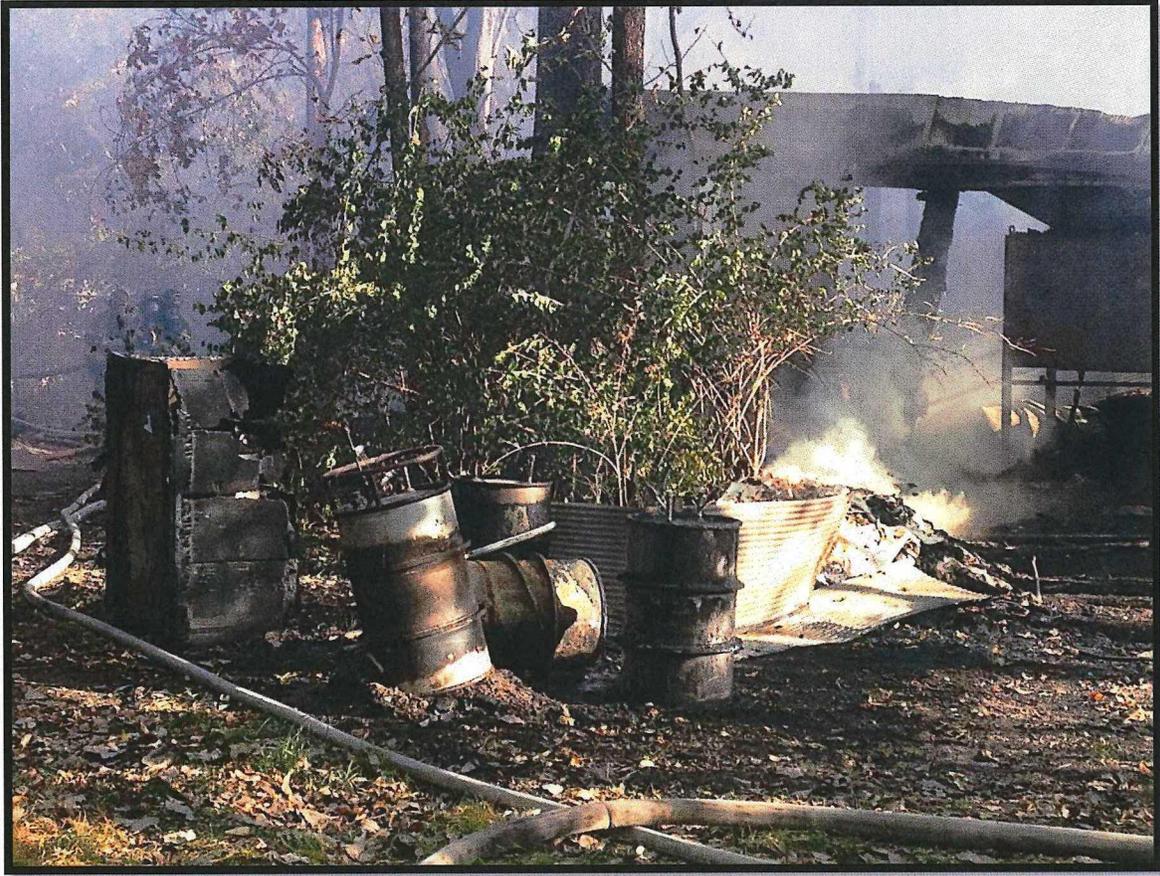
However, township fire departments were again called upon to extinguish a structure fire at Barn 1 in October 2015. This fire also involved the five drums and burned off the plastic overpacking and caused severe damage and scorching to the drums. MCPHD and IDEM responded and MCPHD requested EPA assistance. EPA was able to obtain access and mobilized ERRS and START contractors to securing and stabilizing the five drums while assessing the Site for other hazardous substances, pollutants or contaminants.

B-4 – Water reactive drums damaged and scorched by fire

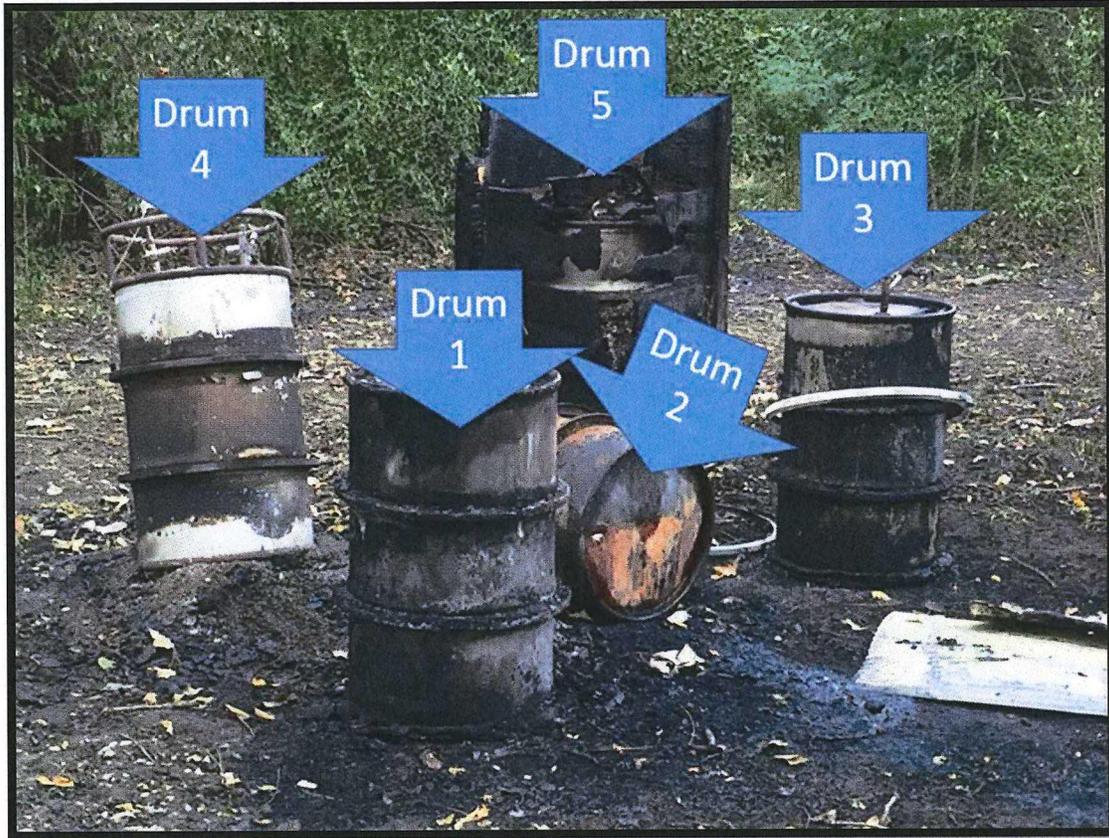
The OSC, MCPHD, IDEM, START and ERRS conducted a site walk during which they observed and documented the five drums. The OSC designated the drums as Drum 1, 2, 3, 4 and 5 for tracking purposes (Figure B-5). All five drums were heavily scorched and damaged from heat.

B-5 – Drum Designations

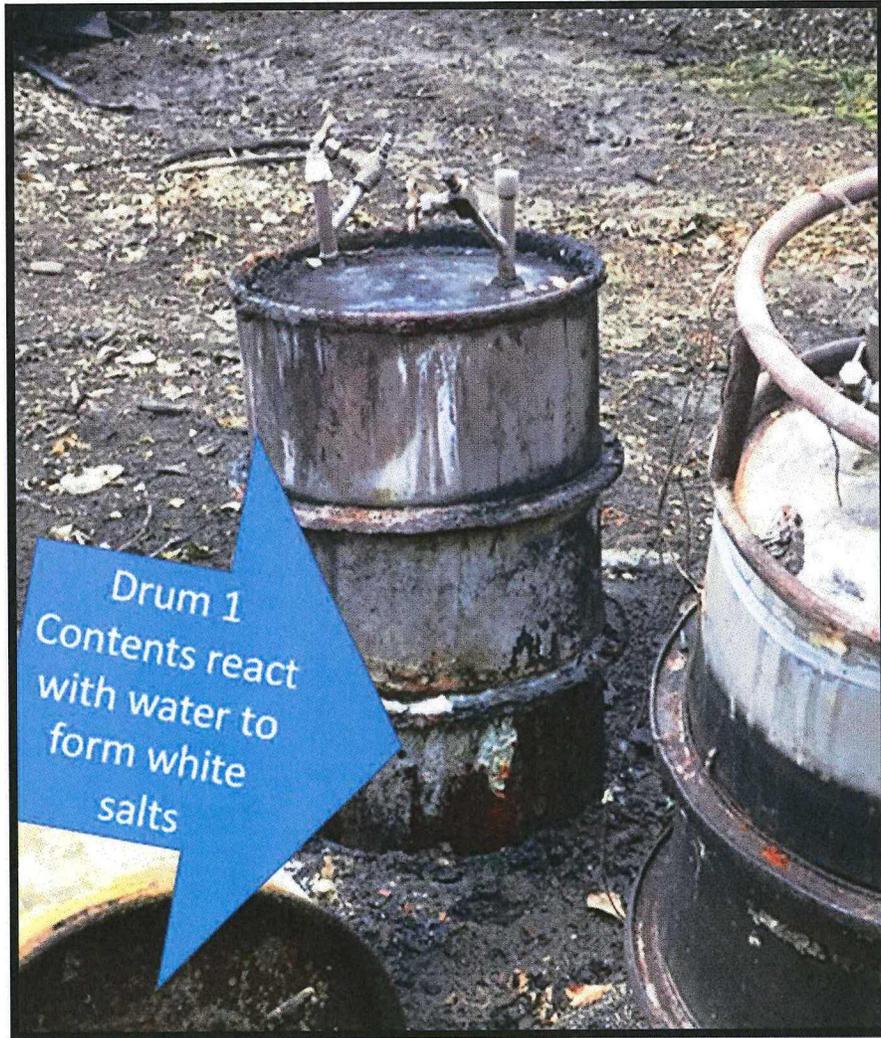
- Drum 1 appeared to have a white salt forming at a leak near the base of the drum (Figure B-6). The breach on Drum 1 was not visible due to salt formation covering the breach.
- Drum 2 was laying on its side and a breach was visible through the bottom of the drum (Figure B-7). The breach on Drum 2 has the shape and appearance of a sharp tool, like an ax head.
- Drums 3 and 4 were scorched but showed no obvious signs of leaks, breaches or reactions.
- Drum 5 was located within a partially burned wood crate and unable to be visually assessed. One panel on the wood crate containing Drum 5 was marked "potassium metal" and "keep water away" (Figure B-8).

- Drum 1 is breached and forming corrosive solids and liquids at the leak. Field screening with pH paper and lab testing conducted by EPA ERT (Sample Drum 1_11415) document the pH of the corrosive liquid at 14 standard units. A liquid waste meets the characteristic of corrosivity (D002) if the waste is liquid and has a pH of less than or equal to 2 or greater than or equal to 12.5. 40 C.F.R. § 261.22(a)(1).

B-6 – Breach and salt forming on Drum 1

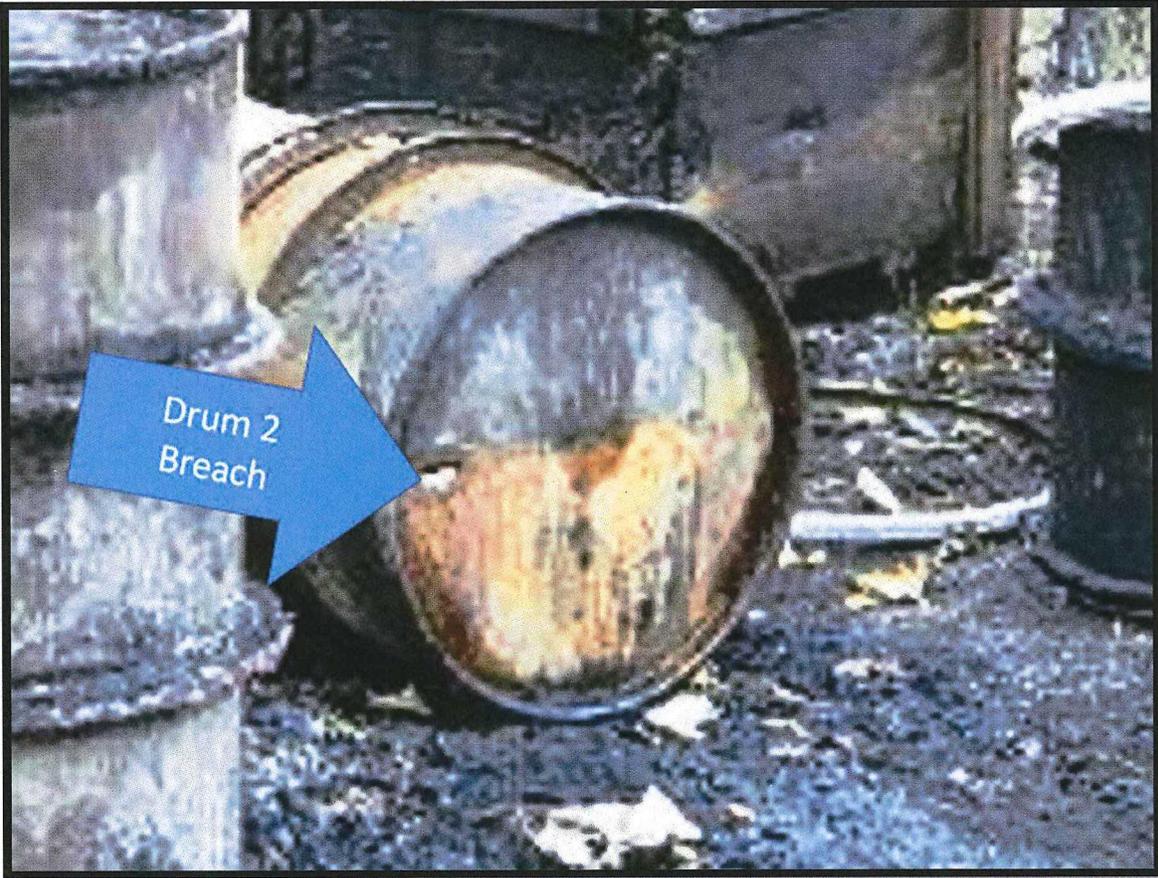
Furthermore, the Site is not fenced and trespassing and metal theft have already occurred. EPA documented Drums 1 and 2 have been breached, the breach in Drum 2 has the shape of an ax head, and the Wayne Township Fire and Hazmat Department has determined that disturbing Drum 2 causes spontaneous fire. The drums are made of valuable stainless steel and it is possible the drum was intentionally breached in order to drain the container prior to recycling the metal container.

B-7 – Breach in Drum 2

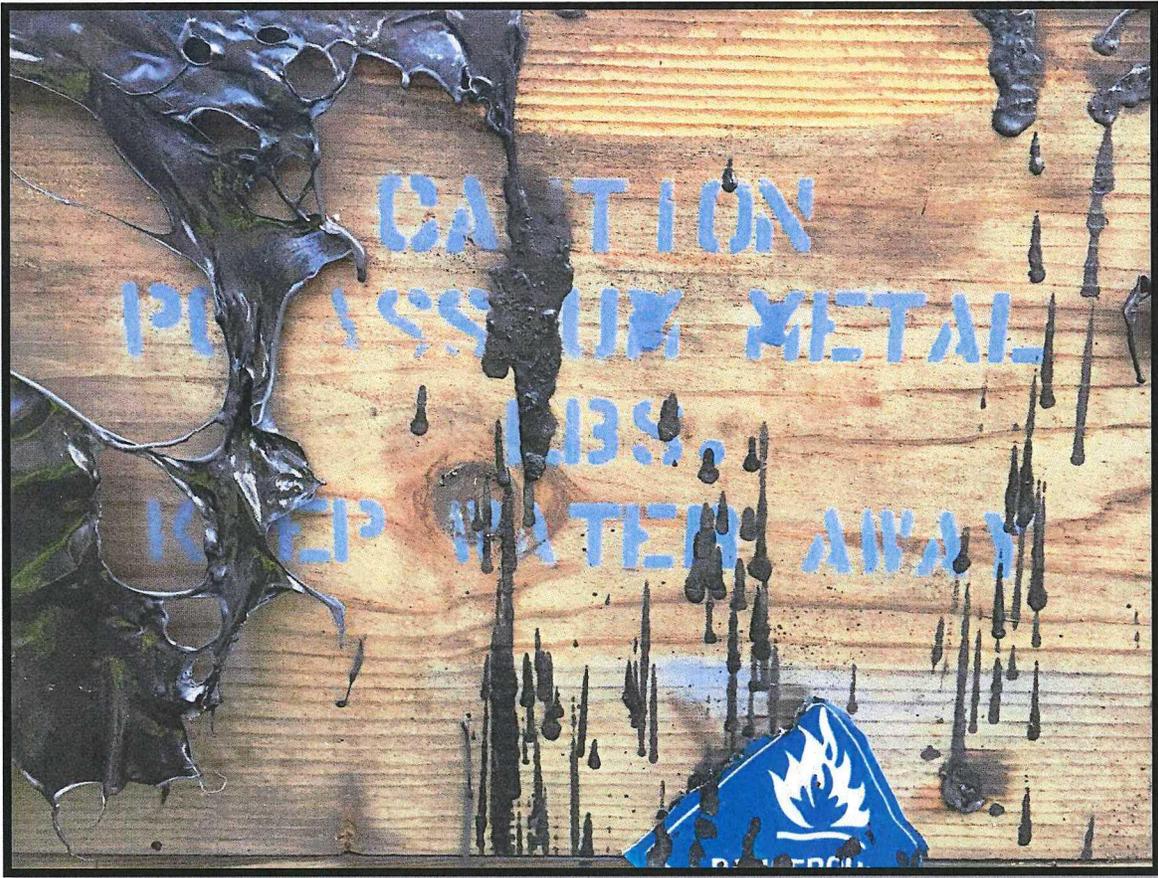
B-8 – Labeling on Drum 5, “potassium metal” and “keep water away”

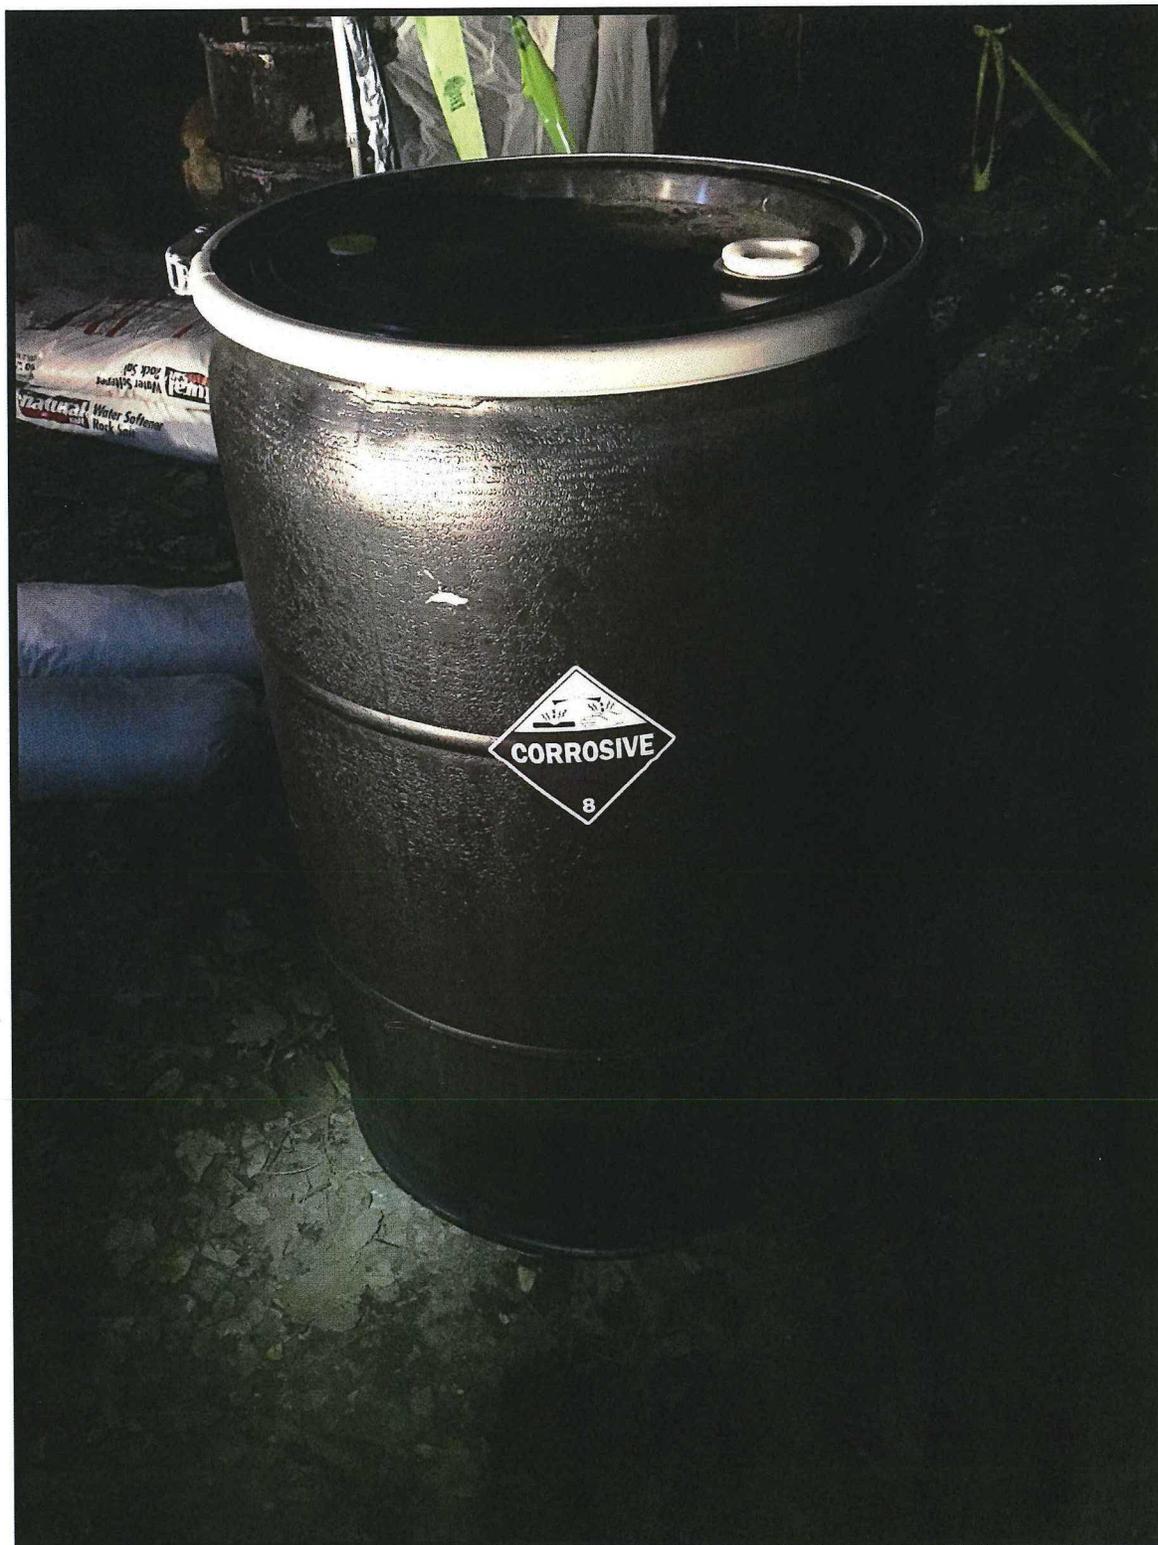
During the October 23 site visit, wetted soil was discovered at the base of Drums 1 and 2 and the liquid had a pH of 14. ERRS hand excavated the wetted soil to prevent further migration of spilled materials. Excavated materials were placed in a black poly overpack drum and staged with the five drums (Figure B-9).

High levels of hazardous substances or pollutants or contaminants in soils largely at or near the surface, that may migrate is present at the Site. On October 23, 2015, EPA discovered soils being wetted by corrosive liquids leaking from Drums 1 and/or 2. The corrosive liquids had a pH of 14 which meets the hazardous characteristic for corrosivity (D002) under 40 C.F.R. § 261.22(a)(1). EPA removed some of the contaminated soils, but additional removal may be necessary.

B-9 – Caustic liquids and contaminated soils were excavated for disposal

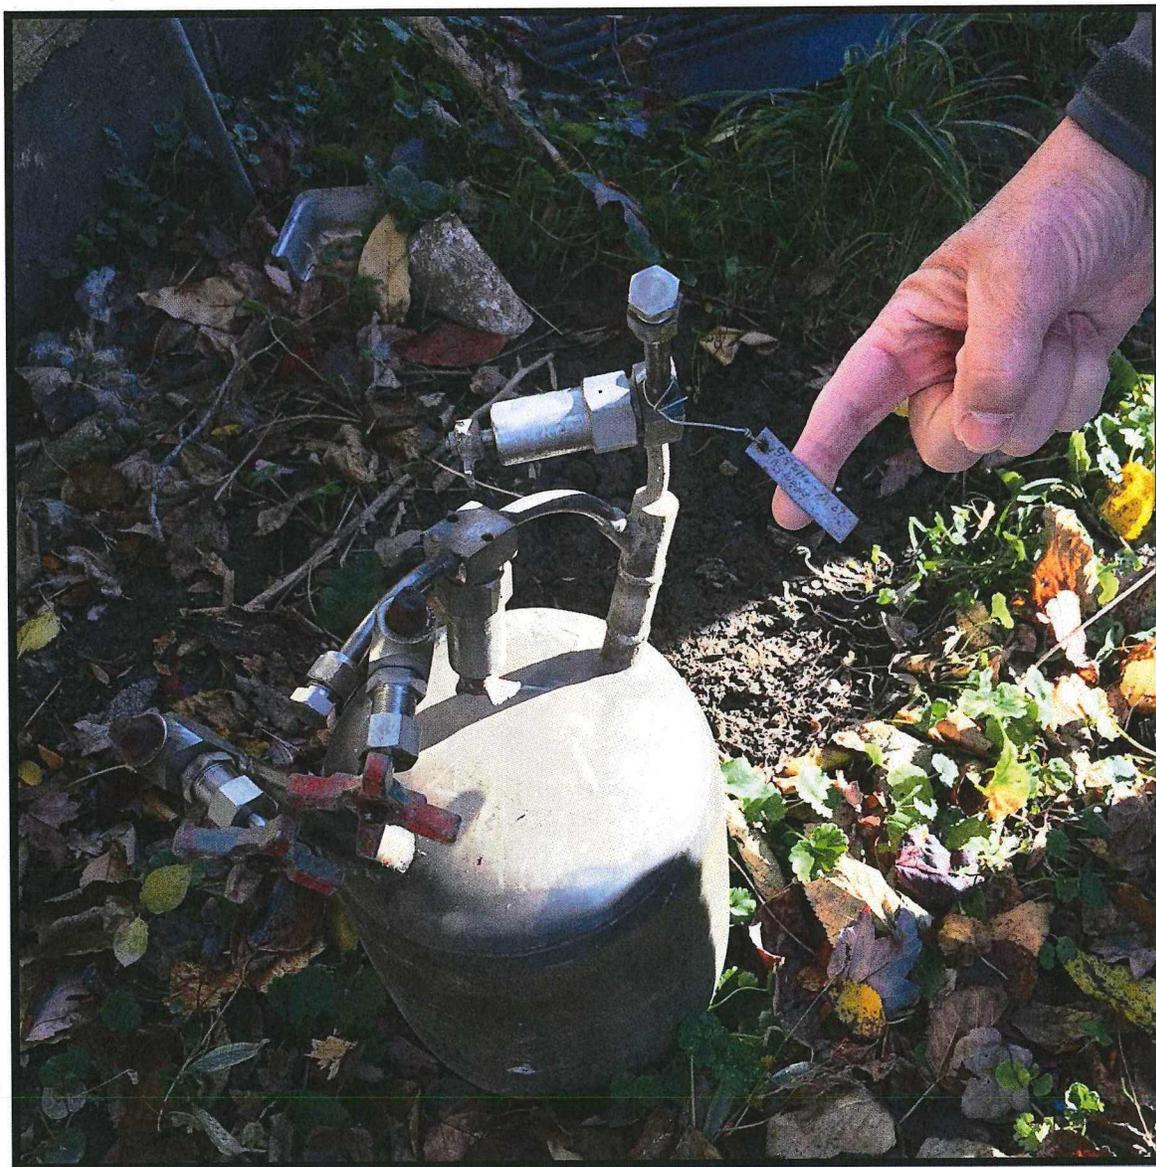
On November 10, 2015, the OSC assessed a small stainless steel reactor vessel ERRS had discovered at the Site. A stamped tag on the vessel stated 99% mercury, 1% lithium by weight (Figure B-10). It is not clear whether this vessel is related to the visitor's report made November 6, 2015. The vessel was sealed and did not indicate the amount of mercury or lithium that may have been inside the vessel. On November 16, 2015, IDEM and ERRS discovered the vessel was missing. An investigation is still ongoing by EPA, ERRS and IDEM for the whereabouts of the vessel which may have been stolen for the value of scrap stainless steel metal.

B-10 – Stainless steel vessel marked mercury and lithium by weight

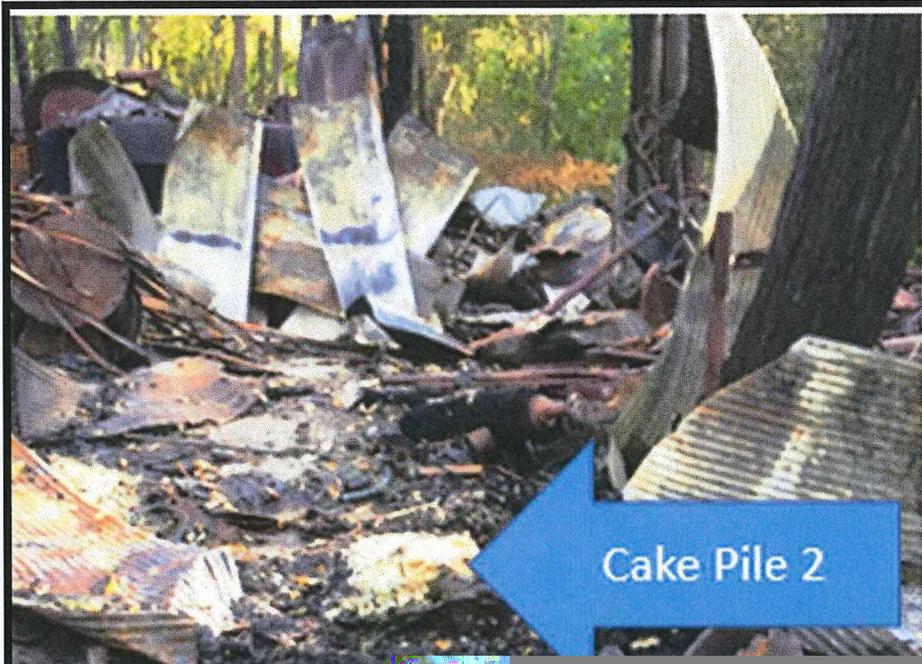
- Cake Piles 1 and 2 became exposed and unconfined when Barn 1 burned to the ground. Using litmus paper in the field, START determined the cake piles have a pH of 14 standard units. Strong corrosive wastes can readily corrode or dissolve flesh, metal or other materials. Lab results for Cake Piles 1 and 2 are pending.

B-11 – Cake Piles 1 and 2 in Barn 1

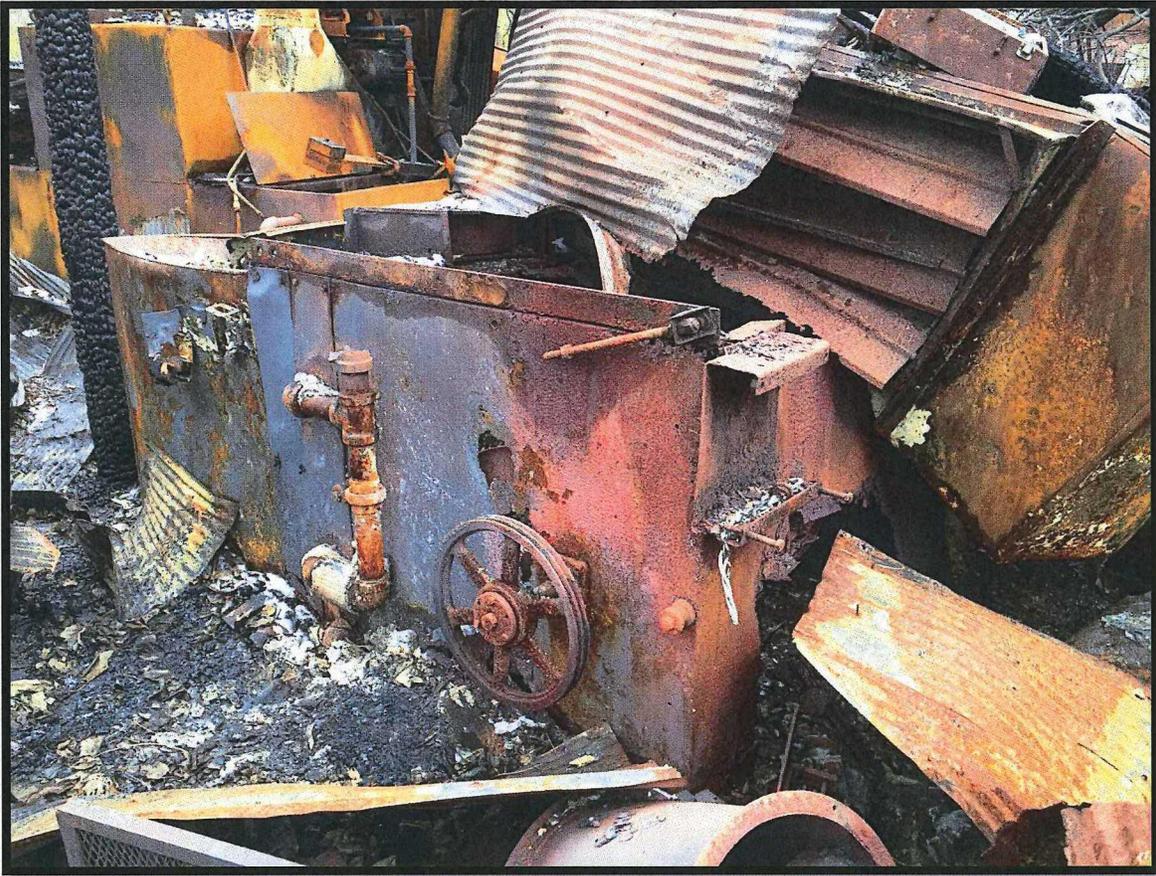
B-14 – Package Plant 2 in Barn 1

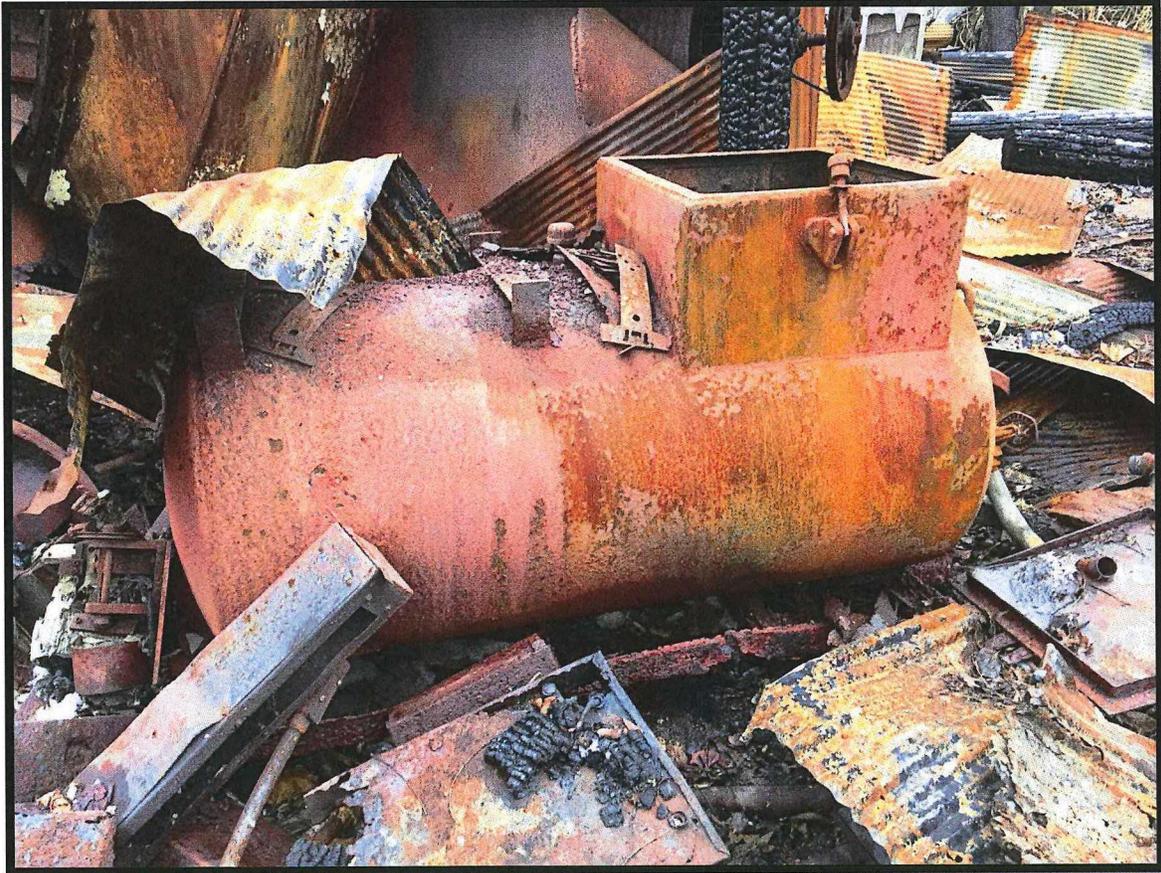
B-15 – Day Tank in Barn 1

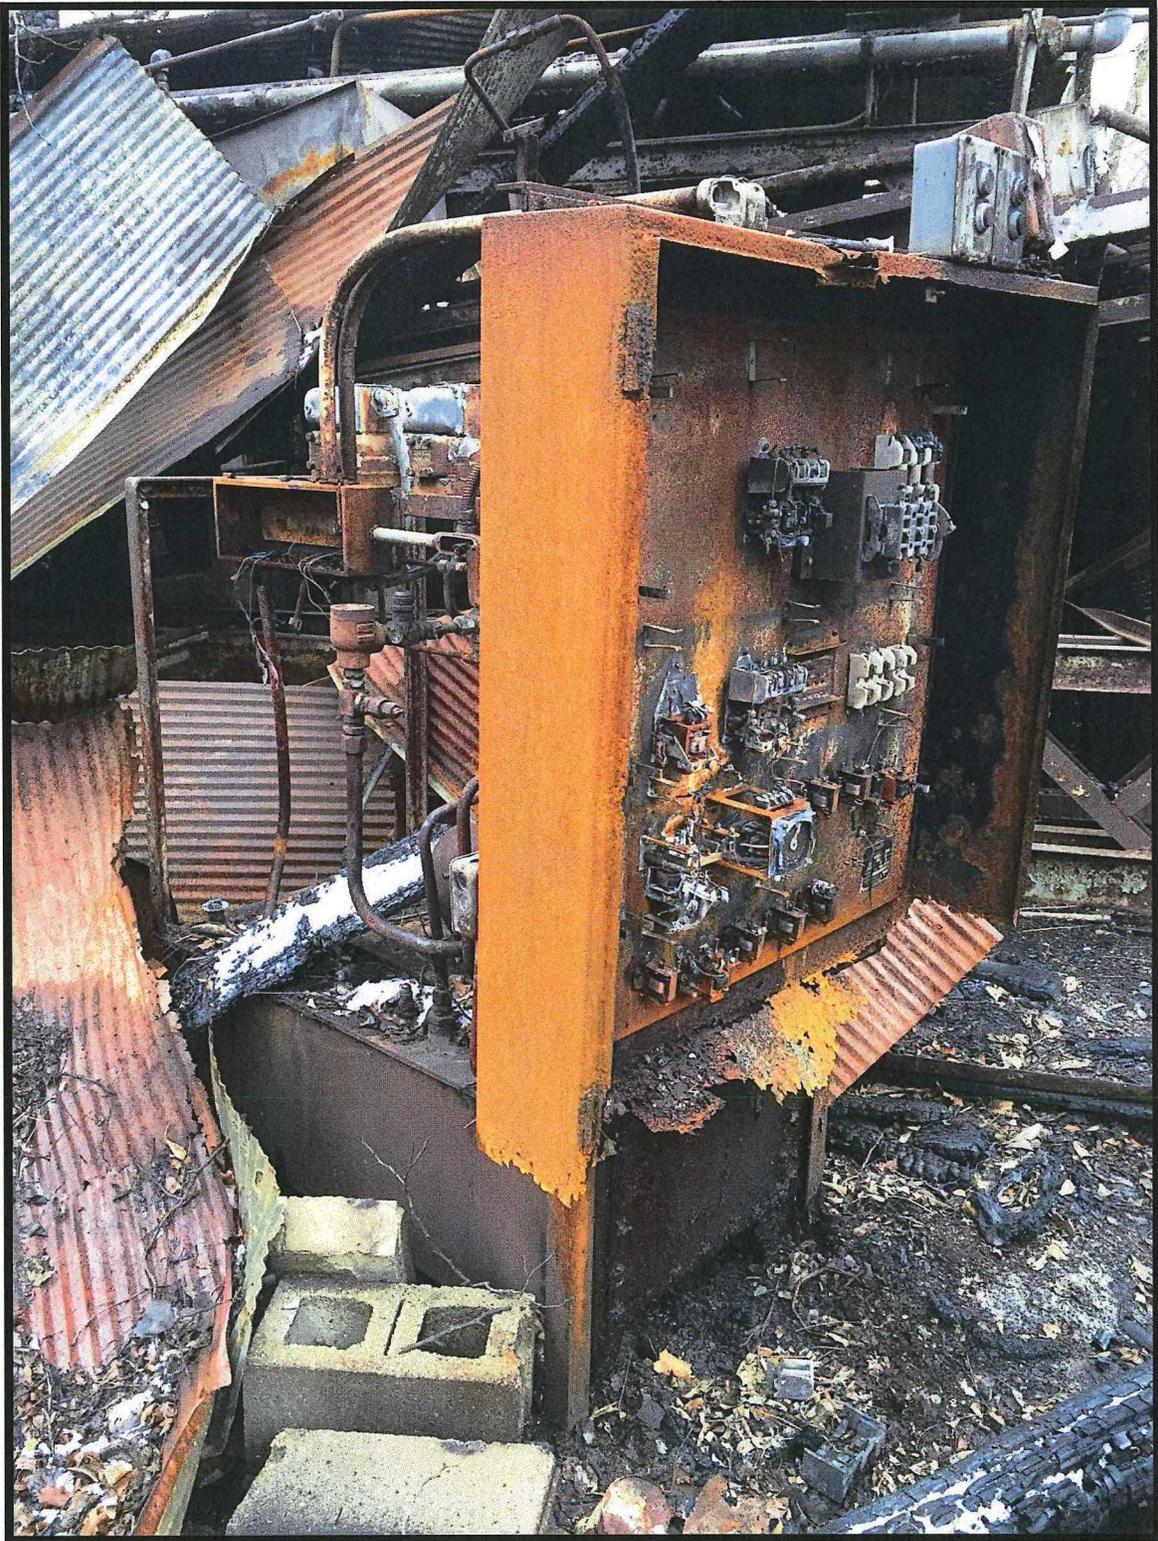
B-17 – Electric control panel / transformer

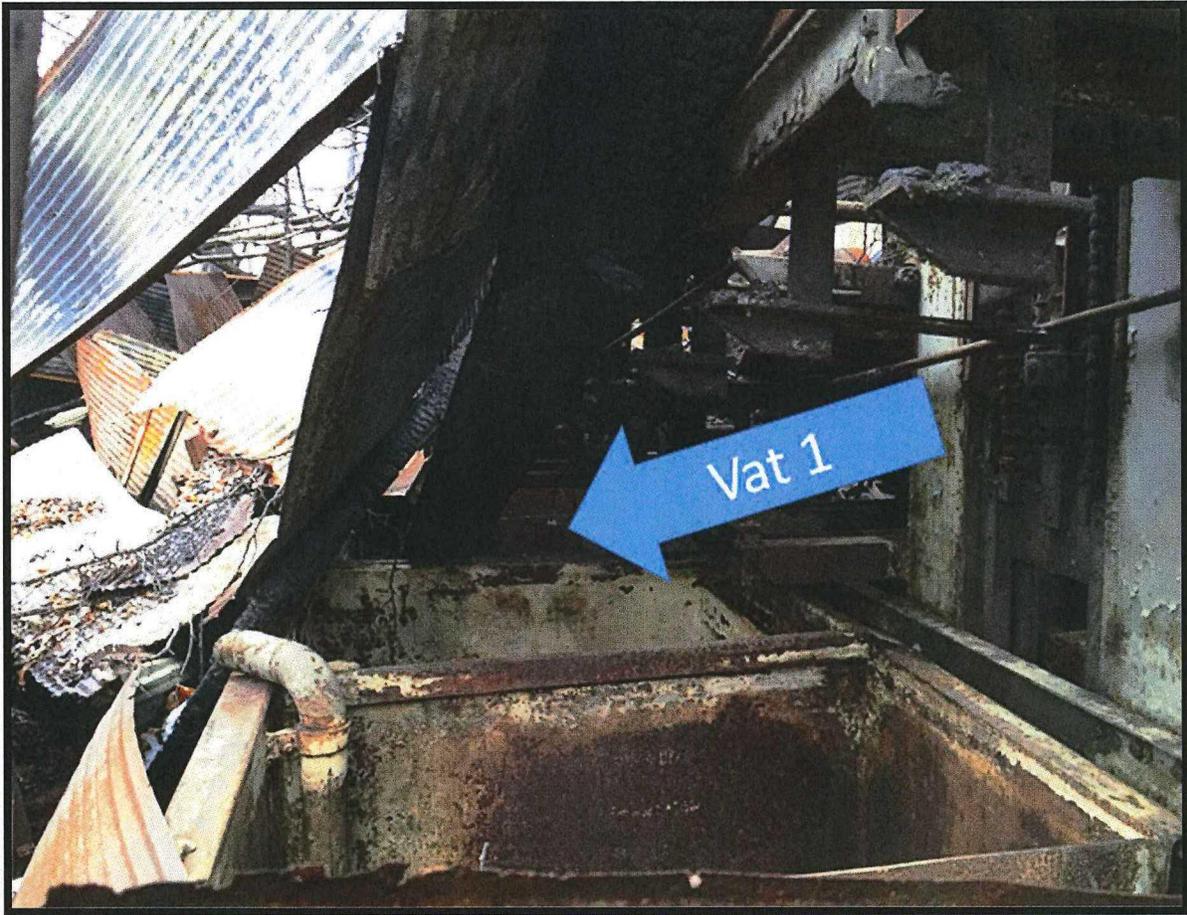
In addition to the five drums, the OSC observed: old plating vats and a plating line stored outdoors and in Barn 1 (Figures: B-18, B-19, B-20, B-21). The OSC also observed what appeared to be materials (Cake Piles 1 and 2) that were likely contained within drums prior to the October 20, 2015 fire at Barn 1 (Figure B-11). The OSC observed various other containers, including cans, buckets, drums and compressed gas cylinders. The OSC and START made plans to return for a full site assessment that would include further inventory of containers, evaluation of wastes, sampling collection, lab analysis, and a site assessment report.

B-18 – Electroplating Vat 1

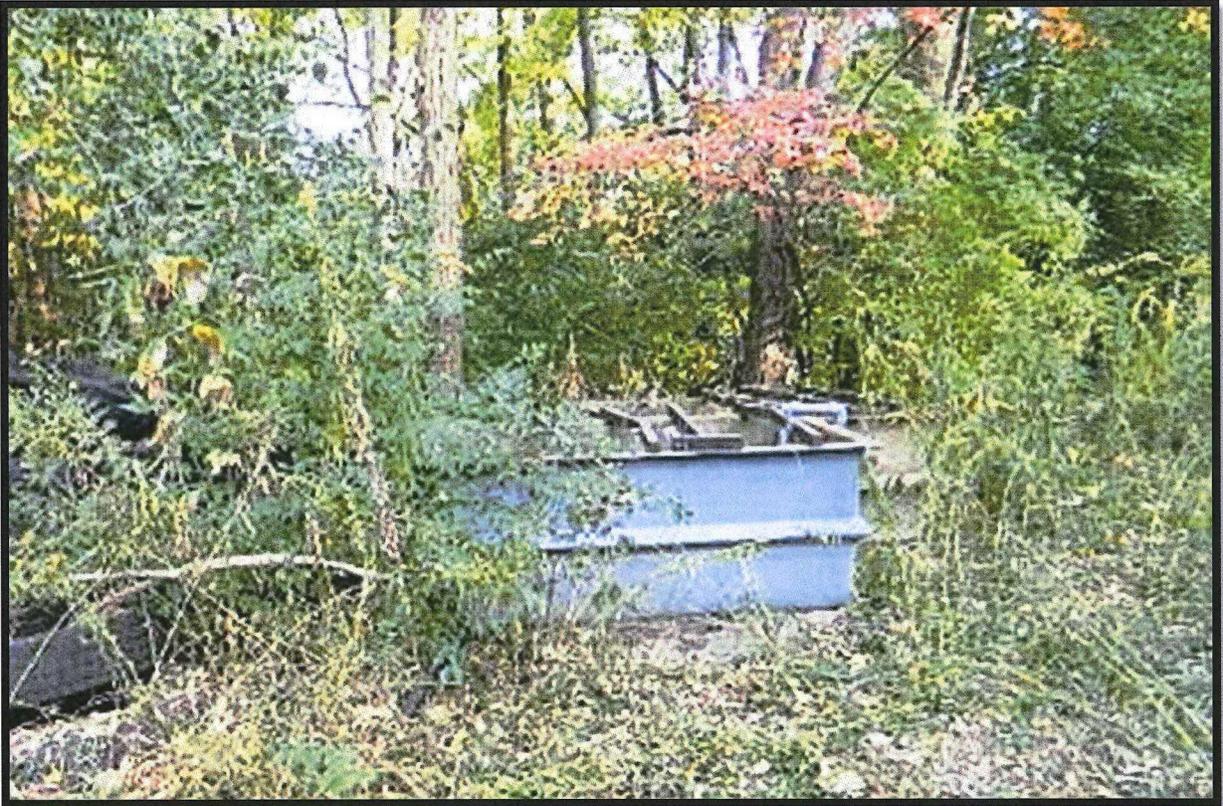
B-19 – Vat 2

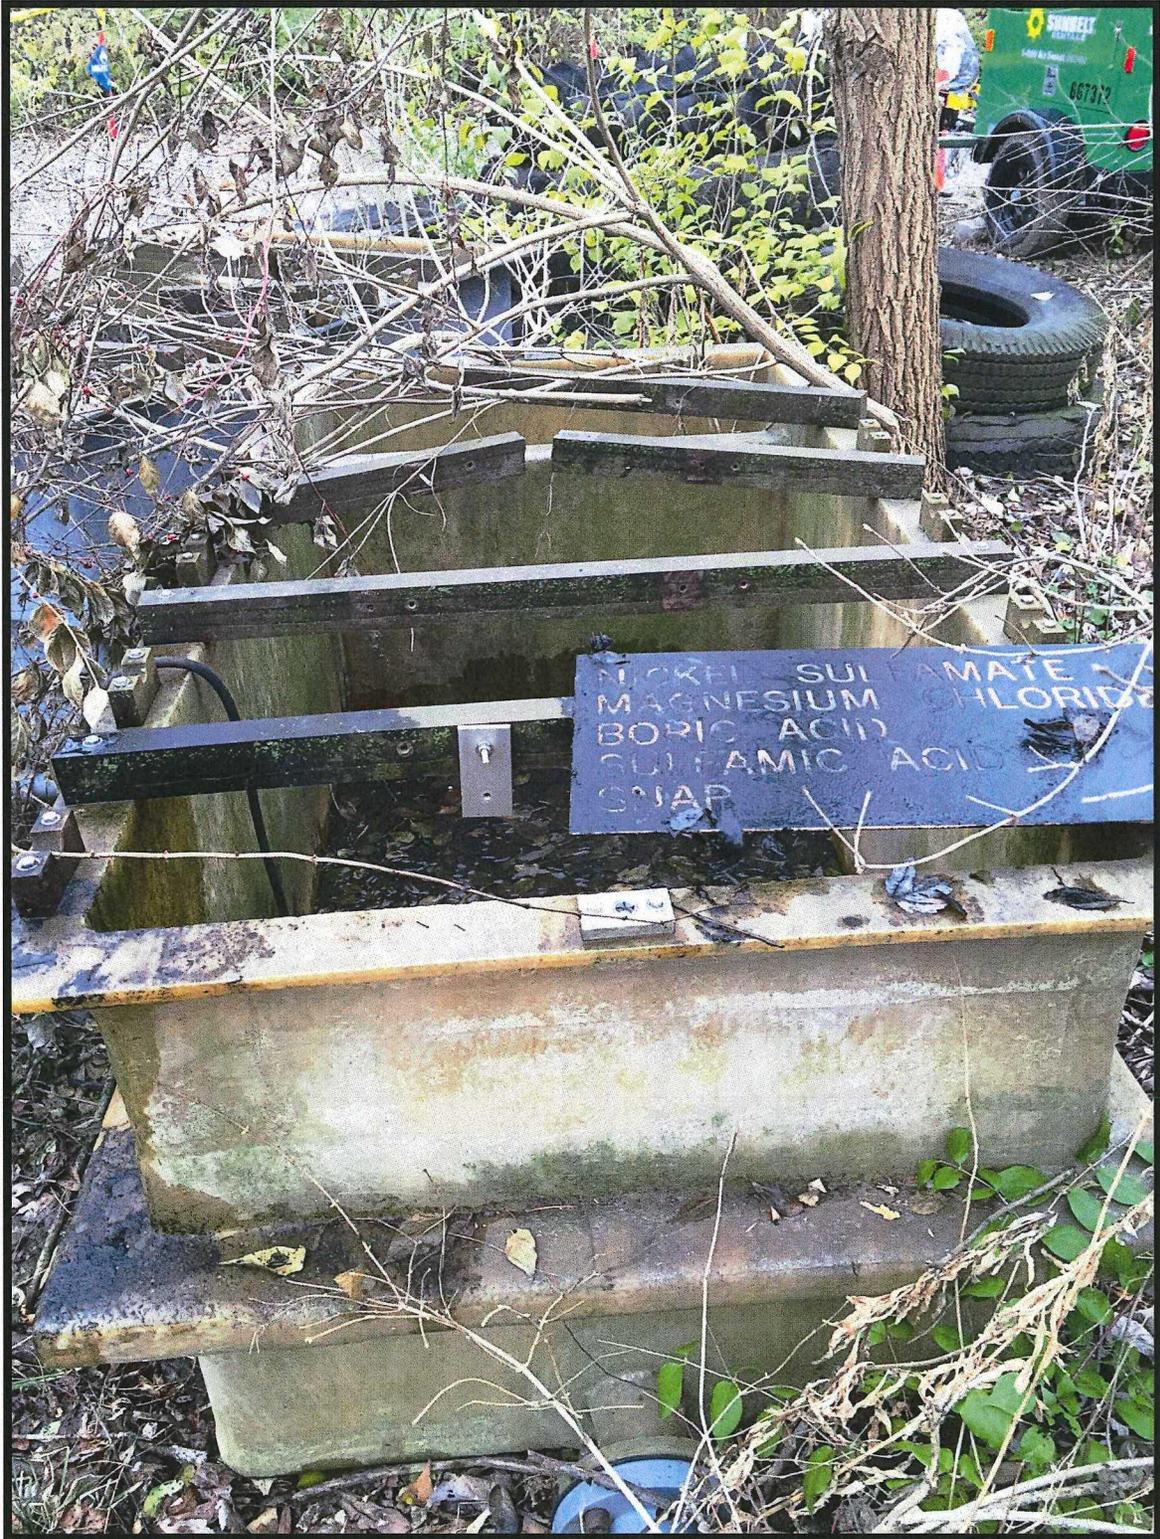
B-20 – Vat 3

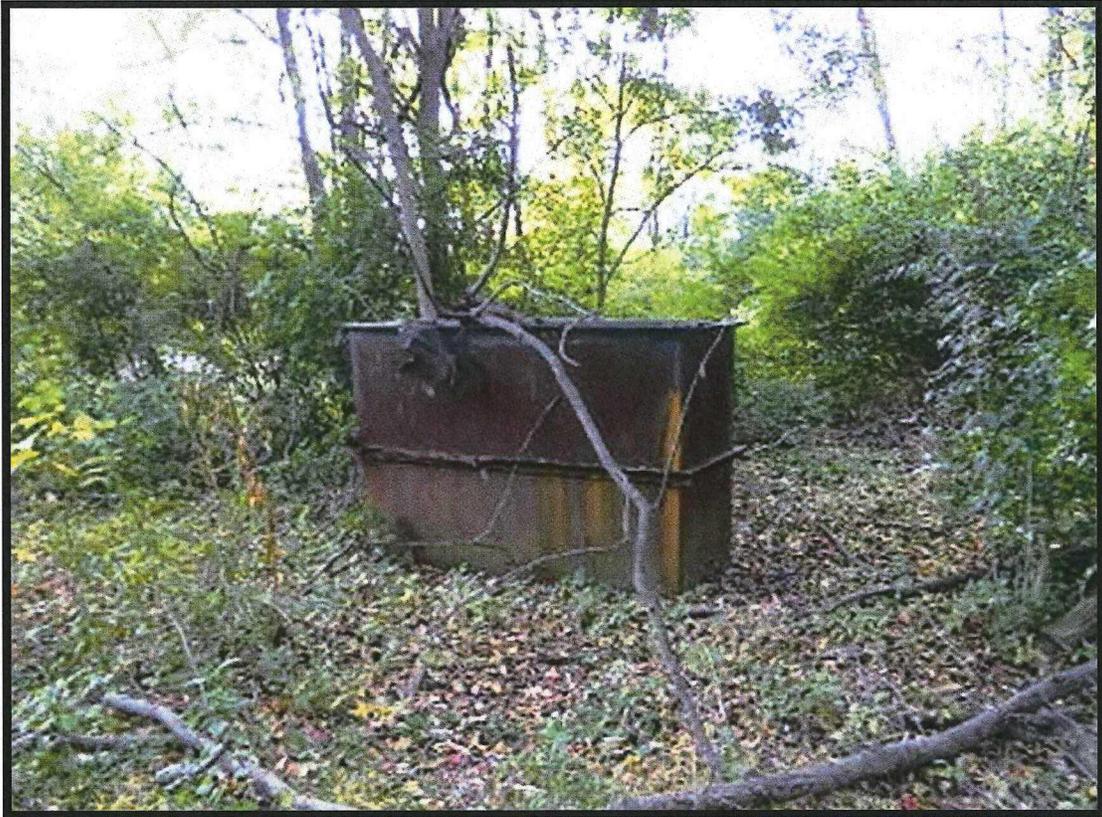
B-21 – Vat 4
