SF₆ Emission Reduction and Leak Repair in Japan

The Federation of Electric Power Companies (FEPC)

The Japan Electrical Manufacturers' Association (JEMA)

29-11-2006

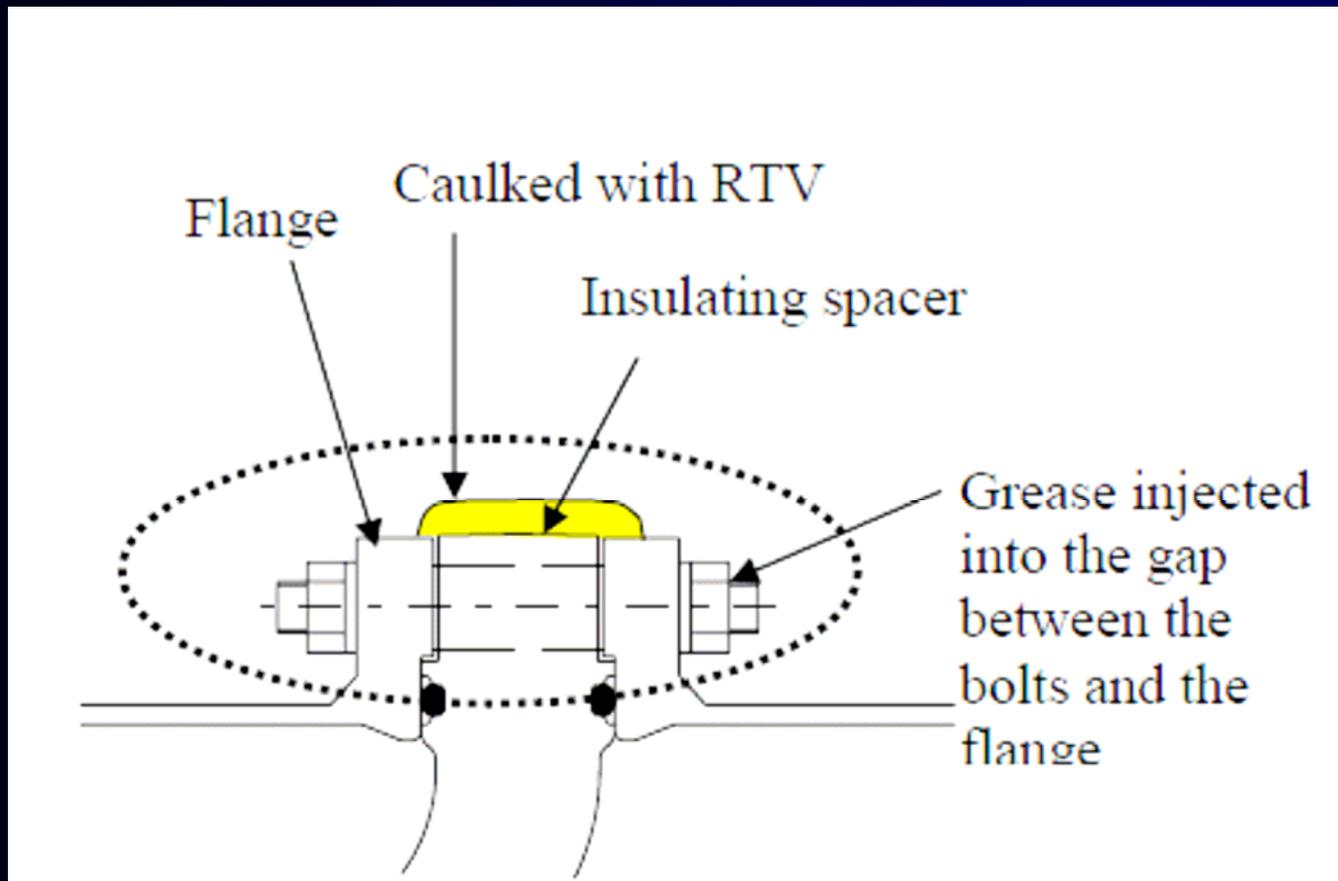
Flange Corrosion

**SF₆ Leakage**

Countermeasure against flange corrosion of GIS

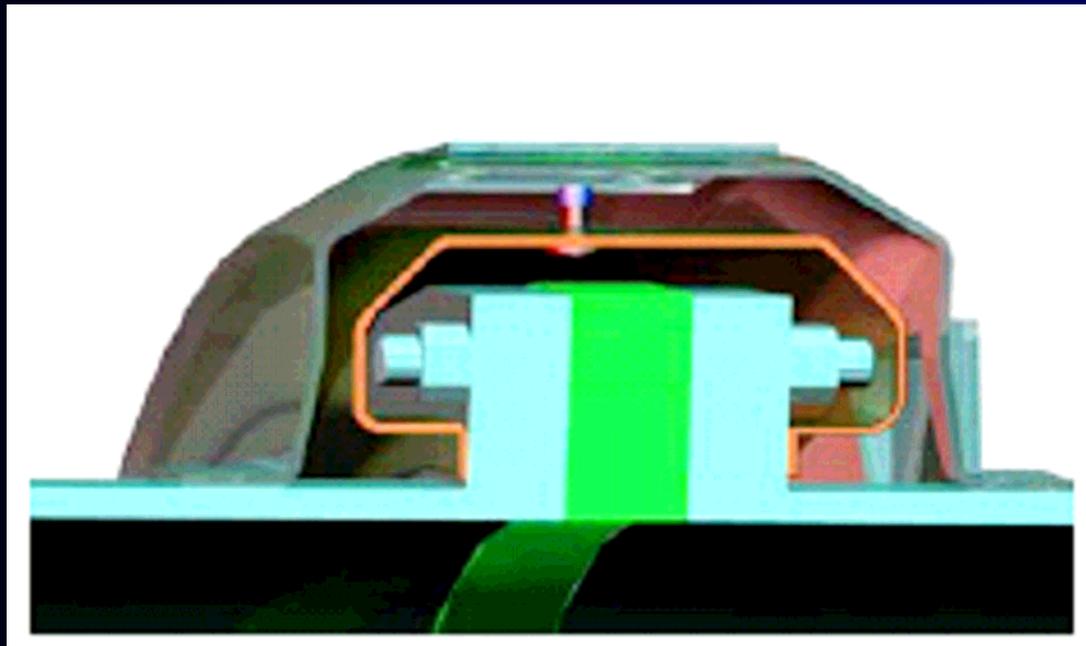
Flange Corrosion

**SF₆ Leakage**

The double shell concept (Filling up the shell with resin)

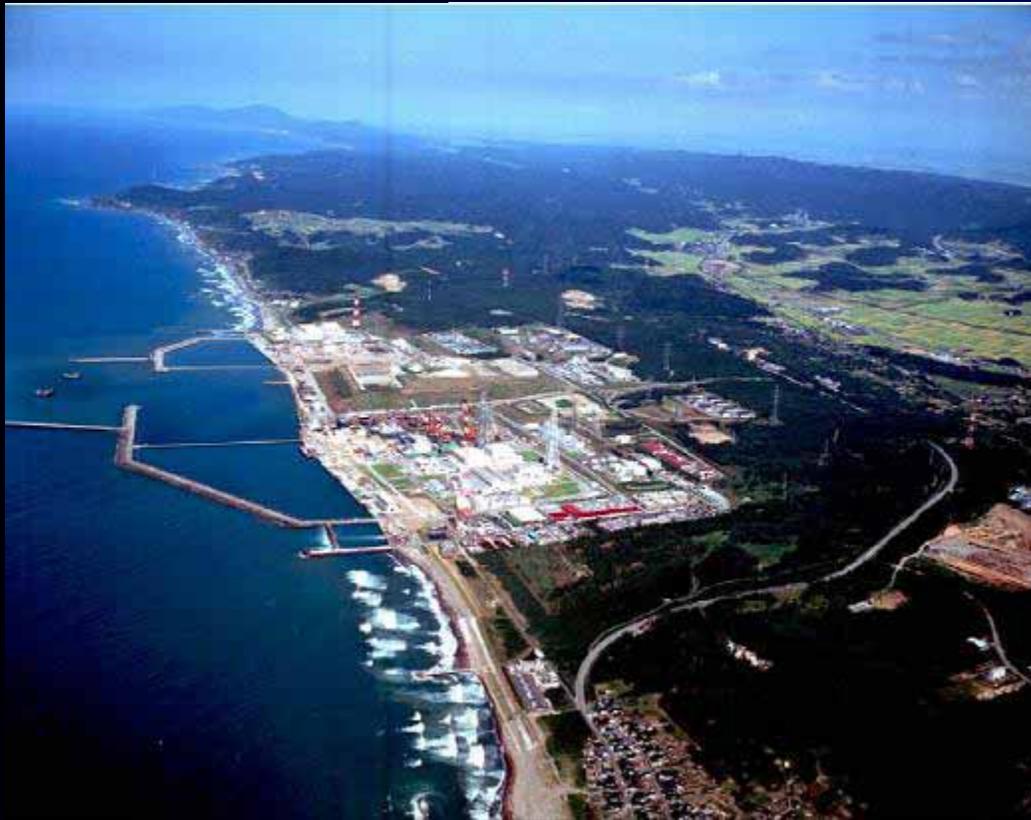
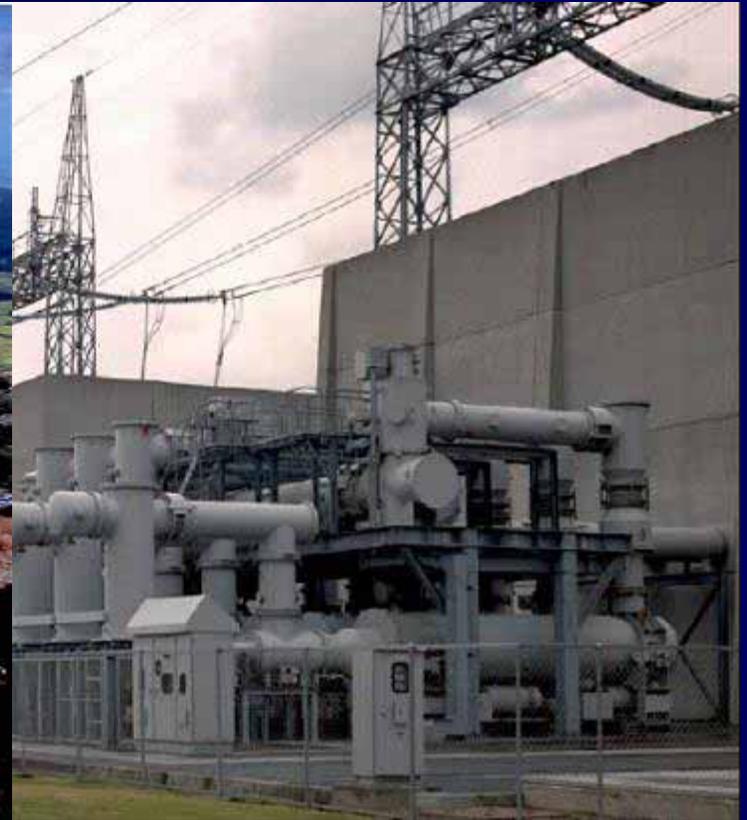
550kV GIS installed in coastal area

Gas leakage from the bellows by Stress Corrosion Crack

Recently we experienced the gas leakage from the bellows of GIS owing to Stress Corrosion Crack in outdoor GIS after 20 years' Service.

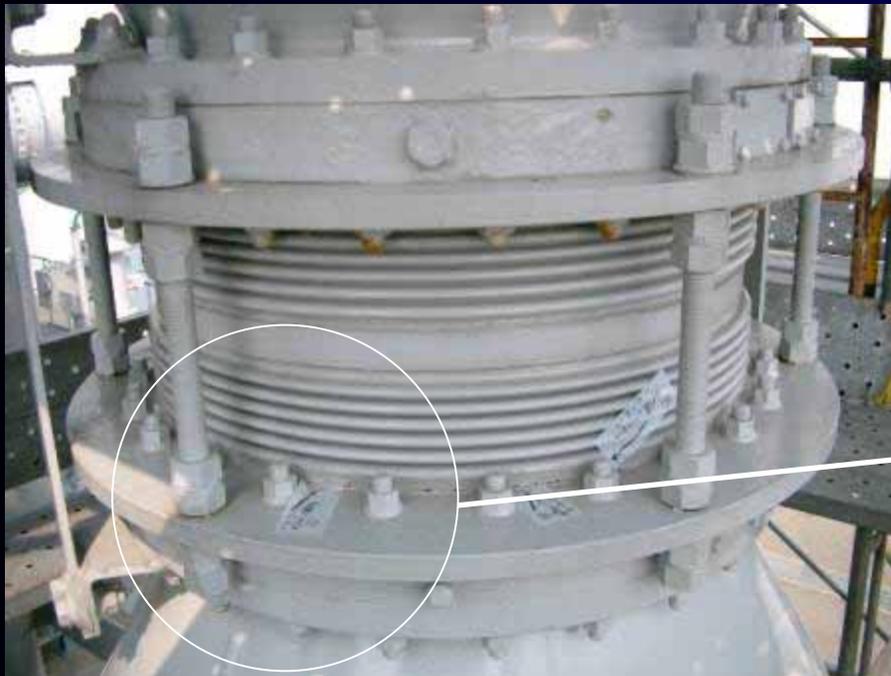
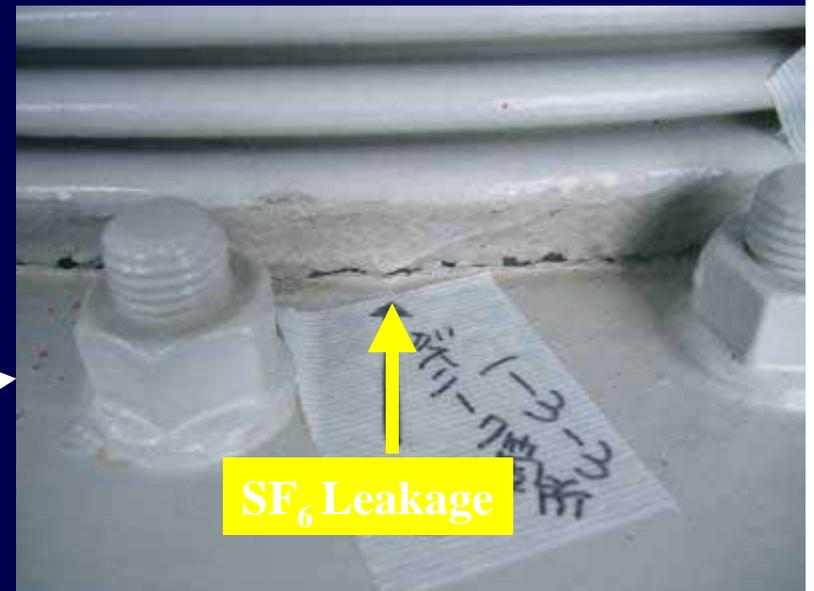
Gas leakage from the bellows by SCC

1. The life expectancy is assumed 50 years based on the life of O ring and the corrosion of the flange. The material of the bellows is a stainless steel which thickness is approx. 1.5mm.
2. The stain material (NaCl etc) adheres to the bellows. This causes stress corrosion crack (SCC) around the flange and the welded parts of bellows.
3. As a result, the replace of bellows became necessary in 20 years.
