ILLINOIS ENVIRONMENTAL PROTECTION AGENCY

Re: Internet/Wagner Castings
LPC# 1150155186 – Macon County
SF/Tech

DRAWING:
APPENDIX 1 SITE PLAN

**RE: Preliminary Phase I Environmental Site Assessment Findings
Former Wagner Castings Company / Internet Foundry
825 - 830 N. Lowber Street / 700 N. Jasper Street / 1275 E. Sangamon Street
Decatur, Illinois 62521
LPC No. 1150155186
USEPA ID No. ILD000814699**

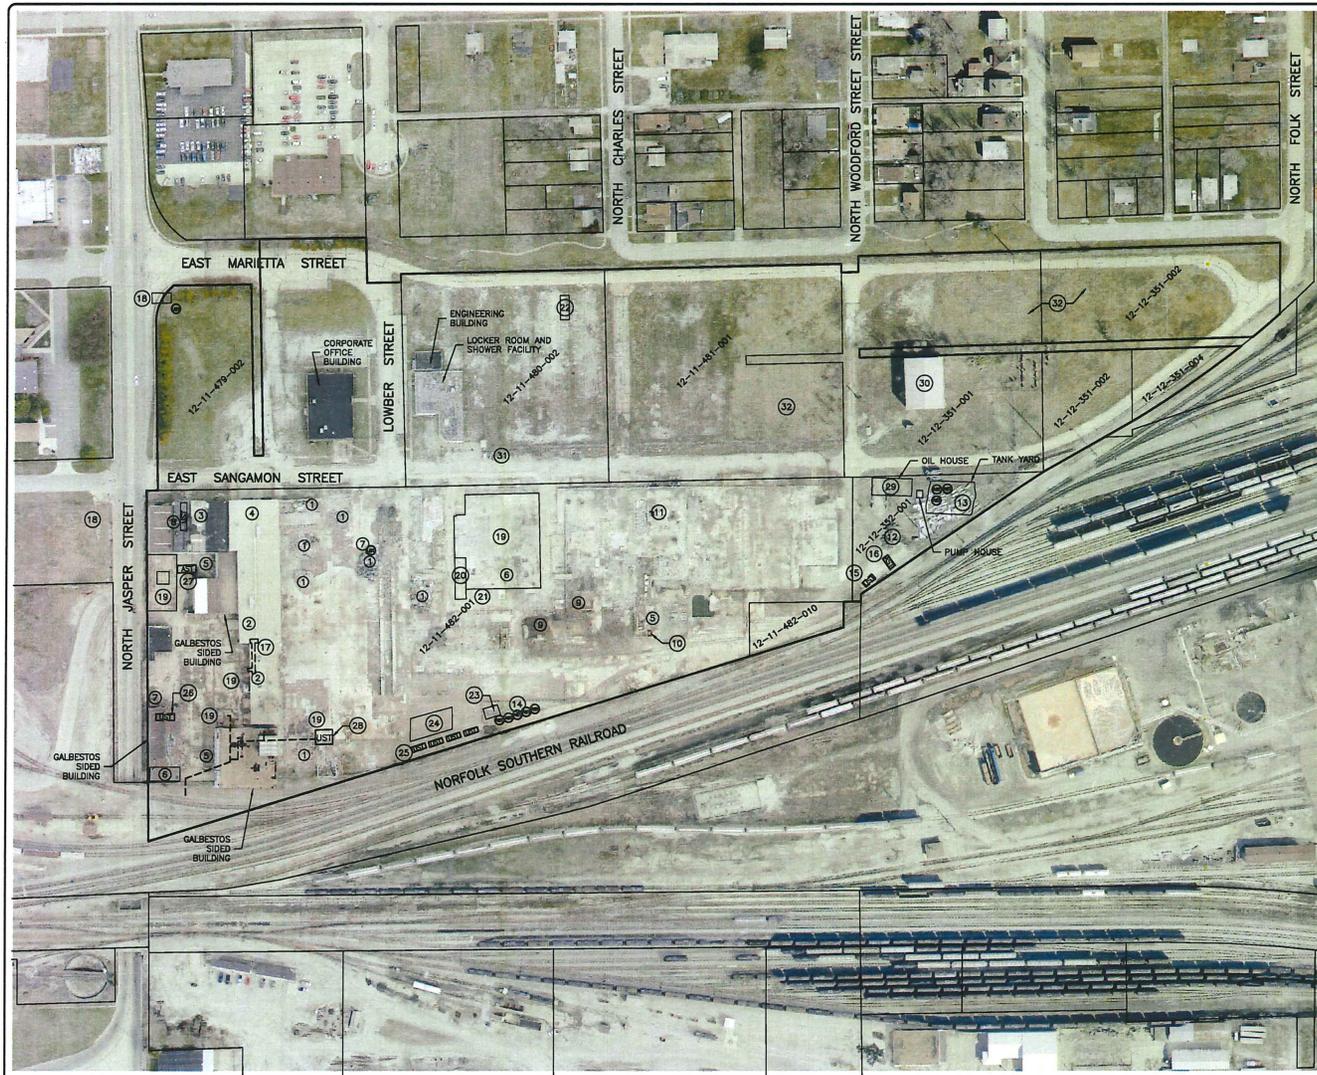
A large volume of stock-piled electrical transformers were present at the northern limits of the remaining industrial structure (Site Plan #4). Some of the transformers contained labels indicating they are of non-PCB content and some contained no identifying labels related to PCB content. Also present to the west of the transformers were multiple 55-gallon drums labeled "Hazardous Waste" and "Caution Contains PCBs". These drums appeared to be generally full and the lids were secure. However, staining was observed around the base of one drum as depicted in Attachment 3. Although a roof is present at the area, some sides of the structure have been removed as part of historical demolition activities, allowing direct access by unauthorized visitors and partial exposure to weather elements.

Just as concerning is what environmental impact may remain from the areas that the electrical transformers were removed from. During the site reconnaissance, three (3) former transformer yard areas were identified (Site Plan #5). The areas were in very poor condition. No records or evidence of the proper decommissioning of the former transformers have been identified to date. Signage indicates that the local electrical utility provider may have operated at least one of the former transformer yards. PCB impacts to underlying concrete, soil, and groundwater are of concern in addition to the surrounding demolition debris.

At the northeast corner of the site is an unsecured metal clad structure containing wastes that are suspected to have been former foundry-related manufacturing products (Site Plan #30). Multiple 55-gallon drums were observed and labeled as containing caustic liquids, surfactants, and solvents. Also present was what appeared to be foundry sand and chrome oxide (green) powder. Past experience with similar chrome oxide powders demonstrated that the material will typically fail a standard TCLP waste profile test for chromium, rendering it a hazardous waste as a result of toxicity. The sacks containing these powders were significantly weathered, allowing the materials to be actively released and exposed to precipitation runoff that had entered the structure through holes in the roof. Furthermore, the precipitation appeared to be carrying the materials to the exterior of the facility in some areas where they may be impacting soil.

A stockpile of transite (asbestos-cement) panels were observed at the southeastern region of the site (Site Plan #13). The panels are directly exposed to the elements and were exhibiting signs of weathering. It is presumed these panels were removed from the former structures at the time of demolition and stockpiled at their current location. Google Earth imagery depicts the panels showing up at this location sometime between 2009 and 2010.

Adjacent to the stockpiles of transite were a large pile of wire-framed cages of unknown use (Site Plan #12). The cages were wrapped in suspected asbestos-containing fabric insulation that exhibited significant signs of weathering and friability. It is presumed that these cages were used as part of the foundry operations, as they were also observed in some of the remaining structures with the same fabric coating. The wrapped wire cages were also observed in stockpiles of demolition debris that litter the site.

A large quantity of the remaining exterior Galbestos panels are deteriorating and exhibiting signs of friability. As a result, there is significant concern that asbestos fibers and possibly PBCs are potentially being released. The panels are in a state where they will continue to be exposed to the open elements that support deterioration as time goes on.

Piles of suspected asbestos-containing roofing materials and other demolition debris (plaster, floor tile, etc.) were observed throughout the southwestern region of the site (Site Plan #1). The previously-described wire cages wrapped with suspected asbestos fabric insulation was also observed in some of the piles of debris. It appears that when the former buildings were demolished, the salvageable materials were removed and the remaining debris was left onsite where it is currently present. In general, roofing components are typically non-friable. However, these materials were compromised by the demolition activities and subsequently left exposed to seasonal elements. Similar to the Galbestos, these materials have significantly deteriorated and exhibit evidence of friability. As a result, there is significant concern that asbestos fibers are potentially being released. The roofing materials and demolition debris are in a state where they will continue to be exposed to the open elements and further deteriorate.

A number of aboveground storage tanks and 55-gallon drums labeled as containing fuel and used oil remain onsite (Site Plan #s 10/11/31). The tanks and drums contain various amounts of liquids and appear to have been brought to the site to support demolition related equipment. The tanks and drums are directly exposed to the elements and evidence of small releases were observed in some of the areas. The tanks and drums are also located in close proximity to storm sewer inlets located throughout exterior areas of the site.

Several piles of foundry sand mixed with slag, other waste materials, and casted parts are located at the central region of the site (Site Plan #9). Based on our past experiences, similar foundry wastes are known to contain elevated levels of polynuclear aromatic hydrocarbons (PNAs) and heavy metals. The material is currently exposed to the elements. In addition, the material was observed as contacting precipitation, allowing for potential contaminants to be carried into surrounding storm sewer inlets via surface runoff and jeopardizing surface water bodies that the storm sewer systems discharge into. In addition, evidence that animals are coming in contact with the materials was also observed.
