EPA SF₆ Emissions & Reduction Conference

**SF₆ Leak Reduction
Using Online Leak Sealing**

*Liisa Colby, The Colt Group
Deanna Woods, Alliant Energy*

SF₆ Leak Repair Case Study

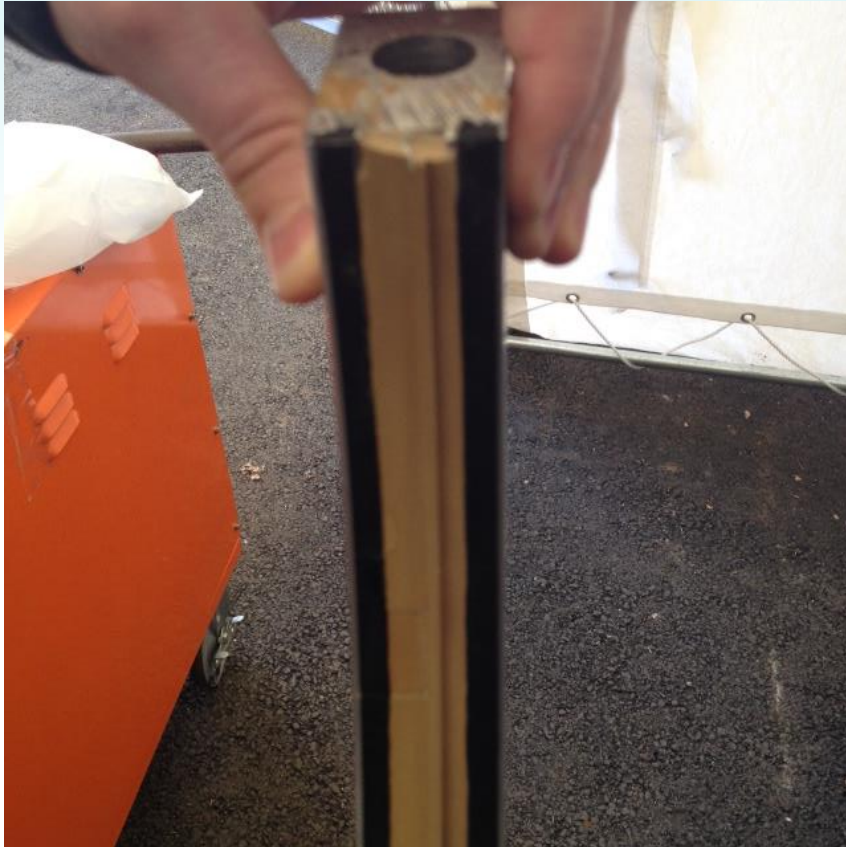
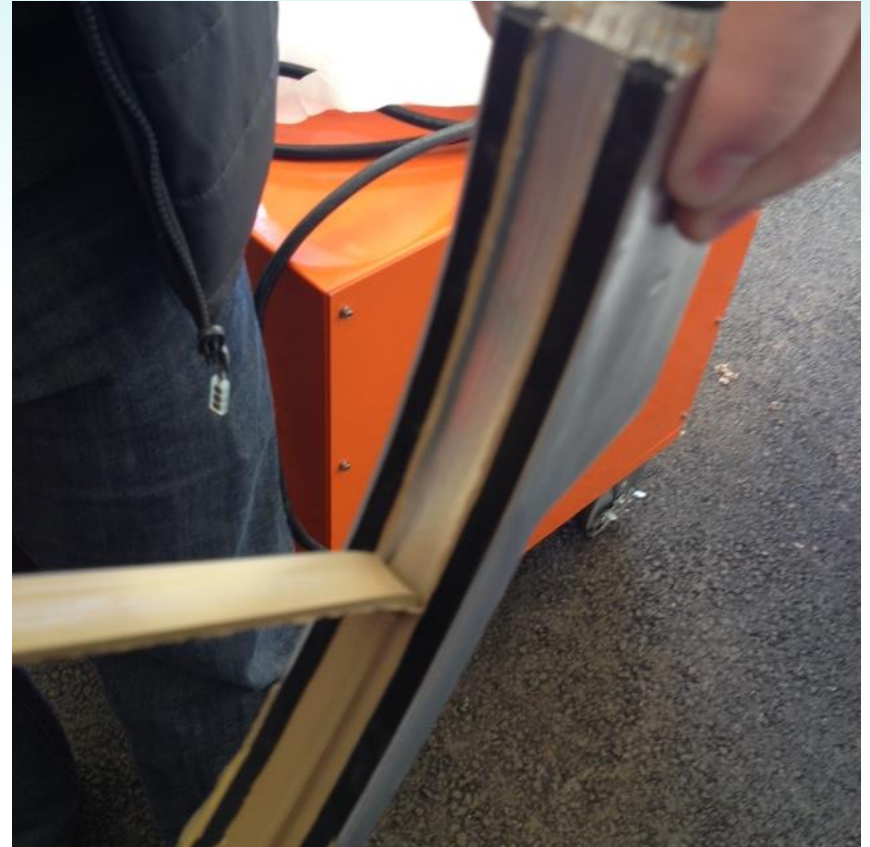
Note that sealant injected remained within designated area

Sealant Removal is easy also
