Navajo Abandoned Uranium Mine Site Screen Report

Church Rock ISL Site

Navajo AUM Eastern Region

May 2009

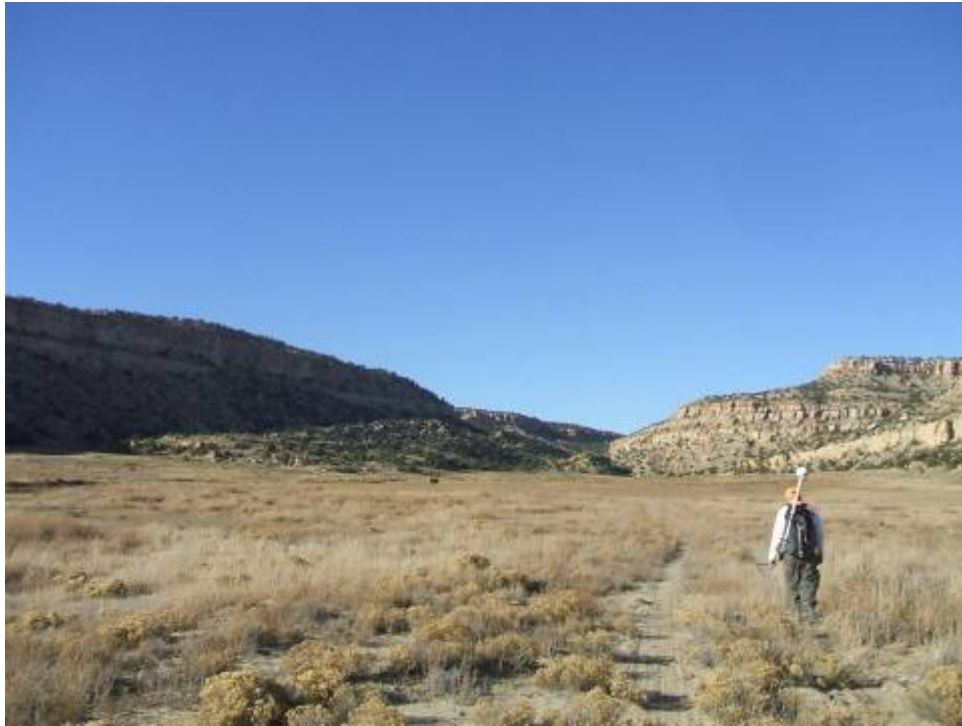
Photo 1. Church Rock ISL mine site, towards the northwest

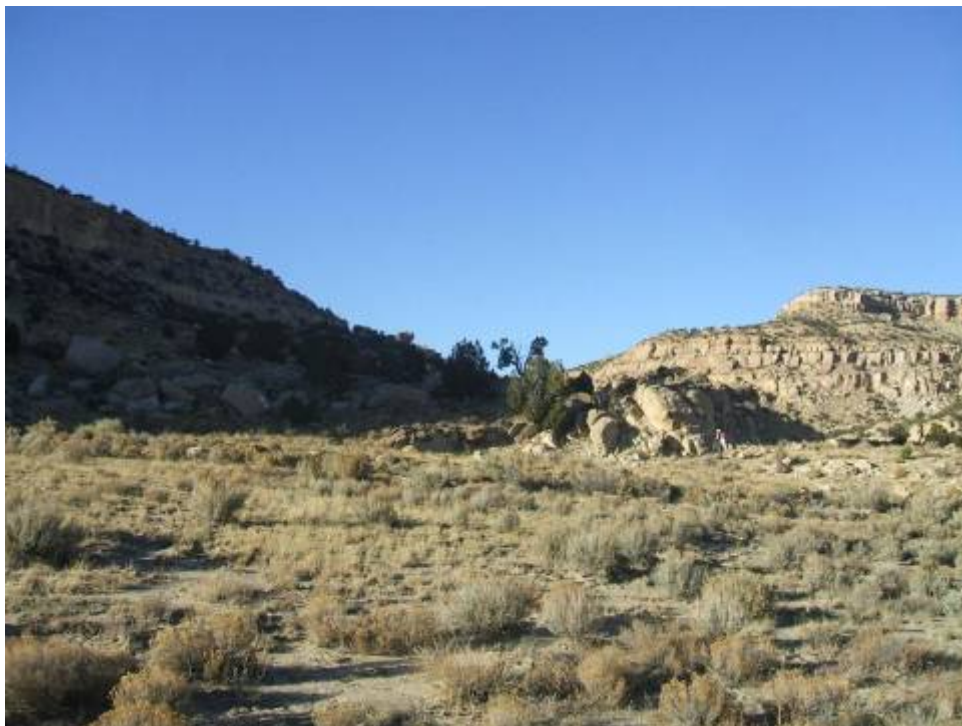
Photo 2. Church Rock ISL mine site, towards the north

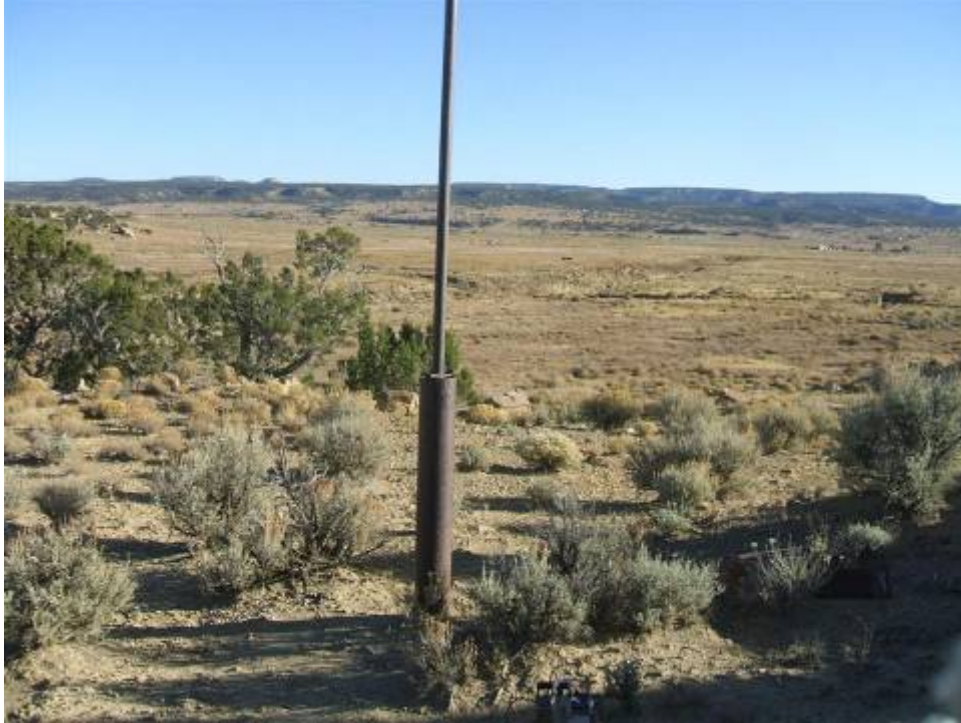
Photo 3. Metal pipe and well within the southern portion of the mine site, towards the southeast

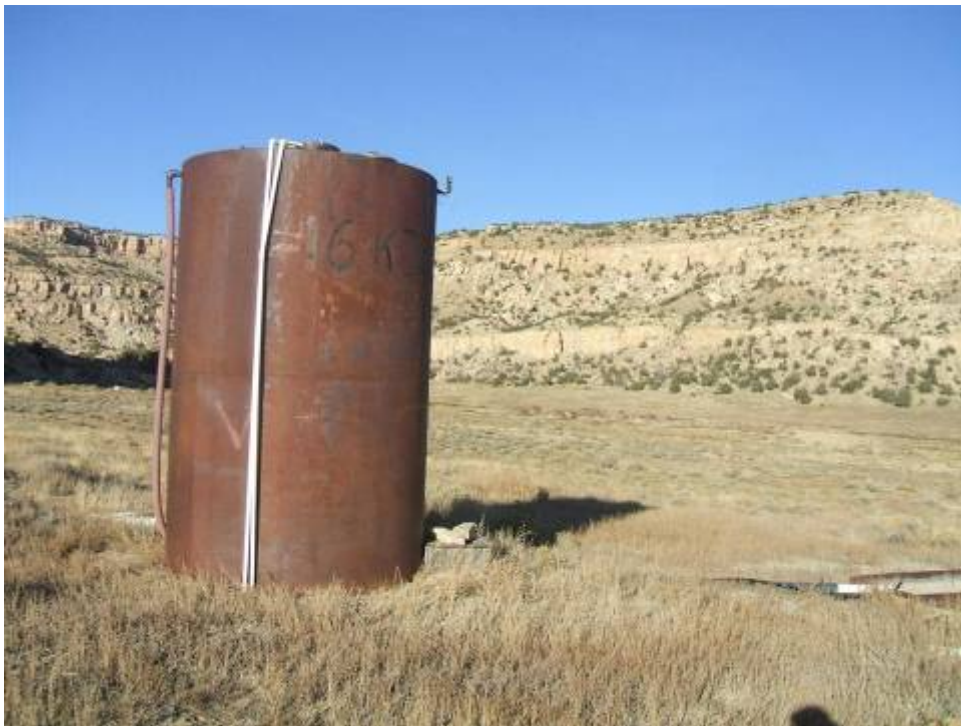
Photo 4. Water tank and feeding trough south of the mine site, towards the north

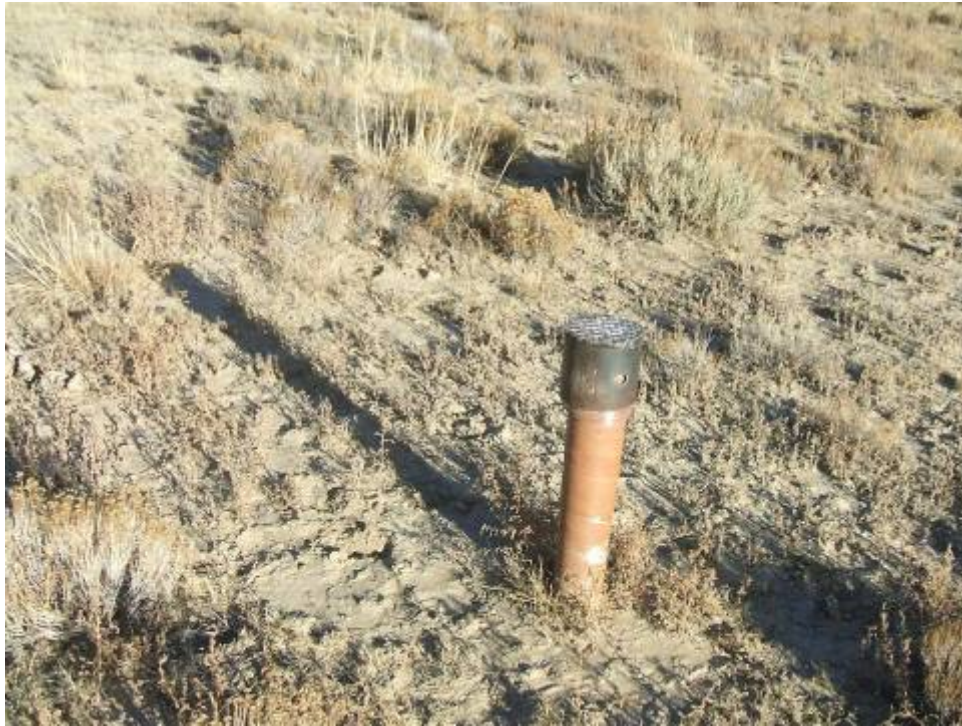
Photo 5. ISL monitoring well surrounding the mine site, towards the east

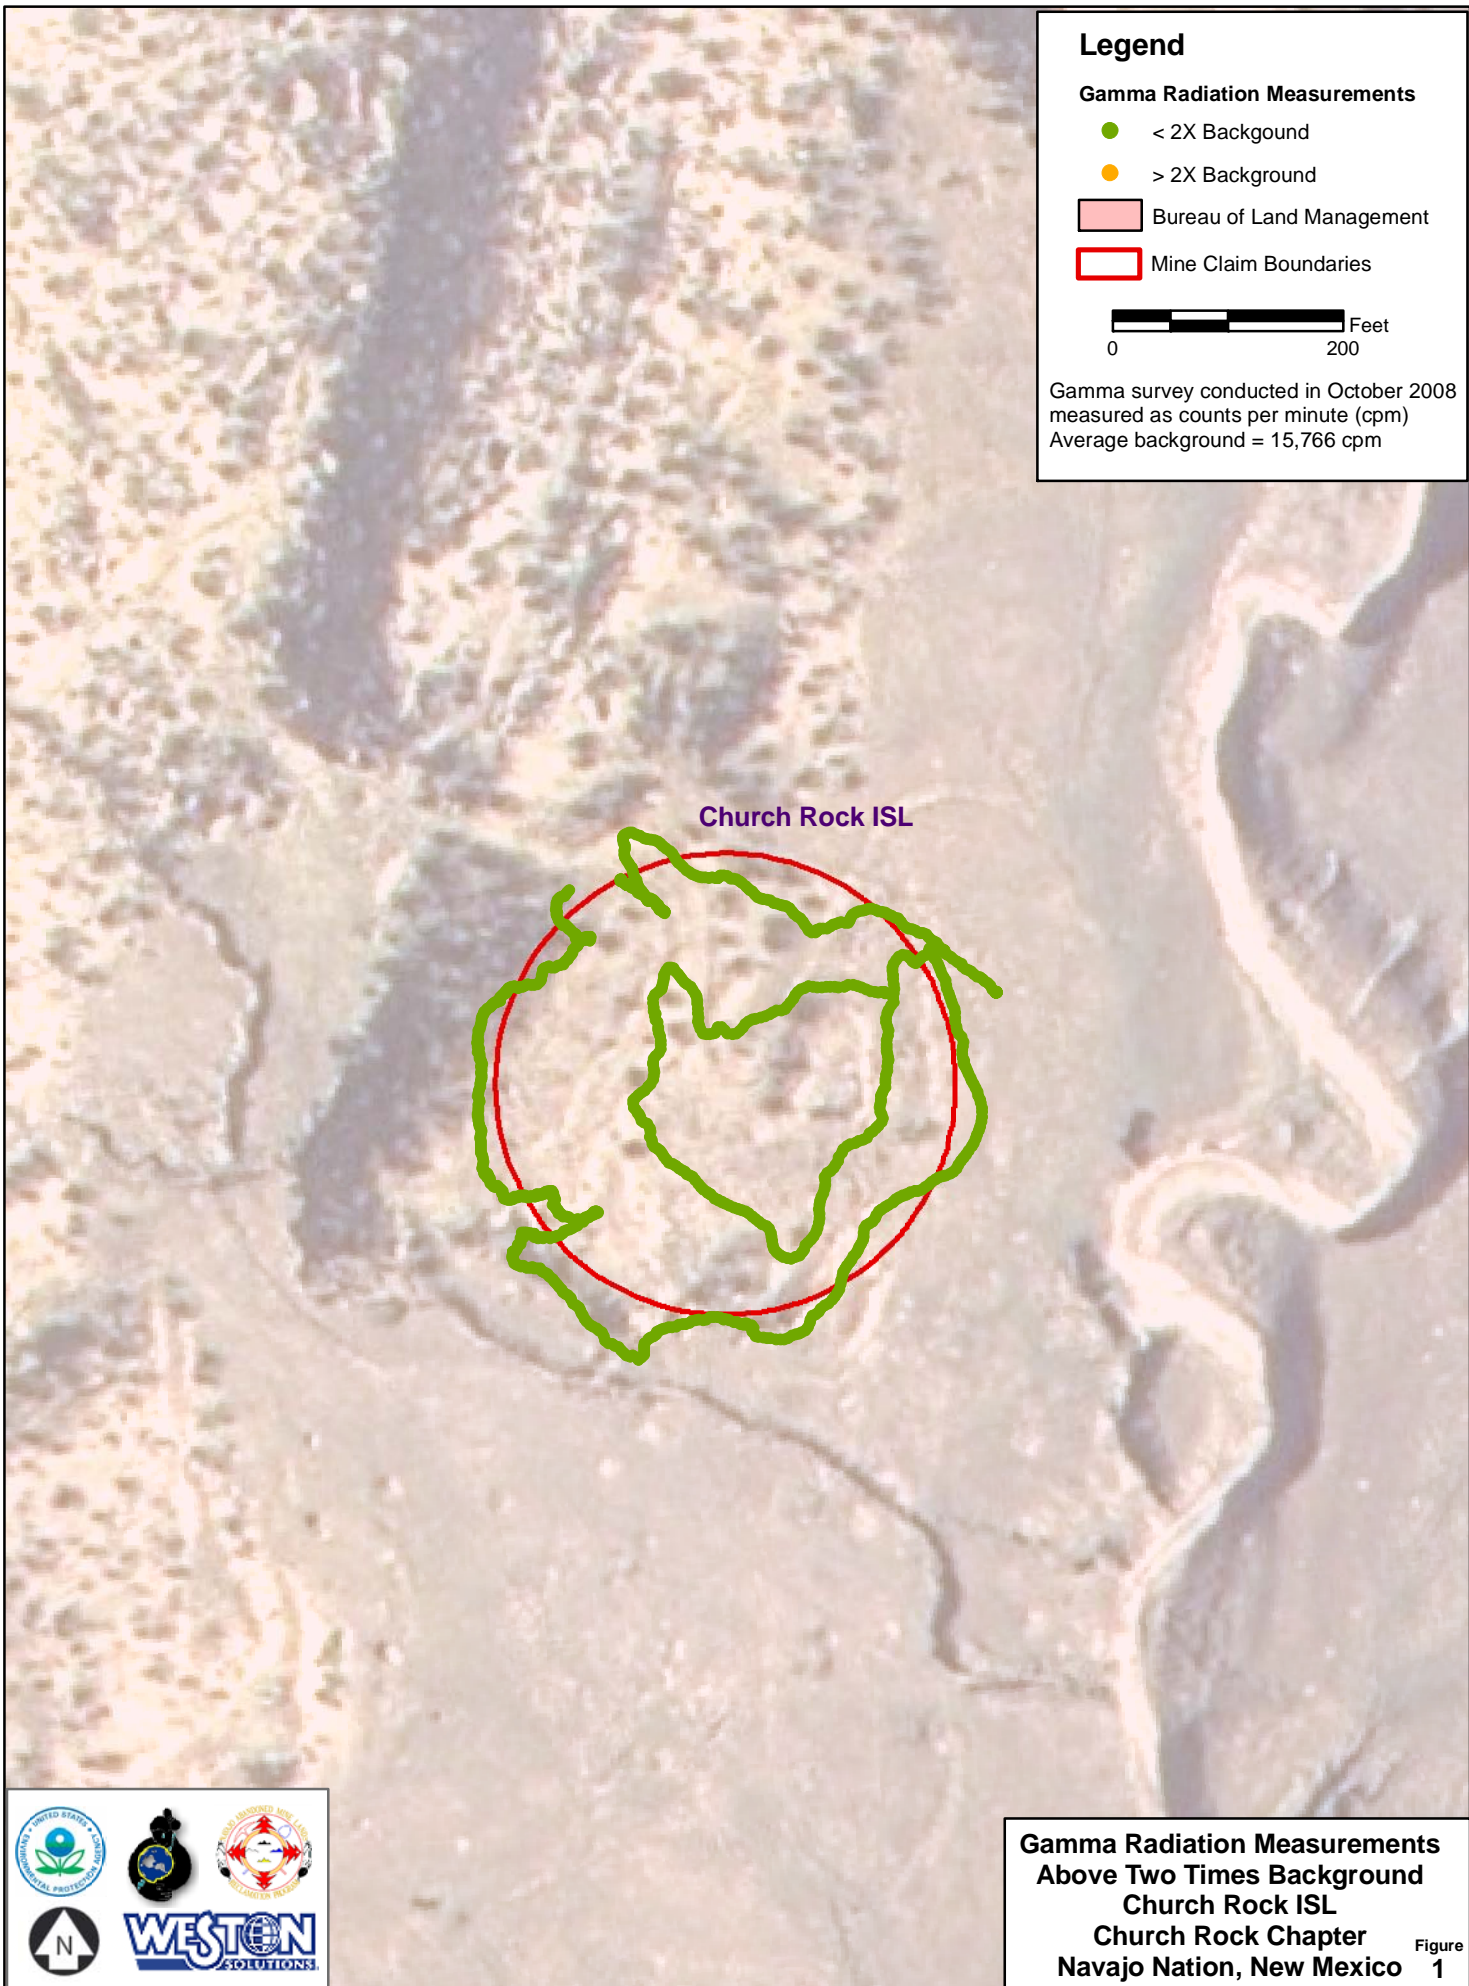
**Gamma Radiation Measurements
 Above Two Times Background
 Church Rock ISL
 Church Rock Chapter
 Navajo Nation, New Mexico** Figure 1

A total of 1,155 gamma radiation measurements were collected from mine sites, ranging from 9,946 cpm to 16,121 cpm. The measurements are represented in Figures 1 and 2.

Gamma survey conducted in October 2008
 measured as counts per minute (cpm)
 Average background = 15,766 cpm
