Navajo Abandoned Uranium Mine Site Screen Report

Section 23 AUM Site

Navajo AUM Eastern Region

May 2009

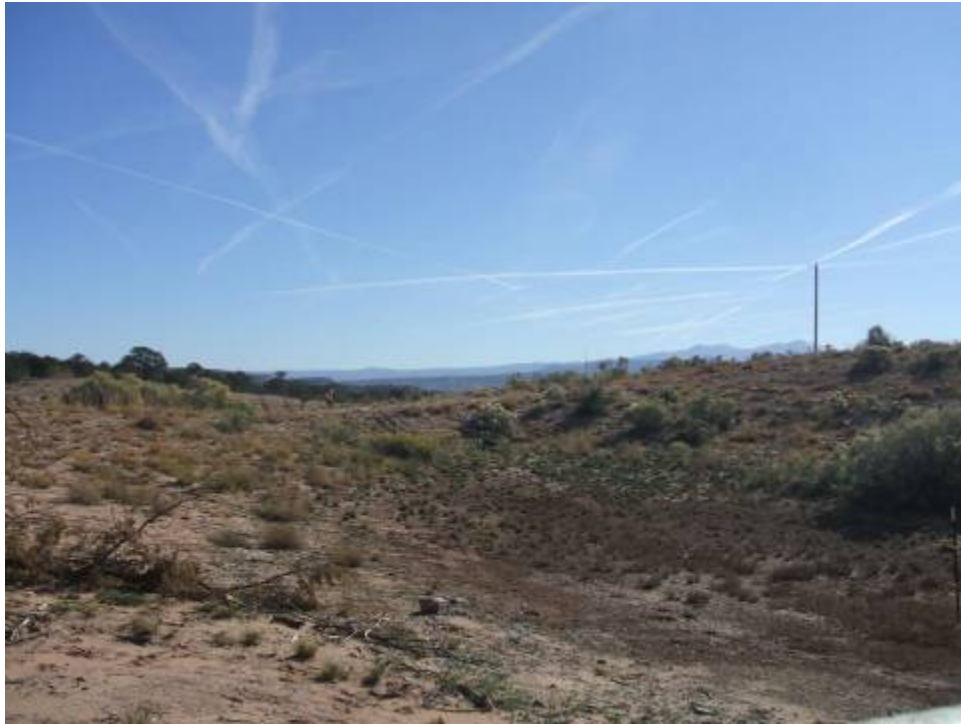
Photo 1. Section 23 mine site, eastern area, towards the east

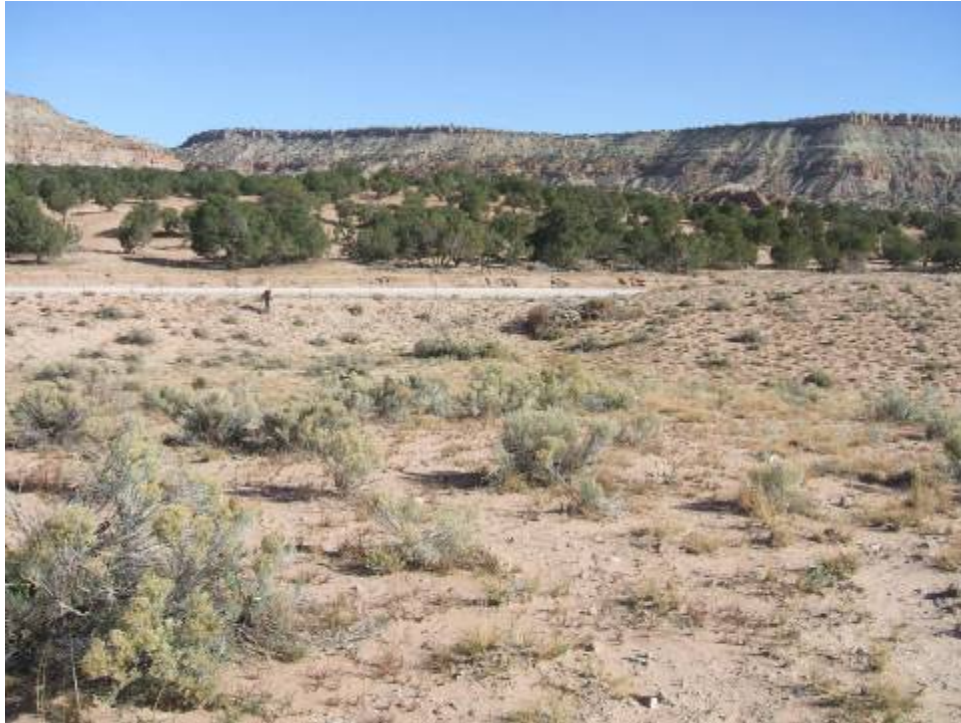
Photo 3. Section 23 mine site, western area, towards the west

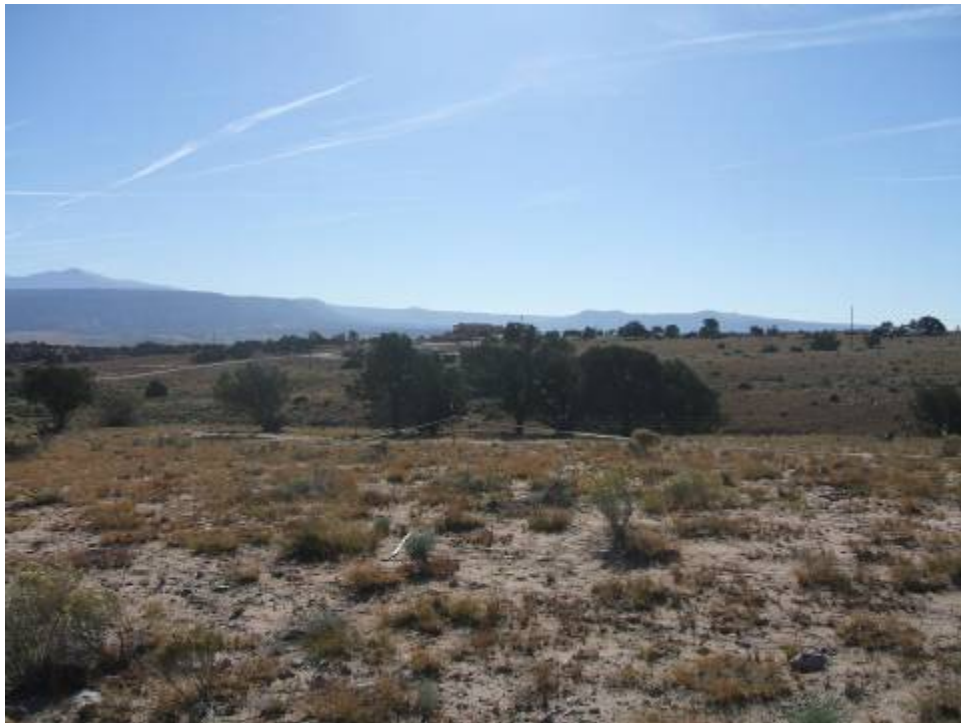
Photo 4. Section 23 mine site, western area, towards the south

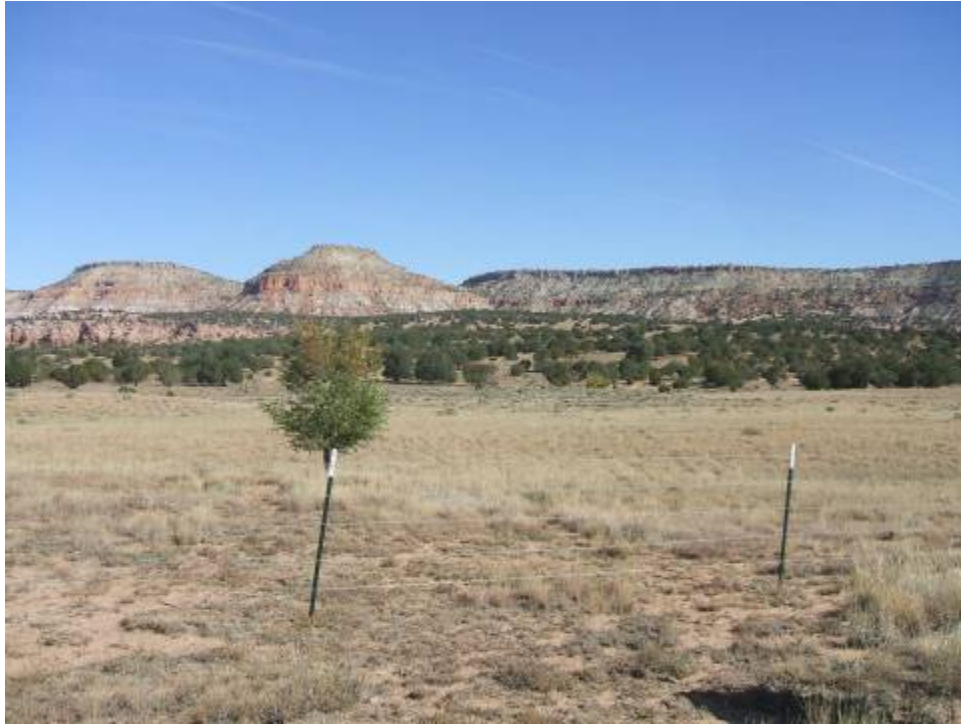
Reclamation status of the mine site is currently unknown. Local residents stated that several open pits had been filled in the western portion of the site, and the resident of the onsite house claimed that the house was built on excavated cover material. No adits or other mine features were observed during the site visit.

Photo 5. Section 23 mine site, former open pit in the western area, towards the north

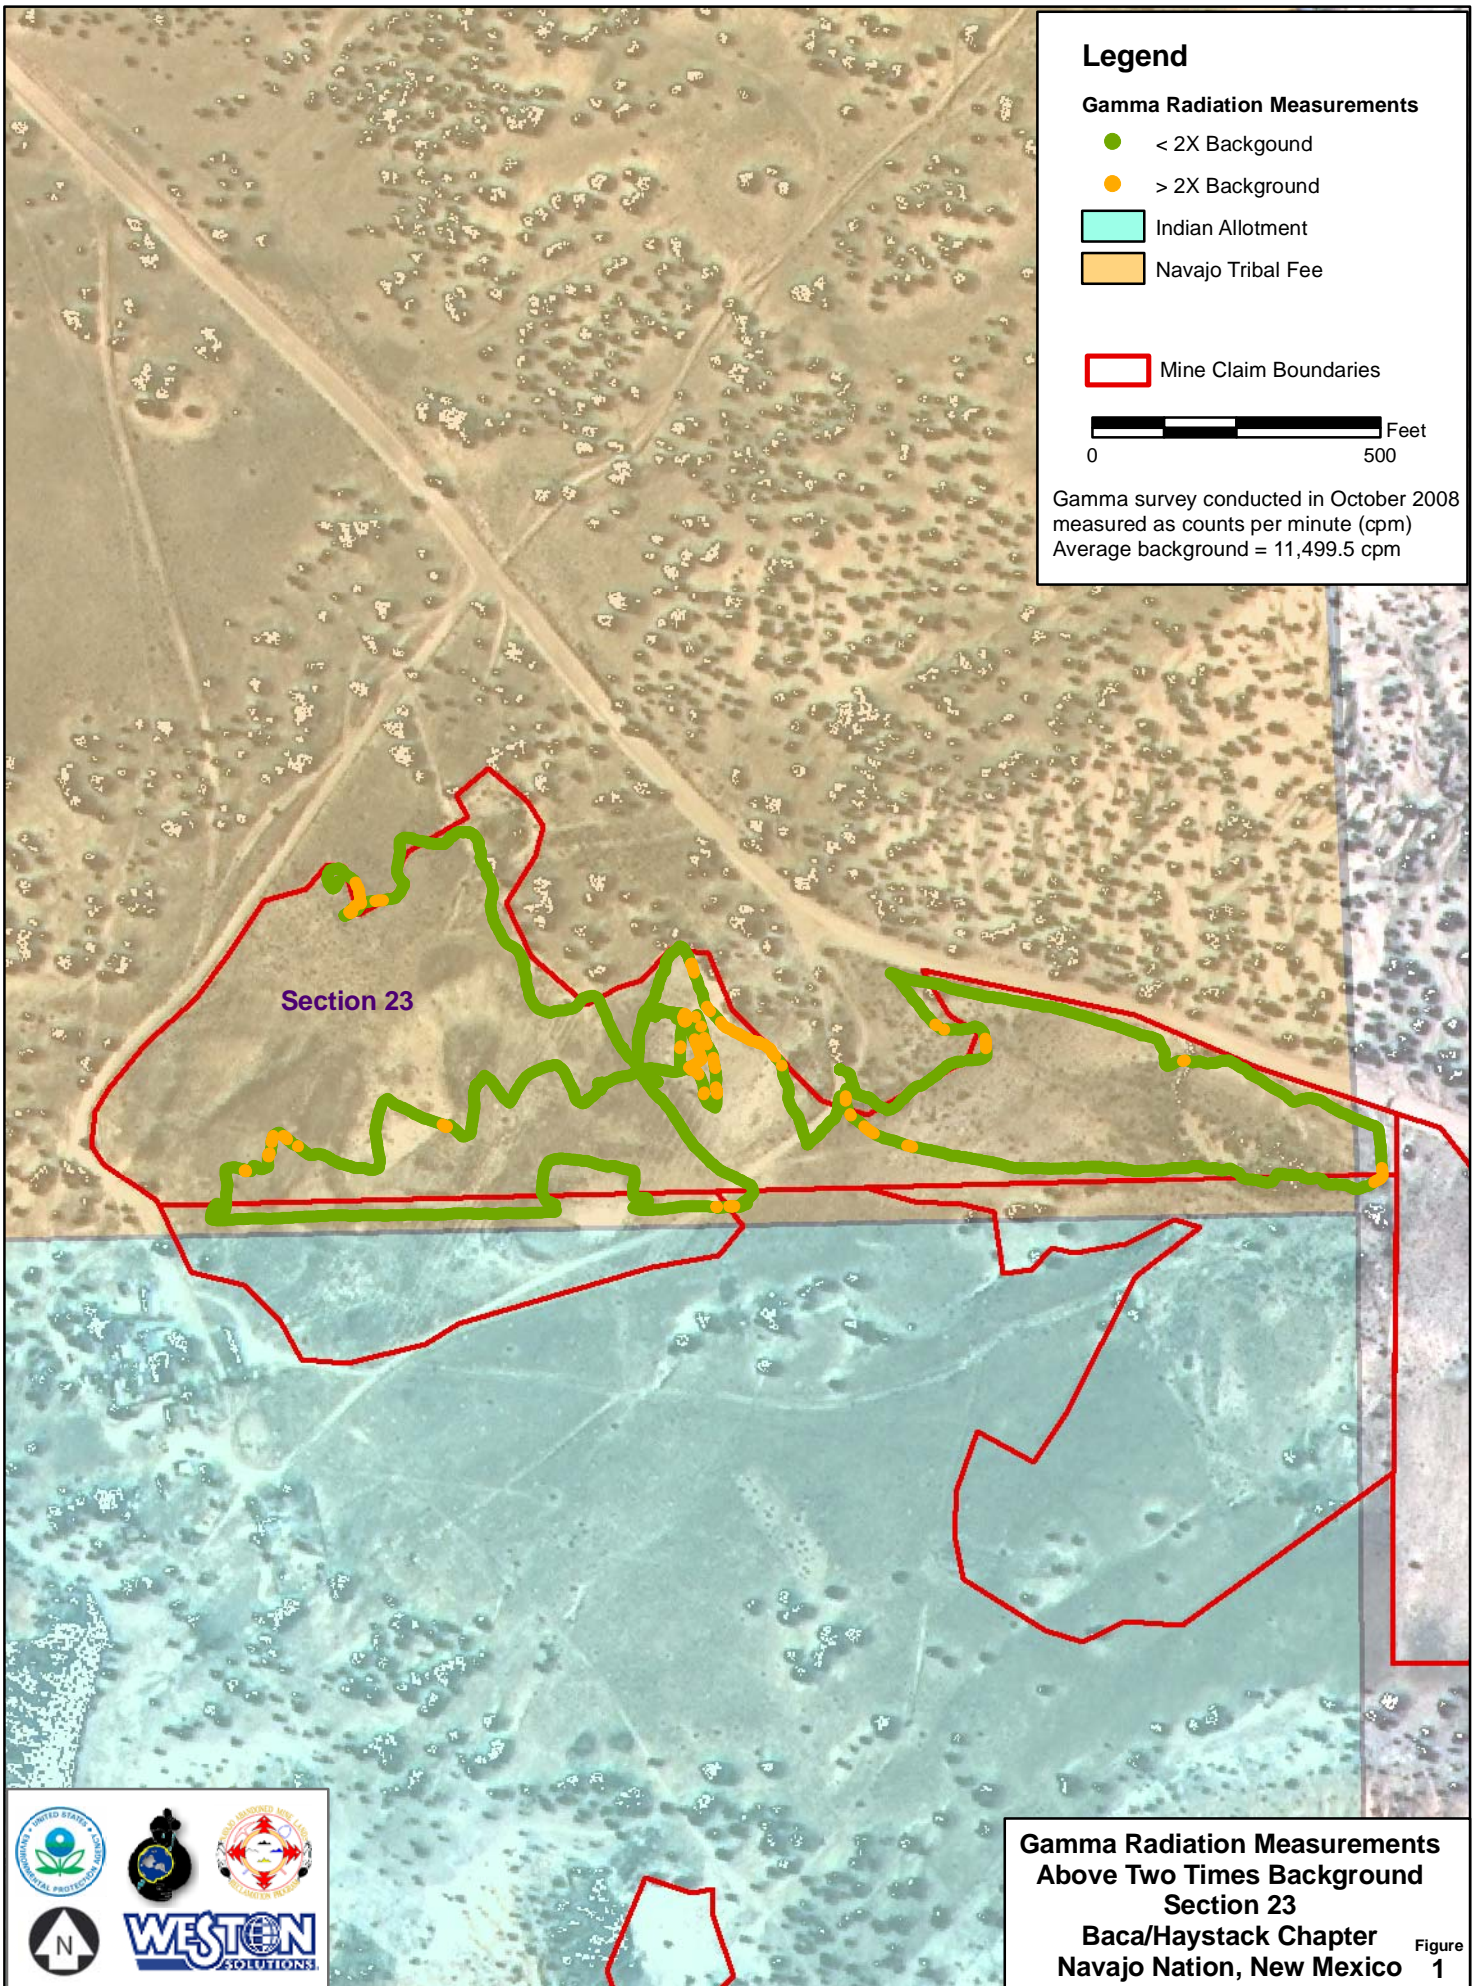
**Gamma Radiation Measurements
Above Two Times Background
Section 23
Baca/Haystack Chapter
Navajo Nation, New Mexico** Figure 1

- The onsite house was measured at gamma radiation level upto 327,456 counts per minute (cpm)
- The levels near the trailer homes were found to be less than two-times background levels.

A total of 3,315 gamma radiation measurements were collected from mine sites, ranging from 5,802 cpm to 327,456 cpm. Measurements were found at their highest near the onsite house. The measurements are represented in Figures 1 and 2.

Gamma survey conducted in October 2008
measured as counts per minute (cpm)
Average background = 11,499.5 cpm
