**Second Five Year Review Report  
Hudson River PCBs Superfund Site**

**APPENDIX 10  
FIVE-YEAR REVIEW SITE INSPECTION  
CHECKLIST**

**APPENDIX 10-1  
FIVE-YEAR REVIEW SITE INSPECTION  
CHECKLIST  
OU-1**

## Five-Year Review Site Inspection Checklist – OU1

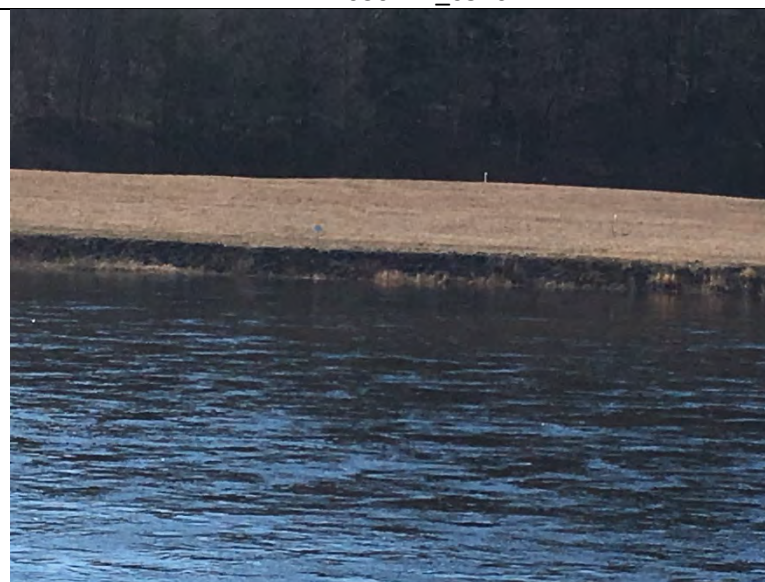
030217\_0512

030217_0512	1430	Western edge of Site 5	West	Mid extent of Site 4
030217_0513	1430	Western edge of Site 5	Northwest	Northern extent of Site 4
030217_0514	1430	Western edge of Site 5	West	Drainage swale on Site 4
030217_0201	1503	Middle of Site 2	Northeast	Northern extent of Site 2

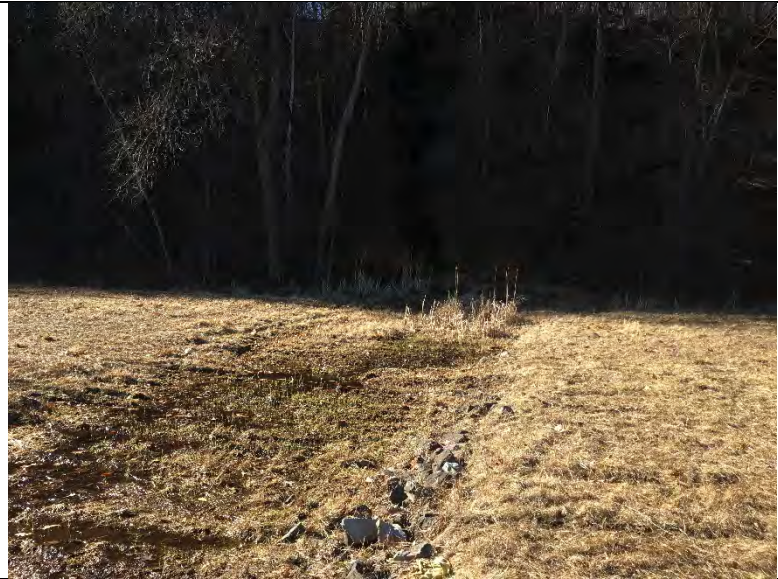
030217\_0202

Photo Name	Time Taken	Location of Photographer	Direction of Photo	Subject
030217_0202	1503	Middle of Site 2	North	Drainage swale on Site 2
030217_0203	1503	Middle of Site 2	Southeast	Drainage swale on Site 2
030217_0204	1503	Middle of Site 2	South	Southern extent of Site 2
030217_0205	1503	Middle of Site 2	Southeast	Southern extent of Site 2 and Southern extent of Site 3
