Purpose: Commonfields of Cahokia – SSO Recon Inspection Trip Report

Facility: Commonfields of Cahokia Sewer District

Date of Inspection: January 26, 2021

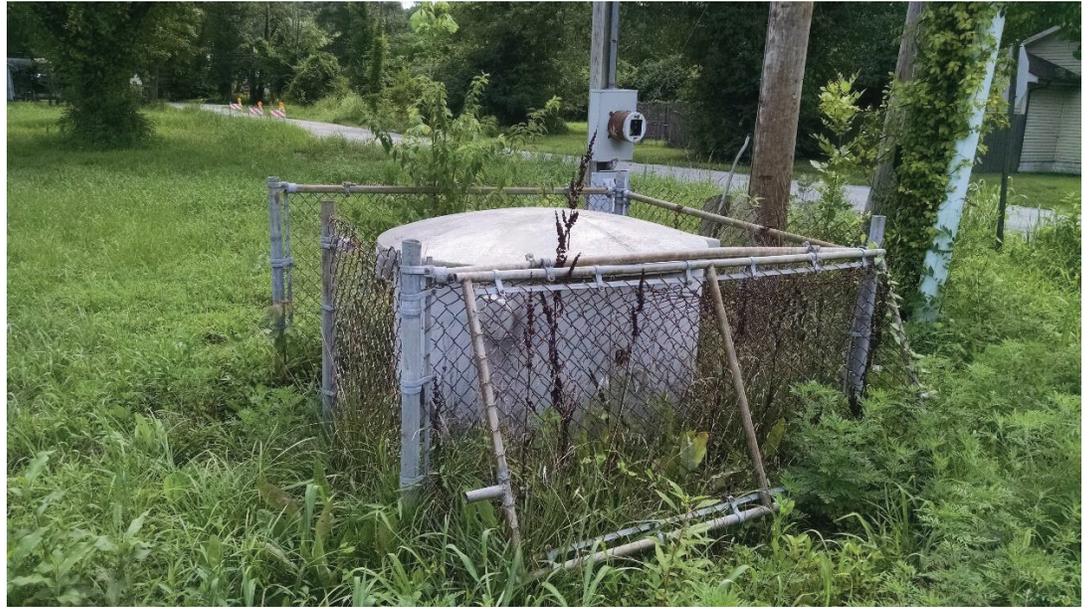
Photo # 001
Date: August 5, 2020
Time: 1:25 p.m.
Taken By: Joe Stitely,DWPC/FOS
Facility: Village of Centerville
Location: Adjacent to Lift Station
Notes: This is a photograph of the lift station near the intersection of N. 82nd street and Bluff Street. The pump station is inoperable, and no bypass pumping has been provided.

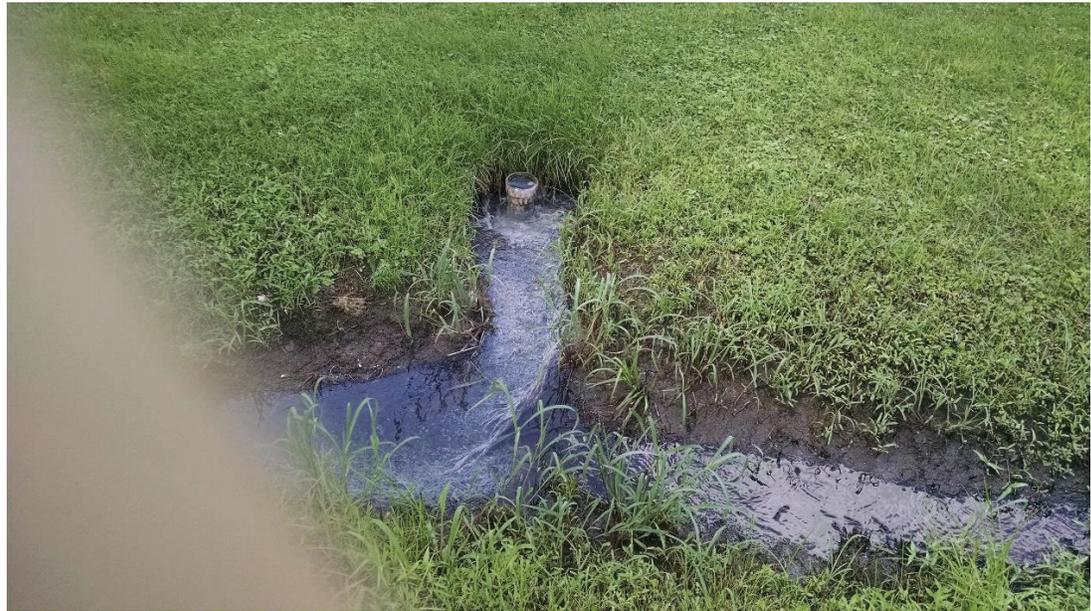
Photo #: 002
Date: August 5, 2020
Time: 1:29 p.m.
Taken By: Joe Stitely,DWPC/FOS
Facility: Village of Centerville
Location: Adjacent to Clean Out
Notes: This is a photograph of the removed clean out cap on the service line at [REDACTED] N. 82nd Street. Note the raw sewage discharging from the clean out.

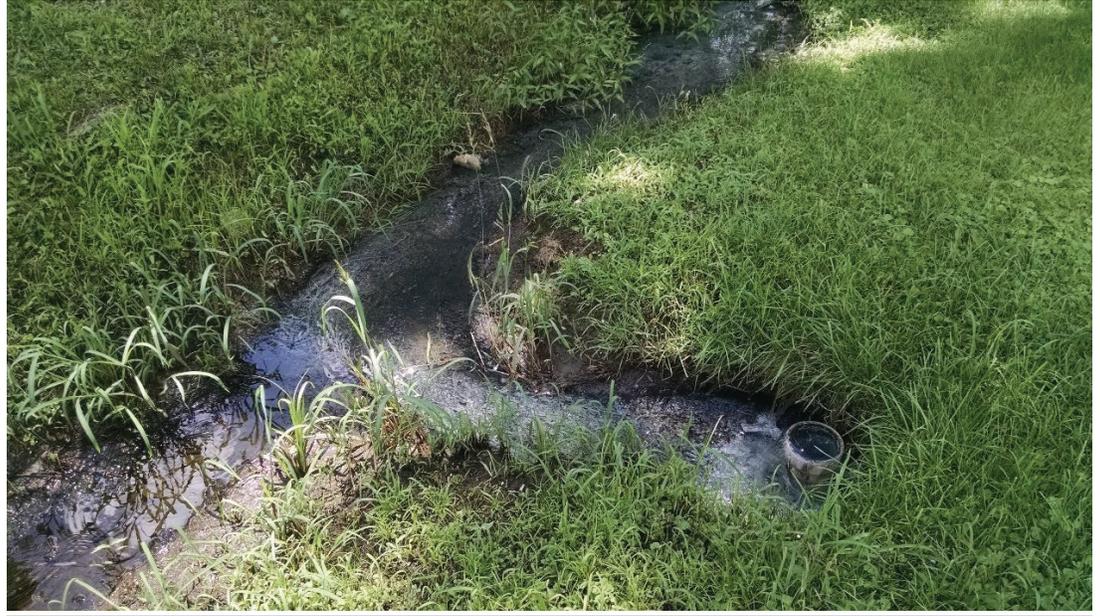
Photo # 003
Date: August 5, 2020
Time: 1:37 p.m.
Taken By: Joe Stitely,DWPC/FOS
Facility: Village of Centerville
Location: Adjacent to Clean Out
Notes: This is another photograph of the removed clean out cap on the service line at [REDACTED] N. 82nd Street. Again, note the raw sewage discharging from the clean out.

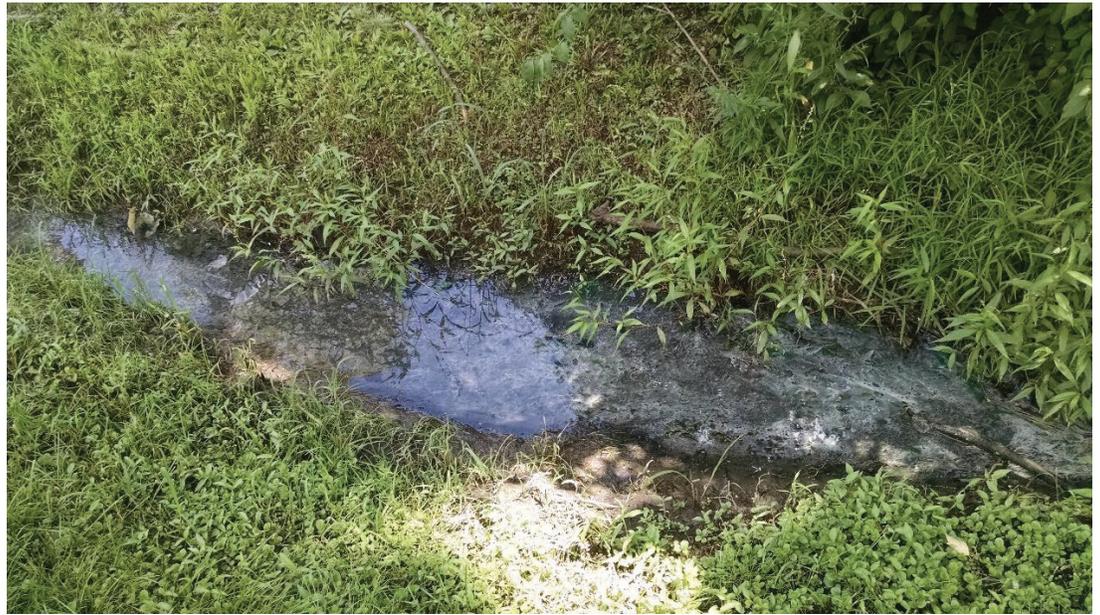
Photo #: 004
Date: August 5, 2020
Time: 1:38 p.m.
Taken By: Joe Stitely,DWPC/FOS
Facility: Village of Centerville
Location: Adjacent to Clean Out
Notes: This is a photograph of the roadside ditch immediately downstream of the removed clean out cap.

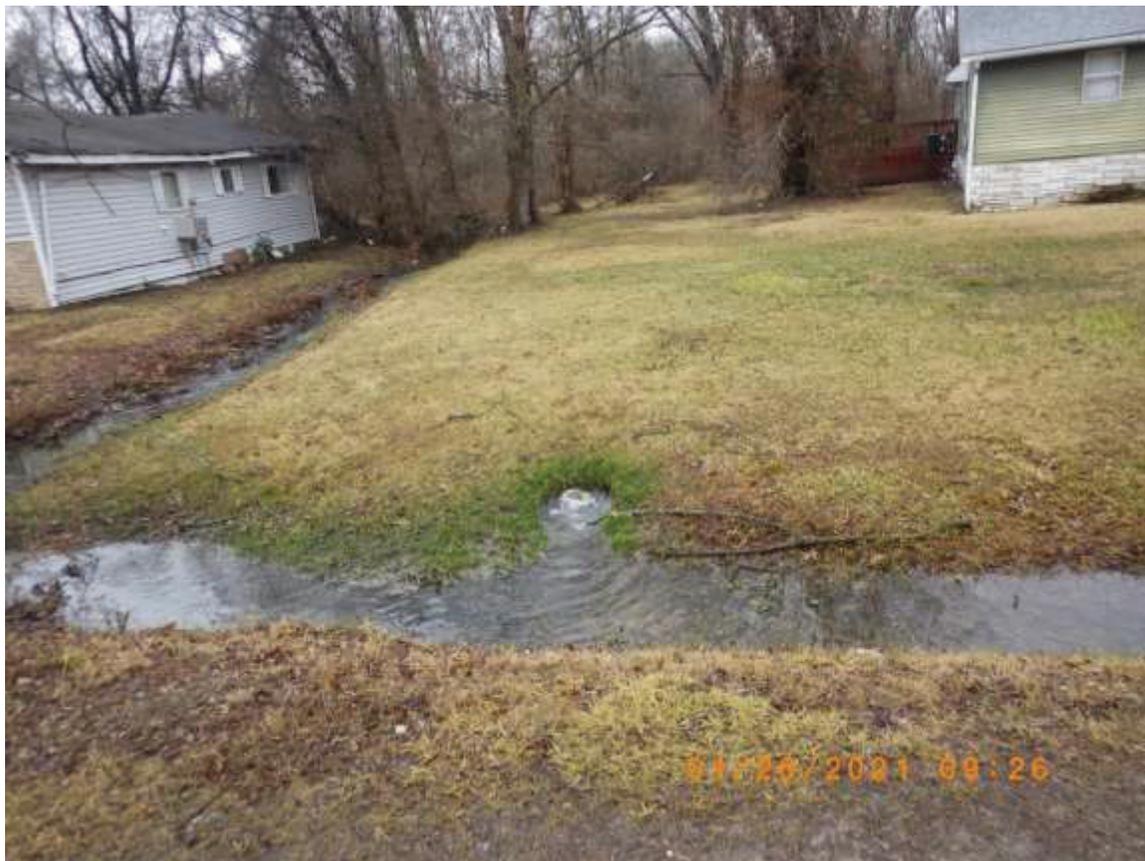
1: COMF0001

I observed raw sewage flowing from a cleanout located in the front yard of the residence at [REDACTED] N. 82nd St. in what is referred to the "Ping-pong area" in Centreville (photographs COMF0001, COMF0002, COMF0003). I noted toilet paper debris in the ditch receiving the sewage and a strong sewage odor. I observed the sewage discharging to the ditch running along the front of the residence and then west toward the residence's backyard continuing to the twin culverts under N 80th Street (photograph COMF0004 and COMF0005). The twin culverts discharge to perennial Canal #1 (photograph COMF0020), which flows into Harding Ditch, a perennial stream, which flows to Prairie du Pont Creek, a perennial stream and tributary to the Mississippi River.

Description: Sewage observed flowing from cleanout in front yard of home. Sewage drains west in ditch between homes toward backyard and to culverts discharging to Canal #1.

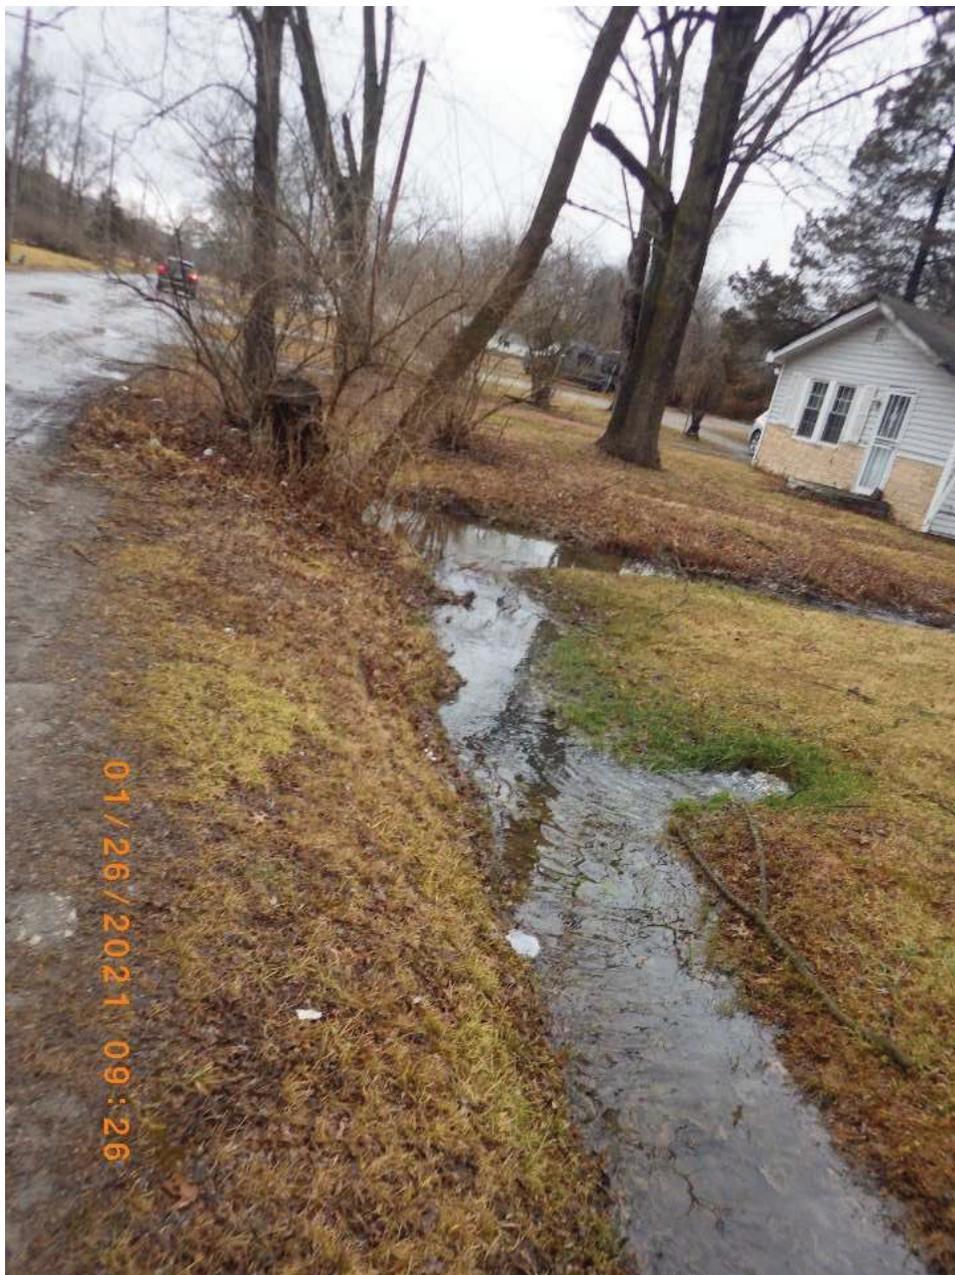
2: COMF0002

Description: Sewage observed flowing from cleanout in front yard of home.

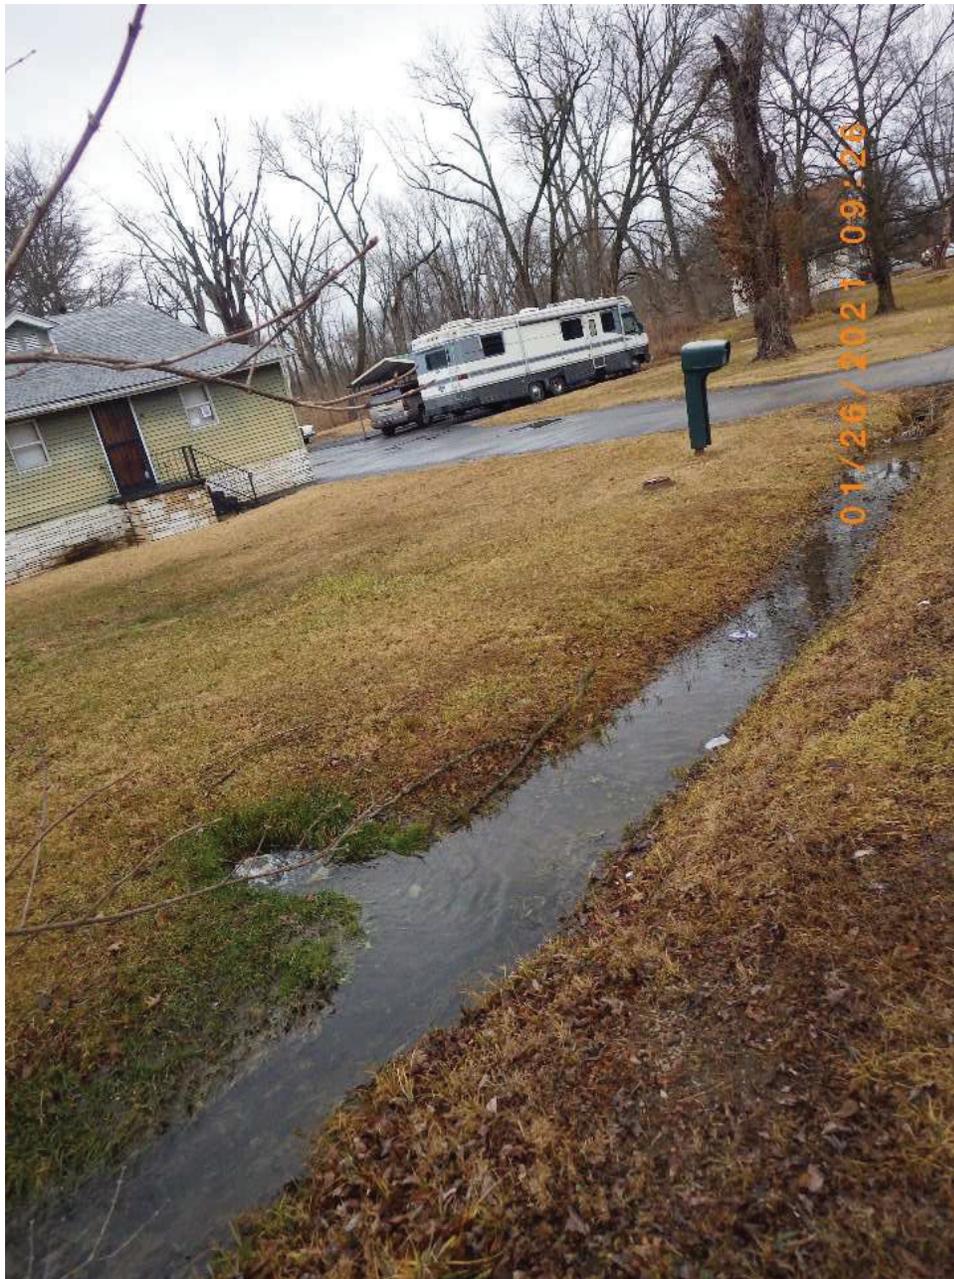
3: COMF0003

Description: Sewage observed flowing from cleanout in front yard of home.

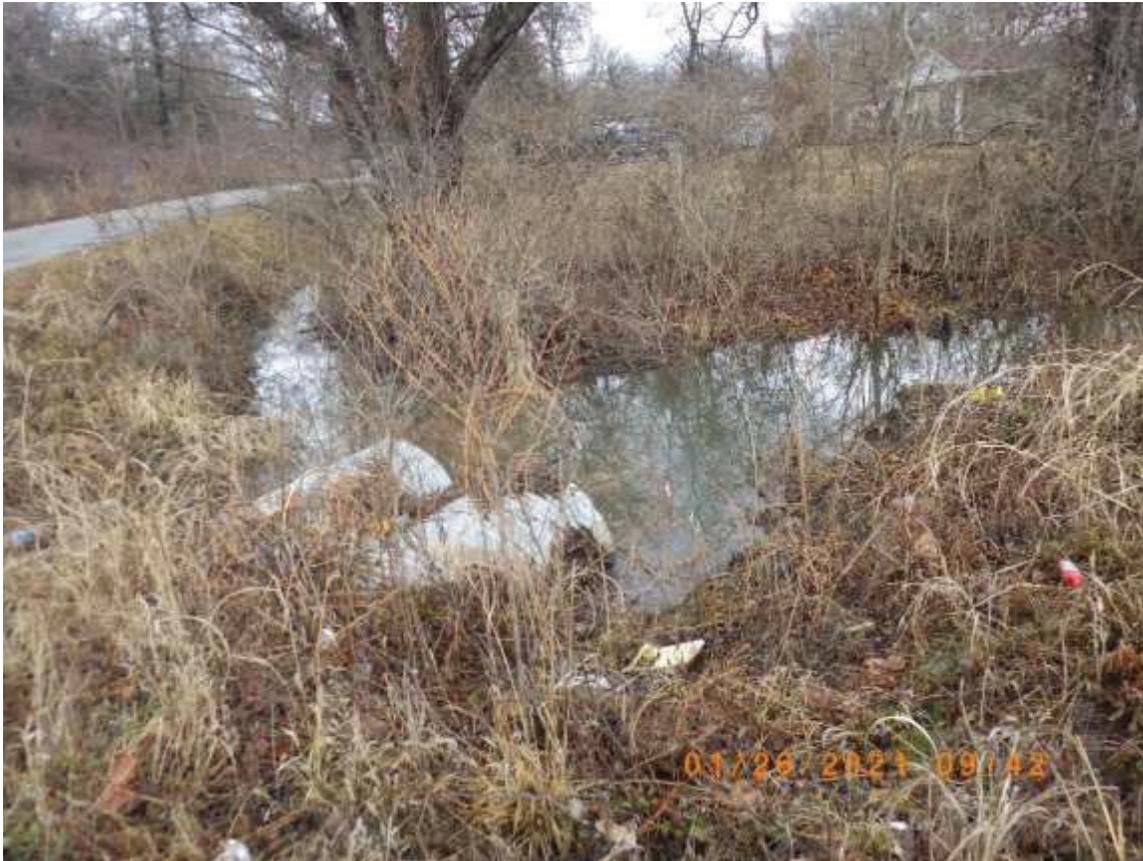
4: COMF0004

Description: Culverts draining "Ping-Pong" area between N 82nd and N 80th Sts. to Canal #1 which flows to Harding Ditch.

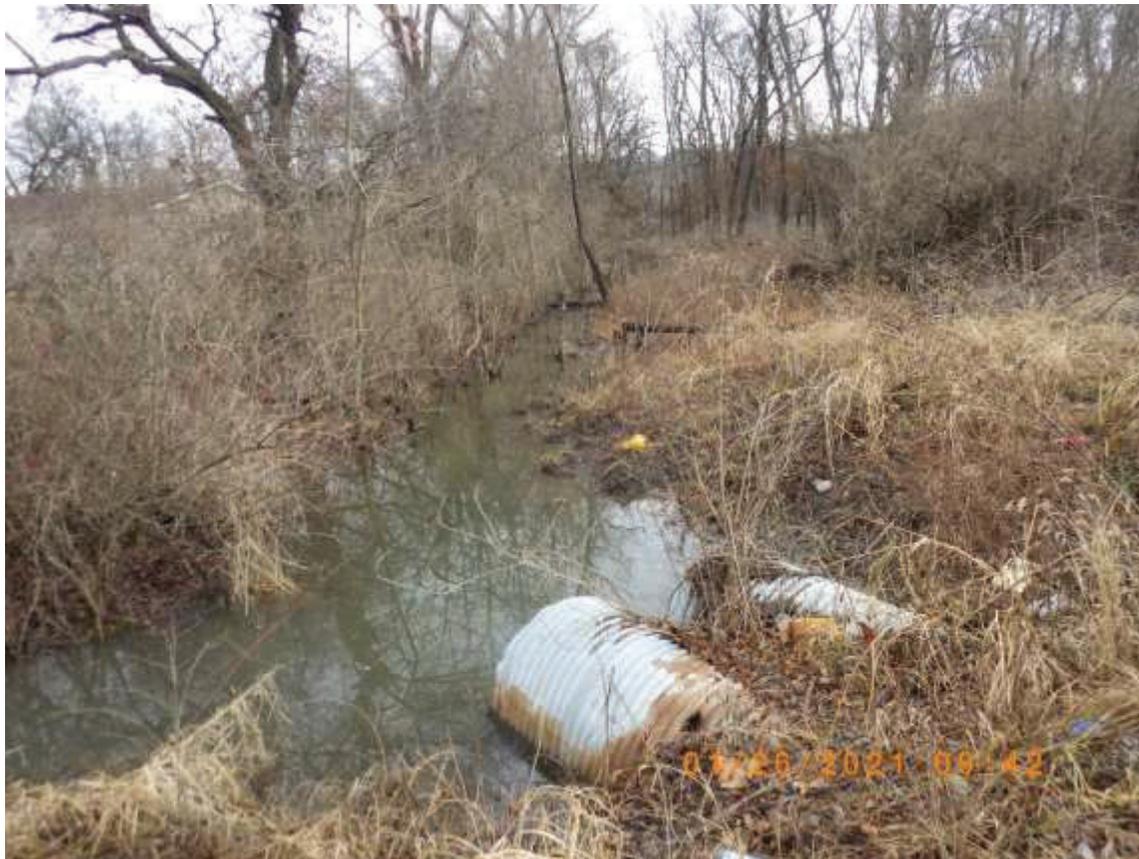
5: COMF0005

Description: Culverts draining "Ping-Pong" area between N 82nd and N 80th Sts. to Canal #1 which flows to Harding Ditch.

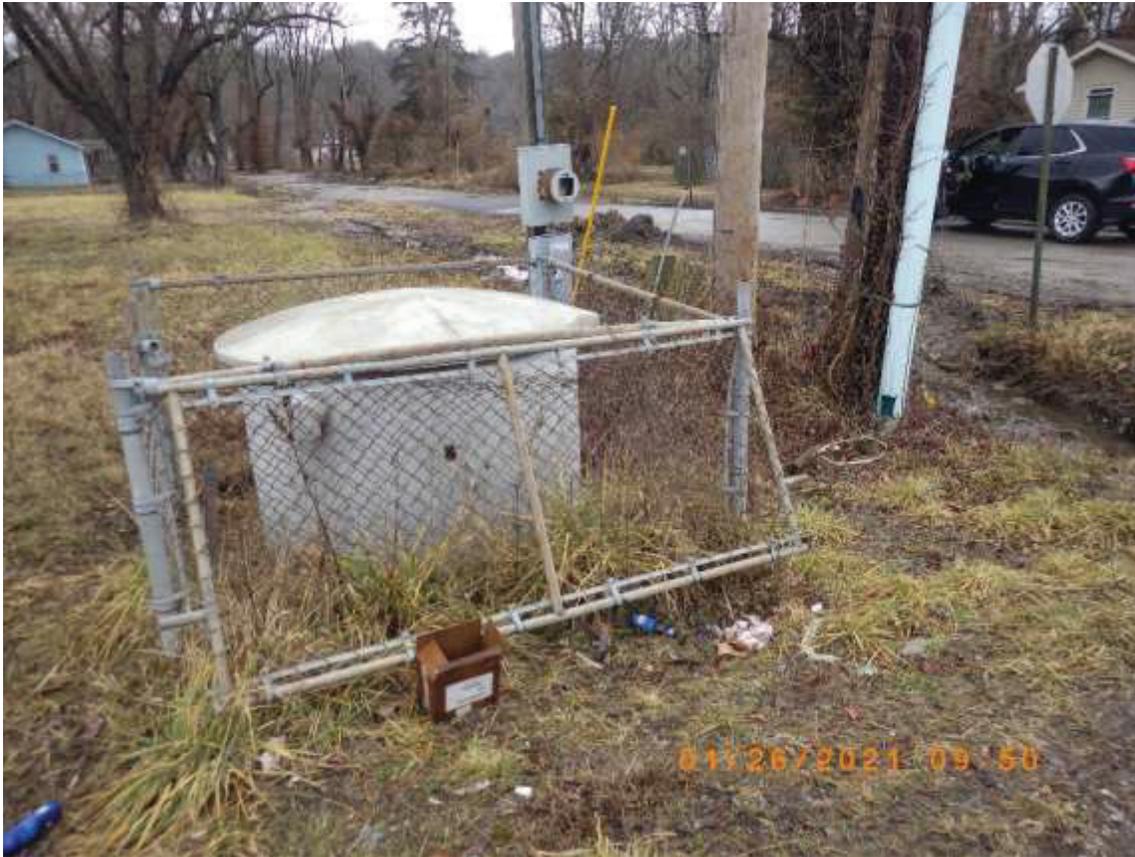
6: COMF0006

Description: Lift station #11

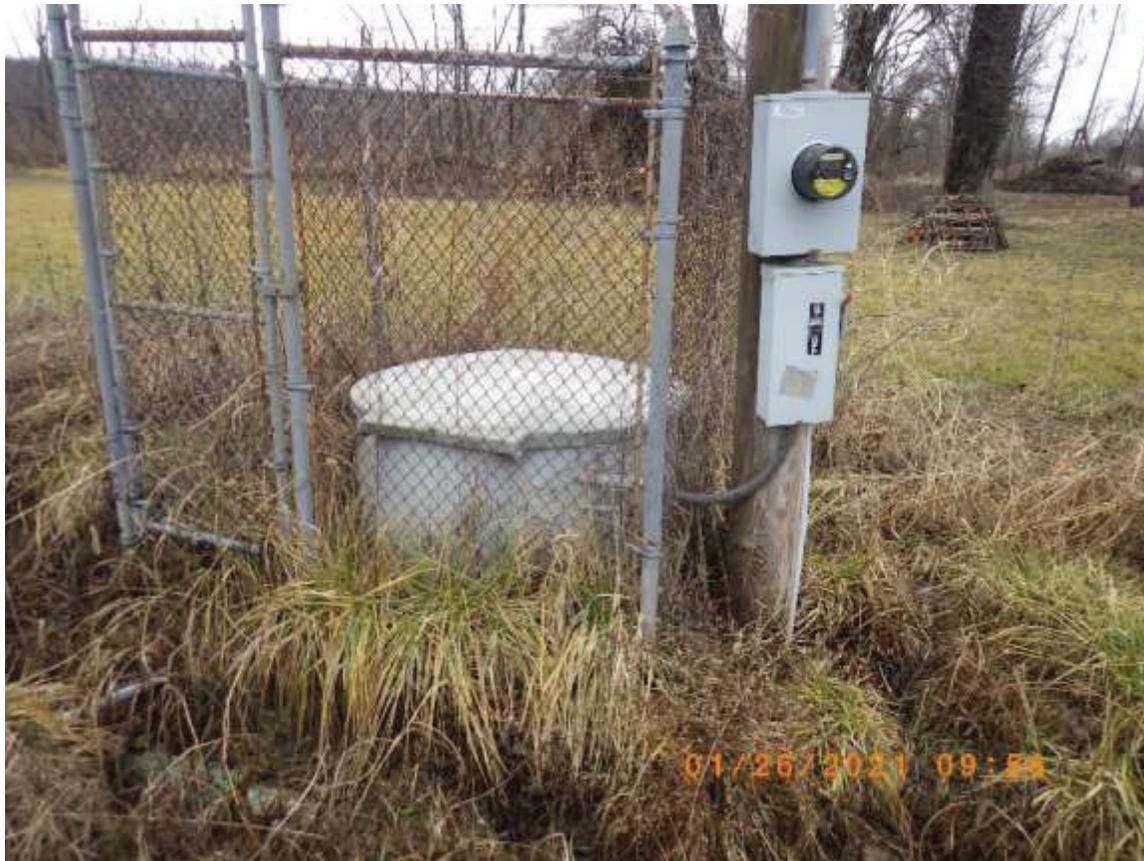
7: COMF0007

Description: Lift station #10. High flows in adjacent manhole but no discharges to surface observed.

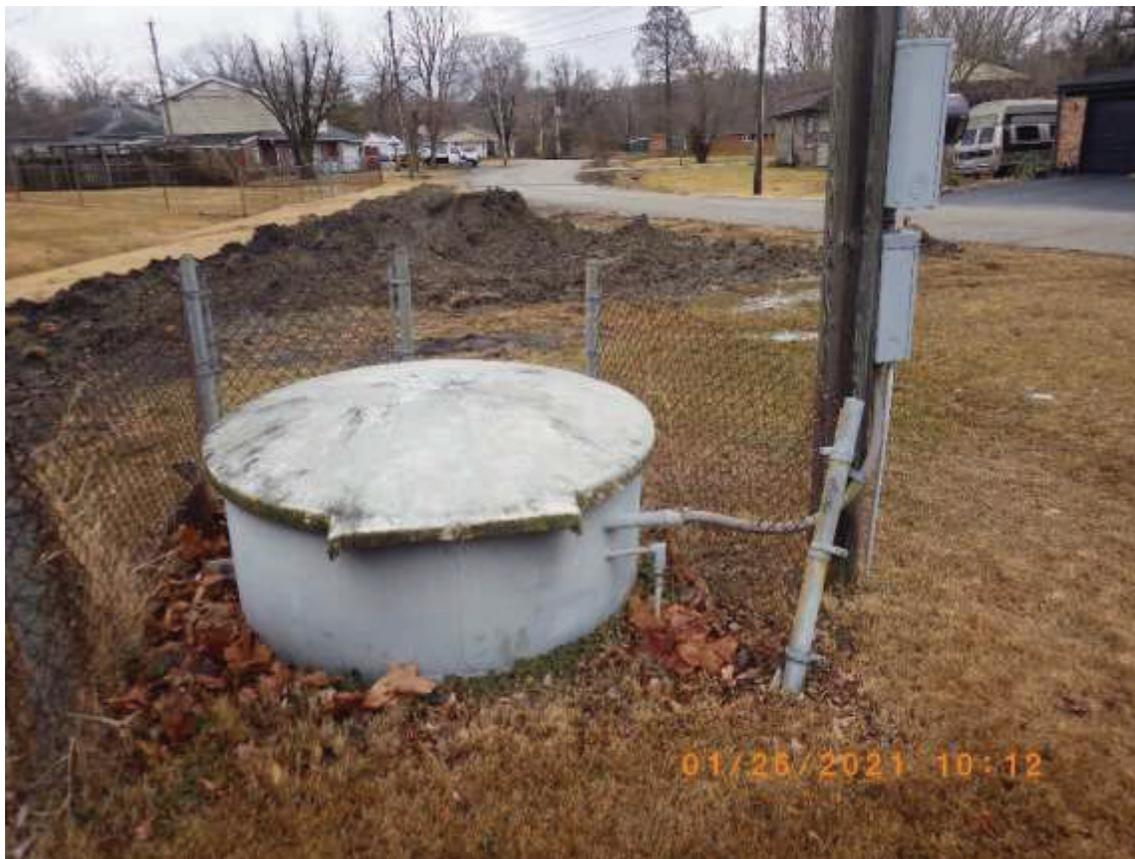
8: COMF0008

Description: Lift station #9. Recent construction adjacent to LS.

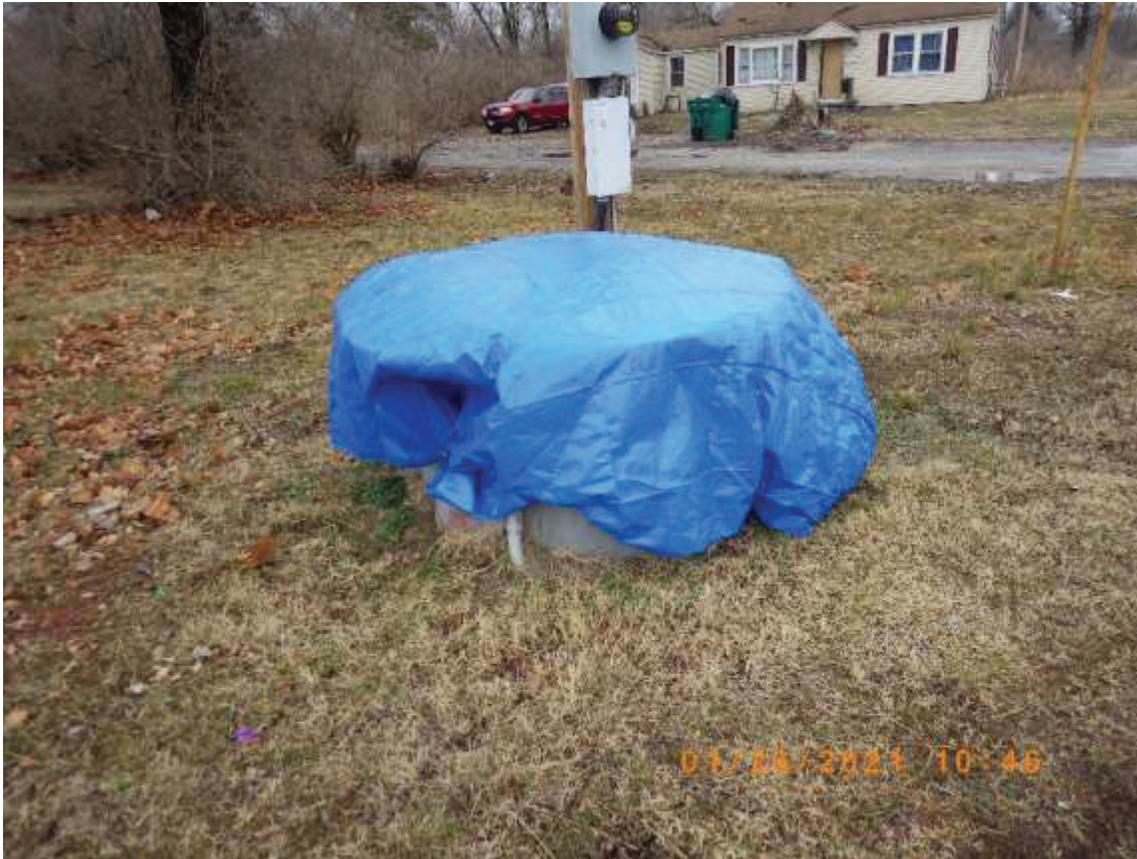
11: COMF0011

Description: Lift station #4. Note lift station covered with blue tarp.

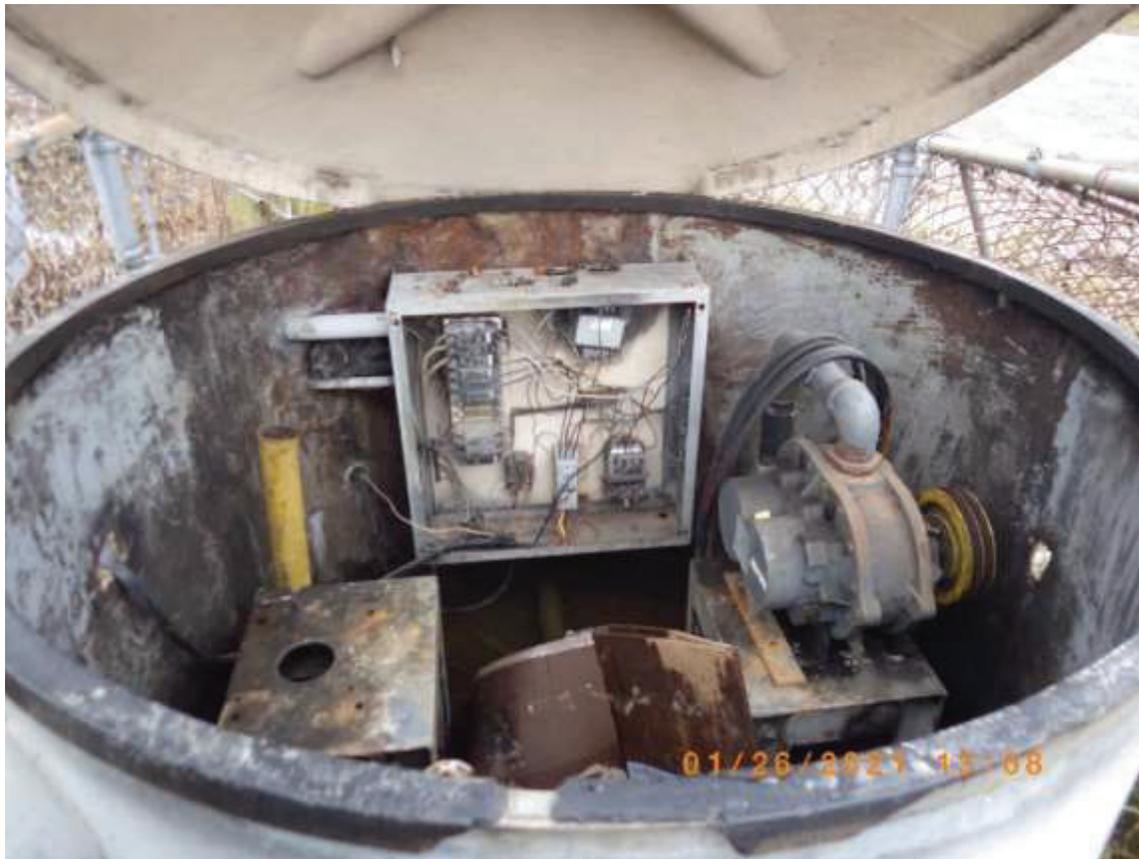
15: COMF0015

Lift Station at N. 82 St. and Bluff: At 13:00, I met up with IEPA inspectors at Lift Station 11 on N. 82 St. and Bluff (photograph COMF0006). According to Mr. Stitely, this is the last lift station prior to entering the East St. Louis sewer system in this area. He added that the lift station had a history of operations and maintenance issues and was operated manually by District staff until recently. Mr. Stitely lifted the lift station's cover and observed an uncovered electrical panel, indicative of poor maintenance (photograph COMF0015).

Description: Lift station #11. Returned to lift station with IEPA inspectors. Note lack of maintenance, no cover on electrical panel.

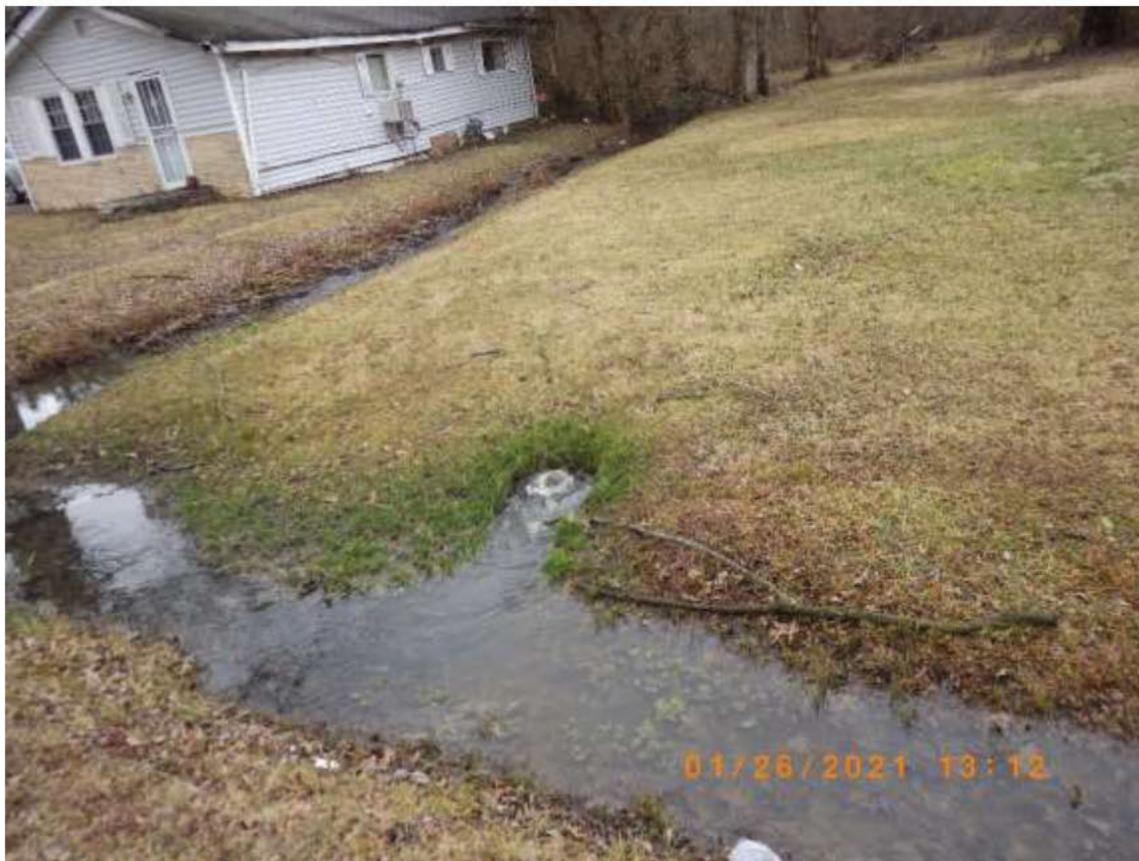
16: COMF0017

I then met the IEPA inspectors at the SSO I observed earlier in the morning in front of [REDACTED] N. 82nd St. Raw sewage was still flowing from the relief point into the ditch (photograph COMF0017; and video COMF0018). Mr. Stitely confirmed that the sewage flowed into the yard behind the residence and through the twin culverts under N. 80th St. then discharging to Canal #1.

Description: [Returned to location with IEPA inspectors] Observed sewage flowing from cleanout in front yard of home. Noted toilet paper and strong sewage odor.

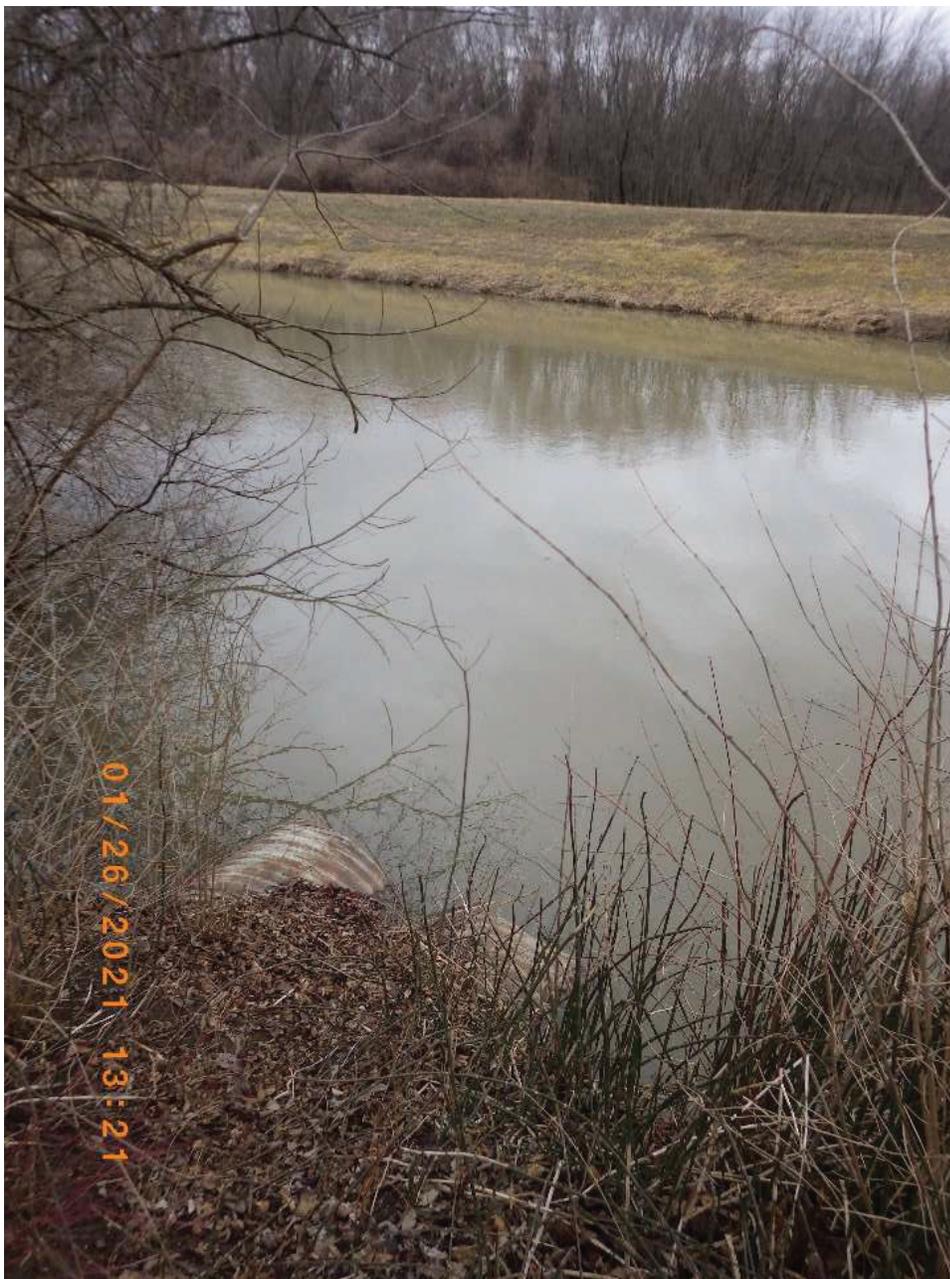
17: COMF0020

We then drove around the corner to the culverts under N. 80th St. Mr. Stitely explained that the culverts may be too low at the outlet to Canal #1 (photograph COMF0020) which may create opportunity for back flow, under high water conditions, towards the Ping-pong area, including the N. 80th and N. 82nd St. neighborhood.

Description: Culvert outlets draining "Ping-Pong" area between N 82nd and N 80th Sts. to Canal #1.

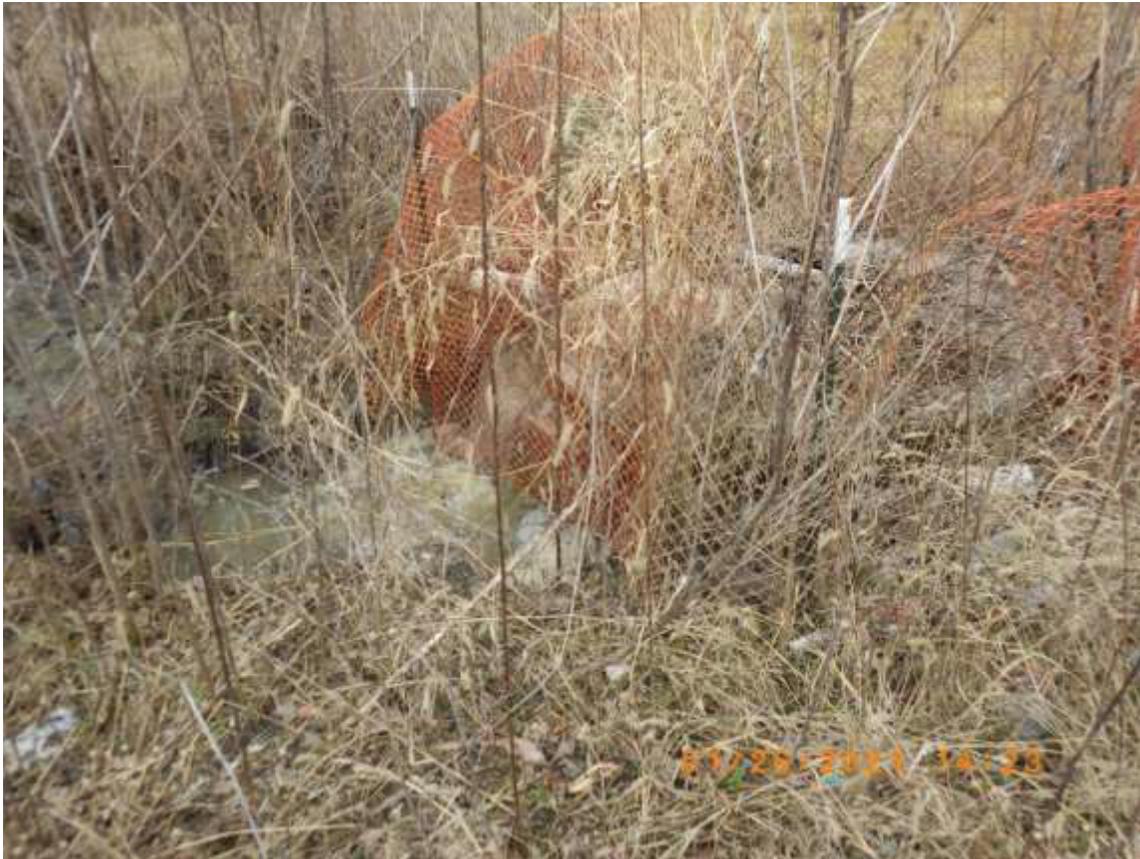
20: COMF0024

The IEPA inspectors departed to respond to a citizen complaint and I continued to Lift Station 22 at Lauralee and Violet. Upon arrival at 14:20, I immediately noticed a strong sewage odor and observed raw sewage overflowing from the lift station (photograph COMF0024). I also captured video of the SSO (video COMF0025). I noted that the manhole cover on the top of the lift station was missing, exposing the lift station to rainwater. A black hose was coming out of the manhole, apparently to facilitate a bypass (photograph COMF0027 and video COMF0026). I noted that the level of sewage in the lift station was just below the lip of the manhole. I did not have access to the field receiving the sewage overflow. As a result, I could not verify the downstream path or impacts of the ongoing sewage overflow.

Description: Lift station 22. Lift station was overflowing. Noted strong sewage odor.

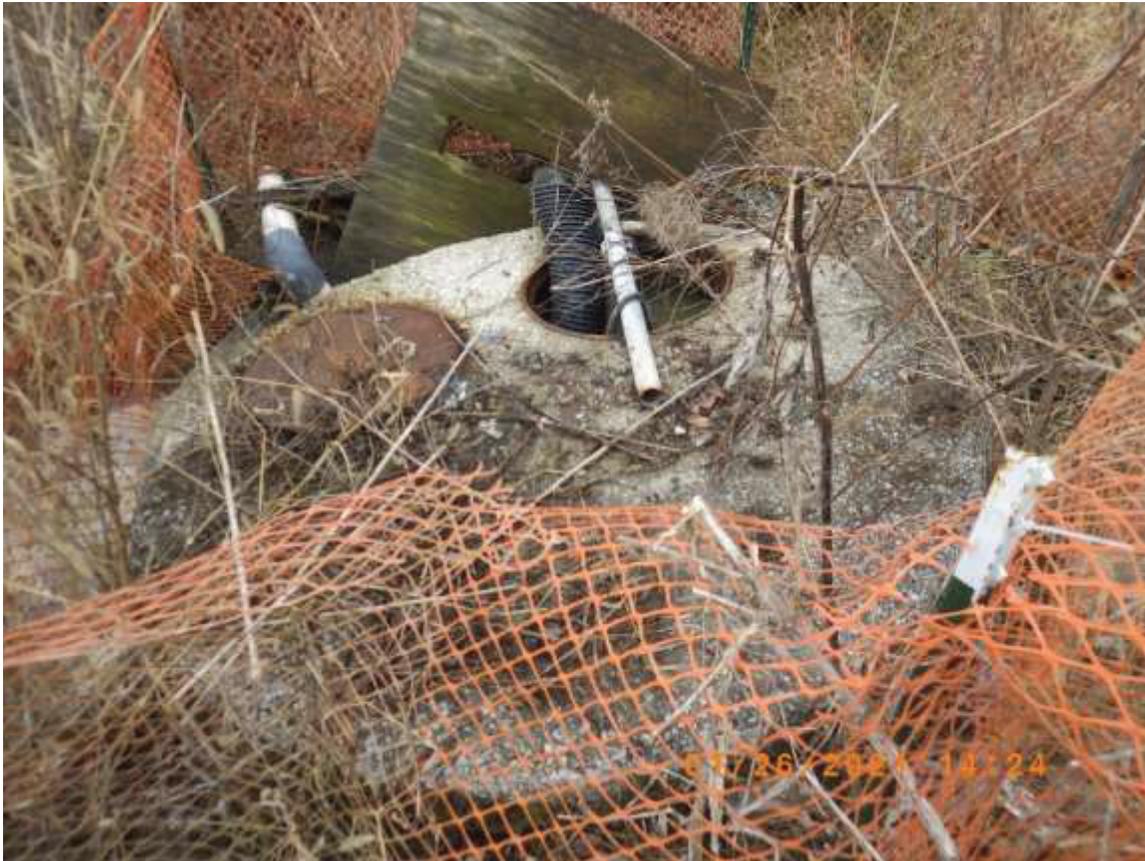
21: COMF0027

Description: Lift station 22. View of top of list station with uncovered manhole. Note black hose and level of sewage just below lip of the manhole.
