APPENDIX I
Stream Habitat Characteristics Data Summary (July and September 2006)

Ecological Risk Assessment for the Standard Mine Site

**Stream Habitat Characteristics Data Summary
July 2006
Standard Mine
Gunnison County, Colorado**

**Prepared For:
United States Environmental Protection Agency, Region 8
Ecosystem Protection and Remediation – Program Support**

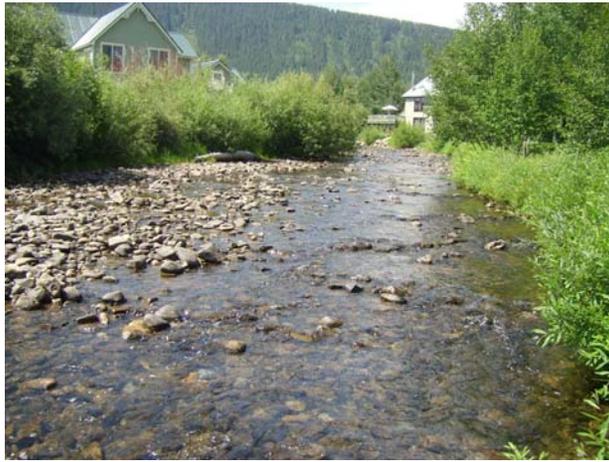
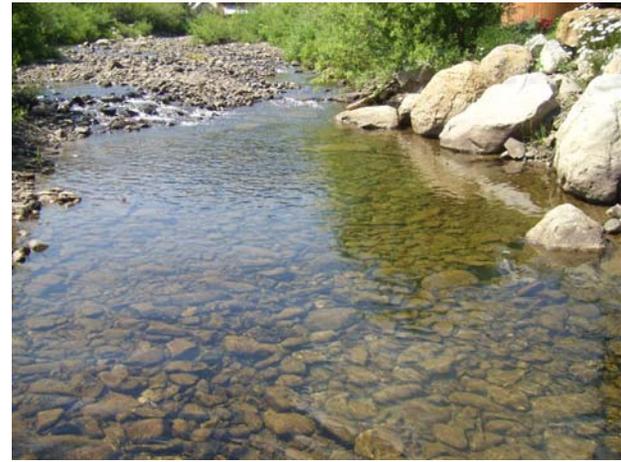
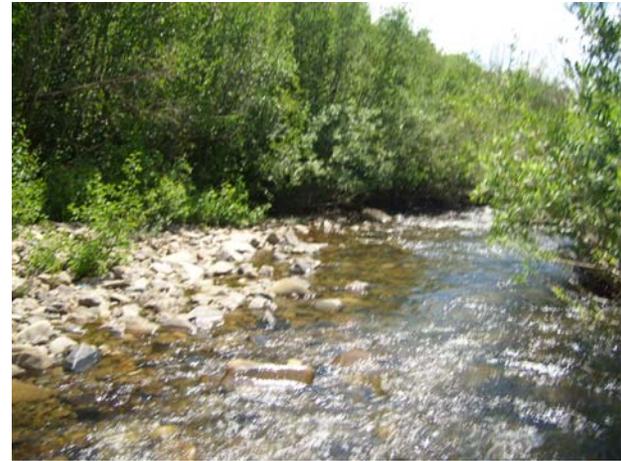
Coal-00 RBP Habitat Score = 159 – Optimal

This site is located on Coal Creek upstream from the confluence of Coal Creek. A 100 meter reach was assessed from a pedestrian bridge (not included in the assessment) upstream along the creek. Residences were located along both creek banks, however significant bank alteration was not observed. Overall flow along the reach was low, resulting in a marginal score for Channel Flow Status. The reach scored either optimal or suboptimal for the remaining parameters, resulting in an optimal overall score.

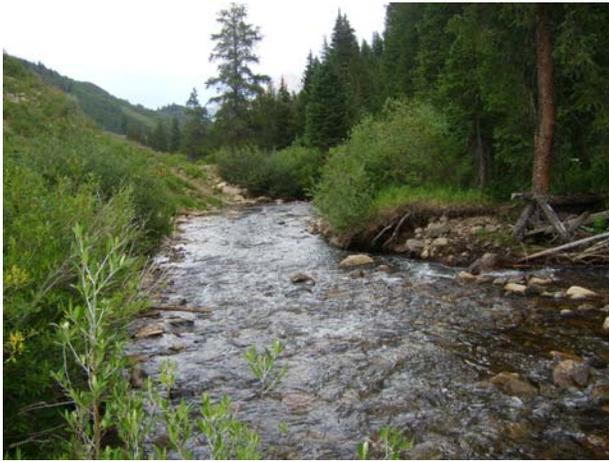
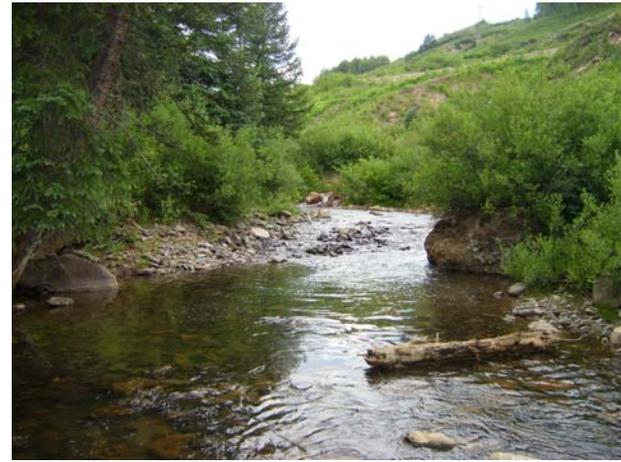
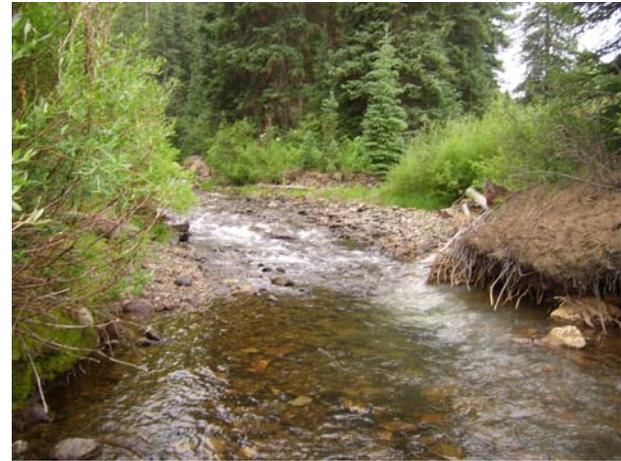
Coal-05 RBP Habitat Score = 166 – Optimal

This site is located on Coal Creek approximately 50 meters downstream of the Keystone Mine Waste Water Treatment Facility discharge. A 100 meter reach was assessed from

the point of discharge confluence extending downstream. The majority of parameters scored optimal, with two suboptimal scores (Sediment Deposition and Bank Stability for the left bank). Some sediment deposition was noted at various locations along the reach, and notable erosion was observed along the left bank. The right bank scored poor for Riparian Vegetative Zone Width due to the close proximity of a highway embankment, resulting in a limited riparian area. Overall the reach received an optimal score.

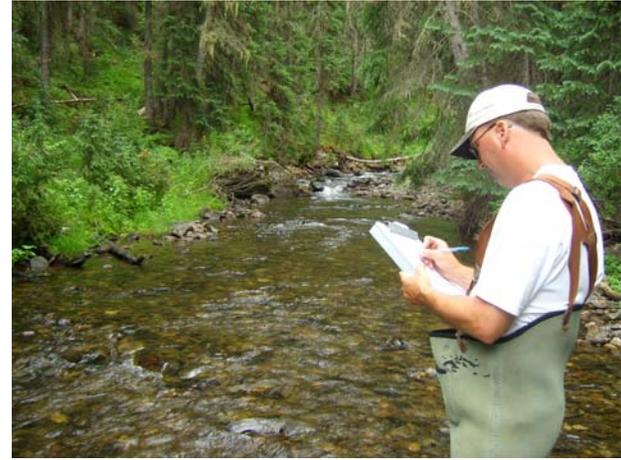
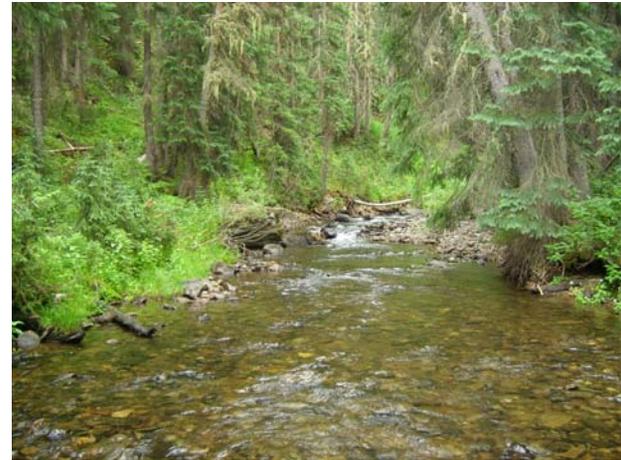
Coal-10 RBP Habitat Score = 167 – Optimal

This site is located approximately 50 meters upstream of the Keystone Mine Waste Water Treatment Facility discharge. A 100 meter reach was assessed from the point of discharge confluence extending upstream. All parameters scored either optimal or suboptimal, with an optimal overall score. The Town of Crested Butte water intake is located within this reach, and included a man-made earthen water diversion. This resulted in less varied depth/flow regime as well as a lower score for Channel Alteration.

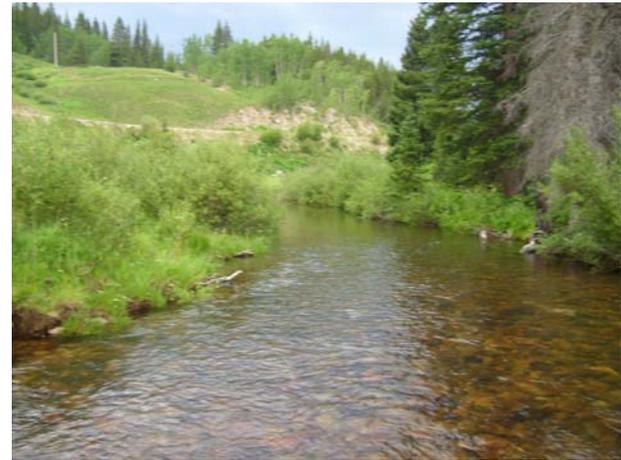
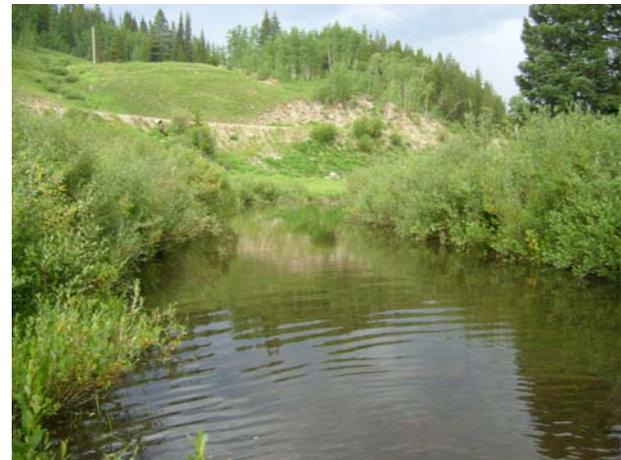
Coal-Opp2 RBP Habitat Score = 183 – Optimal

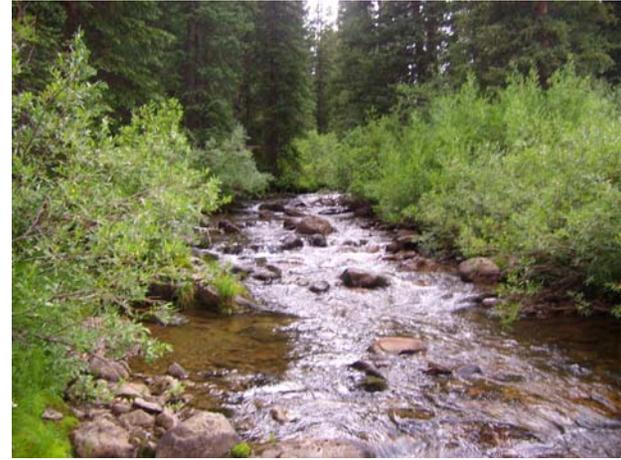
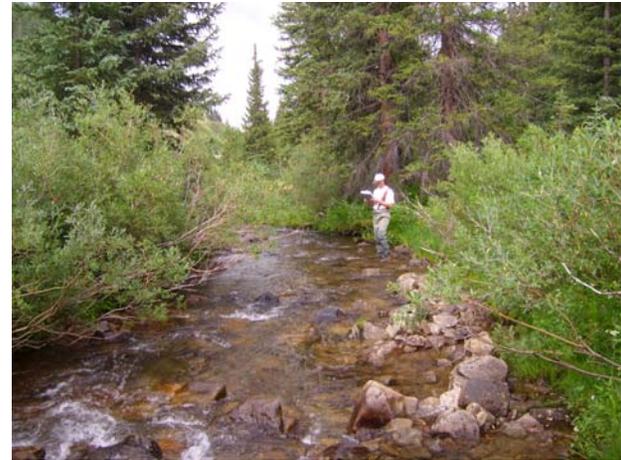
Coal-15 RBP Habitat Score = 193 – Optimal

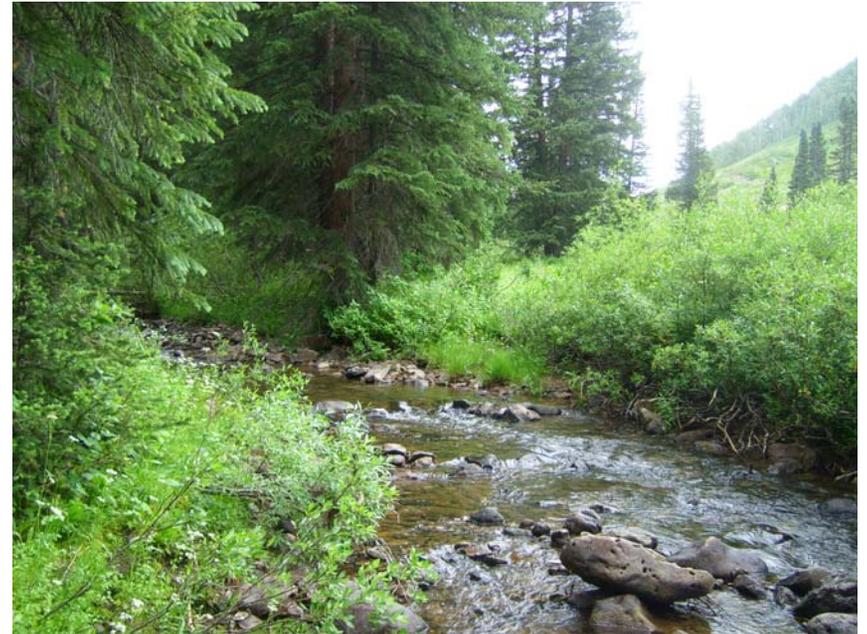
Coal-20 RBP Habitat Score = 188 – Optimal

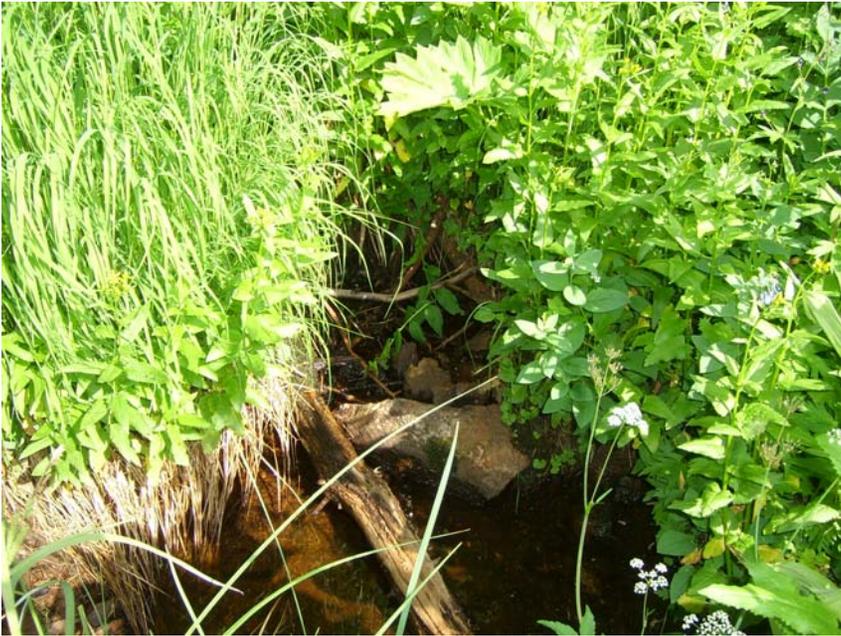
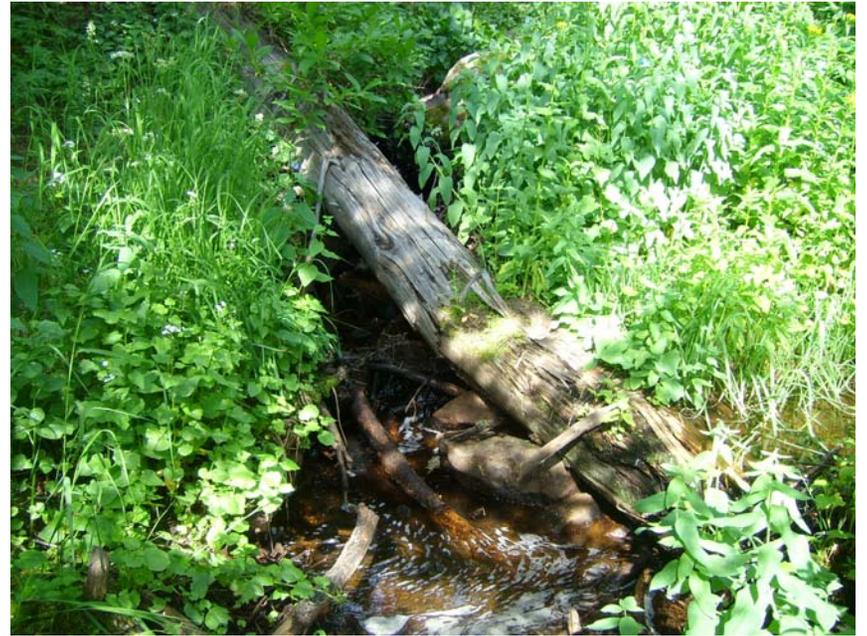
Cop-01

This site is located downstream from Copley Lake (along the Copley Lake outfall flow) before the confluence with Elk Creek. A 100 meter reach was assessed starting at the culvert (located where the outfall crosses the access road adjacent to Elk Creek; not included in the reach), extending upstream towards Copley Lake. Habitat scores for this reach ranged from marginal to optimal. Marginal scores were given due to a consistent slow flow rate over most of the reach, which led to increased sediment deposition and embeddedness. In addition, riffles and/or bends were observed only occasionally over the reach. Overall the reach received a suboptimal score.
