Subject: April 22, 2021 CSO Reconnaissance Inspection Report

Purpose: Metro East Sanitary District Reconnaissance Inspection

Facility: Metro East Sanitary District's East St. Louis Pumping Station

NPDES Permit: IL0028592

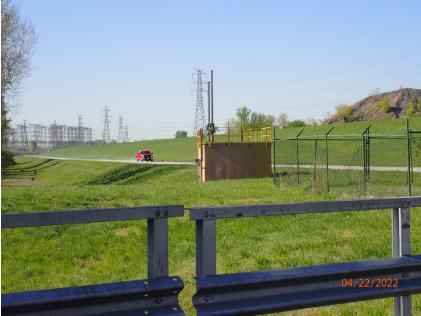
1: P4220001 Description: The gate structure for the 10 ½ foot sewer pipe from East St. Louis. Location: East St. Louis Pumping Station. Camera Direction: South Date/Time: April 22, 2021 / 9:12 A.M.

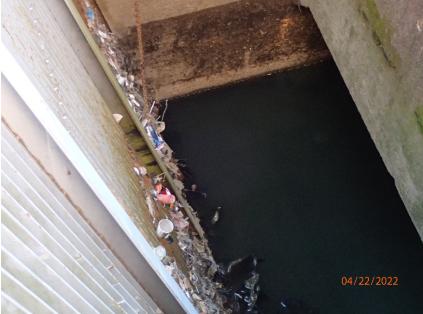
2: P4220002

Description: Bar screen for the 10 ½ foot pipe from East St. Louis. Location: East St. Louis Pumping Station. Camera Direction: Down Date/Time: April 22, 2021 / 9:17 A.M.

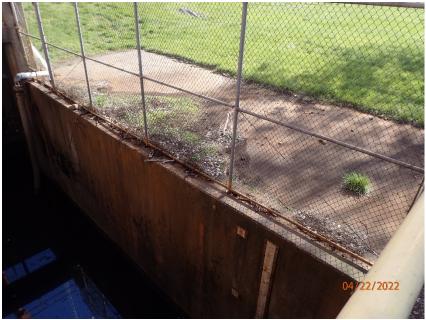
3: P4220003

Description: Inlet fence screens the groundwater flow from groundwater relief wells before it flows into the wet well.

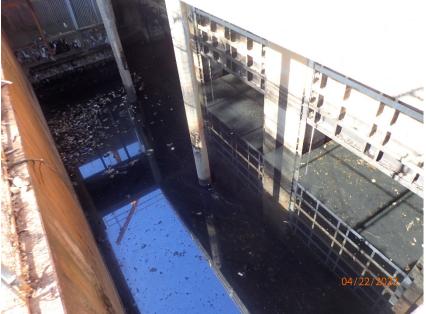
4: P4220004

Description: Gates to the pump station on right hand side of the photo. If the gates close on the $10\frac{1}{2}$ foot and $12\frac{1}{2}$ foot pipes, the wet well fills up and the gates will allow the flow to be pumped to the Mississippi River.

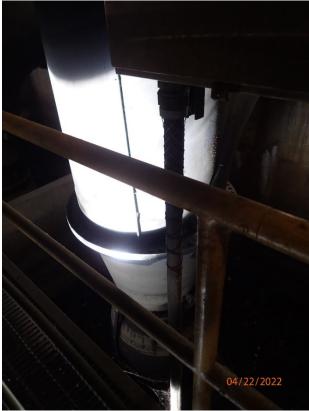
Inside the ESLPS, there are three 140,000 GPM pumps. All the pumps are from the 1970s and they are rarely run. The most run time for any of the three pumps is 270 hours. An MESD operator would have to add air to the water to get the pumps to overcome the pressure of the Mississippi River water when these pumps are turned on. The station has the capacity to run all three pumpsat the same time. Three submersible pumps in the wet well are utilized for smaller volumes of water. The station does not have any backup power.

5: P4220005 Description: One of the three 140,000 GPM pumps in the pump station. Location: East St. Louis Pumping Station. Camera Direction: Inside Date/Time: April 22, 2021 / 9:31 A.M.

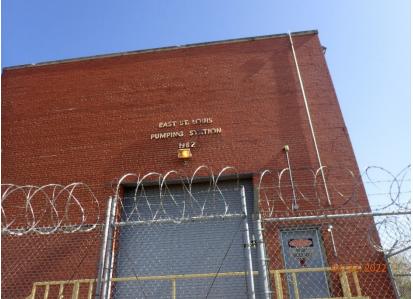
6: P4220006 Description: The East St. Louis Pumping Station was built in 1962. Location: East St. Louis Pumping Station. Camera Direction: Northeast Date/Time: April 22, 2021 / 9:32 A.M. Page 3

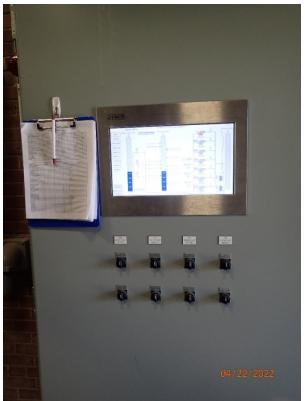
7: P4220007

Description: Control panel for the pumps and gates at the East St. Louis Pump Station. Location: East St. Louis Pumping Station.

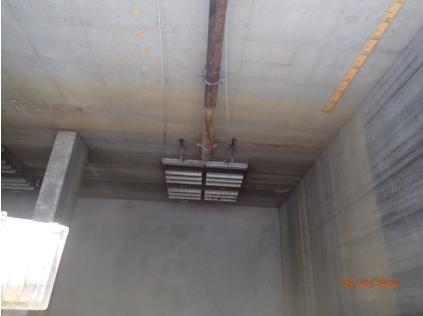
8: P4220008

Description: Looking down into the concrete well where the flow would go once the gates open. That is one of the gates on the wall in the center of the photo.

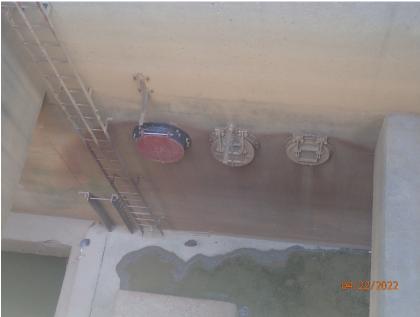
9: P4220009 Description: Three outlets for the submersible pumps that are used to pump lower volumes of water to the well. Location: East St. Louis Pumping Station. Camera Direction: Down Date/Time: April 22, 2021 / 10:09 A.M.

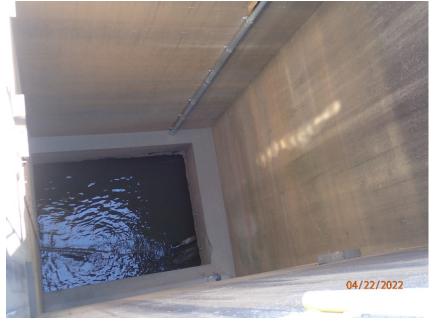
10: P4220010 Description: Looking down into the flow from the 12 $\frac{1}{2}$ foot pipe to the Mississippi River.

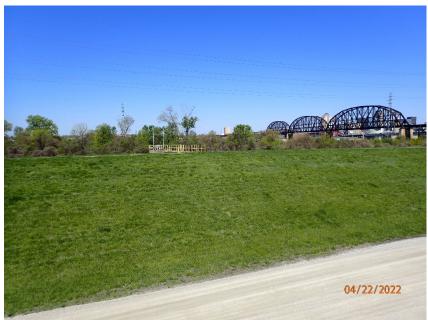
11: P4220011
Description: One of the gate structures for the 12 ½ foot sewer pipe from East St. Louis is on the west side of the levee.
Location: East St. Louis Pumping Station.
Camera Direction: Northwest
Date/Time: April 22, 2021 / 10:11 A.M.

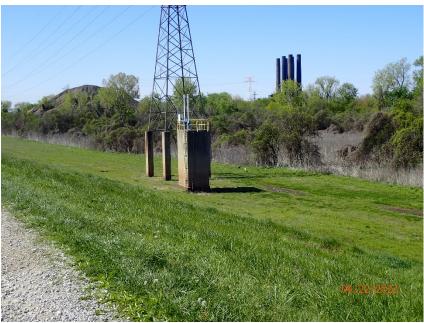
12: P4220012

Description: The gate structure for the 10 $\frac{1}{2}$ foot sewer pipe from East St. Louis on the west side of the levee.

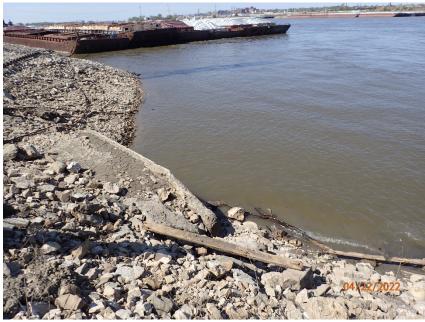
13: P4220013 Description: East St. Louis' CSO Outfall 001 is a 12 ½ foot box culvert outlet. Location: 38.61170N, 90.181846W Camera Direction: Southwest Date/Time: April 22, 2021 / 10:41 A.M.

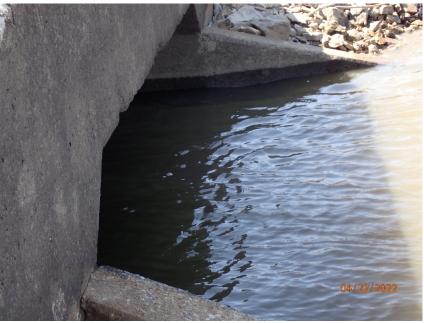
14: P4220014

EPA then walked to the top of the levee and to the two East St. Louis CSO Outfalls on the bank of the Mississippi River. The first outfall, CSO Outfall 001, was located at 38.61170N, 90.181846W, and was a concrete box culvert, 12 ½ feet wide. EPA observed the water in the Mississippi River at the outfall and did not observe any sanitary debris.

Description: East St. Louis' CSO Outfall 001. EPA did not observe any CSO debris in the Mississippi River on the day of the inspection. Location: 38.61170N, 90.181846W Camera Direction: South Date/Time: April 22, 2021 / 10:42 A.M.

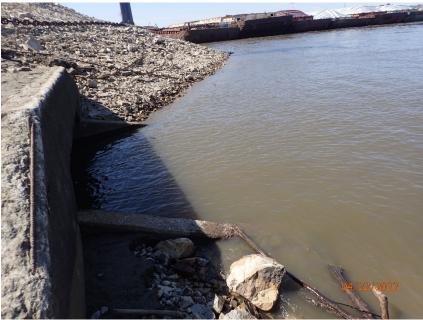
15: P4220015 Description: East St. Louis' CSO Outfall 001 is the outfall for the 12 ½ foot sewer pipe. Location: 38.61170N, 90.181846W Camera Direction: Southwest Date/Time: April 22, 2021 / 10:42 A.M.

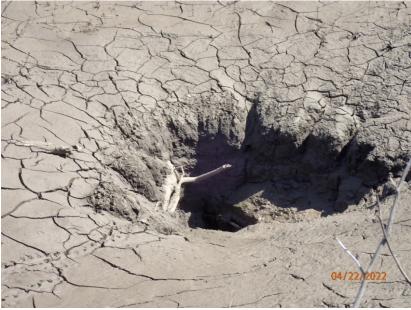
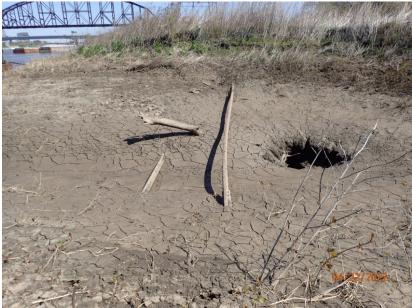
The second outfall, CSO Outfall 002, was located further south along the bank of the Mississippi River at 38.610463N, 90.182033W. The outfall was either below the water level or buried in the bank and EPA could not observe it. Approximately 40 feet east of the bank, there was a washed-out area and a hole where it appears that there had been previous flooding.

Description: Upstream of CSO Outfall 002 location, EPA observed that there has been previous flooding and a hole in the ground. The outfall outlet is not visible because it is either below the water level or buried in the embankment.

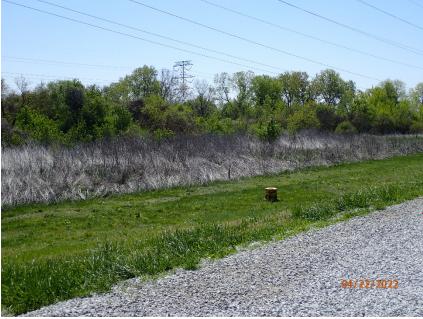
18: P4220018

Description: A groundwater relief well allows water from below the ground to exit the well and flow to the East St. Louis Pumping Station and then into the wet well and eventually back out to the Mississippi River.
