July 9, 2021

Re: **Storm Sewer Rehabilitation Summary Report
Franklin Power Products, Inc./Amphenol Corporation
Administrative Order on Consent, Docket # R8H-5-99-002
EPA ID # IND 044 587 848
Former Bendix Facility
980 Hurricane Road
Franklin, Indiana 46131**

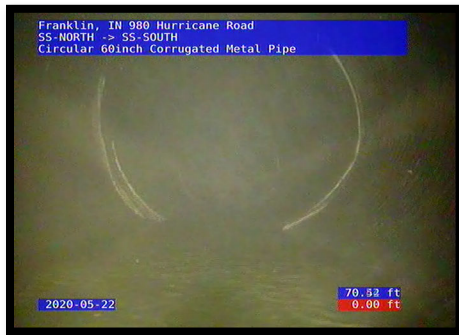
IWM Consulting contracted with a qualified subcontractor (National Gunitite) to rehabilitate the separated storm sewer joints and to re-line the flow invert. Initial inspections indicated that the joints are present approximately every 8 feet, which means approximately 75 joints would be sealed. Joints were found to be separated up to two inches and were potential conduits to the subsurface. The sewer main joints

in the vicinity where the route of the storm main made 90-degree changes in direction were significantly distressed.

Overall visual separation of joint

National Gunitite sealed the joints with a 18-inch full circumferential band using 2-inches of 5,000 pounds per square inch (psi) shotcrete (after it is allowed to cure for 28-days). In addition, the invert of the pipe received a structural lining from the 05:00-07:00 position. The shotcrete throughout the structural rehabilitation was enhanced with 2-inch by 2-inch, 12-gauge, welded wire mesh reinforcement and the final thickness of the shotcrete was approximately 2-inches (1-inch below and 1-inch above the wire mesh). The wire mesh was anchored to the storm sewer pipe using self-taping screws and the wire mesh was tied into the anchors with 16-gauge annealed tie wire.

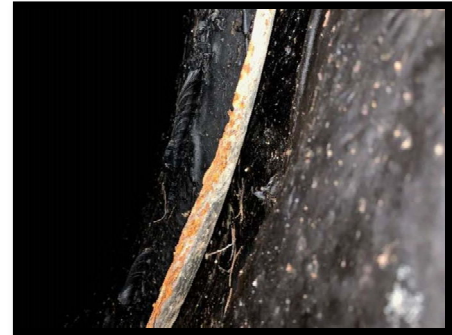
Joint separation

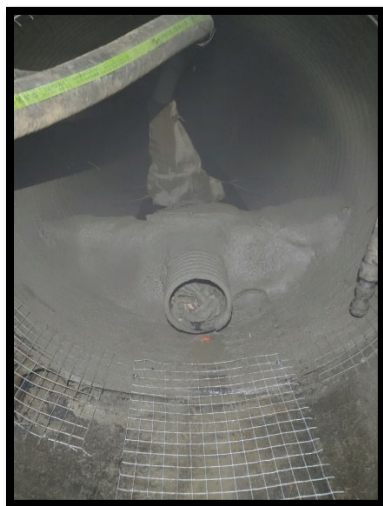
Temporary weir and pump intake

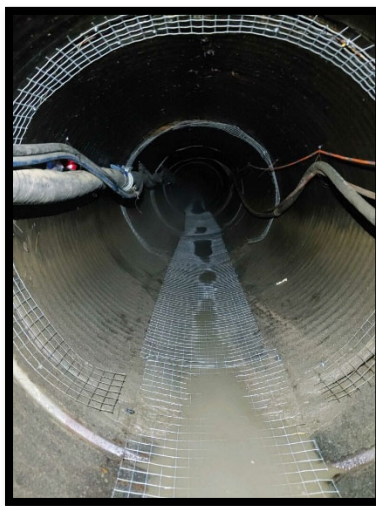
Discharge hose and supply lines

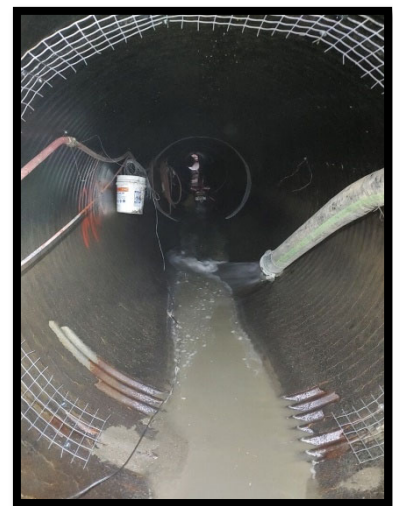
Down-flow discharge area

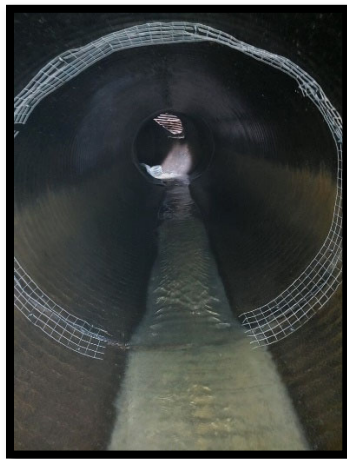
View of wire mesh at joint

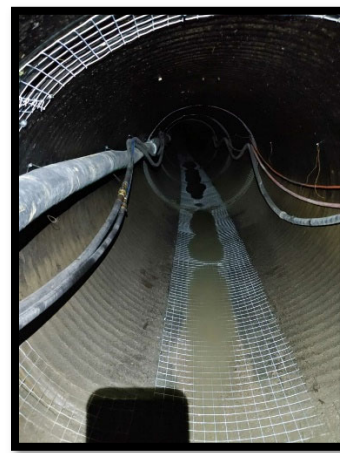
View of wire mesh in invert

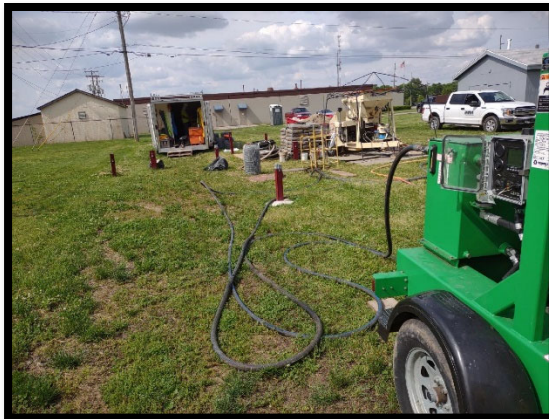
View of dewatering pump and shotcrete mixing equipment

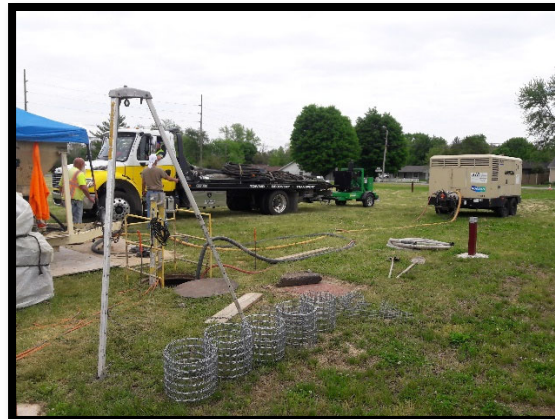
View of compressor for shotcrete application

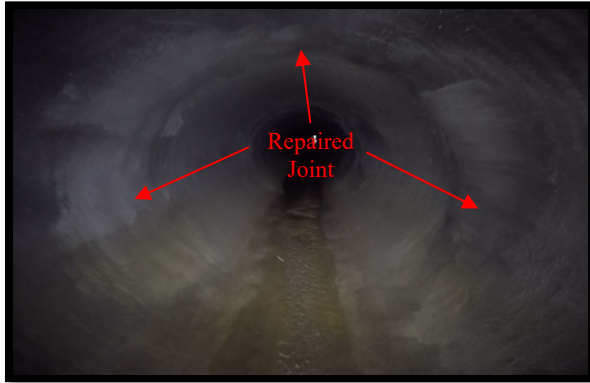
Typical view of repaired storm pipe joint

Based on the final video inspection, the storm sewer rehabilitation activities appear to have adequately sealed any potential areas where water could enter or exit the storm main. This should assist during the implementation of future remediation activities at the Site (i.e., in-situ injections).

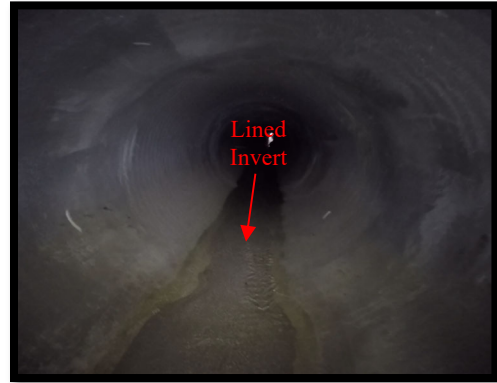
Typical view of lined invert

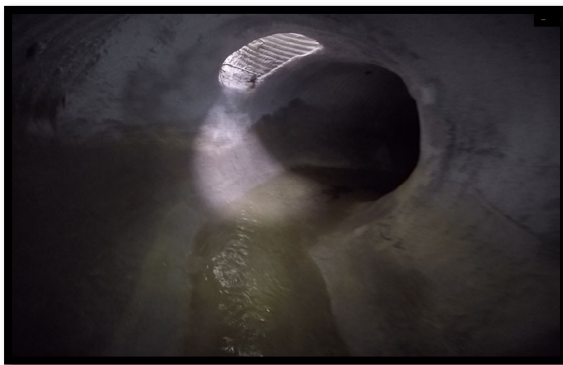
View of repaired main turn at SS-North

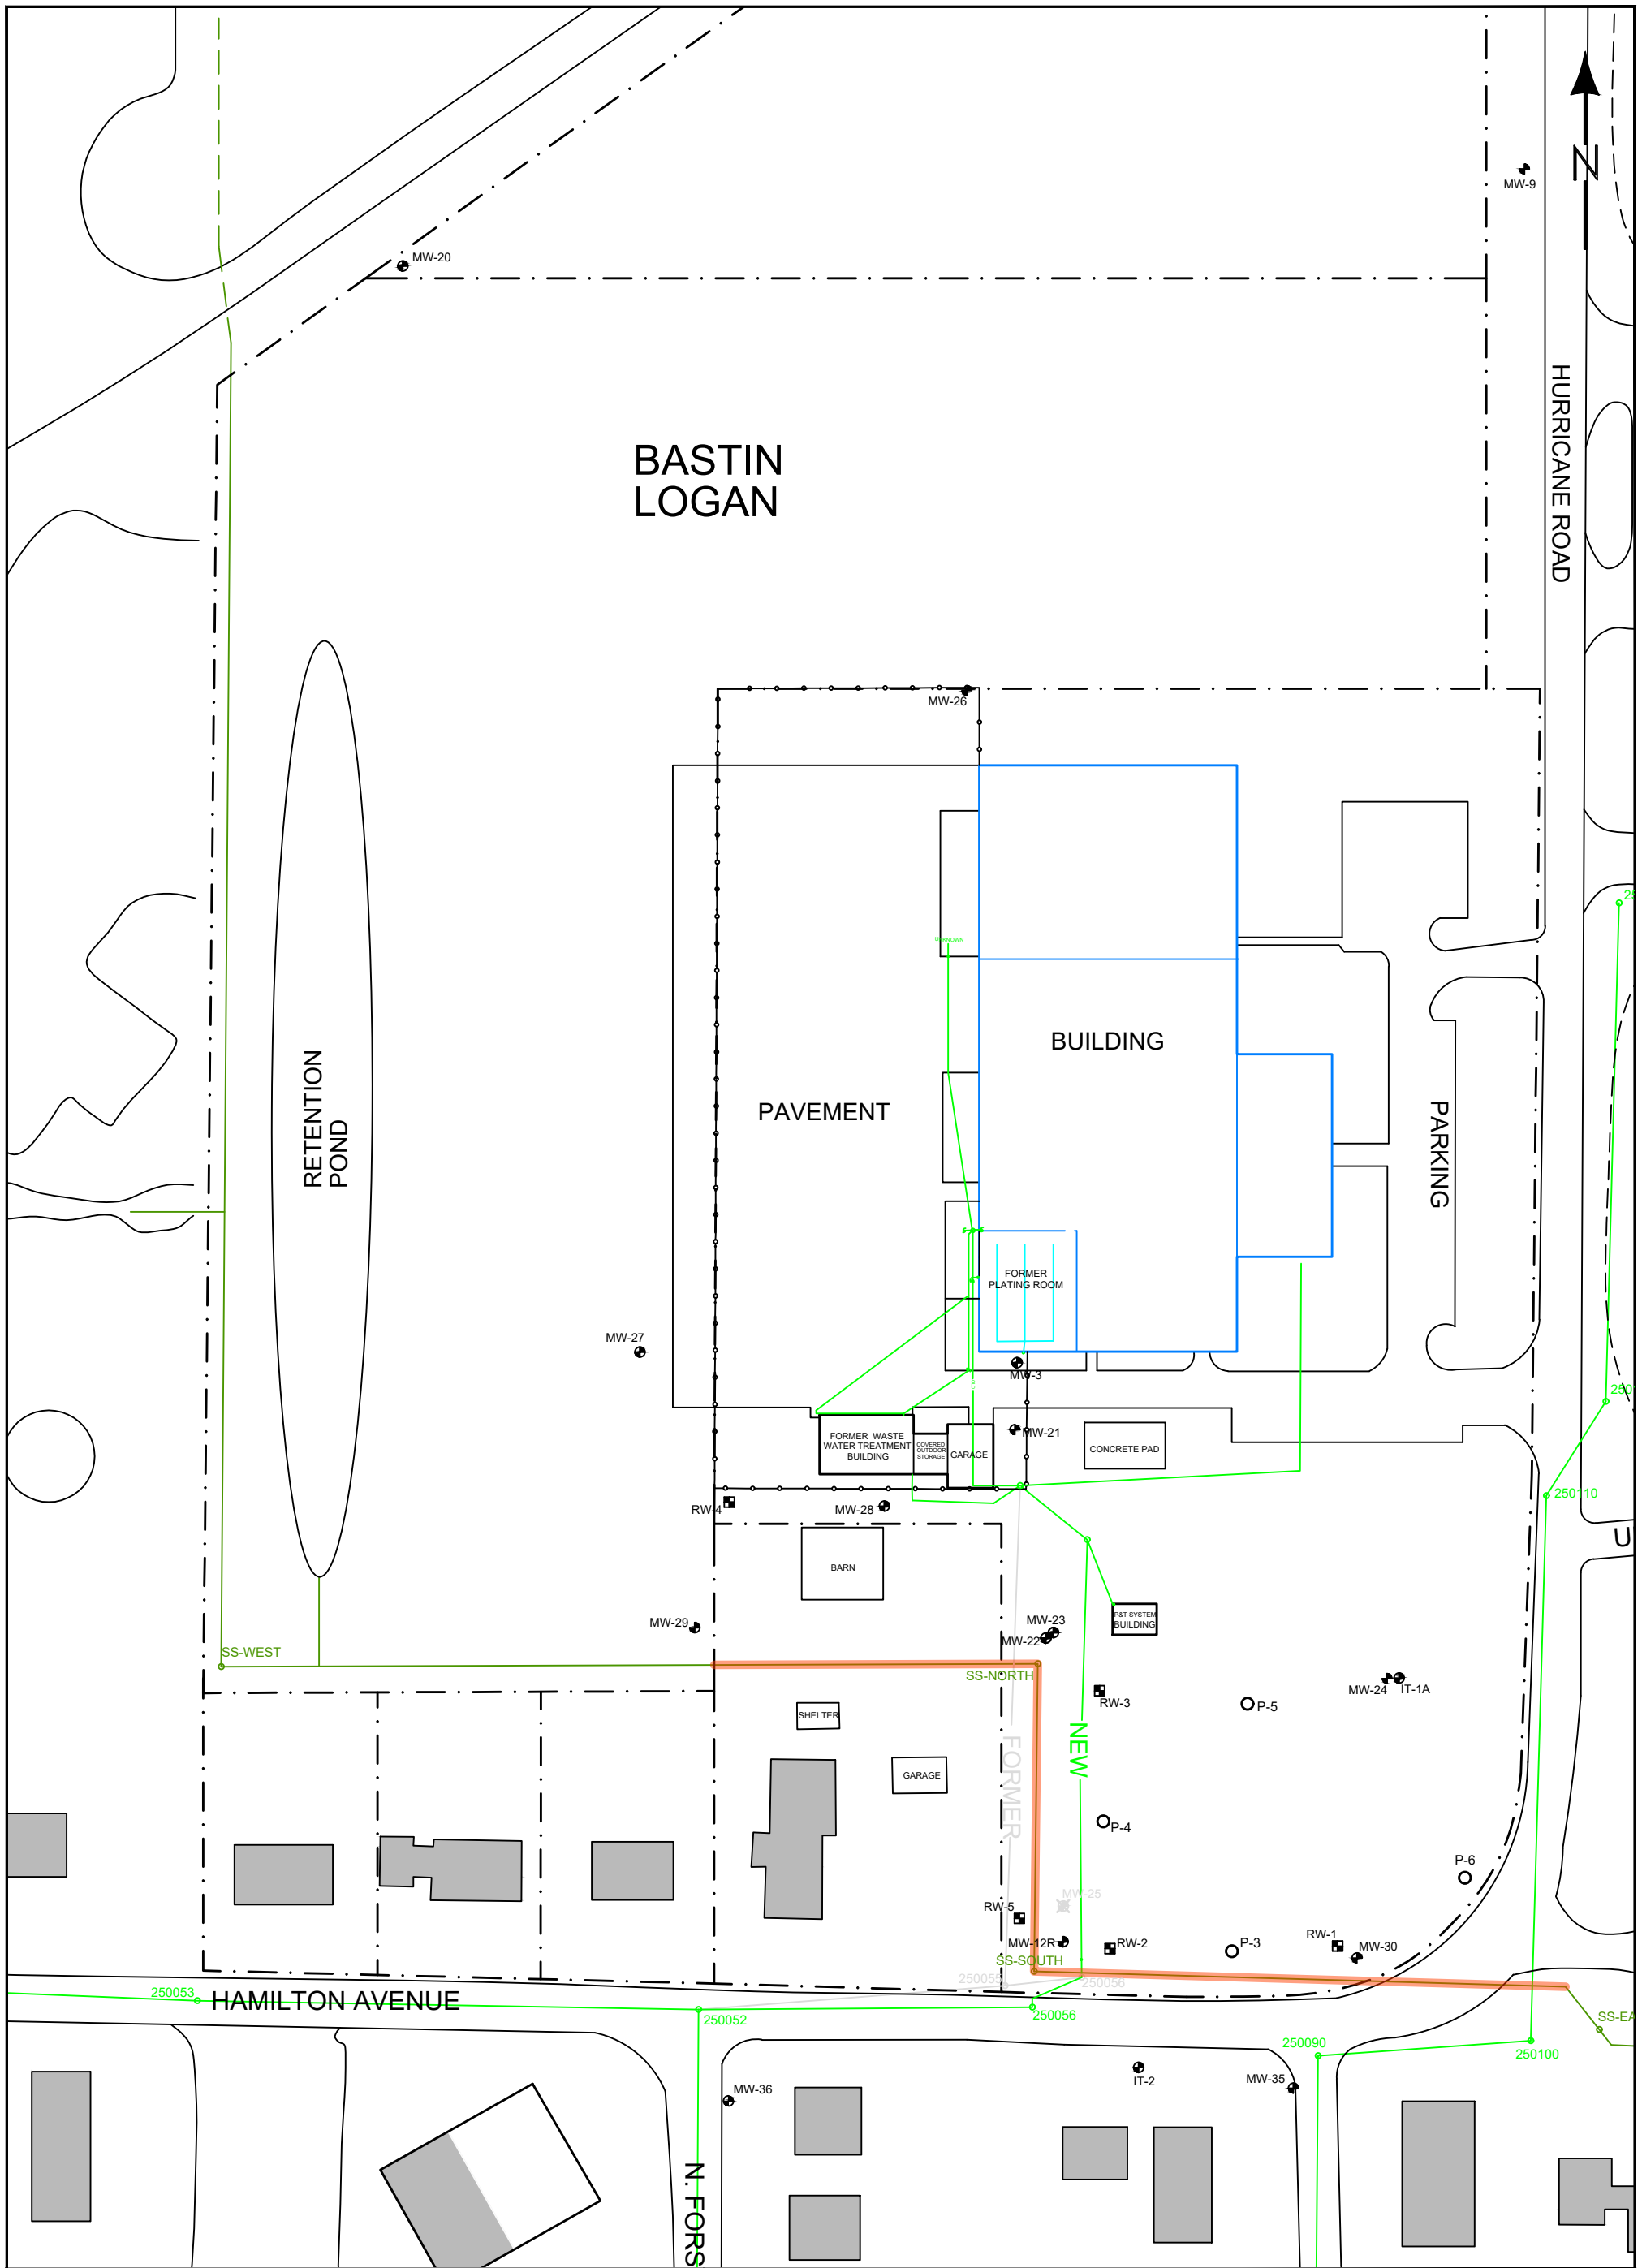
FIGURE 1
STORM SEWER
REHABILITATION

A figure displaying the portion of storm sewer targeted for rehabilitation has been included as **Figure 1**.
