March 29, 2019

Project No. 30401358

**RE: POST-RESPONSE ACTION COMPLETION REPORT – 2018
UNION PACIFIC RAILROAD HOUSTON WOOD PRESERVING WORKS, HOUSTON, TEXAS
4910 LIBERTY ROAD, HOUSTON, HARRIS COUNTY, TEXAS
TCEQ SWR NO. 31547; TCEQ PERMIT/COMPLIANCE PLAN NO. 50343EPA ID NO. TXD000820266
CUSTOMER NO. CN600131098; REGULATED ENTITY NO. RN100674613**

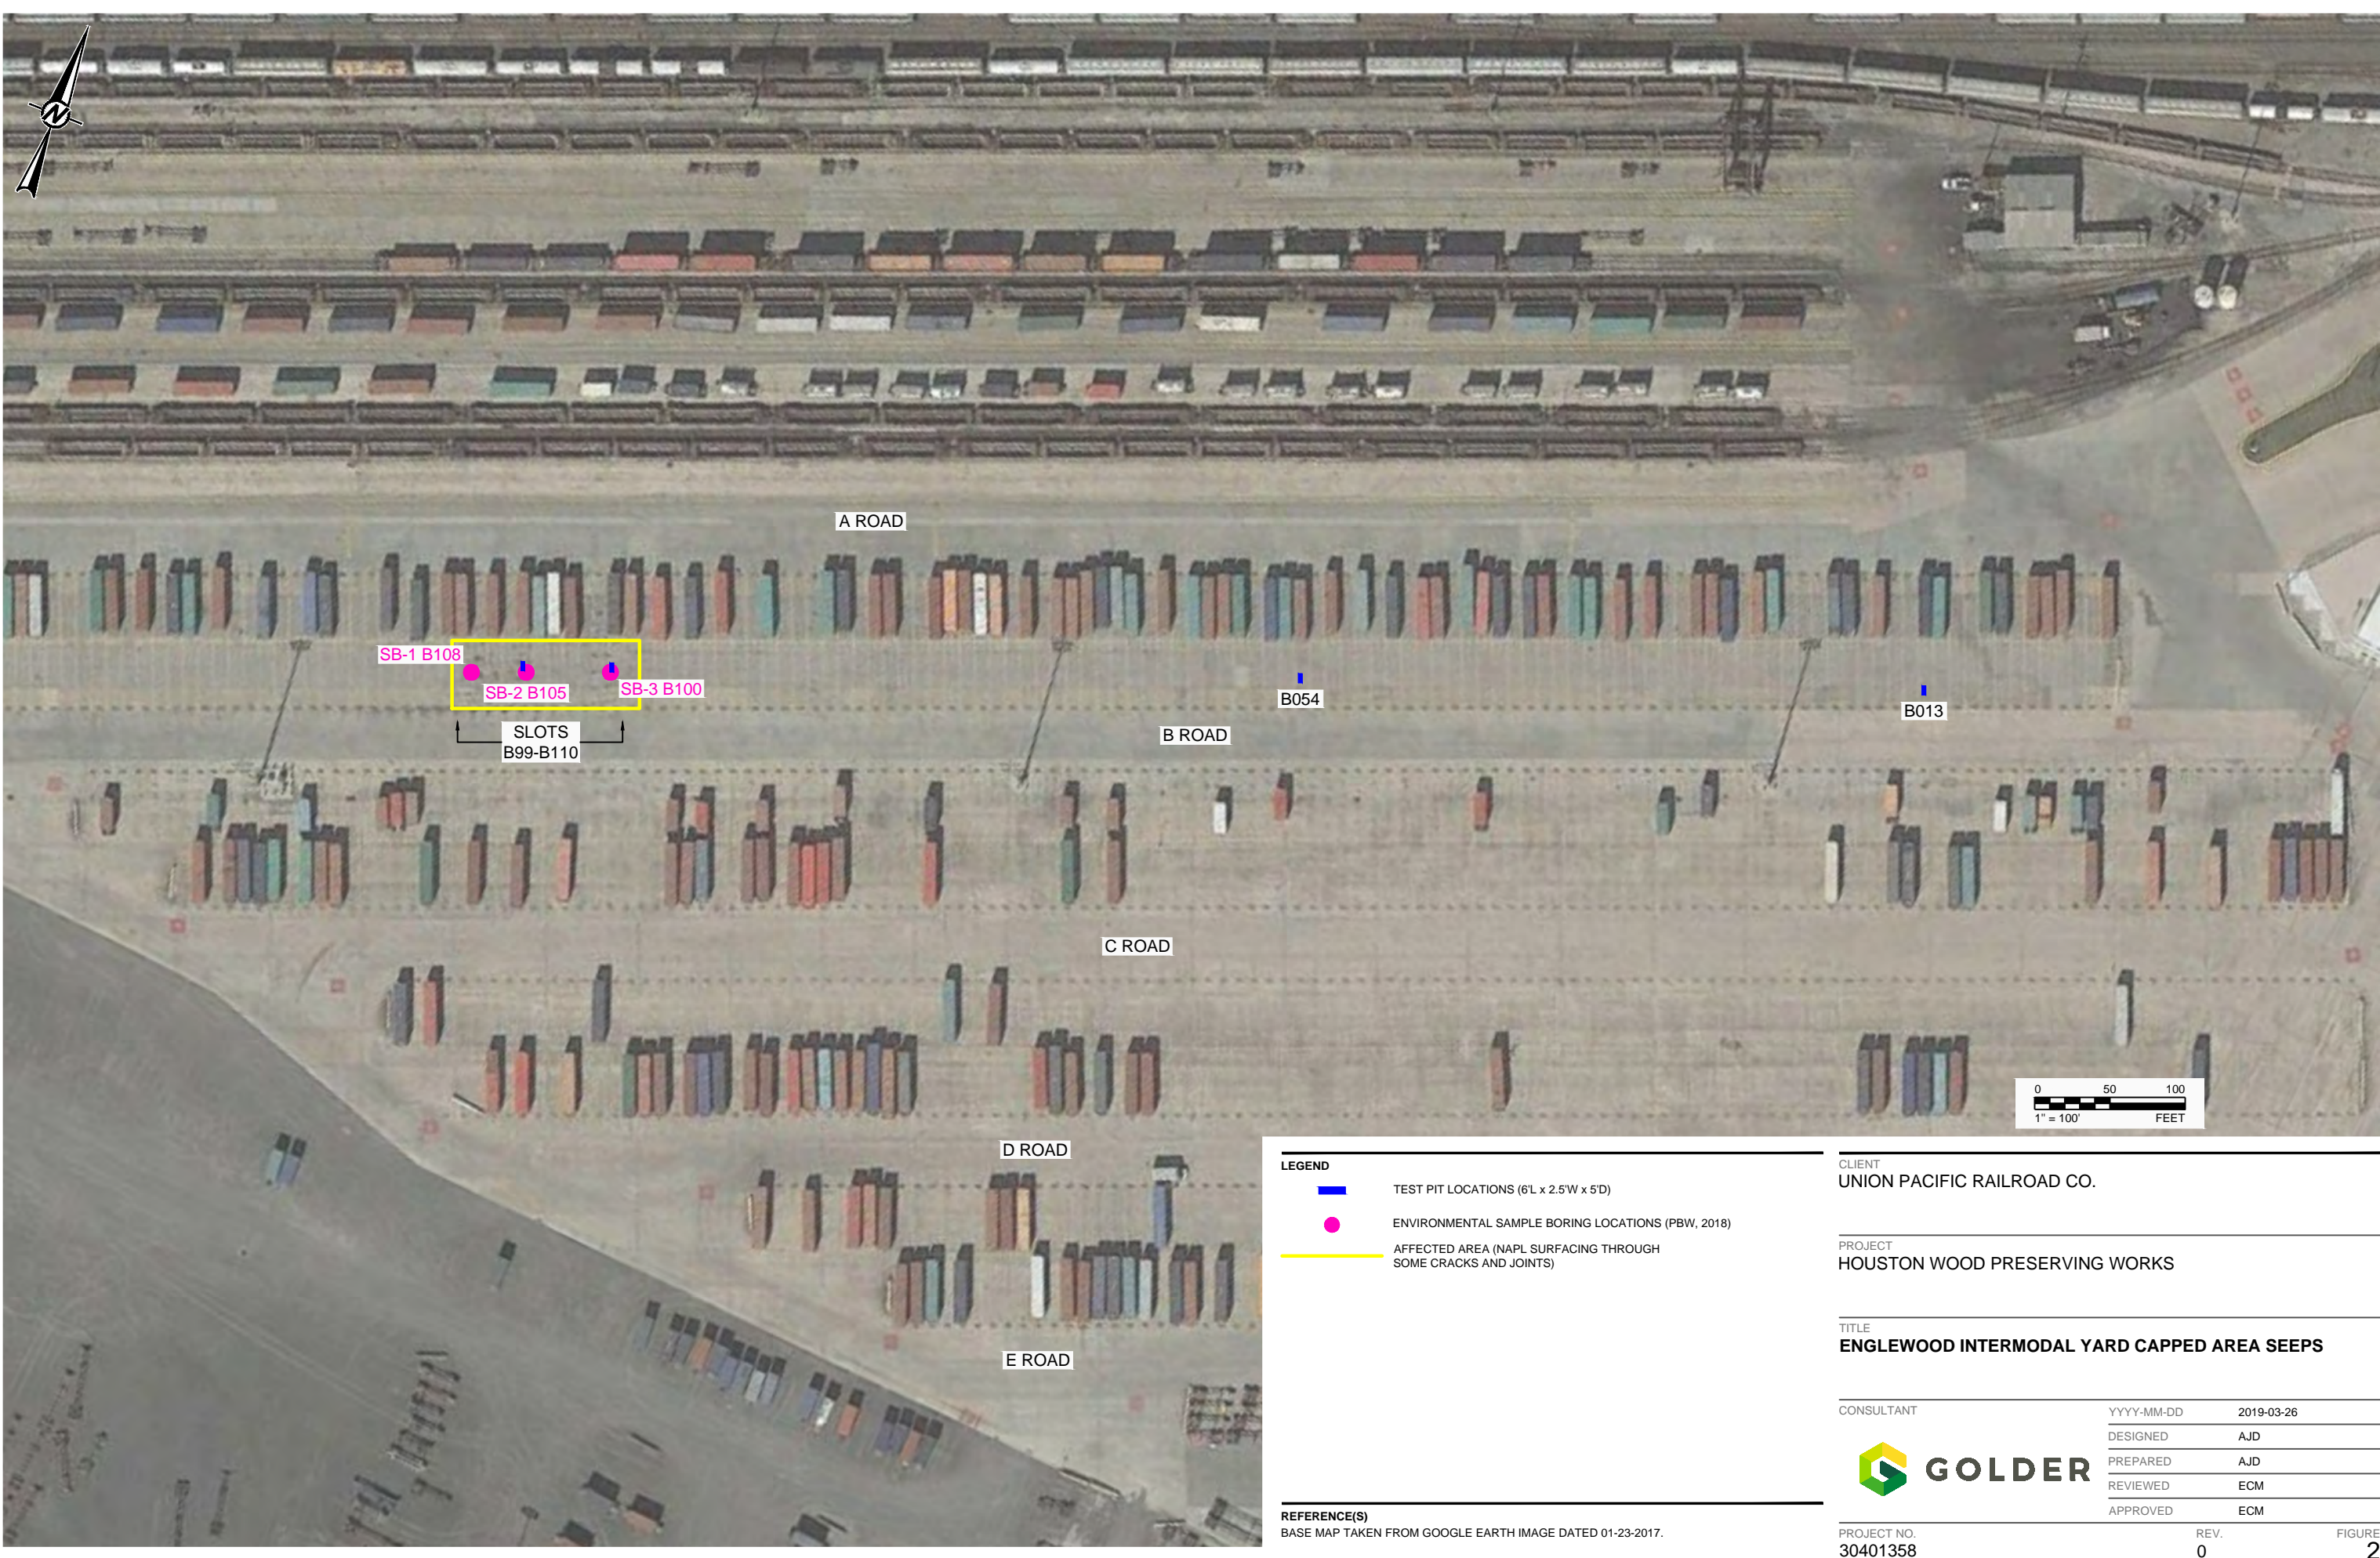
In October 2018, Golder documented the construction of test pits to evaluate the NAPL in the areas where the seeps were observed. The test pits were conducted within the primary area (slots B100-B109) and other areas (parking slots B13 and B54) (Figure 2). Four test pits were excavated to approximately 2.5 feet wide, 6 feet long and 5 feet deep with a mini-excavator. Based on the test pits conducted in the area of the NAPL seeps and the frequency of the occurrence of surface seepage at the B100 to B110 parking slots, the seeps appear to be a result of the volume of the shallow NAPL within the top 3 feet bgs mobilizing during warm weather and, to relieve subsurface pressure, finding preferential pathways to the surface through the concrete pavement's expansion joints and through the cracks in the asphalt pavement.

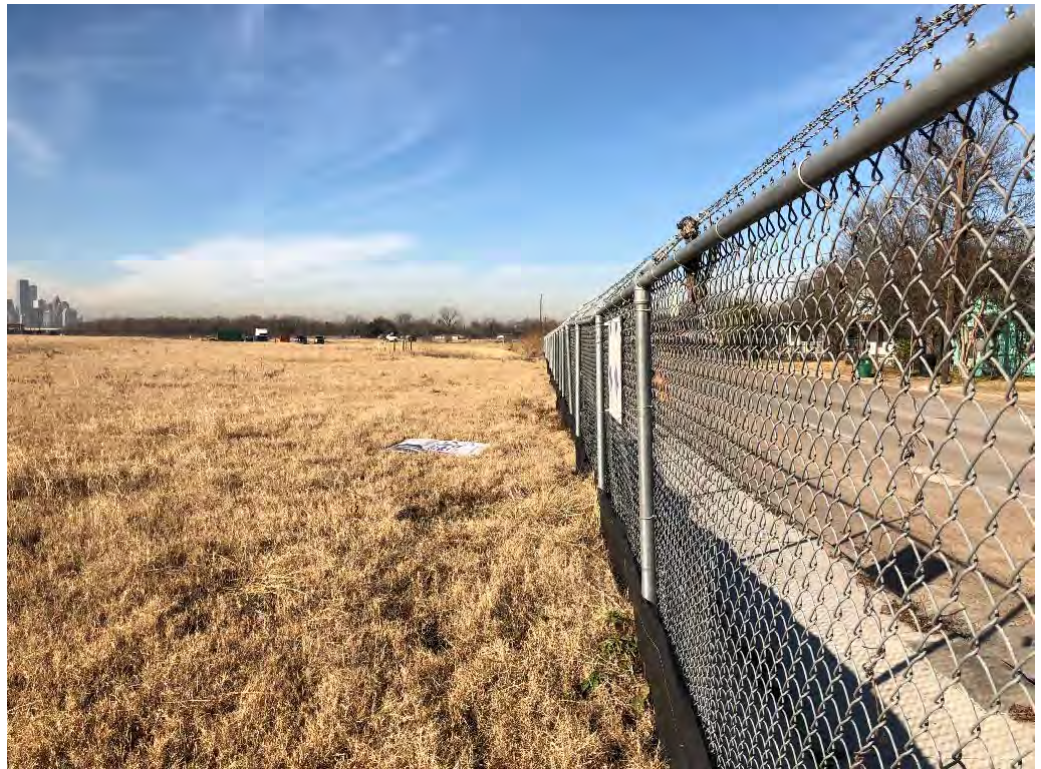
Client Name: Union Pacific Railroad		Site Location: Houston Wood Preserving Works, 4910 Liberty Road, Houston, Texas	Project No. 1358-603
Photo No. 5	Date: 01/25/18	 	
Description: Soil Cap Area: Northern edge of soil cap, looking south, orange paint outlining erosion rill to be repaired. Lat: 29.78753611 Long: -95.31826667			
Photo No. 6	Date: 01/25/18	 	
Description: Soil Cap Area: Northern edge of soil cap, looking south, orange paint outlining erosion rill to be repaired. Lat: 29.78750556 Long: -95.31805556

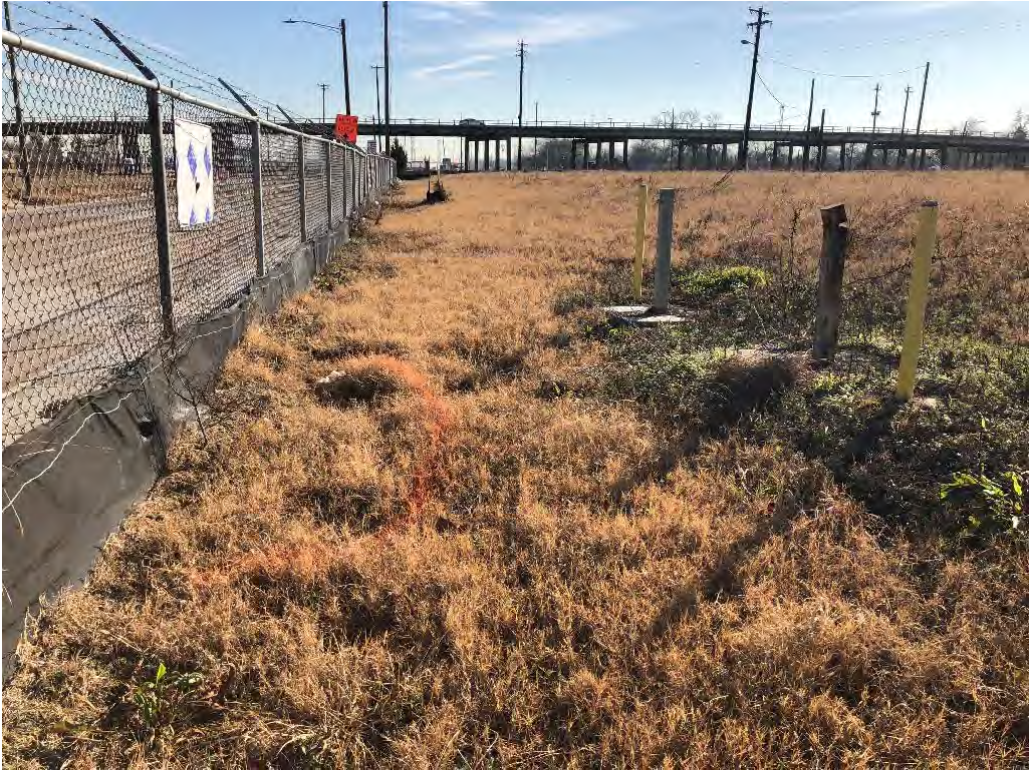
Client Name: Union Pacific Railroad		Site Location: Houston Wood Preserving Works, 4910 Liberty Road, Houston, Texas	Project No.: 1358-603
Photo No.: 7	Date: 01/25/18

Description: Soil Cap Area: North of soil cap, looking east, orange paint outlining depression to be repaired outside of soil cap, monitoring wells MW-57A and MW-57B on right of photo. Lat: 29.78761389 Long: -95.31758056			
Photo No.: 8	Date: 01/25/18

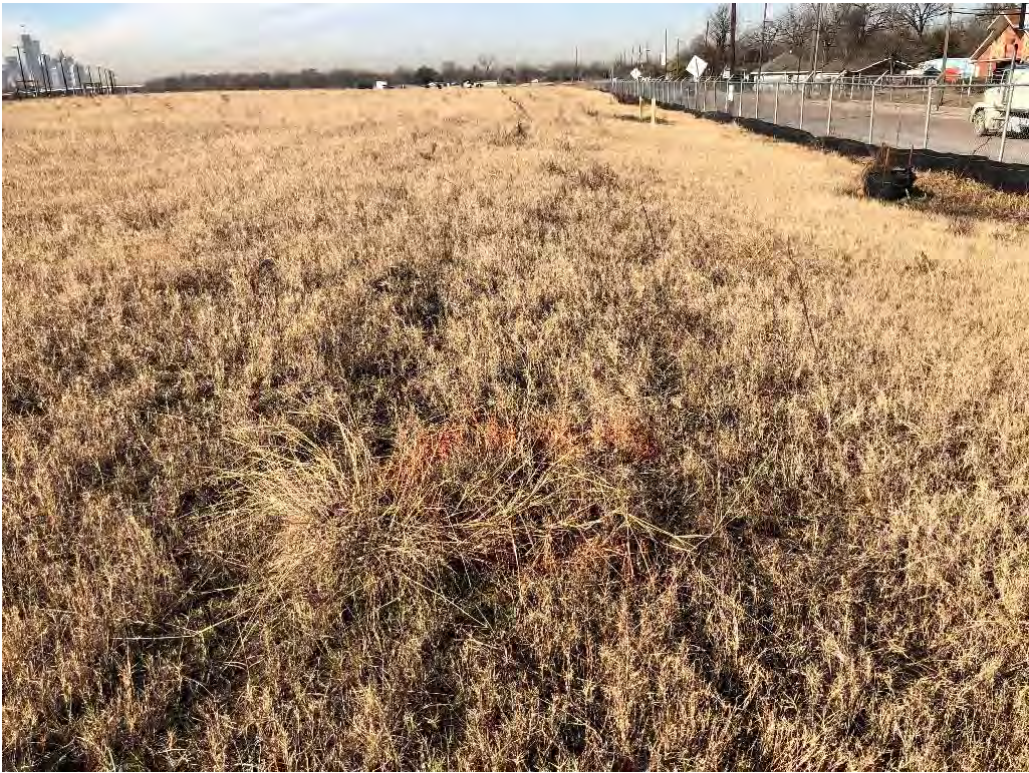
Description: Soil Cap Area: Northern edge of soil cap, looking west, orange paint outlining erosion rill to be repaired. Lat: 29.78758889 Long: -95.31713889

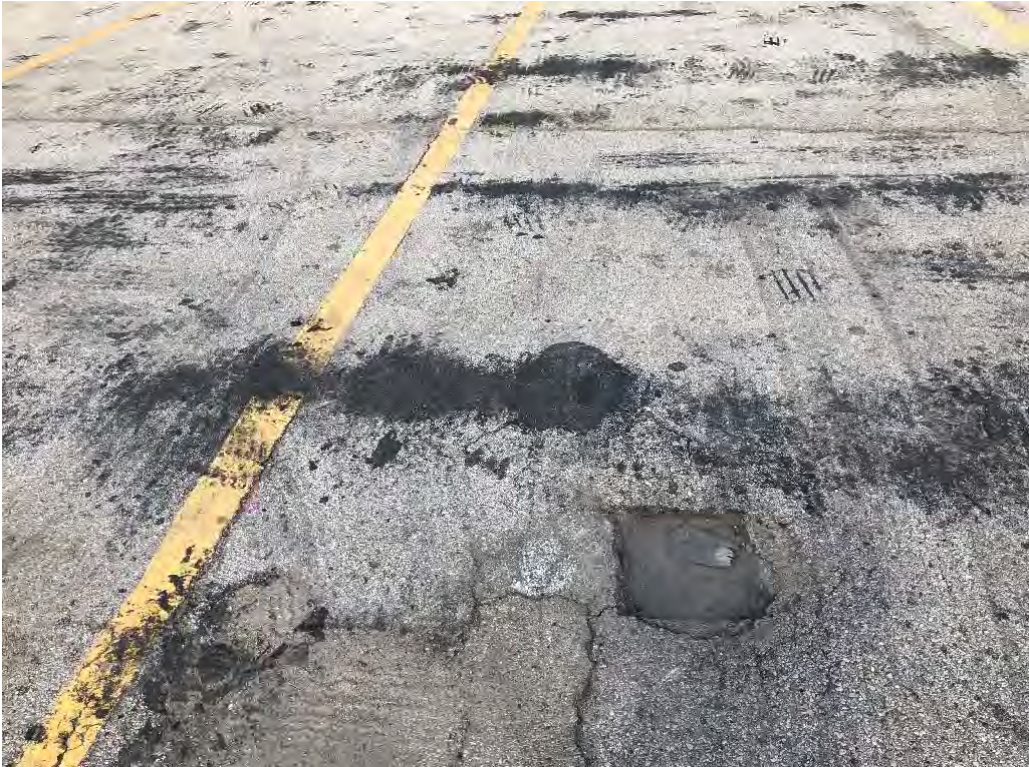
Description: Concrete Cap Area: Remnants of tar-like material seeps near B105, no active seeping noted. Lat: 29.78418333 Long: -95.32097499			
Photo No. 42	Date: 01/25/18	 	
Description: Concrete Cap Area: Remnants of tar-like material seeps near B106 through B109, no active seeping noted, looking southwest. Lat: 29.78415556 Long: -95.320938

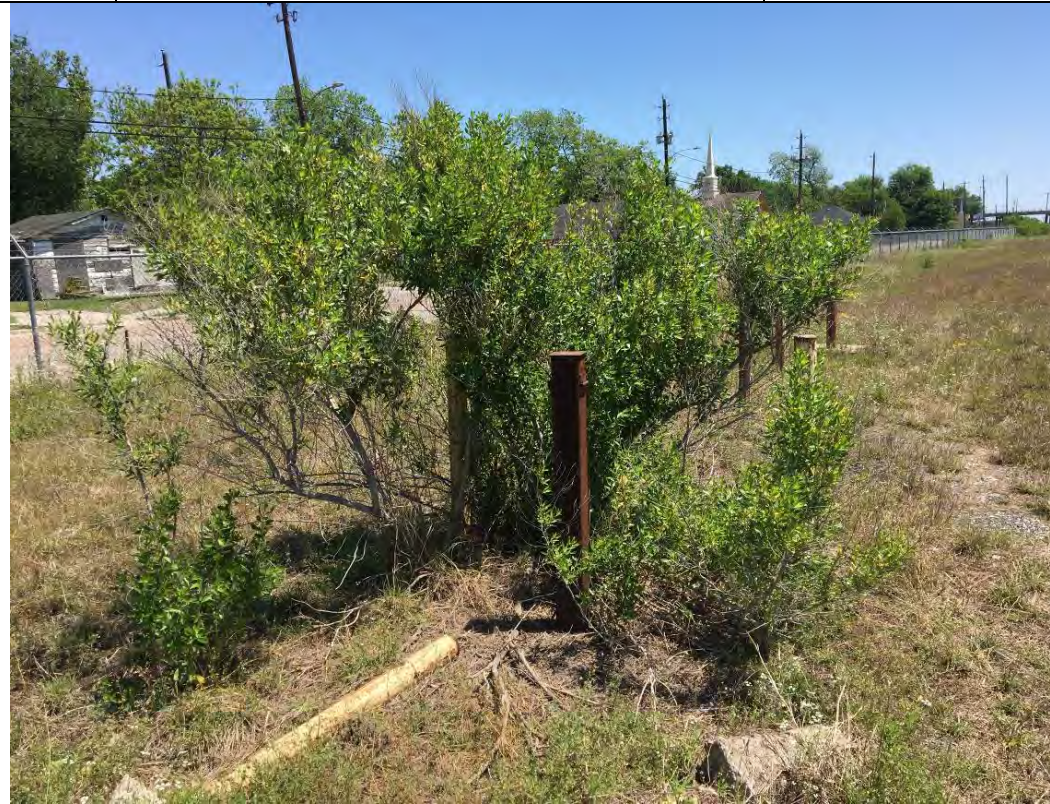
Photo No. 5	Date: 04/26/18
Description: Soil Cap Area: Monitoring well near entrance gate with heavy vegetation, looking east. Lat: 29.787375 Long: -95.32080833000002

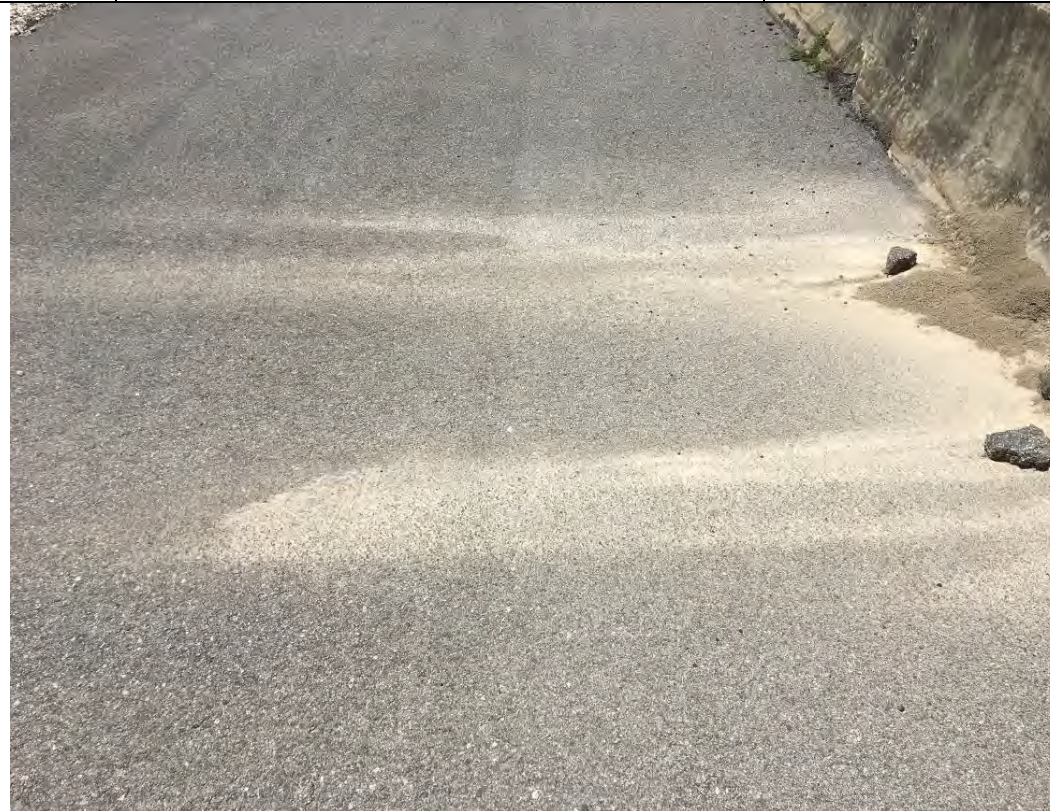
Photo No. 21	Date: 04/26/18
Description: Asphalt Cap Area: View of asphalt cap area, looking northwest. Note ant mounds and soil runoff on asphalt road. Lat: 29.78636667 Long: -95.31923611000001

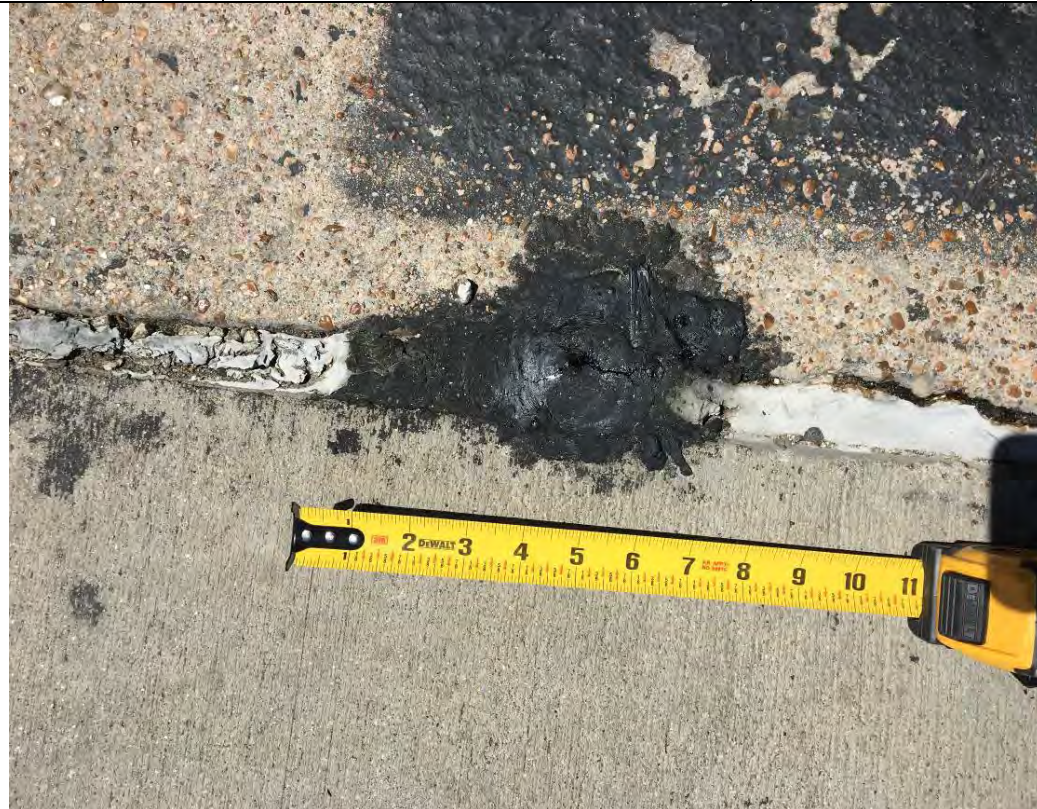
Photo No. 27	Date: 04/26/18
Description: Concrete Cap Area: Active tar-like seeps in the joint at B096. Lat: 29.4733999999999434 Long: -95.191430999999977

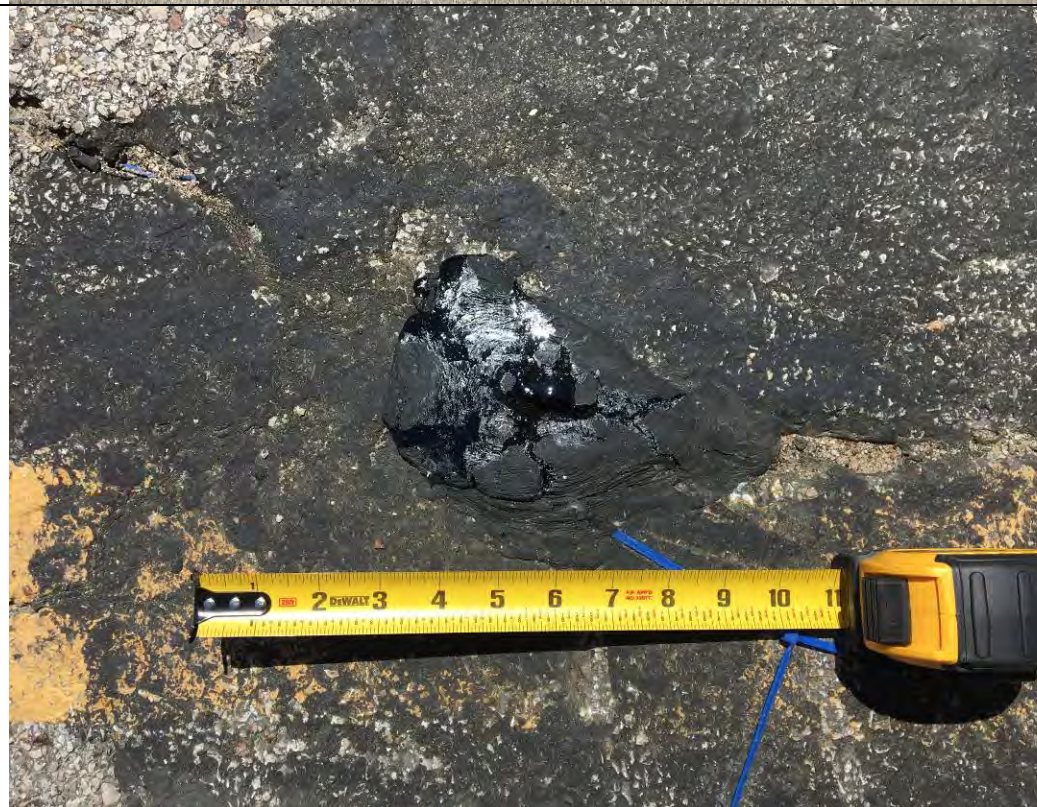
Photo No. 28	Date: 04/26/18
Description: Concrete Cap Area: Fresh tar-like product in a crack in parking spot B101. Lat: 29.47350999 Long: -95.19148300

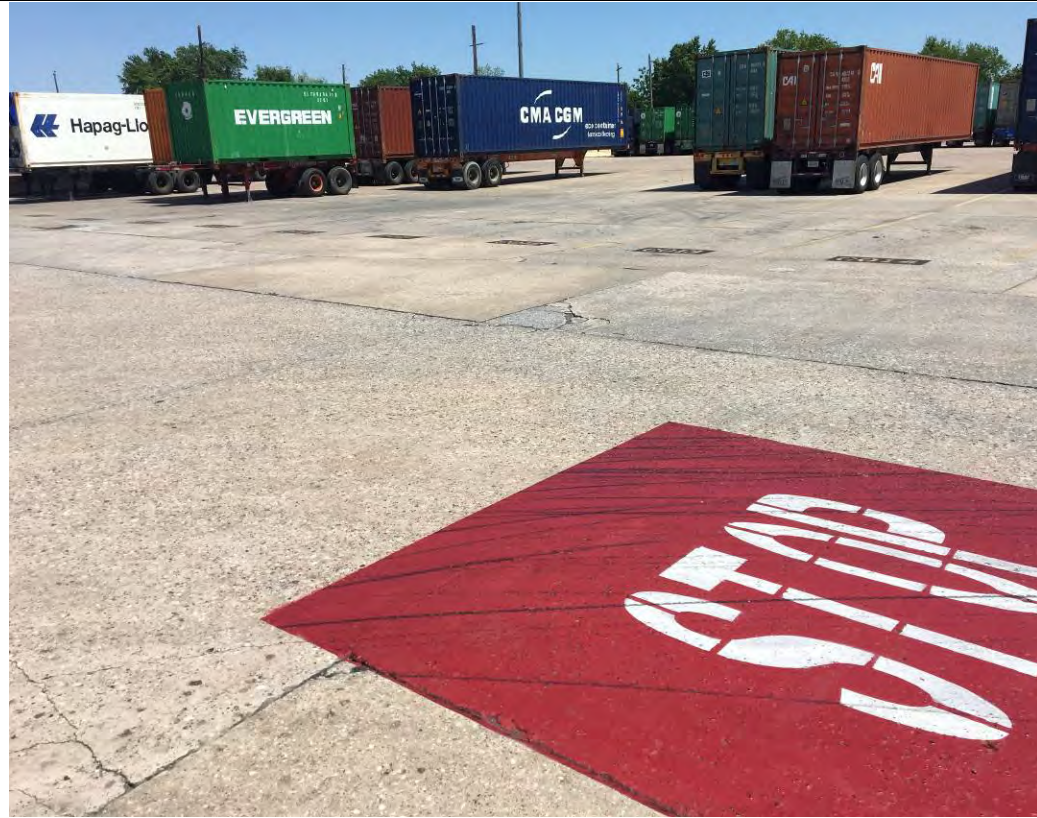
Photo No.: 35	Date: 04/26/18
Description: Concrete Cap Area: Area between B and C row. Concrete in good condition, with minor cracking. Lat: 29.78591667 Long: -95.3169416

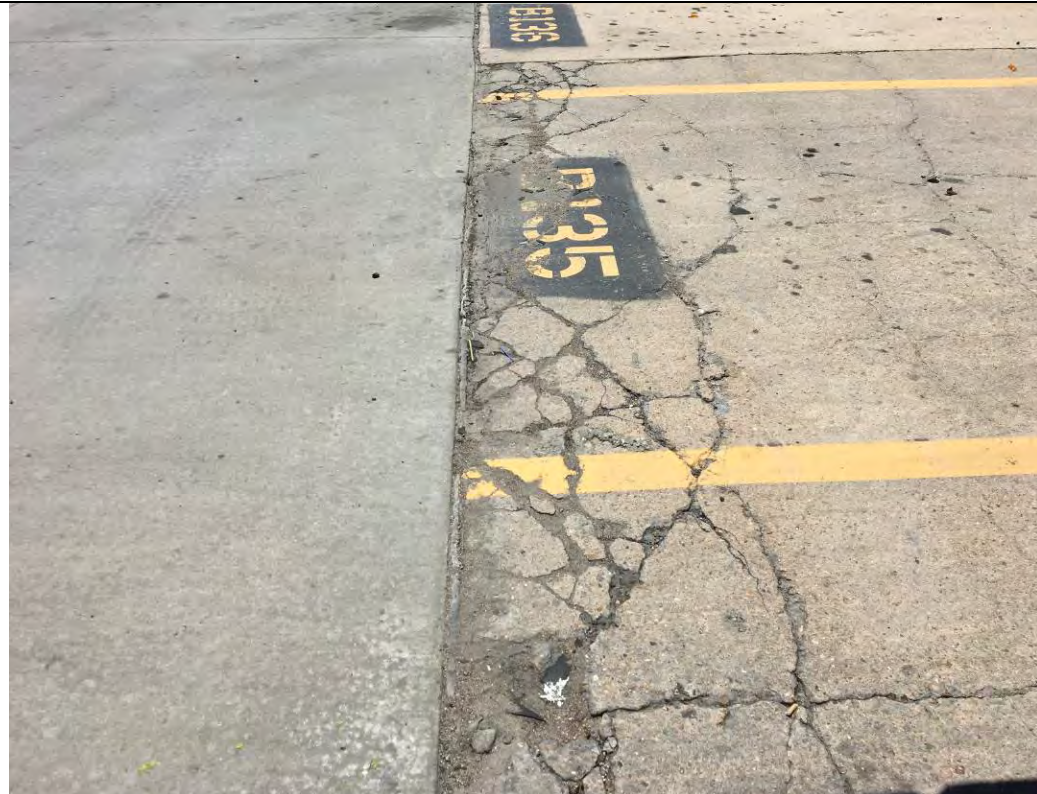
- Concrete Cap (Englewood Intermodal Yard) – Cracks in the pavement were noted, but no soil appeared to be exposed (Photo No. 36 (Lat: 29.78383889, Long: -95.32166943)). In the area of parking slots B100 to B109, the tar-like substance was observed during the inspection surfacing through the joints and cracks in the concrete and asphalt surfaces in the area shown in the attached Figure 2 (Photo Nos 27 through 32 (Lat: 29.78413889, Long: -95.32093056)). Weekly inspections and recovery of the tar-like substance continue to be conducted.

Photo No.: 36	Date: 04/26/18
Description: Concrete Cap Area: Area within B-Row, cracks in the concrete but no exposed soils, looking west. Lat: 29.78383889 Long: -95.32166943

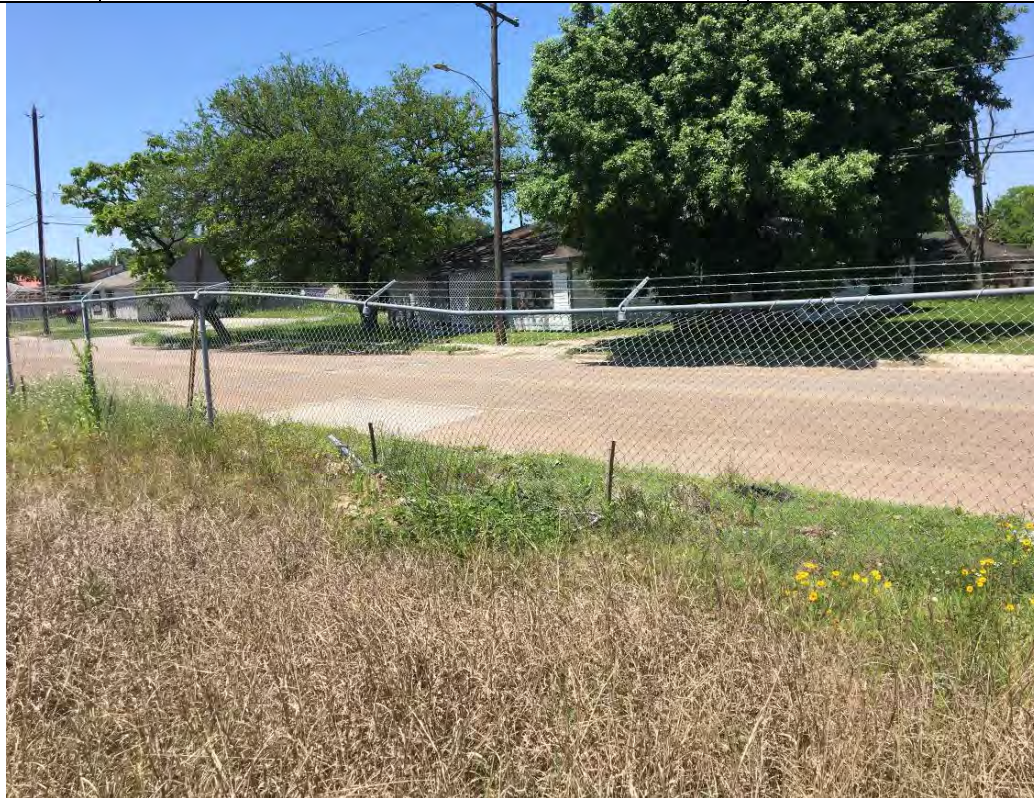
Photo No. 49	Date: 04/26/18
Description: <u>Perimeter Fence:</u> Perimeter fence with missing posts and damaged mesh. Fence appears to have been impacted by a vehicle. Looking northwest. Lat: 29.78755278 Long: -95.32243333

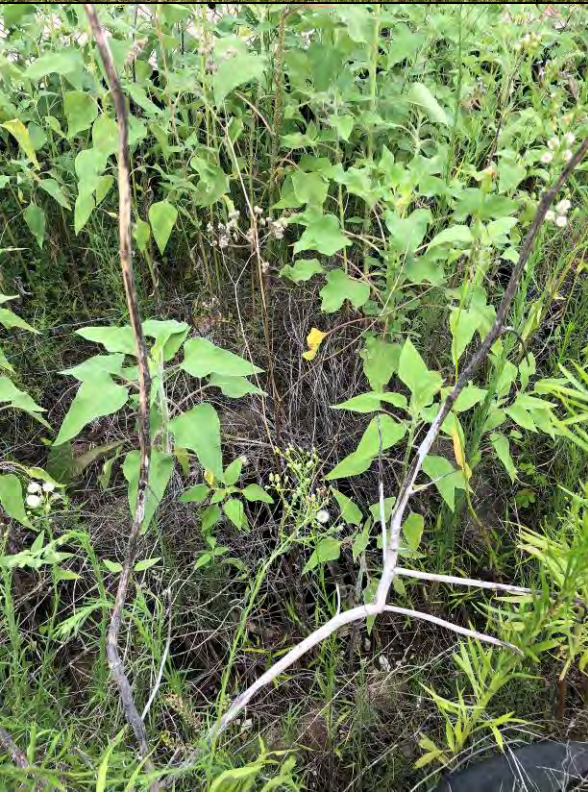
Photo No. 8	Date: 07/05/18

Description: Soil Cap Area: Manhole without a cover surrounded by heavy vegetation near Liberty Rd and Erastus St intersection, looking north. Lat: 29.78761389 Long: -95.31784167000002

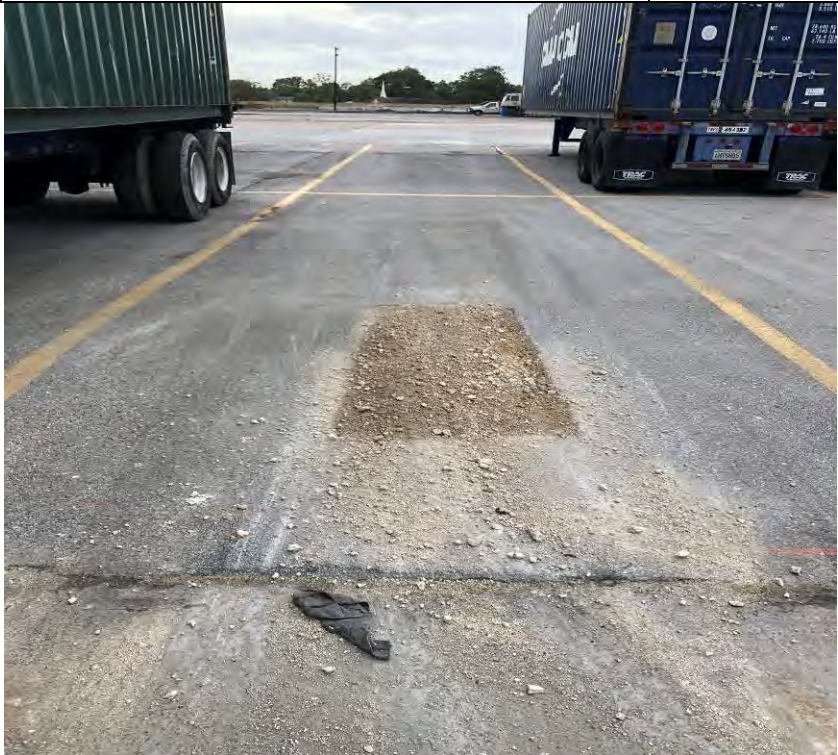
Photo No. 11	Date: 10/31/18
Description: <u>Concrete Cap Area</u> <u>(Englewood Yard):</u> B13 Stall & Test Pit. No evidence of recent NAPL seepage. Facing north. Lat: 29.47713000000000477 Long: -95.19567999999999308

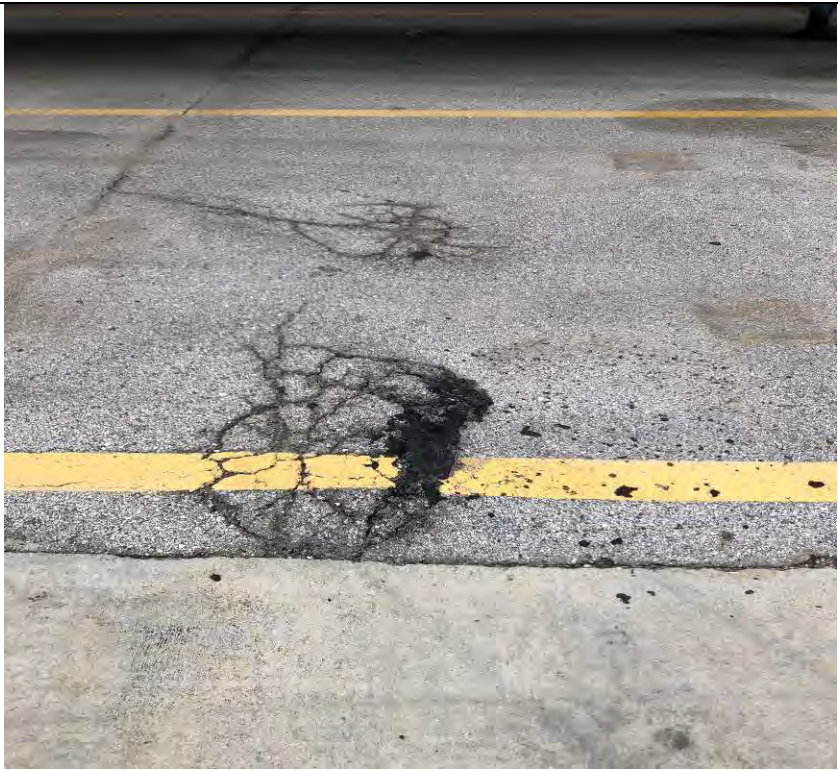
Photo No. 12	Date: 10/31/18
Description: <u>Concrete Cap Area</u> <u>(Englewood Yard):</u> B57 Stall. Evidence of pavement structural deterioration and past NAPL seepage. No evidence of recent seepage. Facing east. Lat: 29.474850000000000582 Long: -95.191032000000000707
