March 31, 2020

Project No. 19119232

**RE: POST-RESPONSE ACTION COMPLETION REPORT – 2019  
UNION PACIFIC RAILROAD HOUSTON WOOD PRESERVING WORKS, HOUSTON, TEXAS  
4910 LIBERTY ROAD, HOUSTON, HARRIS COUNTY, TEXAS  
TCEQ SWR NO. 31547; TCEQ PERMIT/COMPLIANCE PLAN NO. 50343EPA ID NO. TXD000820266  
CUSTOMER NO. CN600131098; REGULATED ENTITY NO. RN100674613**

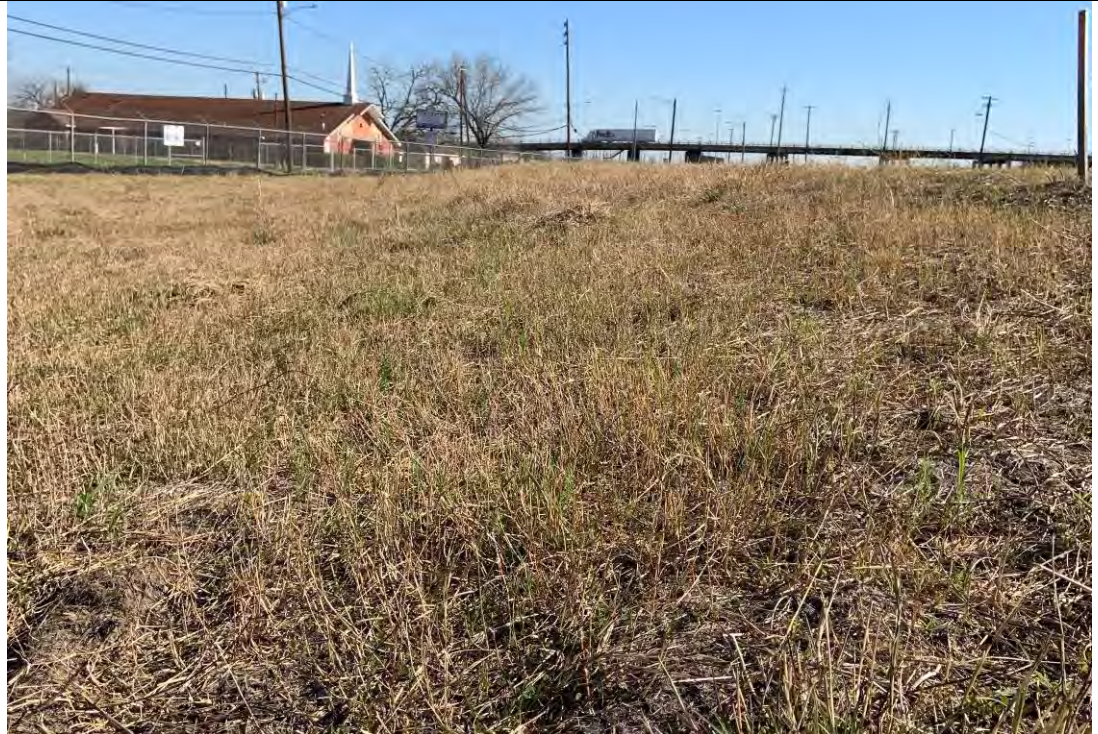
Soil cap well-vegetated in most areas with a low risk of erosion. No major rills observed during inspection. Facing east.

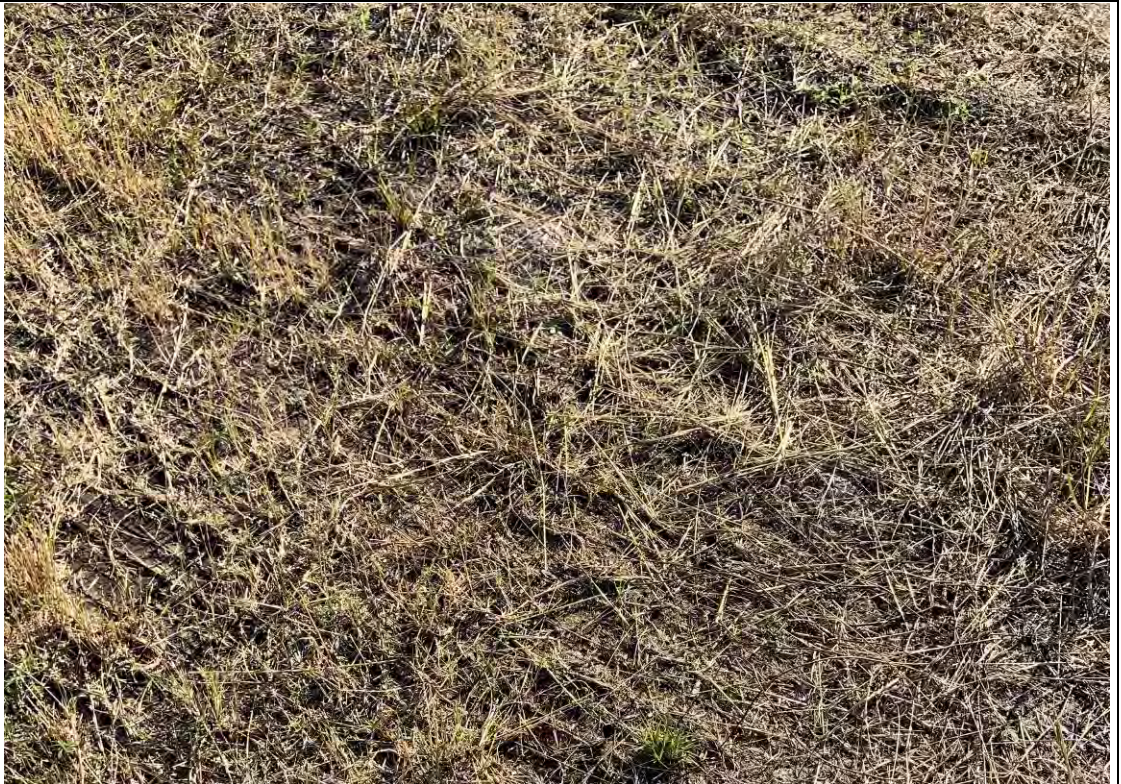
**Photo No.**  
**4**

Soil cap well-vegetated in most areas with a low risk of erosion. No major rills observed during inspection. Facing east.

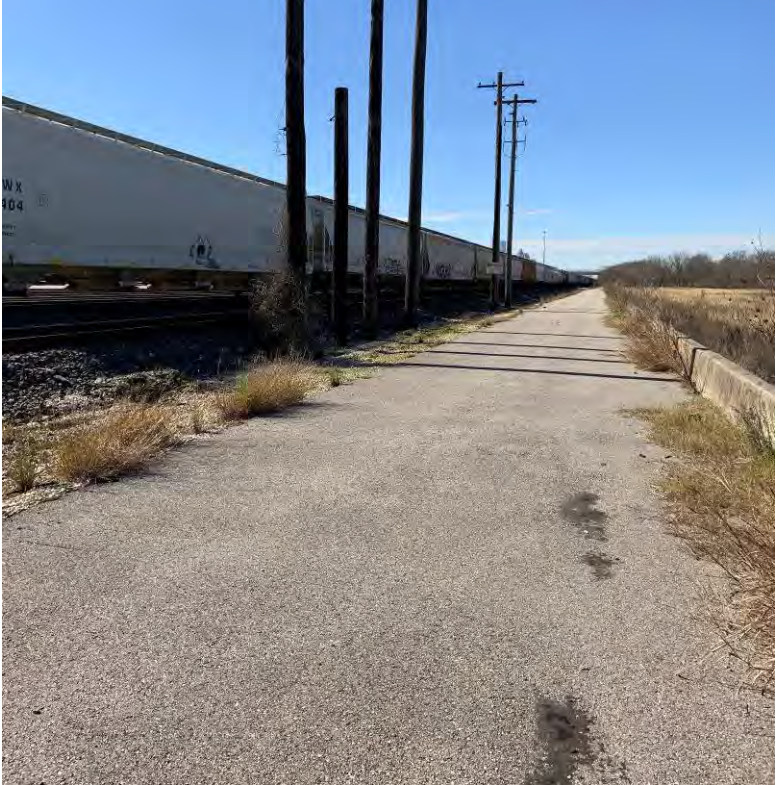
<b>Description:</b>  <b><u>Asphalt Road and Ballast Cap:</u></b> Vegetation growth in ballast cap area. Note small oily stains on pavement, appear the same compared to previous inspections. Facing west.  Lat: 29.785356 Long: -95.321646			
<b>Photo No.</b> <b>12</b>	<b>Date:</b> 1/11/19

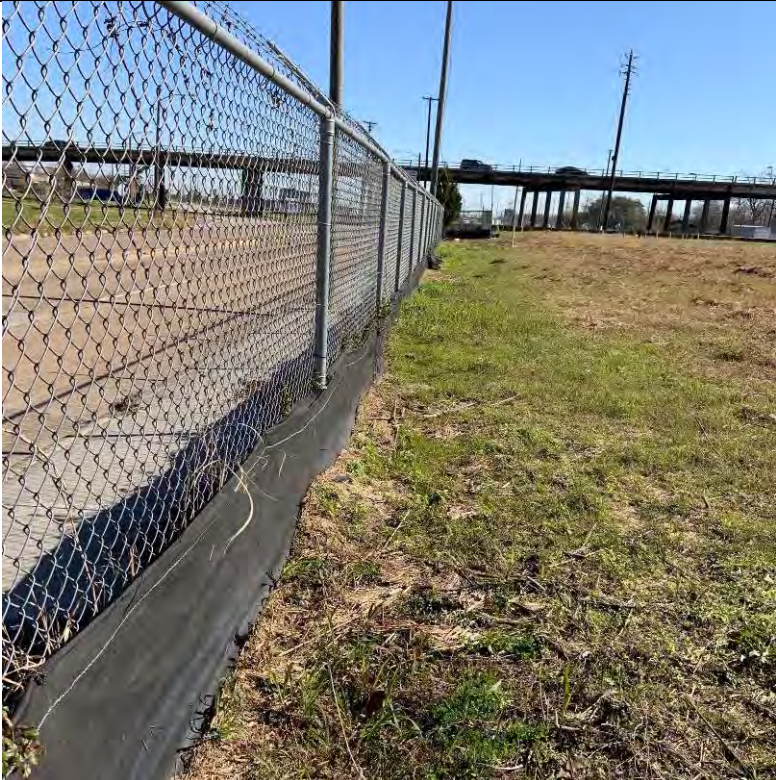
<b>Description:</b>  <b><u>Soil Cap/Security Fence/Concrete Sidewalk Cap:</u></b> View of north side of Soil Cap,(right) and concrete sidewalk cap (left), security fence in good shape Facing east.  Lat: 29.787614 Long: -95.317642

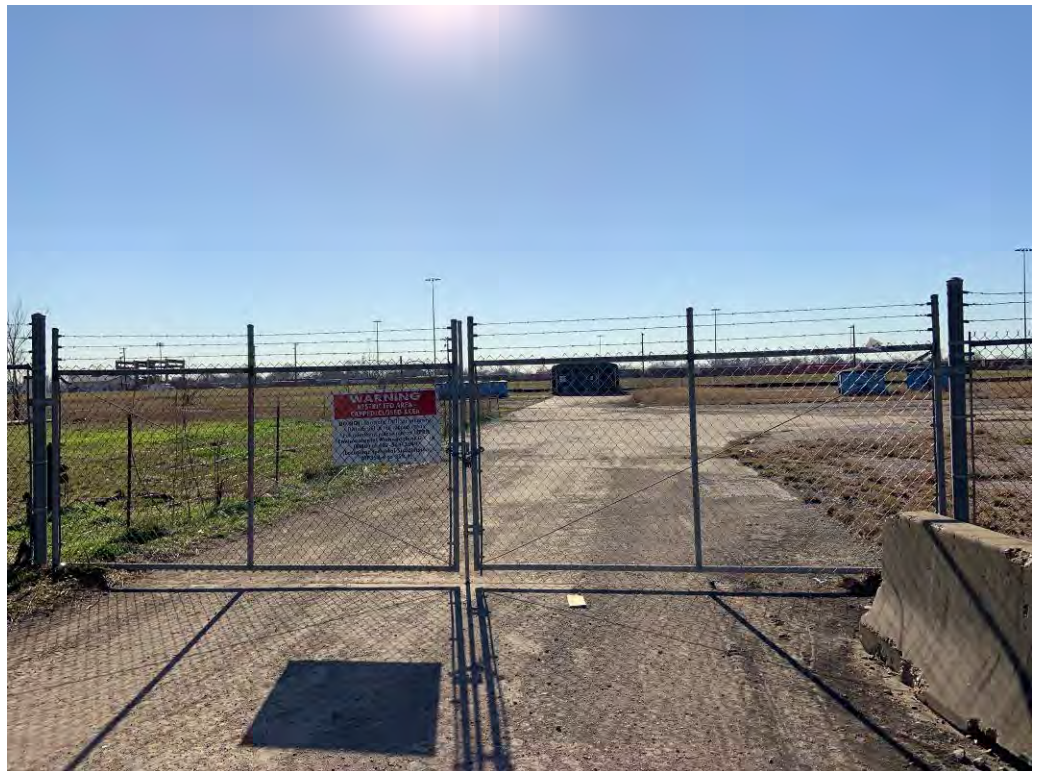
View of main entrance gate. Trash and broken glass in front of photo (out of view). Facing South.

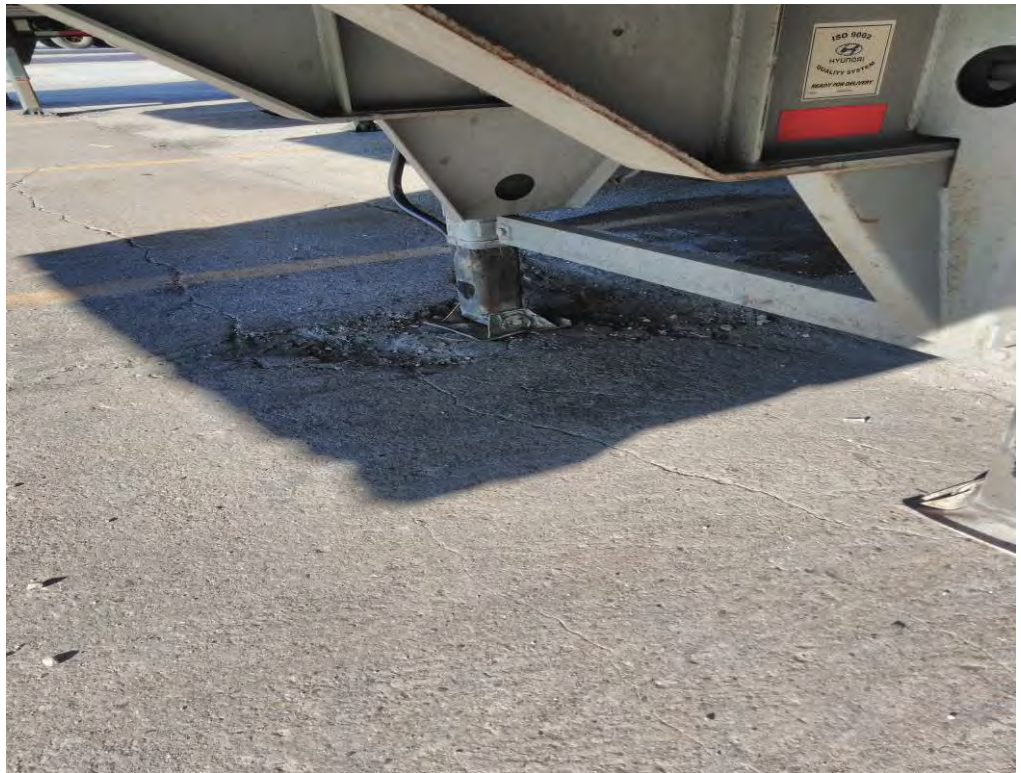
**Concrete Cap Area**  
**(Englewood Yard):**  
Slot B54 Heavy  
cracking. Facing west.

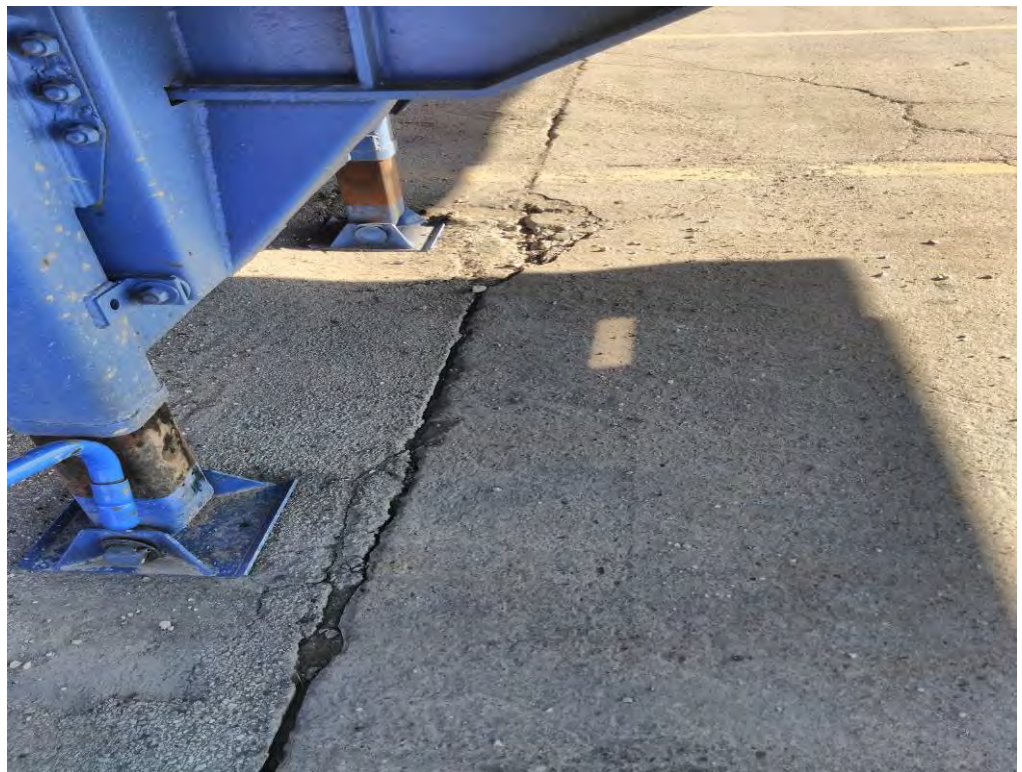
Slot B100. Some  
cracking along joint.  
Facing northeast.

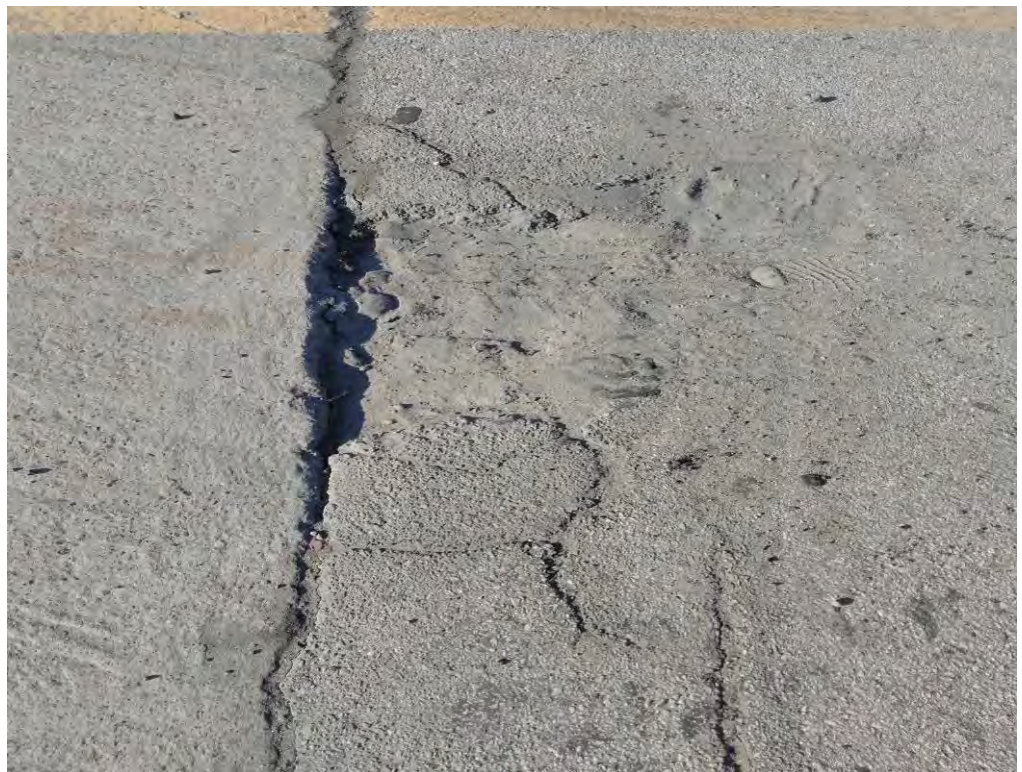
Slot B102, noted  
cracking in pavement.  
Facing west.

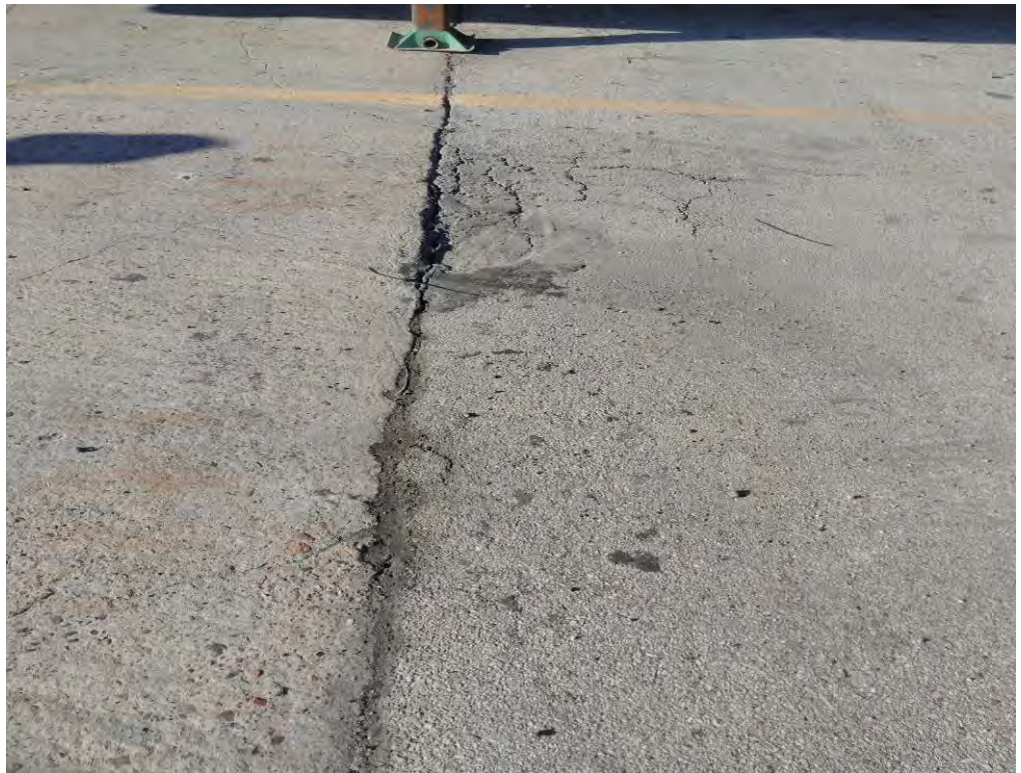
**Concrete Cap Area**  
**(Englewood Yard):**  
Slot B103. Cracks in  
pavement along joint.  
Facing west.

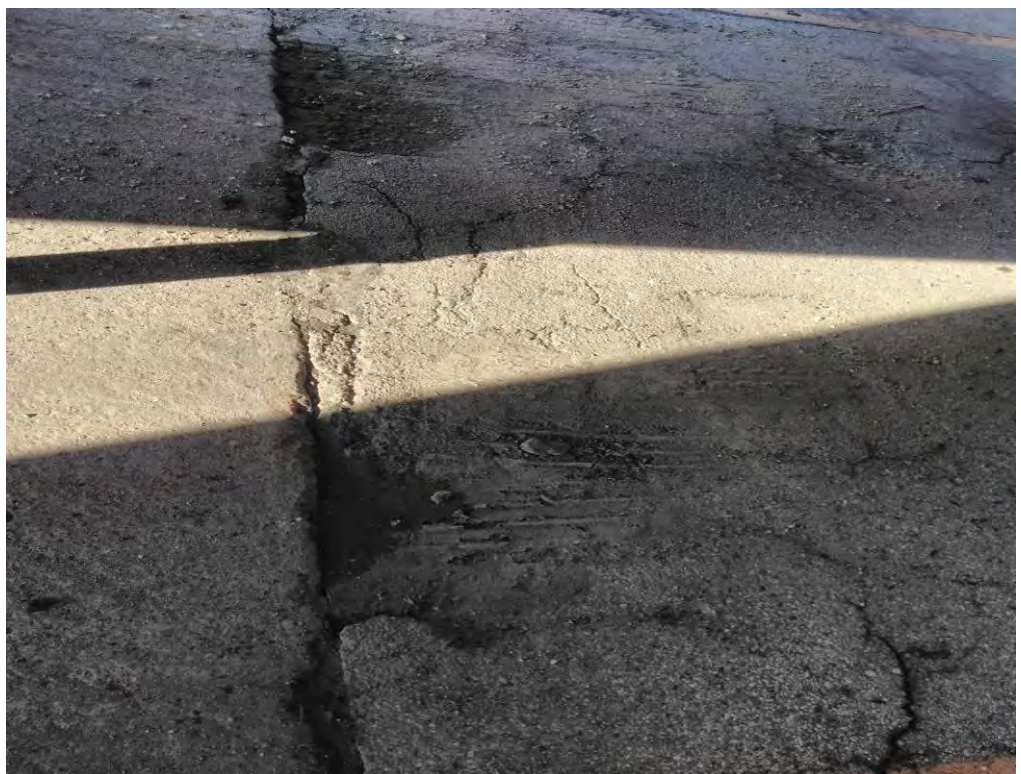
**Photo No.**  
**22**

**Concrete Cap Area**  
**(Englewood Yard):**  
Slot B105 Cracks along  
joint. Facing northwest.

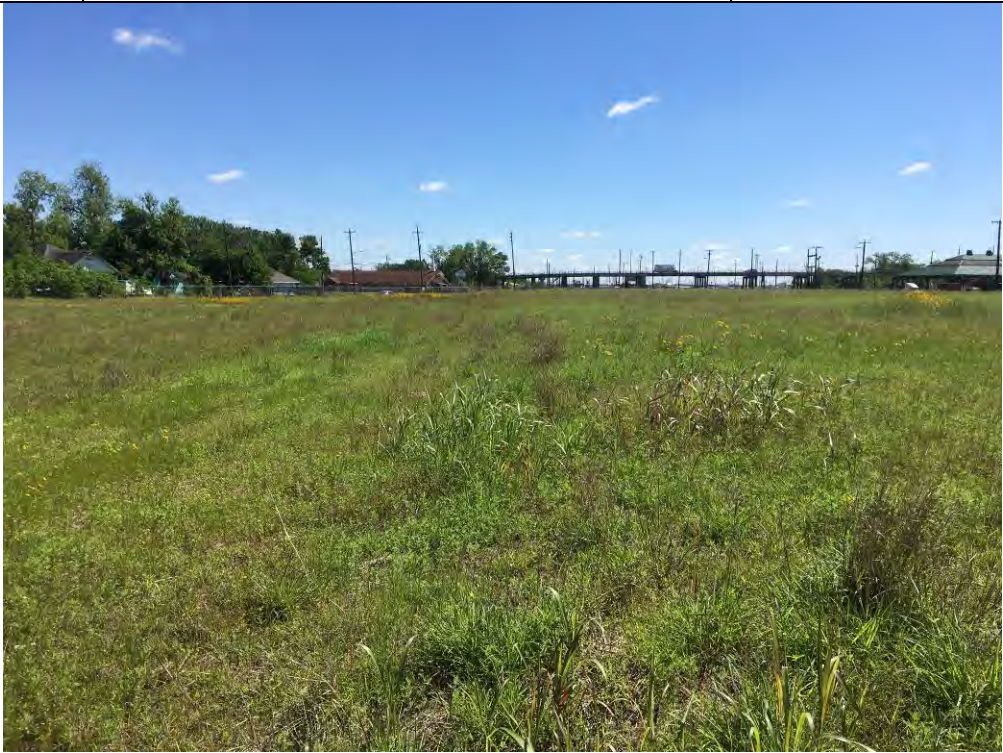
<b>Description:</b>  <b>Soil Cap Area:</b> Soil cap well-vegetated in most areas with a low risk of erosion. No major rills observed during inspection. Facing east.  Lat: 29.786821 Long: -95.320108			
<b>Photo No.</b> <b>2</b>	<b>Date:</b> 04/25/19	 	
<b>Description:</b>  <b>Soil Cap Area:</b> Vegetative growth (pollinators) can be observed along the length of the soil cap. Facing north.  Lat: 29.785959 Long: -95.320891

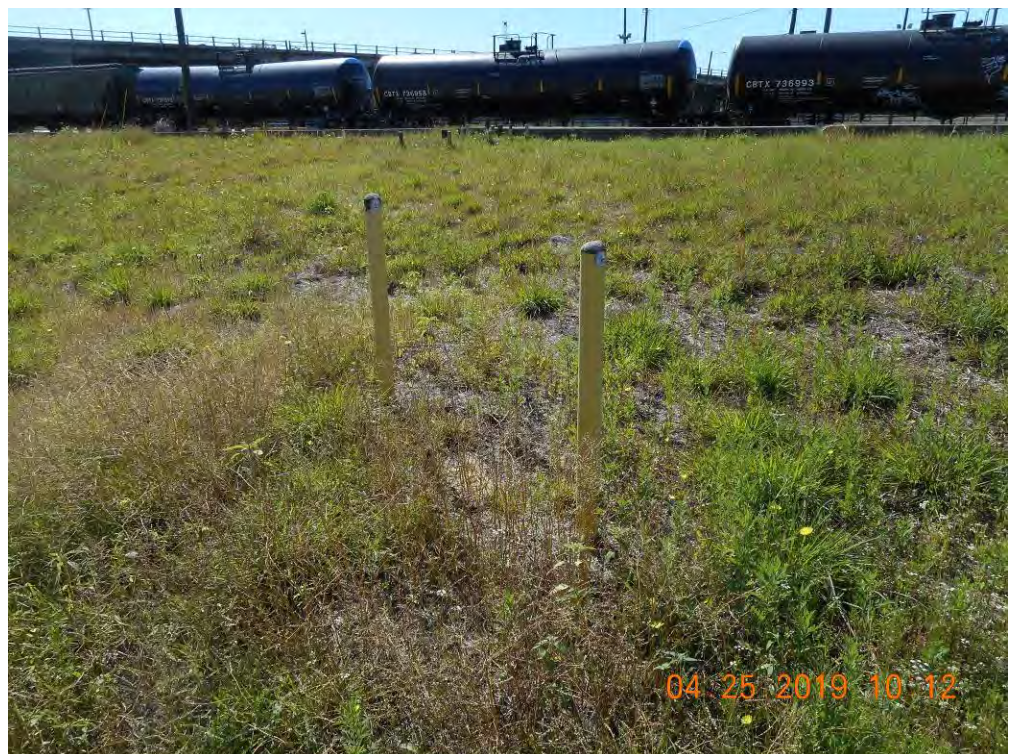
Vegetative growth (pollinators) can be observed along the length of the soil cap, view of monitoring well MW-23C. Facing south.

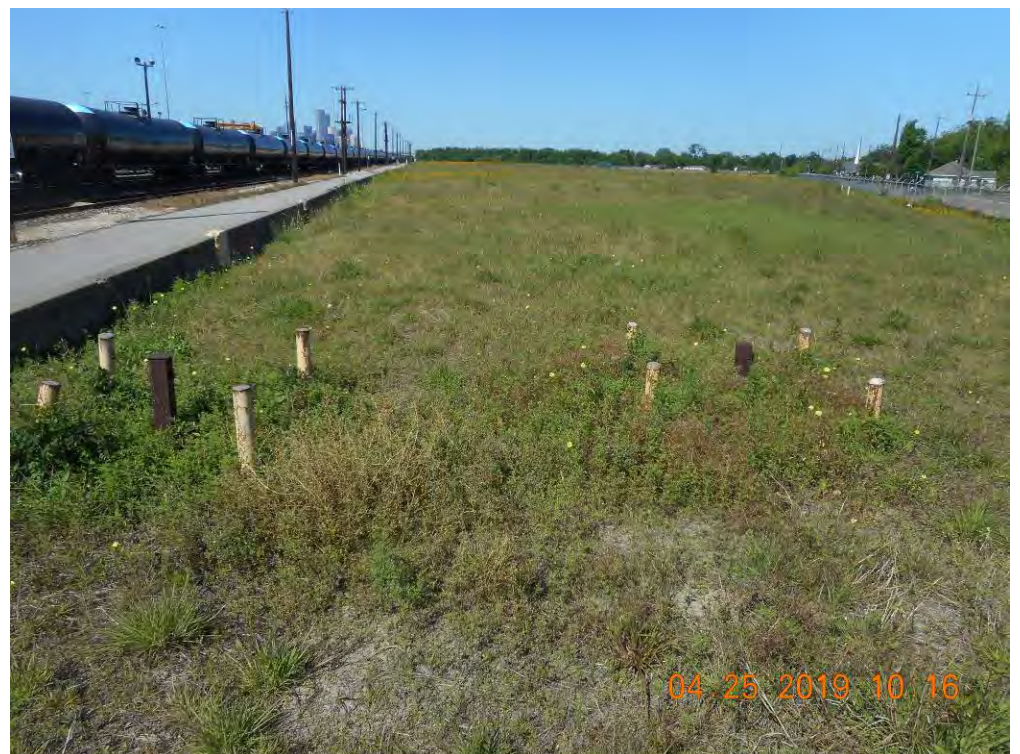
View of monitoring wells MW-  
18A and MW-18C within soil cap  
area, vegetative growth  
(pollinators) can be observed.  
Small bare spots in foreground  
of photo. Facing west.

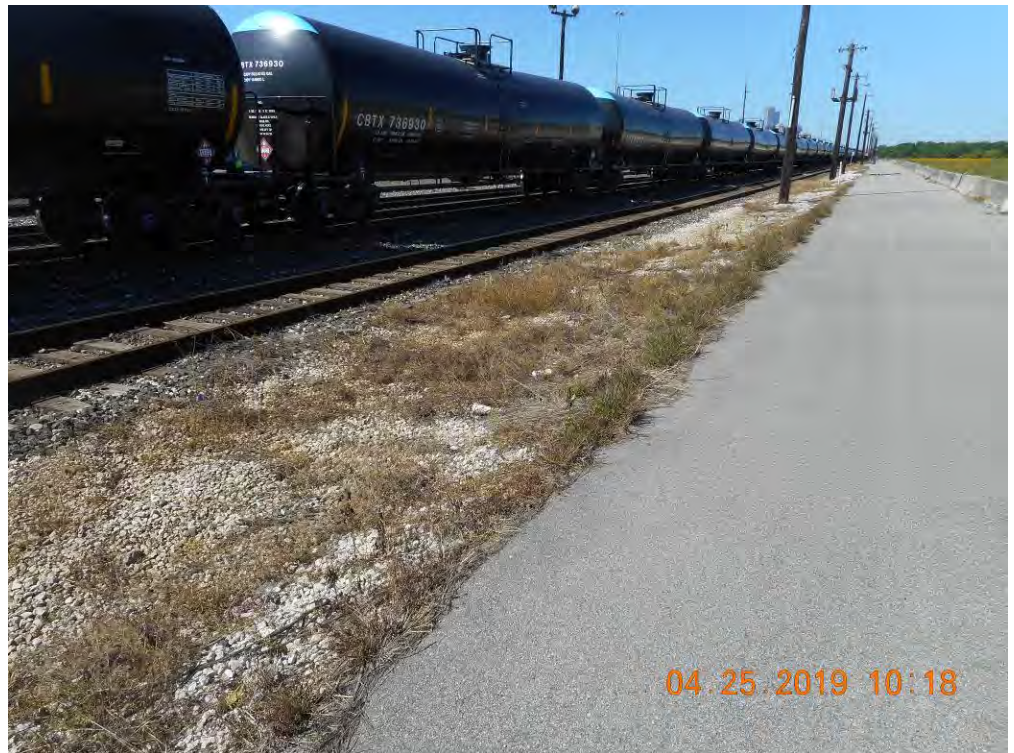
Asphalt roadway in good condition, free of major cracking/damage. Some areas of vegetation growth in ballast cap. Facing west.

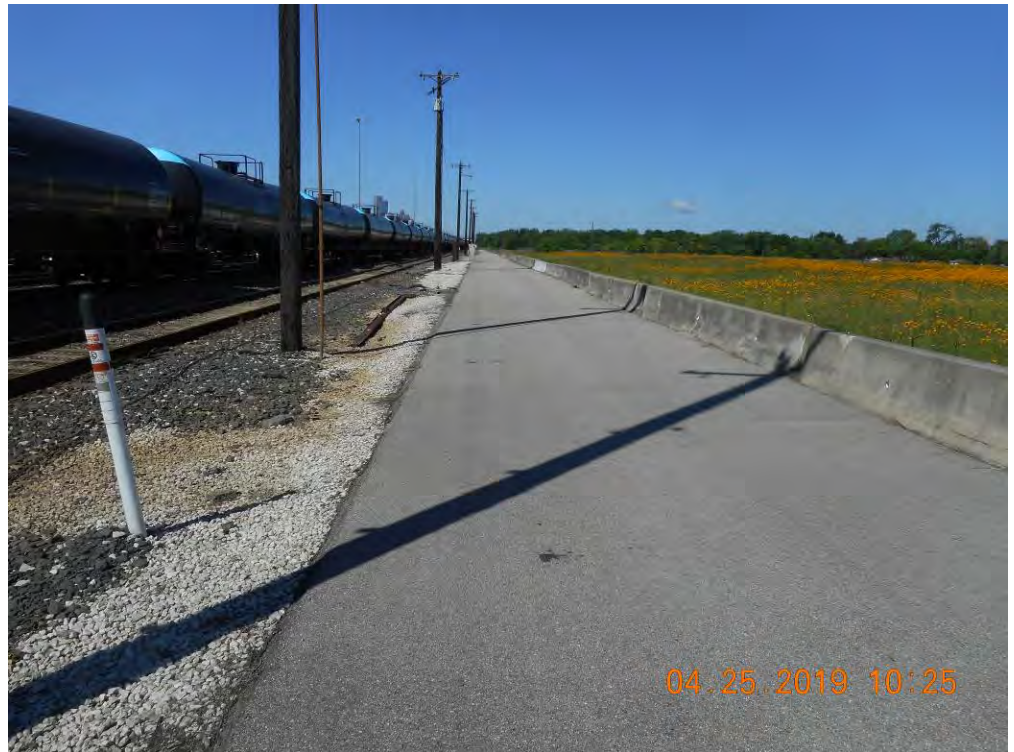
Ballast cap area in good condition with some areas of vegetation growth. Asphalt roadway in good condition. Note pollinators on soil cap on right of photo. Facing west.

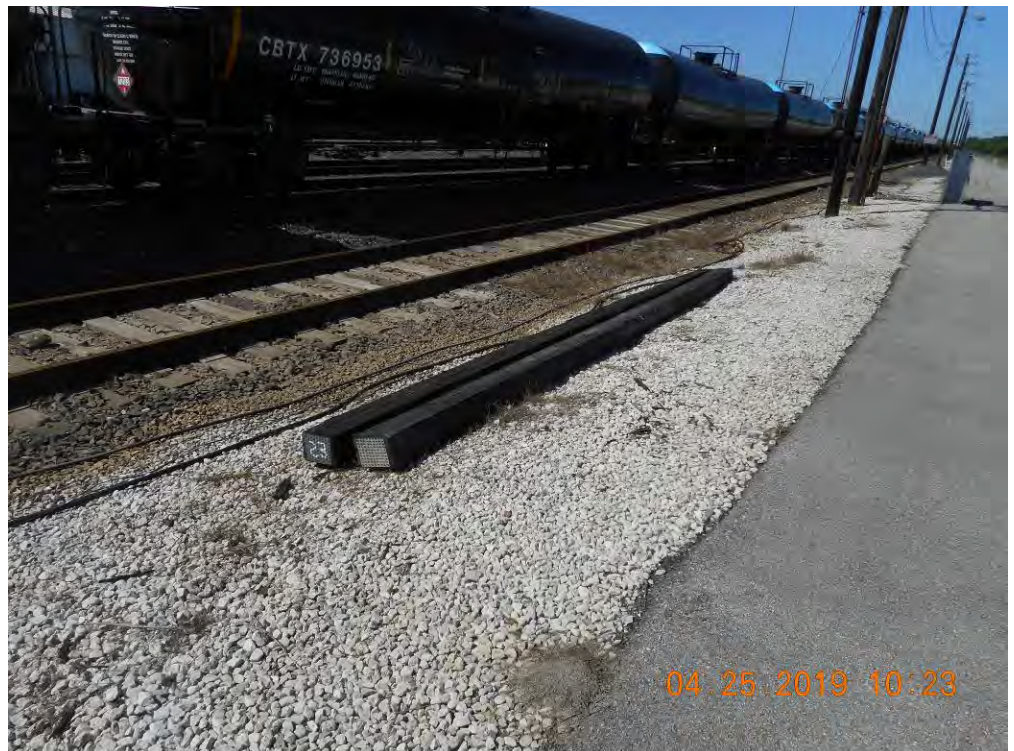
**Photo No.**  
**10**

Some lumber can be found in the ballast area. Facing south.

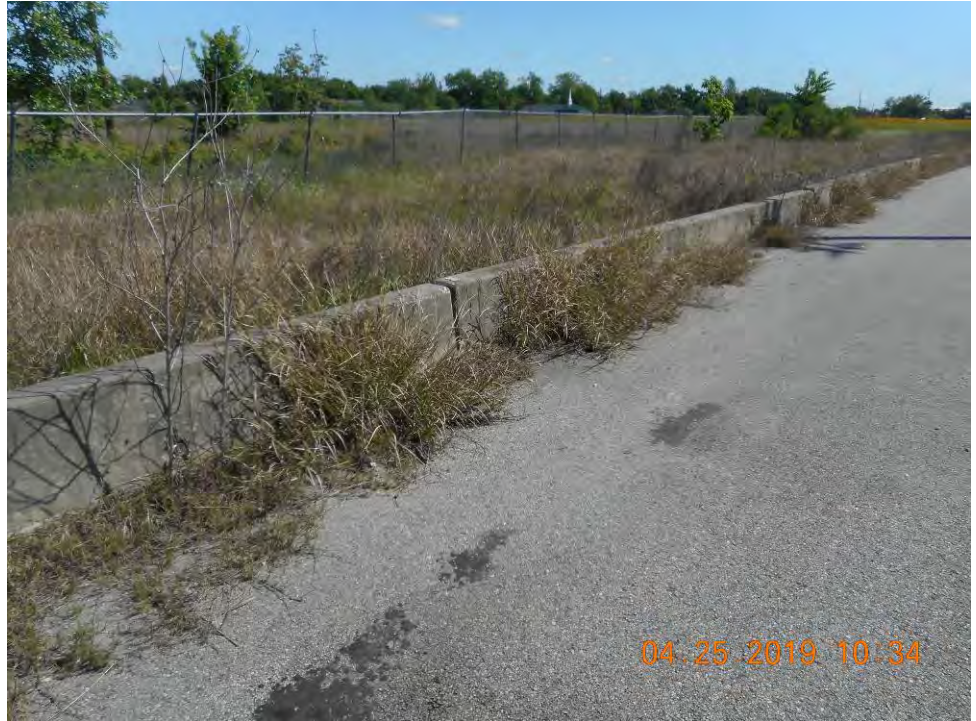
Weeds growing under the concrete barriers. Small oil stains noted, and appear similar to previous inspections. Facing east.

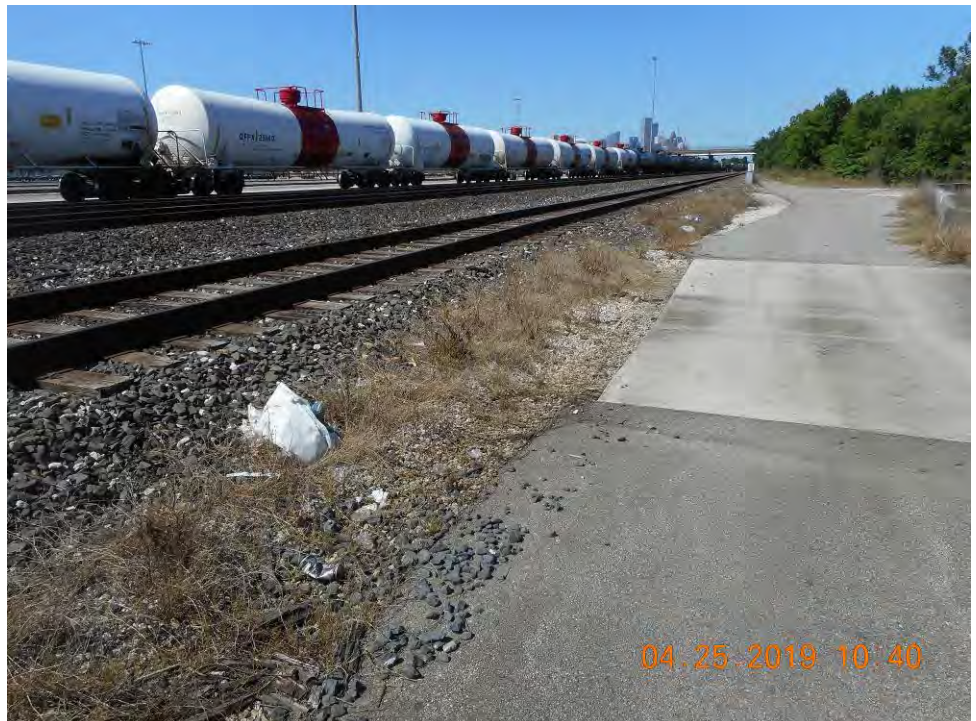
**Photo No.**  
**12**

Some weeds noted on the ballast cap area. Low water crossing within asphalt cap in good shape. Facing west.

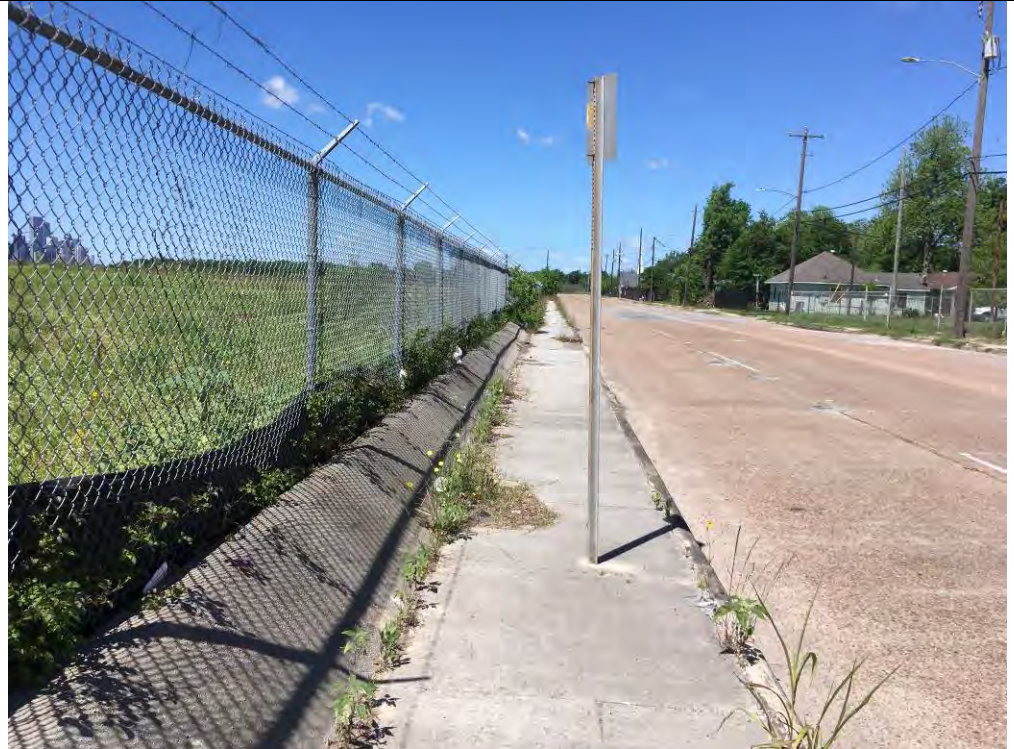
Sidewalk and security fence in good condition. Some areas of vegetation along joints in the sidewalk, damage/silt fencing ripped can be seen. Facing west.

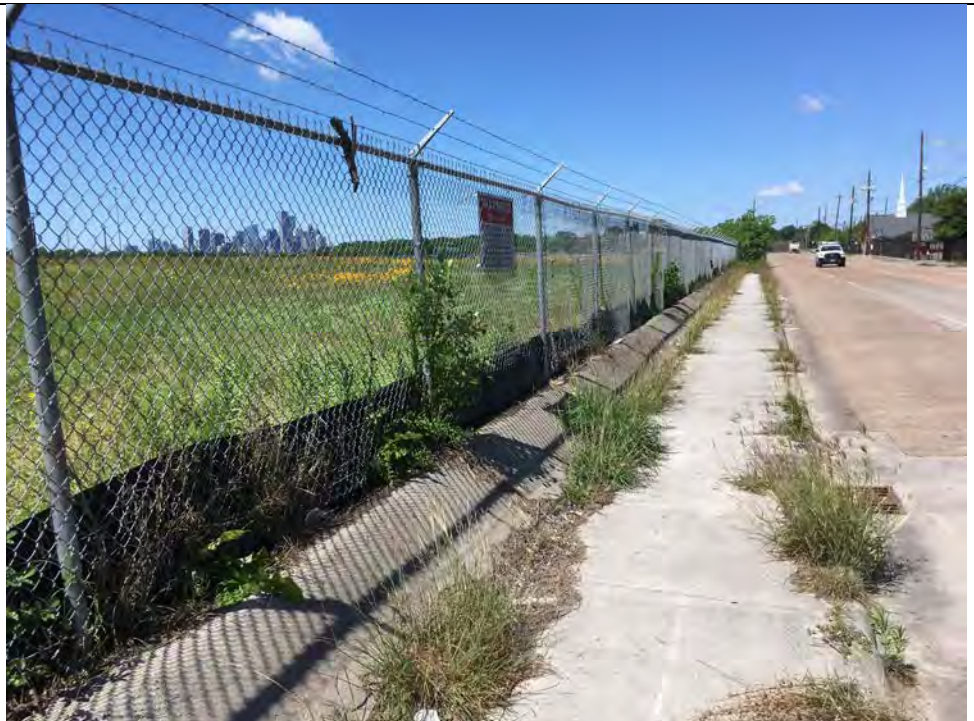
**Photo No.**  
**14**

Sidewalk and security fence in good condition. Areas of vegetation along joints in the sidewalk, Signage in good shape along fence. Facing west.

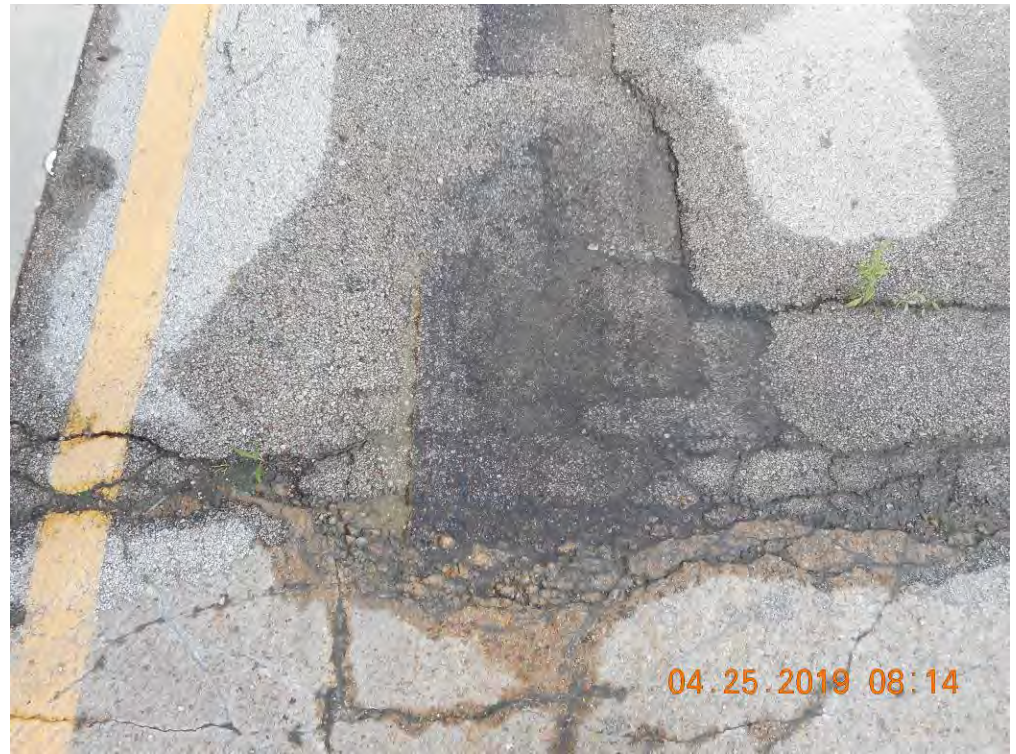
Some cracking/craters in the pavement can be observed in the B Row of the Englewood Yard area. Facing north.

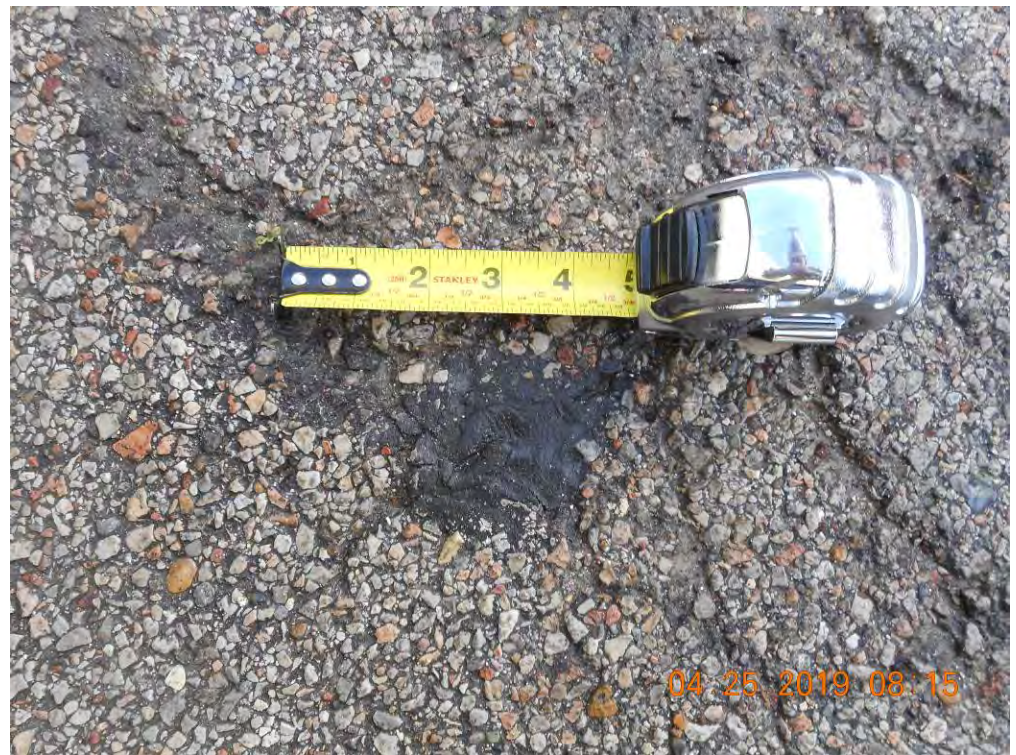
**Photo No.**  
**22**

Slot B057. Evidence of recent NAPL seepage and minor cracking. Facing north.

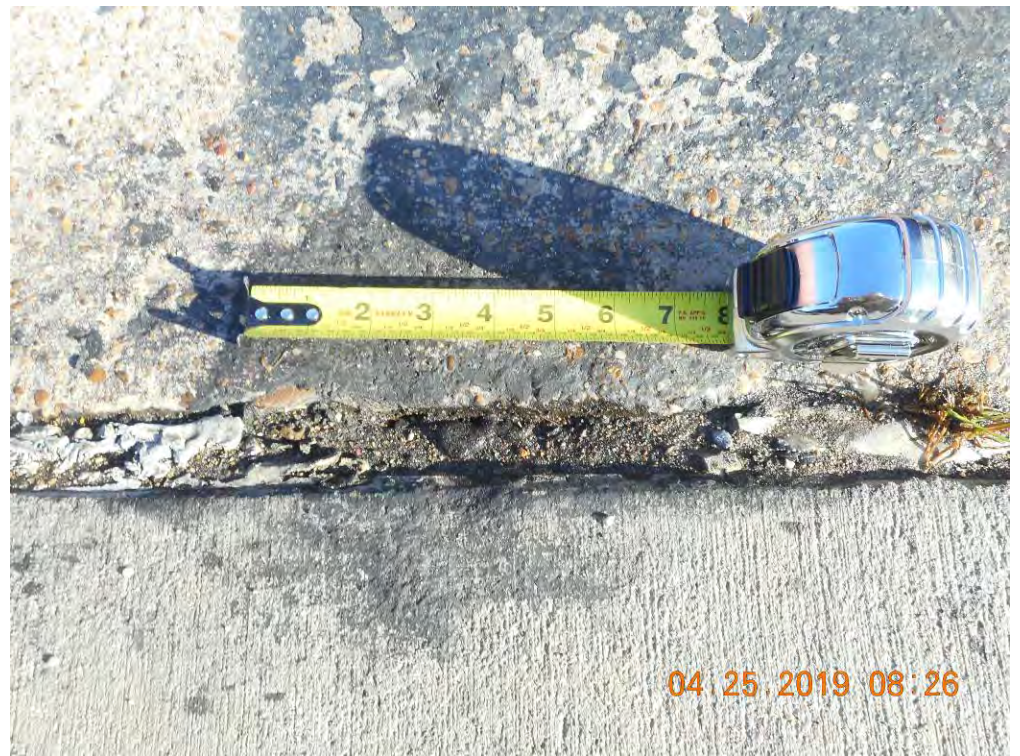
Slot B096,. Evidence of recent NAPL seepage along front of stall. Evidence of missing joint sealant can be observed in the Yard Area along the front of some stalls. Facing north.

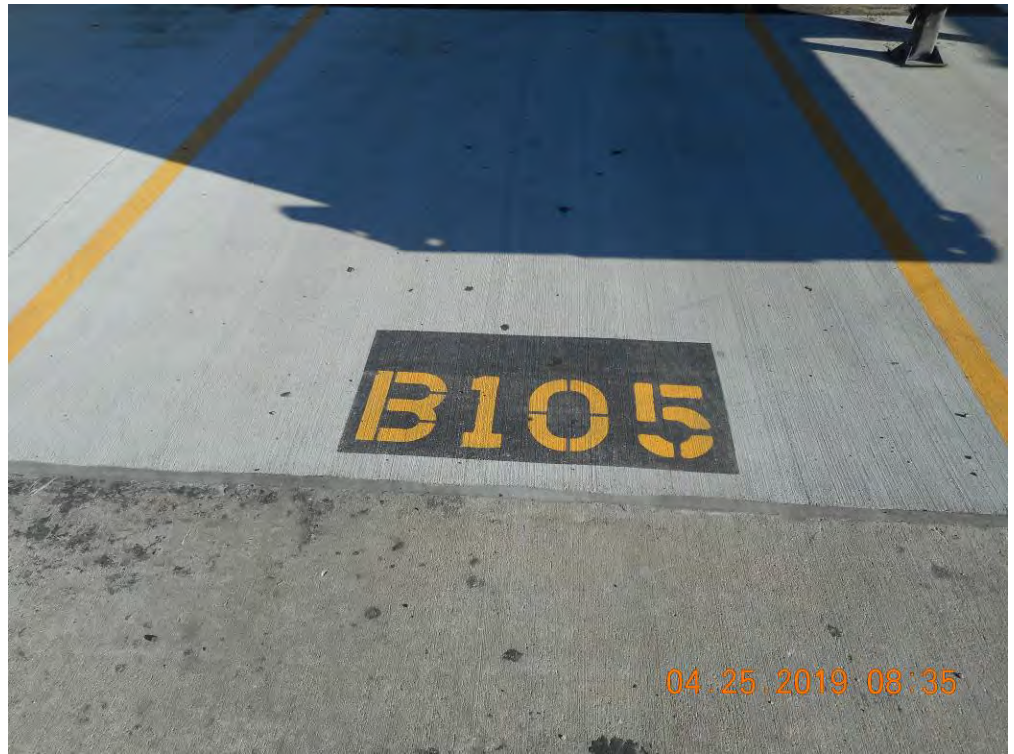
Slot B105. Recently installed  
NAPL Collection System with  
little evidence of cracking, stains,  
etc. Facing north.

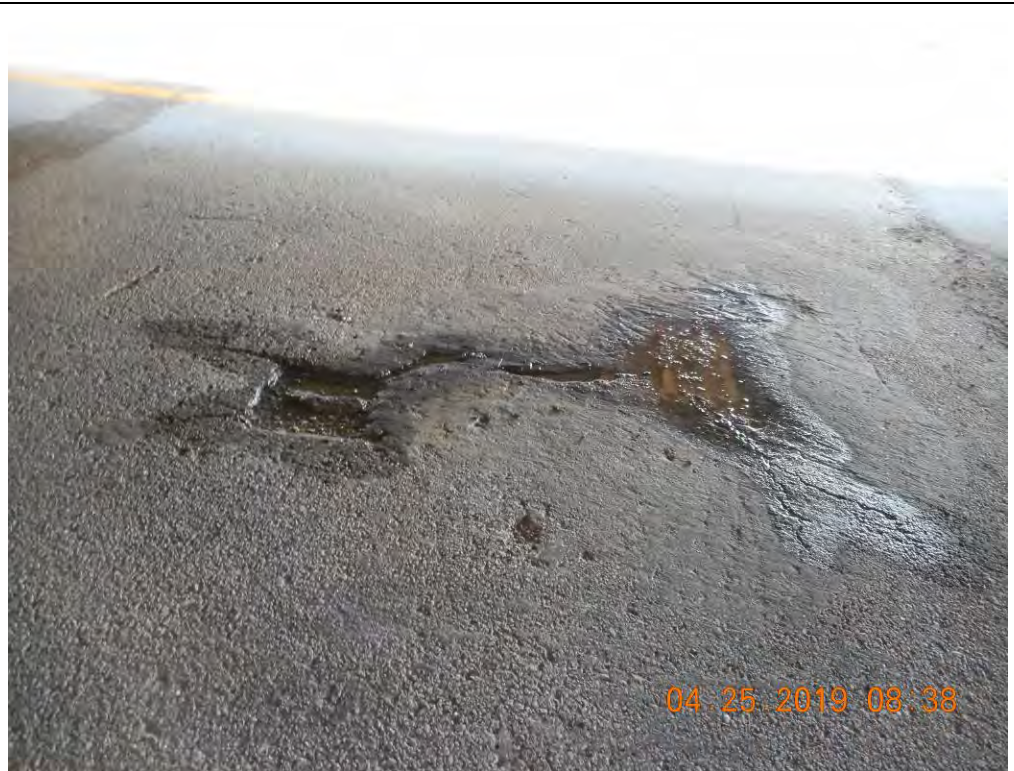
**Photo No.**  
**26**

Slot B108. Some evidence of  
staining in depressions in stall  
surfaces. Facing west.

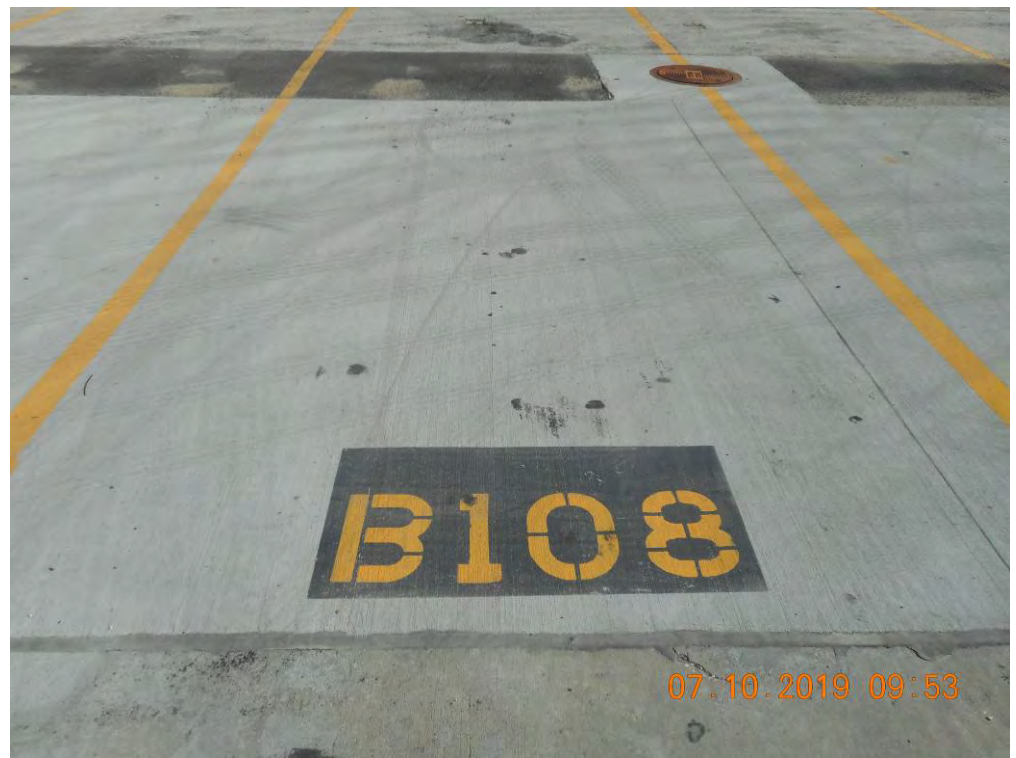
<b>Photo No.</b> <b>27</b>	<b>Date:</b> 07/10/2019
<b>Description:</b>  <b><u>Concrete Cap Area</u></b> <b><u>(Englewood Yard):</u></b> Stall B108. Recently installed concrete/asphalt area in stalls B099-B110 in good condition with little evidence of cracking, stains, etc. Facing northwest.  Lat: 29.784173 Long: -95.321042

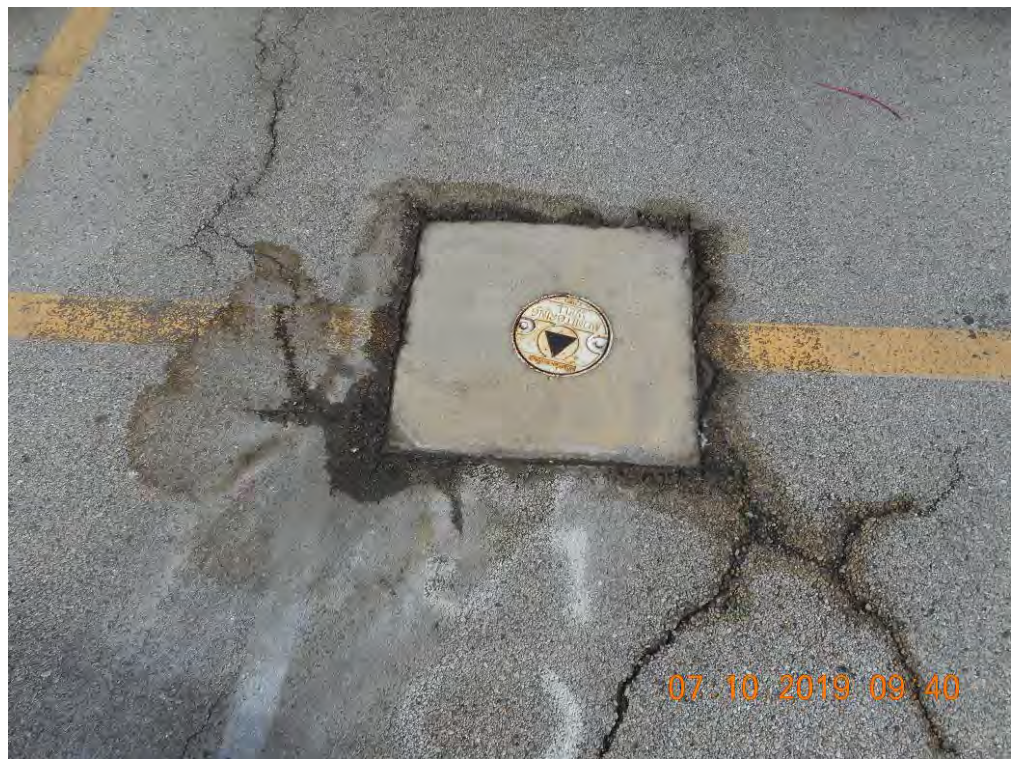
<b>Photo No.</b> <b>28</b>	<b>Date:</b> 07/10/2019
<b>Description:</b>  <b><u>Concrete Cap Area</u></b> <b><u>(Englewood Yard):</u></b> Slot B096. Some evidence of staining from brown water near monitoring well MW-85C. Facing northwest.  Lat: 29.784371 Long: -95.320708

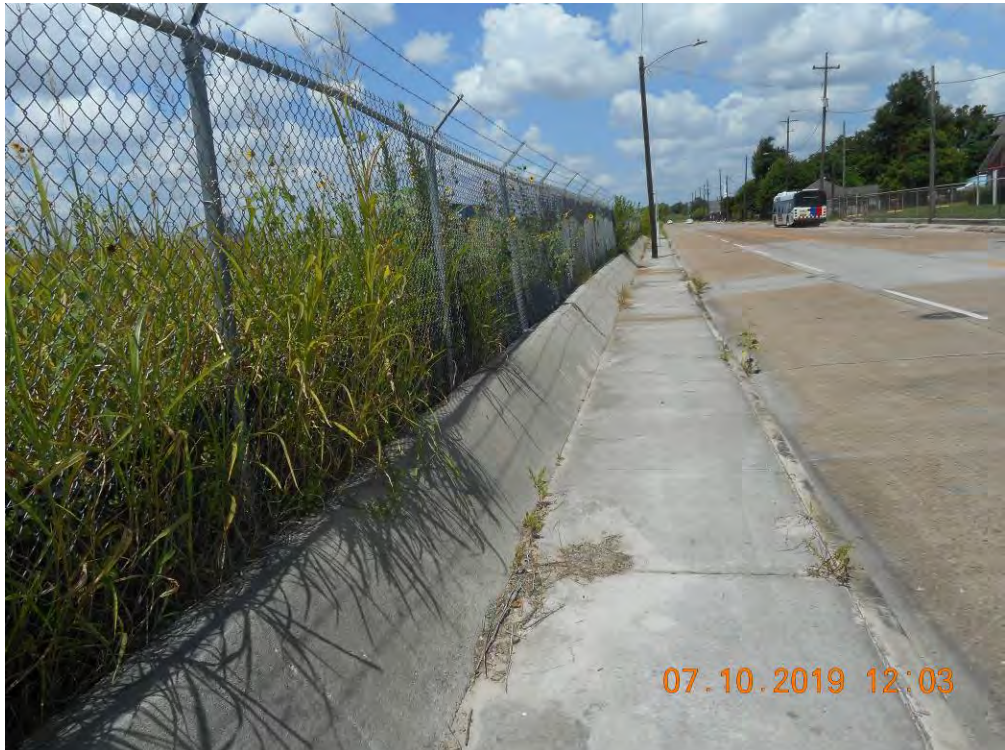
<b>Description:</b>  <b>Concrete Sidewalk Cap:</b> Concrete sidewalk cap in good condition, some weeds/grass growing up within joints. Facing west.  Lat: 29.787641 Long: -95.317236
