March 31, 2020

Project No. 19119232

**RE: POST-RESPONSE ACTION COMPLETION REPORT – 2019  
UNION PACIFIC RAILROAD HOUSTON WOOD PRESERVING WORKS, HOUSTON, TEXAS  
4910 LIBERTY ROAD, HOUSTON, HARRIS COUNTY, TEXAS  
TCEQ SWR NO. 31547; TCEQ PERMIT/COMPLIANCE PLAN NO. 50343EPA ID NO. TXD000820266  
CUSTOMER NO. CN600131098; REGULATED ENTITY NO. RN100674613**

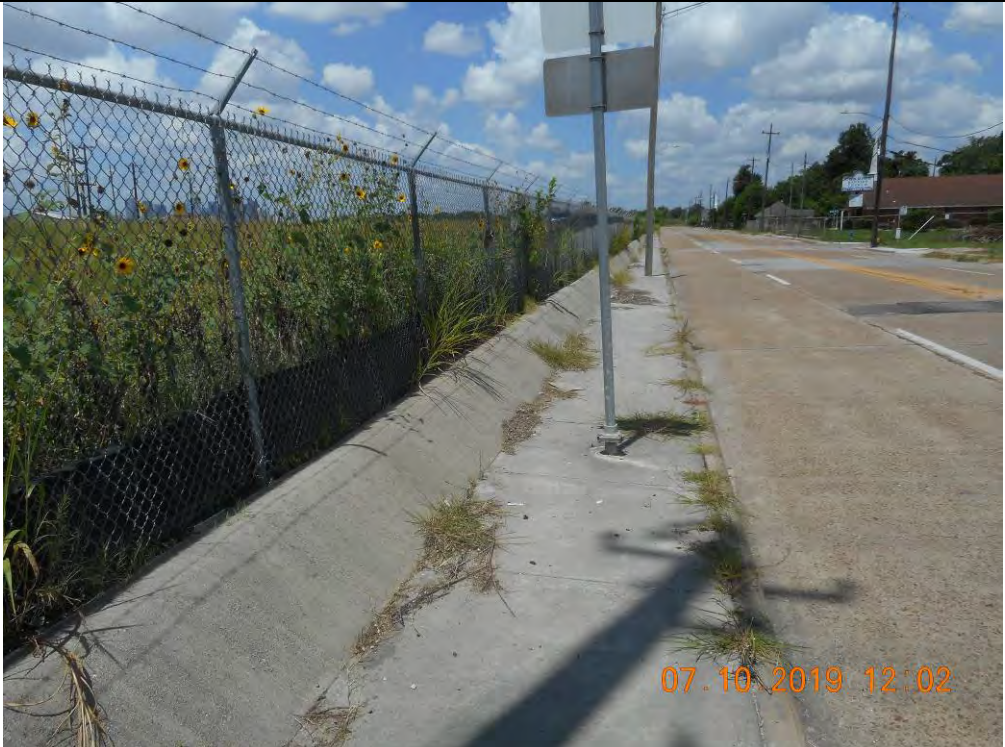
<b>Photo No.</b> <b>32</b>	<b>Date:</b> 07/10/2019

<b>Description:</b>  <b>Concrete Sidewalk Cap:</b> Sidewalk outside security fence in good condition. Some areas have significant vegetative growth and require mowing event. Some areas of damage/silt fencing ripped can be seen. Facing west.  Lat: 29.787621 Long: -95.317774

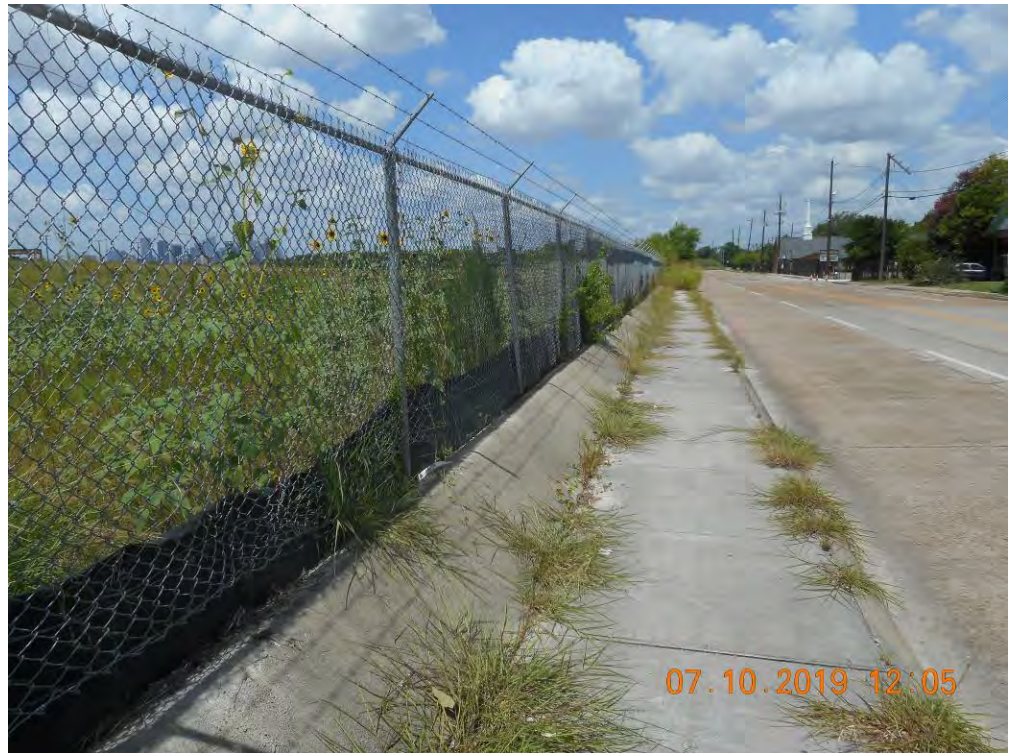
<b>Photo No.</b> <b>33</b>	<b>Date:</b> 07/10/2019
<b>Description:</b>  <b>Concrete Sidewalk Cap:</b> Weeds growing under the concrete barriers. Soil Cap's vegetative cover in good shape. Facing southwest.  Lat: 29.787619 Long: -95.317971

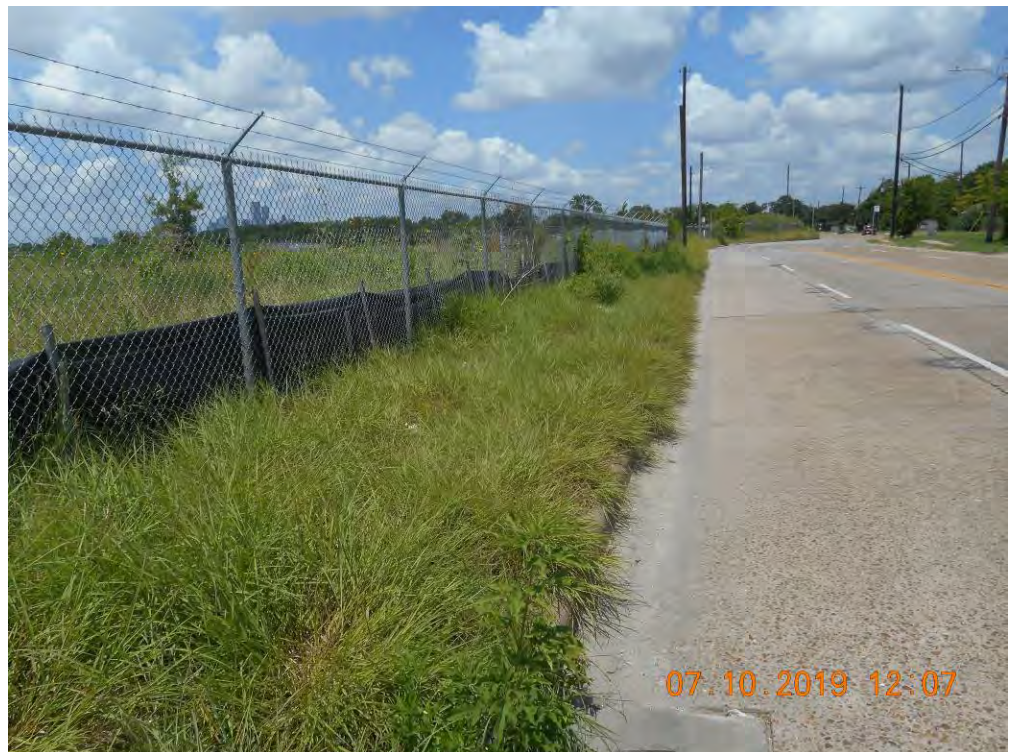
<b>Photo No.</b> <b>34</b>	<b>Date:</b> 07/10/2019
<b>Description:</b>  <b>Security Fence:</b> Security fence along Liberty Road, in good condition. Facing west.  Lat: 29.787526 Long: -95.320386

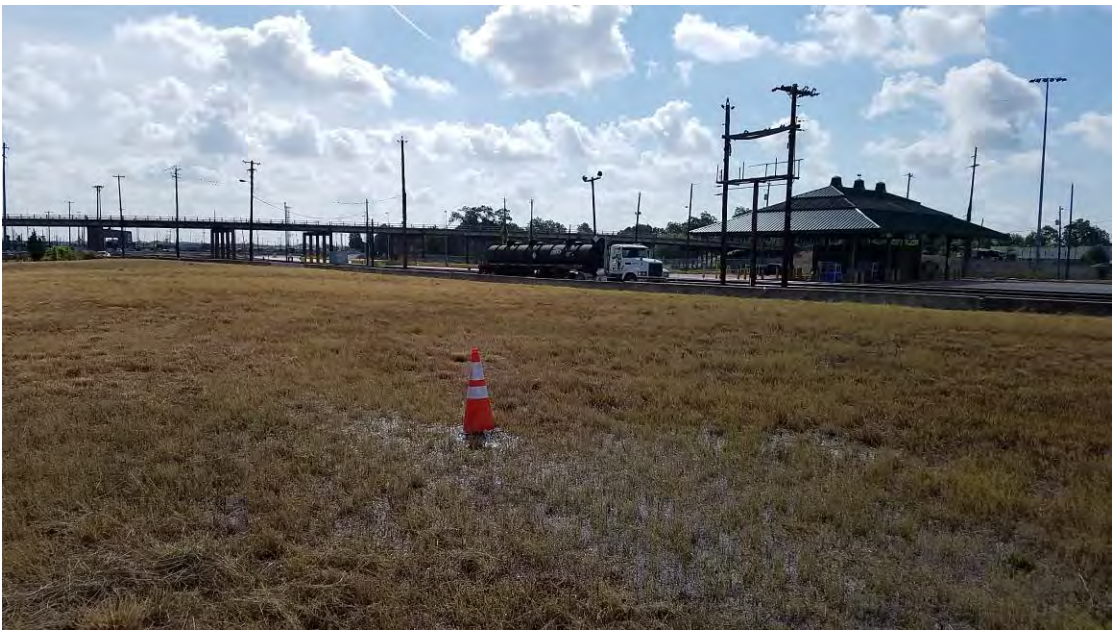
Source area of water line leak at soil cap, looking east.

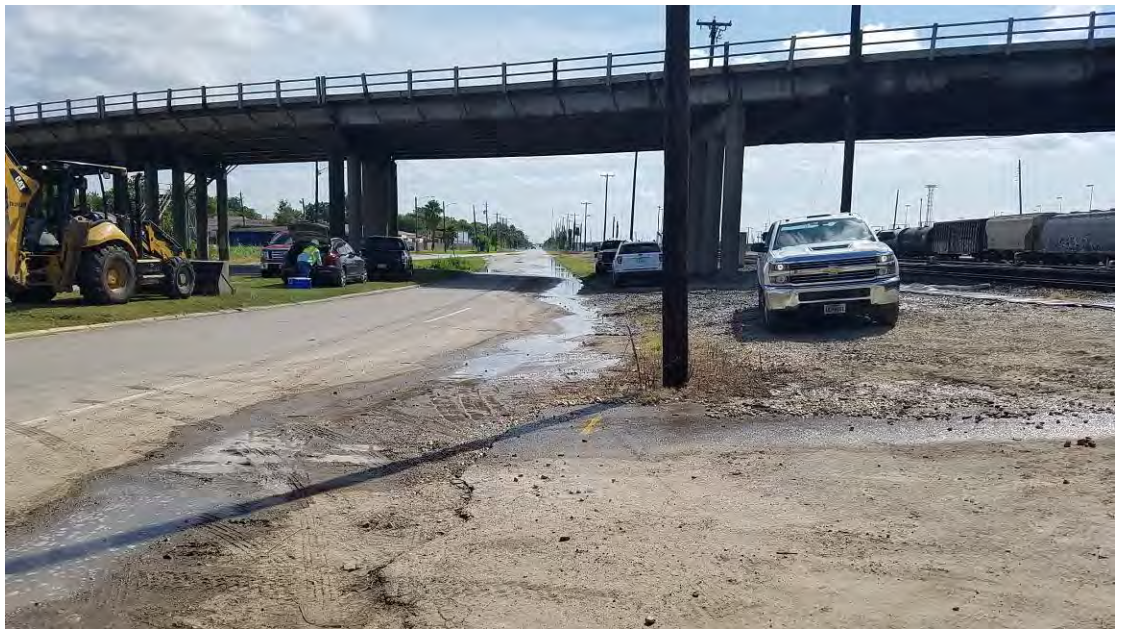
**Photo No.**  
**8**

Runoff reaching Liberty Road, looking East toward Lockwood Drive Bridge.
