**RE: POST-RESPONSE ACTION COMPLETION REPORT – 2020
UNION PACIFIC RAILROAD HOUSTON WOOD PRESERVING WORKS, HOUSTON, TEXAS
4910 LIBERTY ROAD, HOUSTON, HARRIS COUNTY, TEXAS
TCEQ SWR NO. 31547; TCEQ PERMIT/COMPLIANCE PLAN NO. 50343EPA ID NO. TXD000820266
CUSTOMER NO. CN600131098; REGULATED ENTITY NO. RN100674613**

TEXAS COMMISSION ON ENVIRONMENTAL QUALITY Post-Response Action Care Report (PRACR)

SECOND QUARTER 2020 (APRIL 28TH) INSPECTION RECORD AND PHOTOGRAPHIC LOG

THIRD QUARTER 2020 (JULY 23RD) INSPECTION RECORD AND PHOTOGRAPHIC LOGS

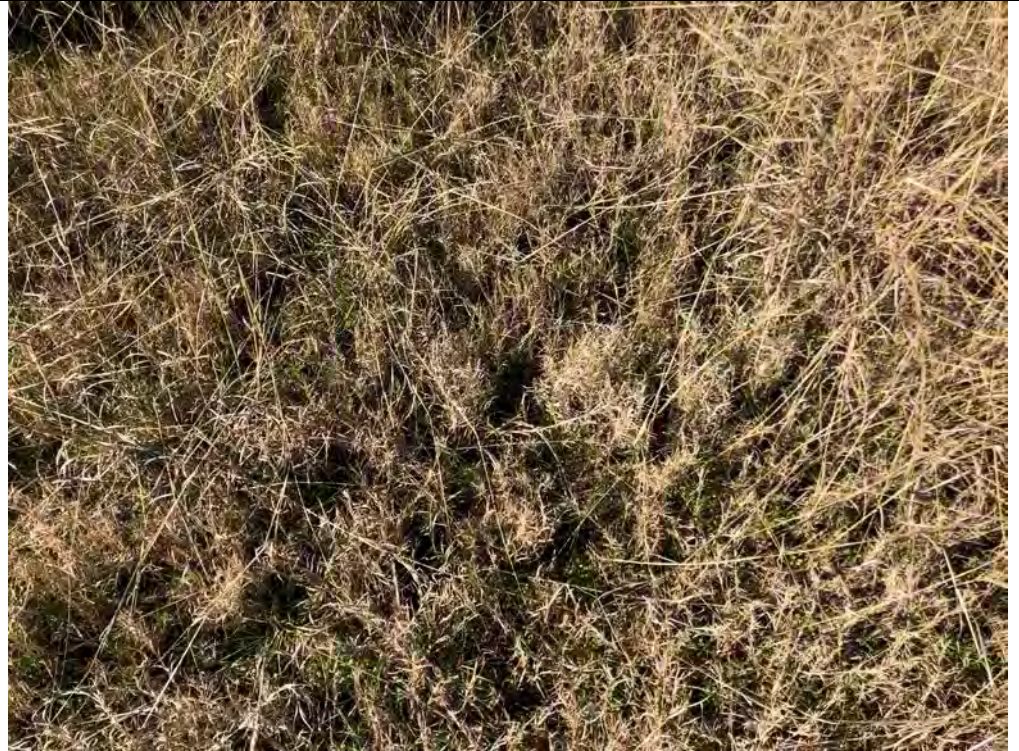
Soil cap well-vegetated in most areas with a low risk of erosion. No major rills observed during inspection. Facing west.

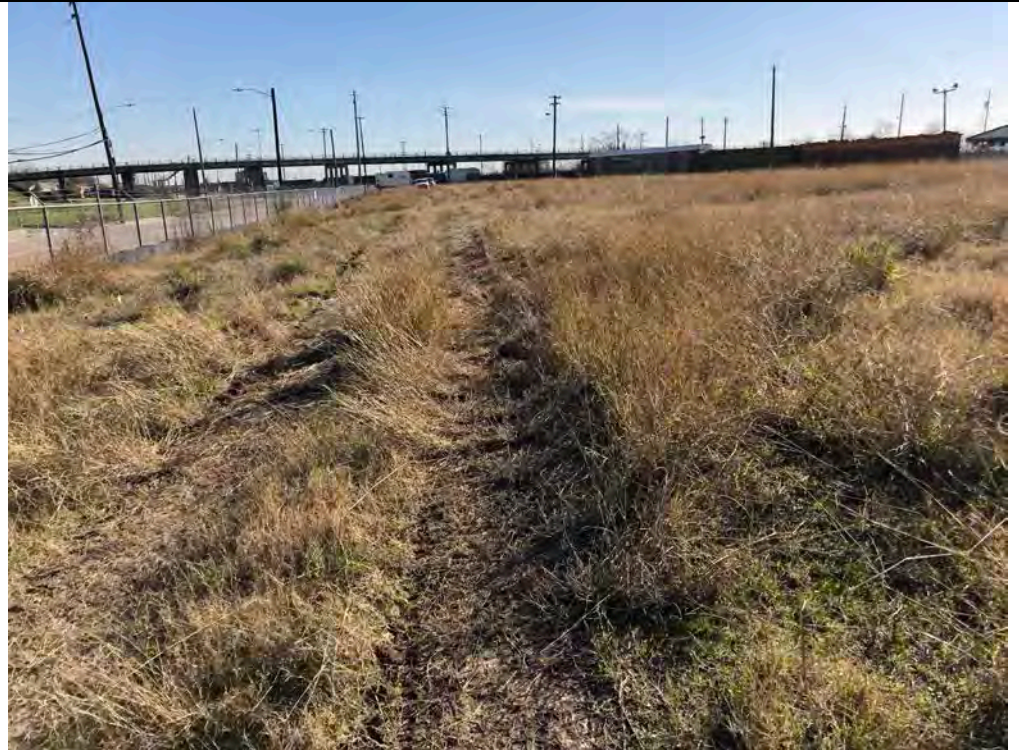
Photo No.
4

- Soil Cap -The soil cap area did not appear to have any significant erosion, sloughing, or subsidence. A few bare spots (Photo No. 4 and 5 (Attachment A)) were noted along the slopes of the soil cap, but the cap appeared to be functioning as designed. Since the inspection occurred in January, most of the vegetation was dormant.

Soil cap well-vegetated in most areas with a low risk of erosion. Some damage to cap and slope due to trucks and rigs driving on it. Possible resodding needed in some areas. Facing east.

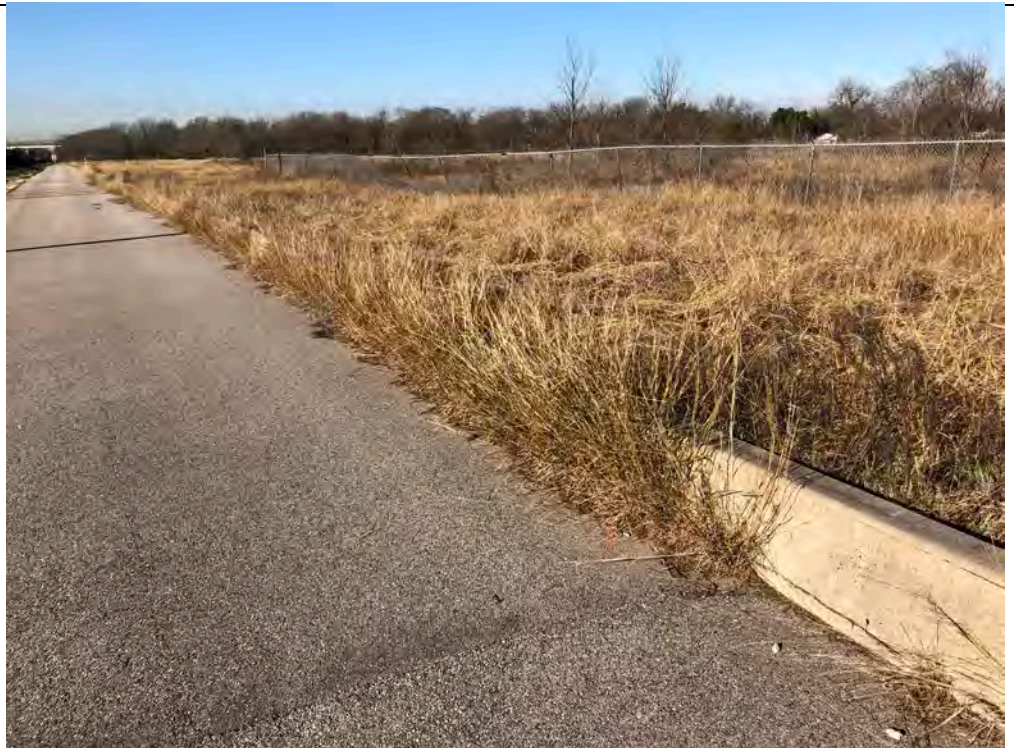
Photo No.
8

- Asphalt Road Cap – Asphalt road cap appeared to be in good condition, with minor cracks observed. Additionally, weeds, minor ant hills, and other vegetation was noticed along the edge of the concrete cap under the barriers (see Photo Nos. 8, 10, and 11).

Weeds and vegetation can be observed growing under the concrete barriers. Facing west.

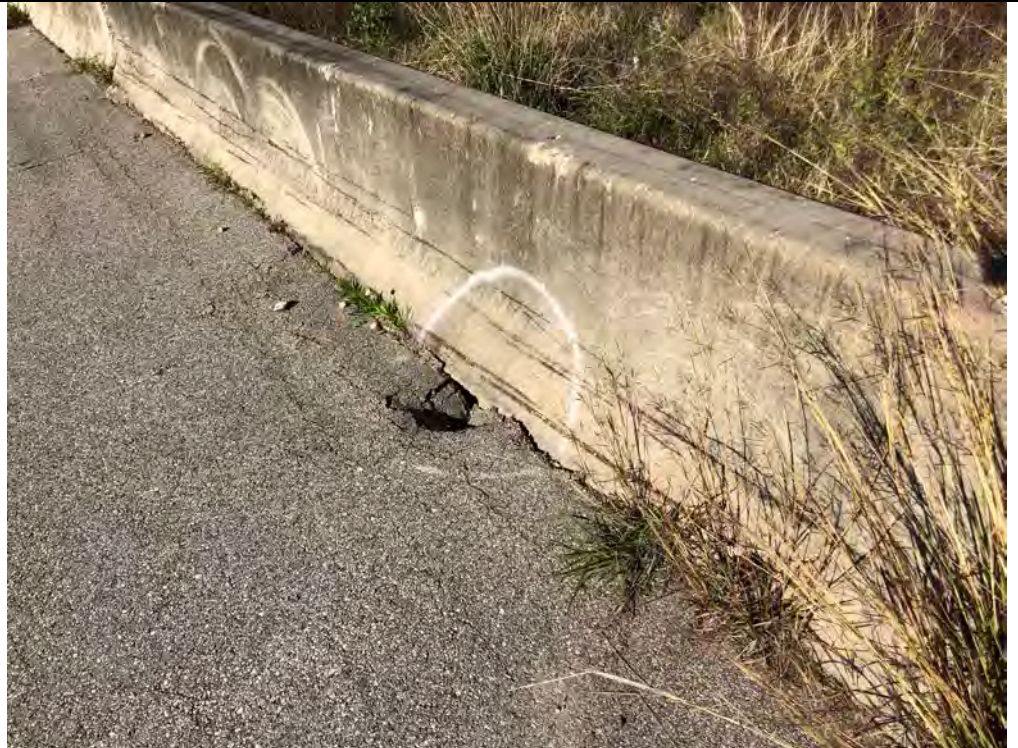
Photo No.
10

Some minor gaps noted between soil cap and roadway. Facing west.

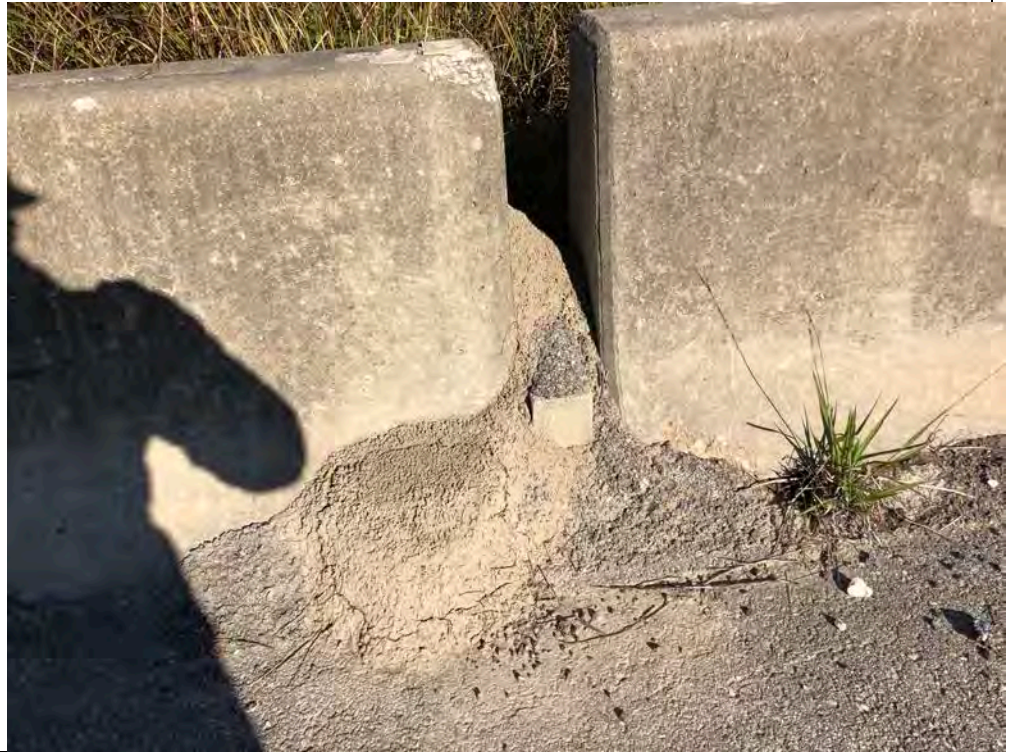
Anthills and small mounds of dirt can be observed on asphalt roadway between concrete barriers. Facing northwest.

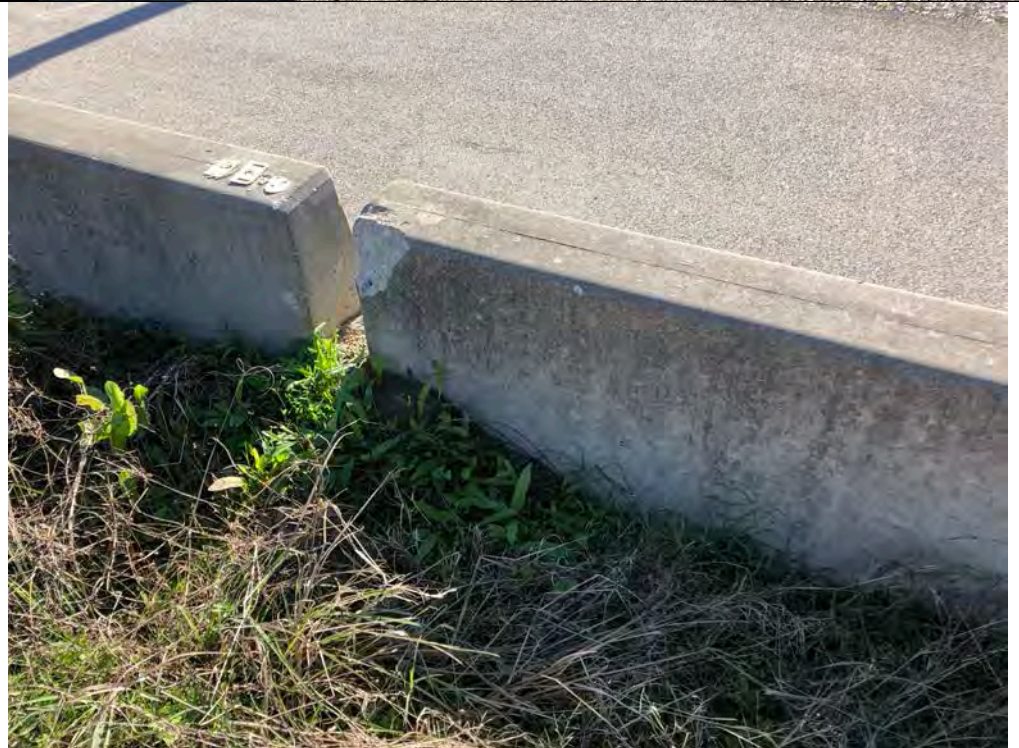
Photo No.
12

Anthills and small mounds of dirt can be observed on asphalt roadway between concrete barriers. Facing southeast.

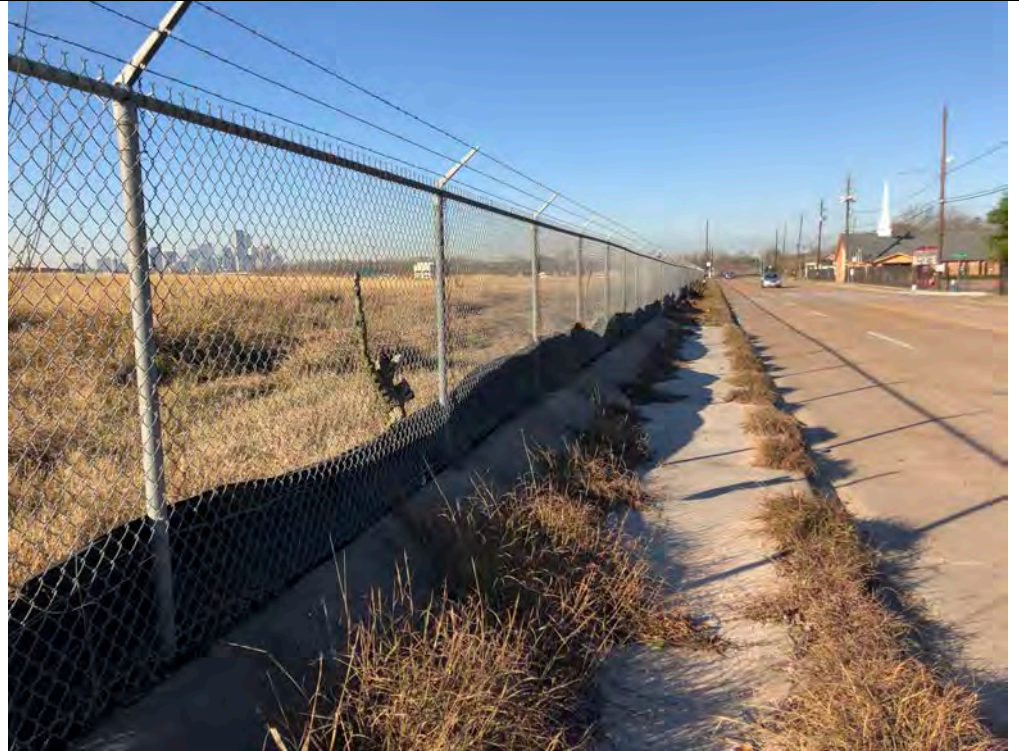
- Concrete Sidewalk Cap – The sidewalk cap area appeared to be in good condition and functioning as intended. Some areas had significant vegetive growth (Photos 13 and 14).

Security Fence/Sidewalk Area:
Sidewalk outside security fence in good condition. Some areas have significant vegetative growth and require mowing event. Facing west.

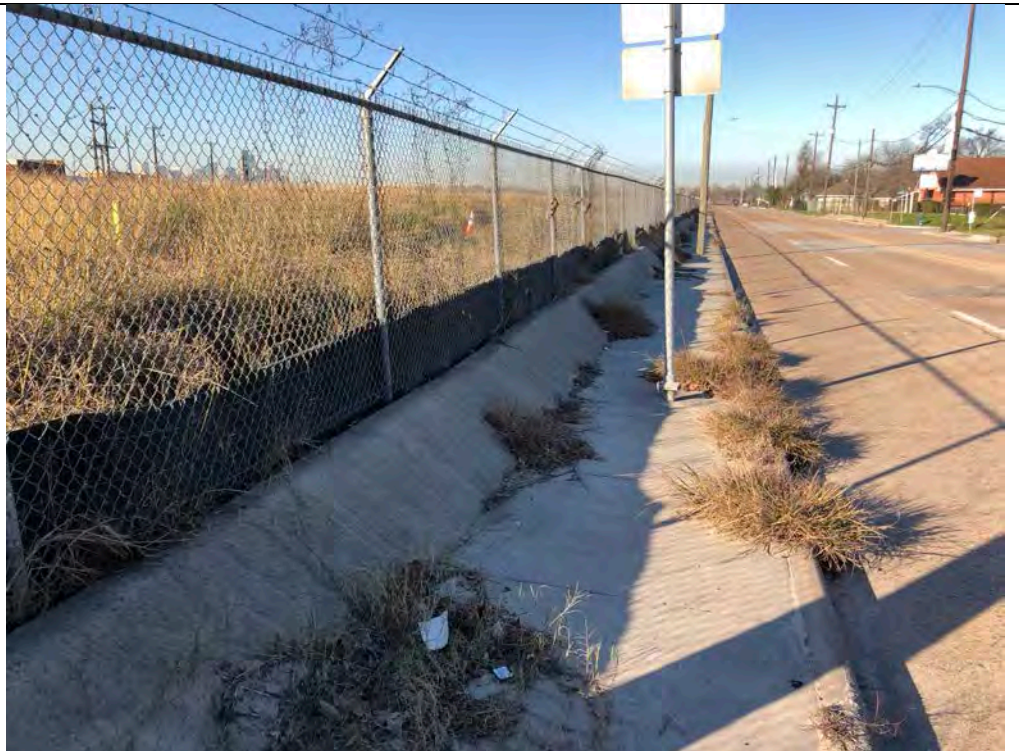
Photo No.
14

Security Fence/Sidewalk Area:
Sidewalk outside security fence in good condition. Some areas have significant vegetative growth and require mowing event. Facing west.

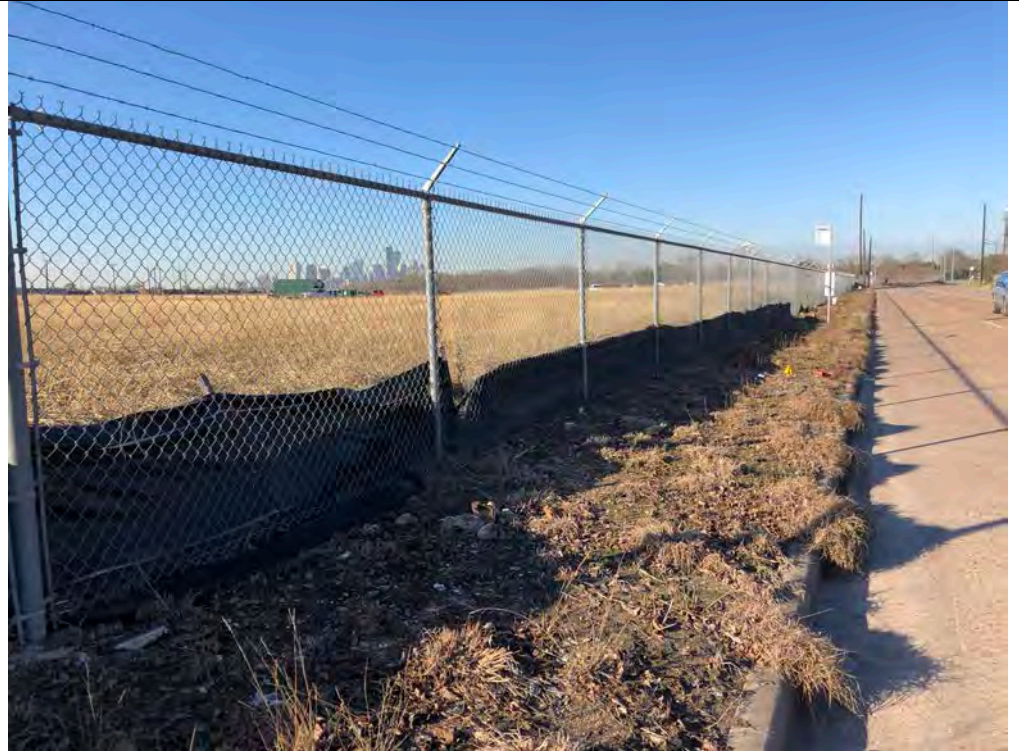
Security fence in good condition. Small hole in fence can be observed. Facing southwest.

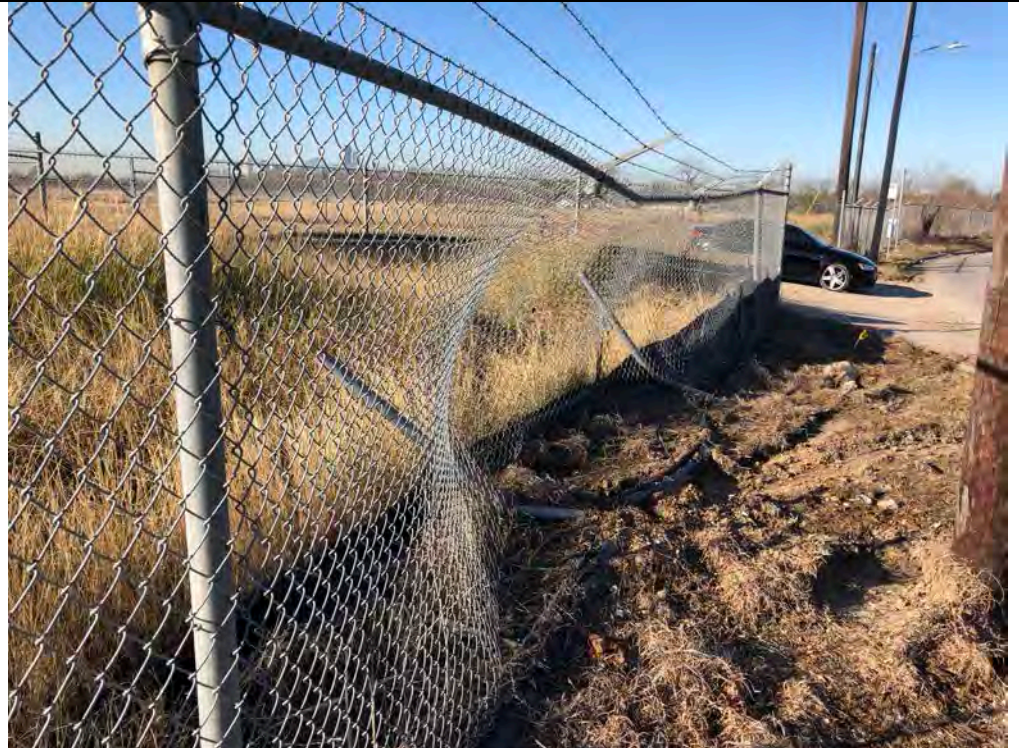
Photo No.
16

Security fence in good condition. Fence damage from vehicle can be observed here, approximately 20' east of the main entrance gate. Facing west.

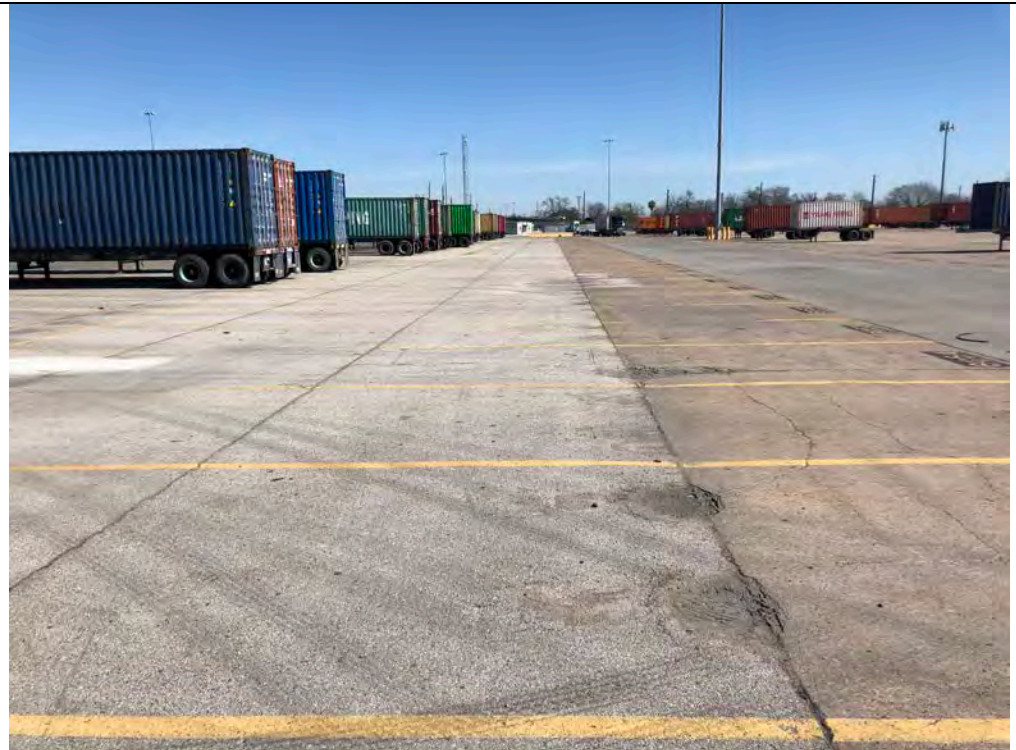
Concrete Cap Area (Englewood Yard):
Some mild cracking/cratering in the pavement can be observed in the B Row of the Englewood Yard area. No visible vegetation or exposed soil was observed. Facing northeast.

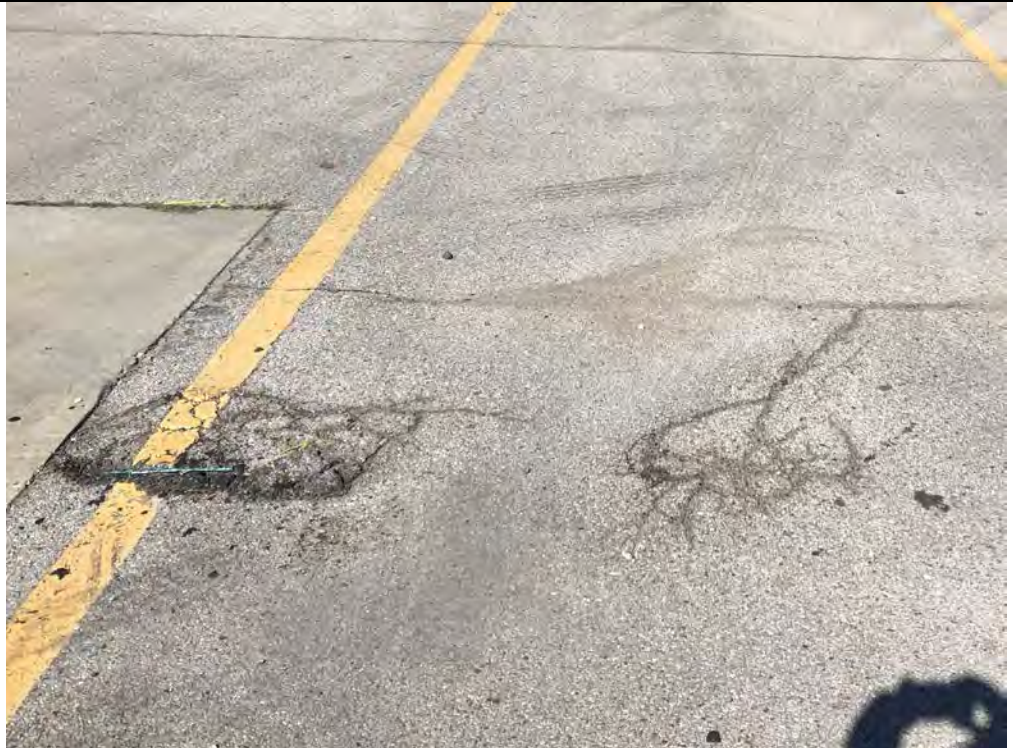
Photo No.
22

B057 stall. Evidence of minor cracking, sometimes producing NAPL seeps. Facing northwest.

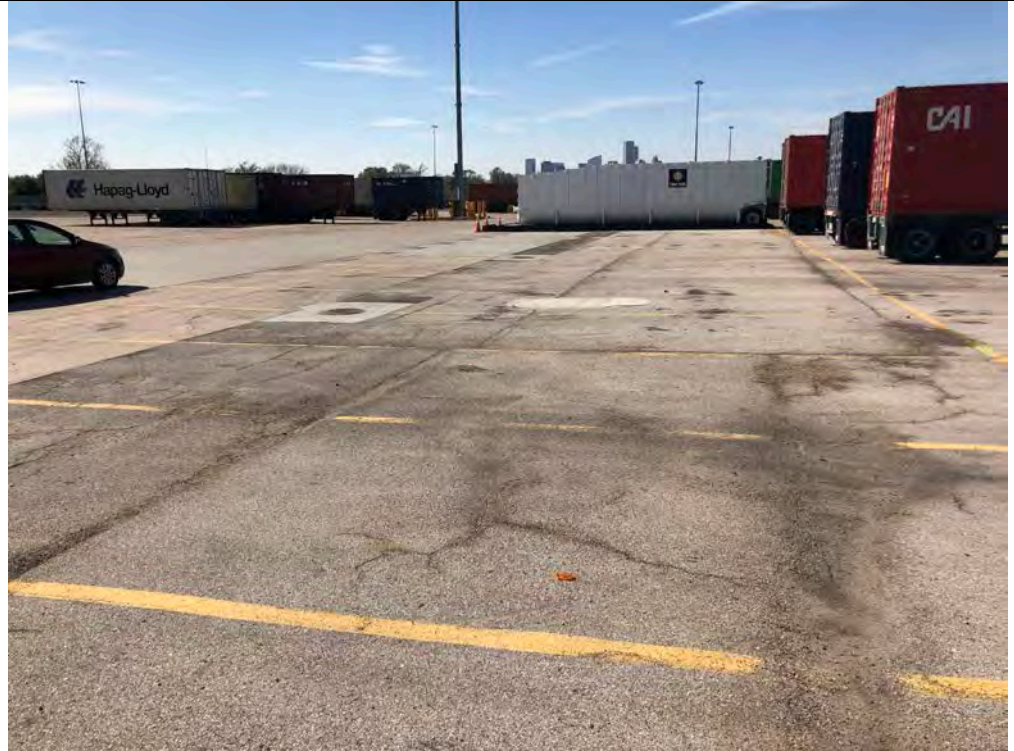
Some cracking/cratering and brown water staining in the pavement can be observed in the B Row of the Englewood Yard area. No visible vegetation or exposed soil was observed. Facing southwest.

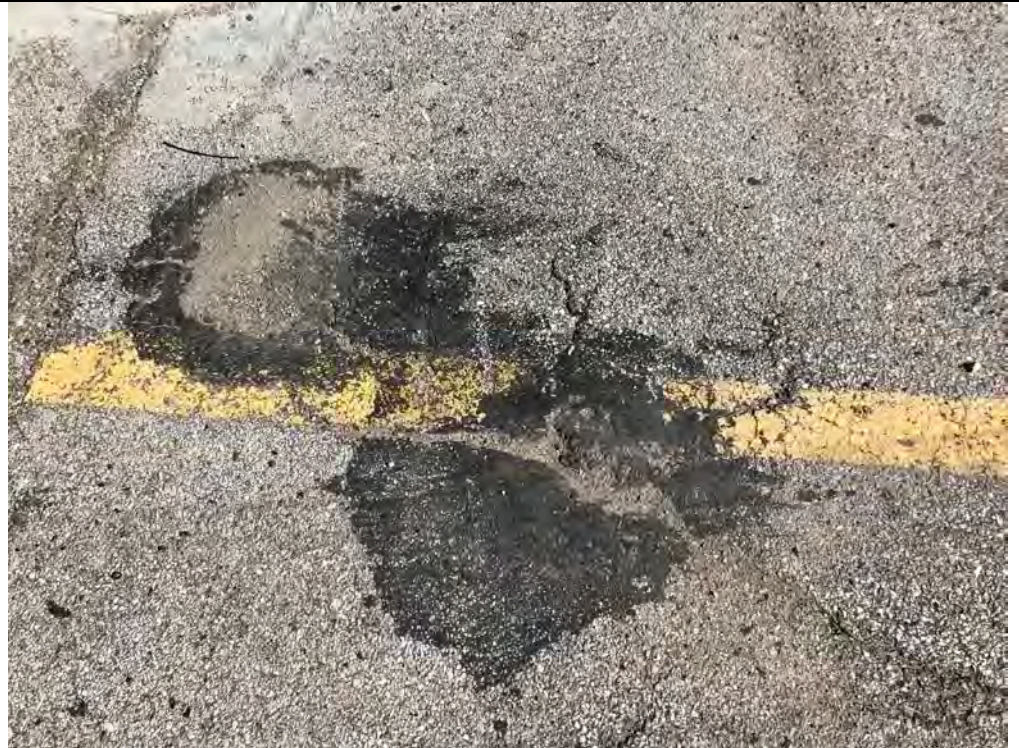
B100/101 stalls. Evidence of minor cracking and recent tar-like substance seepage (in asphalt), though none was present at time of inspection. Facing northeast.

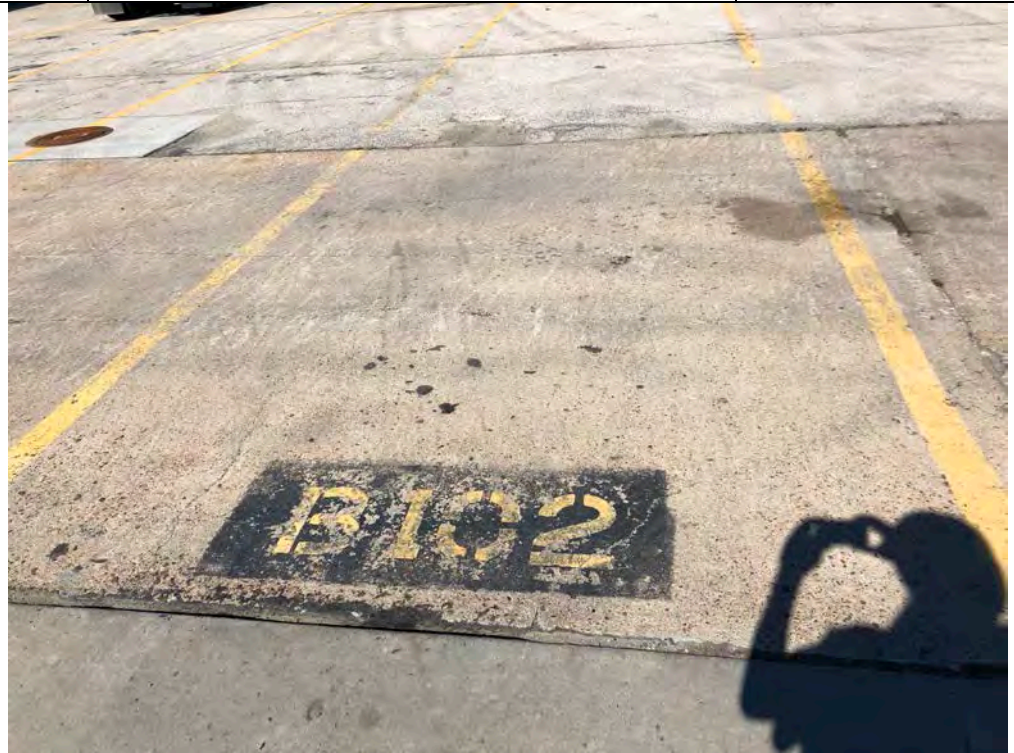
B102 stall. Evidence of minor cracking and recent tar-like substance seepage (in joint), though none was present at time of inspection. Facing northwest.

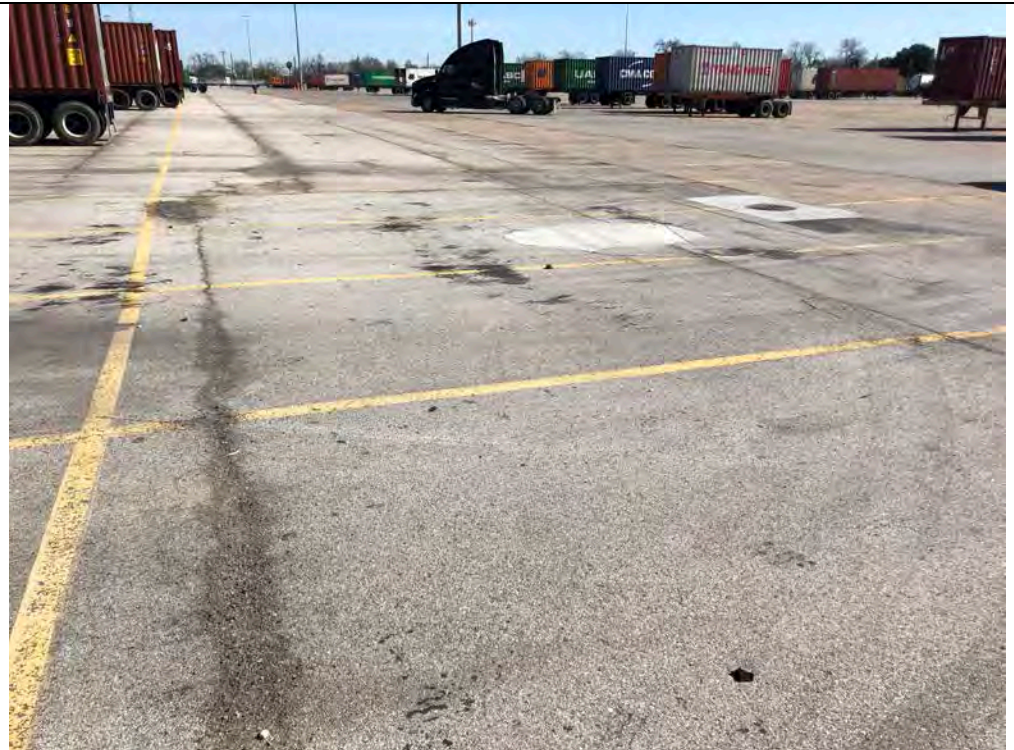
Photo No.
28

Some cracking with mild brown water staining can be observed in the pavement along the back of B Row in the Englewood Yard area. No visible vegetation or exposed soil was observed. Facing northeast.

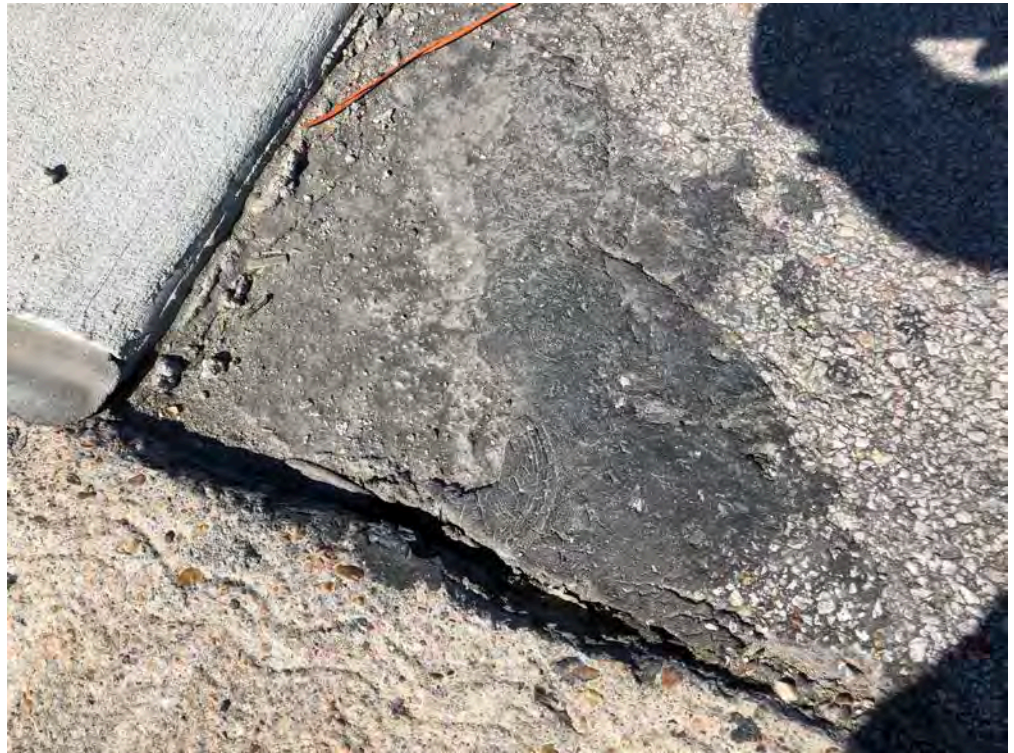
B103 stall. Evidence of minor cracking and recent tar-like substance seepage (in asphalt) on edge of NAPL Collection system, though none was present at time of inspection. Facing northwest.

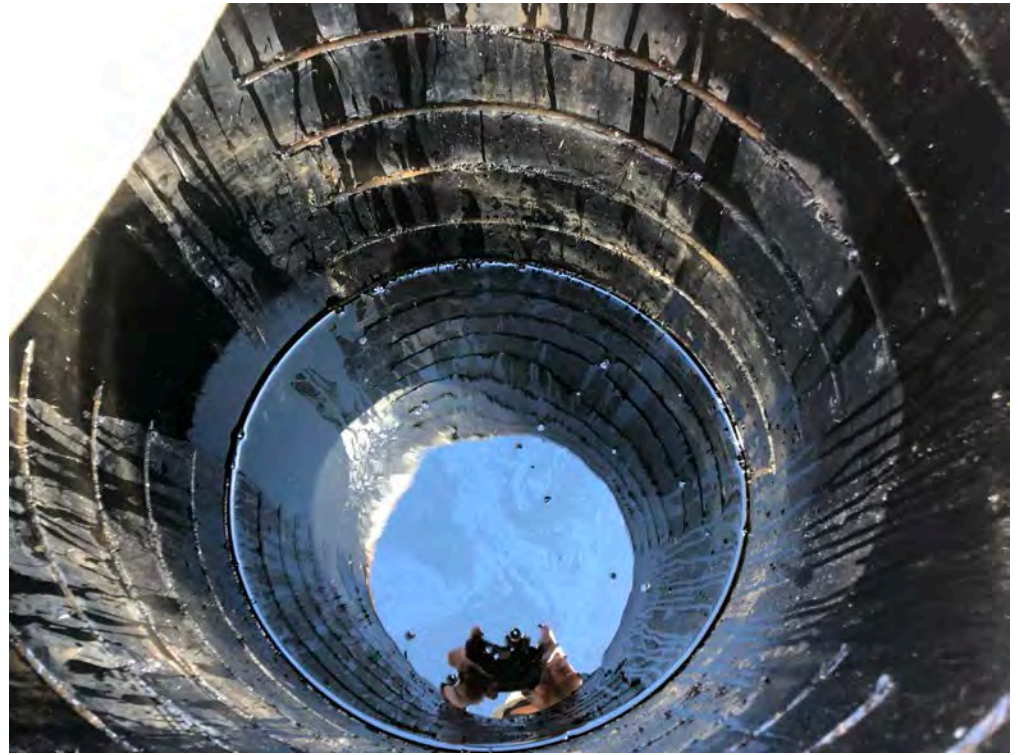
Sump B107/B108. Sump half-filled with water (some observable sheen on surface). Sump B103/B104 is filled similarly (but with no visible sheen). Facing north.

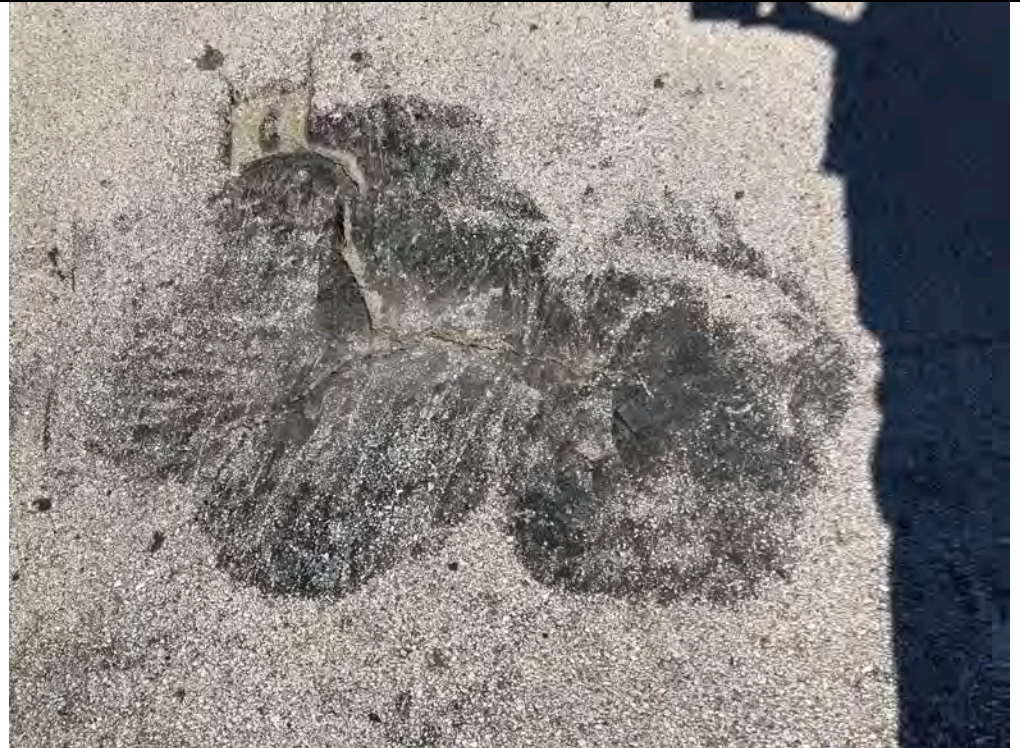
Photo No.
32

B108 stall. Evidence of minor cracking and recent tar-like substance seepage (in asphalt), though none was present at time of inspection. Facing northeast.

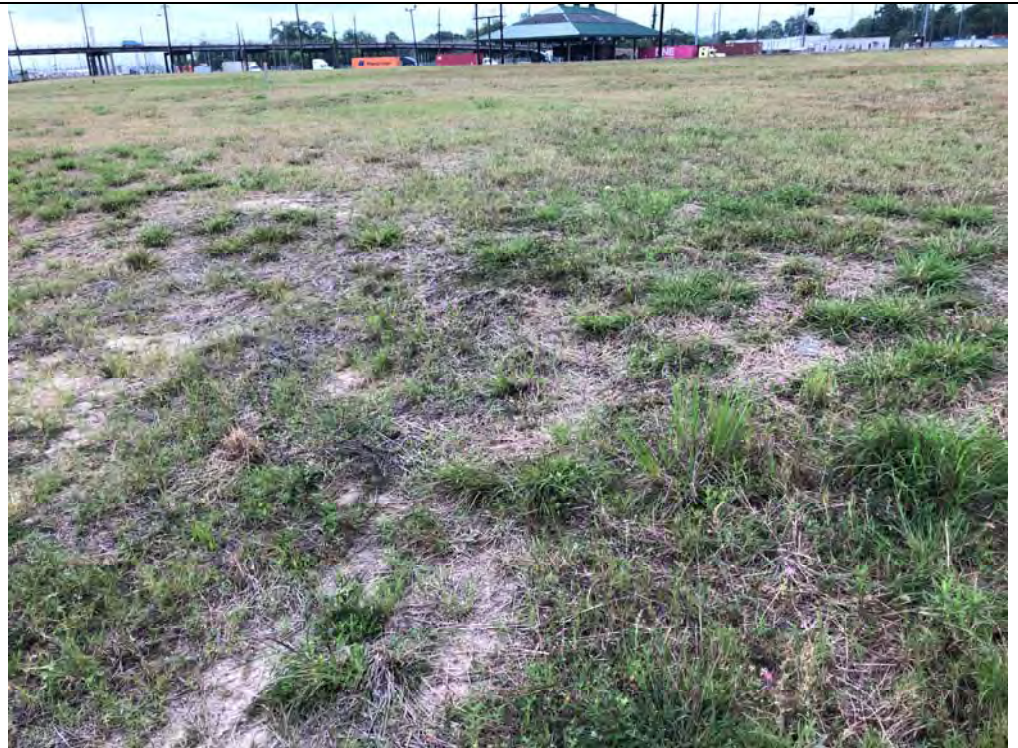
Photo No.
4

- Soil Cap -The soil cap area did not appear to have any significant erosion, sloughing, or subsidence. Pollinator plants were observed across the soil cap area. A few bare spots (Photo No. 4 and 5) were noted on top and along the slopes of the soil cap, but the cap appeared to be functioning as designed.

Soil cap well-vegetated in most areas with a low risk of erosion. Some damage to cap and slope due to trucks and rigs driving on it. Possible resodding needed in some areas. Facing east.

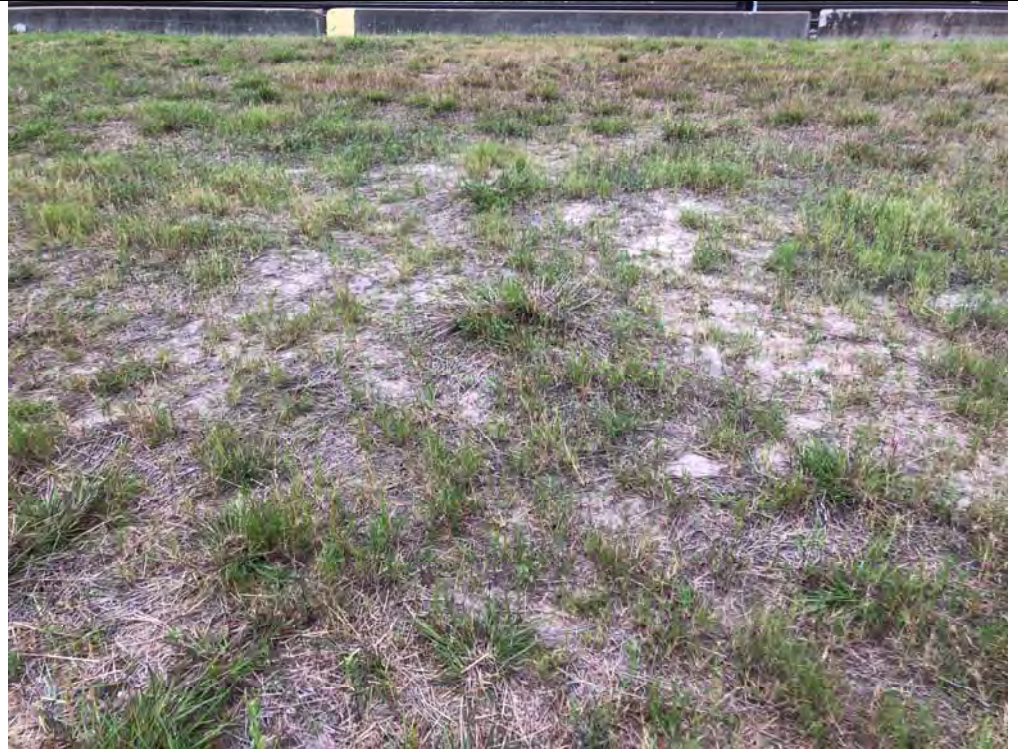
Soil cap well-vegetated in most areas with a low risk of erosion. Some damage to cap and slope due to trucks and rigs driving on it. Possible resodding needed in some areas. Facing southeast.

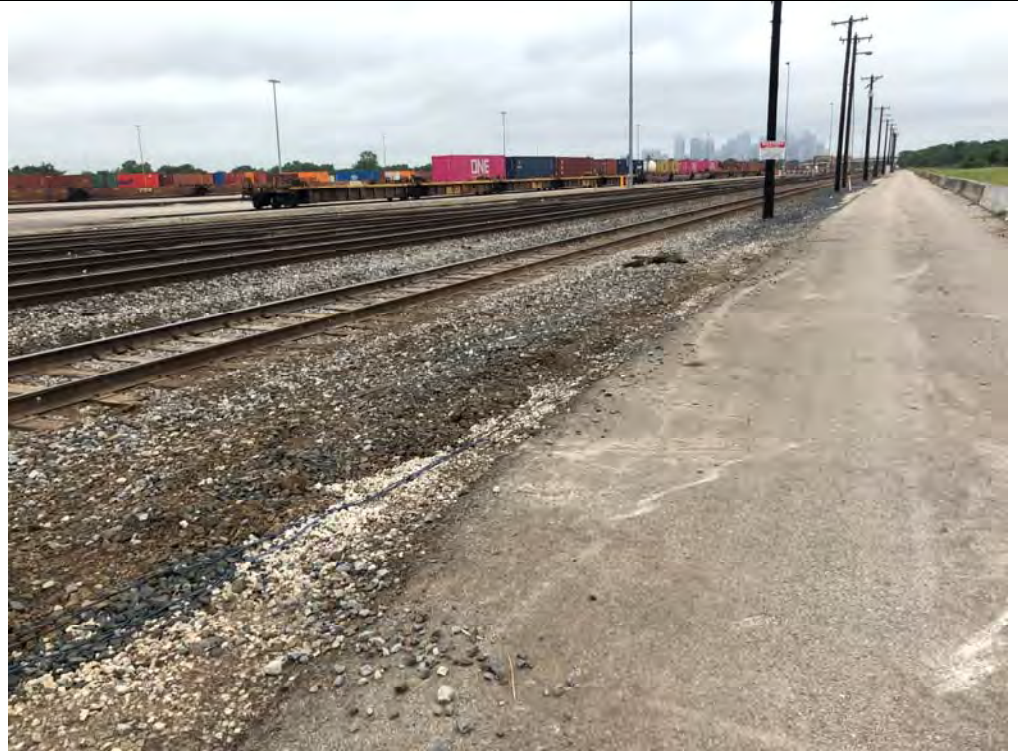
Asphalt roadway in good condition, free of major cracking/damage. Some areas of exposed soil in ballast cap can be observed. Facing southwest.

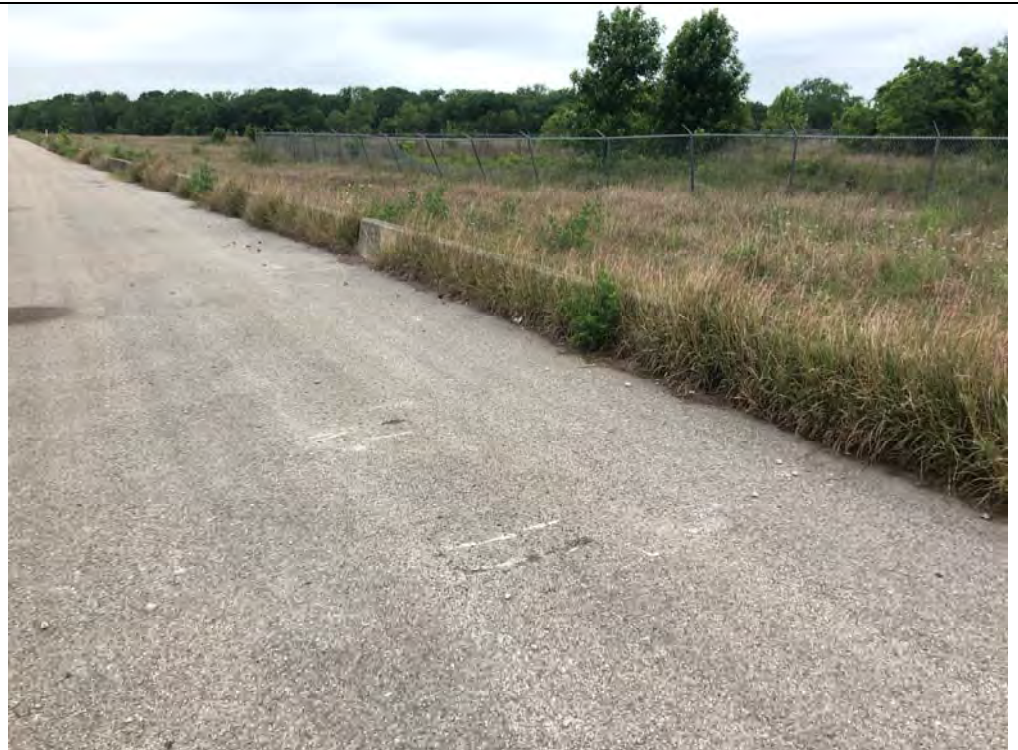
Photo No.
8

- Asphalt Road Cap – Asphalt road cap appeared to be in good condition, with minor cracks observed. Additionally, weeds and other vegetation was noticed along the edge of the concrete cap under the barriers (see Photo Nos. 8, 10, and 11). The small oil stains (see Photo No. 9), which was noted during previous inspections, did not appear to expand in size.

Weeds and vegetation can be observed growing under the concrete barriers. Facing west.

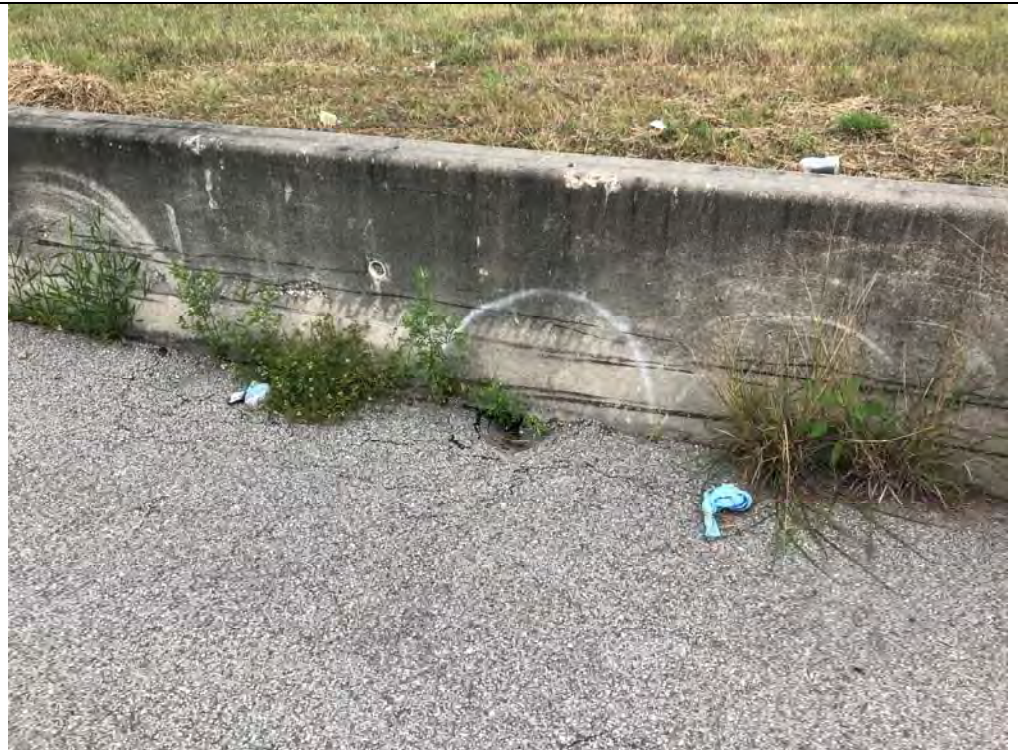
Photo No.
10

Some minor gaps noted between soil cap and roadway. Facing northwest.

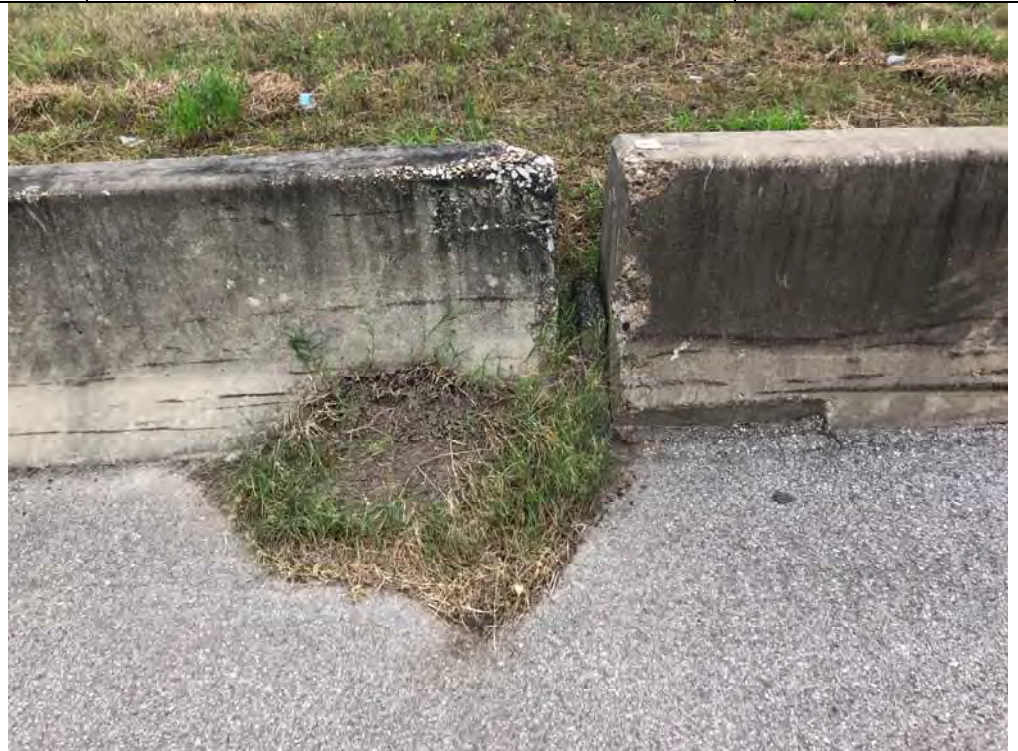
Anthills and small mounds of dirt observed on asphalt roadway between concrete barriers. Facing northwest.

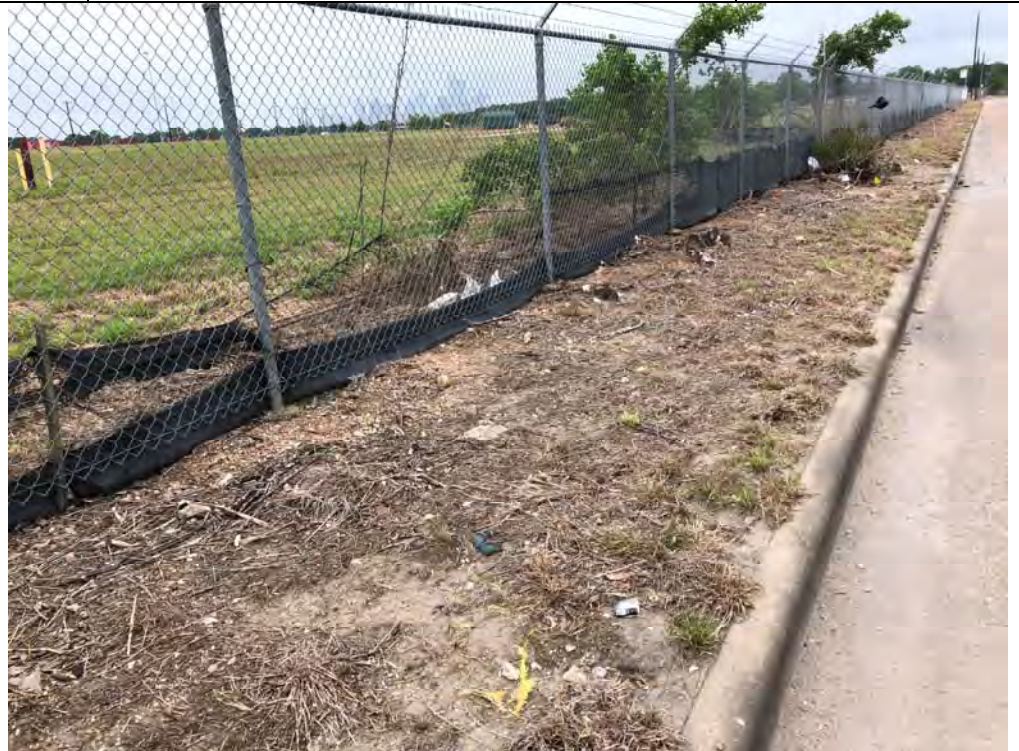
Security Fence:
Some garbage and debris can be observed outside fence. Facing southwest.

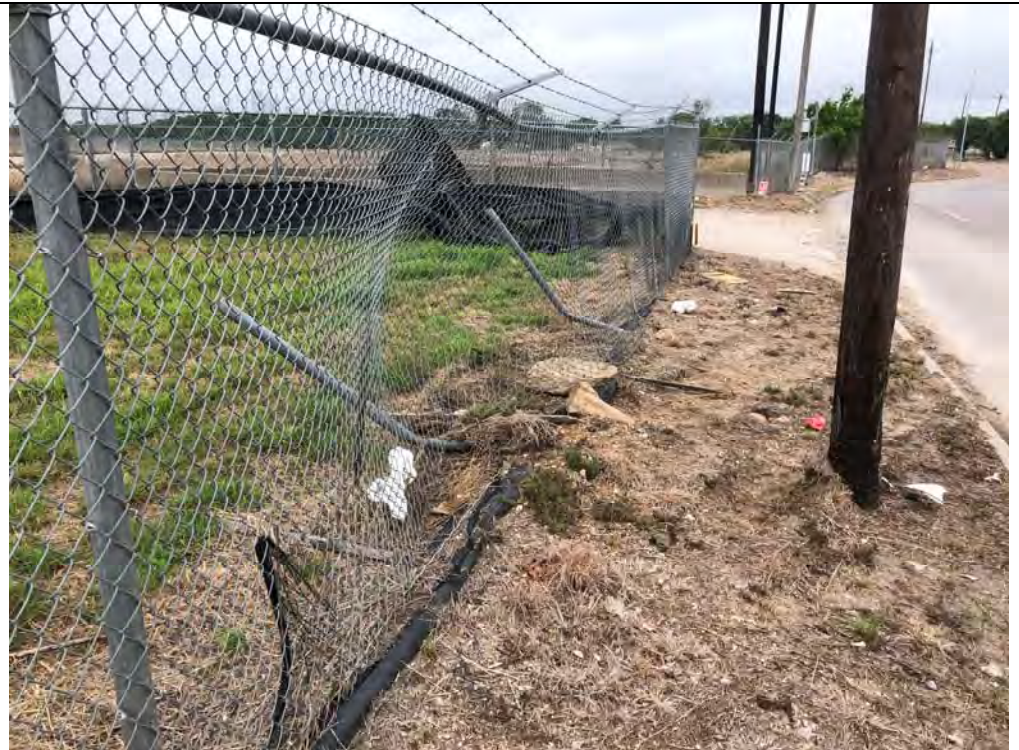
Photo No.
16

Security Fence:
Fence damage from vehicle can be observed here, approximately 20' east of the main entrance gate. Facing west.

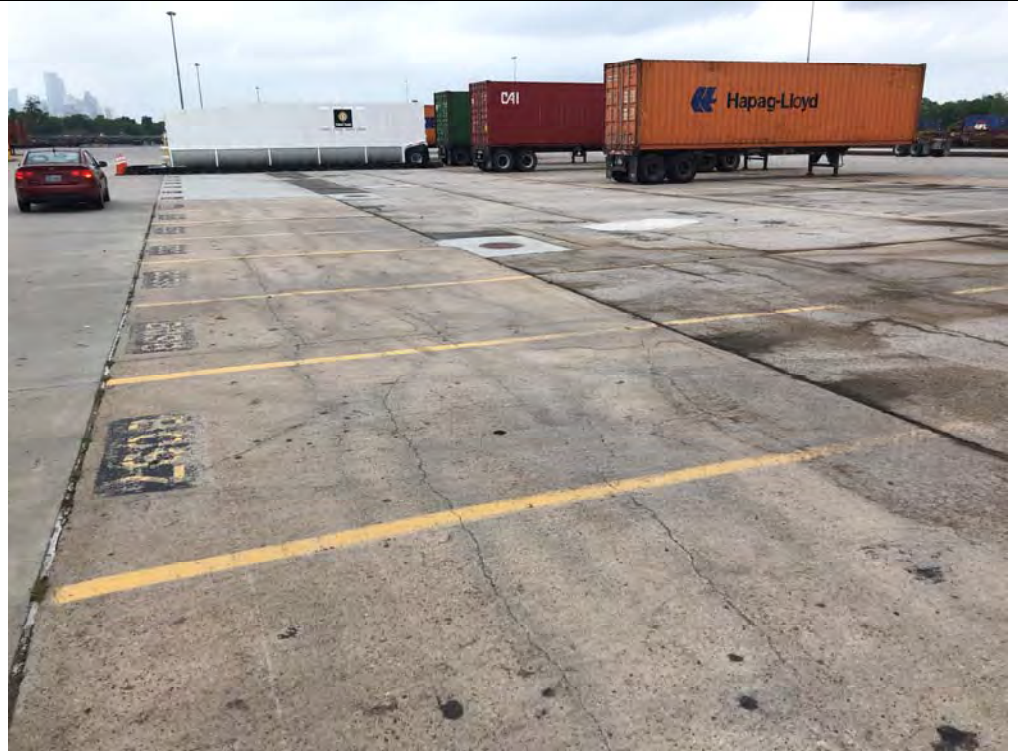
Some cracking/cratering and brown water staining in the pavement can be observed in the B Row of the Englewood Yard area. No visible vegetation or exposed soil was observed. Facing south.
