**RE: POST-RESPONSE ACTION COMPLETION REPORT – 2020
UNION PACIFIC RAILROAD HOUSTON WOOD PRESERVING WORKS, HOUSTON, TEXAS
4910 LIBERTY ROAD, HOUSTON, HARRIS COUNTY, TEXAS
TCEQ SWR NO. 31547; TCEQ PERMIT/COMPLIANCE PLAN NO. 50343EPA ID NO. TXD000820266
CUSTOMER NO. CN600131098; REGULATED ENTITY NO. RN100674613**

TEXAS COMMISSION ON ENVIRONMENTAL QUALITY Post-Response Action Care Report (PRACR)

SECOND QUARTER 2020 (APRIL 28TH) INSPECTION RECORD AND PHOTOGRAPHIC LOG

THIRD QUARTER 2020 (JULY 23RD) INSPECTION RECORD AND PHOTOGRAPHIC LOGS

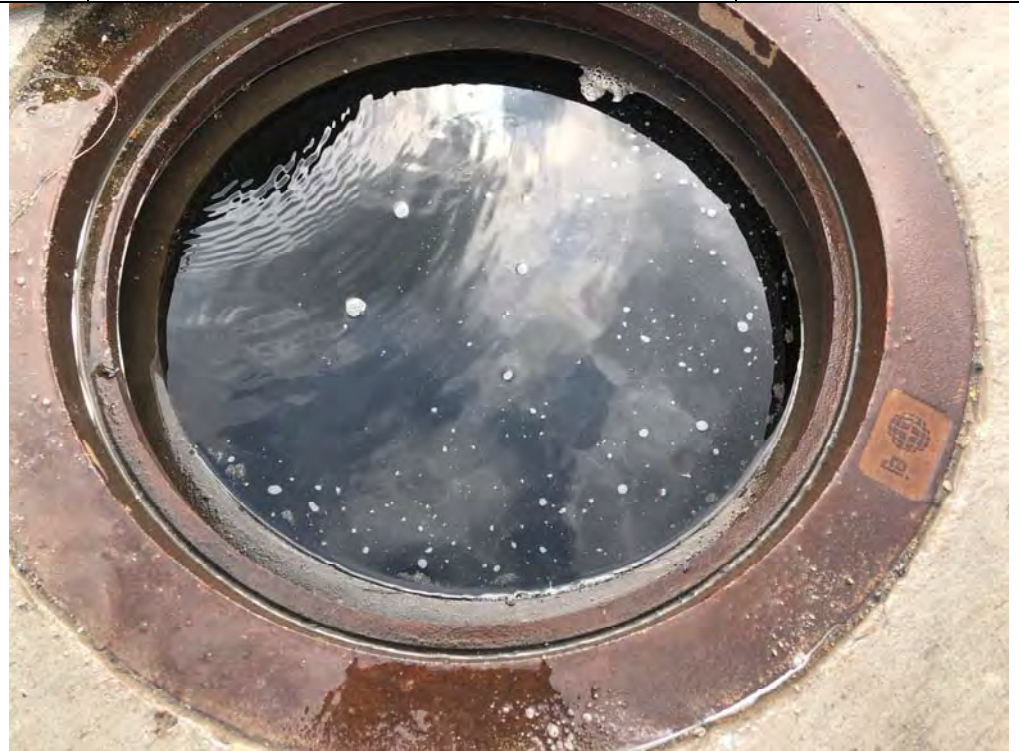
Sump B099/B100. Sump almost totally filled with water (brown in color, but with no sheen or odor). Facing north.
