June 21, 2018 Project No. 30401358

RE: MONTHLY STATUS UPDATE – SOIL CAP AND CONCRETE CAP REPAIRS
UNION PACIFIC RAILROAD HOUSTON WOOD PRESERVING WORKS FACILITY
4910 LIBERTY ROAD FACILITY, HOUSTON, TEXAS
POST-CLOSURE CARE PERMIT NO. HW-50343; INDUSTRIAL SWR NO. 31547

Soil Cap Repair Photographic Log

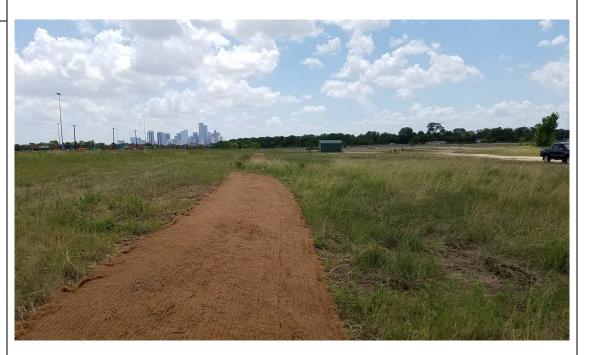
Photo No.

Repairs to the soil cap facing southwest, after placement of topsoil and erosion mats.

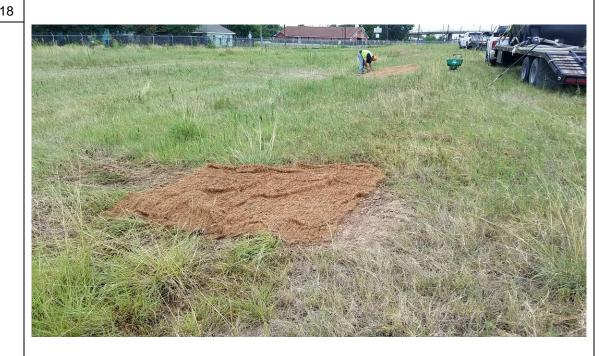
Photo No.

Soil cap, facing northeast, view of repaired area, topsoil and erosion mat.

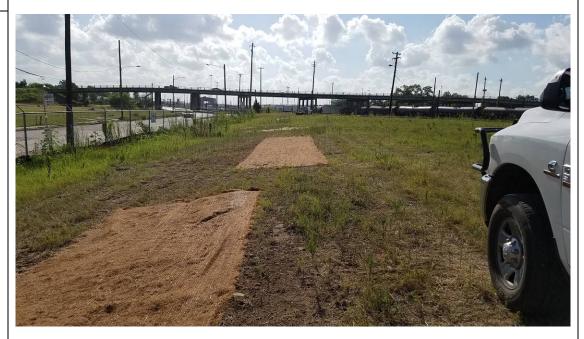
Photo No.

Soil cap, facing east, view of repaired area, topsoil and erosion mat, Liberty Rd to the left, soil cap area to the right.

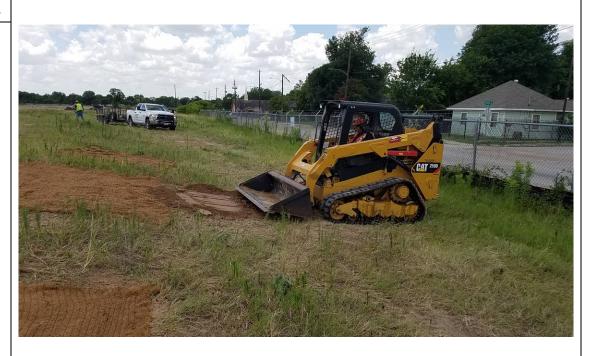
Photo No.

Repairs to soil cap, facing west, view of area being repaired, placing topsoil and erosion mat, Liberty Rd to the right.

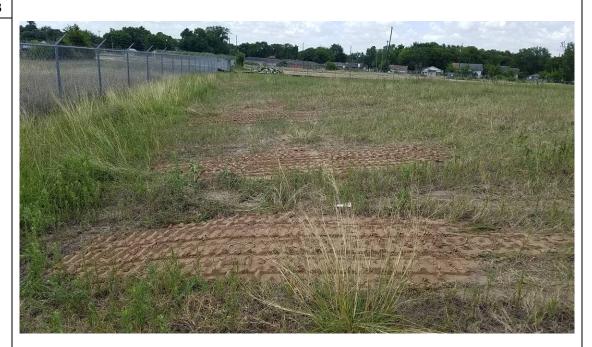
Photo No. 5

Soil Cap Area: Repairs to the west side of the soil cap facing north, after placement of topsoil.

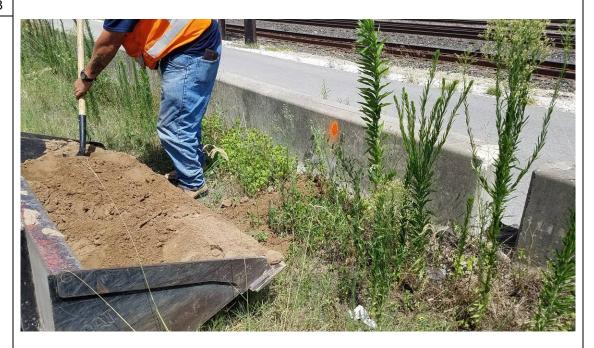
Photo No. 6

Placement of topsoil in areas of settlement along the concrete barriers, facing eastsoutheast.
