**RE: MONTHLY STATUS UPDATE – SOIL CAP AND CONCRETE CAP REPAIRS
UNION PACIFIC RAILROAD HOUSTON WOOD PRESERVING WORKS FACILITY
4910 LIBERTY ROAD FACILITY, HOUSTON, TEXAS
POST-CLOSURE CARE PERMIT NO. HW-50343; INDUSTRIAL SWR NO. 31547**

Soil Cap Repair Photographic Log

Site Location:
Houston Wood Preserving Works, 4910 Liberty Road,
Houston, Texas

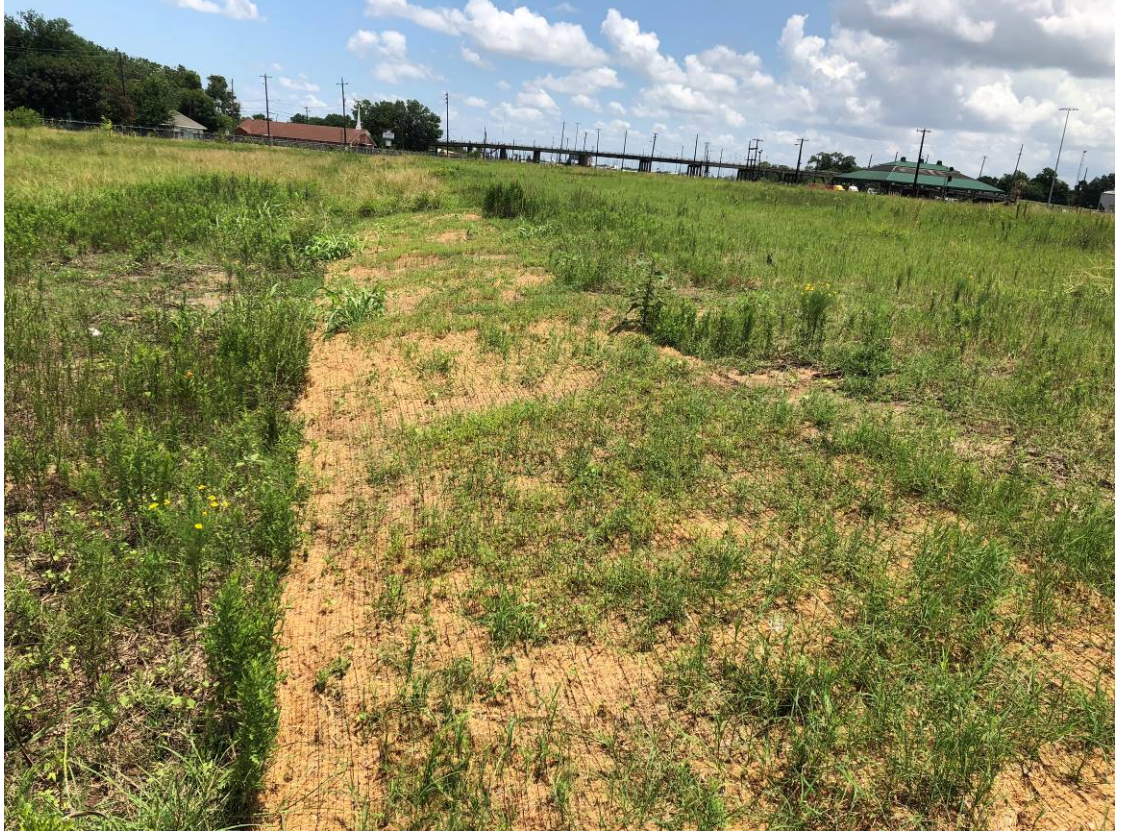
Photo No.
1

Repairs to the soil cap facing northeast, vegetation becoming established.

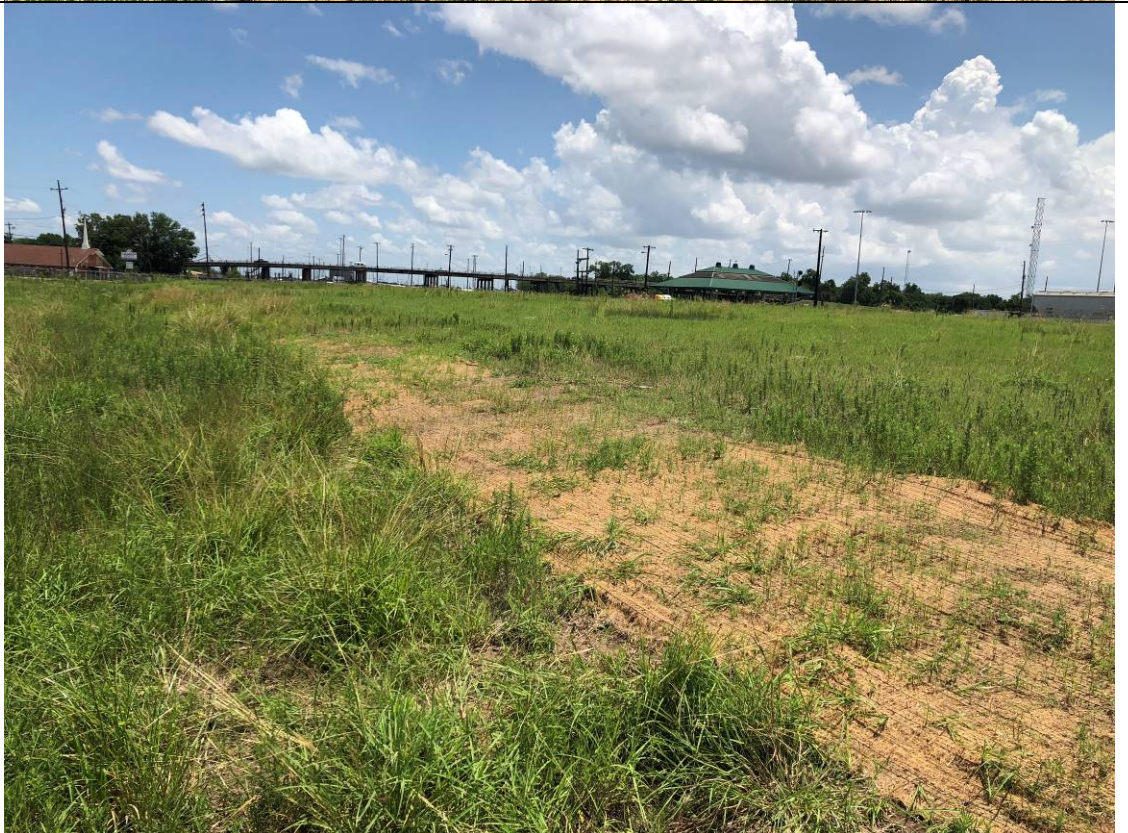
Photo No.
2

Repairs to the soil cap facing northeast, vegetation becoming established.

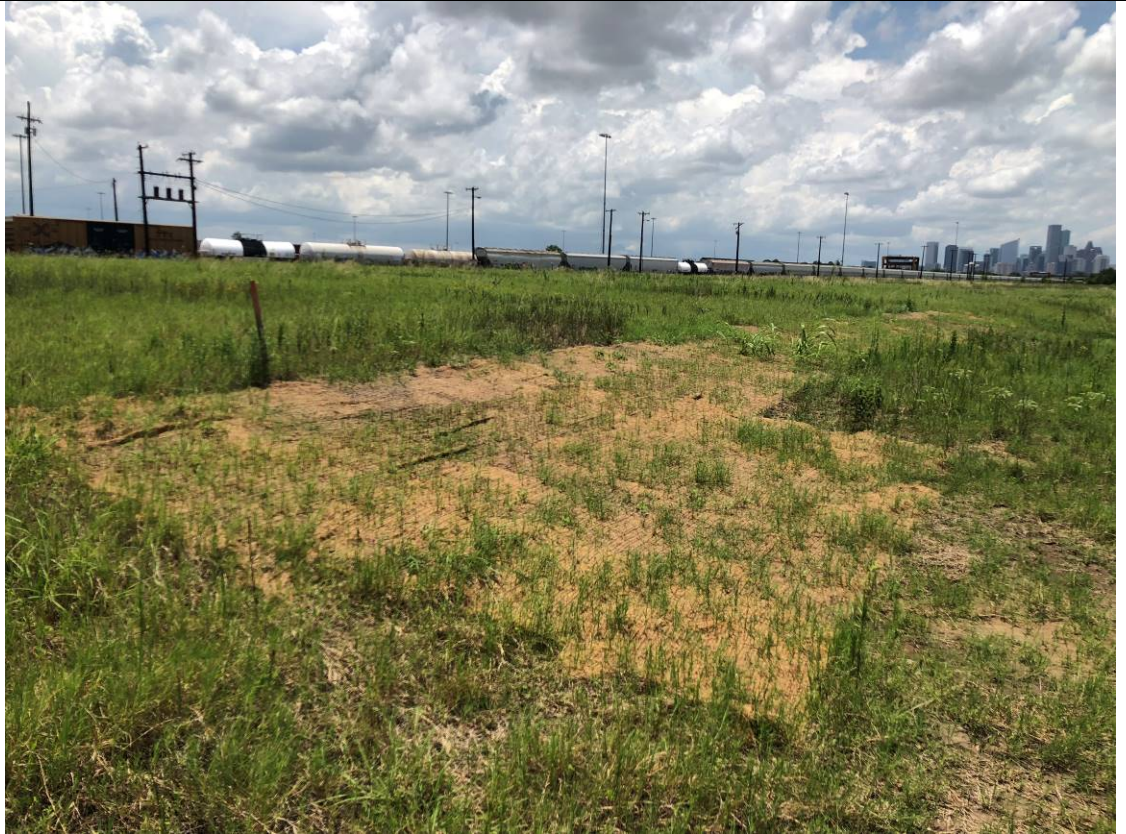
Photo No.
3

Repairs to the soil cap facing southwest, vegetation becoming established.

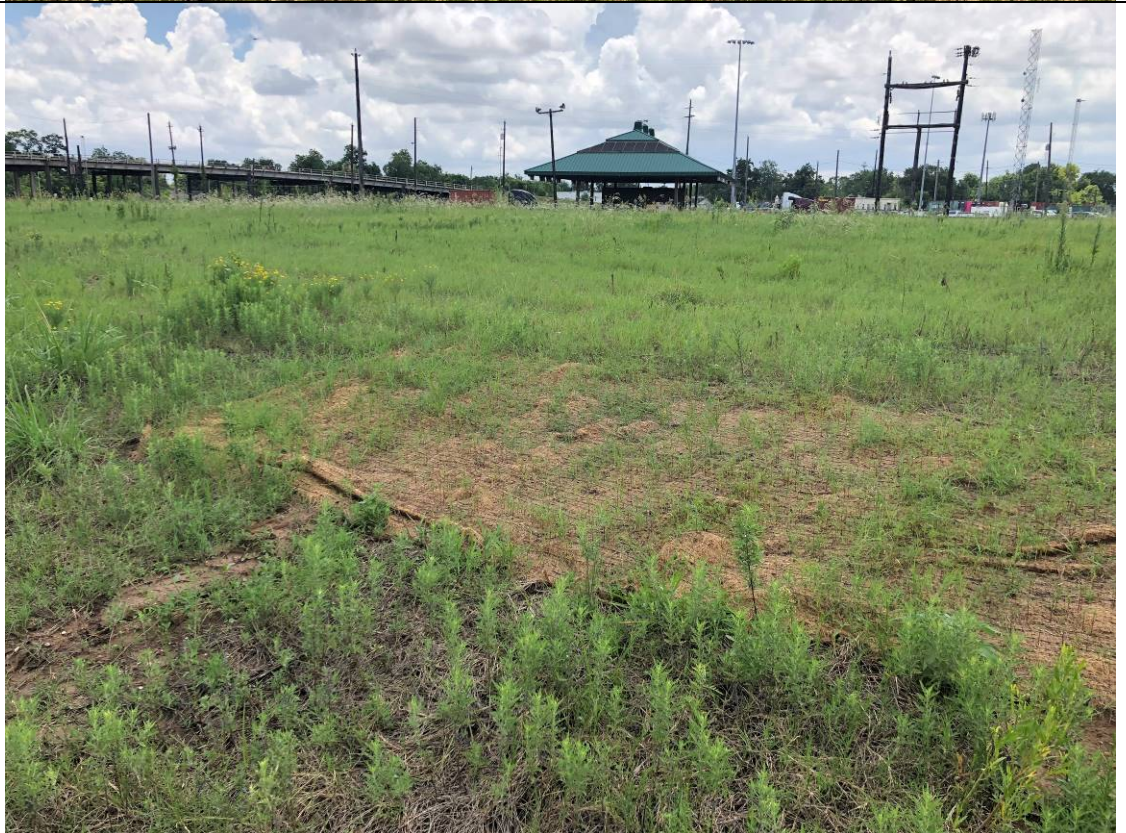
Photo No.
4

Repairs to the soil cap facing southeast, vegetation becoming established.
