August 31, 2018

Project No. 30401358

**RE: MONTHLY STATUS UPDATE – SOIL CAP AND CONCRETE CAP REPAIRS
UNION PACIFIC RAILROAD HOUSTON WOOD PRESERVING WORKS FACILITY
4910 LIBERTY ROAD FACILITY, HOUSTON, TEXAS
POST-CLOSURE CARE PERMIT NO. HW-50343; INDUSTRIAL SWR NO. 31547**

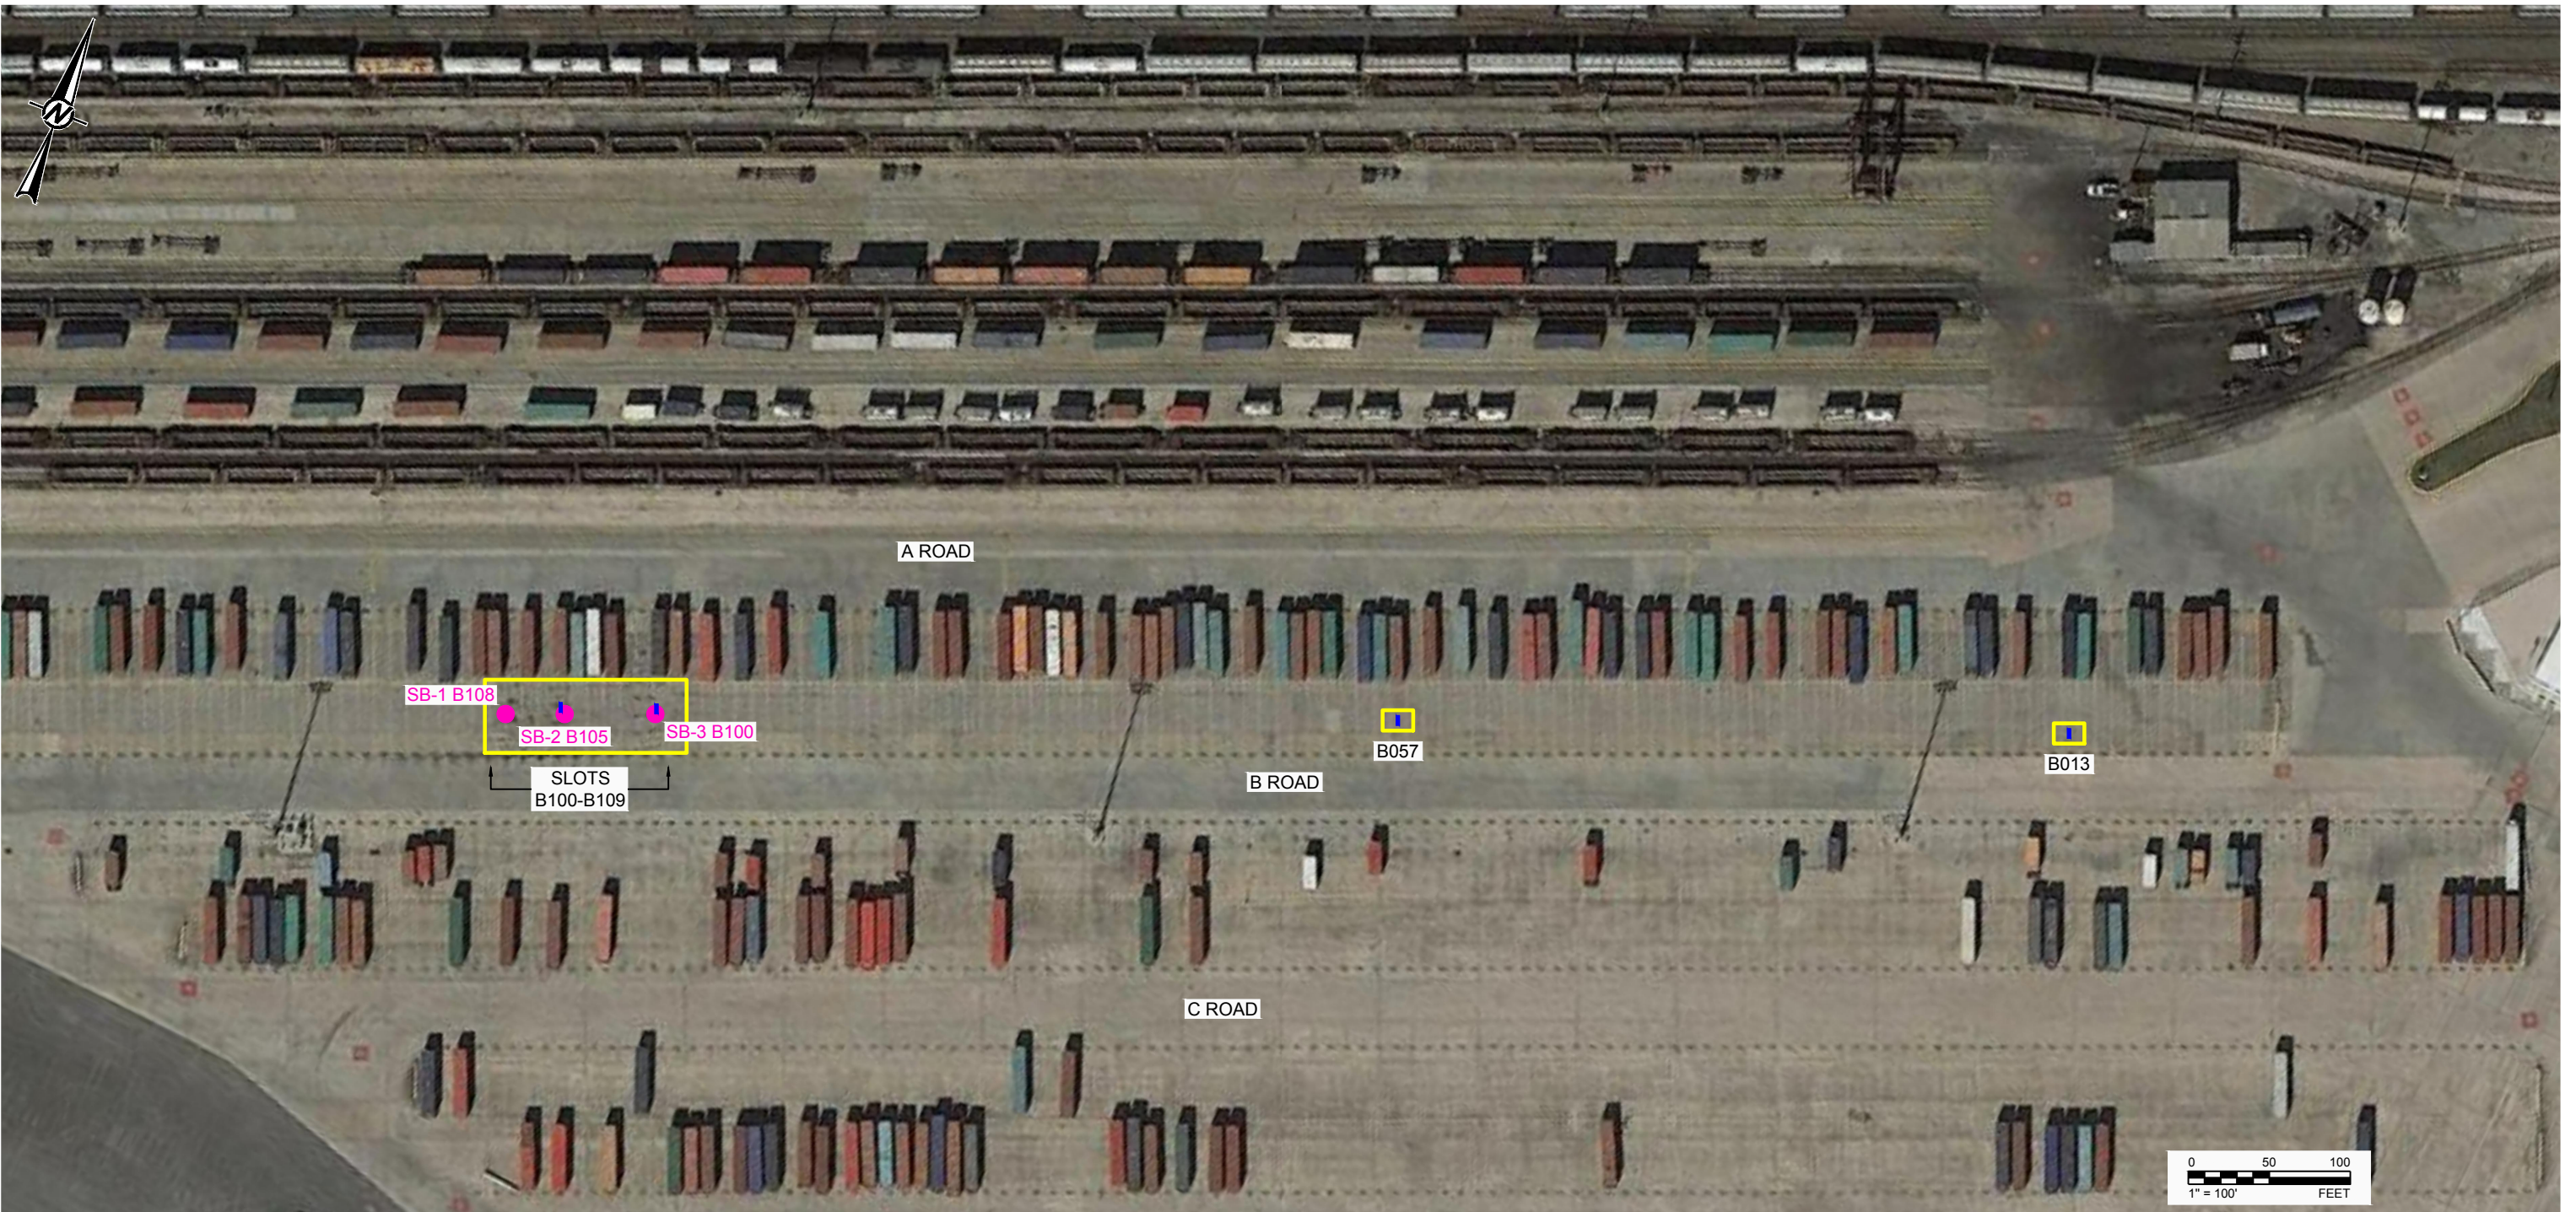
PROJECT NO. 30401358-640 REV. 0 FIGURE 1

The preliminary design described above was developed based on information gathered from three soil borings (SB-1 B108, SB-2 B105, and SB-3 B100 (boring logs provided in Attachment C)) conducted in the

seep area (see Attachment A – Figure 1 for locations). The boring logs indicate the presence of a NAPL saturated zone (NAPL described as a black rubbery material) approximately three feet below grade. Prior to implementing the proposed remedial action, Golder plans to conduct test pits in the area of the planned response action, and at two other areas where small tar-like material seeps have been noted over the past month (parking slots B13 and B57 (Attachment A – Figure 1)), as discussed in the following response. Once the test pits have been conducted and information gathered from the test pits have been evaluated, UPRR will then revise the proposed response action as necessary and submit the proposed remediation design to remediation contractors to provide bids and implement the design (subject to revisions based on the test pits).

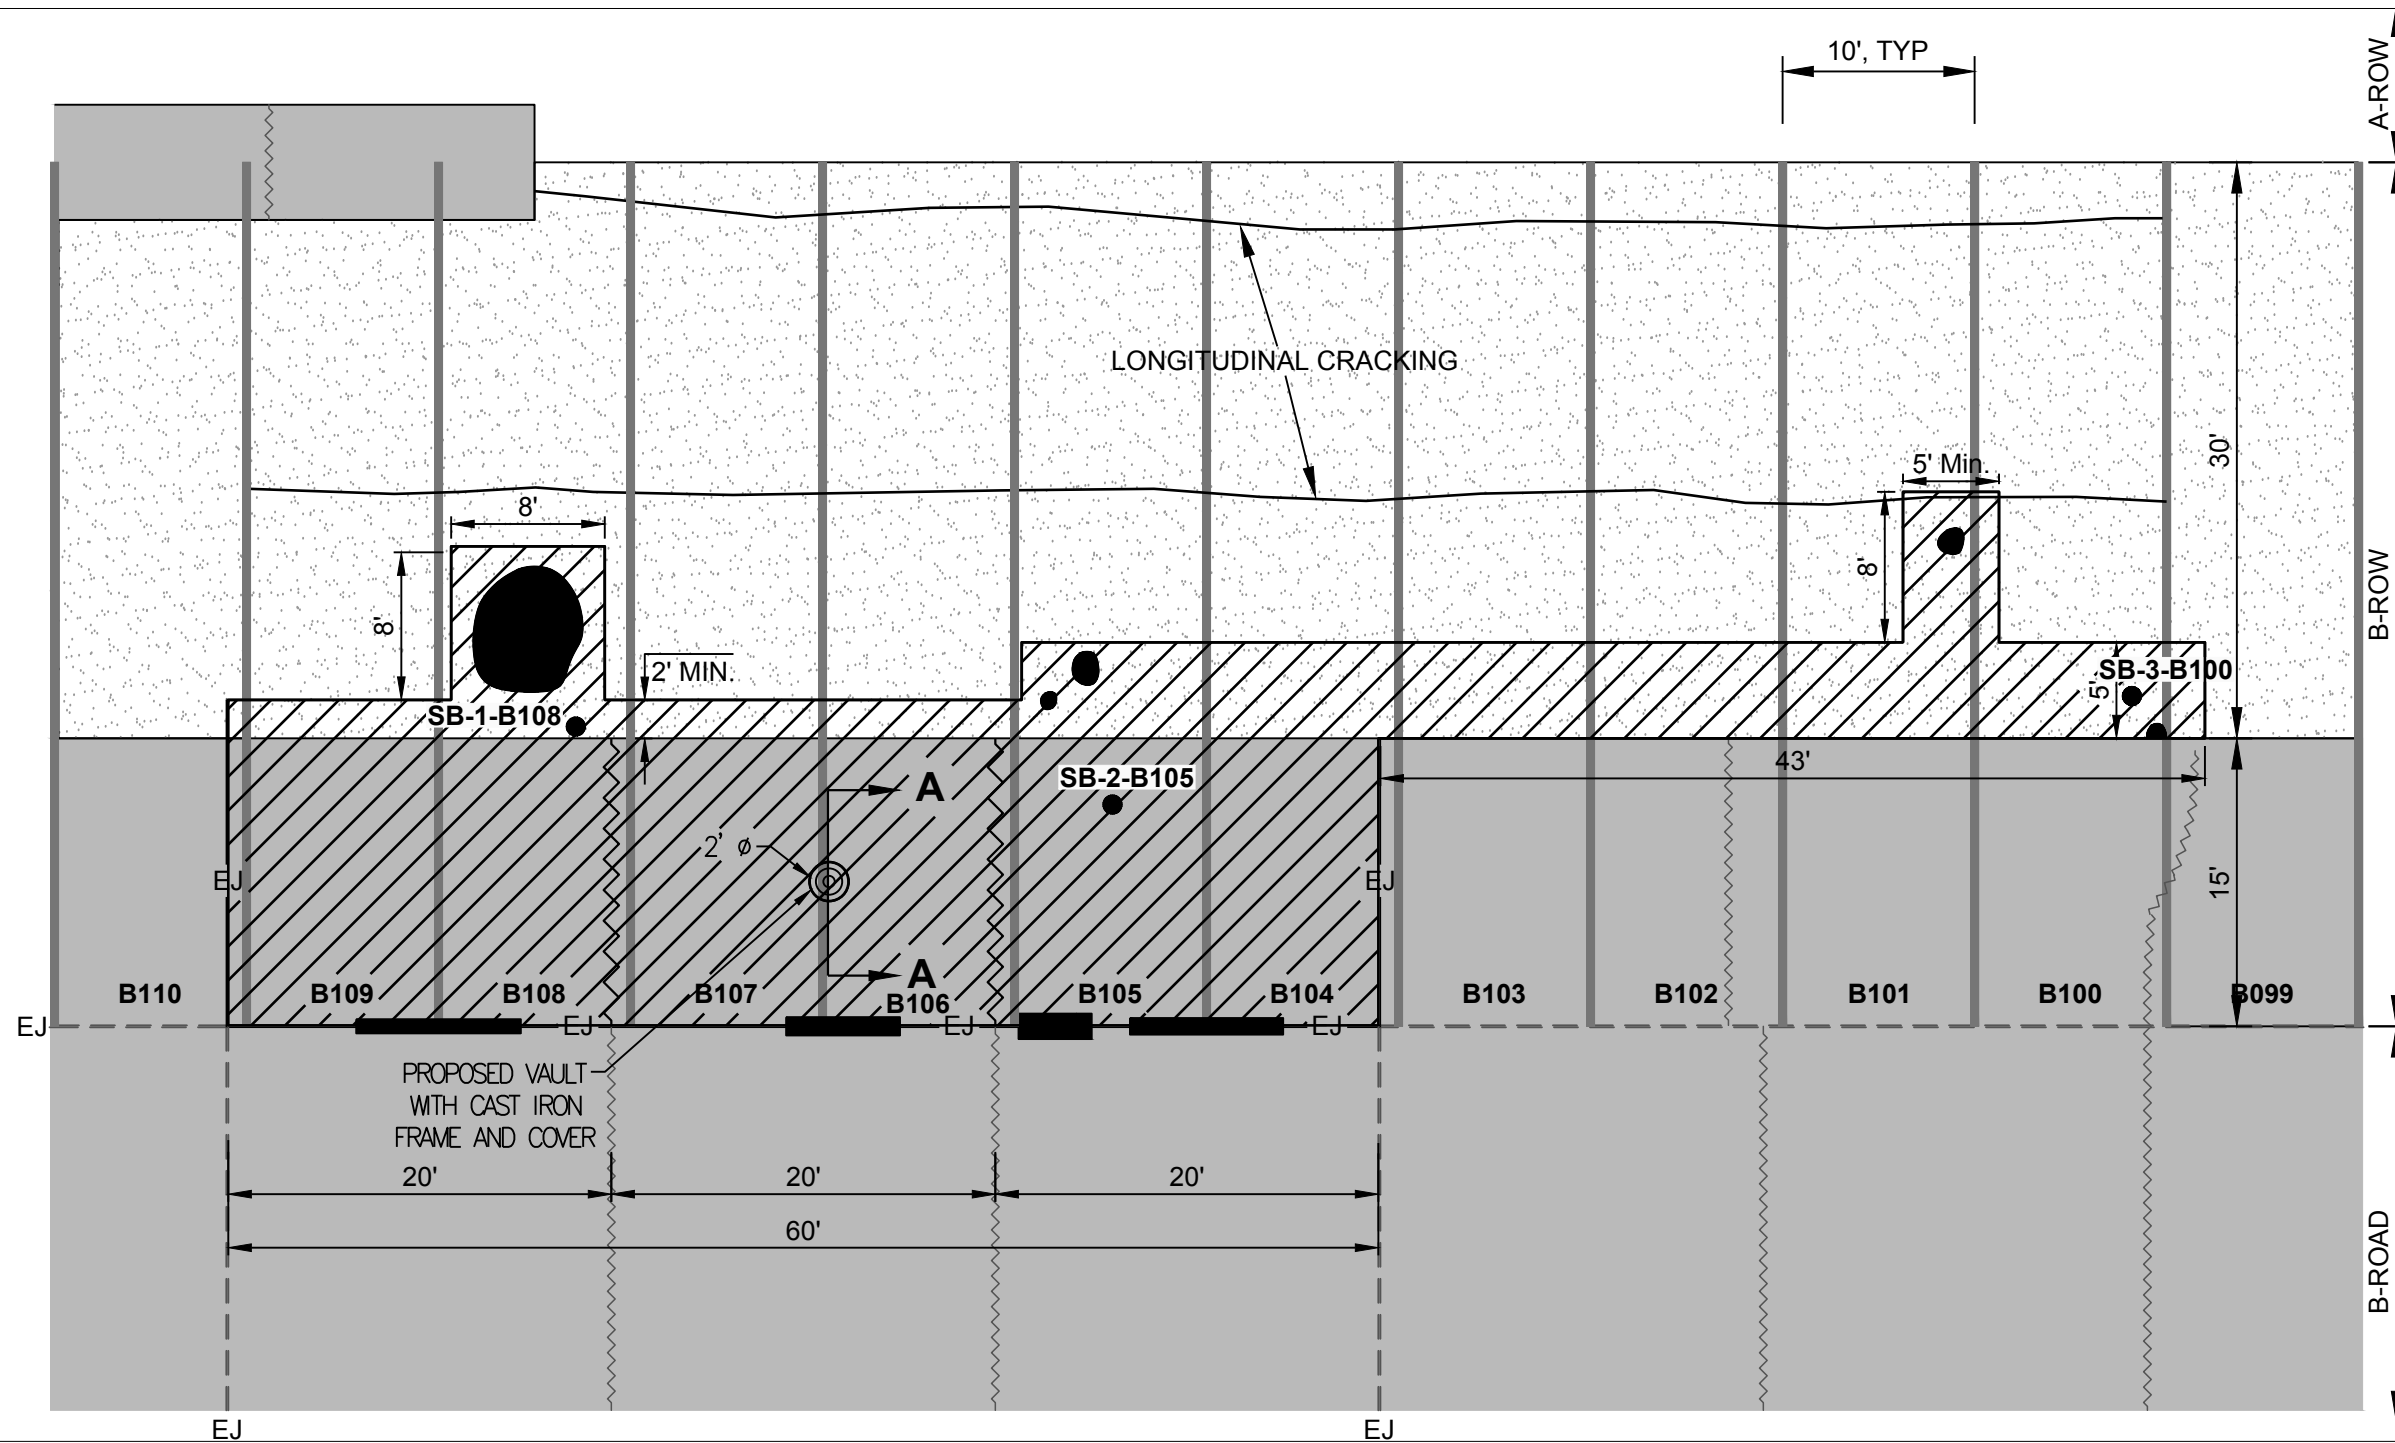
FIGURE
2

Response: Golder developed a response action design to address the tar-like substance seeps present in the B100 to B109 parking slots. The preliminary design drawings are provided in Attachment B of this letter. The preliminary design consists of the following:

- Saw cut and remove the asphalt or concrete cover (approximately 1,395 square feet of area);
- Excavate the existing road base, soil and debris to a depth of approximately 5 feet below grade. The estimated volume of material to be removed is approximately 215 cubic yards (in-place). The excavated material will be placed in roll-off boxes, profiled for disposal, and disposed at a permitted landfill facility;
