**RE: MONTHLY STATUS UPDATE – ENGLEWOOD INTERMODAL YARD – NAPL COLLECTION SYSTEM/CONCRETE CAP REPAIRS  
UNION PACIFIC RAILROAD HOUSTON WOOD PRESERVING WORKS FACILITY  
4910 LIBERTY ROAD FACILITY, HOUSTON, TEXAS  
POST-CLOSURE CARE PERMIT NO. HW-50343; INDUSTRIAL SWR NO. 31547**

Attachment NAPL Collection System Inspection Photographs -March/April

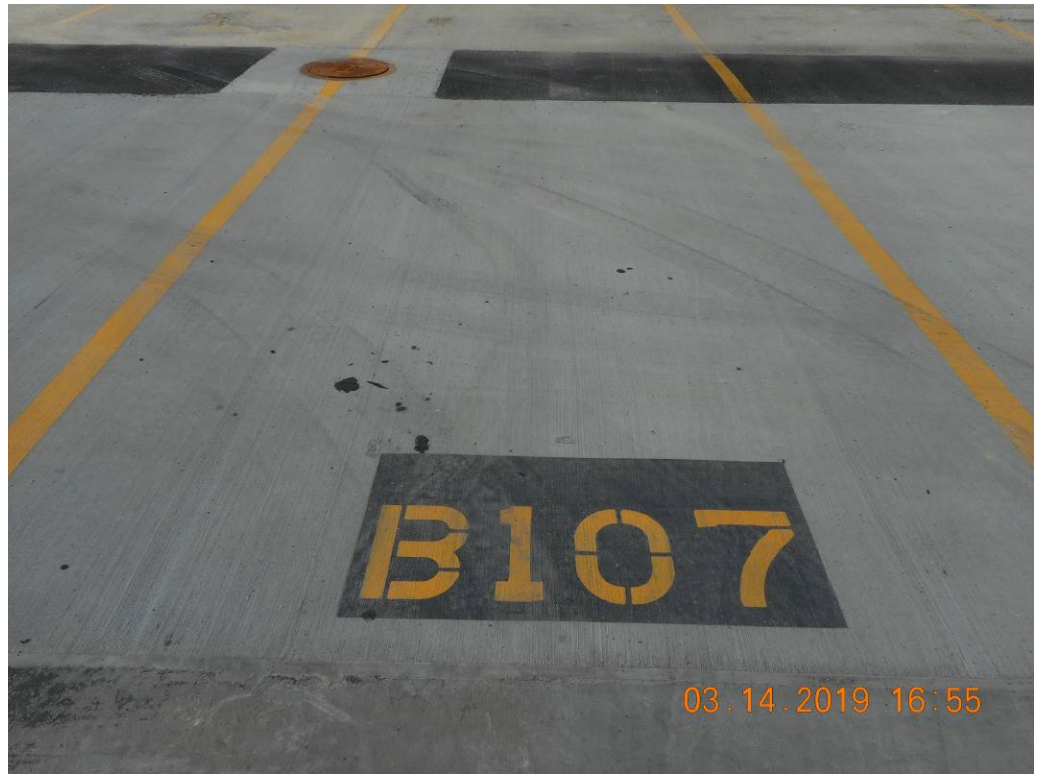
**Photo No.**  
**1**

View of parking slot B107 where the NAPL Collection System was installed, view of Sump 3 (B107/B108) in the background of photo, looking northwest.

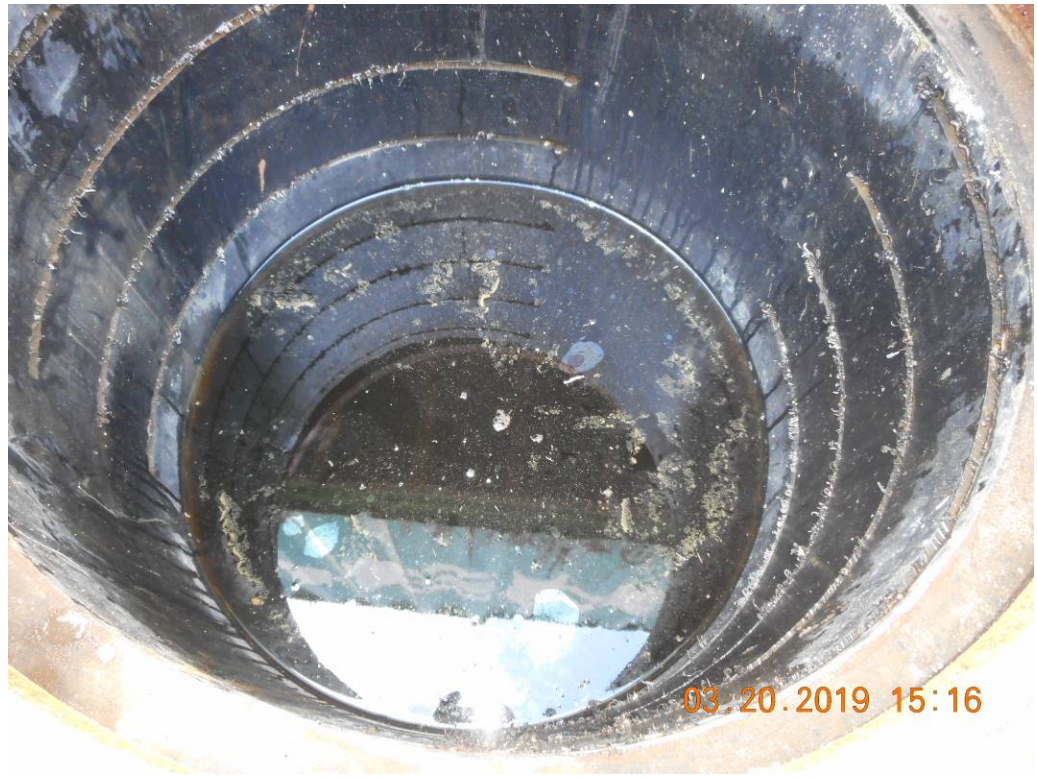
**Photo No.**  
**2**

View of NAPL collection system sump, note slight sheen on water.

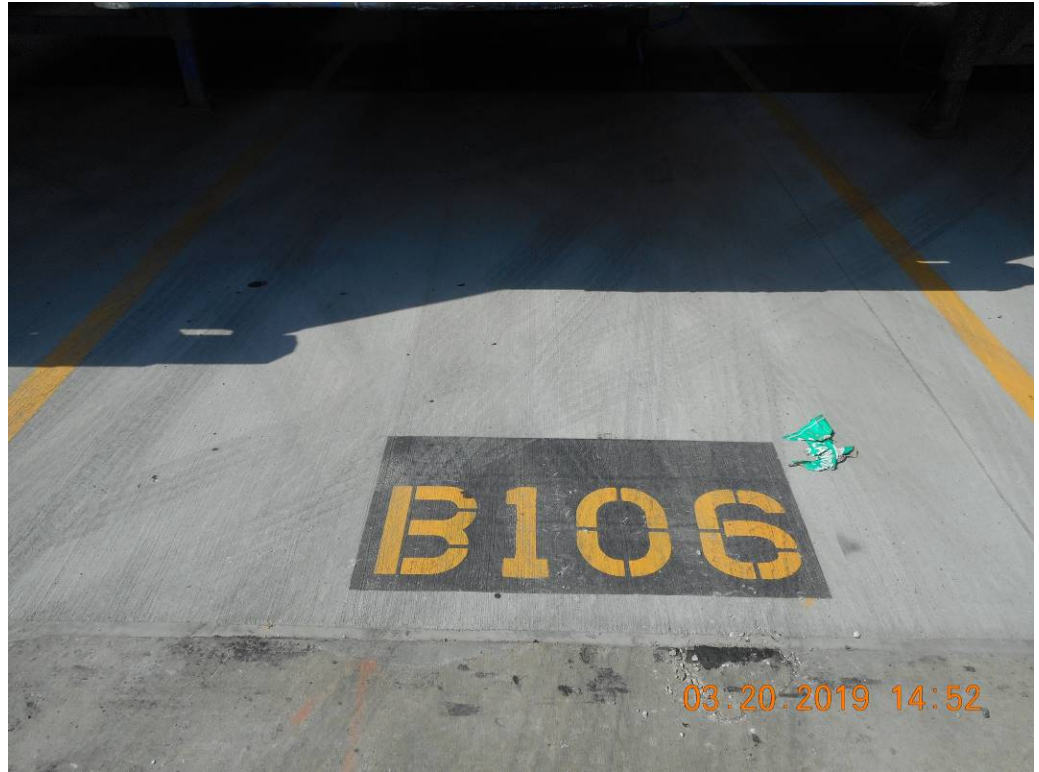
**Photo No.**  
**3**

View of slot B106 within the NAPL Collection System, looking north, note tar-like material at joint below the slot label.

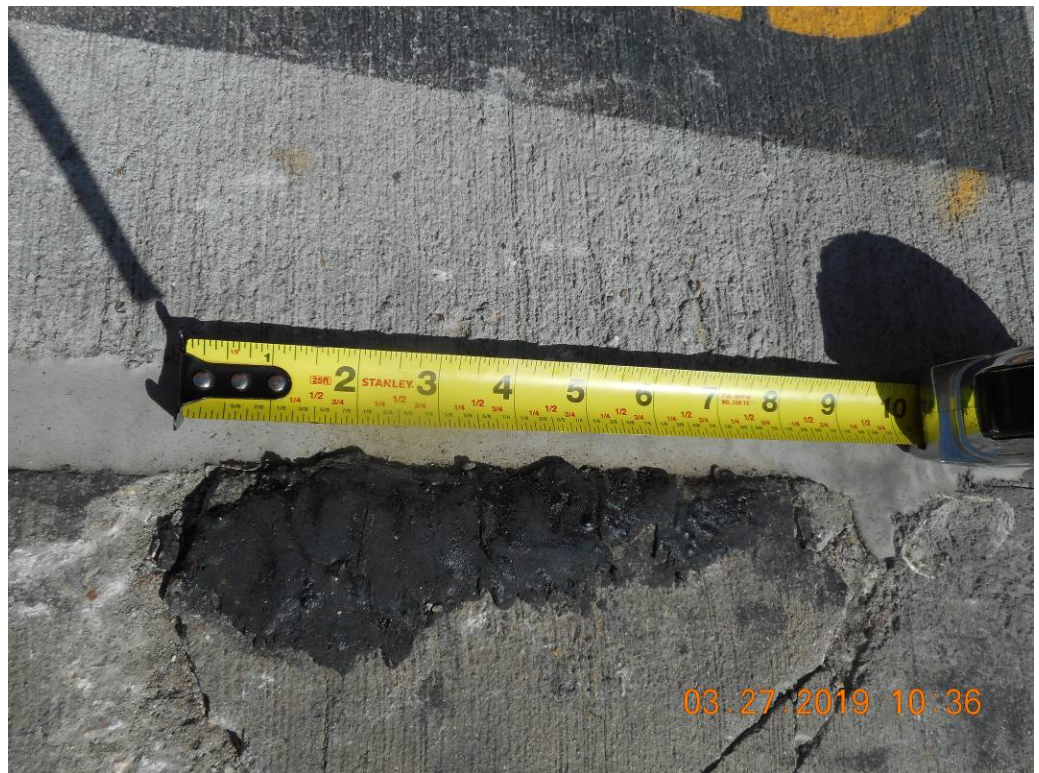
**Photo No.**  
**4**

View of slot B106, close-up photo of tar-like material.

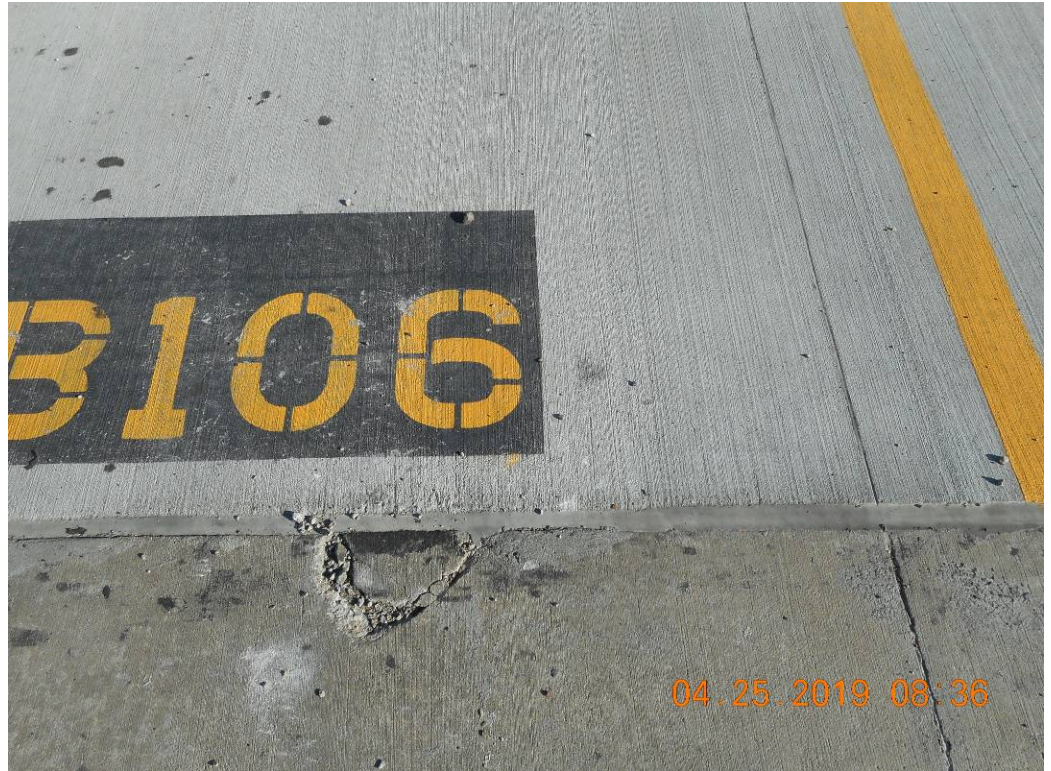
**Photo No.**  
5

View of slot B106, looking north, following removal of tar-like material on 04/04/19, no additional seepage noted after 04/04/19.

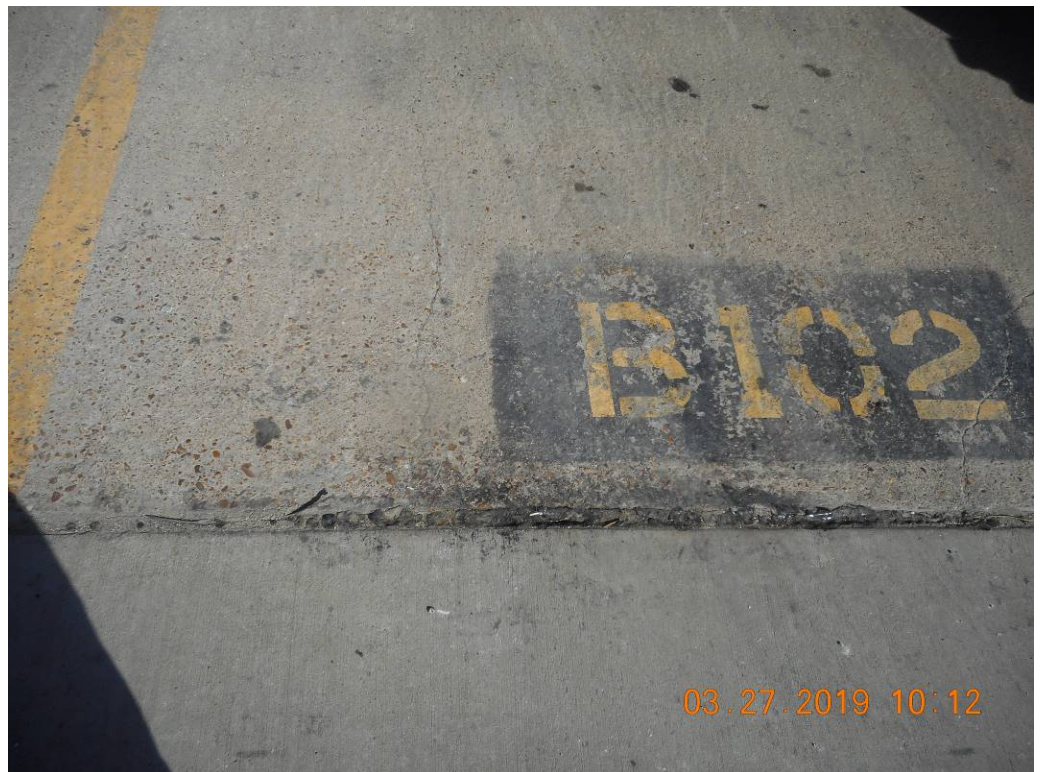
**Photo No.**  
6

View of slot B102, looking north, small amount of tar-like material observed in concrete joint.

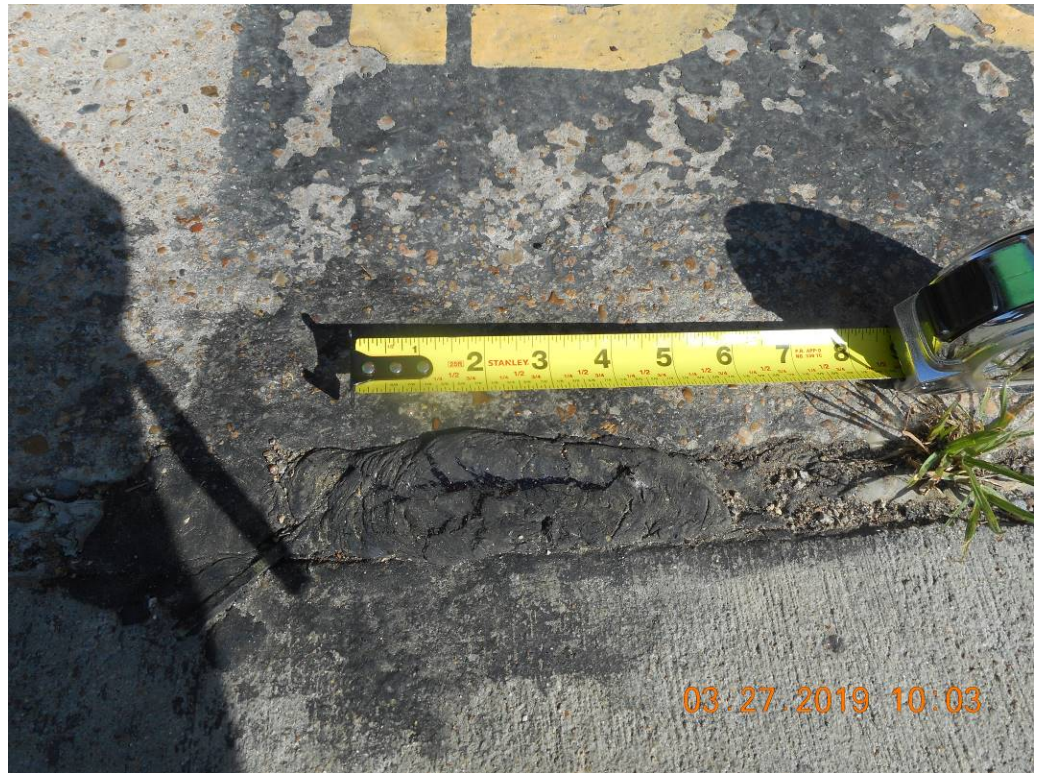
**Photo No.**  
**7**

View of slot B96, small amount of tar-like material in concrete joint, scrapped up on 04/04/19.

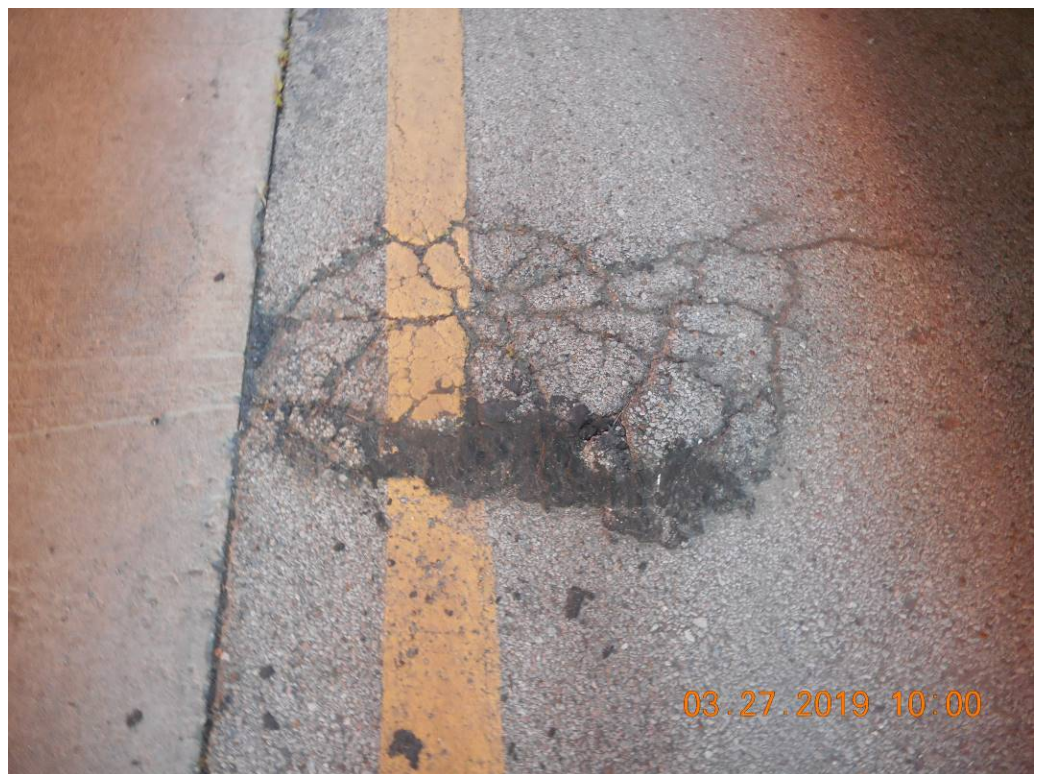
**Photo No.**  
**8**

View of slot B57, small amount of tar-like material in cracks in asphalt, scrapped up on 04/04/19.

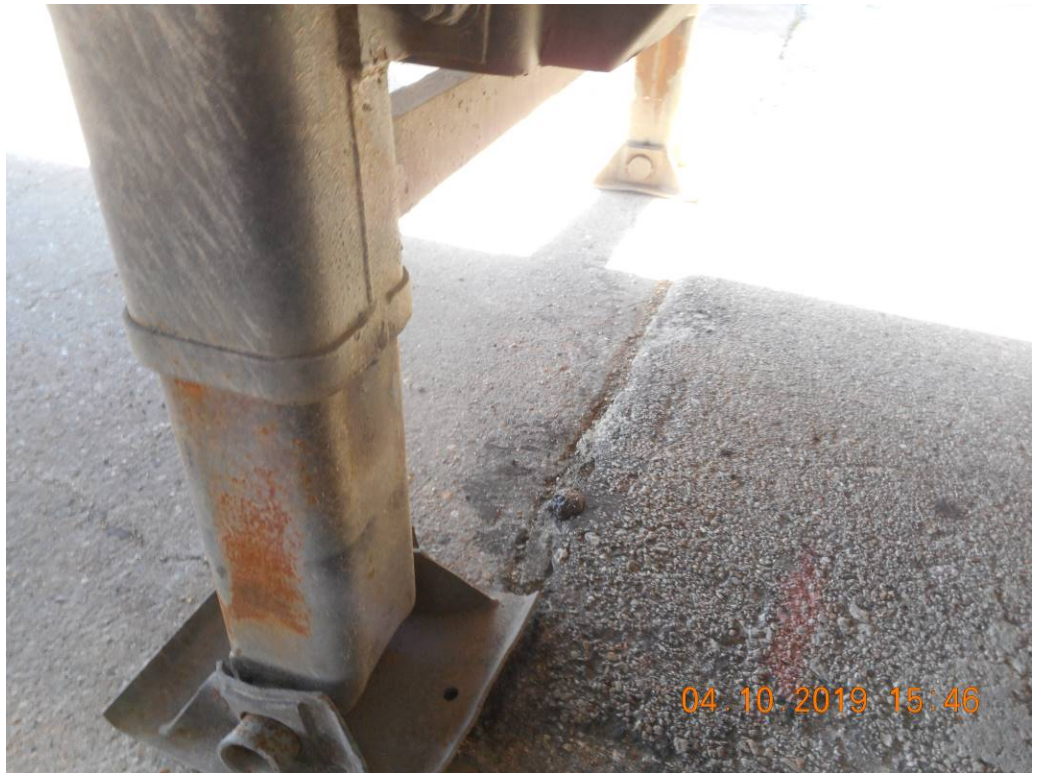
**Photo No.**  
9

View of slot B013, looking west, note small amount of tar-like material seep in center of photo at the concrete joint.

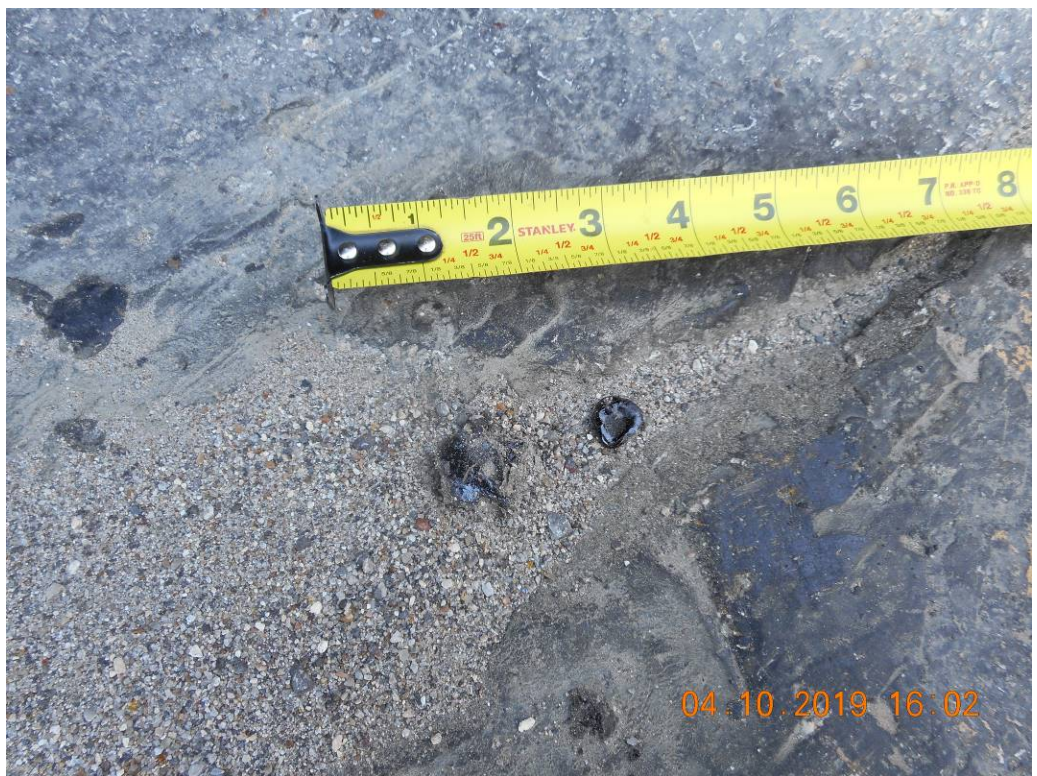
**Photo No.**  
10

View of slot B101 where a small amount of tar-like material observed, scrapped up on 04/10/19.

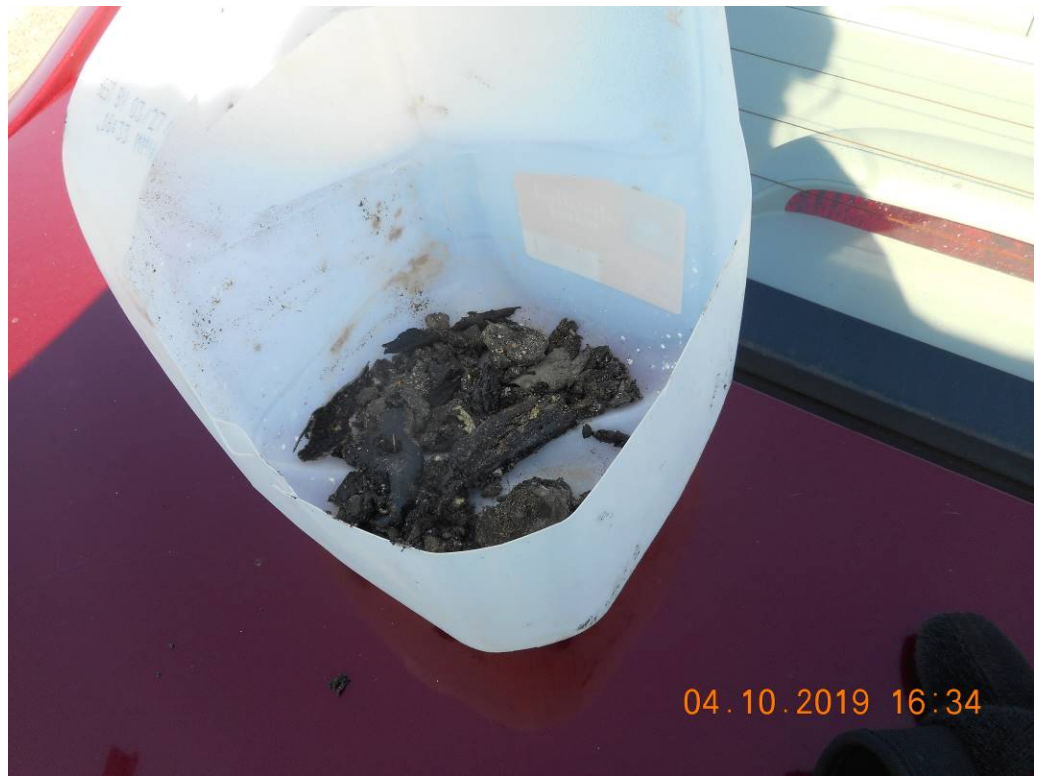
<b>Photo No.</b> 11	<b>Date:</b> 04/10/19
------------------------	--------------------------

**Description:**  
View of tar-like material scrapped from the parking slots on 4/10/19, then placed in on-site drum.
