Project No. 30401358

**RE: MONTHLY STATUS UPDATE – ENGLEWOOD INTERMODAL YARD – NAPL COLLECTION SYSTEM/CONCRETE CAP REPAIRS  
UNION PACIFIC RAILROAD HOUSTON WOOD PRESERVING WORKS FACILITY  
4910 LIBERTY ROAD FACILITY, HOUSTON, TEXAS  
POST-CLOSURE CARE PERMIT NO. HW-50343; INDUSTRIAL SWR NO. 31547**

Attachment NAPL Collection System Inspection Photographs -May

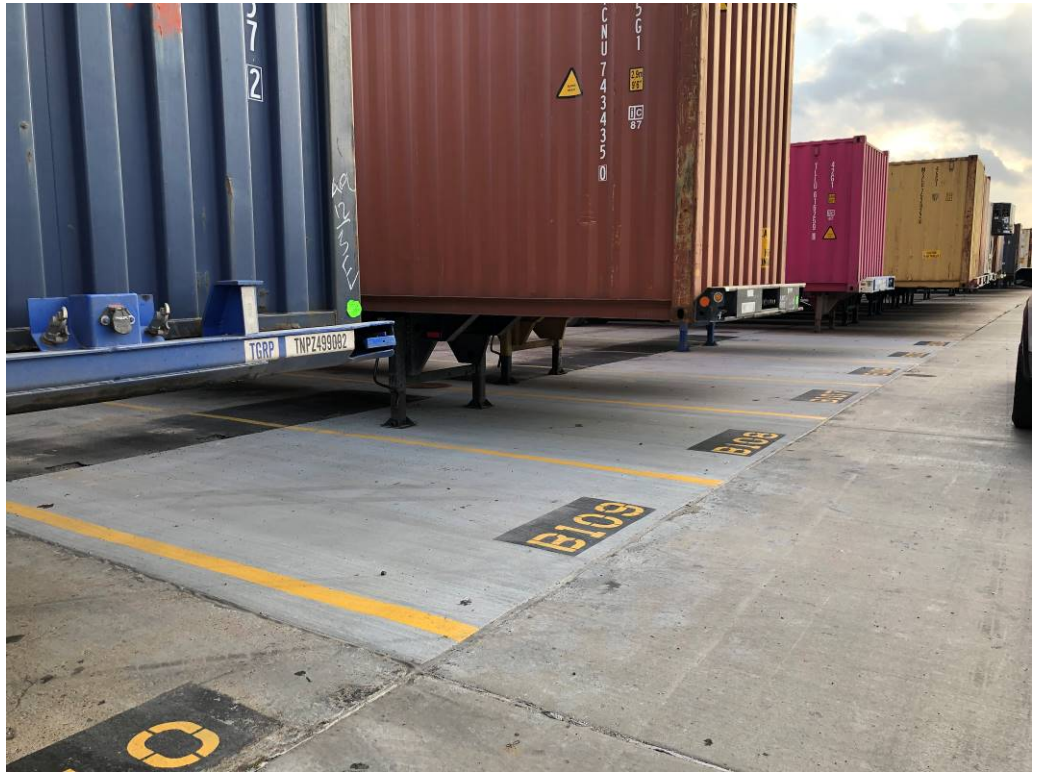
**Photo No.**  
**1**

View of NAPL  
Collection System  
(Slots B104 – B109)  
was installed, looking  
east.

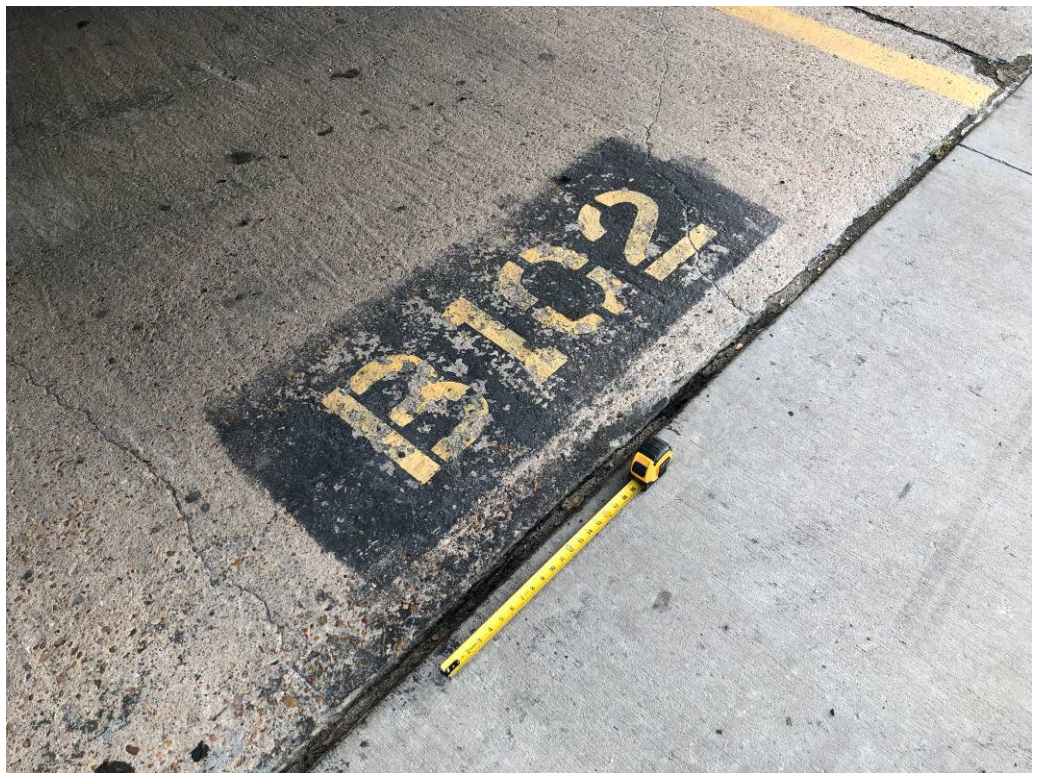
**Photo No.**  
**2**

- None of the tar-like material seeps were noted on the south end of stall B106 along the concrete joint with the NAPL Collection System.
- For areas outside the NAPL Collection System, very small amounts of tar-like material were noted near or within stalls B013, B057, B096, B101, B102, B105, and B108 where previous seeps have been observed. The small amount of observed tar-like material was scrapped up and placed on a drum on site.

View of slot B102,  
looking north, very  
small amount of tar-like  
material observed in  
concrete joint.

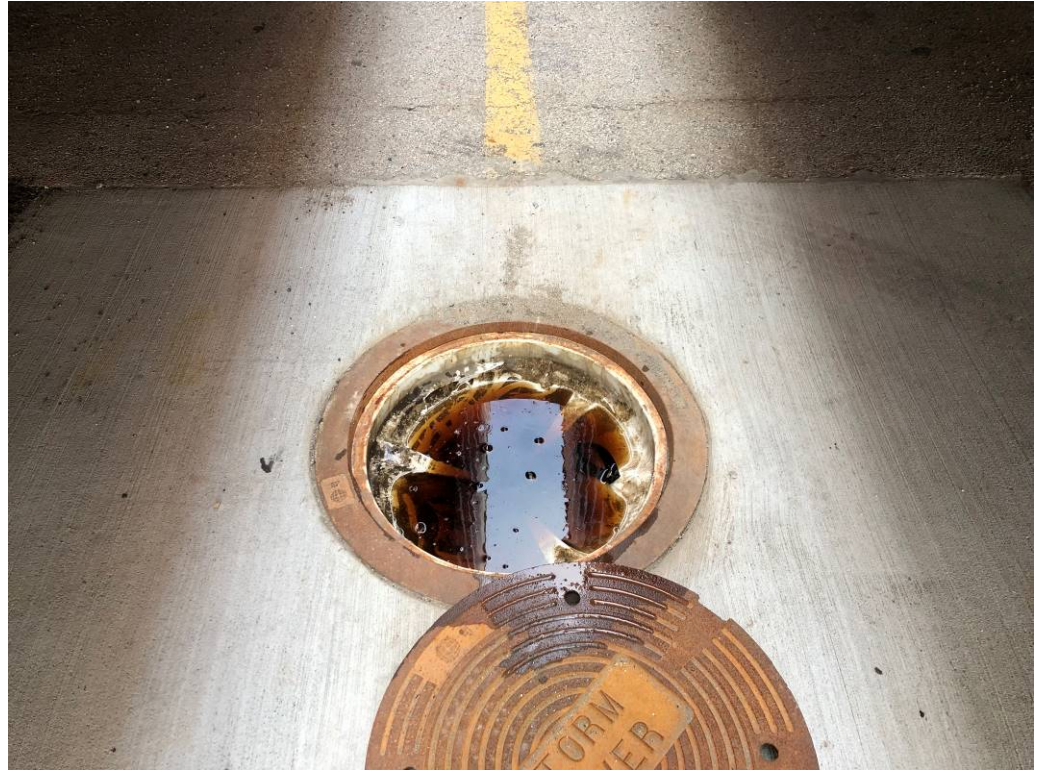
**Photo No.**  
**3**

- No significant amount of NAPL has been visually observed within the three NAPL collection sumps (Sump 1 (B099/B100 slots), Sump 2 (B103/B104 slots), and Sump 3 (B107/B108 slots)). However, as discussed in the April 2019 update, water has collected within the NAPL collection sumps. The water in Sump 1 was observed as being dark brown in color (no odor or observable characteristics of petroleum hydrocarbons were observed). The water in the sumps was pumped out on May 9<sup>th</sup> (pumped roughly half of the water from the sumps, approximately 5,000 gallons) and again on May 24, 2019 (pumped most of the water present in the sumps). During the May 24, 2019 pump down, NAPL with the water was noted in the vacuum truck. Since there was NAPL recovered, the fluids were transferred to a frac tank and separate samples of the water and NAPL were collected to recharacterize the recovered fluids for disposal. Samples of the fluids were collected on May 24,

**B99-B100 Sump:**  
 View of B99-B100 sump as part of the NAPL Collection System, looking north, note dark brown colored water pooled in the inflow protector.

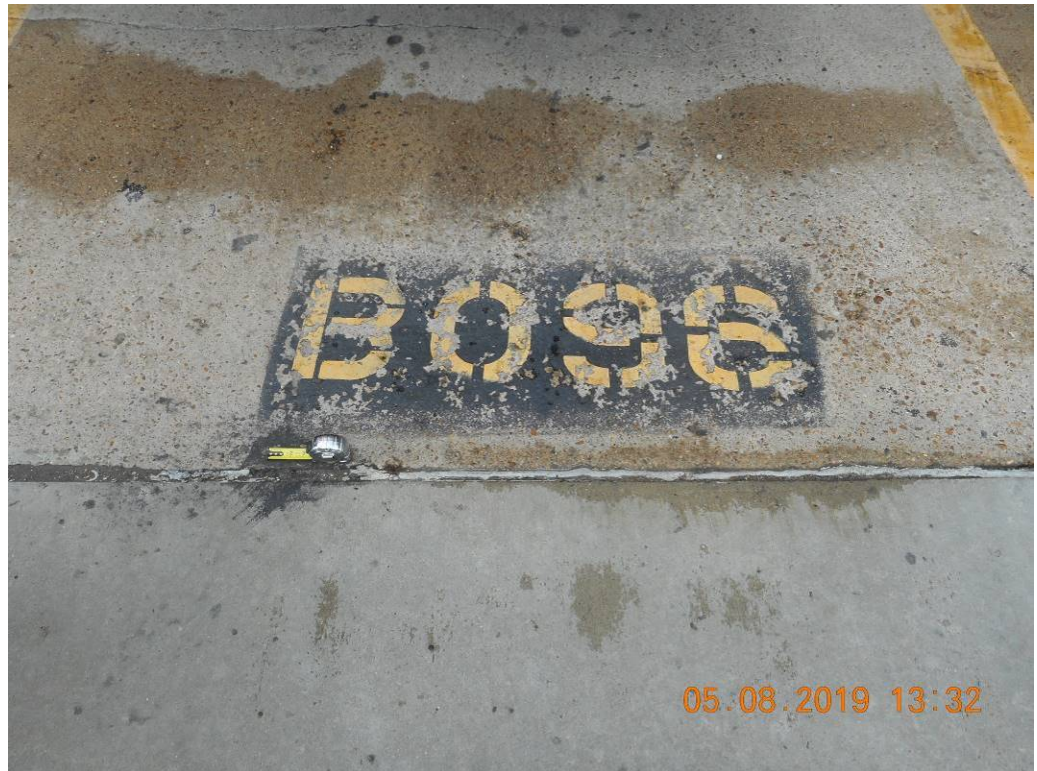
**Photo No.**  
**4**

**Slot B96:**  
 View of slot B96, very small amount of tar-like substance seep.

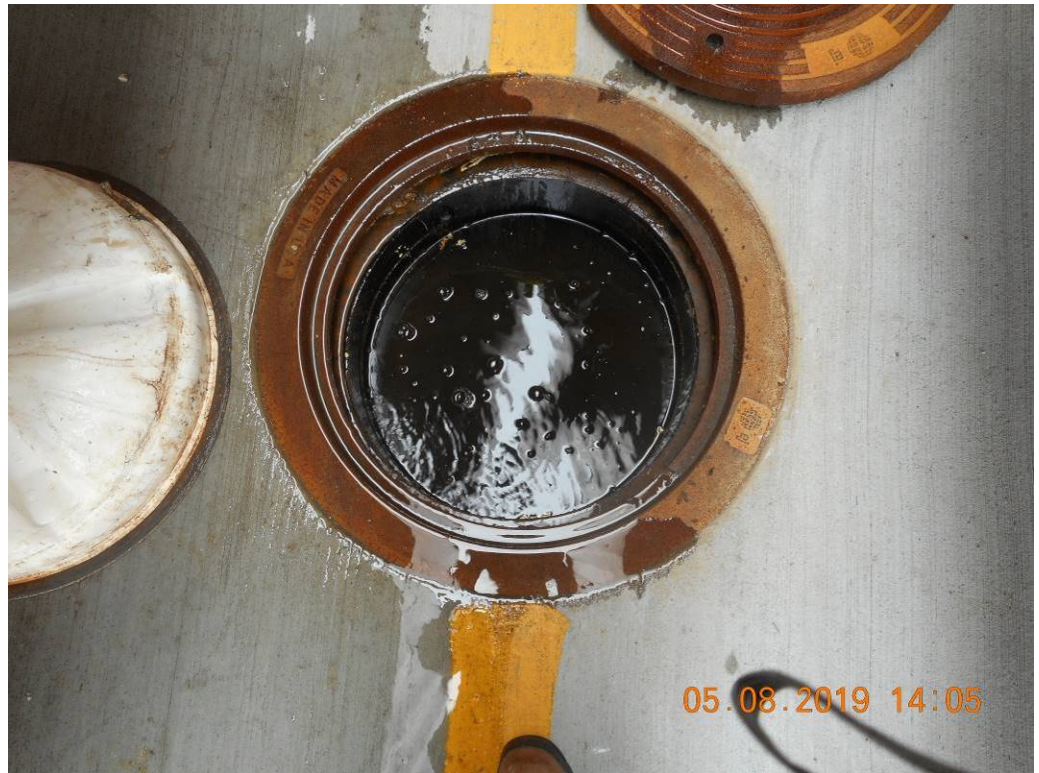
**Photo No.**  
5

**B103-B104 Sump:**  
View of B103-B104  
Sump near full with  
water, slight sheen  
noted on the water.

2019. Once the analytical data from the water and NAPL samples are received and reviewed, the fluids will be characterized and scheduled for disposal.

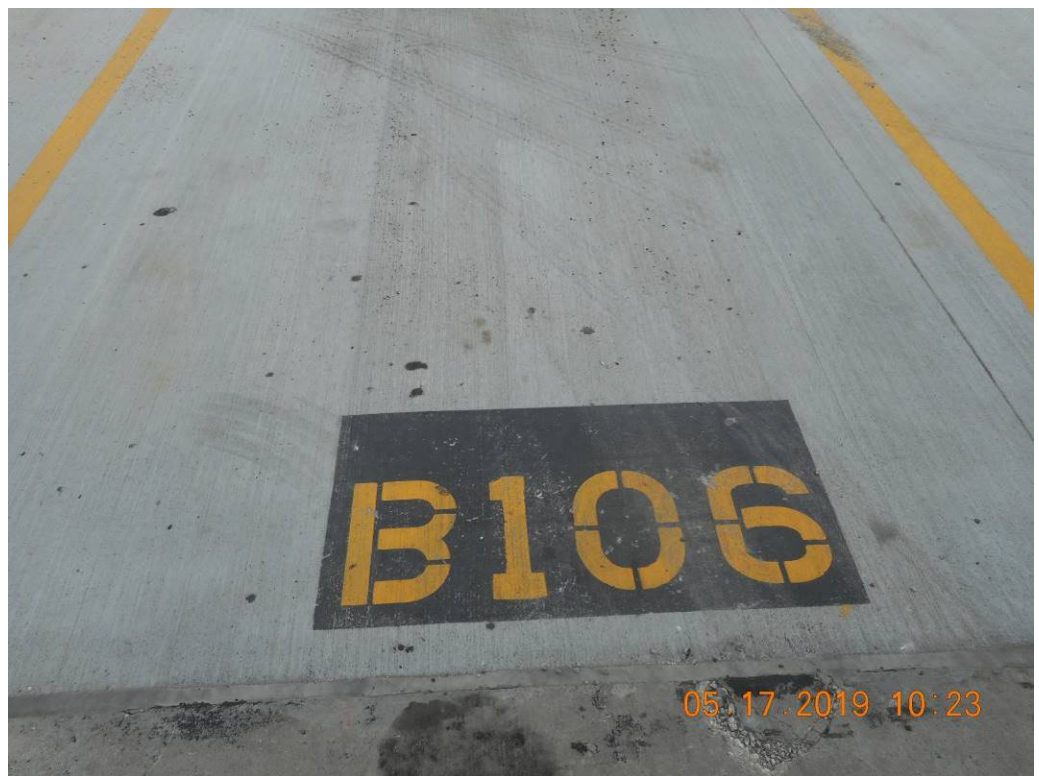
**Photo No.**  
6

**Slot B106:**  
View of slot B106,  
looking north, no tar-  
like material observed  
in concrete joint.

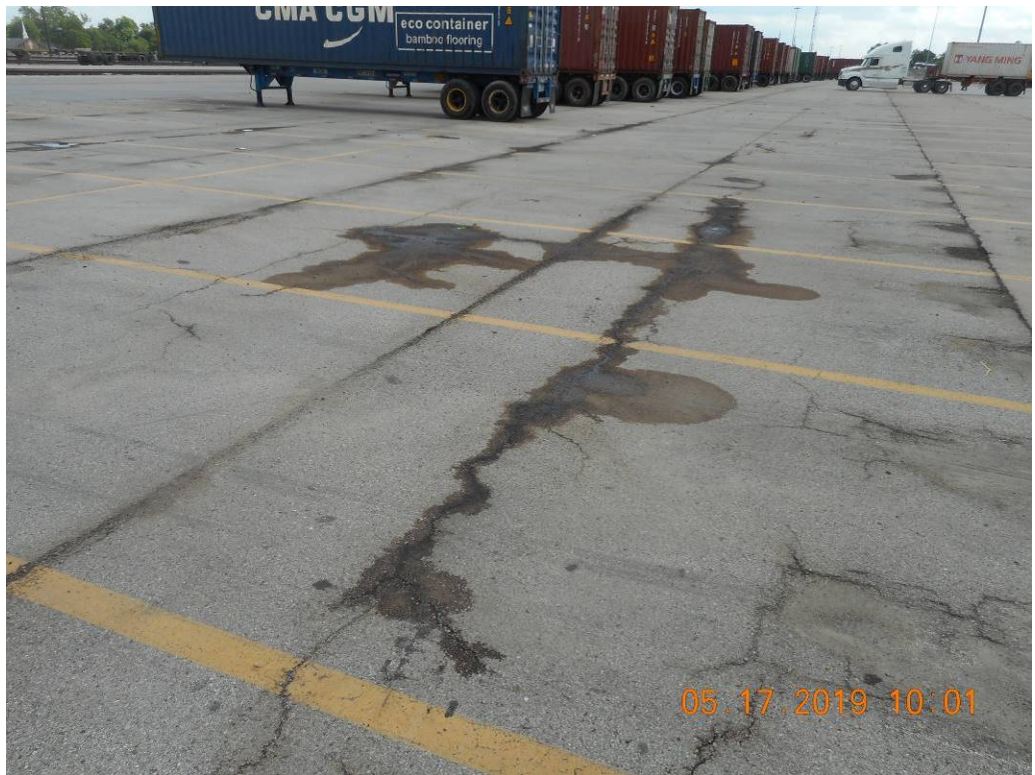
**Photo No.**  
7

- Areas of brown stains on the concrete pavement and evidence of seeps of a dark brown to black water were observed along cracks in the pavement and low-lying areas. The staining and seeps were observed throughout the B-Row (predominately in the B090 – B098 area) but were also observed within the A-Row and C-Row. On May 23, 2019, UPRR contractor United States Environmental Services (USES) was called to the Site to pressure wash the areas and collect the fluids, which were placed in a tote on site. USES returned to the site on May 28, 2019 and pressure washed the area and recovered the fluids with a vacuum truck. Based on observations during the pressure washing, the dark brown to black water does not appear to be related to petroleum hydrocarbons (no sheen, no odor, and can be removed with pressure washer). However, a sample of the recovered water stored in the tote will be collected for characterization to evaluate if there are any petroleum hydrocarbons present. UPRR will continue to have USES conduct weekly site visits to recover the water from the seep areas.

View of slot B96 area looking east, areas of dark, brown water staining on the pavement.

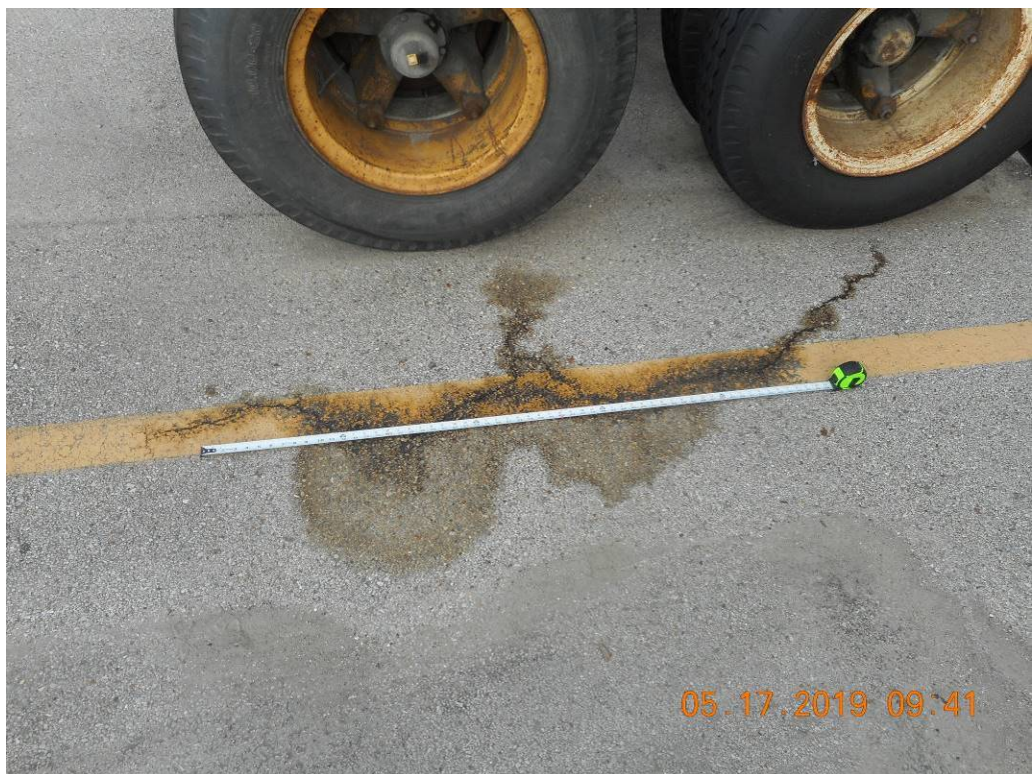
**Photo No.**  
8

View of slot B013, dark, brown water stains in cracks in asphalt.

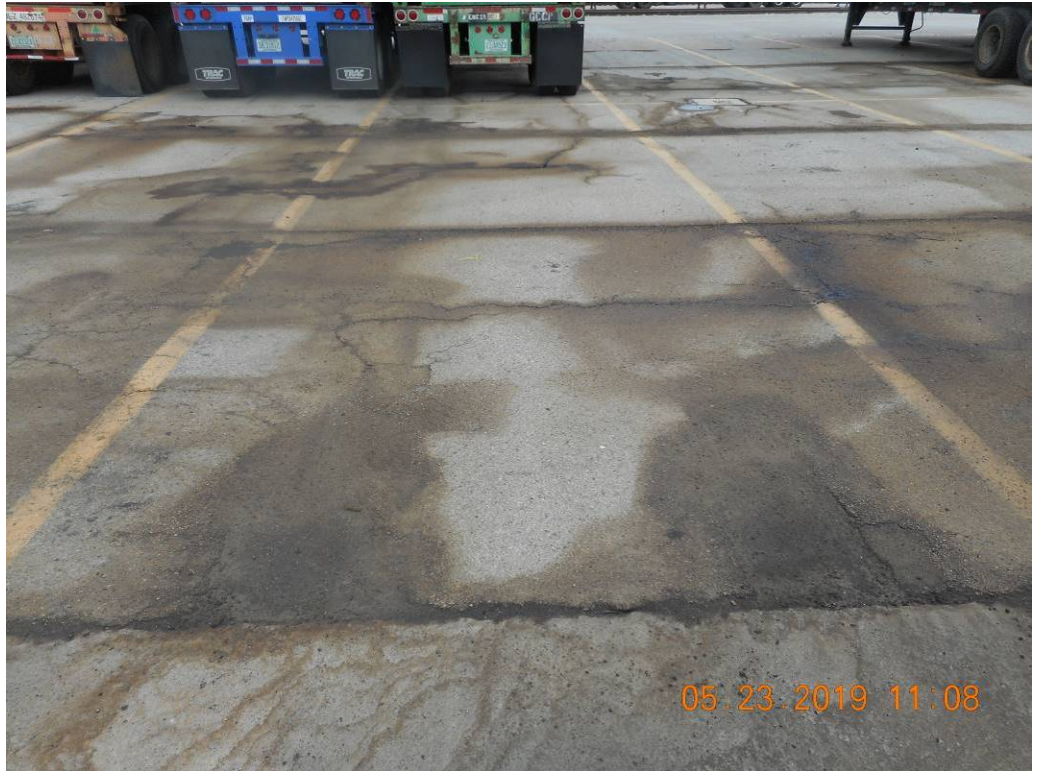
**Photo No.**  
9

View of slot B095, looking north, large area of dark staining, concentrated around cracks and joints of the asphalt.

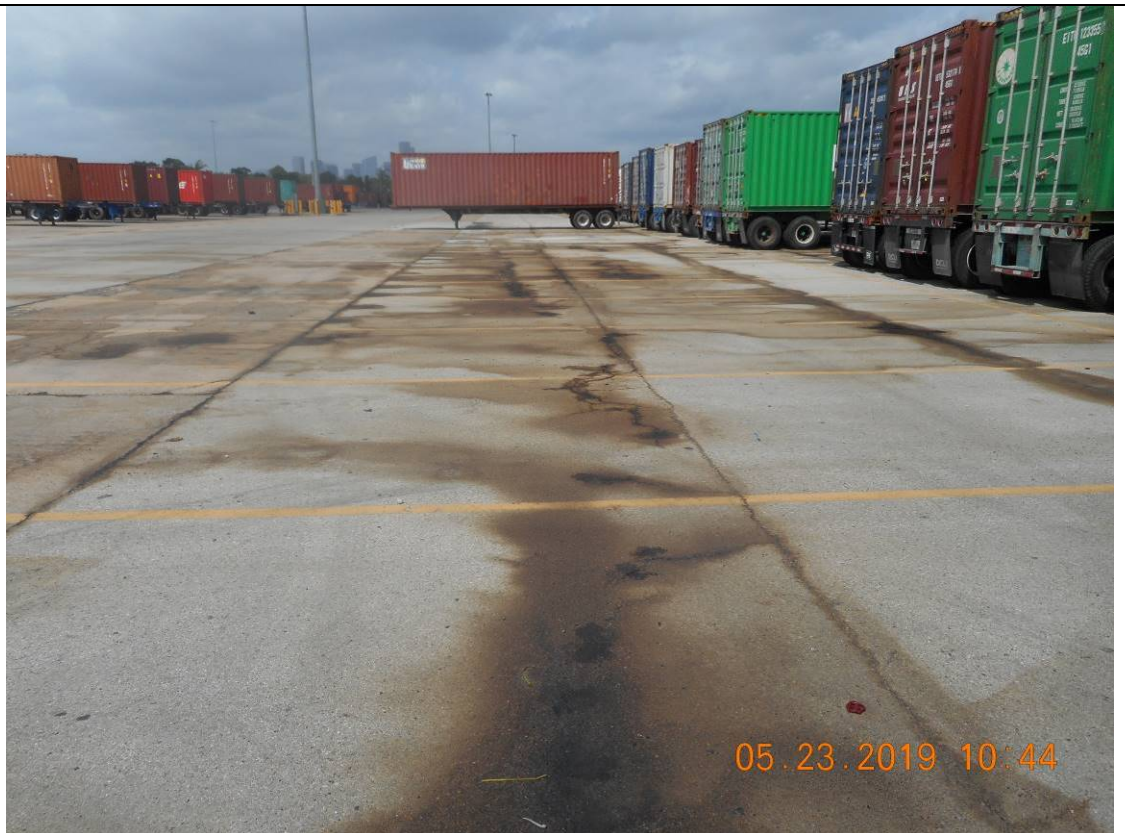
**Photo No.**  
10

View of B-Row slots looking west, large area of dark staining, concentrated around cracks and joints of the asphalt.

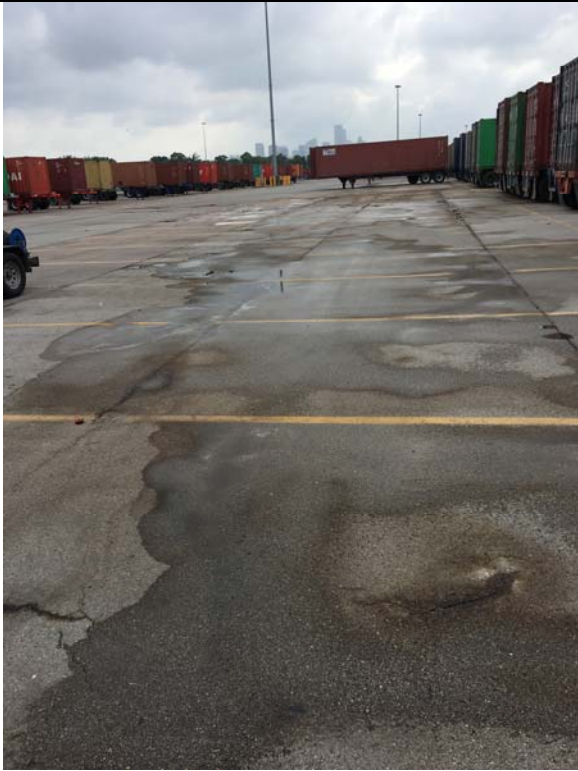
<b>Description:</b>  <b>B-Row Slots:</b> View of B-Row slots looking west, after pressure washing area of dark staining			
<b>Photo No.</b> 12	<b>Date:</b> 05/28/19

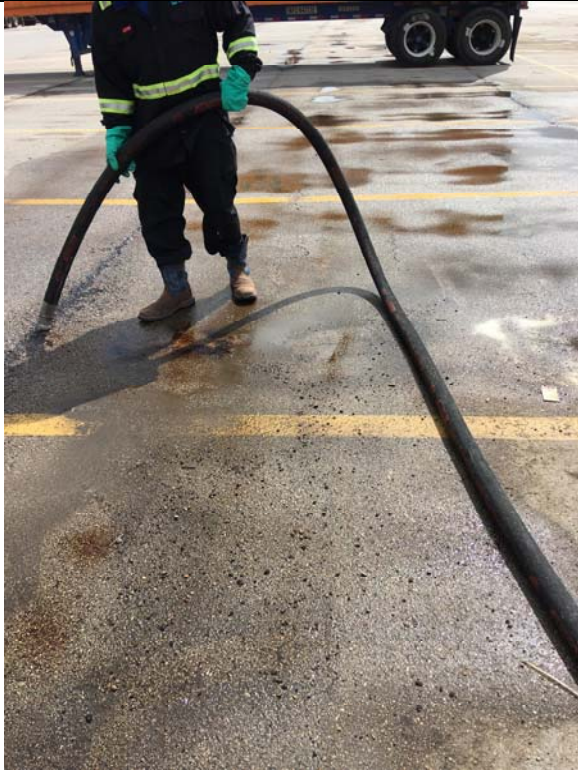
<b>Description:</b>  <b>B-Row Slots:</b> View of B-Row slots looking east, after pressure washing area of dark staining and recovery with vacuum truck.

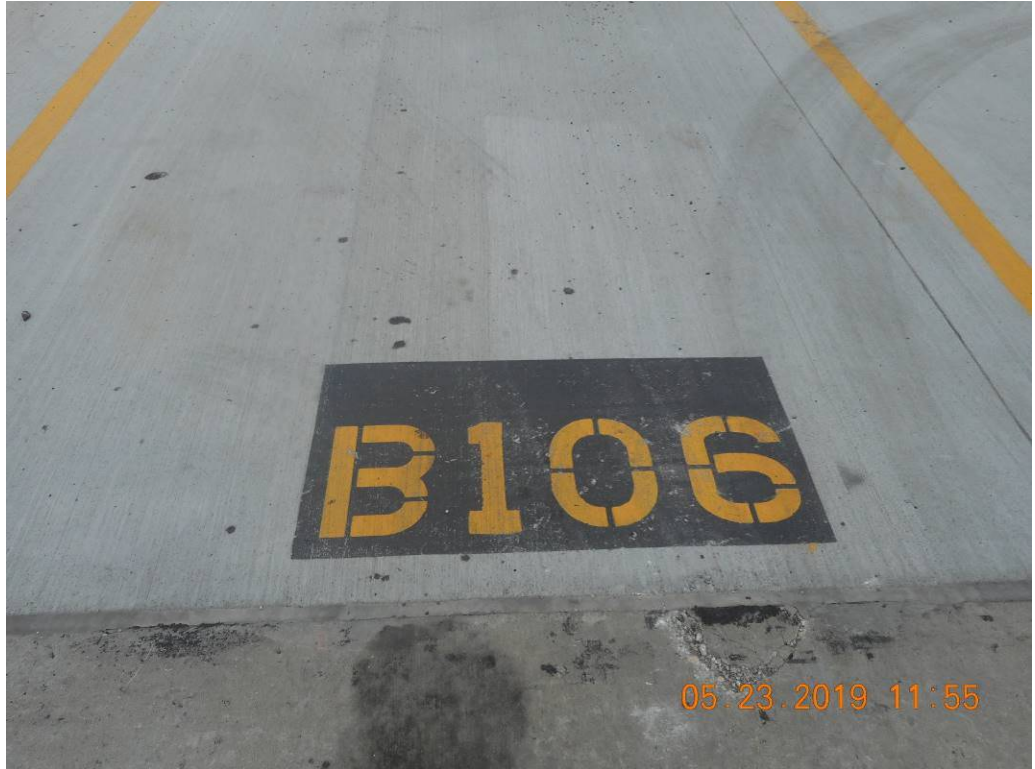
**Photo No.**  
13

**Slot B106:**  
View of slot B106, no tar-like material observed in concrete joint.

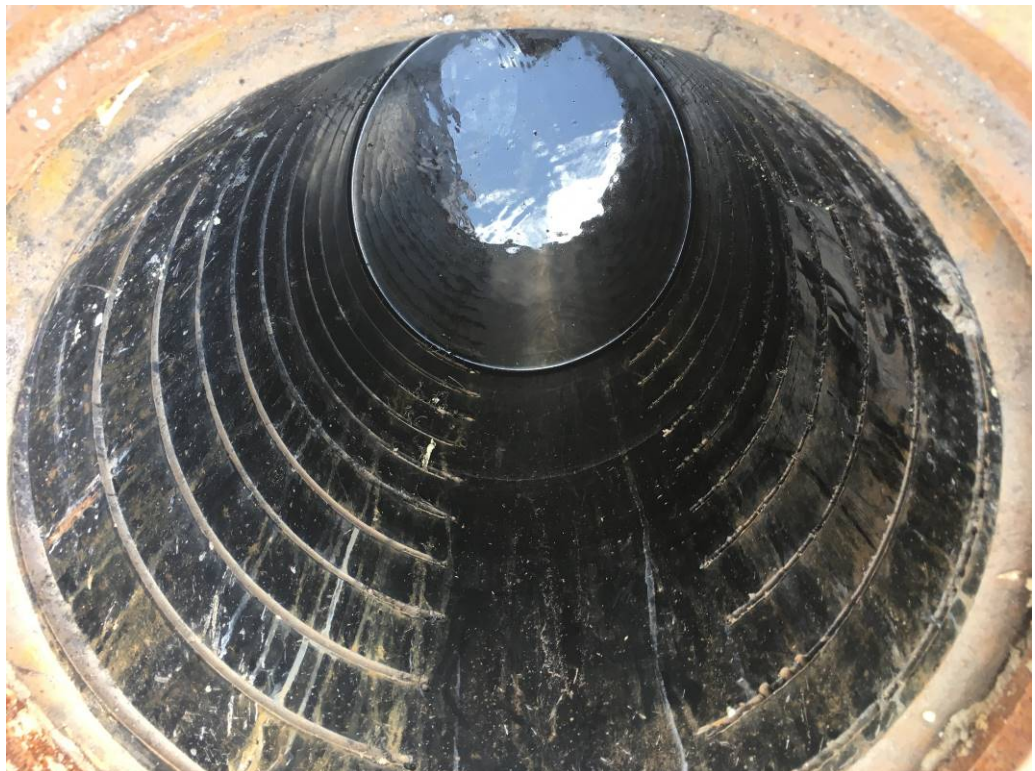
**Photo No.**  
14

**B103-B104 Sump:**  
View of B103-B104 Sump after pump down on May 24, 2019.
