**RE: MONTHLY STATUS UPDATE – ENGLEWOOD INTERMODAL YARD – NAPL COLLECTION SYSTEM/CONCRETE CAP REPAIRS
UNION PACIFIC RAILROAD HOUSTON WOOD PRESERVING WORKS FACILITY
4910 LIBERTY ROAD FACILITY, HOUSTON, TEXAS
POST-CLOSURE CARE PERMIT NO. HW-50343; INDUSTRIAL SWR NO. 31547**

Weekly Inspection Photolog

Site Location:
Englewood Intermodal Yard/Houston Wood Preserving Works, 4910 Liberty Road, Houston, Texas

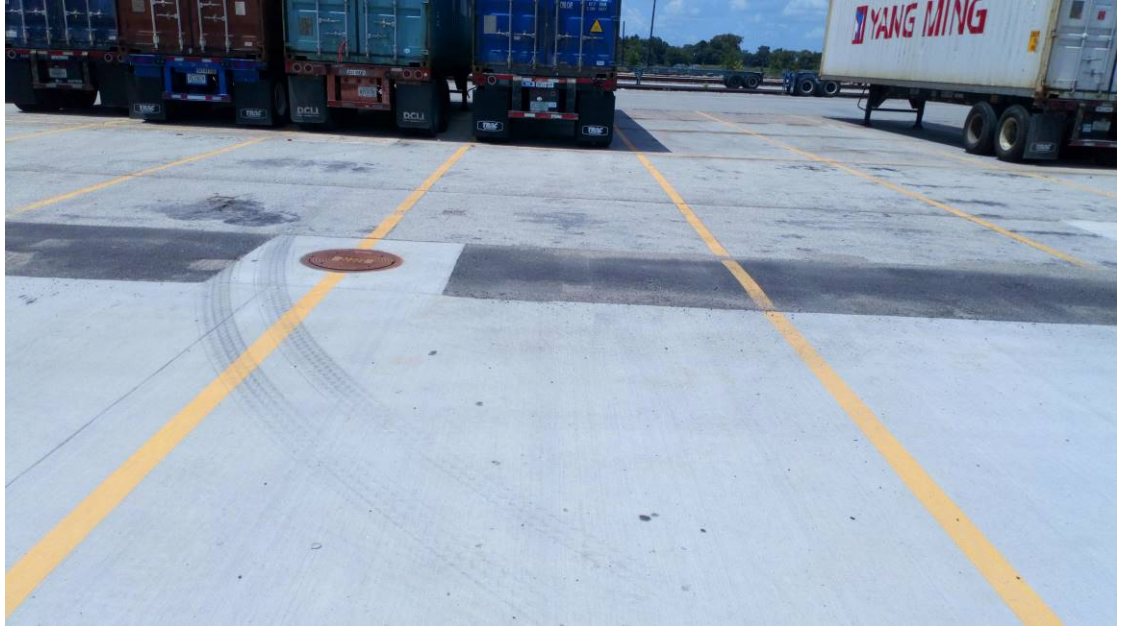
NAPL Collection Sump at B108:

View of B107/B108 NAPL Collection Sump, looking north.

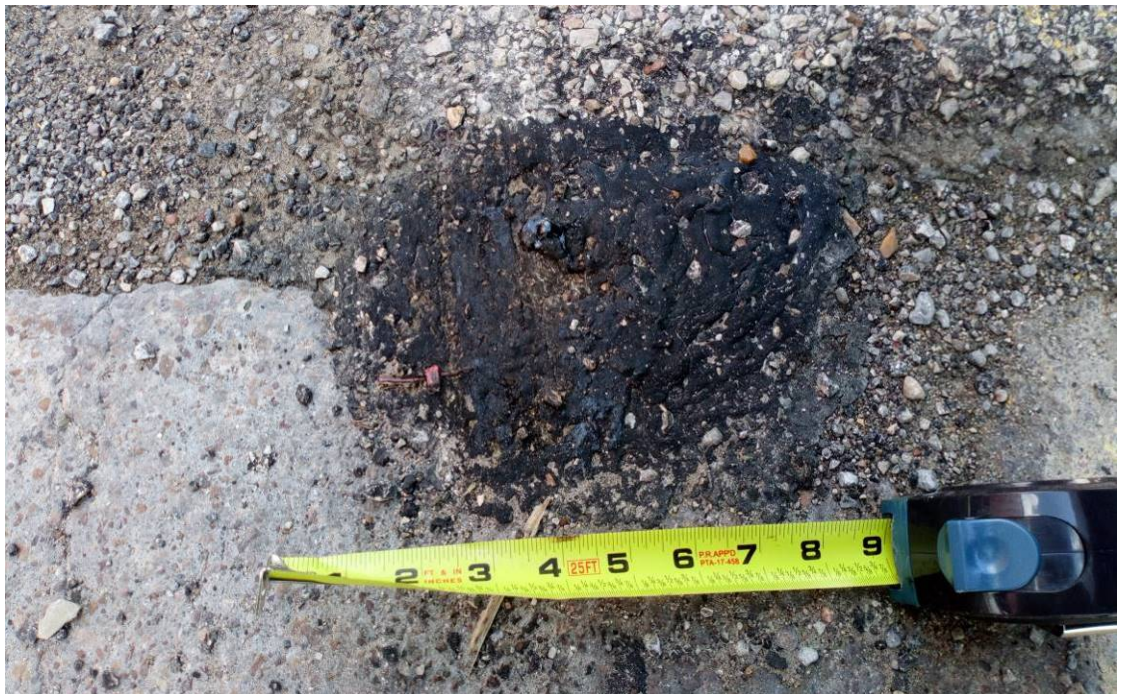
Slot A022:

View of slot A022 looking southeast, very little tar-like material observed in asphalt crack.

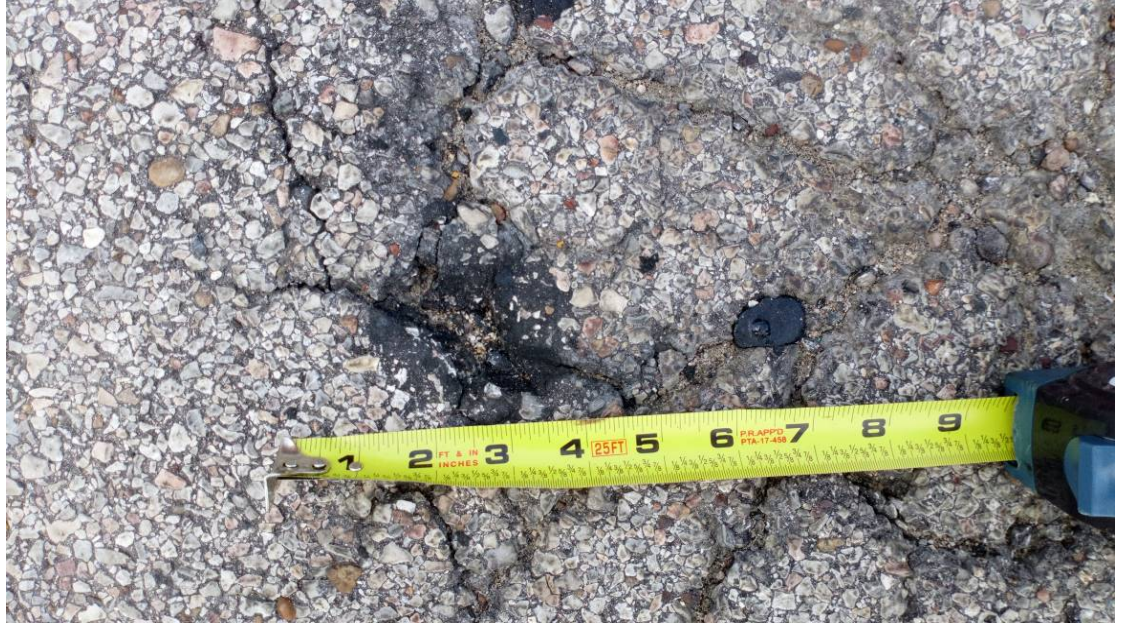
Slot B057:

View of slot B057, very little tar-like material observed in cracks in the asphalt.

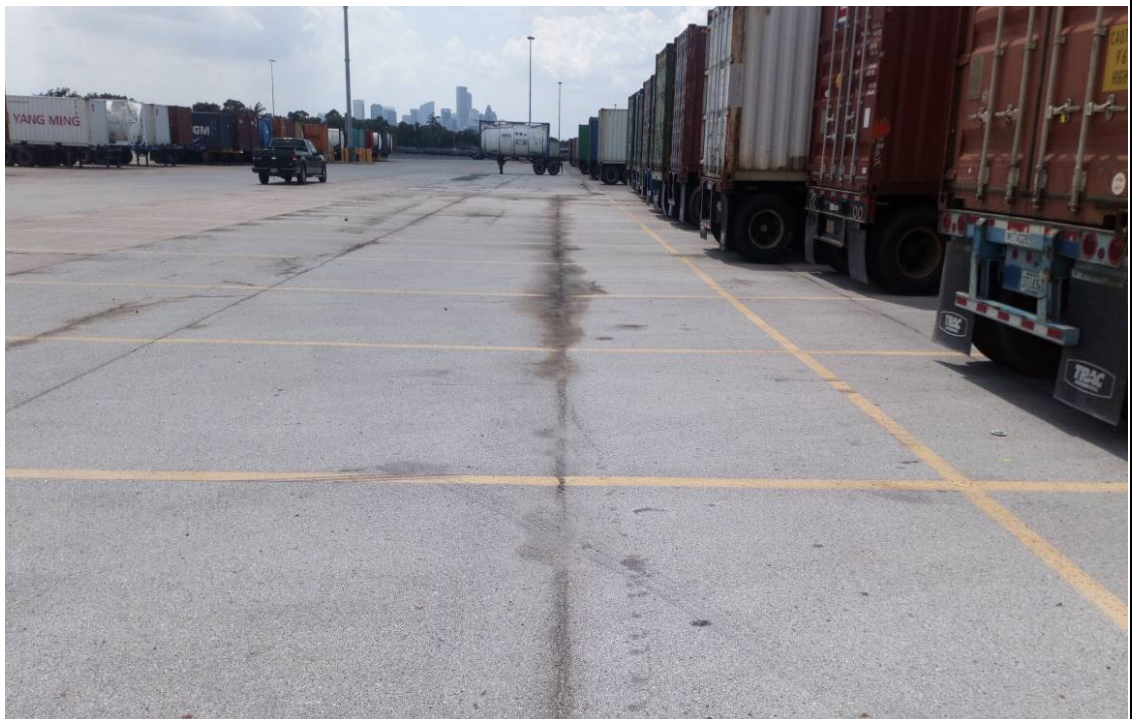
Slots B086-B100:

View of Slots B086 through B100, looking west, some brown staining along asphalt cracks, no standing water observed.

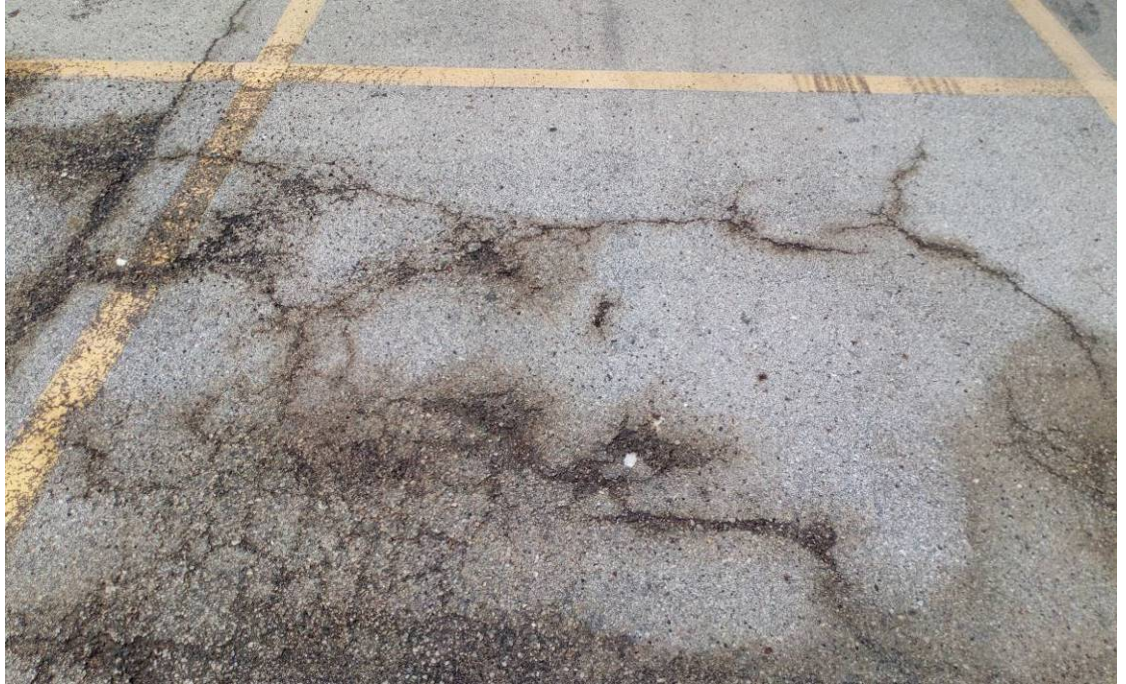
Slots B098:

View of Slot B098, looking north, brown staining along cracks in the asphalt, no standing water observed.

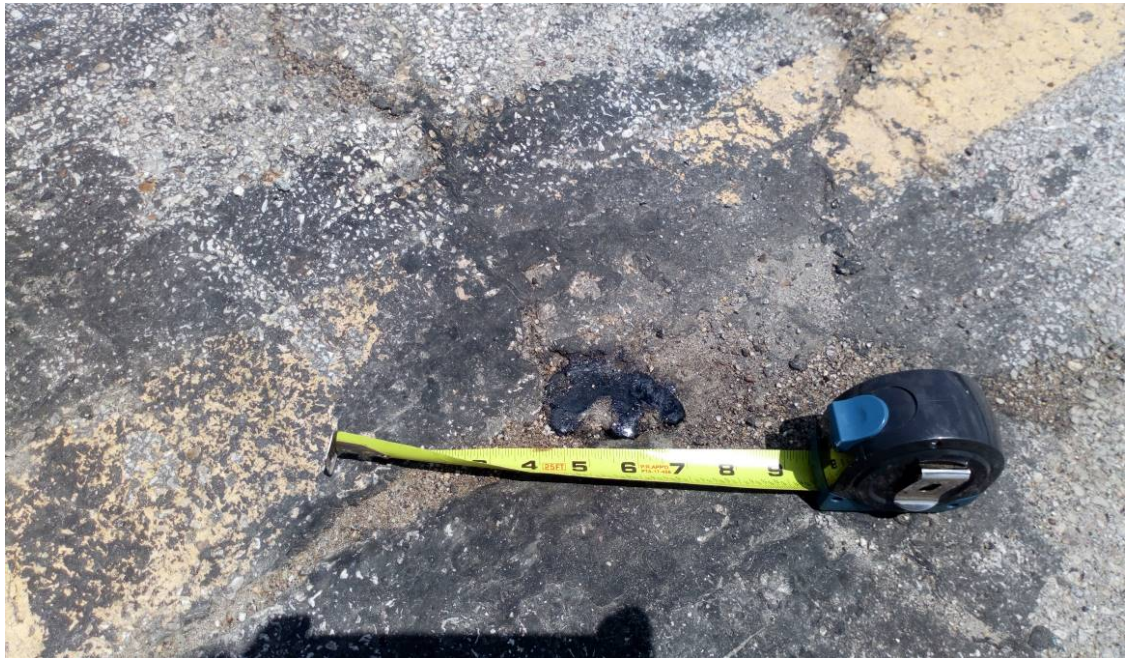
Slot B101:

View of slot B101 looking southwest, tar-like material observed in cracks in the asphalt.

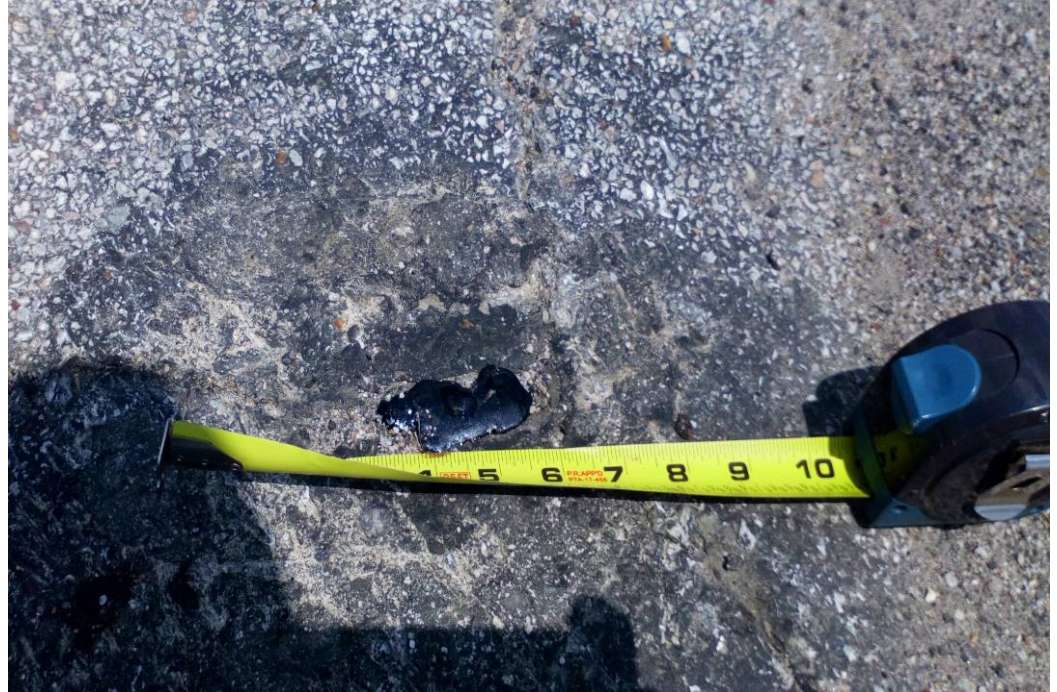
Slot B105:

View of slot B105 looking north, tar-like material observed in asphalt crack.

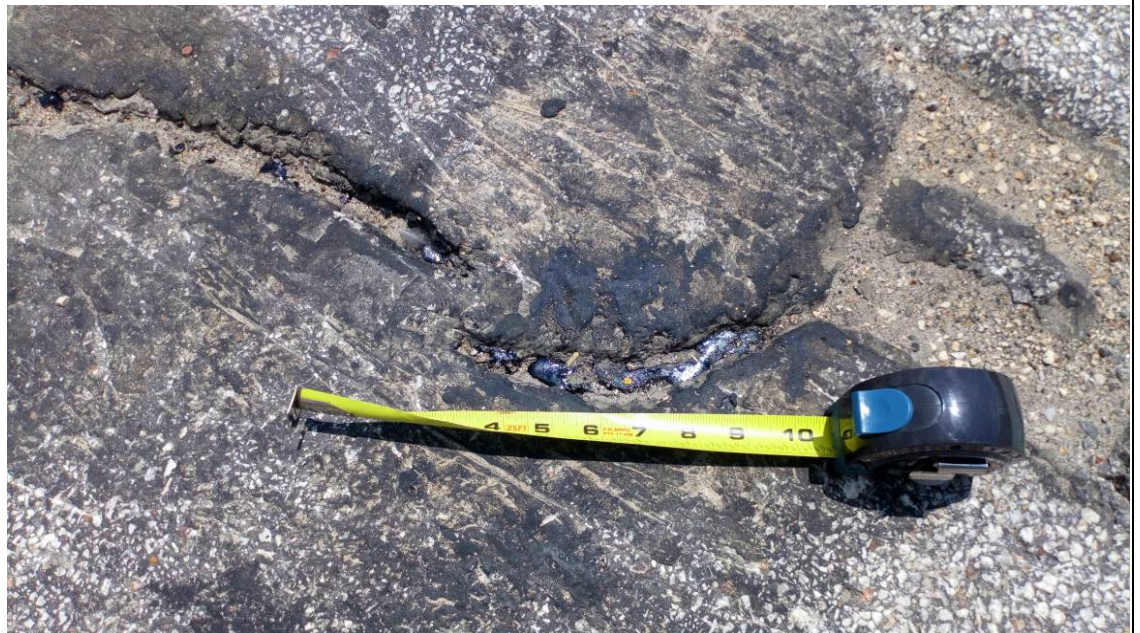
Slot B108:

View of slot B108, little tar-like material observed in asphalt cracks.

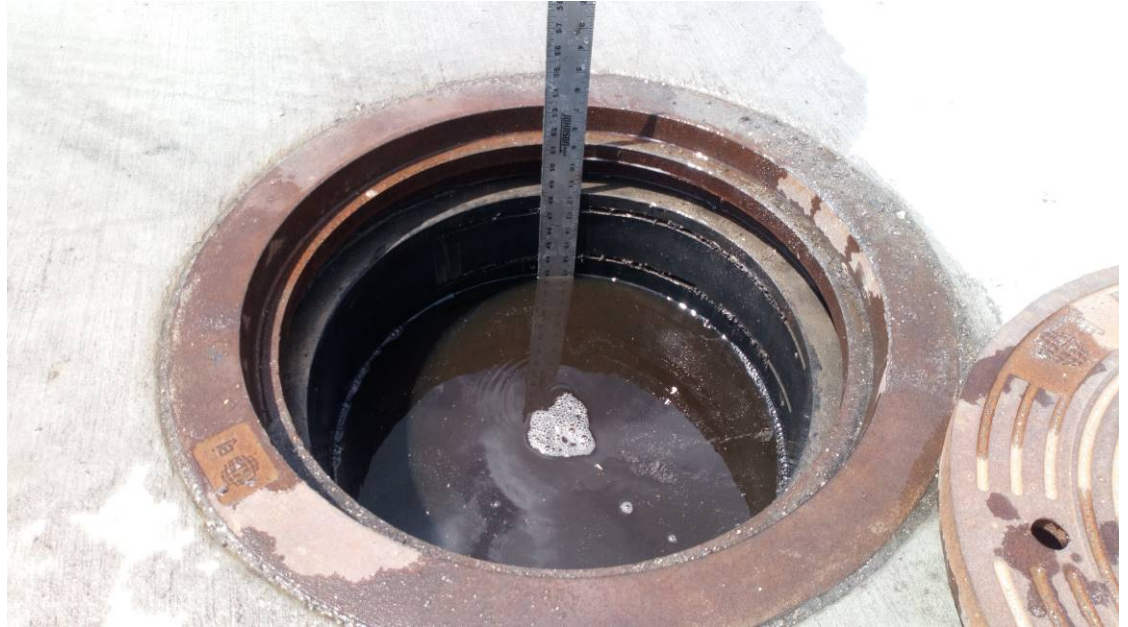
B099 NAPL Collection

View of B099 Sump
note brown stained
water in the sump, no
sheen noted.

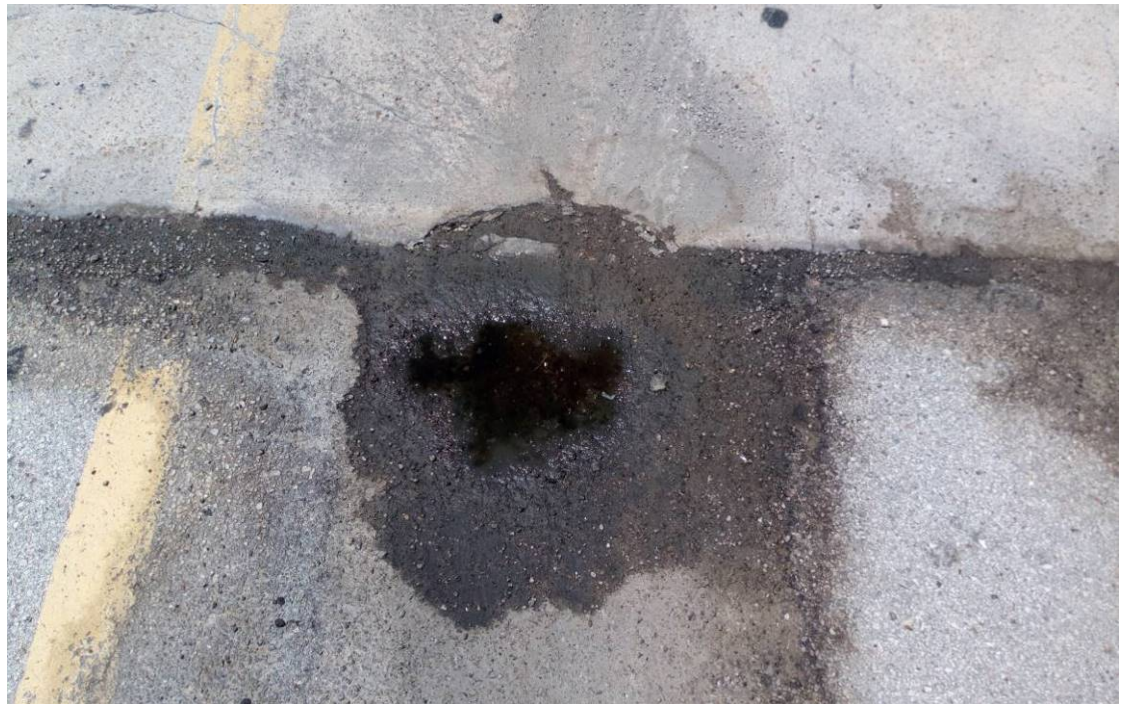
Slot A101:

View of slot A101 (north
of B101), looking north,
small amount of
standing water with
brown staining.

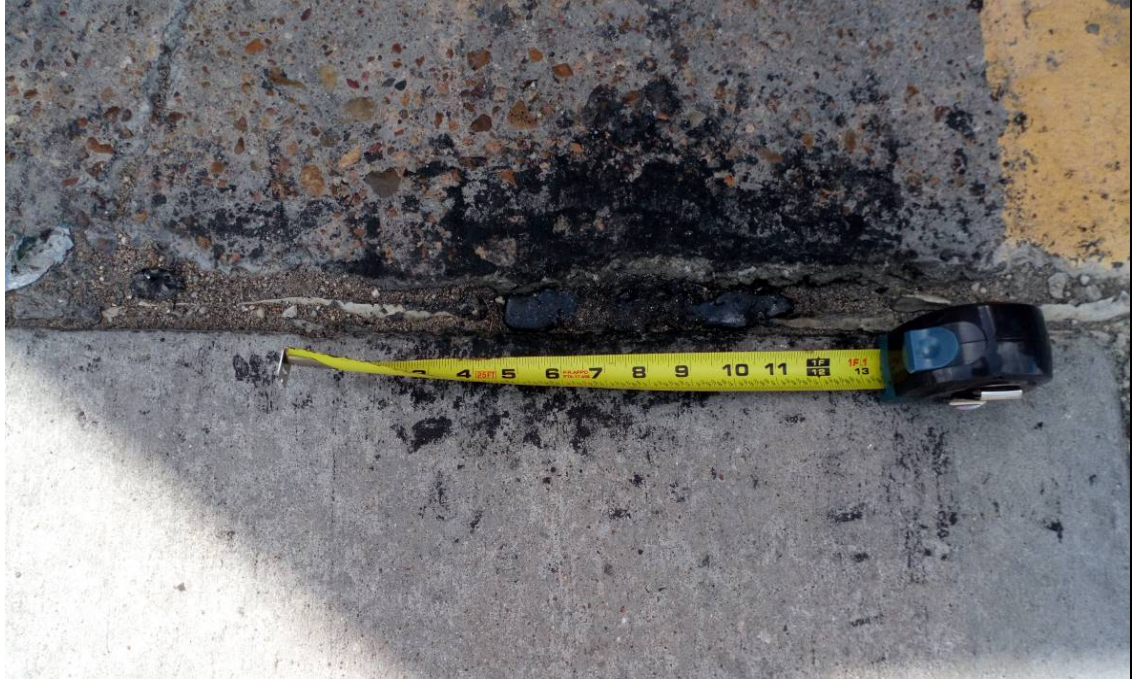
Slot A021:

View of slot A021
 looking south, tar-like
 material observed in
 joint.

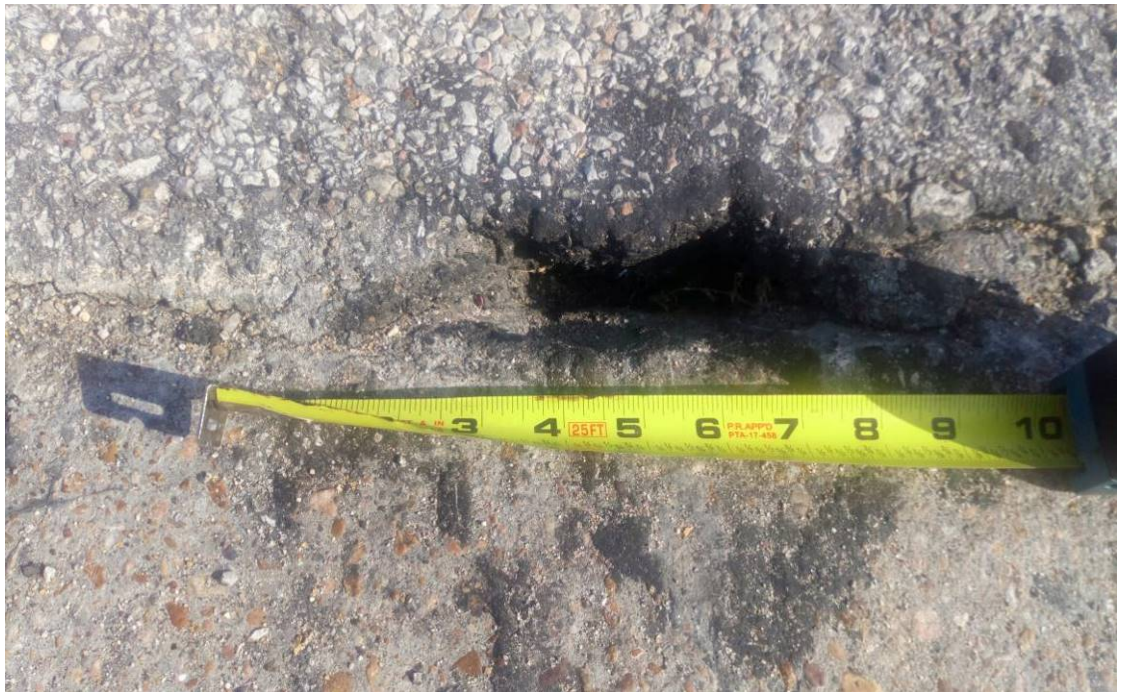
Slot B013:

View of slot B013
 looking north, v. little
 amount of tar-like
 material observed in
 asphalt crack.

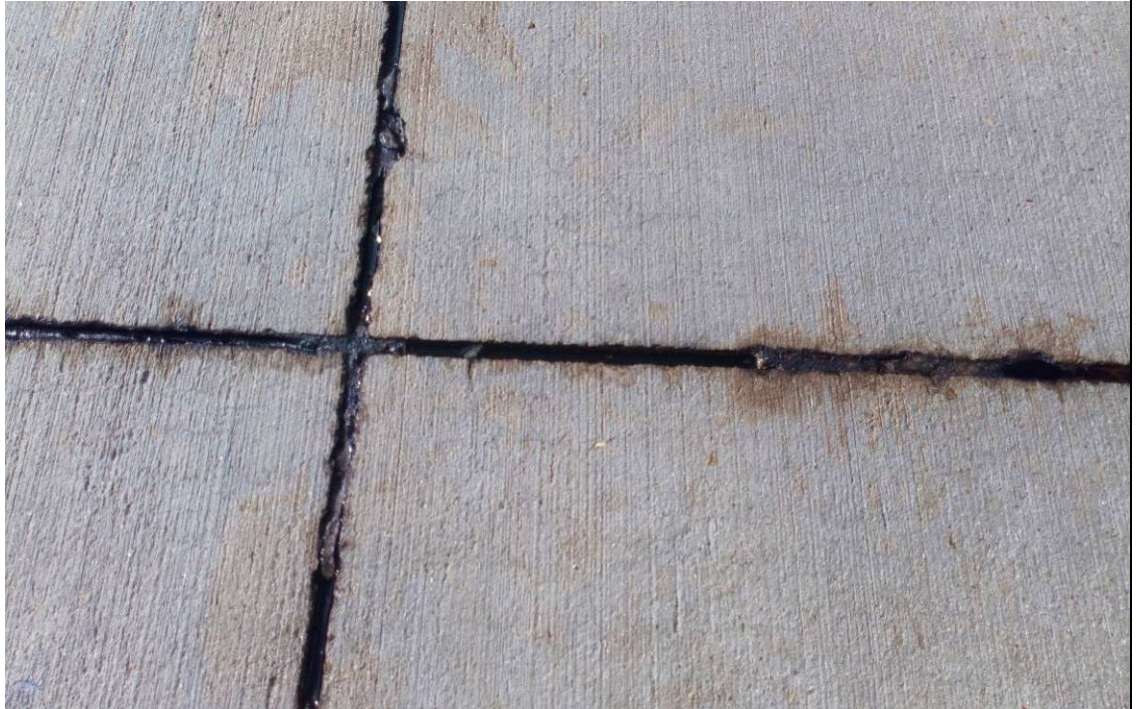
Aisle Between B and C Slots:

View of the aisle between B and C slots near slot B088, dark brown water and brown staining along concrete joints.

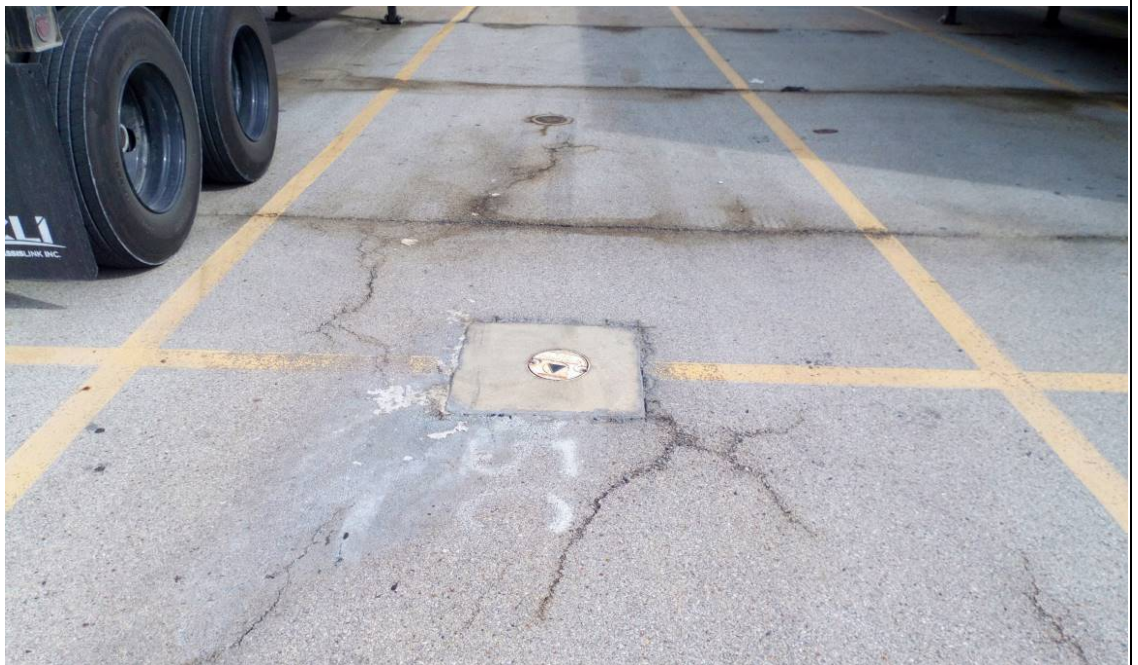
Slot B096/A096:

View of well MW-85C, between slot B096 and A096, looking north, brown staining along joints and asphalt cracks.

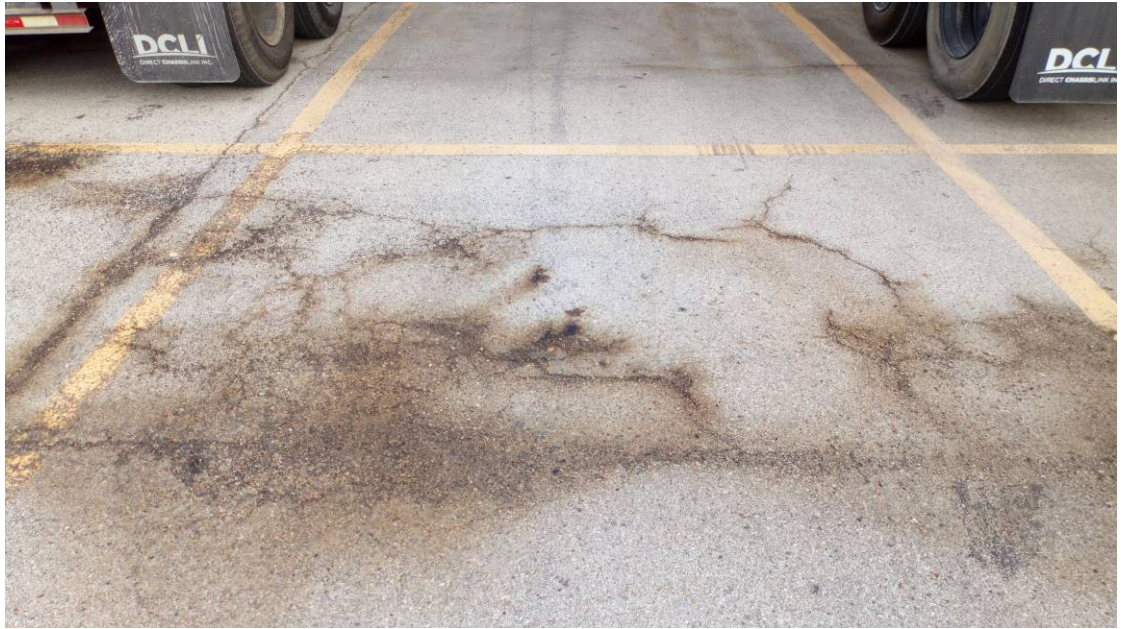
Slot B098:

View of slot B098, brown staining along asphalt cracks, note small amount of dark brown oily substance in spots.

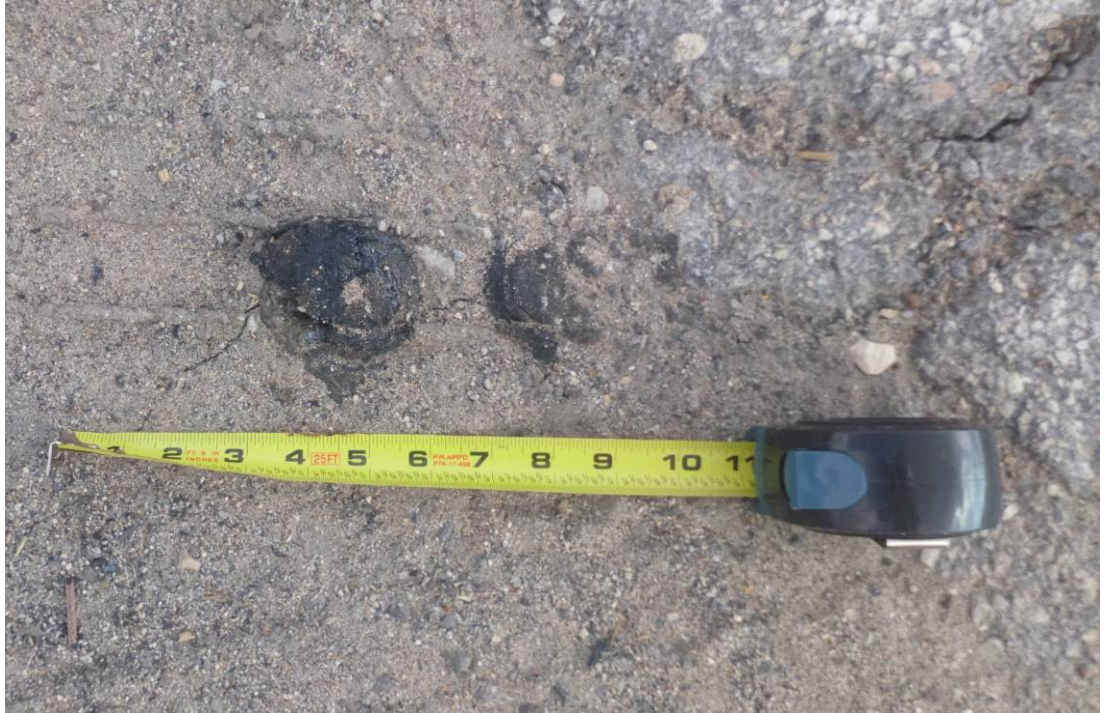
Slot B102:

View of slot B102, tar-like material observed in pothole in asphalt.

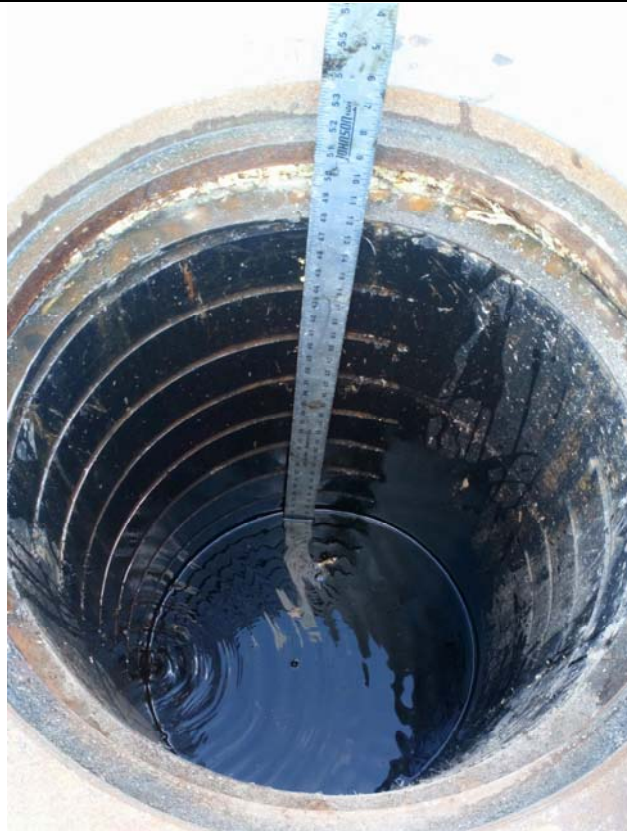
B103/B104 NAPL Collection Sump:

View of B103/B104 Sump, no sheen or odor noted in the water collected in the sump.

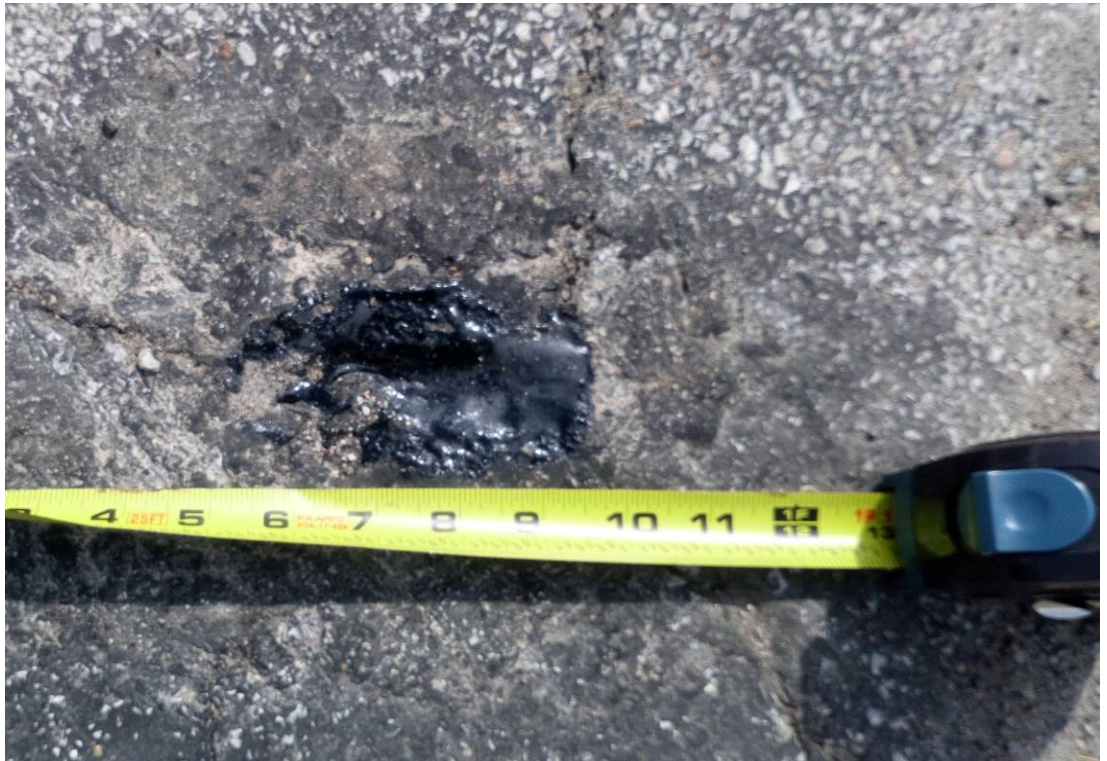
Slot B105:

View of slot B105, tar-like material seep from crack in asphalt.

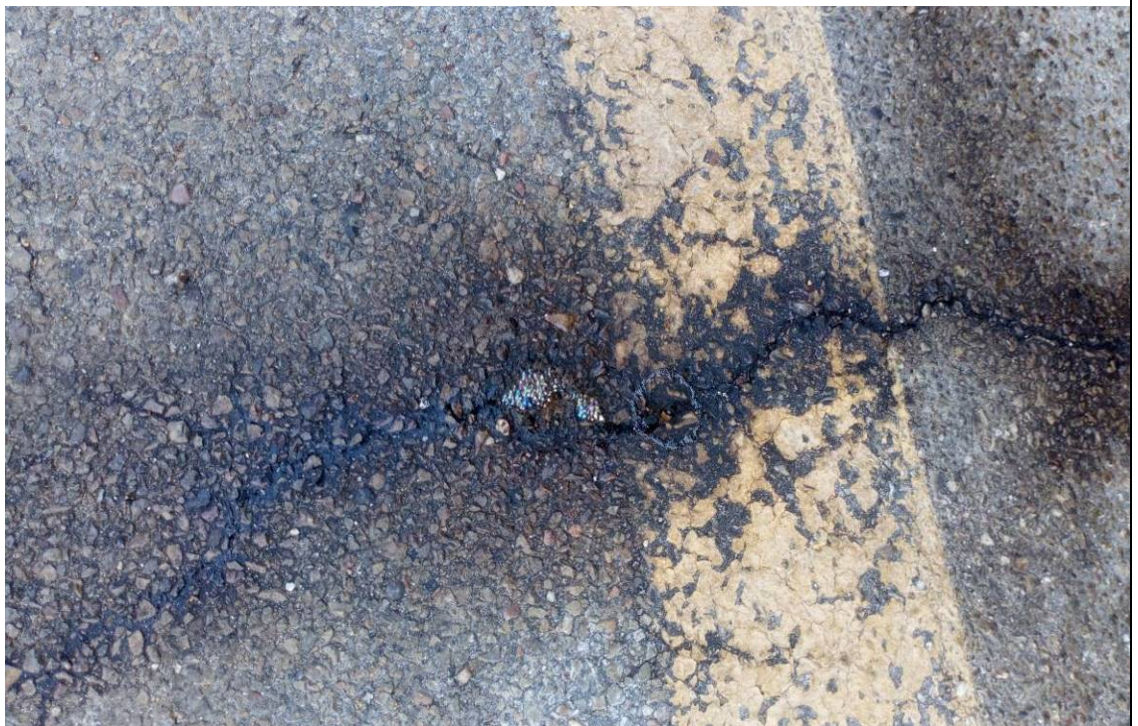
Slot A102:

View of slot A102, brown staining along asphalt crack, brown water with sheen bubbling up from crack, no odor noted.

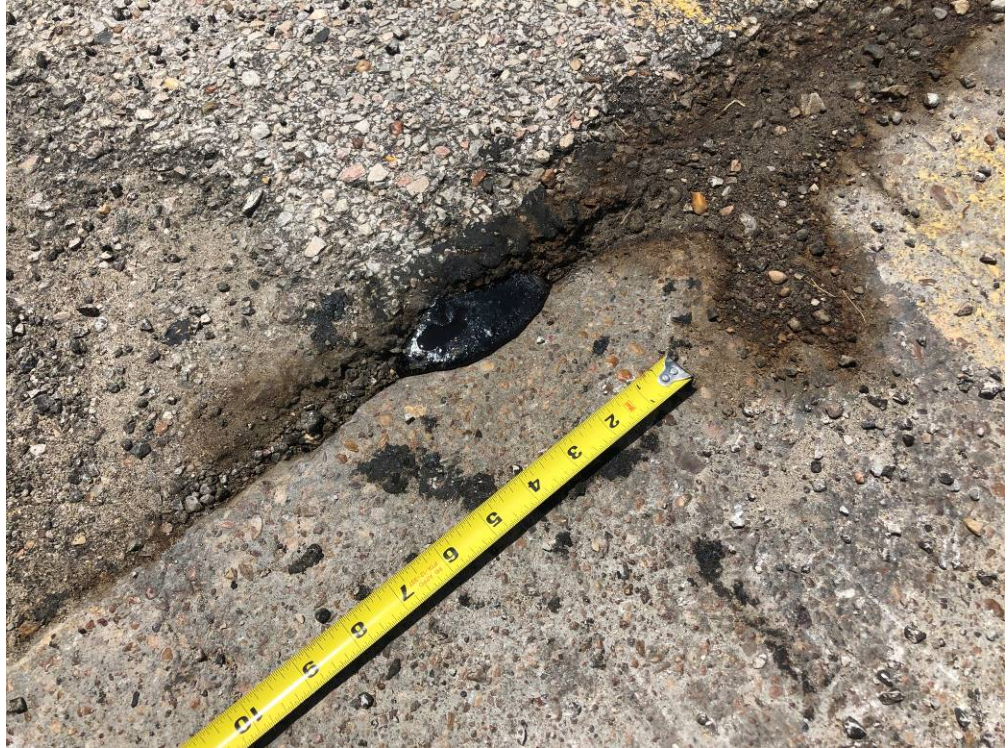
Slot A022:

View of slot A022
looking southeast, tar-
like material observed
in asphalt crack.

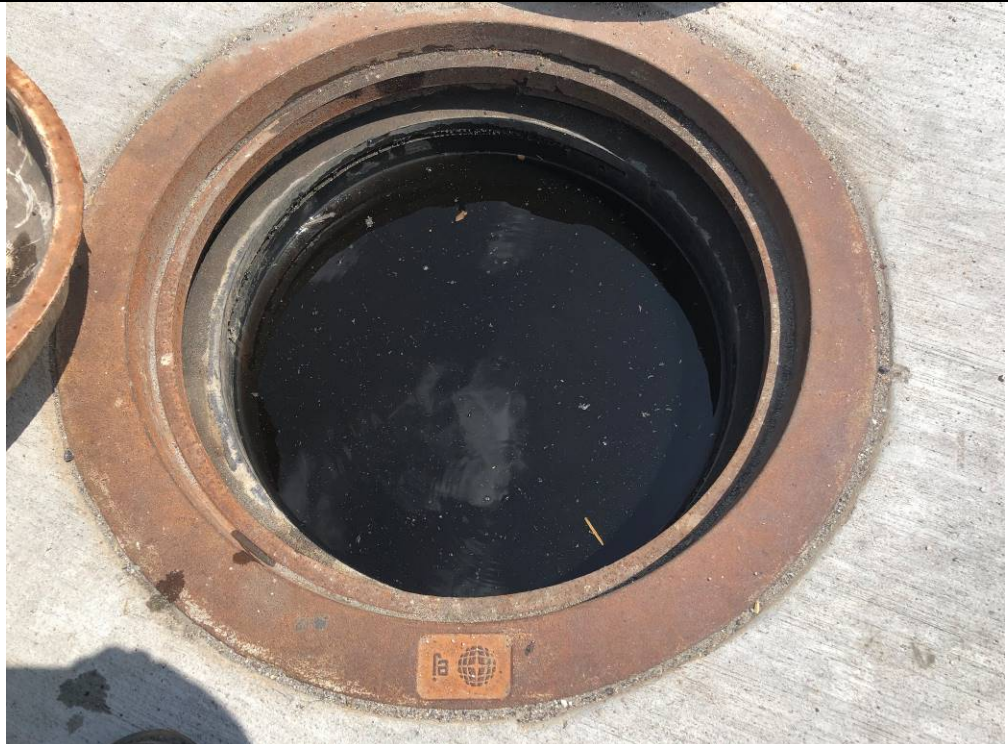
B099/B100 NAPL
Collection Sump:

View of B099/B100
Sump, dark brown
water, no sheen or odor
noted in the water
collected in the sump.

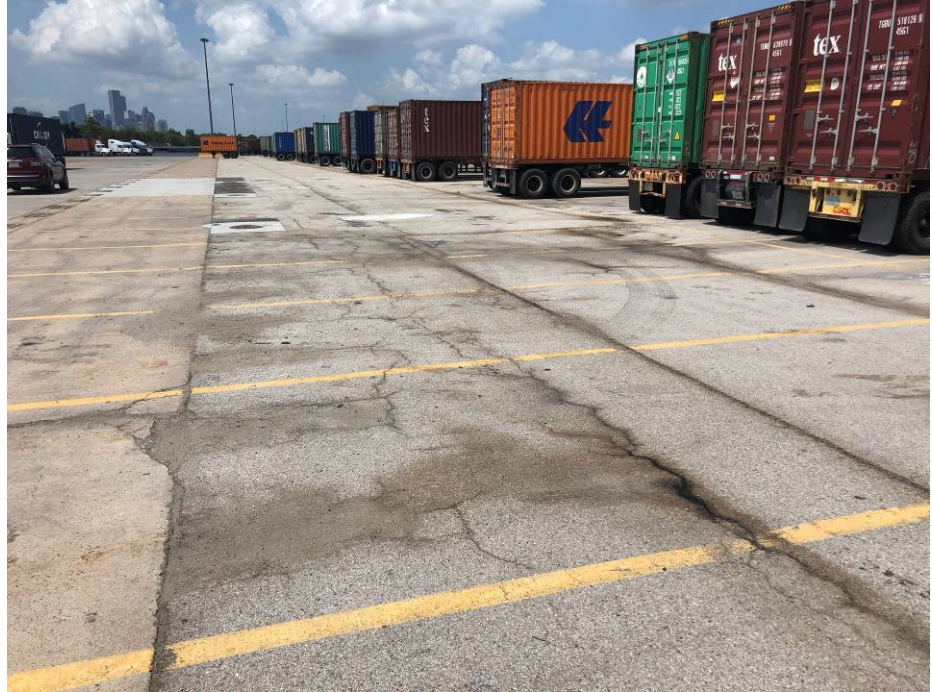
Slots B094-B109:

View of slots B094 through B109, looking southwest, some brown staining along asphalt cracks, no standing water observed but small amount of brown water noted in cracks.

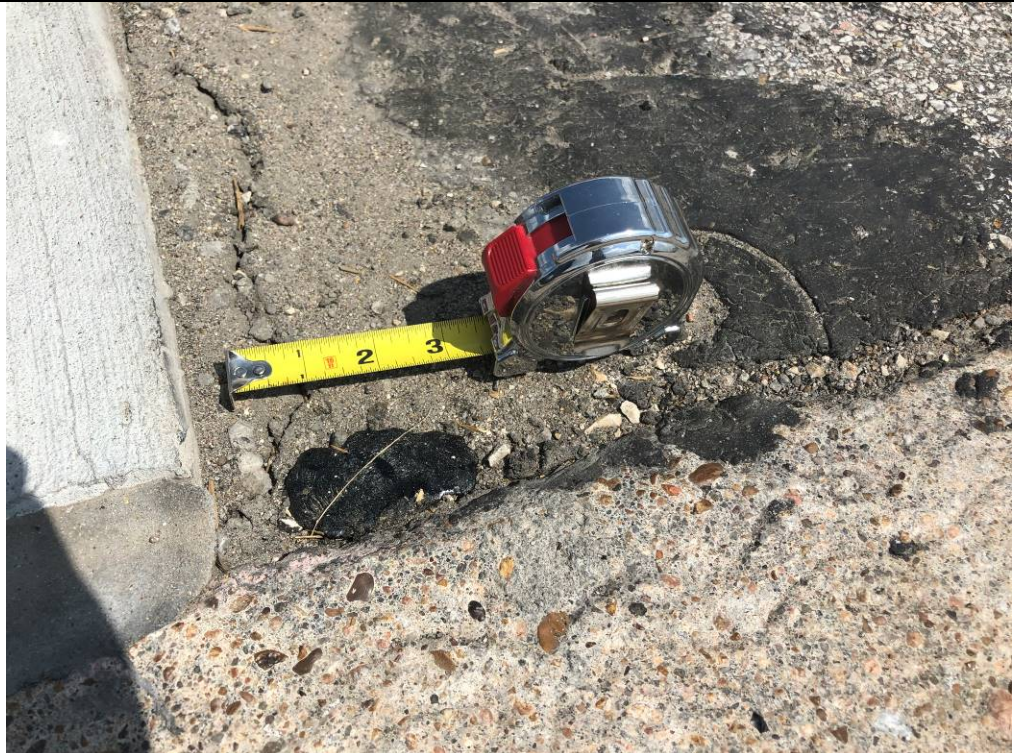
Slot B103:

- A small amount of tar-like material was noted adjacent to the NAPL Collection System at Slot B103 during the August 14th inspection (Photograph 24). No other seeps were noted around the NAPL Collection Systems, including the area on the south end of stall B106 along the concrete joint with the NAPL Collection System where the tar-like material had been previously noted.

View of slot B103, tar-like material along seam near NAPL collection system excavation.

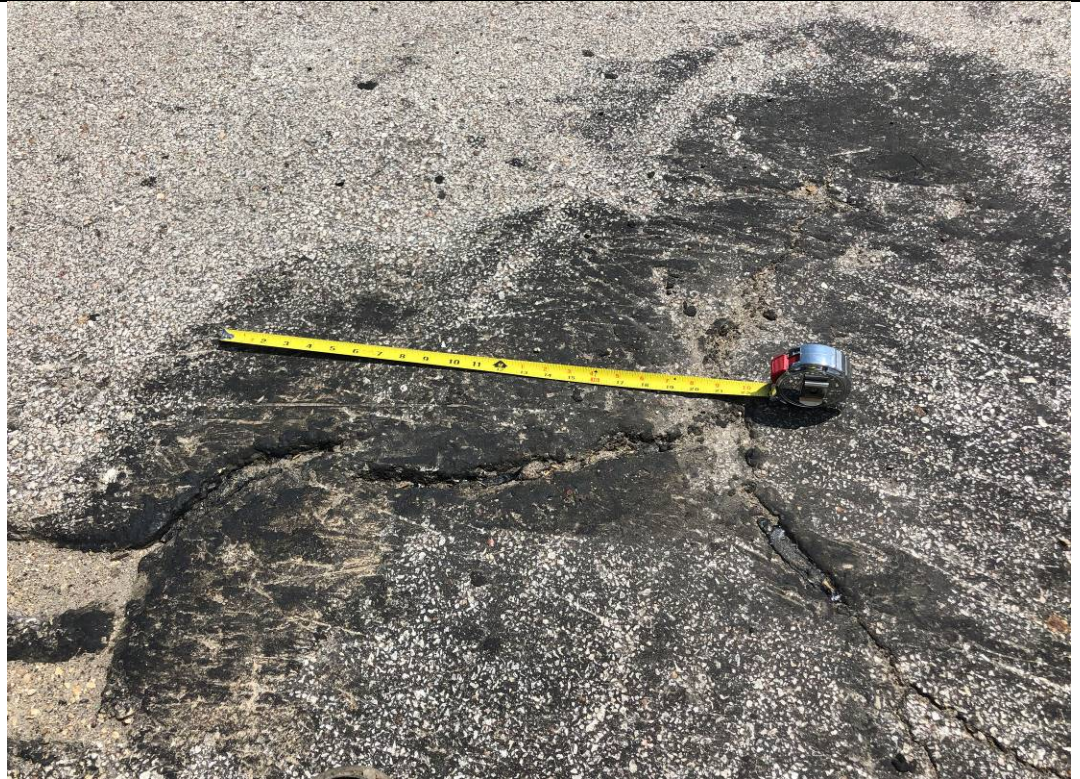
Slot B108:

View of slot B108, tar-like material observed in asphalt cracks.

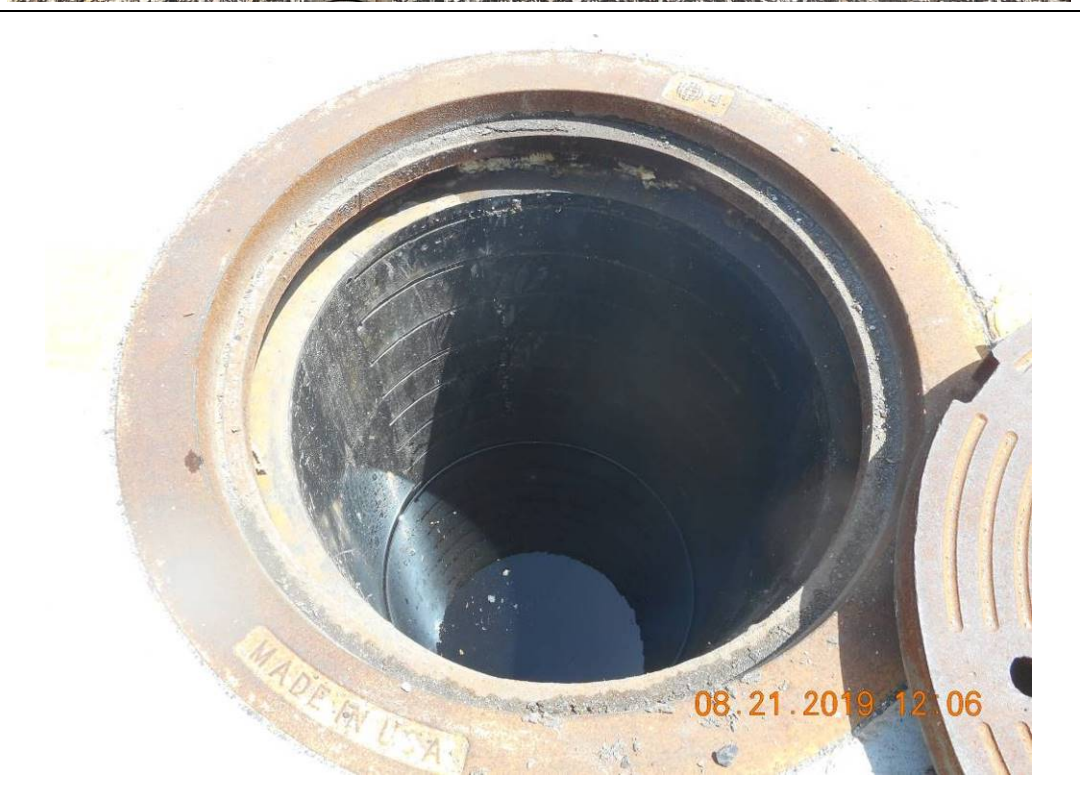
**B103/B104 NAPL
Collection Sump:**

View of B103/B104
NAPL Collection Sump, no odor or sheen noted
in the water collected in
the sump.

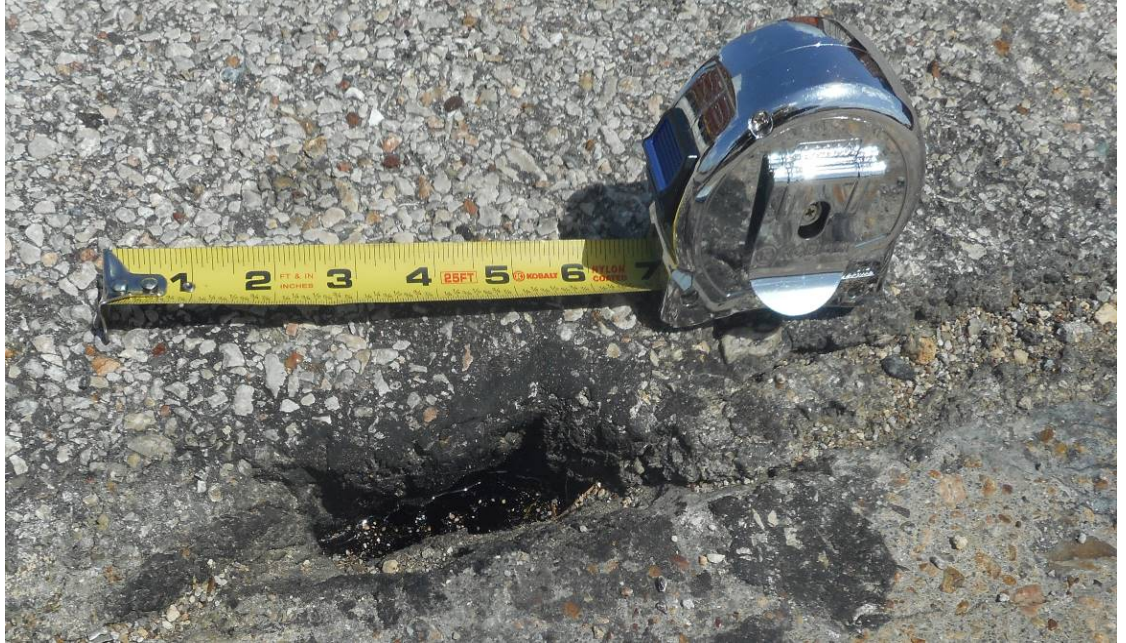
Slot B013:

View of slot B013 looking north, small amount of tar-like material observed in asphalt crack.

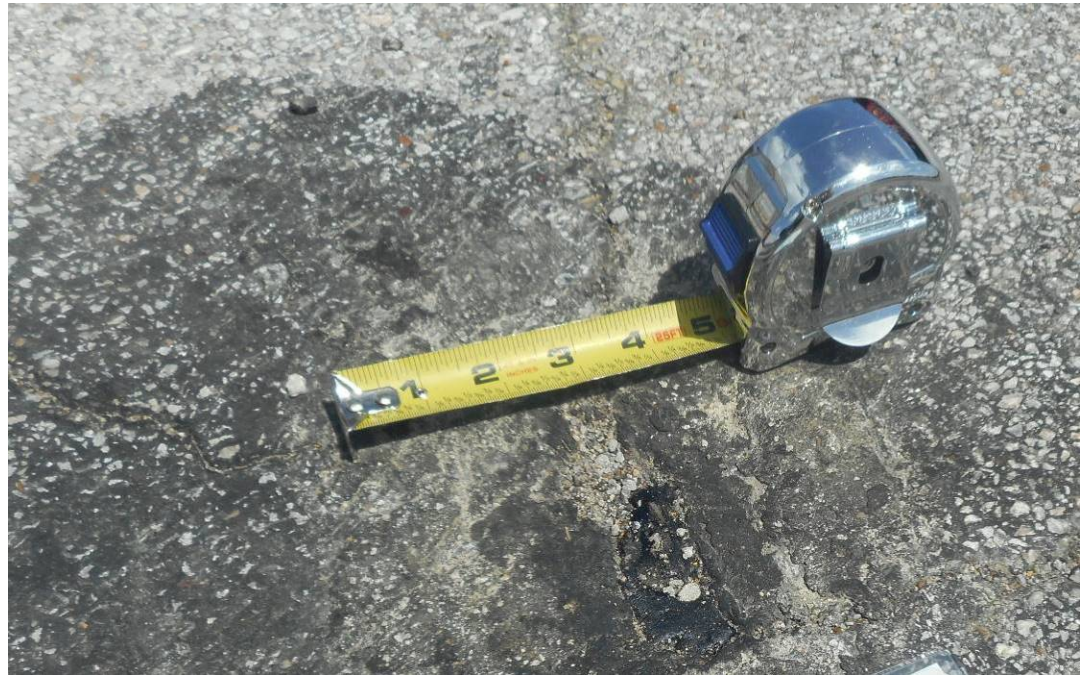
Slot B105:

View of slot B105, tar-like material observed in asphalt cracks.

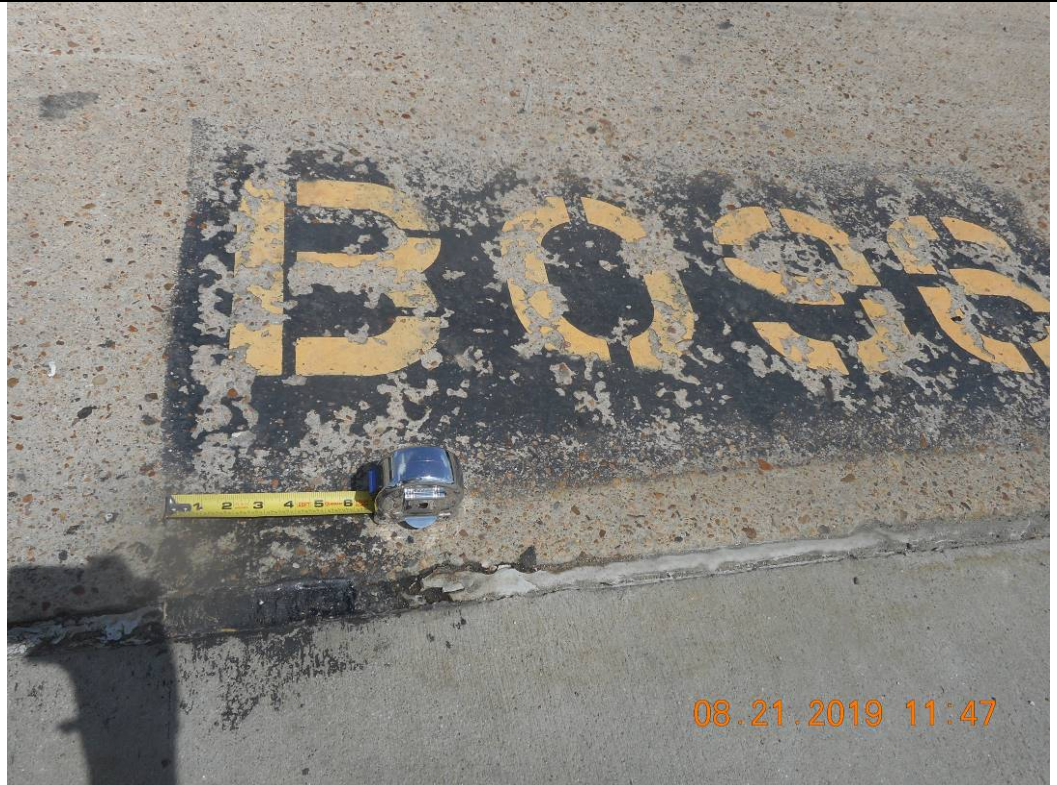
Slot B096:

View of slot B096, tar-like material observed along asphalt/concrete joint.

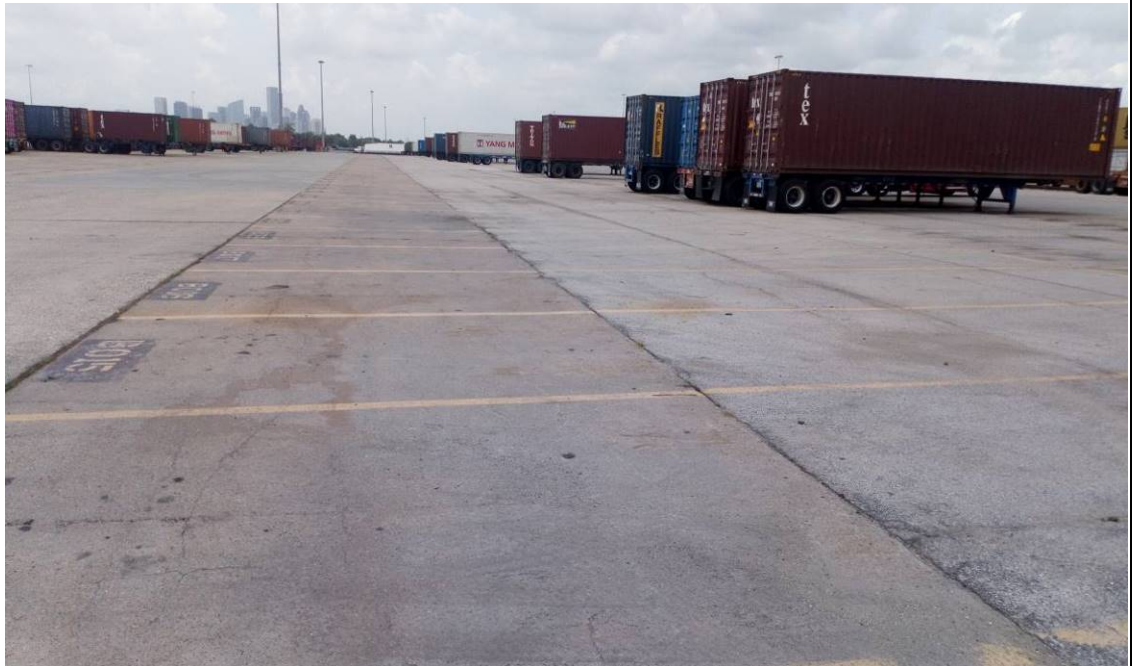
Slot B014:

View from Slot B014 looking southwest, some brown staining along asphalt cracks, no standing water observed.
