**RE: MONTHLY STATUS UPDATE – ENGLEWOOD INTERMODAL YARD – NAPL COLLECTION SYSTEM/CONCRETE CAP REPAIRS
UNION PACIFIC RAILROAD HOUSTON WOOD PRESERVING WORKS FACILITY
4910 LIBERTY ROAD FACILITY, HOUSTON, TEXAS
POST-CLOSURE CARE PERMIT NO. HW-50343; INDUSTRIAL SWR NO. 31547**

Weekly Inspection Photolog

Site Location:
Englewood Intermodal Yard/Houston Wood Preserving Works, 4910 Liberty Road, Houston, Texas

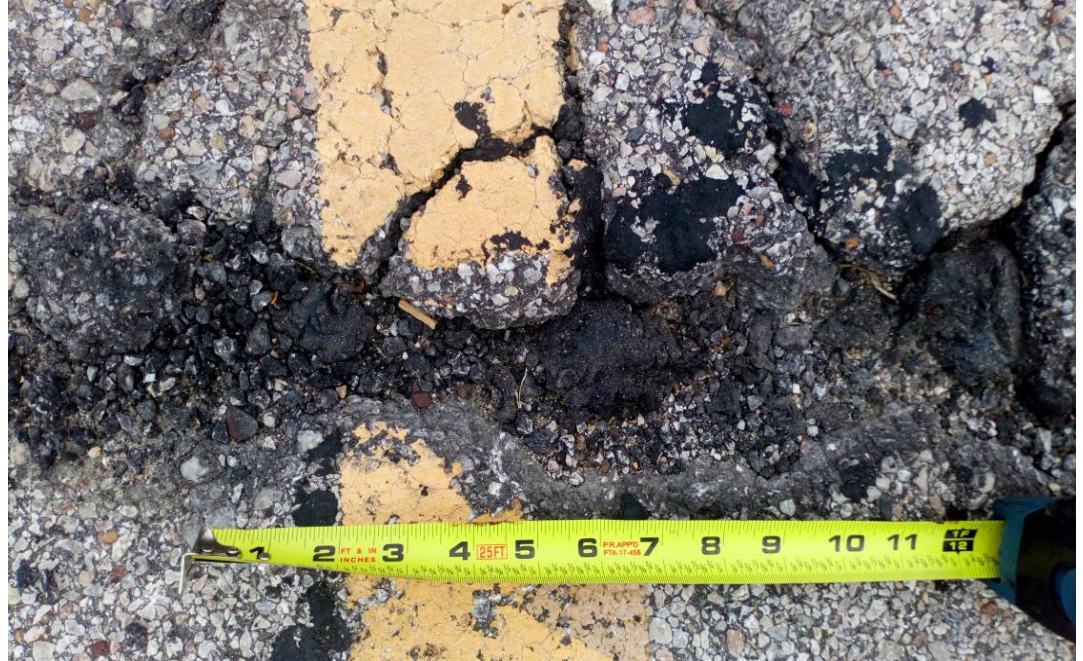
Slot B057:

View of slot B057, tar-like material in asphalt cracks.

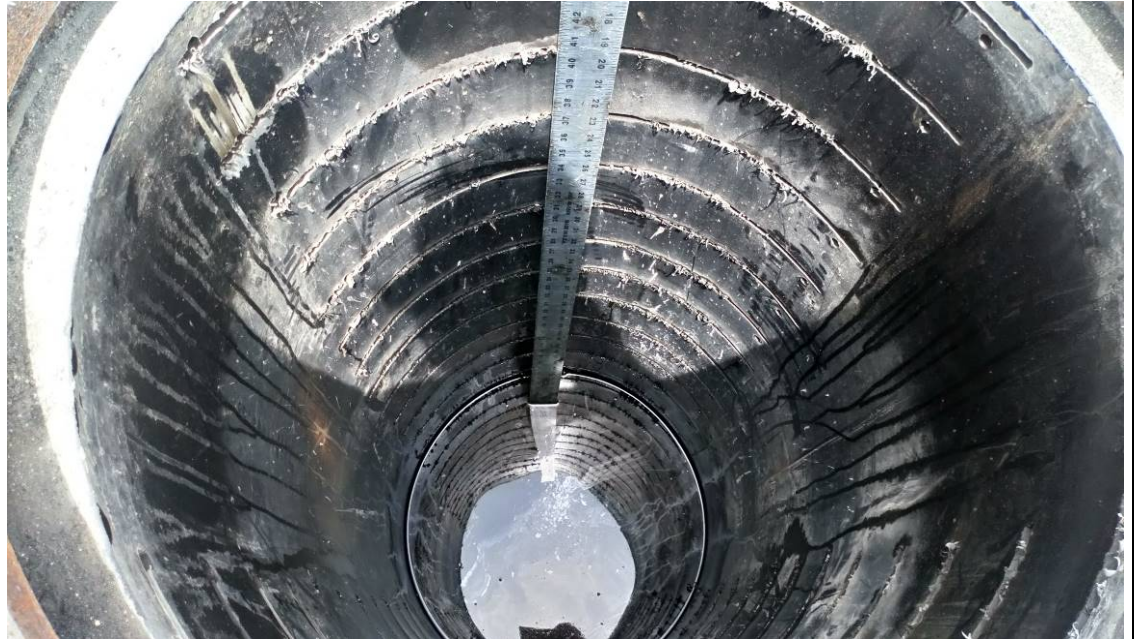
**B099/B100 NAPL
 Collection Sump:**

View of the B099/B100
 NAPL Collection Sump
 water recharge the day
 after a pumpdown
 event, dark brown
 water with sheen and
 no odor noted. No
 NAPL noted in sump.

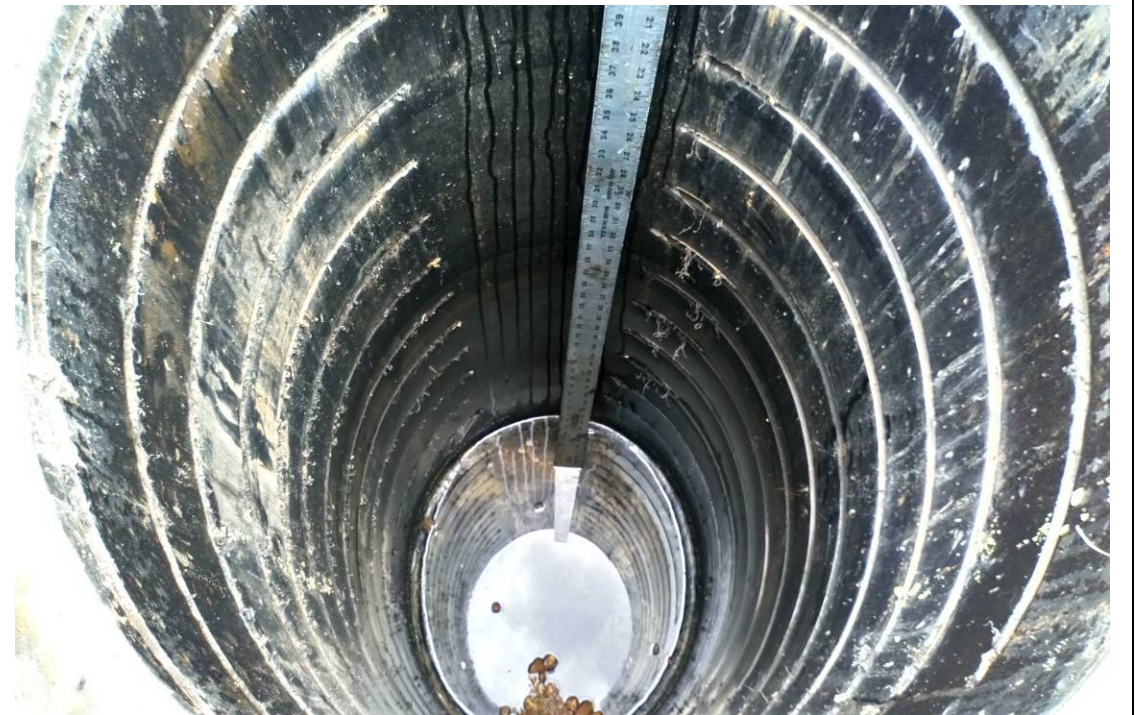
**B103/B104 NAPL
 Collection Sump:**

View of the B103/B104
 NAPL Collection Sump
 water recharge the day
 after a pumpdown
 event, clear water no
 sheen or odor noted.
 No NAPL noted in
 sump.

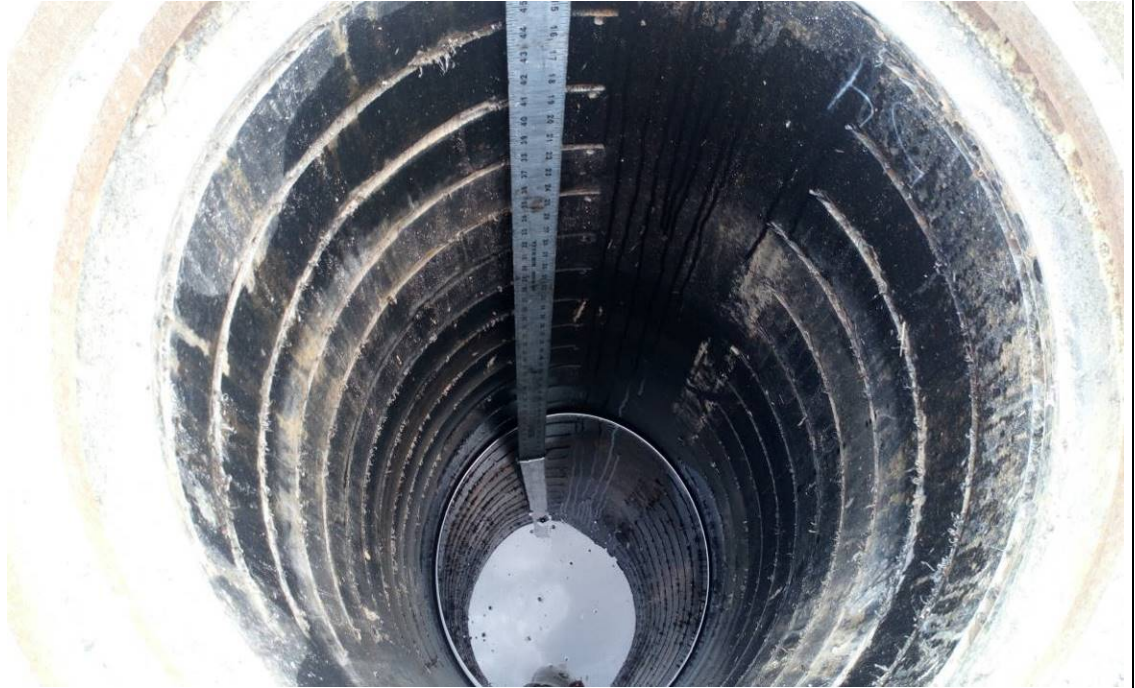
**B107/B108 NAPL
 Collection Sump:**

View of the B107/B108
 NAPL Collection Sump
 water recharge the day
 after a pumpdown
 event, clear water no
 sheen or odor noted.
 No NAPL noted in
 sump.

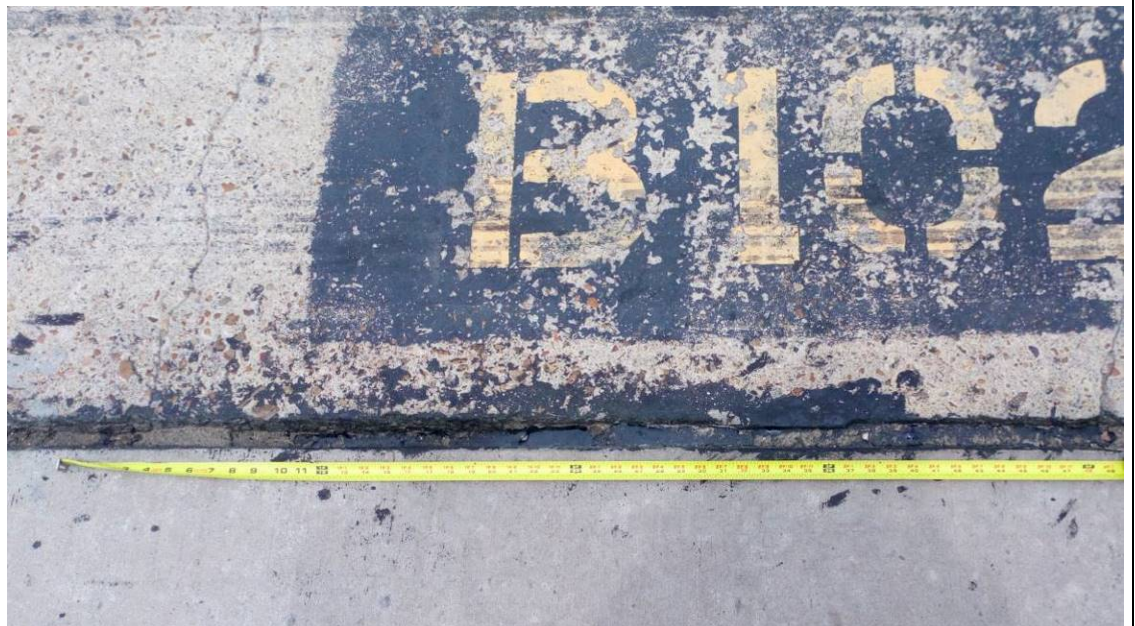
Slot B102:

View of Slot B102, tar-
 like material observed
 along joint.

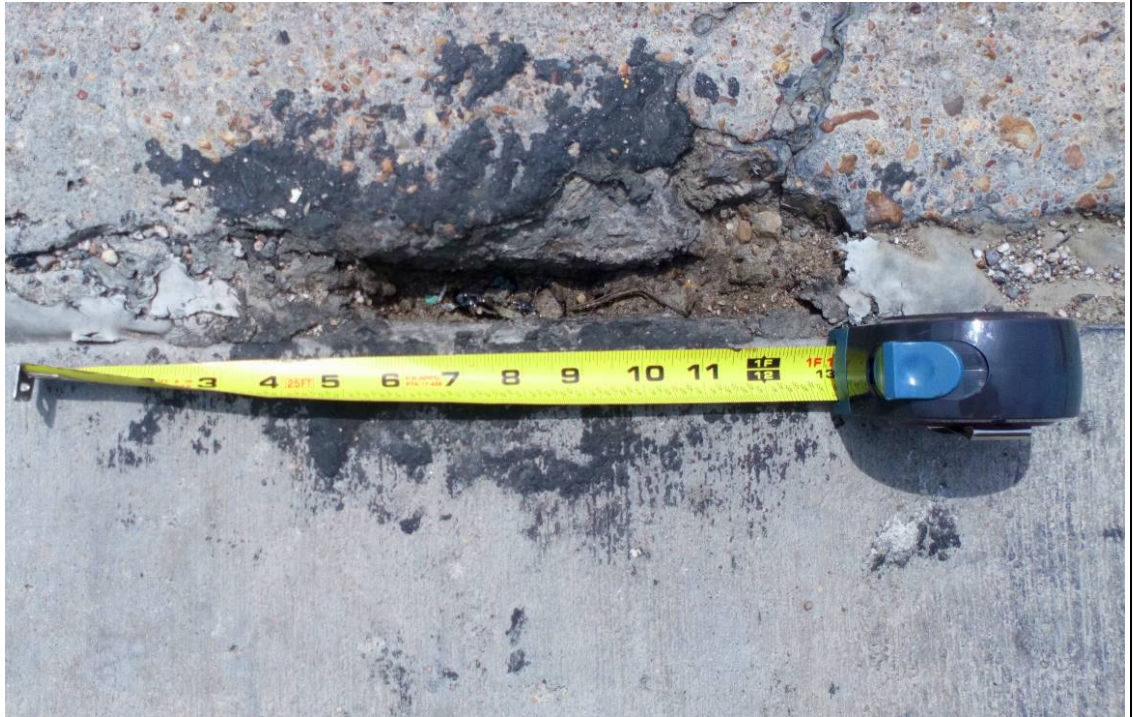
Slot A010:

View of Slot A010, very little amount of tar-like material observed in joint.
