October 1, 2019

**RE: MONTHLY STATUS UPDATE – ENGLEWOOD INTERMODAL YARD – NAPL COLLECTION SYSTEM/CONCRETE CAP REPAIRS
UNION PACIFIC RAILROAD HOUSTON WOOD PRESERVING WORKS FACILITY
4910 LIBERTY ROAD FACILITY, HOUSTON, TEXAS
POST-CLOSURE CARE PERMIT NO. HW-50343; INDUSTRIAL SWR NO. 31547**

Attachment Weekly Inspection Photolog

Weekly Inspection Photolog

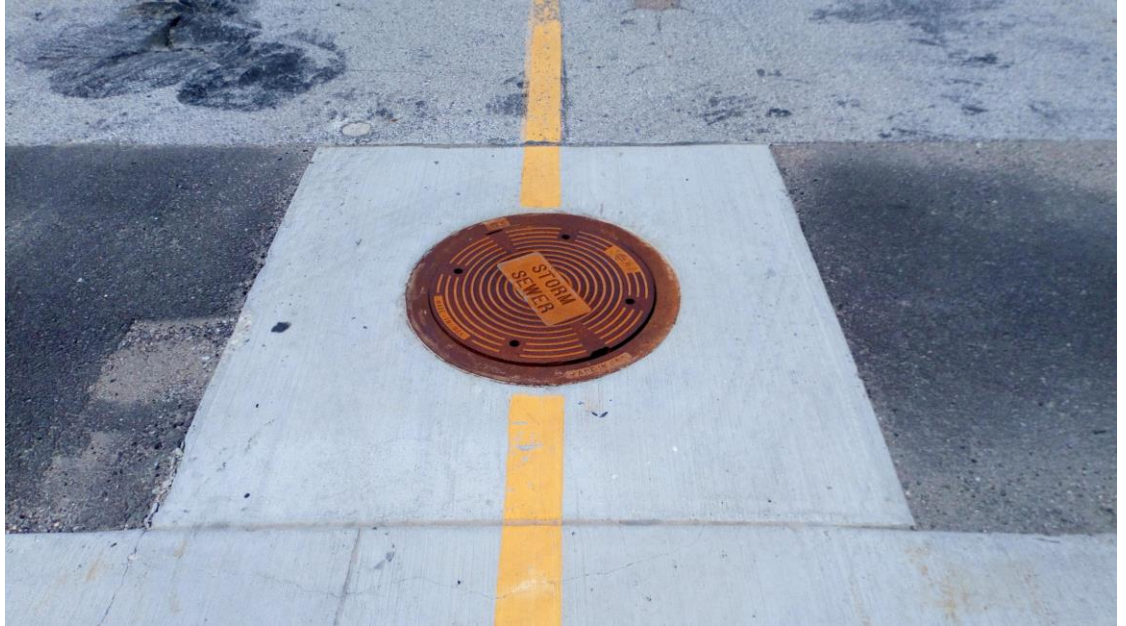
Photo No.
1

NAPL Collection Sump at B108:

View of B107/B108
NAPL Collection Sump,
looking north.

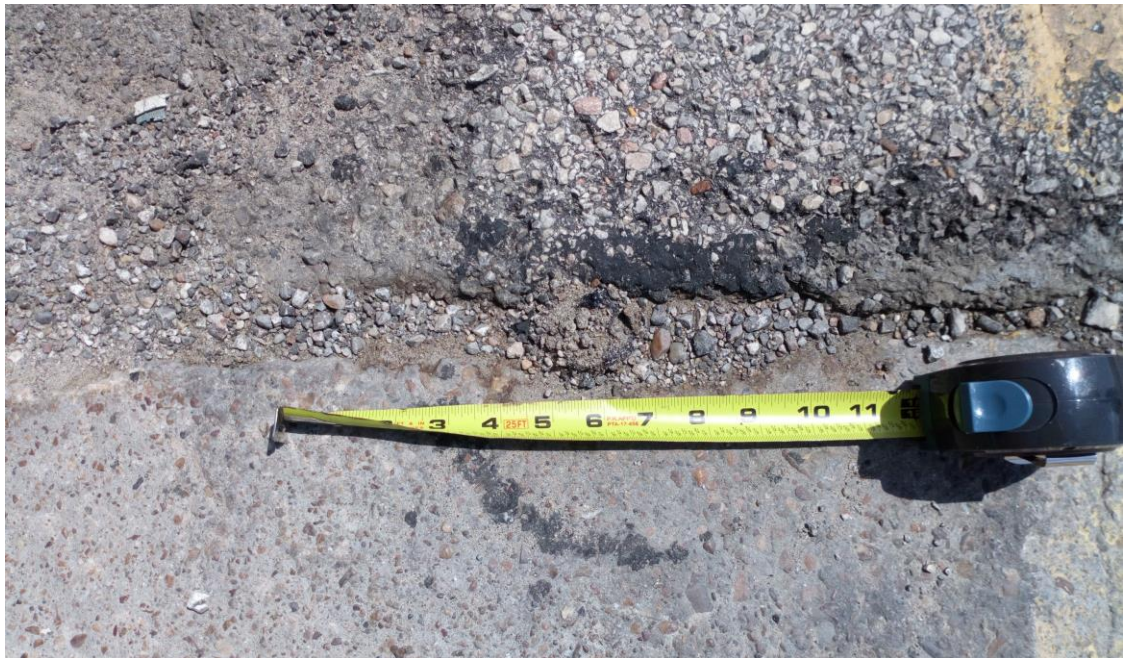
Photo No.
2

Slot A022:

View of slot A022
looking southeast, very
little tar-like material
observed in asphalt
crack.

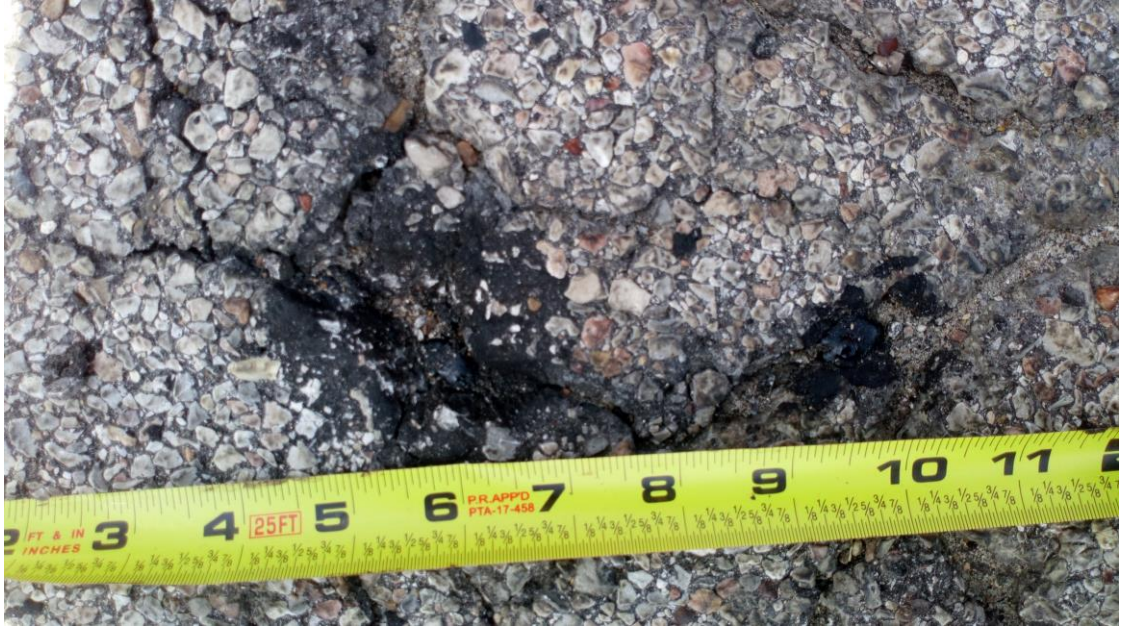
Photo No.
3

Slot B057:

View of slot B057, very little tar-like material observed in cracks in the asphalt.

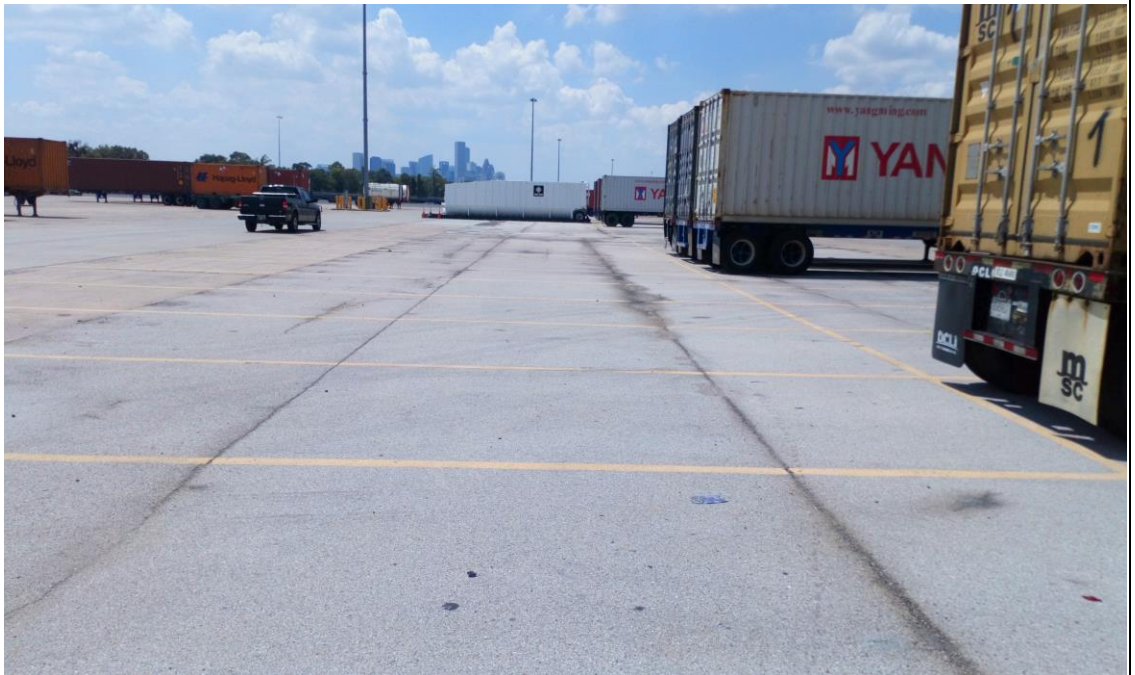
Photo No.
4

Slots B085-B110:

View of Slots B086 through B110, looking west, some brown staining along asphalt cracks, no standing water observed.

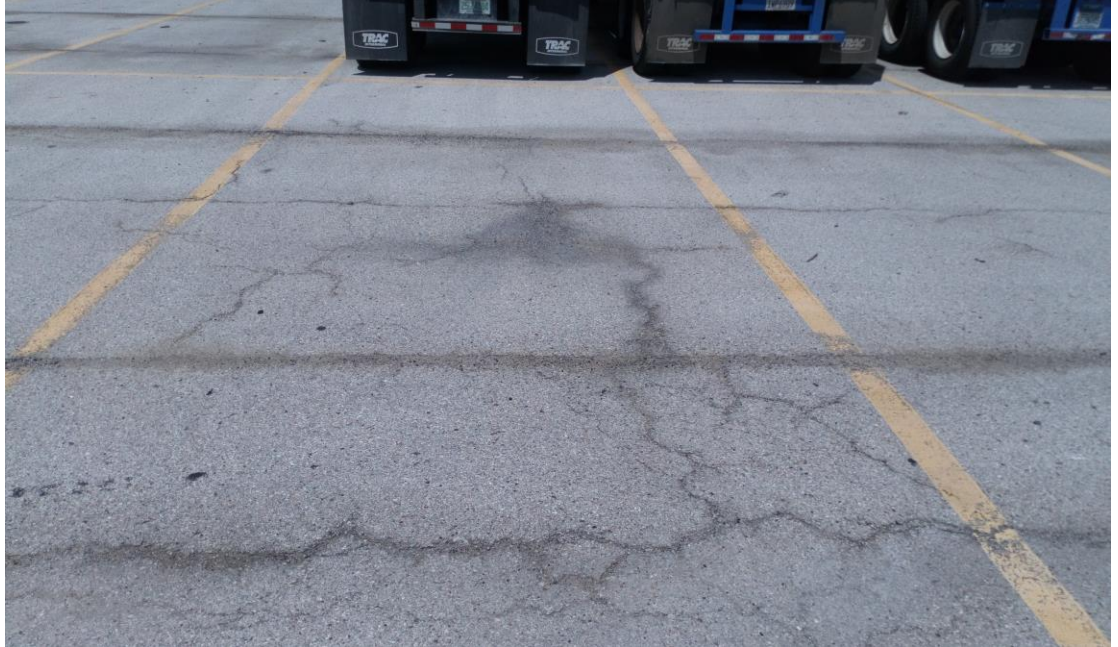
Photo No.
5

Slot B094:
View of Slot B094,
looking north, brown
staining along cracks in
the asphalt, no standing
water observed.

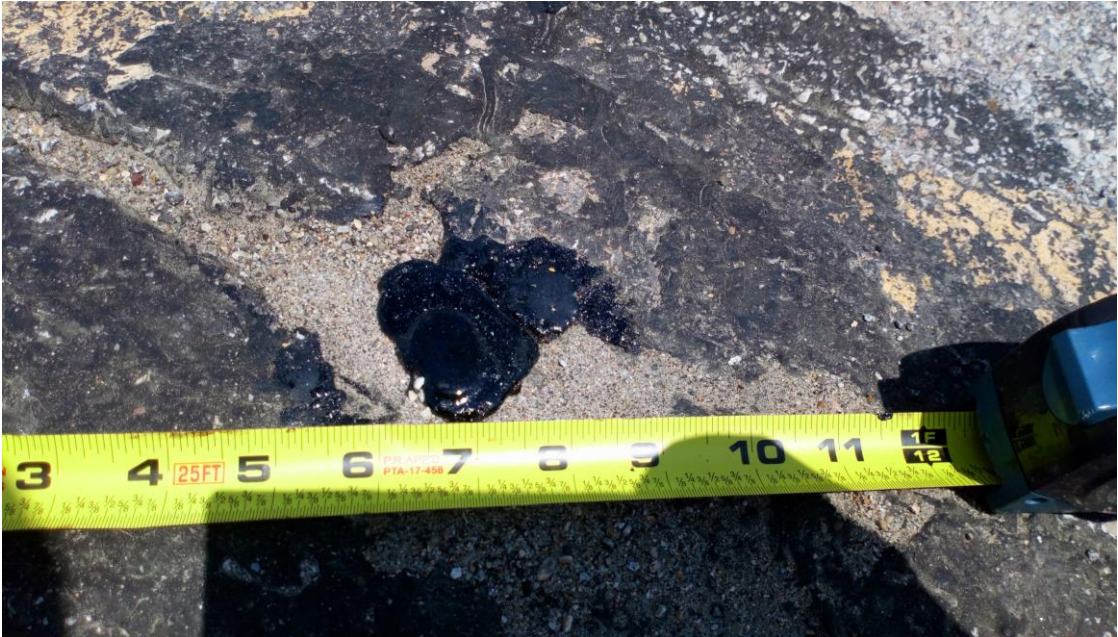
Photo No.
6

Slot B101:
View of slot B101
looking southwest, tar-
like material observed
in cracks in the asphalt.

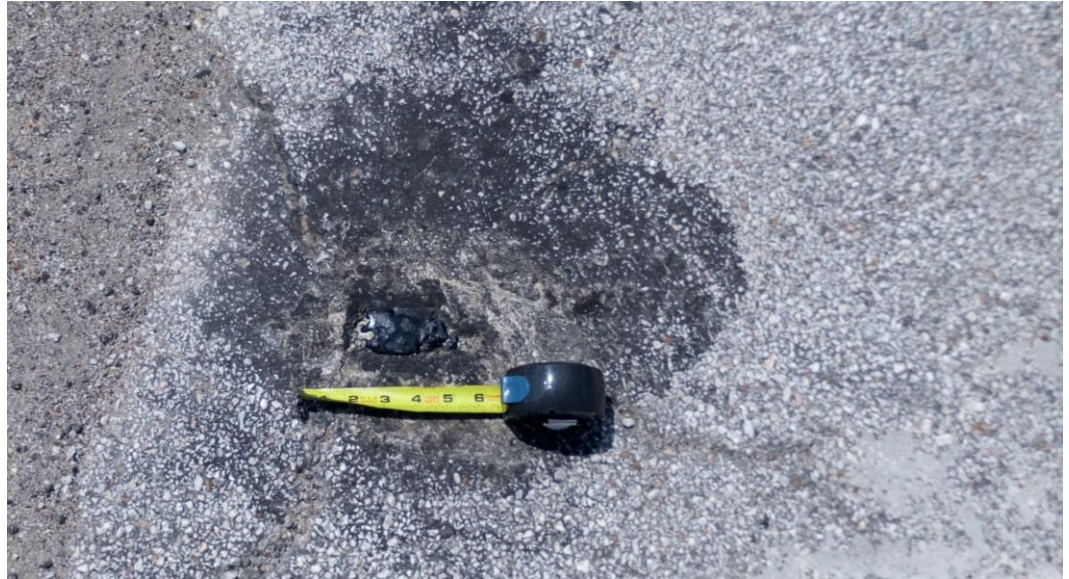
Photo No.
7

Slot B105:

View of slot B105 looking north, tar-like material observed in asphalt crack.

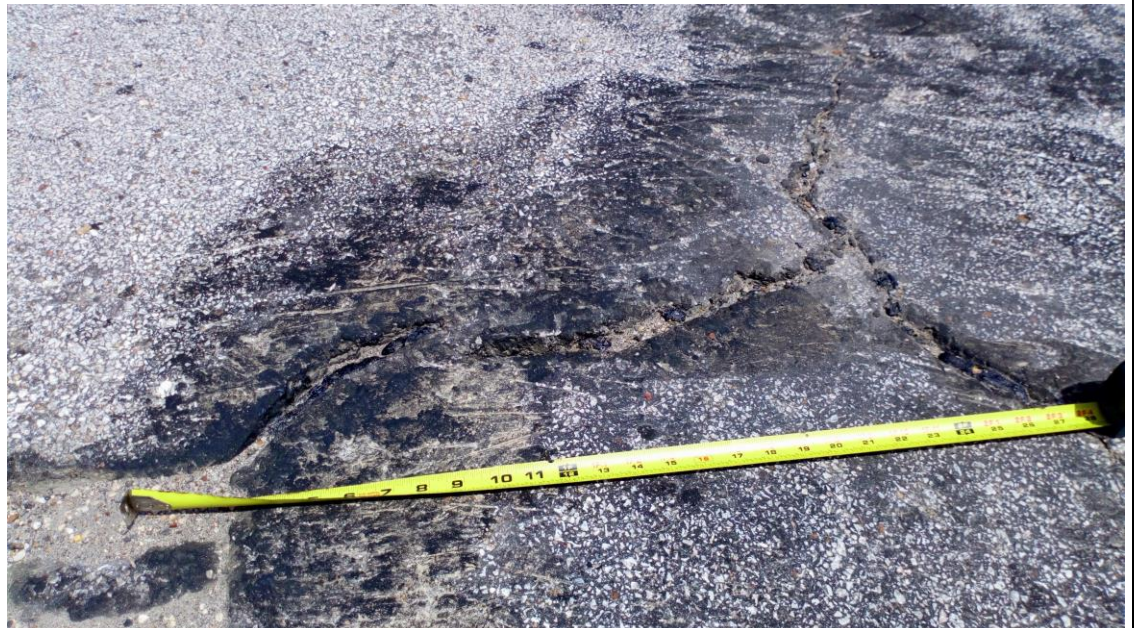
Photo No.
8

Slot B108:

View of slot B108, little tar-like material observed in asphalt cracks.

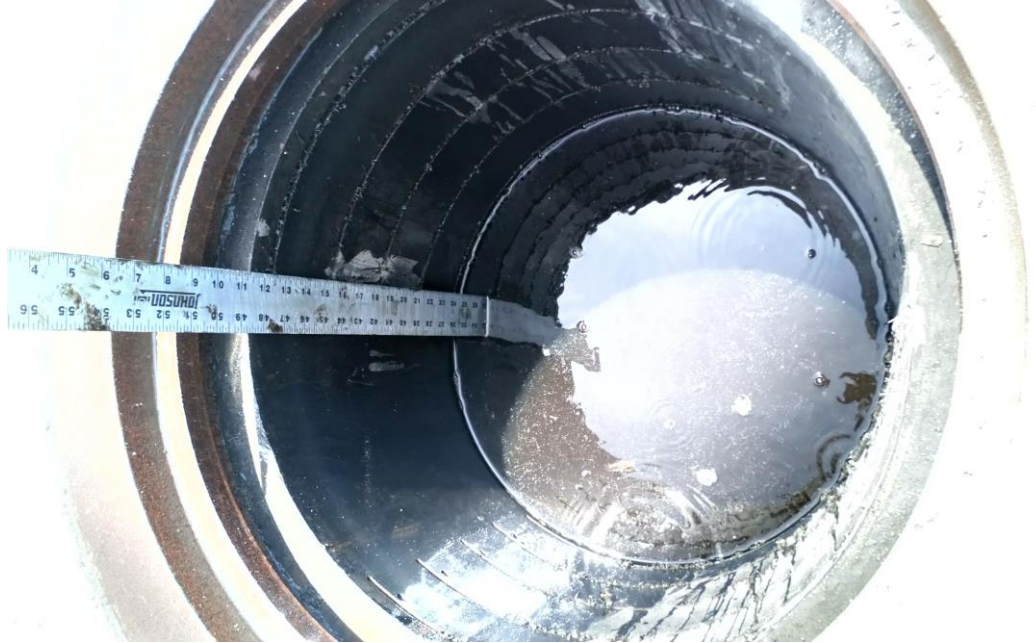
Photo No.
9

B099 NAPL Collection

Sump:

View of B099 Sump note brown stained water in the sump, slight sheen noted.

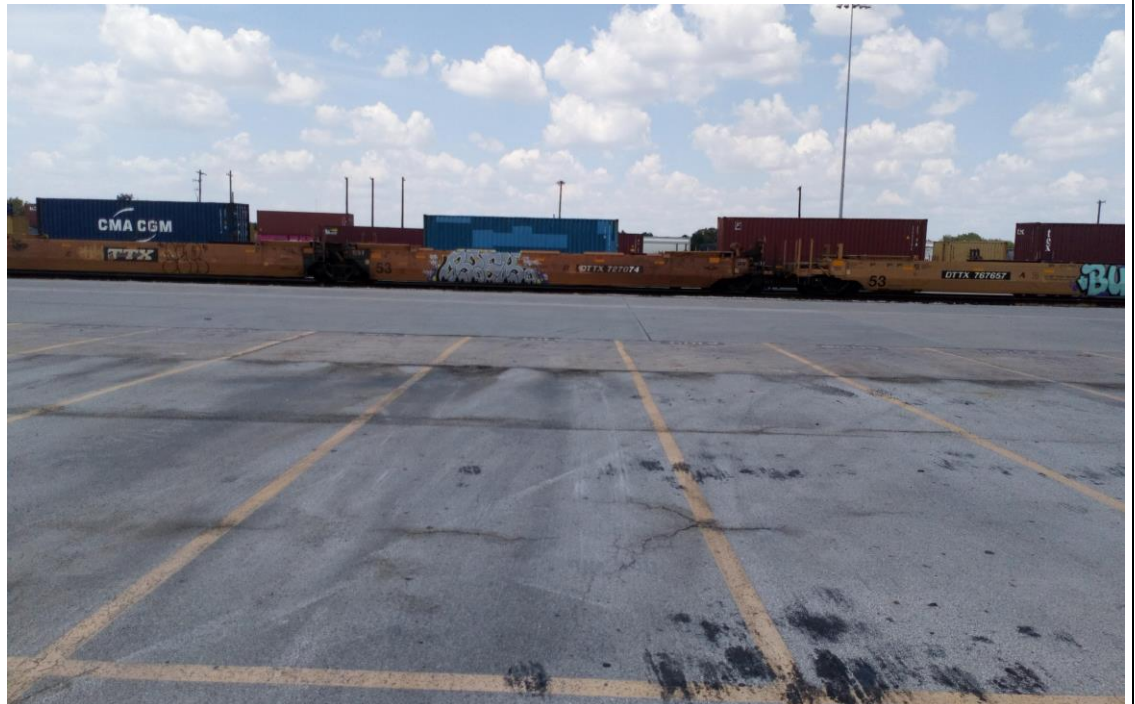
Photo No.
10

Slot A101:

View of slot A101 (north of B101), looking north, brown staining along cracks in the asphalt, no standing water observed.

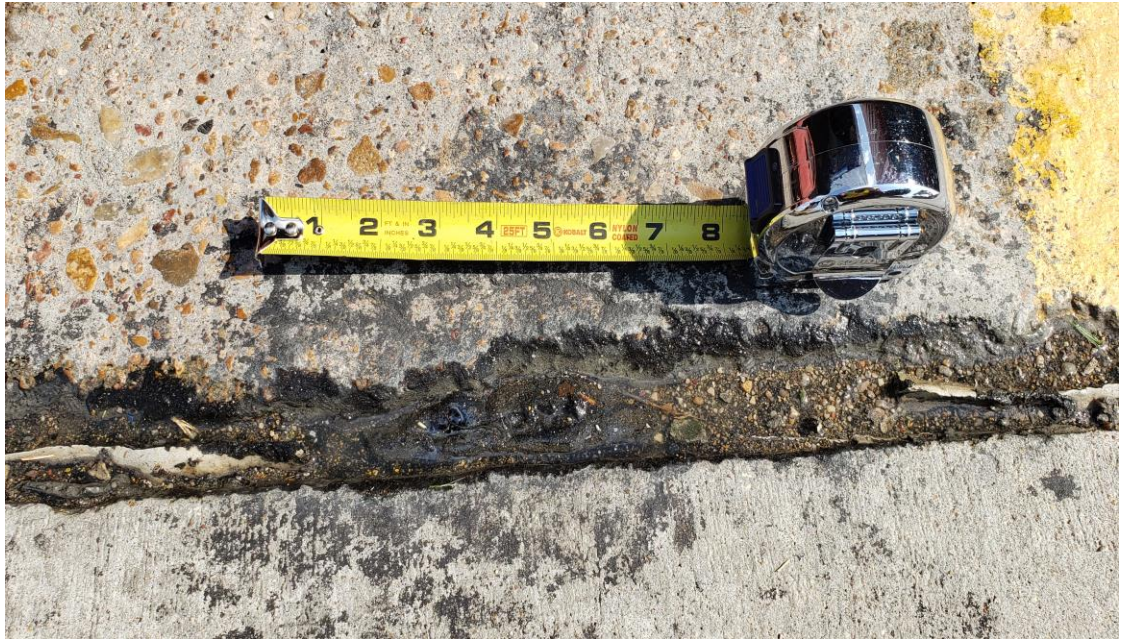
Photo No.
11

Slot A021:
View of slot A021 looking south, tar-like material observed in joint.

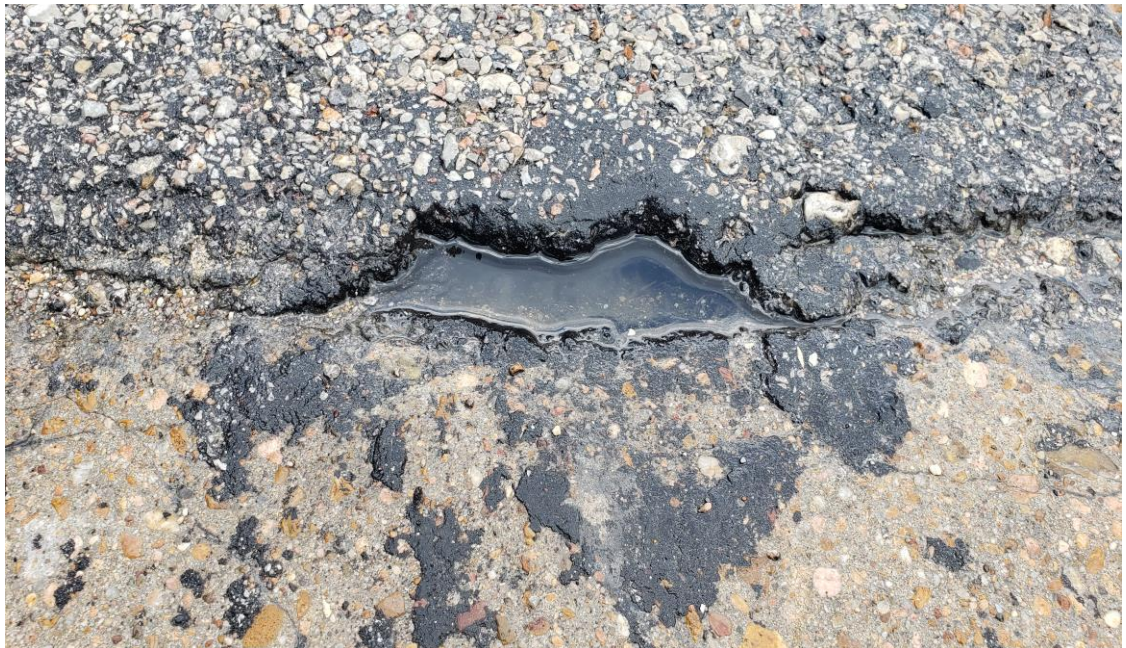
Photo No.
12

Slot B013:
View of slot B013 looking north, standing water from rainfall observed in asphalt crack, no tar-like material or sheen observed.

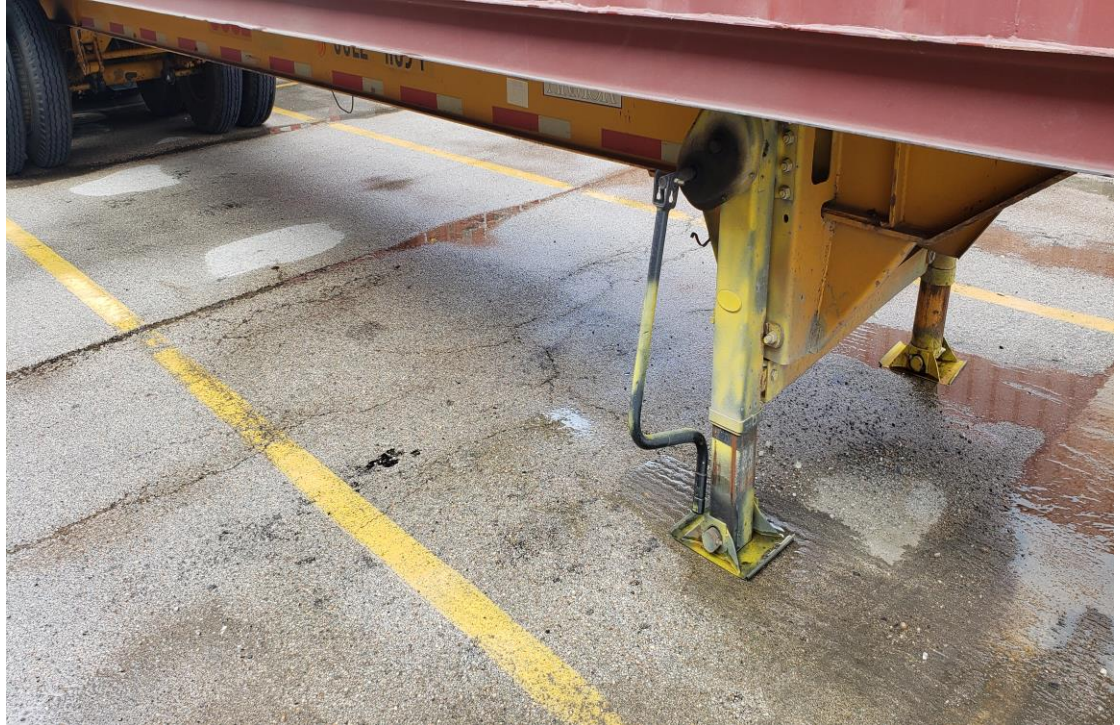
Photo No.
13

Slot B096:

View of slot B096, brown staining along asphalt cracks, standing water from rainfall was observed without sheen or discoloration.

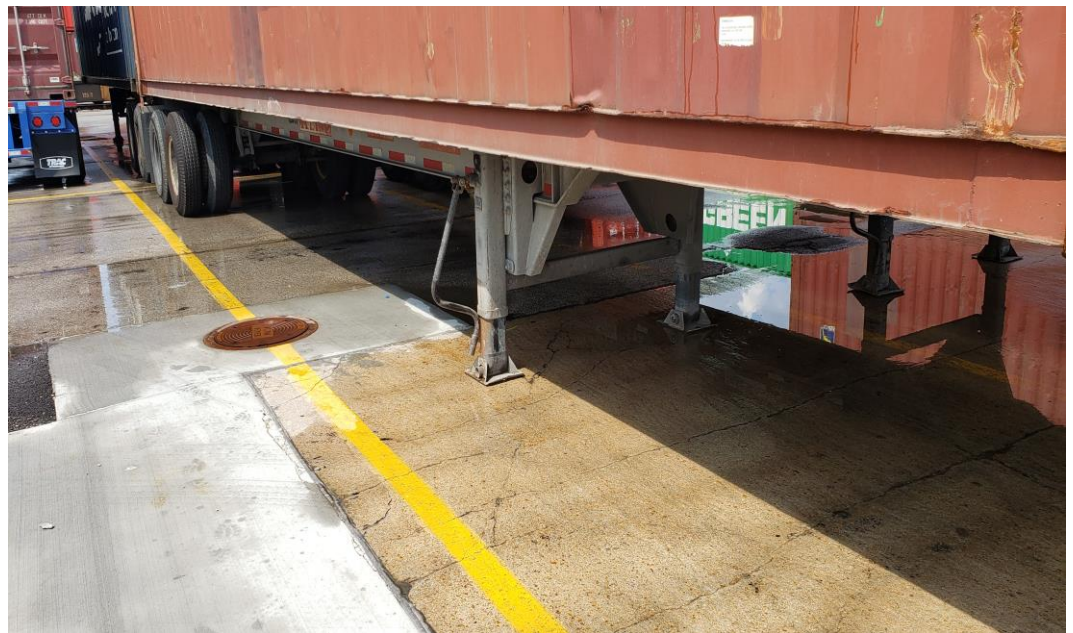
Photo No.
14

NAPL Collection Sump at B103:

View of B103/B104 NAPL Collection Sump area, looking north. Standing water from rainfall observed without sheen or discoloration.

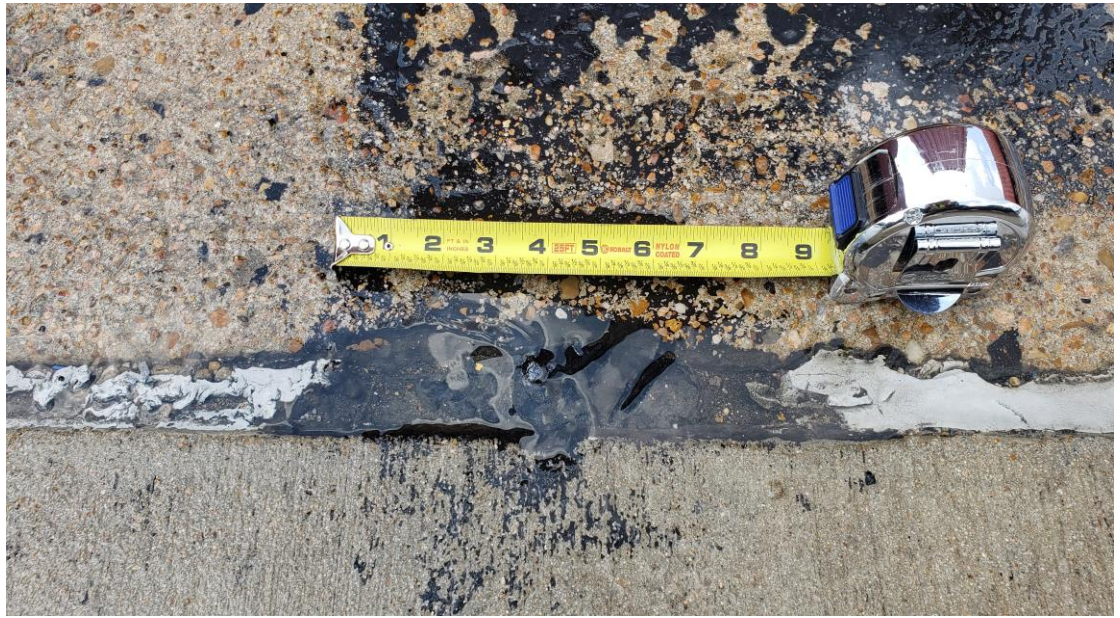
Photo No.
15

Slot B096:

View of slot B096, little amount of tar-like material observed in asphalt joint. Standing water from rainfall observed without sheen or discoloration.

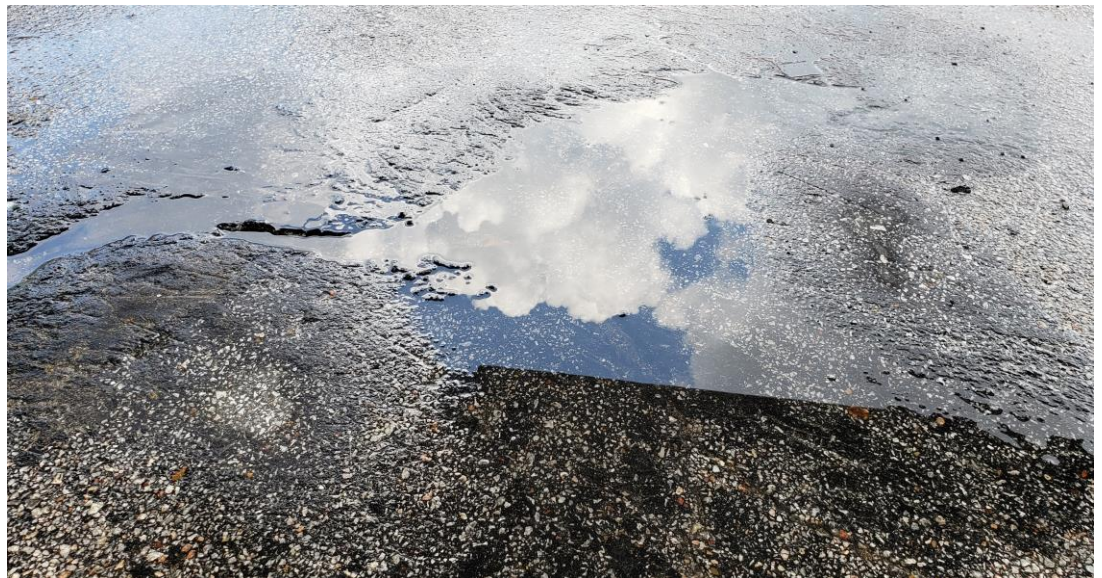
Photo No.
16

Slot B108:

View of slot B108 looking north, standing water from rainfall observed in asphalt crack, no tar-like material or sheen observed.

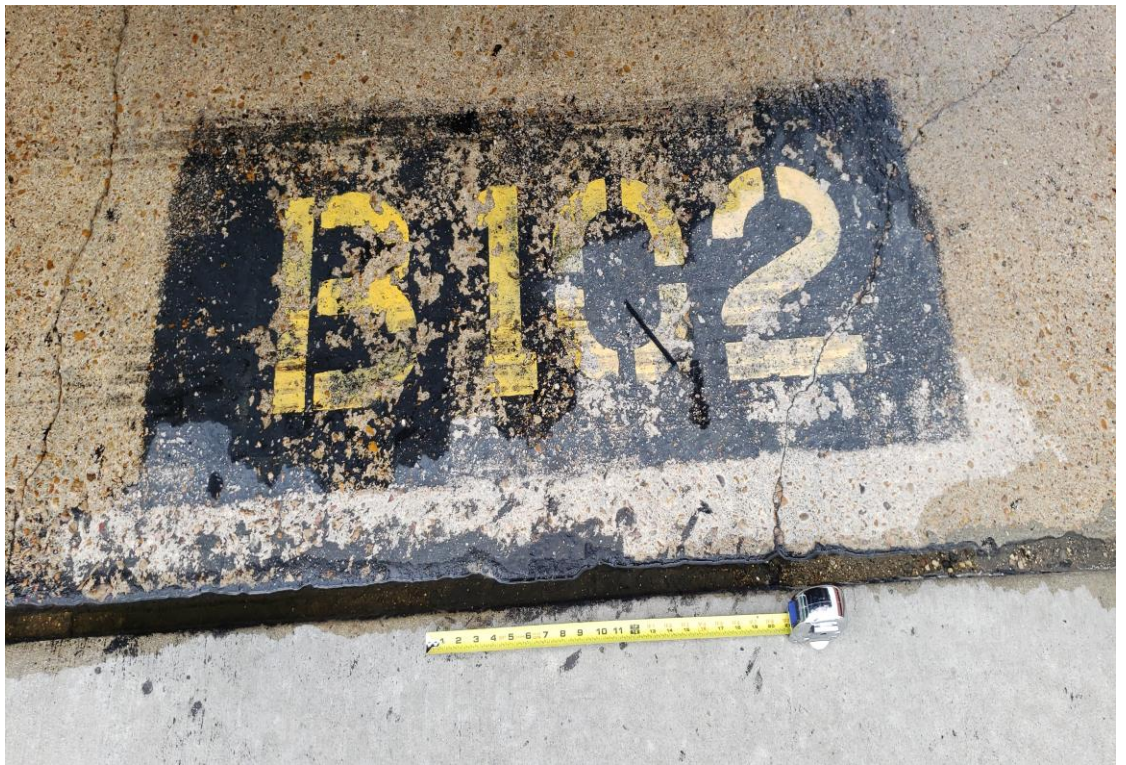
Photo No.
17

Slot B102:

View of slot B102, tar-like material observed in asphalt joint. Standing water from rainfall observed without sheen or discoloration.

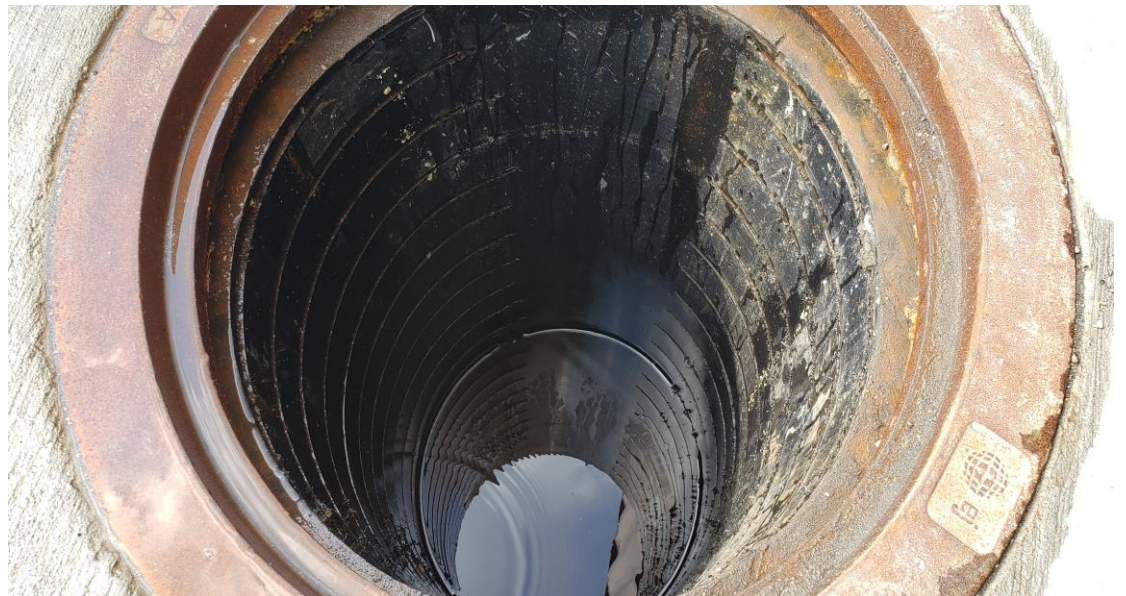
Photo No.
18

B103/B104 NAPL Collection Sump:

View of B103/B104 Sump, no sheen or odor noted in the water collected in the sump.

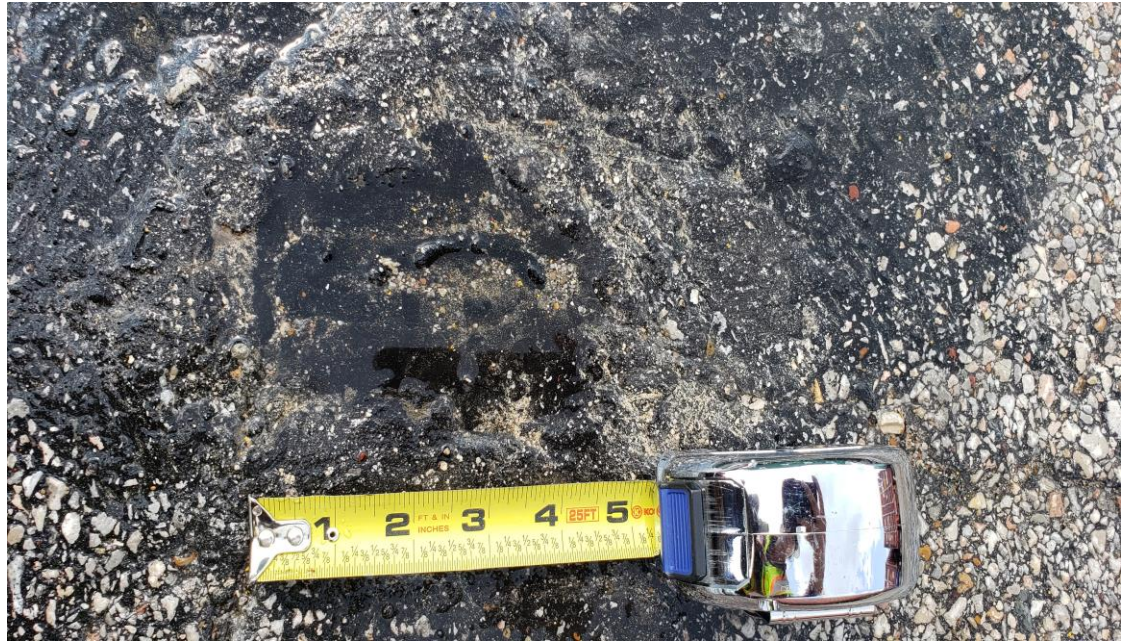
Photo No.
19

Slot B105:

View of slot B105, tar-like material seep from crack in asphalt. Standing water from rainfall observed without sheen or discoloration.

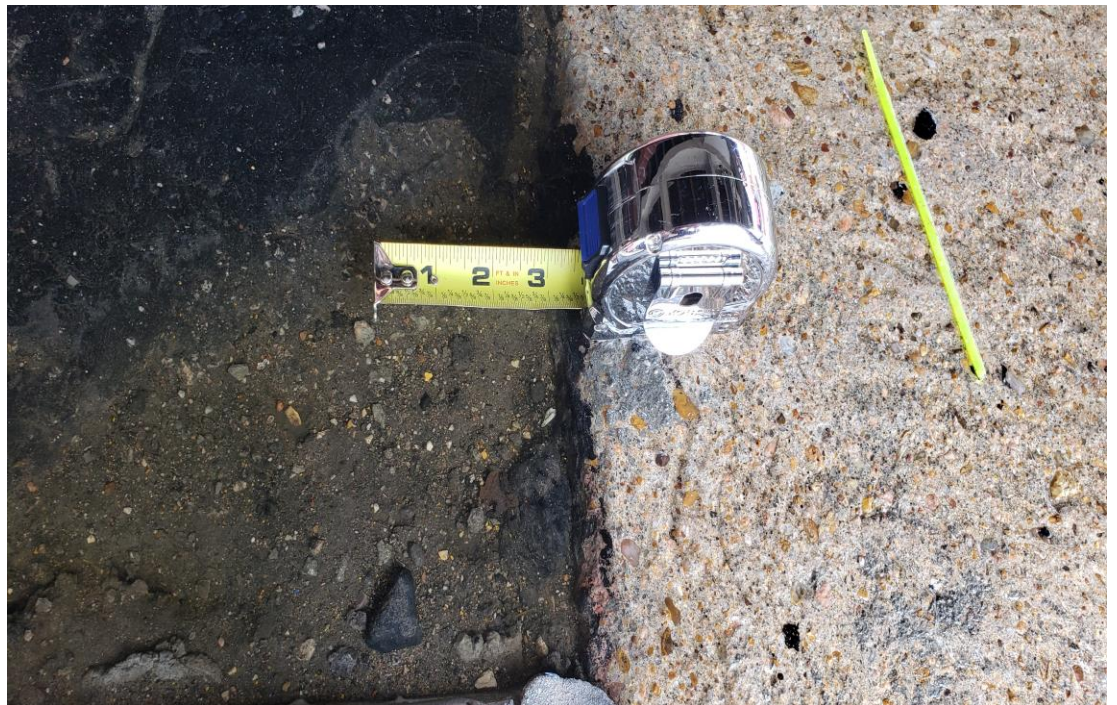
Photo No.
20

Slot B103:

View of slot B103, tar-like material along seam near NAPL collection system excavation. Standing water from rainfall observed without sheen or discoloration.

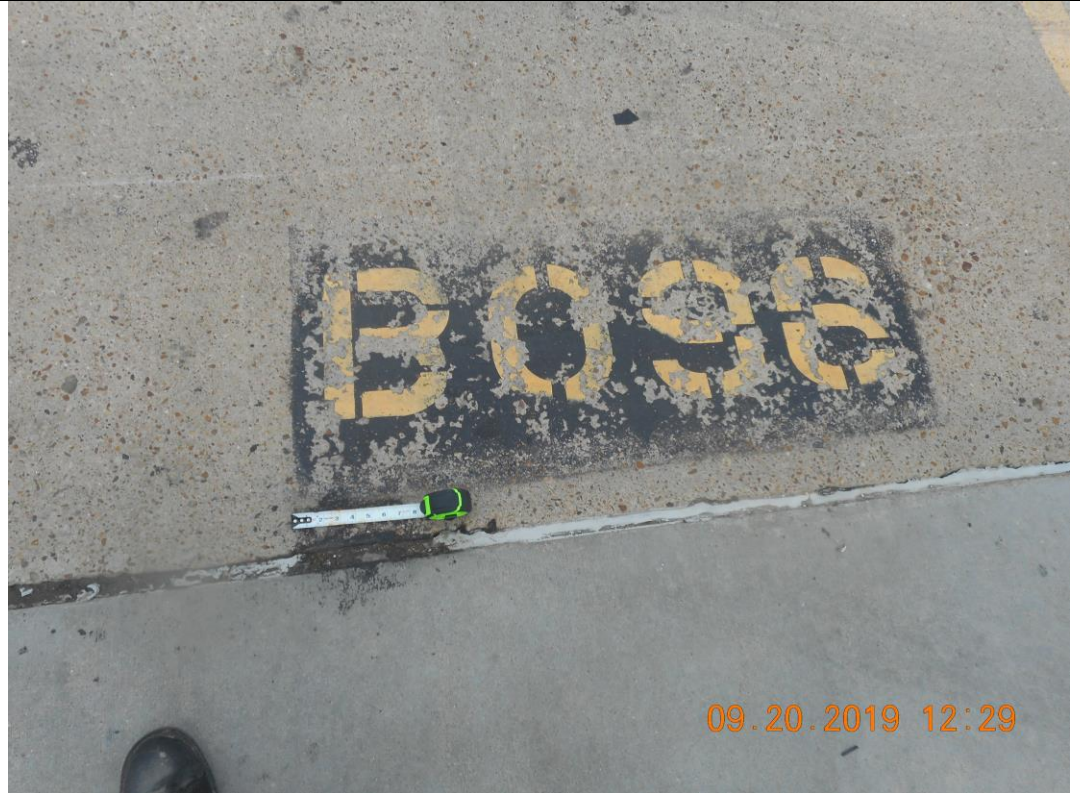
Photo No.
21

Slot B096:

View of slot B096, tar-like material observed in asphalt joint.

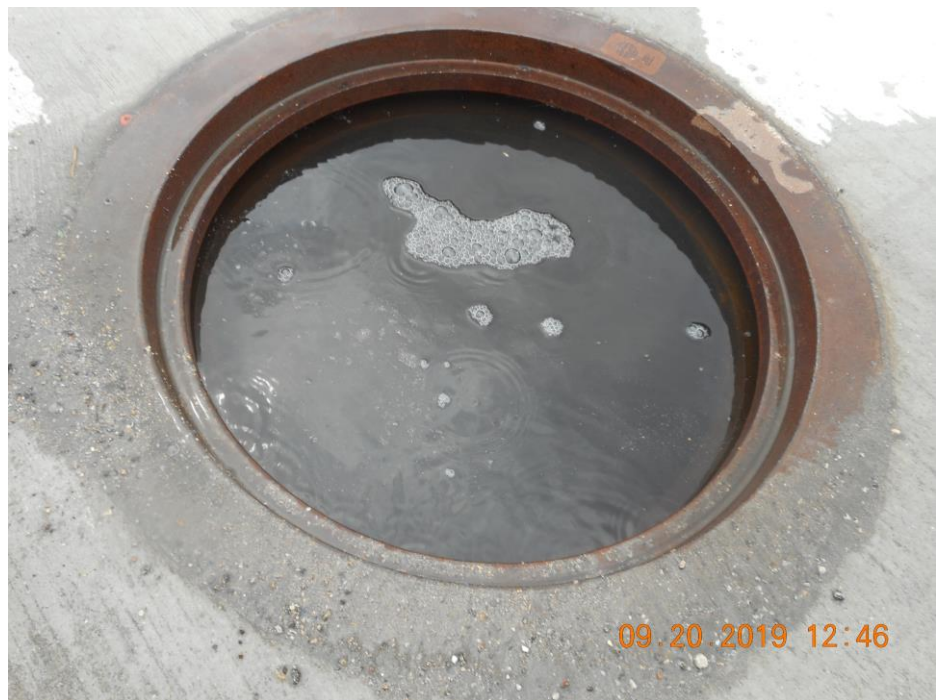
Photo No.
22

B099/B100 NAPL Collection Sump:

View of B099/B100 Sump, dark brown water, no sheen or odor noted in the water collected in the sump.

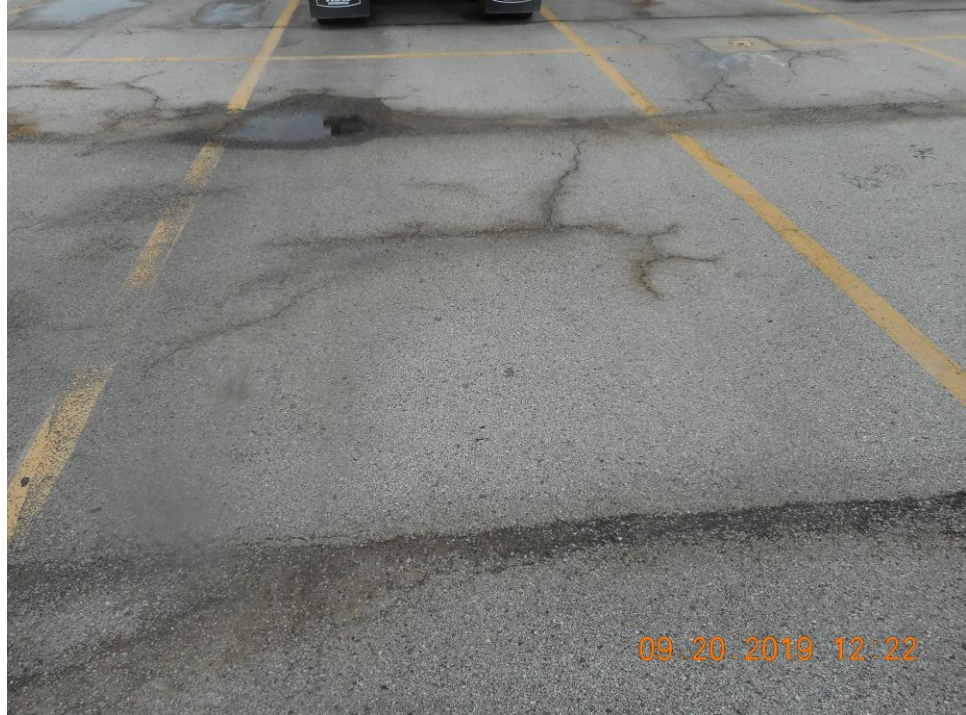
Photo No.
23

Slot B097:

View of slot B097, looking north, some brown staining along asphalt cracks, standing water observed without sheen or discoloration.

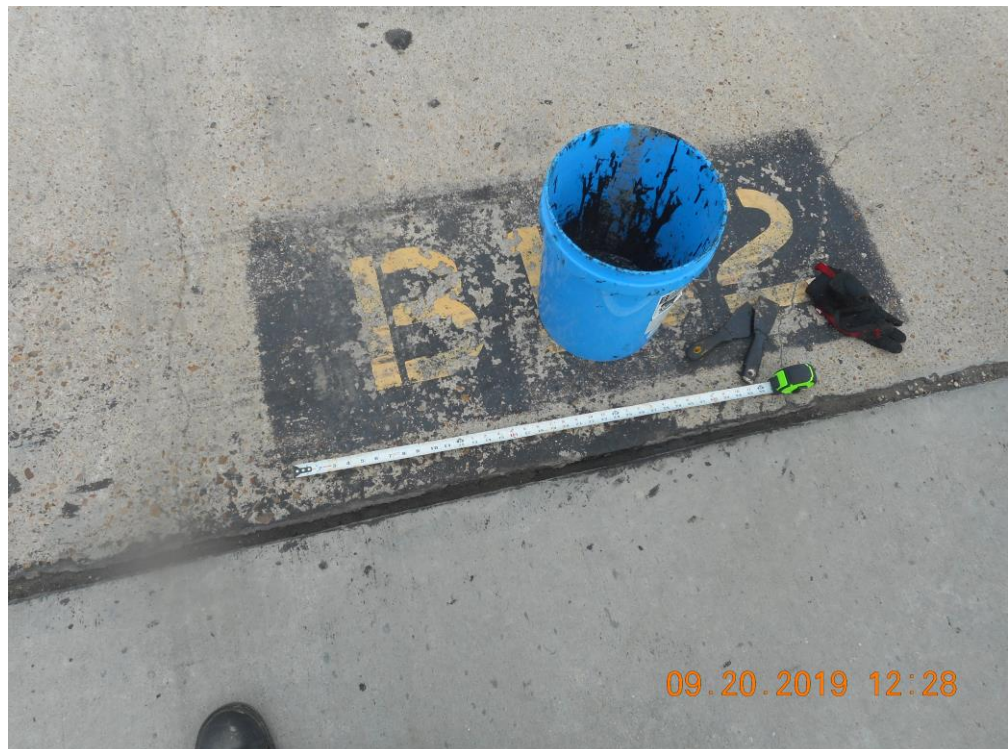
Photo No.
24

- A small amount of tar-like material was noted adjacent to the NAPL Collection System at Slot B103 during the August 14th inspection (Photograph 24). No other seeps were noted around the NAPL Collection Systems, including the area on the south end of stall B106 along the concrete joint with the NAPL Collection System where the tar-like material had been previously noted.

Slot B102:

View of slot B102, tar-like material observed in asphalt joint.

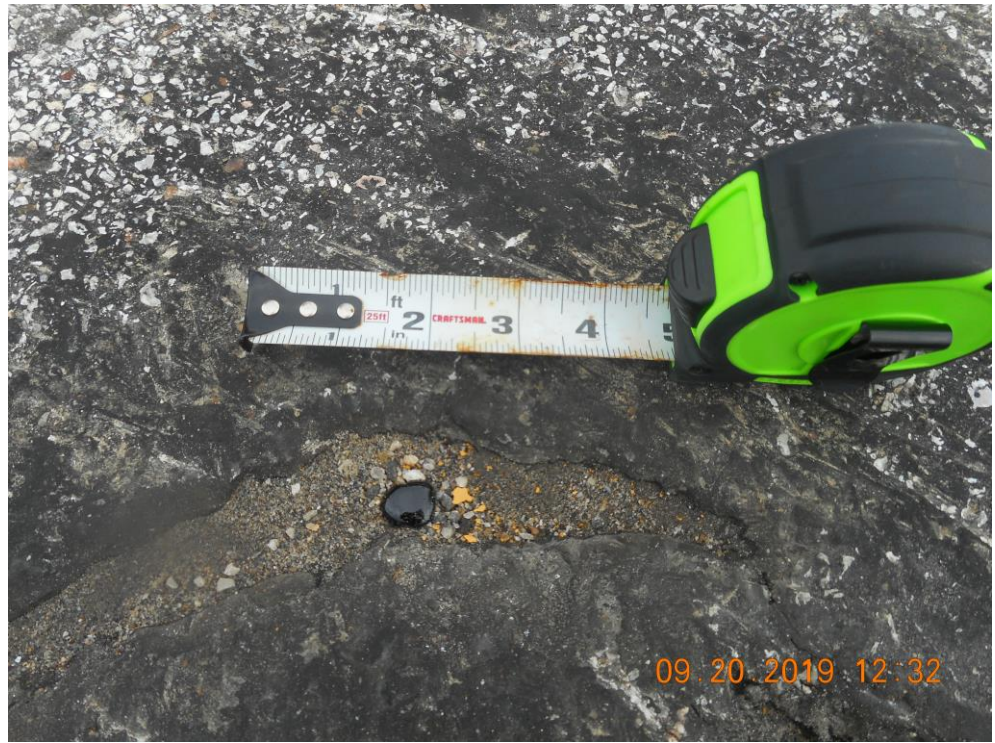
Photo No.
25

Slot B108:

View of slot B108, very little amount of tar-like material observed in asphalt cracks.

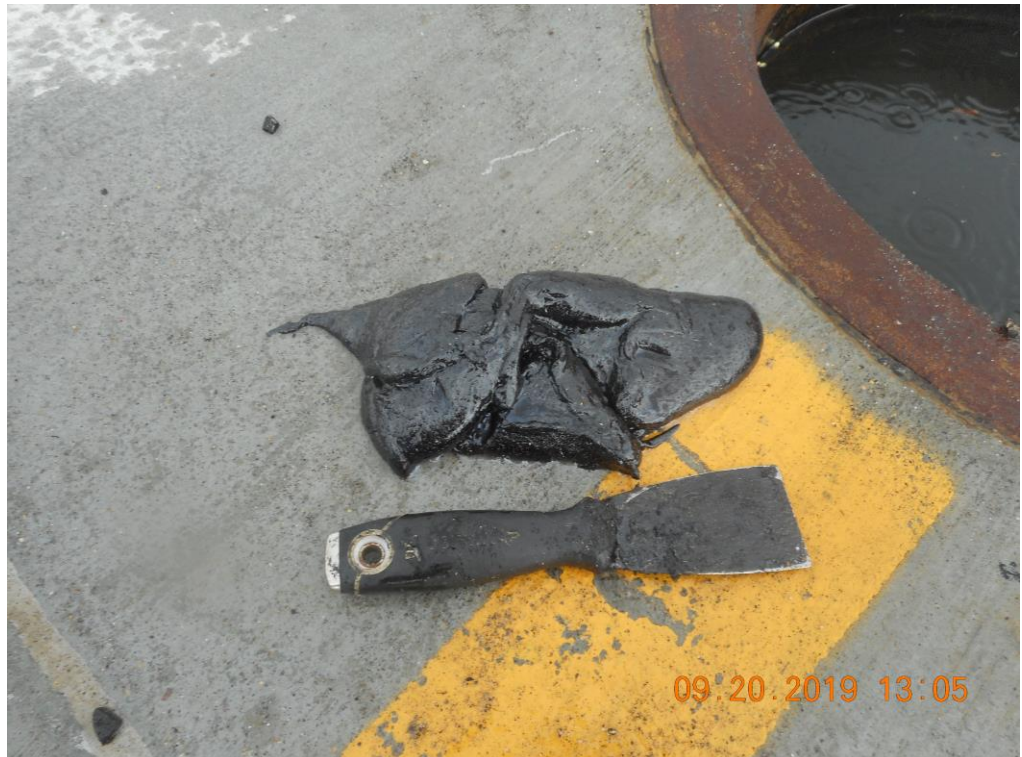
Photo No.
26

B107/B108 NAPL Collection Sump:

View of B107/B108 NAPL Collection Sump, note tar-like material removed from the sump, no odor or sheen noted in the water collected in the sump.

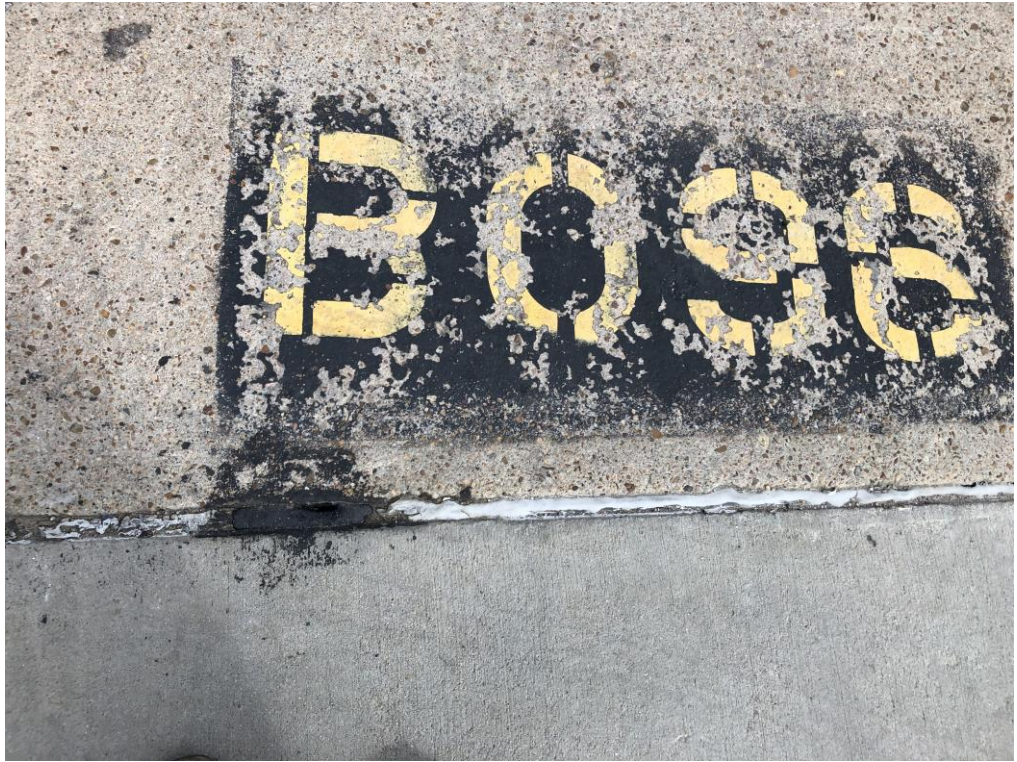
Photo No.
27

Slot B096:

View of slot B096, tar-like material observed in asphalt joint.

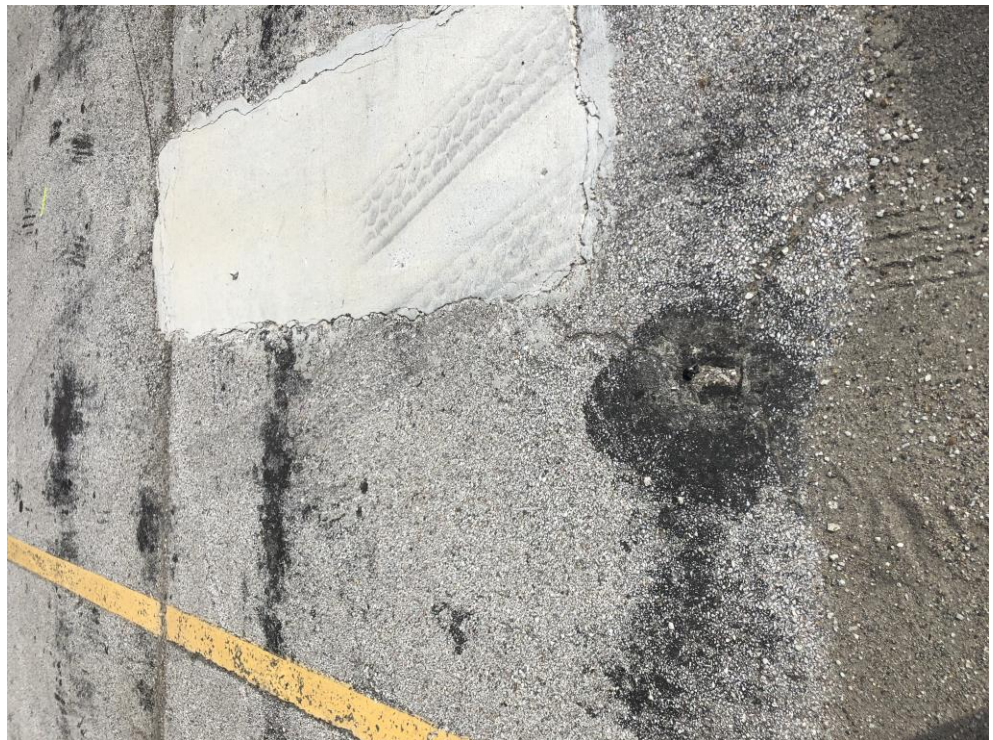
Photo No.
28

Slot B105:

View of slot B105, tar-like material observed in asphalt cracks.

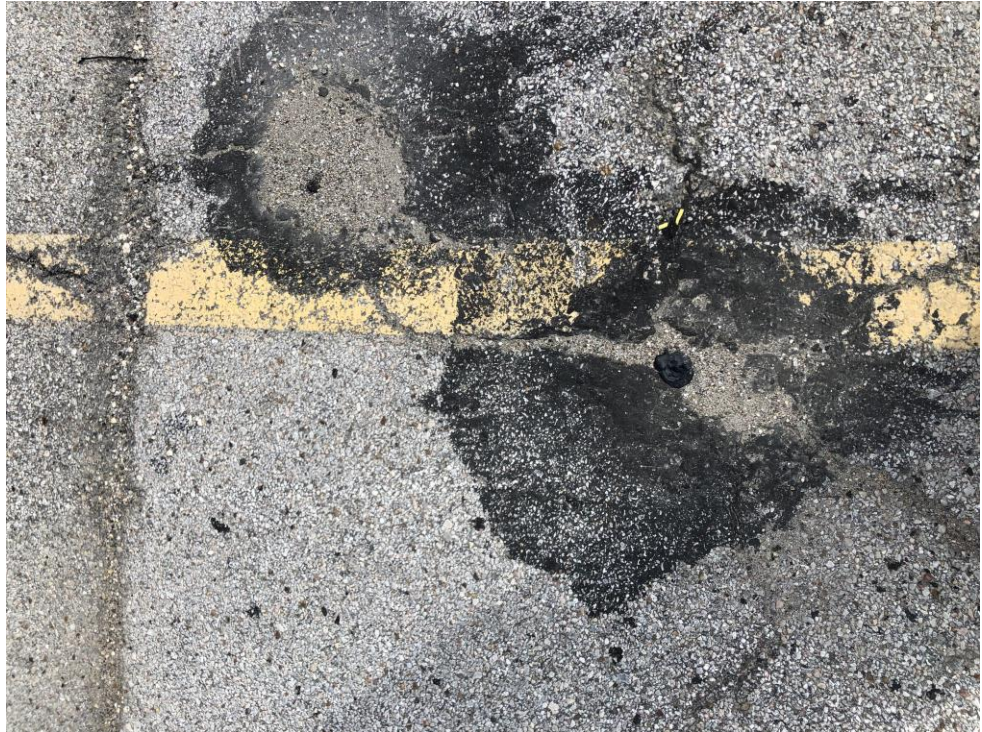
Photo No.
29

Slot B101:

View of slot B101, very little tar-like material in asphalt cracks.

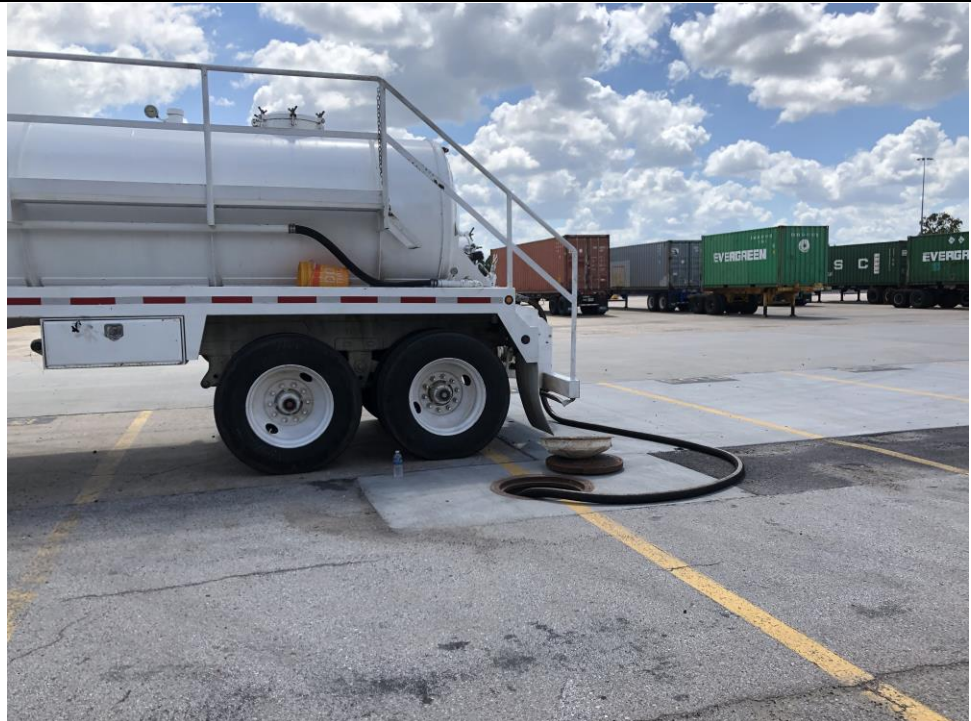
Photo No.
30

B103/B104 NAPL Collection Sump:

View of the B103/B104 NAPL Collection Sump during a pumpdown event.
