October 1, 2019

**RE: MONTHLY STATUS UPDATE – ENGLEWOOD INTERMODAL YARD – NAPL COLLECTION SYSTEM/CONCRETE CAP REPAIRS
UNION PACIFIC RAILROAD HOUSTON WOOD PRESERVING WORKS FACILITY
4910 LIBERTY ROAD FACILITY, HOUSTON, TEXAS
POST-CLOSURE CARE PERMIT NO. HW-50343; INDUSTRIAL SWR NO. 31547**

Attachment Weekly Inspection Photolog

Weekly Inspection Photolog

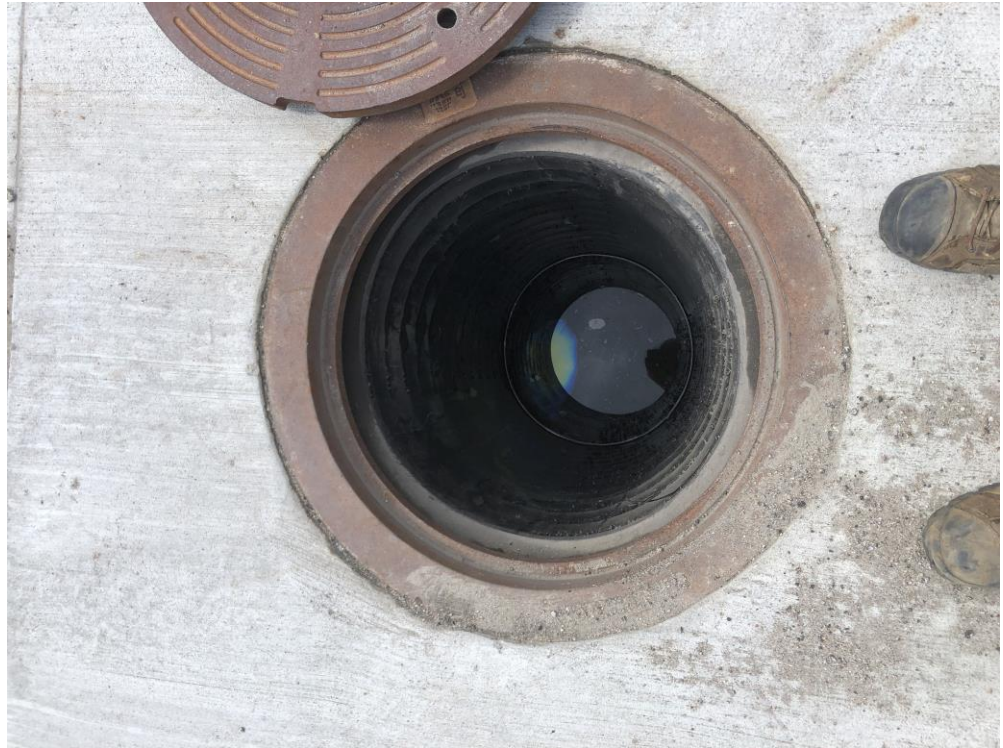
Photo No.
31

**B099/B100 NAPL
 Collection Sump:**

View of the B099/B100
 NAPL Collection Sump
 water recharge the day
 after a pumpdown
 event, dark brown
 water with sheen and
 no odor noted. No
 NAPL noted in sump.

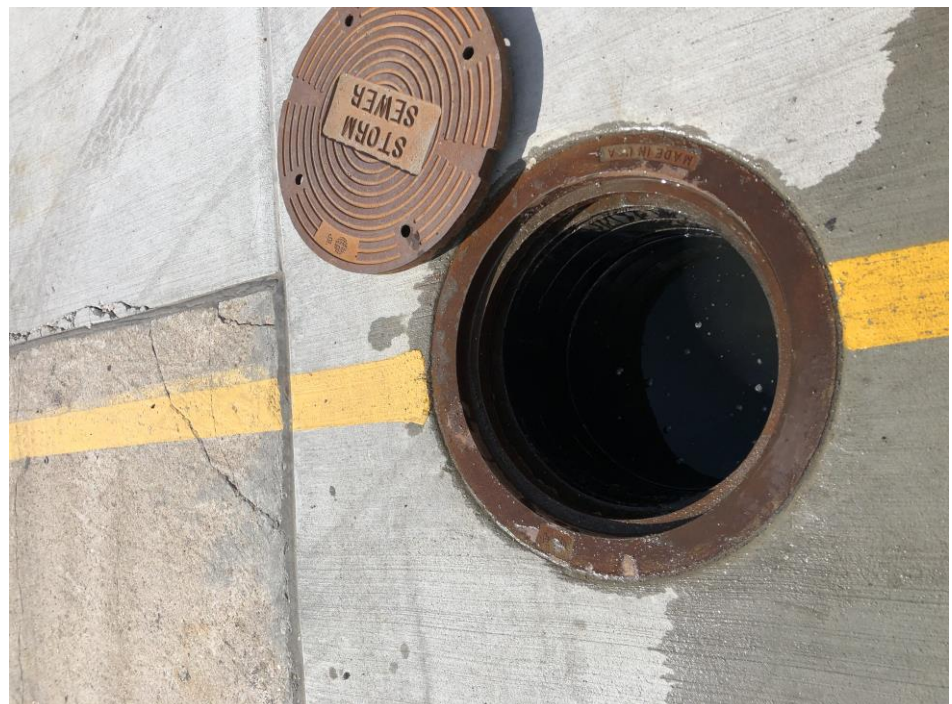
Photo No.
32

**B103/B104 NAPL
 Collection Sump:**

View of the B103/B104
 NAPL Collection Sump
 prior to pumpdown, no
 odor or sheen noted on
 water collected in the
 sump
