Project No. 19119232

**RE: MONTHLY STATUS UPDATE – ENGLEWOOD INTERMODAL YARD – NAPL COLLECTION SYSTEM/CONCRETE CAP REPAIRS
UNION PACIFIC RAILROAD HOUSTON WOOD PRESERVING WORKS FACILITY
4910 LIBERTY ROAD FACILITY, HOUSTON, TEXAS
POST-CLOSURE CARE PERMIT NO. HW-50343; INDUSTRIAL SWR NO. 31547**

Weekly Inspection Photolog

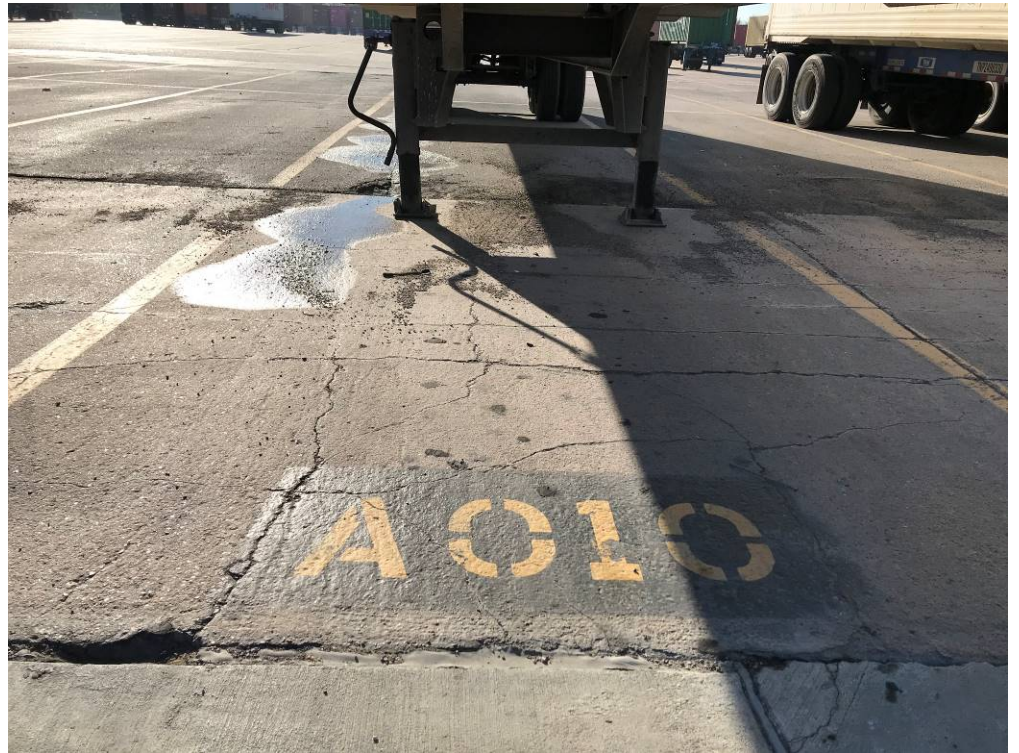
Photo No.
1

Slot A010, no tar-like material seeps observed, looking south. Water on ground from recent rain event.

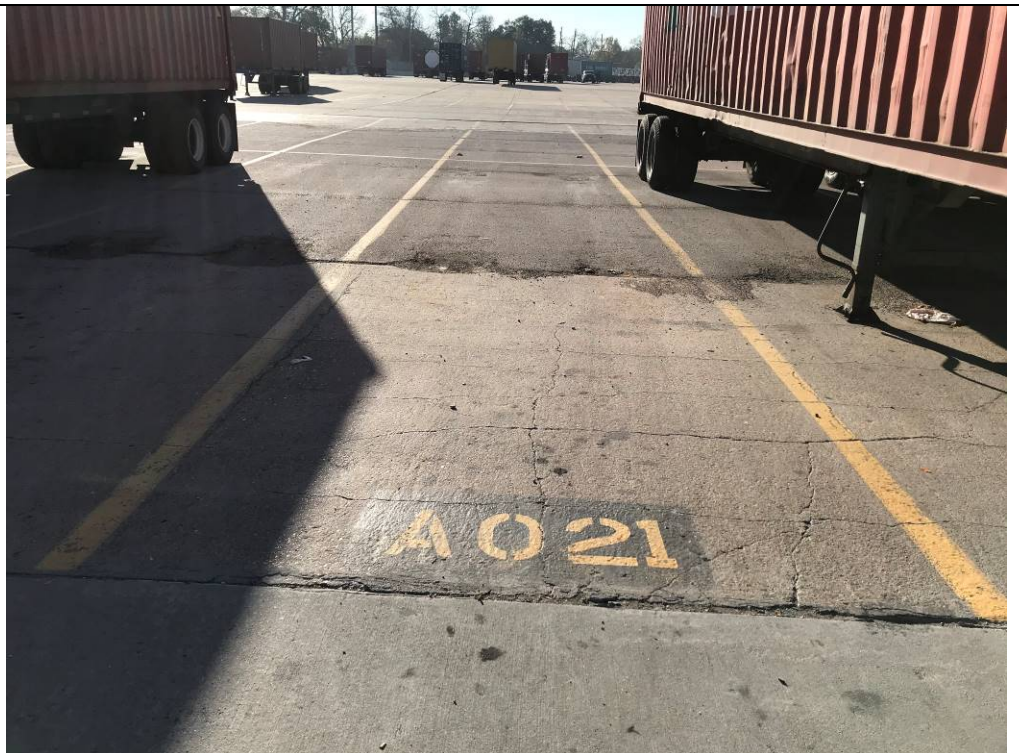
Photo No.
2

Slot A021, no tar-like material seeps observed, looking south.

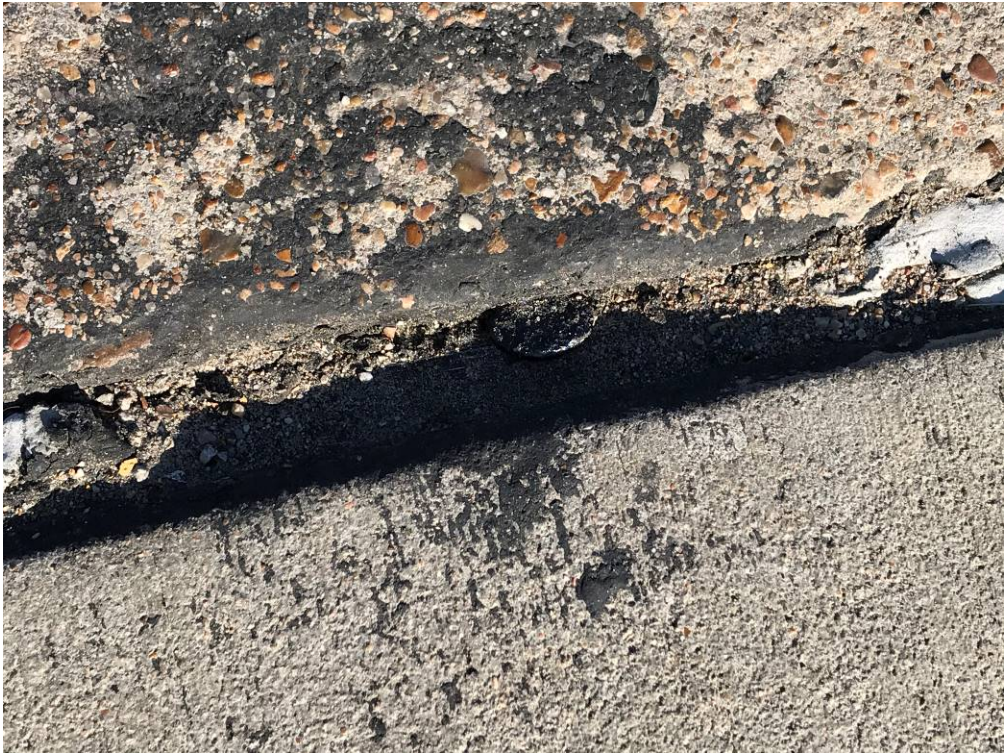
Client Name: Union Pacific Railroad		Site Location: Englewood Houston, Texas	Project No.: 19119232
Photo No.: 3	Date: 12/03/2019

Description: Slot B096, very small amount of tar-like material seeping at joint, material was removed. Lat: 29.7842528 Long: - 95.3206250			
Photo No.: 4	Date: 12/03/2019

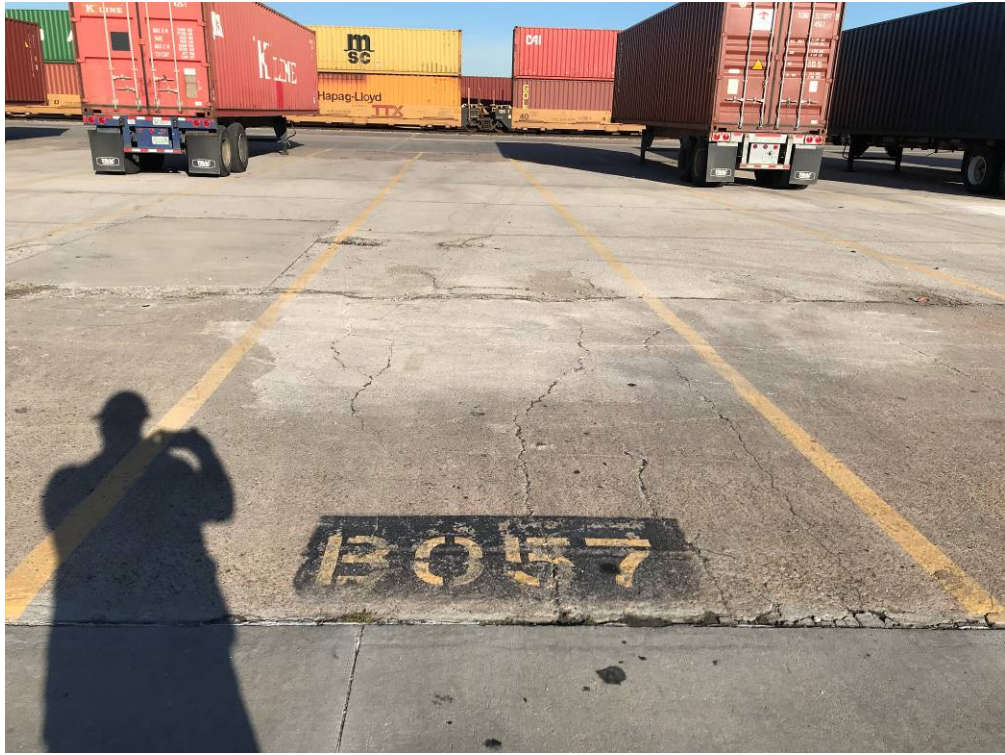
Description: Slot B057, no tar-like material seeps observed, looking north. Residual staining noted in foreground of photo. Lat: 29.7847472 Long: - 95.3195417

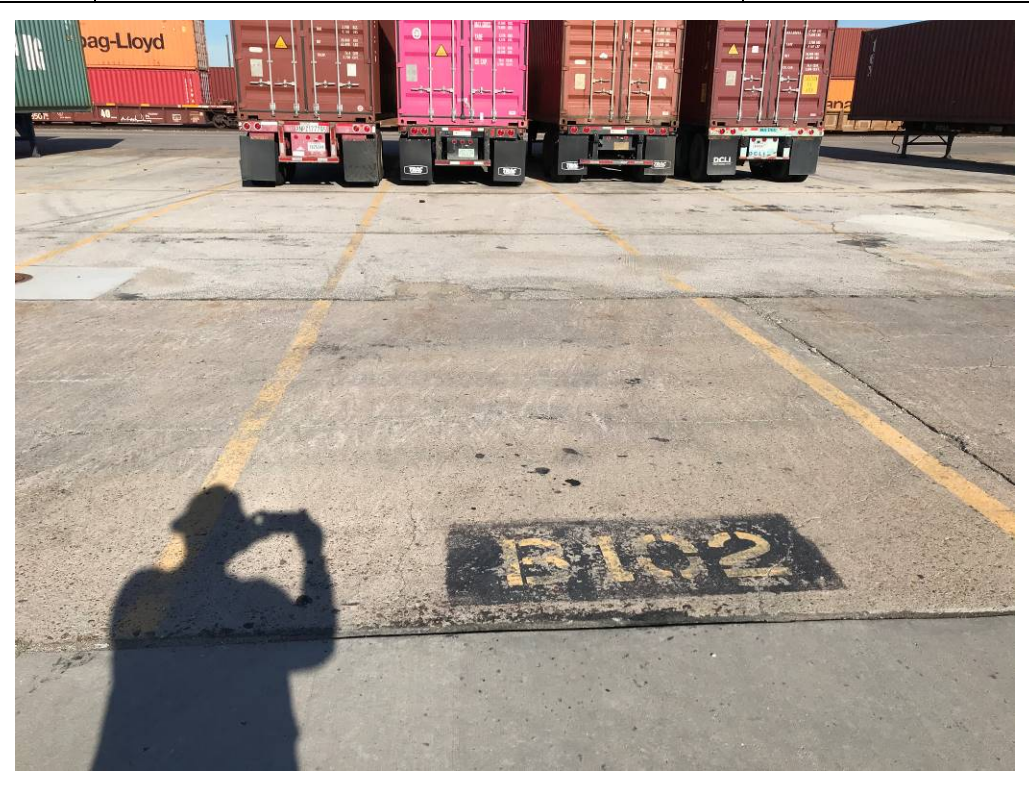
Photo No. 5	Date: 12/03/2019
Description: Slot B102, no tar-like material seeps observed, looking north. Lat: 29.7841806 Long: - 95.3208083

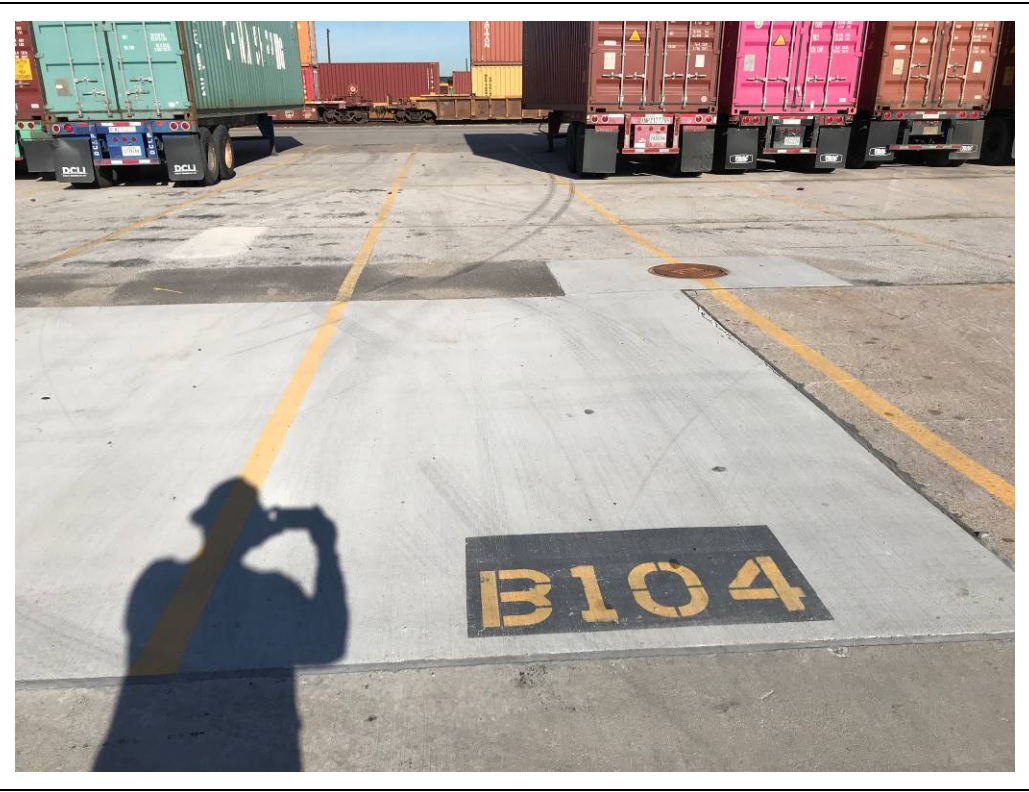
Photo No. 6	Date: 12/03/2019
Description: Slot B104, view of NAPL Collection System (Sump 103/104 in foreground). No tar-like material seeps observed, looking north. Lat: 29.7841639 Long: - 95.3208694

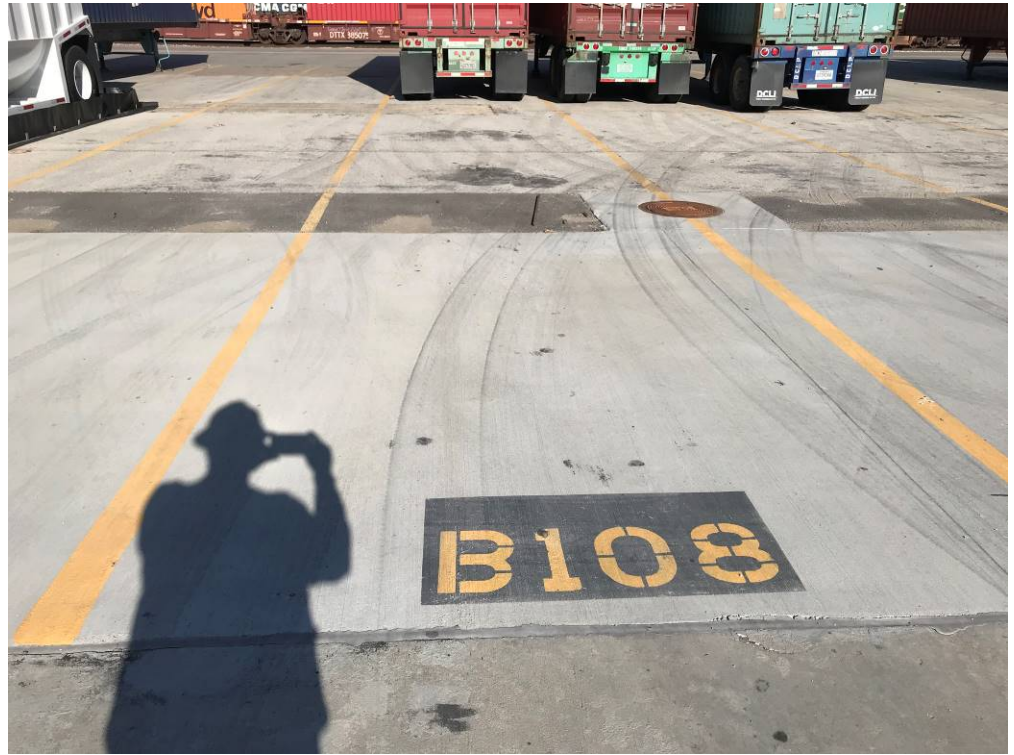
Photo No.
7

Slot B108, view of NAPL Collection System (Sump 107/108 in foreground). No tar-like material seeps observed, looking north.

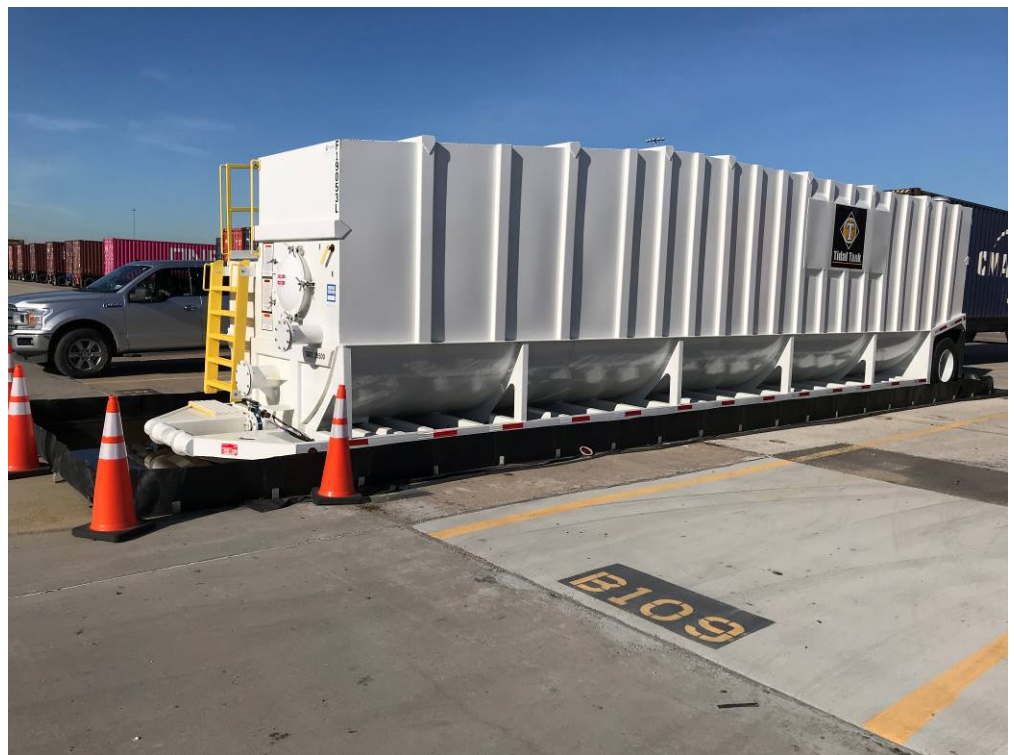
Photo No.
8

Frac tank for storage of pumped down water from NAPL Collection Sumps (in Slot B110), some stormwater noted in secondary containment, looking west.

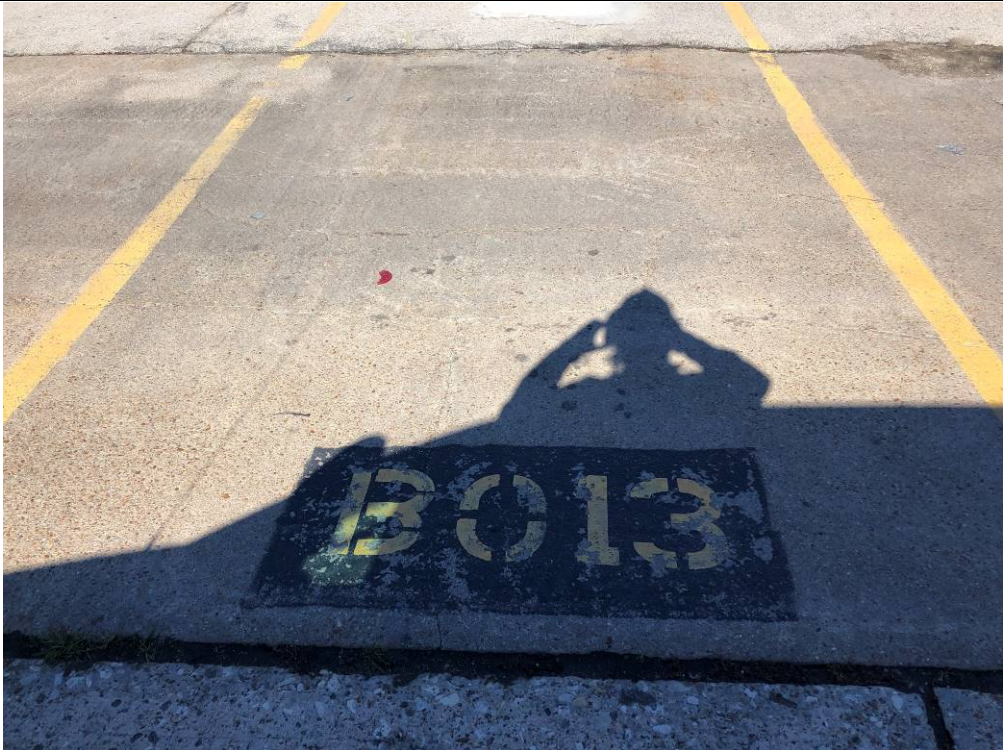
Client Name: Union Pacific Railroad		Site Location: Englewood Houston, Texas	Project No.: 19119232
Photo No.: 9	Date: 12/11/2019

Description: Slot B013, no tar-like material seeps observed, looking north. Lat: 29.785217 Long: - 95.318261			
Photo No.: 10	Date: 12/11/2019

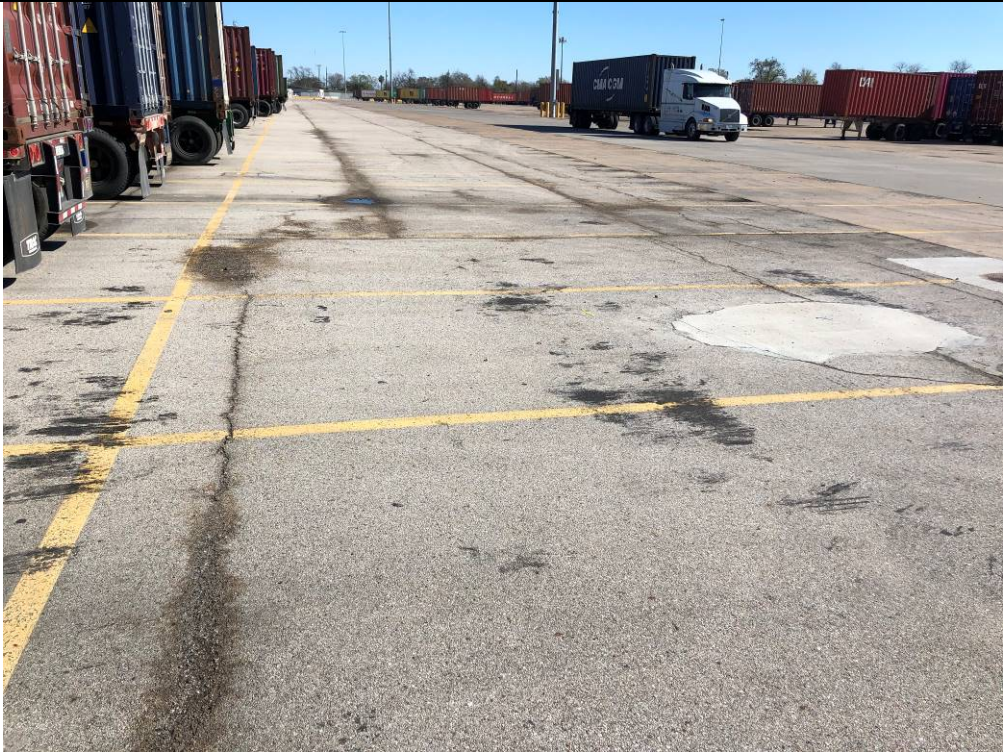
Description: Slot B101, looking east. Residual staining along joint running east-west. No seep water noted (residual water from recent rain event). Lat: 29.784211 Long: - 95.320769

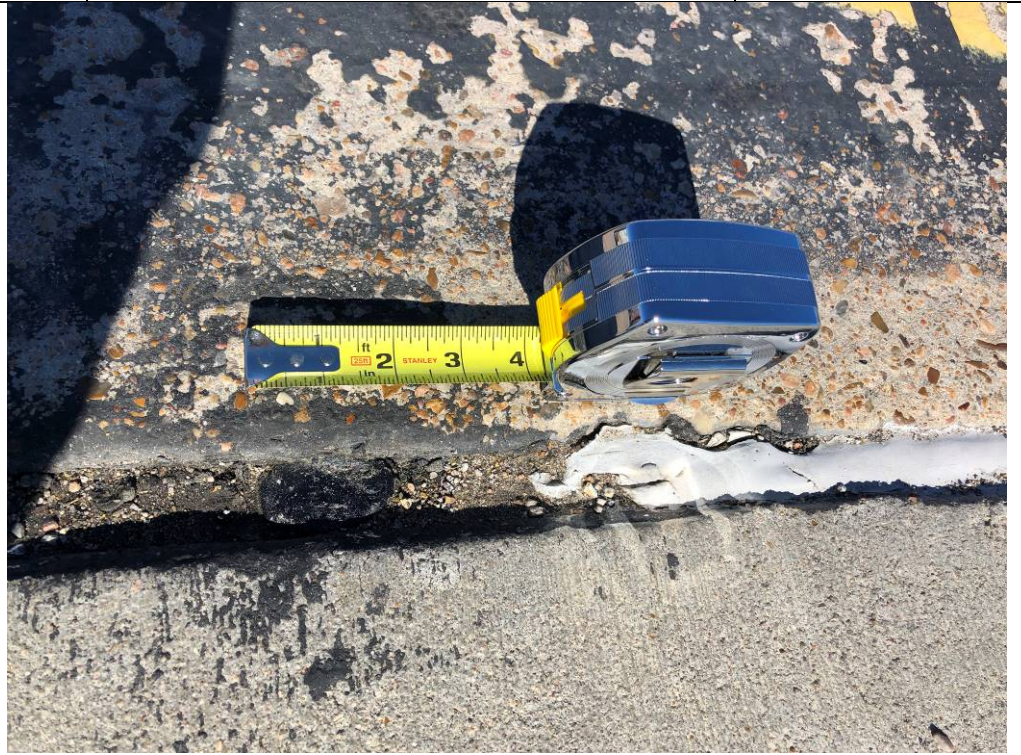
Photo No. 11	Date: 12/11/2019
------------------------	----------------------------

Slot B096, very small amount of tar-like material seeping at joint. Material was removed.

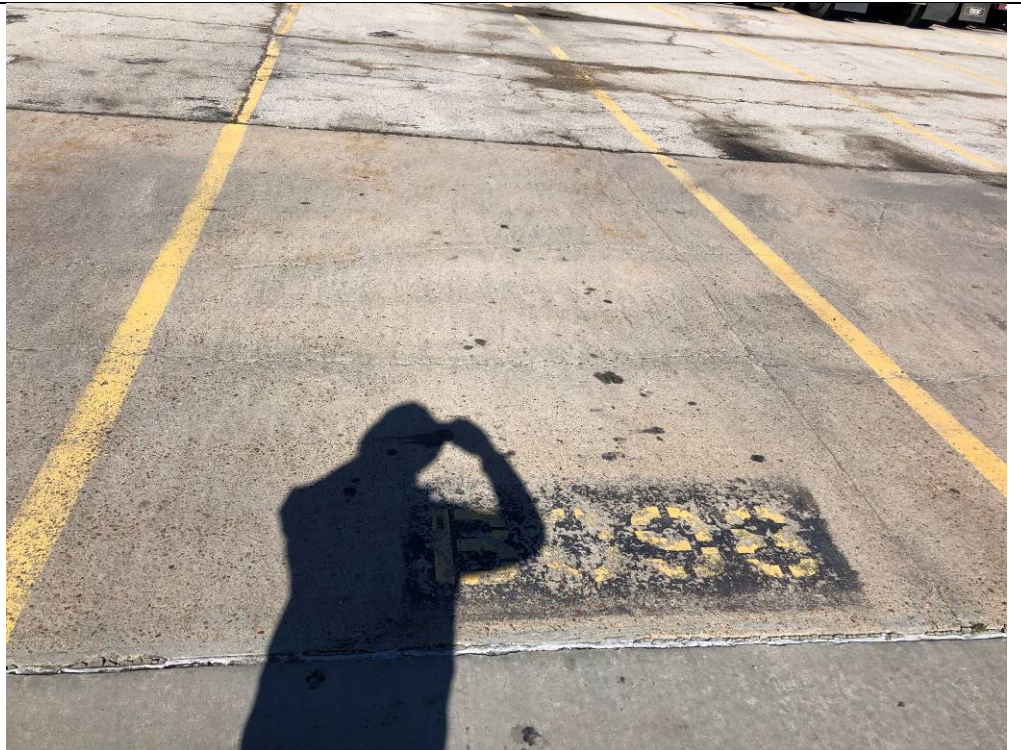
Photo No. 12	Date: 12/11/2019
------------------------	----------------------------

Slot B098, no tar-like material seeps observed, looking north.

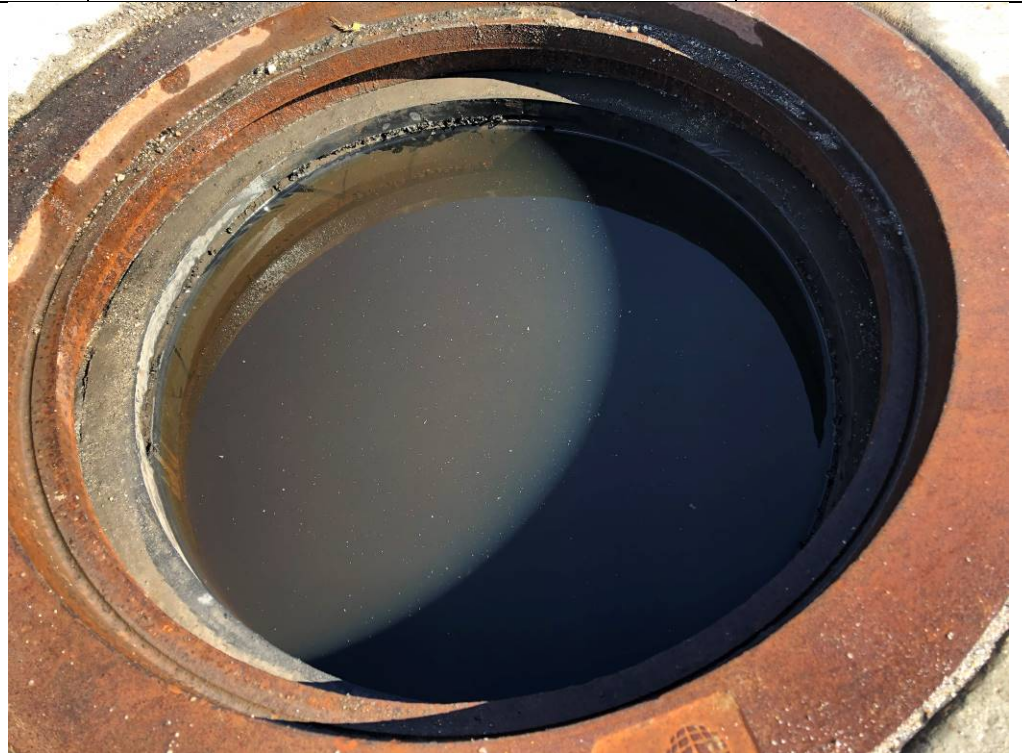
Photo No. 13	Date: 12/11/2019
Description: Sump B099/B100, approx. 1.5 inches of freeboard in sump, no sheen or odors noted. Lat: 29.7844000 Long: - 95.3205861

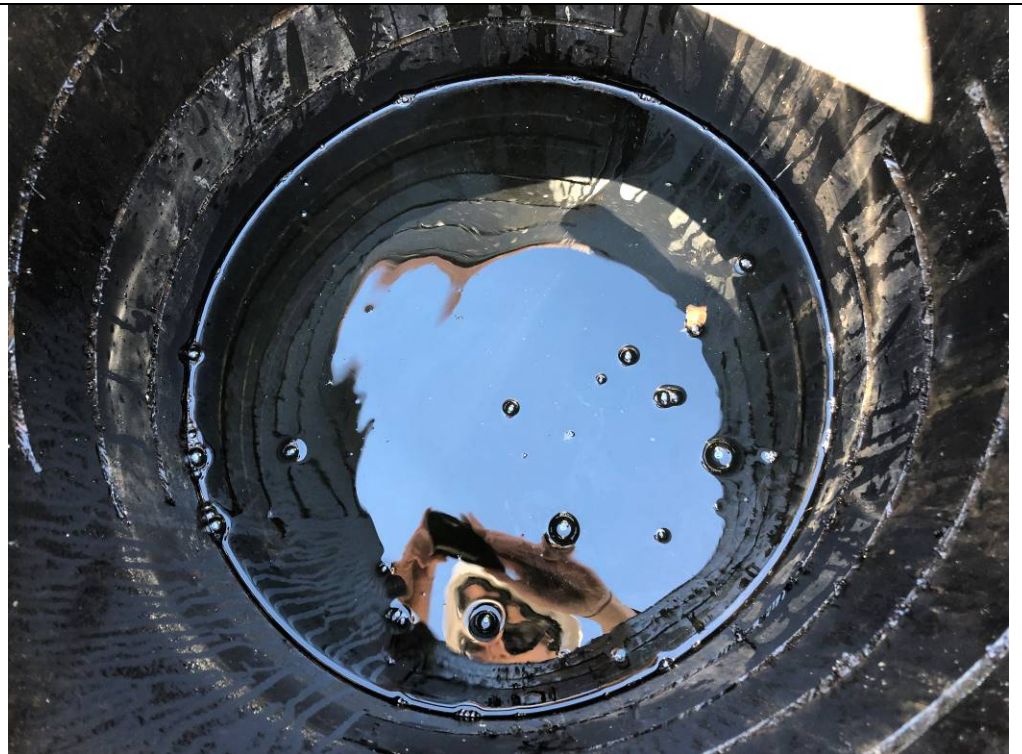
Photo No. 14	Date: 12/11/2019
Description: Sump B107/B108, approx. 16.5 inches of freeboard in sump, no sheen or odors noted. However, small amount of tar-like material removed from bottom of sump. Lat: 29.7842861 Long: - 95.3208611

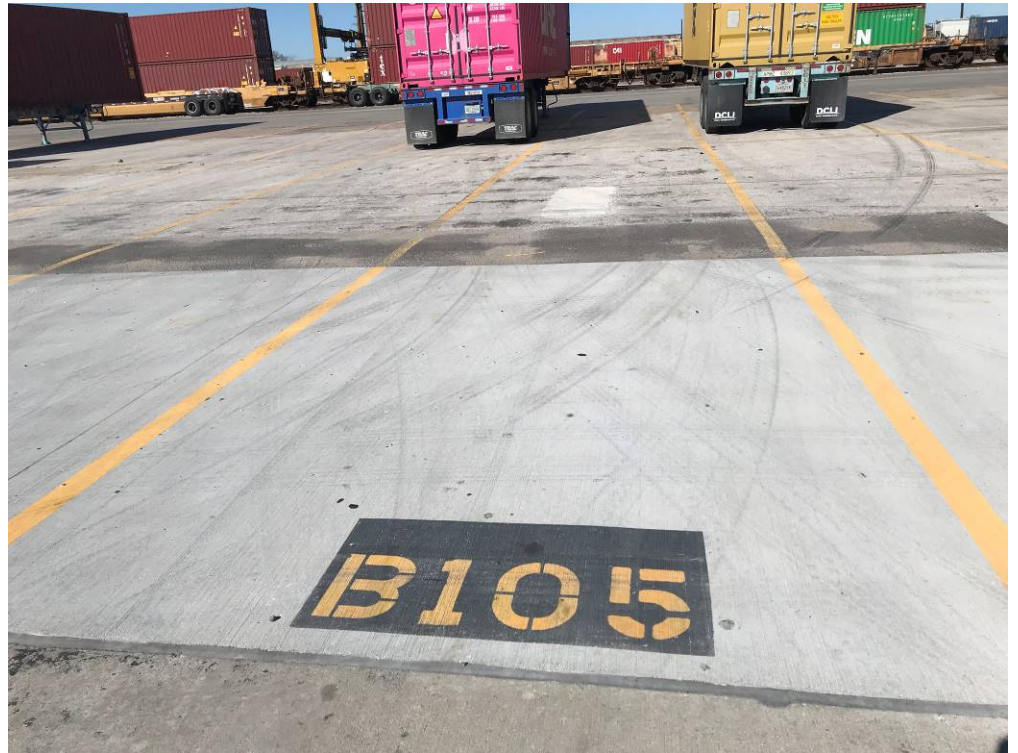
Photo No.
15

Slot B105, no tar-like material seeps observed, looking north.

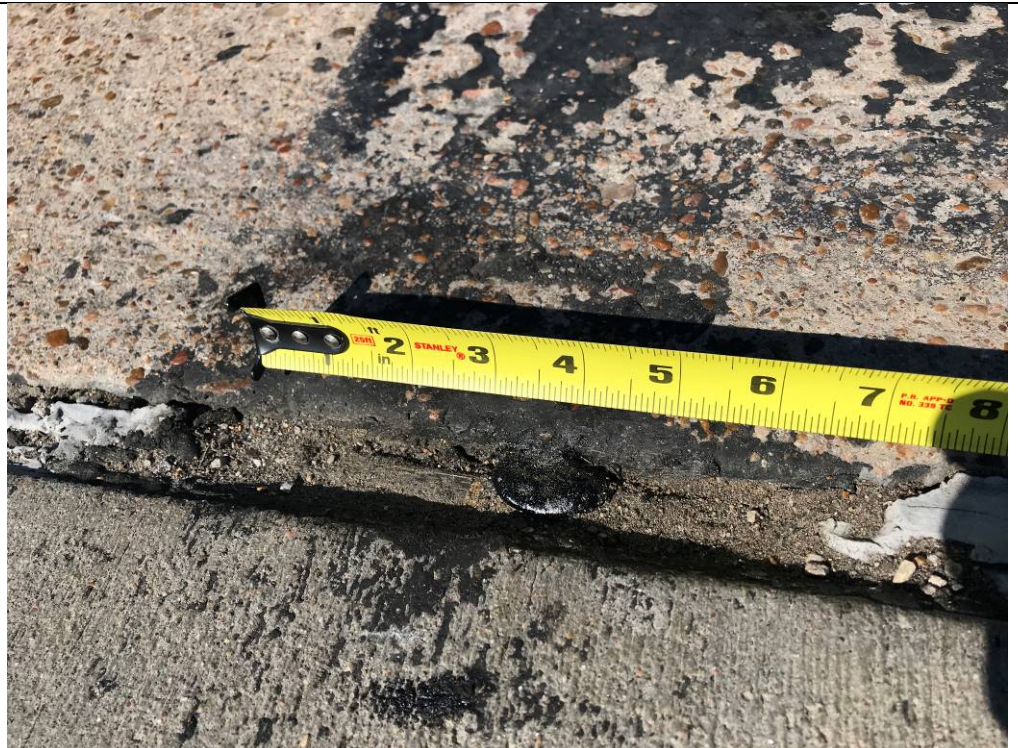
Photo No.
16

Slot B096, very small amount of tar-like material seeping at joint, material was removed.

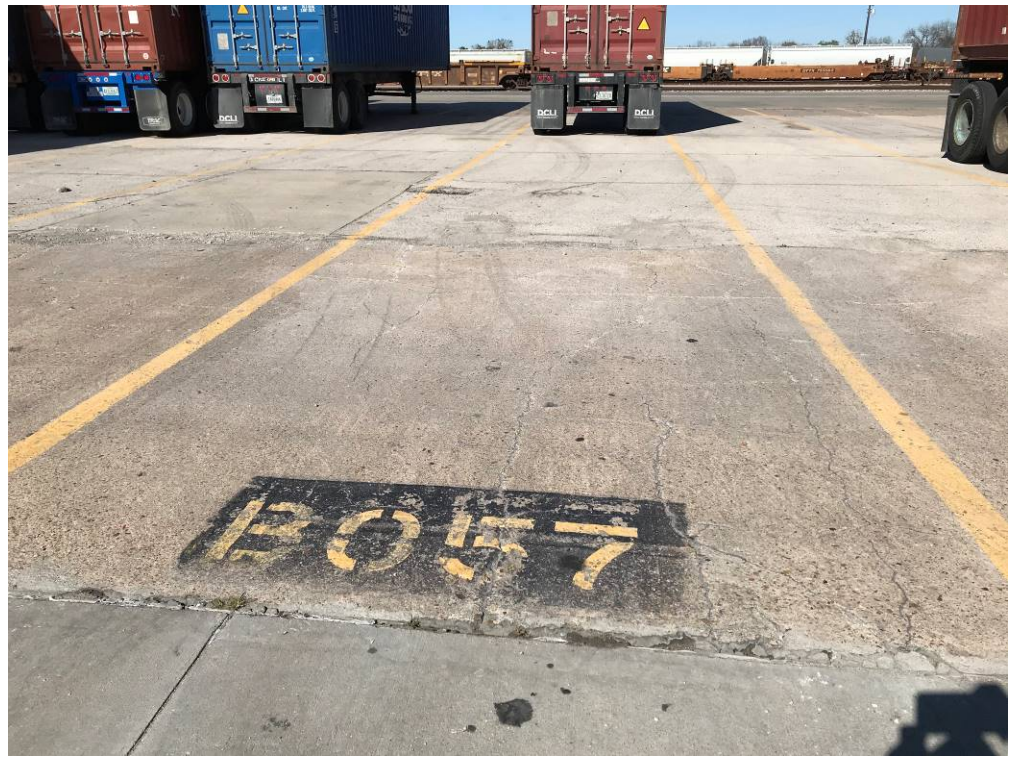
Photo No. 17	Date: 12/17/2019
Description: Slot B057, no tar-like material seeps observed, looking north. Lat: 29.7847166 Long: - 95.3195417

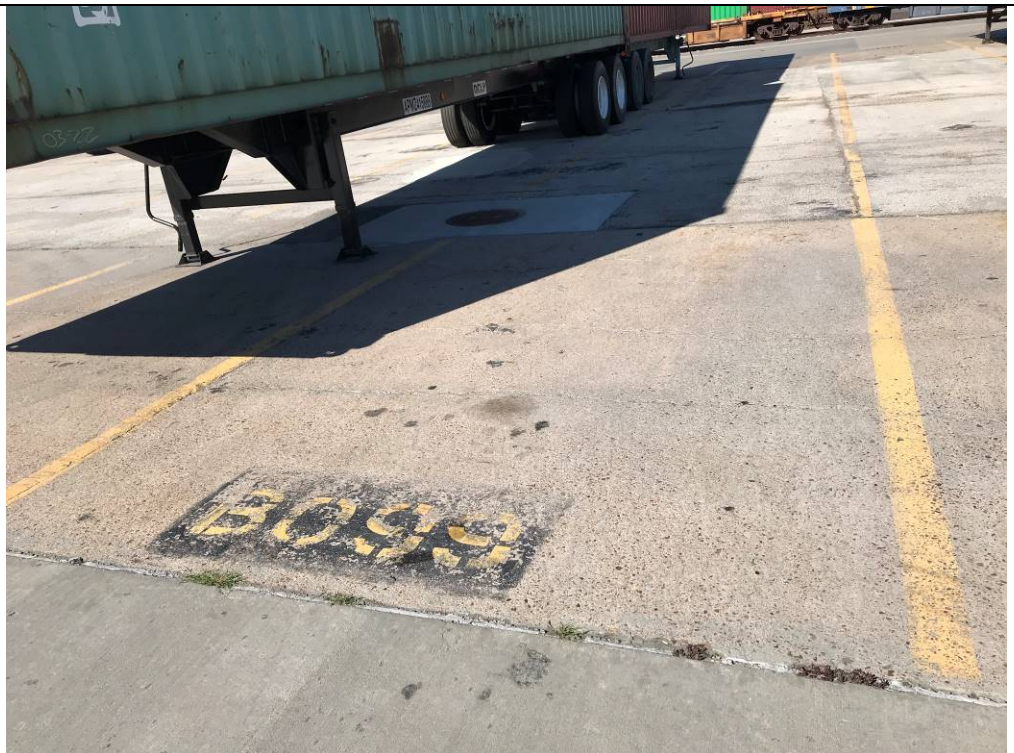
Photo No. 18	Date: 12/17/2019
-------------------------------	----------------------------

Description: Slot B099, view of NAPL Collection System (Sump 099/100 in foreground). No tar-like material seeps observed, looking north. Lat: 29.7842472 Long: - 95.3206944	
---	--

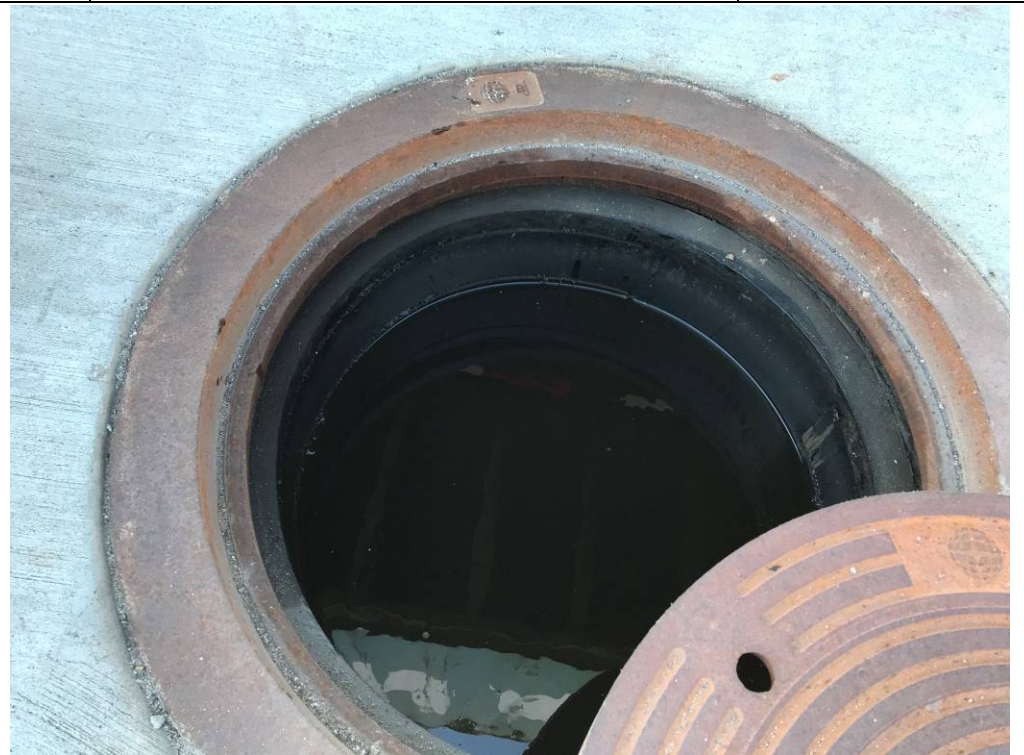
Photo No. 19	Date: 12/17/2019
Description: Sump B099/B100, approx. 5 inches of freeboard in sump, no sheen or odors noted Lat: 29.7844000 Long: - 95.3205861

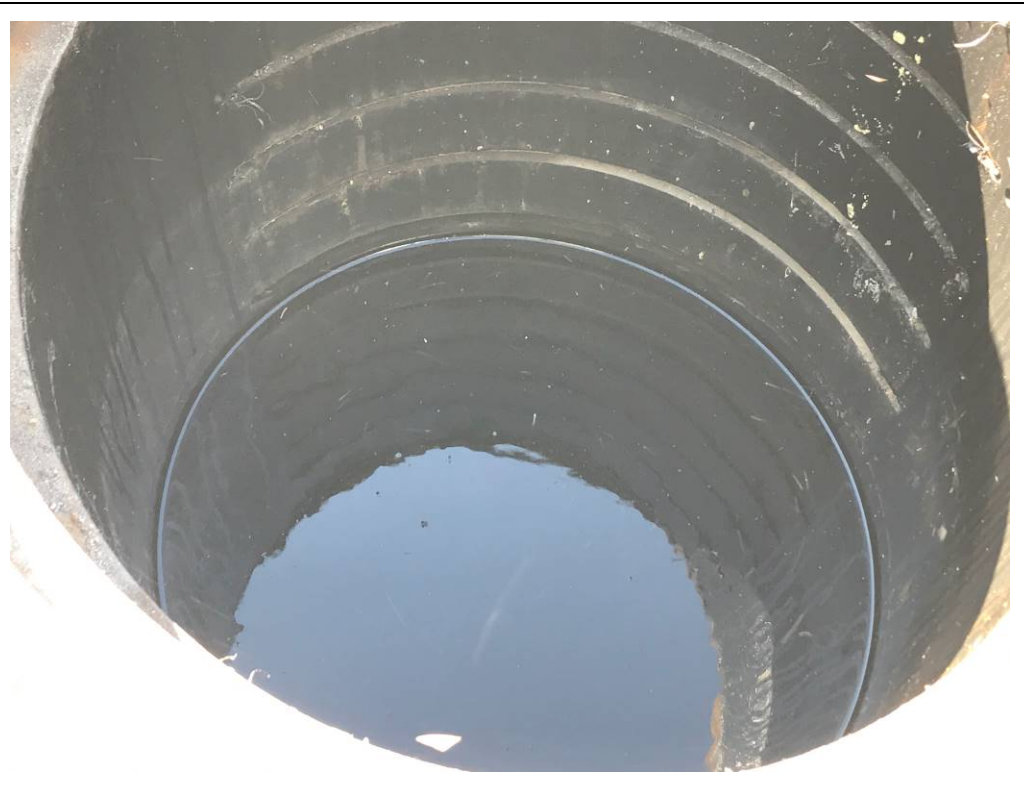
Photo No. 20	Date: 12/17/2019
Description: Sump B103/B104, approx. 19.5 inches of freeboard in sump, no sheen or odors noted. Lat: 29.7842861 Long: - 95.3208611

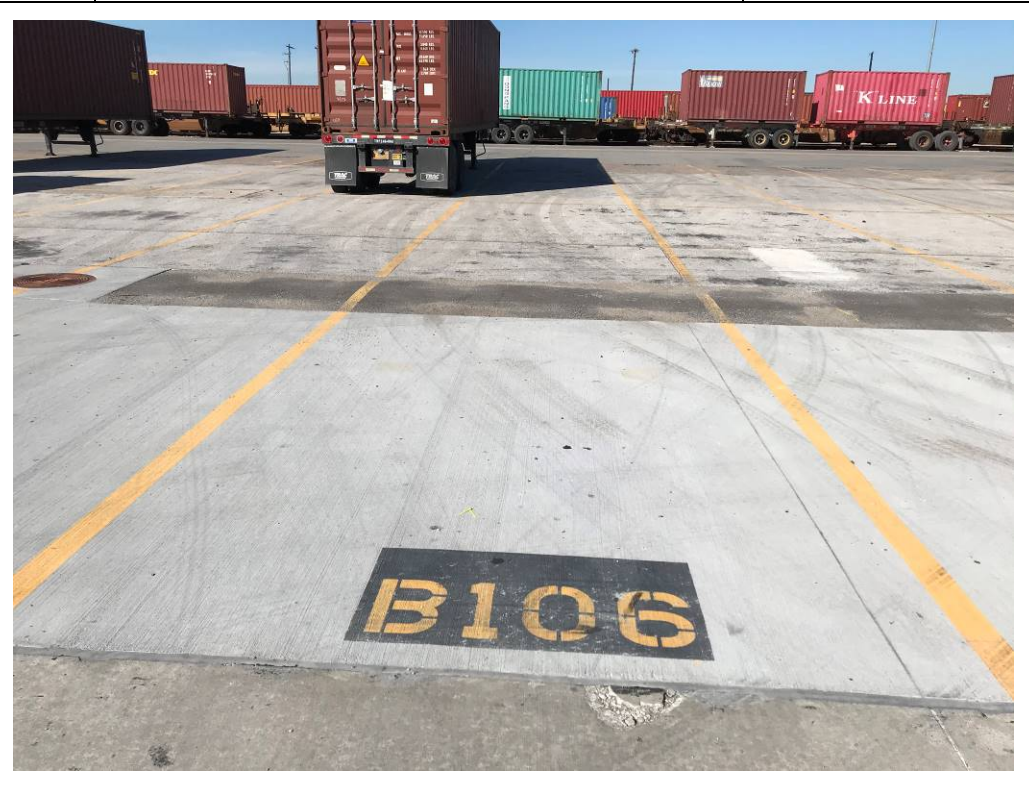
Photo No. 21	Date: 12/23/2019
Description Slot B106, no tar-like material seeps observed, looking north. Lat: 29.7841194 Long: - 95.3209306

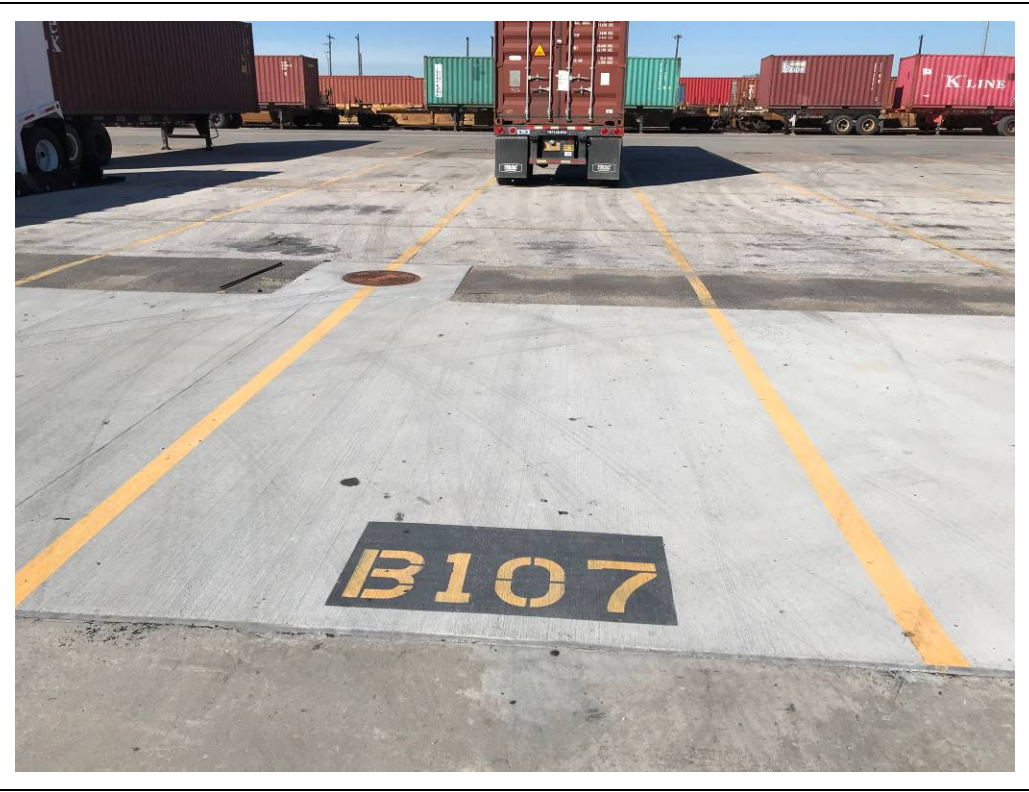
Photo No. 22	Date: 12/23/2019
Description: Slot B107, view of NAPL Collection System (Sump 107/108 in foreground). No tar-like material seeps observed, looking north. Lat: 29.7841028 Long: - 95.3209611

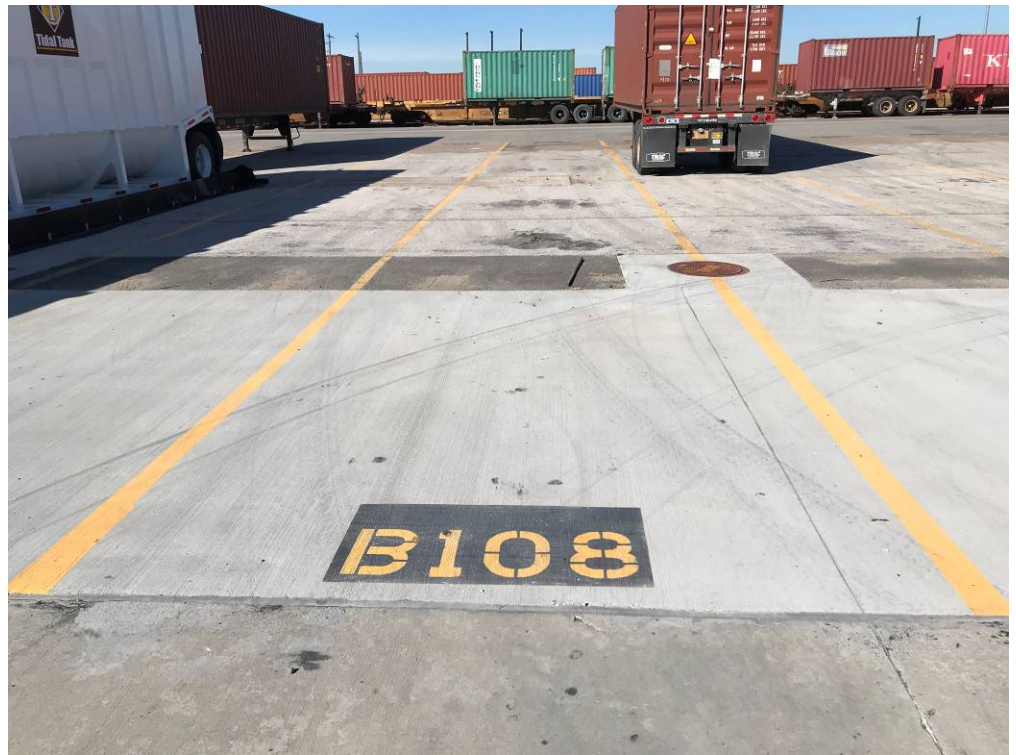
Photo No.
23

Slot B108, view of NAPL Collection System (Sump 107/108 in foreground). No tar-like material seeps observed, looking north.

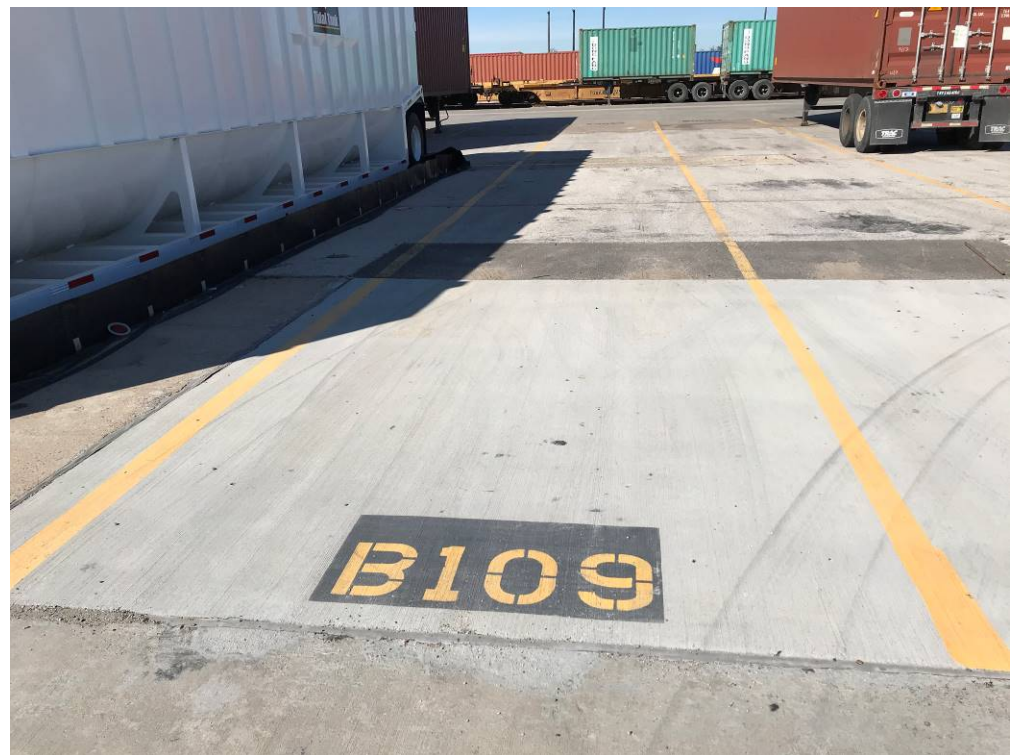
Photo No.
24

Slot B109, no tar-like material seeps observed, looking north.
