Project No. 19119232

**RE: MONTHLY STATUS UPDATE – ENGLEWOOD INTERMODAL YARD – NAPL COLLECTION SYSTEM/CONCRETE CAP REPAIRS
UNION PACIFIC RAILROAD HOUSTON WOOD PRESERVING WORKS FACILITY
4910 LIBERTY ROAD FACILITY, HOUSTON, TEXAS
POST-CLOSURE CARE PERMIT NO. HW-50343; INDUSTRIAL SWR NO. 31547**

Weekly Inspection Photolog

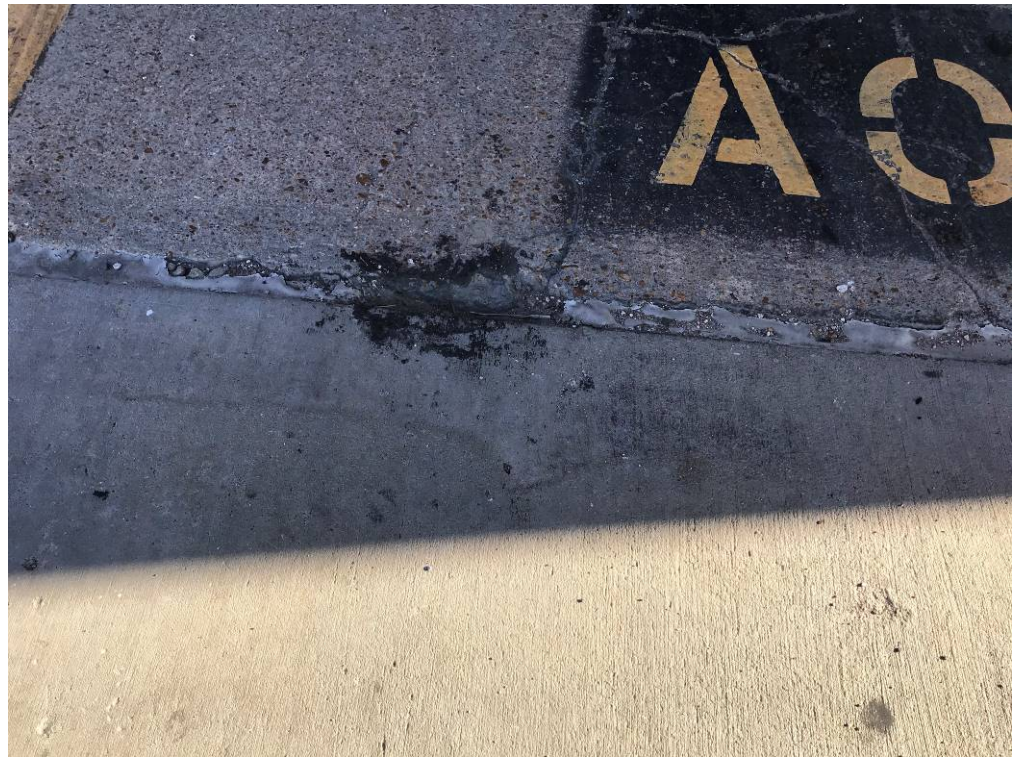
Photo No. 1	Date: 11/06/2019
Description: Slot A010, no tar-like material seeps observed, looking south.

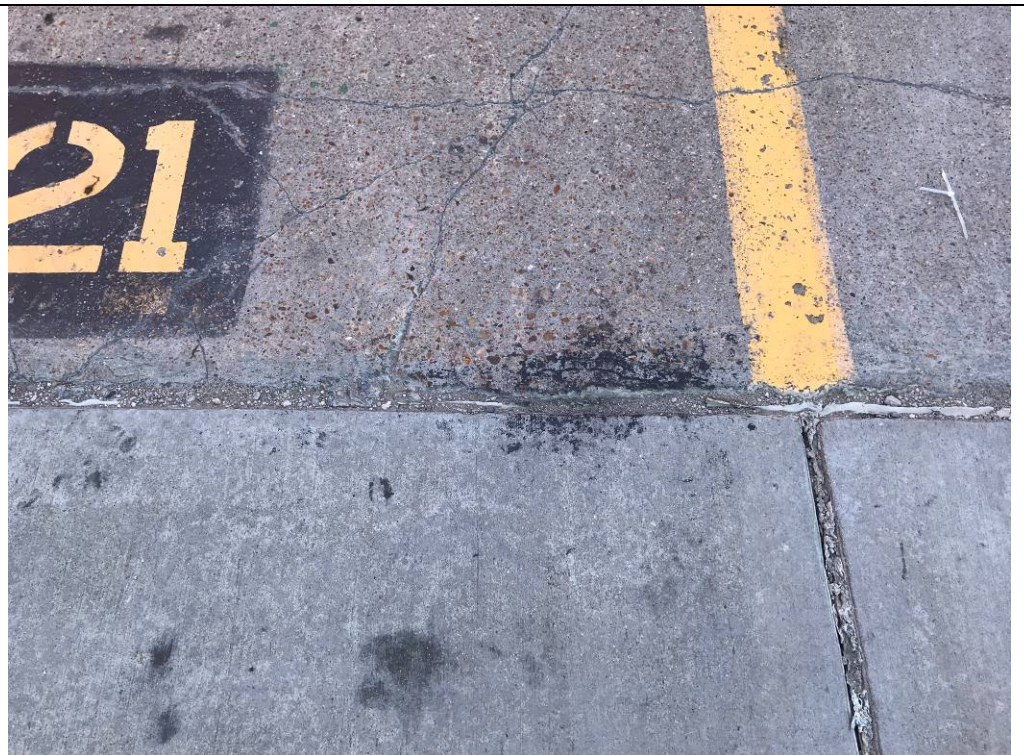
Photo No. 2	Date: 11/06/2019
------------------------------	----------------------------

Description: Slot A021, no tar-like material seeps observed, looking south.	
---	--

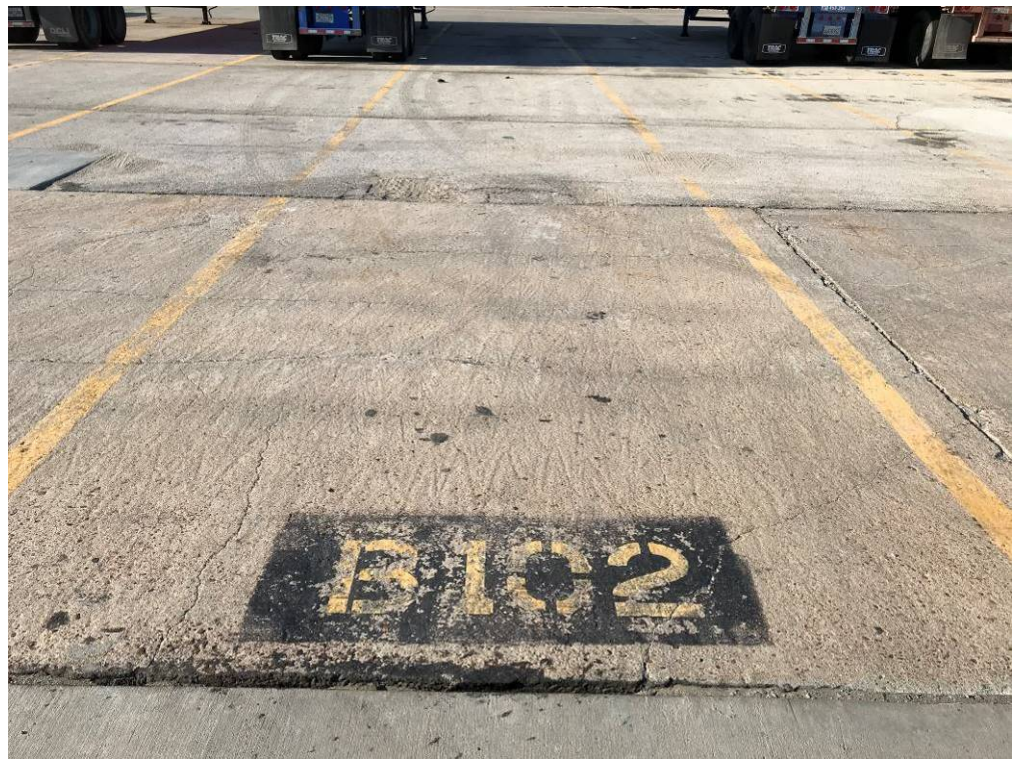
Photo No.: 5	Date: 11/06/2019
------------------------	----------------------------

Description:
Slot B102, no tar-like material seeps observed, looking north.

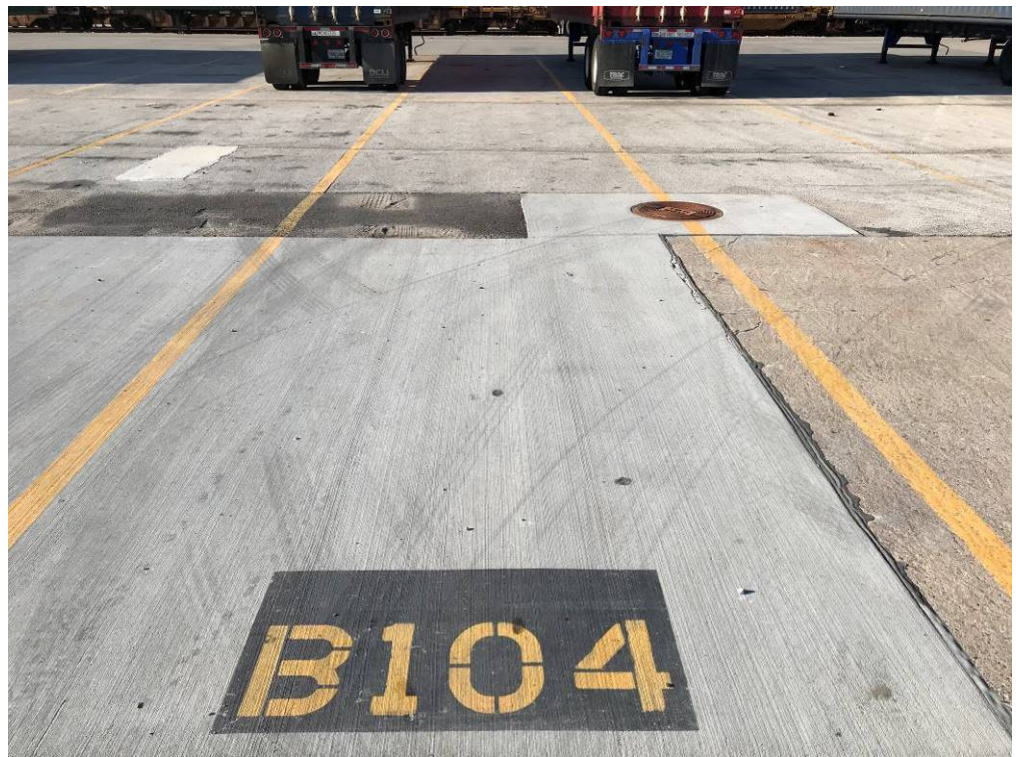
Photo No.: 6	Date: 11/06/2019
------------------------	----------------------------

Description:
Slot B104, view of NAPL Collection System (Sump 103/104 in foreground). No tar-like material seeps observed, looking north.

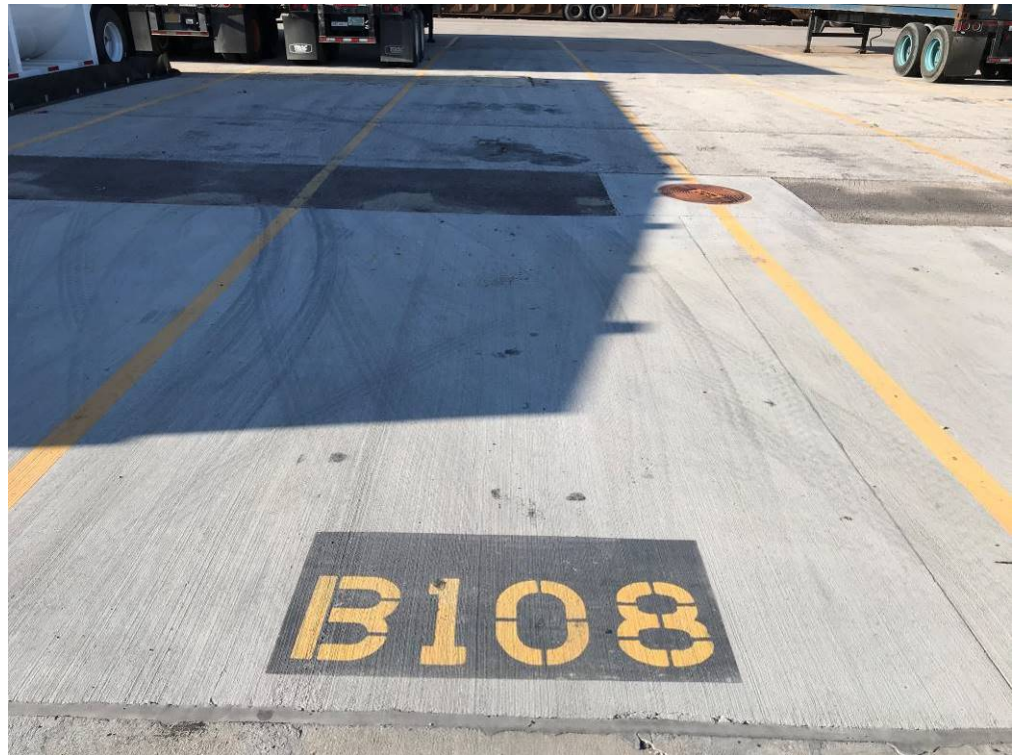
Photo No.
7

Slot B108, view of NAPL Collection System (Sump 107/108 in foreground). No tar-like material seeps observed, looking north.

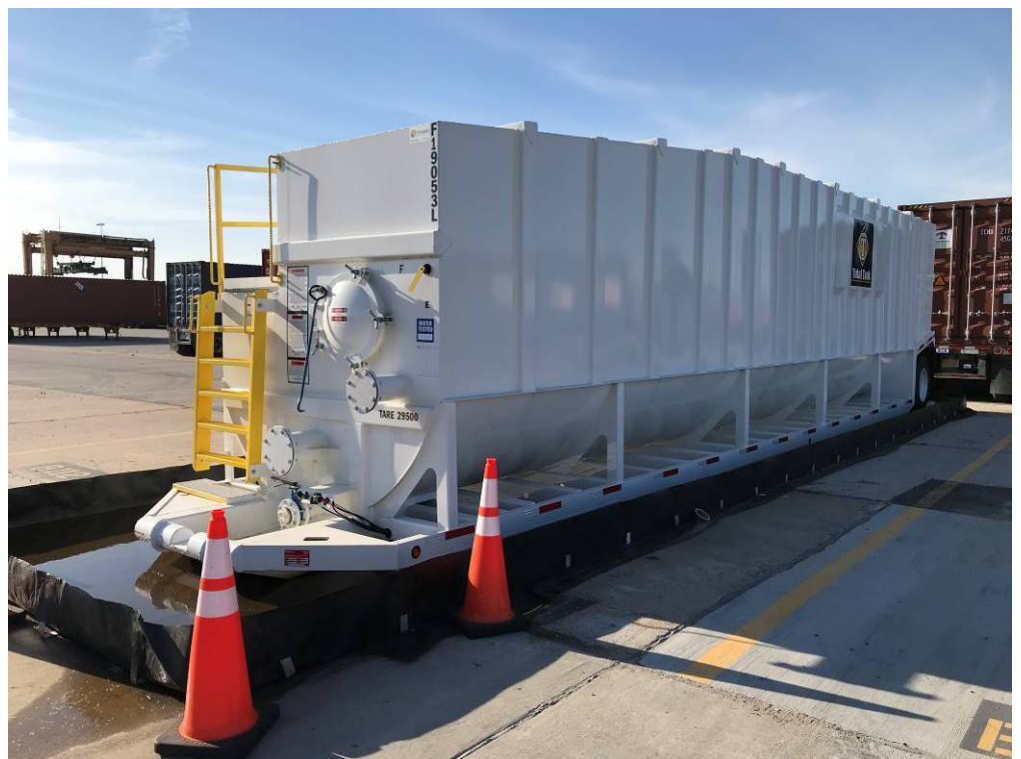
Photo No.
8

Frac tank for storage of pumped down water from NAPL Collection Sumps (in Slot B110), some stormwater noted in secondary containment, looking northwest.

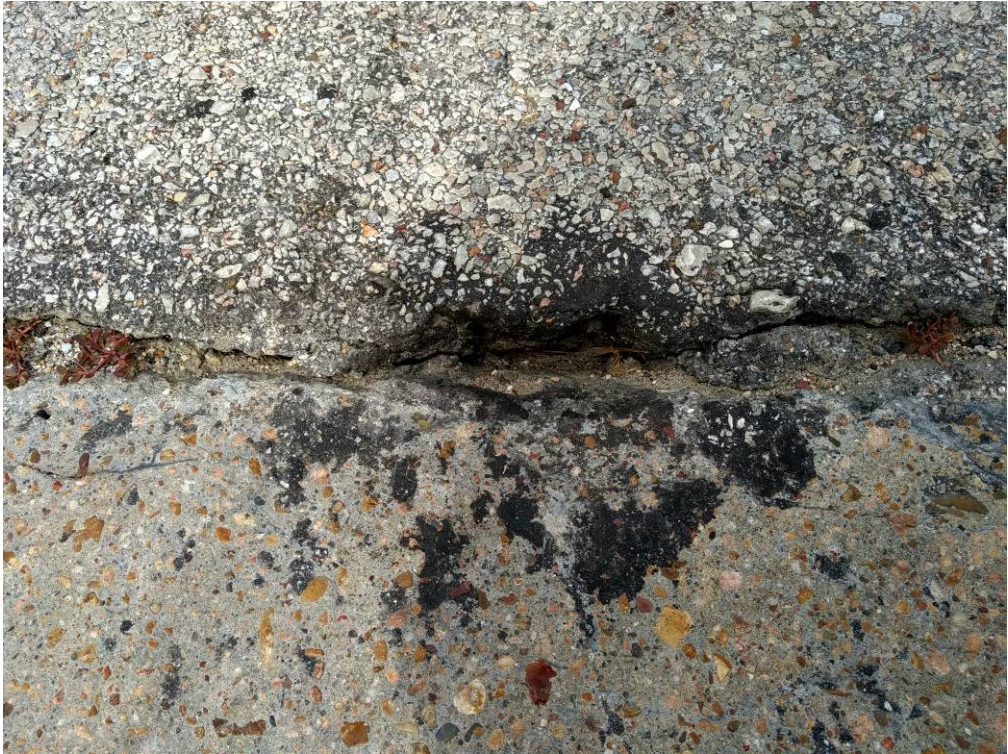
Description: Slot B013, no tar-like material seeps observed, looking north.			
Photo No.: 10	Date: 11/13/2019

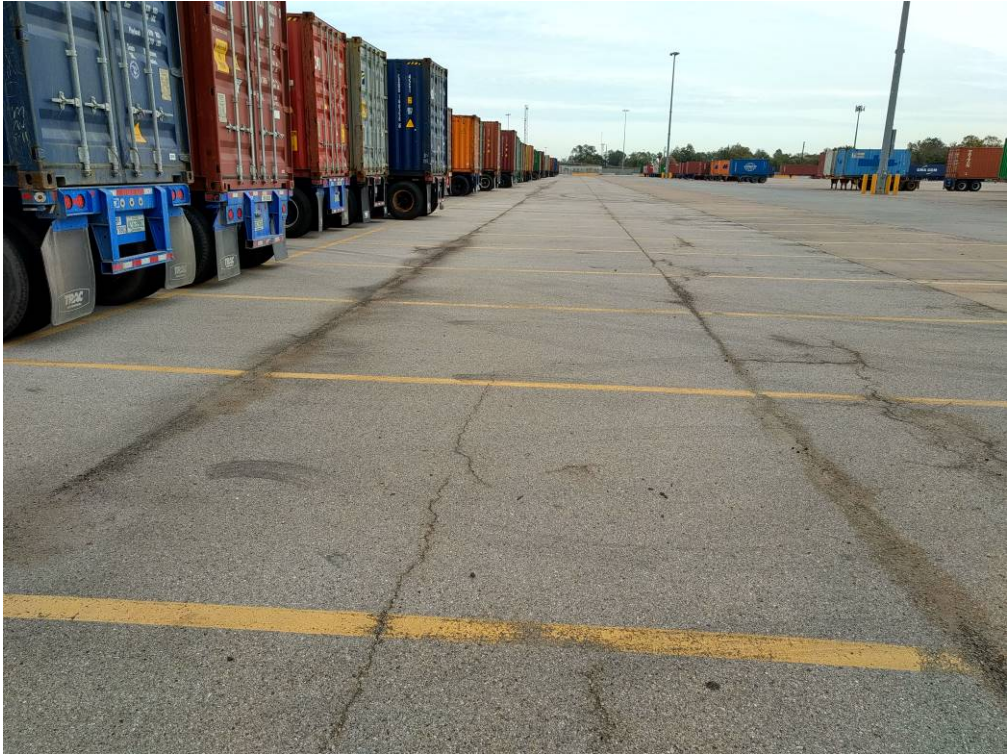
Description: Slot B094, looking east. Residual staining along joint running east-west. No seep water noted.

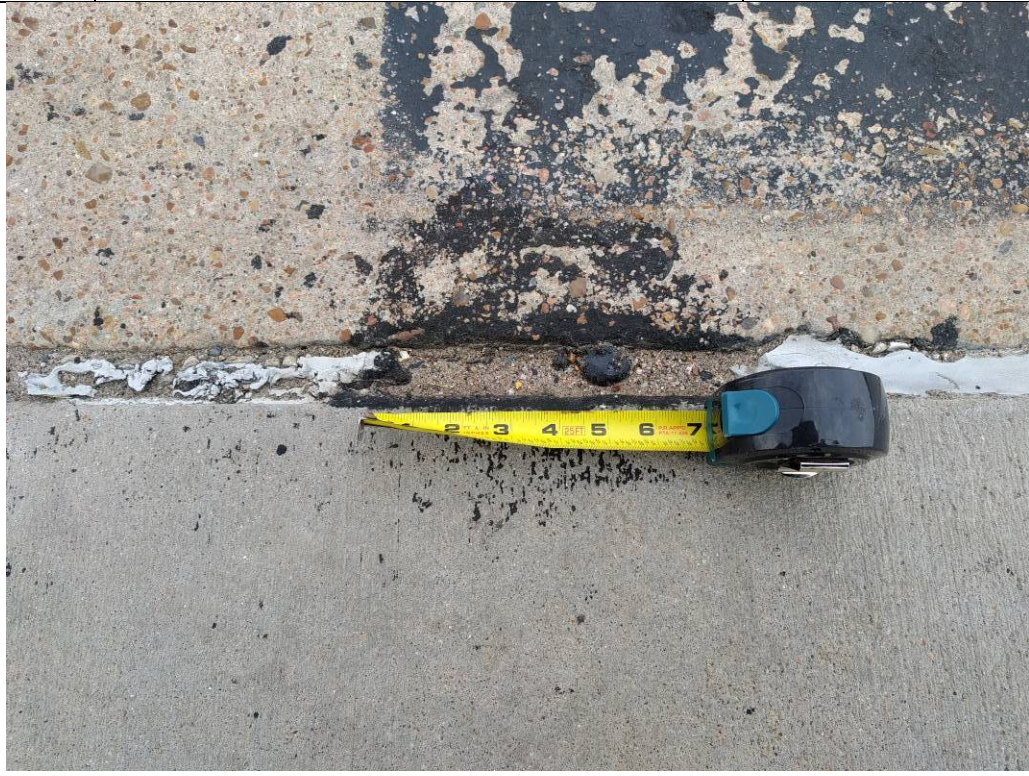
Photo No. 11	Date: 11/13/2019
------------------------	----------------------------

- For areas outside the NAPL Collection System, very small amounts of tar-like material were noted near or within stalls B096 and B101 where previous seeps have been observed. The amount of the tar-like material seeping has significantly decreased over the past month. Less than 0.1 gallons of the tar-like material was recovered during November.
- There were no water seeps noted in the Englewood Intermodal Yard area during the weekly inspections in November, similar to the September and October 2019 inspections.

Slot B096, very small amount of tar-like material seeping at joint. Material was removed.

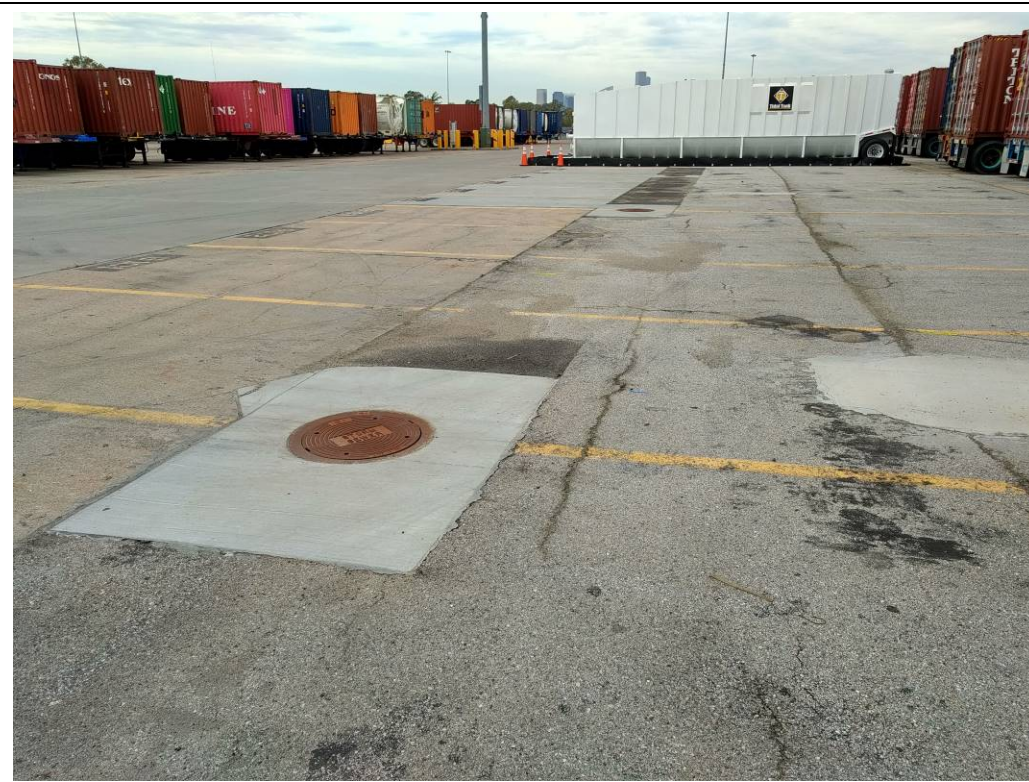
Photo No. 12	Date: 11/13/2019
------------------------	----------------------------

Slot B098, looking west. No tar-like seeps noted within the NAPL Collection System area, Sump B099/B100 left of center of photo.

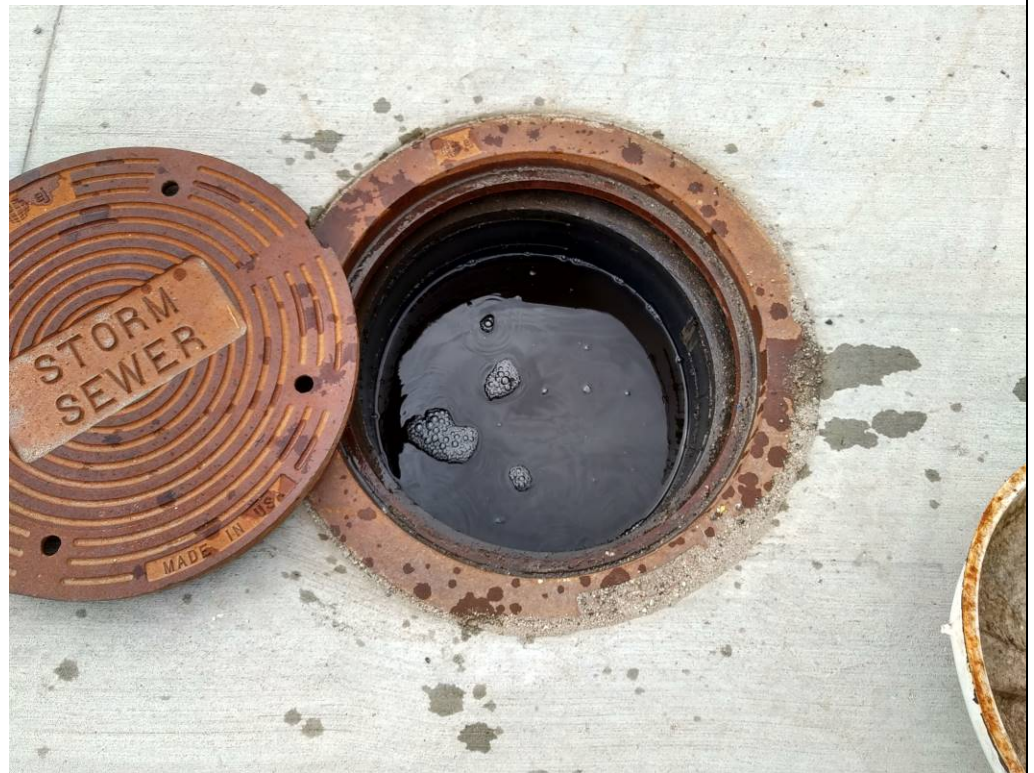
Photo No.
13

Sump B099/B100, approx. 7 inches of freeboard in sump, no sheen or odors noted.

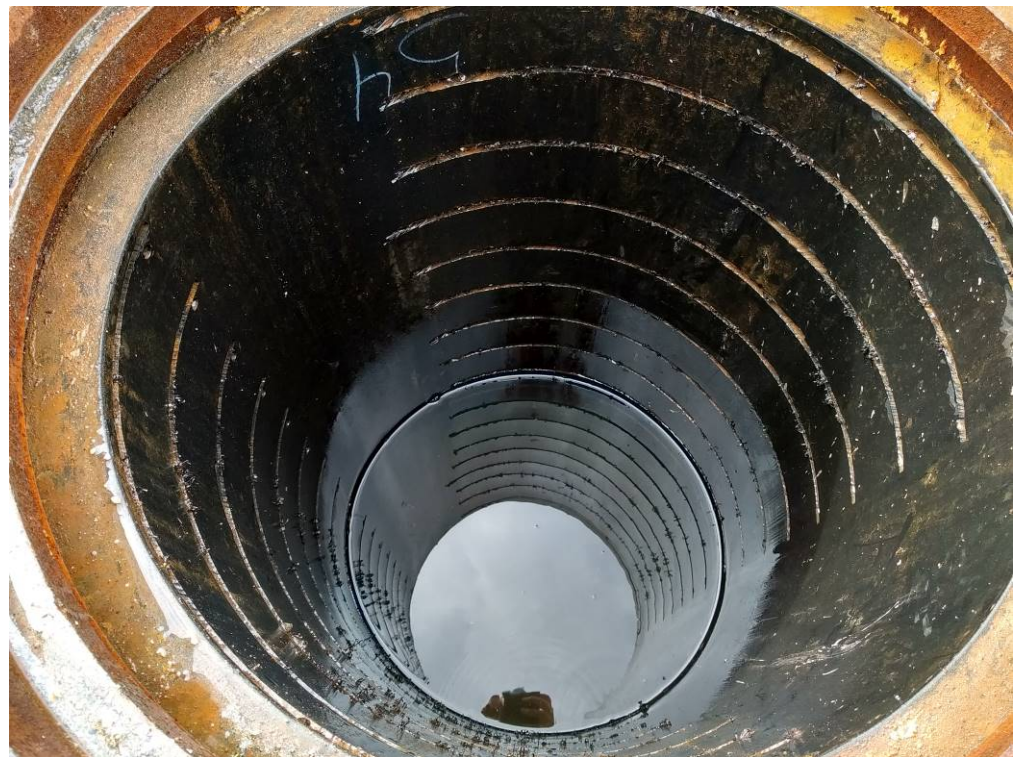
Photo No.
14

- No significant amount of NAPL has been visually observed within NAPL collection Sump 1 (B099/B100 slots) or Sump 2 (B103/B104 slots). A small amount of dense NAPL (DNAPL) appearing as a tar-like substance was recovered from Sump 3 (B107/B108 slots) on November 13, 2019. Less than 0.1 gallons were recovered.
- Water continues to collect in the NAPL collection sumps. Water tends to collect more rapidly in Sump 1 compared to Sumps 2 or 3 following pump down events. No pump downs of the sumps were conducted in November. The previous pump down was conducted on October 29, 2019.

Sump B107/B108, approx. 29 inches of freeboard in sump, no sheen or odors noted. However, small amount of tar-like material removed from bottom of sump.

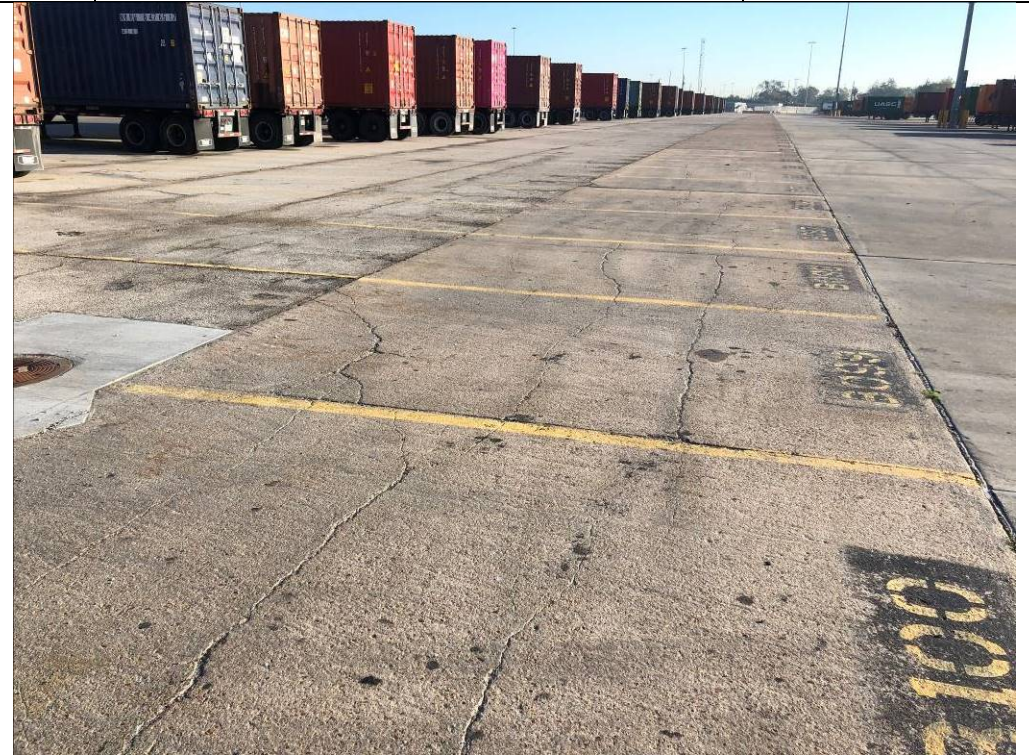
Photo No. 15	Date: 11/19/2019
-------------------------------	----------------------------

Slots B100-B094, looking east, no tar-like material seeps noted NAPL observed

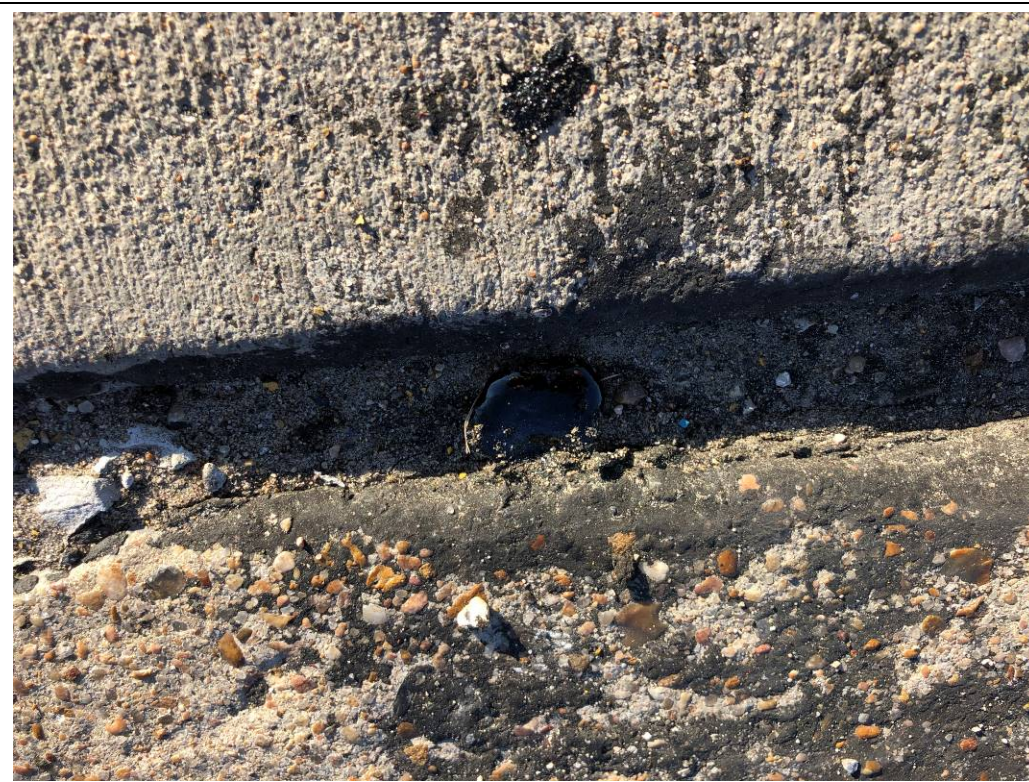
Photo No. 16	Date: 11/19/2019
-------------------------------	----------------------------

Slot B096, very small amount of tar-like material seeping at joint, material was removed.

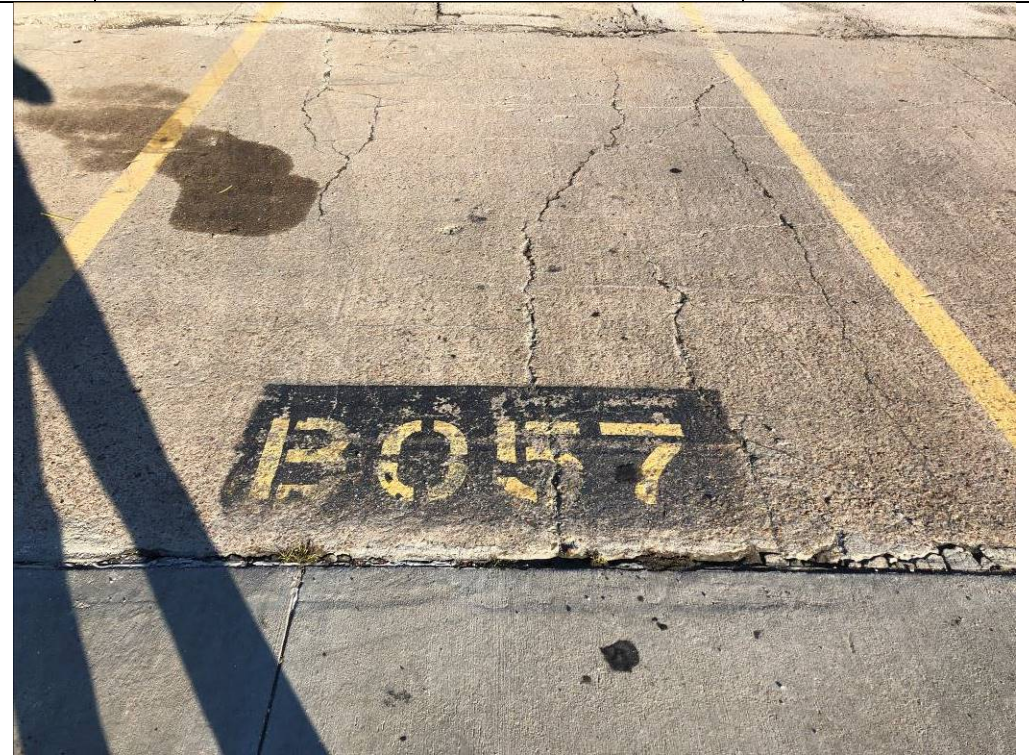
Photo No.: 17	Date: 11/19/2019
-------------------------	----------------------------

Slot B057, no tar-like material seeps observed, looking north.

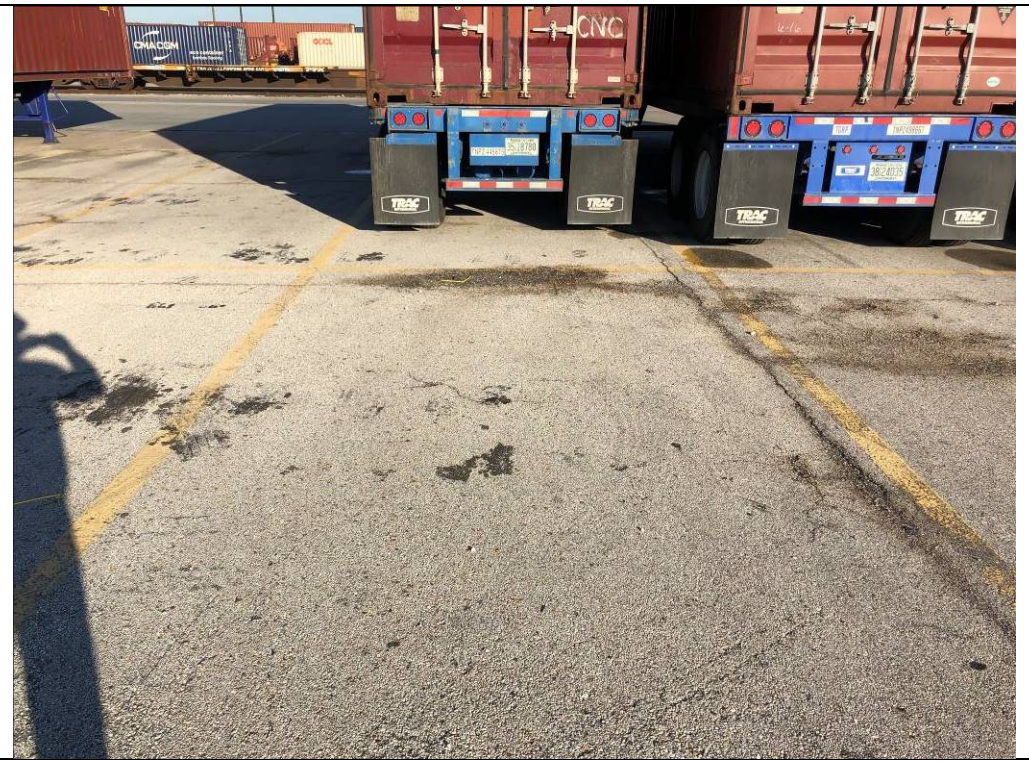
Photo No.: 18	Date: 11/19/2019
-------------------------	----------------------------

Slot B099, no tar-like material seeps observed, looking north.

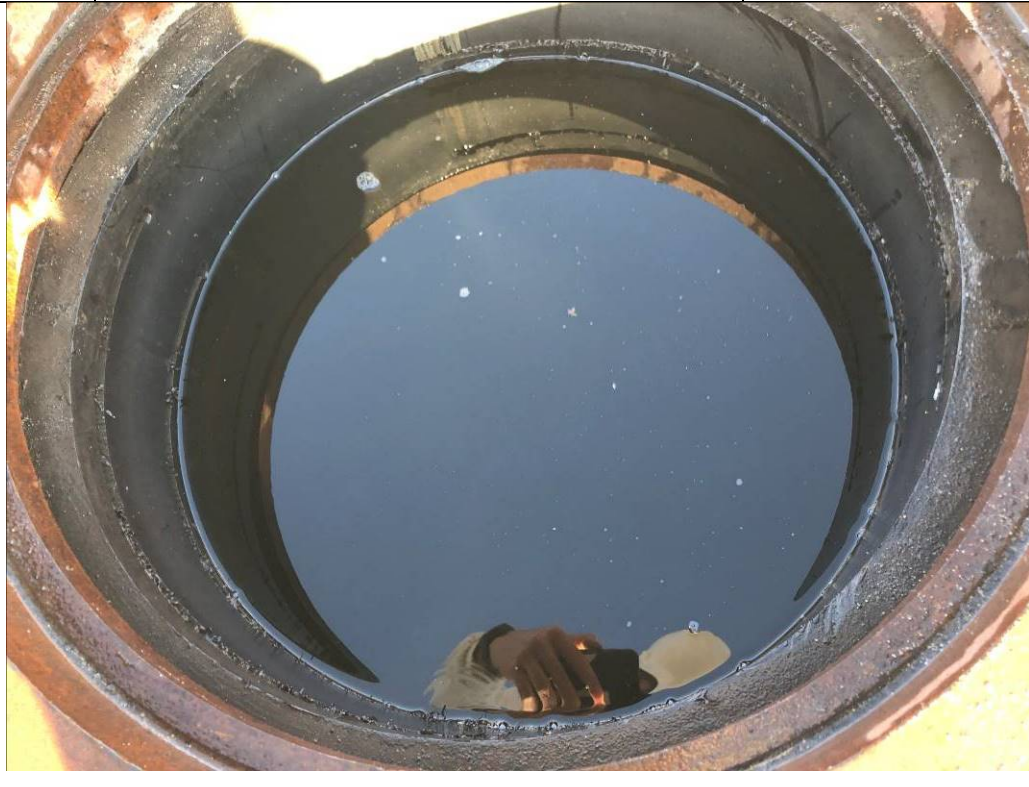
Photo No. 19	Date: 11/19/2019
-------------------------------	----------------------------

Sump B099/B100, approx. 4 inches of freeboard in sump, no sheen or odors noted

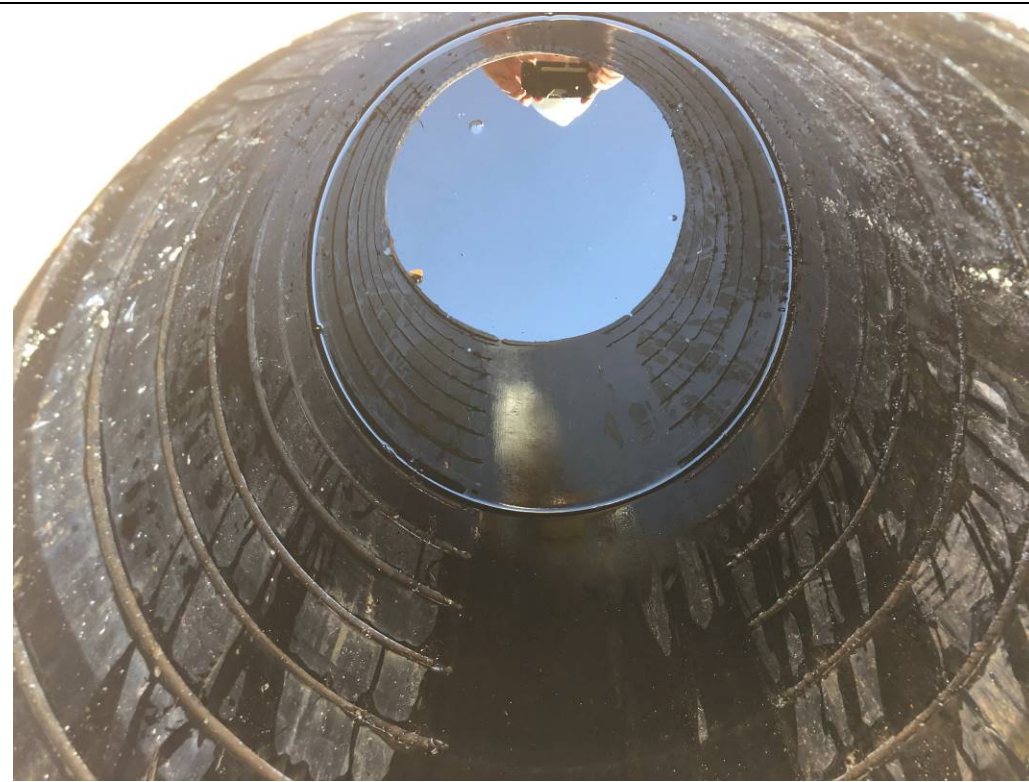
Photo No. 20	Date: 11/19/2019
-------------------------------	----------------------------

Sump B103/B104, approx. 26 inches of freeboard in sump, no sheen or odors noted.
