April 3, 2020

Project No. 19119232

**RE: MONTHLY STATUS UPDATE – ENGLEWOOD INTERMODAL YARD – NAPL COLLECTION SYSTEM/CONCRETE CAP REPAIRS  
UNION PACIFIC RAILROAD HOUSTON WOOD PRESERVING WORKS FACILITY  
4910 LIBERTY ROAD FACILITY, HOUSTON, TEXAS  
POST-CLOSURE CARE PERMIT NO. HW-50343; INDUSTRIAL SWR NO. 31547**

# PHOTOGRAPHIC LOG

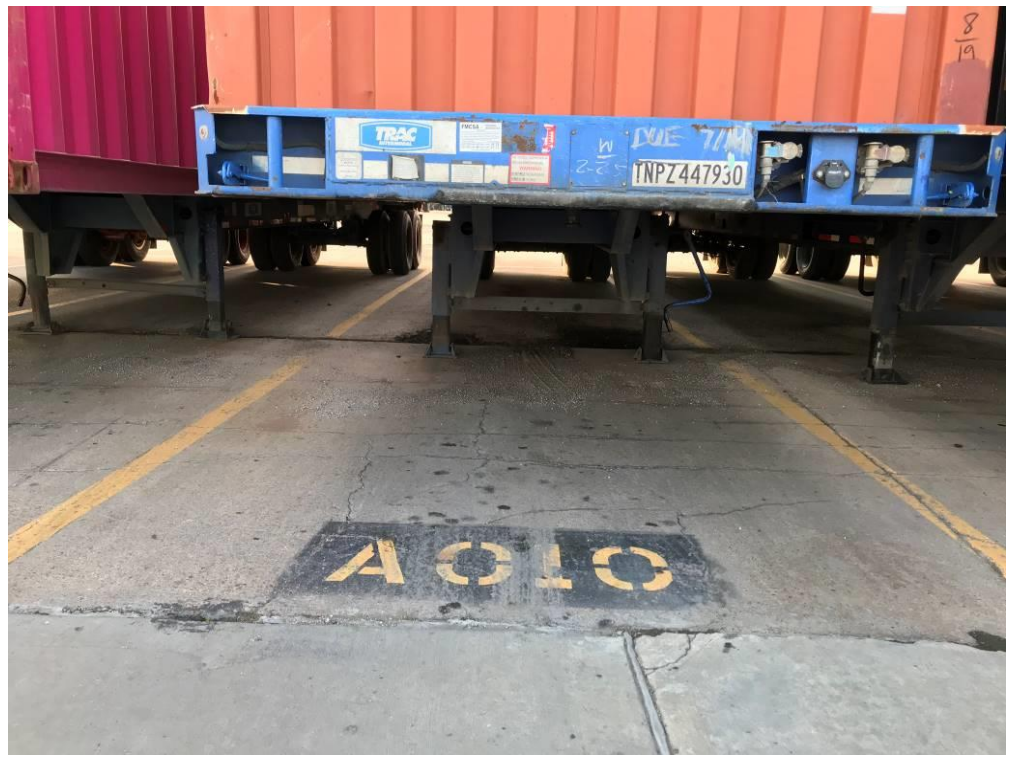
<b>Photo No.</b> 1	<b>Date:</b> 03/06/2020
<b>Description:</b>  Slot A010, no tar-like material seeps observed, looking south.  Lat: 29.7855833, Long: -95.318375

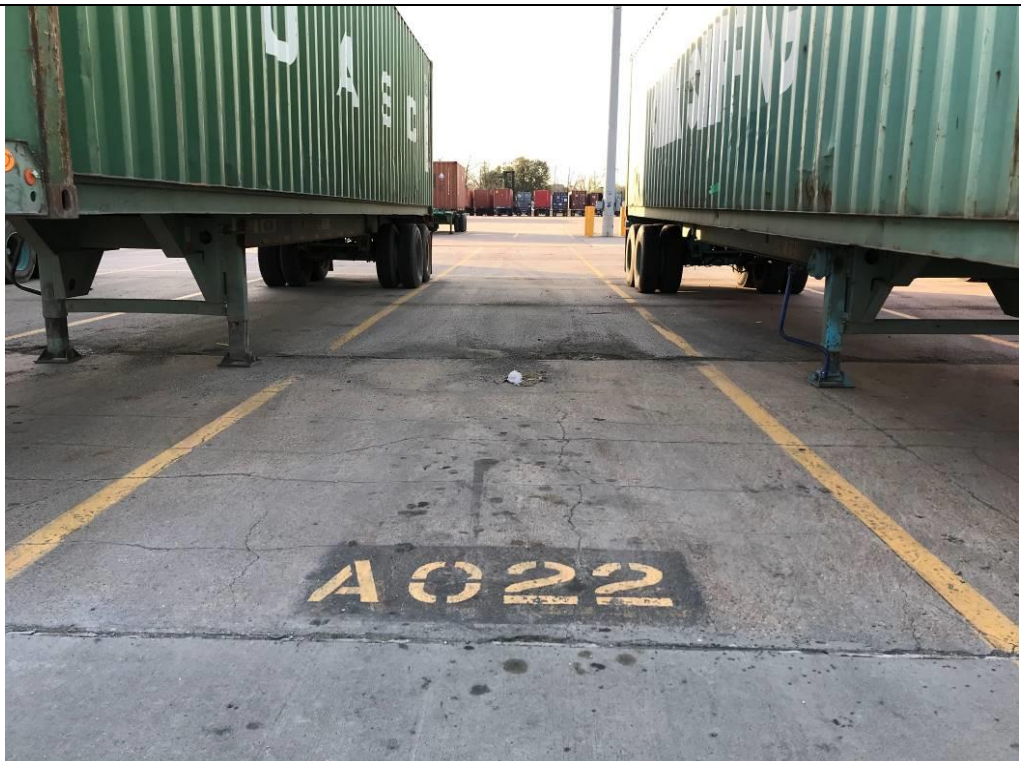
<b>Photo No.</b> 2	<b>Date:</b> 03/06/2020
-----------------------	----------------------------

<b>Description:</b>  Slot A022, no tar-like material seeps observed, looking south.  Lat: 29.785382 Long: -95.318678	
---	--

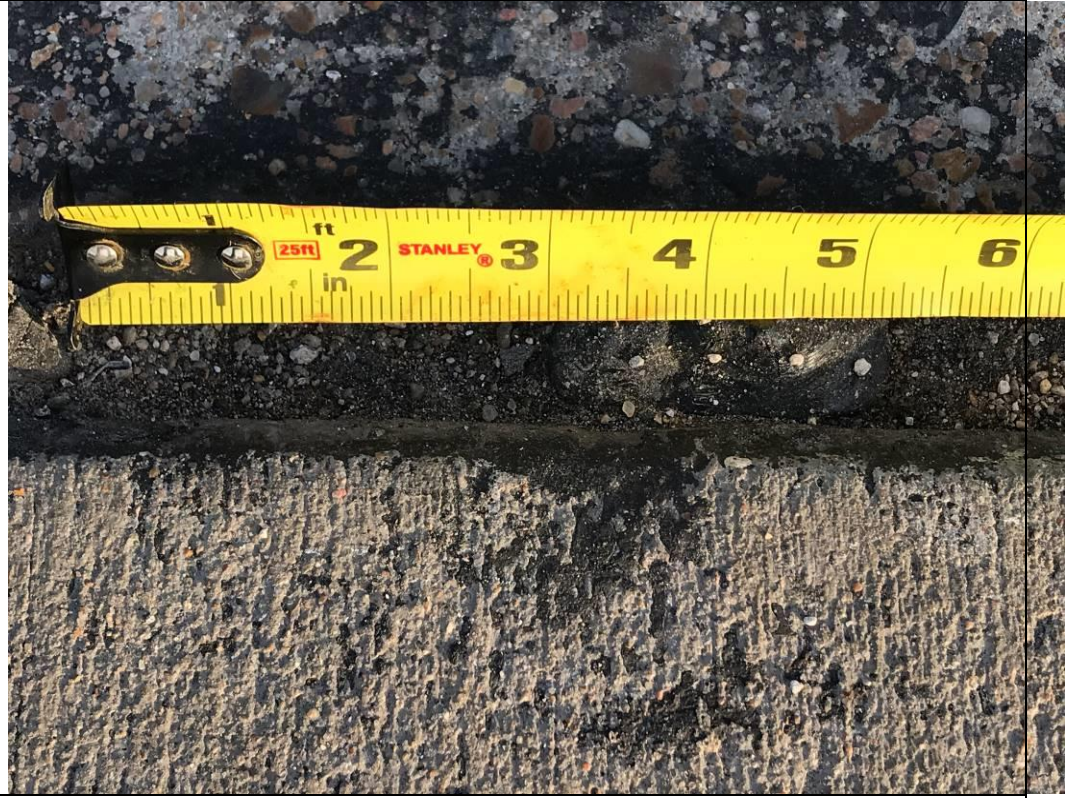
<b>Photo No.</b> 3	<b>Date:</b> 03/06/2020
<b>Description:</b>  Slot B096, very small amount of tar-like material seeping at joint, material was removed.  Lat: 29.7842528 Long: - 95.3206250

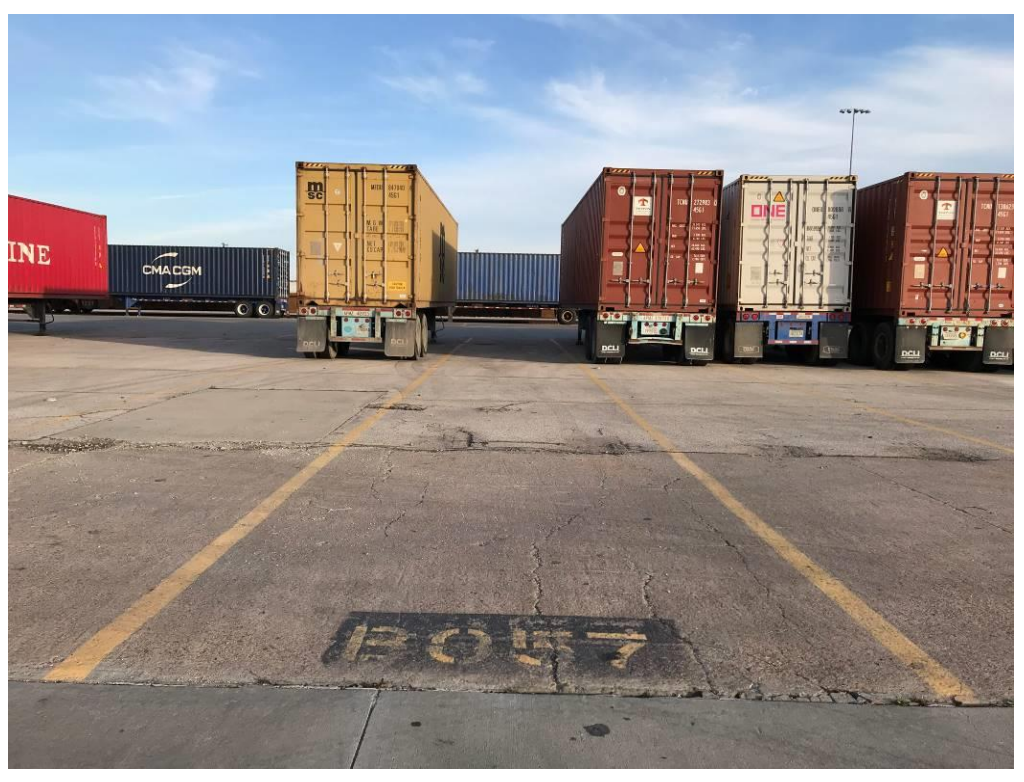
<b>Photo No.</b> 4	<b>Date:</b> 03/06/2020
<b>Description:</b>  Slot B057, no tar-like material seeps observed.  Lat: 29.7847472 Long: - 95.3195417

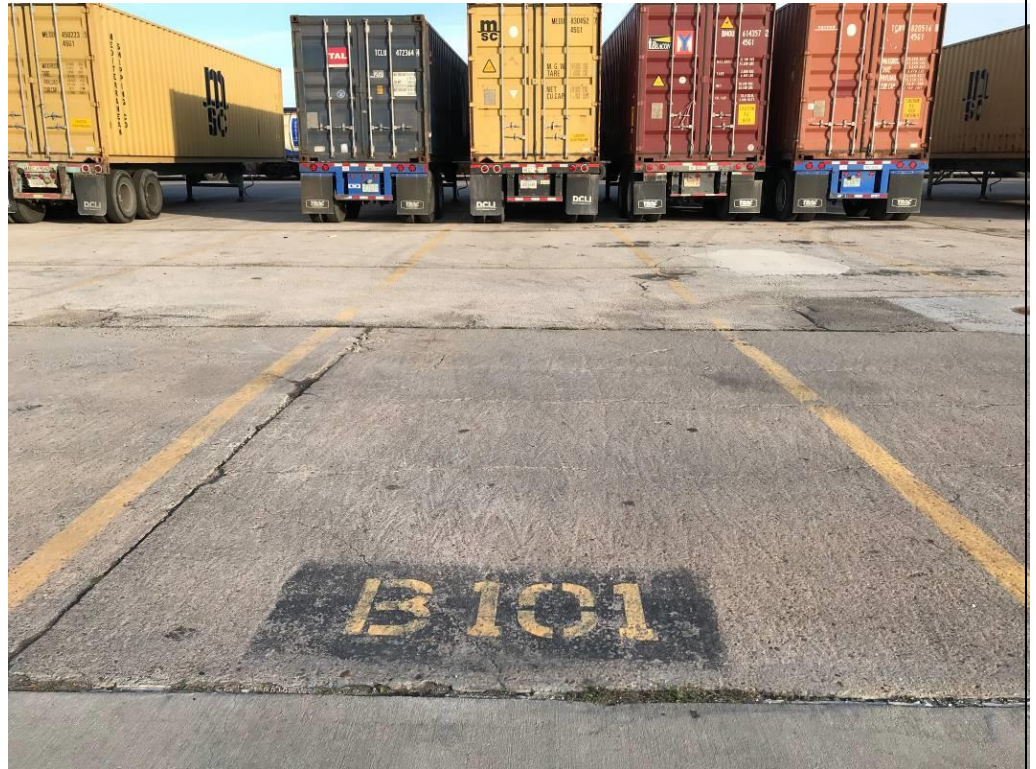
**Photo No.**  
5

Slot B101, no tar-like material seeping observed, looking northeast.

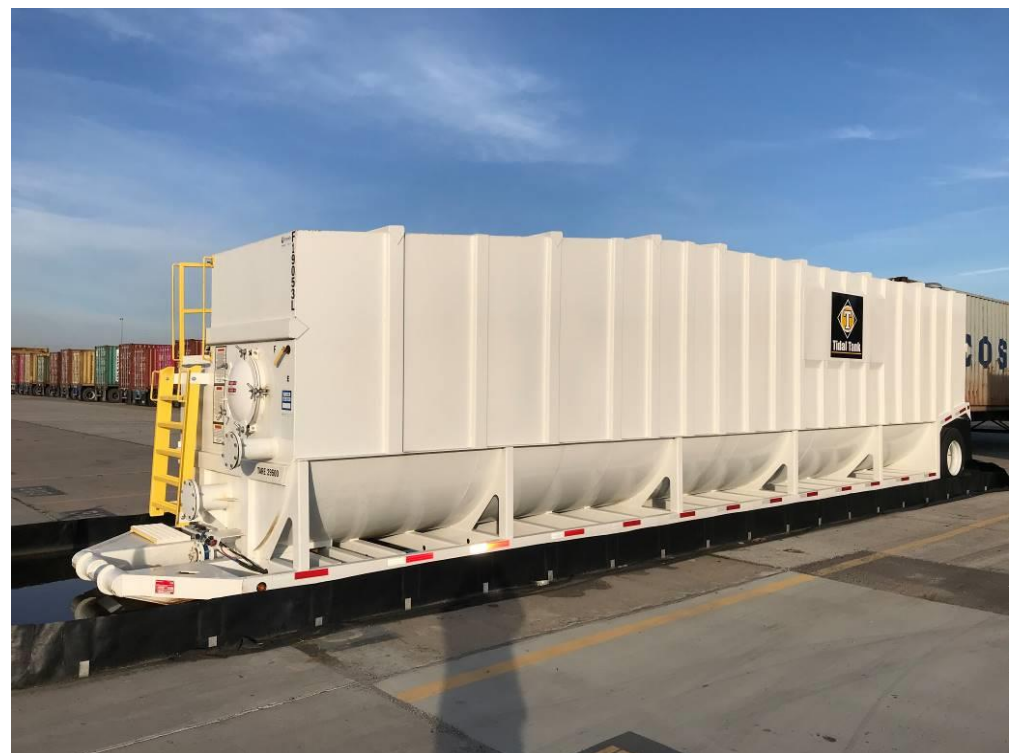
**Photo No.**  
6

Frac tank for storage of pumped down water from NAPL Collection Sumps (in Slot B110), looking northwest.

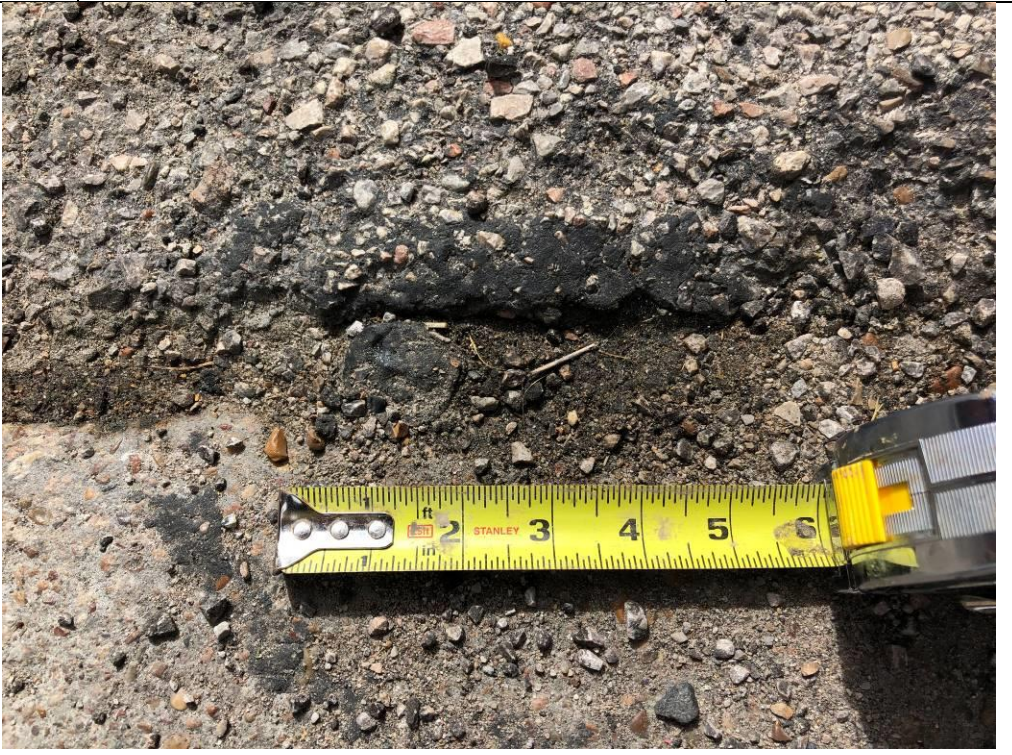
<b>Photo No.</b> 7	<b>Date:</b> 03/11/2020
<b>Description:</b>  Slot A022, very small amount of tar-like material seeping at joint, material was removed.  Lat: 29.785382 Long: -95.318678

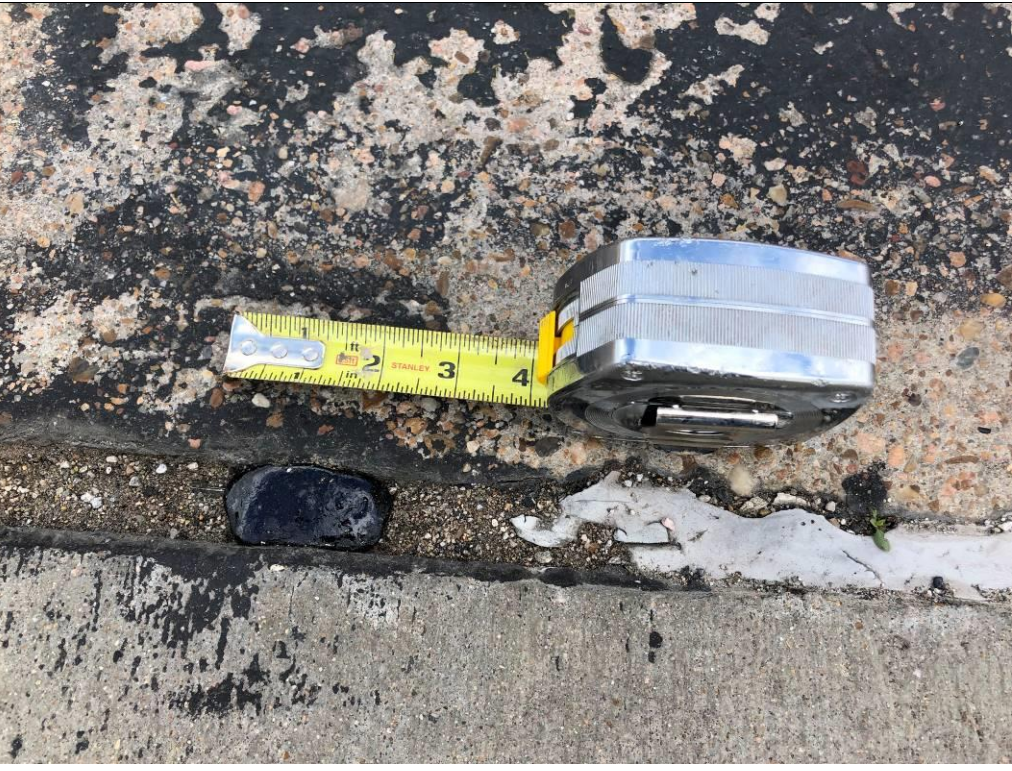
<b>Photo No.</b> 8	<b>Date:</b> 03/11/2020
<b>Description:</b>  Slot B096, very small amount of tar-like material seeping at joint, material was removed.  Lat: 29.7842528 Long: -95.3206250

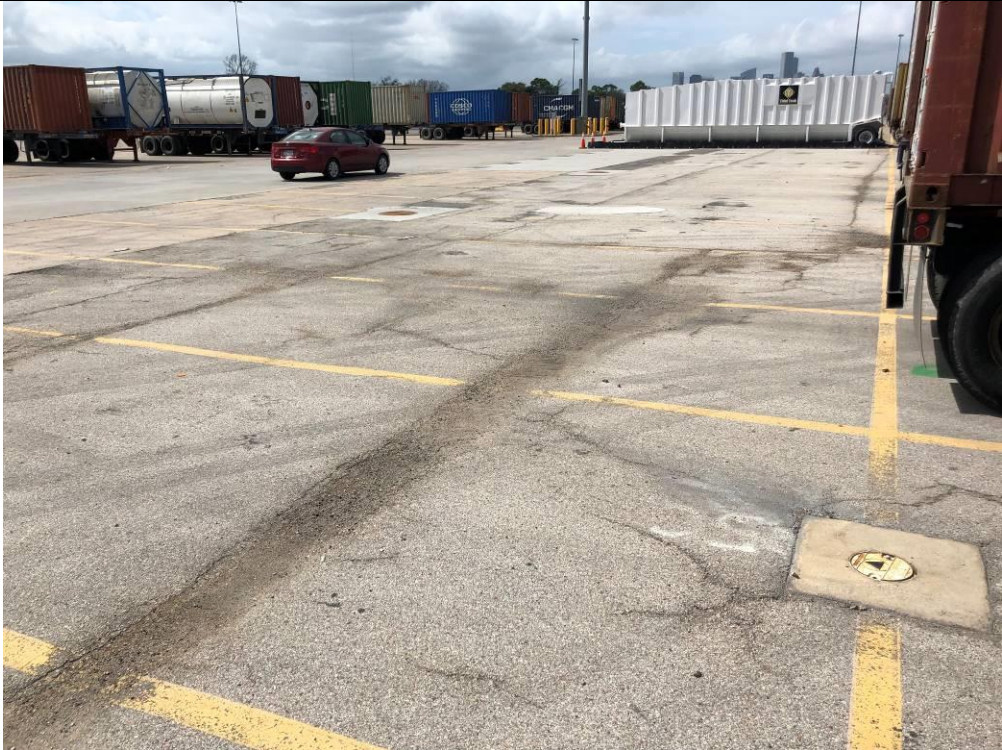
<b>Description:</b>  Slots B096-B110, NAPL Collection System and frac tank in the background, looking southwest.  Lat: 29.785217 Long: - 95.318261			
<b>Photo No.:</b> 10	<b>Date:</b> 03/11/2020

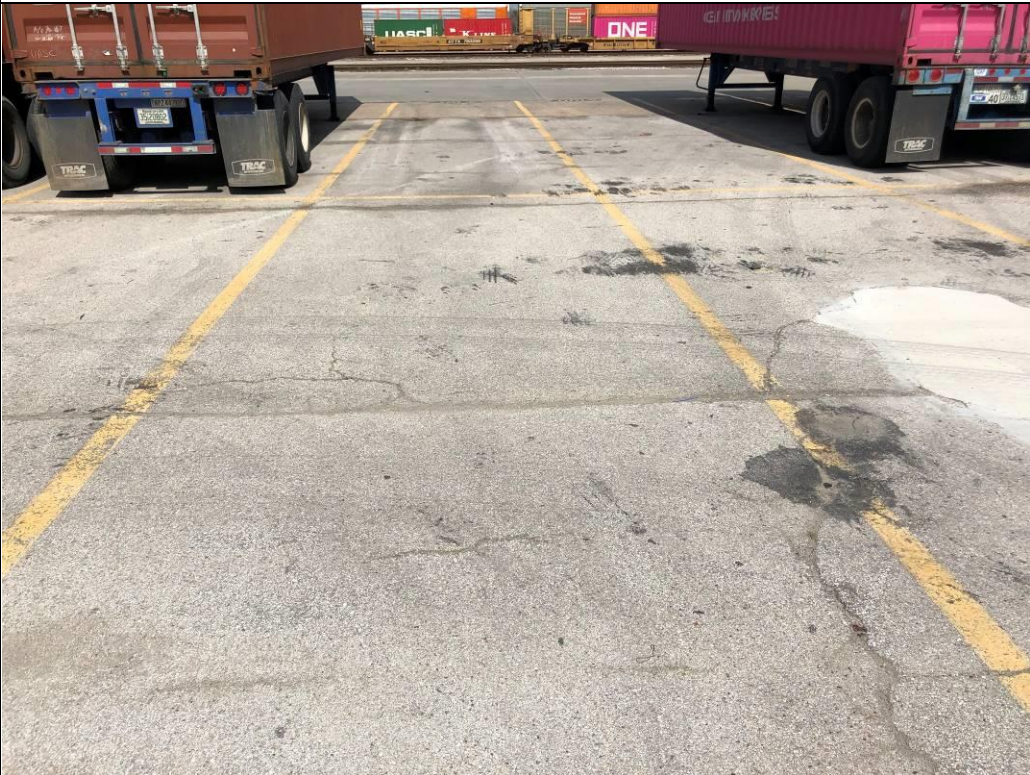
<b>Description:</b>  Slot B101, very small amount of tar-like material seeping at crack (eastern side of the slot), material was removed, looking north.  Lat: 29.784275 Long: - 95.320813

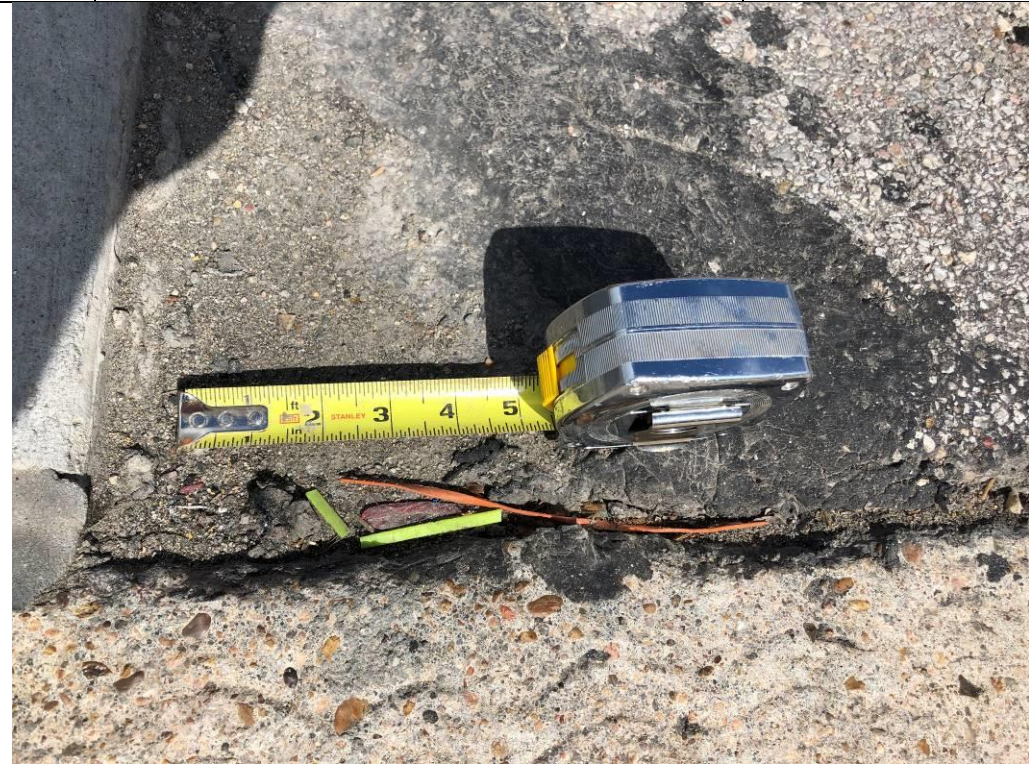
<b>Photo No.</b> 11	<b>Date:</b> 03/11/2020
------------------------	----------------------------

- A small amount of tar-like material was noted adjacent to the NAPL Collection System at Slot B103 where a previous seep has been noted. No other seeps were noted around the NAPL Collection Systems. For areas outside the NAPL Collection System, very small amounts of tar-like material were noted in stalls A021, B096, B101, B102, and B108 where previous seeps have been observed. The overall amount of the tar-like material seeping has started to increase over the past month as daily high temperatures have increased. Less than 0.2 gallons of the tar-like material was recovered during March 2020, most of which was recovered on March 27, 2020.
- Brown staining with a small amount of standing brown water was observed along asphalt joints and cracks in stalls A108-A111 and B013-B026 (Photographs 19 and 20) during the weekly inspections on March 27, 2020.

Slot B103, very small amount of tar-like material seeping at joint near the NAPL Collection System Sump 103/104, material was removed.

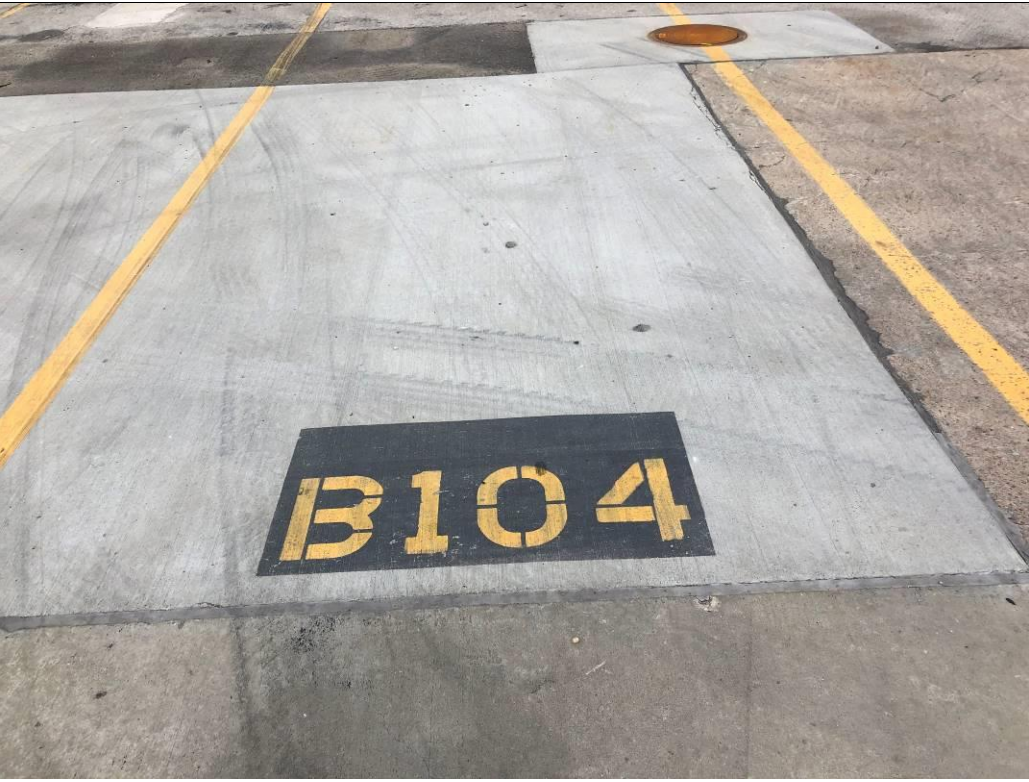
<b>Photo No.</b> 12	<b>Date:</b> 03/11/2020
------------------------	----------------------------

Slot B104, view of NAPL Collection System (Sump 103/104 in foreground). No tar-like material seeps observed, looking north.

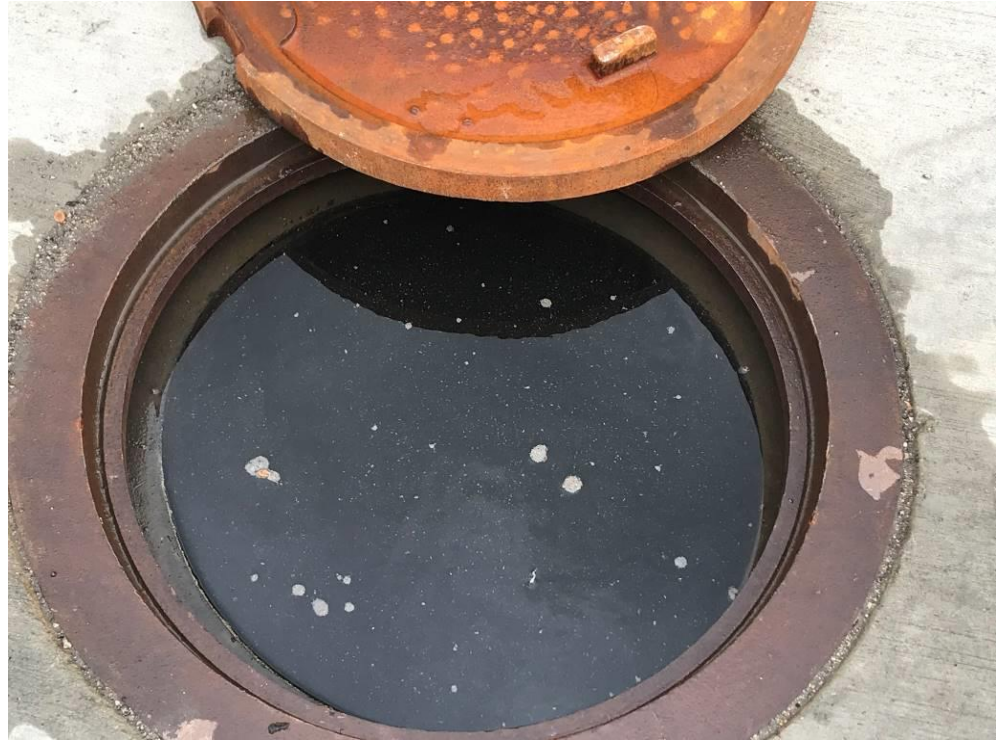
<b>Photo No.</b> <b>13</b>	<b>Date:</b> 03/18/2020
<b>Description:</b>  Sump B099/B100, 0 inches of freeboard in sump, no sheen or odors noted.  Lat: 29.7844000 Long: - 95.3205861

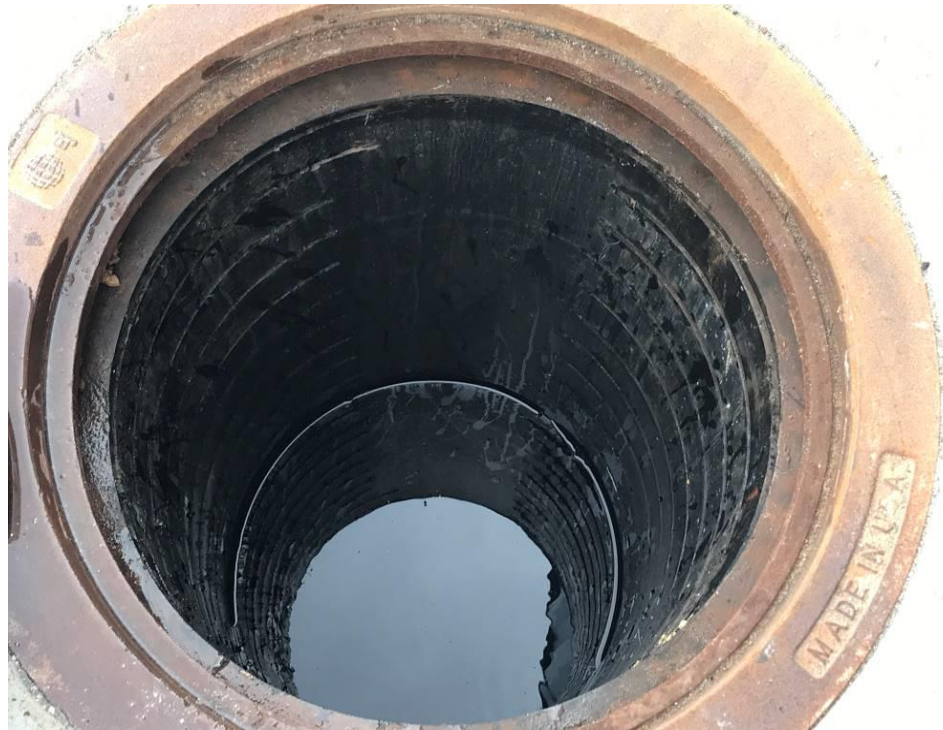
<b>Photo No.</b> <b>14</b>	<b>Date:</b> 03/18/2020
<b>Description:</b>  Sump B103/B104, 35.5 inches of freeboard in sump, no sheen or odors noted.  Lat: 29.7842861 Long: - 95.3208611

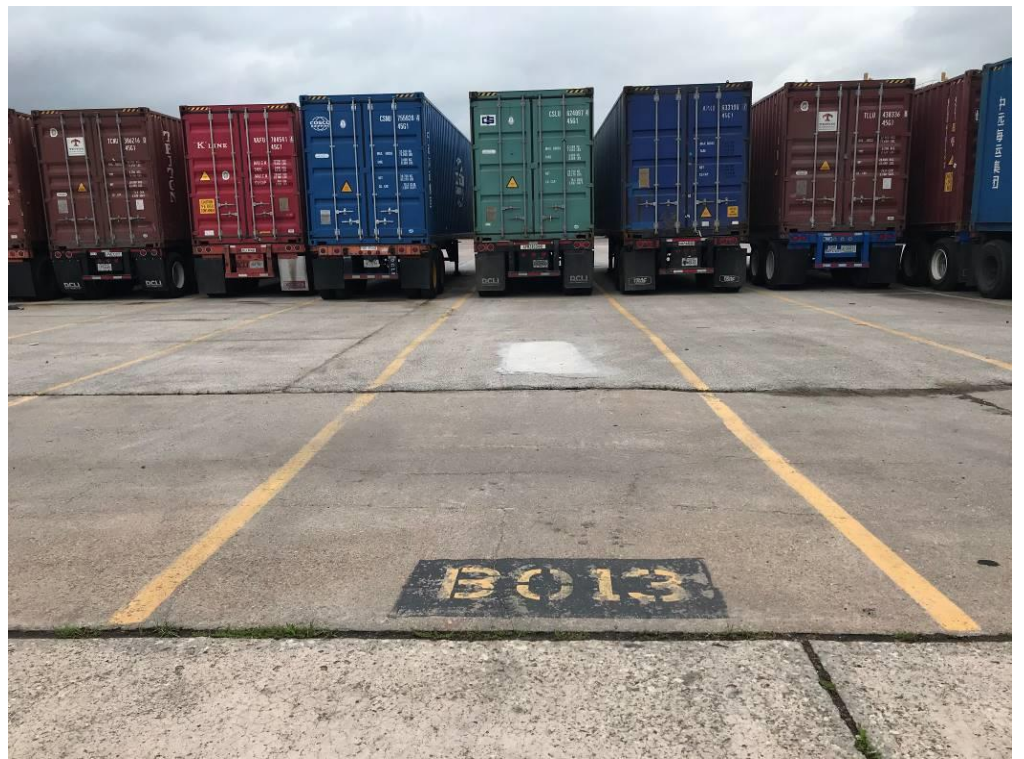
<b>Photo No.</b> <b>15</b>	<b>Date:</b> 03/18/2020
-------------------------------	----------------------------

Slot B013, no tar-like material seeps observed, looking north.

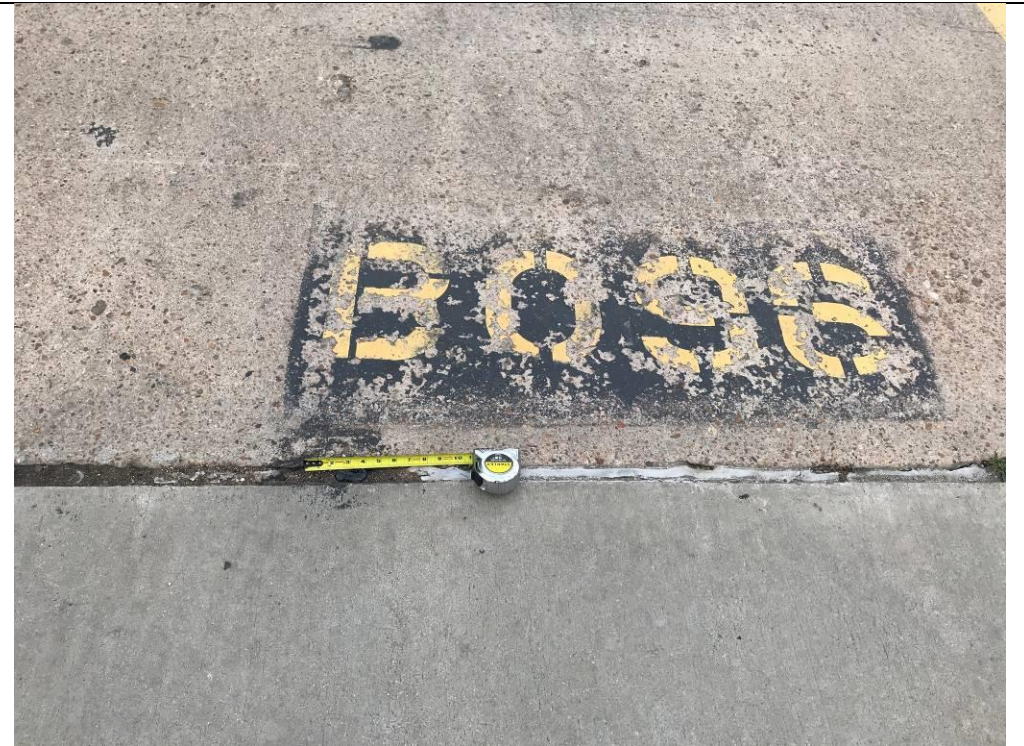
<b>Photo No.</b> <b>16</b>	<b>Date:</b> 03/18/2020
-------------------------------	----------------------------

Slot B096, very small amount of tar-like material seeping at joint, material was removed.

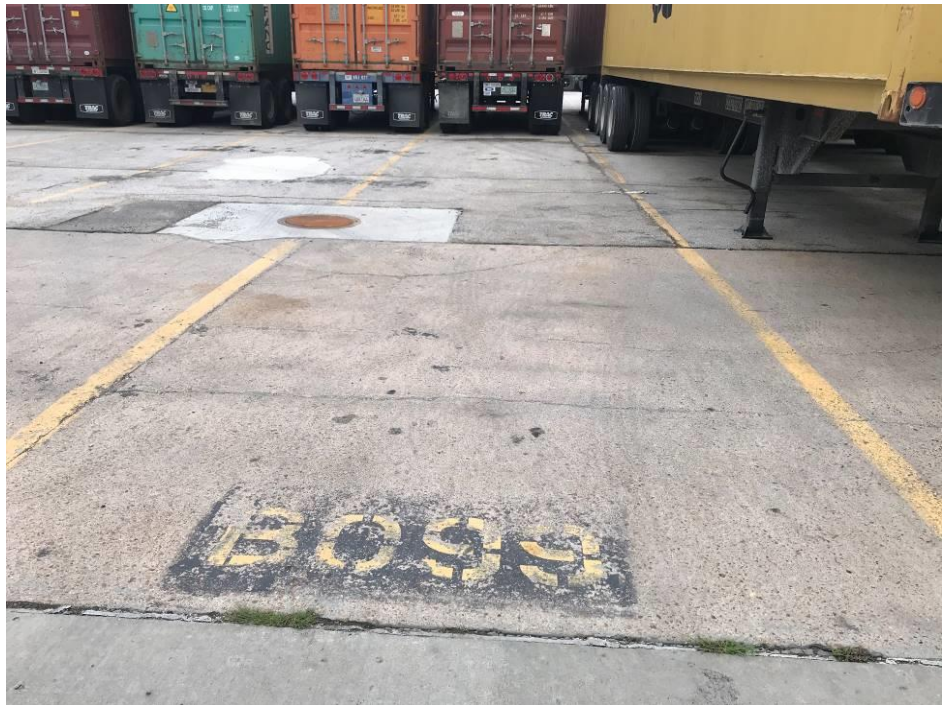
<b>Photo No.</b> 17	<b>Date:</b> 03/18/2020
<b>Description:</b>  Slot B099, view of NAPL Collection System (Sump 099/100 in background). No tar-like material seeps observed, looking north.  Lat: 29.7842472 Long: - 95.3206944

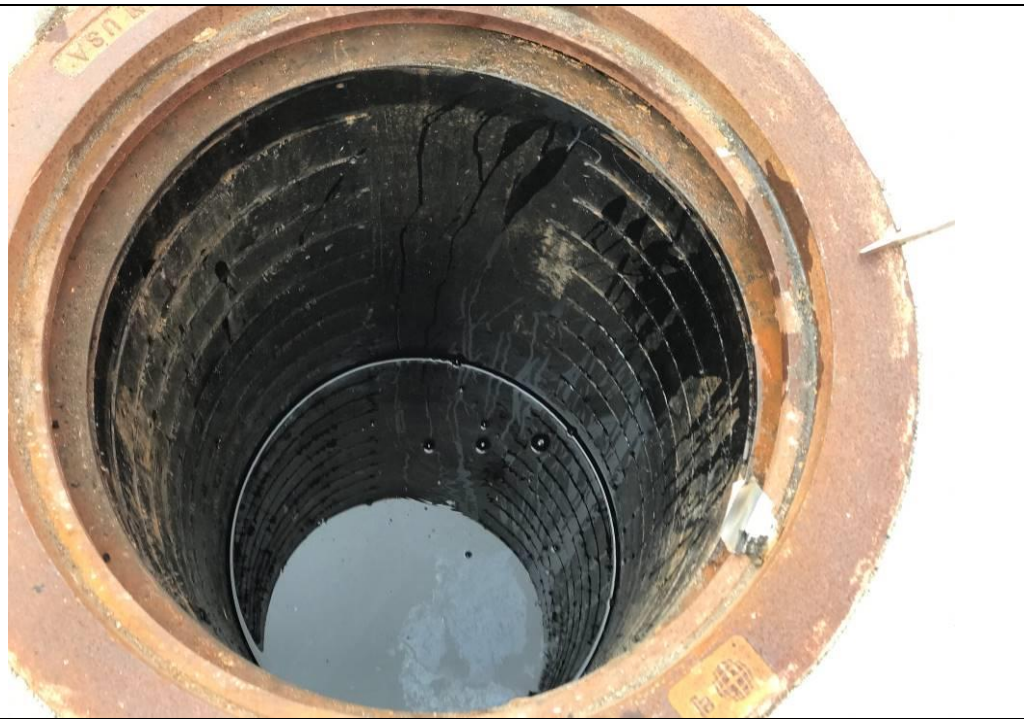
<b>Photo No.</b> 18	<b>Date:</b> 03/18/2020
------------------------	----------------------------

<b>Description:</b>  Sump B107/B108, approx. 35.5 inches of freeboard in sump, no sheen or odors noted. No tar-like material noted.  Lat: 29.7842861 Long: - 95.3208611	
--	--

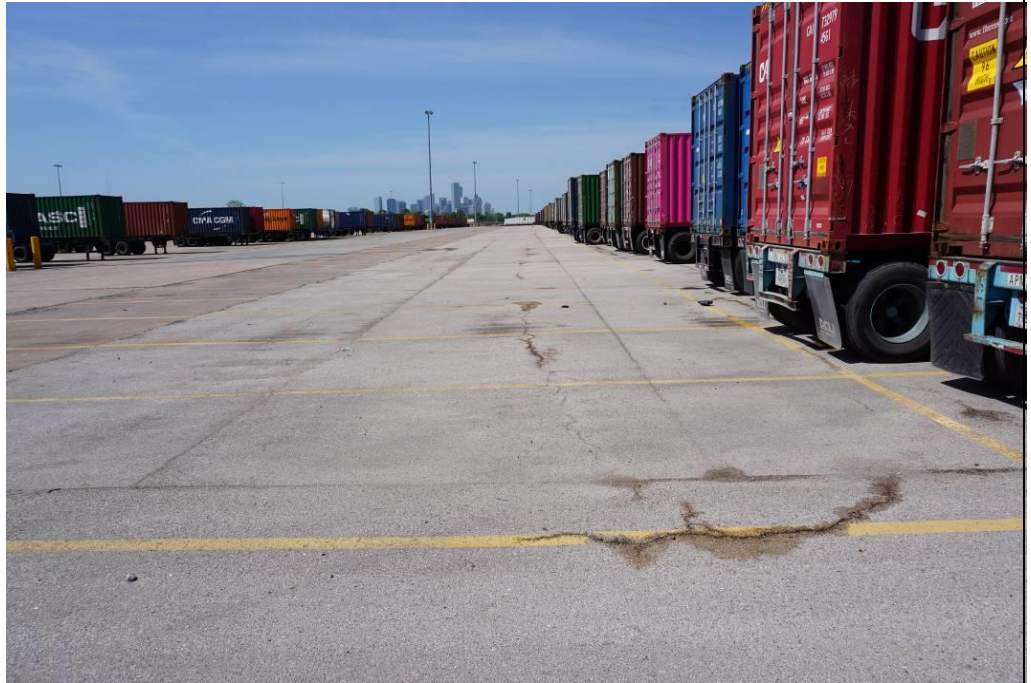
<b>Photo No.</b> <b>19</b>	<b>Date:</b> 03/27/2020
<b>Description:</b>  Slot B113-B026, brown staining and brown water observed in asphalt cracks, looking west.  Lat: 29.785217 Long: - 95.318261

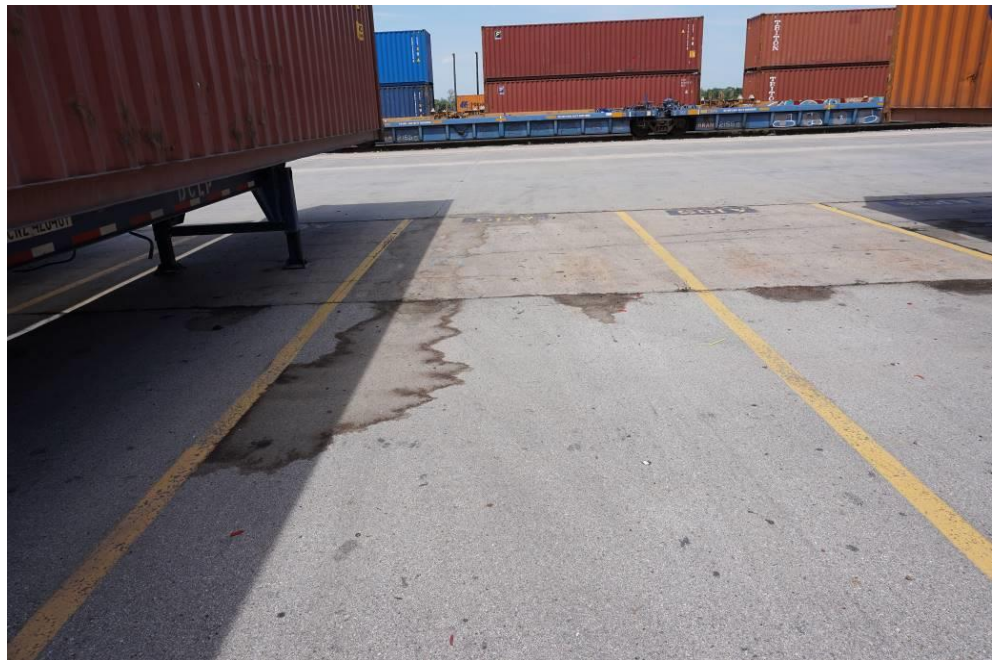
<b>Photo No.</b> <b>20</b>	<b>Date:</b> 03/27/2020
<b>Description:</b>  Slot A110, brown staining and brown water observed along asphalt joint, looking north.  Lat: 29.784304 Long: -95.321166

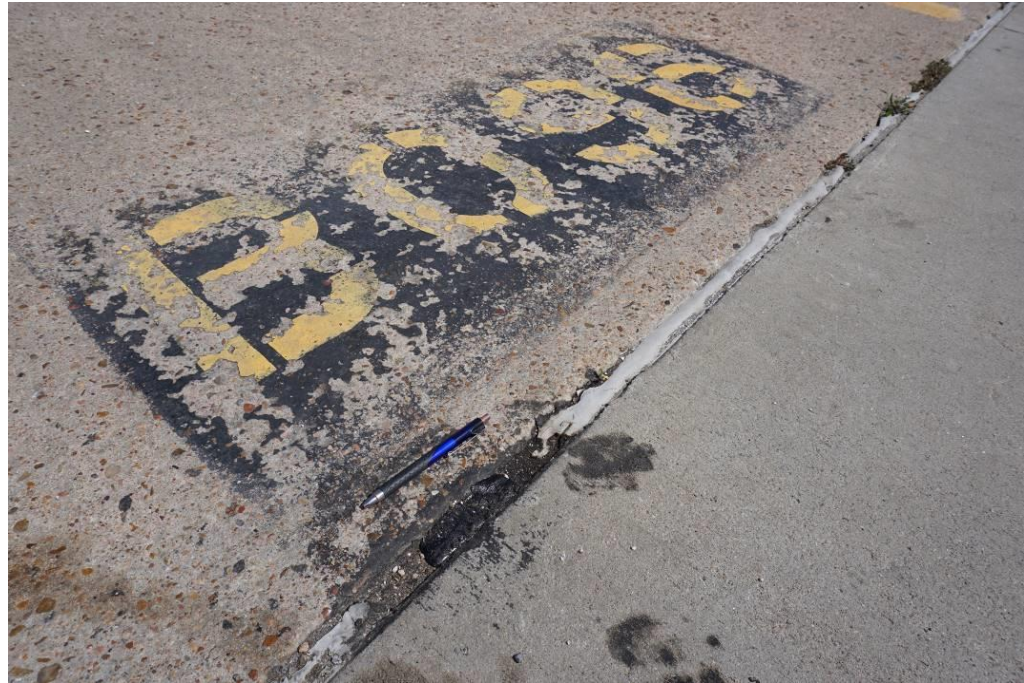
<b>Photo No.</b> <b>21</b>	<b>Date:</b> 03/27/2020
<b>Description</b>  Slot B096, small amount of tar-like material seeping at joint, material was removed.  Lat: 29.7842528 Long: - 95.3206250

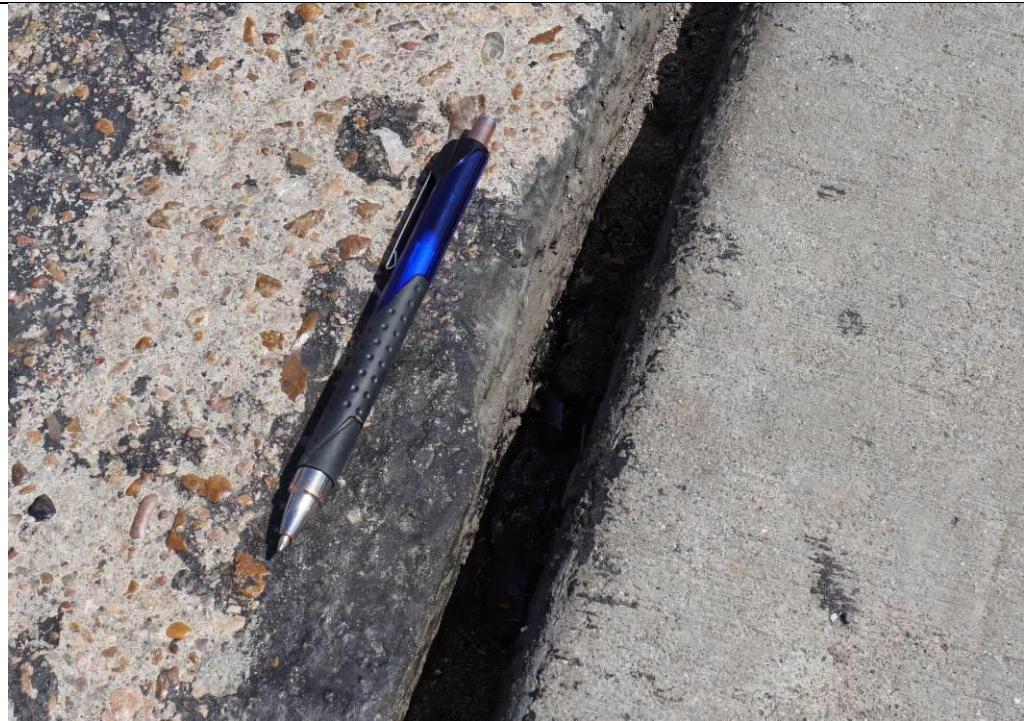
<b>Photo No.</b> <b>22</b>	<b>Date:</b> 03/27/2020
<b>Description:</b>  Slot B102, small amount of tar-like material seeping at joint, material was removed.  Lat: 29.7842203 Long: - 95.320827

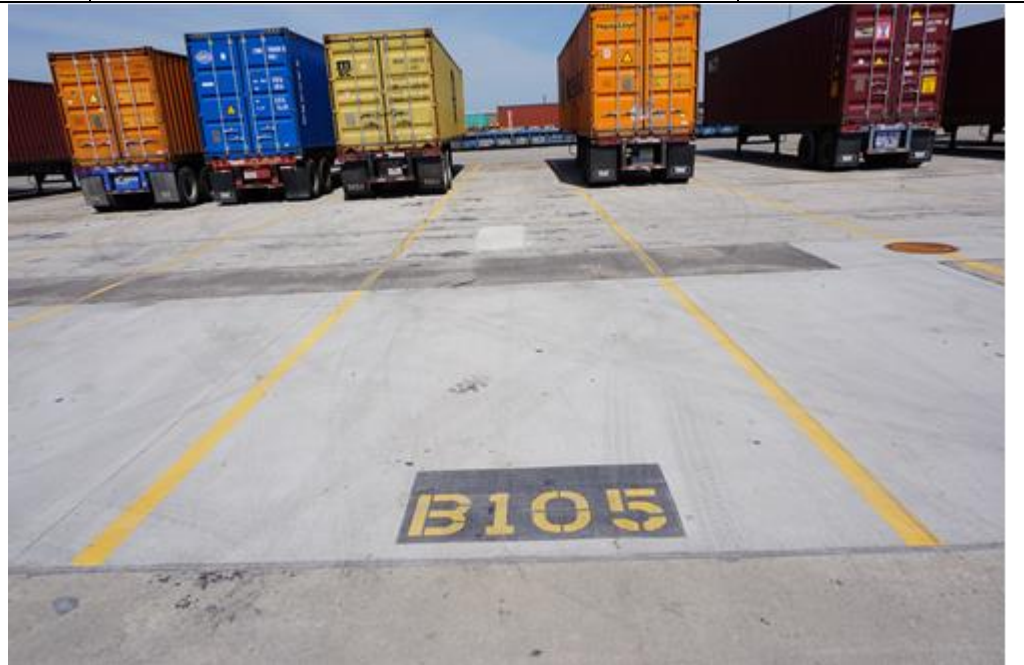
<b>Photo No.</b> <b>23</b>	<b>Date:</b> 03/27/2020
<b>Description:</b>  Slot B105, no tar-like material seeps observed, looking north.  Lat: 29.7841472 Long: - 95.3208777

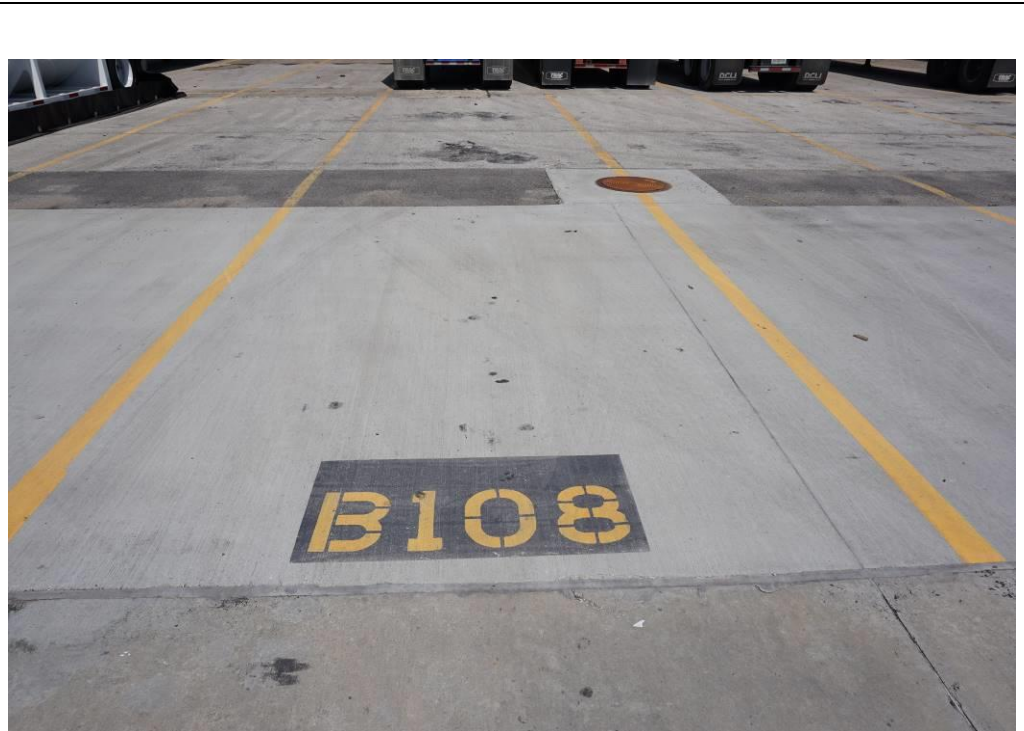
<b>Photo No.</b> <b>24</b>	<b>Date:</b> 03/27/2020
<b>Description:</b>  Slot B108, view of NAPL Collection System (Sump 107/108 in background). Very small amount of tar-like material seeping at asphalt crack near center of the slot, material was removed, looking north.  Lat: 29.784125 Long: - 95.320989
