June 2, 2020

**RE: MONTHLY STATUS UPDATE – ENGLEWOOD INTERMODAL YARD – NAPL COLLECTION SYSTEM/CONCRETE CAP REPAIRS
UNION PACIFIC RAILROAD HOUSTON WOOD PRESERVING WORKS FACILITY
4910 LIBERTY ROAD FACILITY, HOUSTON, TEXAS
POST-CLOSURE CARE PERMIT NO. HW-50343; INDUSTRIAL SWR NO. 31547**

Weekly Inspection Photolog

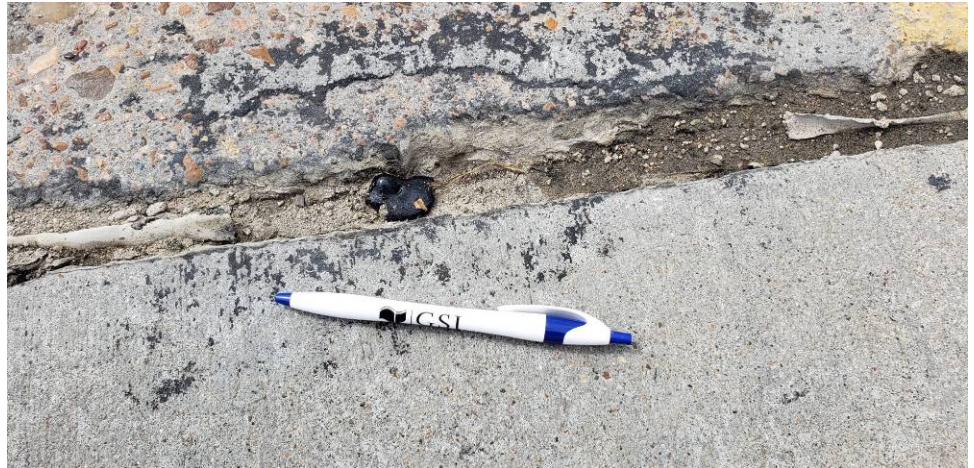
Photo No. 1	Date: 05/04/2020
------------------------------	----------------------------

Slot A021, very little tar-like material seeping at joint, material was removed.

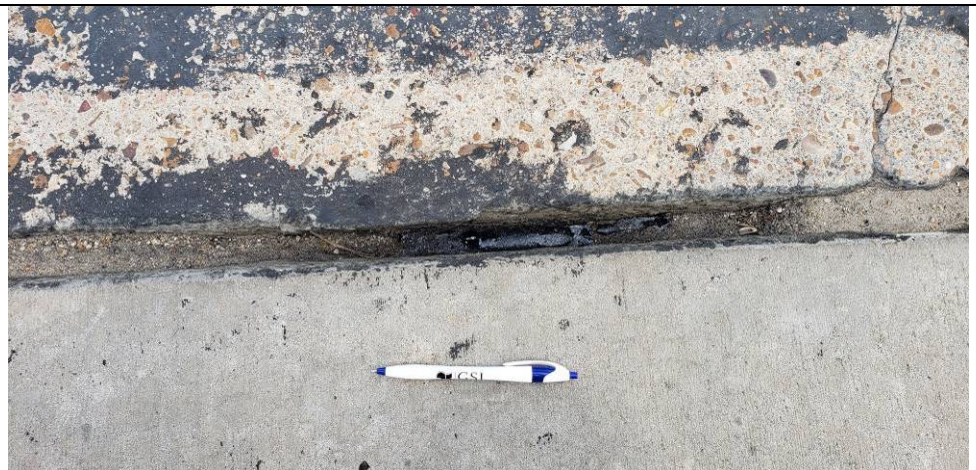
Photo No. 2	Date: 05/04/2020
------------------------------	----------------------------

Slot B102, very small amount of tar-like material seeping at joint, material was removed.

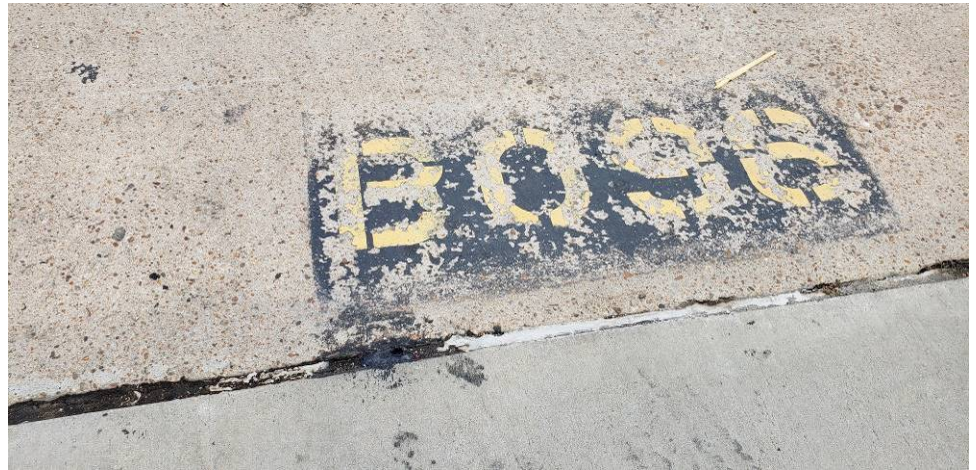
Photo No. 3	Date: 05/04/2020
------------------------------	----------------------------

Slot B096, very small amount of tar-like material seeping at joint, material was removed.

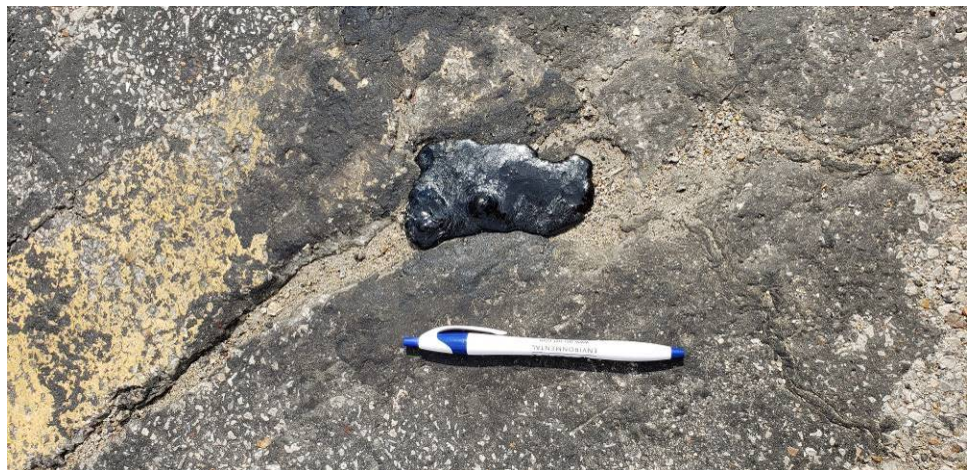
Photo No. 4	Date: 05/04/2020
------------------------------	----------------------------

Slot B101, small amount of tar-like material seeping at asphalt crack, material was removed.

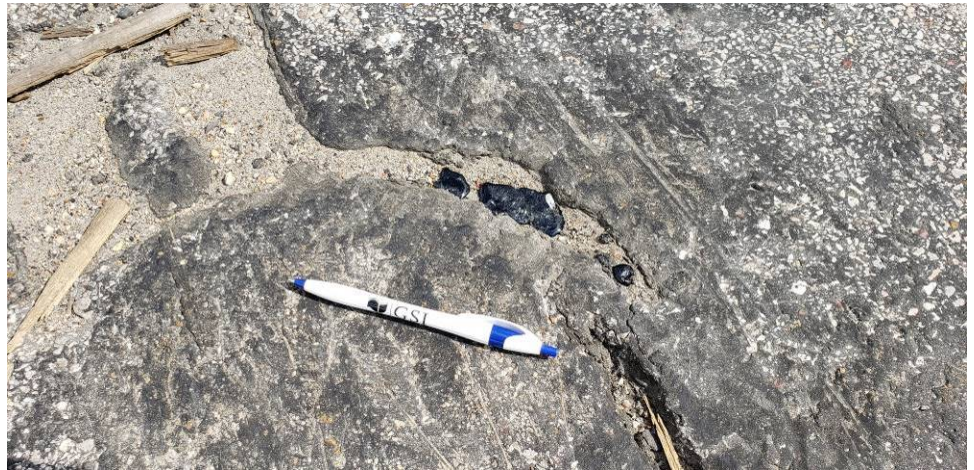
Photo No. 5	Date: 05/04/2020
-----------------------	----------------------------

Slot B108, very small amount tar-like material seeping at asphalt crack, material was removed.

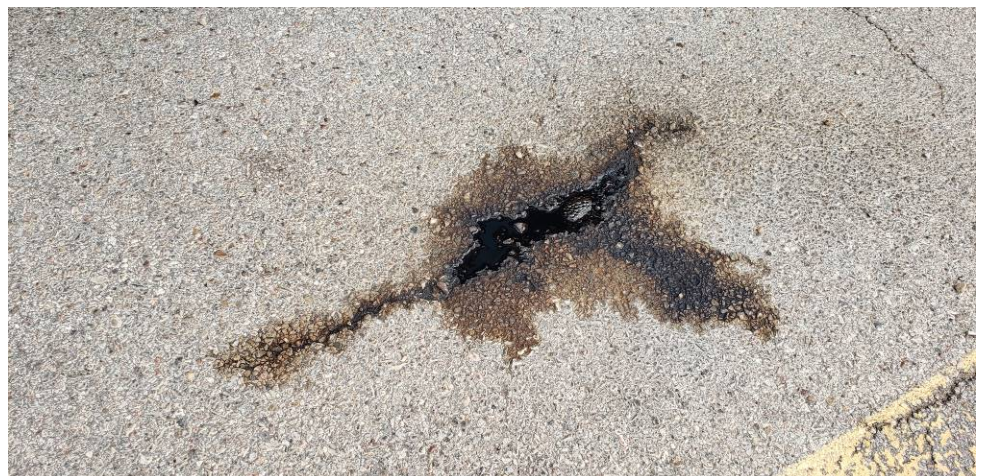
Photo No. 6	Date: 05/04/2020
-----------------------	----------------------------

Brown water observed in crack within Stall A015.

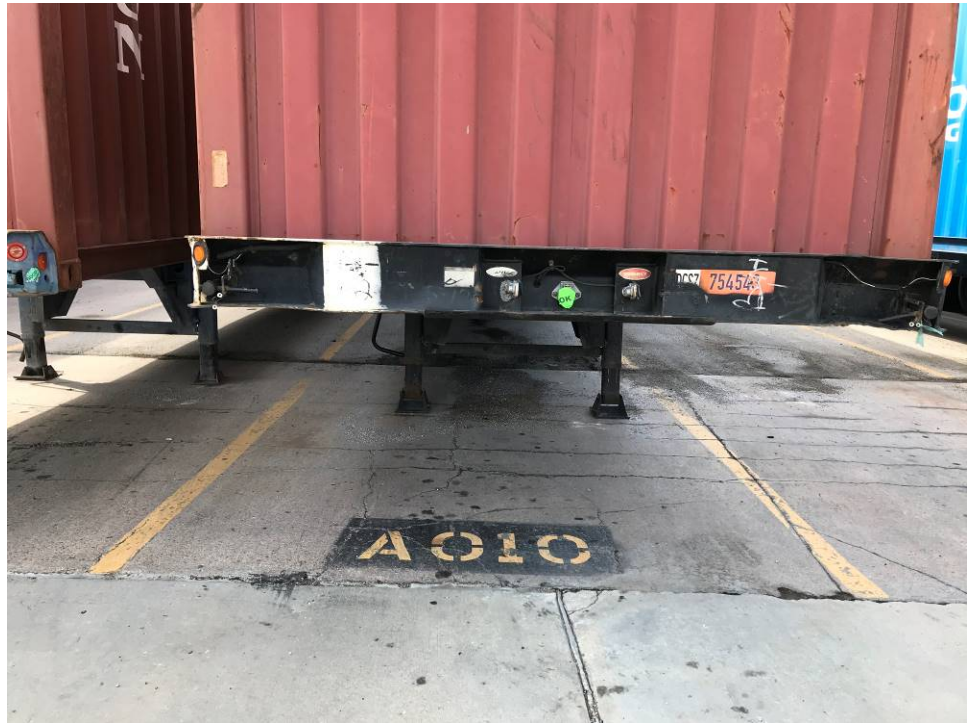
Photo No. 7	Date: 05/12/2020
Description: Slot A010, no tar-like material seeps observed, looking south. Lat: 29.7855833, Long: -95.318375

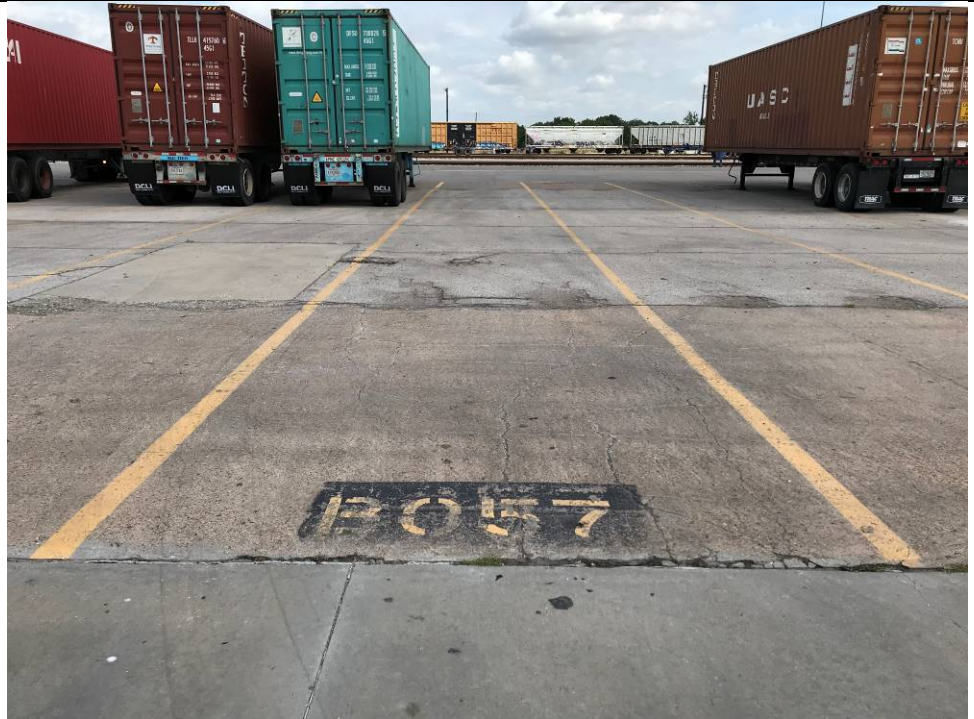
Photo No. 8	Date: 05/12/2020
Description: Slot B057, no tar-like material seeps observed. Lat: 29.7847472 Long: -95.3195417

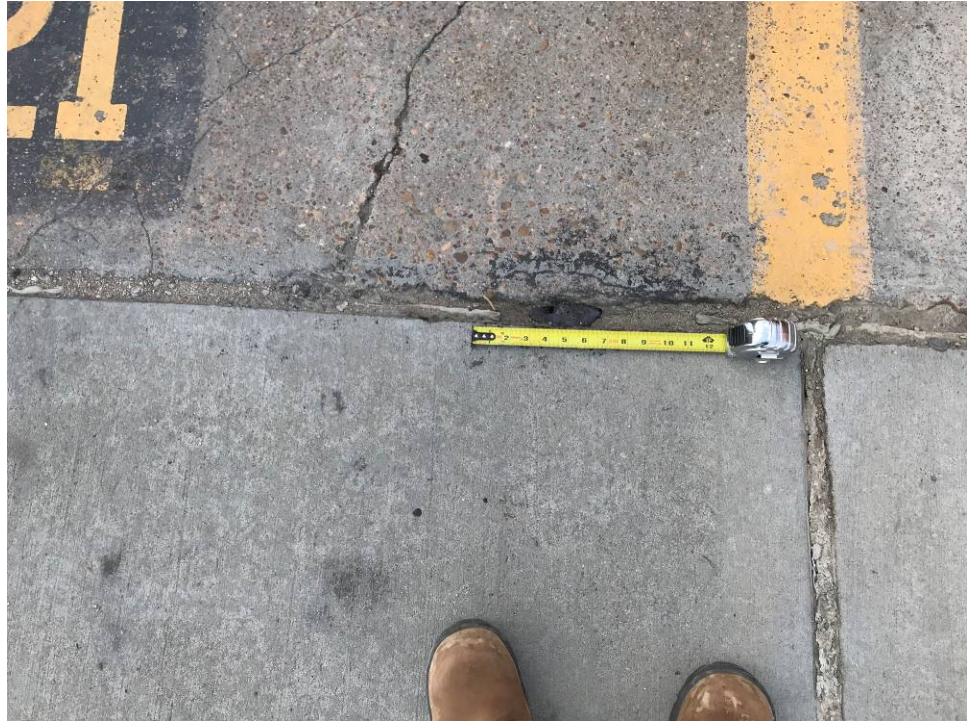
Photo No.
11

Slot A021, very little tar-like material seeping at joint, material was removed.

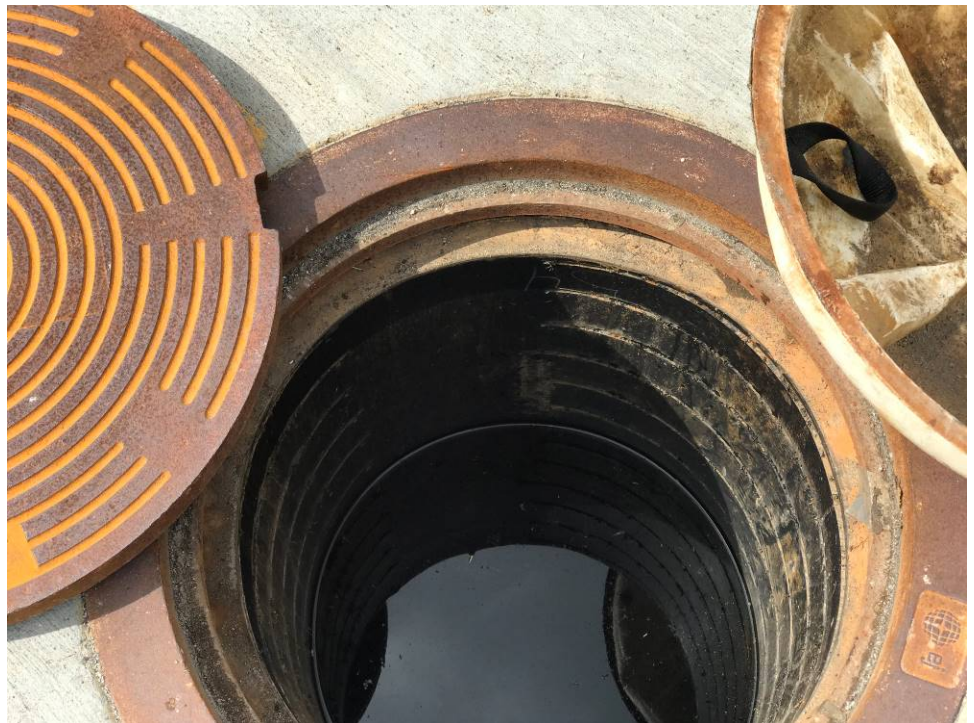
Photo No.
12

Sump B107/B108, approx. 19 inches of freeboard in sump, no sheen or odors noted. No tar-like material noted.

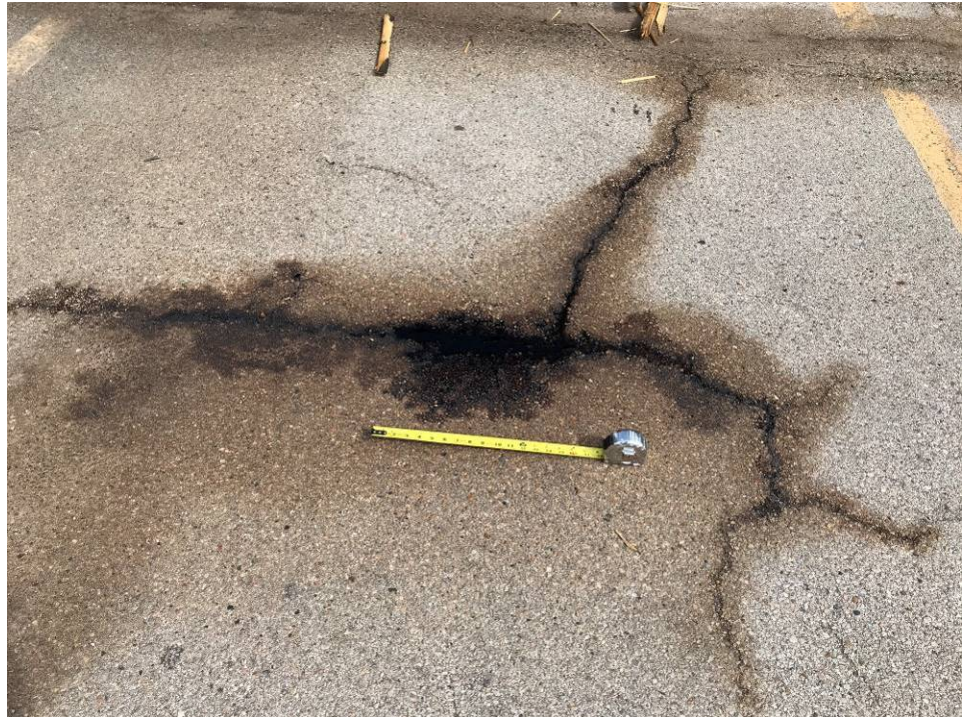
Photo No.
13

Brown staining and water observed along the crack in the asphalt within Stall B097, later cleaned by USES.

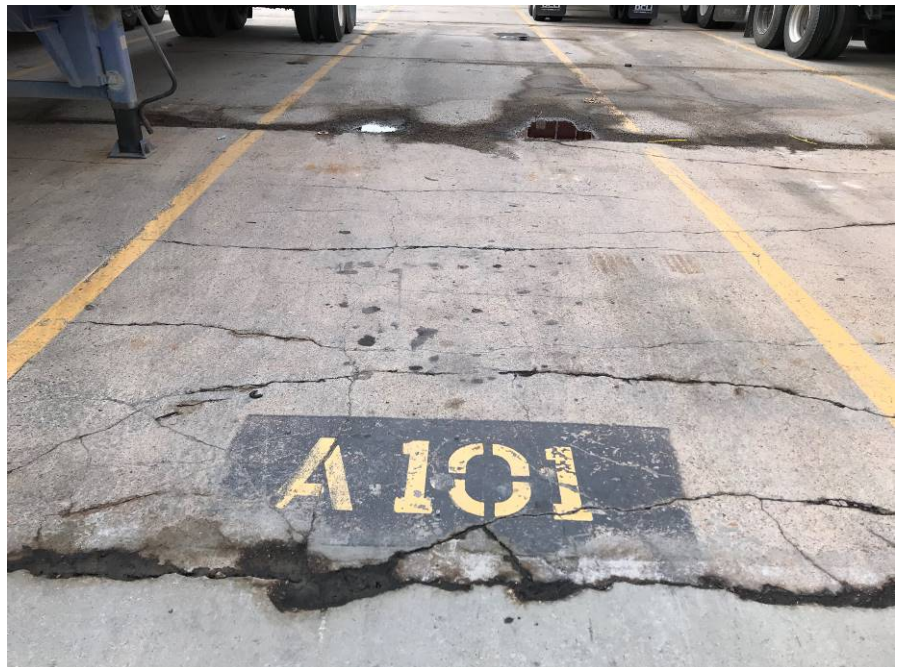
Photo No.
14

Brown water observed in Stall A101, later recovered and cleaned by USES.

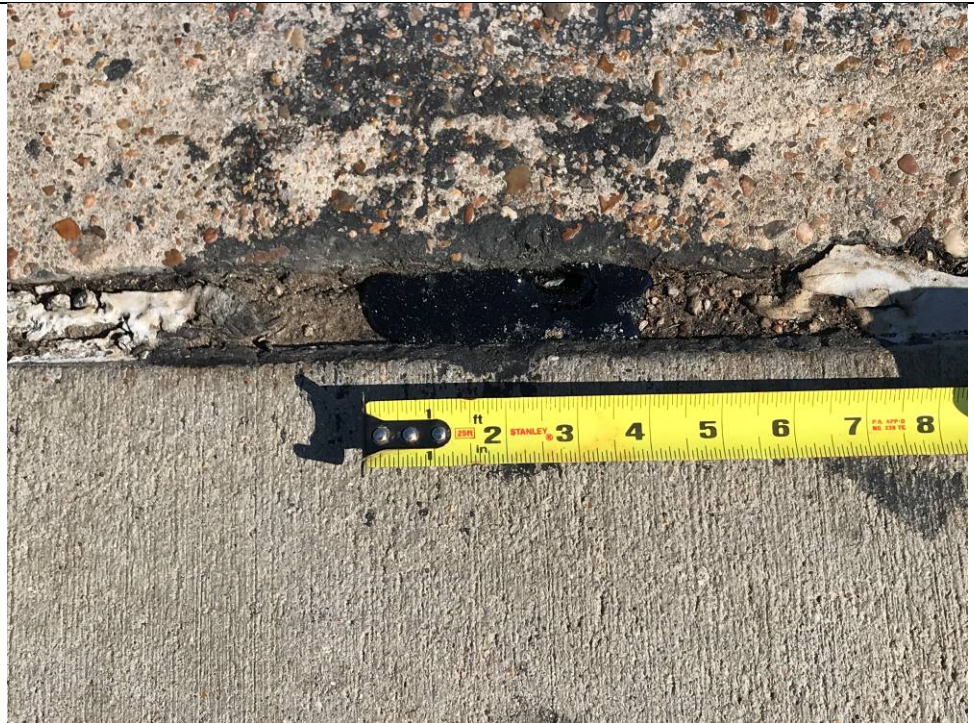
Photo No. 18	Date: 05/19/2020
-------------------------------	----------------------------

Slot B096, small amount of tar-like material seeping at joint, material was removed.

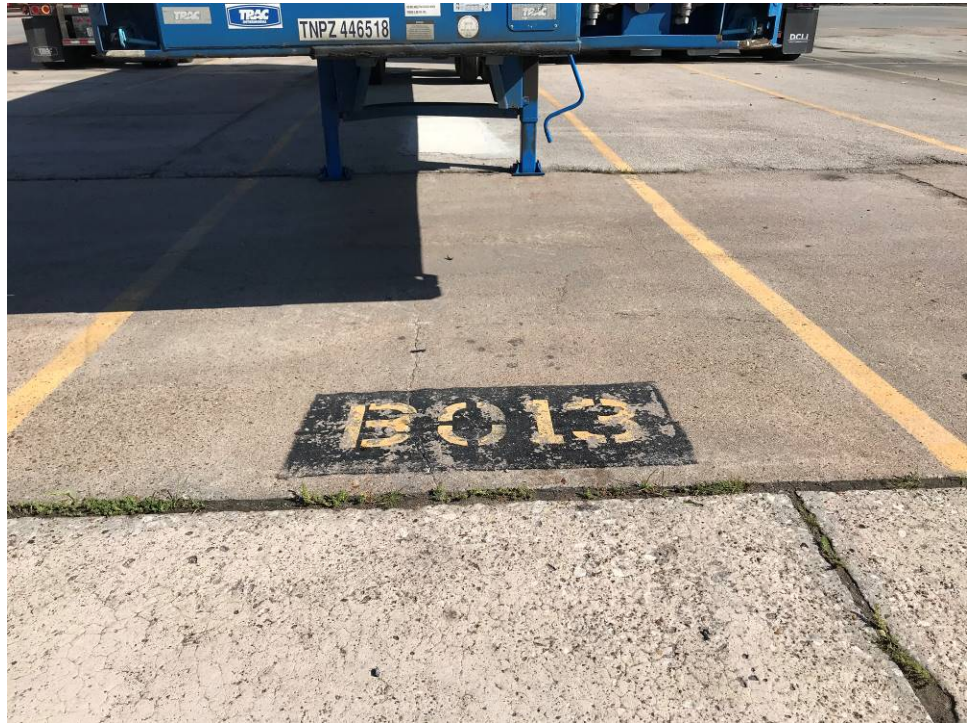
Photo No. 19	Date: 05/19/2020
Description: Slot B013, no tar-like material seeps observed, looking north. Lat: 29.785217 Long: - 95.318261

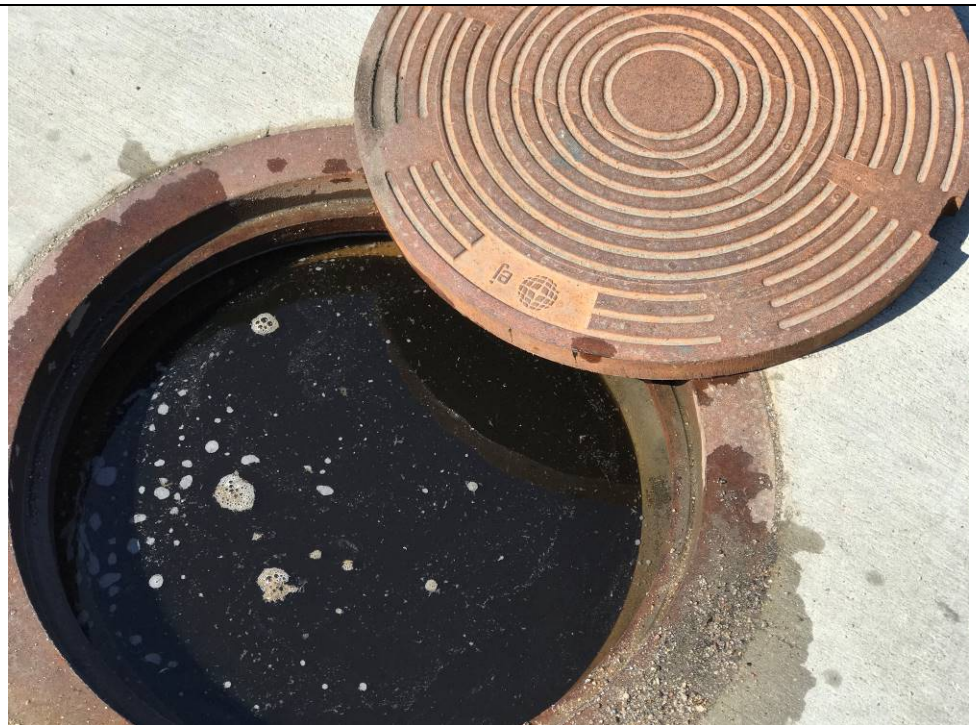
Description: Sump B099/B100, 0.5 inches of freeboard in sump, no sheen or odors noted. Sump was pumped down by USES on 5/22. Lat: 29.7844000 Long: - 95.3205861	
---	--

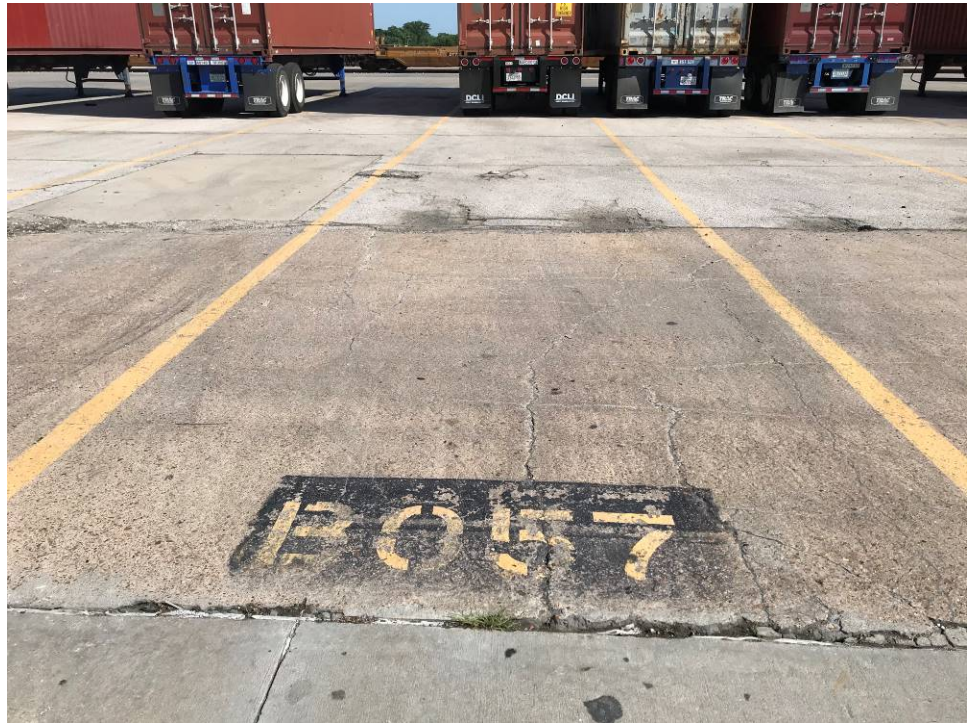
Photo No. 21	Date: 05/19/2020
Description: Slot B057, no tar-like material seeps observed, looking north. Lat: 29.7847472 Long: - 95.3195417

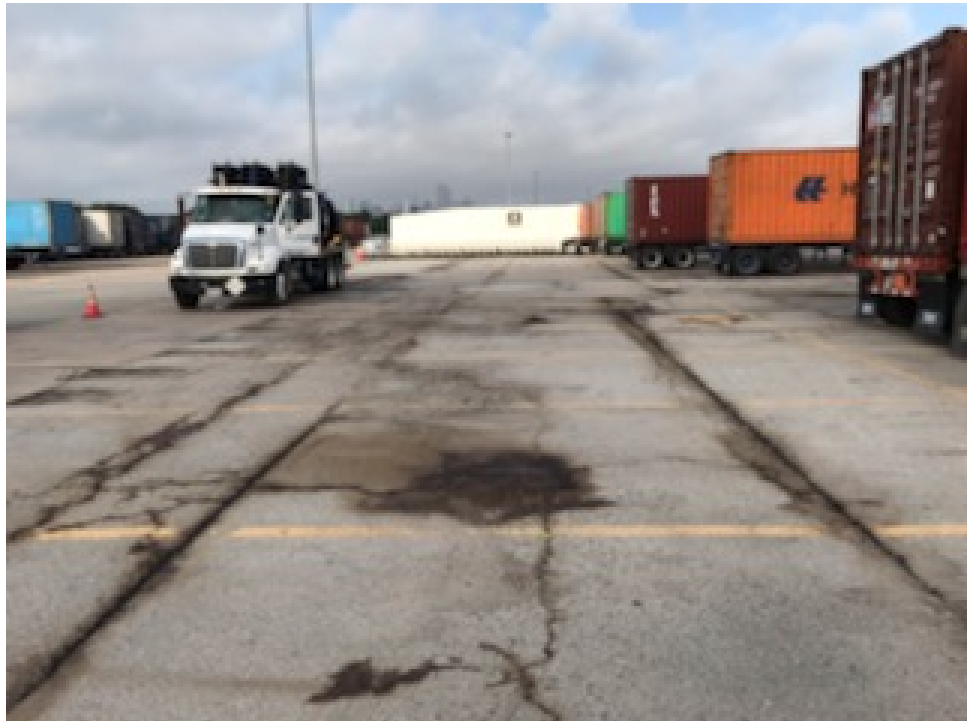
- Beginning in May, brown staining and seep water was observed along asphalt joints and cracks throughout the B-Row (predominately in the B090 – B098 area) but was also observed within the A-Row. The most extensive staining and seep water was observed during the weekly inspections on May 12th and 19th, 2020. USES was called out to the Site on May 14th and 22nd to pressure wash the areas and collect the fluids, which were placed in a tote on site next to the frac tank used to temporarily store water pumped from the NAPL Collection sumps. UPRR will continue to have USES pressure wash the areas where the brown staining and seeps are observed as needed. A sample of the water in the tote will be collected in June for waste characterization.

Photo No. 22	Date: 05/22/2020
Description: Slots B096-B110, brown water and staining observed along asphalt cracks, USES onsite to pressure wash and collect the water. NAPL Collection System and frac tank in the background, looking southwest. Lat: 29.785217 Long: - 95.318261

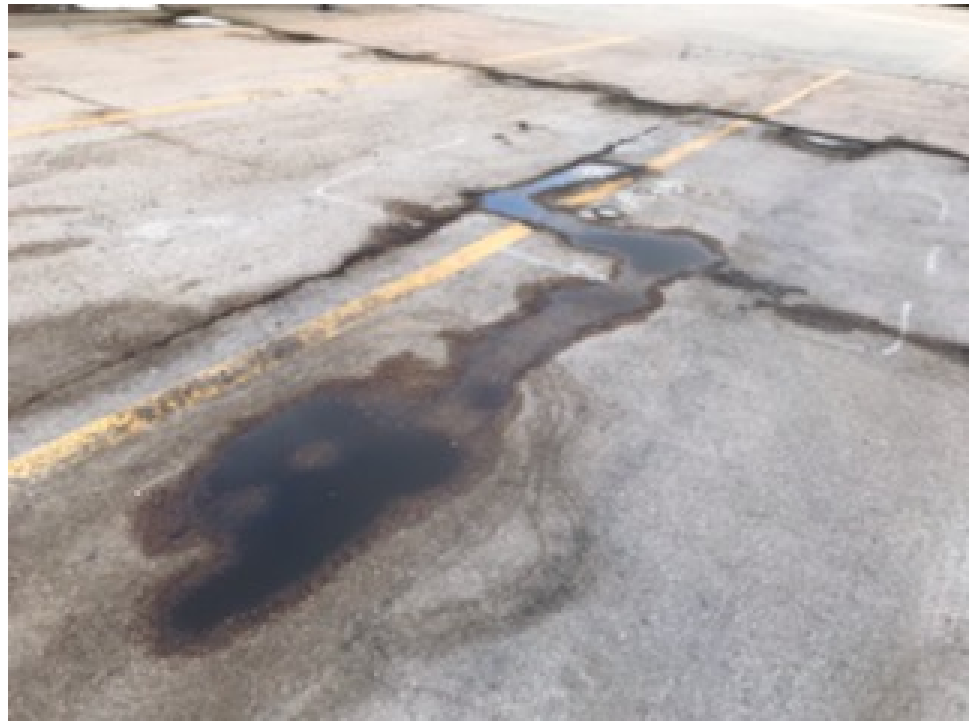
Photo No. 23	Date: 05/22/2020
-------------------------------	----------------------------

Brown water observed in Stall B099, later cleaned by USES.

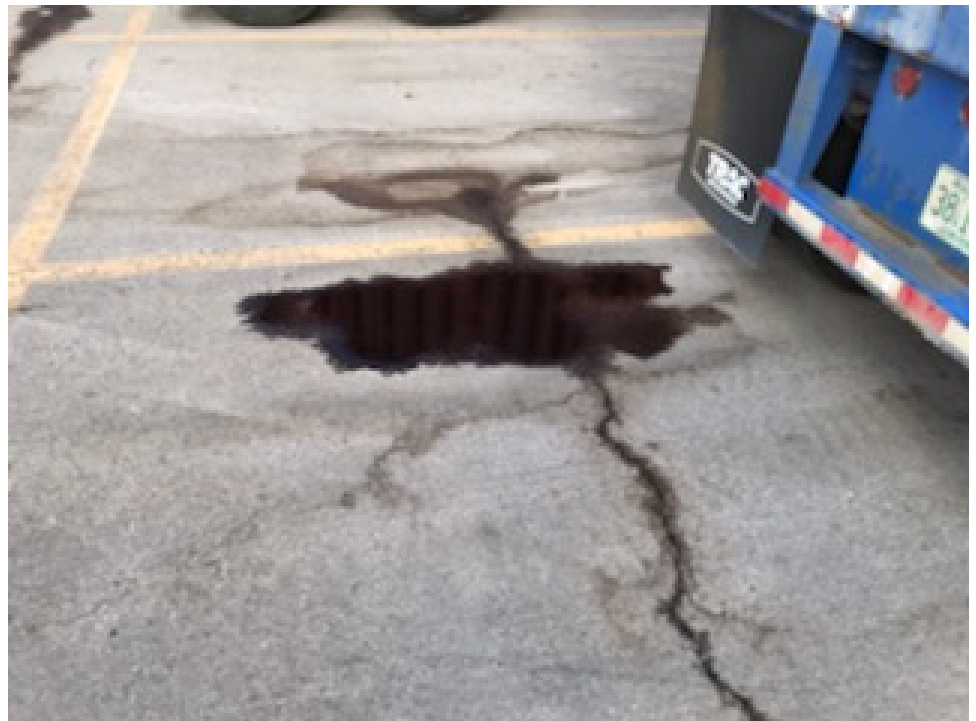
Photo No. 24	Date: 05/22/2020
-------------------------------	----------------------------

Brown water observed in Stall B013, later cleaned by USES.

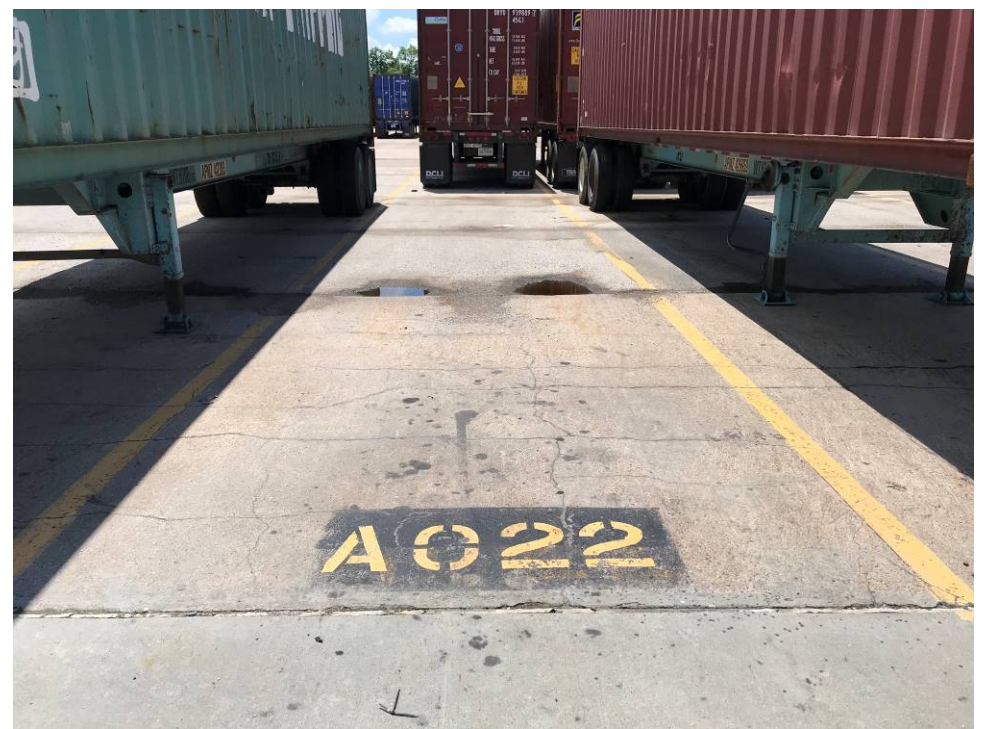
Photo No.: 25	Date: 05/27/2020
-------------------------	----------------------------

Slot A022, no tar-like material seeps observed, water on pavement from recent rain event noted, looking south.

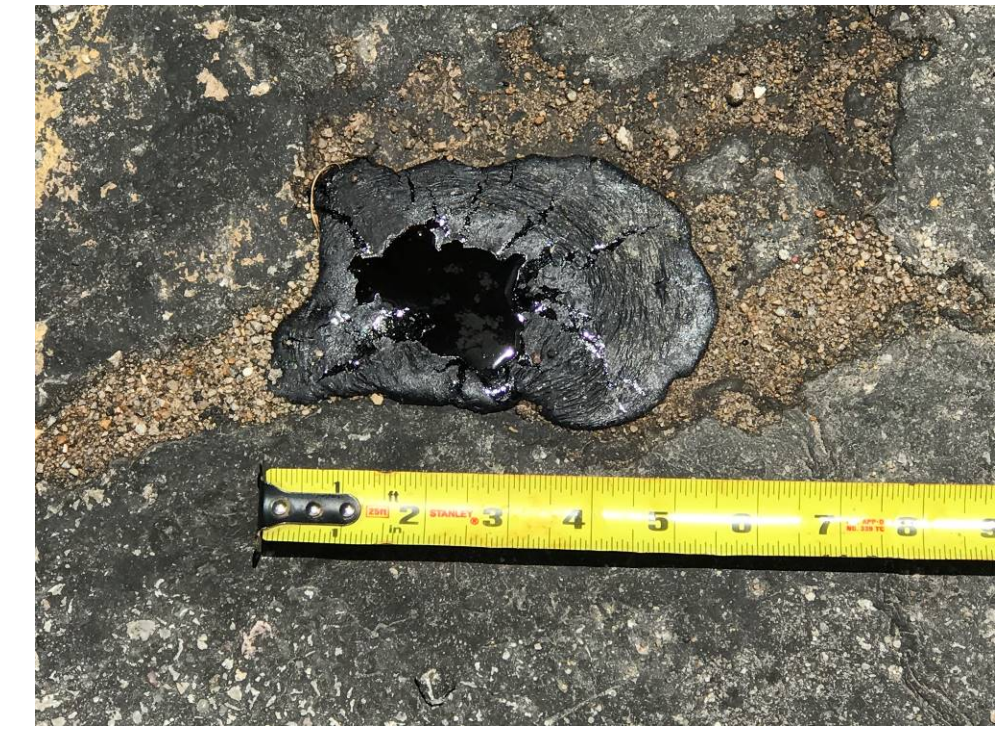
Photo No.: 26	Date: 05/27/2020
-------------------------	----------------------------

Slot B101, small amount of tar-like material seeping at asphalt crack, material was removed.

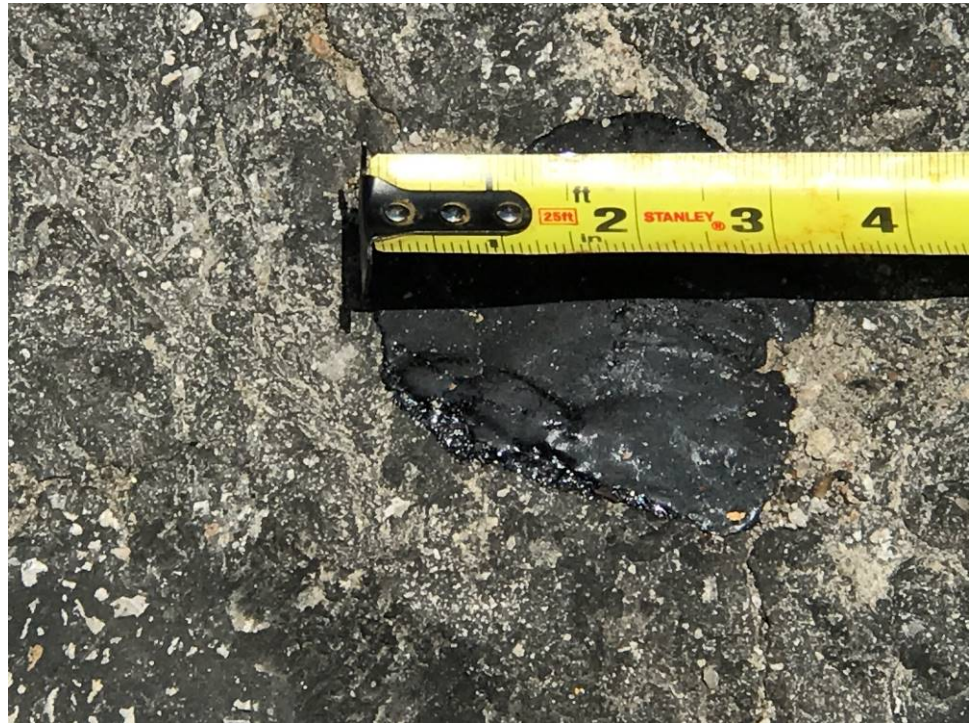
Photo No.: 27	Date: 05/27/2020
-------------------------	----------------------------

Slot B105, small amount tar-like material seeping at asphalt crack, material was removed.

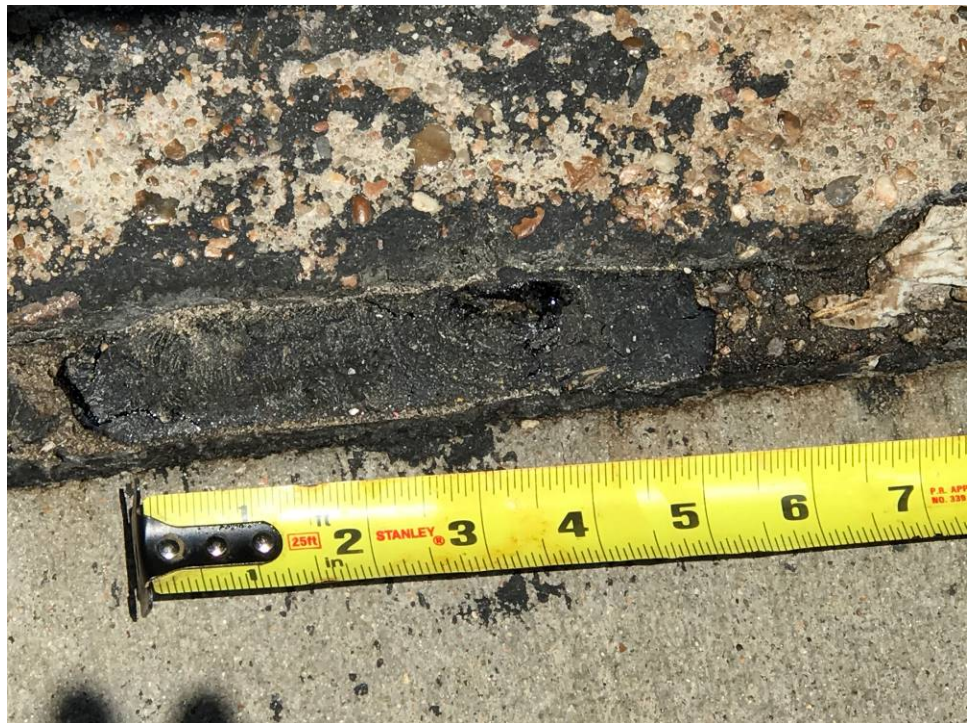
Photo No.: 28	Date: 05/04/2020
-------------------------	----------------------------

Slot B096, small amount of tar-like material removed from sump.

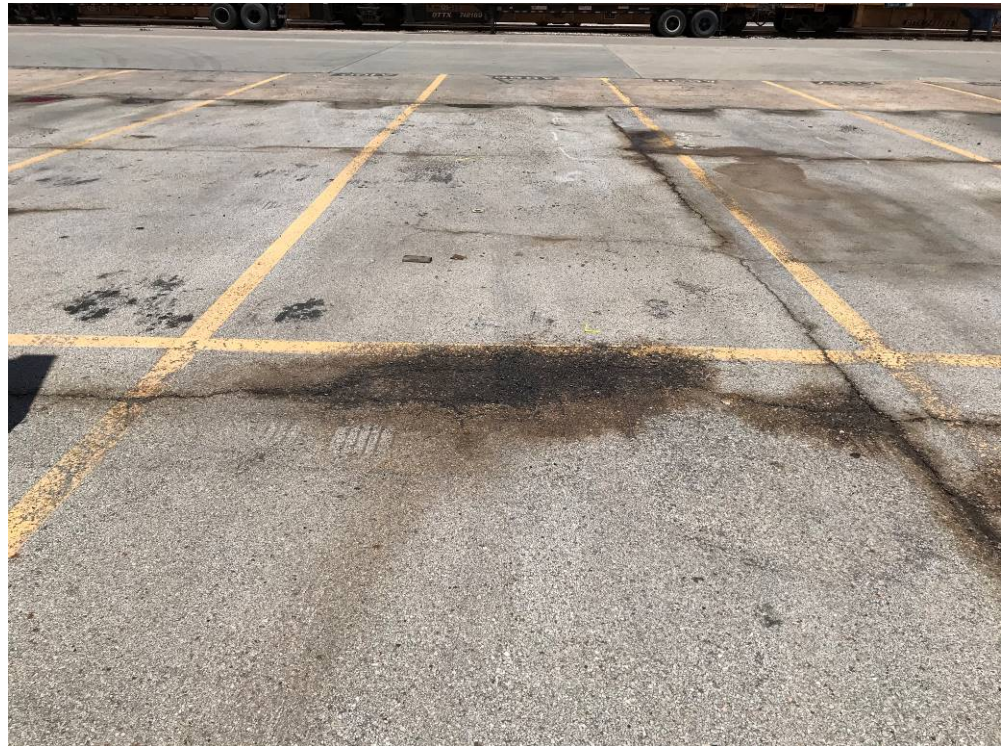
Photo No.
30

Slot B099, brown staining observed along asphalt cracks in slot B099 and surrounding slots, looking southeast.

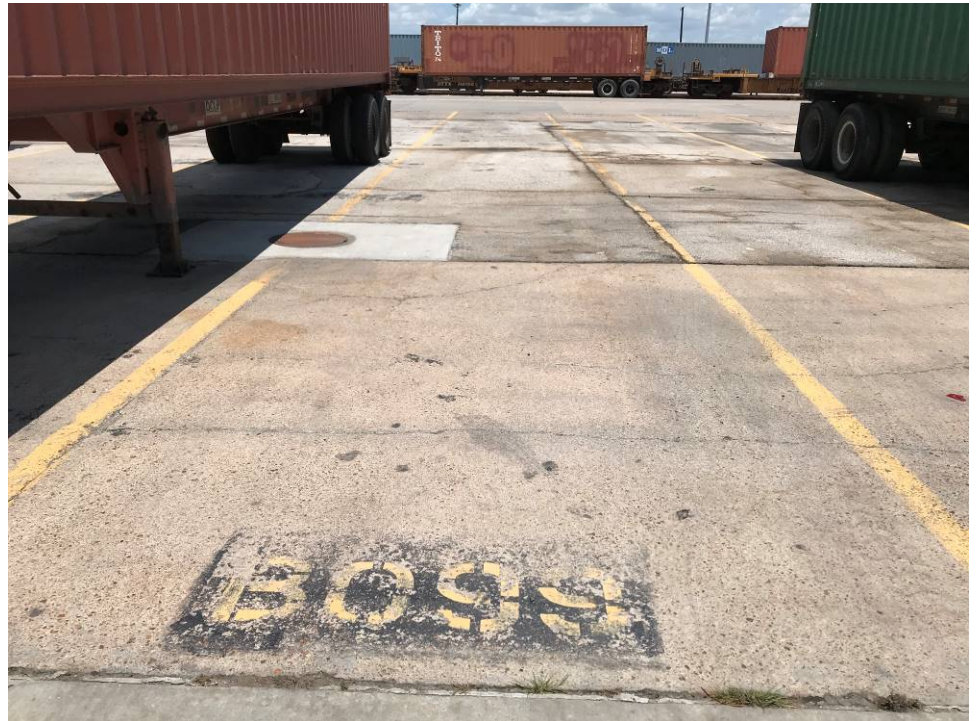
Photo No.: 31	Date: 05/27/2020
-------------------------	----------------------------

Slot B099, view of NAPL Collection System (Sump 099/100 in background). No tar-like material seeps observed, looking north.

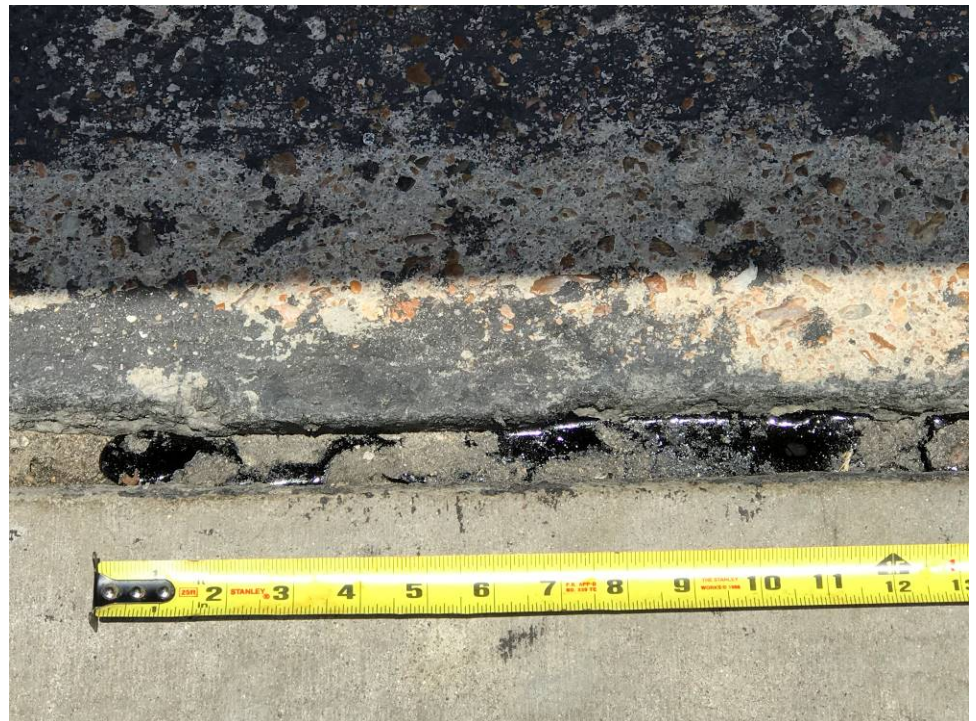
Photo No.: 32	Date: 05/27/2020
-------------------------	----------------------------

Slot B102, small amount of tar-like material seeping at joint, material was removed.
