July 10, 2020

Project No. 19119232

**RE: MONTHLY STATUS UPDATE – ENGLEWOOD INTERMODAL YARD – NAPL COLLECTION SYSTEM/CONCRETE CAP REPAIRS
UNION PACIFIC RAILROAD HOUSTON WOOD PRESERVING WORKS FACILITY
4910 LIBERTY ROAD FACILITY, HOUSTON, TEXAS
POST-CLOSURE CARE PERMIT NO. HW-50343; INDUSTRIAL SWR NO. 31547**

Weekly Inspection Photolog

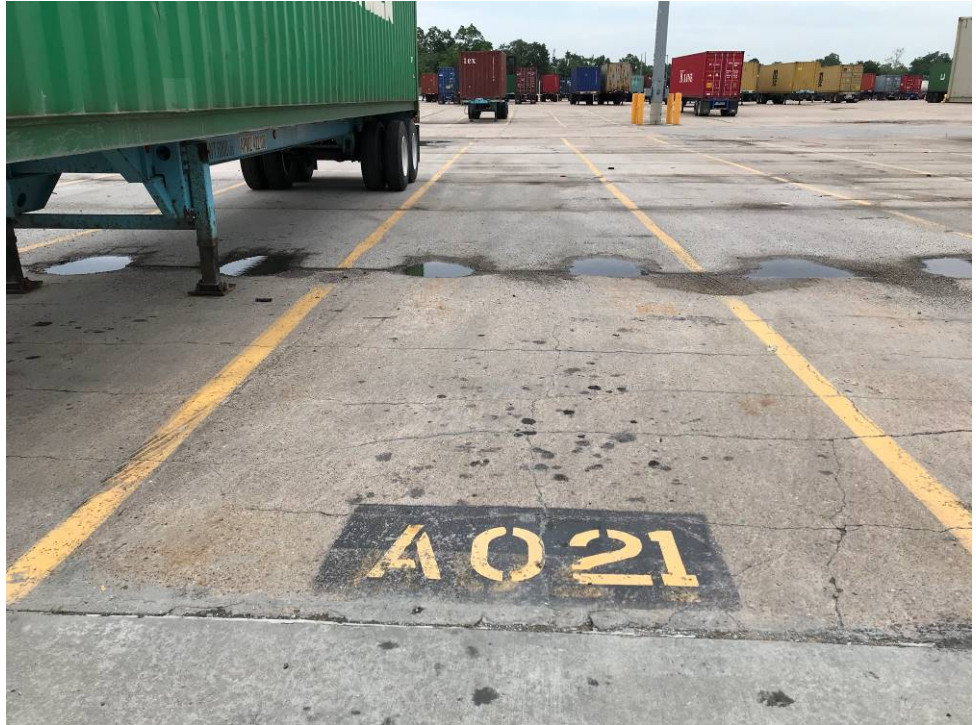
Photo No. 1	Date: 06/01/2020
-----------------------	----------------------------

Slot A021, no tar-like material seeps observed, water on pavement from recent rain event, looking south.

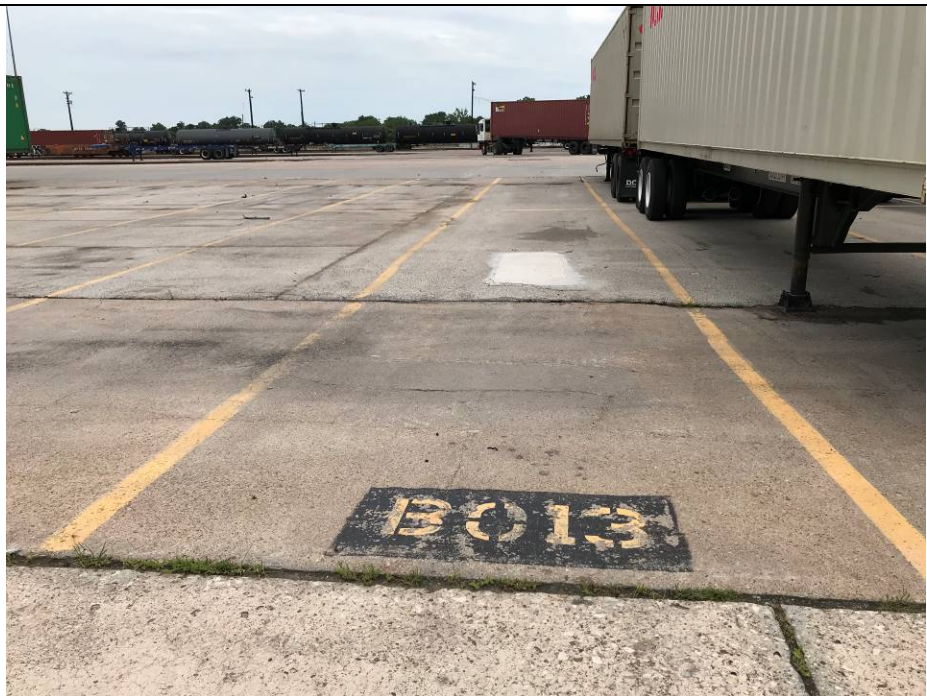
Photo No. 2	Date: 06/01/2020
-----------------------	----------------------------

Slot B013, no tar-like material seeps observed, looking north.

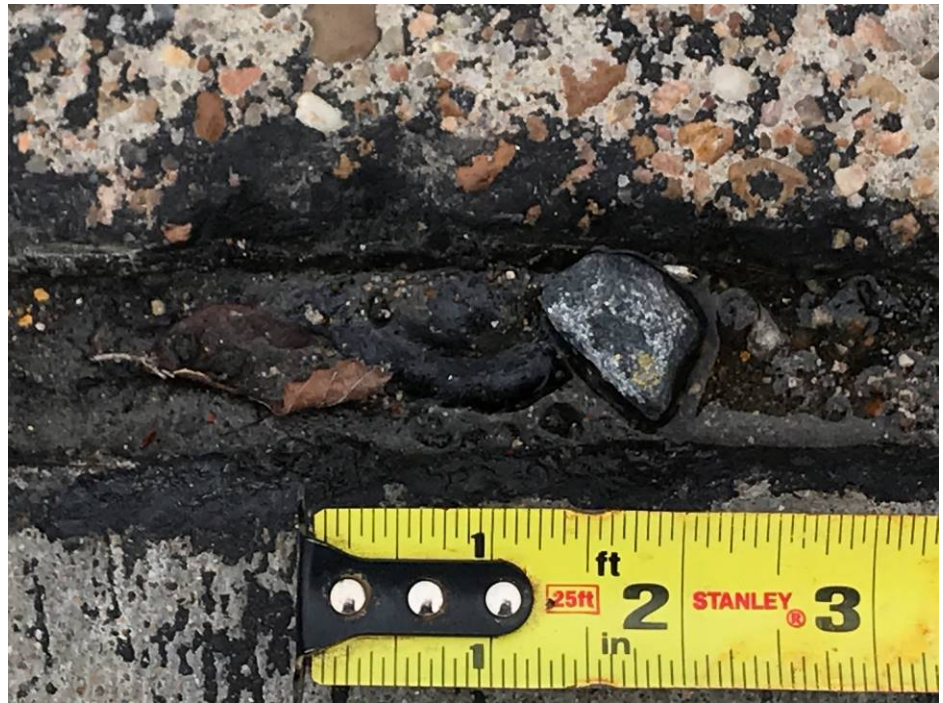
Photo No. 3	Date: 06/01/2020
Description: Slot B096, very small amount of tar-like material seeping at joint, material was removed. Lat: 29.7842528 Long: - 95.3206250

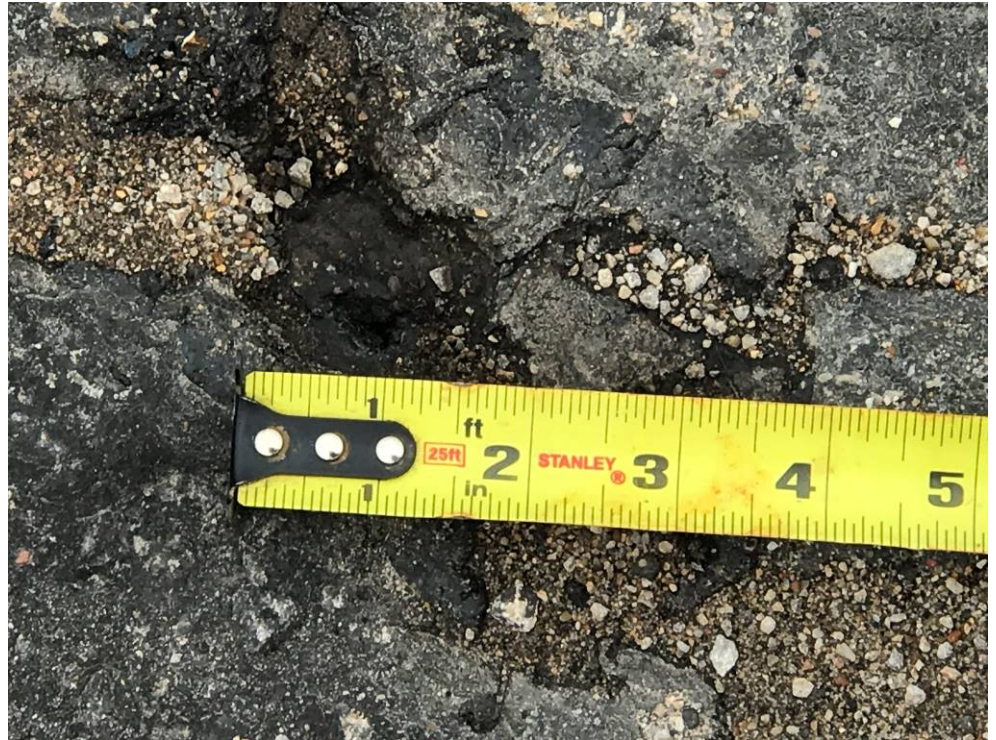
Photo No. 4	Date: 06/01/2020
Description: Slot B101, very small amount of tar-like material seeping at asphalt crack, material was removed. Lat: 29.784275 Long: - 95.320813

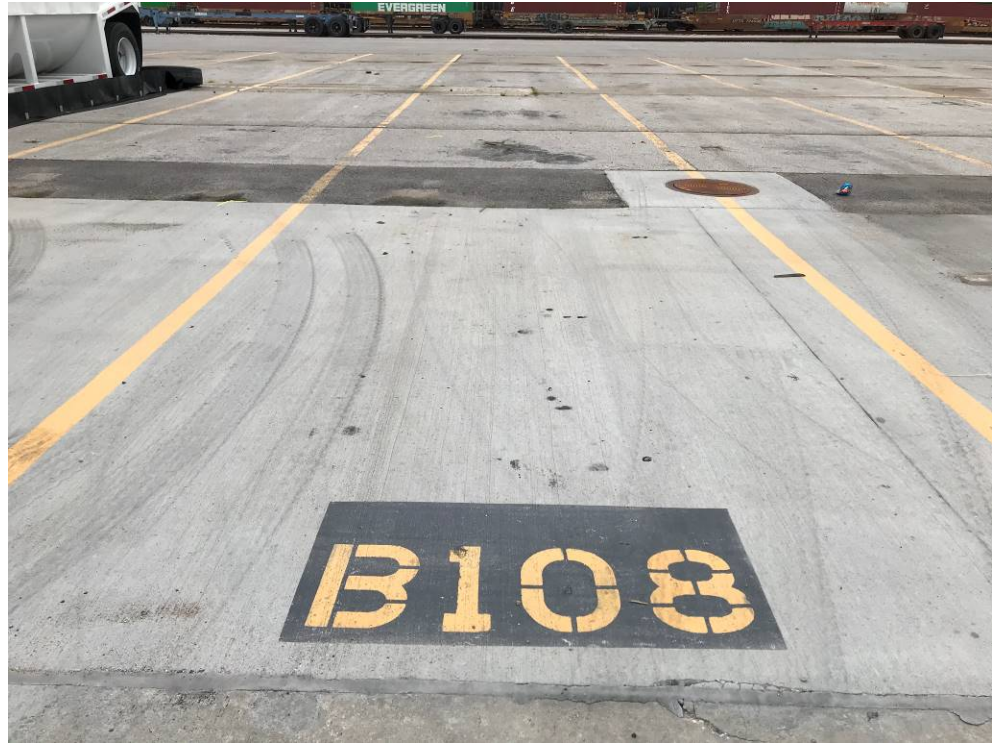
Photo No.
5

Slot B108, view of NAPL Collection System (Sump 107/108 in background). No tar-like material seeps observed, looking north.

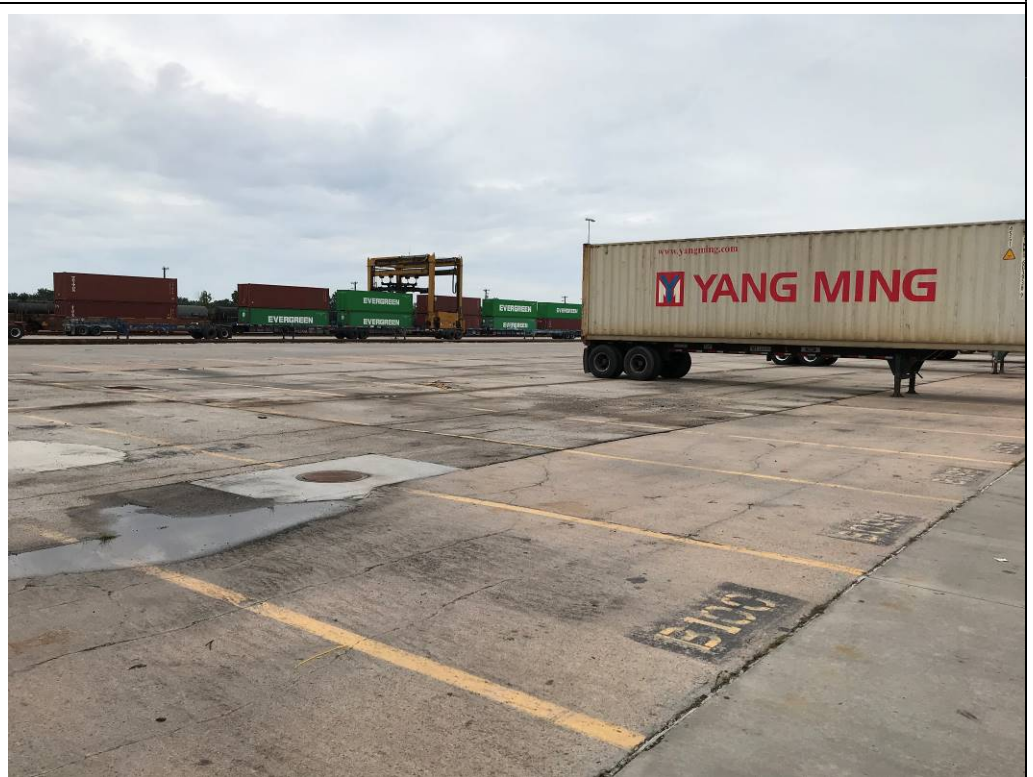
Photo No.
6

Slot B100, view of NAPL Collection System (Sump 099/100) and overview of surrounding slots, minimal brown staining observed along asphalt cracks, water from recent rain event on pavement.

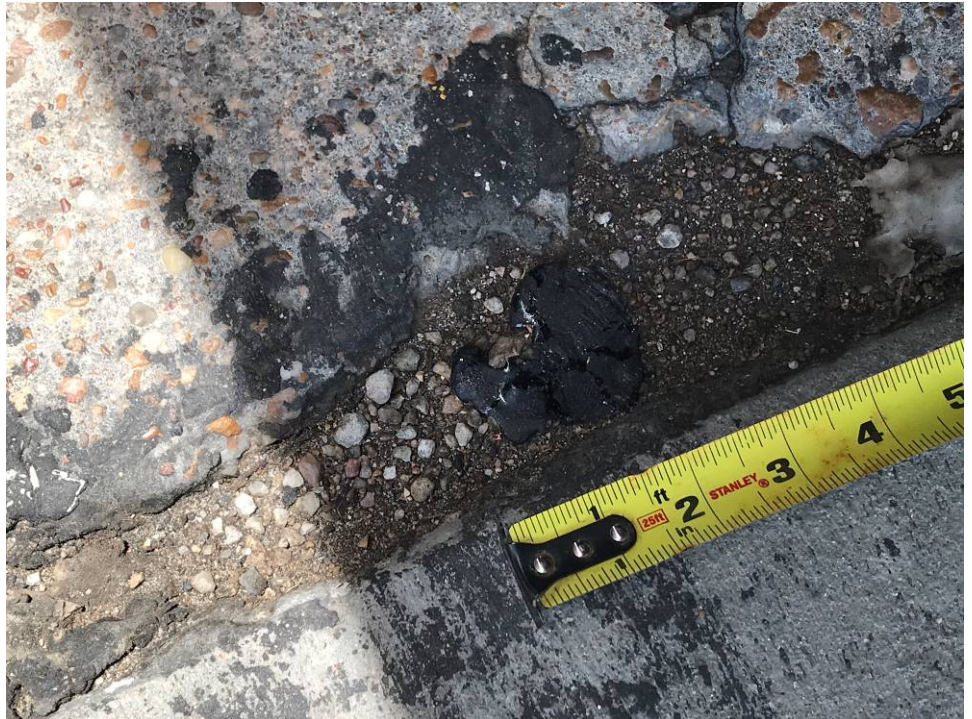
Photo No. 7	Date: 06/10/2020
Description: Slot A010, very small amount of tar-like material seeping at joint, material was removed. Lat: 29.7855833, Long: -95.318375

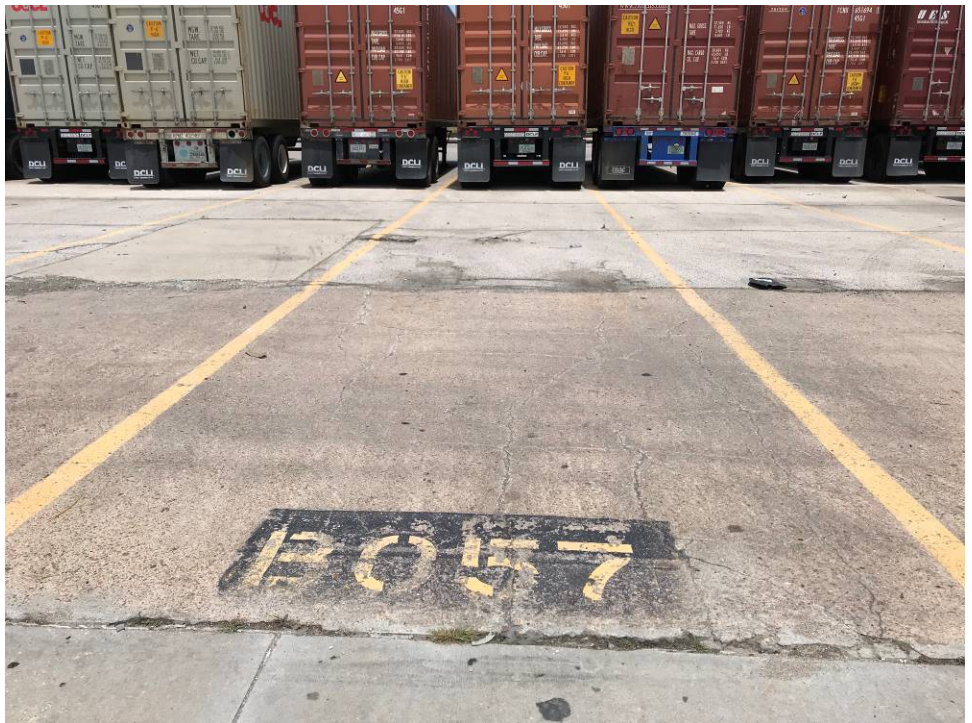
Photo No. 8	Date: 06/10/2020
Description: Slot B057, no tar-like material seeps observed. Lat: 29.7847472 Long: - 95.3195417

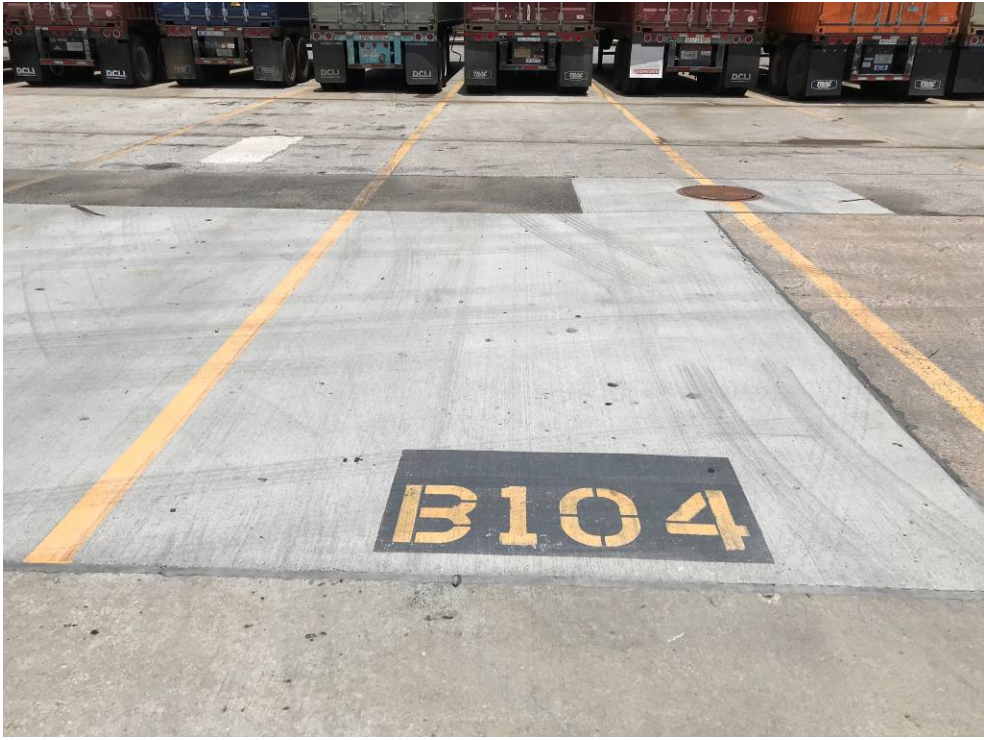
Description: Slot B104, view of NAPL Collection System (Sump 103/104 in foreground). No tar-like material seeps observed, looking north. Lat: 29.7841639 Long: - 95.3208694			
Photo No.: 10	Date: 06/10/2020

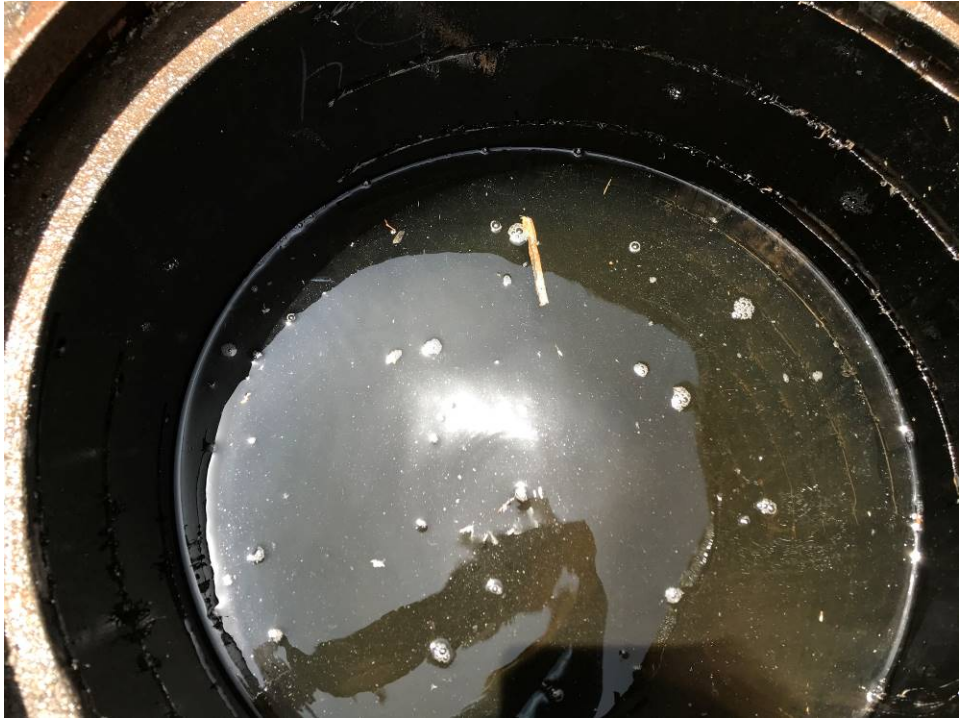
Description: Sump B103/B104, 10 inches of freeboard in sump, no sheen or odors noted. Lat: 29.7842861 Long: - 95.3208611

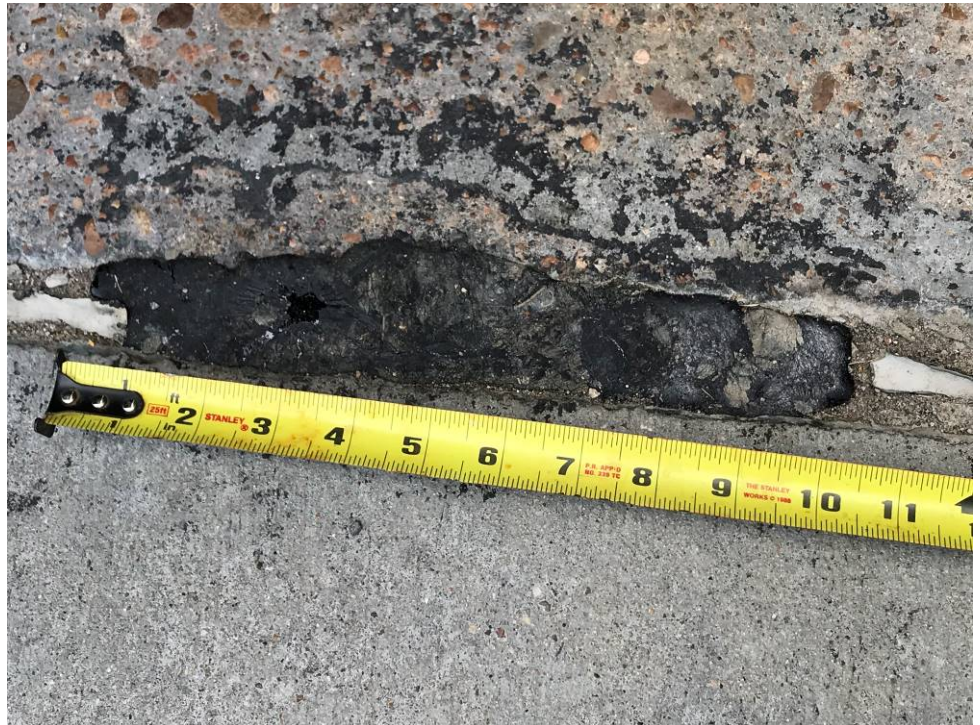
Photo No.: 11	Date: 06/10/2020
-------------------------	----------------------------

Slot A021, small amount of tar-like material seeping at joint, material was removed.

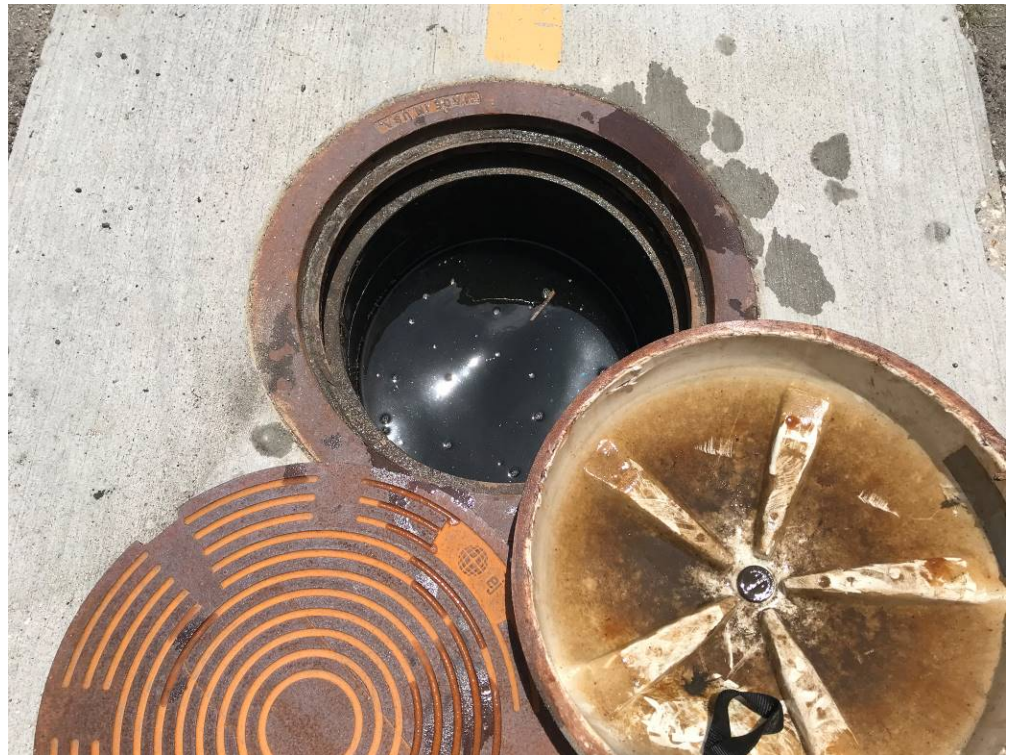
Photo No.: 12	Date: 06/10/2020
-------------------------	----------------------------

Sump B107/B108, 9 inches of freeboard in sump, no sheen or odors noted. No tar-like material noted.

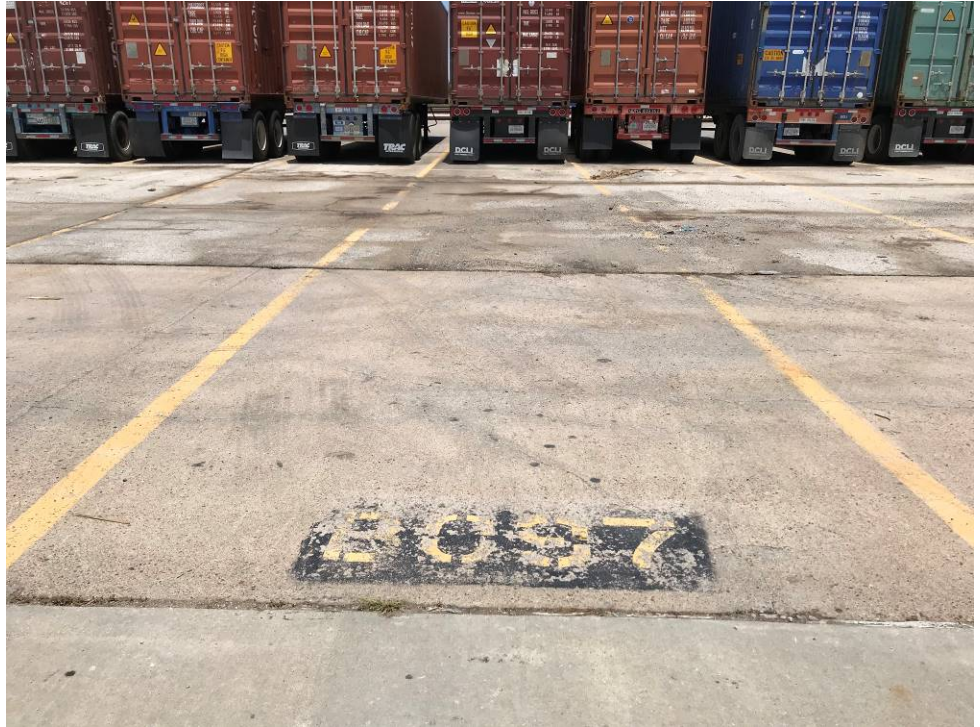
Photo No. 13	Date: 06/10/2020
Description: Slot B097, residual brown staining observed along the crack in the asphalt, looking north. Lat: 29.784402 Long: -95.320520

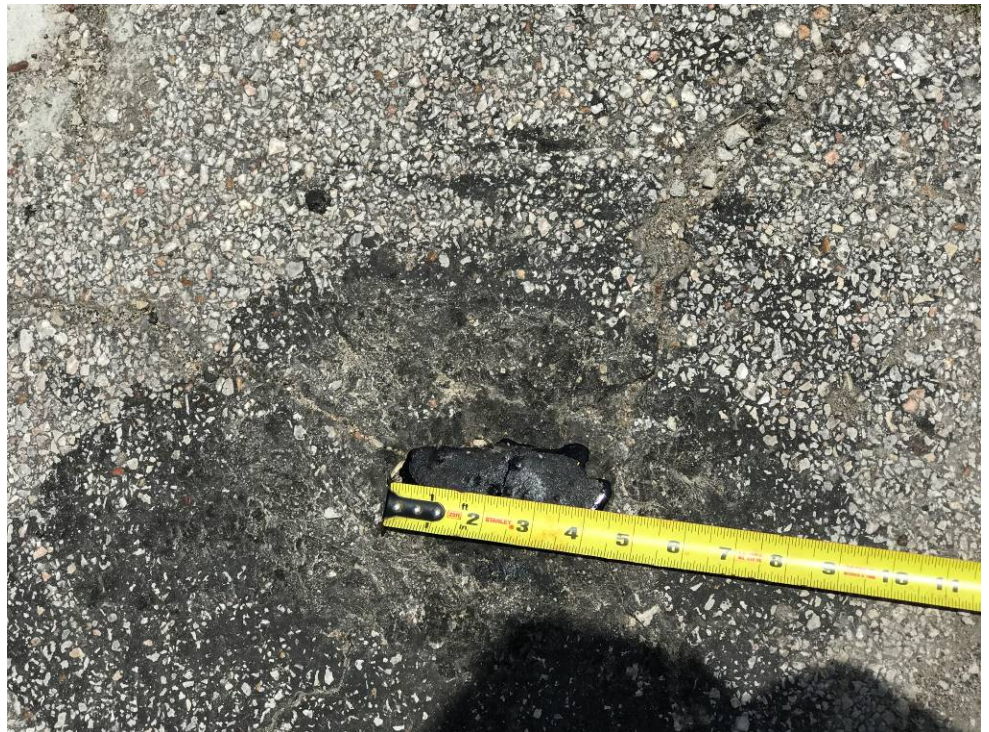
Photo No. 14	Date: 06/10/2020
Description: Slot B105, small amount tar-like material seeping at asphalt crack, material was removed. Lat: 29.7841472 Long: - 95.3208777

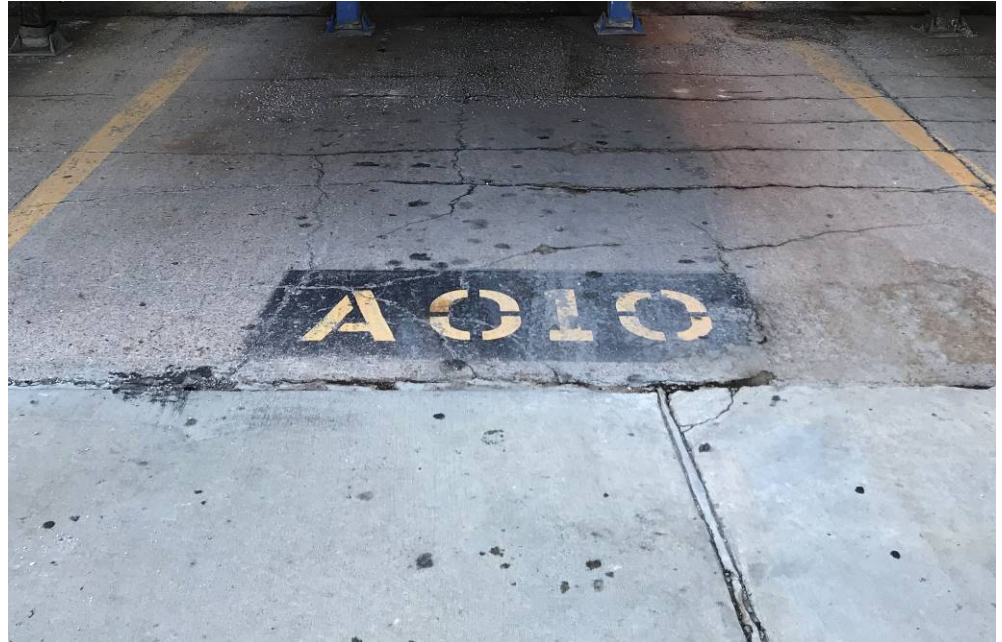
Photo No.
15

Slot A010, very small amount of tar-like material seeping at joint, material was removed.

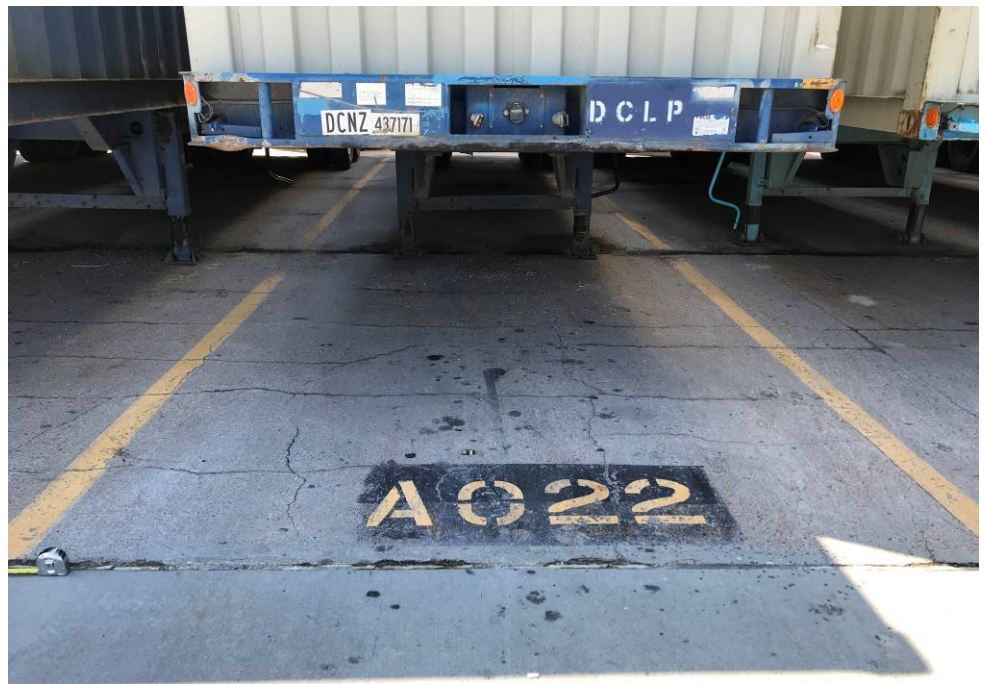
Photo No.
16

Slot A022, no tar-like material seeps observed, looking south.

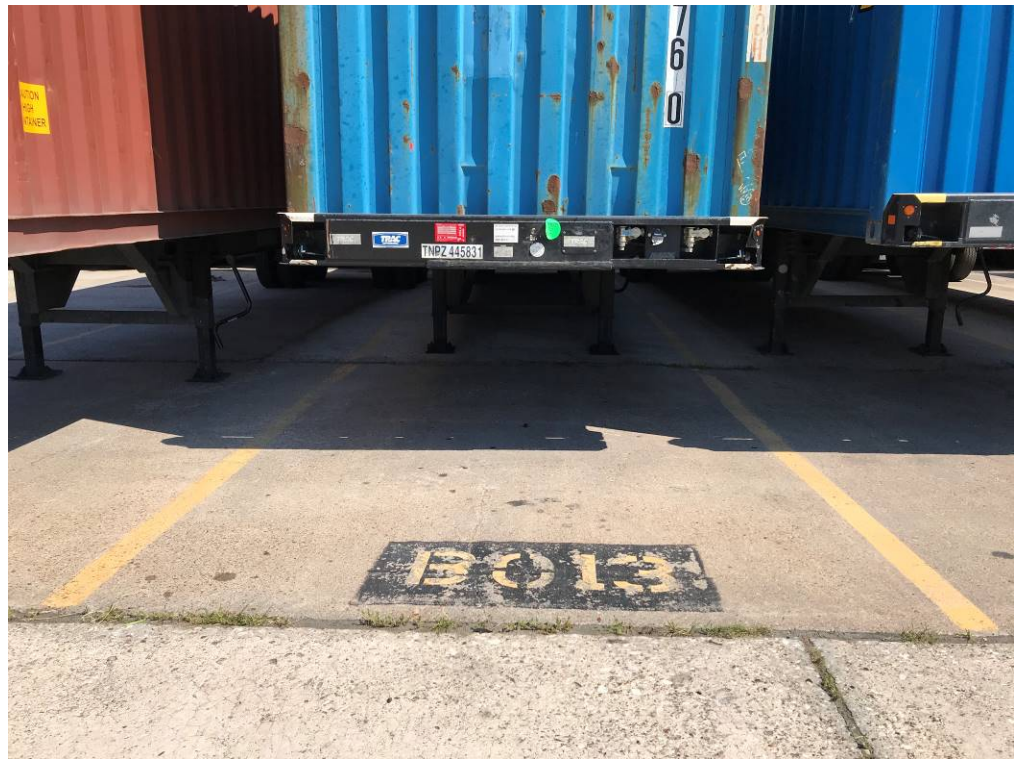
Photo No.
17

Slot B013, no tar-like material seeps observed, looking north.

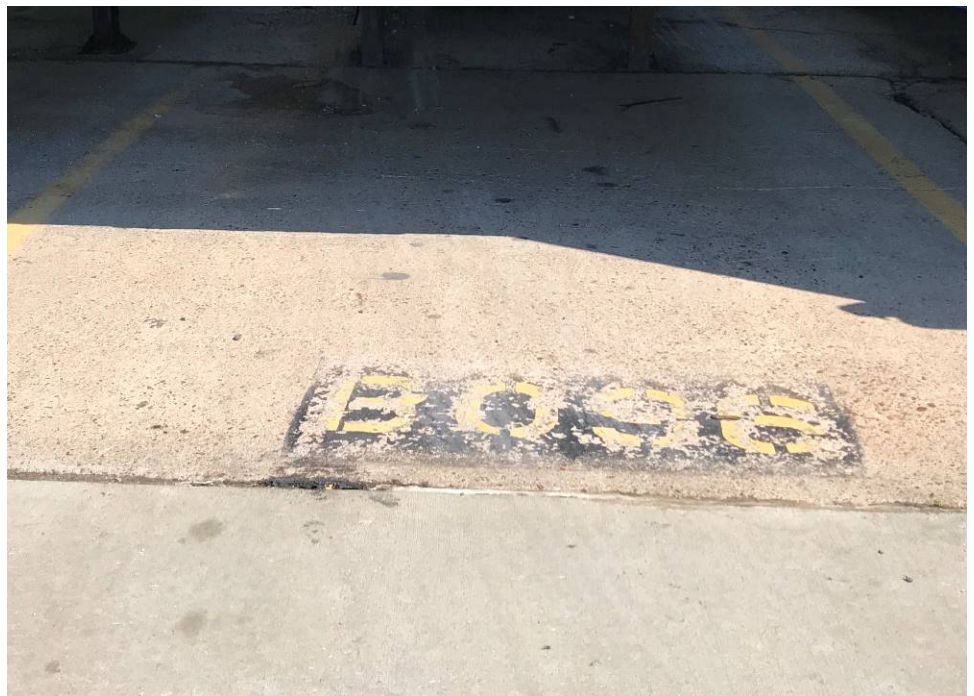
Photo No.
18

Slot B096, small amount of tar-like material seeping at joint, material was removed.

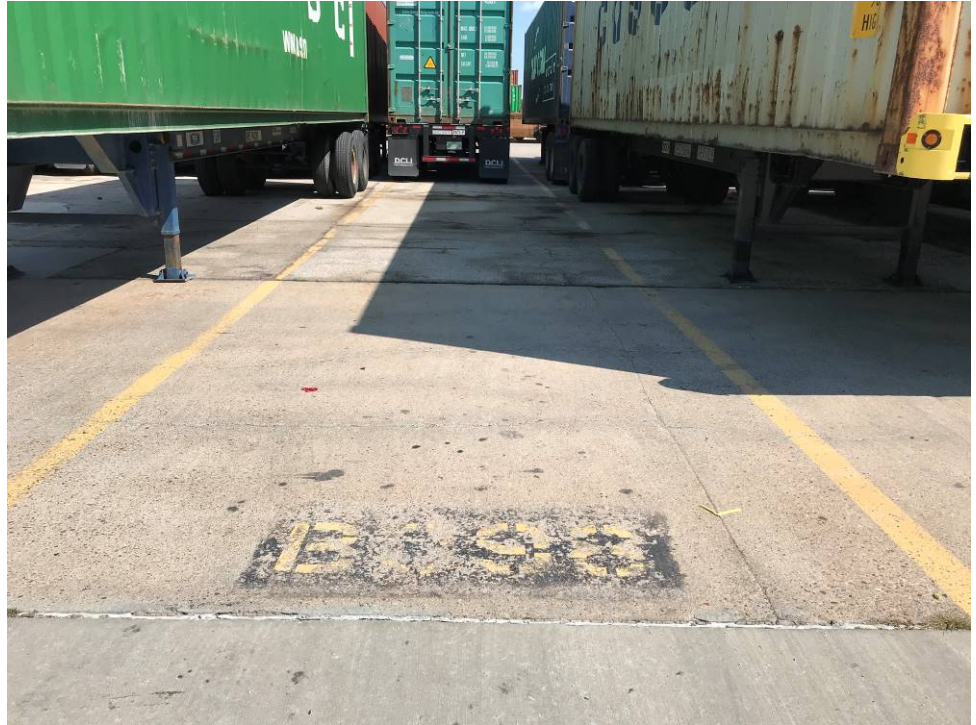
Photo No. 19	Date: 06/17/2020
Description: Slot B098, residual brown staining observed along the crack in the asphalt, looking north. Lat: 29.784236 Long: -95.320642

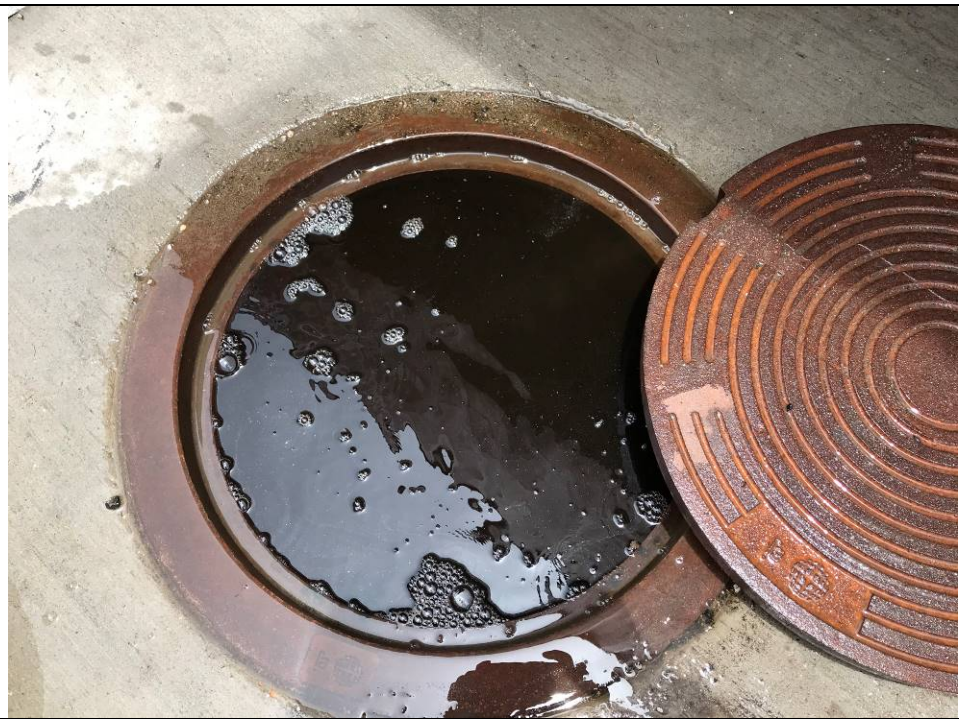
Photo No. 20	Date: 06/25/2020
-------------------------------	----------------------------

Description: Sump B099/B100, 0 inches of freeboard in sump, no sheen or odors noted, water from recent rain event on pavement. Sump was pumped down by USES on 5/22. Lat: 29.7844000 Long: - 95.3205861	
---	--

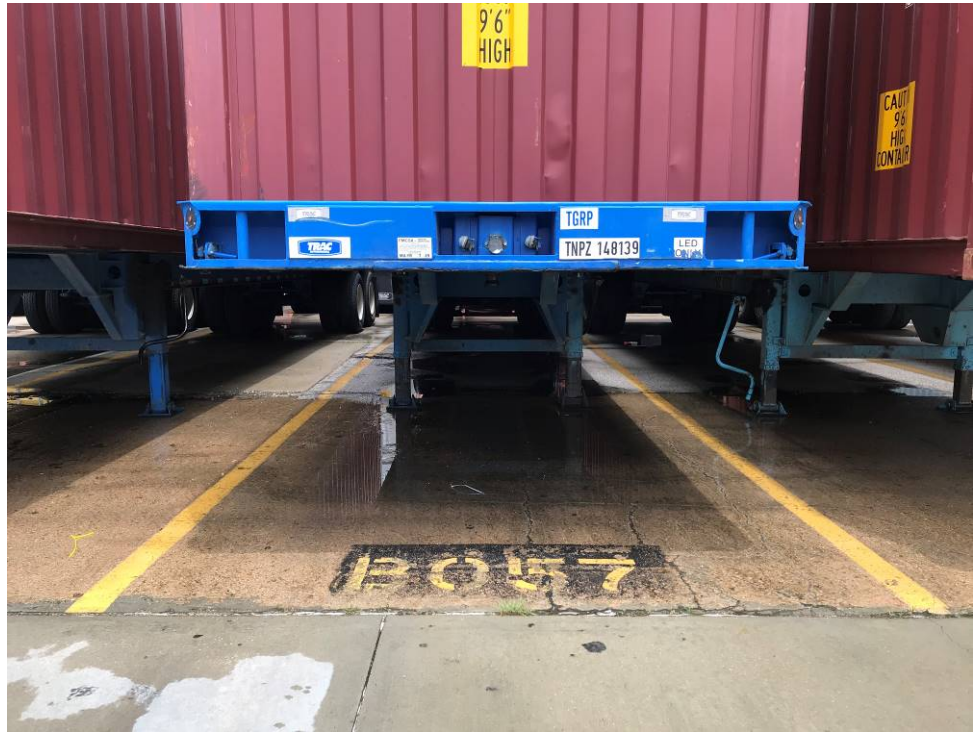
Photo No.
21

Slot B057, no tar-like material seeps observed, water from recent rain event on pavement, looking north.

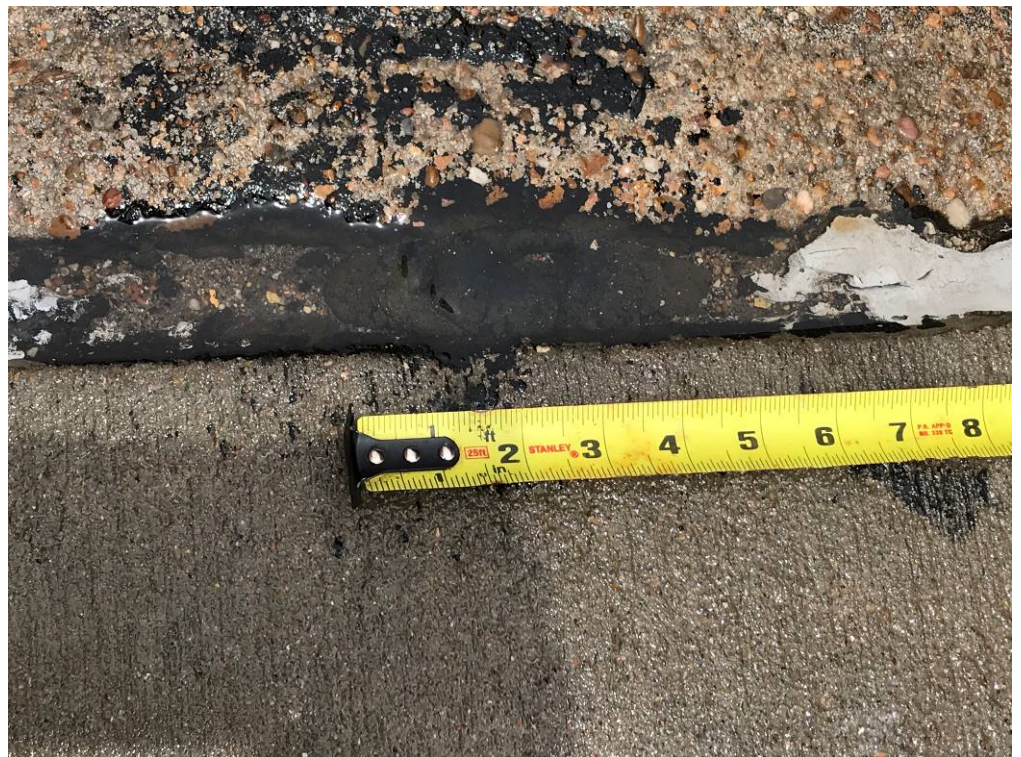
Photo No.
22

Slot B096, small amount of tar-like material seeping at joint, material was removed, water from recent rain event on pavement.

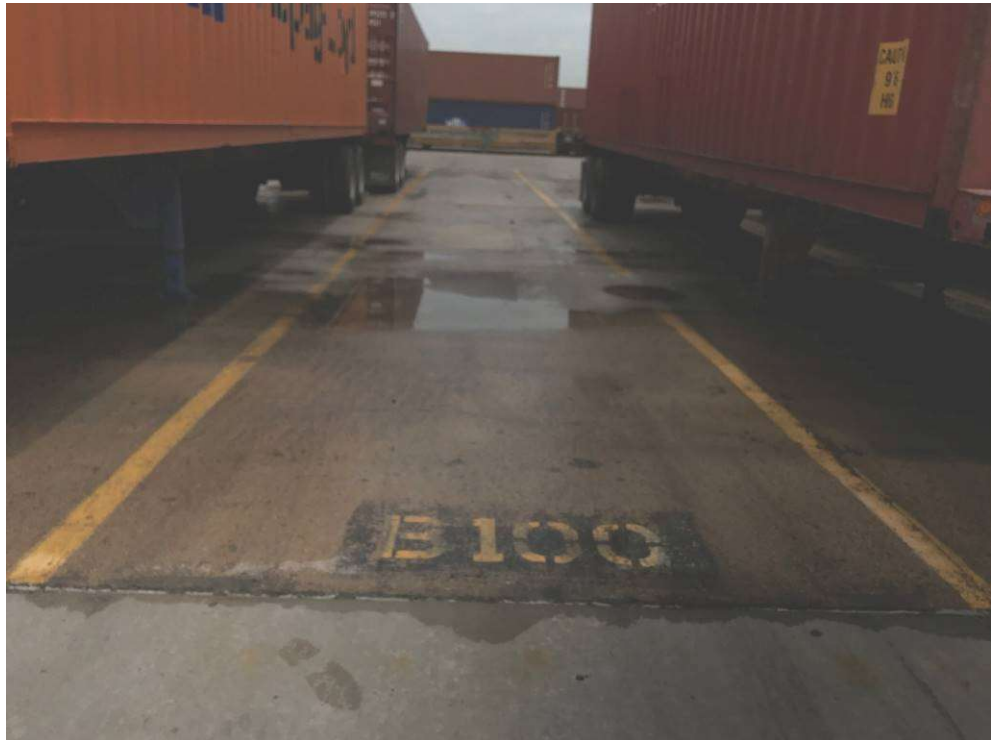
Photo No.
23

Slot B100, view of NAPL Collection System (Sump 099/100 in background). No tar-like material seeps observed, water from rain event on pavement, looking north.

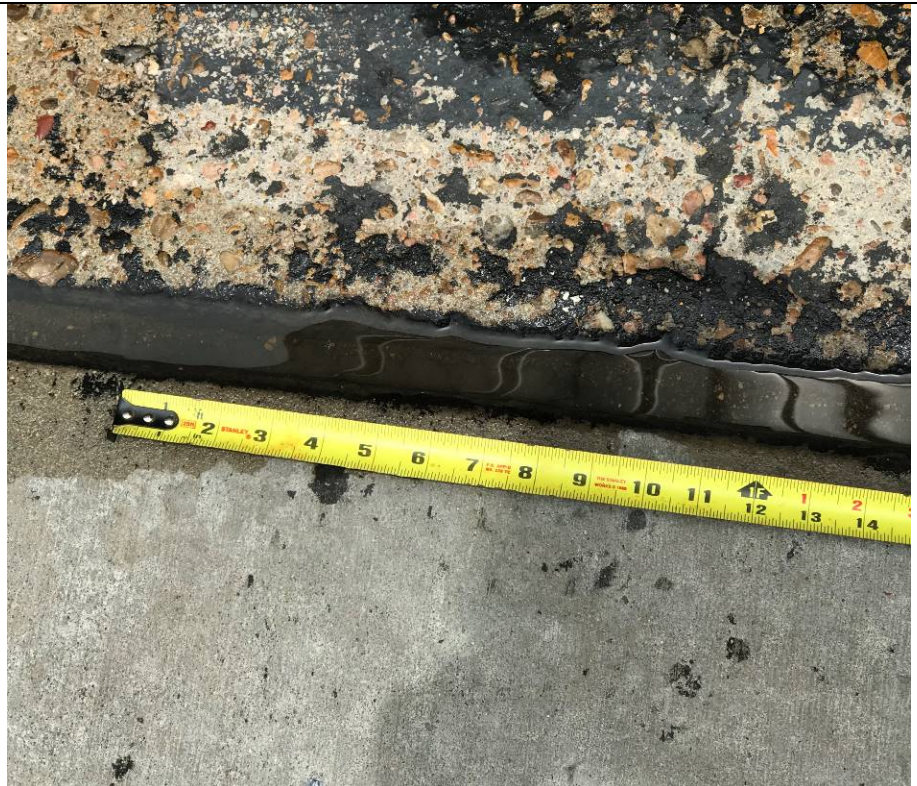
Photo No.
24

Slot B102, small amount of tar-like material seeping at joint, material was removed, water from recent rain event in joint.

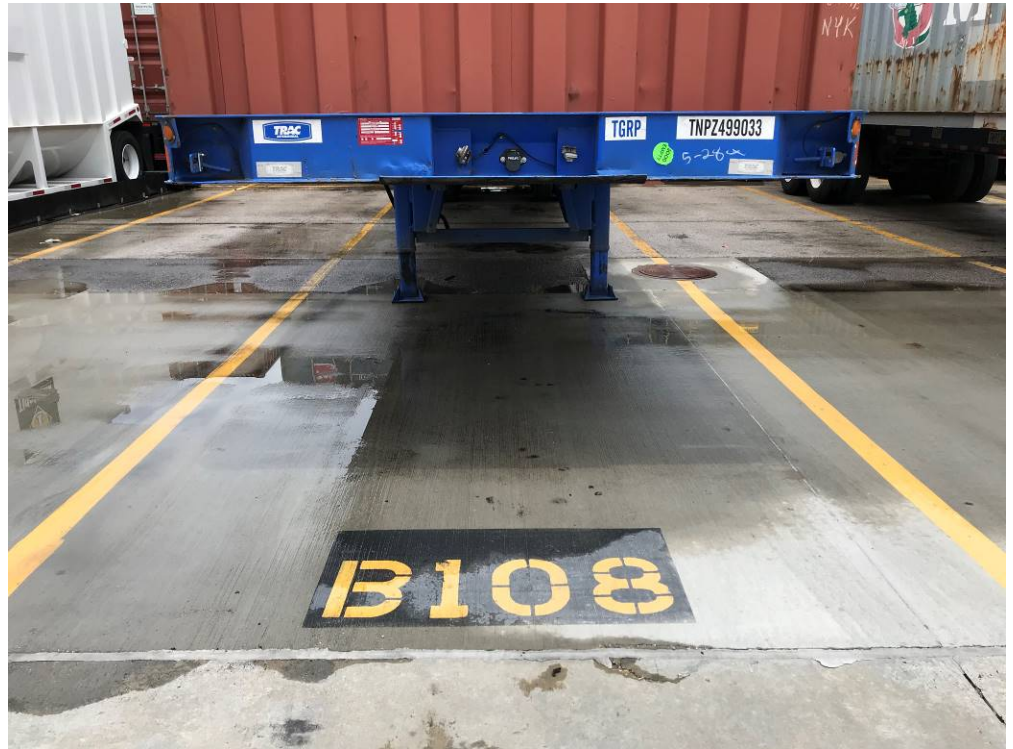
Photo No.
25

Slot B108, view of NAPL Collection System (Sump 107/108 in background). No tar-like material seeps observed, water from recent rain event on pavement, looking north.

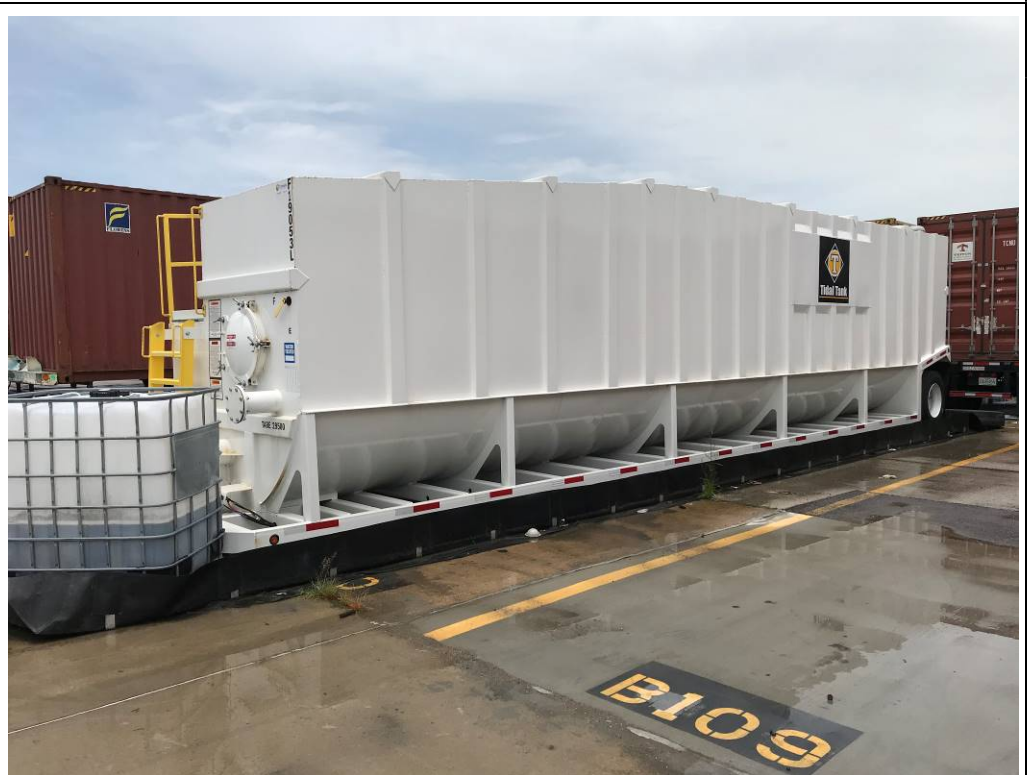
Photo No.
26

Frac tank for storage of pumped down water from NAPL Collection Sumps (in Slot B110) and tote for storage of recovered pressure wash water/brown water, water from recent rain event on pavement, looking northwest.
