Project No. 19119232

**RE: MONTHLY STATUS UPDATE – ENGLEWOOD INTERMODAL YARD – NAPL COLLECTION SYSTEM/CONCRETE CAP REPAIRS
UNION PACIFIC RAILROAD HOUSTON WOOD PRESERVING WORKS FACILITY
4910 LIBERTY ROAD FACILITY, HOUSTON, TEXAS
POST-CLOSURE CARE PERMIT NO. HW-50343; INDUSTRIAL SWR NO. 31547**

Weekly Inspection Photolog

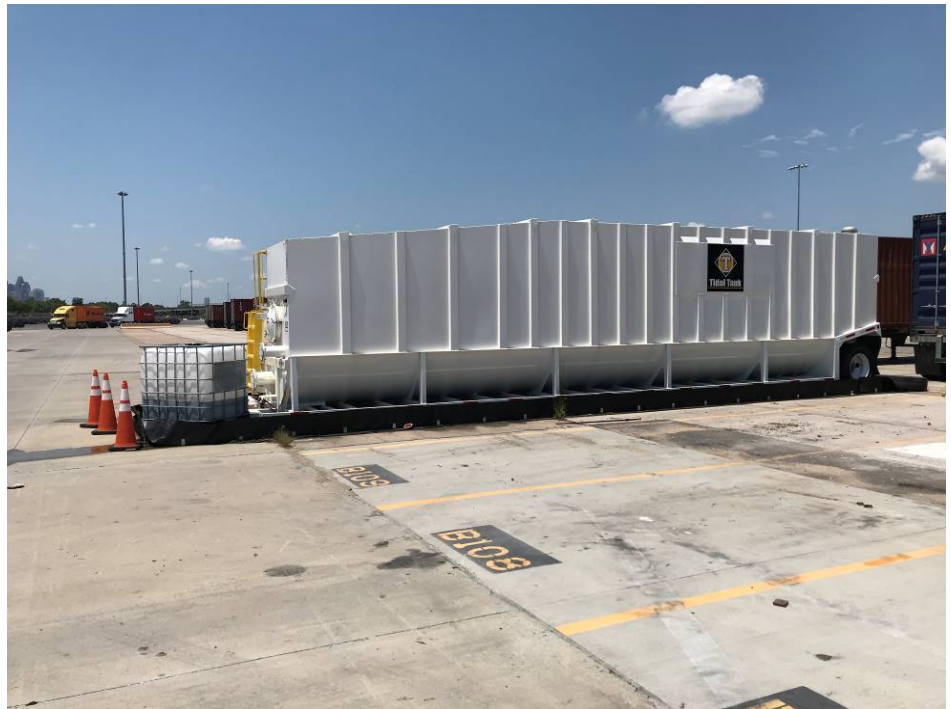
Photo No. 1	Date: 08/05/2020
Description: Frac tank for storage of pumped down water from NAPL Collection Sumps (in Slot B110) and tote for storage of recovered pressure wash water/brown water, water from recent rain event on pavement, looking northwest. Lat: 29.7841028 Long: - 95.3209833

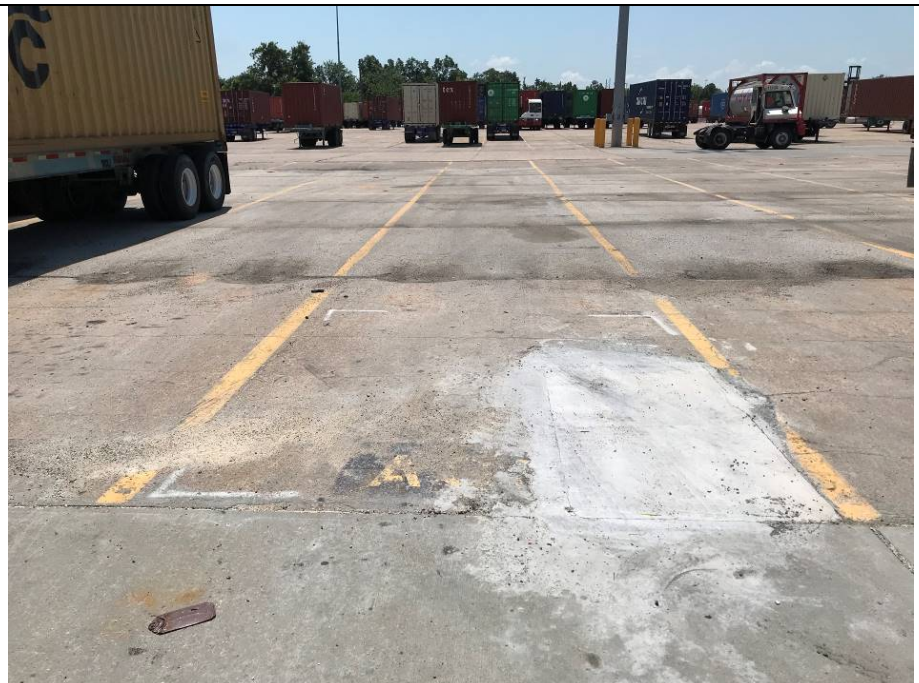
Photo No. 2	Date: 08/05/2020
------------------------------	----------------------------

Description: Slot A021, no tar-like material seeps observed, looking south. Lat: 29.785392, Long: -95.318655	
--------------------------------------------------------------------------------------------------------------------------------------	--

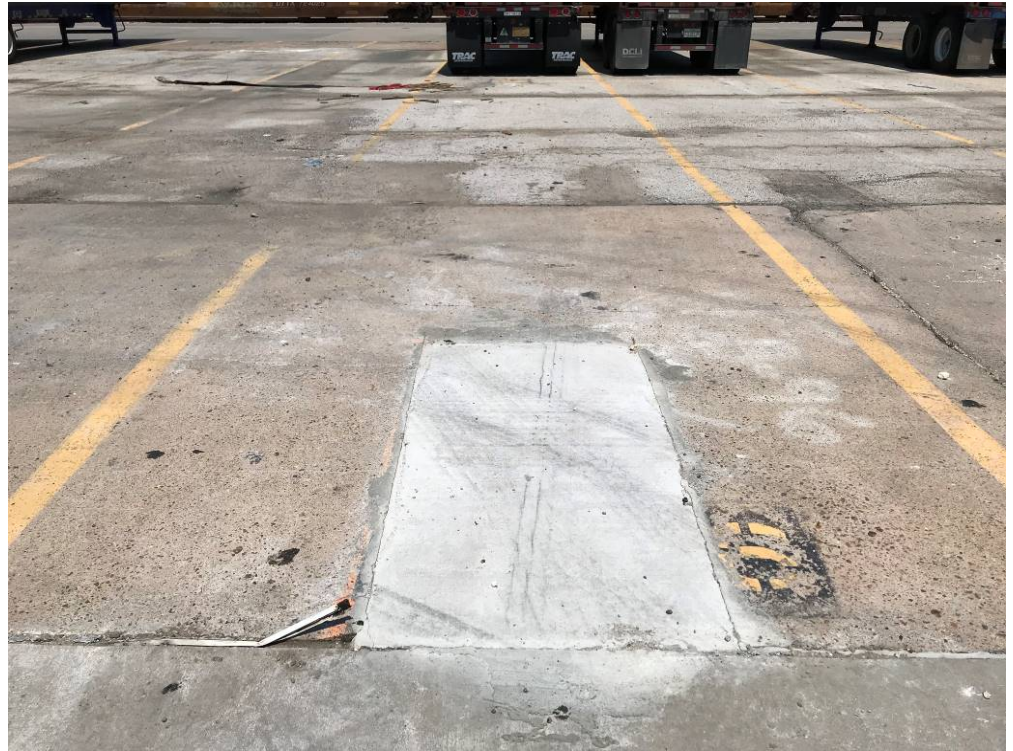
Photo No.
3

Slot B096, no tar-like material seeps observed, looking north.

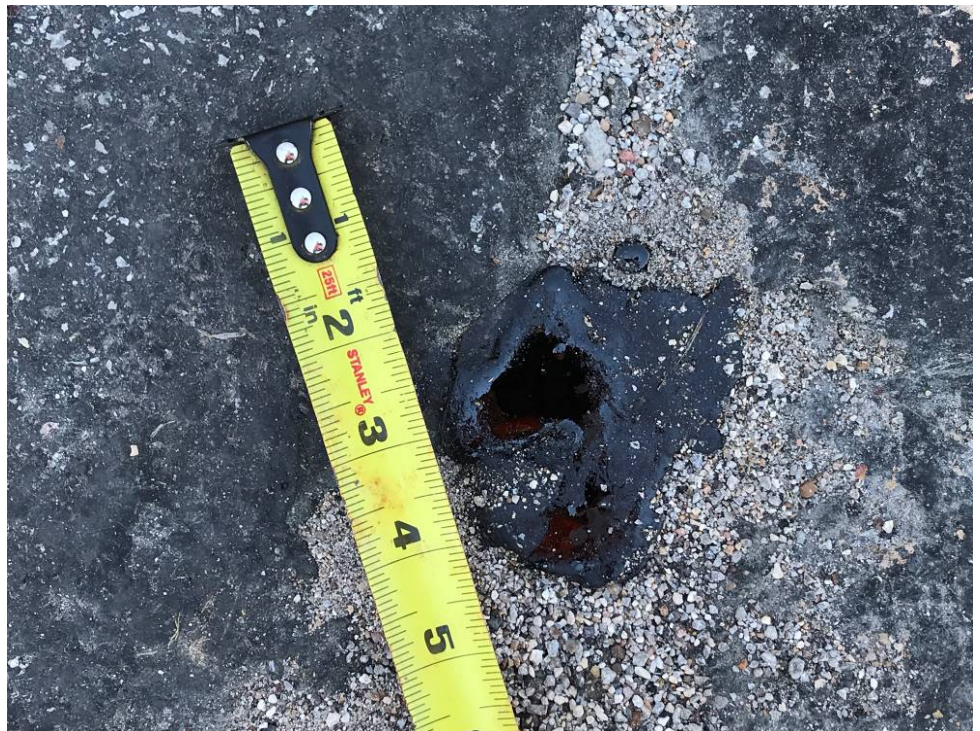
Photo No.
4

Slot B101, small amount of tar-like material seeping at asphalt crack, material was removed.

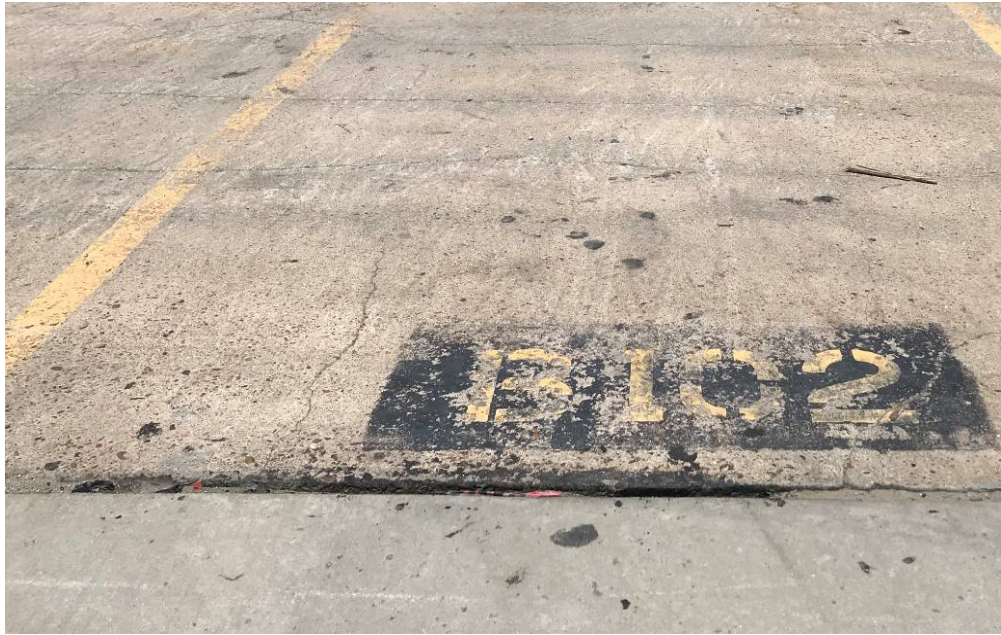
Photo No. 5	Date: 08/05/2020
-----------------------	----------------------------

Slot B102, small amount of tar-like material seeping at joint, material was removed.

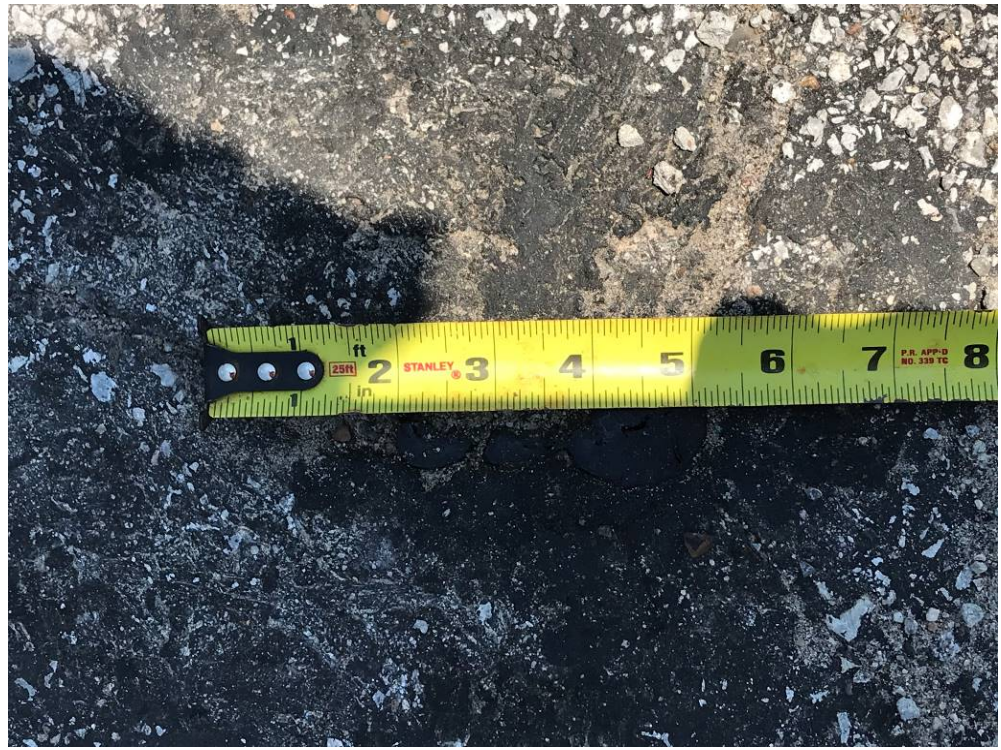
Photo No. 6	Date: 08/05/2020
-----------------------	----------------------------

Slot B105, very small amount of tar-like material seeping at asphalt crack, material was removed.

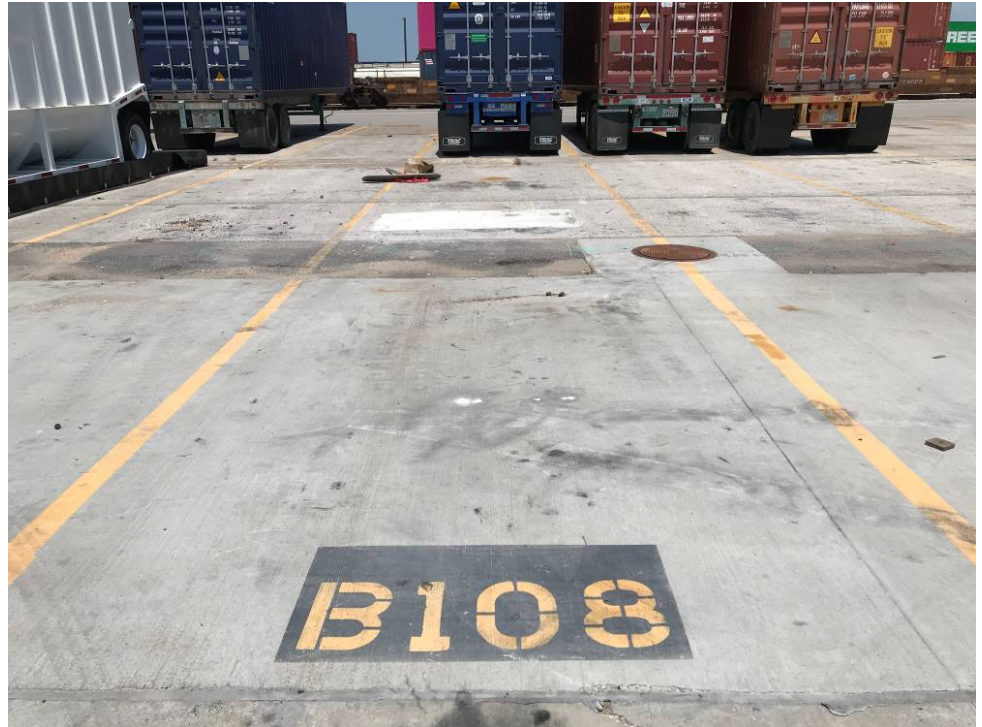
Photo No.
7

Slot B108, view of NAPL Collection System (Sump 107/108 in background). No tar-like material seeps observed, looking north.

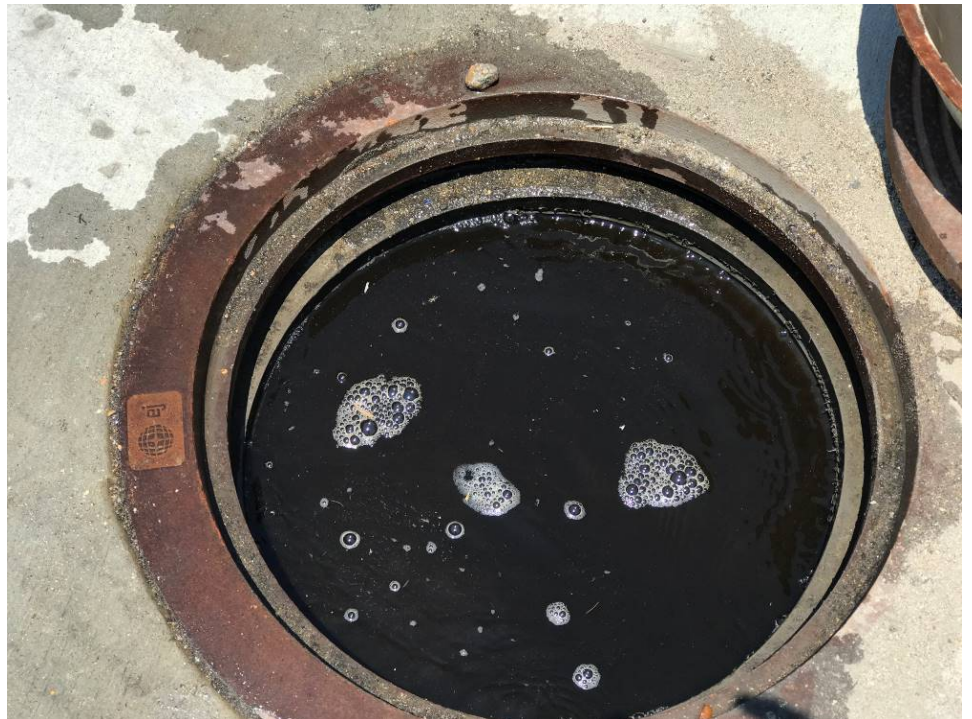
Photo No.
8

Sump 1 (B099/B100), 0 inches of freeboard in sump, no sheen or odors noted.

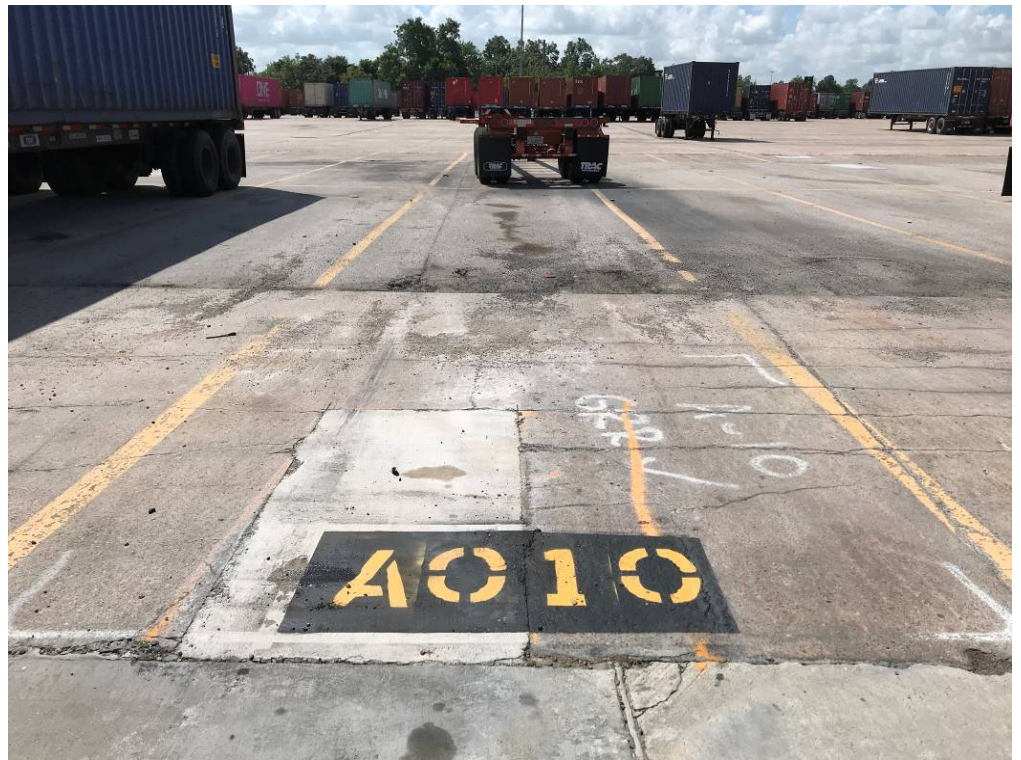
Photo No.
9

Slot A010, no tar-like material seeps observed, looking south.

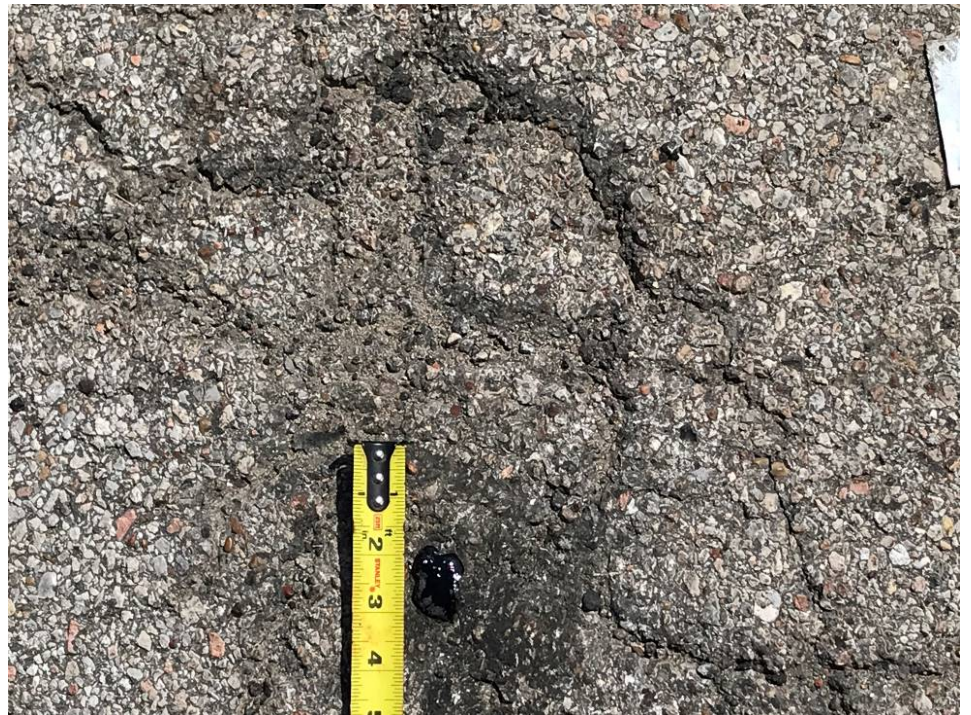
Photo No.
10

Slot B057, very small amount of tar-like material seeping at asphalt crack, material was removed.

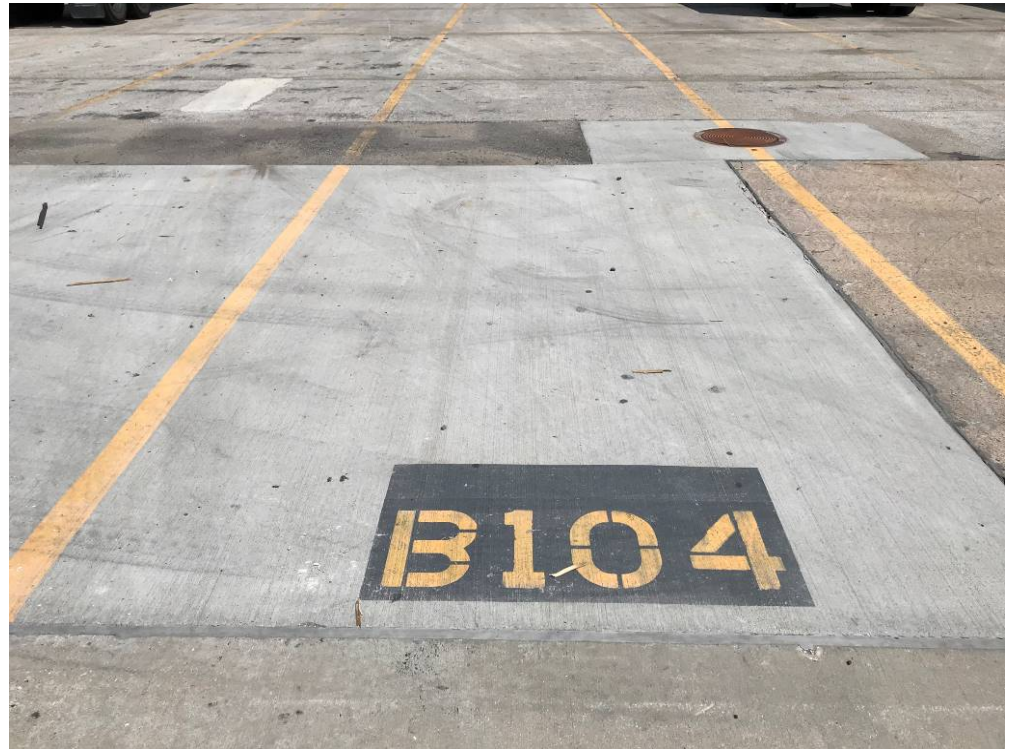
Photo No.
11

Slot B104, view of NAPL Collection System (Sump 103/104 in foreground). No tar-like material seeps observed, looking north.

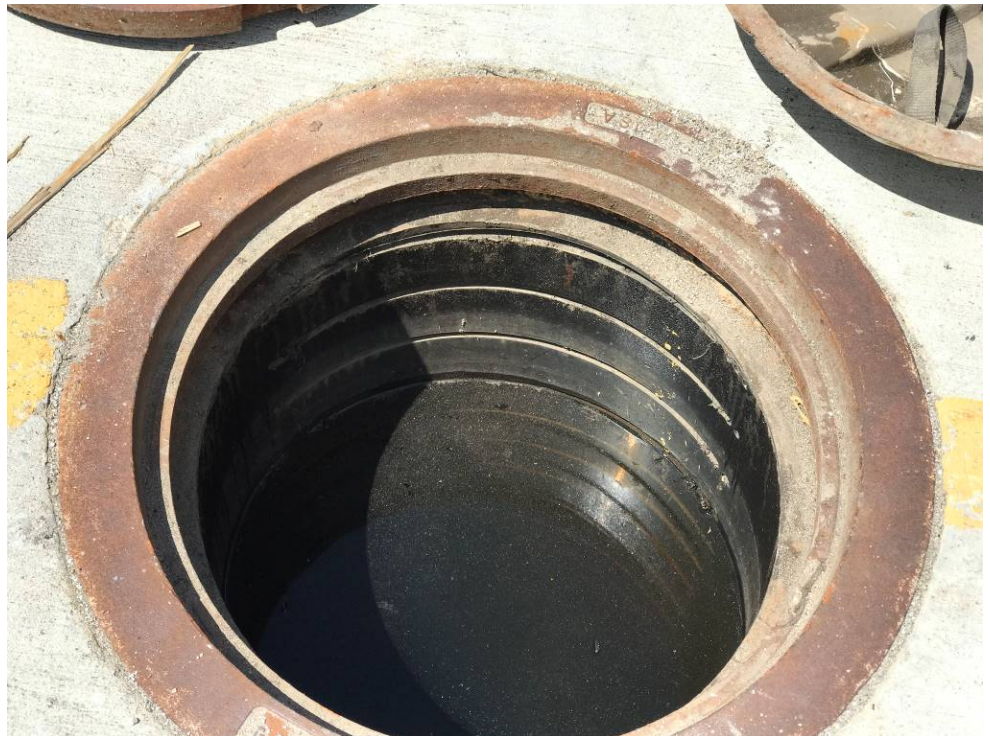
Photo No.
12

Sump 2 (B103/B104), 11 inches of freeboard in sump, no sheen or odors noted.

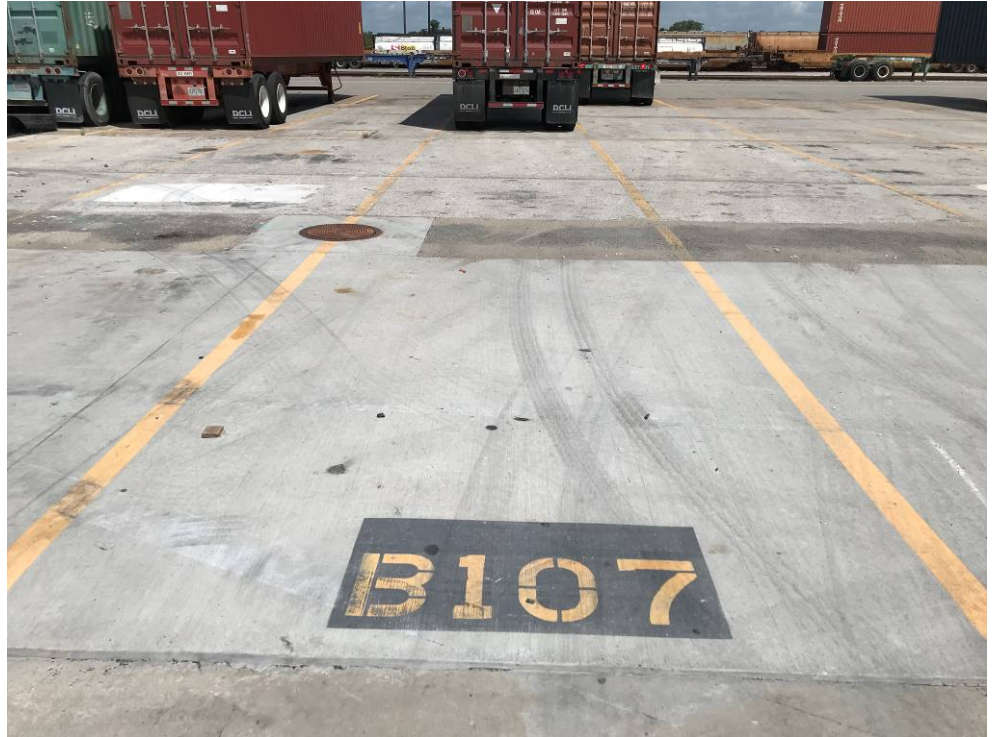
Photo No.
13

Slot B107, view of NAPL Collection System (Sump 3 (B107B/108) in background). No tar-like material seeps observed, looking north.

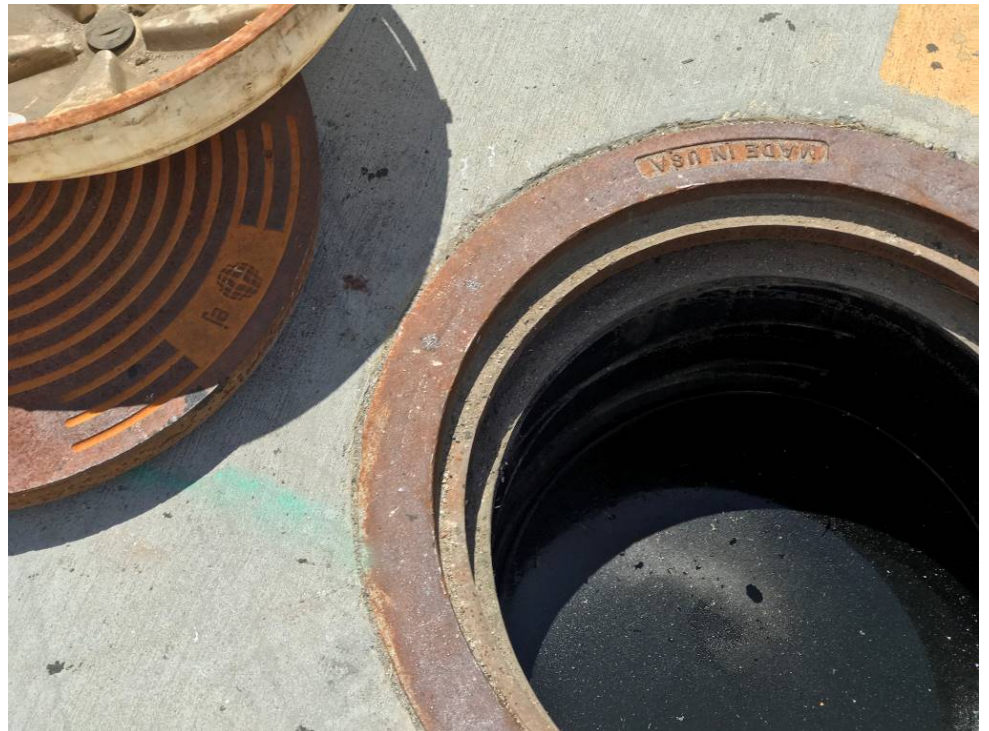
Photo No.
14

Sump 3 (B107/B108), 10 inches of freeboard in sump. No sheen, odor, or tar-like material observed.

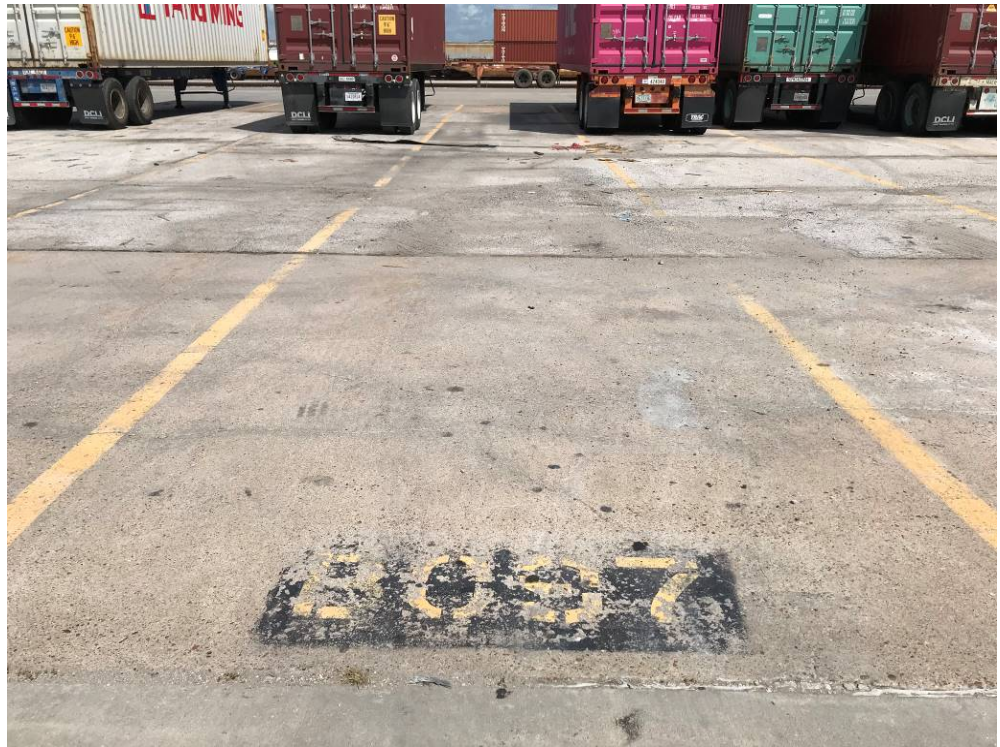
Photo No. 15	Date: 08/12/2020
Description: Slot B097, residual brown staining observed along the crack in the asphalt, looking north. Lat: 29.784402 Long: -95.320520

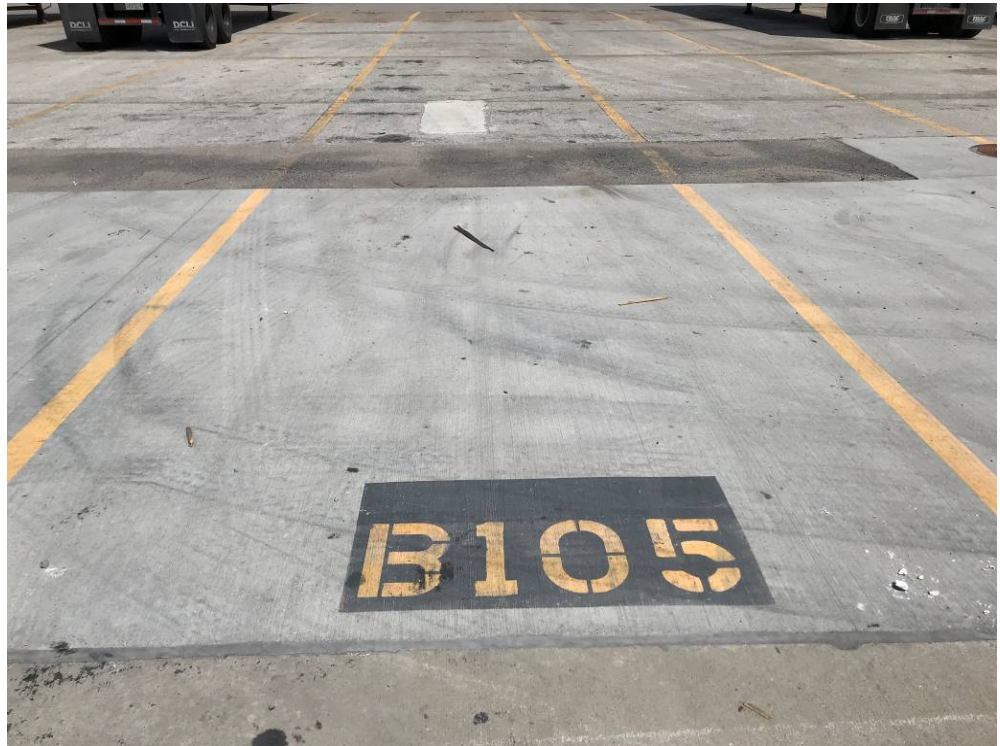
Photo No. 16	Date: 08/12/2020
Description: Slot B105, no tar-like material seeps observed, looking north. Lat: 29.7841472 Long: - 95.3208777

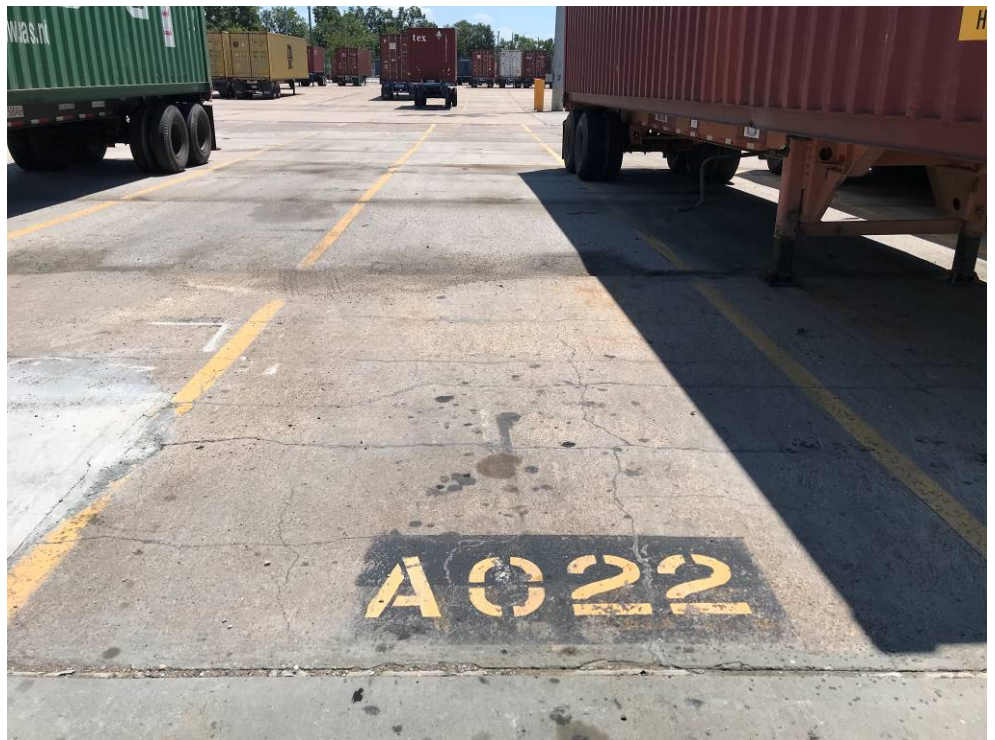
Photo No.
17

Slot A022, no tar-like material seeps observed, looking south.

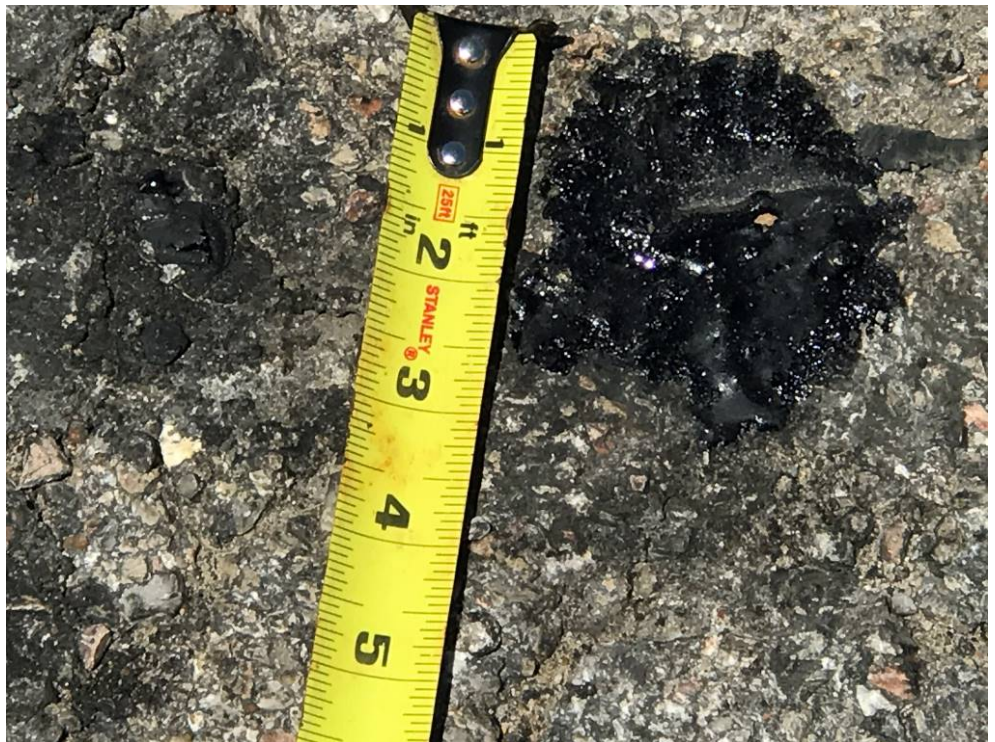
Photo No.
18

Slot B057, very small amount of tar-like material seeping at asphalt crack, material was removed.

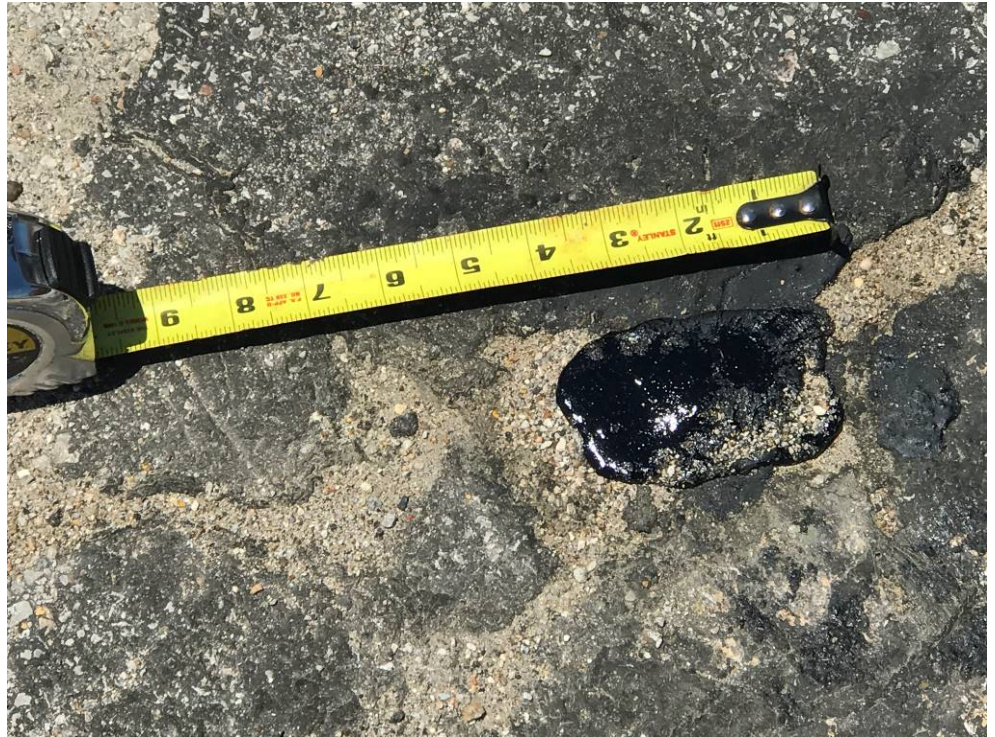
Photo No.
19

Slot B101, small amount of tar-like material seeping at asphalt crack. Material was removed.

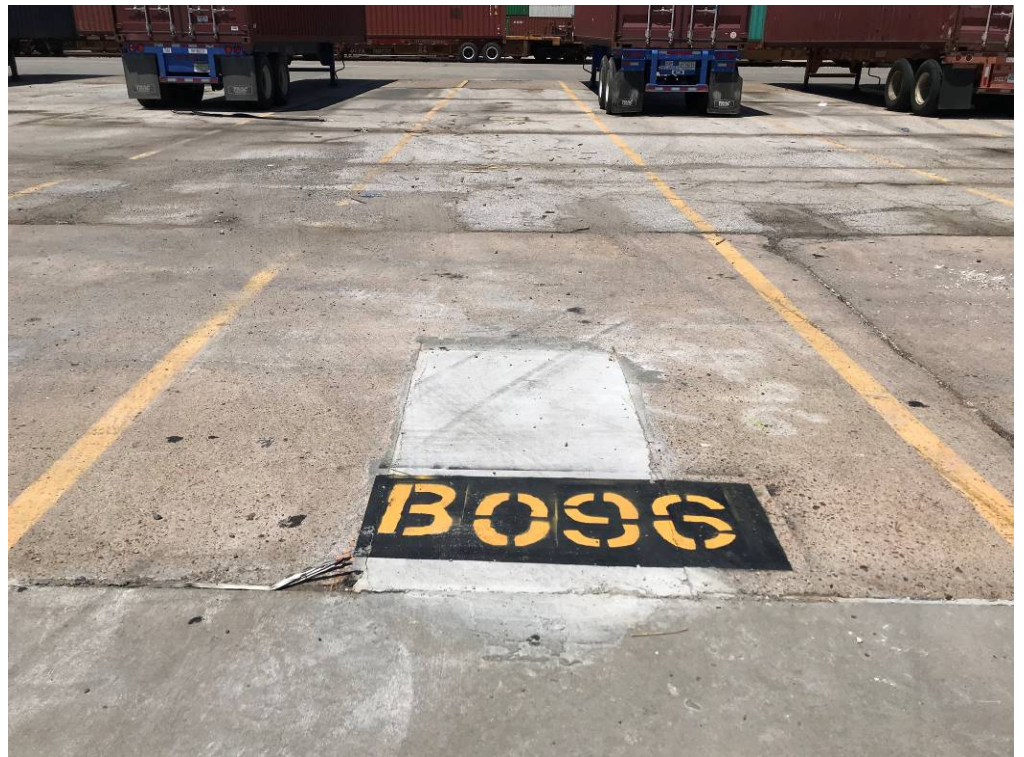
Photo No.
20

Slot B096, no tar-like material seeps observed, looking north.

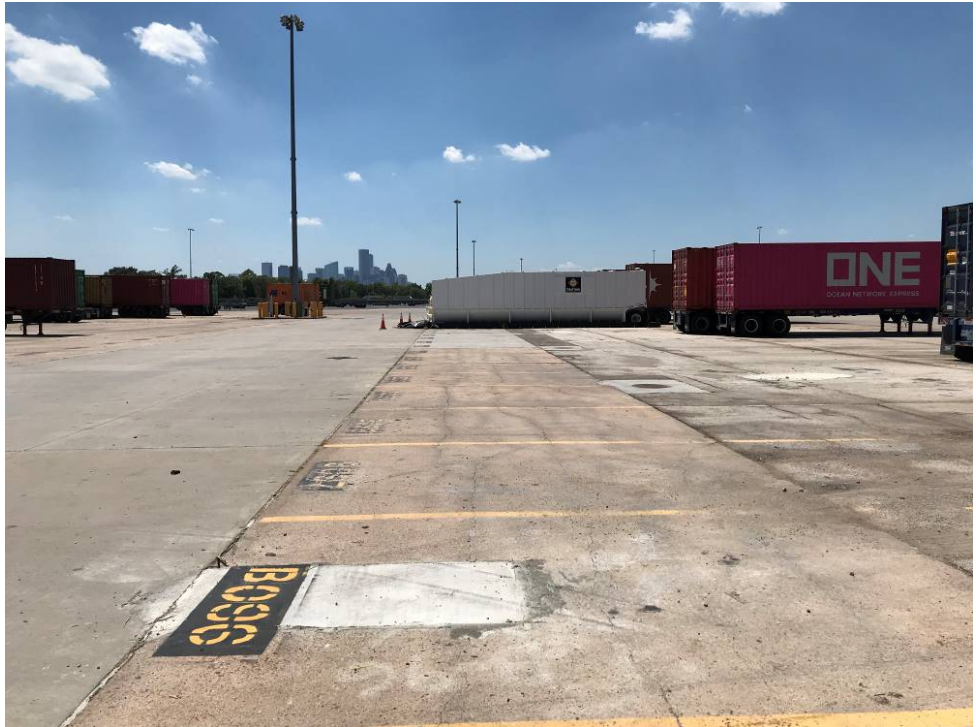
Photo No. 21	Date: 08/19/2020
Description: Slots B097-B110, NAPL collection system visible in background, residual brown staining observed along the crack in the asphalt, looking west. Lat: 29.784236 Long: -95.320642

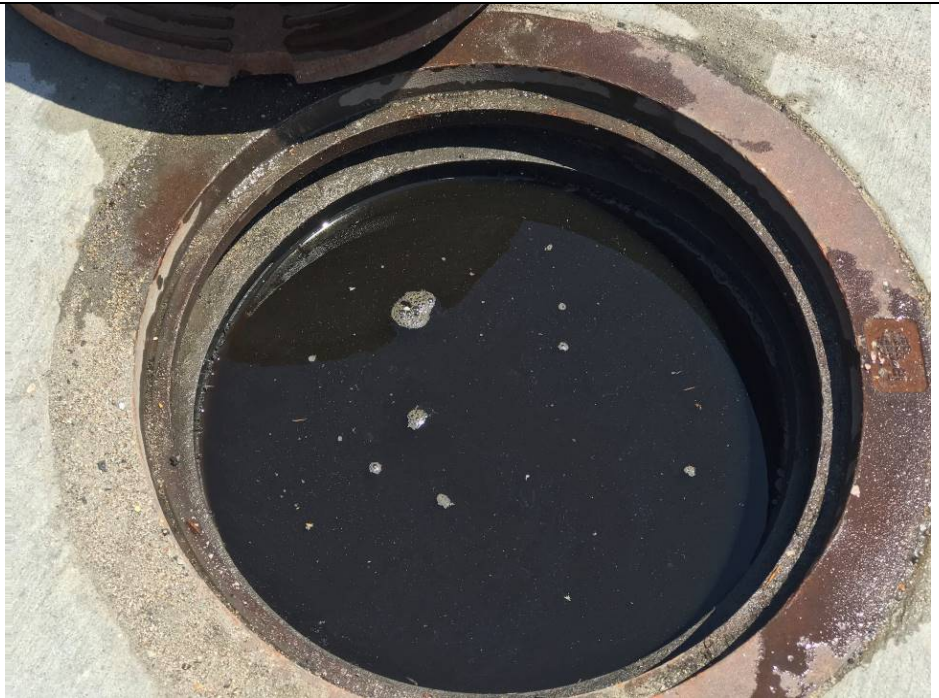
Photo No. 22	Date: 08/19/2020
-------------------------------	----------------------------

Description: Sump 1 (B099/B100), 0 inches of freeboard in sump, no sheen or odor noted. Lat: 29.7844000 Long: - 95.3205861	
----------------------------------------------------------------------------------------------------------------------------------------------------	--

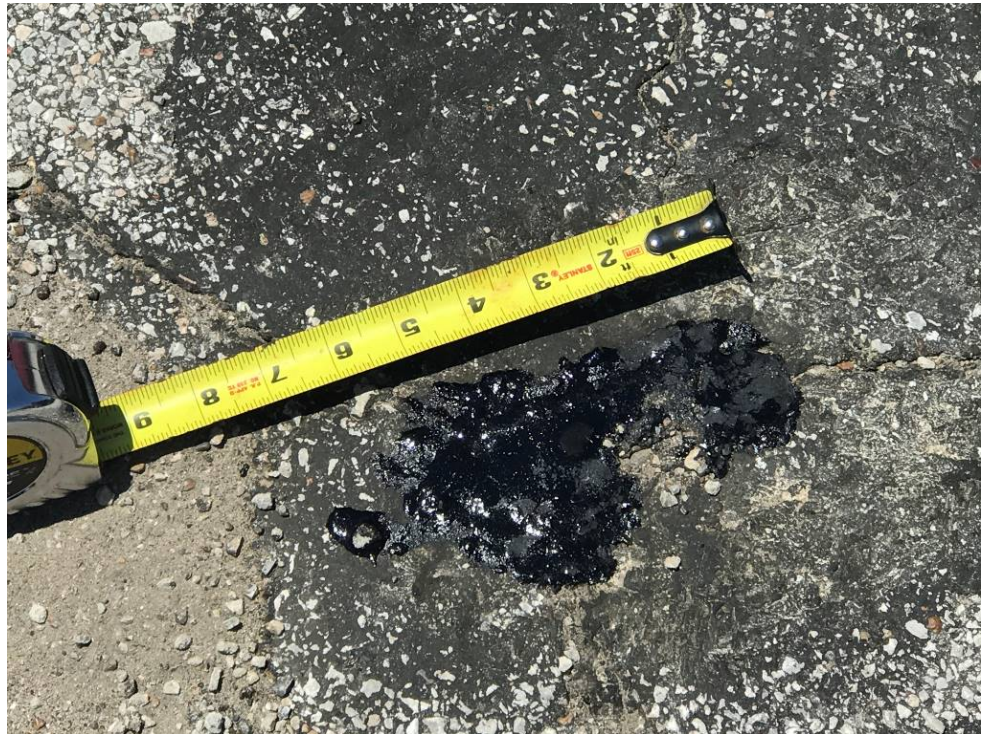
Photo No.
23

Slot B105, very small amount of tar-like material seeping at asphalt crack, material was removed.

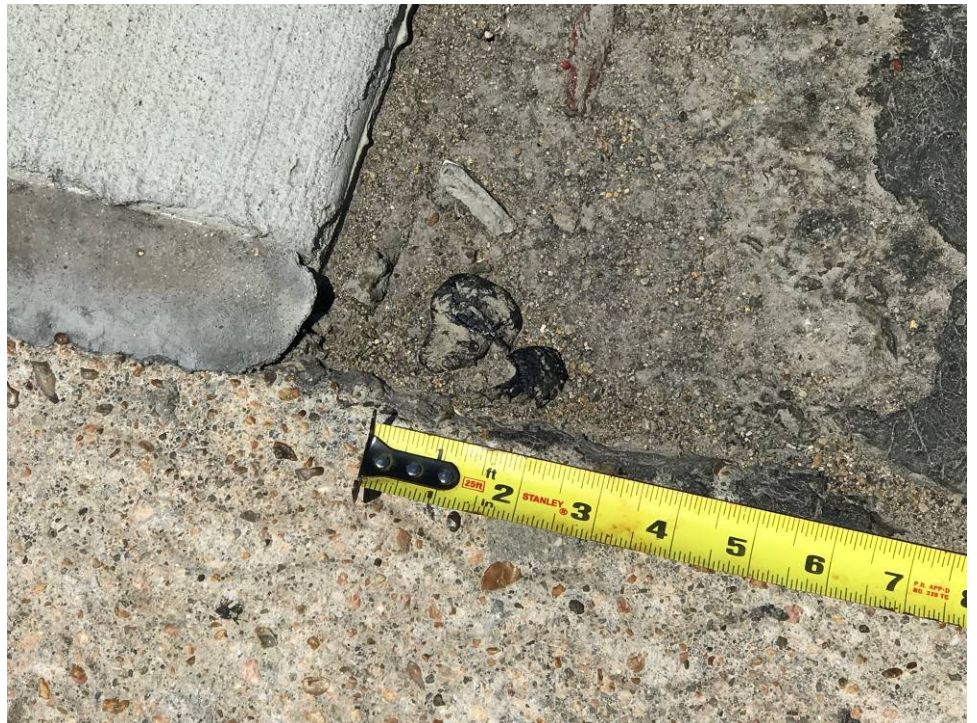
Photo No.
24

- A small amount of tar-like NAPL was observed seeping at a joint immediately adjacent to the NAPL Collection System in slot B103 on August 19, 2020 (see photolog). No other seeps were observed within the NAPL Collection System area. For areas outside the NAPL Collection System, very small amounts of tar-like material were noted on the concrete surface in stalls B057, B101, B102, and B105 where previous seeps have been observed. The overall amount of material recovered during August 2020 decreased slightly from July 2020 with a total of less than 1 gallon of the tar-like material recovered.

Slot B103, very small amount of tar-like material seeping at joint. Material was removed.

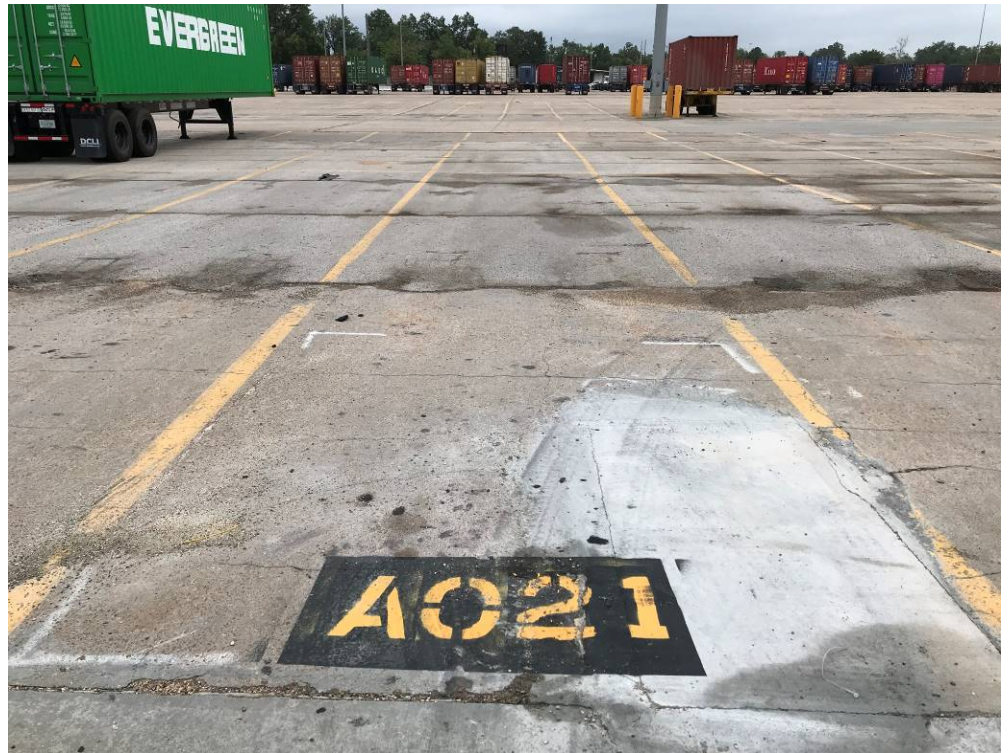
Photo No.
25

Slot A021, no tar-like material seeps observed, looking south.

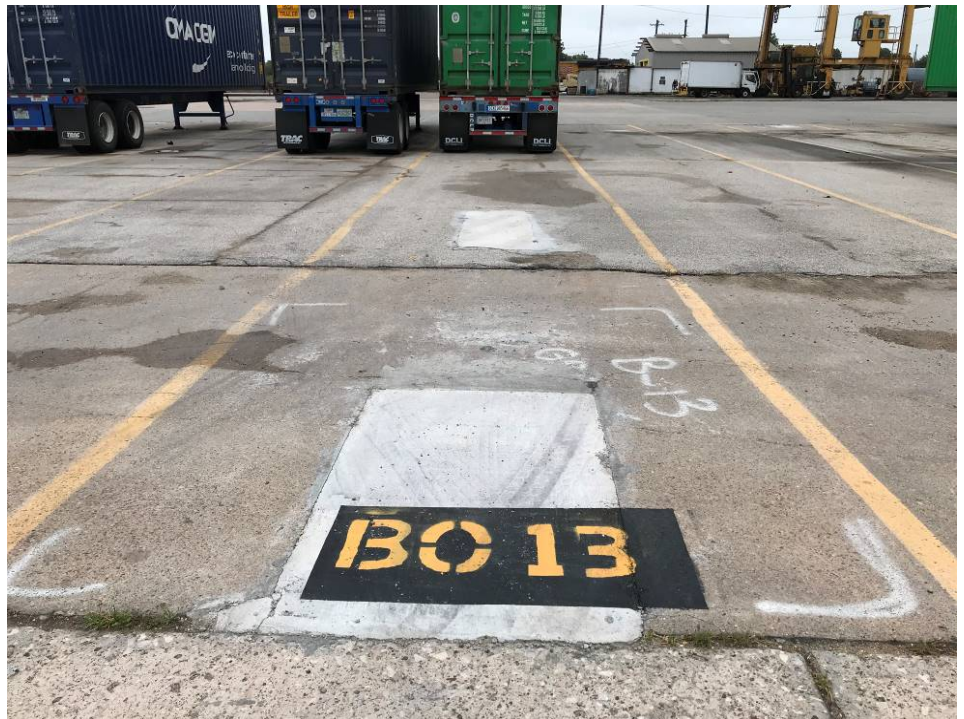
Photo No.
26

Slot B013, no tar-like material seeps observed, looking north.

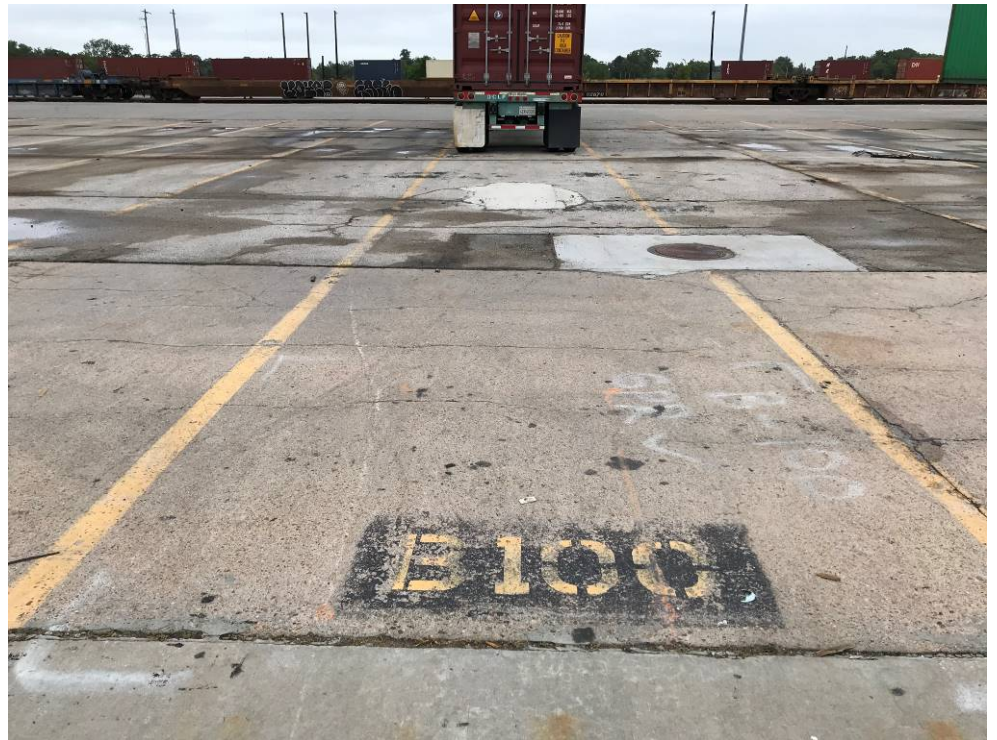
Photo No.
27

Slot B100, view of NAPL Collection System (Sump 099/100 in background). Standing brown water observed along asphalt cracks. Area wet from recent rainfall event. No tar-like material seeps observed, looking north.

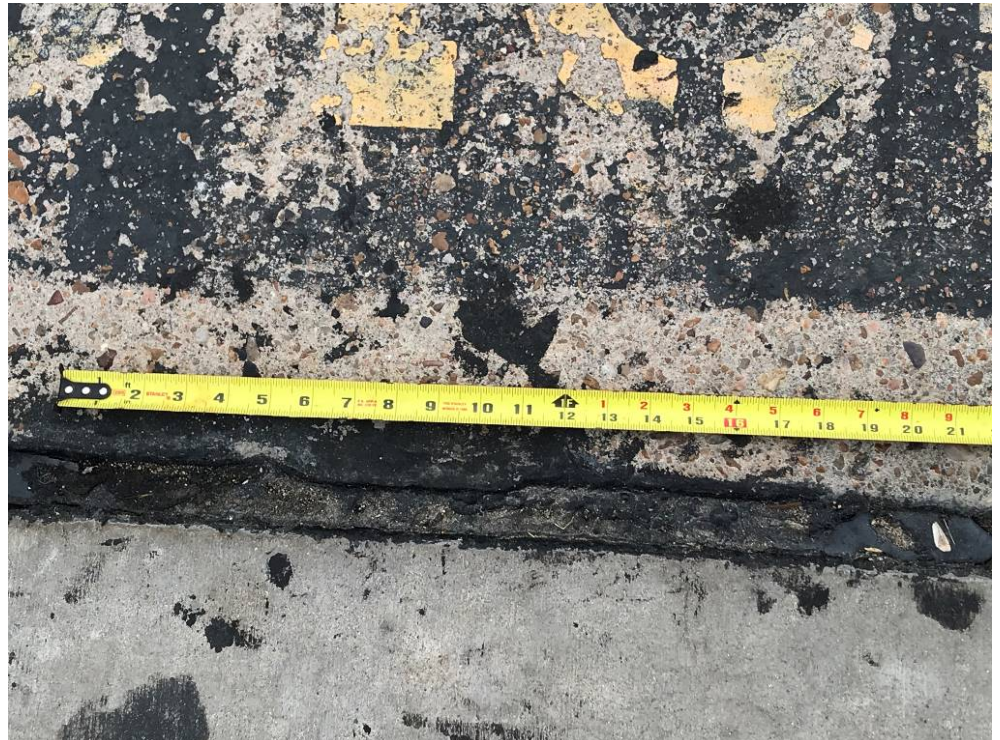
Photo No.
28

Slot B102, small amount of tar-like material seeping at joint, material was removed.

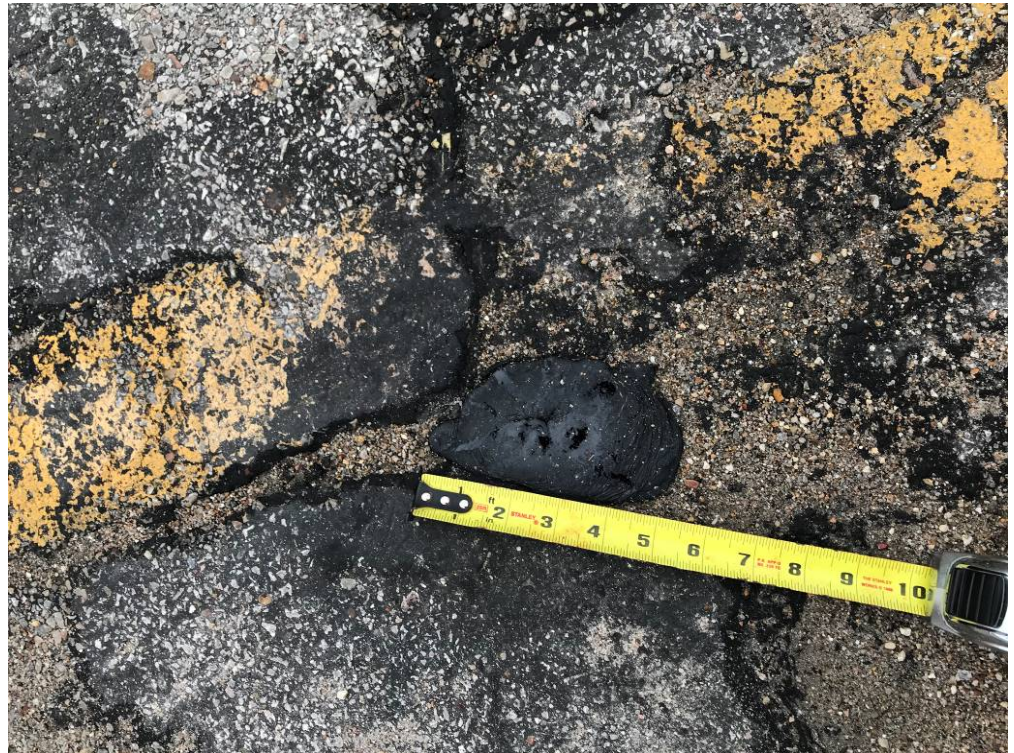
Photo No. 29	Date: 08/26/2020
Description: Slot B101, very small amount of tar-like material seeping at asphalt crack. Material was removed. Lat: 29.784275 Long: - 95.320813

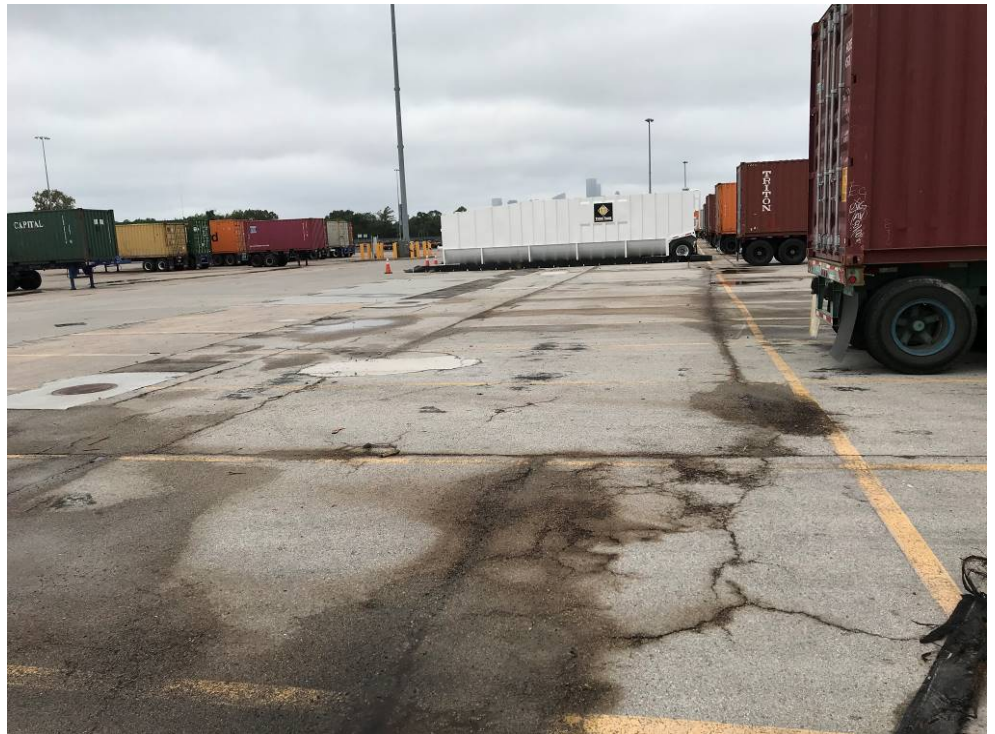
Photo No. 30	Date: 08/26/2020
Description: Slots B097-B110, NAPL collection system visible in background, standing brown water observed along the cracks in the asphalt, looking west. Area wet from recent rainfall event. Lat: 29.784236 Long: -95.320642
