Project No. 19119232

**RE: MONTHLY STATUS UPDATE – ENGLEWOOD INTERMODAL YARD – NAPL COLLECTION SYSTEM/CONCRETE CAP REPAIRS
UNION PACIFIC RAILROAD HOUSTON WOOD PRESERVING WORKS FACILITY
4910 LIBERTY ROAD FACILITY, HOUSTON, TEXAS
POST-CLOSURE CARE PERMIT NO. HW-50343; INDUSTRIAL SWR NO. 31547**

Weekly Inspection Photolog

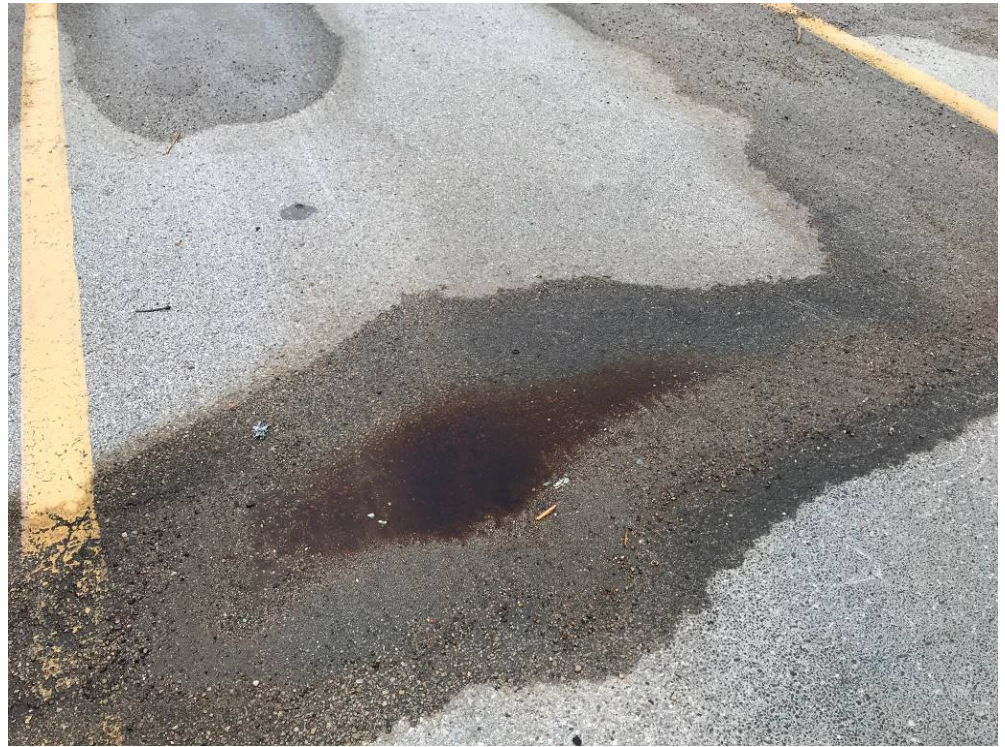
Photo No. 31	Date: 08/26/2020
Description: Slot A096, standing brown water observed. Area wet from recent rainfall event. Lat: 29.784442 Long: -95.320739

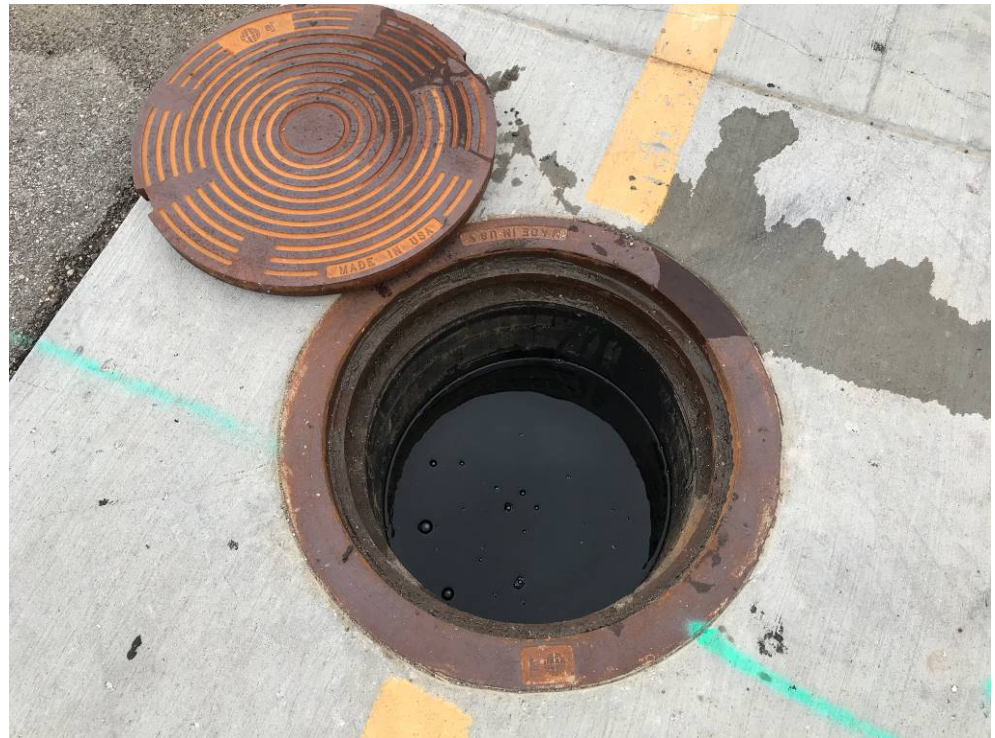
Photo No. 32	Date: 08/26/2020
Description: Sump 3 (B107/B108), 10 inches of freeboard in sump. No sheen, odor, or tar-like material observed. Lat: 29.7842861 Long: - 95.3208611
