Project No. 19119232

**RE: MONTHLY STATUS UPDATE – ENGLEWOOD INTERMODAL YARD – NAPL COLLECTION SYSTEM/CONCRETE CAP REPAIRS  
UNION PACIFIC RAILROAD HOUSTON WOOD PRESERVING WORKS FACILITY  
4910 LIBERTY ROAD FACILITY, HOUSTON, TEXAS  
POST-CLOSURE CARE PERMIT NO. HW-50343; INDUSTRIAL SWR NO. 31547**

## Weekly Inspection Photolog

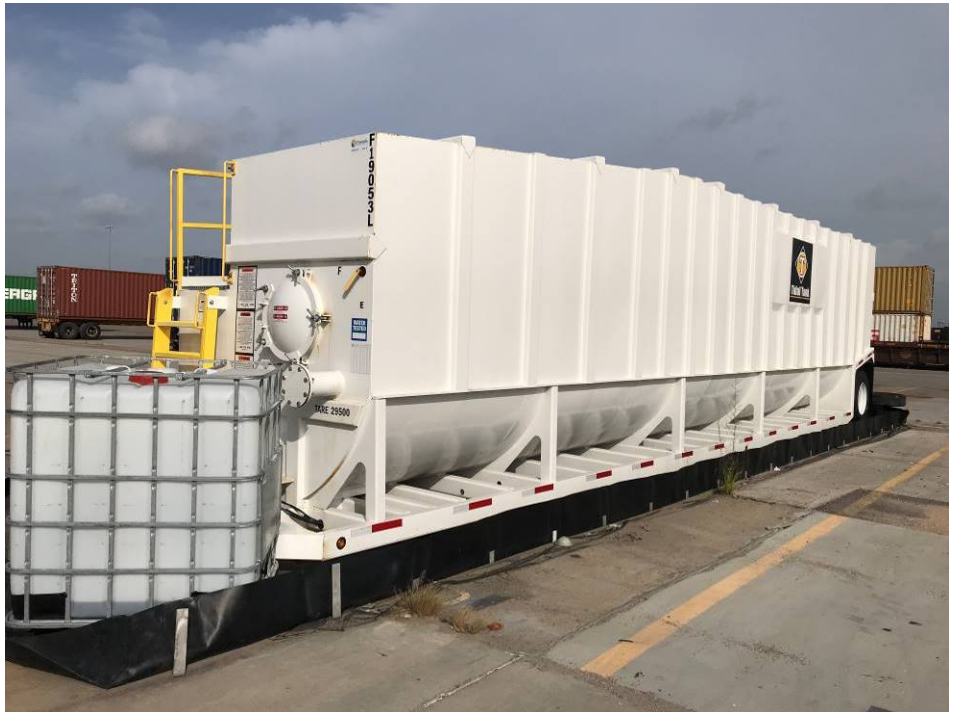
<b>Photo No.</b> 1	<b>Date:</b> 09/02/2020
<b>Description:</b>  Frac tank for storage of pumped down water from NAPL Collection Sumps (in Slot B110) and tote for storage of recovered pressure wash water/brown water, looking northwest.  Lat: 29.7841028 Long: - 95.3209833

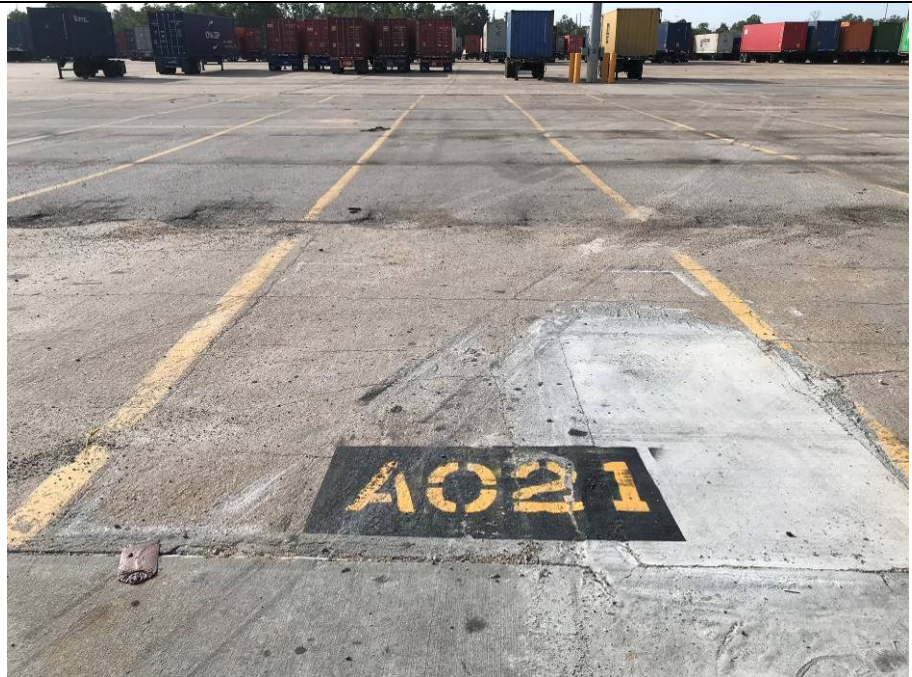
<b>Photo No.</b> 2	<b>Date:</b> 09/02/2020
-----------------------	----------------------------

<b>Description:</b>  Slot A021, no tar-like material seeps observed where test pit (July 2020) conducted, looking south.  Lat: 29.785392, Long: -95.318655	
---	--

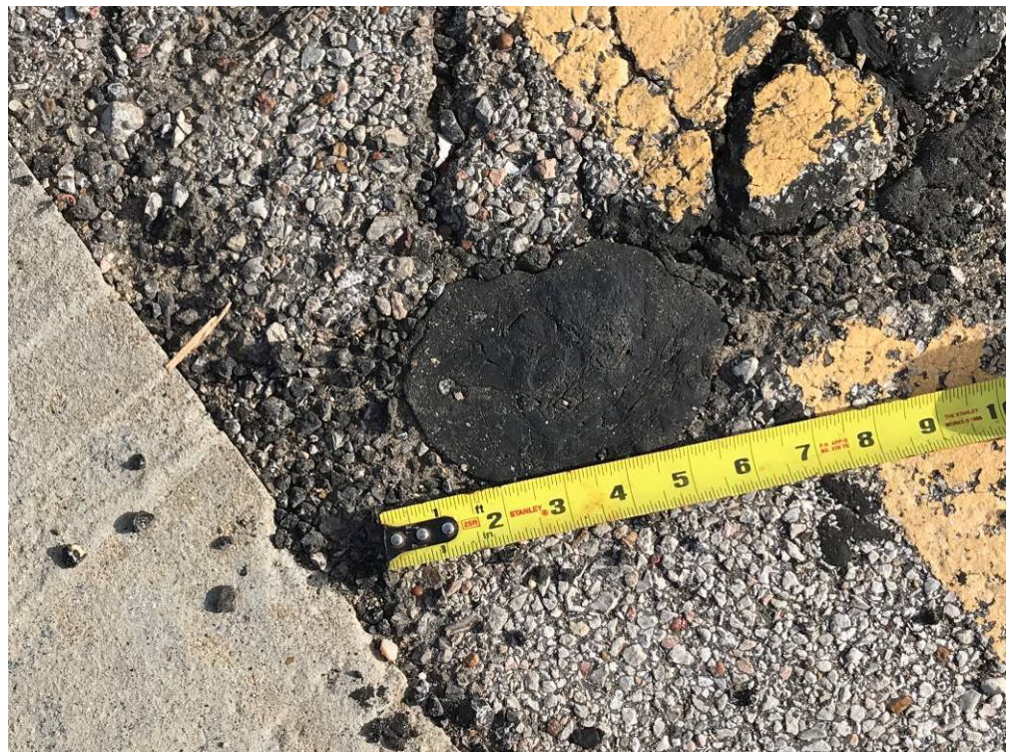
<b>Photo No.</b> 3	<b>Date:</b> 09/02/2020
<b>Description:</b>  Slot B057, small amount of tar-like material seeping at asphalt crack (not near test pit), material was removed.  Lat: 29.7847472 Long: - 95.3195417

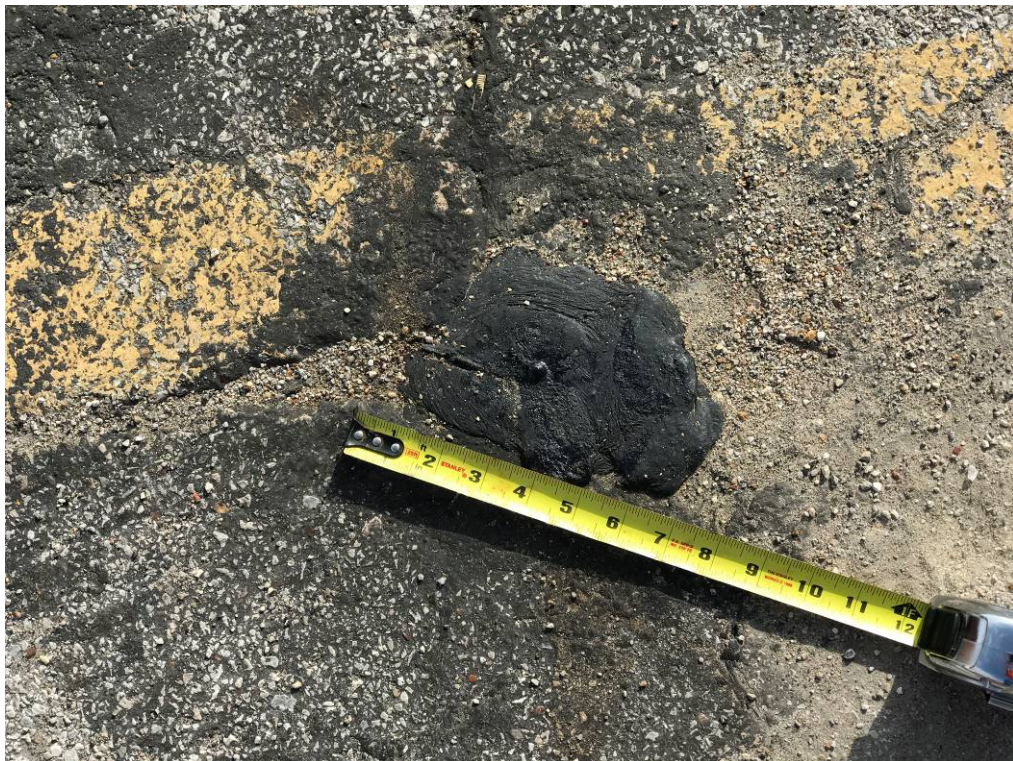
<b>Photo No.</b> 4	<b>Date:</b> 09/02/2020
<b>Description:</b>  Slot B101, small amount of tar-like material seeping at asphalt crack, material was removed.  Lat: 29.784275 Long: - 95.320813

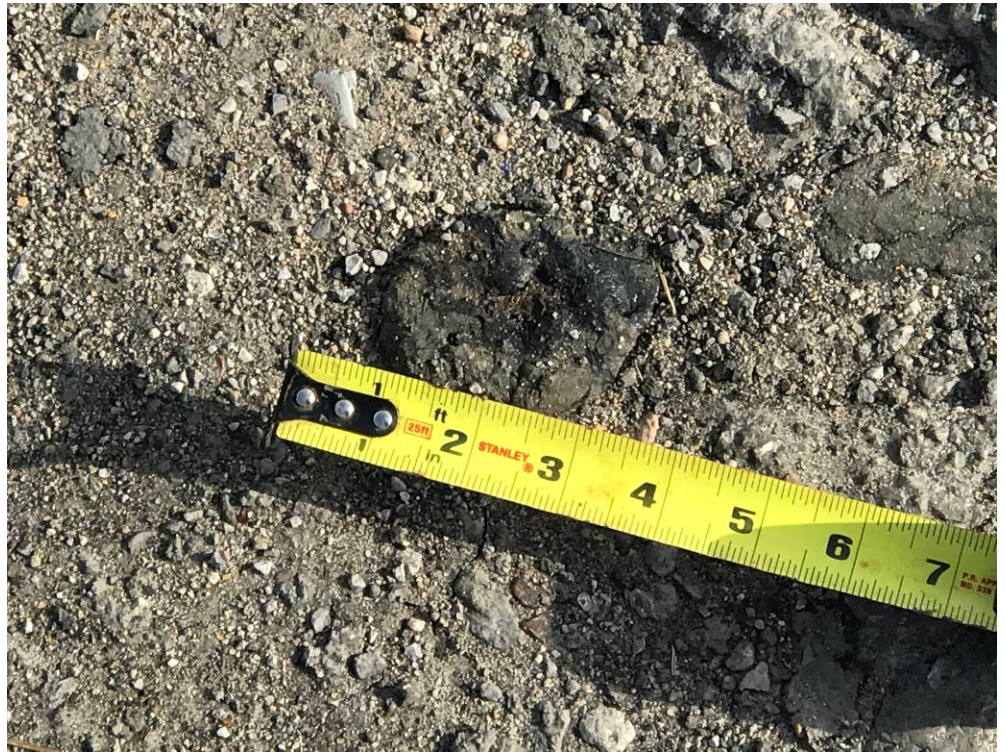
**Photo No.**  
**5**

Slot B102, very small amount of tar-like material seeping at asphalt crack, material was removed.

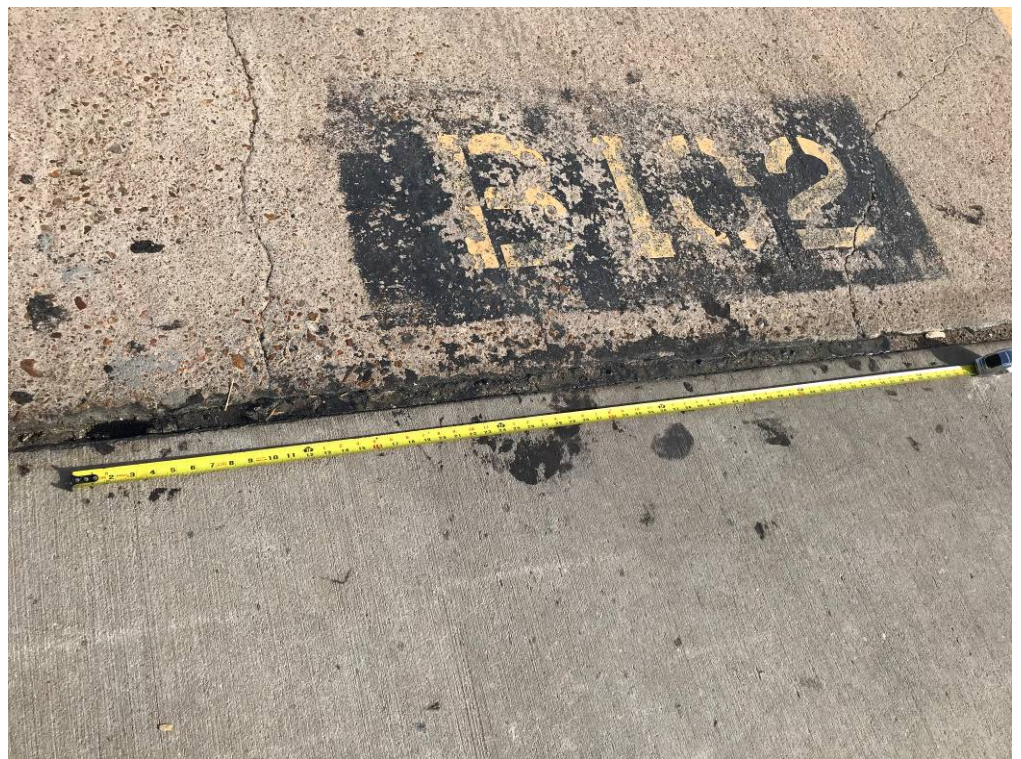
**Photo No.**  
**6**

Slot B102, small amount of tar-like material seeping at joint, material was removed.

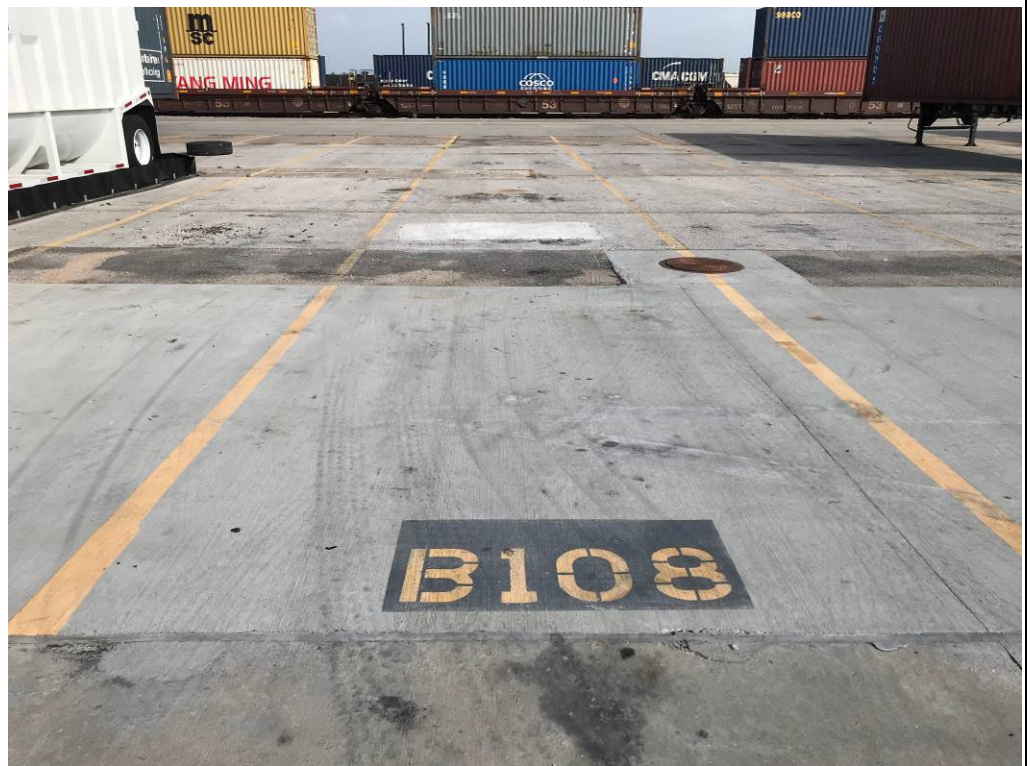
**Photo No.**  
7

Slot B108, view of NAPL Collection System (Sump B107/B108 and test pit in background). No tar-like material seeps observed, looking north.

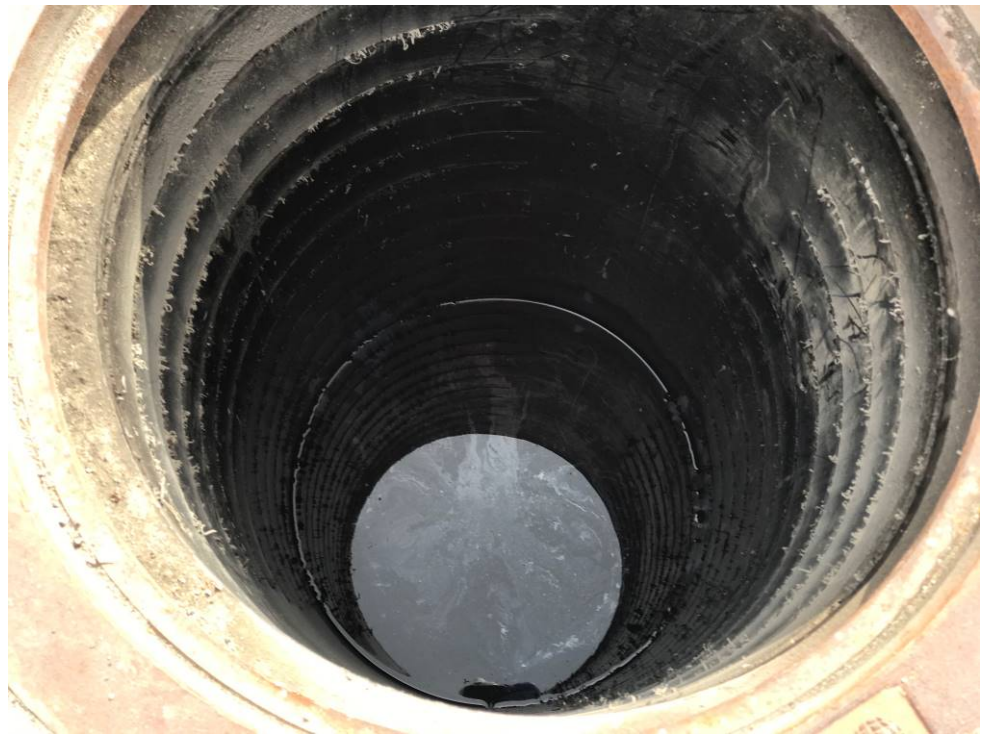
**Photo No.**  
8

Sump 1 (B099/B100), 43 inches of freeboard in sump, sheen visible on water, no odors noted.

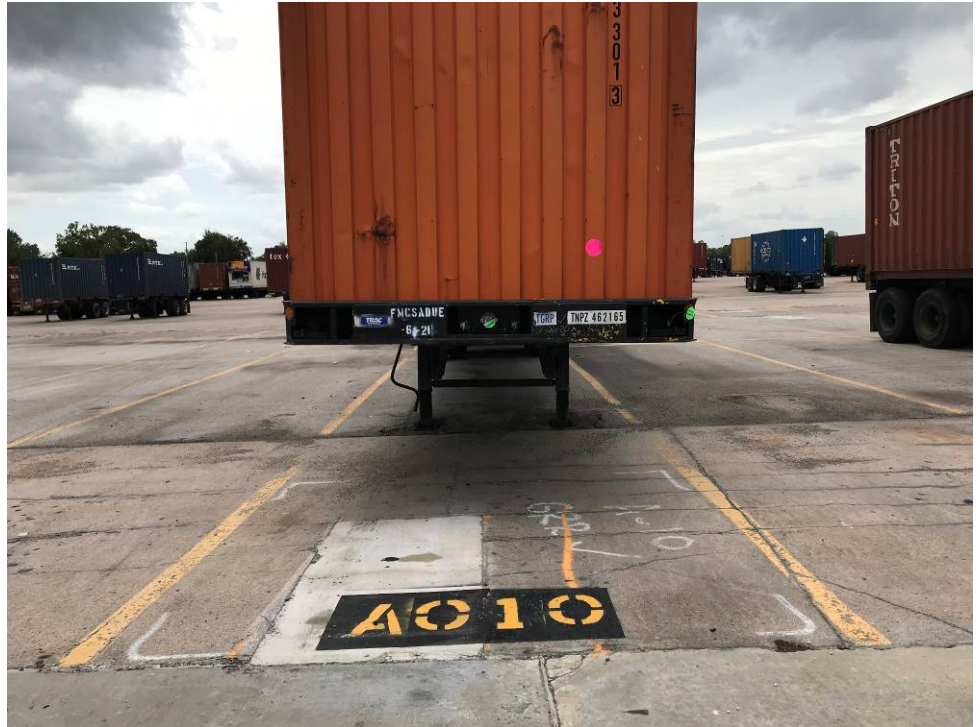
**Photo No.**  
**9**

Slot A010, no tar-like material seeps observed where test pit (July 2020) conducted, looking south.

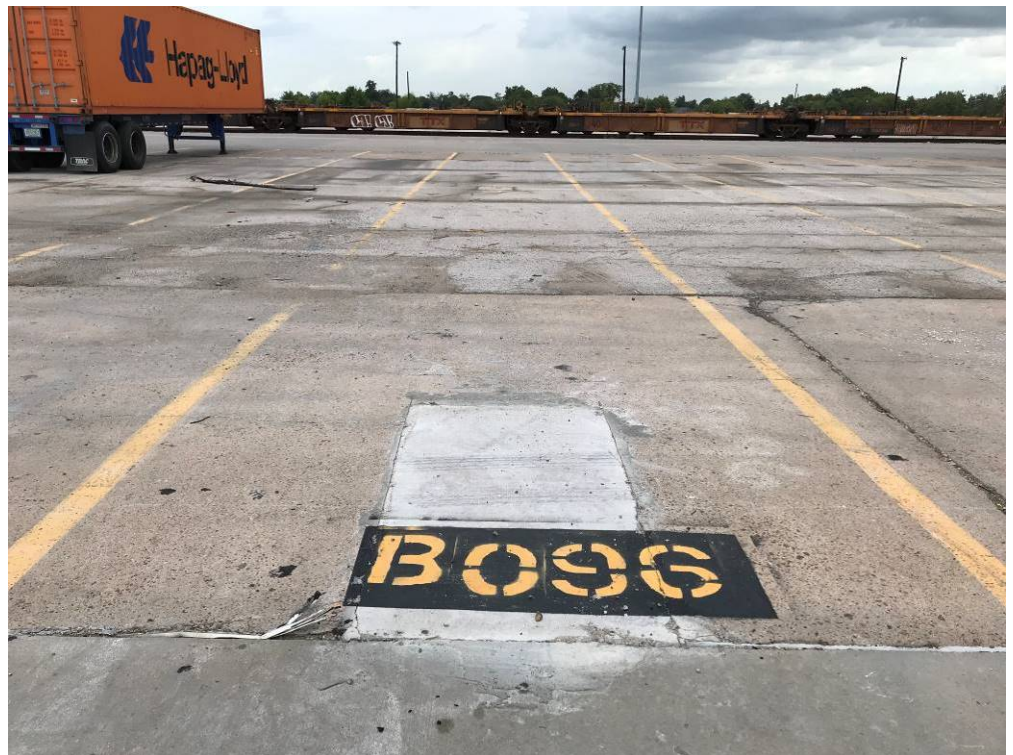
**Photo No.**  
**10**

Slot B096, no tar-like material seeps observed where test pit (July 2020) conducted, looking north.

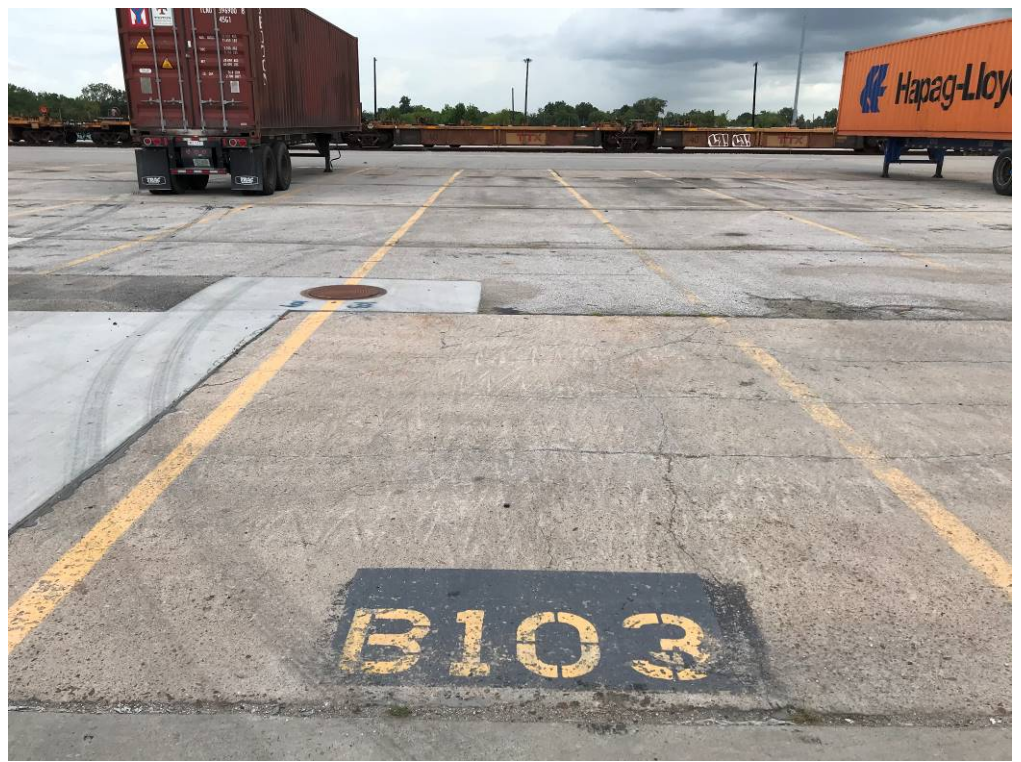
**Photo No.**  
13

Slot B103, view of NAPL Collection System (Sump 103/104 in foreground). No tar-like material seeps observed, looking north.

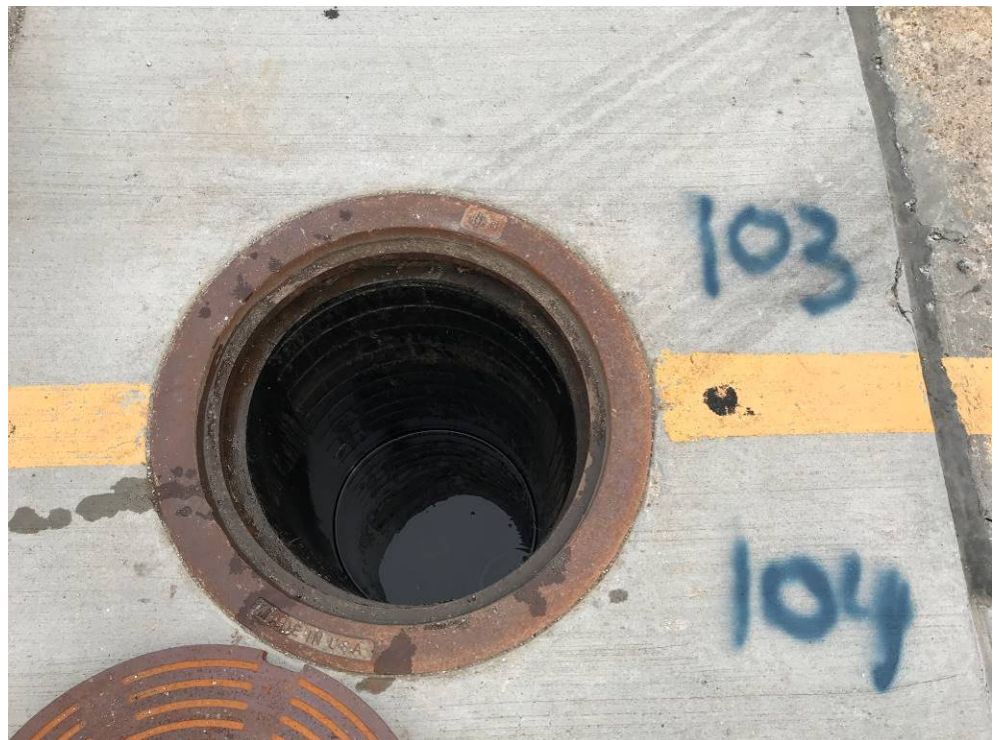
**Photo No.**  
14

Sump 2 (B103/B104), 37 inches of freeboard in sump, no sheen or odors noted.

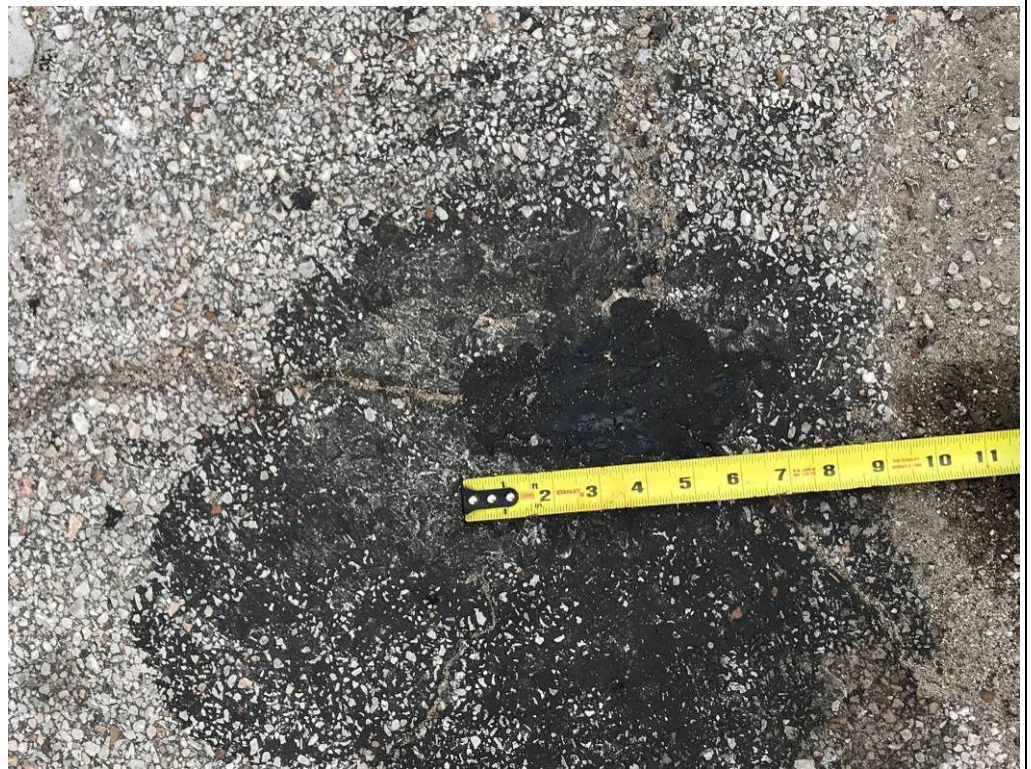
**Photo No.**  
**15**

Slot B105, small amount of tar-like material seeping at asphalt crack, material was removed.

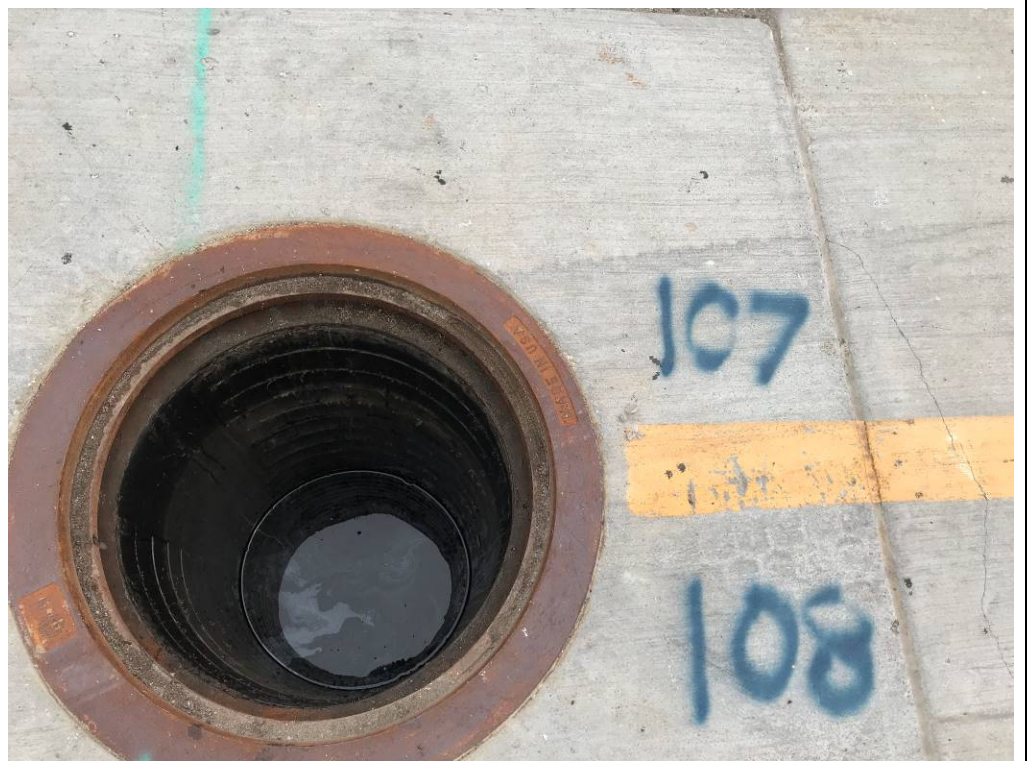
**Photo No.**  
**16**

Sump 3 (B107/B108), 36 inches of freeboard in sump. Sheen visible on water, no odor or tar-like material observed.

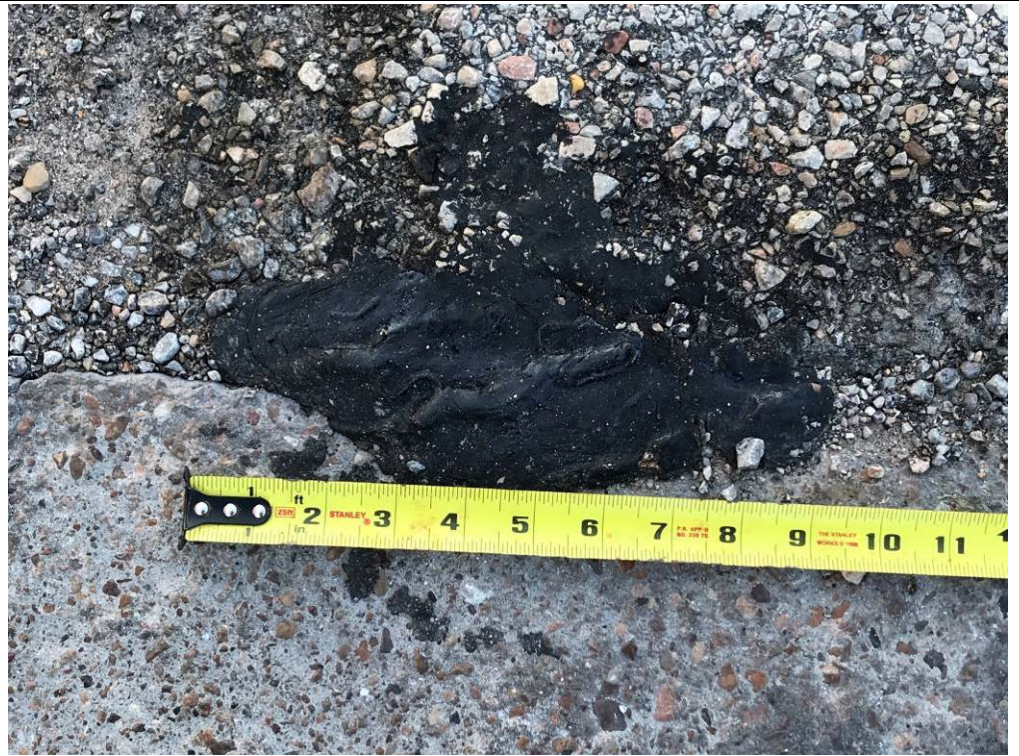
**Photo No.**  
**17**

Slot A022, small amount of tar-like material seeping at joint, material was removed.

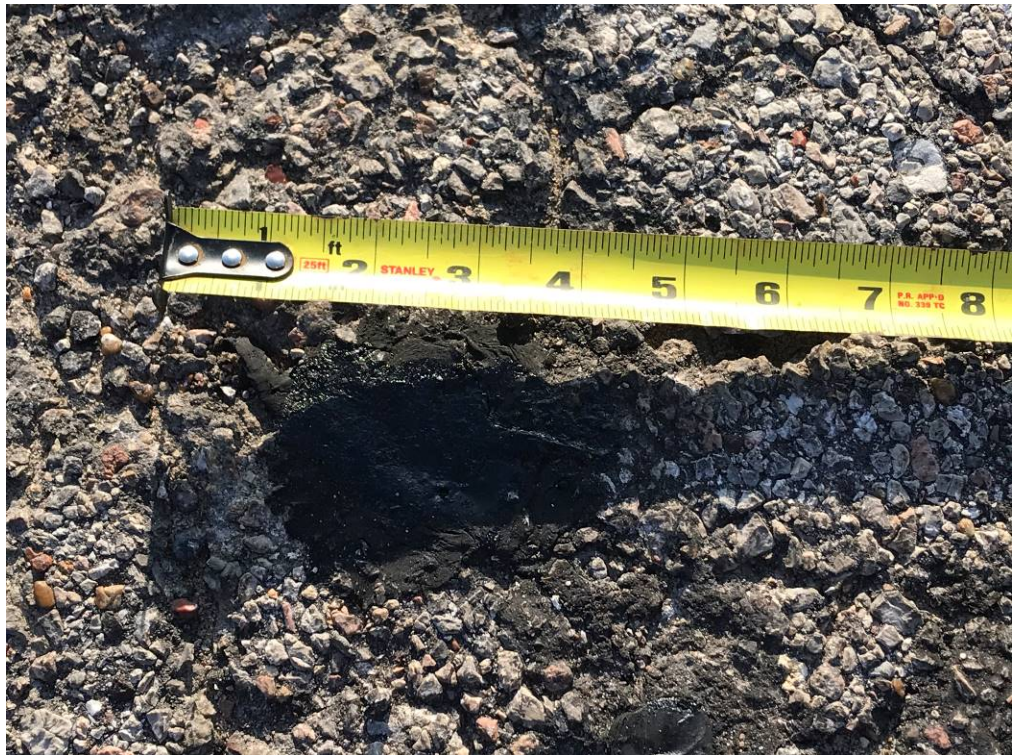
**Photo No.**  
**18**

Slot B057, small amount of tar-like material seeping at asphalt crack, material was removed.

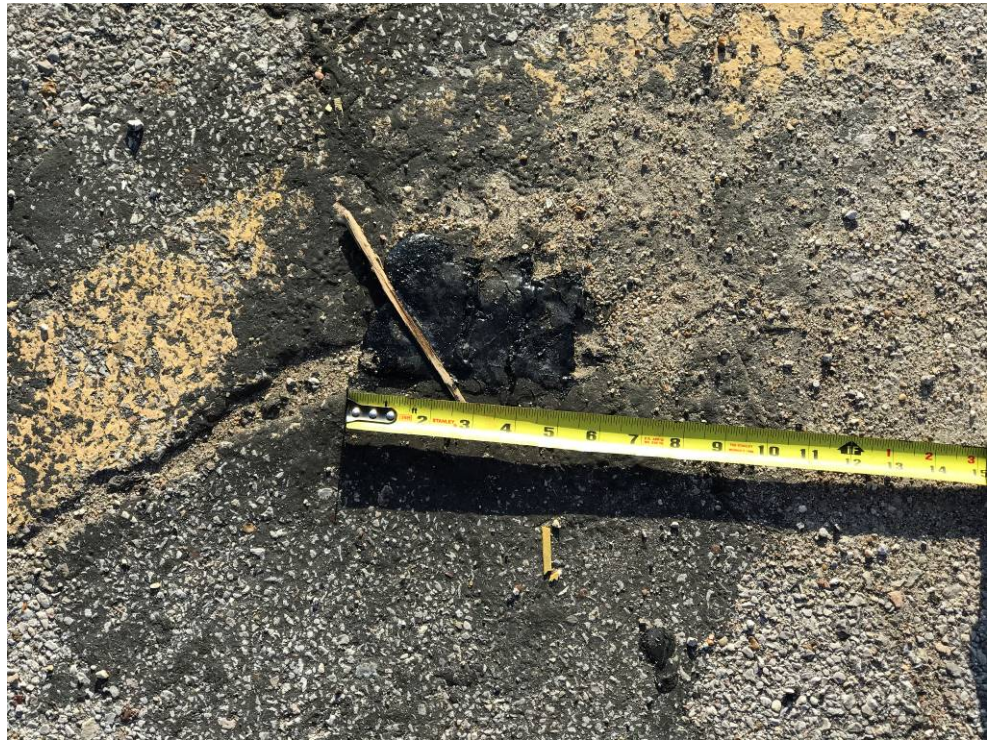
**Photo No.**  
**19**

Slot B101, small amount of tar-like material seeping at asphalt crack. Material was removed.

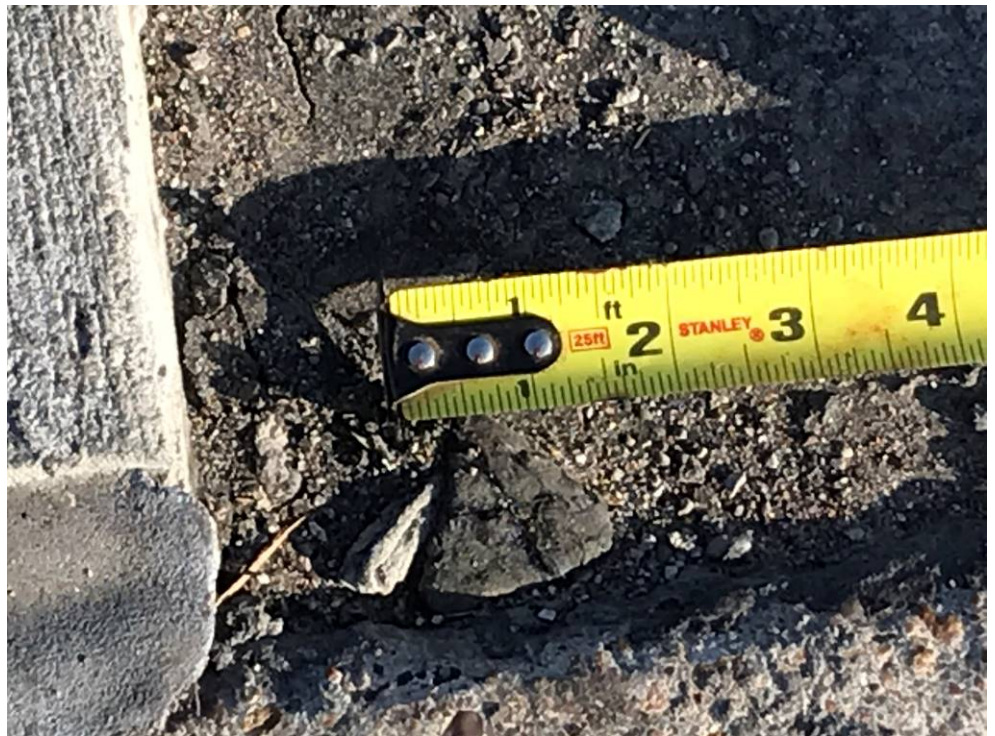
**Photo No.**  
**20**

- A small amount of tar-like NAPL was observed seeping at a joint immediately adjacent to the NAPL Collection System in slot B103 on September 15, 2020 (see photolog, Photo No. 20). No other seeps were observed within the NAPL Collection System area. For areas outside the NAPL Collection System, very small amounts of tar-like material were noted on the concrete surface in stalls A022, B057, B101, B102, and B105 where previous seeps have been observed. The overall amount of material recovered during September 2020 was similar to August 2020 with a total of less than 1 gallon of the tar-like material recovered.

Slot B103, very small amount of tar-like material seeping at joint. Material was removed.

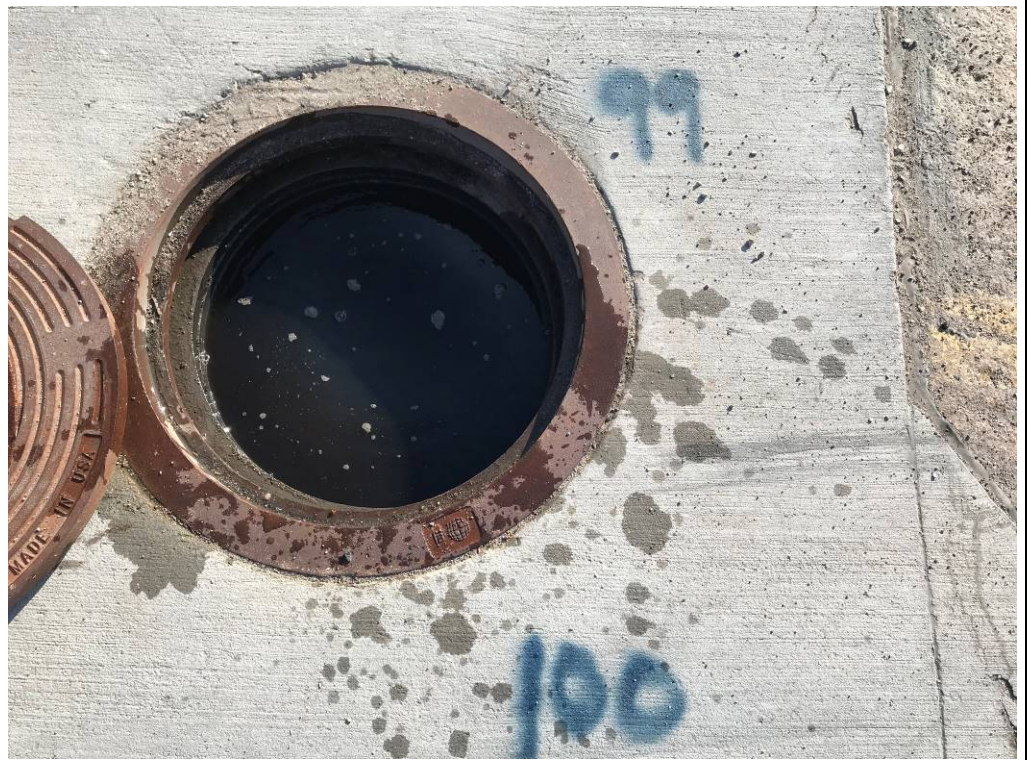
**Photo No.**  
**21**

Sump 1 (B099/B100), 1 inch of freeboard in sump, no sheen or odor noted.

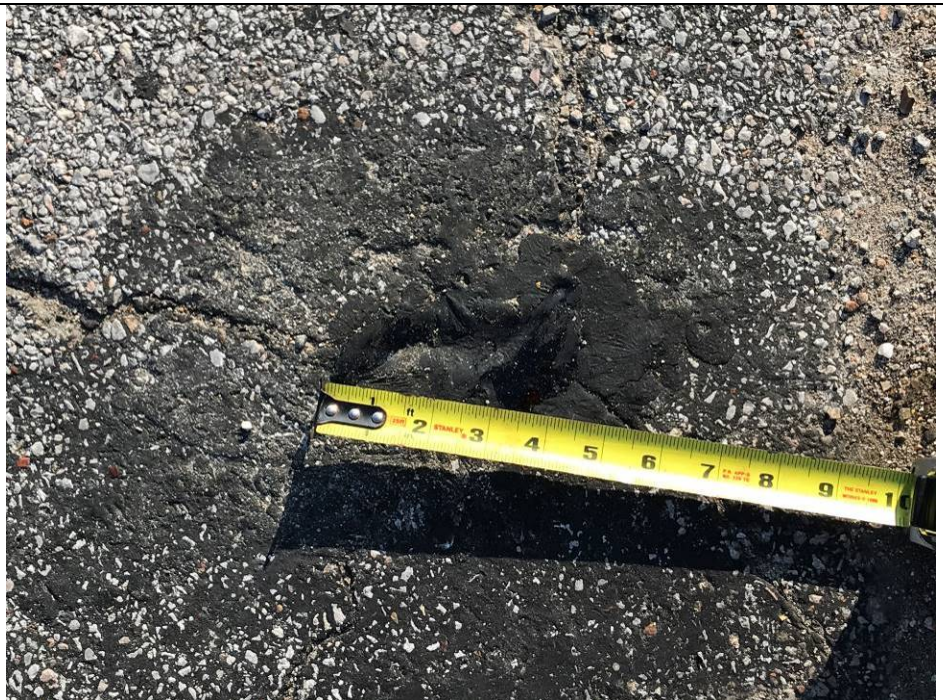
**Photo No.**  
**22**

Slot B105, small amount of tar-like material seeping at asphalt crack, material was removed.

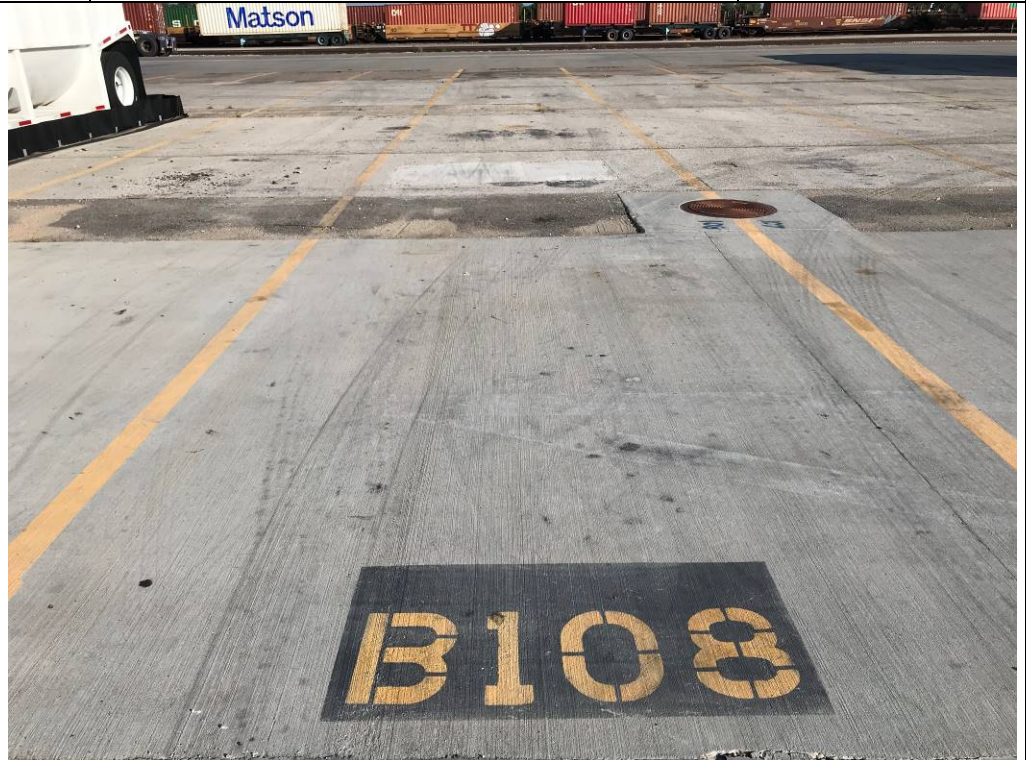
**Photo No.**  
**23**

Slot B108, view of NAPL Collection System (Sump 3 (B107B/108) and test pit in background). No tar-like material seeps observed, looking north.

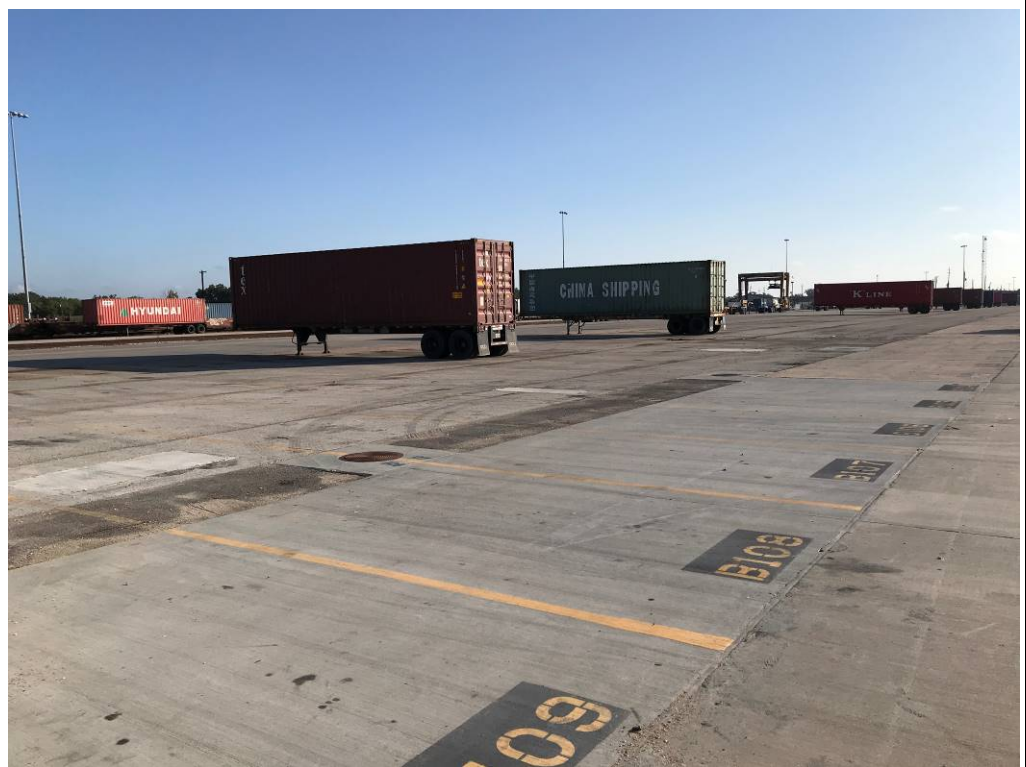
**Photo No.**  
**24**

Slots B109-B097, NAPL collection system visible in background, residual brown staining observed along the crack in the asphalt, looking northeast.

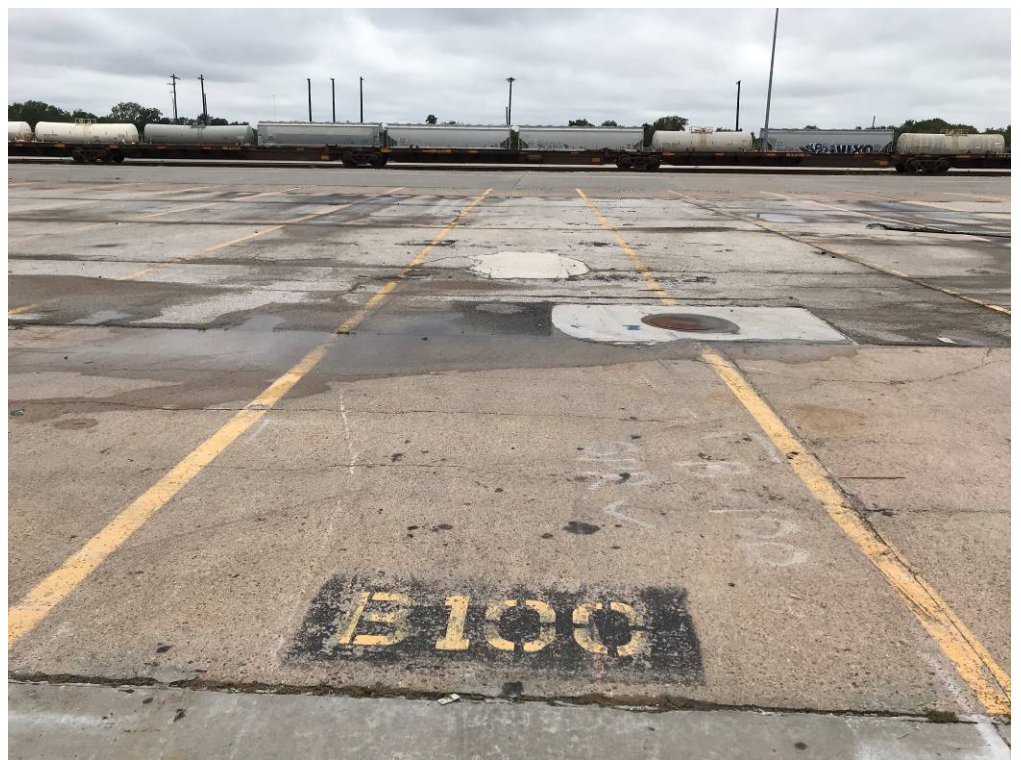
**Photo No.**  
**27**

Slot B100, view of NAPL Collection System (Sump 099/100 in background). Water on pavement from recent rainfall event. No tar-like material seeps observed, looking north.

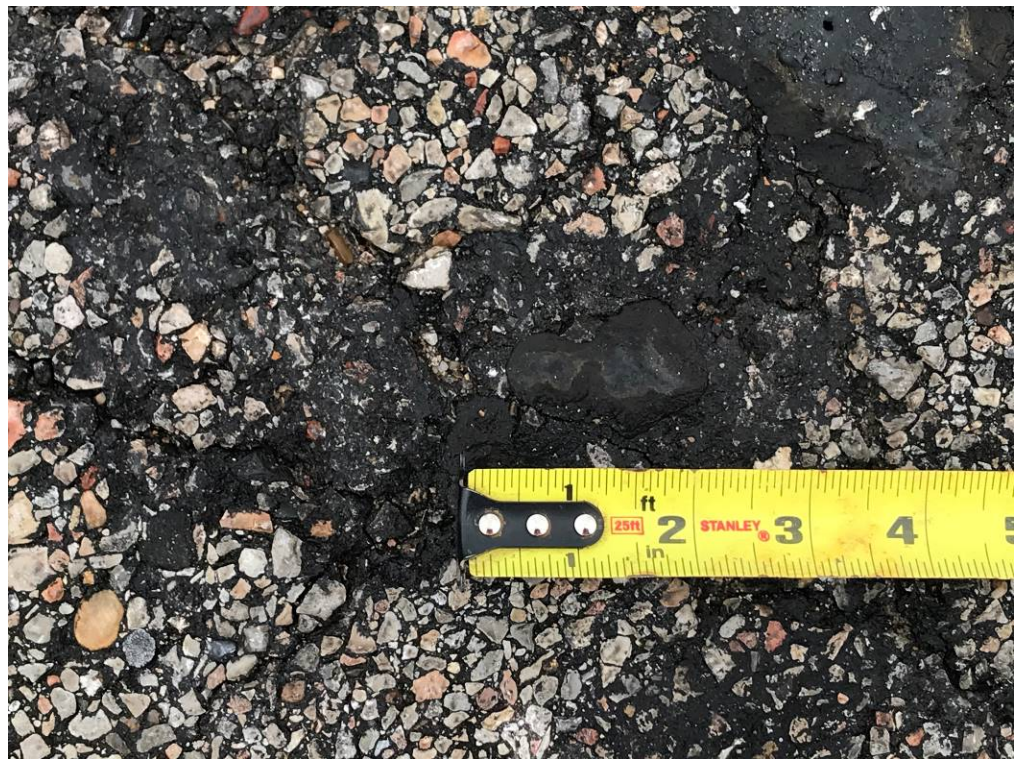
**Photo No.**  
**28**

Slot B057, small amount of tar-like material seeping at asphalt crack, material was removed.

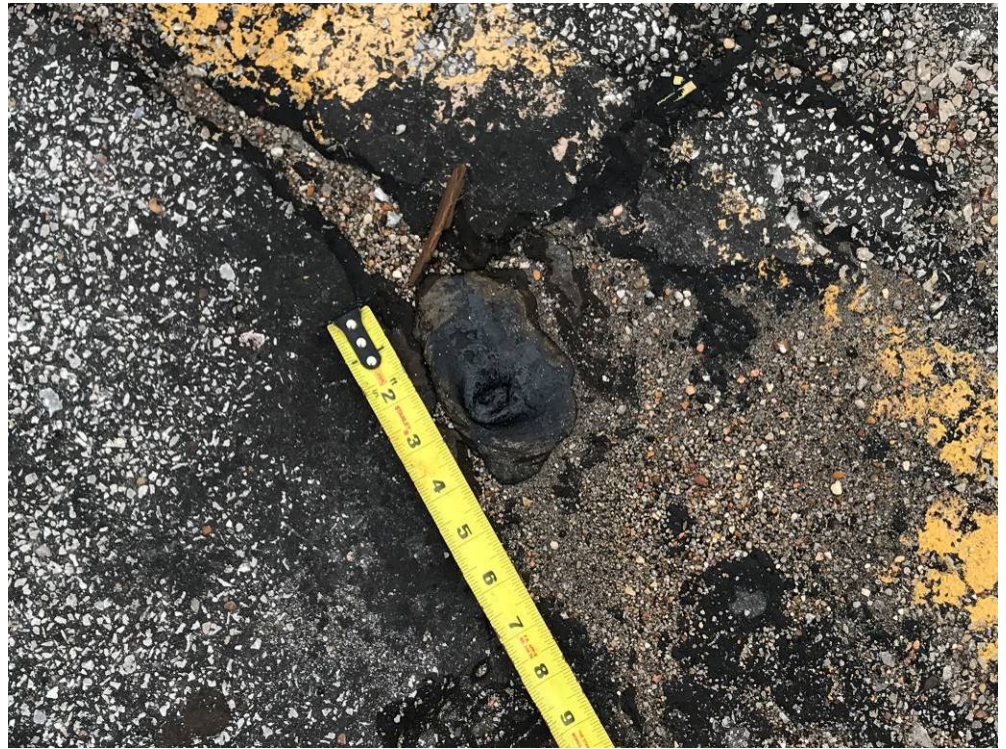
**Photo No.**  
**29**

Slot B101, very small amount of tar-like material seeping at asphalt crack. Material was removed.

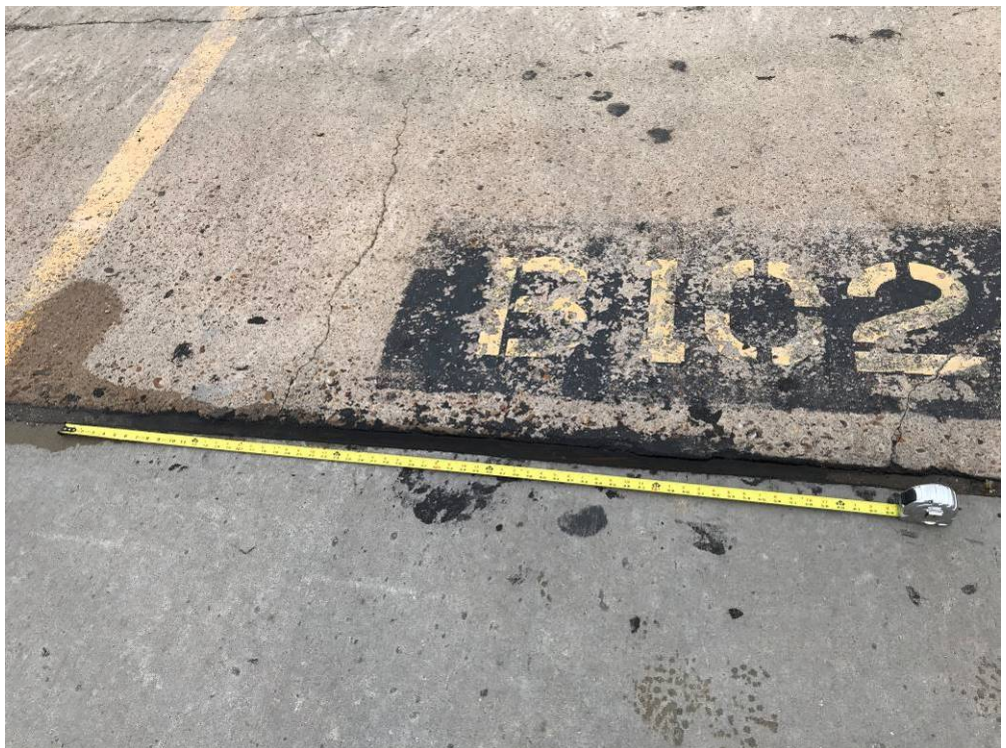
**Photo No.**  
**30**

Slot B102, small amount of tar-like material seeping at joint, water in joint from recent rain event, material was removed.

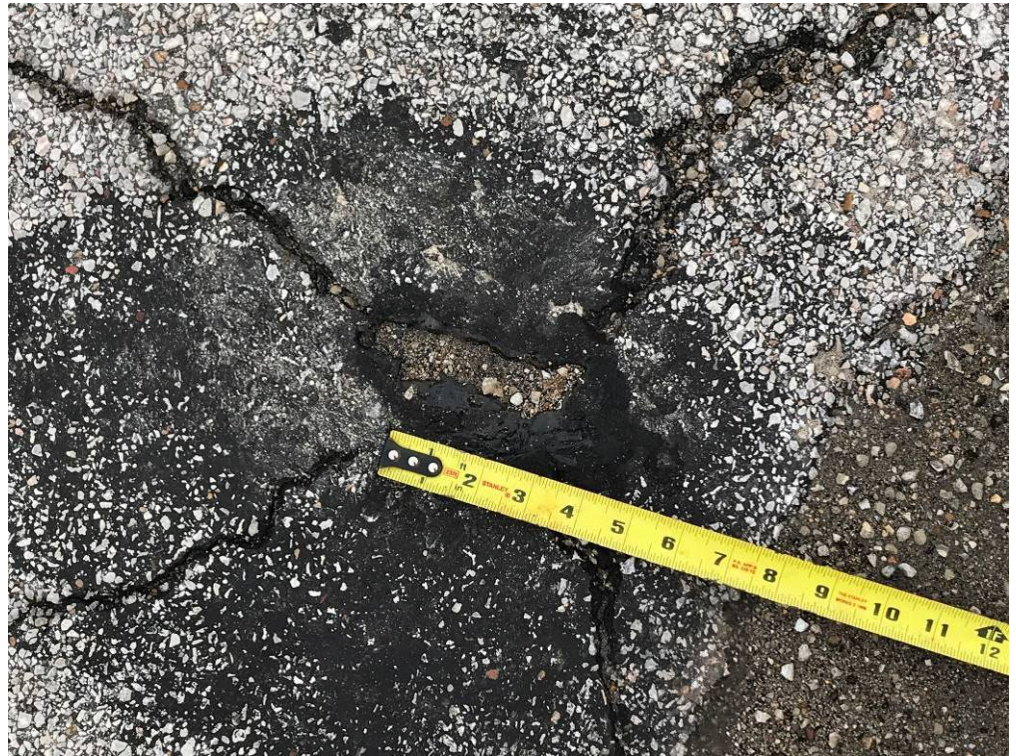
**Photo No.**  
31

Slot B105, small amount of tar-like material seeping at asphalt crack, material was removed.

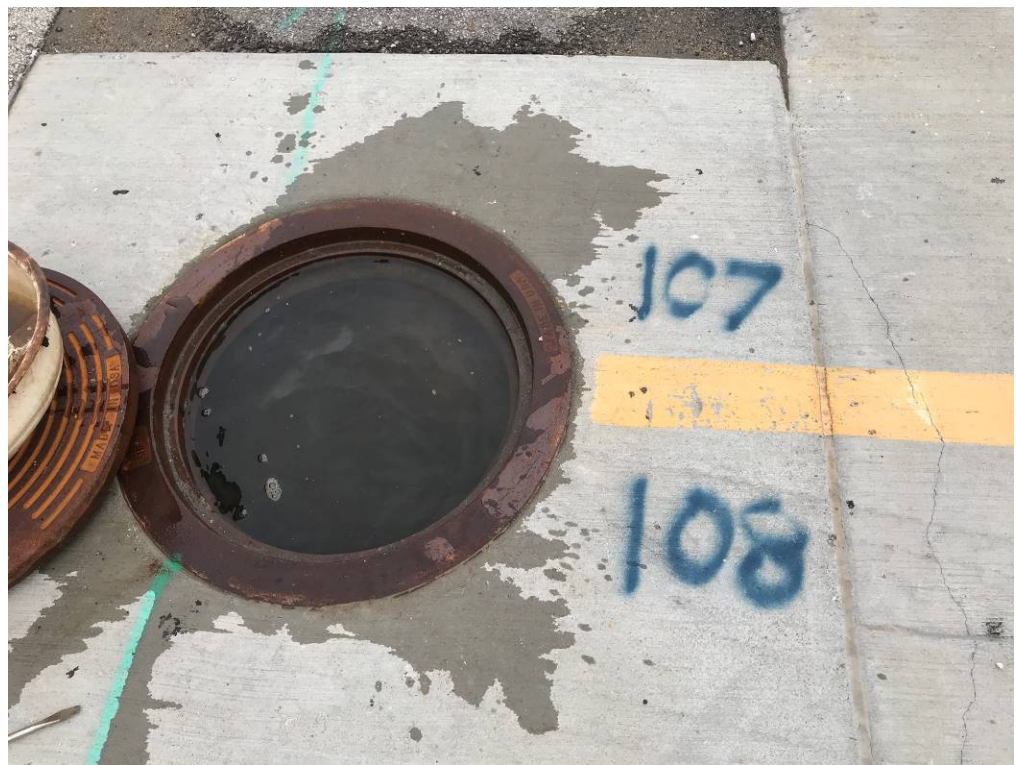
**Photo No.**  
32

Sump 3 (B107/B108), 0 inches of freeboard in sump. No sheen, odor, or tar-like material observed.
