Project No. 19119232

**RE: MONTHLY STATUS UPDATE – ENGLEWOOD INTERMODAL YARD – NAPL COLLECTION SYSTEM/CONCRETE CAP REPAIRS  
UNION PACIFIC RAILROAD HOUSTON WOOD PRESERVING WORKS FACILITY  
4910 LIBERTY ROAD FACILITY, HOUSTON, TEXAS  
POST-CLOSURE CARE PERMIT NO. HW-50343; INDUSTRIAL SWR NO. 31547**

## Weekly Inspection Photolog

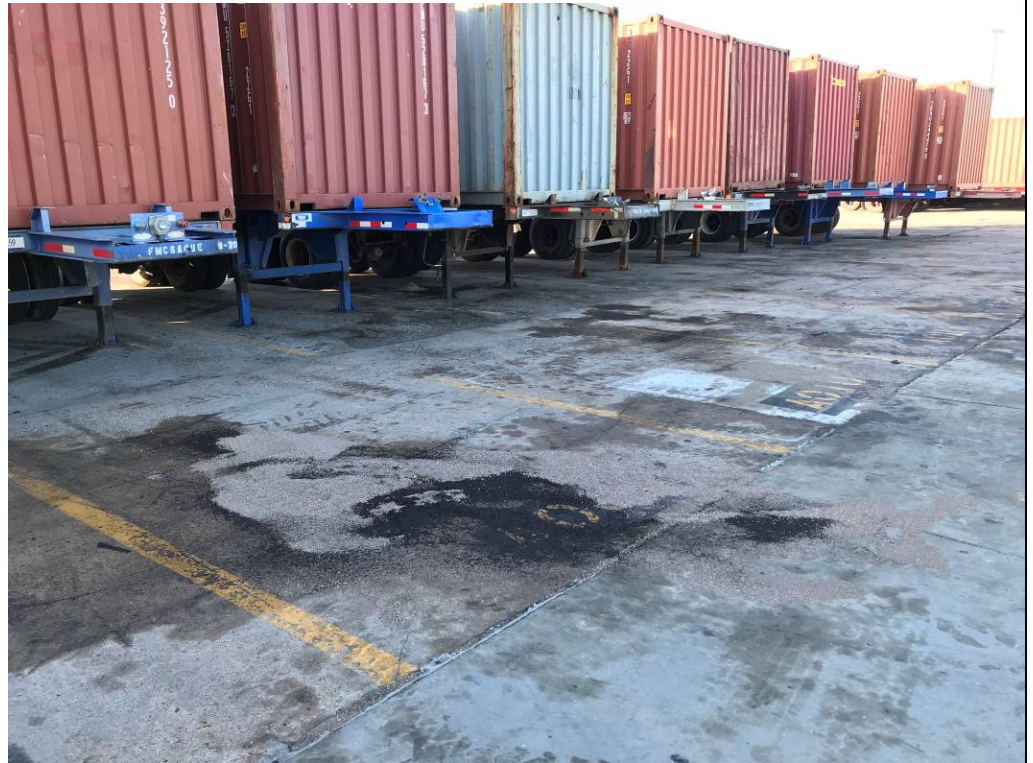
**Photo No.**  
**33**

- During the September 30, 2020 weekly inspection, oil staining and absorbents (sand and litter) were noted in the A-Row (predominately in slots A008-A016). UPRR confirmed that the staining was from hydraulic oil from maintenance activities on a container crane and not related to the NAPL or water seeps. USES was called out to the site on October 1, 2020 and added more absorbents to collect the residual oil. USES then removed the absorbents from the site. Photos of the staining observed during the September 30<sup>th</sup> inspection as well as photos from after USES's site visit are included in the photolog (Photos No. 33, 34, 39, and 40).

Slot A008-A015, cleanup of a hydraulic oil spill from a container crane in progress, UPRR Contractor United States Environmental Services (USES) was called out for further clean up, no tar-like material observed where test pit (July 2020) conducted, looking southwest

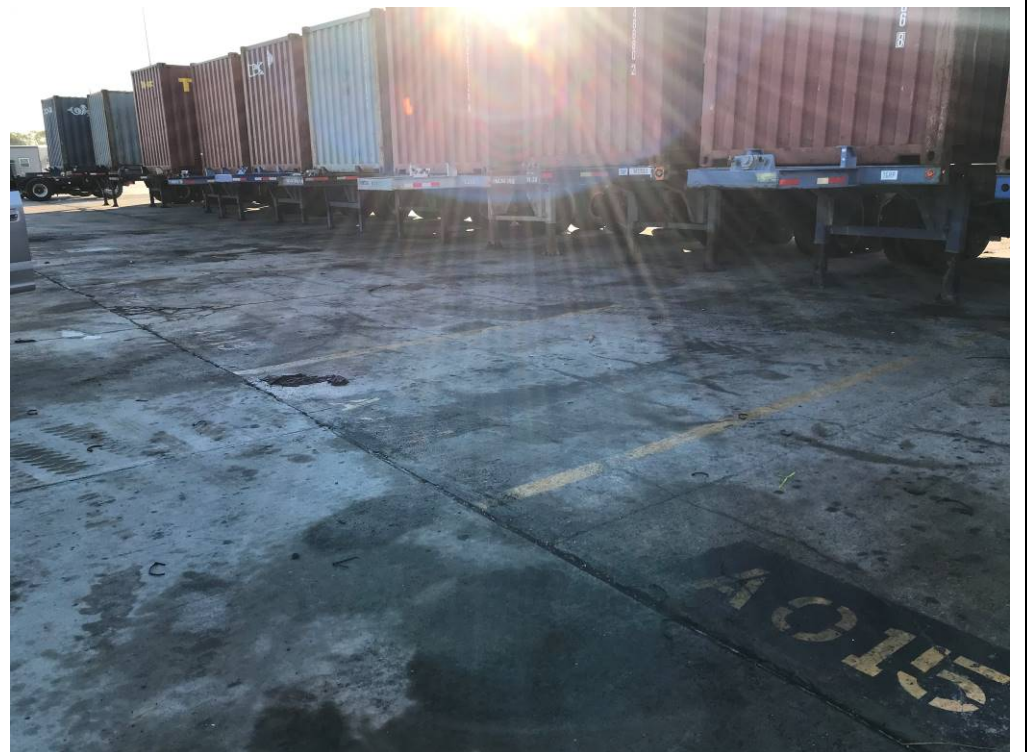
**Photo No.**  
**34**

Slot A015-A008, cleanup of a hydraulic oil spill from a container crane in progress, no tar-like material seeping observed, looking southeast.

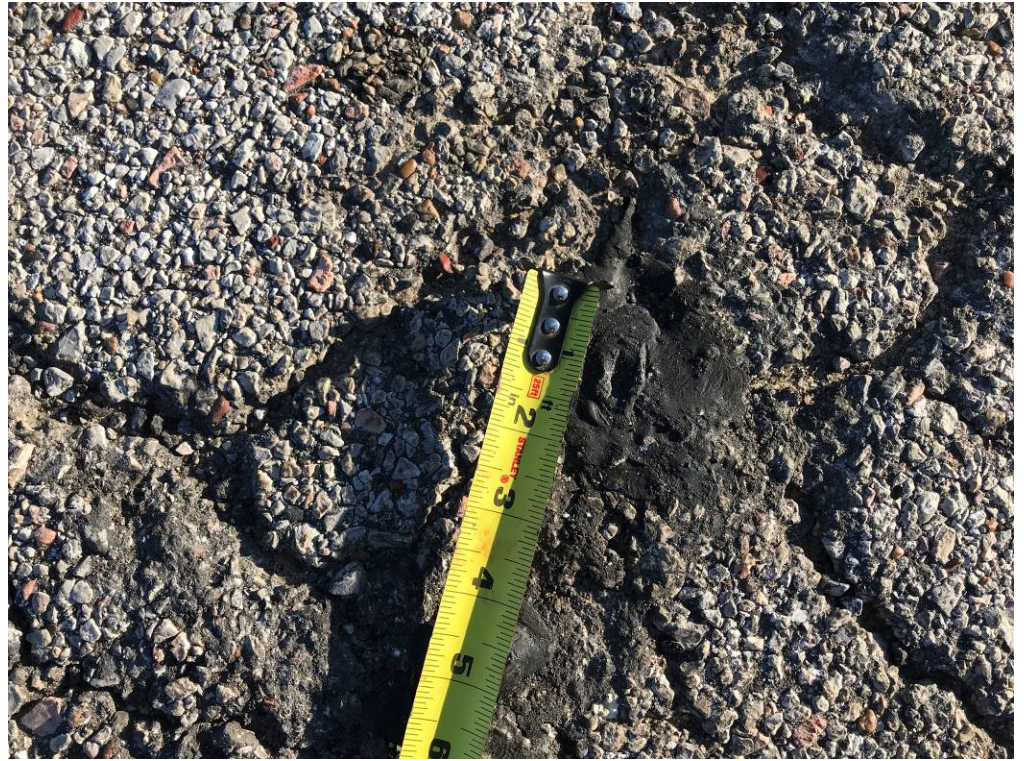
**Photo No.**  
**35**

Slot B057, very small amount of tar-like material seeping at asphalt crack, material was removed.

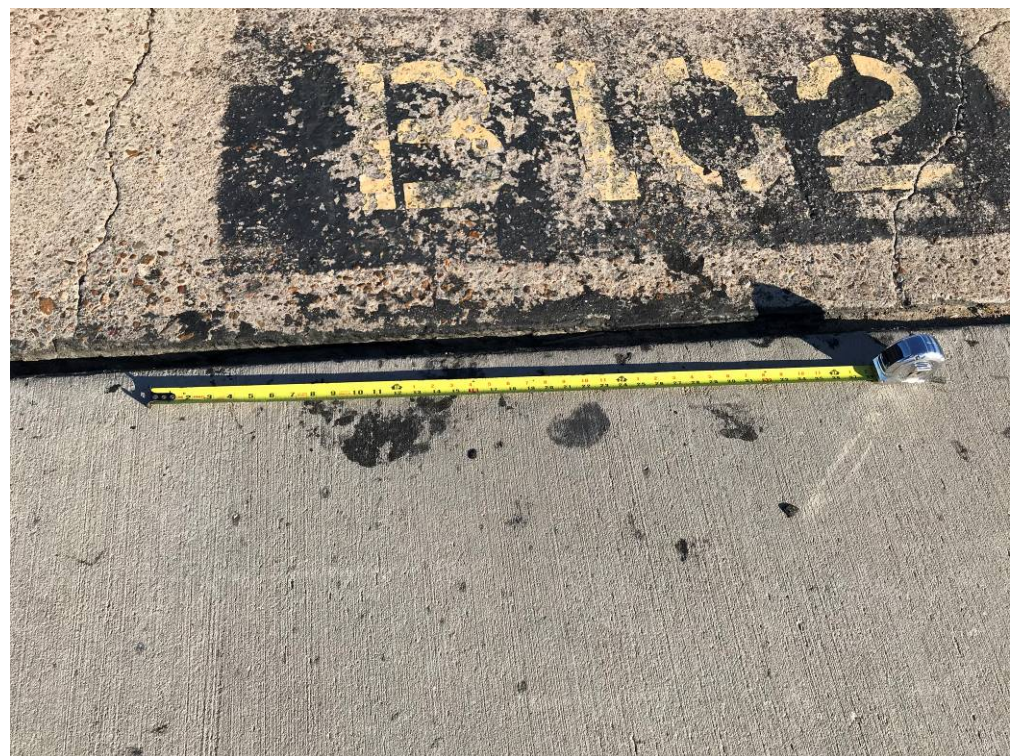
**Photo No.**  
**36**

Slot B102, small amount of tar-like material seeping at joint, material was removed.

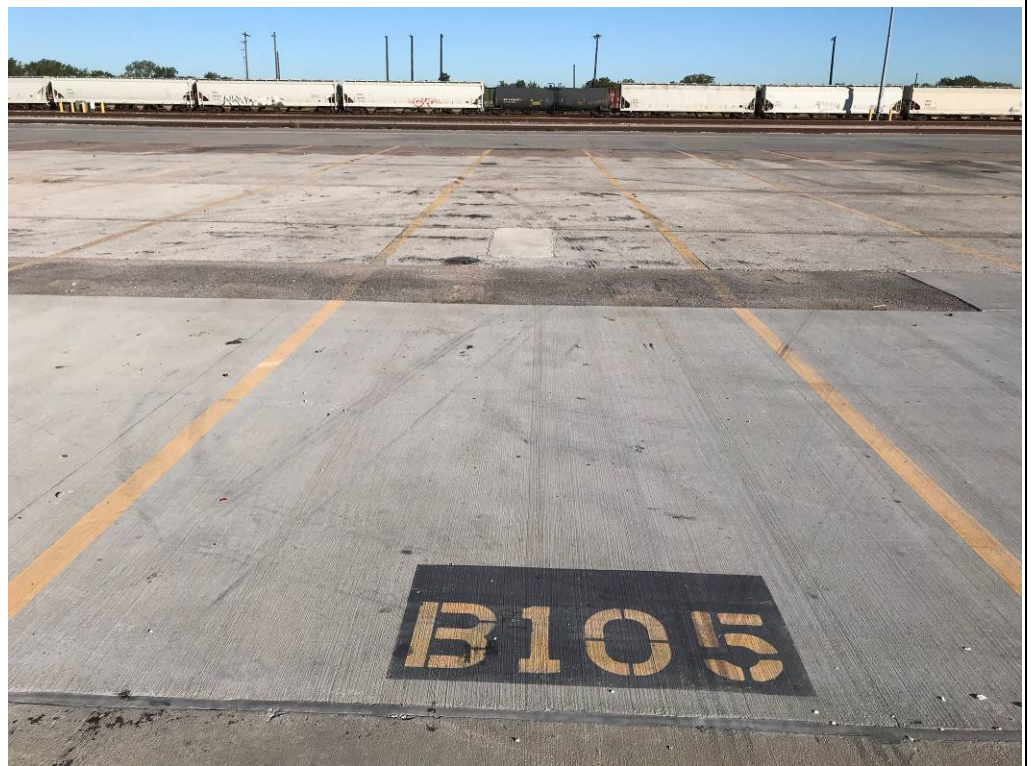
**Photo No.**  
**37**

Slot B105, no tar-like material seeps observed, looking north.

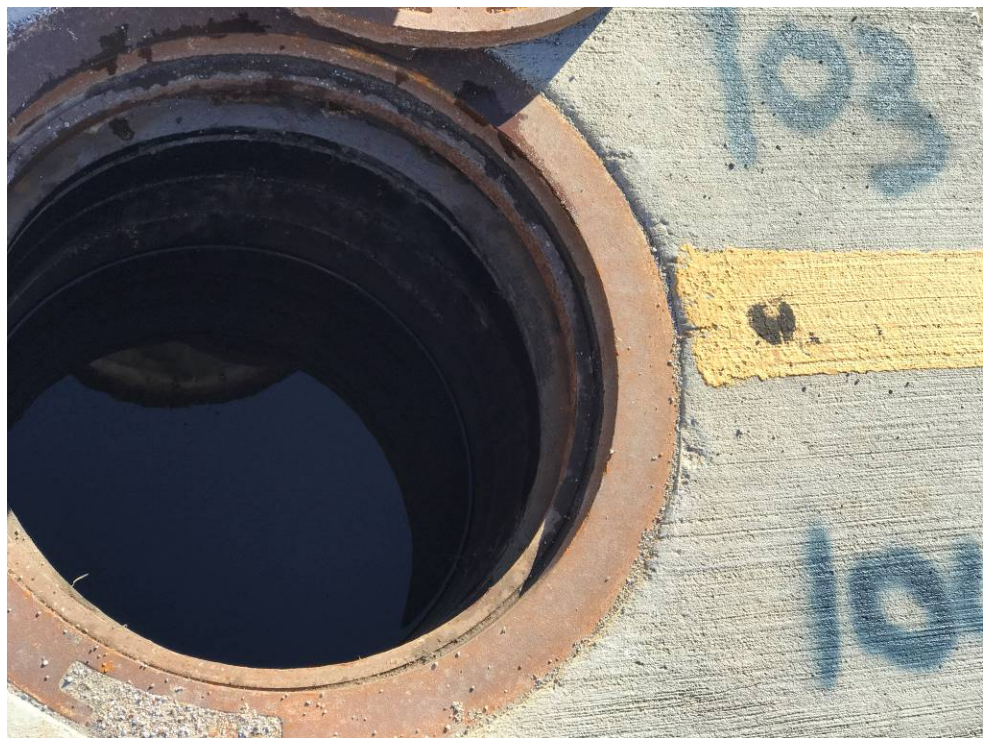
**Photo No.**  
**38**

Sump 2 (B103/B104), 10 inches of freeboard in sump, no sheen or odors noted.

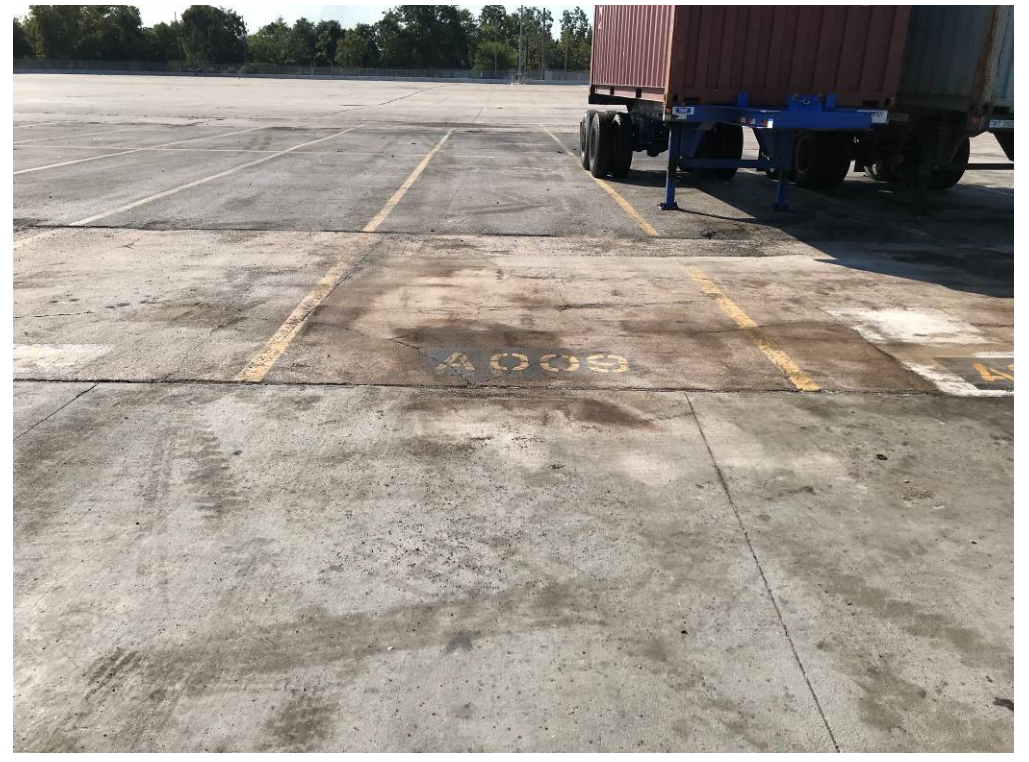
<b>Photo No.</b> 39	<b>Date:</b> 10/02/2020
------------------------	----------------------------

Slot A009, After USES cleanup (10/1/2020) of the hydraulic oil spill from a container crane, looking south.

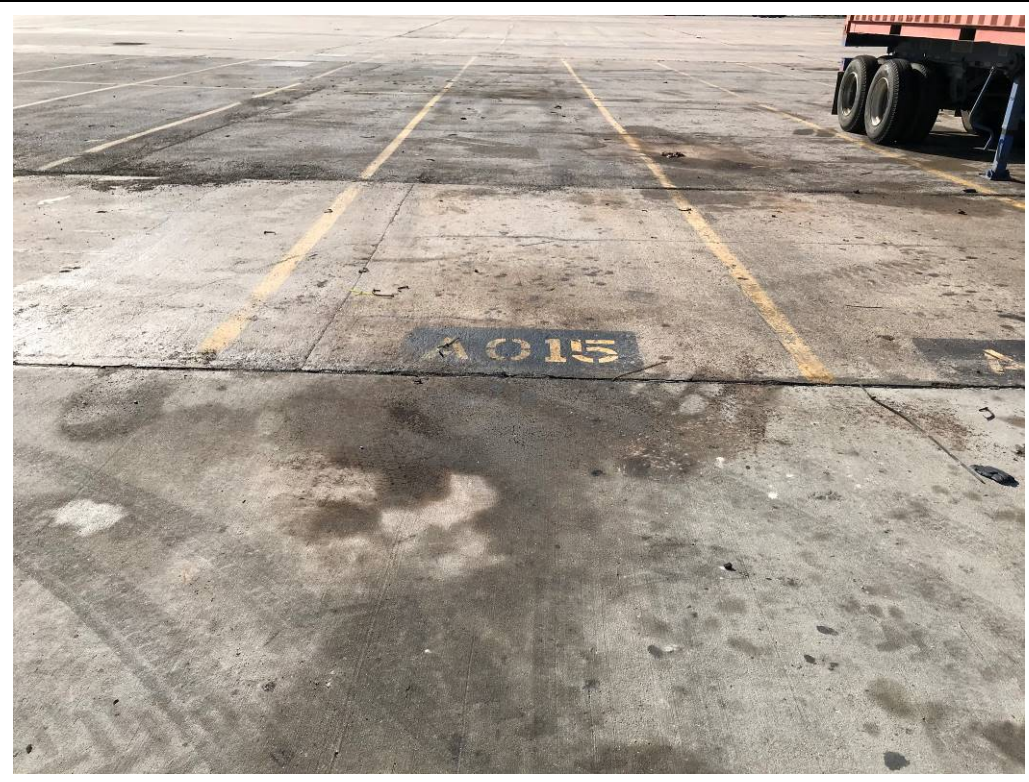
<b>Photo No.</b> 40	<b>Date:</b> 10/02/2020
------------------------	----------------------------

Slot A015, After USES cleanup (10/1/2020) of the hydraulic oil spill from a container crane, looking south.
