November 19, 2020

Project No. 19119232

**RE: MONTHLY STATUS UPDATE – ENGLEWOOD INTERMODAL YARD – NAPL COLLECTION SYSTEM/CONCRETE CAP REPAIRS  
UNION PACIFIC RAILROAD HOUSTON WOOD PRESERVING WORKS FACILITY  
4910 LIBERTY ROAD FACILITY, HOUSTON, TEXAS  
POST-CLOSURE CARE PERMIT NO. HW-50343; INDUSTRIAL SWR NO. 31547**

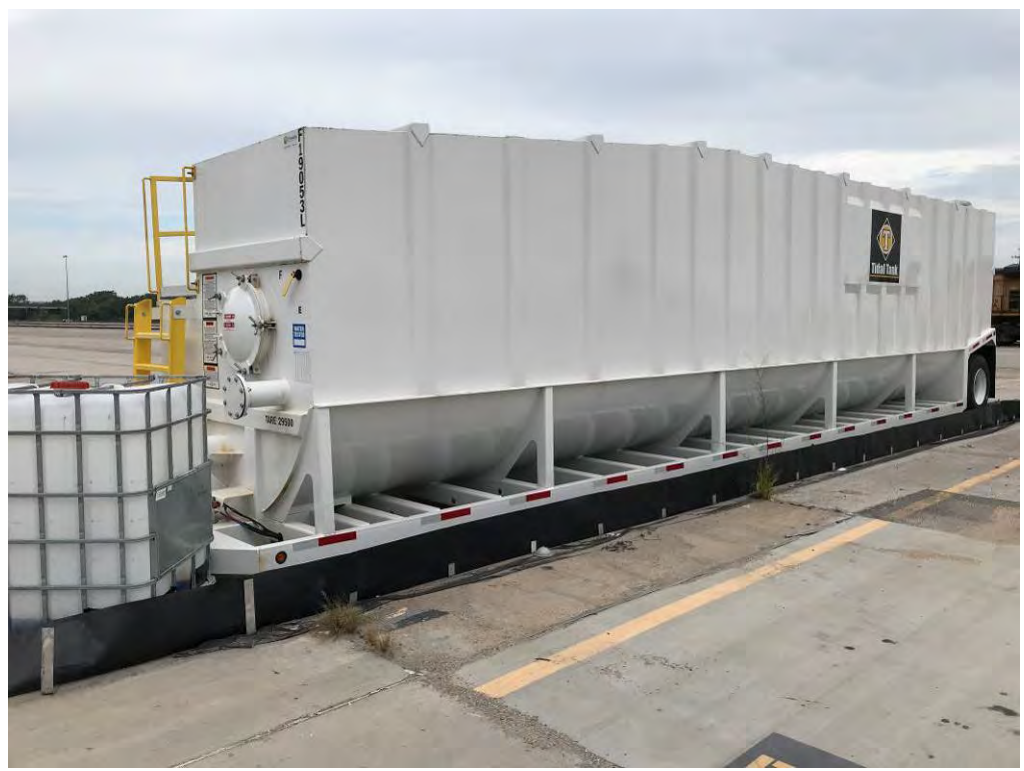
<b>Photo No.</b> 1	<b>Date:</b> 10/08/2020
<b>Description:</b>  Frac tank for storage of pumped down water from NAPL Collection Sumps (in Slot B110) and tote for storage of recovered pressure wash water/brown water, looking northwest.  Lat: 29.7841028 Long: - 95.3209833

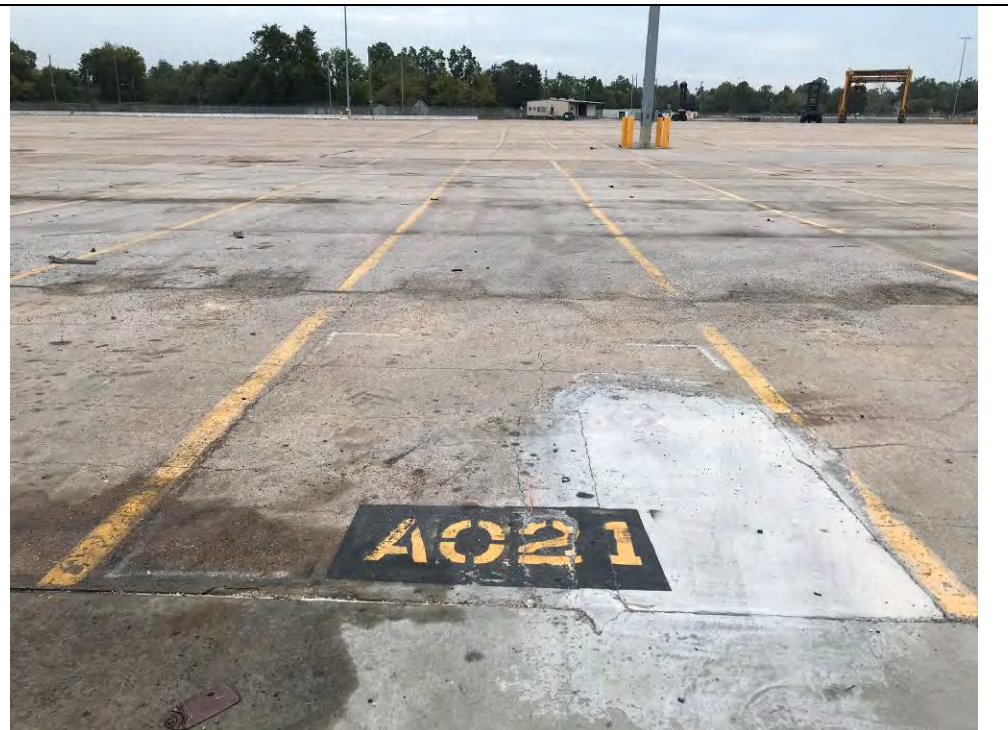
<b>Photo No.</b> 2	<b>Date:</b> 10/08/2020
-----------------------	----------------------------

<b>Description:</b>  Slot A021, no tar-like material seeps observed where test pit (July 2020) conducted, looking south.  Lat: 29.785392, Long: -95.318655	
---	--

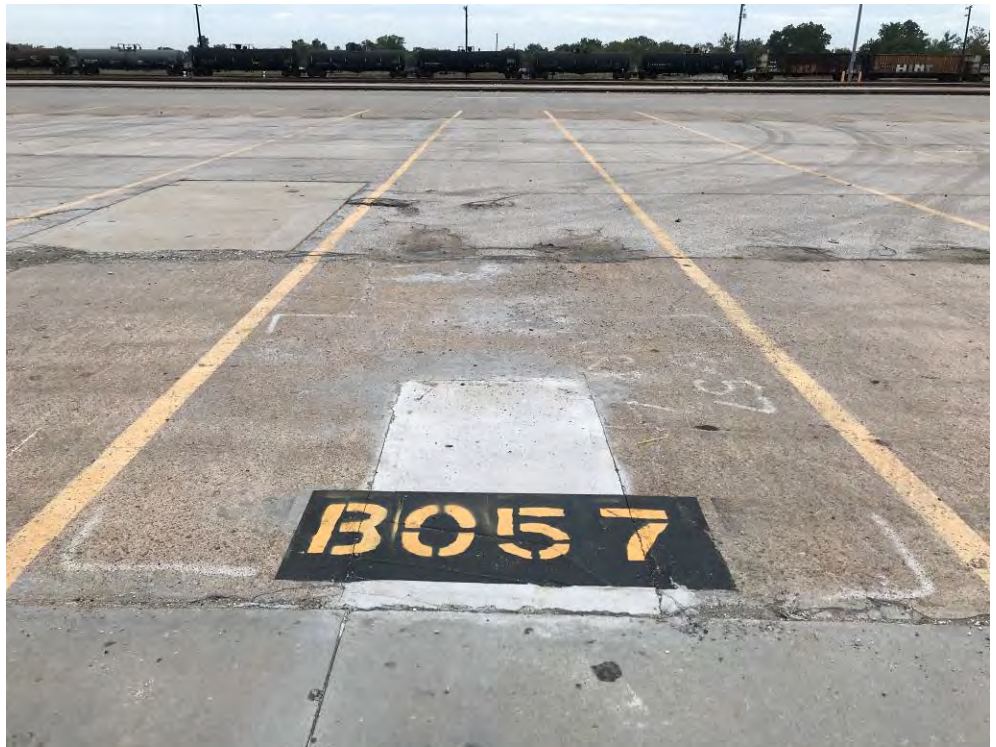
**Photo No.**  
**3**

Slot B057, no tar-like material seeps observed where test pit (July 2020) conducted, looking north.

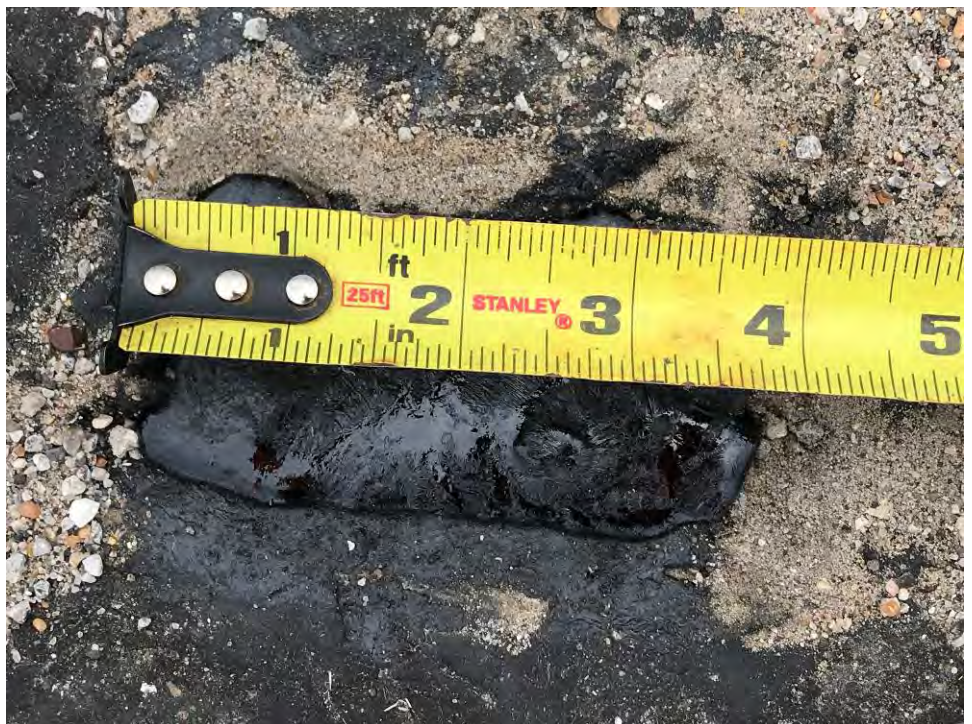
**Photo No.**  
**4**

Slot B101, small amount of tar-like material seeping at asphalt crack, material was removed.

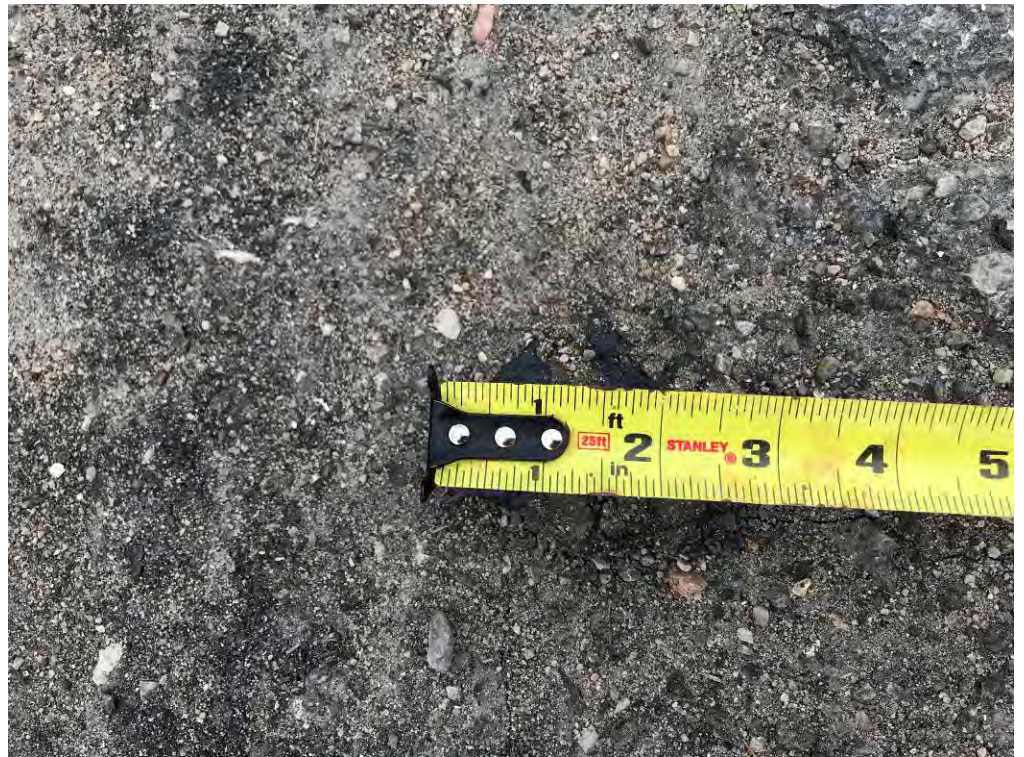
<b>Photo No.</b> 5	<b>Date:</b> 10/08/2020
<b>Description:</b>  Slot B102, very small amount of tar-like material seeping at asphalt crack, material was removed.  Lat: 29.7842203 Long: - 95.320827

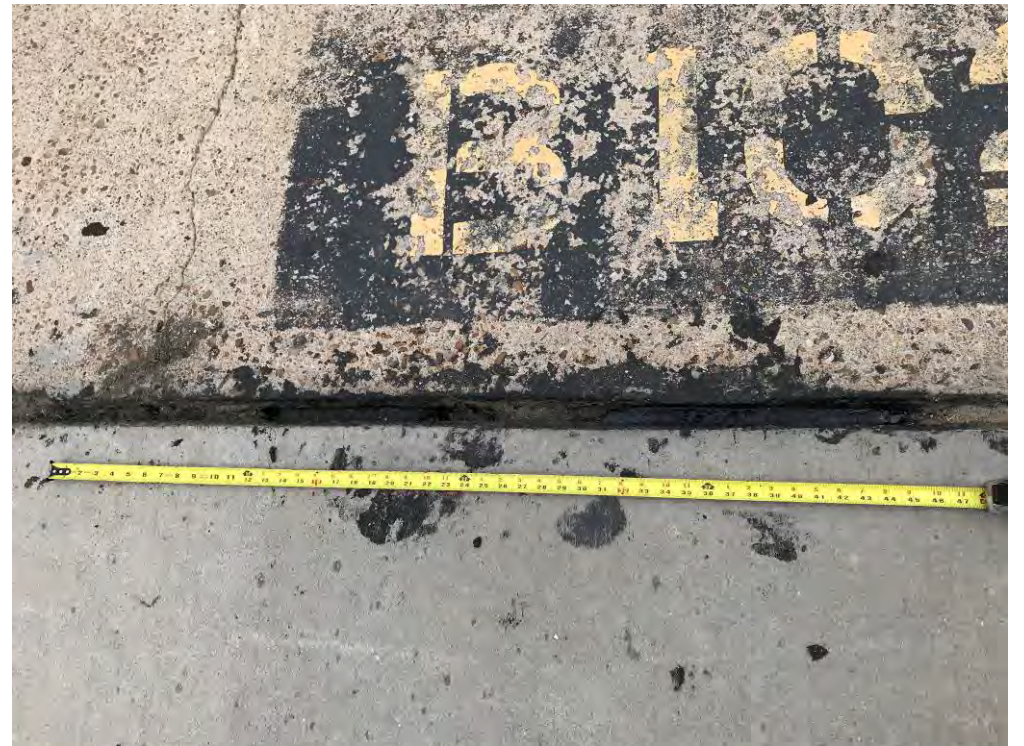
<b>Photo No.</b> 6	<b>Date:</b> 10/08/2020
<b>Description:</b>  Slot B102, small amount of tar-like material seeping at joint, material was removed.  Lat: 29.7842203 Long: - 95.320827

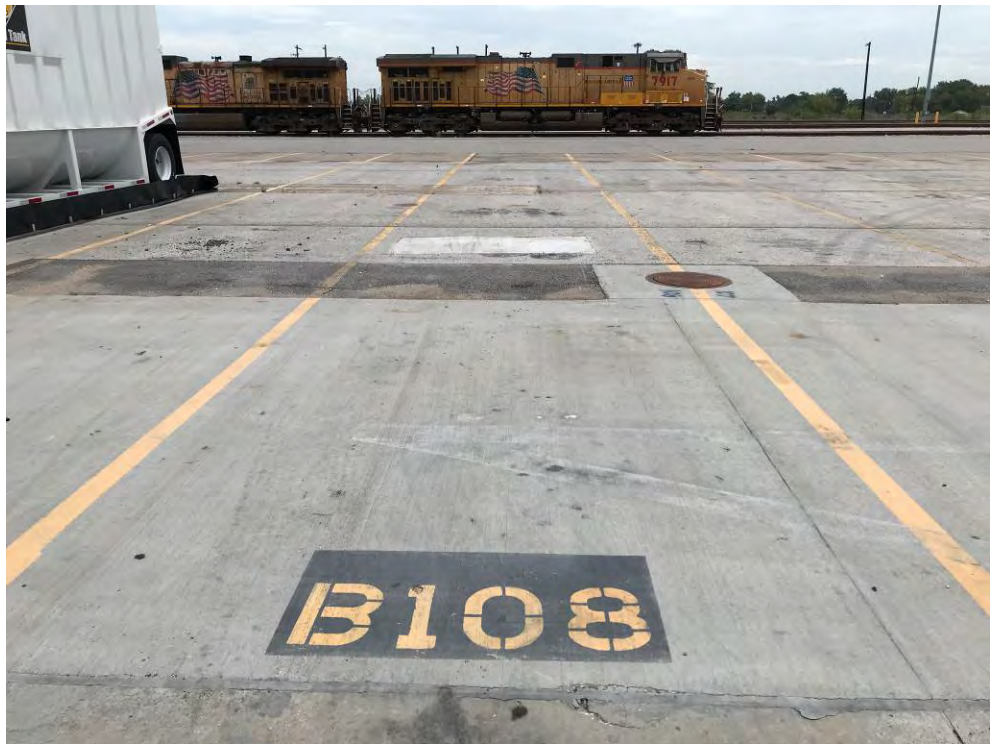
<b>Photo No.:</b> 7	<b>Date:</b> 10/08/2020
------------------------	----------------------------

Slot B108, view of NAPL Collection System (Sump B107/B108 and test pit in background). No tar-like material seeps observed, looking north.

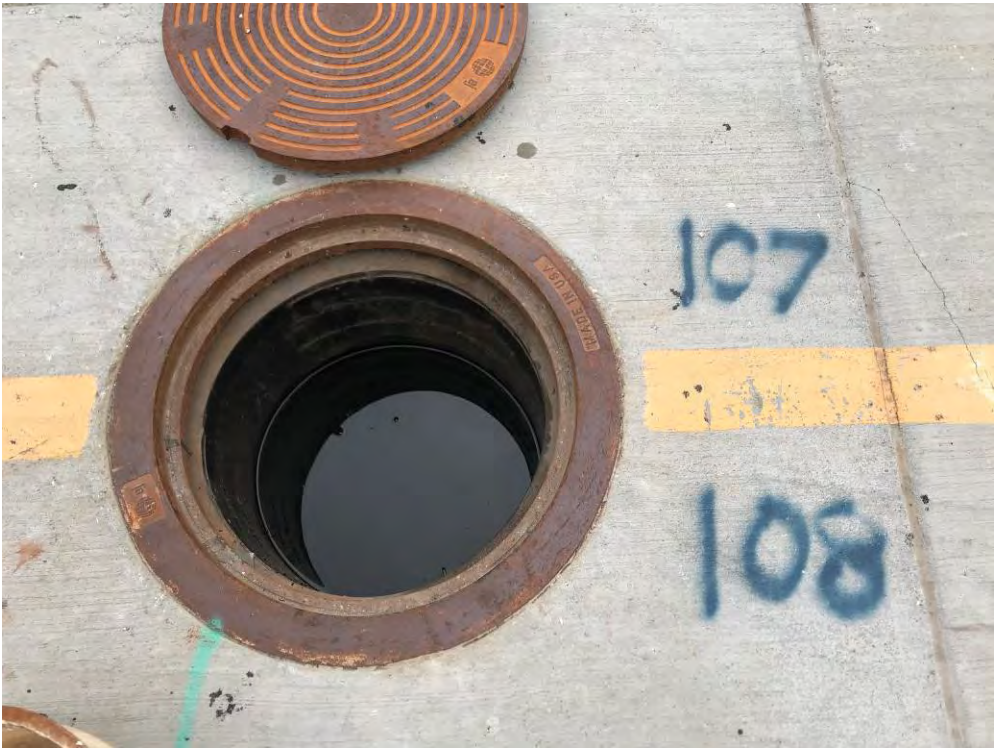
<b>Photo No.:</b> 8	<b>Date:</b> 10/08/2020
------------------------	----------------------------

Sump 3 (B107/B108), 11.5 inches of freeboard in sump. Sheen visible on water, no odor or tar-like material observed.

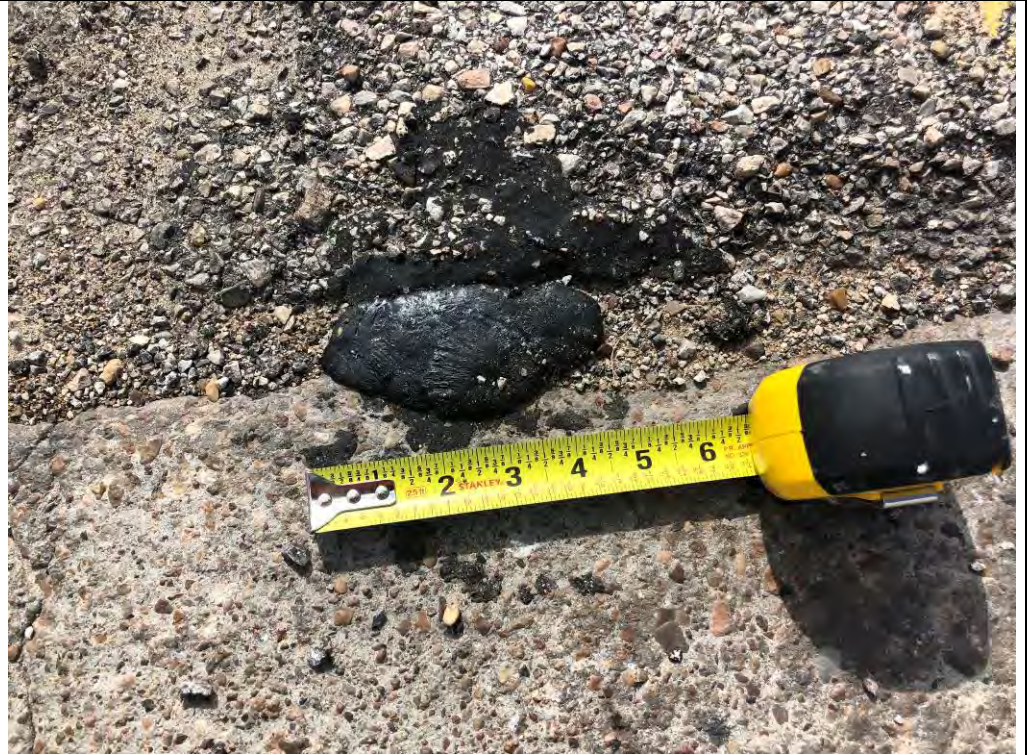
**Photo No.**  
**9**

Slot A022, small amount of tar-like material seeping at joint, material was removed.

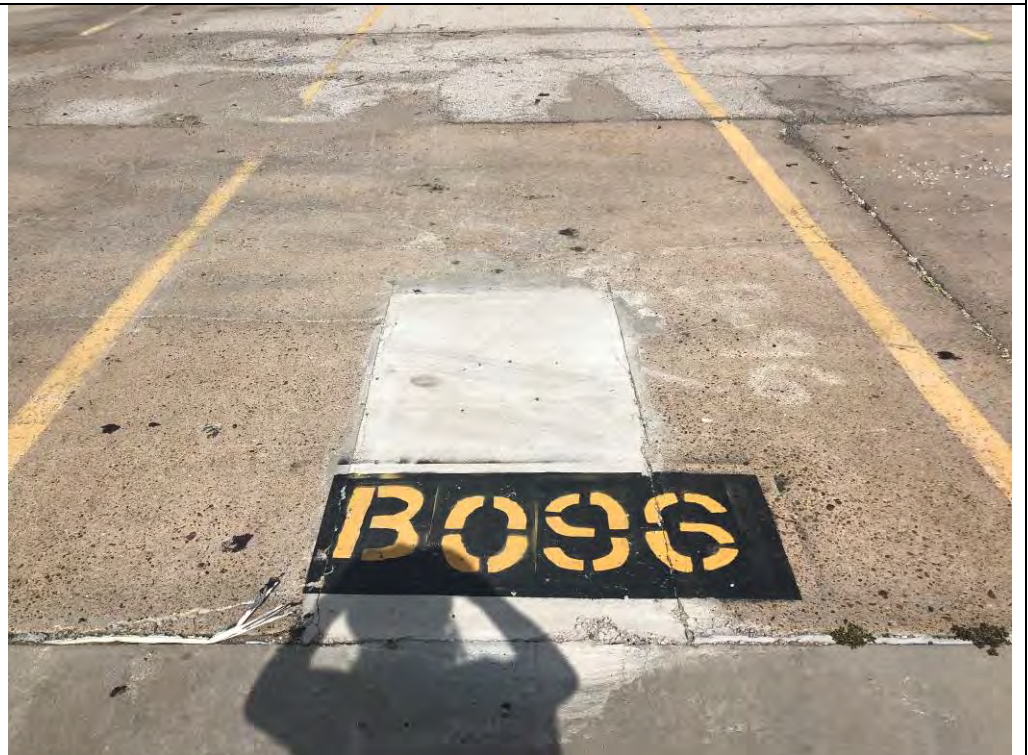
**Photo No.**  
**10**

Slot B096, no tar-like material seeps observed where test pit (July 2020) conducted, looking north.

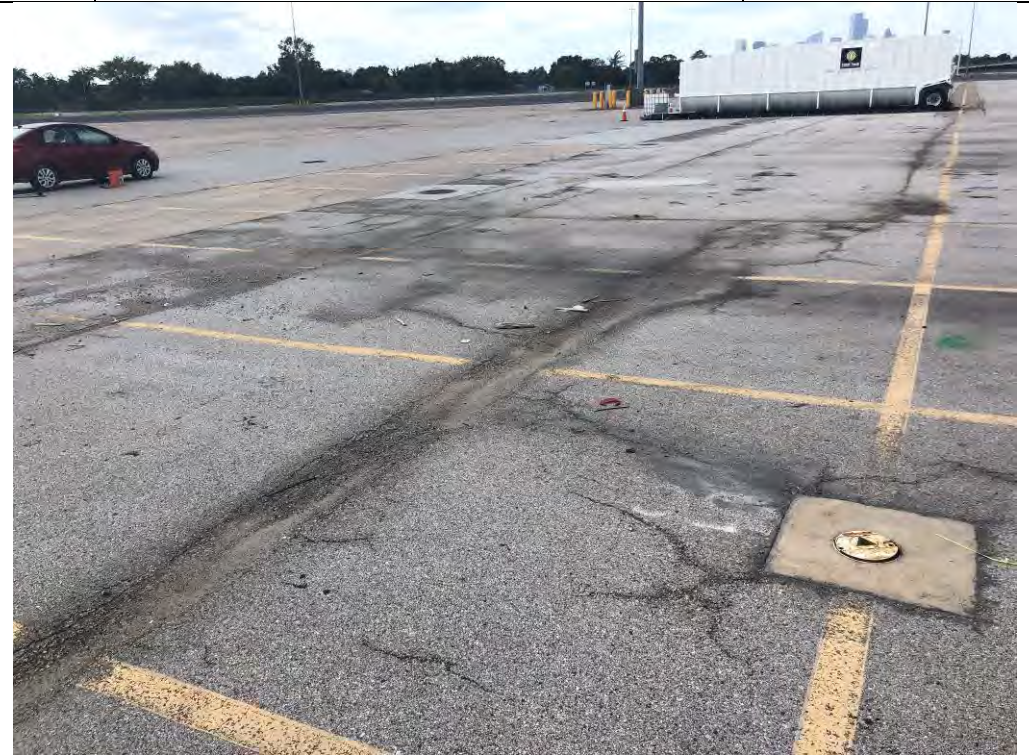
<b>Photo No.:</b> 11	<b>Date:</b> 10/15/2020
-------------------------	----------------------------

Slots B096-B110, NAPL collection system visible in background, residual brown staining observed along the crack in the asphalt, looking southwest.

- No wide-spread seep water was observed during the October 2020 inspections. UPRR will continue to have USES pressure wash the areas where the brown staining and seeps are observed as needed.

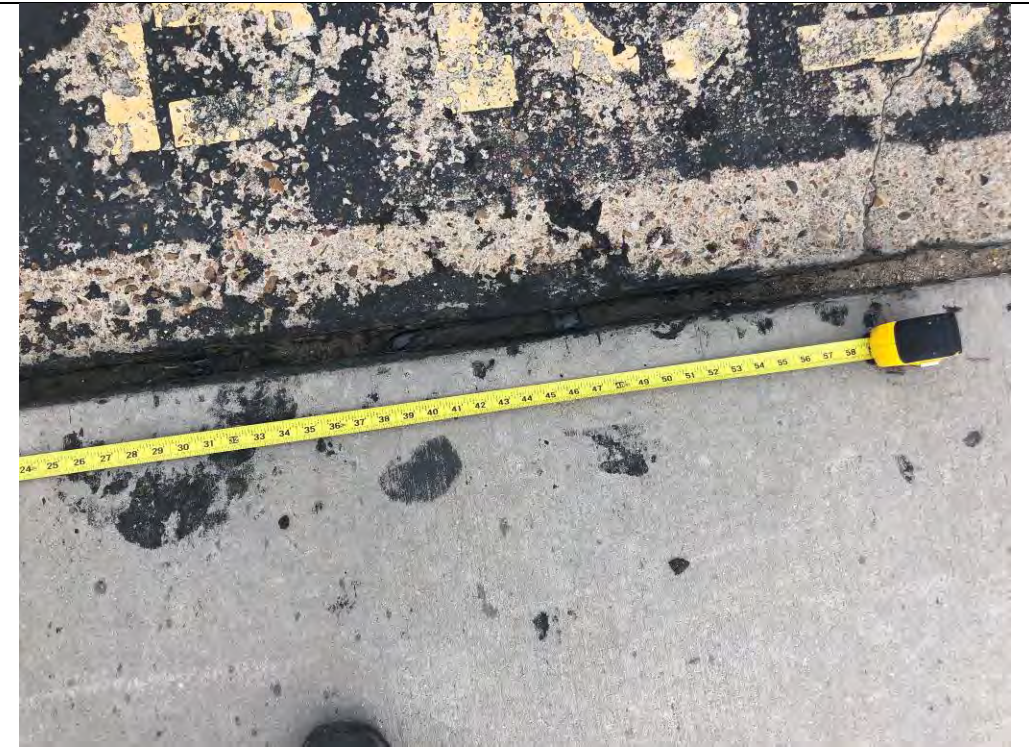
<b>Photo No.:</b> 12	<b>Date:</b> 10/15/2020
-------------------------	----------------------------

Slot B102, small amount of tar-like material seeping at joint, material was removed.

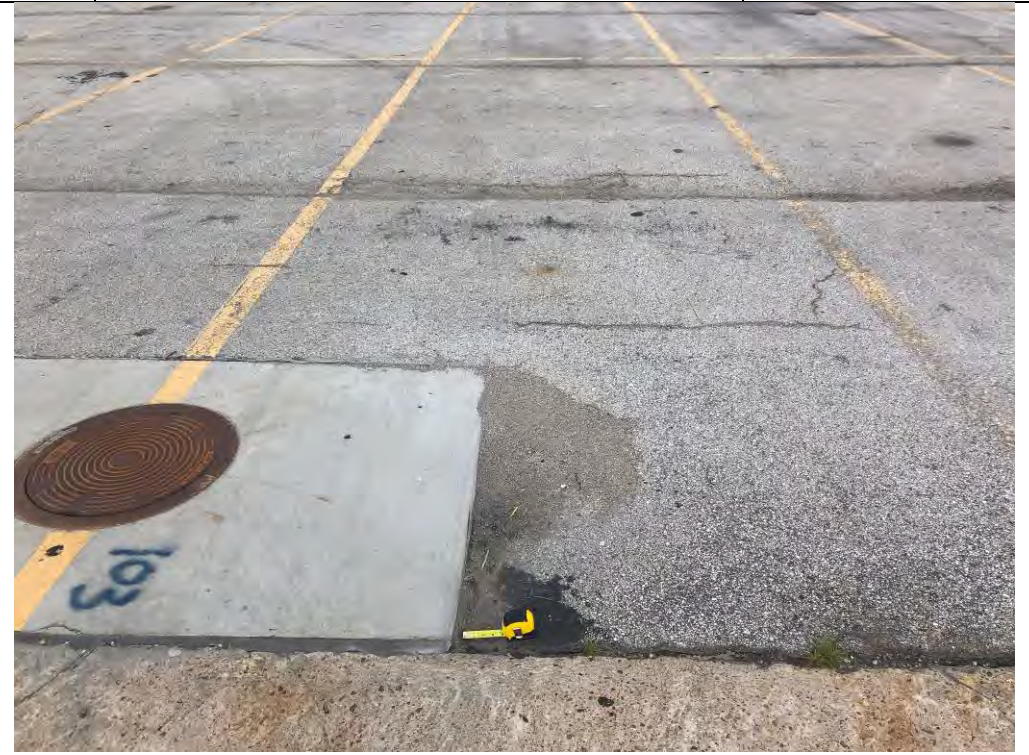
<b>Photo No.</b> <b>13</b>	<b>Date:</b> 10/15/2020
-------------------------------	----------------------------

- A small amount of tar-like NAPL was observed at a concrete/asphalt surface joint located immediately adjacent to the NAPL Collection System in slot B103 on October 15, 2020 (see photolog, Photo No. 13). No other seeps were observed within the NAPL Collection System area. For areas outside the NAPL Collection System, very small amounts of tar-like material were noted on the concrete surface in stalls A022, B057, B101, B102, and B105 where previous seeps have been observed. The overall amount of material recovered during October 2020 was similar to September 2020 with a total of less than 1 gallon of the tar-like material recovered.

Slot B103, view of NAPL Collection System (Sump 103/104 on left). Very small amount of tar-like material seeping at the joint adjacent to the sump, looking north.

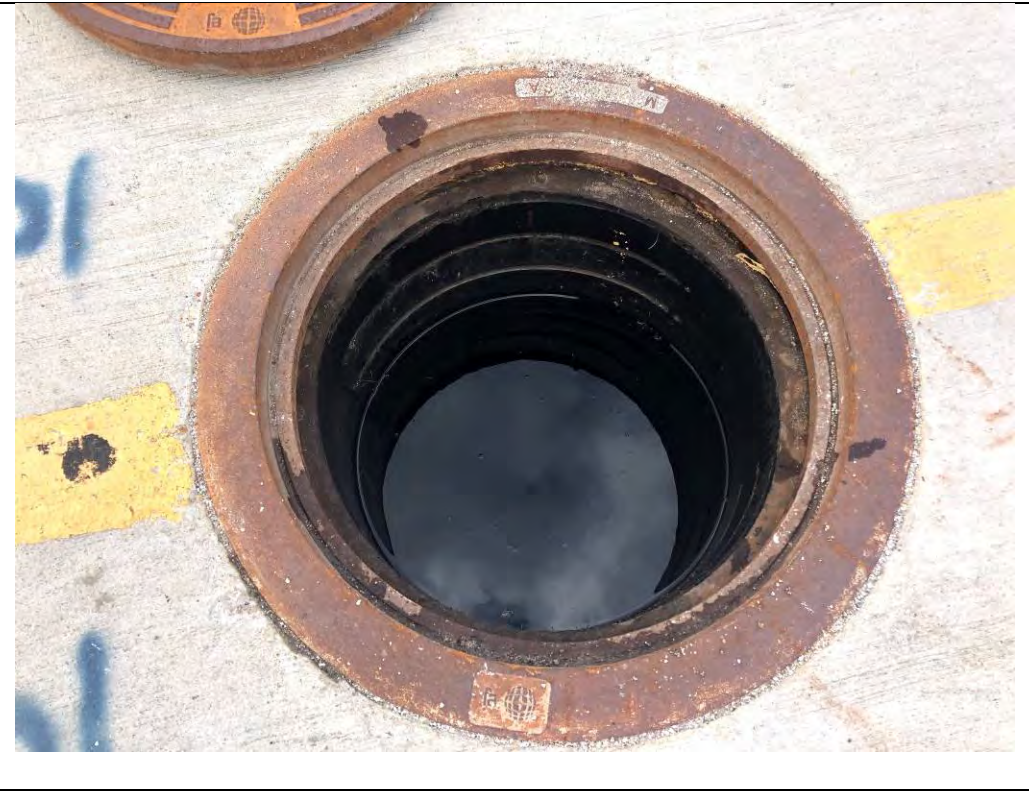
<b>Photo No.</b> <b>14</b>	<b>Date:</b> 10/15/2020
-------------------------------	----------------------------

Sump 2 (B103/B104), 11 inches of freeboard in sump, no sheen or odors noted.

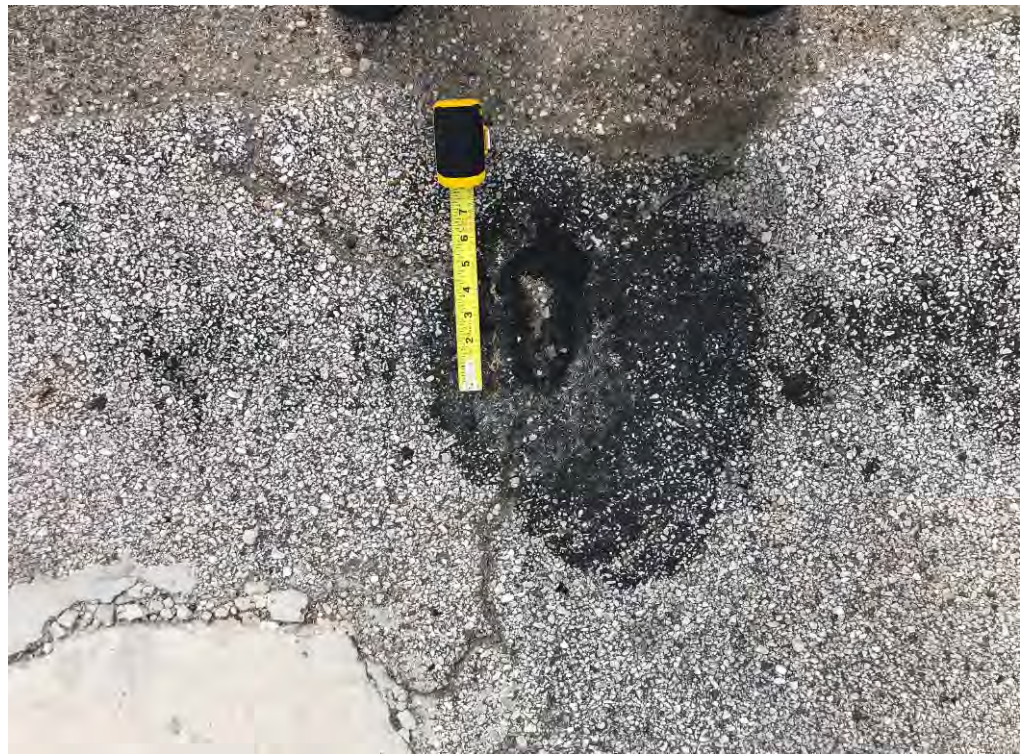
<b>Photo No.</b> <b>15</b>	<b>Date:</b> 10/15/2020
<b>Description:</b>  Slot B105, small amount of tar-like material seeping at asphalt crack, material was removed.  Lat: 29.7841472 Long: - 95.3208777

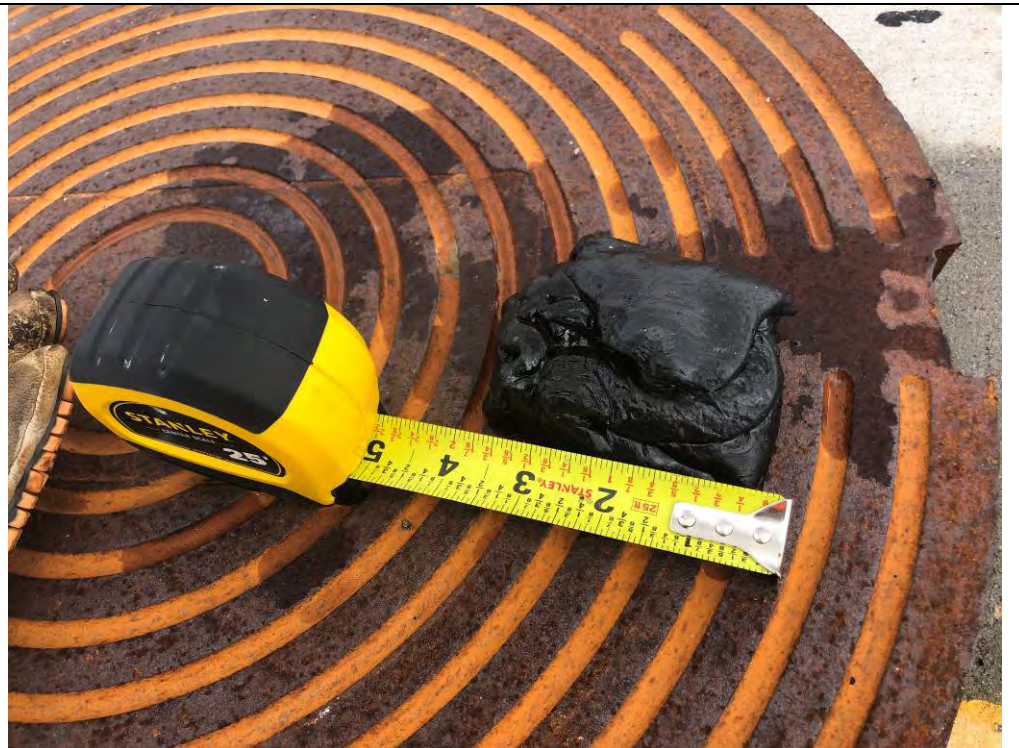
<b>Photo No.</b> <b>16</b>	<b>Date:</b> 10/15/2020
<b>Description:</b>  Sump 3 (B107/B108), approximately 3.5 oz of tar-like material recovered from the sump. No sheen visible on water and no odor observed.  Lat: 29.7842861 Long: - 95.3208611

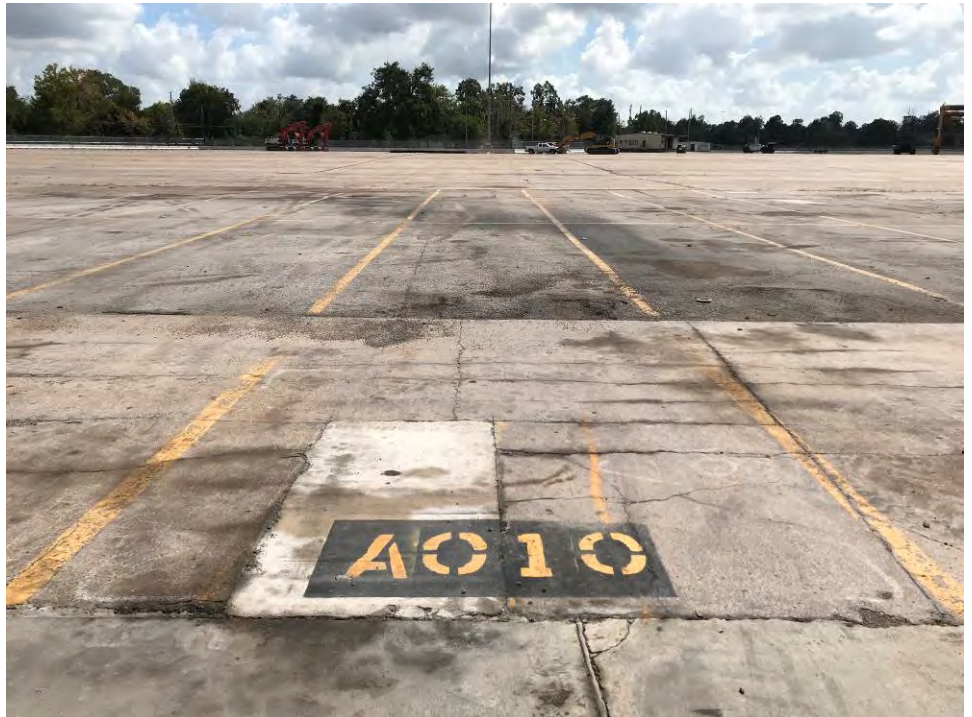
**Photo No.**  
**17**

Slot A010, no tar-like material seeps observed where test pit (July 2020) conducted, looking south.

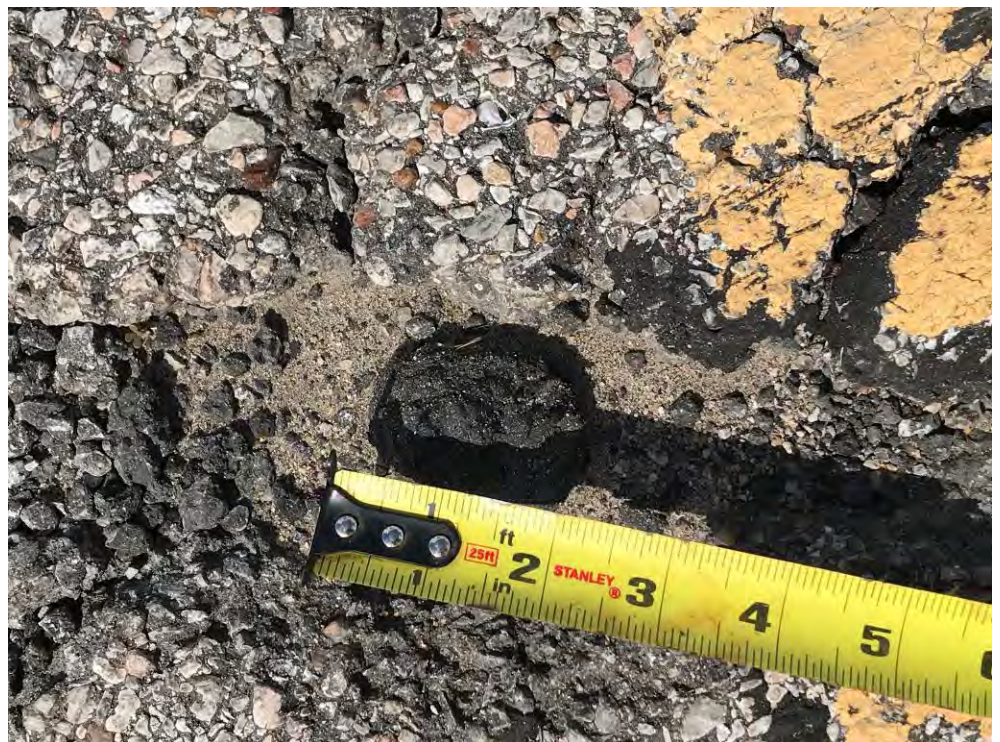
**Photo No.**  
**18**

Slot B057, small amount of tar-like material seeping at asphalt crack (not near July 2020 test pit), material was removed.

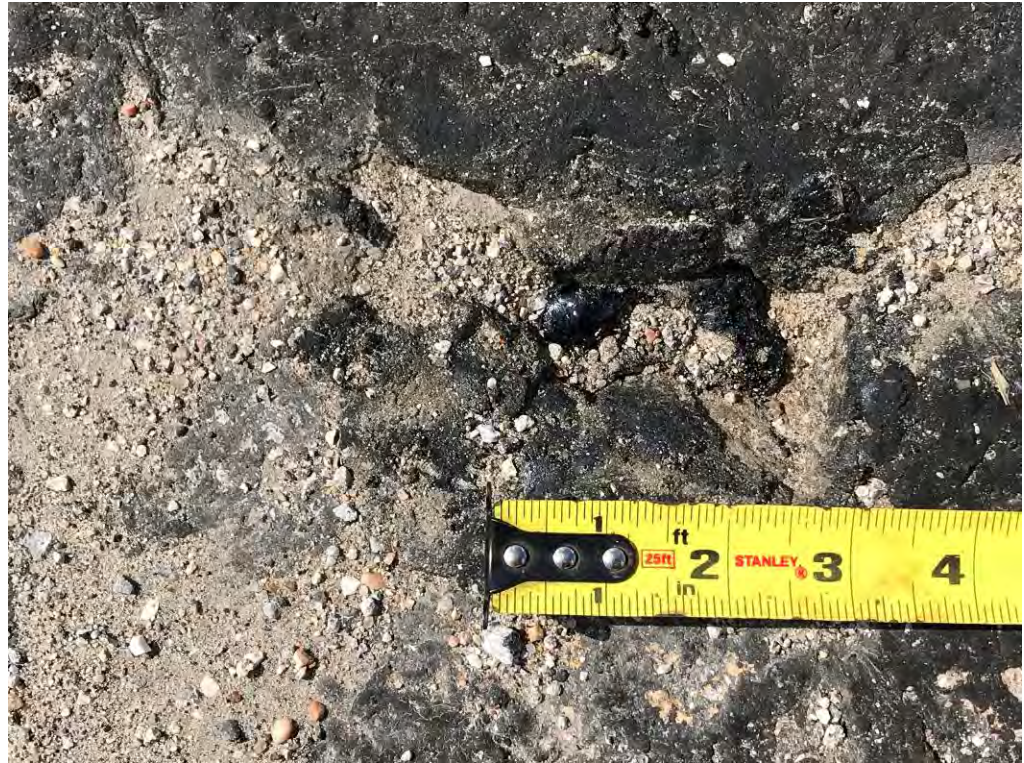
<b>Photo No.</b> <b>19</b>	<b>Date:</b> 10/21/2020
<b>Description:</b>  Slot B101, small amount of tar-like material seeping at asphalt crack. Material was removed.  Lat: 29.784275 Long: - 95.320813

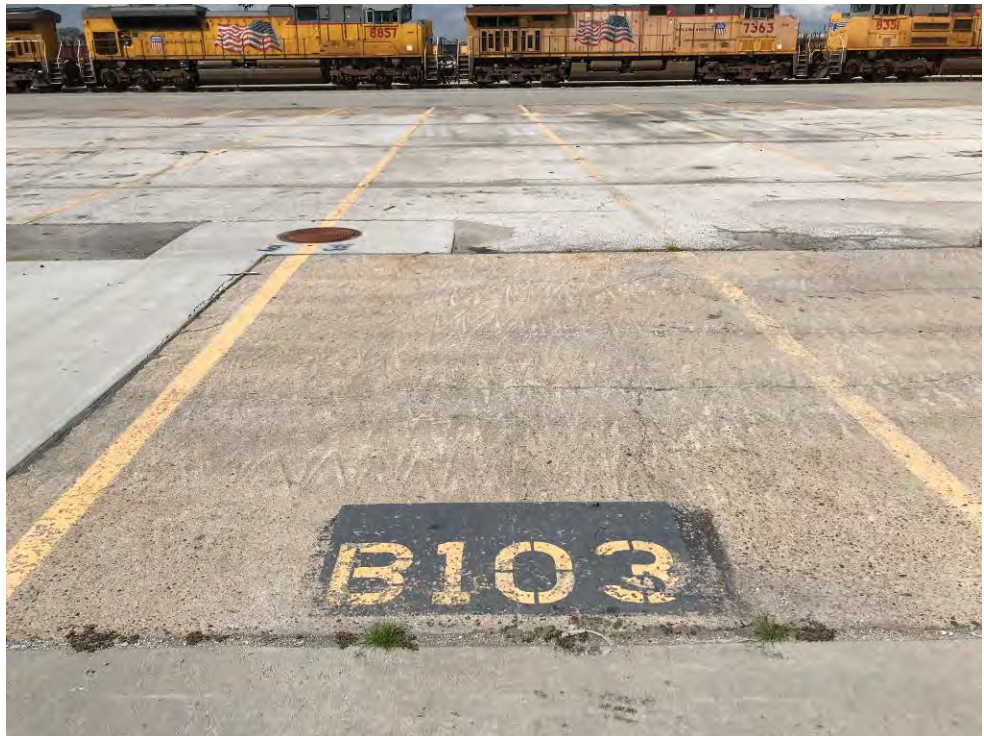
<b>Photo No.</b> <b>20</b>	<b>Date:</b> 10/21/2020
<b>Description:</b>  Slot B103, view of NAPL Collection System (Sump 2, B103/B104). No tar-like material seeps observed, looking north.  Lat: 29.7841639 Long: - 95.3208694

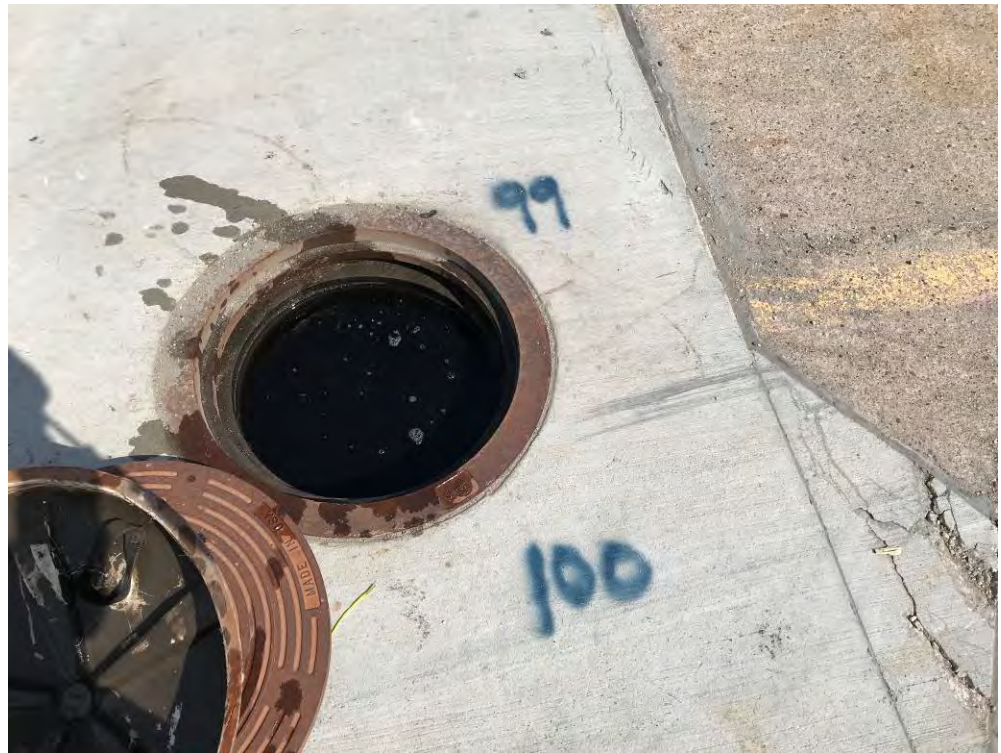
<b>Photo No.</b> <b>21</b>	<b>Date:</b> 10/21/2020
<b>Description:</b>  Sump 1 (B099/B100), 1 inch of freeboard in sump, no sheen or odor noted.  Lat: 29.7844000 Long: - 95.3205861

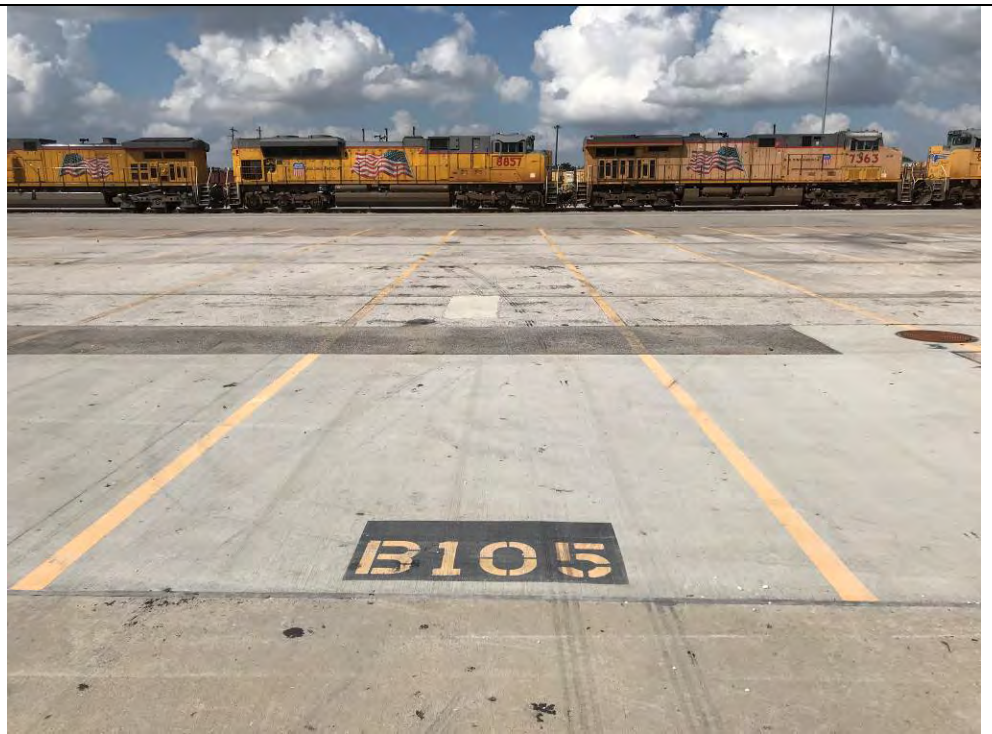
<b>Photo No.</b> <b>22</b>	<b>Date:</b> 10/21/2020
-------------------------------	----------------------------

<b>Description:</b>  Slot B105, no tar-like material seeps observed, looking north.  Lat: 29.7841472 Long: - 95.3208777	
--	--

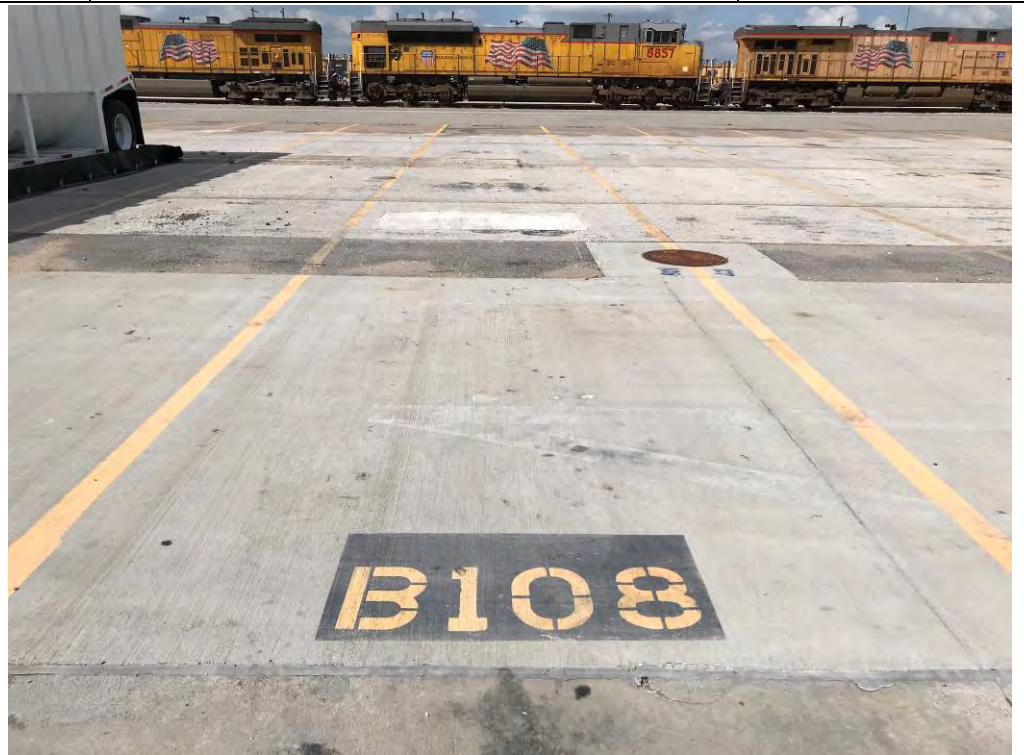
<b>Photo No.</b> <b>23</b>	<b>Date:</b> 10/21/2020
<b>Description:</b>  Slot B108, view of NAPL Collection System (Sump 3 (B107B/108) and test pit in background). No tar-like material seeps observed, looking north.  Lat: 29.784125 Long: - 95.320989

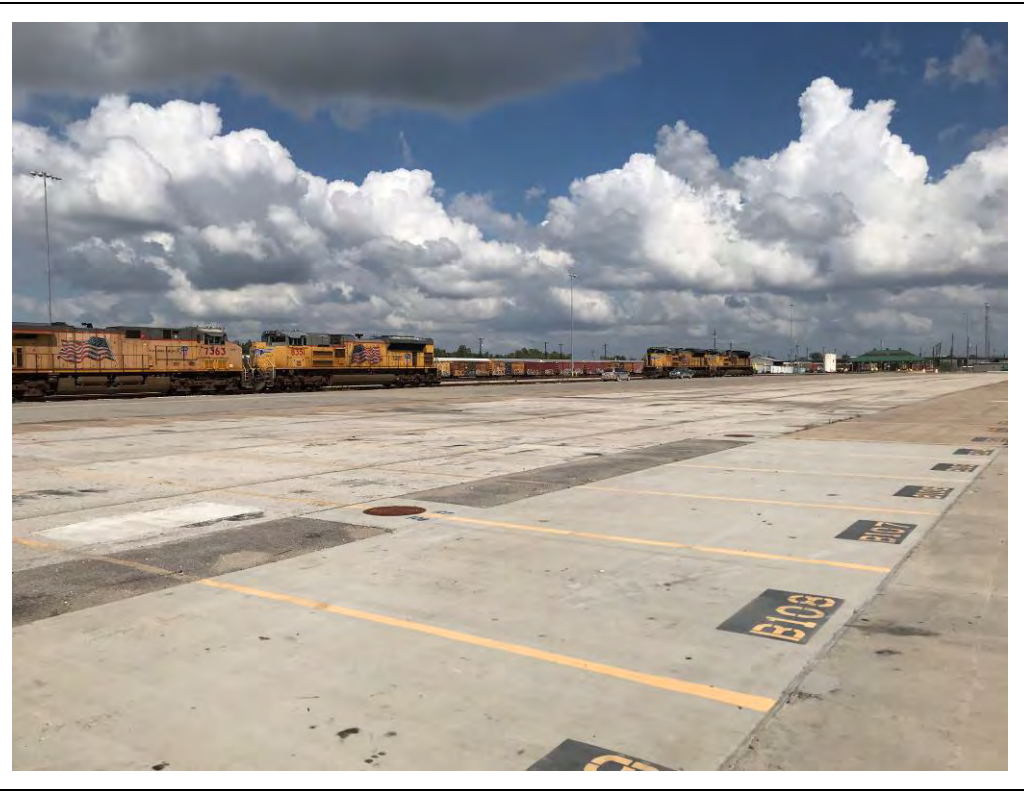
<b>Photo No.</b> <b>24</b>	<b>Date:</b> 10/21/2020
<b>Description:</b>  Slots B109-B097, NAPL collection system visible in background, residual brown staining observed along the crack in the asphalt, looking northeast.  Lat: 29.784116 Long: -95.321022

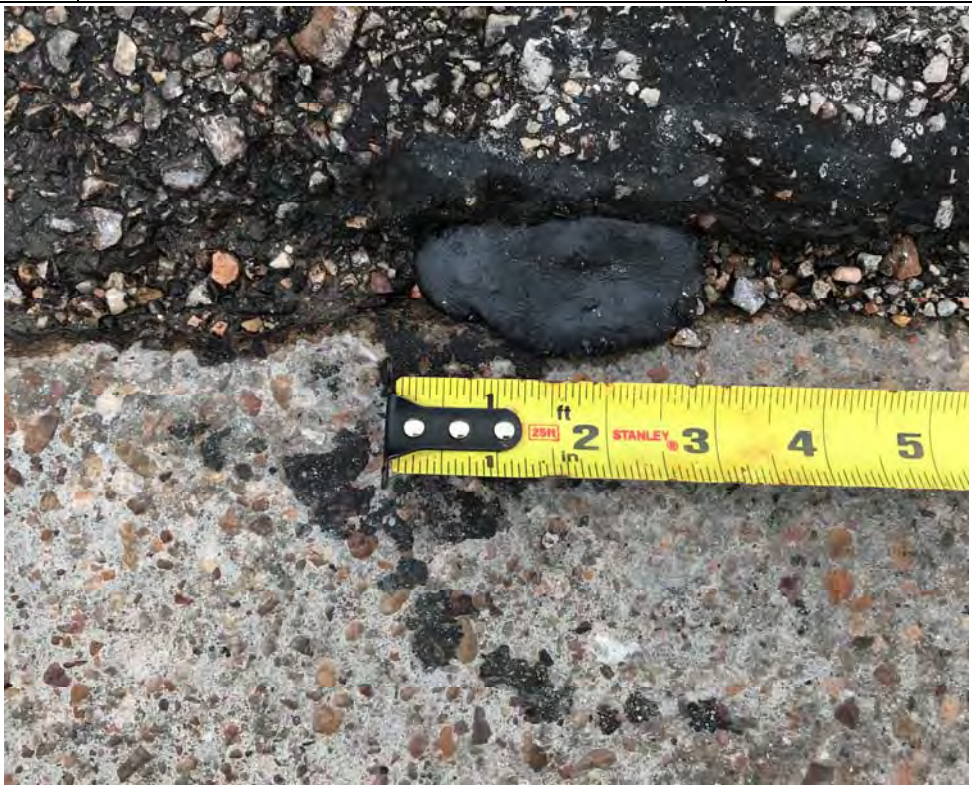
<b>Photo No.</b> <b>25</b>	<b>Date:</b> 10/28/2020
<b>Description</b>  Slot A022, small amount of tar-like material seeping at joint, material was removed.  Lat: 29.785392, Long: -95.318655

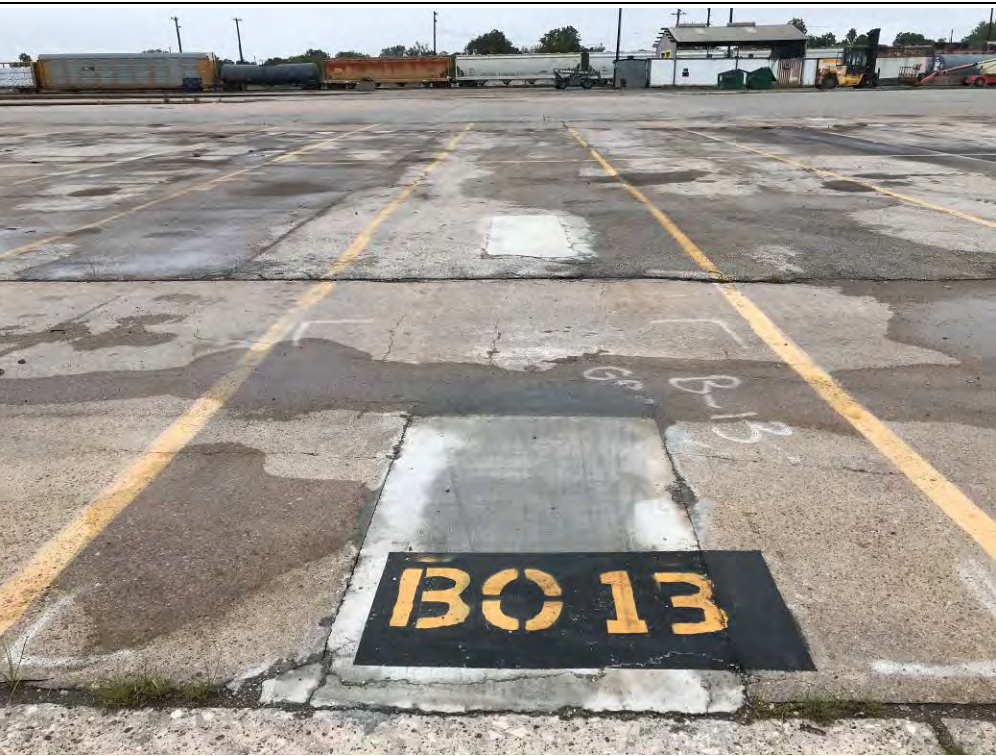
<b>Photo No.</b> <b>26</b>	<b>Date:</b> 10/28/2020
<b>Description:</b>  Slot B013, no tar-like material seeps observed where test pit (July 2020) conducted, water on pavement from recent rain event, looking north.  Lat: 29.785217 Long: - 95.318261

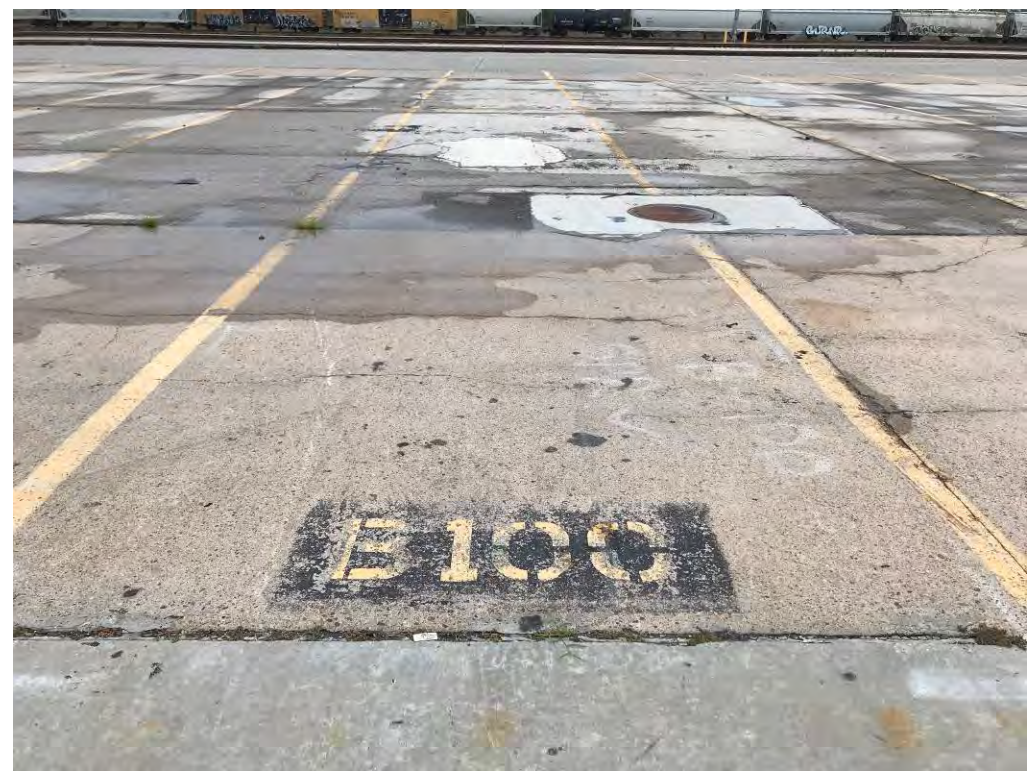
<b>Photo No.:</b> 27	<b>Date:</b> 10/28/2020
-------------------------	----------------------------

Slot B100, view of NAPL Collection System (Sump 099/100 in background). Water on pavement from recent rainfall event. No tar-like material seeps observed, looking north.

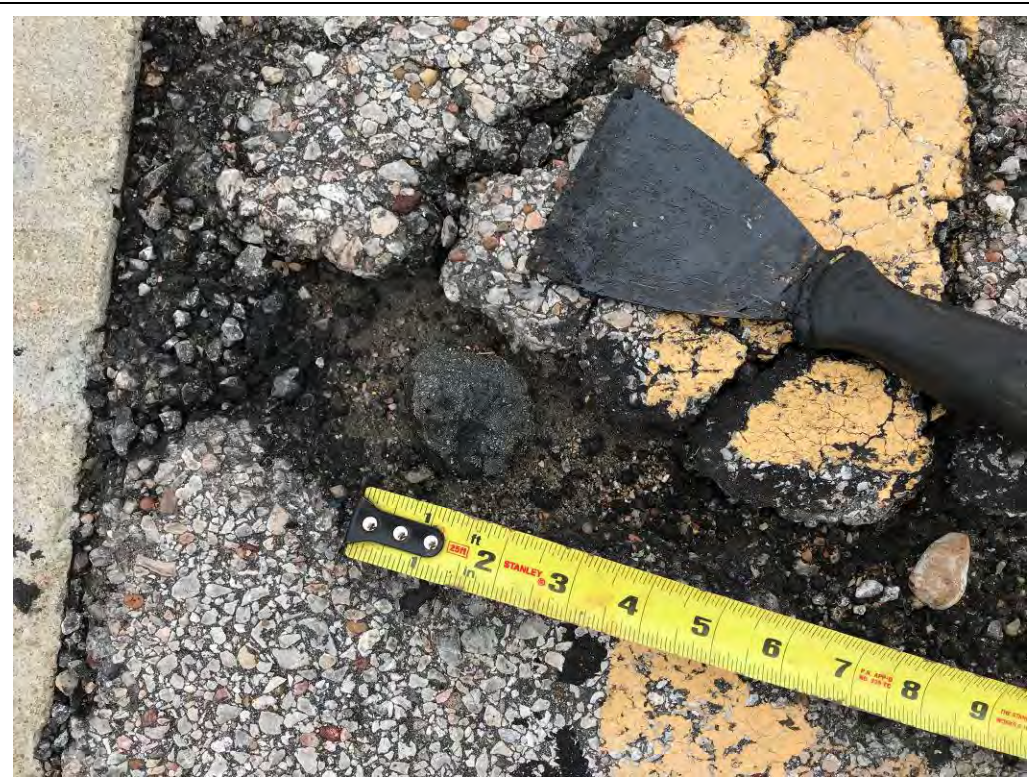
<b>Photo No.:</b> 28	<b>Date:</b> 10/28/2020
-------------------------	----------------------------

Slot B057, small amount of tar-like material seeping at asphalt crack (not near July 2020 test pit), material was removed.
