November 19, 2020

Project No. 19119232

**RE: MONTHLY STATUS UPDATE – ENGLEWOOD INTERMODAL YARD – NAPL COLLECTION SYSTEM/CONCRETE CAP REPAIRS  
UNION PACIFIC RAILROAD HOUSTON WOOD PRESERVING WORKS FACILITY  
4910 LIBERTY ROAD FACILITY, HOUSTON, TEXAS  
POST-CLOSURE CARE PERMIT NO. HW-50343; INDUSTRIAL SWR NO. 31547**

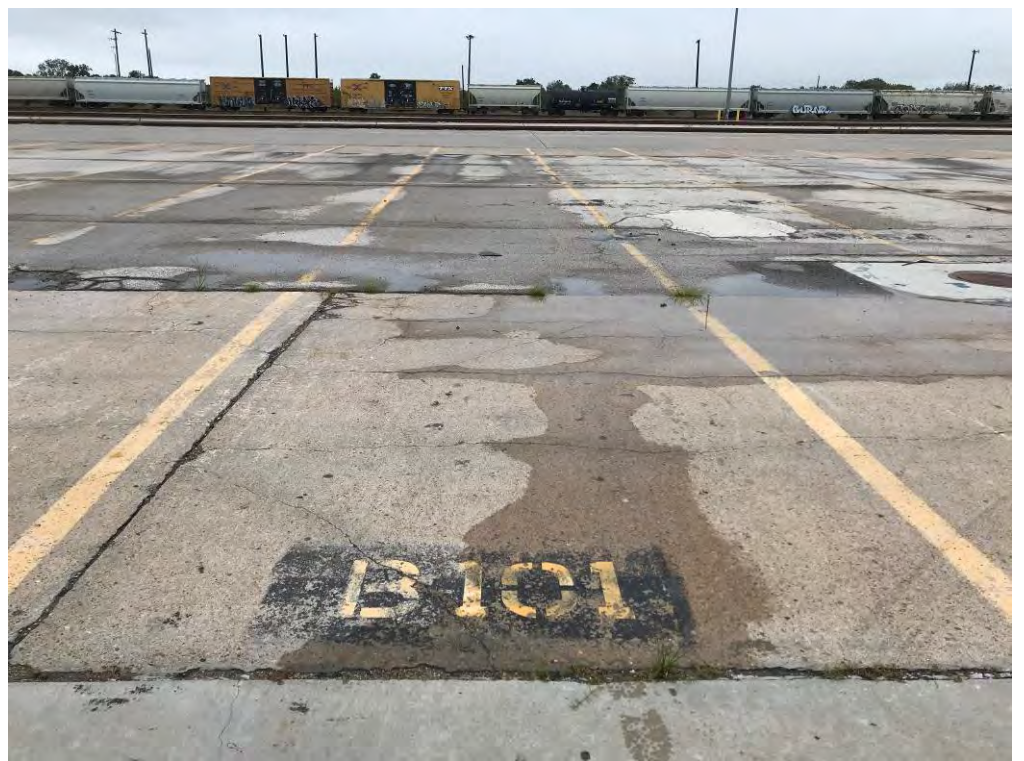
<b>Photo No.</b> <b>29</b>	<b>Date:</b> 10/28/2020
-------------------------------	----------------------------

Slot B101, no tar-like material seeps observed, water on pavement from recent rain event, looking north.

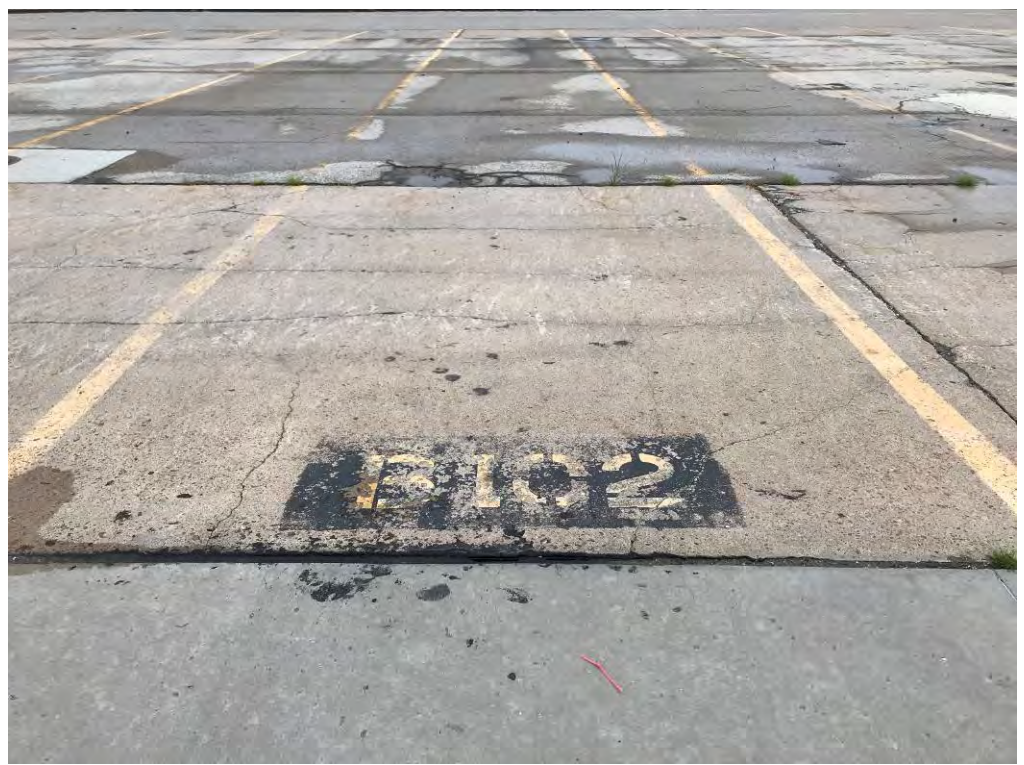
<b>Photo No.</b> <b>30</b>	<b>Date:</b> 10/28/2020
-------------------------------	----------------------------

Slot B102, no tar-like material seeps observed, water on pavement from recent rain event, looking north.

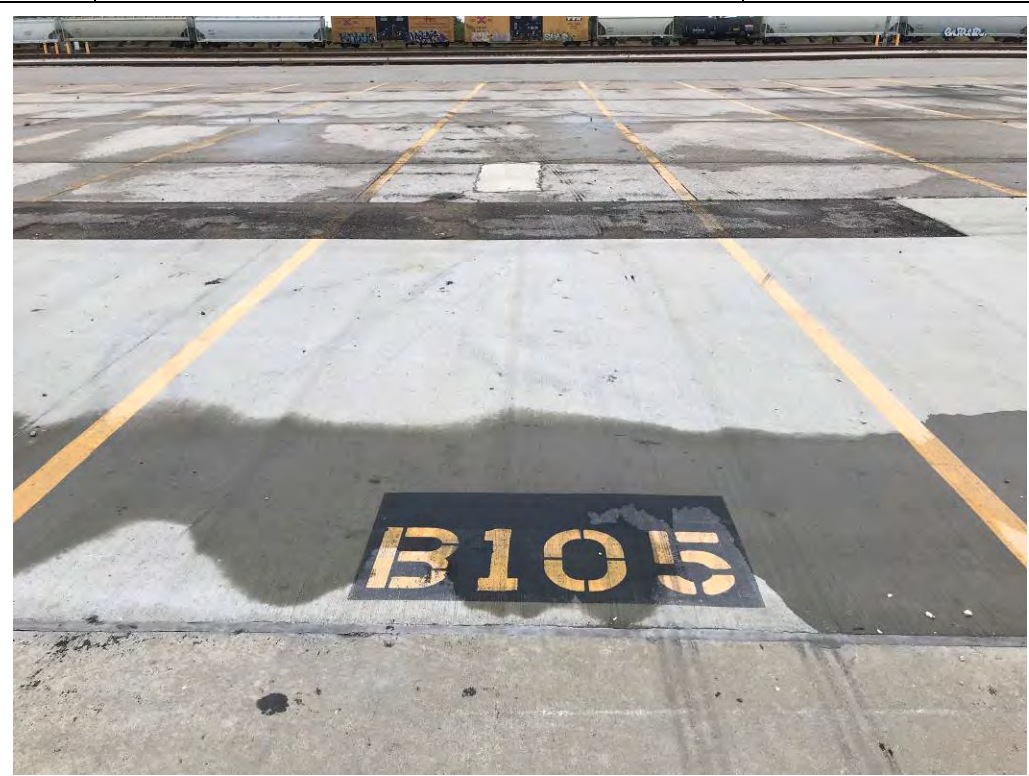
<b>Photo No.</b> <b>31</b>	<b>Date:</b> 10/28/2020
<b>Description:</b>  Slot B105, no tar-like material seeps observed, water on pavement from recent rain event, looking north.  Lat: 29.7841472 Long: - 95.3208777

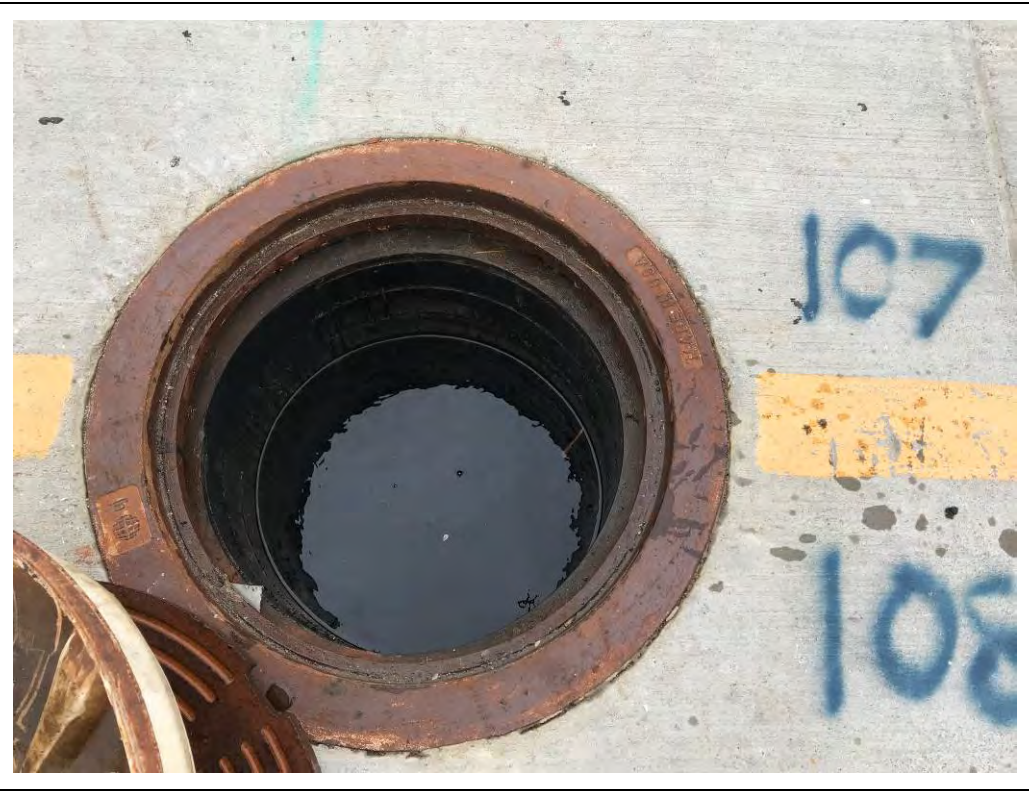
<b>Photo No.</b> <b>32</b>	<b>Date:</b> 10/28/2020
-------------------------------	----------------------------

<b>Description:</b>  Sump 3 (B107/B108), 10 inches of freeboard in sump. No sheen, odor, or tar-like material observed.  Lat: 29.7842861 Long: - 95.3208611	
--	--
