December 10, 2020

Project No. 19119232

**RE: MONTHLY STATUS UPDATE – ENGLEWOOD INTERMODAL YARD – NAPL COLLECTION SYSTEM/CONCRETE CAP REPAIRS
UNION PACIFIC RAILROAD HOUSTON WOOD PRESERVING WORKS FACILITY
4910 LIBERTY ROAD FACILITY, HOUSTON, TEXAS
POST-CLOSURE CARE PERMIT NO. HW-50343; INDUSTRIAL SWR NO. 31547**

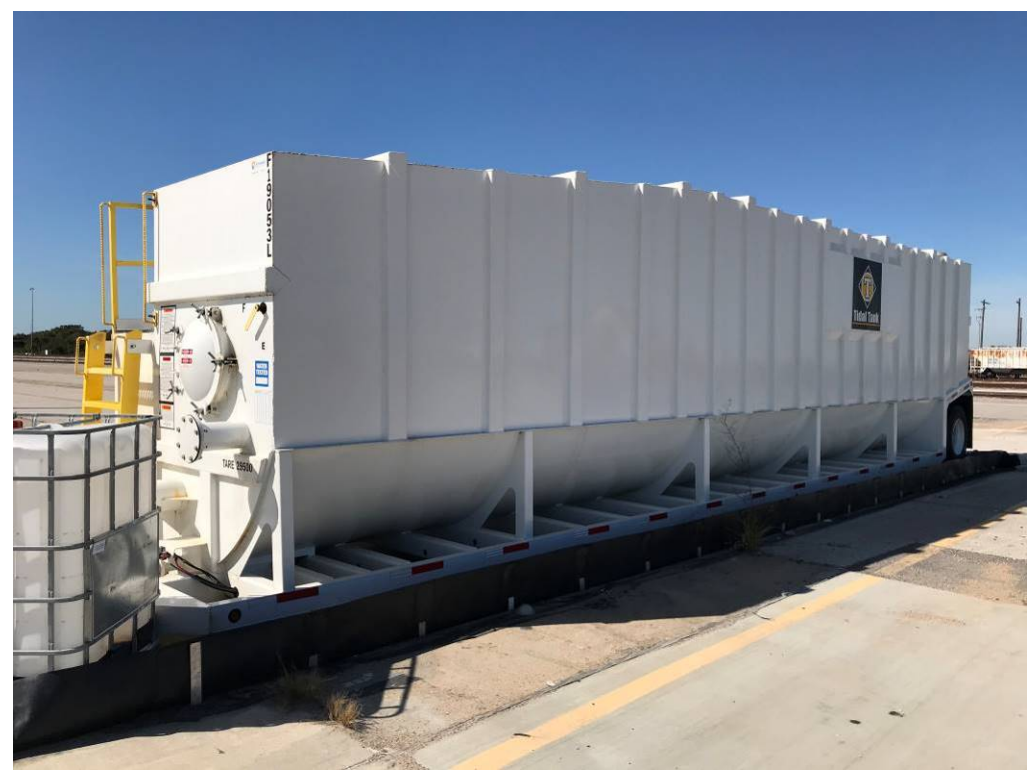
Photo No. 1	Date: 11/04/2020
------------------------------	----------------------------

Frac tank for storage of pumped down water from NAPL Collection Sumps (in Slot B110) and tote for storage of recovered pressure wash water/brown water, looking northwest.

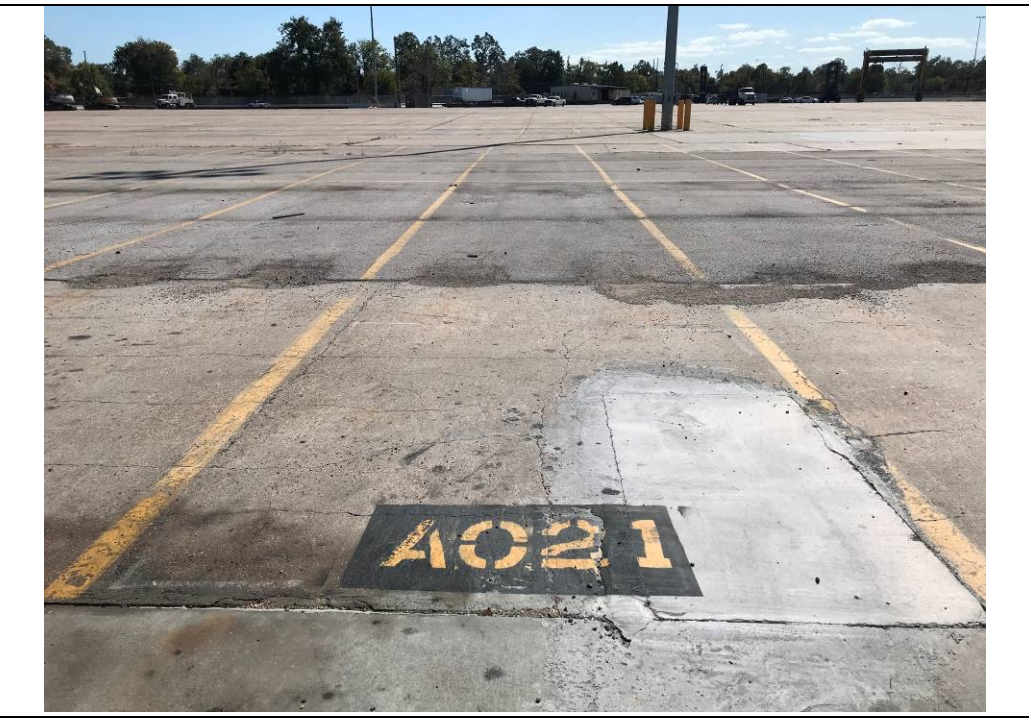
Photo No. 2	Date: 11/04/2020
------------------------------	----------------------------

Slot A021, no tar-like material seeps observed where test pit (July 2020) conducted, looking south.

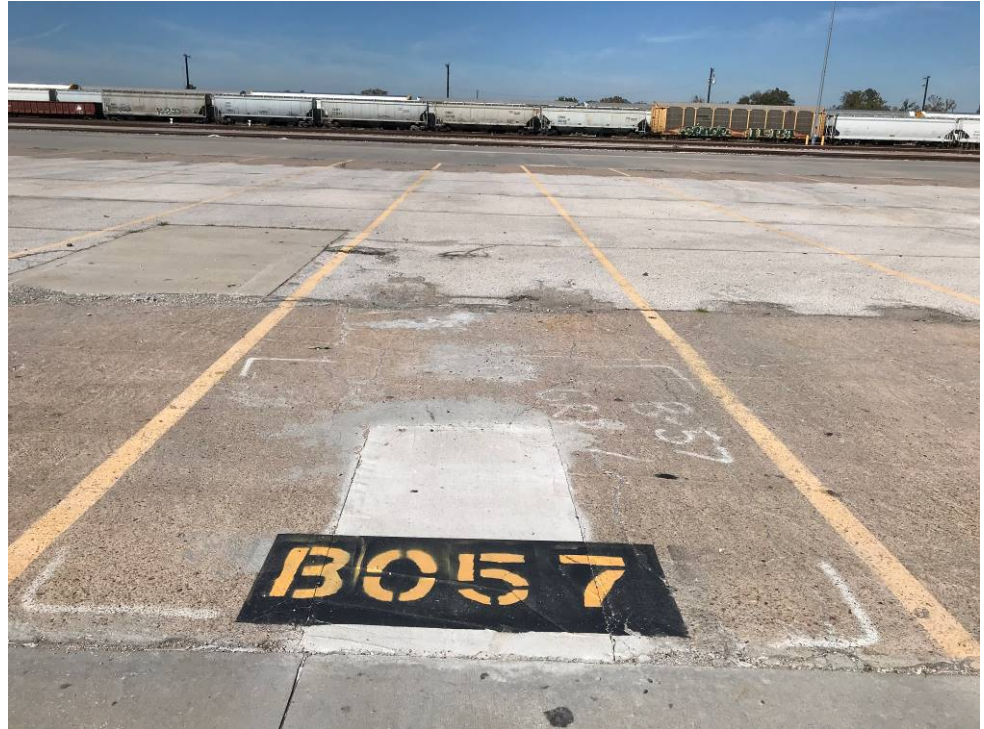
Photo No. 3	Date: 11/04/2020
Description: Slot B057, no tar-like material seeps observed where test pit (July 2020) conducted, looking north. Lat: 29.7847472 Long: - 95.3195417

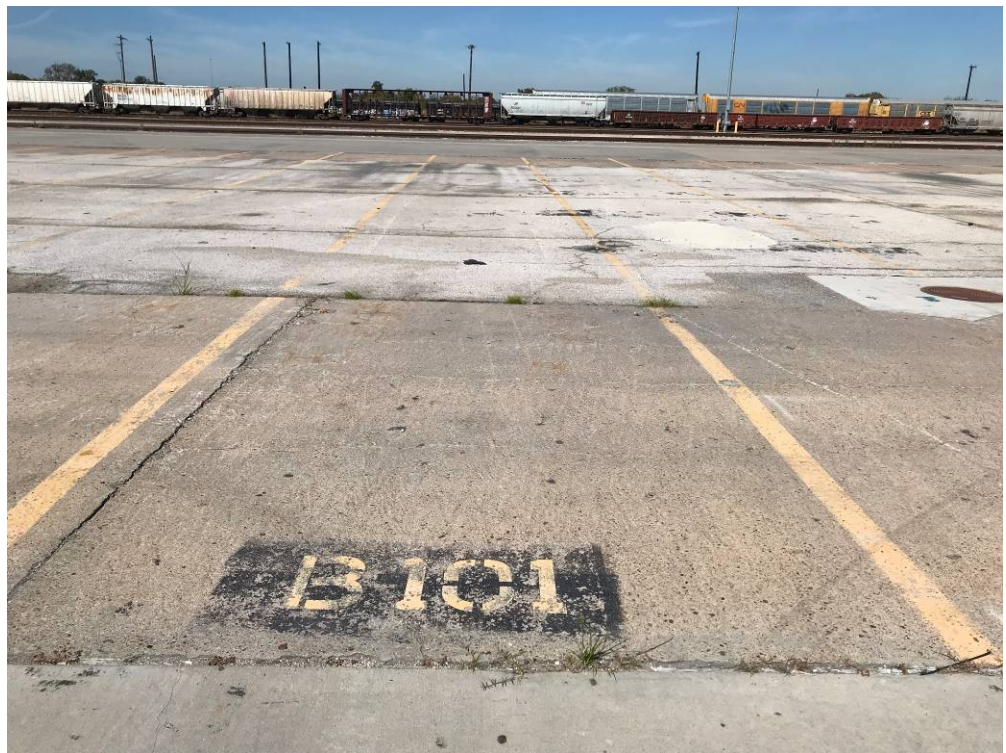
Photo No. 4	Date: 11/04/2020
Description: Slot B101, no tar-like material seeps observed, looking north. Lat: 29.784275 Long: - 95.320813

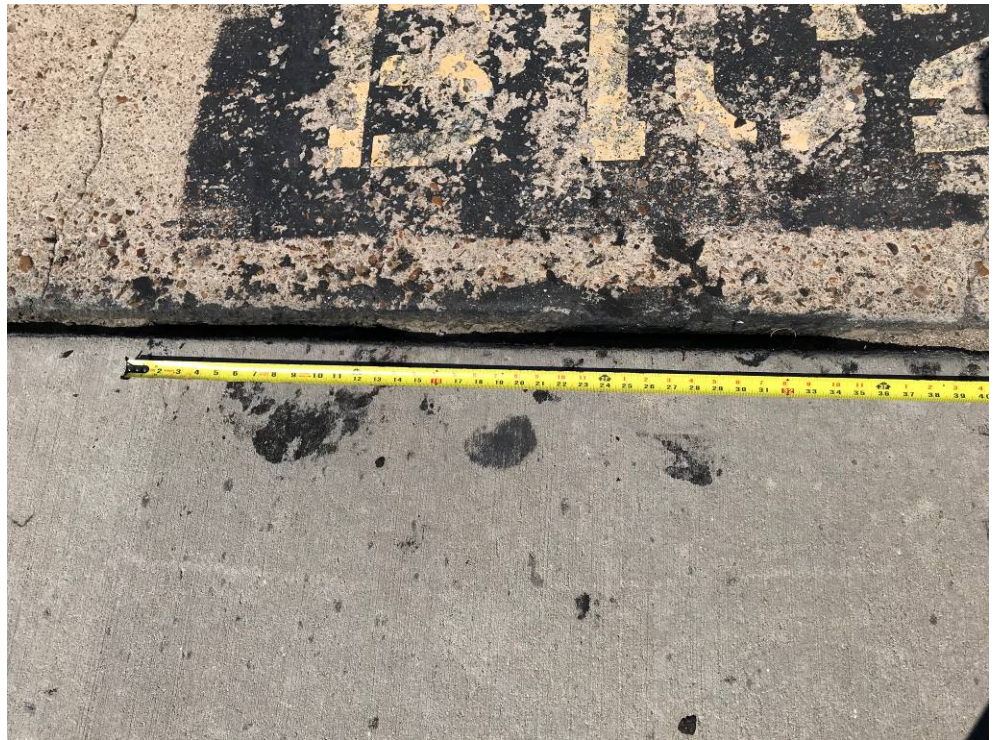
Photo No. 5	Date: 11/04/2020
Description: Slot B102, small amount of tar-like material seeping at asphalt joint, material was removed. Lat: 29.7842203 Long: - 95.320827

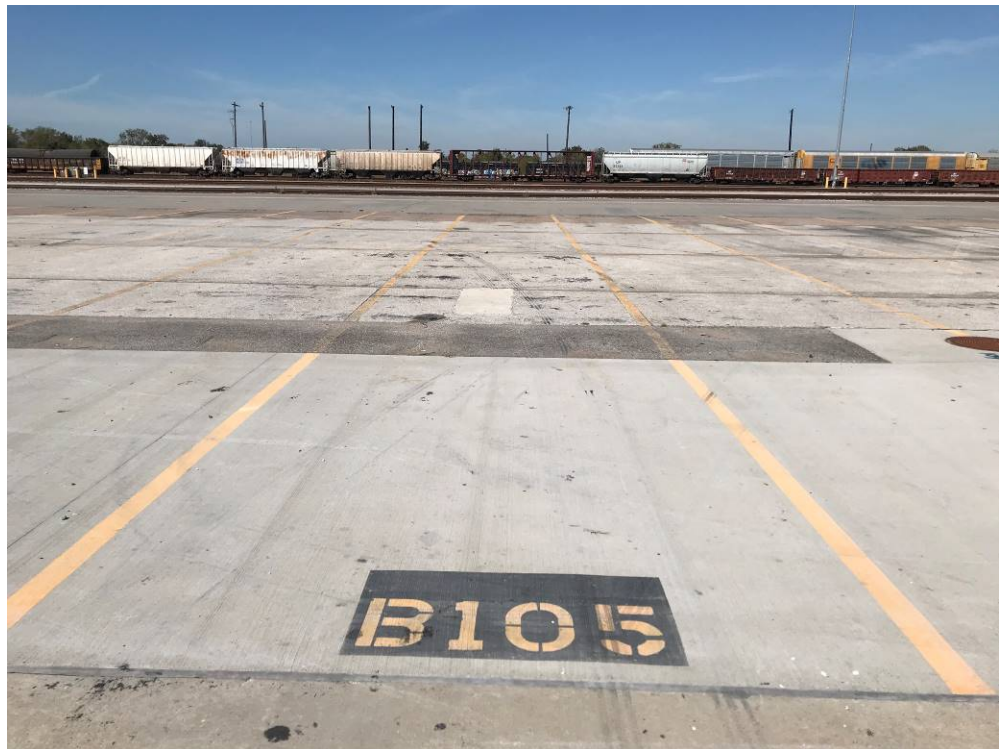
Photo No. 6	Date: 11/04/2020
Description: Slot B105, no tar-like material seeps observed, looking north. Lat: 29.7841472 Long: - 95.3208777

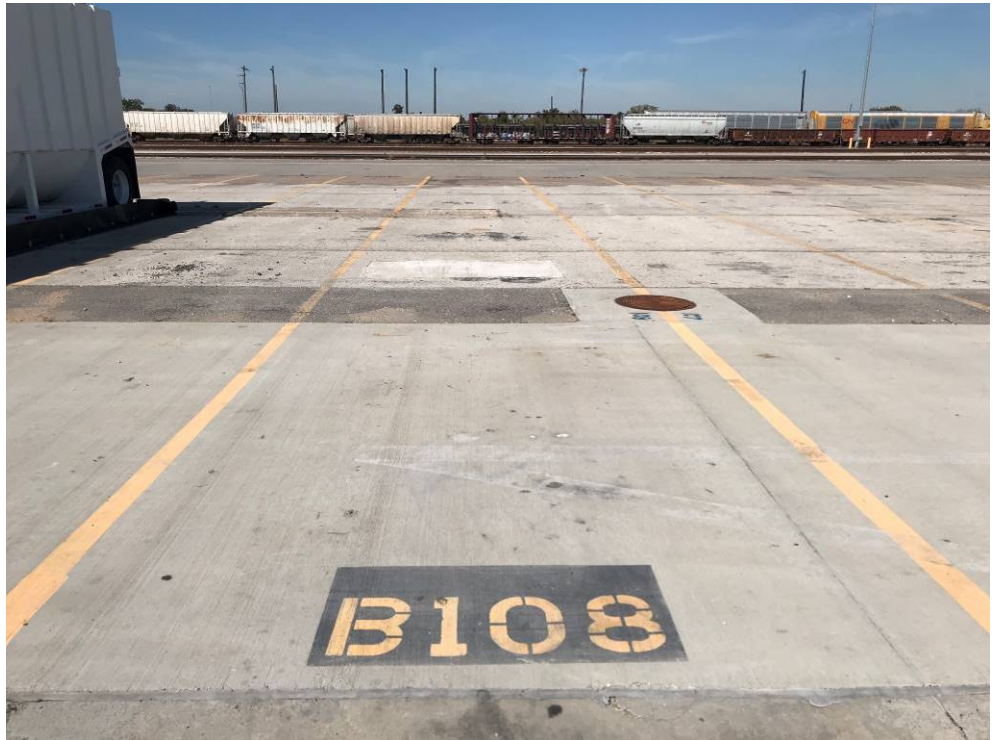
Photo No.: 7	Date: 11/04/2020
------------------------	----------------------------

Slot B108, view of NAPL Collection System (Sump B107/B108 and test pit in background). No tar-like material seeps observed, looking north.

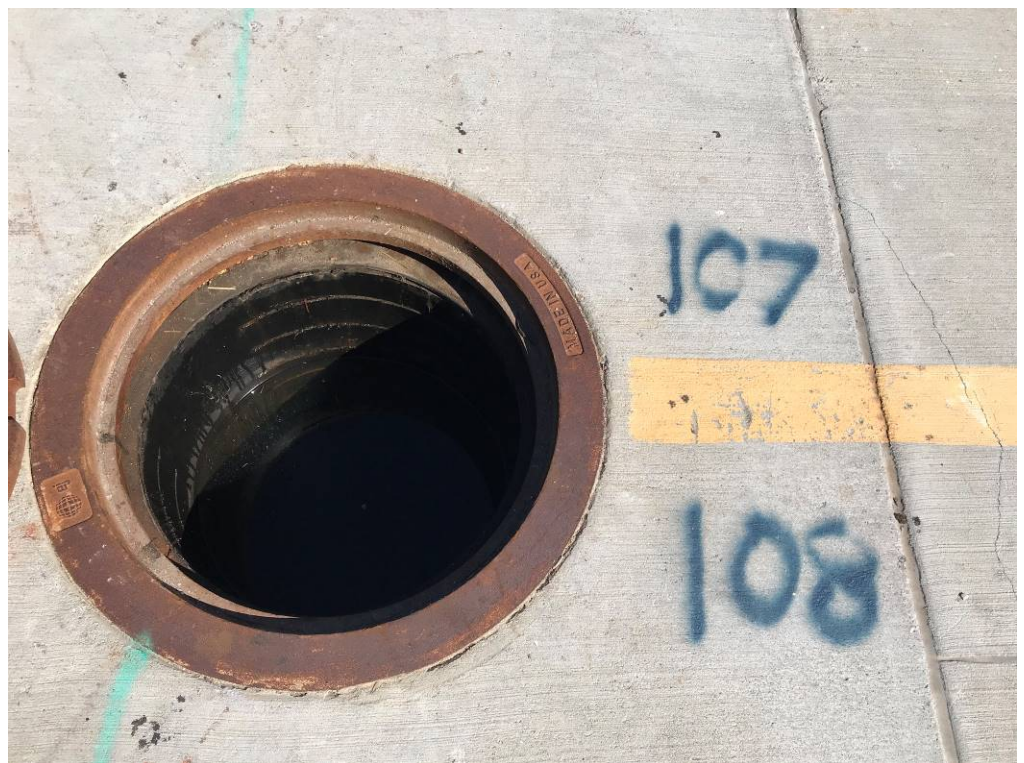
Photo No.: 8	Date: 11/04/2020
------------------------	----------------------------

Sump 3 (B107/B108), 12 inches of freeboard in sump. No sheen, odor or tar-like material observed.

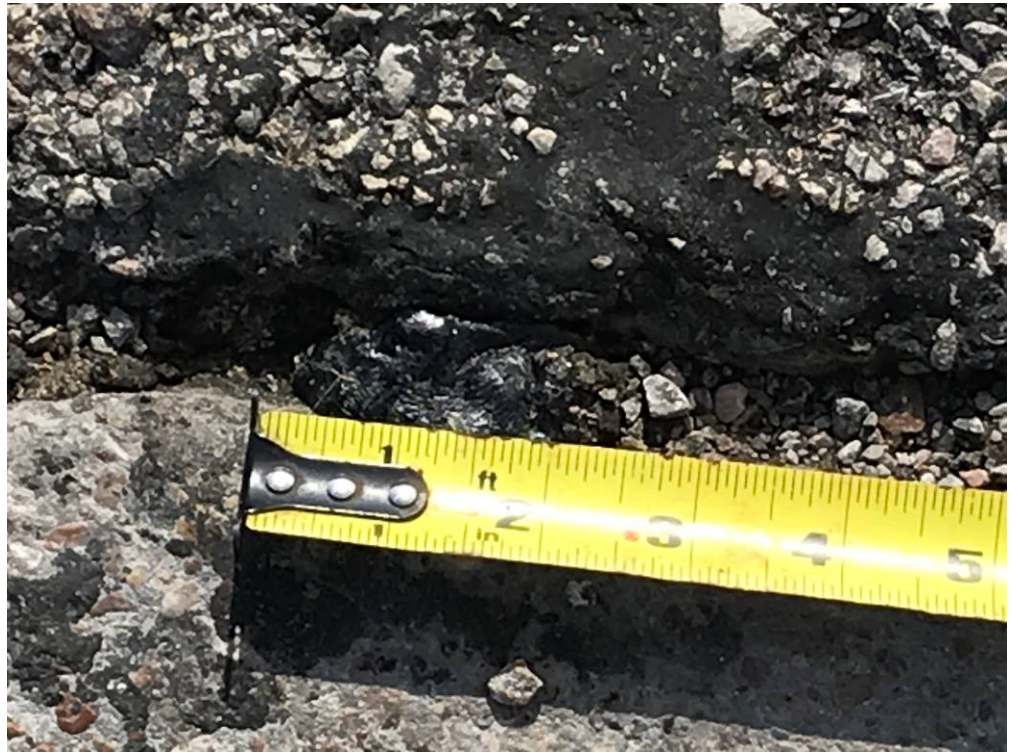
Photo No.
9

Slot A022, very small amount of tar-like material seeping at joint, material was removed.

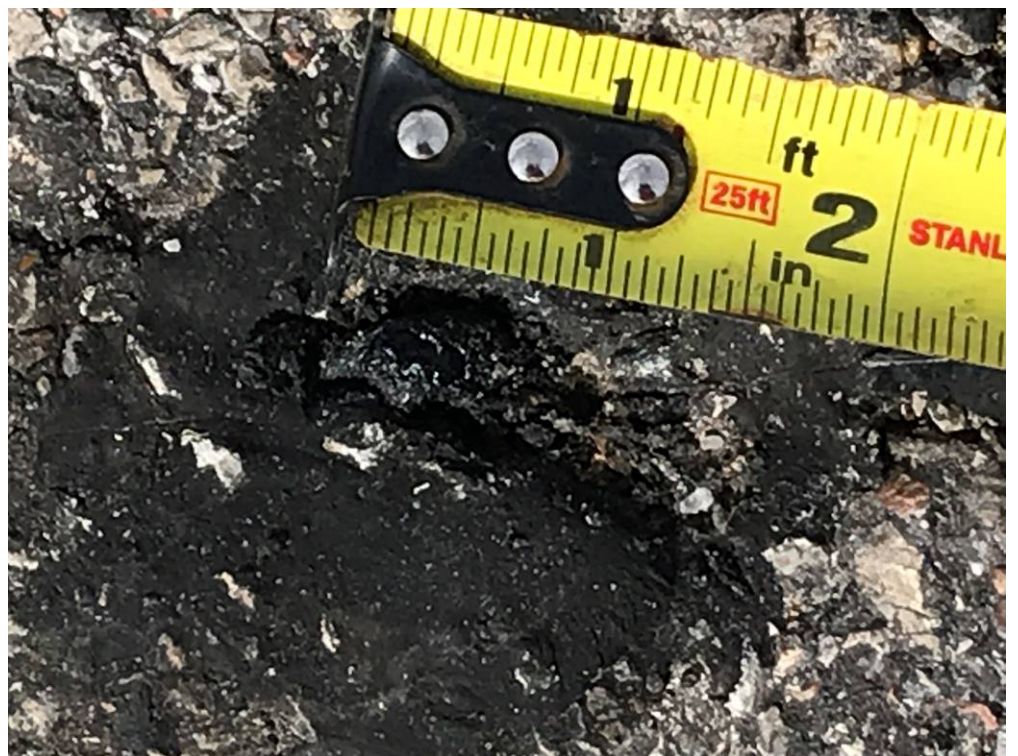
Photo No.
10

Slot B057, very small amount of tar-like material seeping at asphalt crack (not near July 2020 test pit), material was removed.

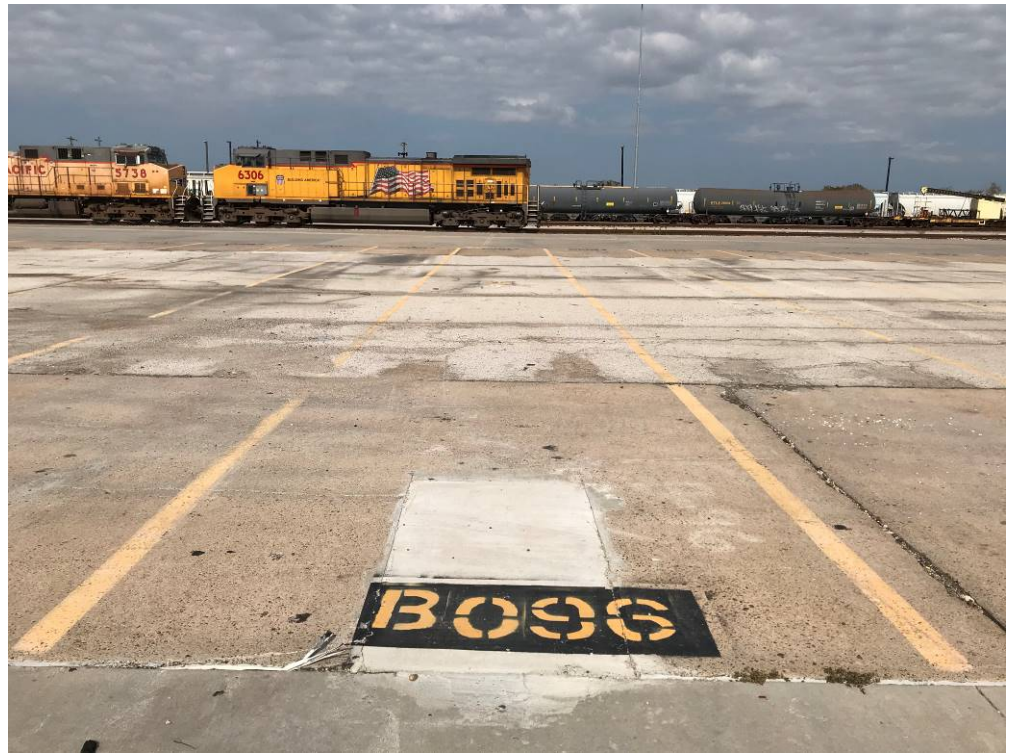
Photo No. 11	Date: 11/11/2020
Description: Slot B096, no tar-like material seeps observed where test pit (July 2020) conducted, looking north. Lat: 29.7842528 Long: - 95.3206250

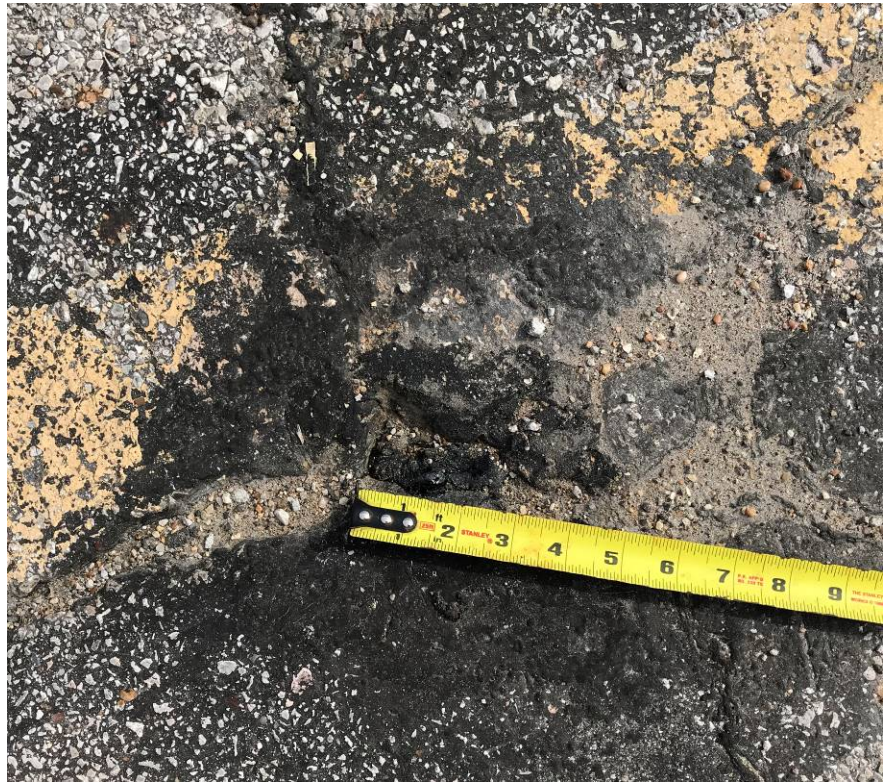
Photo No. 12	Date: 11/11/2020
Description: Slot B101, very small amount of tar-like material seeping at asphalt crack. Material was removed. Lat: 29.784275 Long: - 95.320813

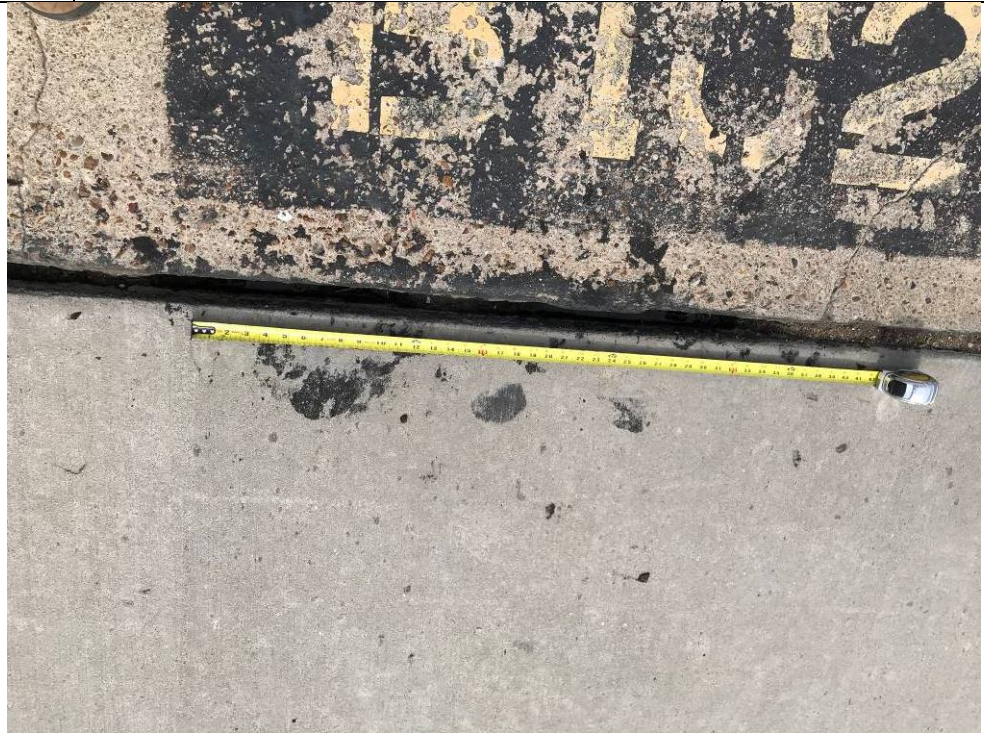
Photo No. 13	Date: 11/11/2020
Description: Slot B102, small amount of tar-like material seeping at asphalt joint, material was removed.	
Lat: 29.7842203 Long: - 95.320827

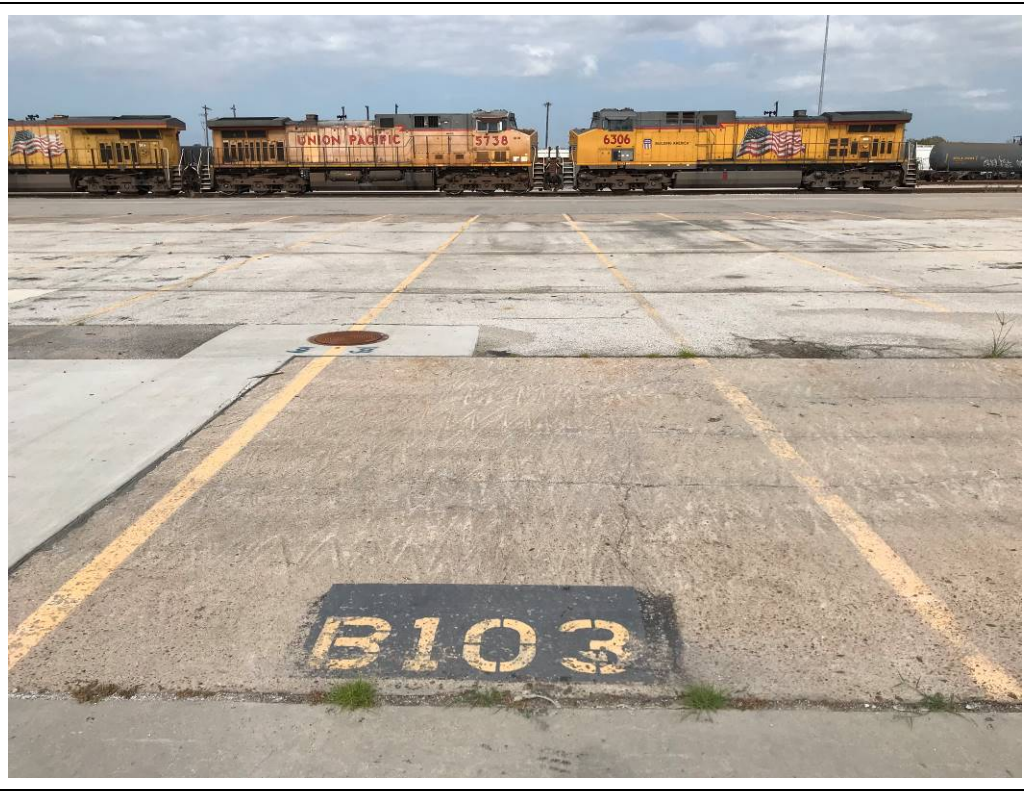
Photo No. 14	Date: 11/11/2020
Description: Slot B103, view of NAPL Collection System (Sump 103/104 on left). No tar-like material seeps observed, looking north.	
Lat: 29.7841639 Long: - 95.3208694

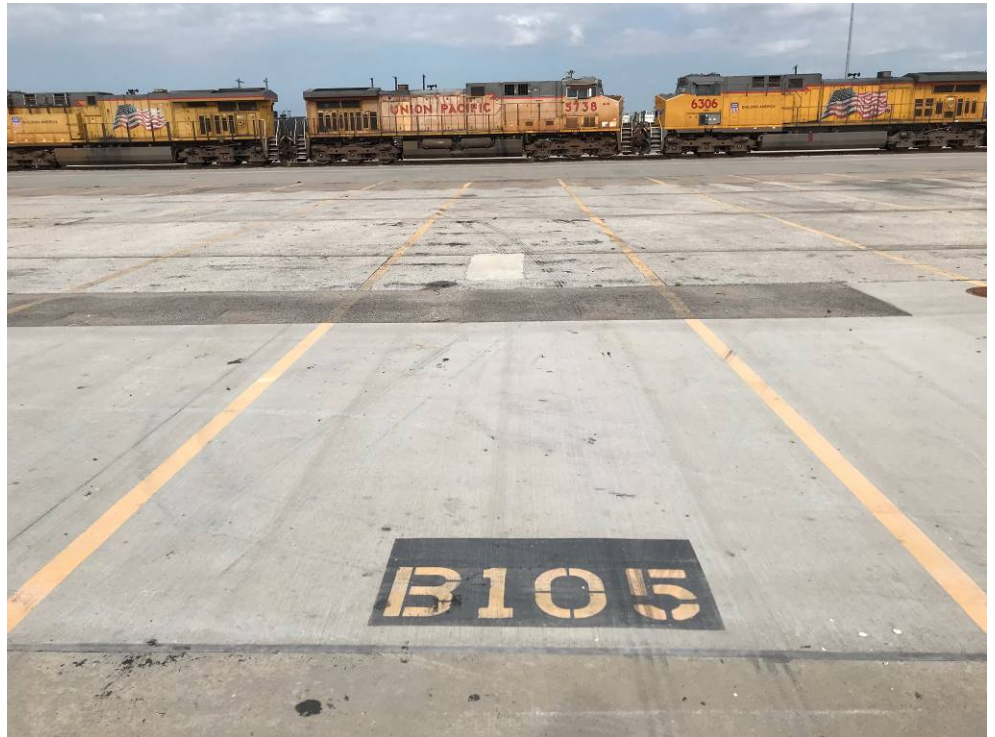
Photo No. 15	Date: 11/11/2020
Description: Slot B105, no tar-like material seeps observed, looking north Lat: 29.7841472 Long: - 95.3208777

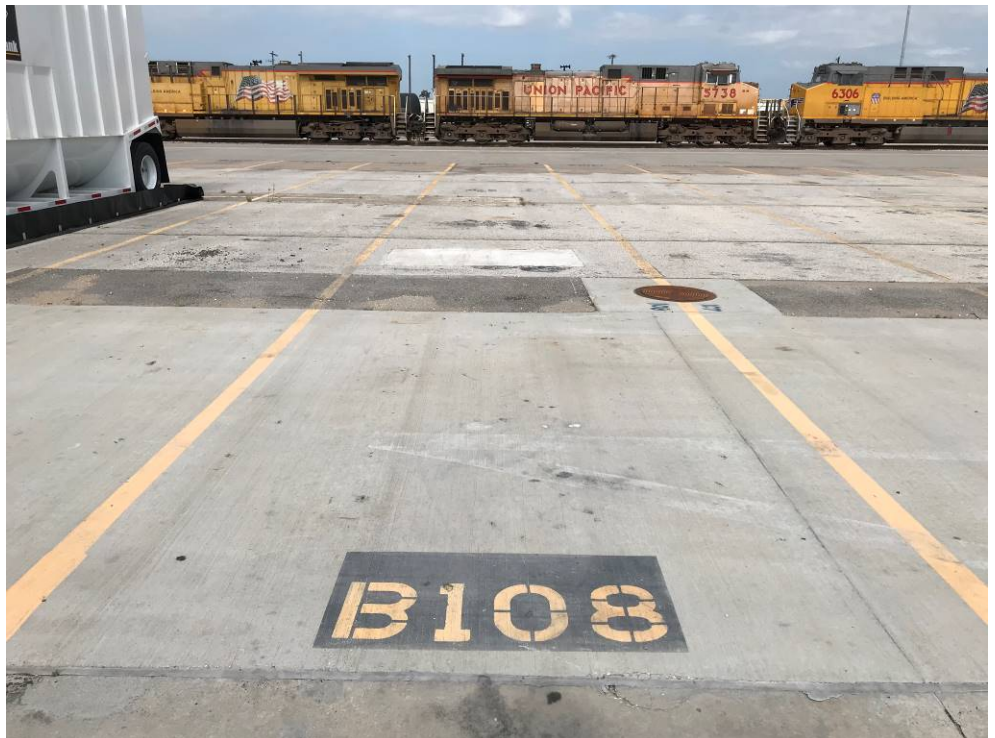
Photo No. 16	Date: 11/11/2020
Description: Slot B108, view of NAPL Collection System (Sump B107/B108 and test pit in background). No tar-like material seeps observed, looking north. Lat: 29.784125 Long: - 95.320989

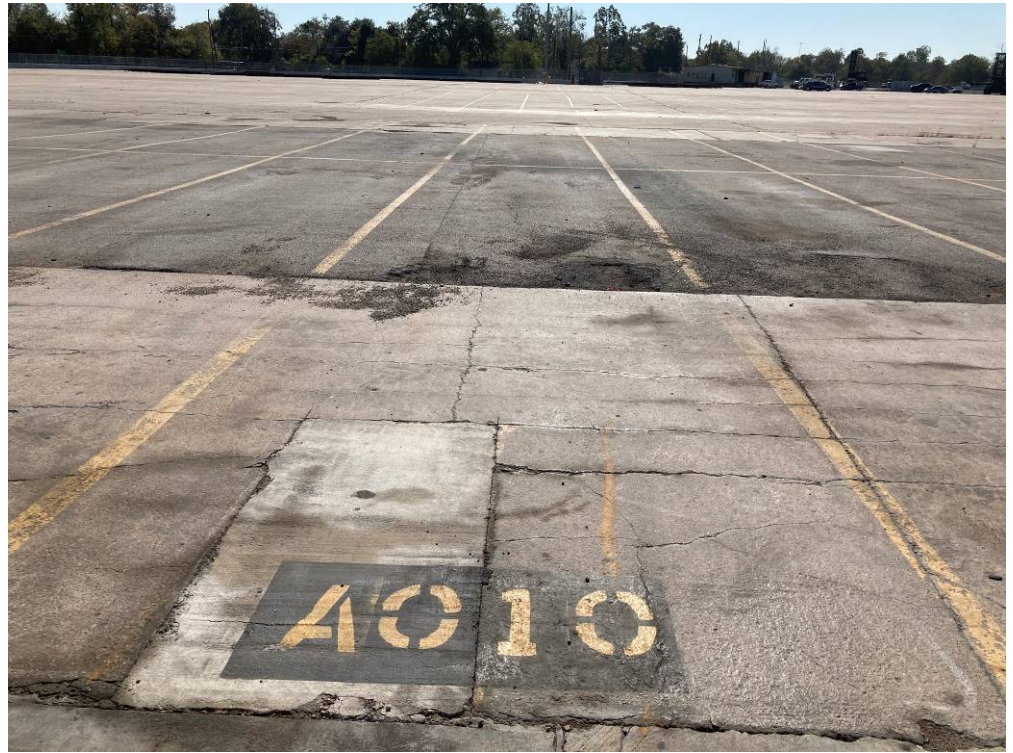
Photo No.
17

Slot A010, no tar-like material seeps observed where test pit (July 2020) conducted, looking south.

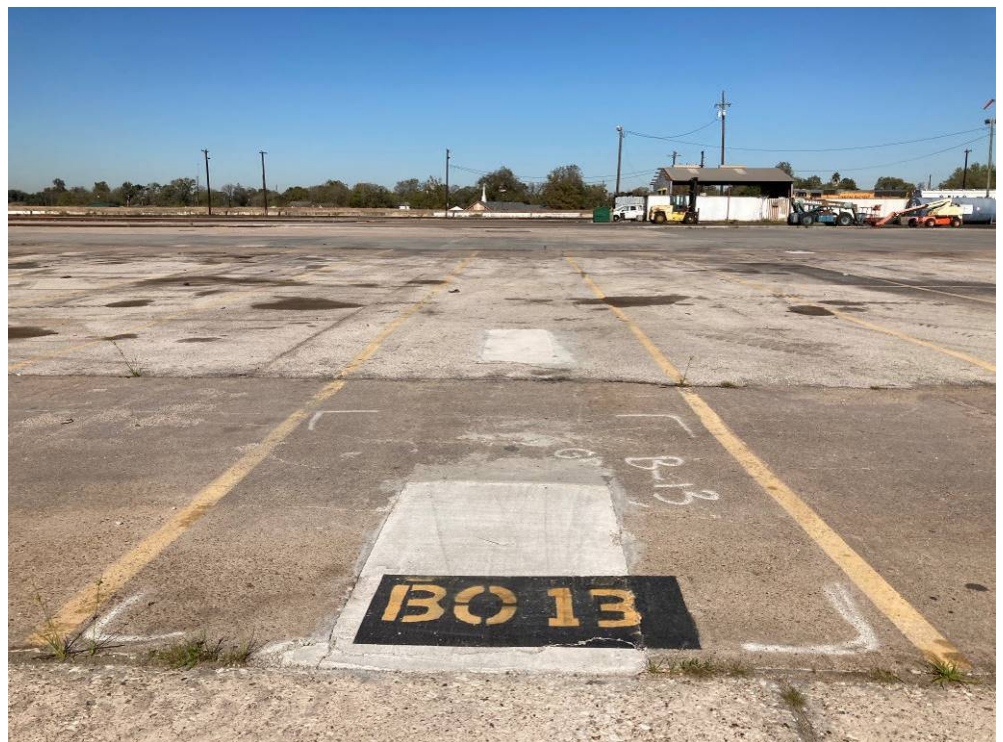
Photo No.
18

Slot B013, no tar-like material seeps observed where test pit (July 2020) conducted, looking north.

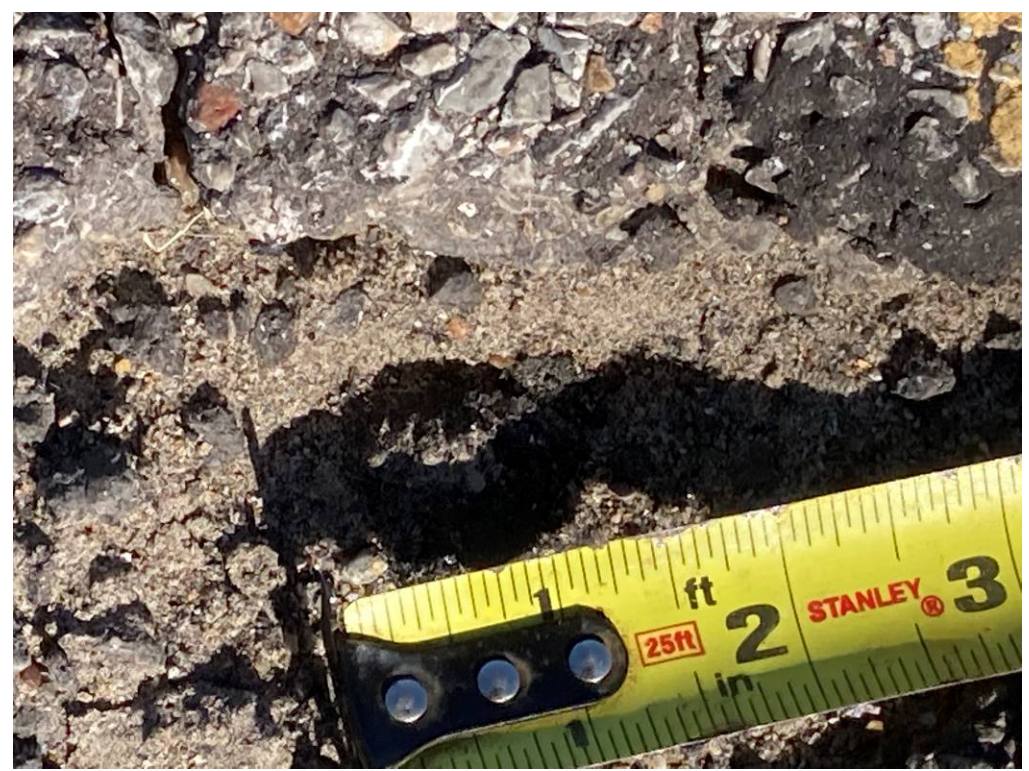
Photo No. 19	Date: 11/18/2020
-------------------------------	----------------------------

Slot B057, very small amount of tar-like material seeping at asphalt crack (not near July 2020 test pit), material was removed.

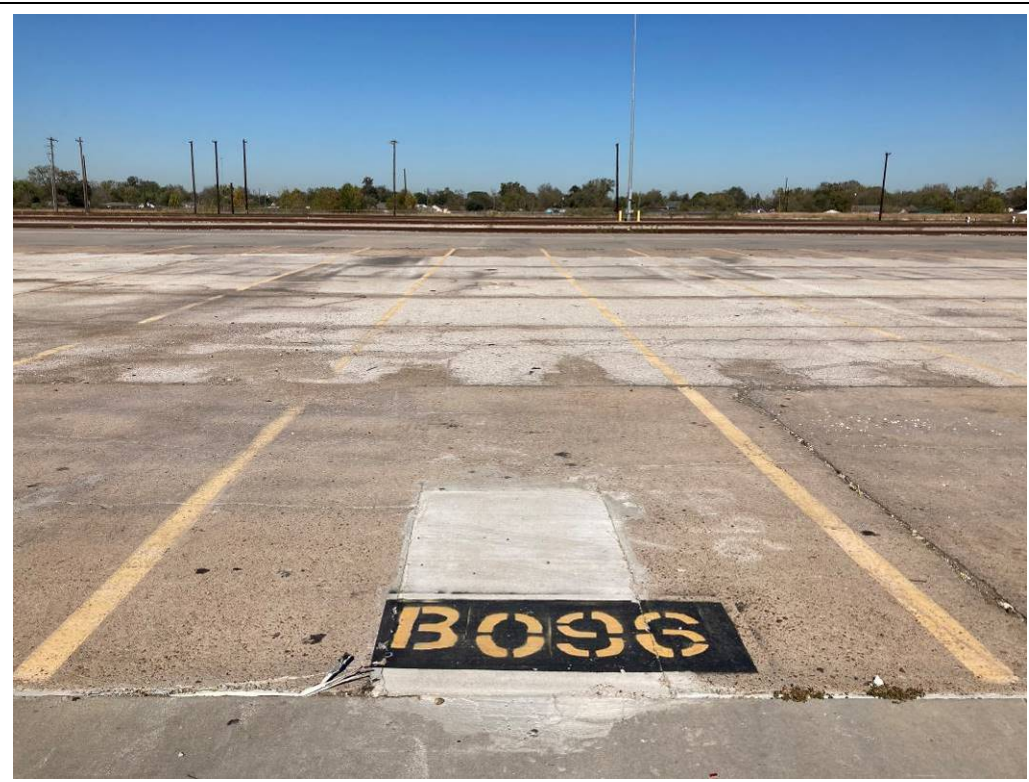
Photo No. 20	Date: 11/18/2020
-------------------------------	----------------------------

Slot B096, no tar-like material seeps observed where test pit (July 2020) conducted, looking north.

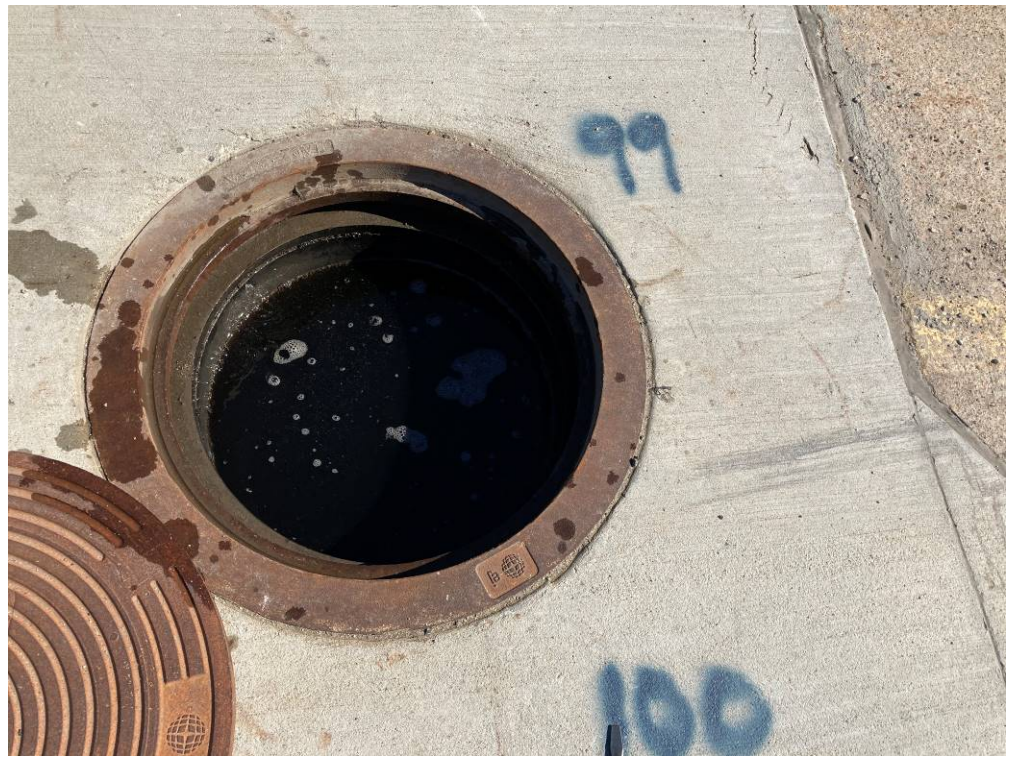
Photo No. 21	Date: 11/18/2020
Description: Sump 1 (B099/B100), 3.5 inches of freeboard in sump, no sheen or odor noted. Lat: 29.7844000 Long: - 95.3205861

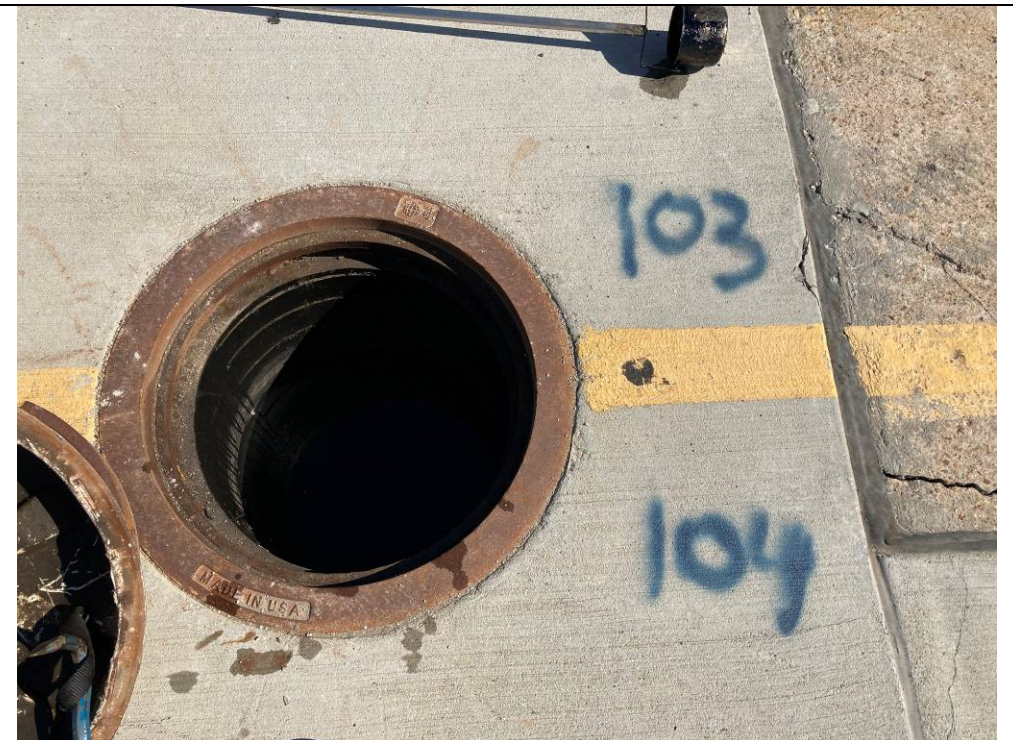
Photo No. 22	Date: 11/18/2020
-------------------------------	----------------------------

Description: Sump 2 (B103/B104), 12 inches of freeboard in sump, no sheen or odors noted. Lat: 29.7842861 Long: - 95.3208611	
--	--

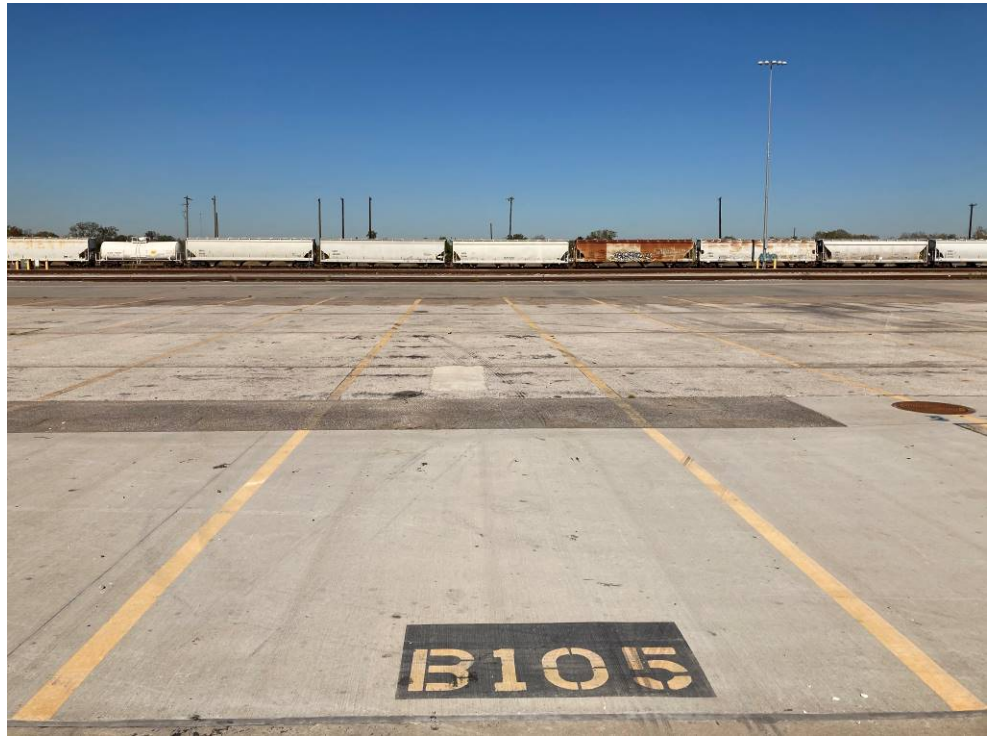
Photo No. 23	Date: 11/18/2020
Description: Slot B105, no tar-like material seeps observed, looking north. Lat: 29.7841472 Long: -95.3208777

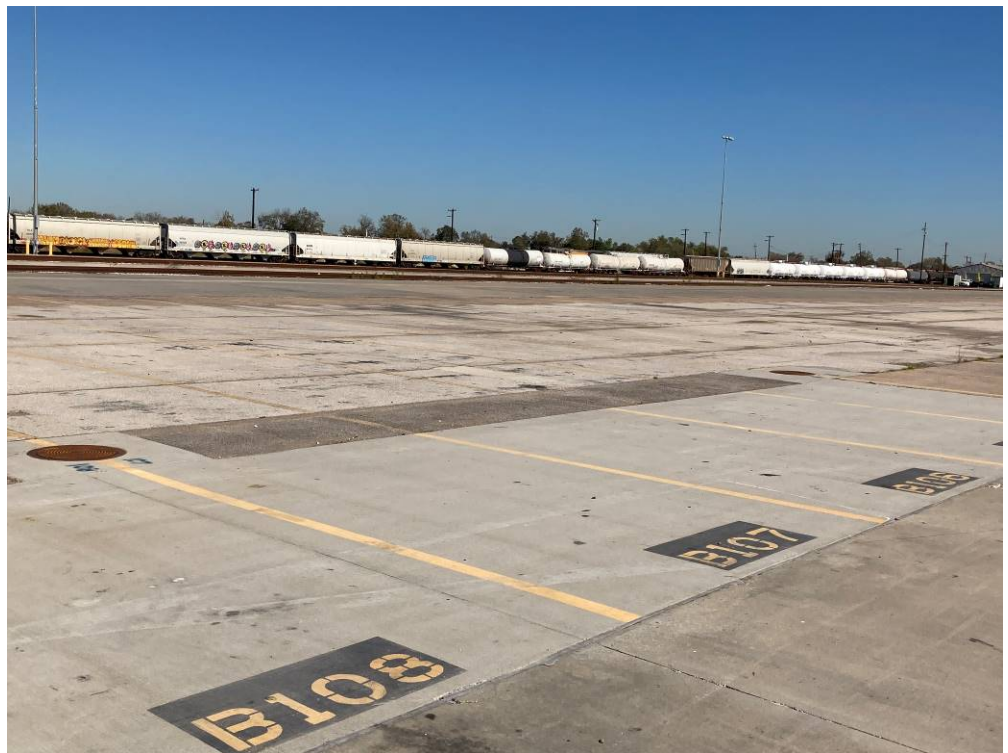
Photo No. 24	Date: 11/18/2020
Description: Slots B109-B097, NAPL collection system visible in background, residual brown staining observed along the crack in the asphalt, looking northeast. Lat: 29.784116 Long: -95.321022

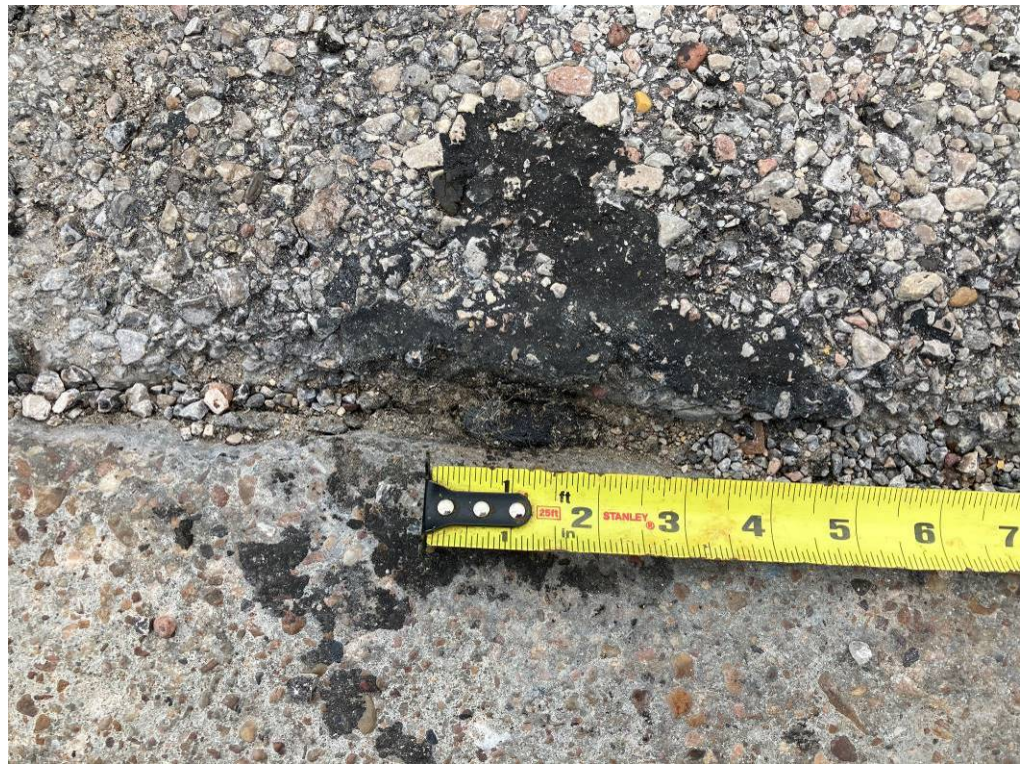
Photo No. 25	Date: 11/24/2020
Description Slot A022, very small amount of tar-like material seeping at joint, material was removed. Lat: 29.785392, Long: -95.318655

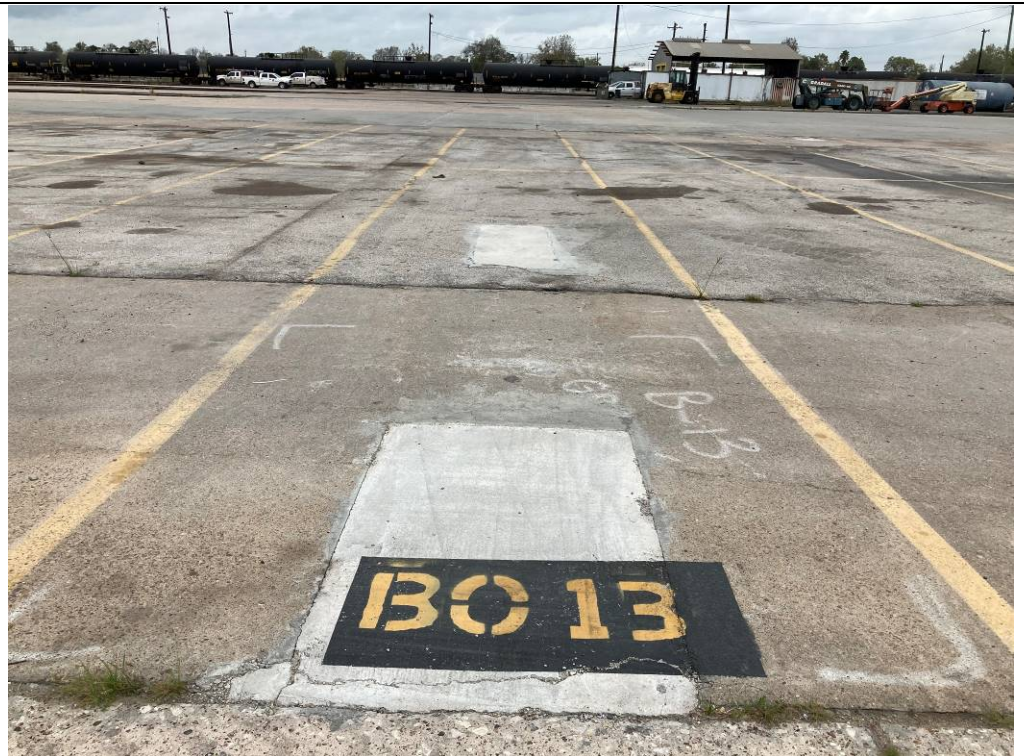
Photo No. 26	Date: 11/24/2020
Description: Slot B013, no tar-like material seeps observed where test pit (July 2020) conducted, looking north. Lat: 29.785217 Long: - 95.318261

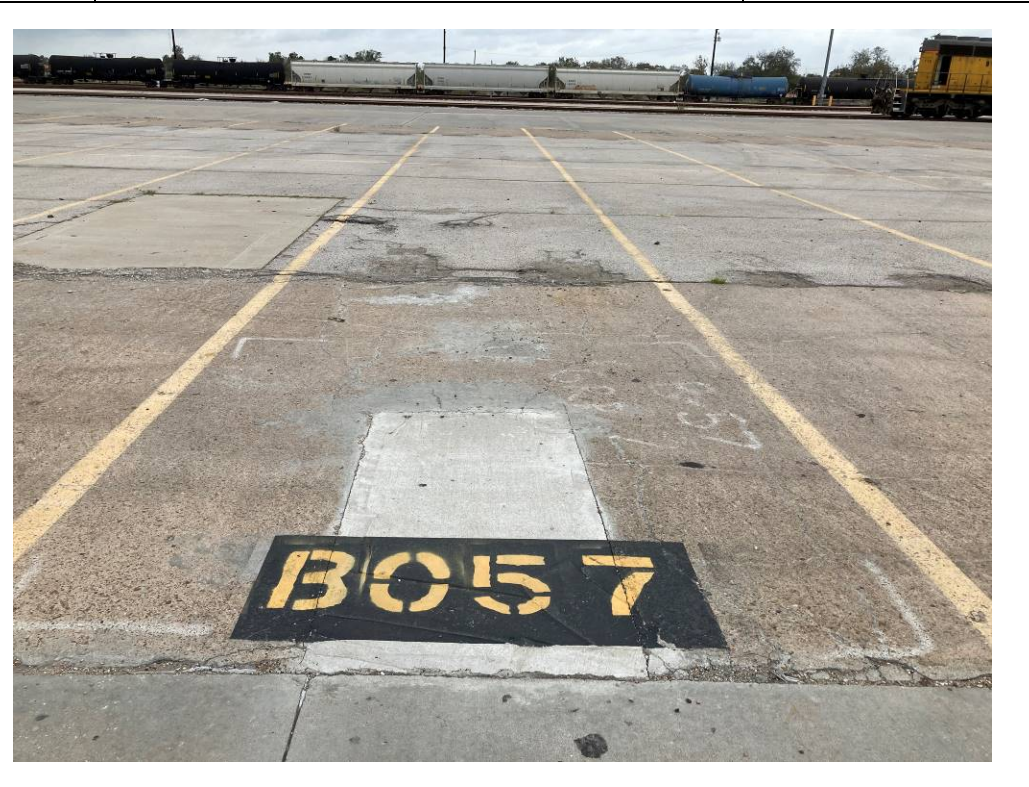
Photo No. 27	Date: 11/24/2020
Description: Slot B057, no tar-like material seeps observed, looking north. Lat: 29.7847472 Long: - 95.3195417

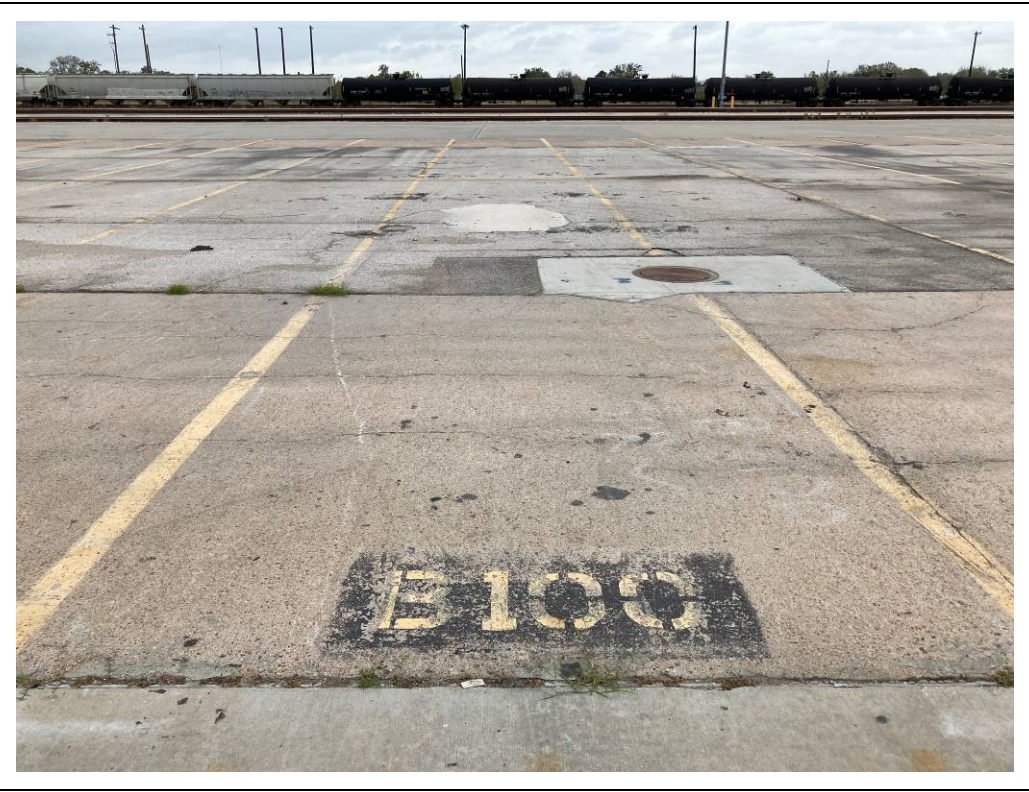
Photo No. 28	Date: 11/24/2020
Description: Slot B100, view of NAPL Collection System (Sump 099/100 in background). No tar-like material seeps observed, looking north. Lat: 29.7842472 Long: - 95.3206944
