December 10, 2020

Project No. 19119232

**RE: MONTHLY STATUS UPDATE – ENGLEWOOD INTERMODAL YARD – NAPL COLLECTION SYSTEM/CONCRETE CAP REPAIRS
UNION PACIFIC RAILROAD HOUSTON WOOD PRESERVING WORKS FACILITY
4910 LIBERTY ROAD FACILITY, HOUSTON, TEXAS
POST-CLOSURE CARE PERMIT NO. HW-50343; INDUSTRIAL SWR NO. 31547**

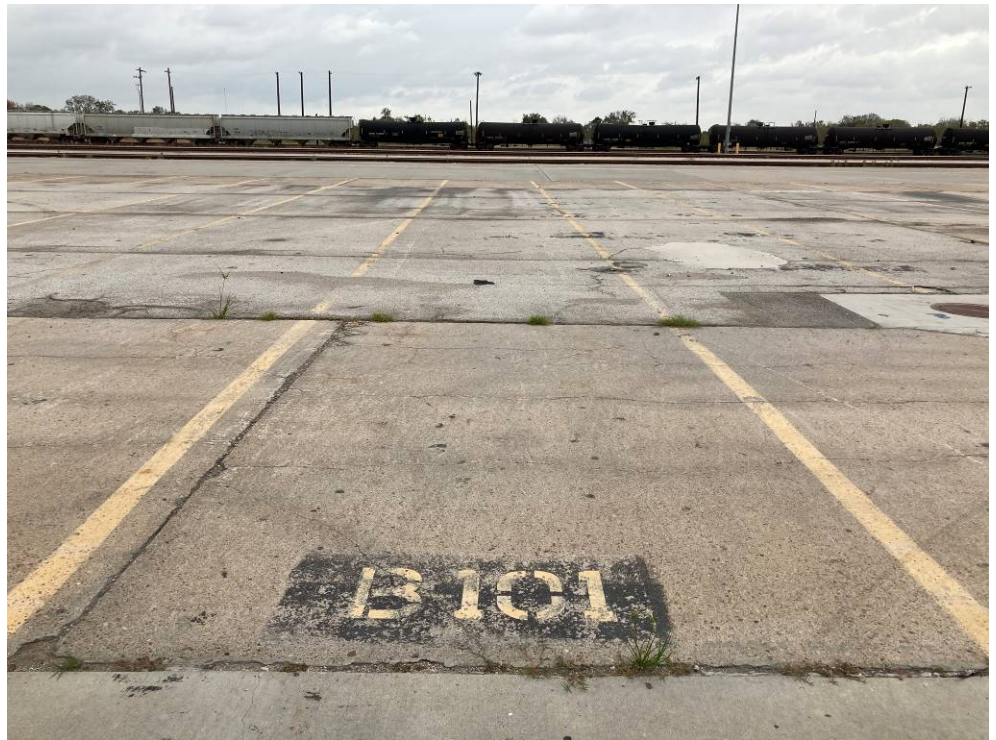
Photo No.: 29	Date: 11/24/2020
Description: Slot B101, no tar-like material seeps observed, looking north. Lat: 29.784275 Long: - 95.320813

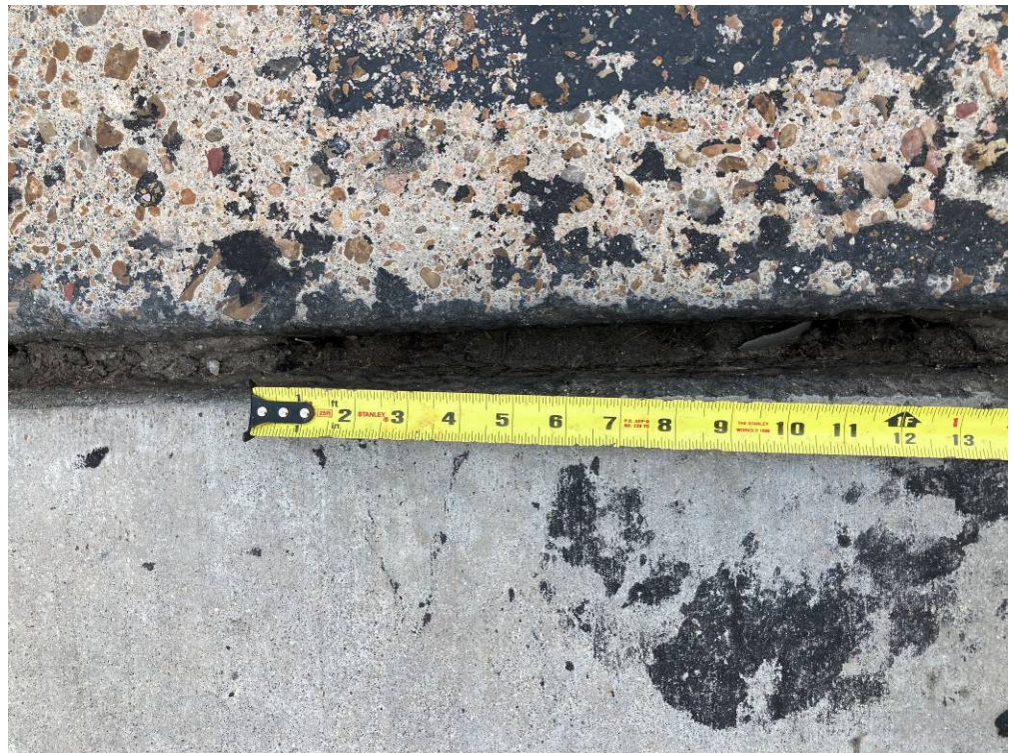
Photo No.: 30	Date: 11/24/2020
Description: Slot B102, very small amount of tar-like material seeping at joint, material was removed. Lat: 29.7842203 Long: - 95.320827

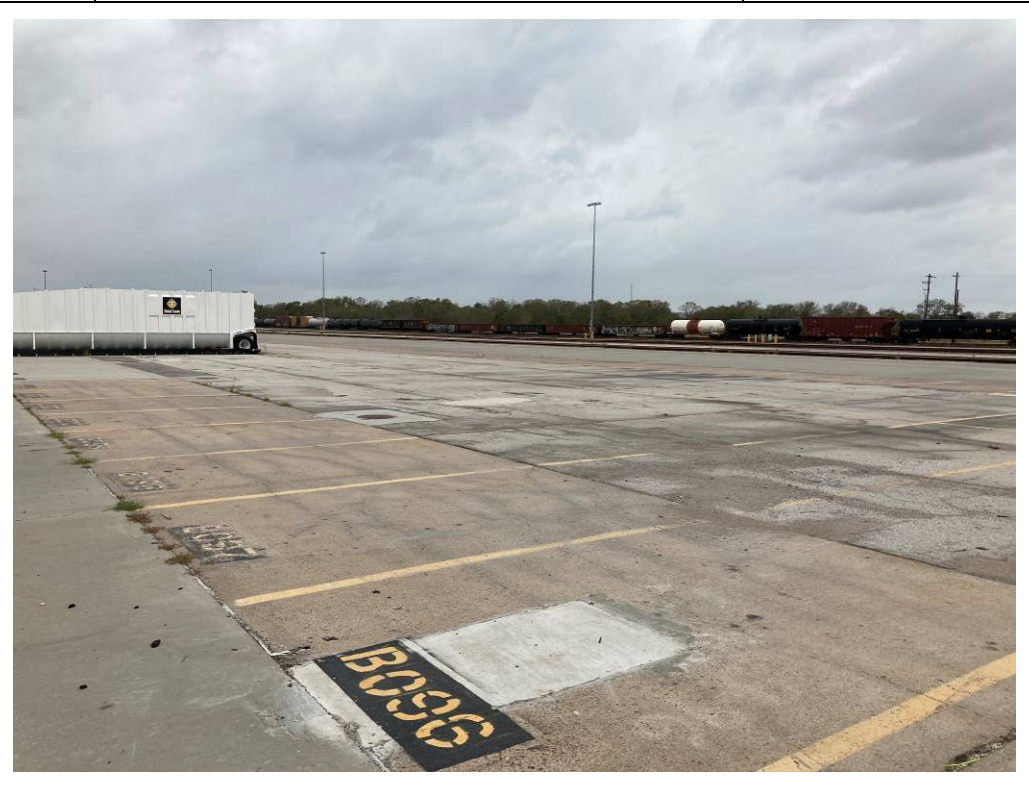
Photo No. 31	Date: 11/24/2020
-------------------------------	----------------------------

Slots B096-B109, NAPL collection system visible in background, residual brown staining observed along the crack in the asphalt, looking northwest.

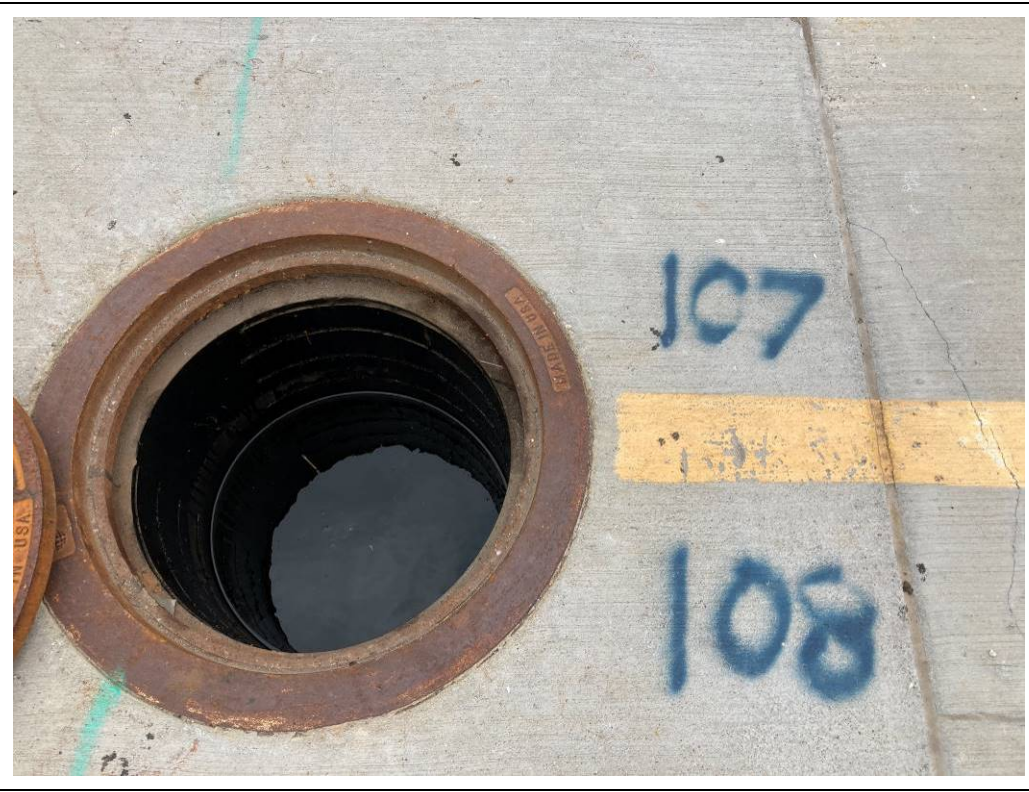
Photo No. 32	Date: 11/24/2020
-------------------------------	----------------------------

Sump 3 (B107/B108), 13.5 inches of freeboard in sump. No sheen, odor, or tar-like material observed.

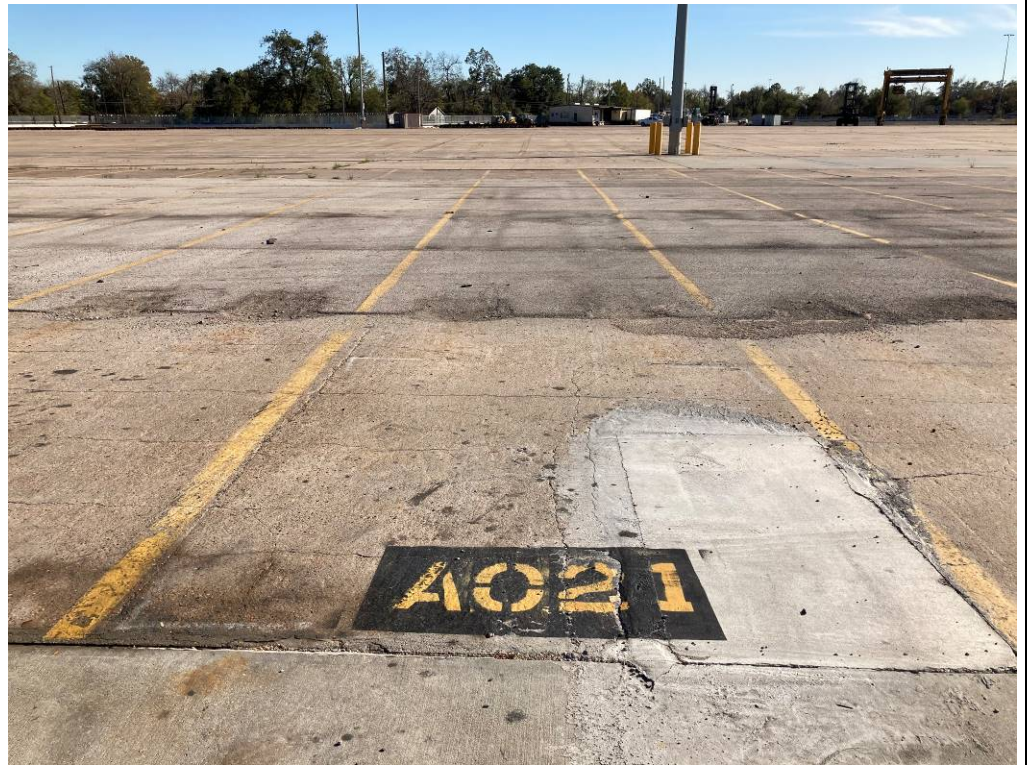
Photo No.
33

Slot A021, no tar-like material seeps observed where test pit (July 2020) conducted, looking south.

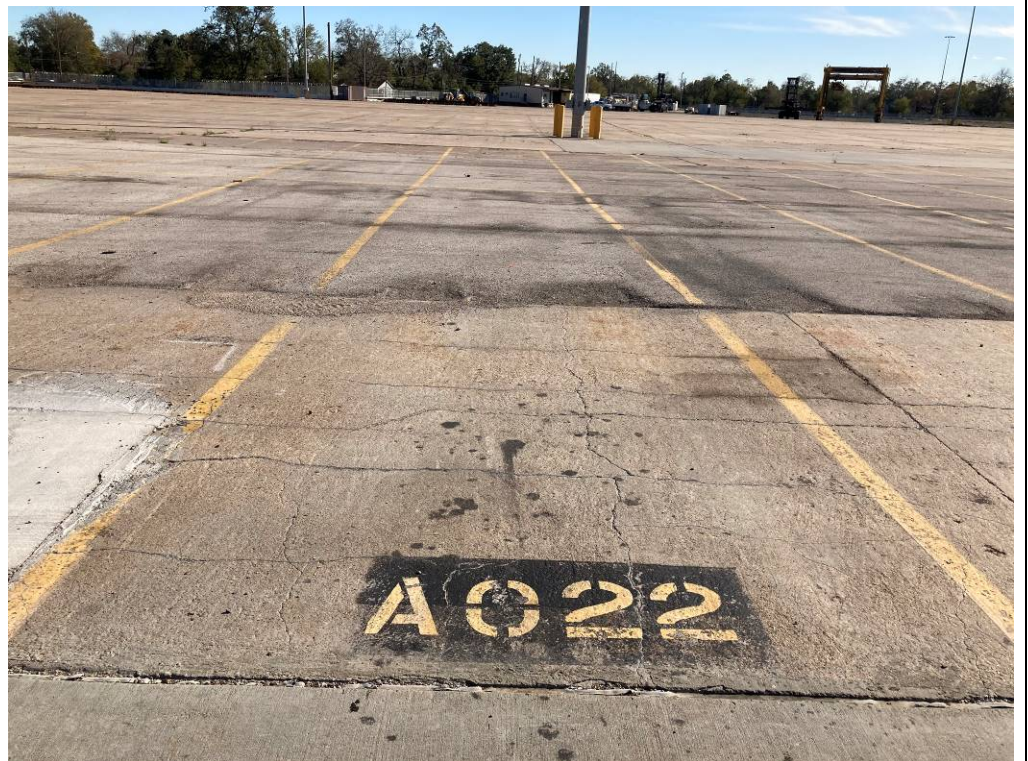
Photo No.
34

Slot A022, no tar-like material seeps observed, looking south.

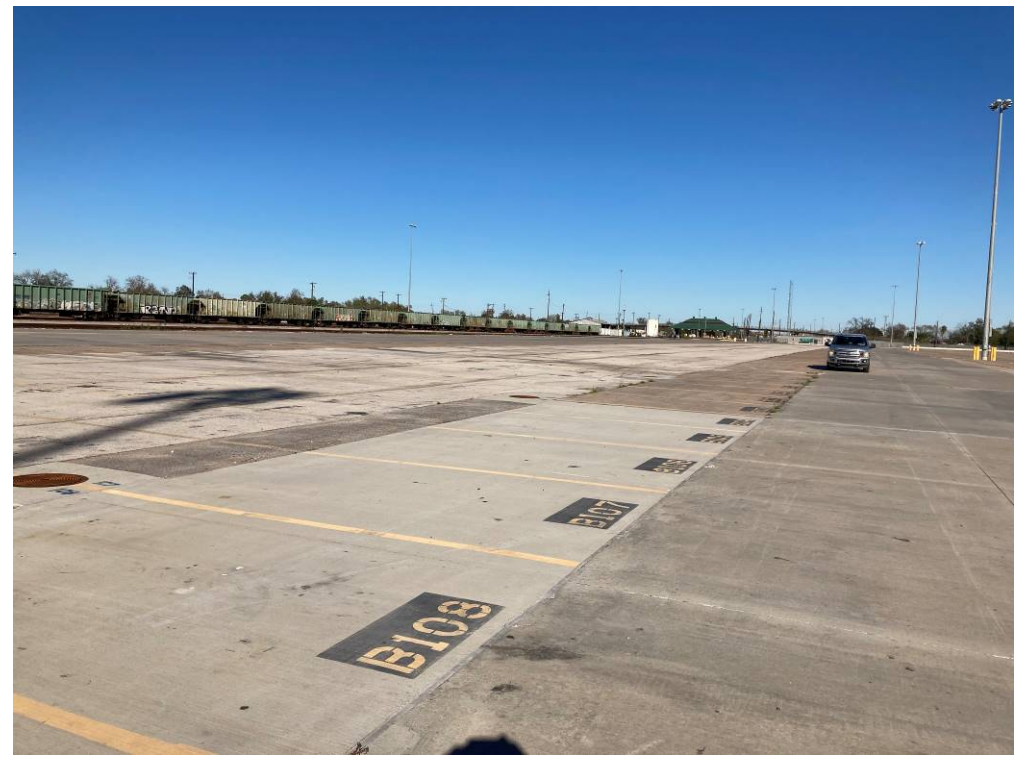
Photo No. 35	Date: 11/30/2020
-------------------------------	----------------------------

Slots B108-B096, NAPL collection system visible in background, residual brown staining observed along the crack in the asphalt, looking northeast.

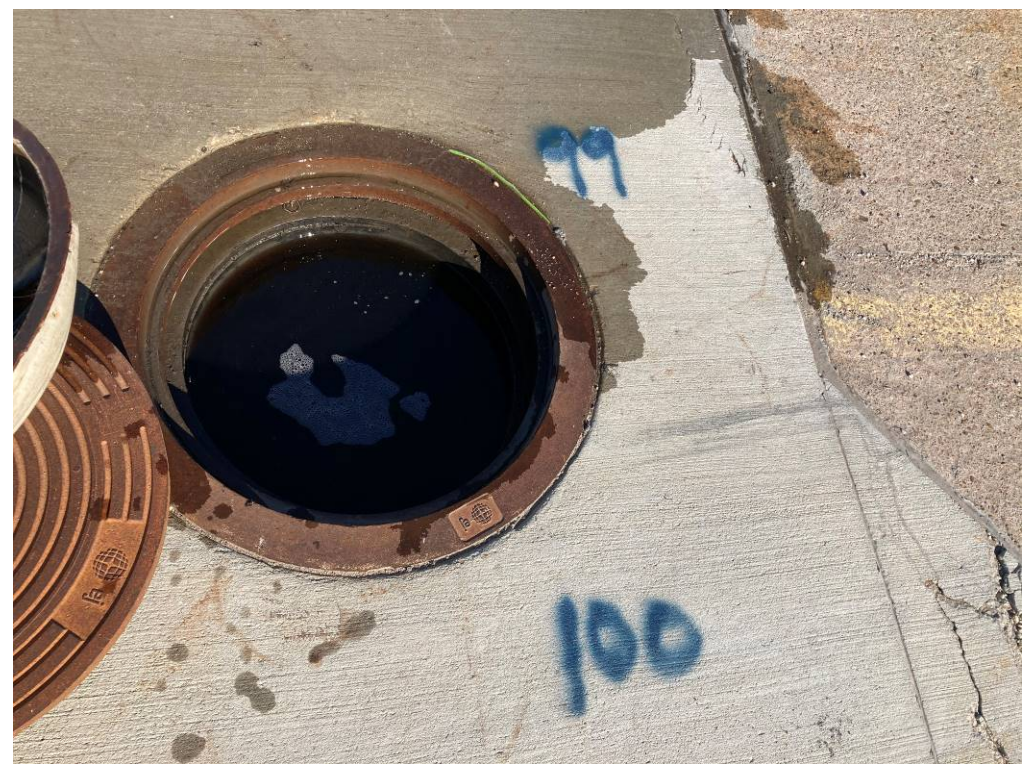
Photo No. 36	Date: 11/30/2020
-------------------------------	----------------------------

Sump 1 (B099/B100), 2 inches of freeboard in sump, no sheen or odor noted.

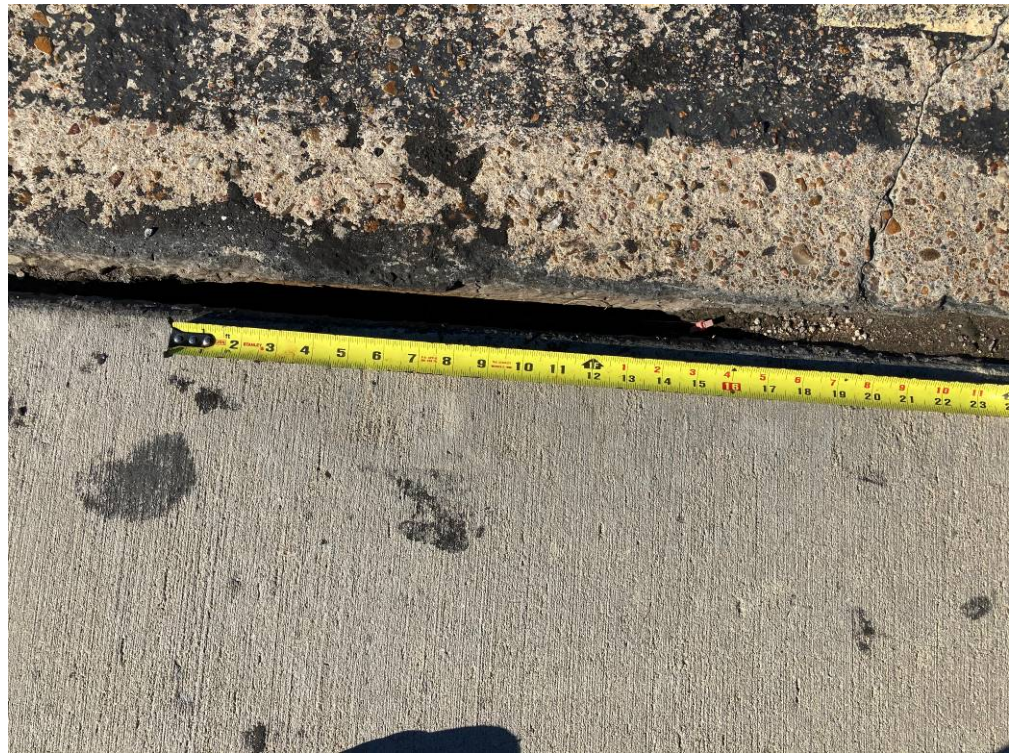
Photo No.: 37	Date: 11/30/2020
Description: Slot B102, very small amount of tar-like material seeping at asphalt joint, material was removed. Lat: 29.7842203 Long: - 95.320827

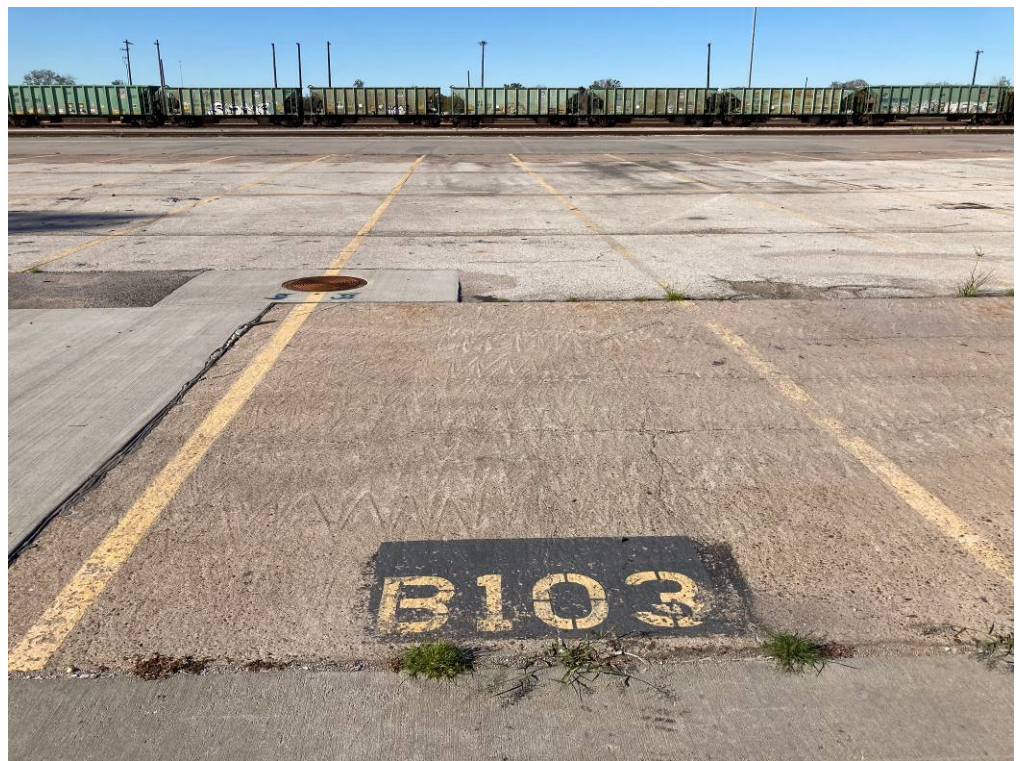
Photo No.: 38	Date: 11/30/2020
Description: Slot B103, view of NAPL Collection System (Sump 103/104 on left). No tar-like material seeps observed, looking north. Lat: 29.7841639 Long: - 95.3208694

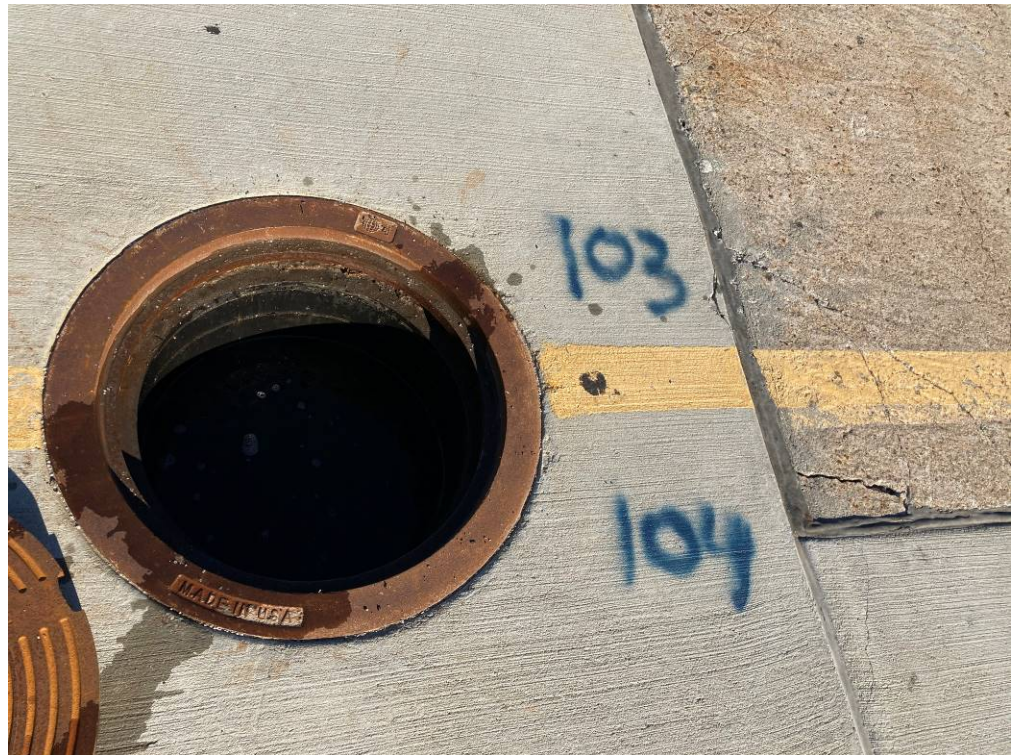
Photo No. 39	Date: 11/30/2020
------------------------	----------------------------

Sump 2 (B103/B104), 7 inches of freeboard in sump, no sheen or odors noted.

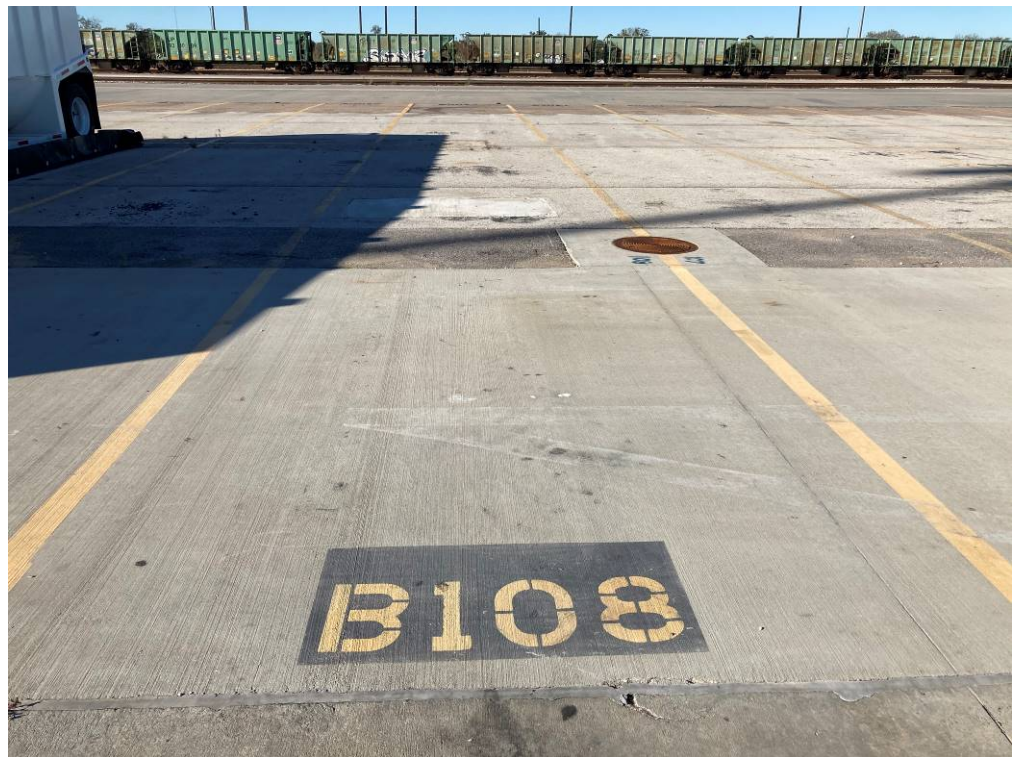
Photo No. 40	Date: 11/30/2020
------------------------	----------------------------

Slot B108, view of NAPL Collection System (Sump B107/B108 and test pit in background). No tar-like material seeps observed, looking north.
