January 20, 2021

Project No. 19119232

**RE: MONTHLY STATUS UPDATE – ENGLEWOOD INTERMODAL YARD – NAPL COLLECTION SYSTEM/CONCRETE CAP REPAIRS
UNION PACIFIC RAILROAD HOUSTON WOOD PRESERVING WORKS FACILITY
4910 LIBERTY ROAD FACILITY, HOUSTON, TEXAS
POST-CLOSURE CARE PERMIT NO. HW-50343; INDUSTRIAL SWR NO. 31547**

Weekly Inspection Photolog

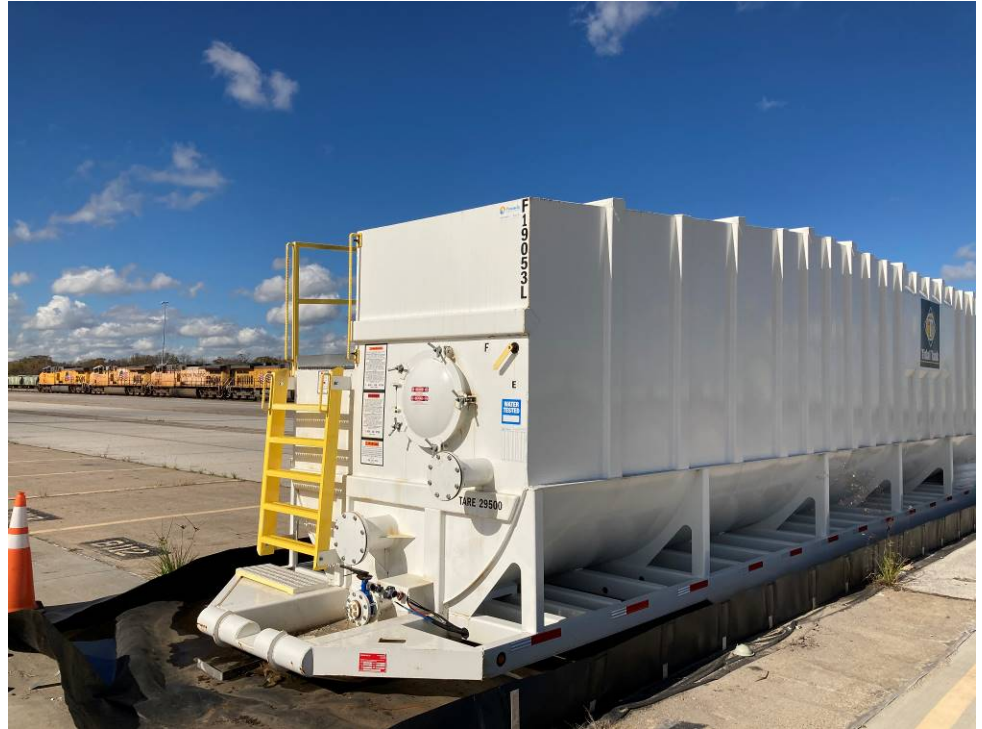
Photo No. 1	Date: 12/10/2020
Description: Frac tank for storage of pumped down water from NAPL Collection Sumps (in Slot B110), looking northwest. Lat: 29.7841028 Long: - 95.3209833

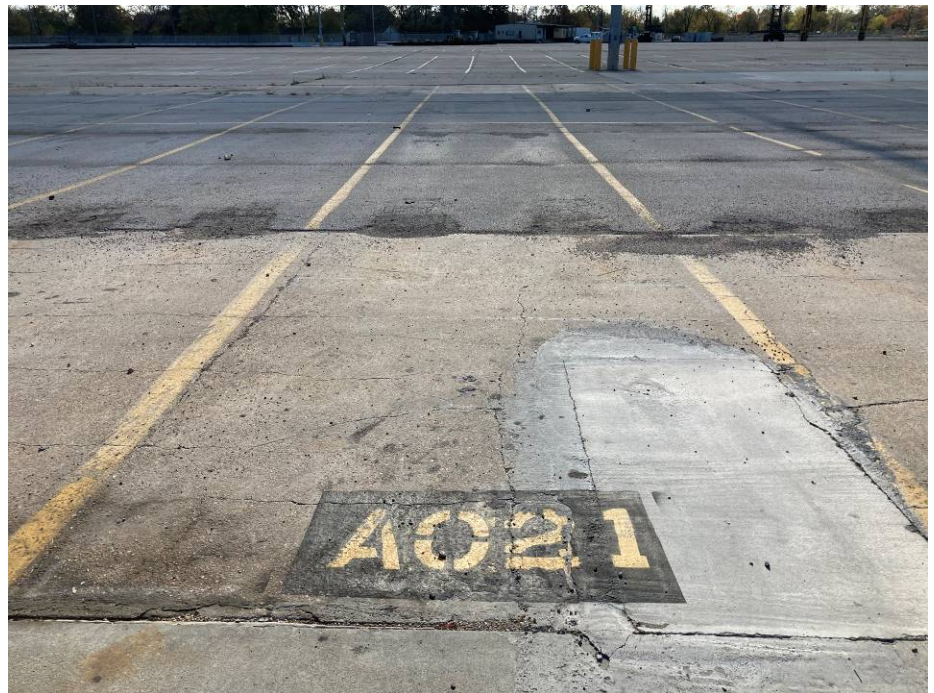
Photo No. 2	Date: 12/10/2020
-----------------------	----------------------------

Description: Slot A021, no tar-like material seeps observed where test pit (July 2020) conducted, looking south. Lat: 29.785392, Long: -95.318655	
---	--

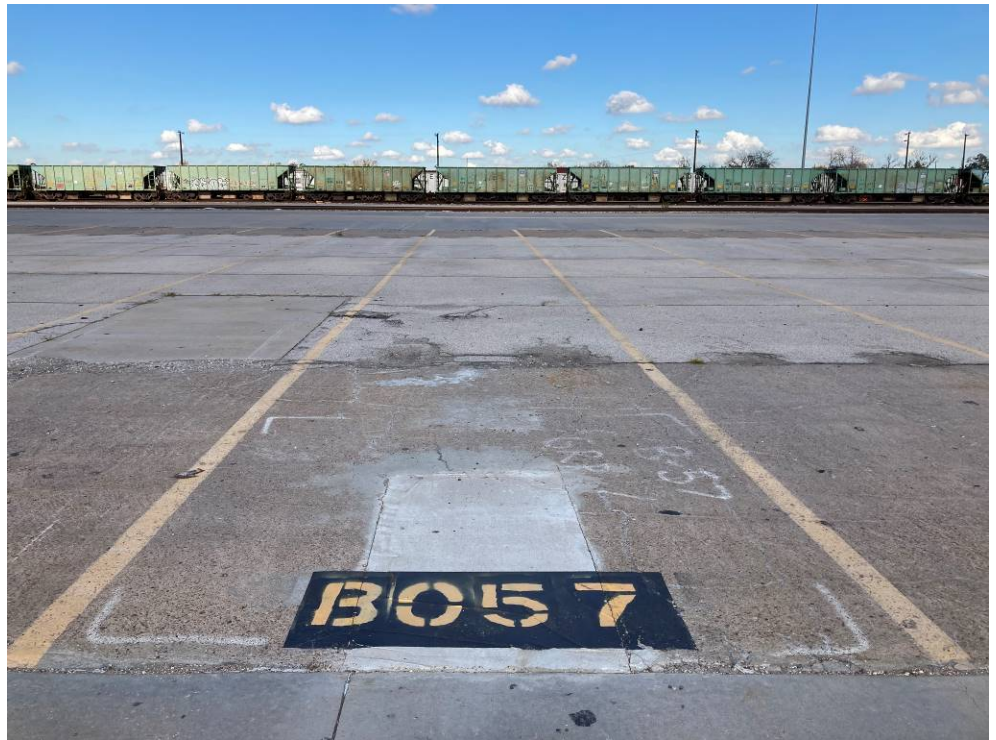
Photo No. 3	Date: 12/10/2020
Description: Slot B057, no tar-like material seeps observed where test pit (July 2020) conducted, looking north. Lat: 29.7847472 Long: - 95.3195417

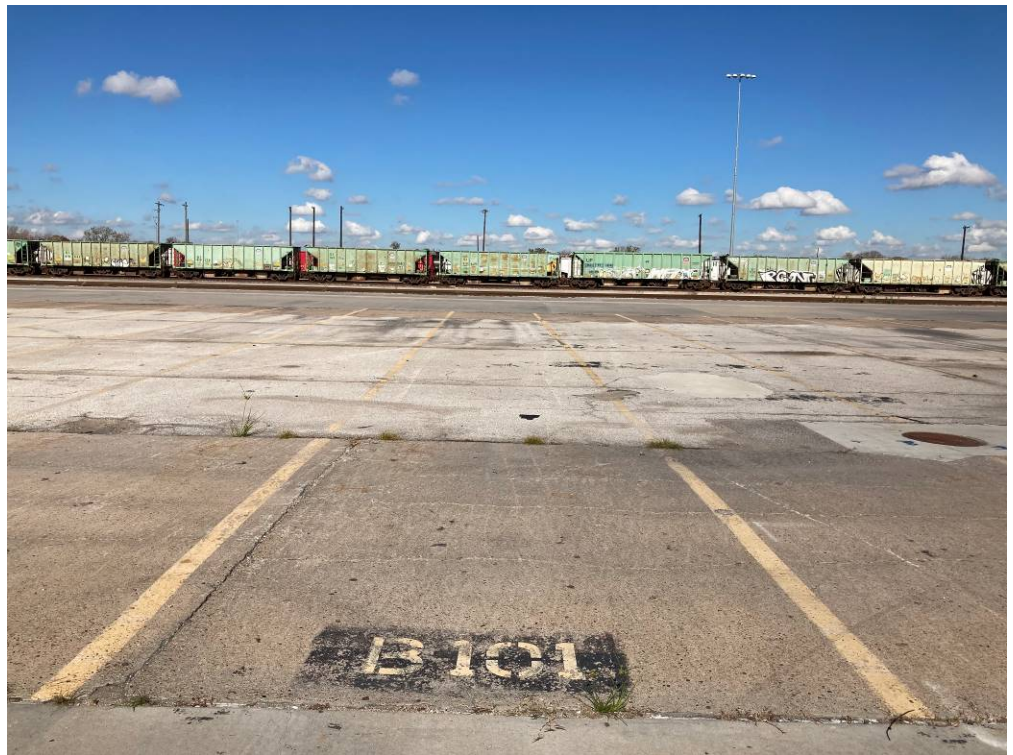
Photo No. 4	Date: 12/10/2020
Description: Slot B101, no tar-like material seeps observed, looking north. Lat: 29.784275 Long: - 95.320813

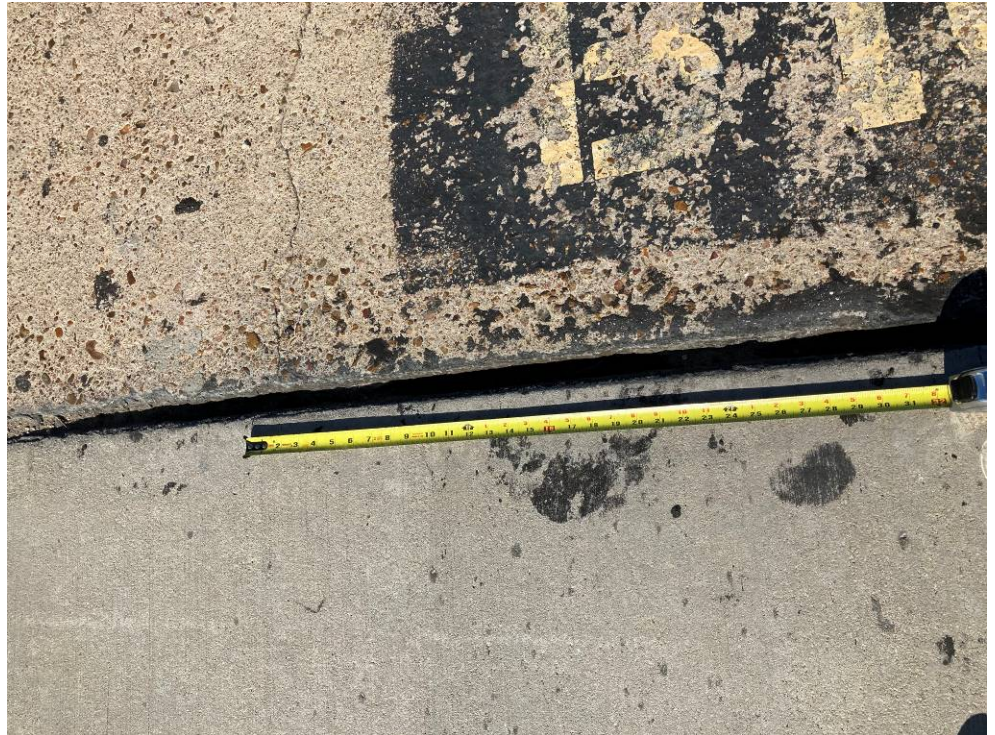
- No tar-like NAPL seeps were observed within the NAPL Collection System area during the month of December. For areas outside the NAPL Collection System, very small amounts of tar-like material were consistently noted in the joint in stall B102 where previous seeping has been observed. A very small amount of tar-like material was observed on the concrete surface once in stall B101 during the December 23, 2020 inspection and once in stall B105 during the December 30, 2020 inspection where previous seeps have been noted. The overall amount of tar-like material removed from the concrete surface during December 2020 was less than 0.25 gallons.

Photo No. 5	Date: 12/10/2020
Description: Slot B102, small amount of tar-like material seeping at asphalt joint, material was removed. Lat: 29.7842203 Long: - 95.320827

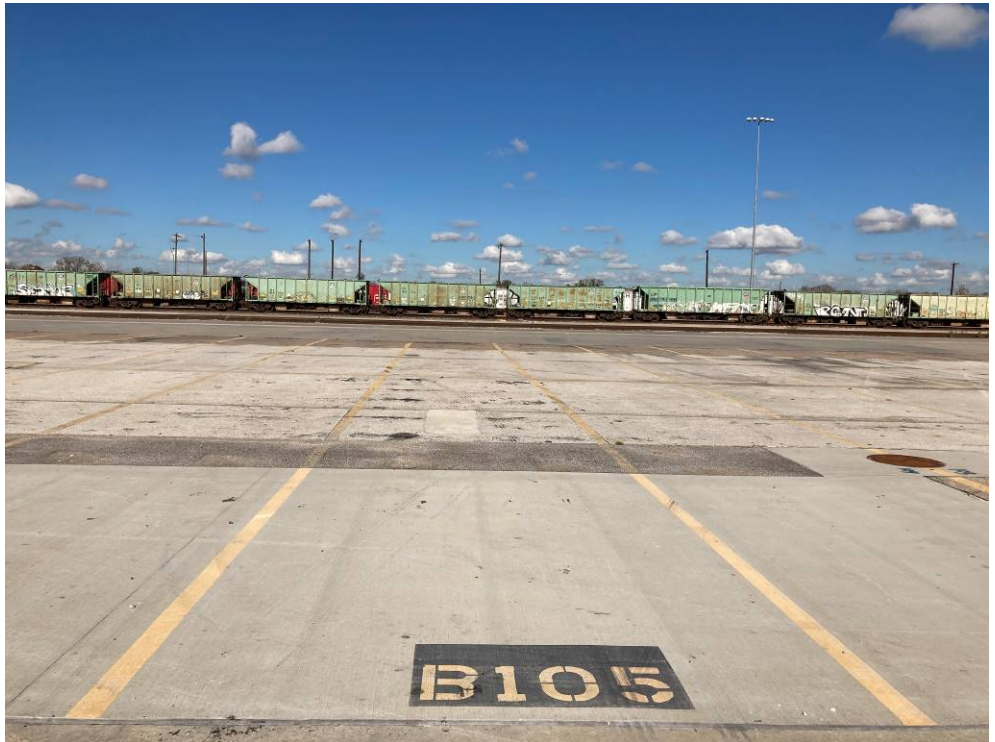
Photo No. 6	Date: 12/10/2020
Description: Slot B105, no tar-like material seeps observed, looking north. Lat: 29.7841472 Long: - 95.3208777

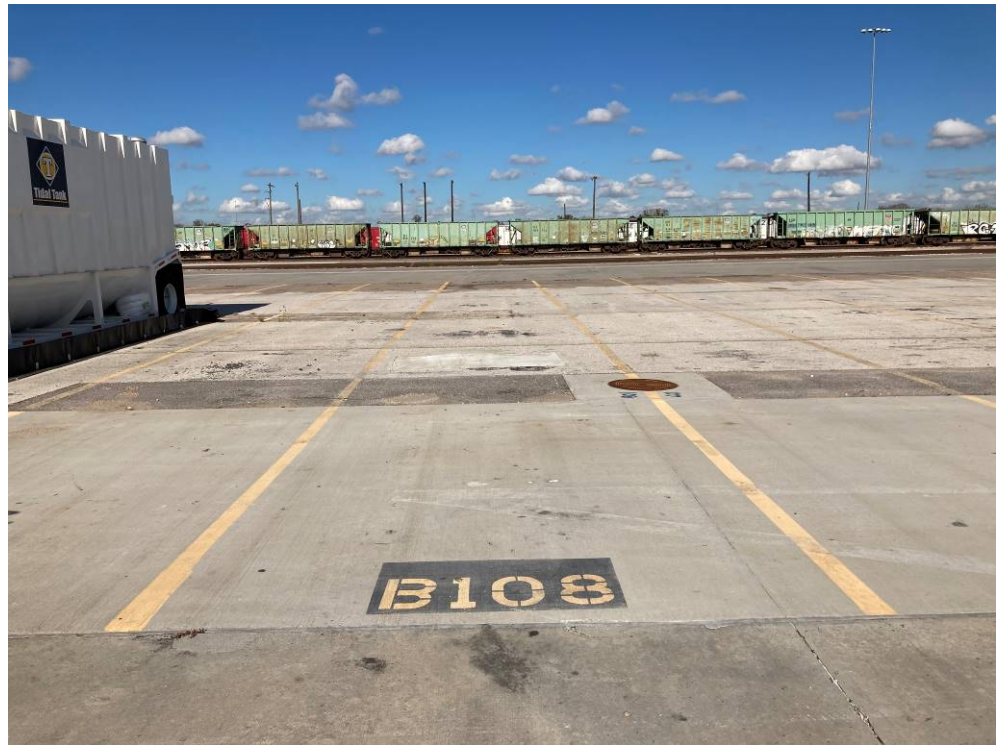
Photo No. 7	Date: 12/10/2020
-----------------------	----------------------------

Slot B108, view of NAPL Collection System (Sump B107/B108 and test pit in background). No tar-like material seeps observed, looking north.

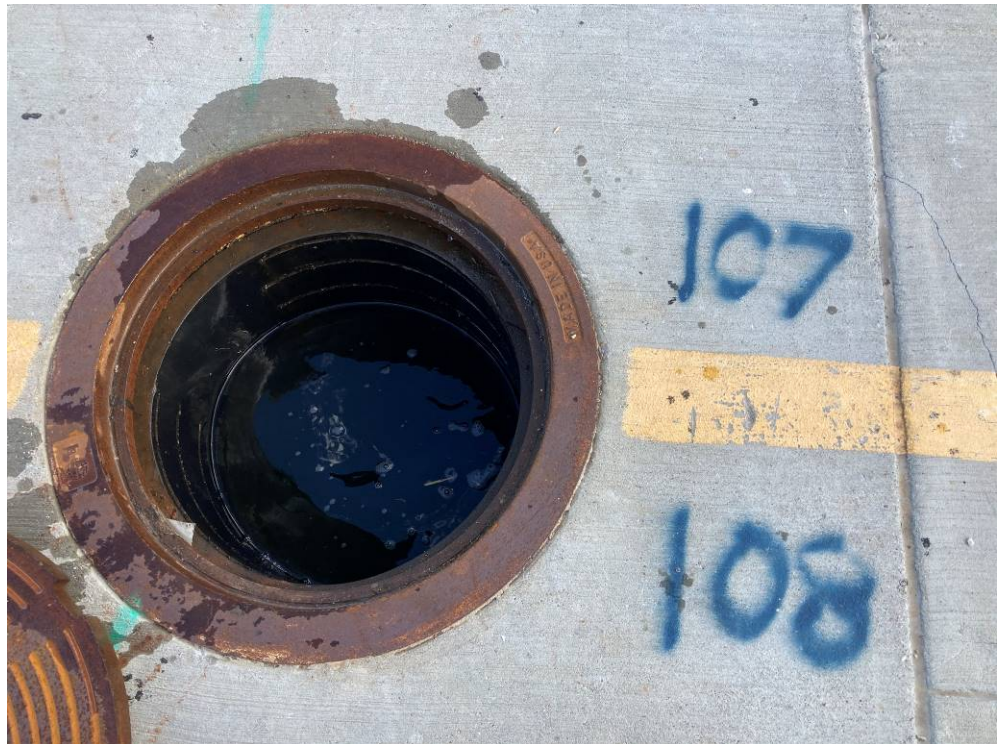
Photo No. 8	Date: 12/10/2020
-----------------------	----------------------------

Sump 3 (B107/B108), 10 inches of freeboard in sump. No sheen, odor or tar-like material observed.

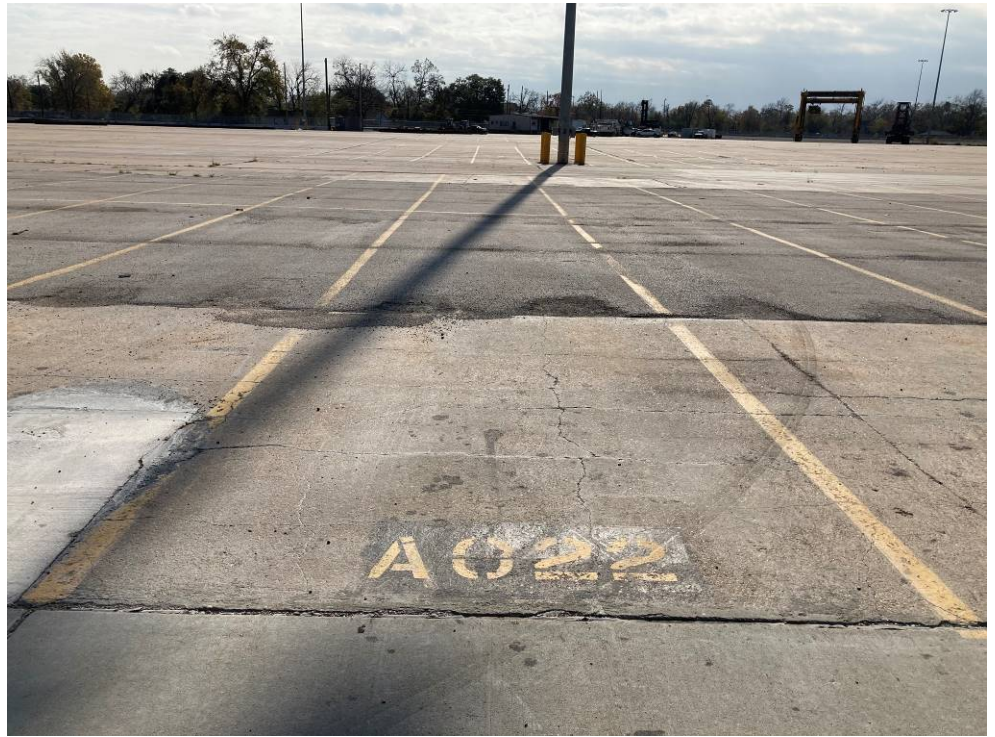
Photo No.
9

Slot A022, no tar-like material seeps observed, looking south.

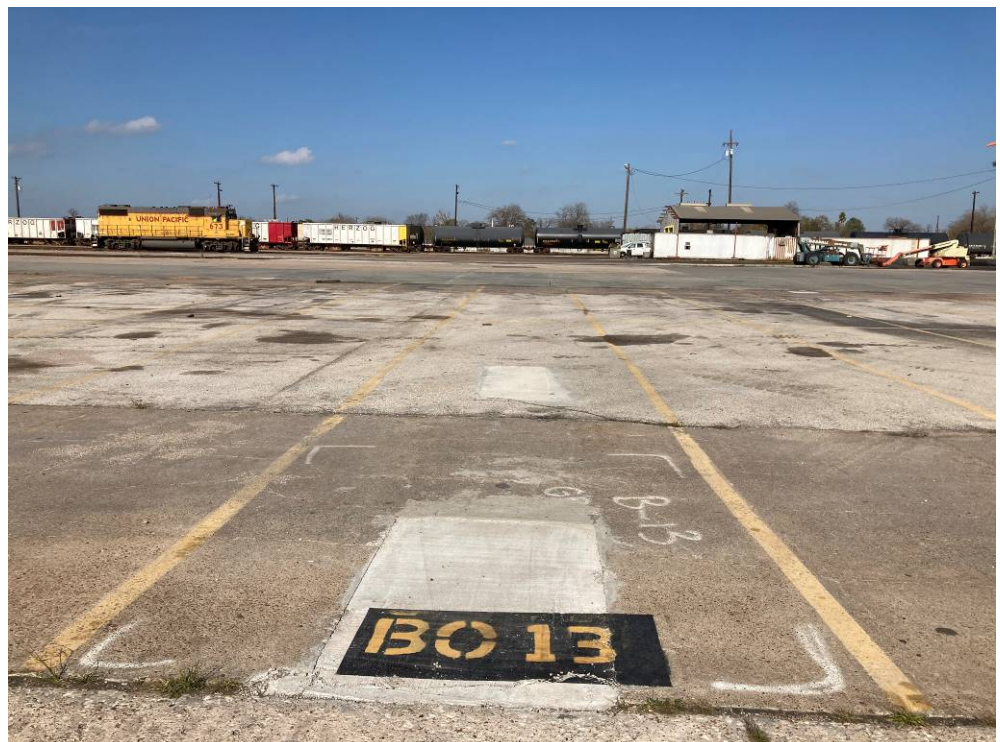
Photo No.
10

Slot B013, no tar-like material seeps observed where test pit (July 2020) conducted, looking north.

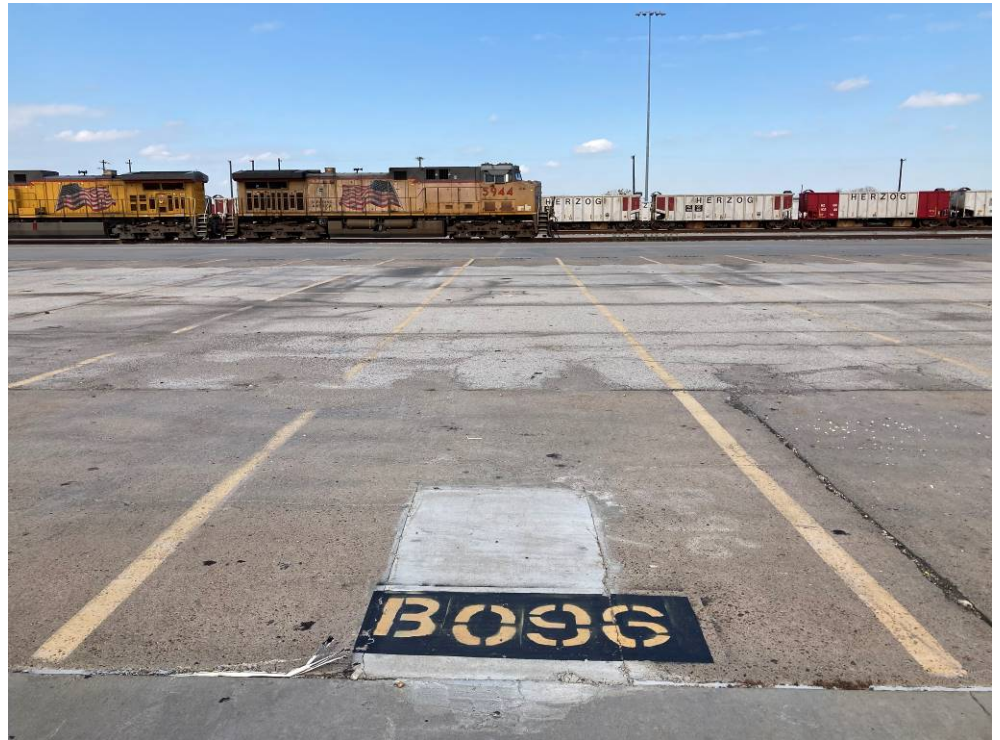
Photo No.
11

Slot B096, no tar-like material seeps observed where test pit (July 2020) conducted, looking north.

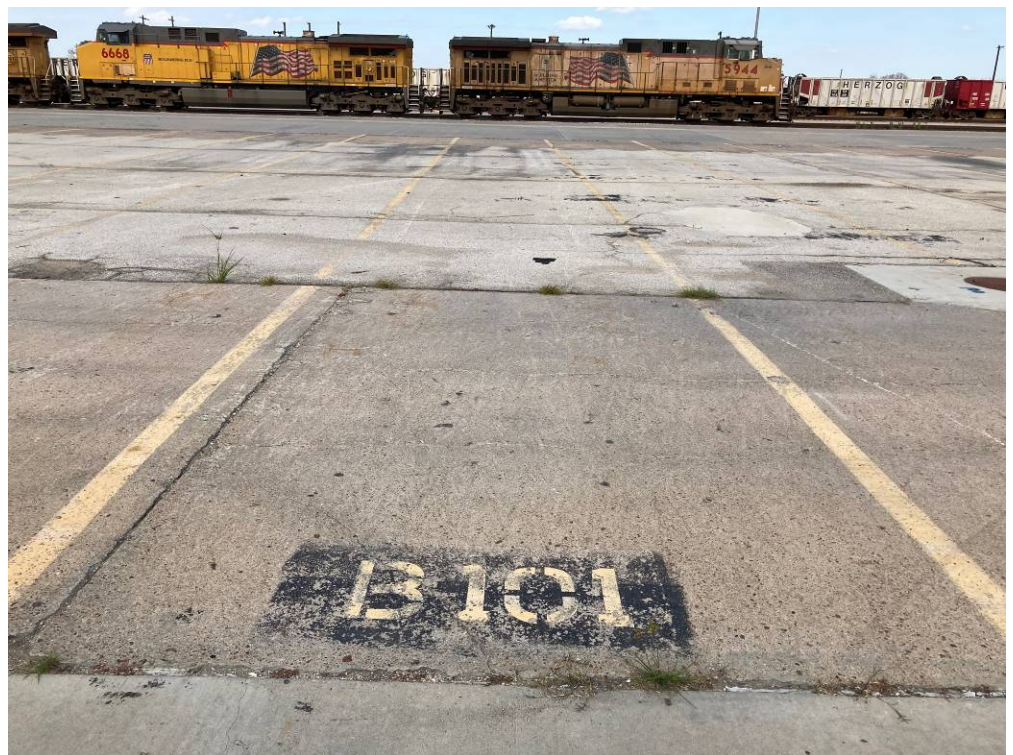
Photo No.
12

Slot B101, very small amount of tar-like material seeping at asphalt crack. Material was removed.

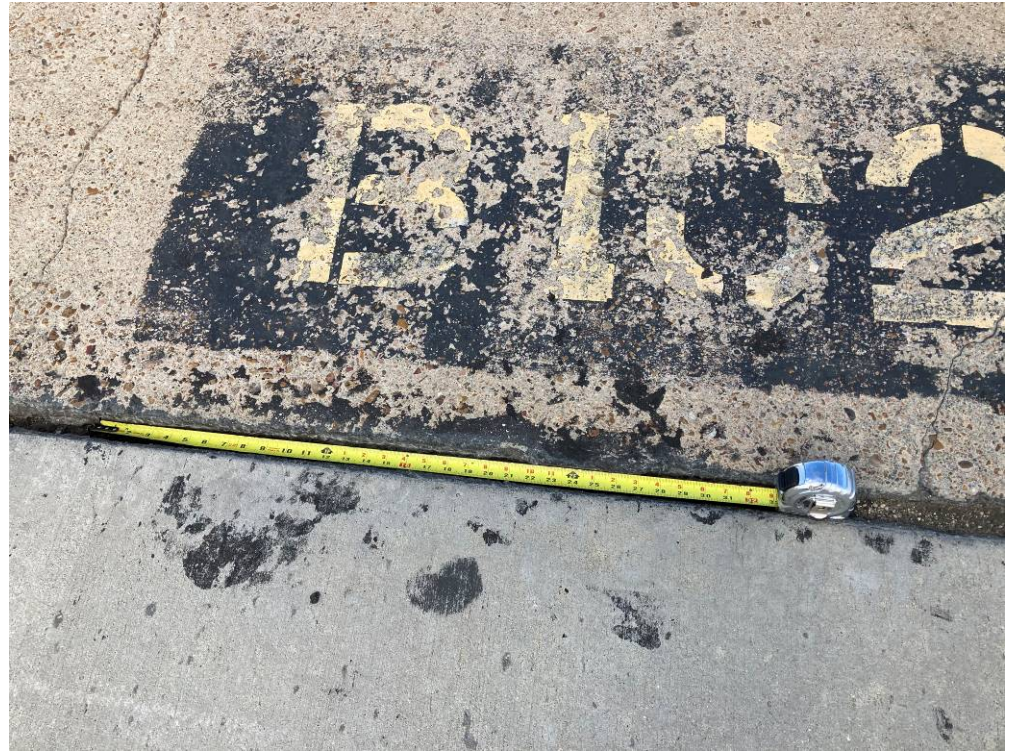
Photo No. 13	Date: 12/18/2020
Description: Slot B102, small amount of tar-like material seeping at asphalt joint, material was removed.	
Lat: 29.7842203 Long: - 95.320827

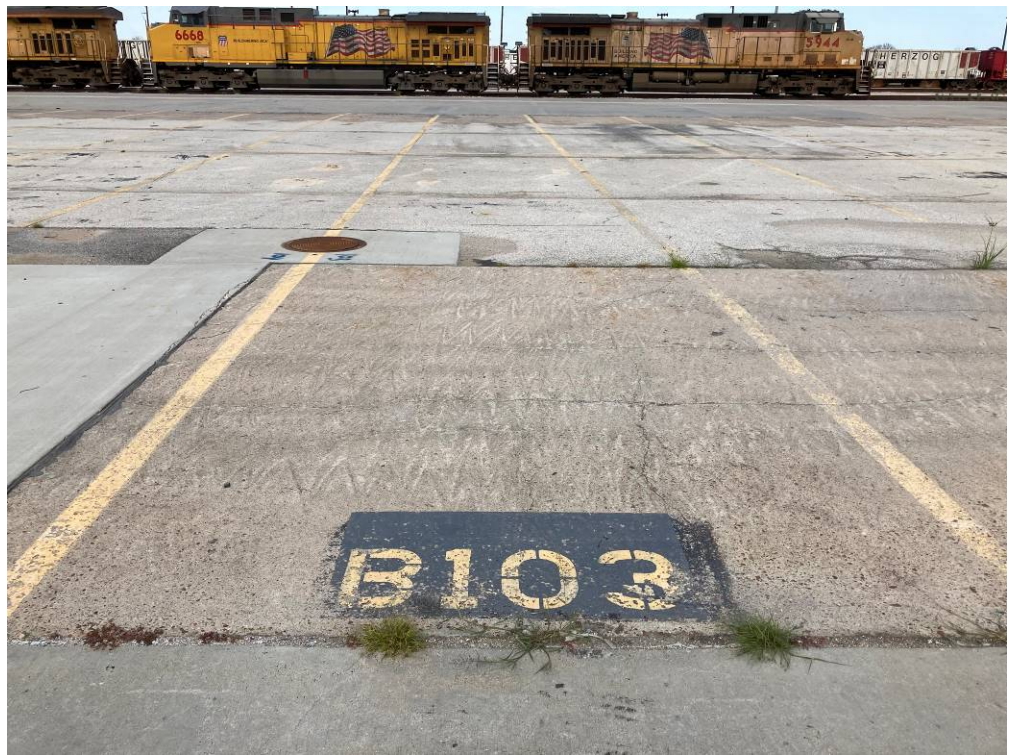
Description: Slot B103, view of NAPL Collection System (Sump 103/104 on left). No tar-like material seeps observed, looking north.	
Lat: 29.7841639 Long: - 95.3208694

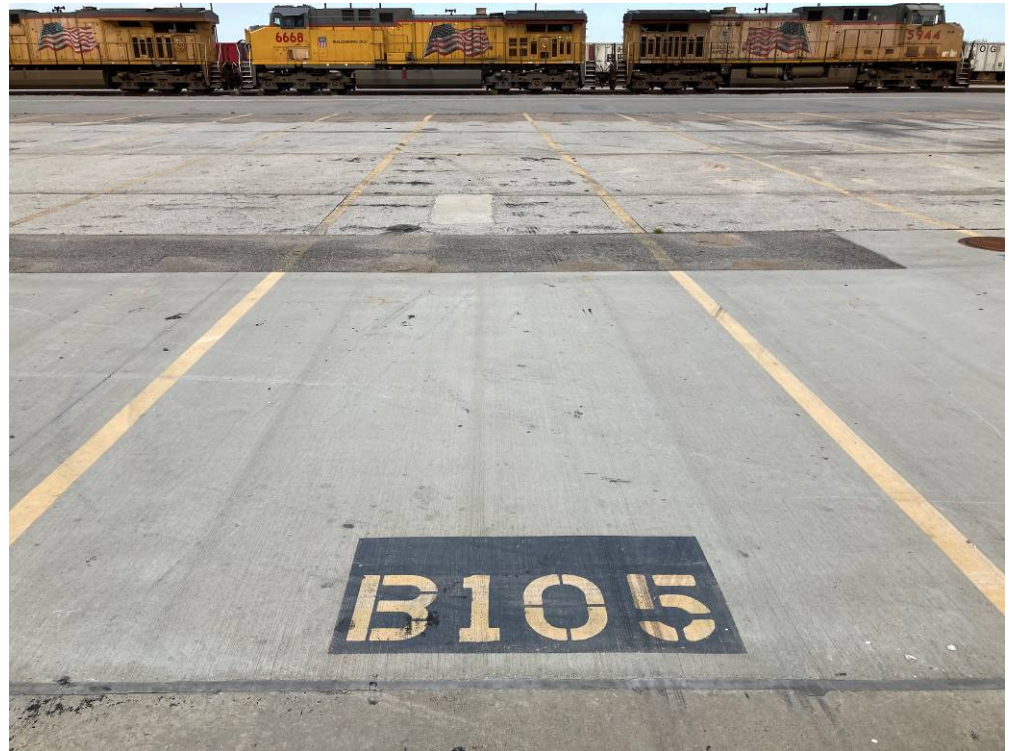
Photo No. 15	Date: 12/18/2020
Description: Slot B105, no tar-like material seeps observed, looking north. Lat: 29.7841472 Long: - 95.3208777

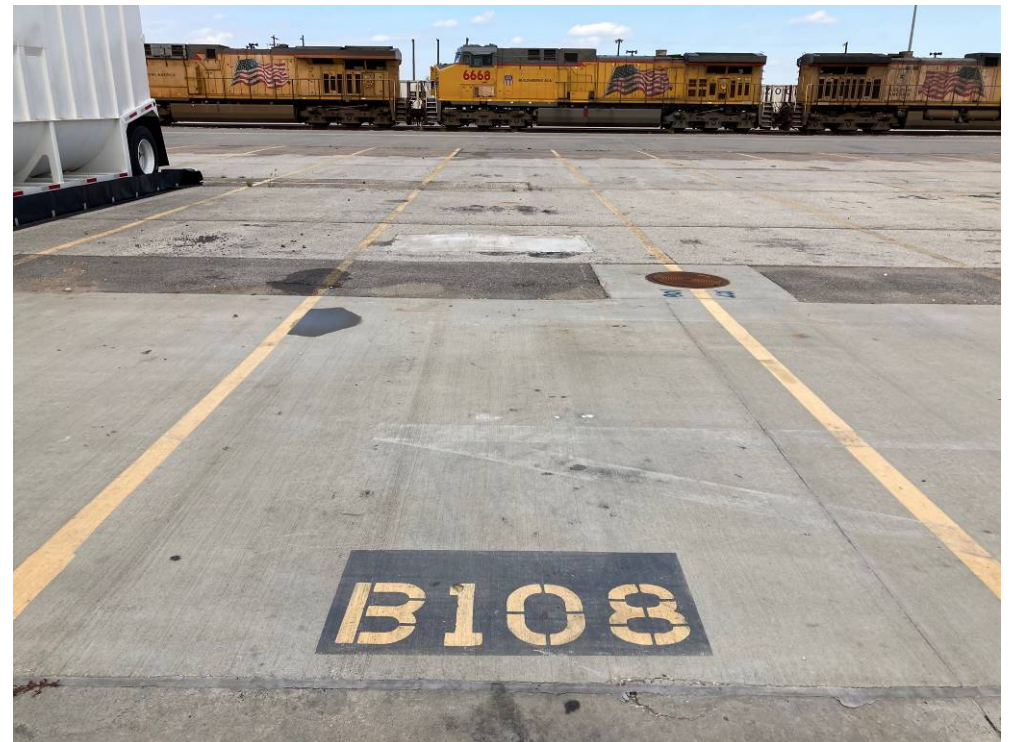
Photo No. 16	Date: 12/18/2020
Description: Slot B108, view of NAPL Collection System (Sump B107/B108 and test pit in background). No tar-like material seeps observed, looking north. Lat: 29.784125 Long: - 95.320989

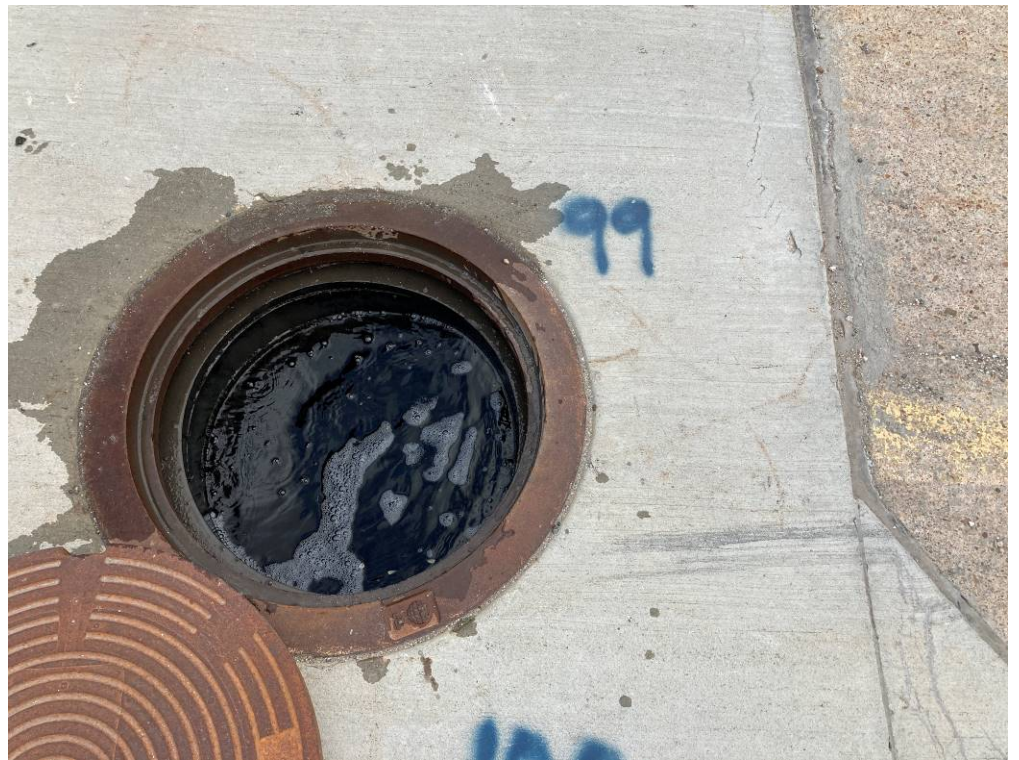
Photo No.
17

Sump 1 (B099/B100), 4 inches of freeboard in sump, no sheen or odor noted.

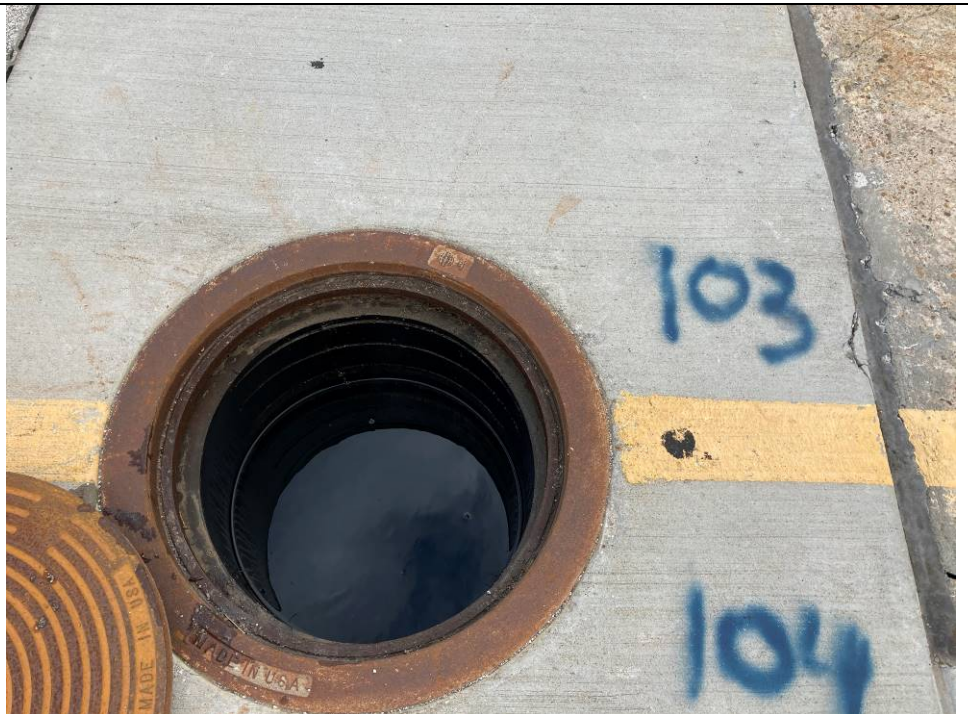
Photo No.
18

Sump 2 (B103/B104), 10 inches of freeboard in sump, no sheen or odors noted.

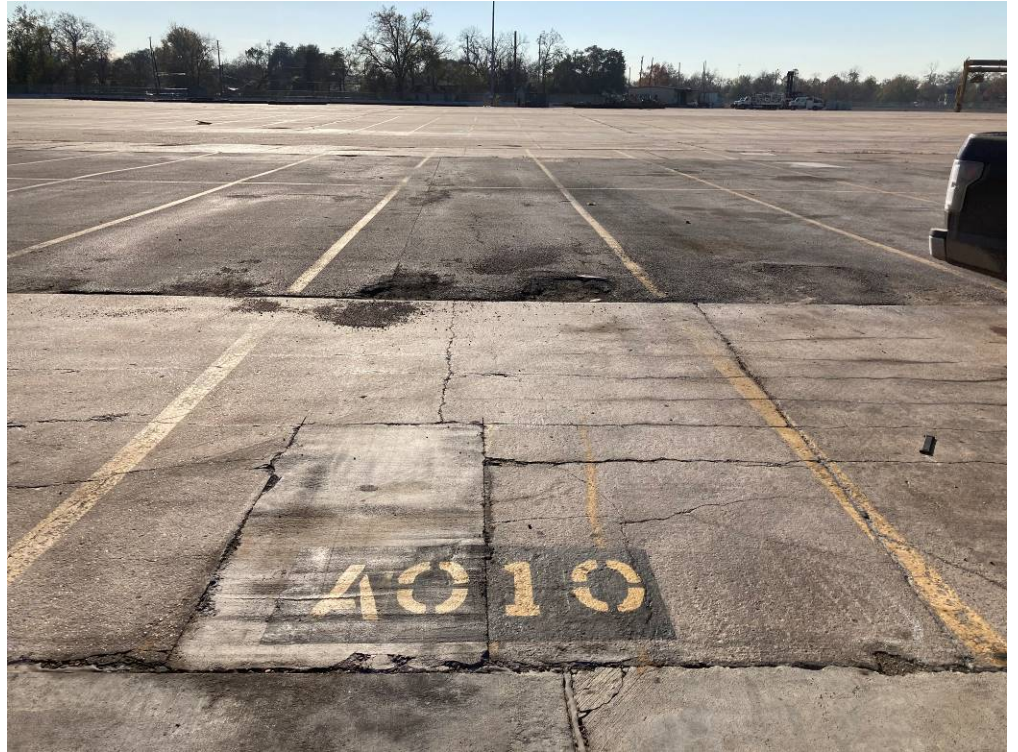
Photo No.
19

Slot A010, no tar-like material seeps observed where test pit (July 2020) conducted, looking south.

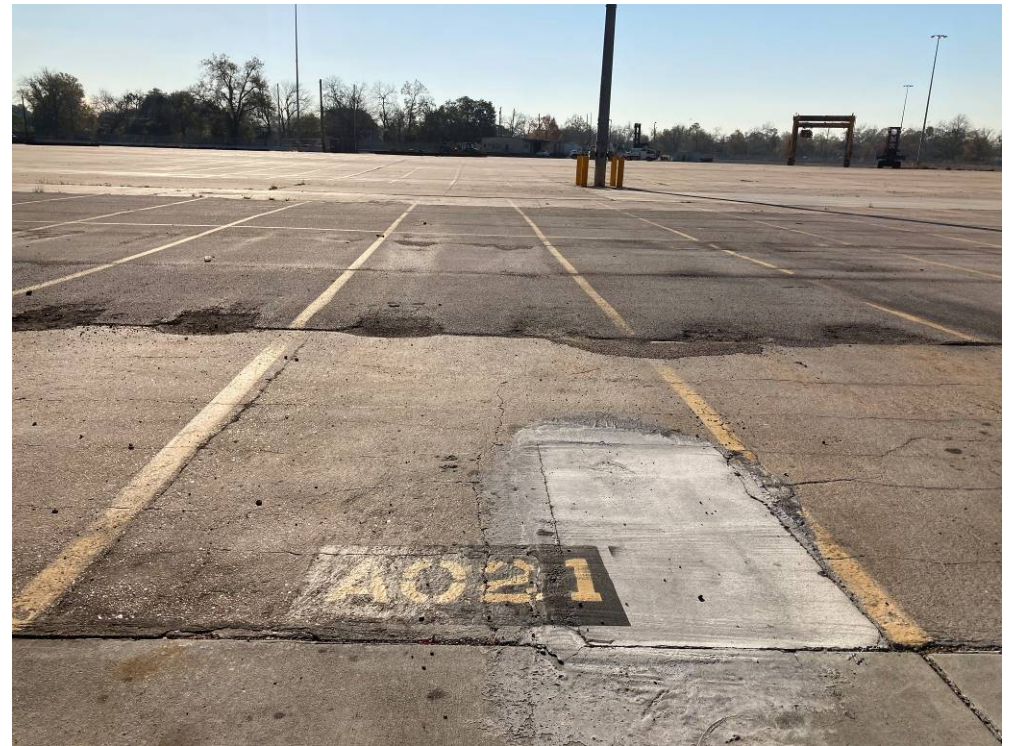
Photo No.
20

Slot A021, no tar-like material seeps observed where test pit (July 2020) conducted, looking south.

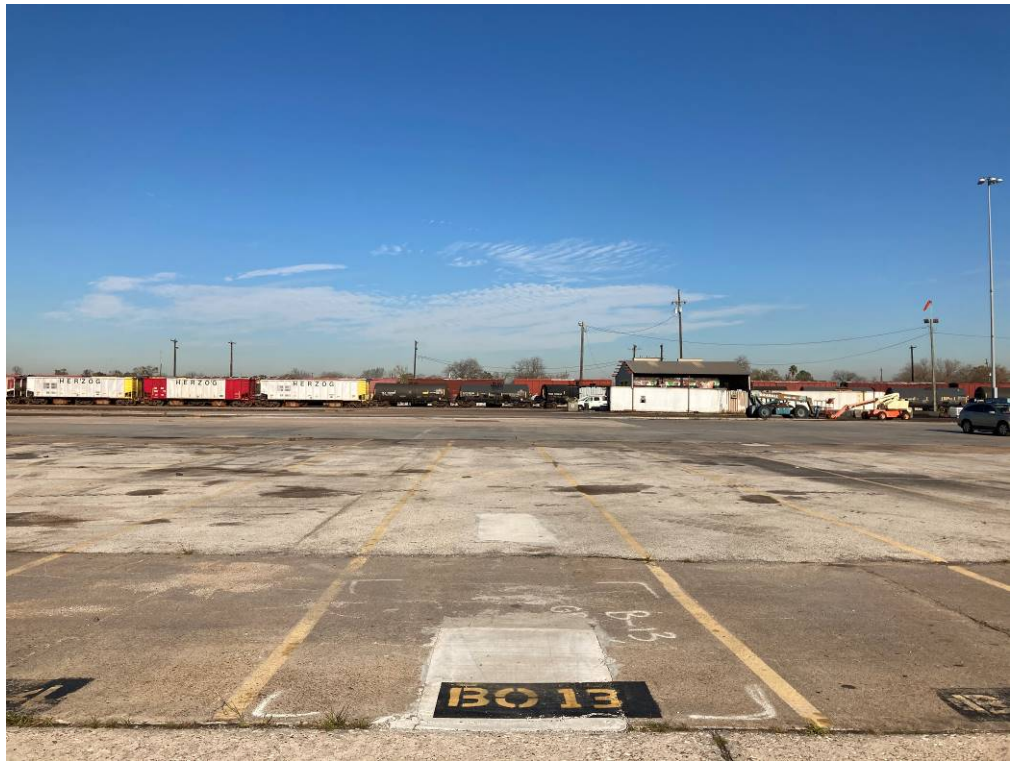
Photo No. 21	Date: 12/23/2020
Description: Slot B013, no tar-like material seeps observed where test pit (July 2020) conducted, looking north. Lat: 29.785217 Long: - 95.318261

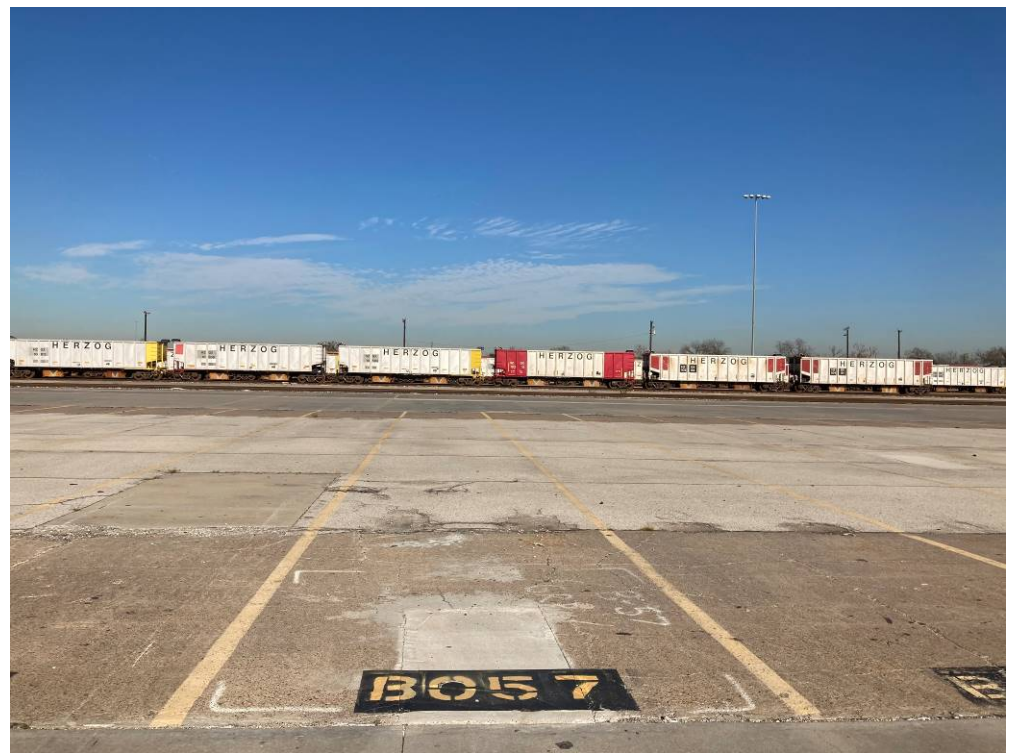
Photo No. 22	Date: 12/23/2020
Description: Slot B057, no tar-like material seeps observed where test pit (July 2020) conducted, looking north. Lat: 29.7847472 Long: - 95.3195417

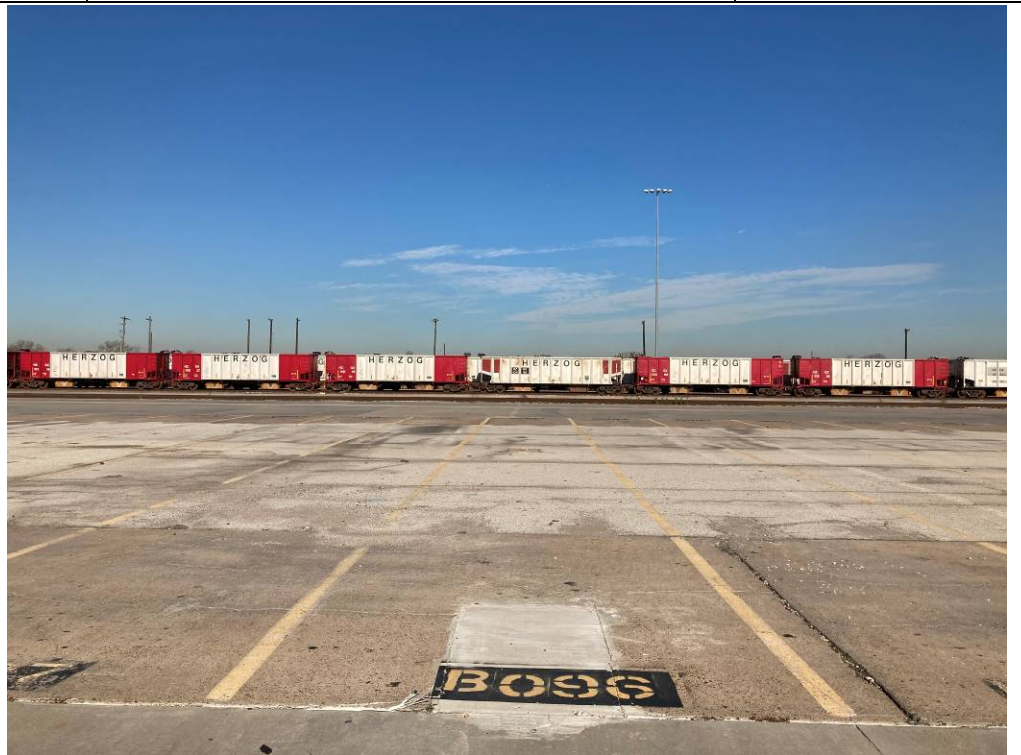
Photo No.: 23	Date: 12/23/2020
Description: Slot B096, no tar-like material seeps observed where test pit (July 2020) conducted, looking north. Lat: 29.7842528 Long: - 95.3206250

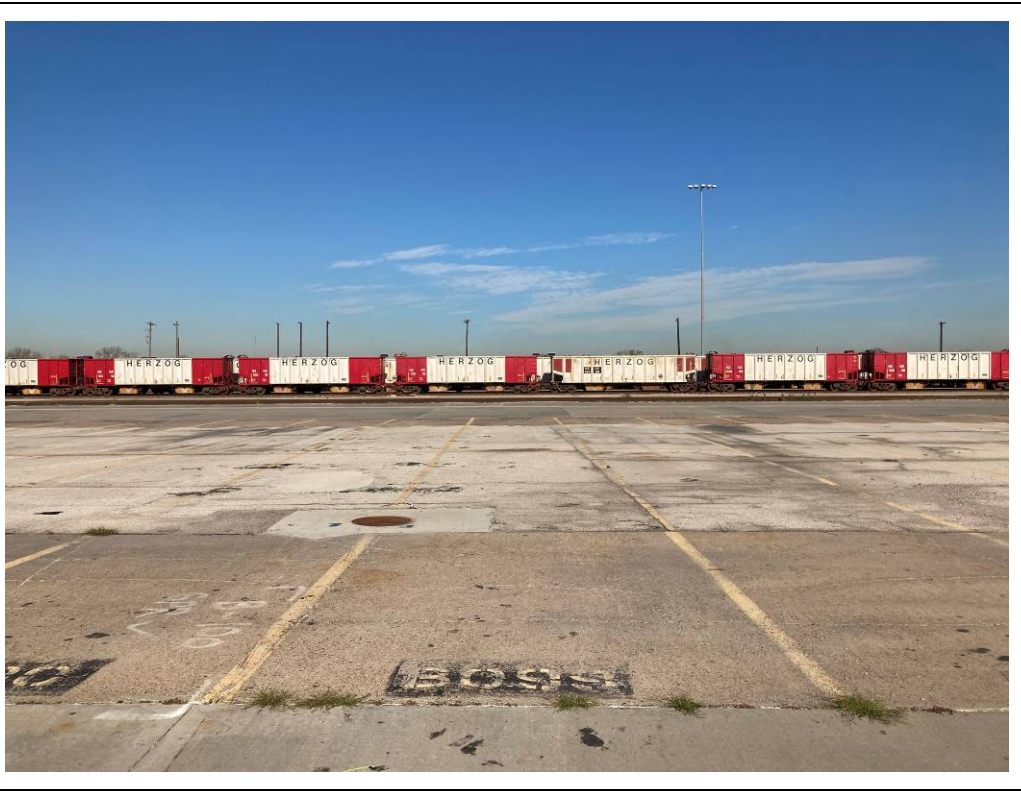
Photo No.: 24	Date: 12/30/2020
Description: Slot B099, view of NAPL Collection System (Sump 099/100 in background). No tar-like material seeps observed, looking north. Lat: 29.7842472 Long: - 95.3206944

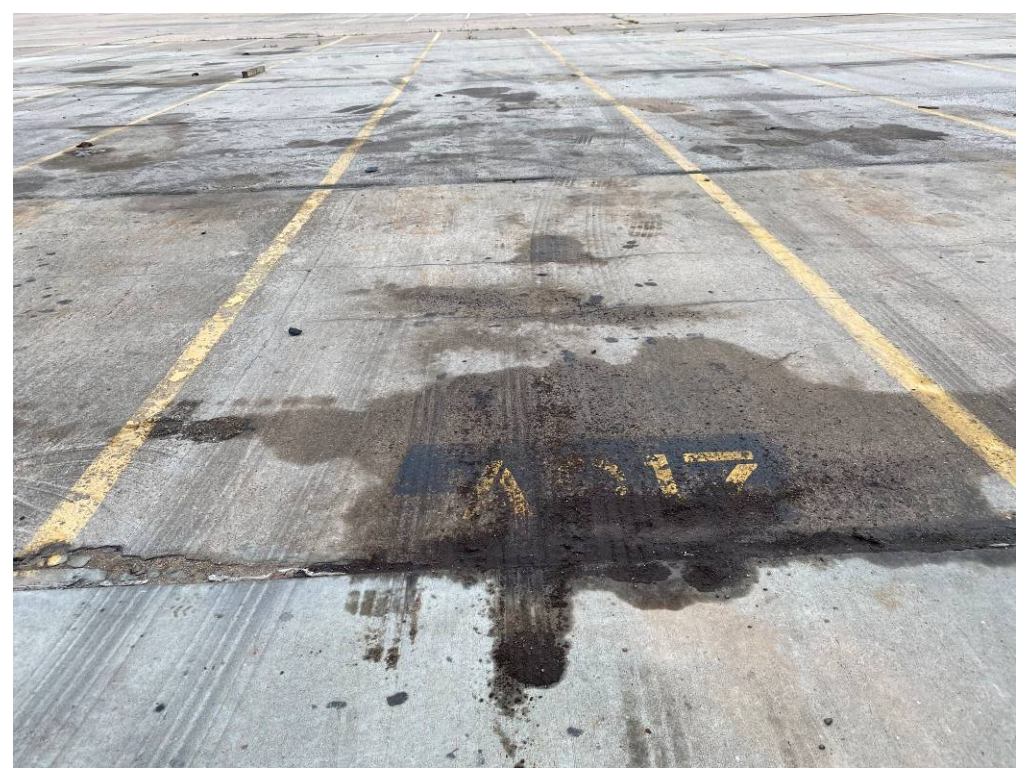
Photo No. 25	Date: 12/30/2020
-------------------------------	----------------------------

- During the inspection on December 30, 2020, a small area of localized staining was observed at the northern joint of Slot A017 (Photo 25), which is likely residual staining from the maintenance activities on a container crane noted in September 2020.

Slot A017, localized staining observed on concrete, likely from hydraulic oil from maintenance activities on a container crane in September 2020, no standing water or tar-like material seeps observed, looking south.

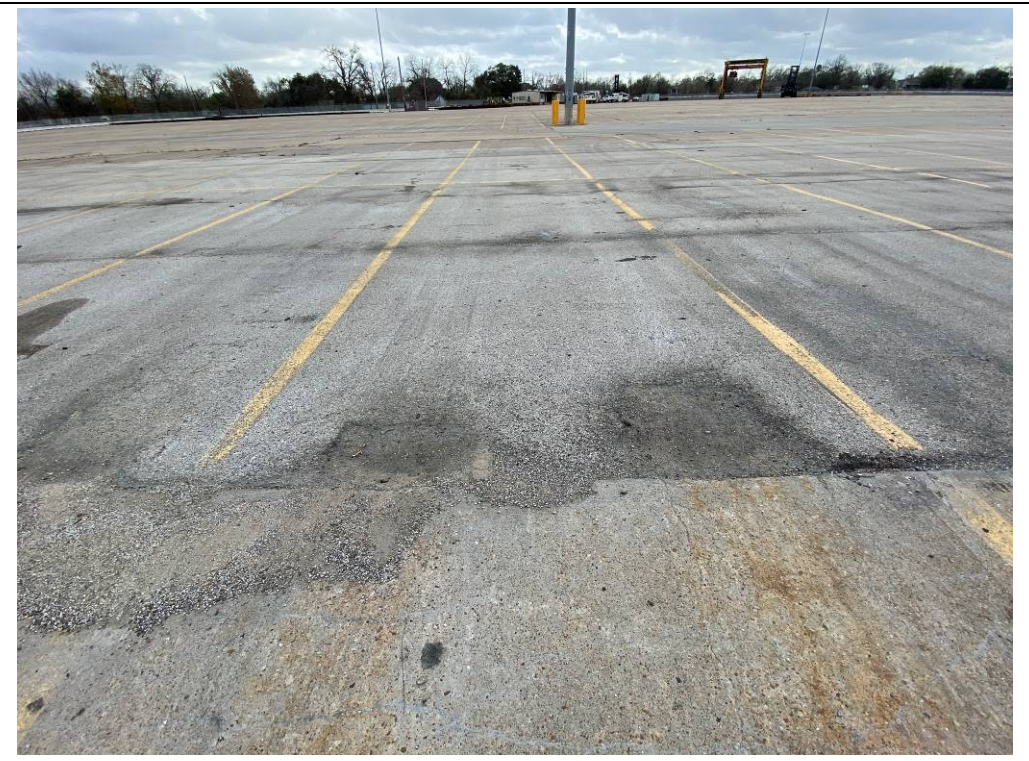
Photo No. 26	Date: 12/30/2020
-------------------------------	----------------------------

Slot A022, no tar-like material seeps observed, looking south.

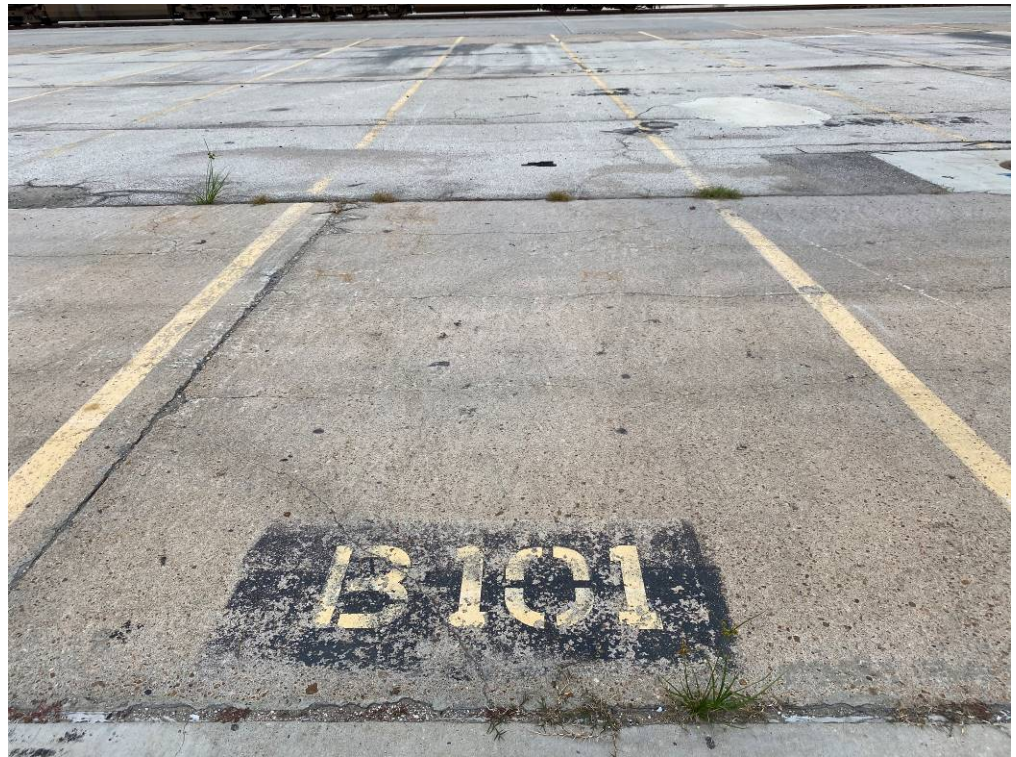
Photo No. 27	Date: 12/30/2020
Description: Slot B101, no tar-like material seeps observed, looking north. Lat: 29.784275 Long: - 95.320813

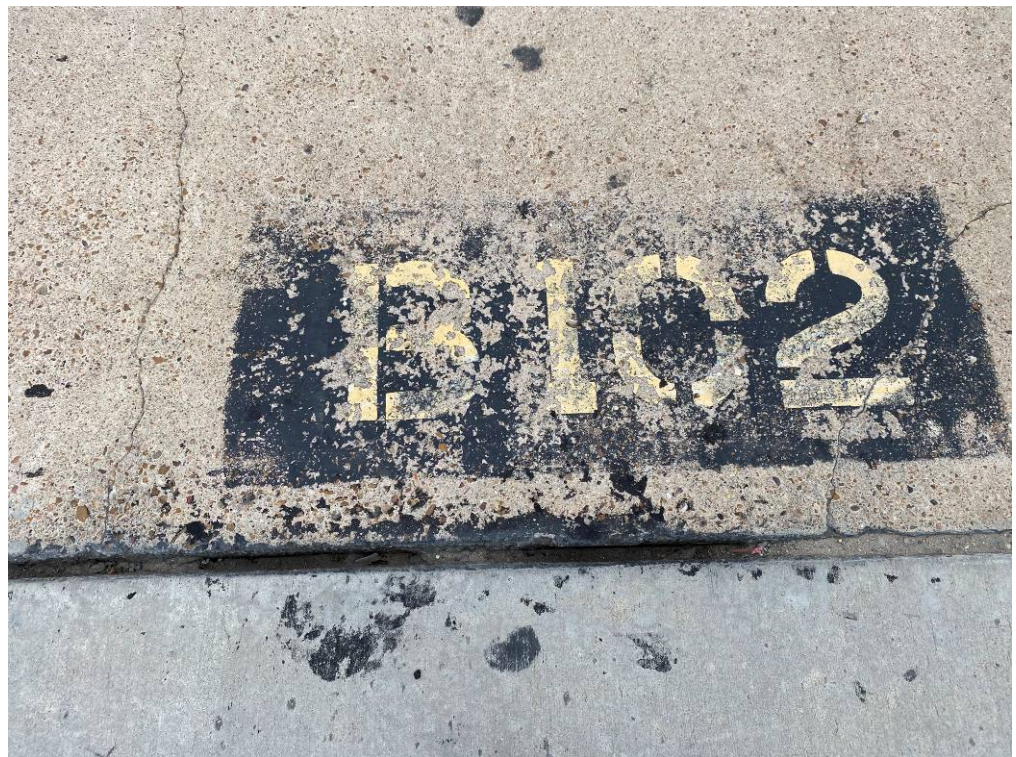
Photo No. 28	Date: 12/30/2020
Description: Slot B102, no tar-like material seeps observed, looking north. Lat: 29.7842203 Long: - 95.320827
