January 20, 2021

Project No. 19119232

**RE: MONTHLY STATUS UPDATE – ENGLEWOOD INTERMODAL YARD – NAPL COLLECTION SYSTEM/CONCRETE CAP REPAIRS
UNION PACIFIC RAILROAD HOUSTON WOOD PRESERVING WORKS FACILITY
4910 LIBERTY ROAD FACILITY, HOUSTON, TEXAS
POST-CLOSURE CARE PERMIT NO. HW-50343; INDUSTRIAL SWR NO. 31547**

Weekly Inspection Photolog

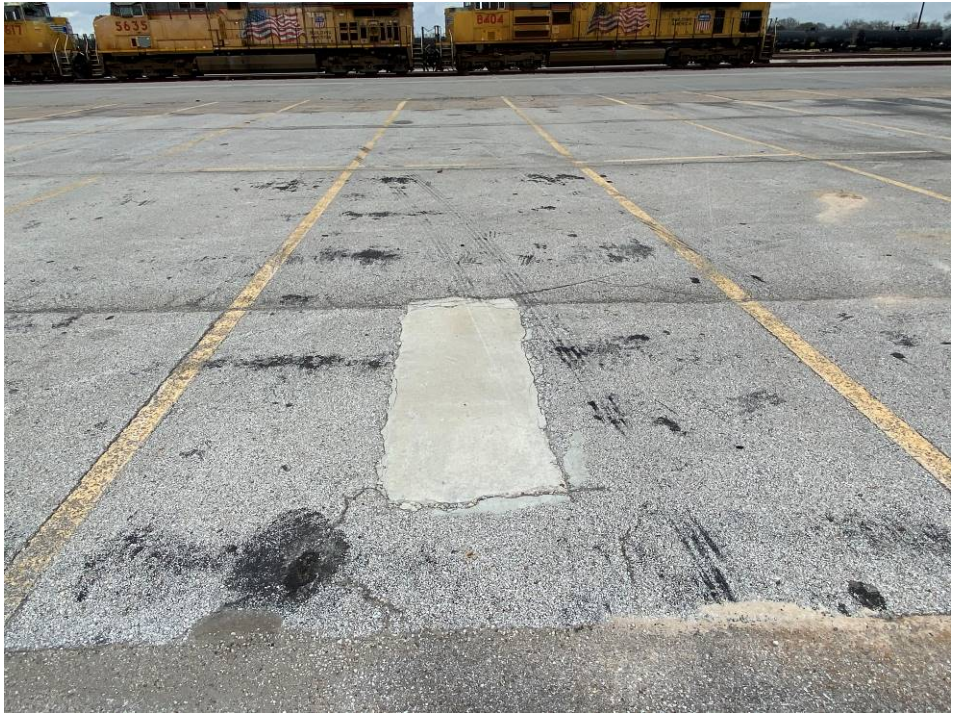
Photo No. 29	Date: 12/30/2020
Description: Slot B105, small amount of tar-like material seeping at asphalt crack, material was removed, looking north. Lat: 29.7841472 Long: - 95.3208777

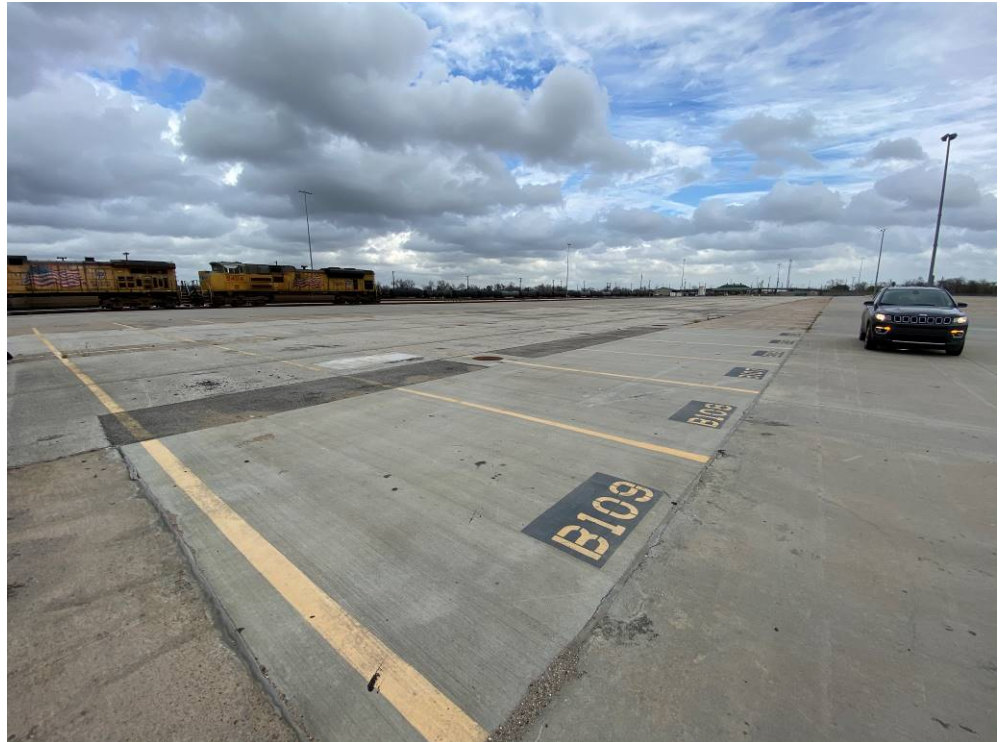
Photo No. 30	Date: 12/30/2020
Description: Slots B109-B097, NAPL collection system visible in background, residual brown staining observed along the crack in the asphalt, looking northeast. Lat: 29.784116 Long: -95.321022

- No widespread seep water was observed in the paved areas during the December 2020 inspections. UPRR will continue to have USES pressure wash the areas where the brown staining and seeps are observed as needed. Recovered wash water stored in a tote from previous events was removed from site by UPRR contractor NRC on November 30, 2020 and taken to Seabreeze Landfill for disposal. The final manifests are provided in Attachment B.

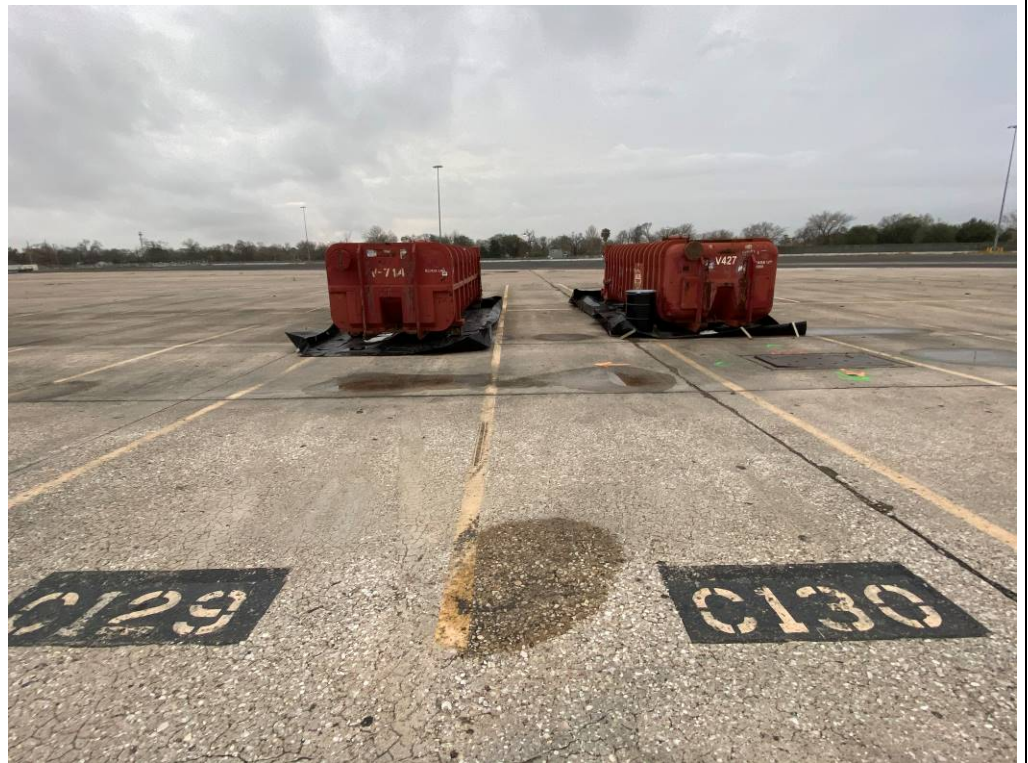
Photo No.
31

- On December 8, 2020, GPRS was subcontracted to perform a camera survey on the storm sewer pipes in the Intermodal Yard as part of the Englewood IM Yard Test Pit Evaluation. The camera was unable to advance the full length of several drainpipes due to build-up of sediments and deposits (e.g., mud) within the drainpipes. A sheen was observed upon disturbance of the deposits and booms were placed in the catch basins as a precautionary measure. Golder, on behalf of UPRR, coordinated with USES to remove the obstructions within sections of the storm system on December 21 and 22, 2020. Water and material from the obstruction removal effort were placed in two vacuum boxes and stored onsite in stalls C129 and C131 (Photo 31). Used booms from the obstruction removal effort were placed in a 55-gallon drum and stored onsite with the vacuum boxes (Photo 32). Another camera survey is scheduled in January 2021. Details on the camera and obstruction removal activities will be provided in the Englewood IM Yard Test Pit Evaluation Report indicated above.

Slots C129-C131, vacuum boxes containing water from storm sewer cleanout, looking south.

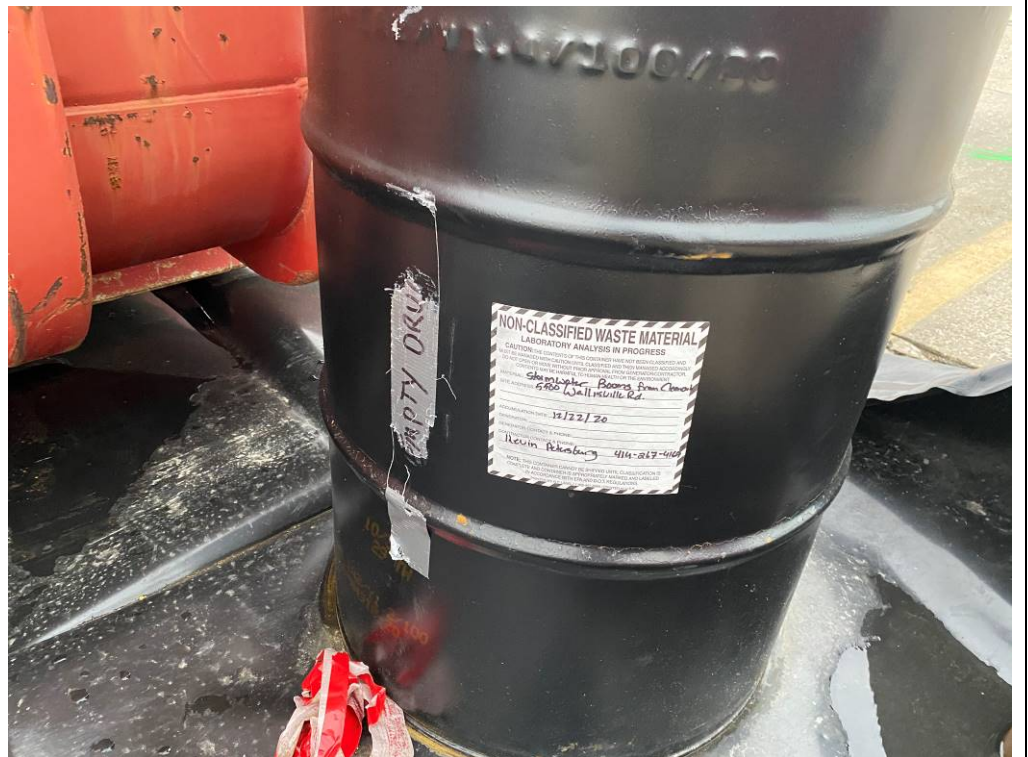
Photo No.
32

Slot C130, 55-gallon drum containing stormwater booms from storm sewer cleanout.
