March 17, 2021

Project No. 19119232

**RE: MONTHLY STATUS UPDATE – ENGLEWOOD INTERMODAL YARD – NAPL COLLECTION SYSTEM/CONCRETE CAP REPAIRS
UNION PACIFIC RAILROAD HOUSTON WOOD PRESERVING WORKS FACILITY
4910 LIBERTY ROAD FACILITY, HOUSTON, TEXAS
POST-CLOSURE CARE PERMIT NO. HW-50343; INDUSTRIAL SWR NO. 31547**

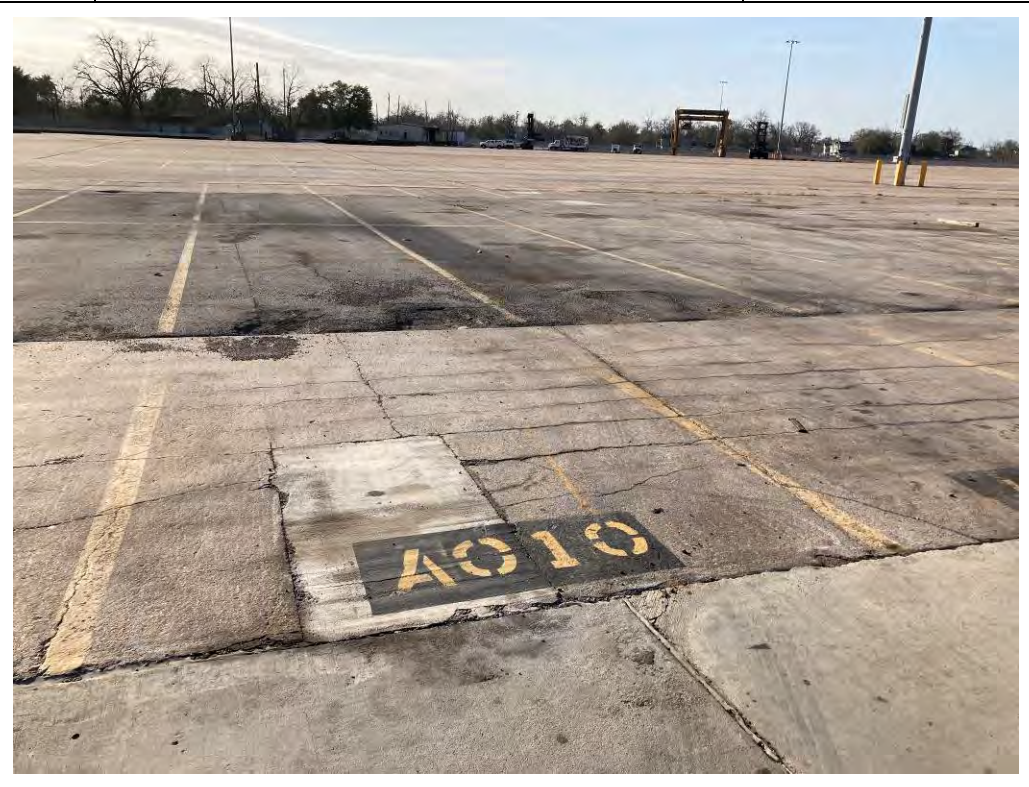
Photo No. 1	Date: 2/4/2021
Description: Slot A010, no tar-like material seeps observed where test pit conducted (July 2020), looking southwest. Lat: 29.7855833, Long: -95.318375

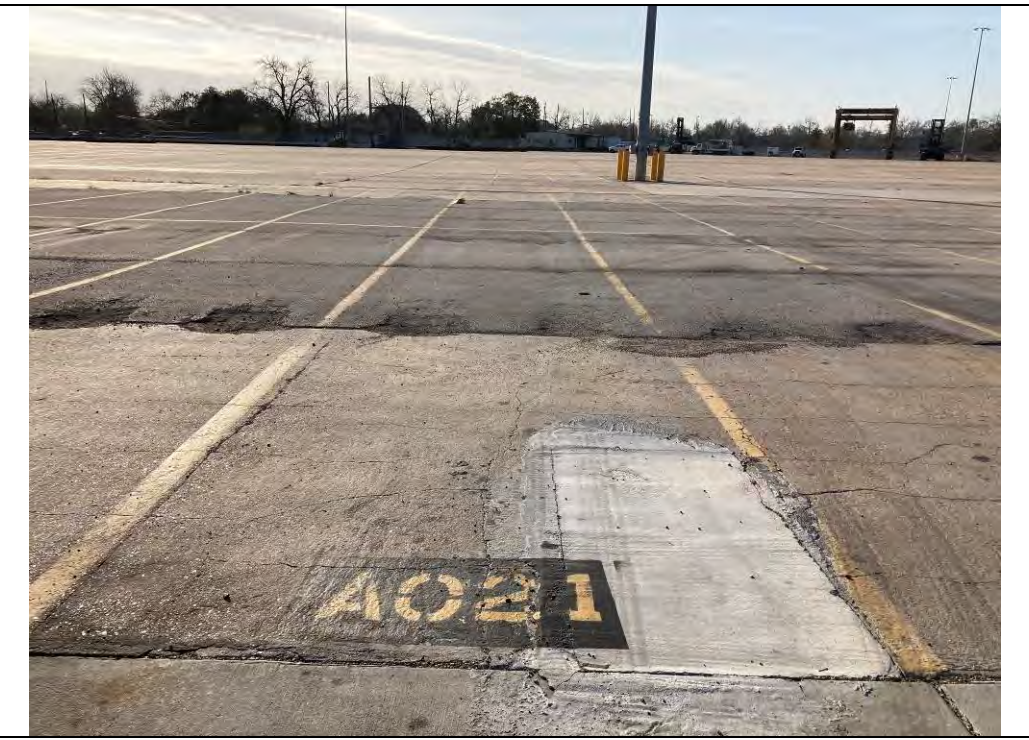
Photo No. 2	Date: 2/4/2021
-----------------------	--------------------------

Description: Slot A021, no tar-like material seeps observed where test pit conducted (July 2020), looking south. Lat: 29.785392, Long: -95.318655	
---	--

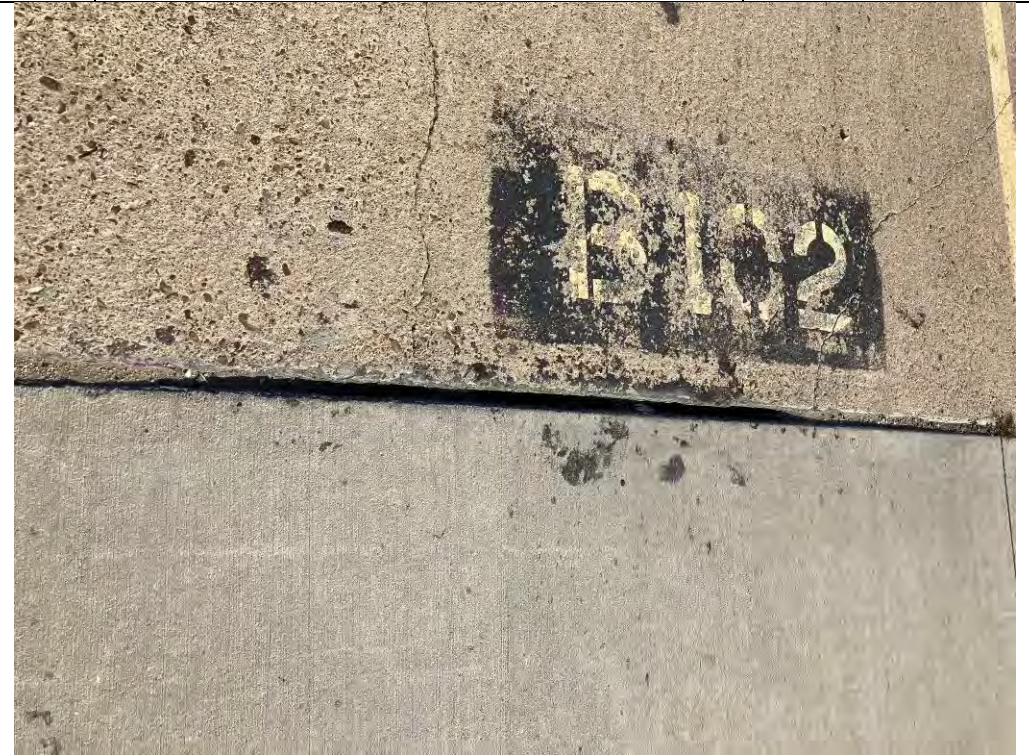
Photo No. 5	Date: 2/4/2021
Description: Slot B102, no tar-like material seeps observed. Lat: 29.7842203 Long: - 95.320827

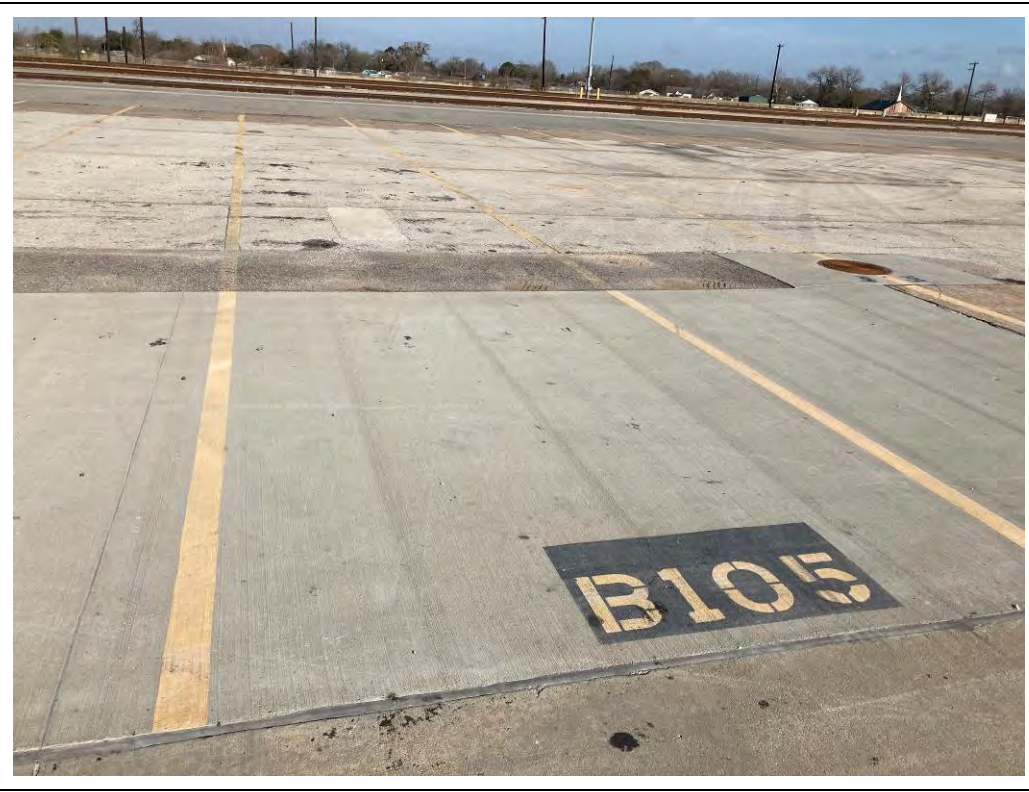
Photo No. 6	Date: 2/4/2021
Description: Slot B105, no tar-like material seeps observed, looking northeast. Lat: 29.7841472 Long: - 95.3208777

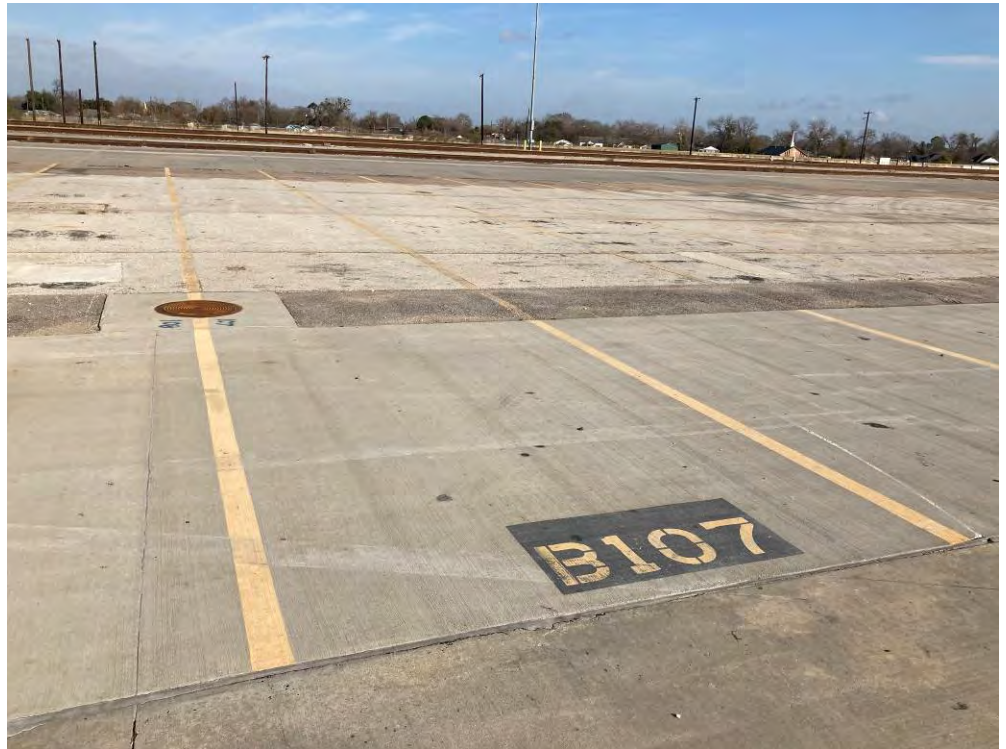
Photo No. 7	Date: 2/4/2021
Description: Slot B107, view of NAPL Collection System (Sump B107/B108 and test pit in background). No tar-like material seeps observed, looking northeast. Lat: 29.784139 Long: -95.320964

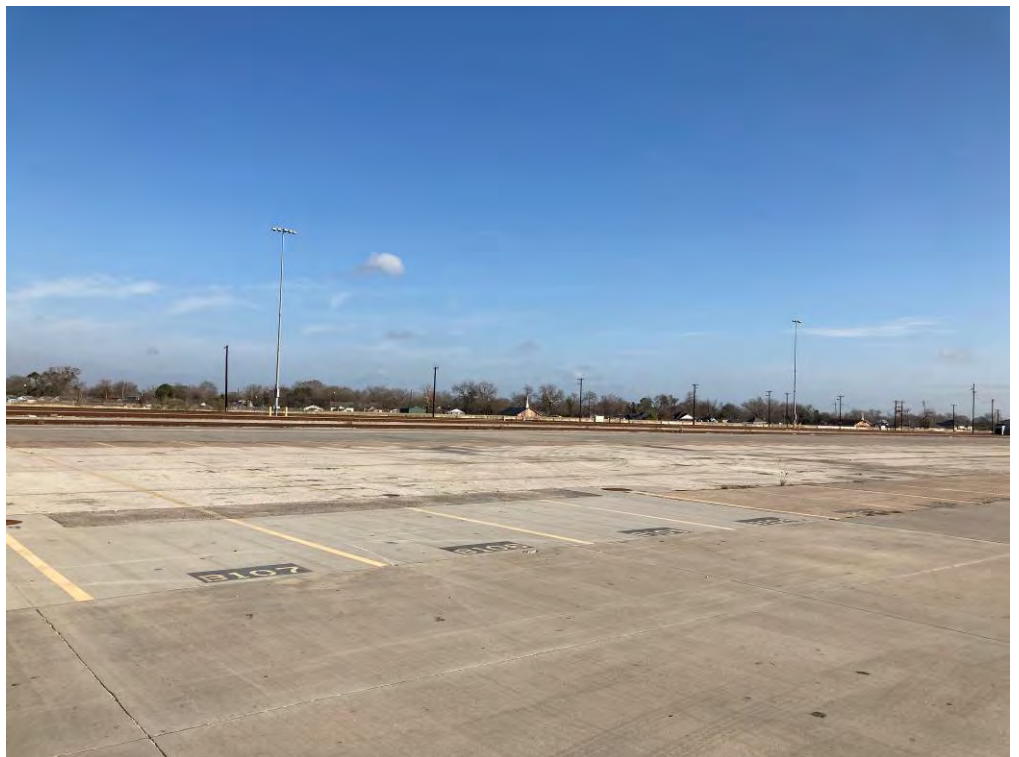
Photo No. 8	Date: 2/4/2021
Description: Slots B108-B097, NAPL collection system visible in background, looking northeast. Lat: 29.784116 Long: -95.321022

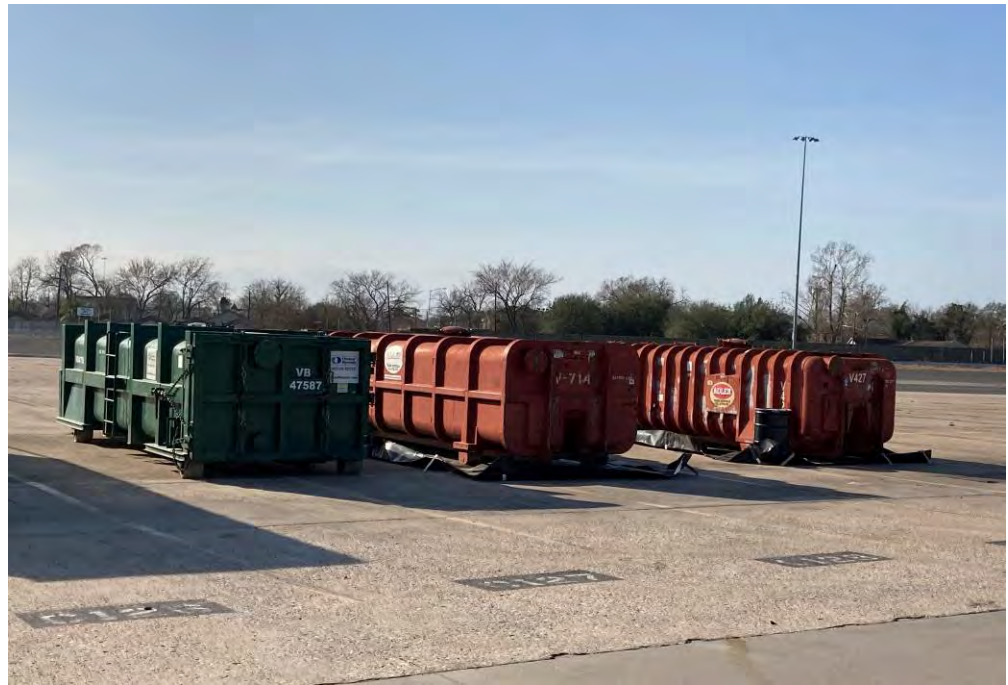
- During the last week of January, a frac tank was staged at parking slot B109 (Photo 10) and a vacuum box was staged near stalls C129 and C131 (Photo 9) containing waste from UPRR activities not related to the Site. These wastes will be disposed of in accordance with state and federal regulations.

Photo No. 9	Date: 2/4/2021
Description: Slots C127-C131, the two red vacuum boxes containing water from storm sewer obstruction removal activities, looking southwest. The green vacuum box contains waste not related to site activities (other UPRR activities). Lat: 29.783922 Long: -95.321122

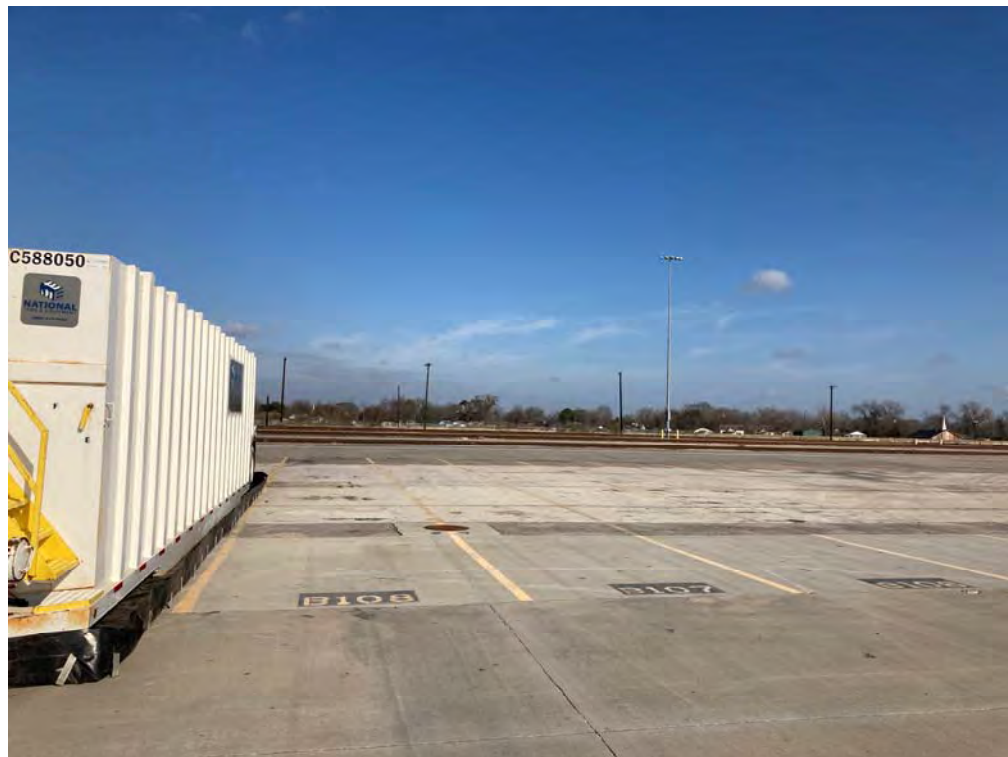
Photo No. 10	Date: 2/4/2021
Description: Slot B108, view of NAPL Collection System (Sump B107/B108 and test pit in background). No tar-like material seeps observed where test pit (July 2020) conducted, looking north. Frac tank staged in slot B109 for other UPRR activities and not related to Site activities. Lat: 29.784125 Long: - 95.320989

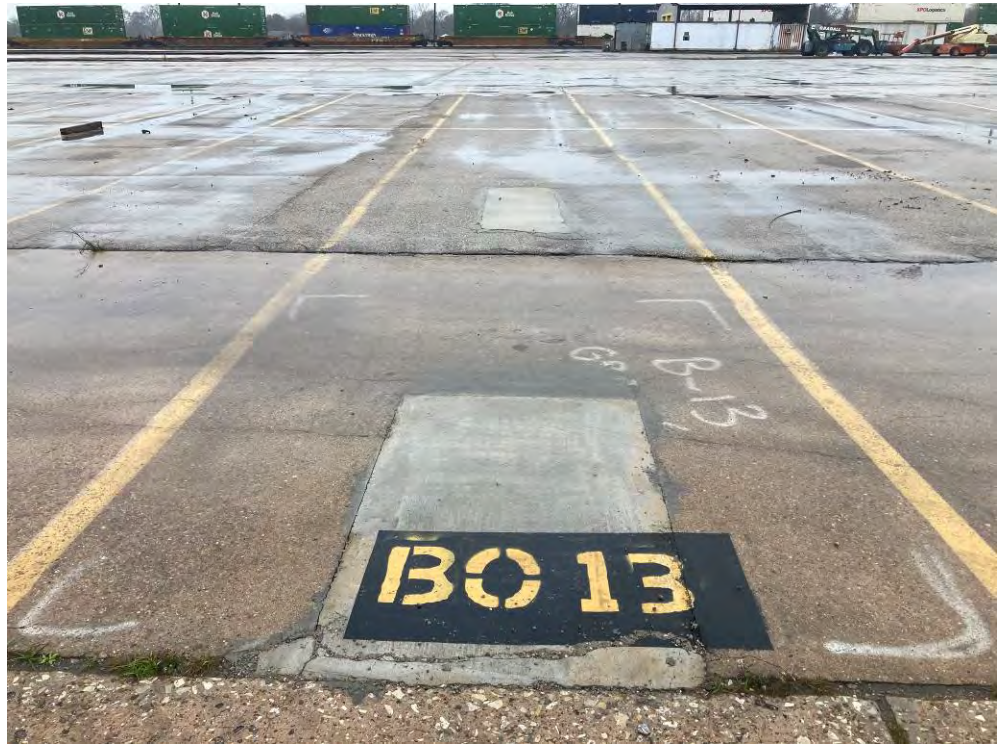
Photo No.
11

Slot B013, no tar-like material seeps observed where test pit (July 2020) conducted, pavement wet from rain, looking north.

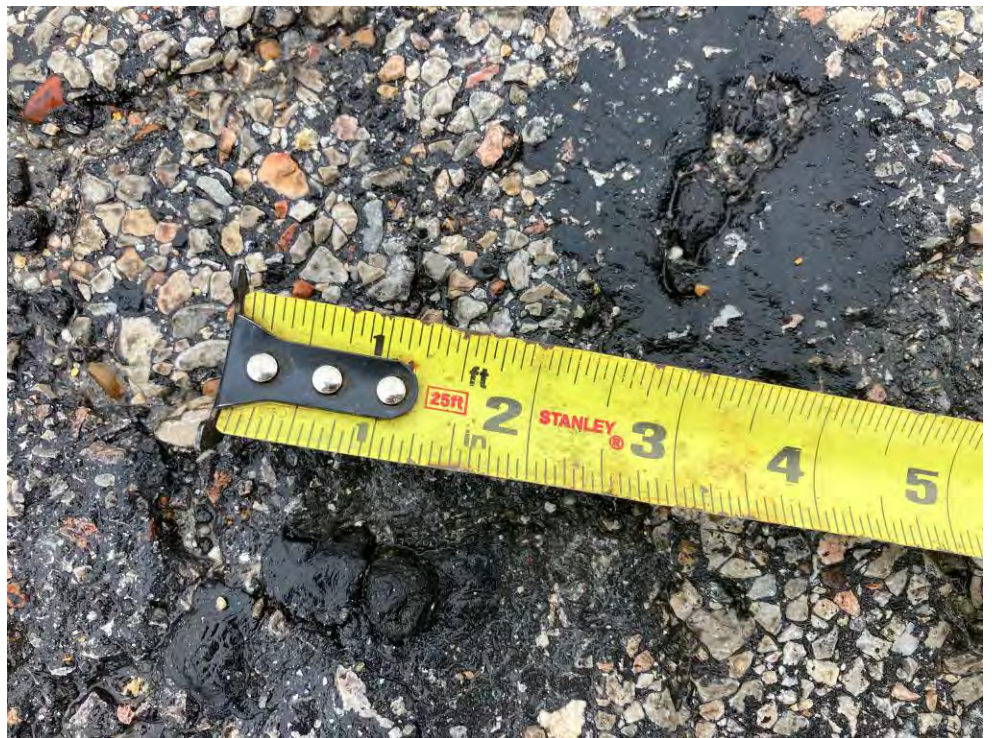
Photo No.
12

- No tar-like NAPL seeps were observed within the NAPL Collection System area during the month of February. For areas outside the NAPL Collection System, a very small amount of tar-like material was observed on the concrete surface in stall B057 during the February 10, 2021 inspection and stalls A022, B057, and B101 during the February 24, 2021 inspection. The tar-like material observed in stall B057 was not at the location of the July 2020 test pit. The overall amount of tar-like material removed from the concrete surface during February 2021 was less than 0.1 gallons.

Slot B057, very small amount of tar-like material seeping at asphalt crack (not at July 2020 test pit), material was removed, pavement wet from rain.

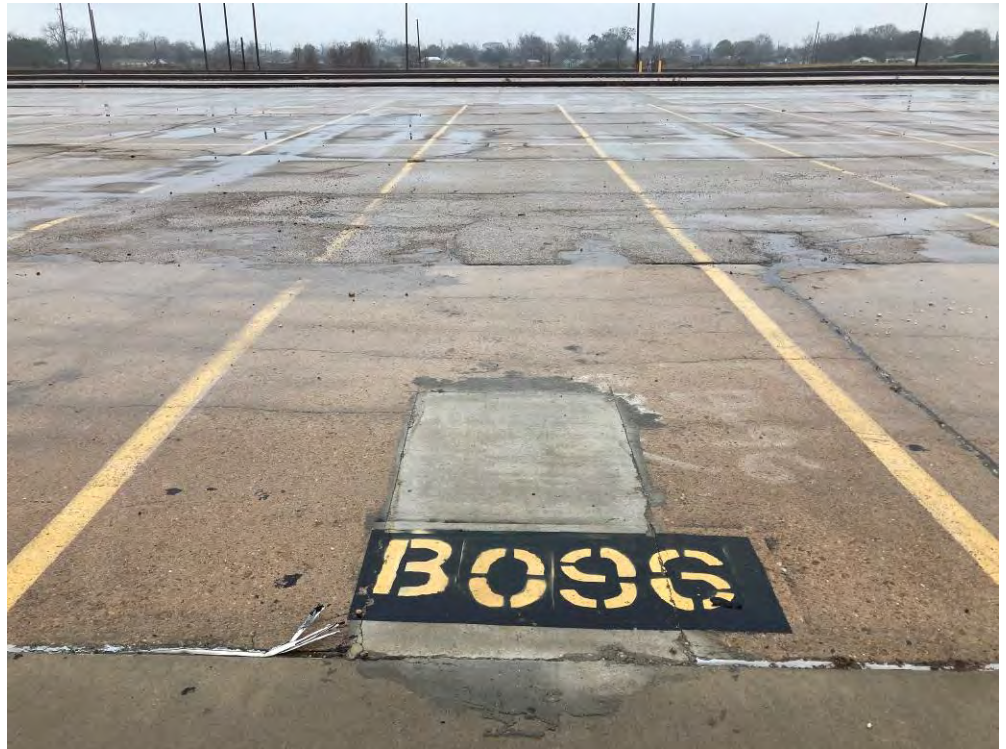
Photo No. 13	Date: 2/10/2021
Description: Slot B096, no tar-like material seeps observed where test pit conducted (July 2020), pavement wet from rain, looking north. Lat: 29.7842528 Long: - 95.3206250

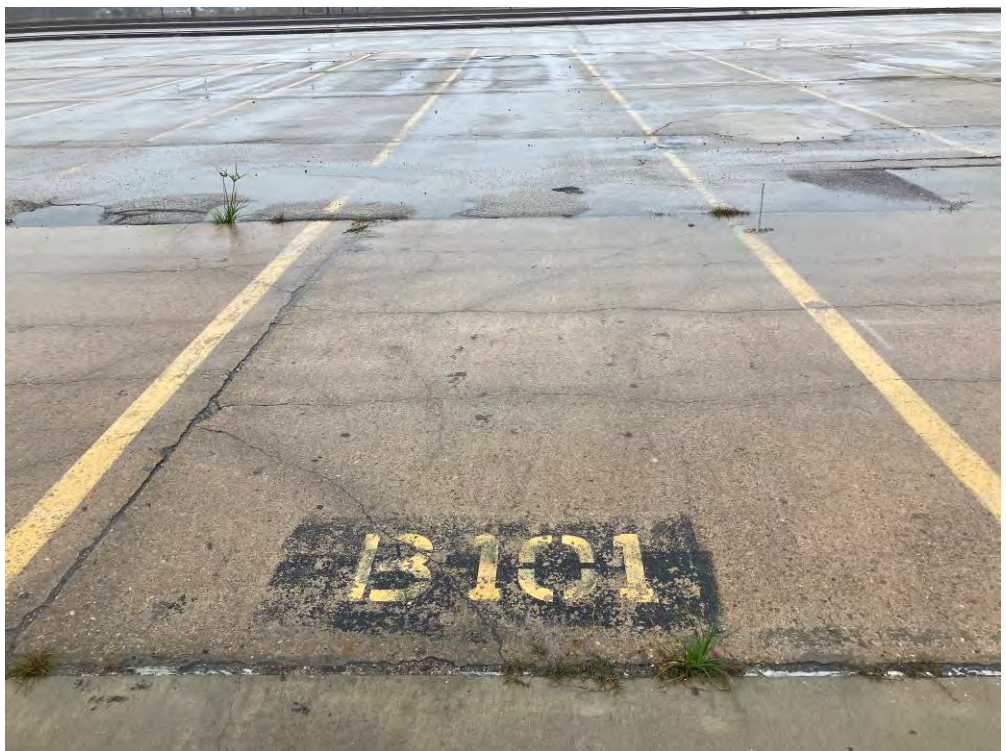
Photo No. 14	Date: 2/10/2021
Description: Slot B101, no tar-like material seeps observed, pavement wet from rain, looking north. Lat: 29.784275 Long: - 95.320813

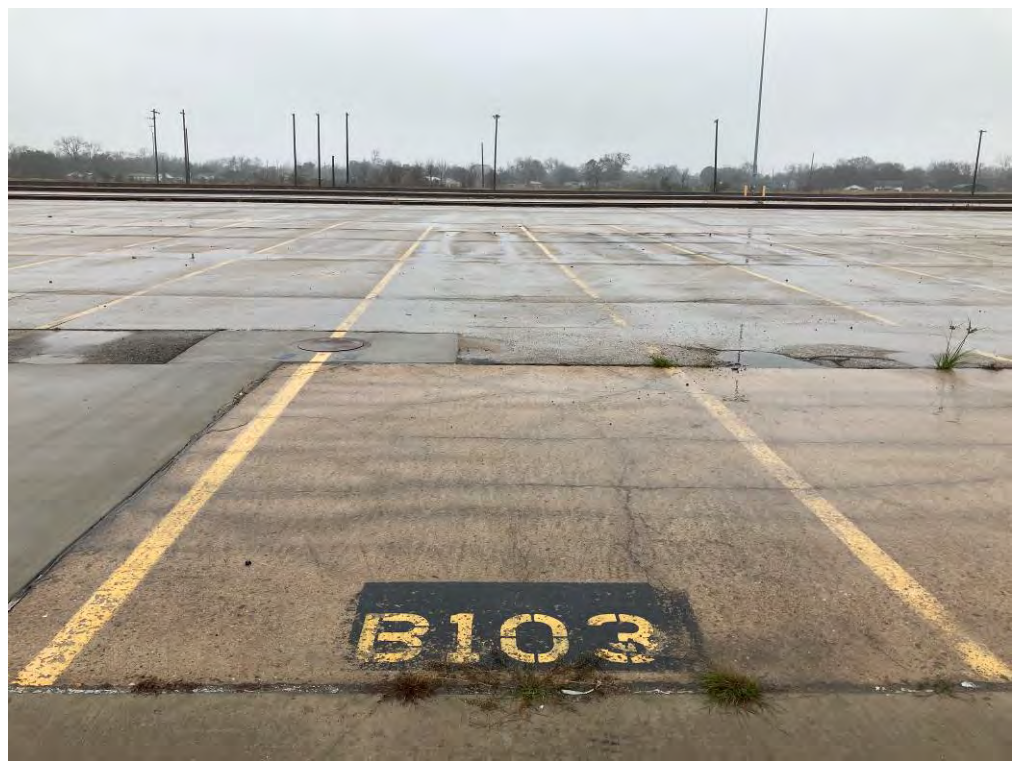
Photo No.
15

Slot B103, view of NAPL Collection System (Sump 103/104 on left). No tar-like material seeps observed, pavement wet from rain, looking north.

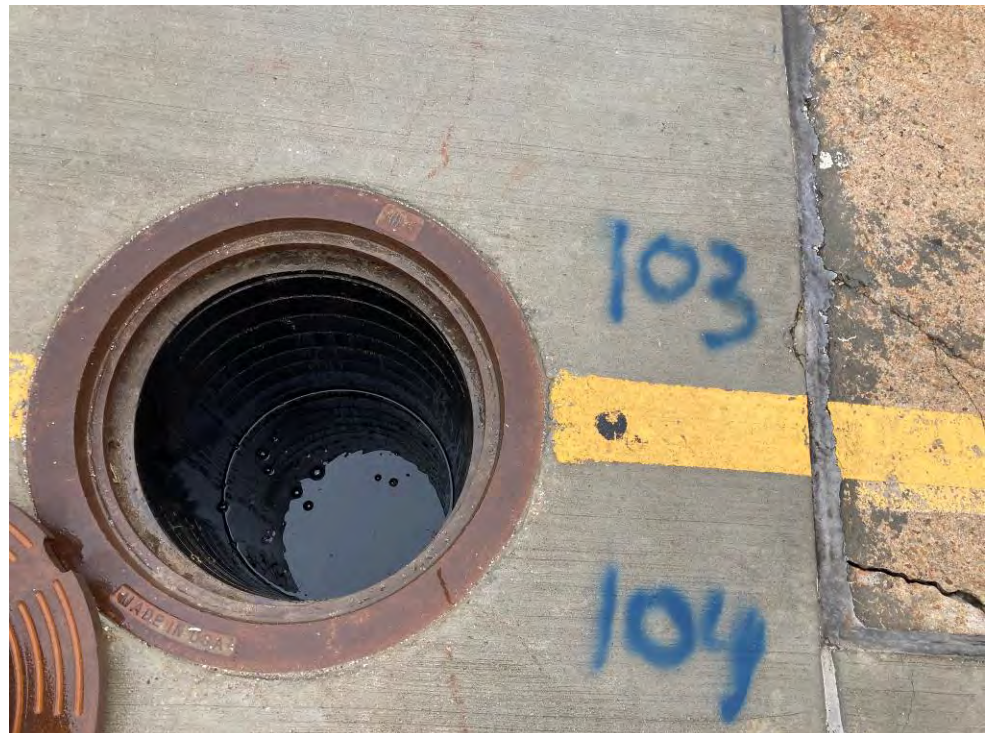
Photo No.
16

Sump 2 (B103/B104), 27 inches of freeboard in sump, no sheen or odors noted, pavement wet from rain.

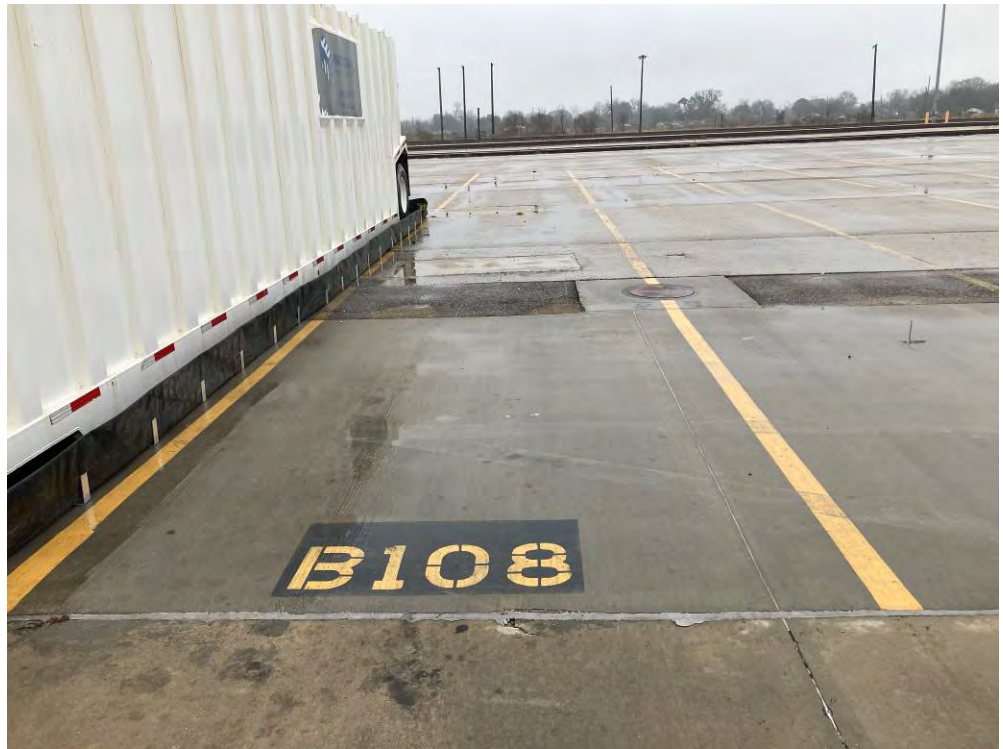
Photo No. 17	Date: 2/10/2021
Description: Slot B108, view of NAPL Collection System (Sump B107/B108 and test pit in background). No tar-like material seeps observed where test pit conducted (July 2020), pavement wet from rain, looking north. Lat: 29.784125 Long: - 95.320989

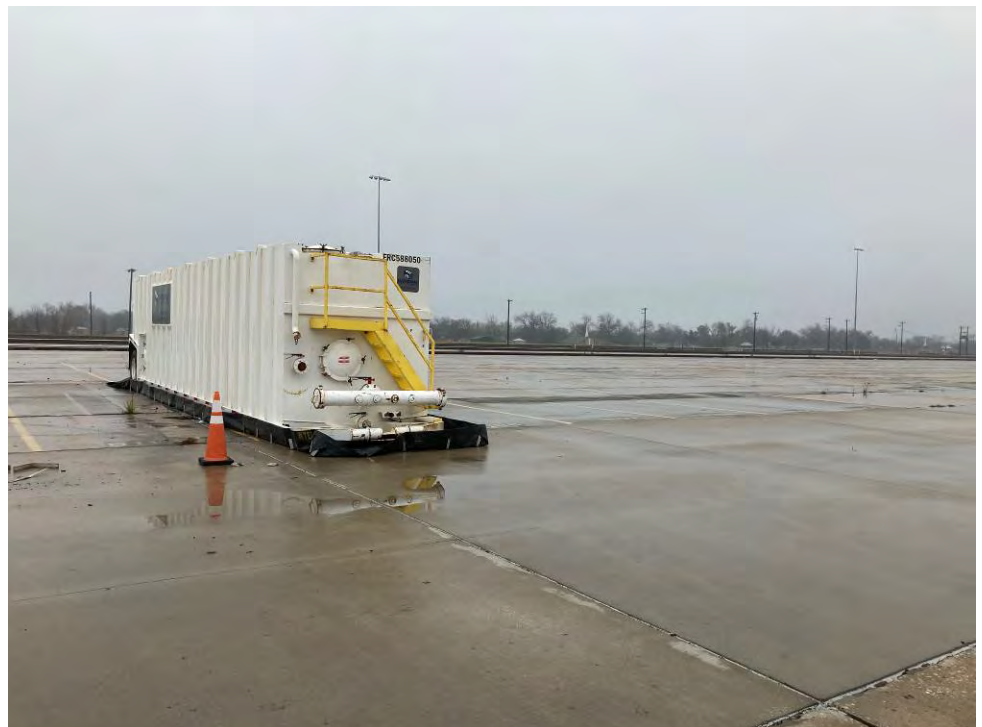
Photo No. 18	Date: 2/10/2021
Description: Frac tank staged in slot B109 for other UPRR activities and not related to Site activities. Pavement wet from rain. Frac tank that was staged in slot B110 for storage of pumped down water from NAPL Collection Sumps was taken offsite on 1/29/2021. Lat: 29.7841028 Long: - 95.3209833

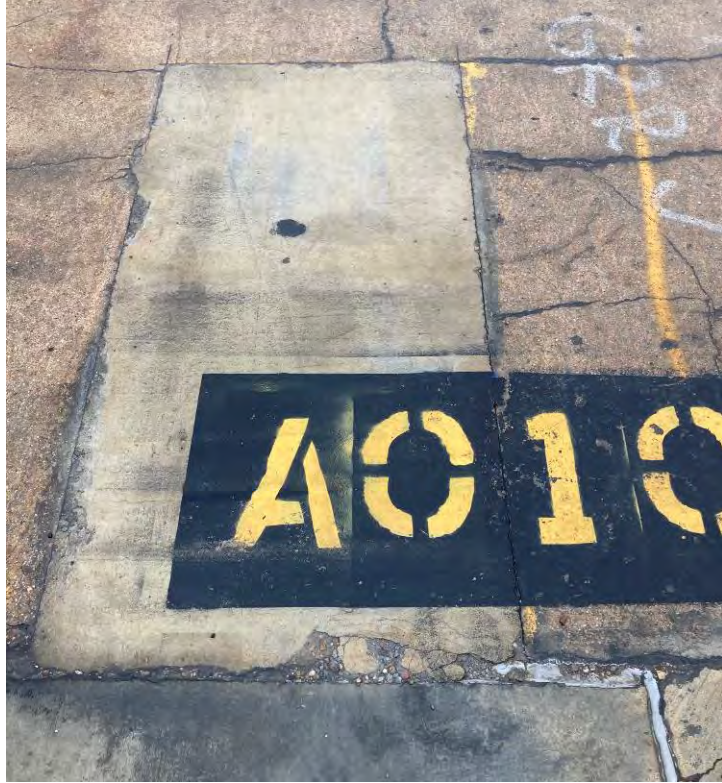
Photo No.
19

Slot A010, no tar-like material seeps observed where test pit conducted (July 2020), pavement wet from rain.

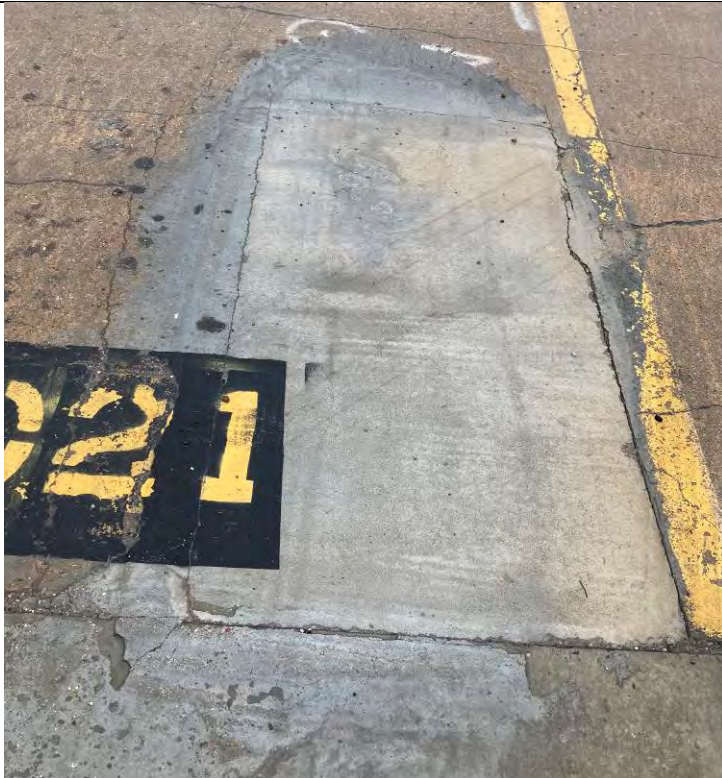
Photo No.
20

Slot A021, no tar-like material seeps observed where test pit conducted (July 2020), pavement wet from rain.

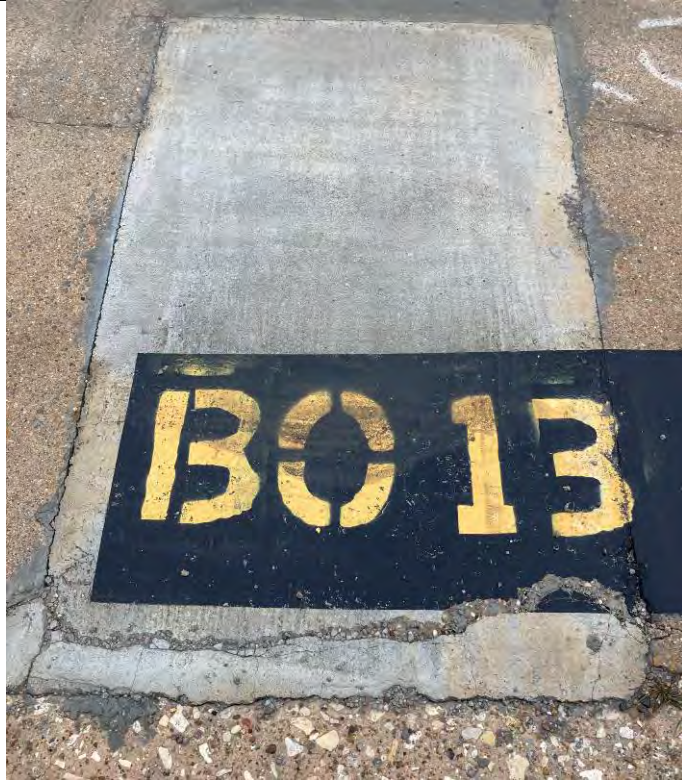
Photo No.
21

Slot B013, no tar-like material seeps observed where test pit conducted (July 2020), pavement wet from rain.

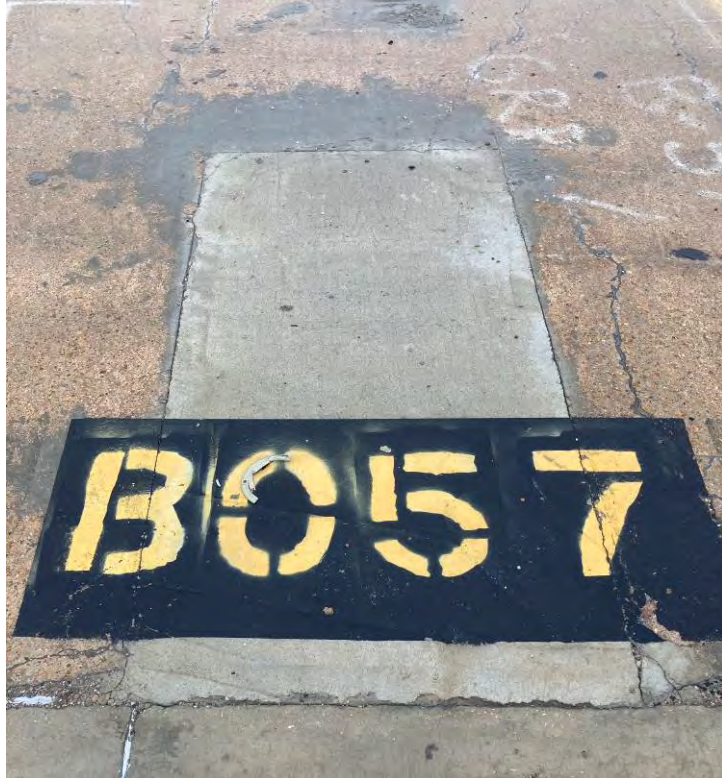
Photo No.
22

Slot B057, no tar-like material seeps observed where test pit conducted (July 2020), pavement wet from rain.

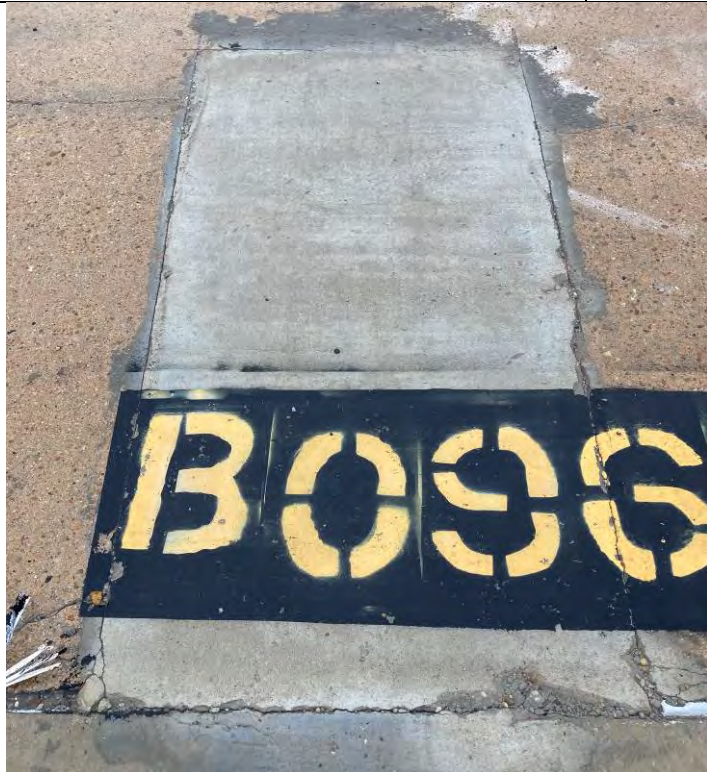
Photo No. 23	Date: 2/17/2021
Description: Slot B096, no tar-like material seeps observed where test pit conducted (July 2020), pavement wet from rain. Lat: 29.7842528 Long: - 95.3206250

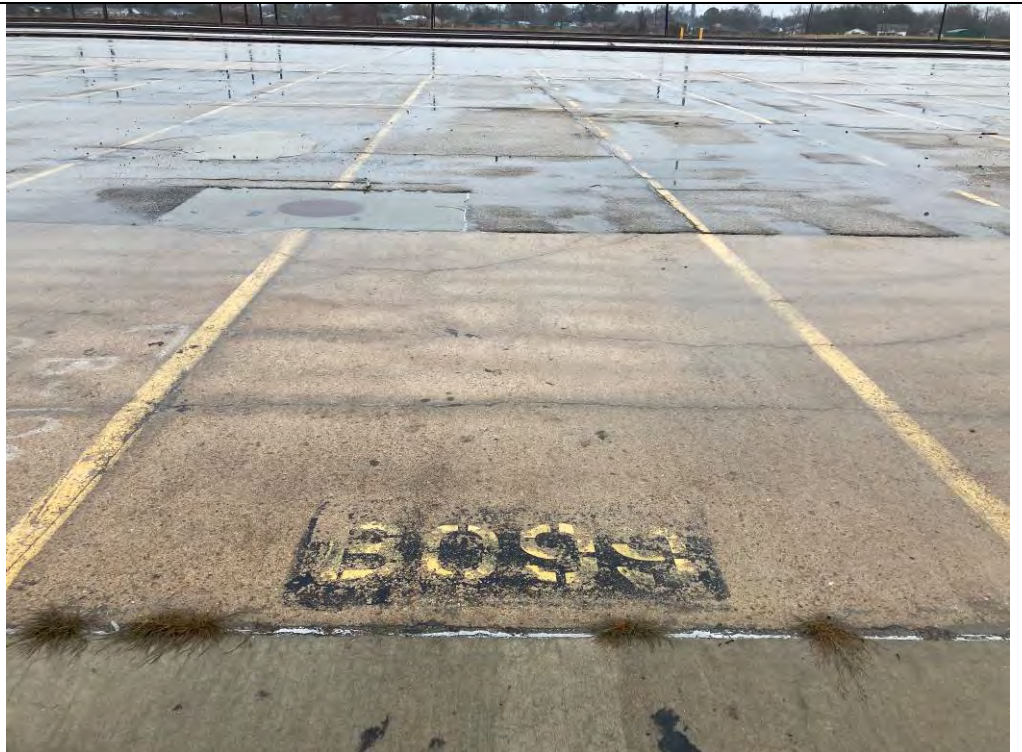
Photo No. 24	Date: 2/17/2021
Description: Slot B099, view of NAPL Collection System (Sump 099/100 in background). No tar-like material seeps observed, standing water on pavement from rain (note ponding over cover for sump), looking north. Lat: 29.7842472 Long: - 95.3206944

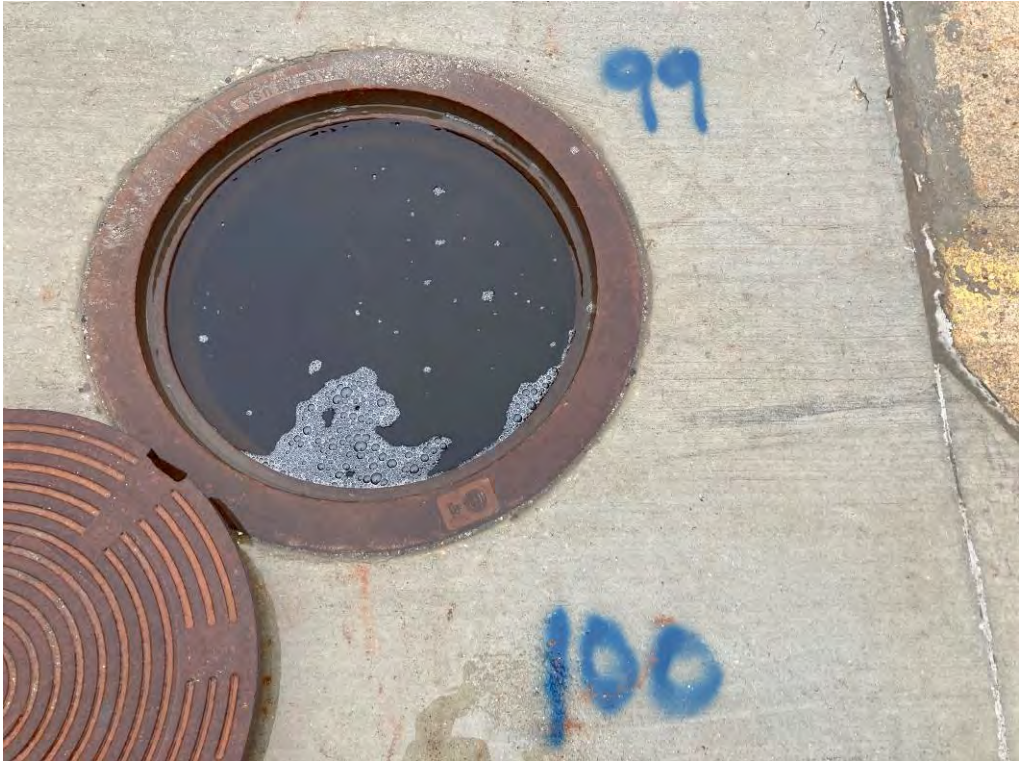
Description: Sump 1 (B099/B100), 0 inches of freeboard in sump, no sheen or odor noted. Pavement wet from rain. Lat: 29.7844000 Long: - 95.3205861			
Photo No.: 26	Date: 2/17/2021

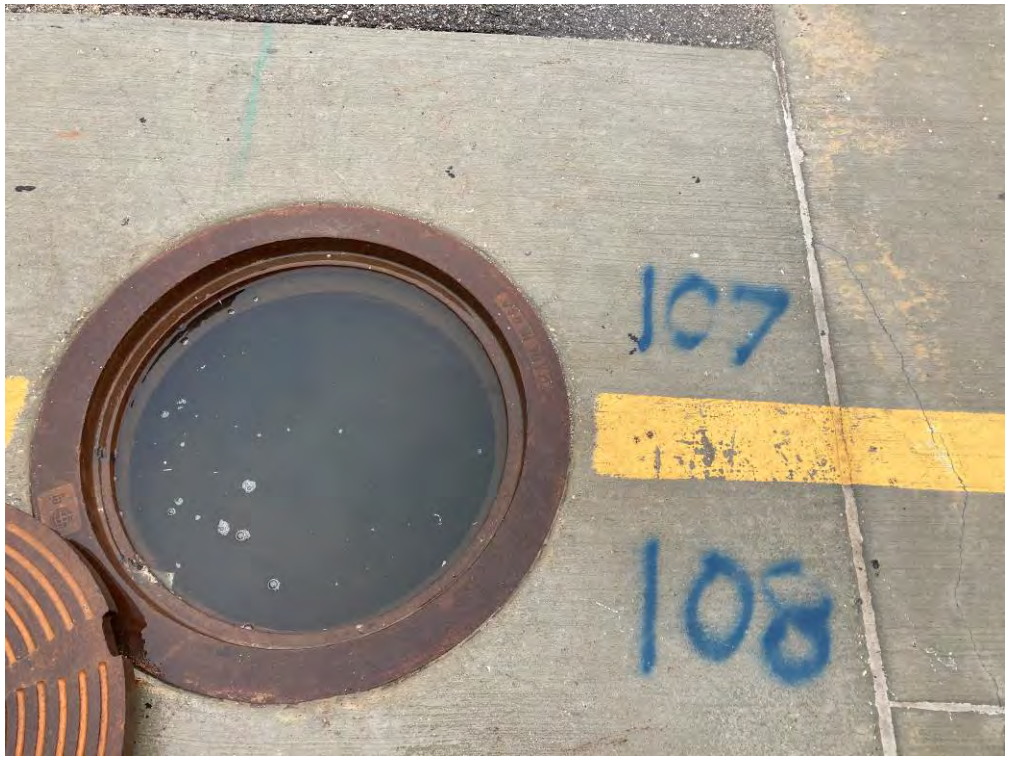
Description: Sump 3 (B107/B108), 0 inches of freeboard in sump. No sheen, odor or tar-like material observed. Pavement wet from rain. Lat: 29.7842861 Long: - 95.3208611

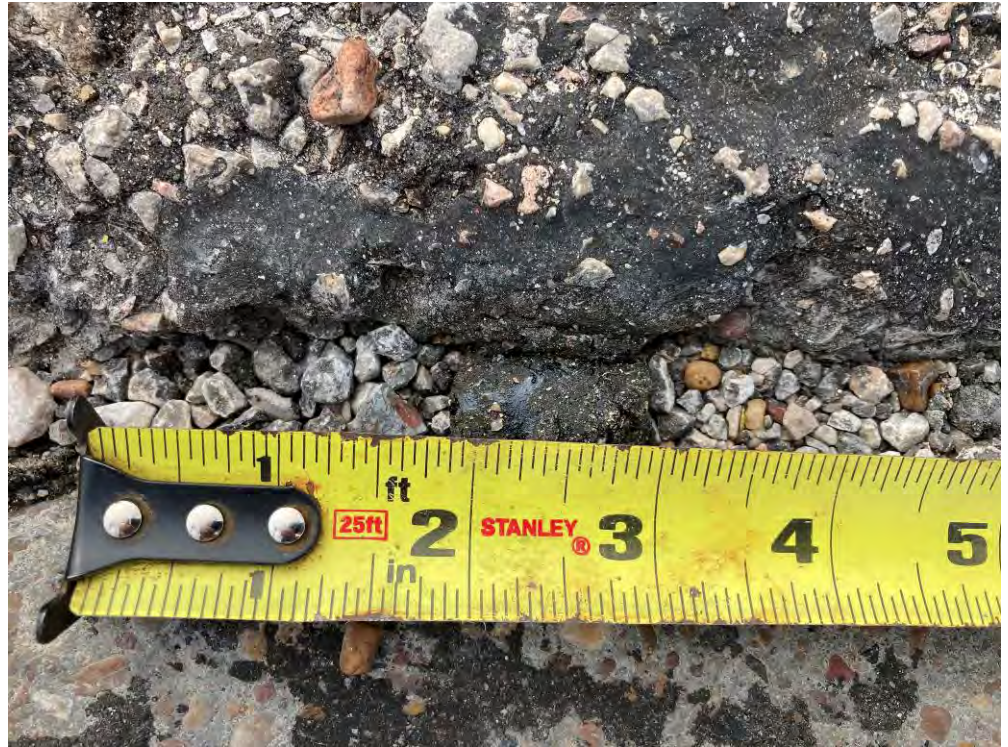
Photo No. 27	Date: 2/24/2021
Description Slot A022, very small amount of tar-like material seeping at asphalt crack, material was removed. Lat: 29.785392, Long: -95.318655

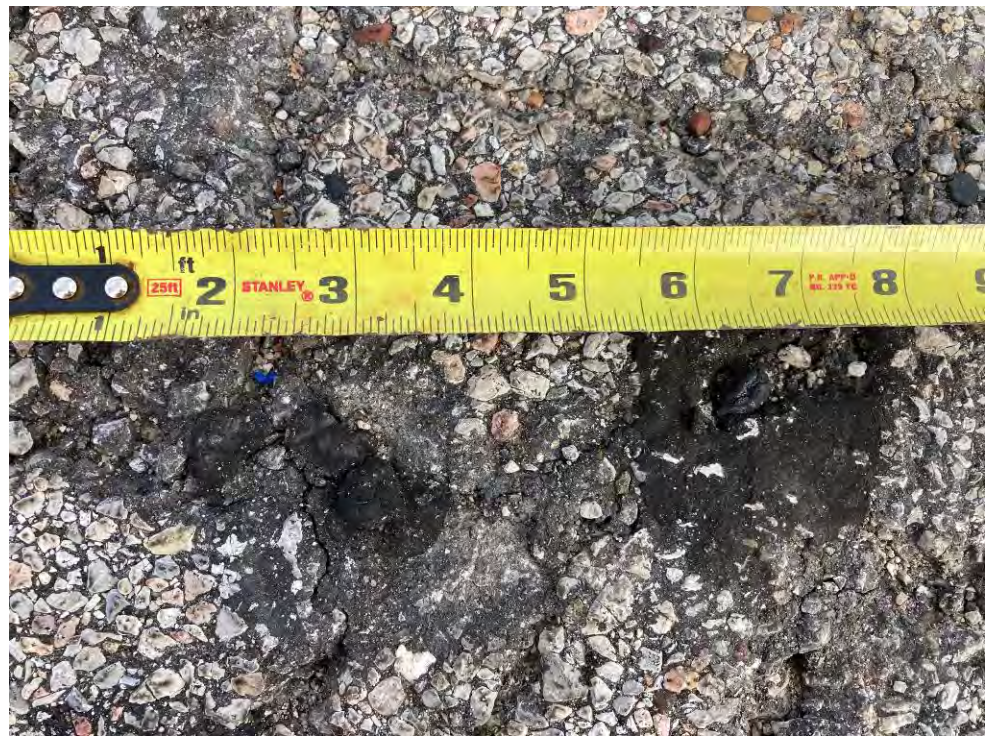
Photo No. 28	Date: 2/24/2021
Description: Slot B057, very small amount of tar-like material seeping at asphalt crack (not near where July 2020 test pit conducted), material was removed. Lat: 29.7847472 Long: - 95.3195417

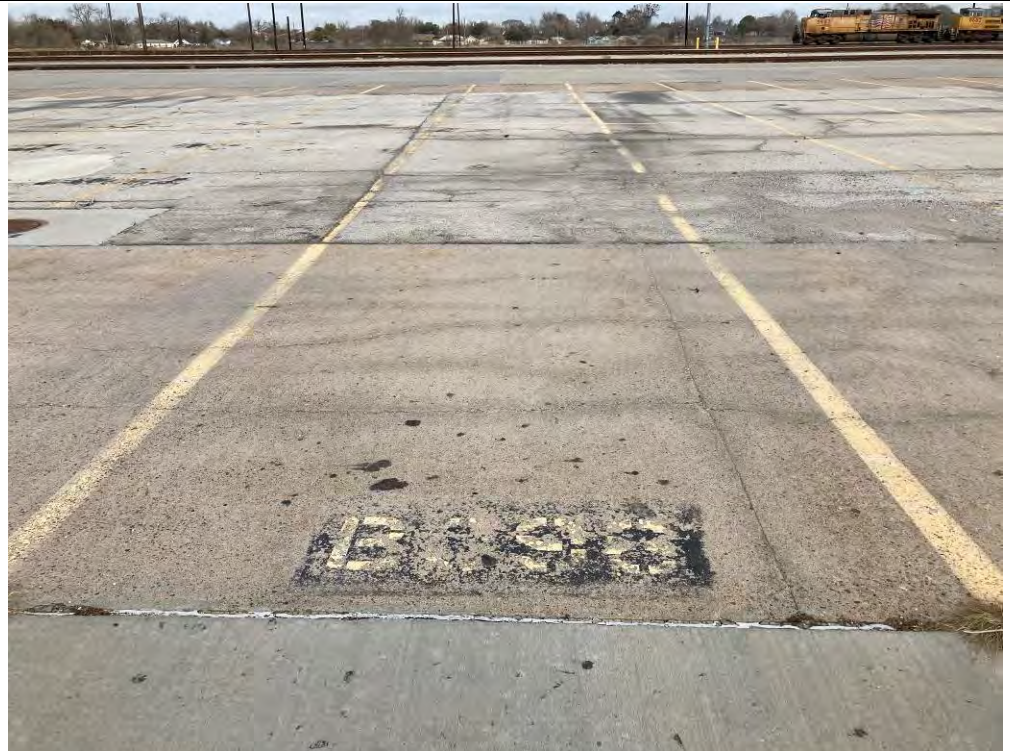
Photo No.
29

Slot B098, no tar-like material seeps observed, residual brown staining along asphalt cracks, looking north.

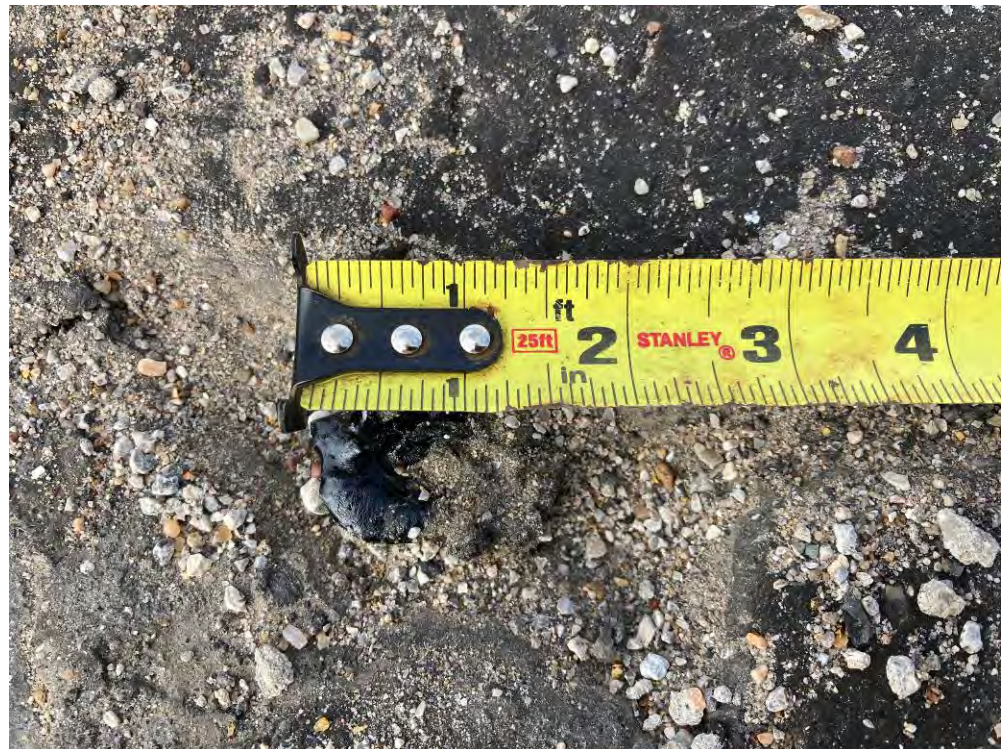
Photo No.
30

Slot B101, very small amount of tar-like material seeping at asphalt crack, material was removed.

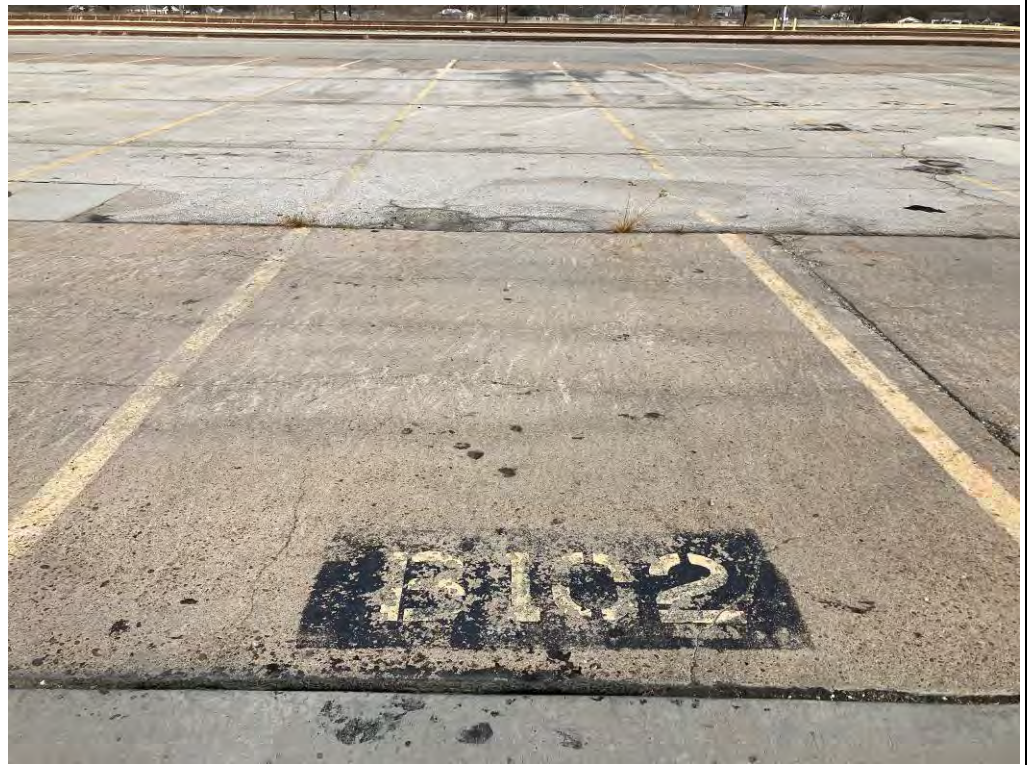
Photo No.
31

Slot B102, no tar-like material seeps observed, looking north.
