March 17, 2021

Project No. 19119232

**RE: MONTHLY STATUS UPDATE – ENGLEWOOD INTERMODAL YARD – NAPL COLLECTION SYSTEM/CONCRETE CAP REPAIRS
UNION PACIFIC RAILROAD HOUSTON WOOD PRESERVING WORKS FACILITY
4910 LIBERTY ROAD FACILITY, HOUSTON, TEXAS
POST-CLOSURE CARE PERMIT NO. HW-50343; INDUSTRIAL SWR NO. 31547**

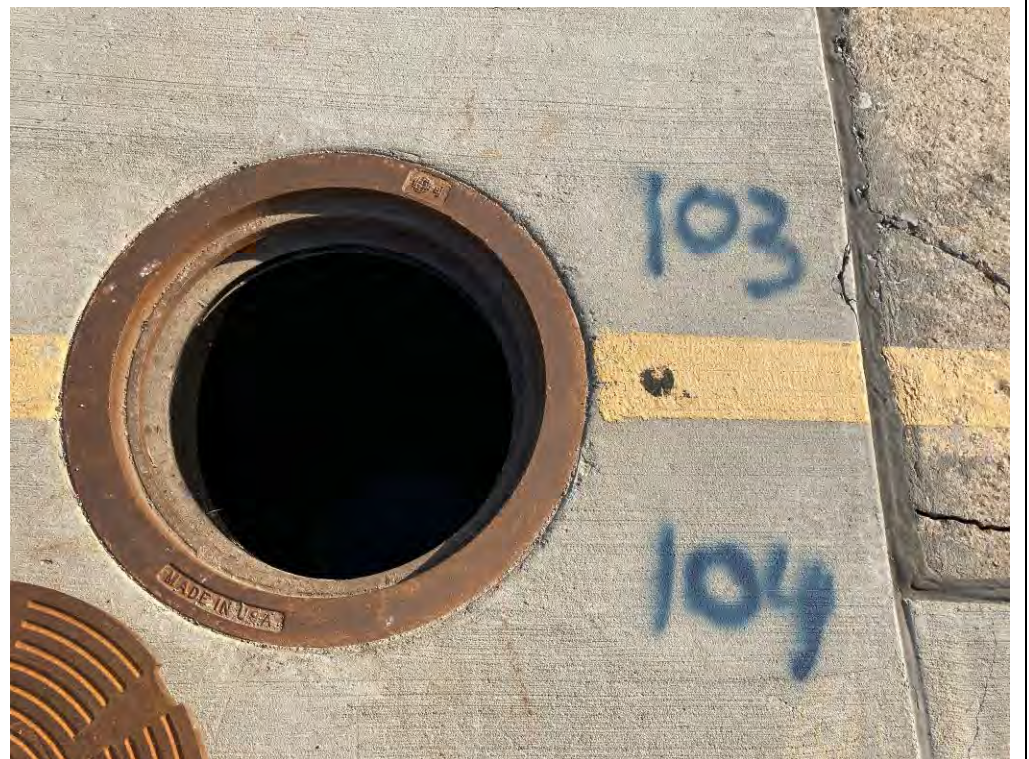
Photo No.
32

Sump 2 (B103/B104), 10 inches of freeboard in sump. No sheen or odor observed.

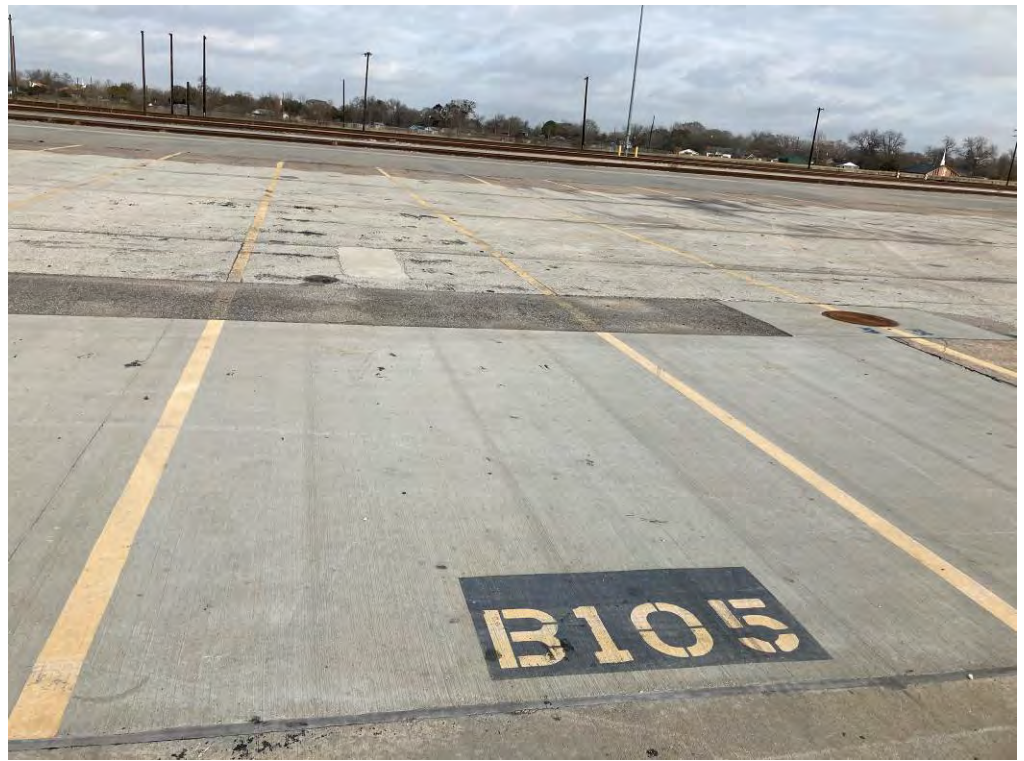
Photo No. 33	Date: 2/24/2021
Description: Slot B105, no tar-like material seeps observed, looking northeast. Lat: 29.7841472 Long: - 95.3208777

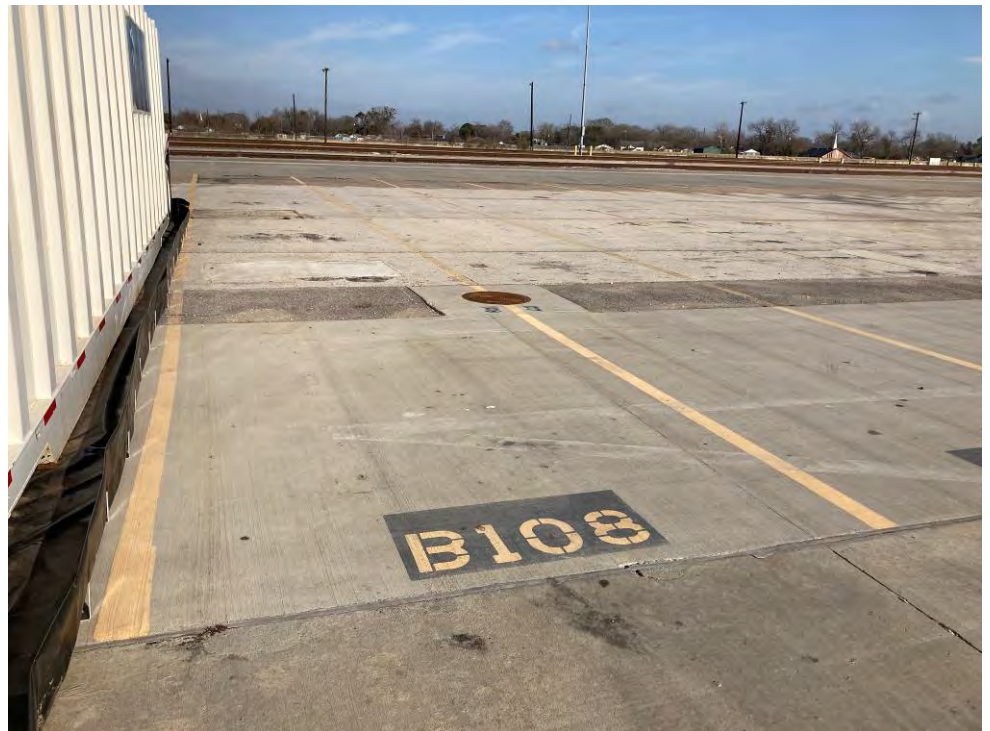
Photo No. 34	Date: 2/24/2021
Description: Slot B108, view of NAPL Collection System (Sump B107/B108 and test pit in background). No tar-like material seeps observed where test pit (July 2020) conducted, looking northeast. Lat: 29.784125 Long: - 95.320989
