May 14, 2021

Project No. 19119232

**RE: MONTHLY STATUS UPDATE – ENGLEWOOD INTERMODAL YARD – NAPL COLLECTION SYSTEM/CONCRETE CAP REPAIRS  
UNION PACIFIC RAILROAD HOUSTON WOOD PRESERVING WORKS FACILITY  
4910 LIBERTY ROAD FACILITY, HOUSTON, TEXAS  
POST-CLOSURE CARE PERMIT NO. HW-50343; INDUSTRIAL SWR NO. 31547**

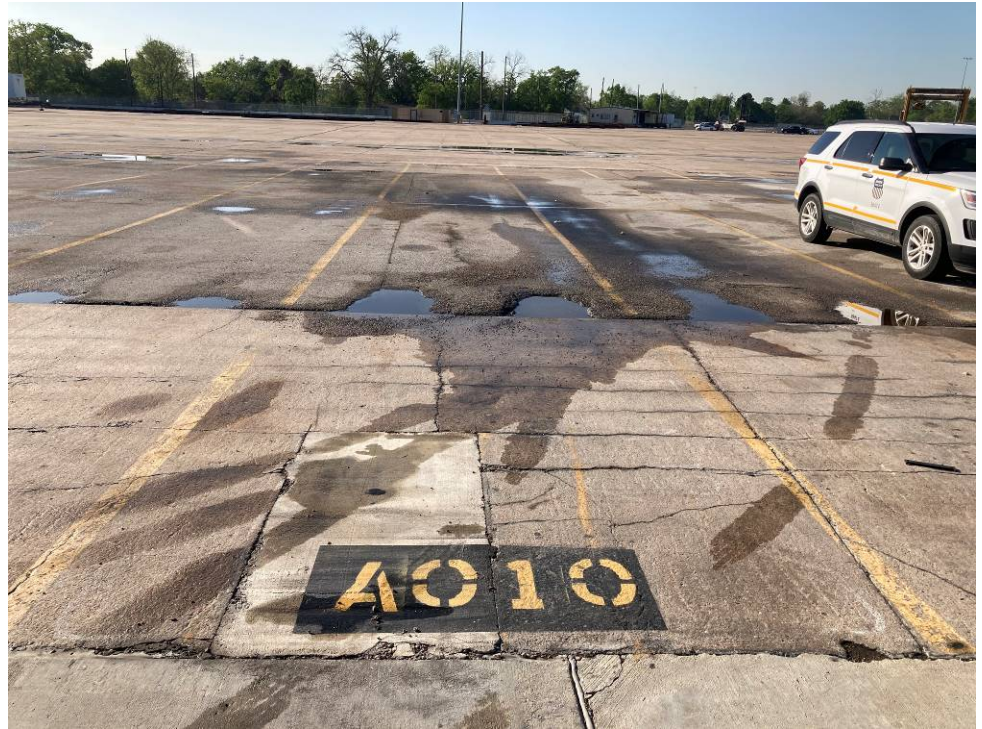
<b>Photo No.</b> 1	<b>Date:</b> 4/8/2021
<b>Description:</b>  Slot A010, no tar-like material seeps observed where test pit conducted (July 2020), pavement wet from a recent rain event, looking southeast.  Lat: 29.7855833, Long: -95.318375

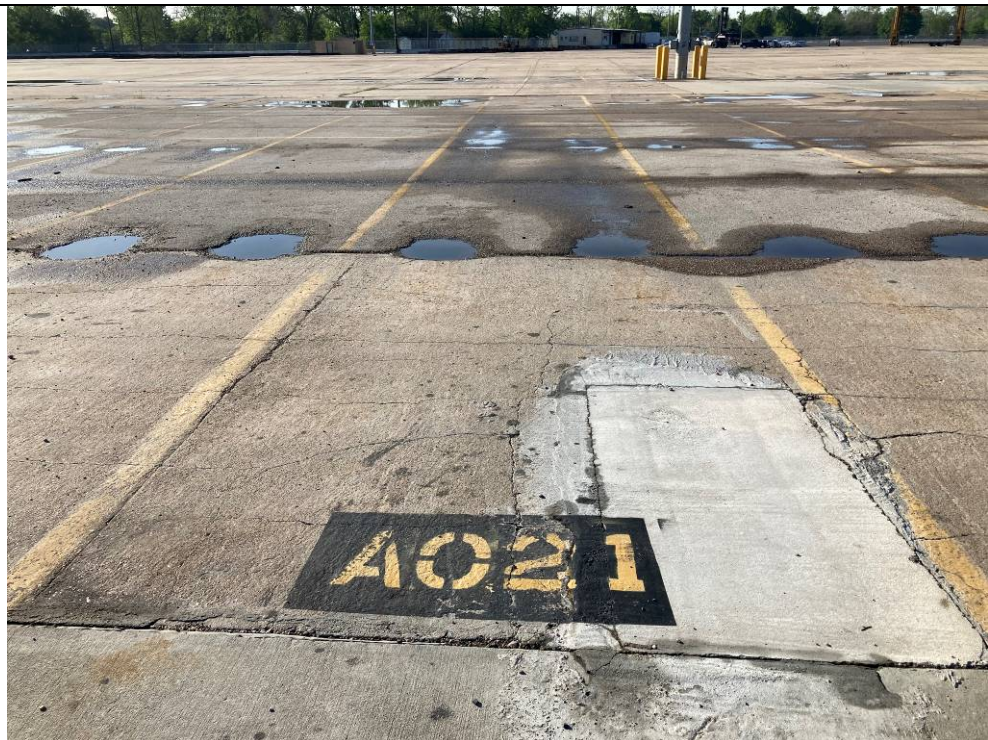
<b>Photo No.</b> 2	<b>Date:</b> 4/8/2021
-----------------------	--------------------------

<b>Description:</b>  Slot A021, no tar-like material seeps observed where test pit conducted (July 2020), pavement wet from a recent rain event, looking southeast.  Lat: 29.785392, Long: -95.318655	
--	--

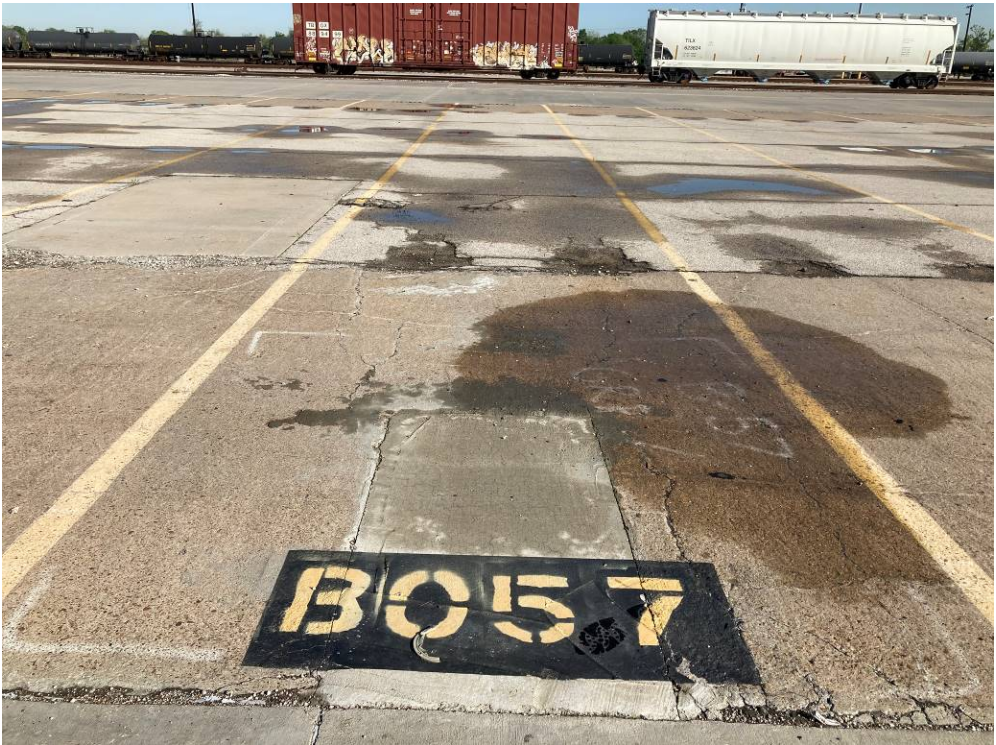
<b>Photo No.</b> 5	<b>Date:</b> 4/8/2021
<b>Description:</b>  Slot B057, no tar-like material seeps observed where test pit conducted (July 2020), pavement wet from a recent rain event, looking northwest.  Lat: 29.7847472 Long: - 95.3195417

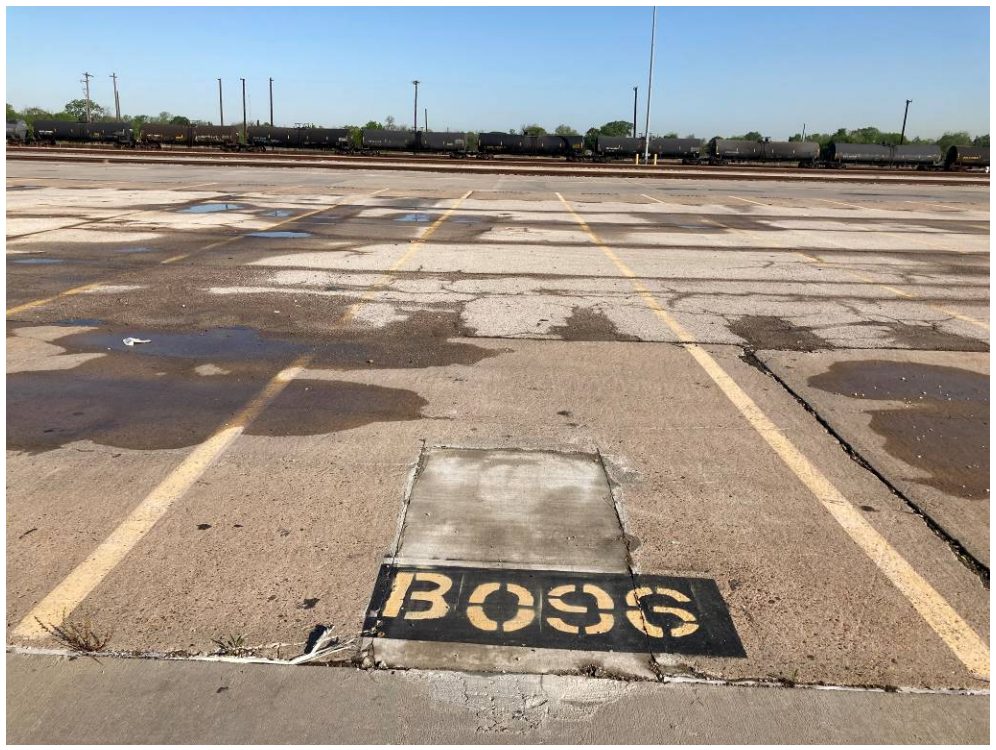
<b>Photo No.</b> 6	<b>Date:</b> 4/8/2021
<b>Description:</b>  Slot B096, no tar-like material seeps observed where test pit conducted (July 2020), pavement wet from a recent rain event, looking northwest.  Lat: 29.7842528 Long: - 95.3206250

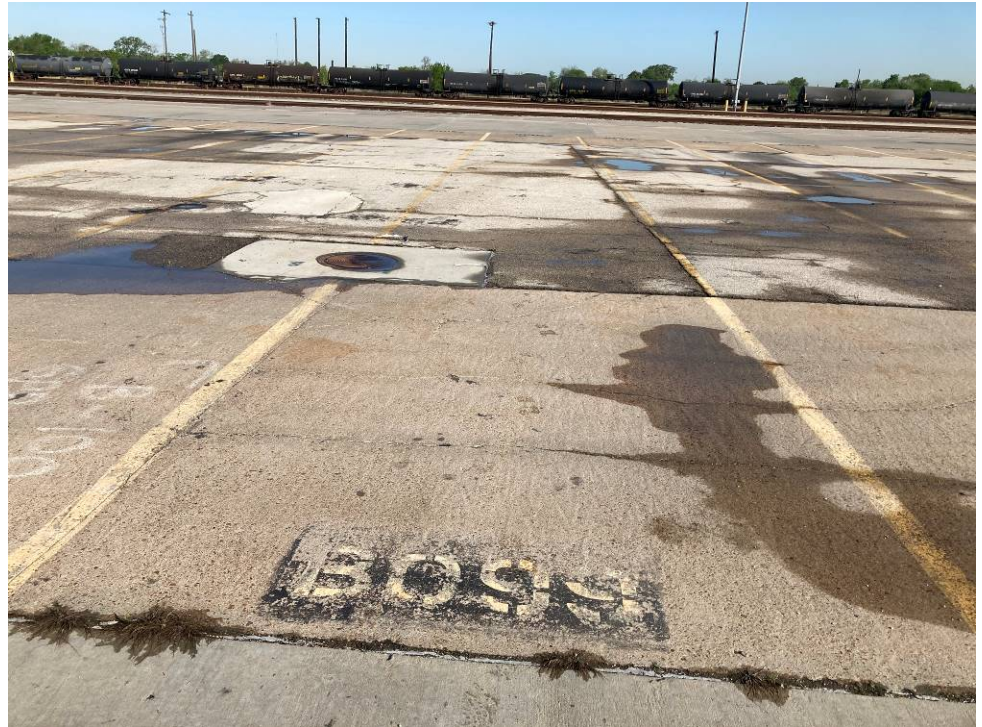
**Photo No.**  
**7**

Sump 1 (B099/B100), pavement wet from a recent rain event, looking northwest.

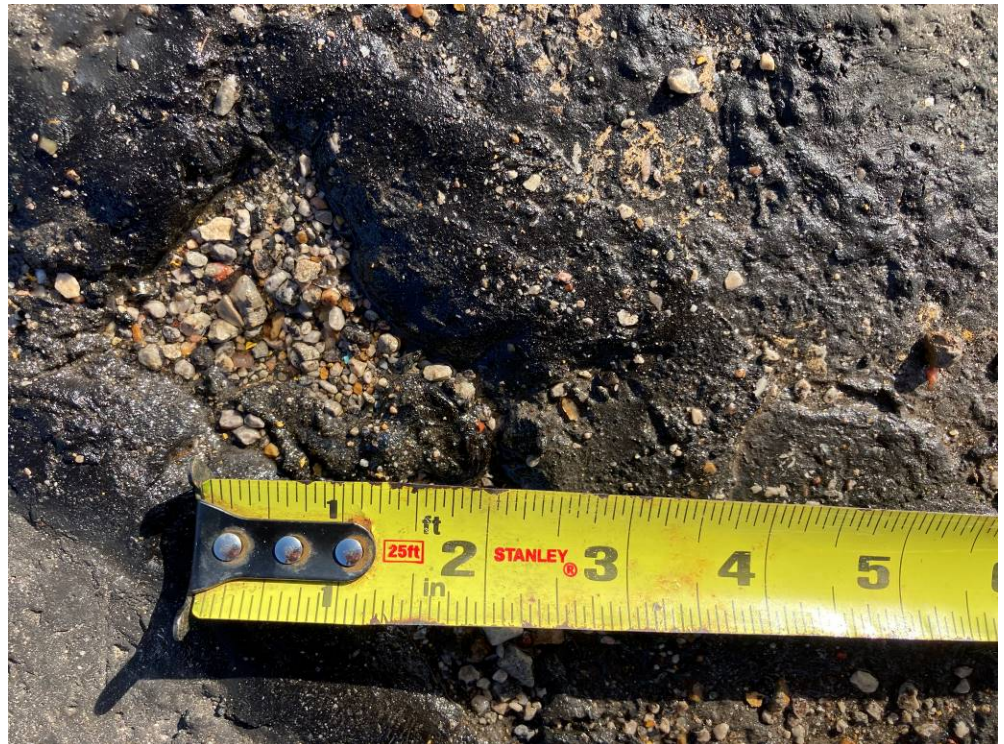
**Photo No.**  
**8**

Slot B101, very small amount of tar-like material seeping at asphalt crack, material was removed.

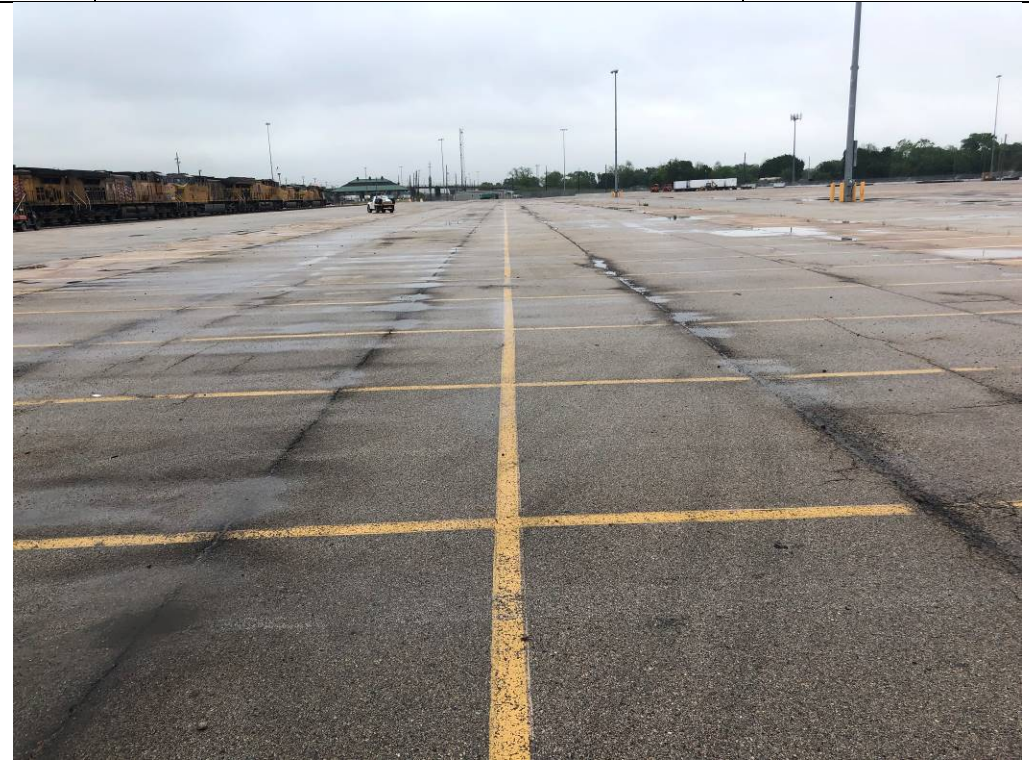
<b>Photo No.</b> <b>9</b>	<b>Date:</b> 4/14/2021
------------------------------	---------------------------

- No widespread seep water was observed in the paved areas during the April 2021 inspections. Standing water from a recent rain event was observed to have some discoloration in certain discrete areas (e.g., Slots B096-B001 and B057) during the April 14<sup>th</sup> inspection. No sheen was observed on the water.

Slots B096-B001, pavement wet from recent rain event, some discoloring observed, no sheen observed, looking northeast.

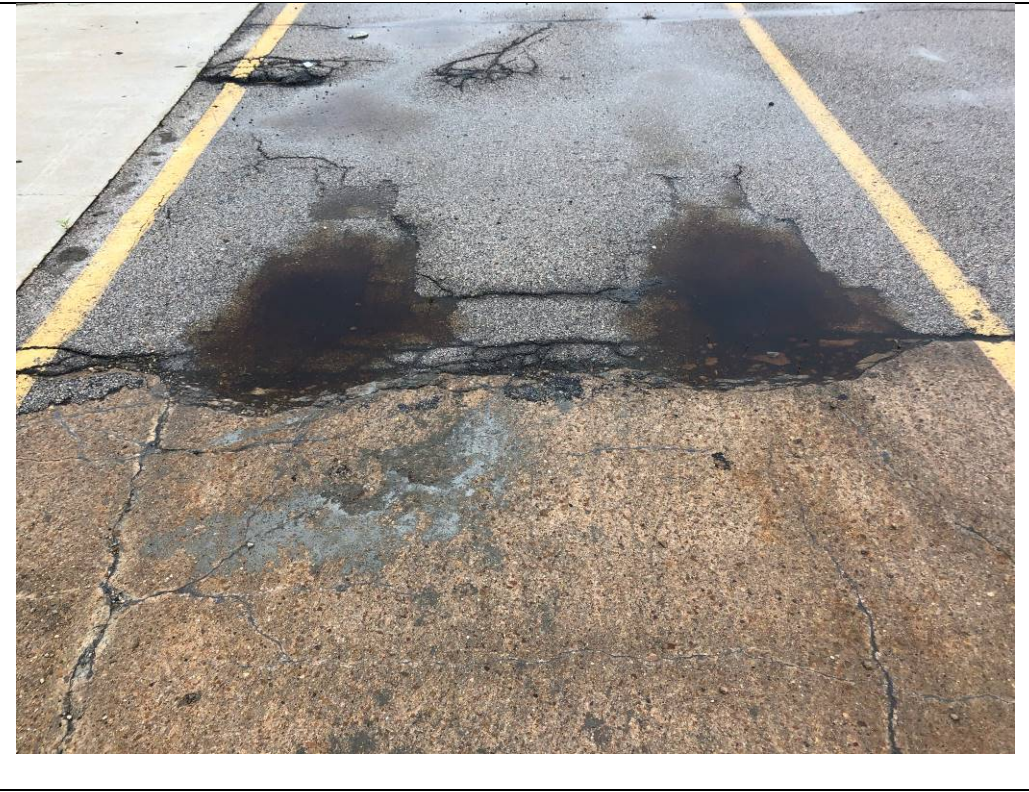
<b>Photo No.</b> <b>10</b>	<b>Date:</b> 4/14/2021
-------------------------------	---------------------------

Slot B057, discolored standing water from recent rain event observed, no sheen observed, no tar-like material seeps observed where test pit conducted (July 2020), looking northwest.

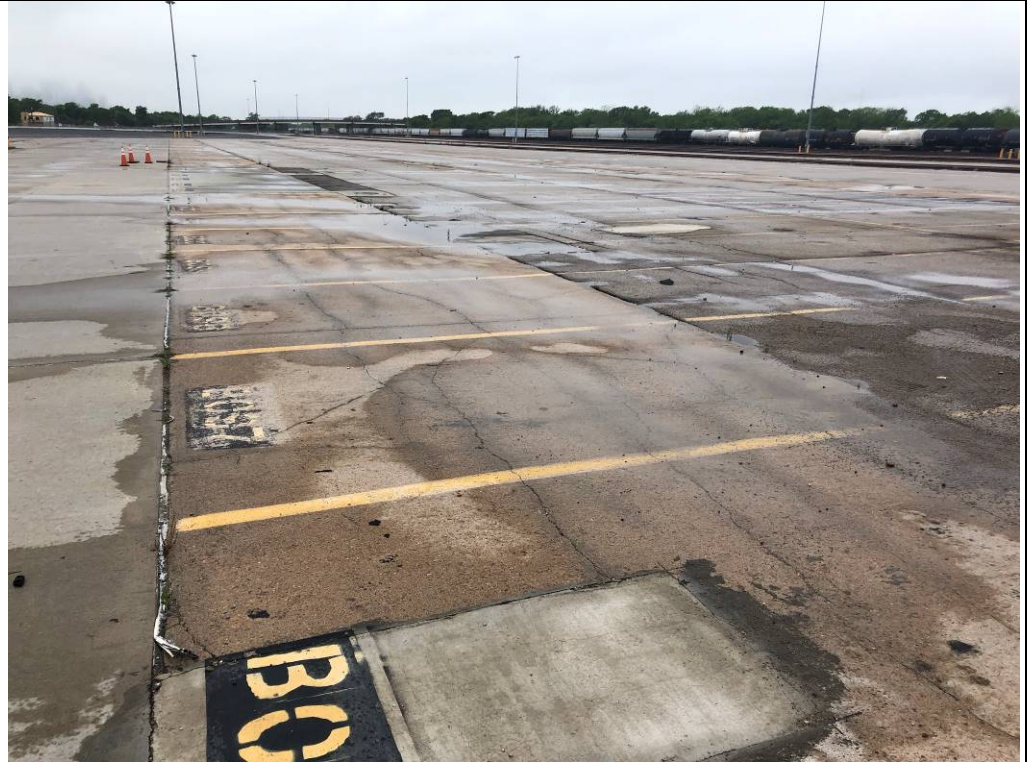
**Photo No.**  
**11**

Slots B096-B110, no tar-like material seeps observed where test pit conducted (July 2020), pavement wet from recent rain event, looking southwest.

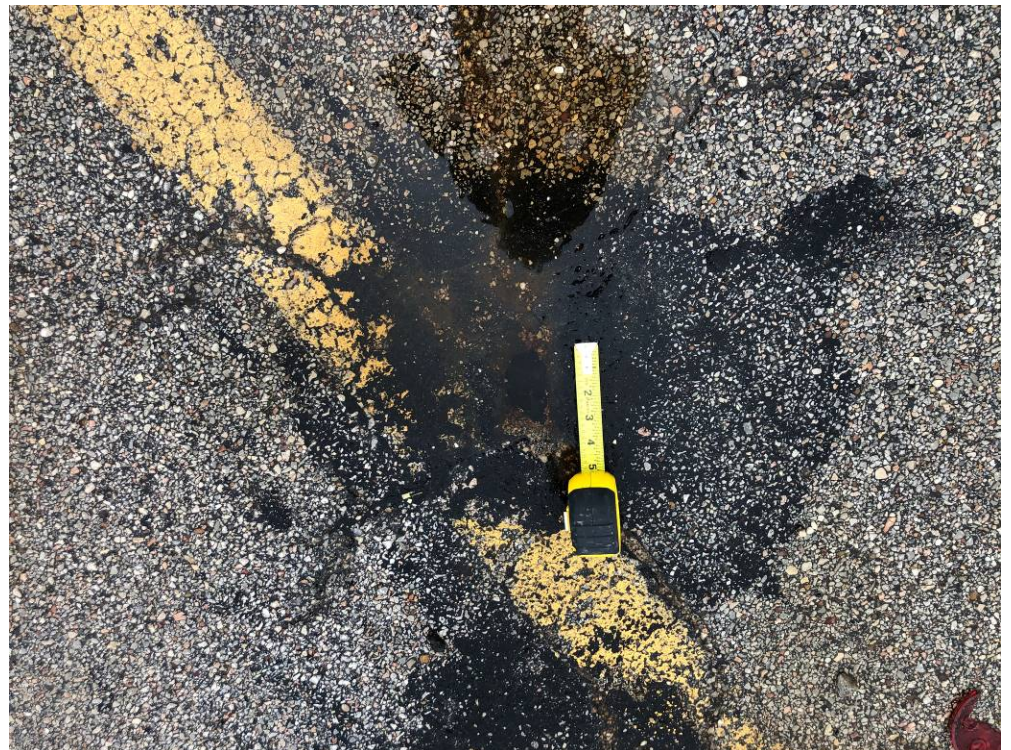
**Photo No.**  
**12**

Slot B101, very small amount of tar-like material seeping at asphalt crack, material was removed, discolored standing water from recent rain event observed

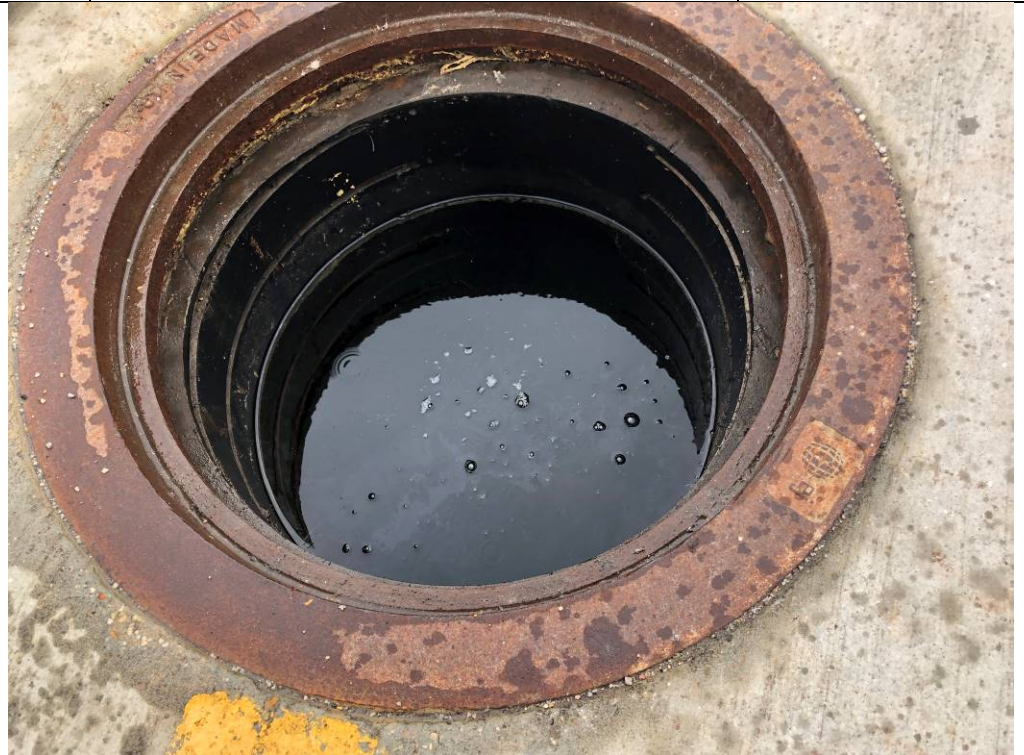
<b>Photo No.</b> <b>13</b>	<b>Date:</b> 4/14/2021
<b>Description:</b>  Sump 2 (B103/B104), 6.5 inches of freeboard in sump, sheen observed, no odors noted.  Lat: 29.7842861 Long: - 95.3208611

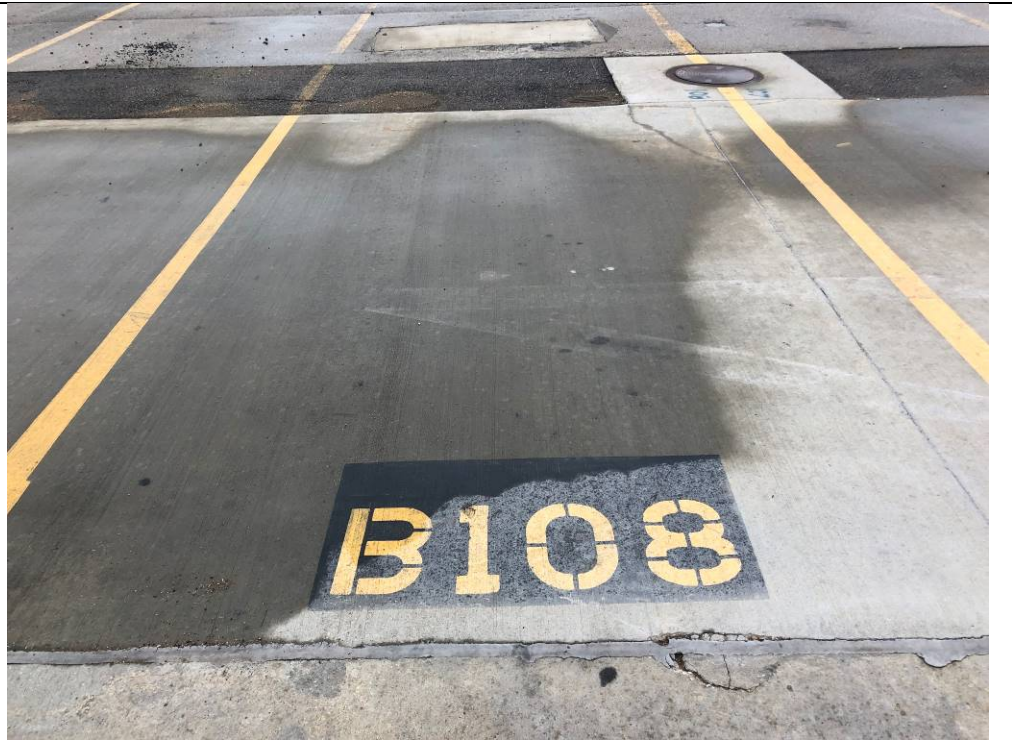
<b>Photo No.</b> <b>14</b>	<b>Date:</b> 4/14/2021
<b>Description:</b>  Slot B108, view of NAPL Collection System (Sump B107/B108 and test pit in background). No tar-like material seeps observed where test pit conducted (July 2020), pavement wet from recent rain event looking northwest.  Lat: 29.784125 Long: - 95.320989

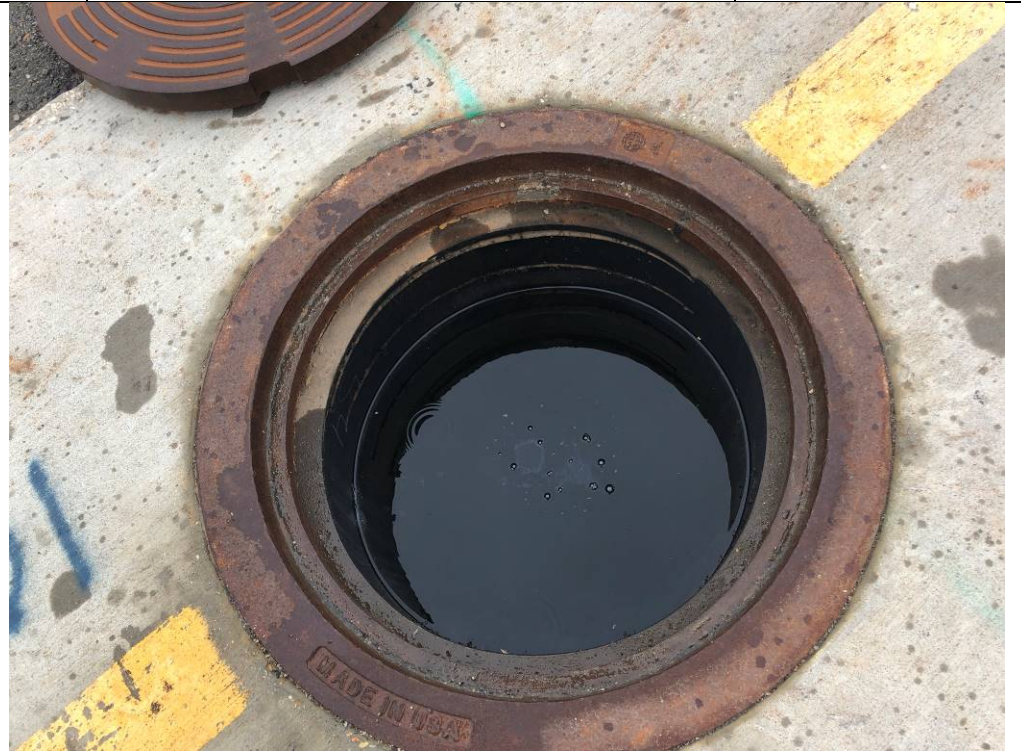
<b>Photo No.</b> <b>15</b>	<b>Date:</b> 4/14/2021
-------------------------------	---------------------------

Sump 3 (B107/B108), 6 inches of freeboard in sump. Sheen observed and approximately 1.5 oz of tar-like material recovered. No odors noted.

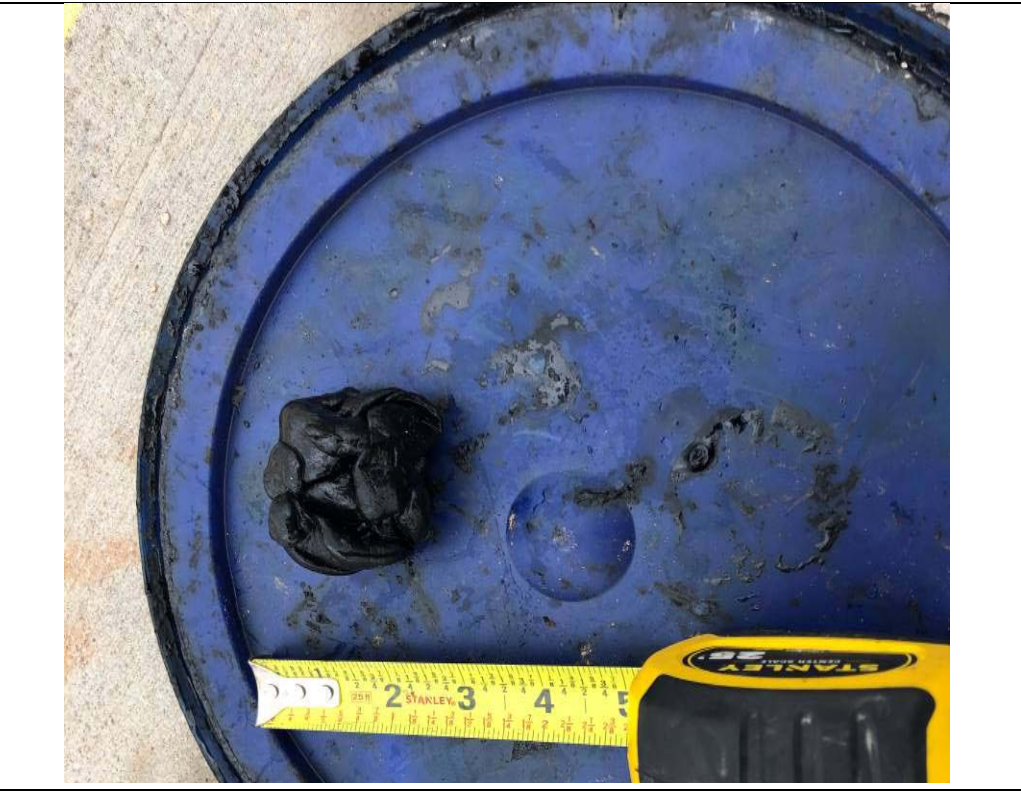
<b>Photo No.</b> <b>16</b>	<b>Date:</b> 4/14/2021
-------------------------------	---------------------------

Sump 3 (B107/B108), approximately 1.5 oz of tar-like material recovered from sump.

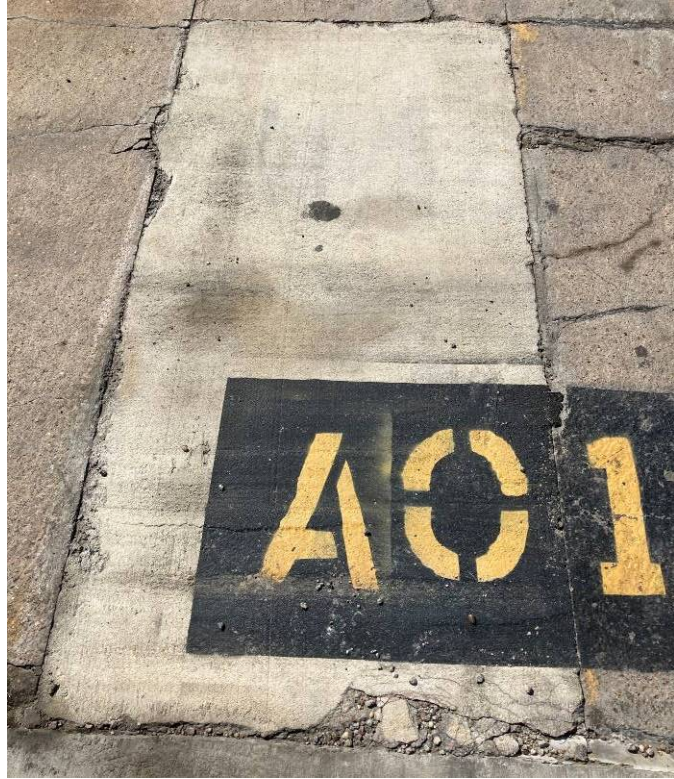
**Photo No.**  
**17**

Slot A010, no tar-like material seeps observed where test pit conducted (July 2020).

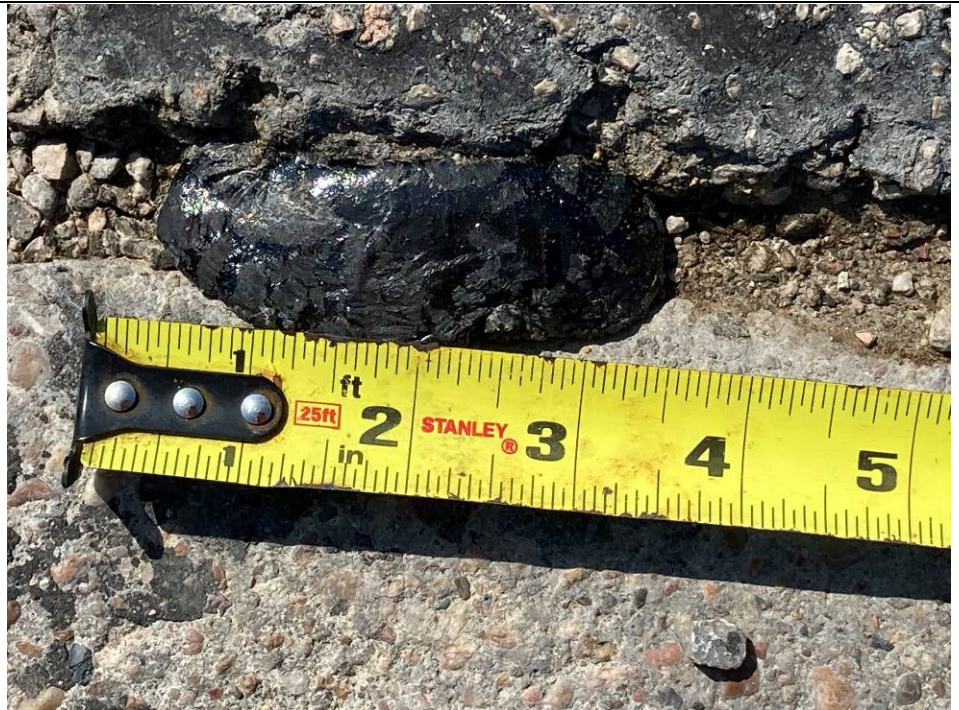
**Photo No.**  
**18**

Slot A022, small amount of tar-like material seeping at asphalt crack, material was removed.

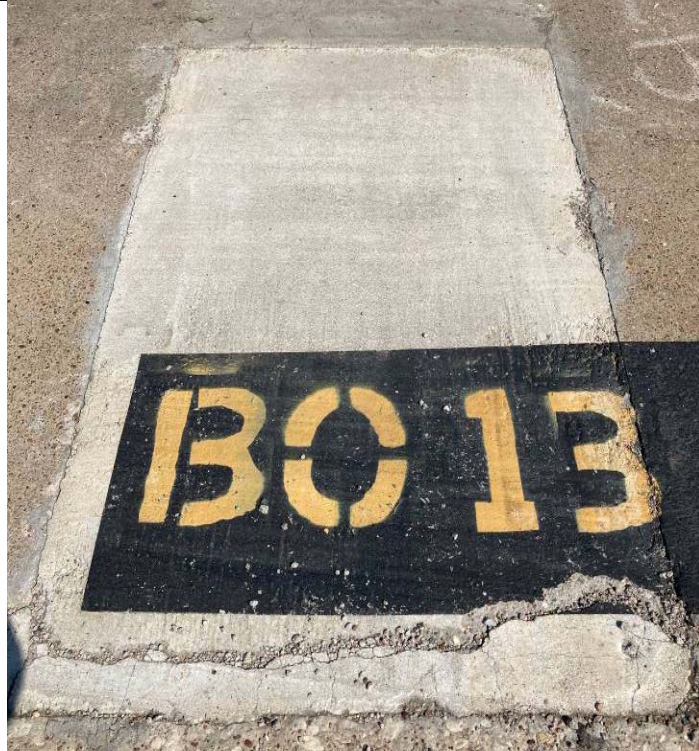
**Photo No.**  
**19**

Slot B013, no tar-like material seeps observed where test pit conducted (July 2020).

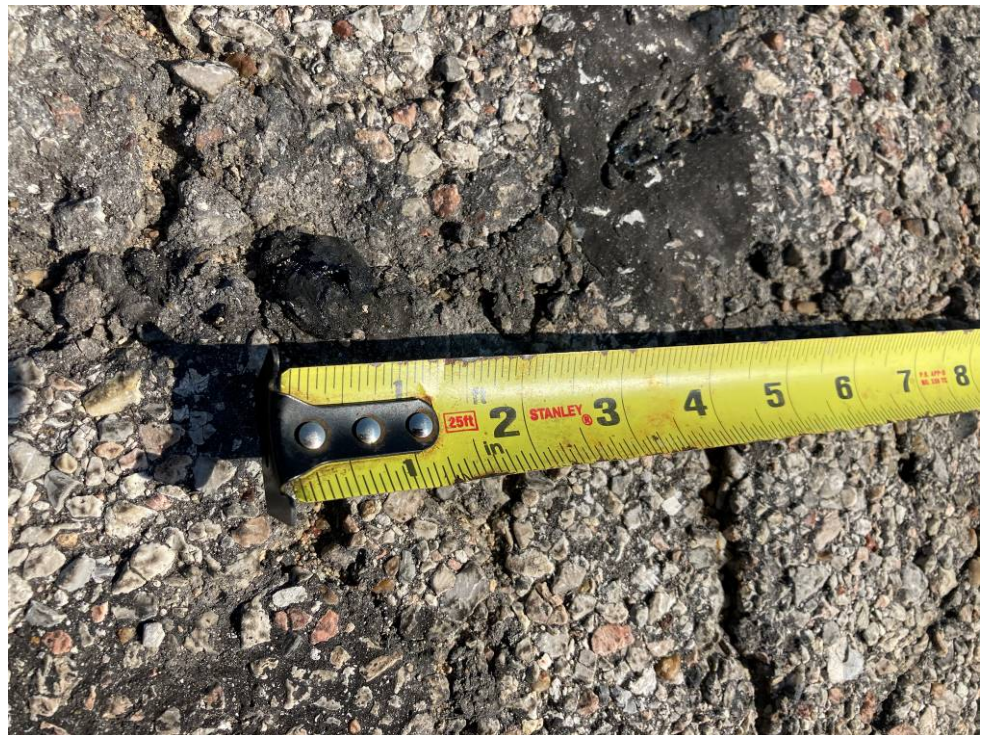
**Photo No.**  
**20**

Slot B057, very small amount of tar-like material seeping at asphalt crack (not at July 2020 test pit), material was removed.

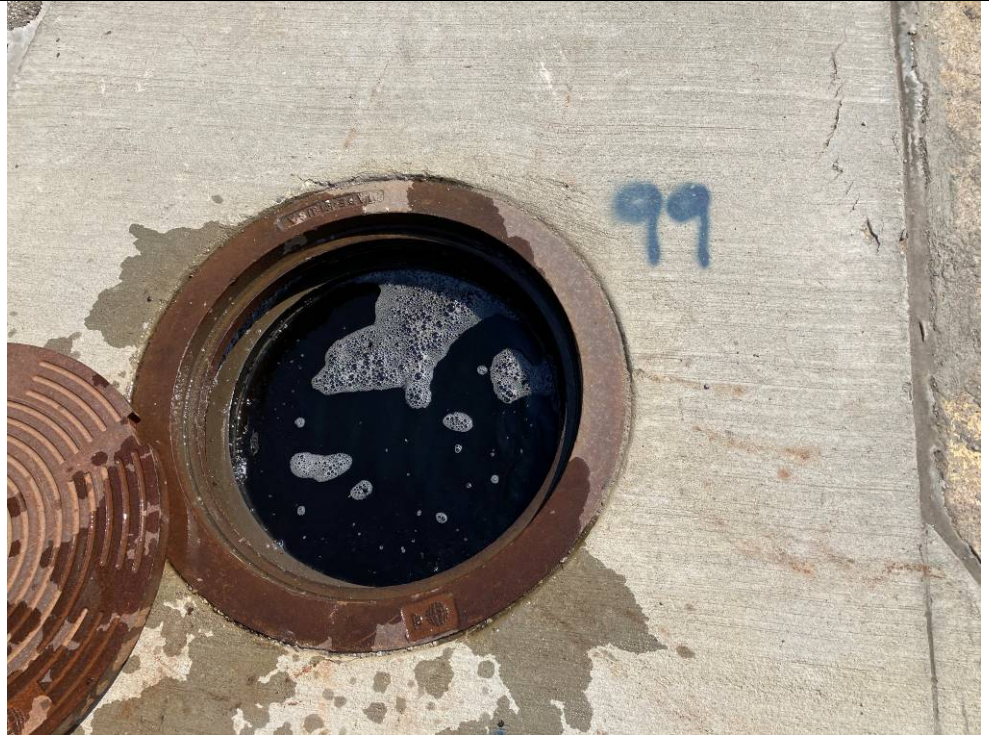
**Photo No.**  
**21**

Sump 1 (B099/B100), 0.5 inches of freeboard in sump, no sheen or odor noted.

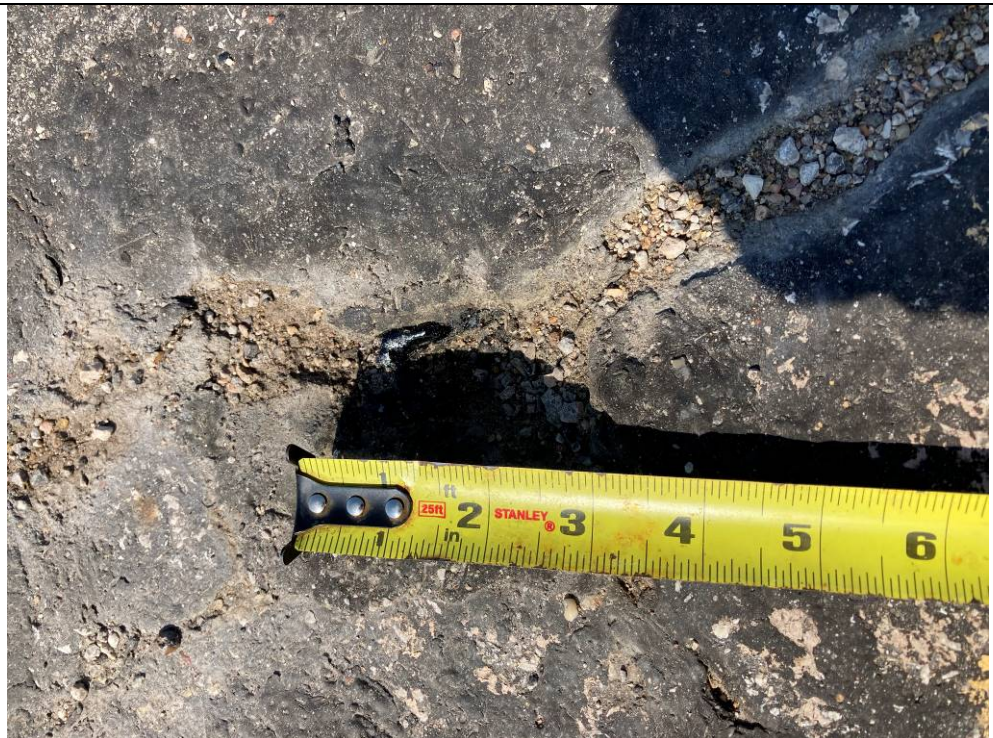
**Photo No.**  
**22**

Slot B101, very small amount of tar-like material seeping at asphalt crack, material was removed.

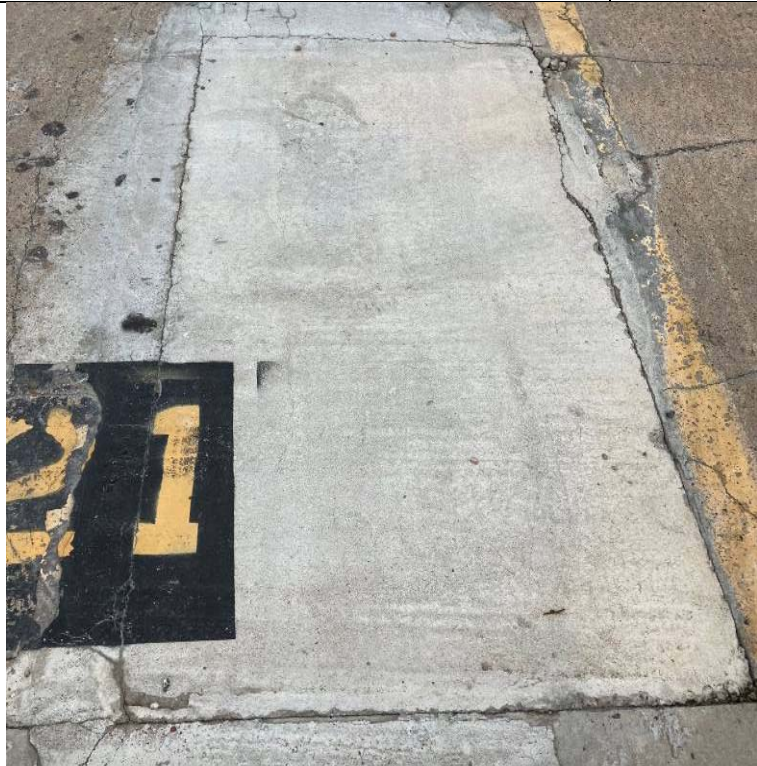
<b>Photo No.</b> <b>25</b>	<b>Date:</b> 4/28/2021
<b>Description</b>  Slot A021, no tar-like material seeps observed where test pit conducted (July 2020).  Lat: 29.785392, Long: -95.318655

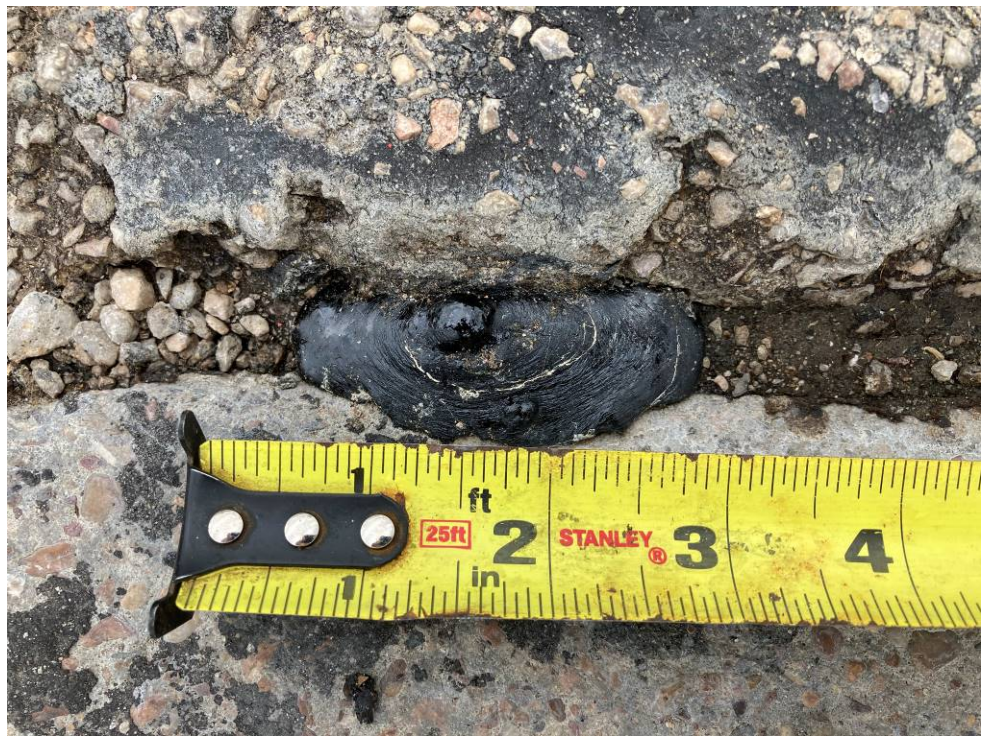
<b>Photo No.</b> <b>26</b>	<b>Date:</b> 4/28/2021
<b>Description:</b>  Slot A022, very small amount of tar-like material seeping at asphalt crack, material was removed.  Lat: 29.785392, Long: -95.318655

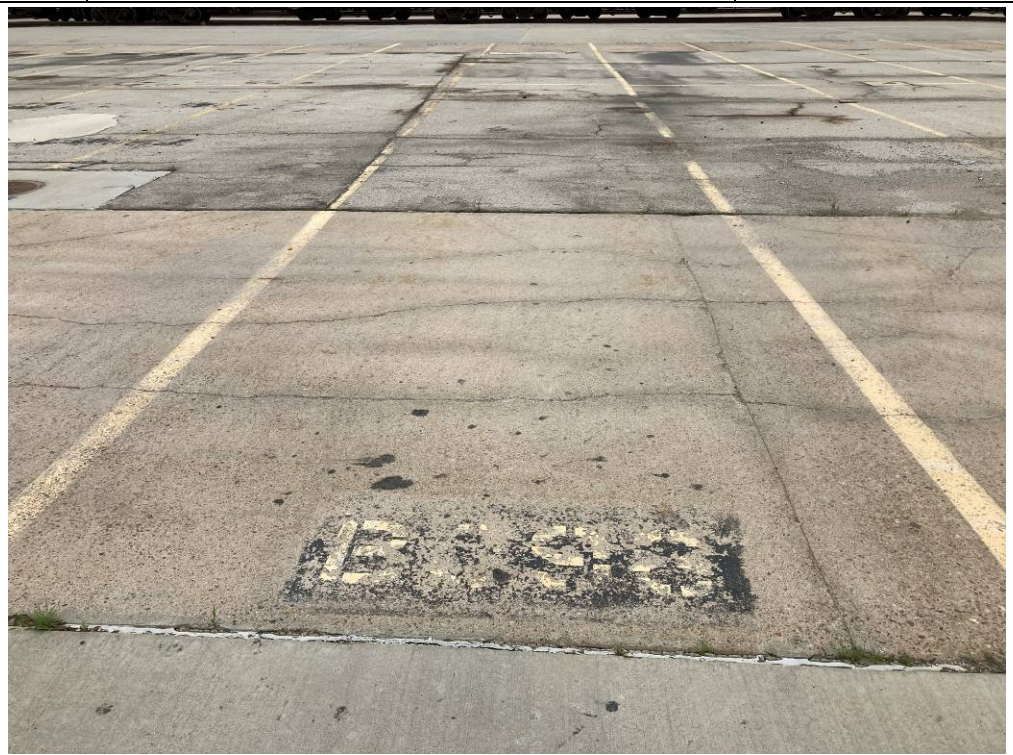
<b>Photo No.:</b> 27	<b>Date:</b> 4/28/2021
<b>Description:</b>  Slot B098, no tar-like material seeps observed, residual brown staining along asphalt cracks, looking northwest.  Lat: 29.7842587 Long: - 95.3206699

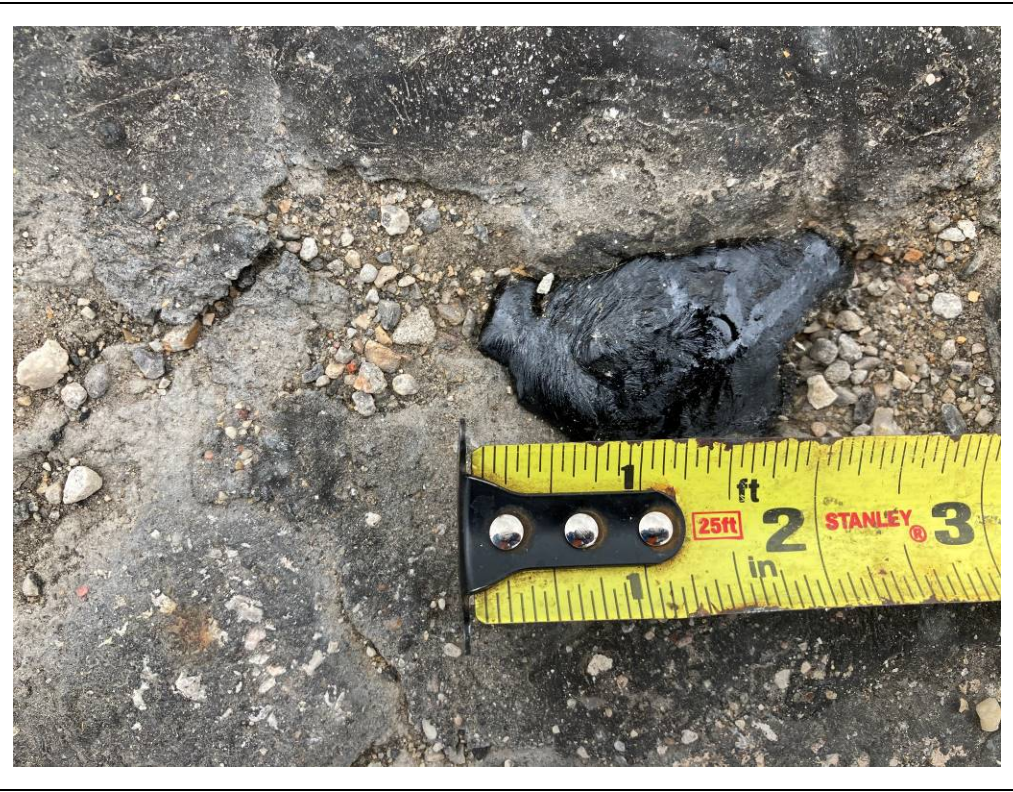
<b>Photo No.:</b> 28	<b>Date:</b> 4/28/2021
<b>Description:</b>  Slot B101, very small amount of tar-like material seeping at asphalt crack, material was removed.  Lat: 29.784275 Long: - 95.320813

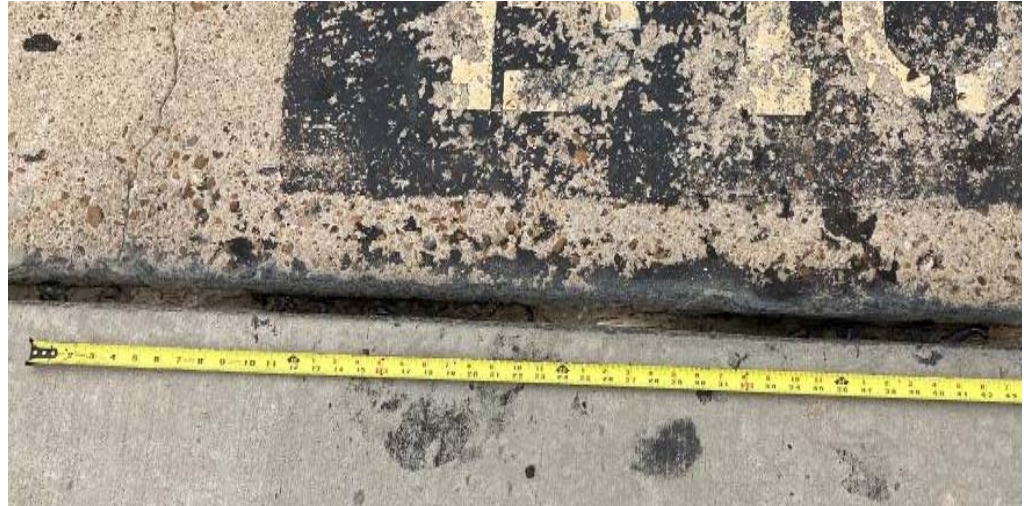
<b>Photo No.</b> <b>29</b>	<b>Date:</b> 4/28/2021
-------------------------------	---------------------------

Slot B102, small amount of tar-like material seeping at joint, material was removed.

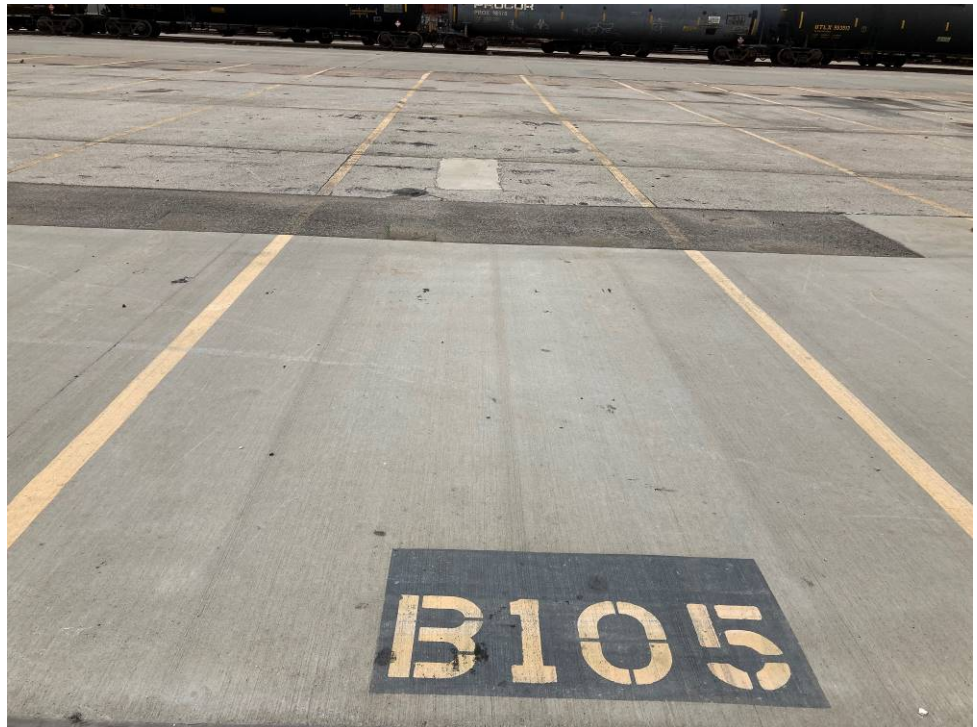
<b>Photo No.</b> <b>30</b>	<b>Date:</b> 4/28/2021
-------------------------------	---------------------------

Slot B105, no tar-like material seeps observed, looking northwest.

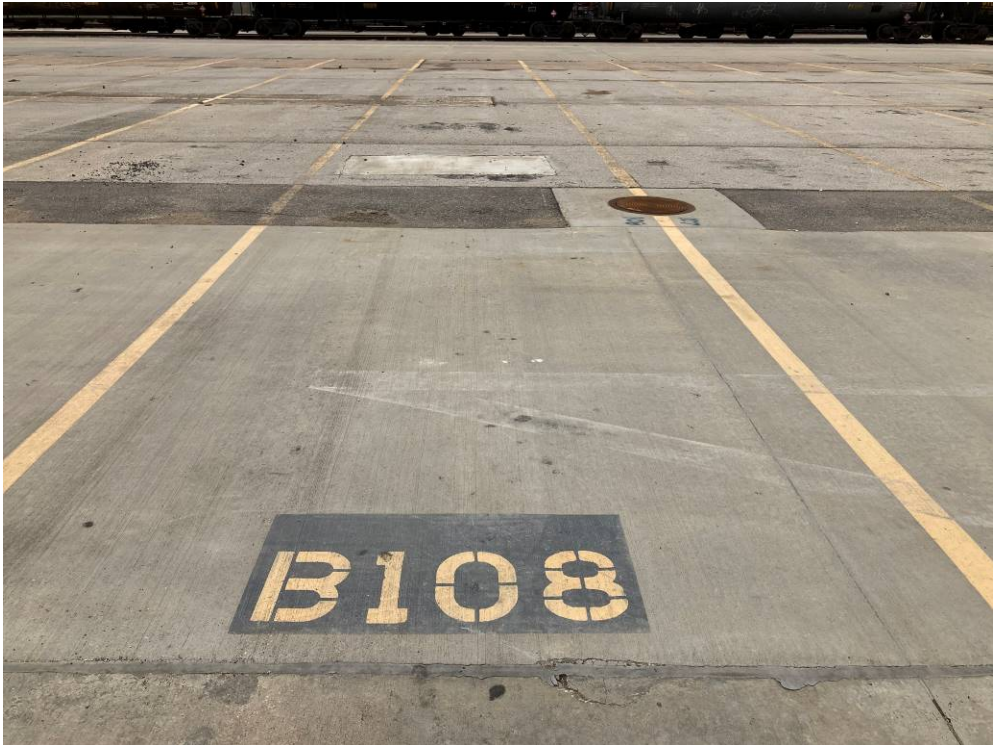
<b>Photo No.</b> <b>31</b>	<b>Date:</b> 4/28/2021
<b>Description:</b>  Slot B108, view of NAPL Collection System (Sump B107/B108 and test pit in background). No tar-like material seeps observed where test pit (July 2020) conducted, looking north.  Lat: 29.784125 Long: - 95.320989

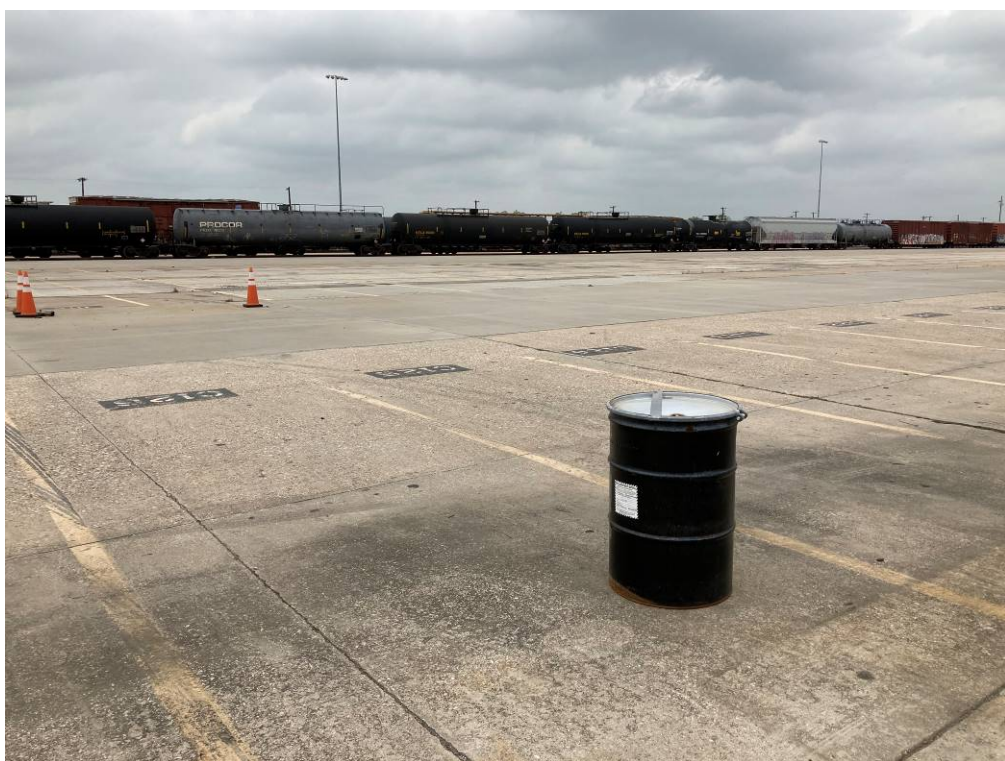
<b>Photo No.</b> <b>32</b>	<b>Date:</b> 4/28/2021
<b>Description:</b>  Slot C126, 55-gallon drum containing booms from the storm sewer camera survey activities.  Lat: 29.783922 Long: -95.321122
