Project No. 19119232

Re: **MONTHLY STATUS UPDATE – ENGLEWOOD INTERMODAL YARD – NAPL COLLECTION SYSTEM/CONCRETE CAP REPAIRS
UNION PACIFIC RAILROAD HOUSTON WOOD PRESERVING WORKS FACILITY
4910 LIBERTY ROAD FACILITY, HOUSTON, TEXAS
POST-CLOSURE CARE PERMIT NO. HW-50343; INDUSTRIAL SWR NO. 31547**

Weekly Inspection Photolog

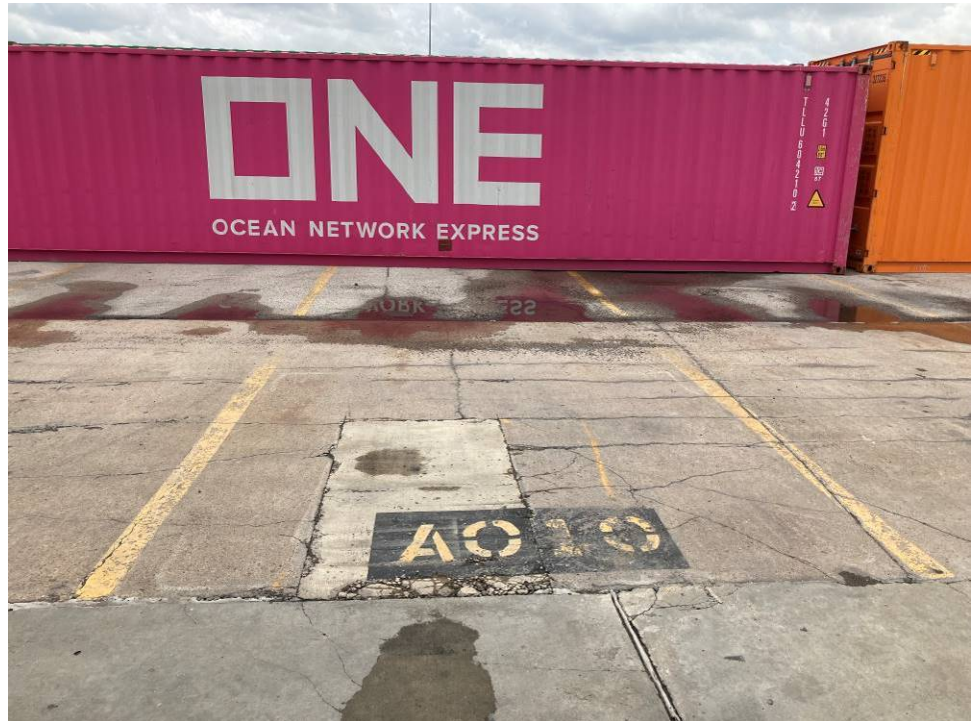
Photo No. 1	Date: 7/7/2021
-----------------------	--------------------------

Slot A010, no tar-like material seeps observed where test pit conducted (July 2020), test pit pavement damaged, water from recent rain event, looking southeast.

- Golder, on behalf of UPRR, submitted to the TCEQ the Englewood IM Yard Test Pit Evaluation Report dated June 2, 2021 summarizing the findings from the test pits installed in July 2020 including weekly inspections since the installation. During the weekly inspections through July 2021, no NAPL seeps have been observed at the seven test pit locations (slots A010, A021, A098, B013, B057, B096, and B108). During the June 30, 2021 inspection, concrete patches covering test pits in slots B013 and B096 were observed to be damaged. During the July 7, 2021 inspection, concrete patches in slots A010 and B057 were observed to be damaged. The A021 concrete patch was observed to be damaged on July 29, 2021. UPRR will coordinate with a subcontractor to repair the concrete patches.

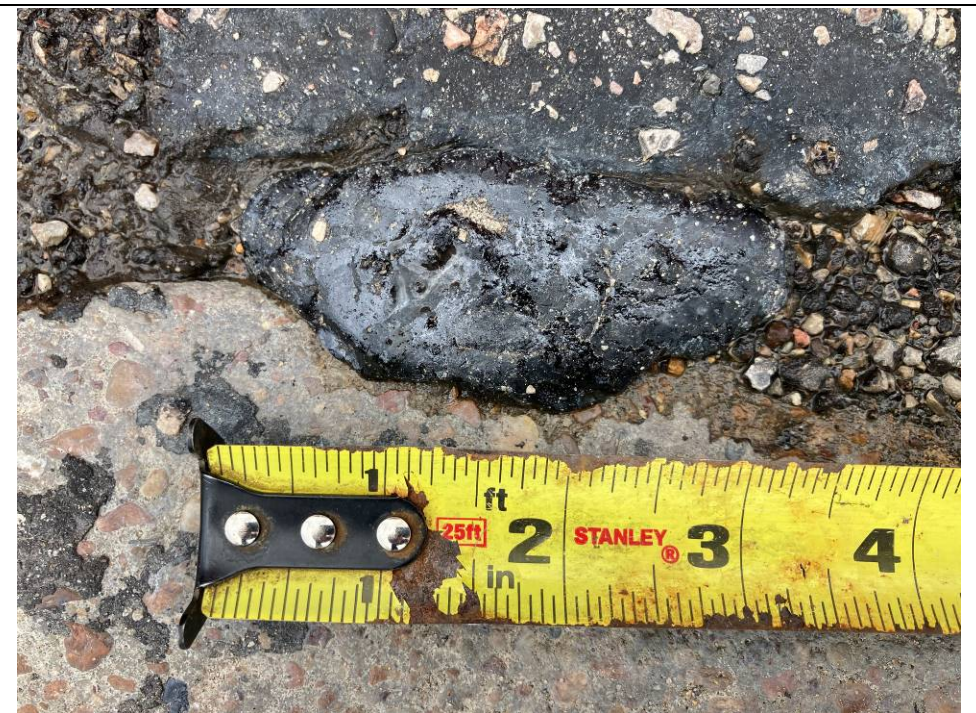
Photo No. 2	Date: 7/7/2021
-----------------------	--------------------------

Slot A022, very small amount of tar-like material seeping at asphalt crack, material was removed.

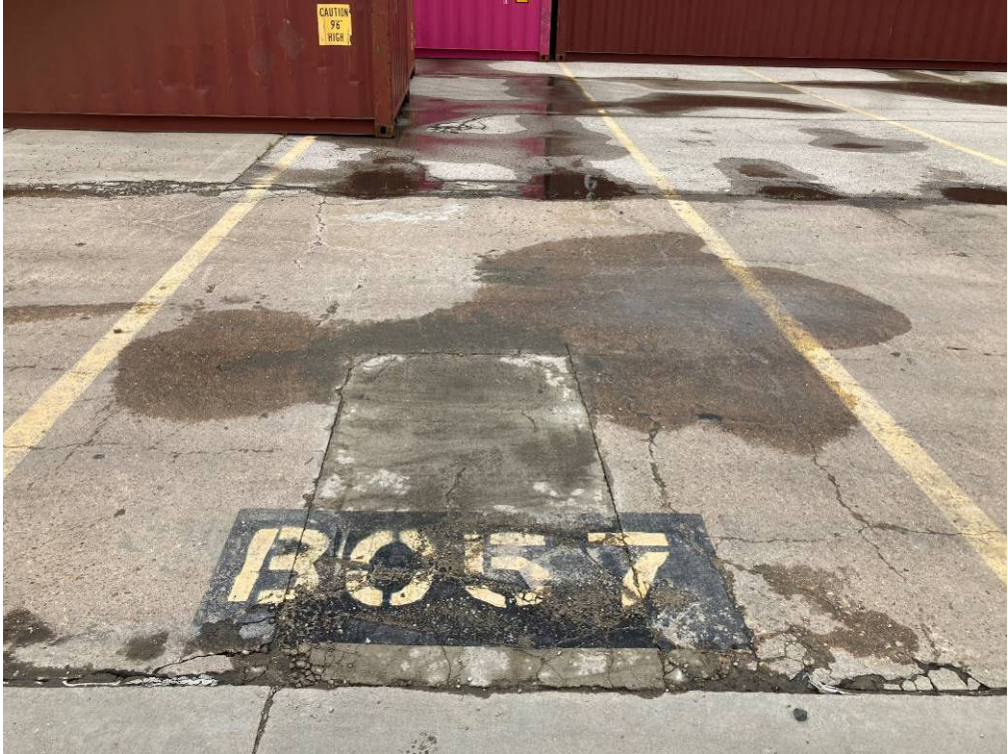
Client Name: Union Pacific Railroad		Site Location: Englewood Houston, Texas	Project No.: 19119232
Photo No.: 3	Date: 7/7/2021

Description: Slot B057, no tar-like material seeps observed where test pit conducted (July 2020), test pit pavement damaged, water from recent rain event, looking northwest. Lat: 29.7847472 Long: - 95.3195417			
Photo No.: 4	Date: 7/7/2021

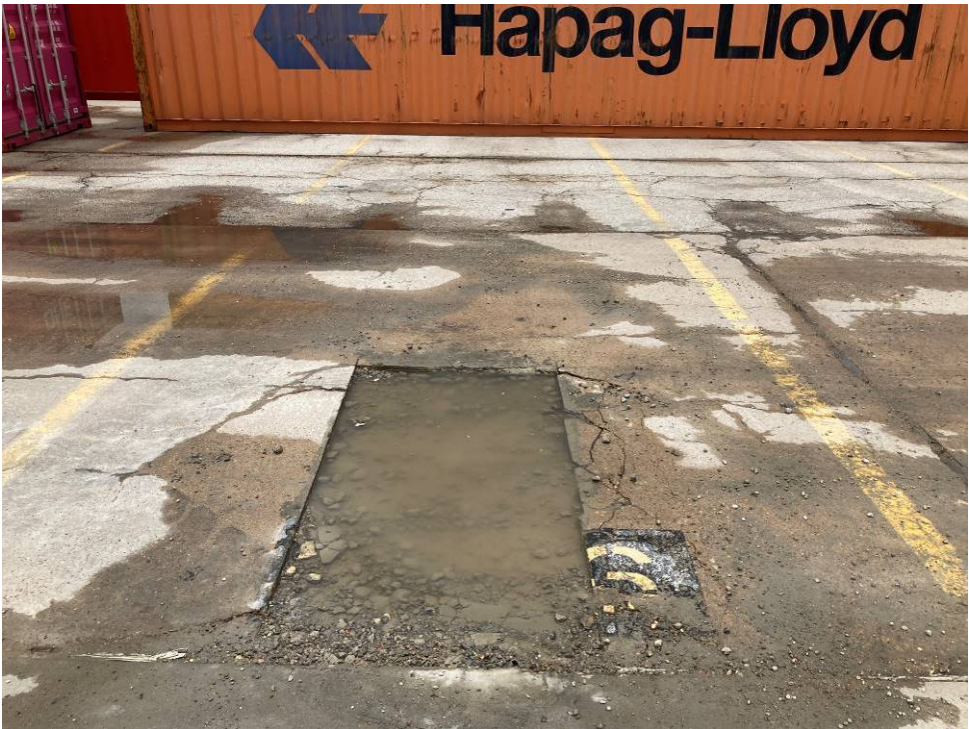
Description: Slot B096, no tar-like material seeps observed where test pit conducted (July 2020), test pit pavement damaged, water from recent rain event, looking northwest. Lat: 29.7842528 Long: - 95.3206250

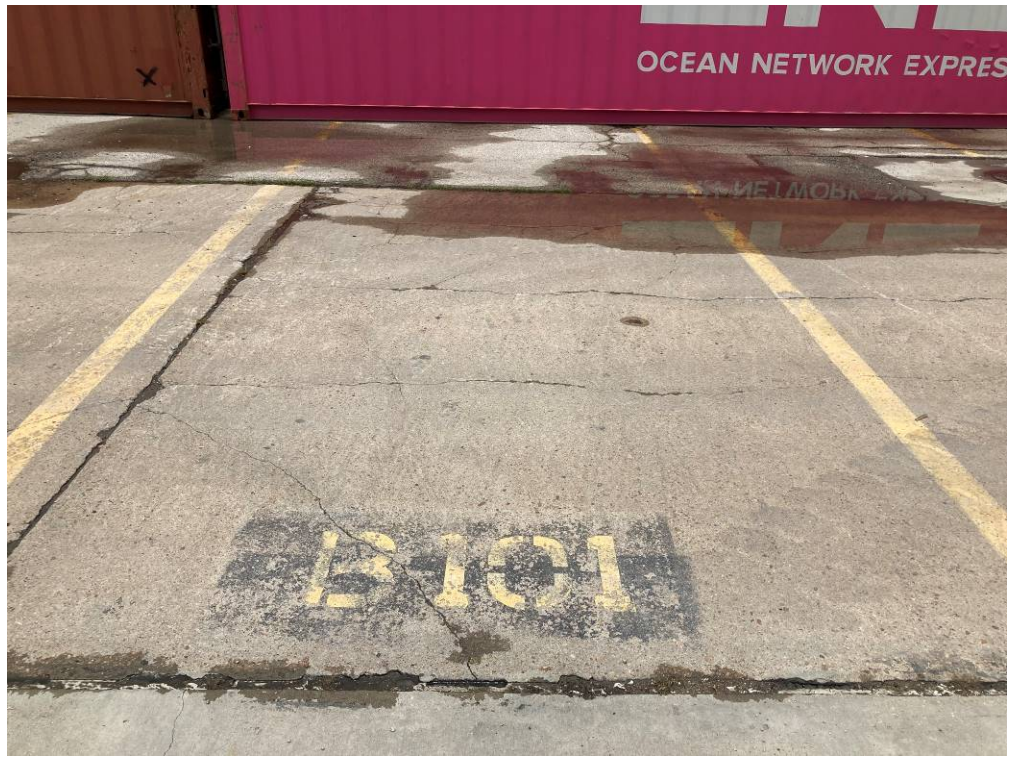
Photo No. 5	Date: 7/7/2021
Description: Slot B101, no tar-like material seeps observed, historical seep location covered by shipping container, water from recent rain event, looking northwest. Lat: 29.784275 Long: - 95.320813

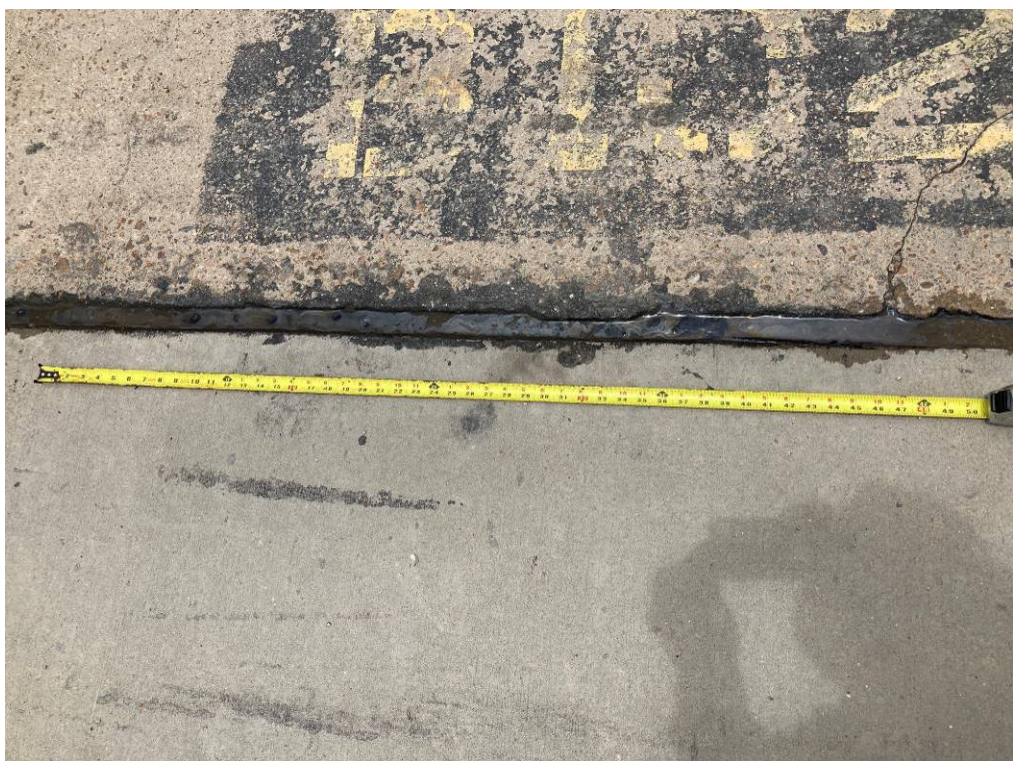
Photo No. 6	Date: 7/7/2021
Description: Slot B102, small amount of tar-like material seeping at pavement joint, material was removed, water from recent rain event. Lat: 29.7842203 Long: - 95.320827

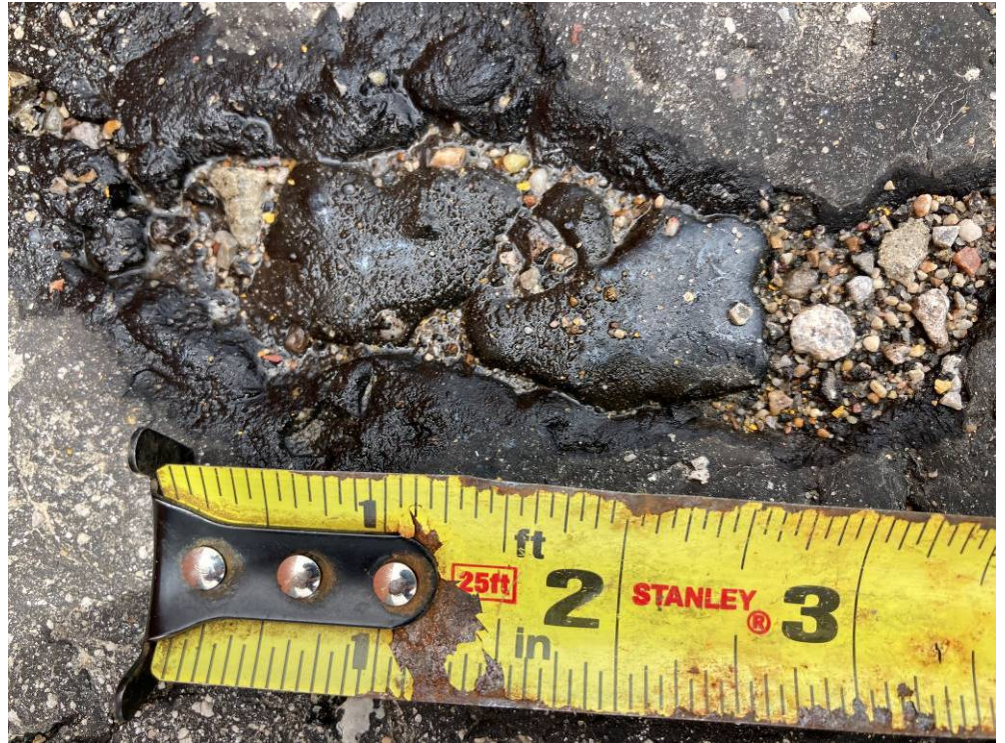
Photo No.
7

- A very small tar-like NAPL surface seep was observed near the NAPL Collection System area in stall B105 during two of the four inspections in July (July 7th and 29th) (Photo Nos. 7 and 37). For areas outside the NAPL Collection System, small amounts of tar-like material were observed on the concrete surface in stalls A022 and B102 during each inspection event in July. Tar-like material observed during the inspection events was recovered using a hand tool to scrape up the material. During July, the number of tar-like material seeps observed during inspections and the total amount of material removed from the concrete surface decreased compared to the June inspections. A total of approximately 1.2 gallons of tar-like material was recovered for the month and placed in a drum for disposal. The drum is staged at the Container Storage Area (CSA).

Slot B105, very small amount of tar-like material seeping at asphalt crack, material was removed.

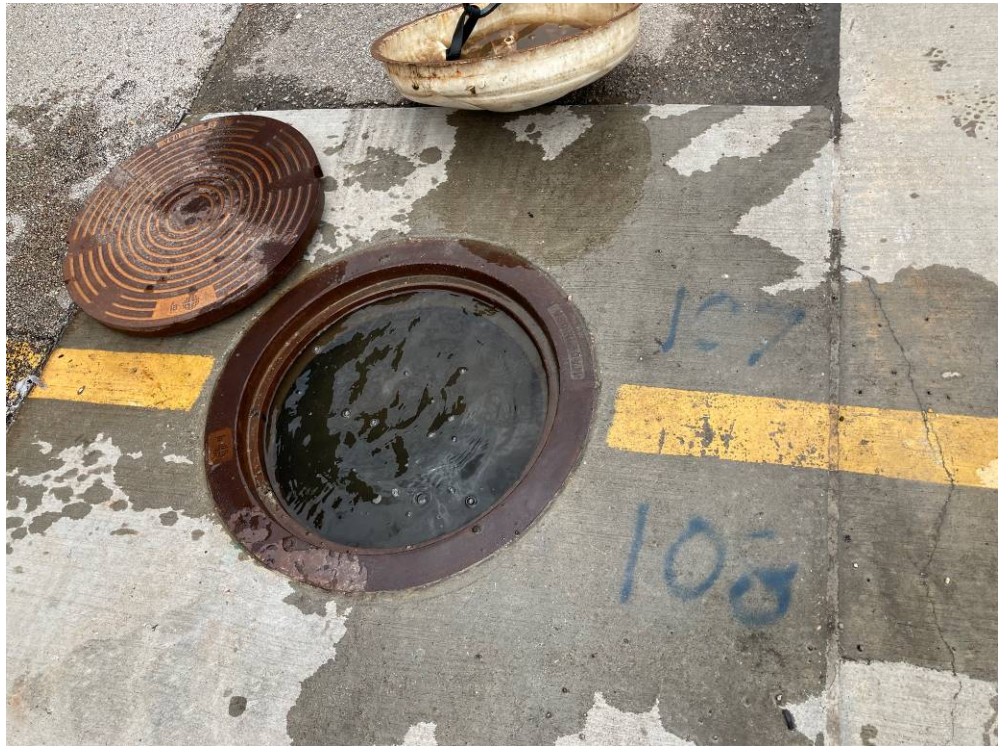
Photo No.
8

Sump 3 (B107/B108), 0 inches of freeboard in sump. No sheen or odors noted. No tar-like material recovered.

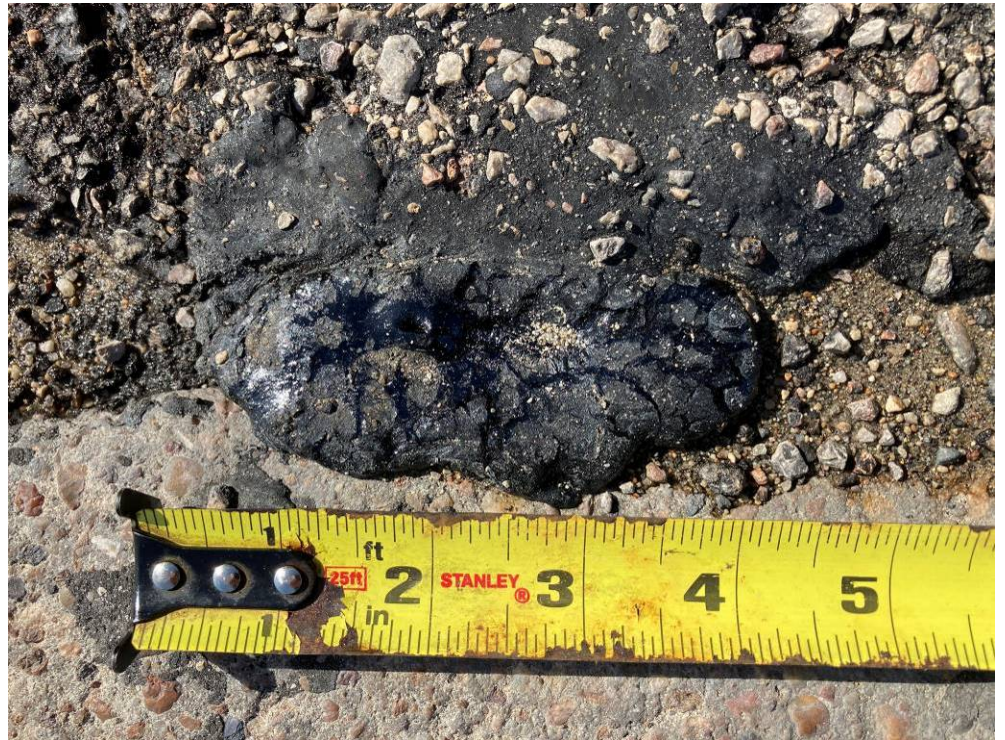
Photo No.
9

Slot A022, very small amount of tar-like material seeping at asphalt crack, material was removed.

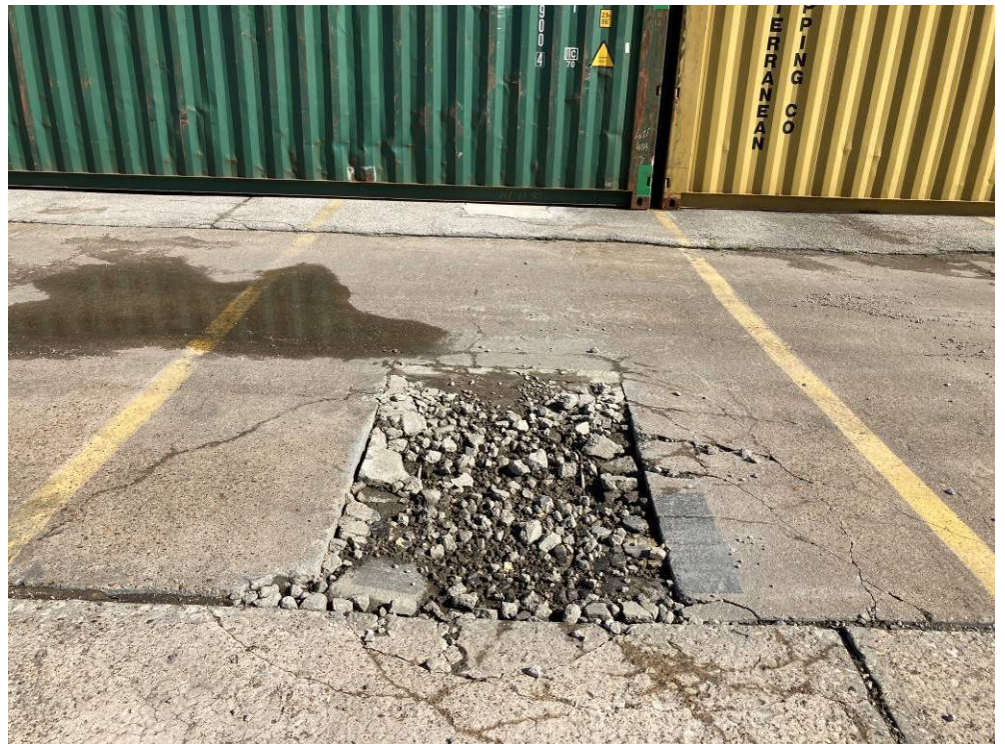
Photo No.
10

Slot B013, no tar-like material seeps observed where test pit conducted (July 2020), test pit pavement damaged, water from recent rain event, looking northwest.

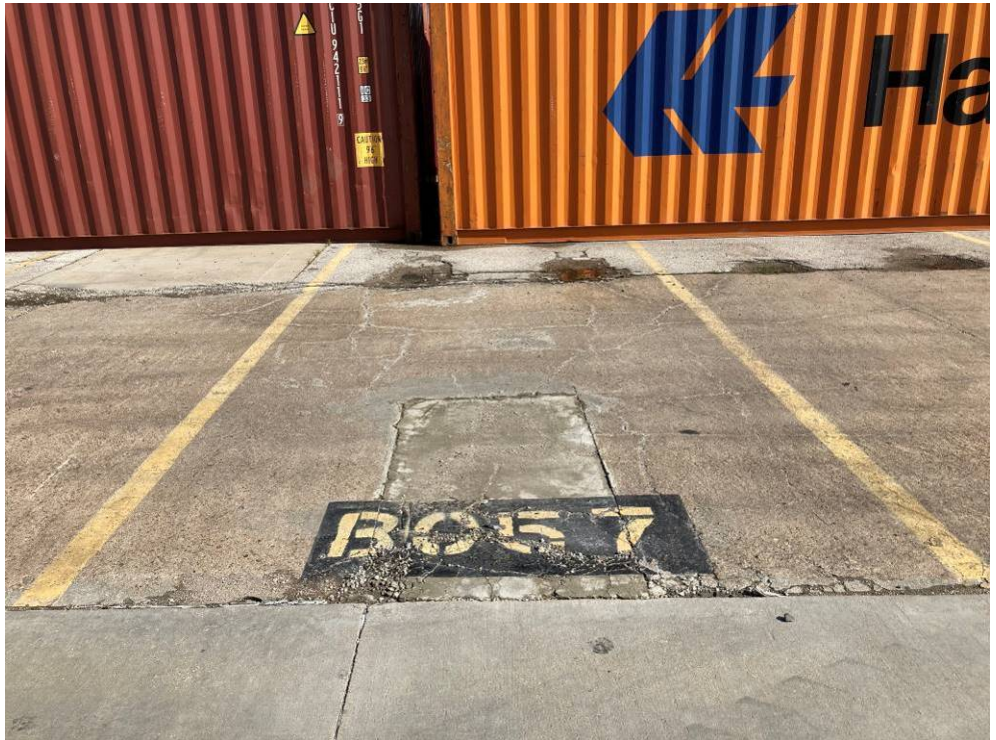
Photo No.
11

Slot B057, no tar-like material seeps observed where test pit conducted (July 2020), historical seep location covered by shipping container, test pit pavement damaged, water from recent rain event, looking northwest.

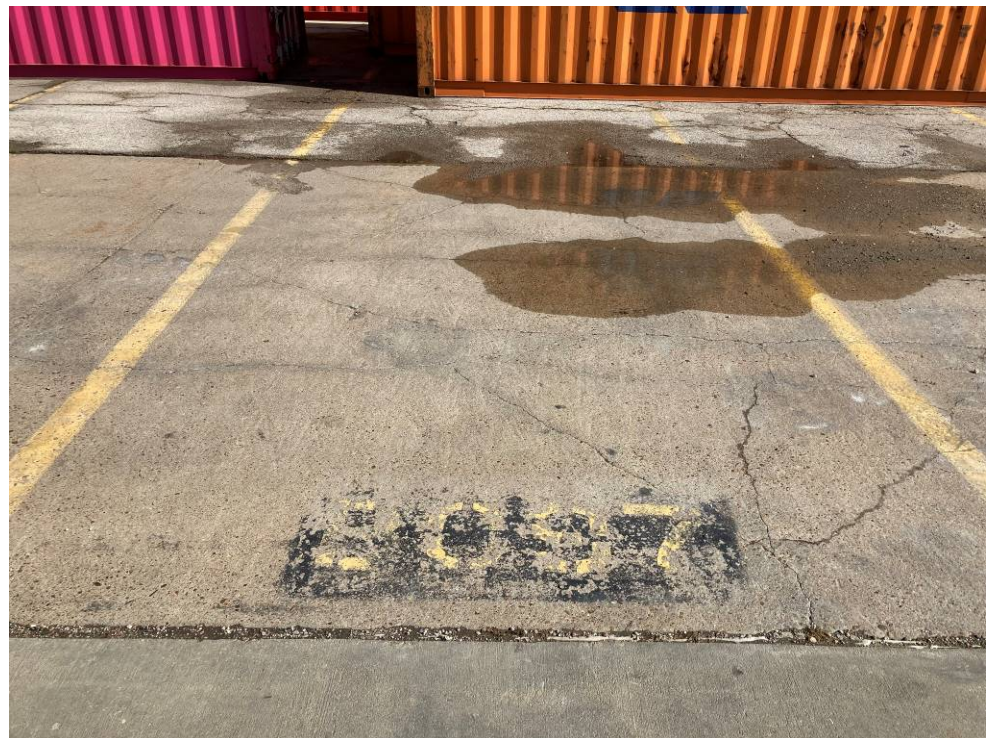
Photo No.
12

Slot B097, no brown staining observed, water from recent rain event, looking northwest.

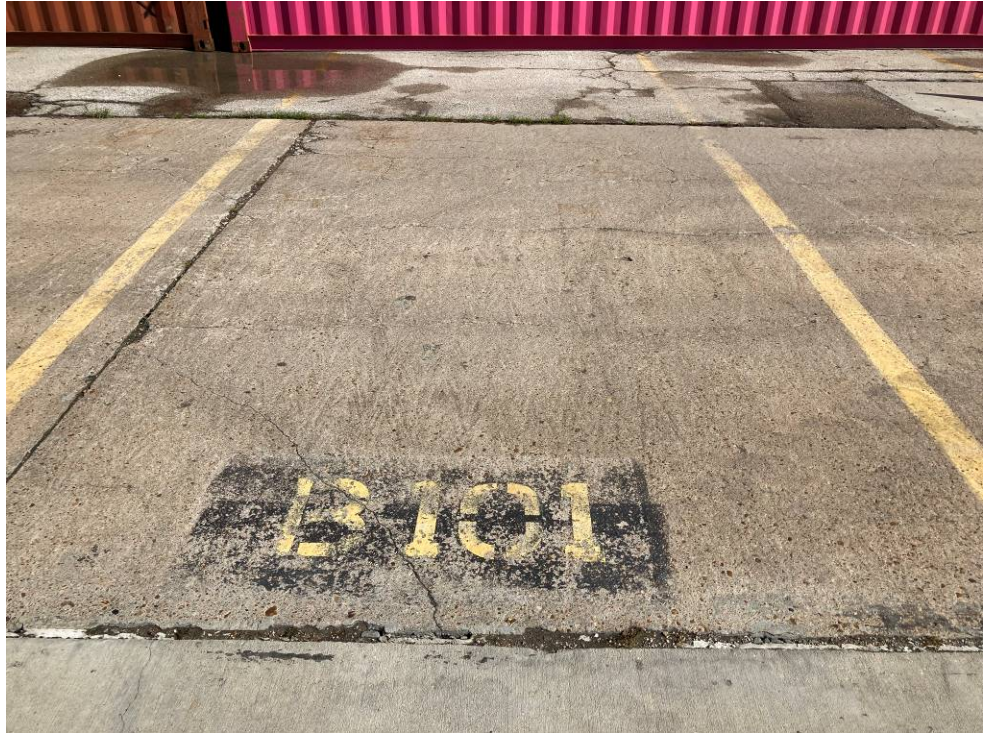
Photo No.
13

Slot B101, no tar-like material seeps observed, historical seep location covered by shipping container, water from recent rain event, looking northwest.

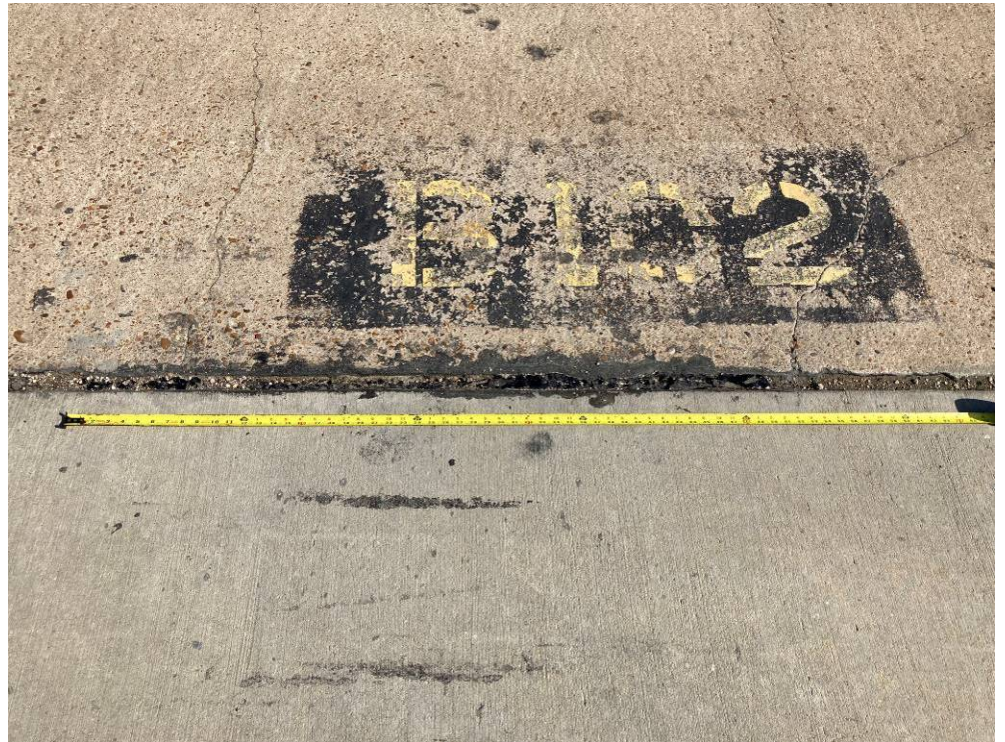
Photo No.
14

Slot B102, small amount of tar-like material seeping at pavement joint, material was removed.

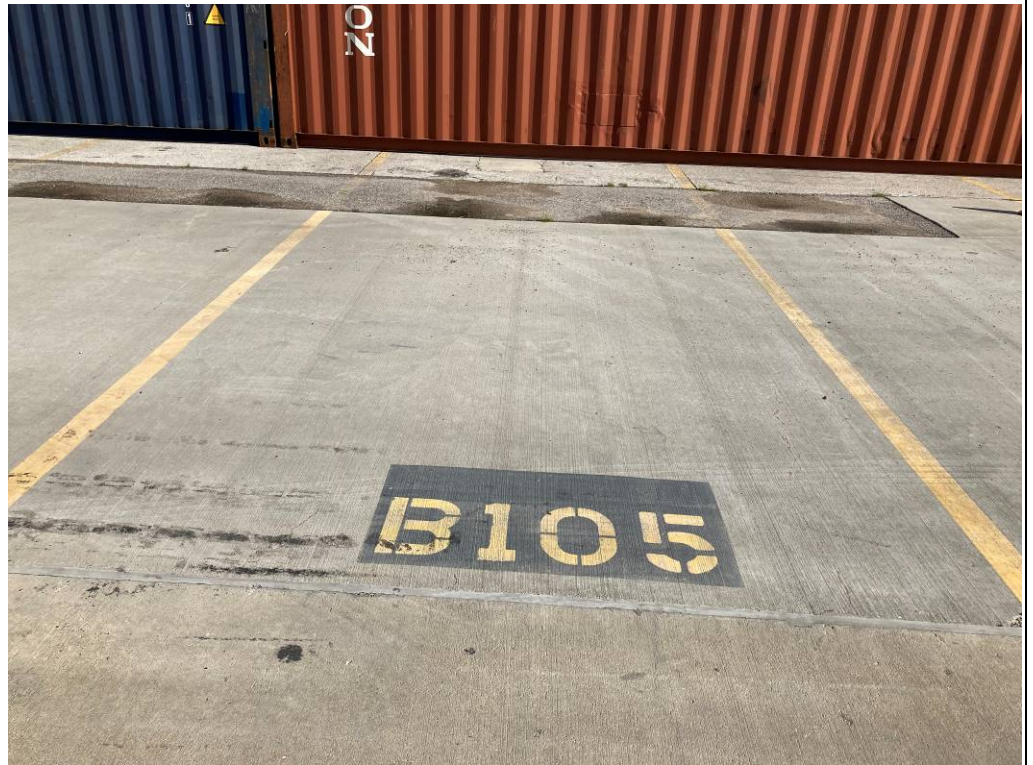
Photo No.
15

Slot B105, no tar-like material seeps observed, looking northwest.

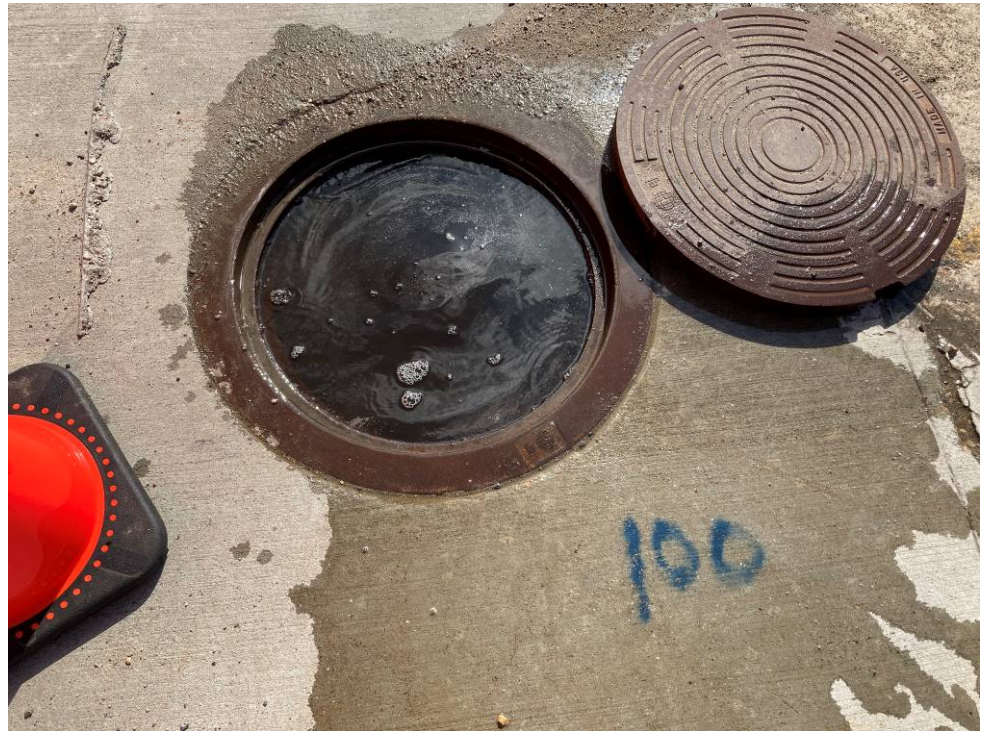
Photo No.
17

Sump 1 (B099/B100), prior to pump down event, 0 inches of freeboard in sump, no sheen or odor noted.

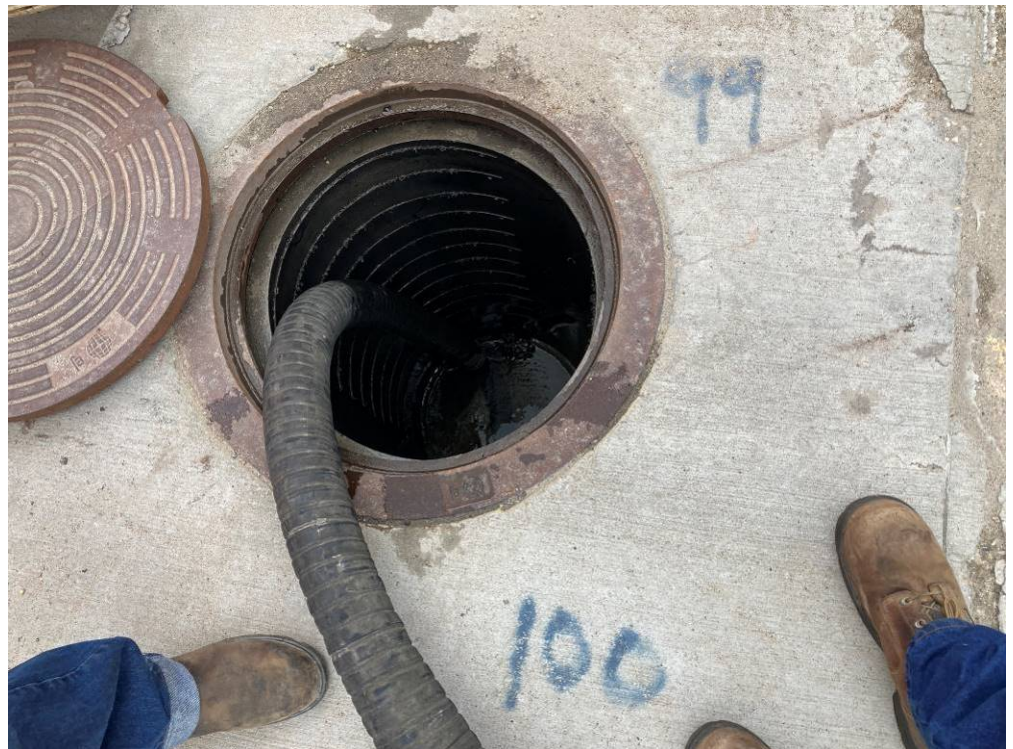
Photo No.
18

Sump 1 (B099/B100), emptied during pump down event, no sheen or odor noted.

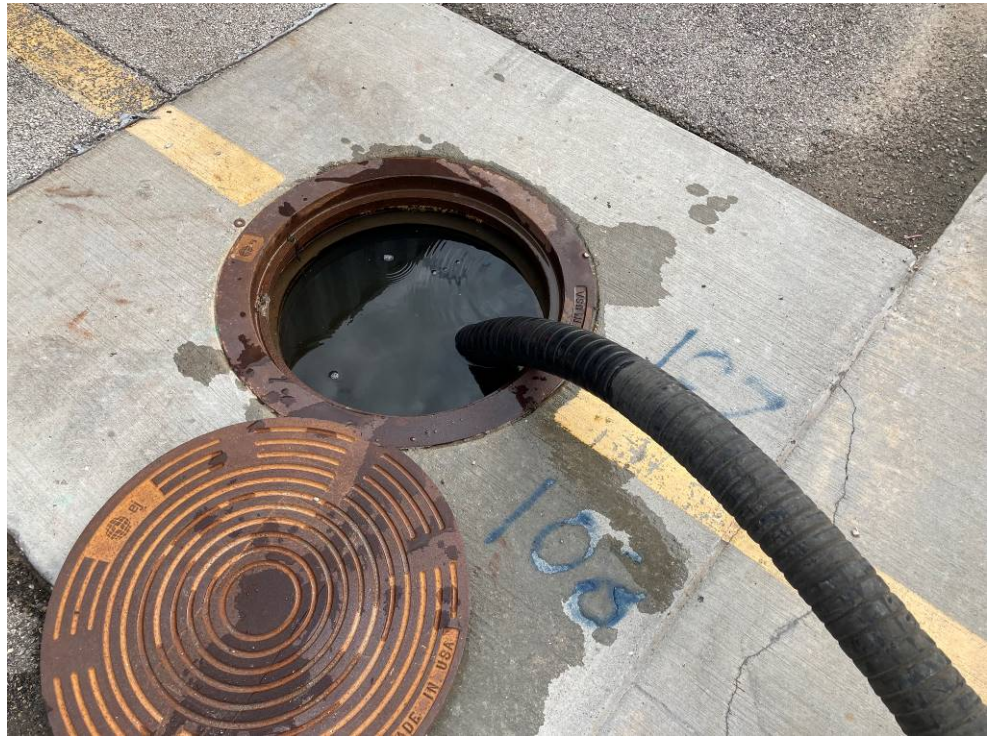
Photo No.
19

Sump 3 (B107/B108), at the start of the pump down event, 0 inch of freeboard in sump. No sheen, odors, or tar-like material noted.

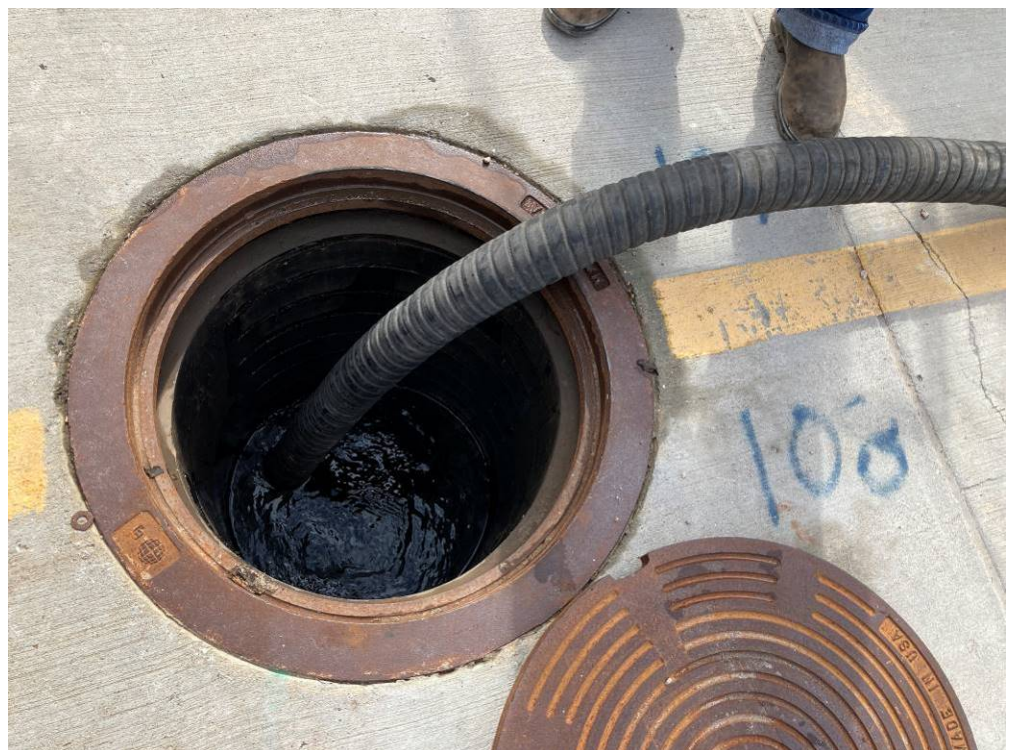
Photo No.
20

Sump 3 (B107/B108), during pump down event. No sheen, odors, or tar-like material noted.

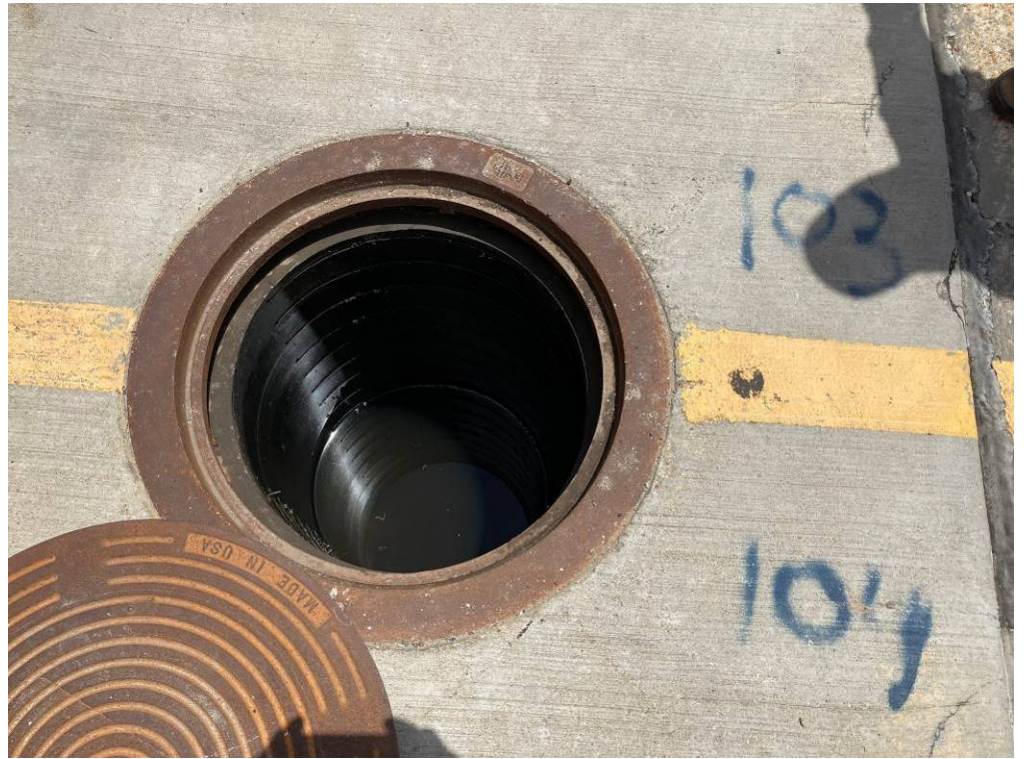
Photo No. 21	Date: 7/15/2021
Description: Sump 2 (B103/B104), during pump down event after removing water from Sump 3, no sheen or odors observed. Lat: 29.7842861 Long: - 95.3208611

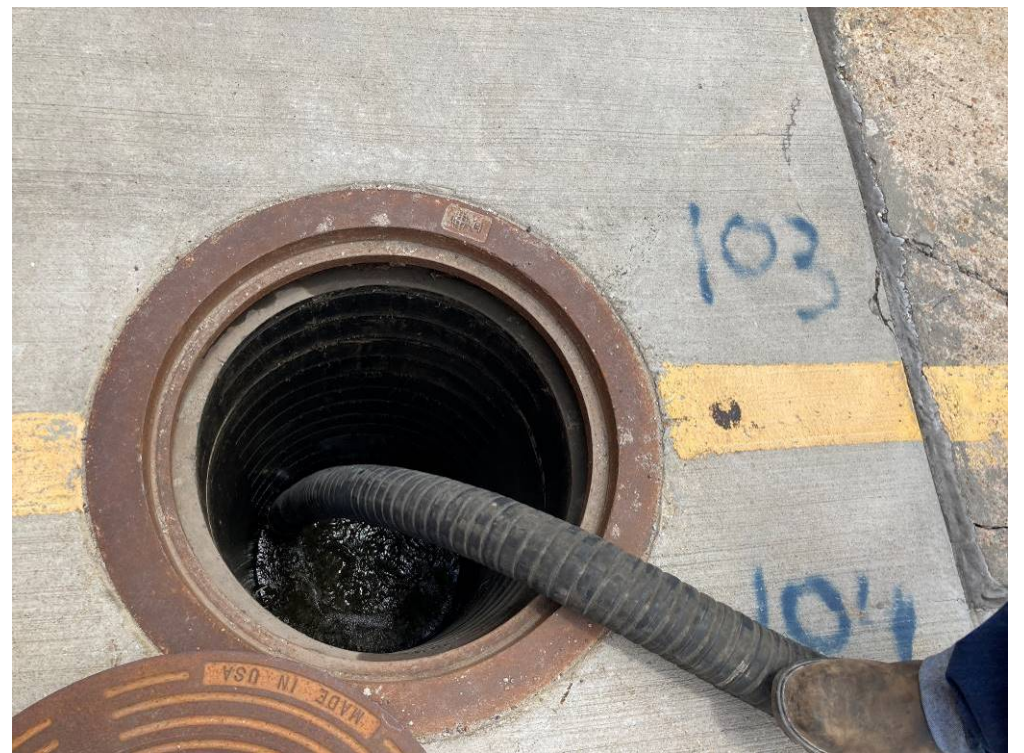
Photo No. 22	Date: 7/15/2021
Description: Sump 2 (B103/B104), water entering sump during pump down event, no sheen or odors observed. Lat: 29.7842861 Long: - 95.3208611

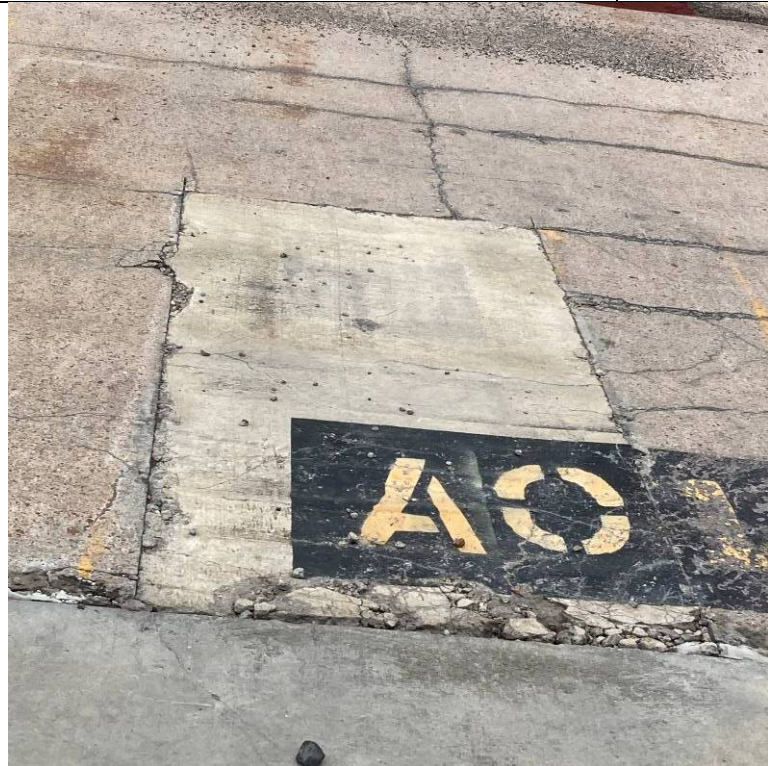
Photo No. 23	Date: 7/21/2021
-------------------------------	---------------------------

Slot A010, no tar-like material seeps observed where test pit conducted (July 2020), test pit pavement damaged.

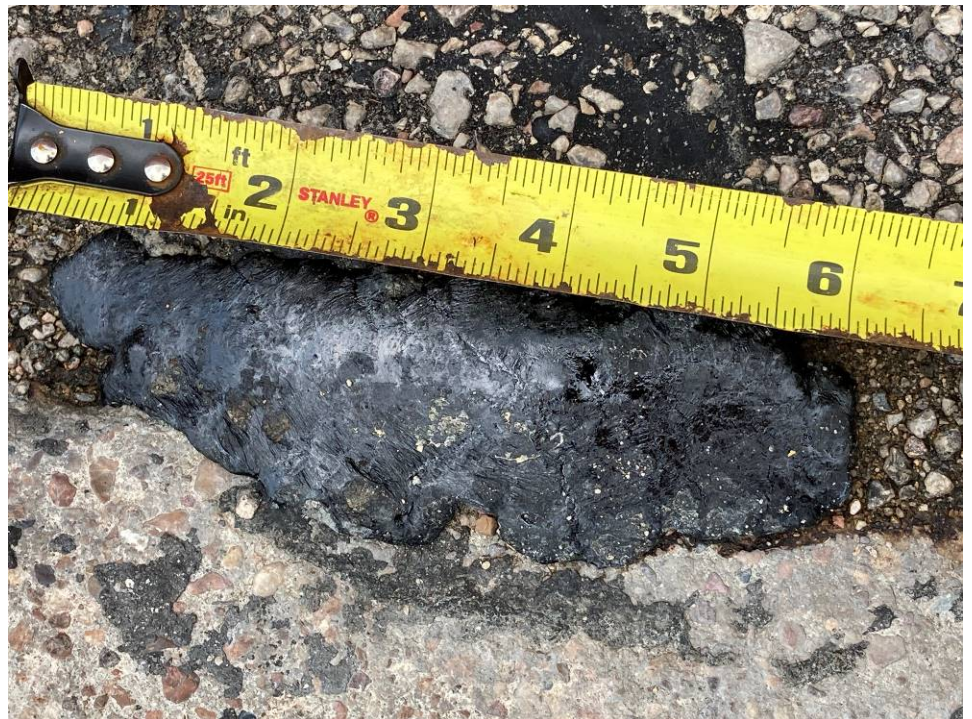
Photo No. 24	Date: 7/21/2021
-------------------------------	---------------------------

Slot A022, small amount of tar-like material seeping at asphalt crack, material was removed.

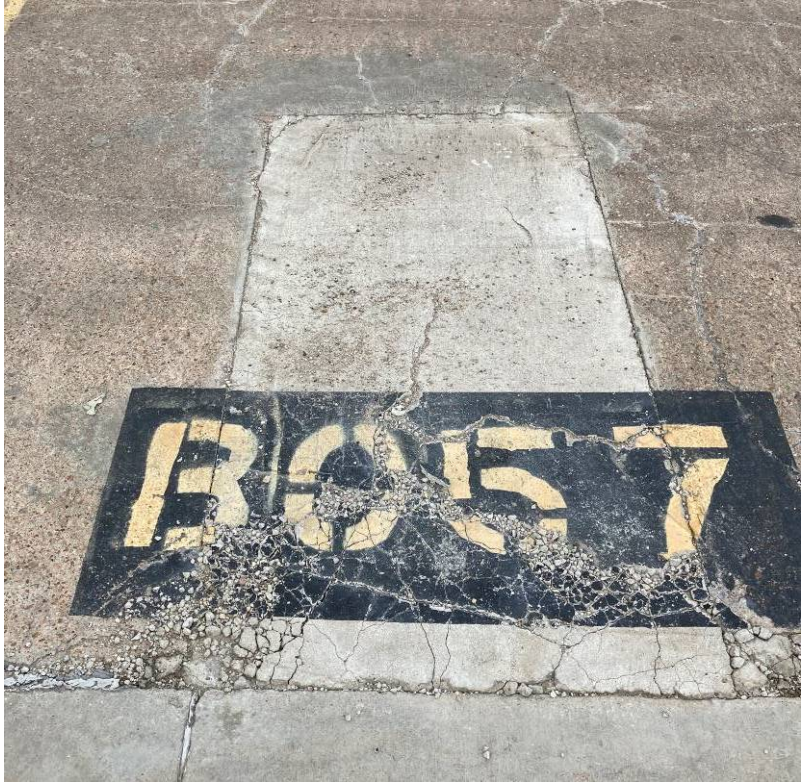
Photo No.
25

Slot B057, no tar-like material seeps observed where test pit conducted (July 2020), historical seep location covered by shipping container, test pit pavement damaged, looking northwest.

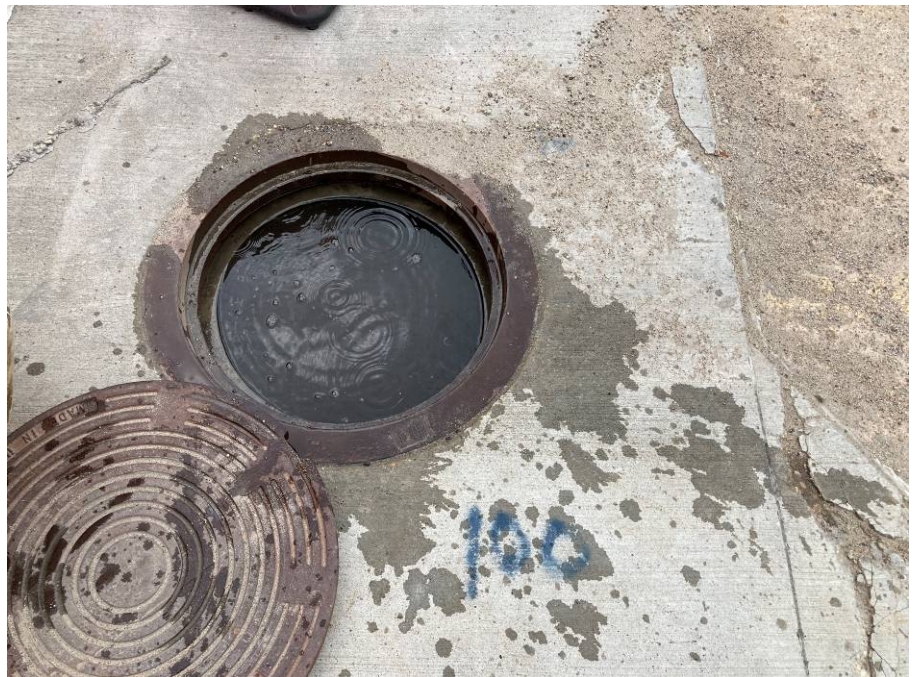
Photo No.
26

Sump 1 (B099/B100), 0 inches of freeboard in sump, no sheen or odor noted.

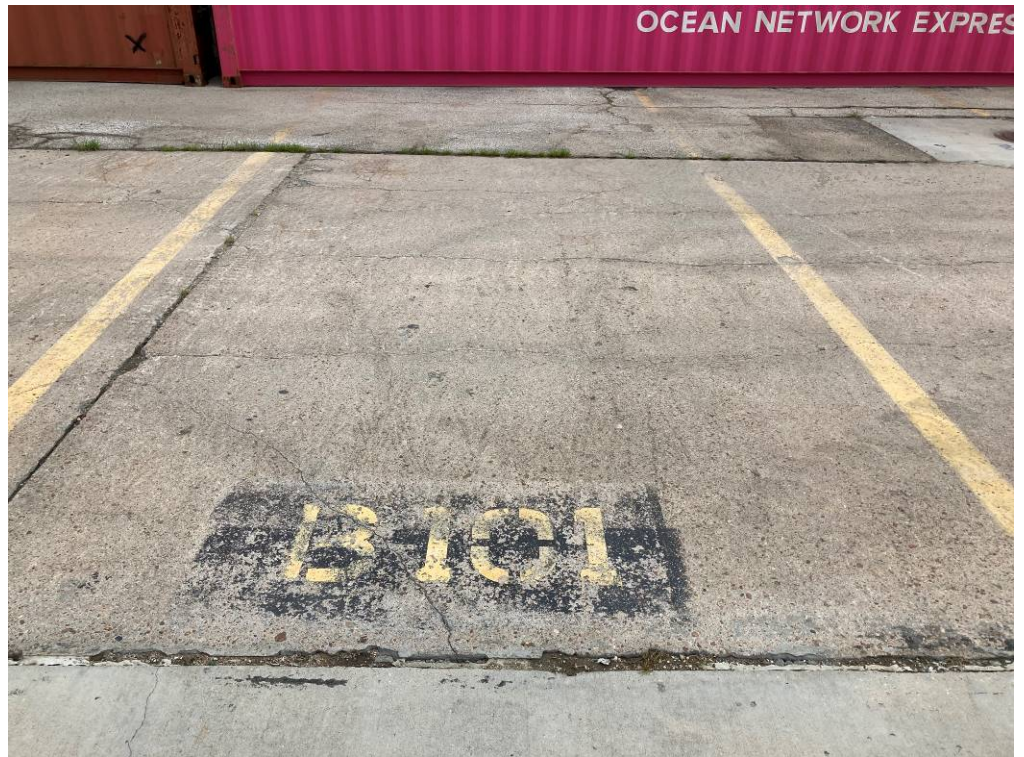
Photo No.
27

Slot B101, no tar-like material seeps observed, historical seep location covered by shipping container, looking northwest.

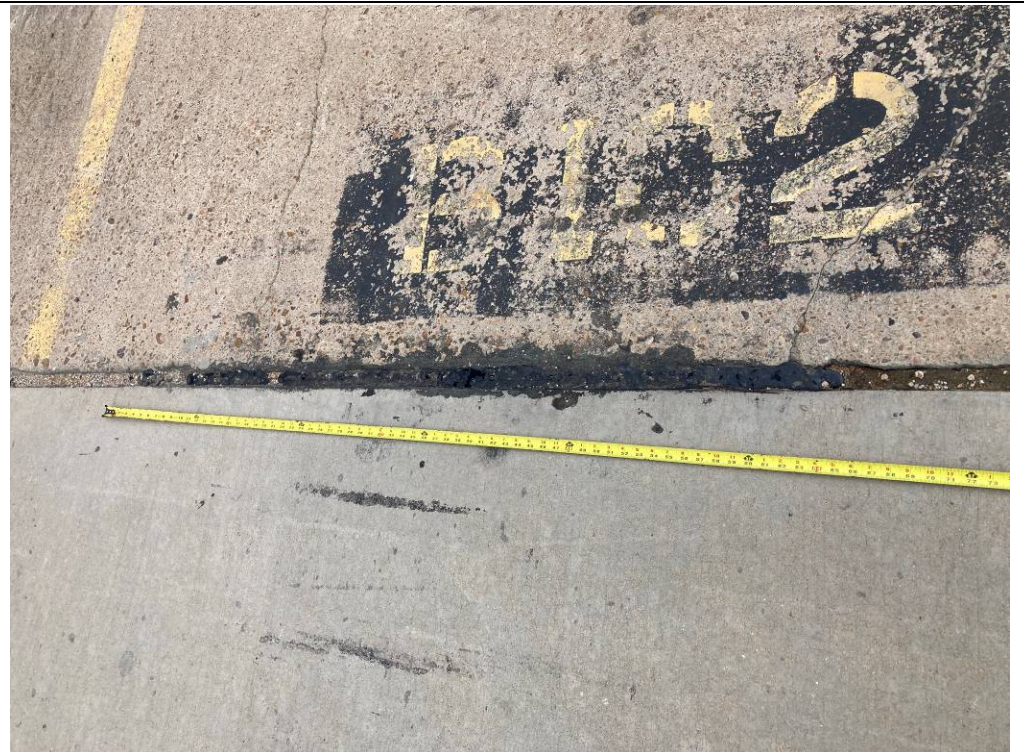
Photo No.
28

Slot B102, small amount of tar-like material seeping at pavement joint, material was removed.

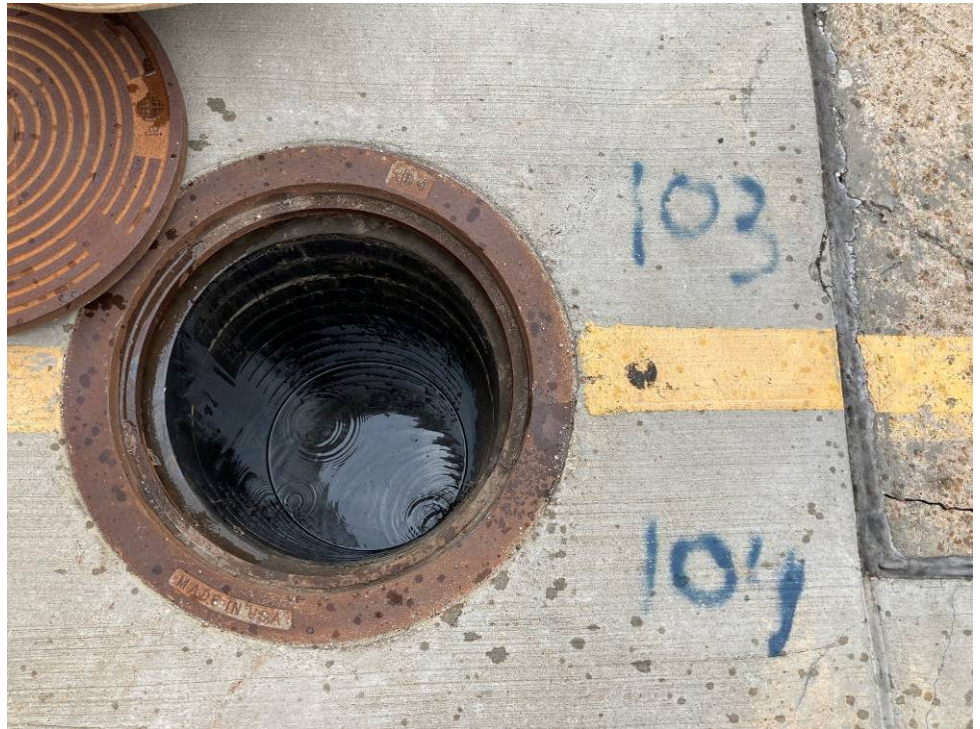
Photo No.
29

Sump 2 (B103/B104), 39 inches of freeboard in sump. No sheen or odors noted.

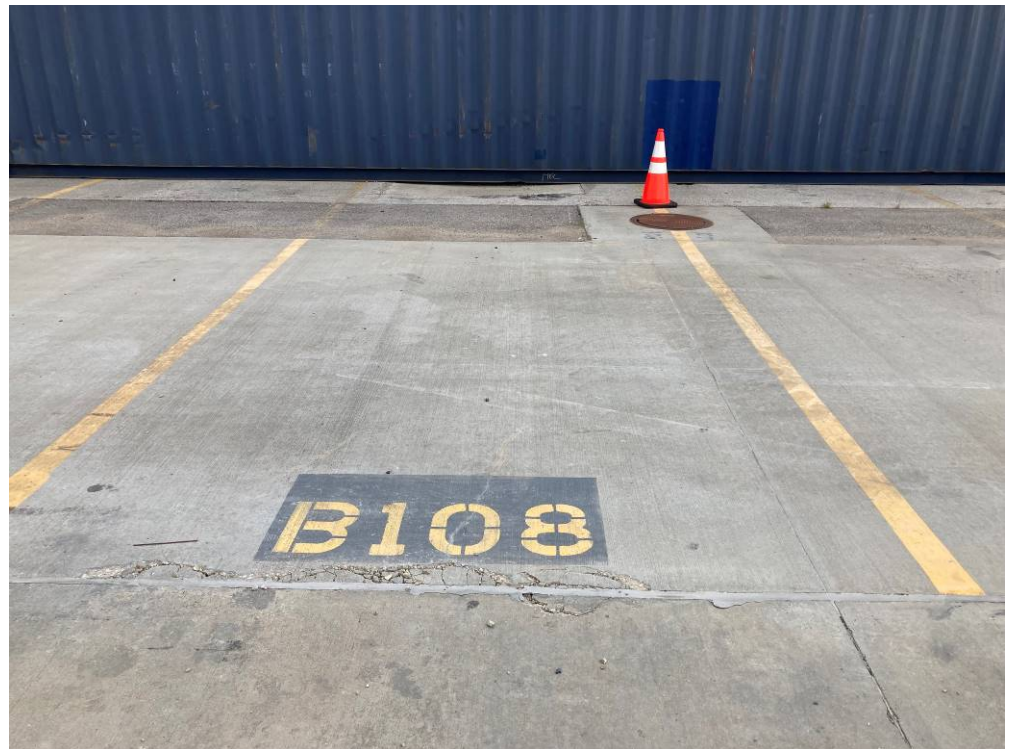
Photo No.
30

Slot B108, view of NAPL Collection System (Sump B107/B108 and test pit in background). No tar-like material seeps observed where test pit (July 2020) conducted, looking northwest.
