Project No. 19119232

Re: **MONTHLY STATUS UPDATE – ENGLEWOOD INTERMODAL YARD – NAPL COLLECTION SYSTEM/CONCRETE CAP REPAIRS
UNION PACIFIC RAILROAD HOUSTON WOOD PRESERVING WORKS FACILITY
4910 LIBERTY ROAD FACILITY, HOUSTON, TEXAS
POST-CLOSURE CARE PERMIT NO. HW-50343; INDUSTRIAL SWR NO. 31547**

Weekly Inspection Photolog

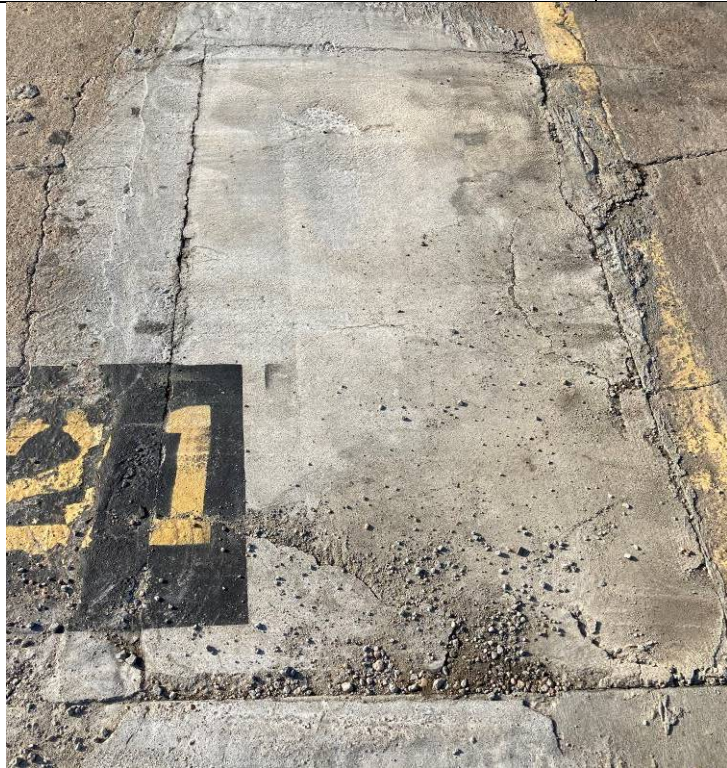
Photo No. 31	Date: 7/29/2021
Description: Slot A021, no tar-like material seeps observed where test pit conducted (July 2020), test pit pavement damaged. Lat: 29.785392, Long: -95.318655

- Golder, on behalf of UPRR, submitted to the TCEQ the Englewood IM Yard Test Pit Evaluation Report dated June 2, 2021 summarizing the findings from the test pits installed in July 2020 including weekly inspections since the installation. During the weekly inspections through July 2021, no NAPL seeps have been observed at the seven test pit locations (slots A010, A021, A098, B013, B057, B096, and B108). During the June 30, 2021 inspection, concrete patches covering test pits in slots B013 and B096 were observed to be damaged. During the July 7, 2021 inspection, concrete patches in slots A010 and B057 were observed to be damaged. The A021 concrete patch was observed to be damaged on July 29, 2021. UPRR will coordinate with a subcontractor to repair the concrete patches.

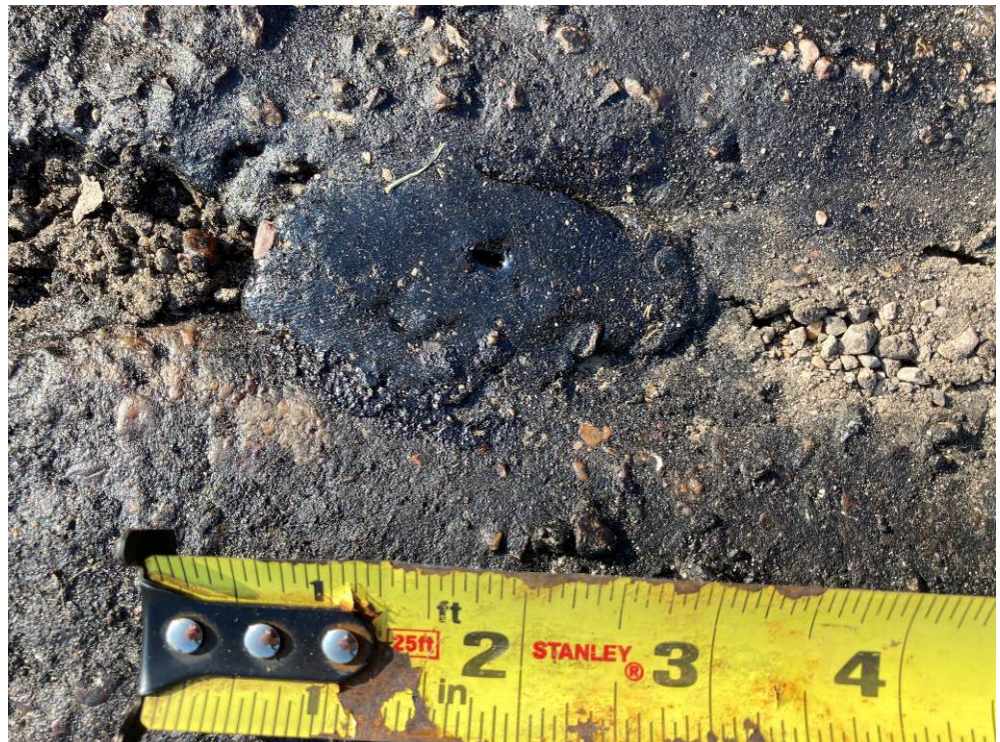
Photo No. 32	Date: 7/29/2021
Description: Slot A022, very small amount of tar-like material seeping at asphalt crack, material was removed. Lat: 29.785392, Long: -95.318655

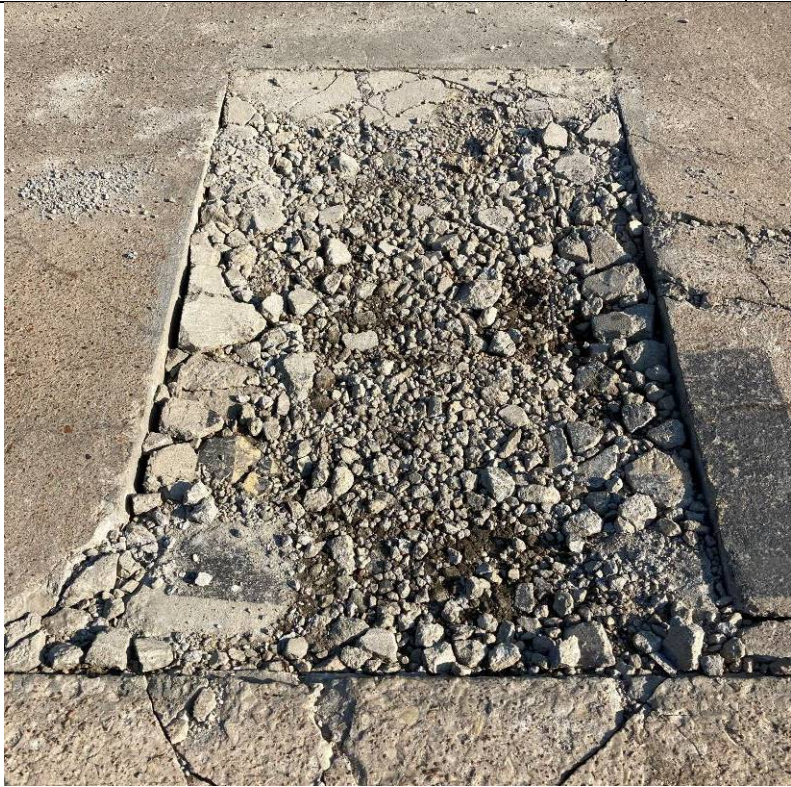
Photo No. 33	Date: 7/29/2021
Description Slot B013, no tar-like material seeps observed where test pit conducted (July 2020), test pit pavement damaged. Lat: 29.785217 Long: - 95.318261

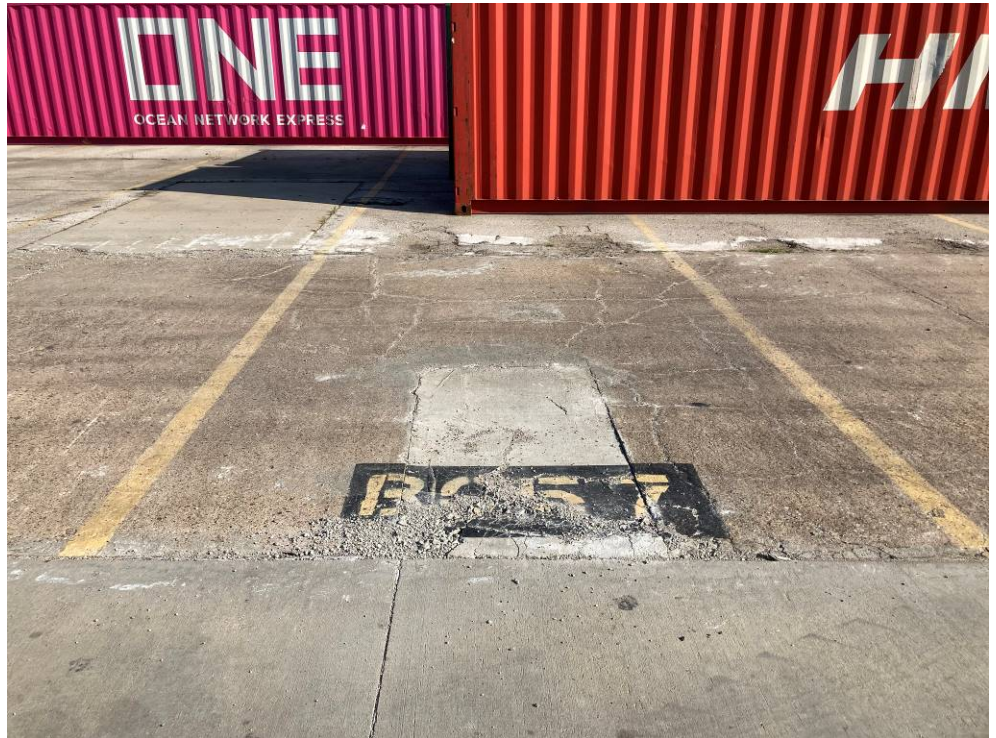
Photo No. 34	Date: 7/29/2021
Description: Slot B057, no tar-like material seeps observed where test pit conducted (July 2020), test pit pavement damaged. Lat: 29.7847472 Long: - 95.3195417

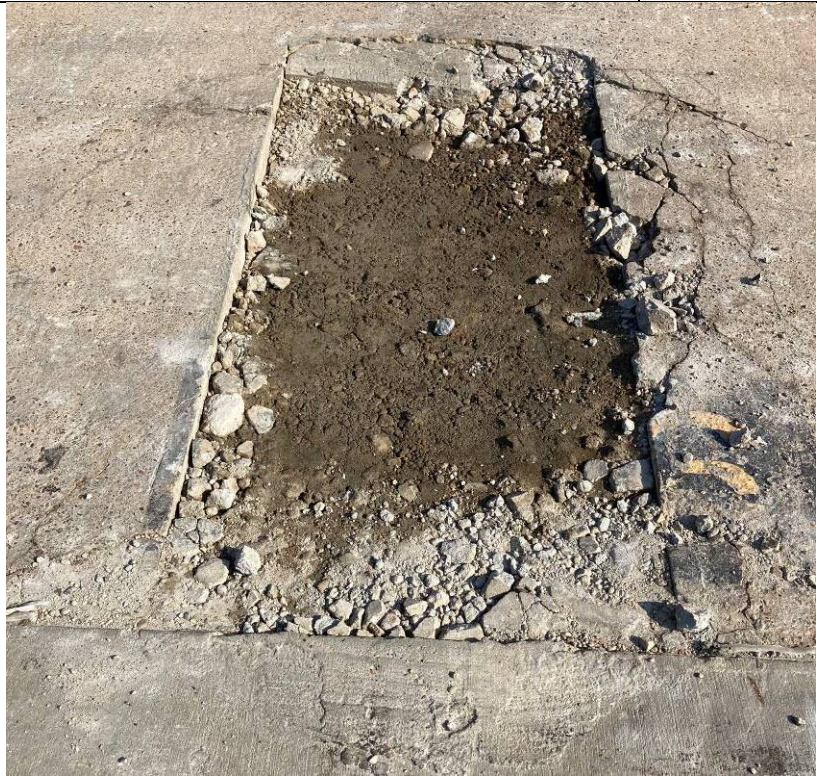
Photo No. 35	Date: 7/29/2021
-------------------------------	---------------------------

Slot B096, no tar-like material seeps observed where test pit conducted (July 2020), test pit pavement damaged.

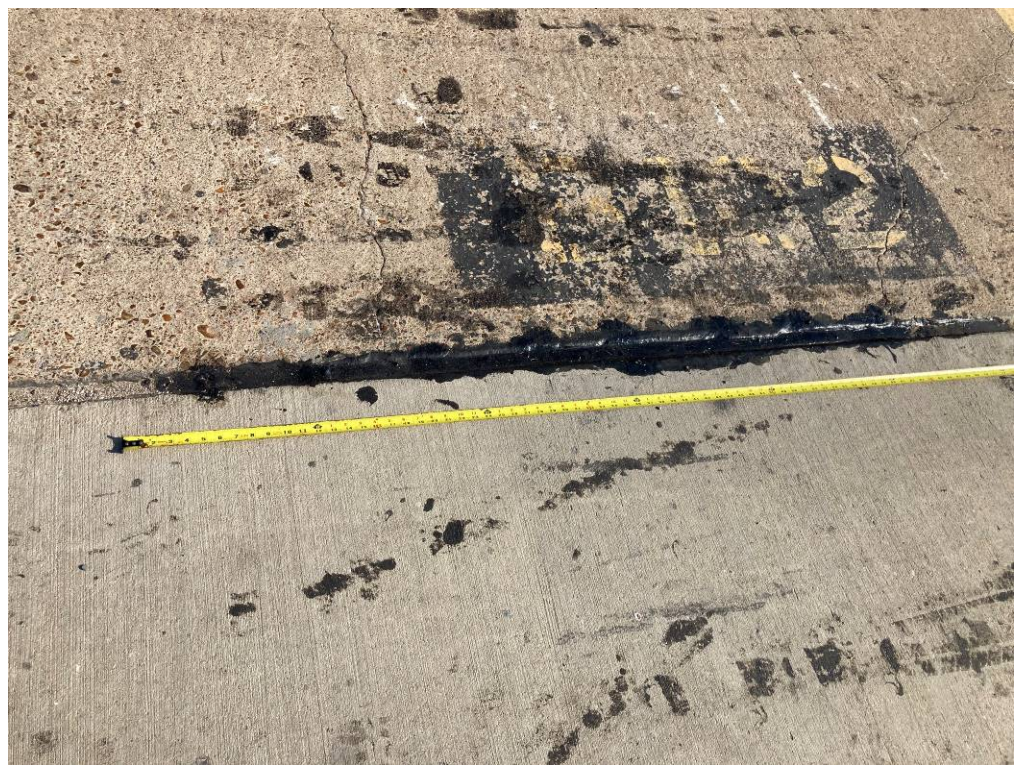
Photo No. 36	Date: 7/29/2021
-------------------------------	---------------------------

Slot B102, small amount of tar-like material seeping at pavement joint, material was removed.

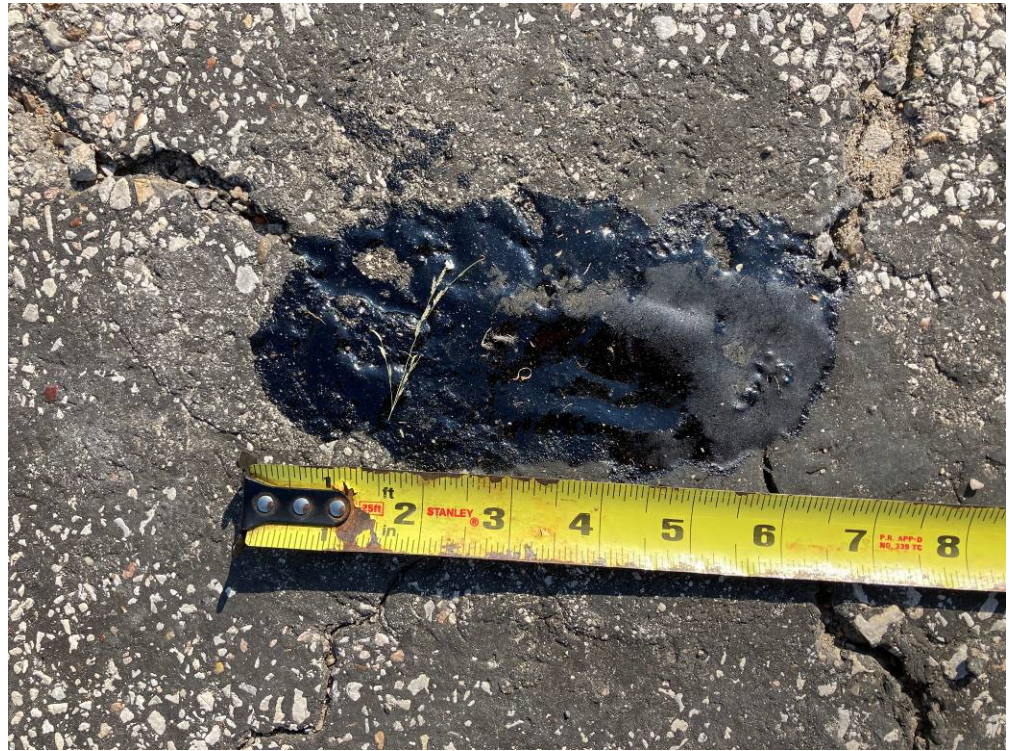
- A very small tar-like NAPL surface seep was observed near the NAPL Collection System area in stall B105 during two of the four inspections in July (July 7th and 29th) (Photo Nos. 7 and 37). For areas outside the NAPL Collection System, small amounts of tar-like material were observed on the concrete surface in stalls A022 and B102 during each inspection event in July. Tar-like material observed during the inspection events was recovered using a hand tool to scrape up the material. During July, the number of tar-like material seeps observed during inspections and the total amount of material removed from the concrete surface decreased compared to the June inspections. A total of approximately 1.2 gallons of tar-like material was recovered for the month and placed in a drum for disposal. The drum is staged at the Container Storage Area (CSA).

Photo No. 37	Date: 7/29/2021
Description: Slot B105, small amount of tar-like material observed seeping observed at asphalt crack, material was removed. Lat: 29.7841472 Long: - 95.3208777

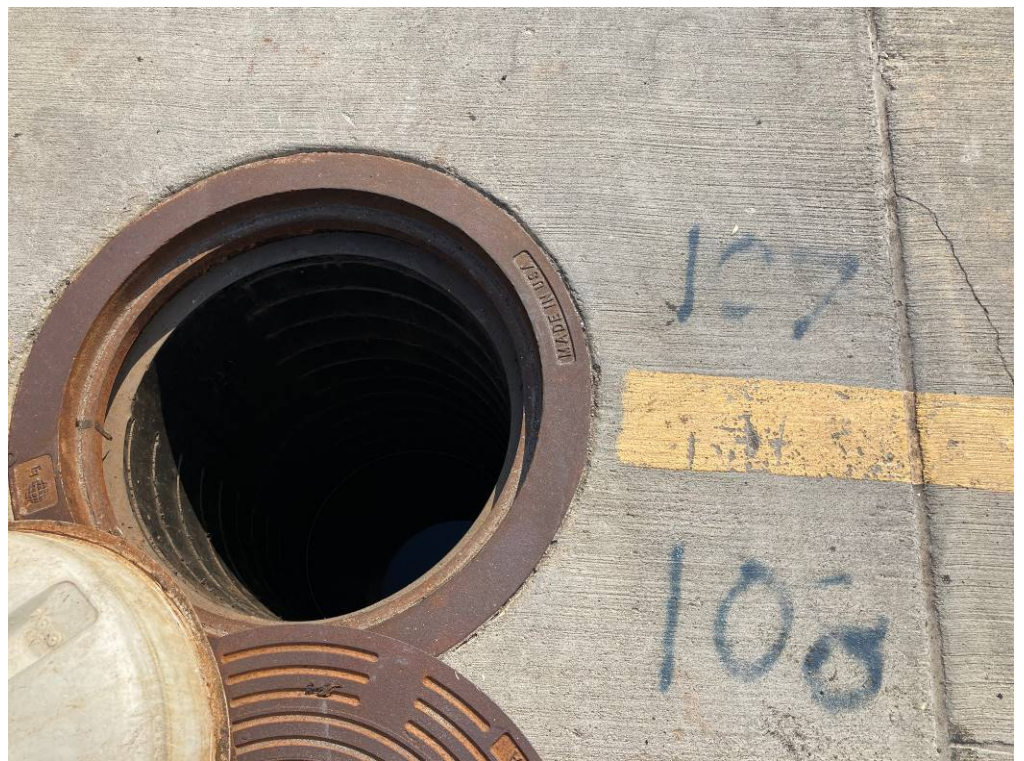
Photo No. 38	Date: 7/29/2021
Description: Sump 3 (B107/B108), 35.5 inches of freeboard in sump. No sheen or odors noted. No tar-like material recovered. Lat: 29.7842861 Long: - 95.3208611
